K-PA-0002
March 10, 1965

SA-9/APOLLO

FIRING TEST REPORT

Saturn I, 1B Test & Systems
Engineering Office
John F. Kennedy Space Center, NASA

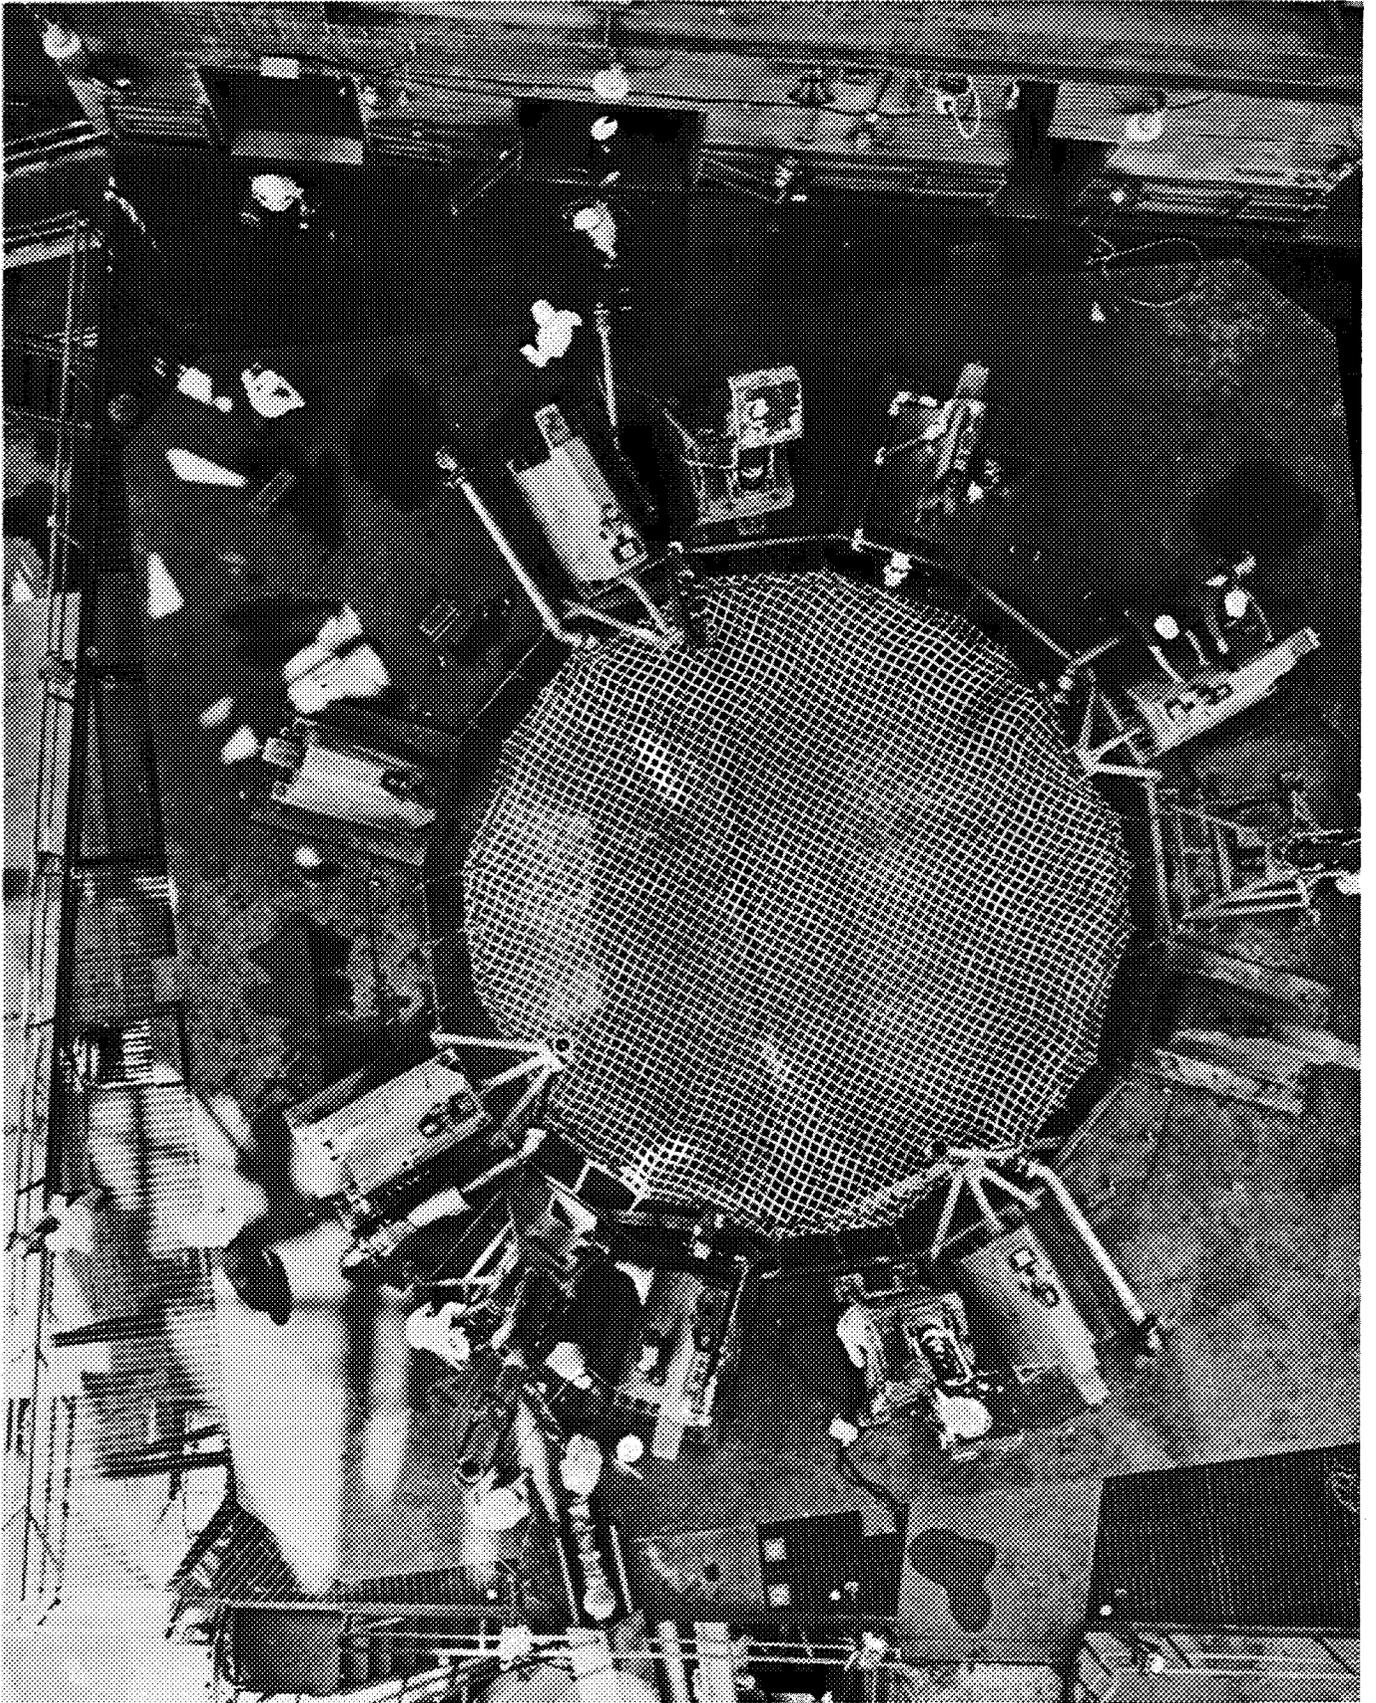
Figure 3. Launcher Deck.

b. No significant damage was noted to the launcher, engine service platform, or main structures of the firing accessories. However, equipment and surfaces above and beneath the launcher were scorched and electrical cables, pneumatic flex lines, water quench hoses, cryogenic flex lines and bellows, and fuel flex hoses were burned beyond repair, figures 3 through 13. Damage to the LOX transfer line and LOX replenish installation atop the launcher was limited to burned flex hoses on the LOX mast and burned flex bellows on the LOX replenish coupler. The flexible elbow at the base of the LOX mast and the flex hose at the LOX replenish coupler, having been covered with blast resistant material, revealed no exterior blast or fire damage. The controlled flexing joints in the LOX replenish installation were sound and appeared to be reusable. The holddown arms received no appreciable damage.
