**S-IVB/V AUXILIARY PROPULSION
SYSTEM 90-DAY RECYCLE
CAPABILITY TEST REPORT,
MODULE I**

**DAC-56728
FEBRUARY 1969**

**PREPARED BY:
MCDONNELL DOUGLAS ASTRONAUTICS COMPANY
WESTERN DIVISION
SATURN S-IVB TEST PLANNING
AND EVALUATION COMMITTEE**

**PREPARED FOR:
NATIONAL AERONAUTICS AND
SPACE ADMINISTRATION
UNDER NASA CONTRACT NAS7-101
MODEL DSV-4B**

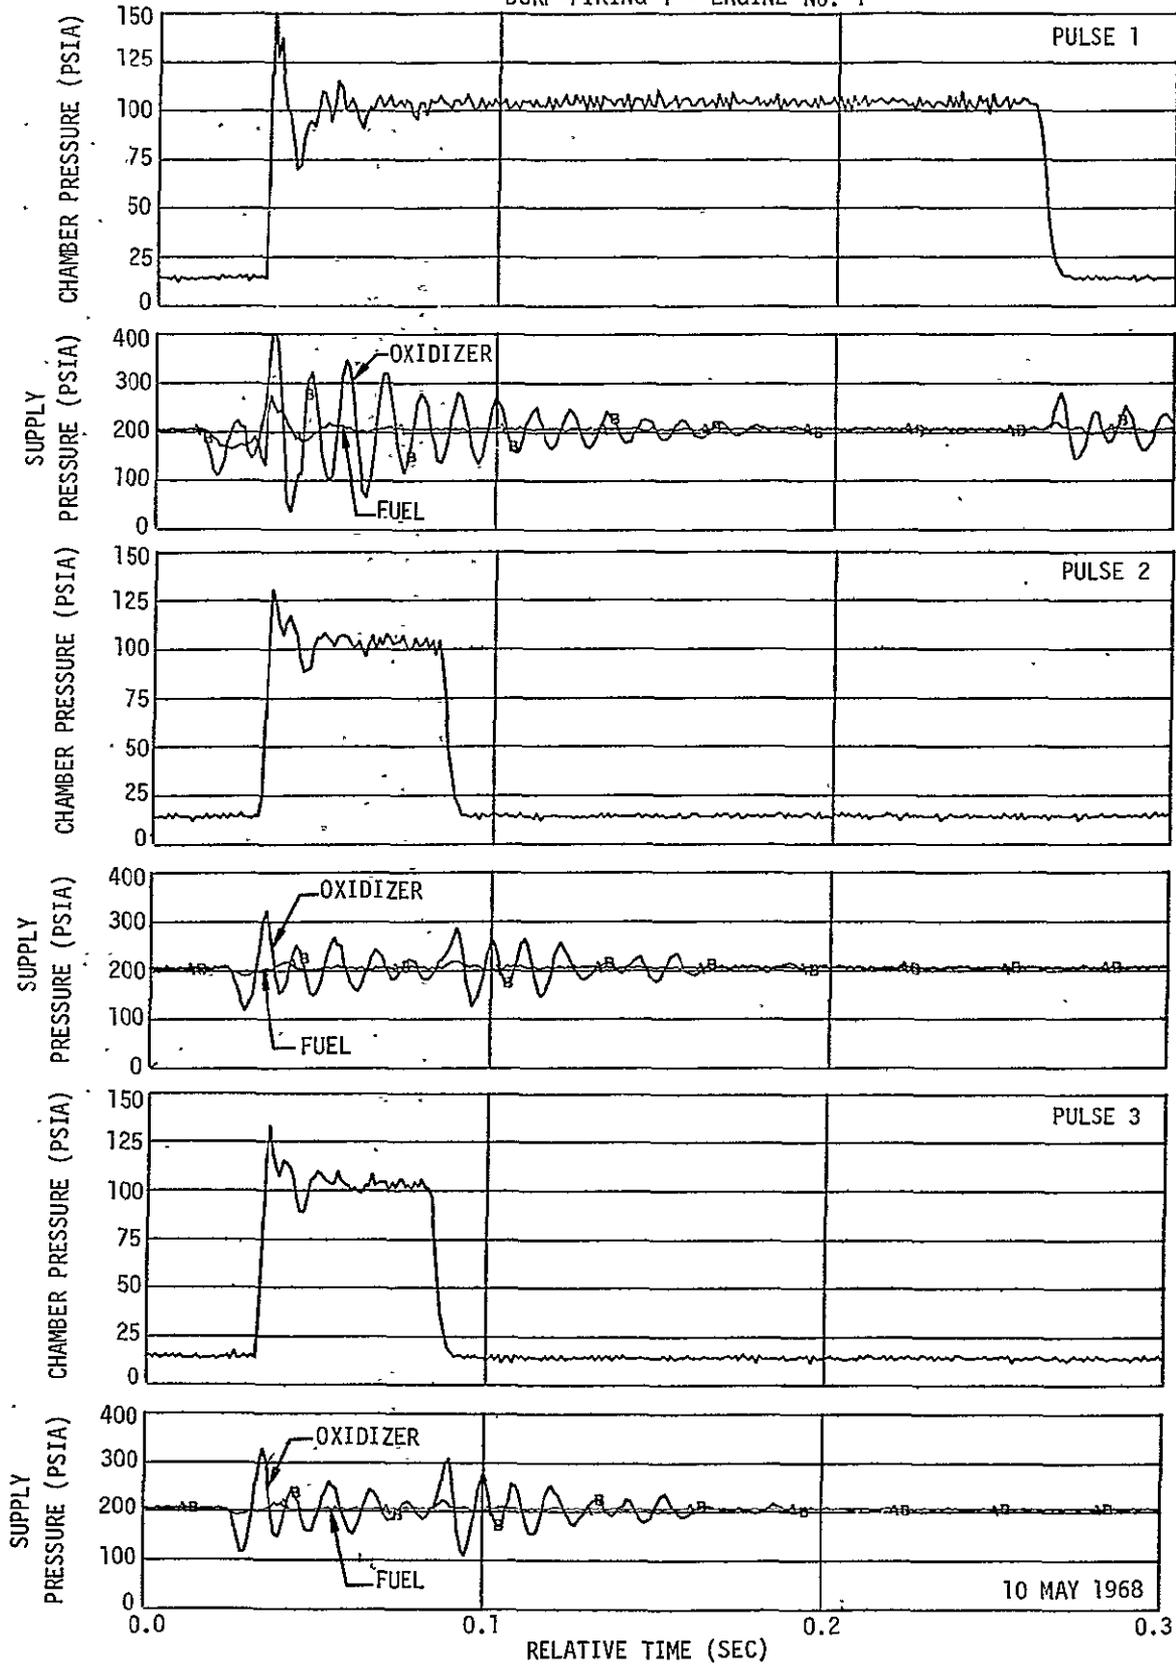
Figure 5-4. Chamber Pressure Levels (Sheet 1 of 24)

During the extended hold test, APS engines 1 and 3 exhibited a significant degradation of chamber pressure while being burp-fired. The ullage engine (No. 4) performed satisfactorily. Investigation indicated a high probability of a restriction of oxidizer flow in the injector tube inlets, injector tubes, and injectors. Supplementary testing results indicated the anomaly to be directly related to firing the engines for short times at sea-level, with an extended hold between firings.

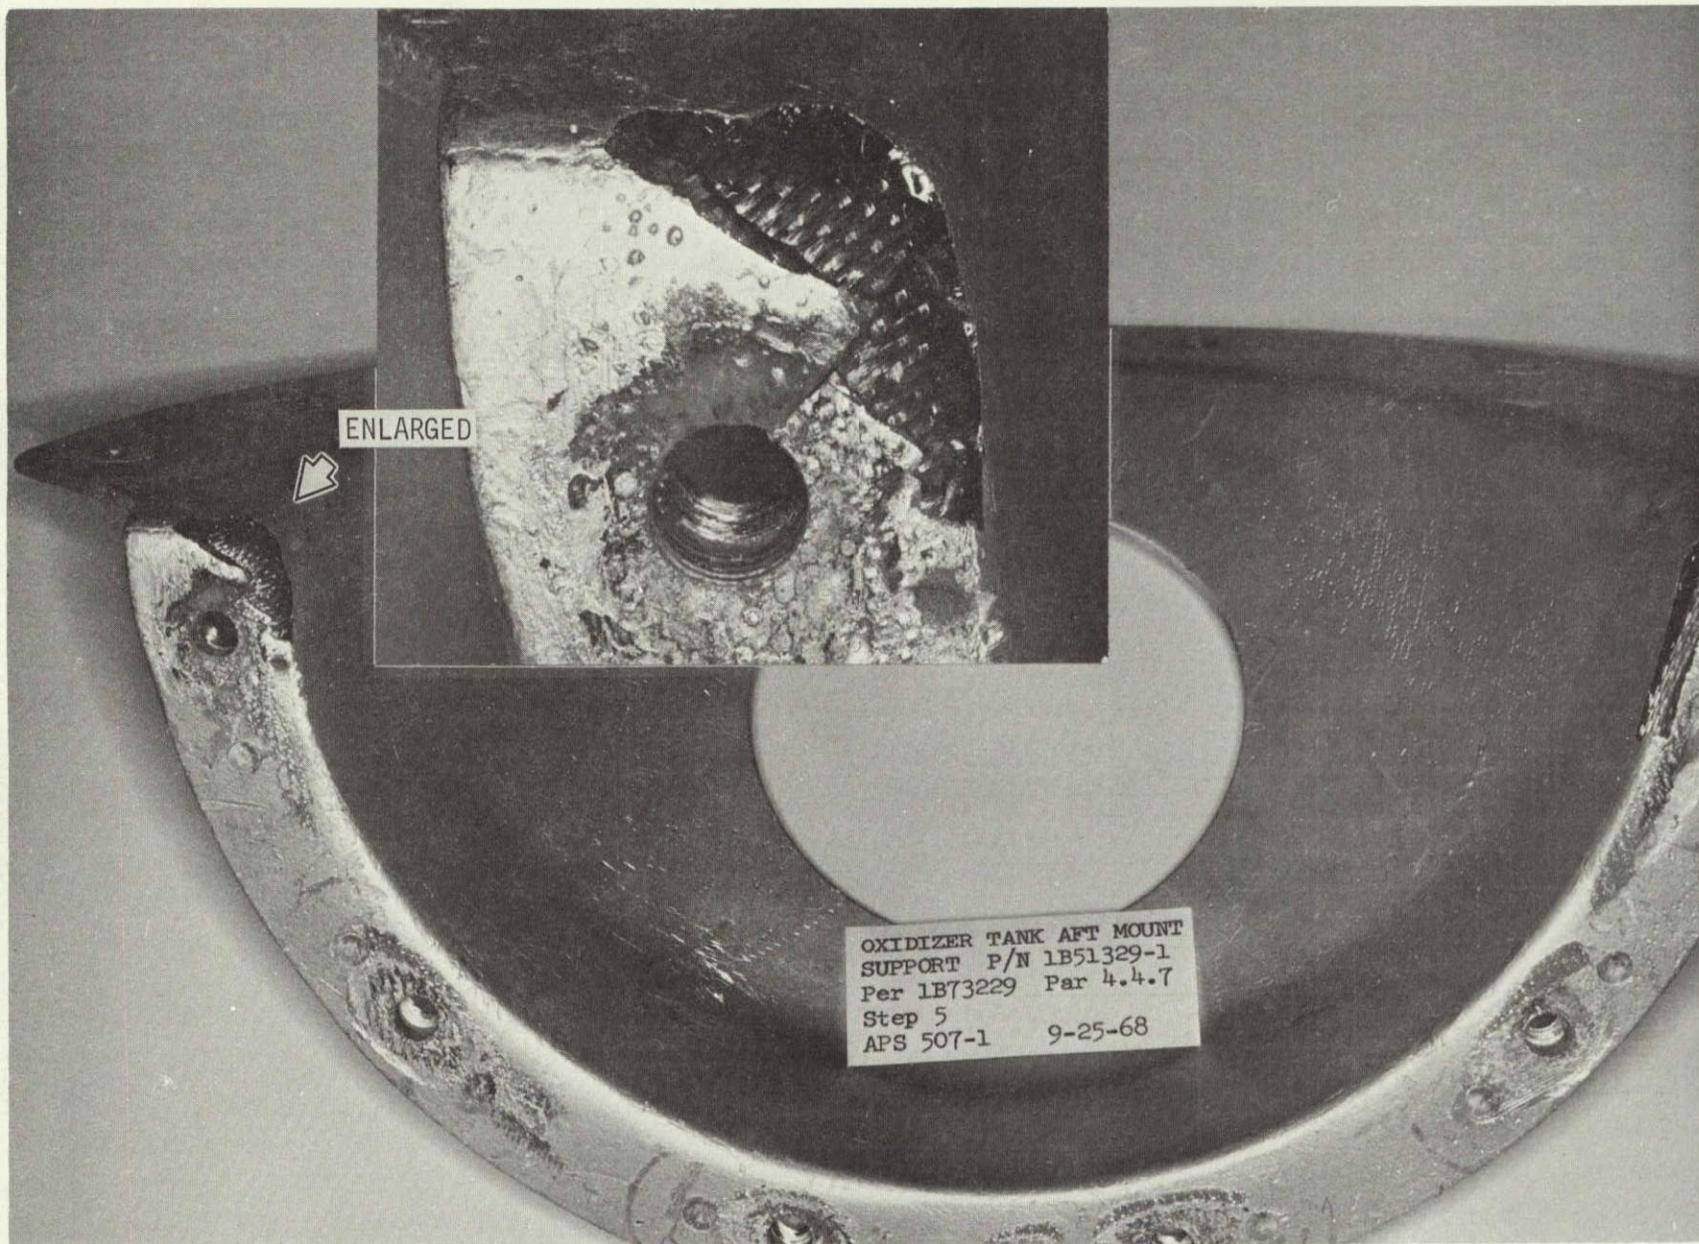
Figure 7-7. Propellant Tank Aft Mount Support (Typical)

On 15 August 1968, during the post thrust axis tests inspection, the oxidizer and fuel tank aft mounts (P/N 1B51329-1 and -2) were found to have minor cracks and chips near the end fasteners (figure 7-7).

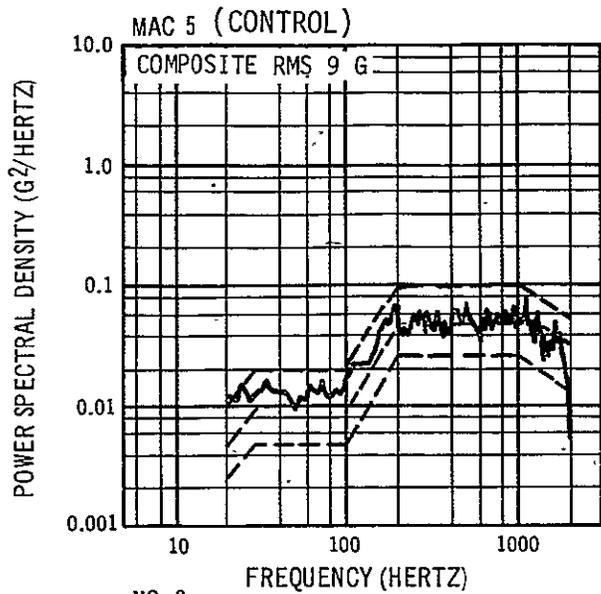
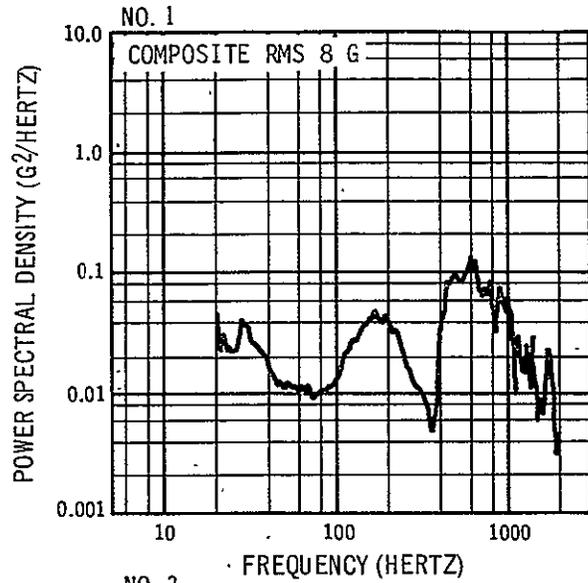
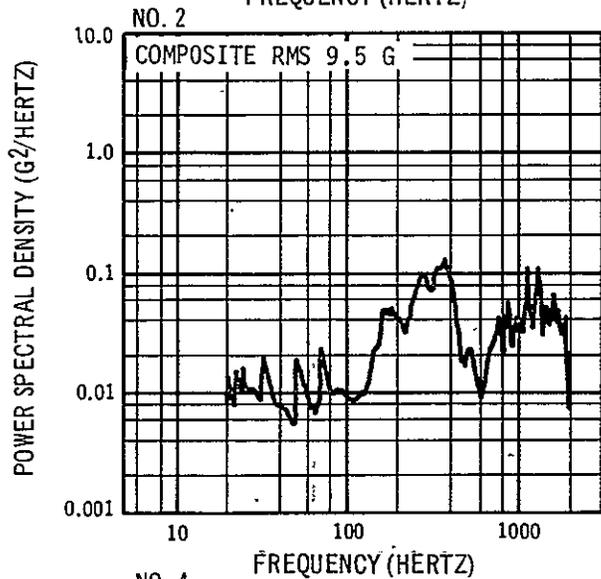
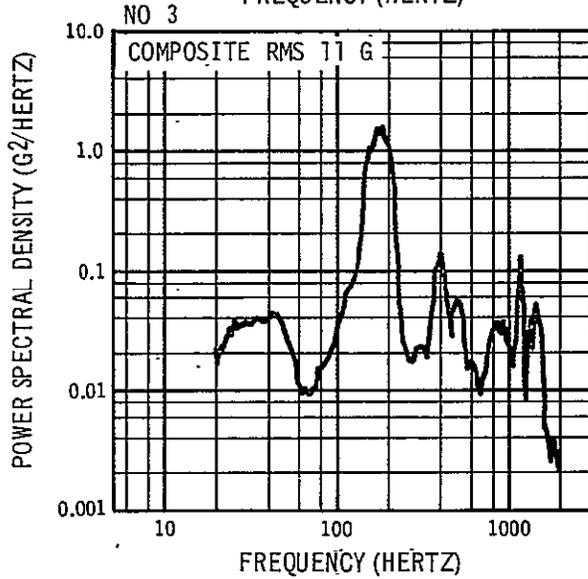
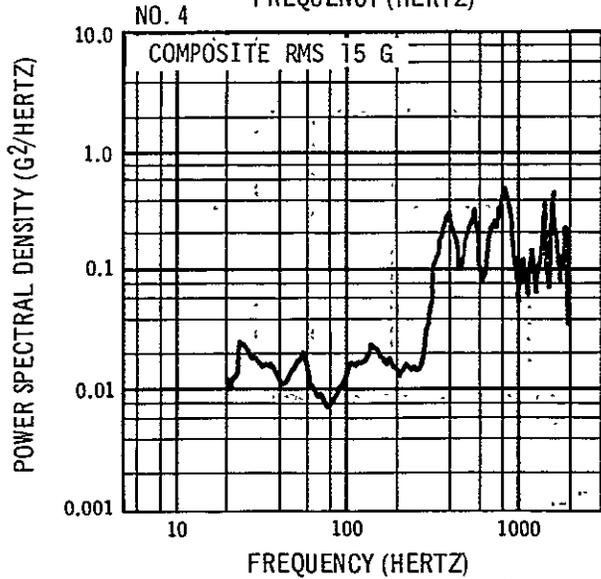
Figure 7-8. Tangential Axis Sinusoidal Sweep

The input was controlled from accelerometer location No. 1. No malfunction or failure was noted during or after the test. The accelerometer No. 1 (control) and accelerometer No. 2 data for this test are presented in figure 7-8. No other response data are presented because of the extremely high tape noise level.

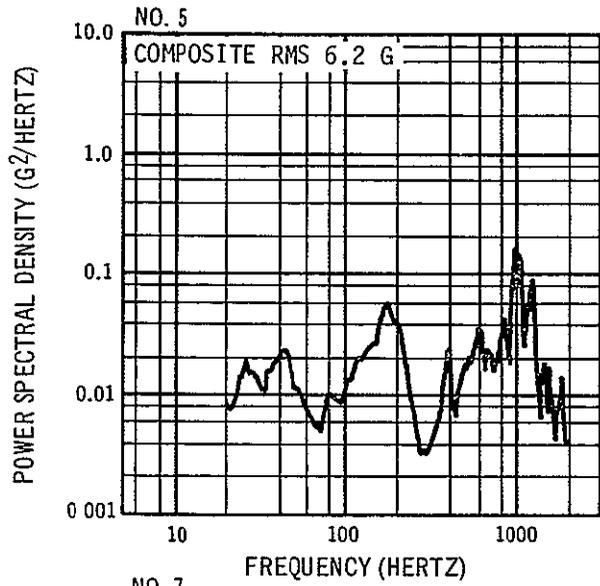
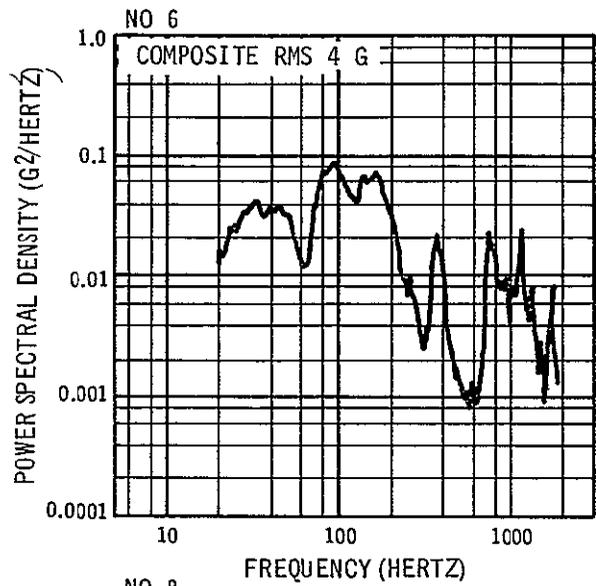
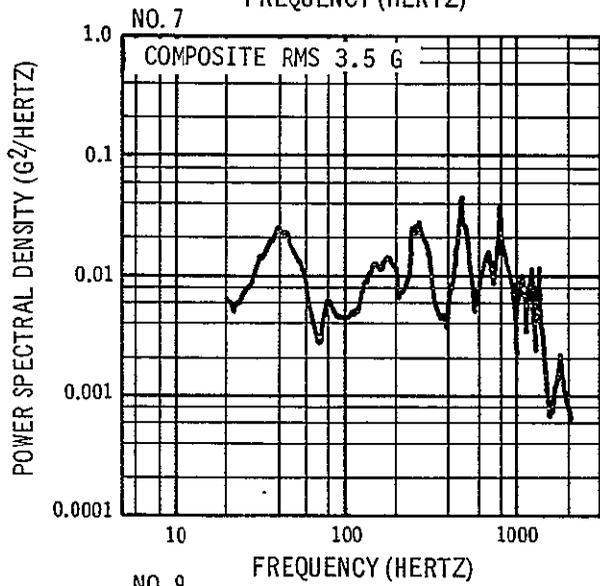
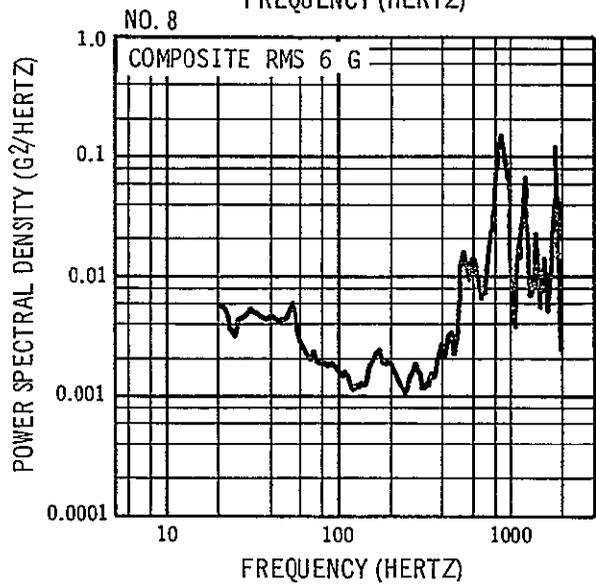
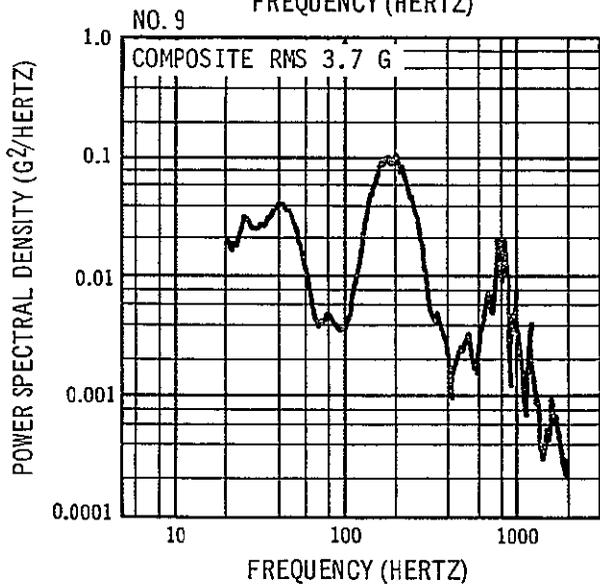
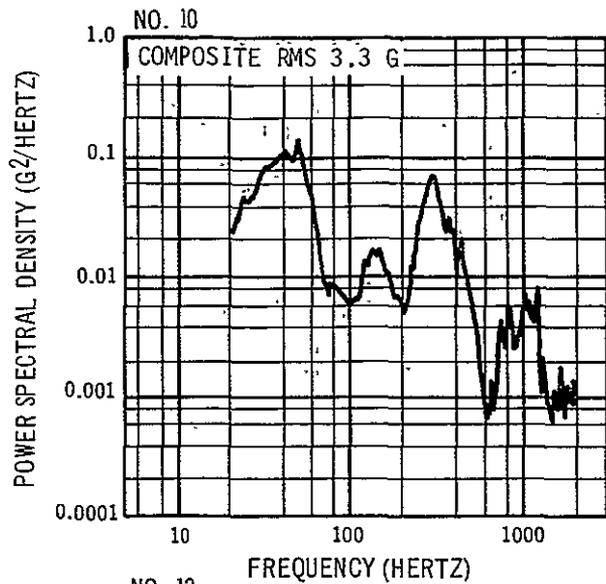
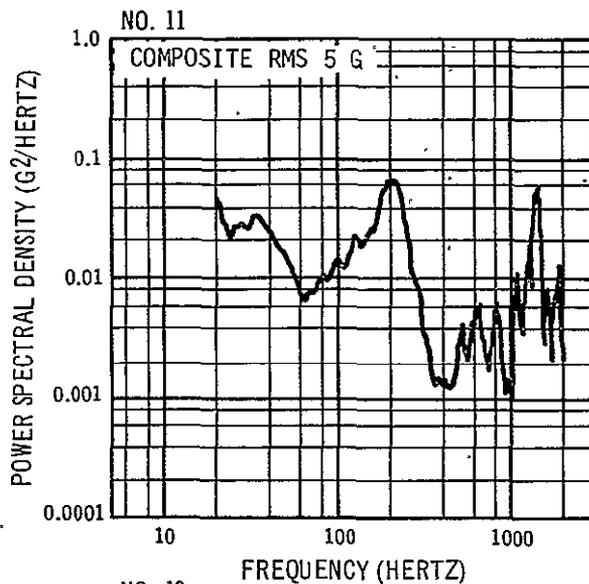
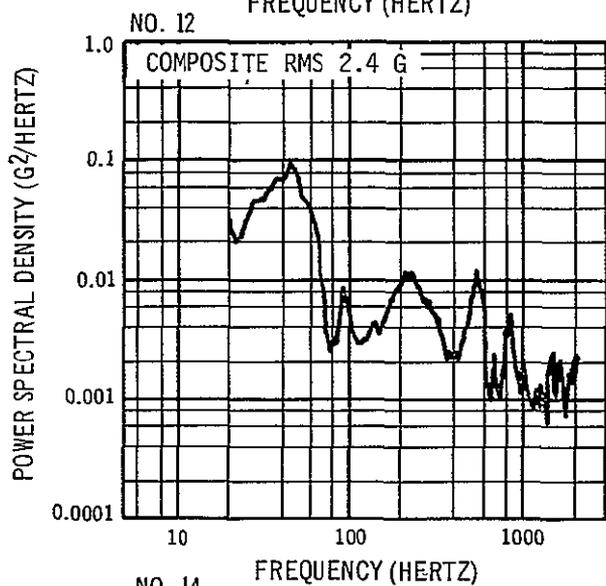
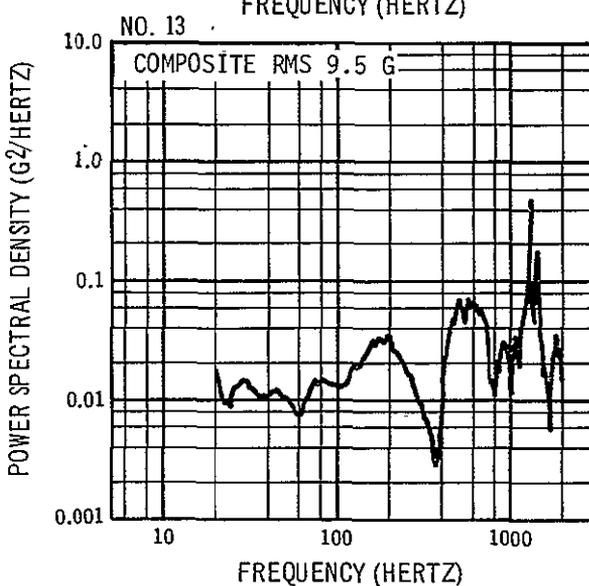
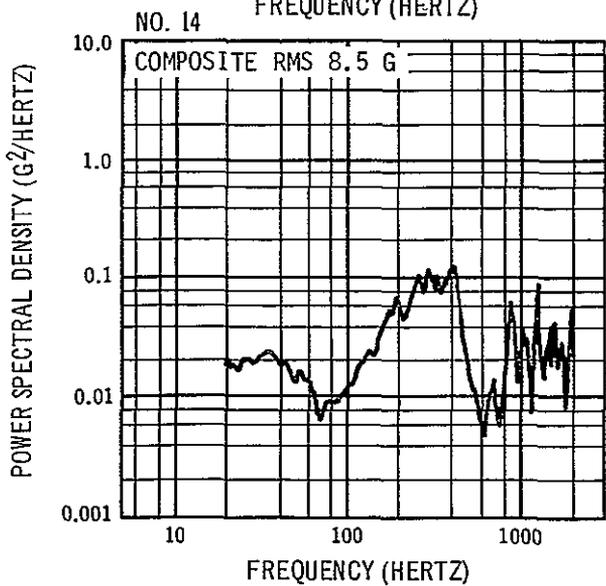
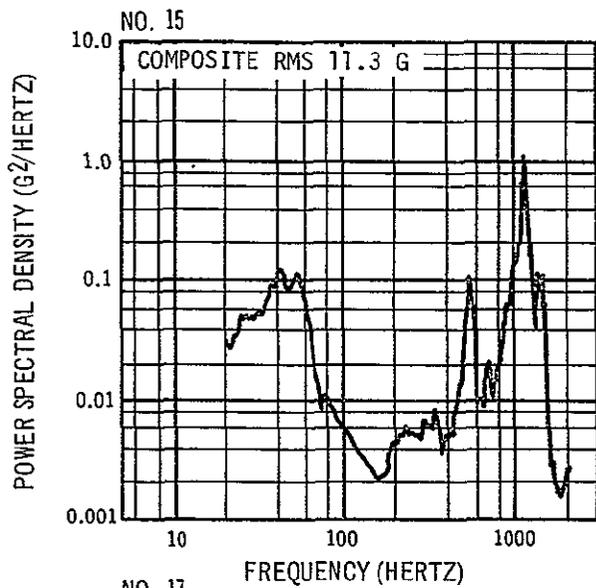
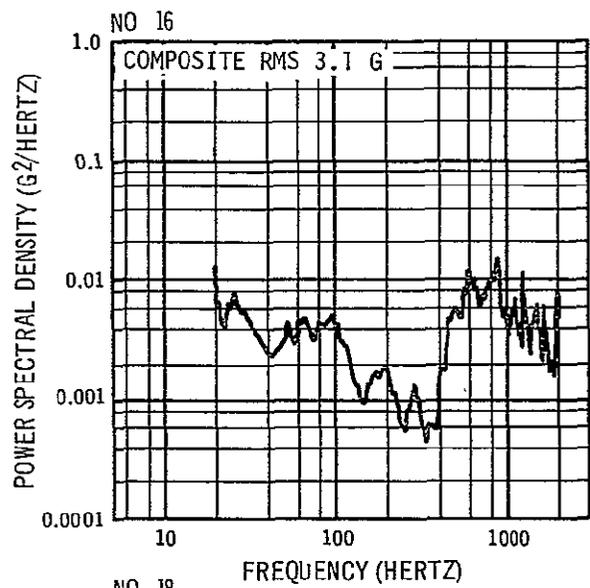
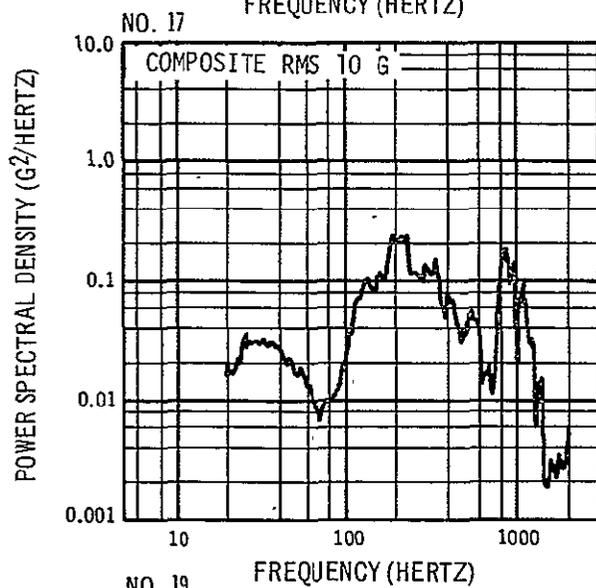
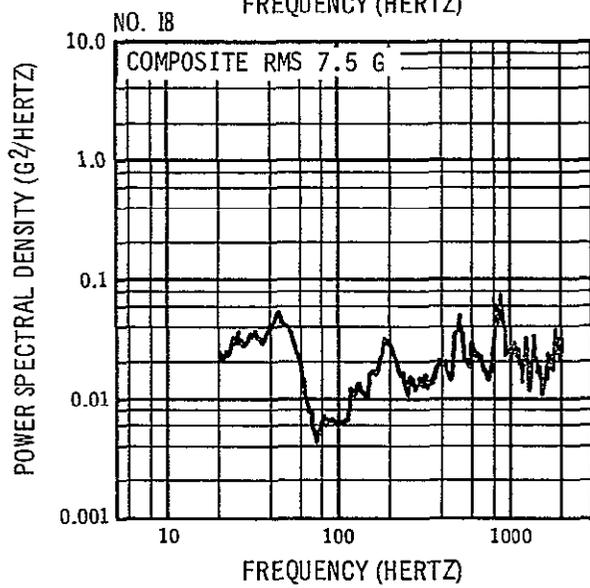
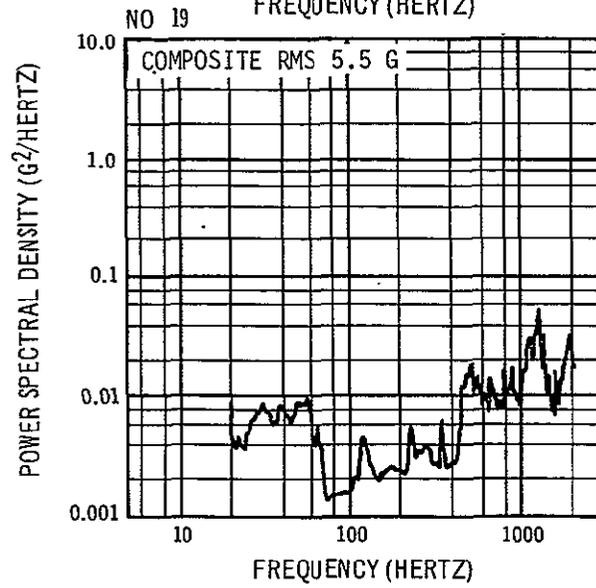
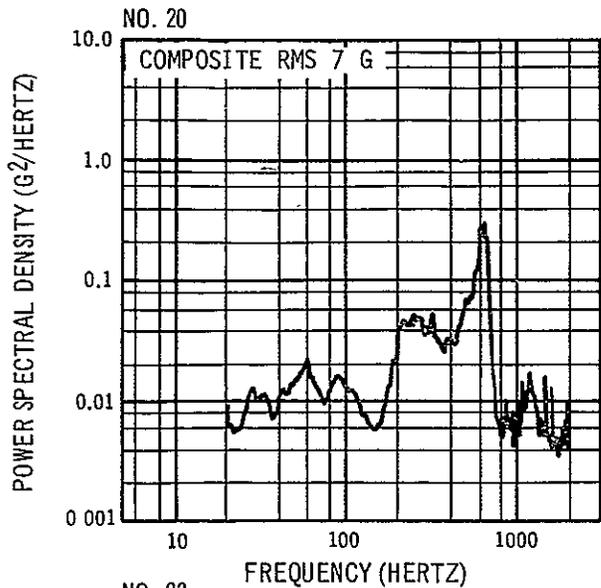
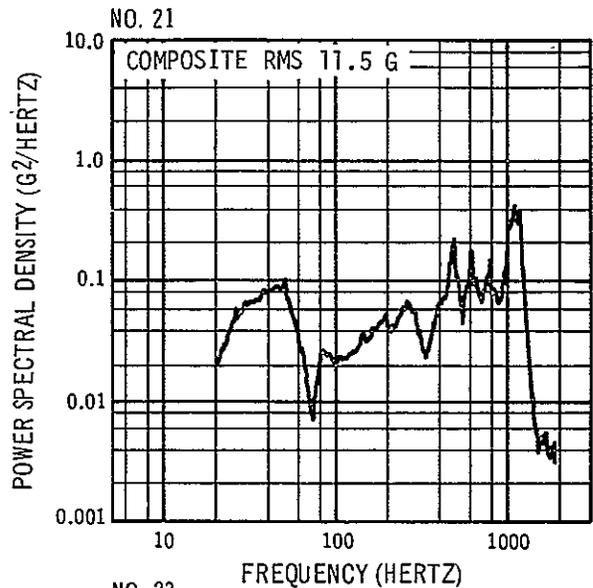
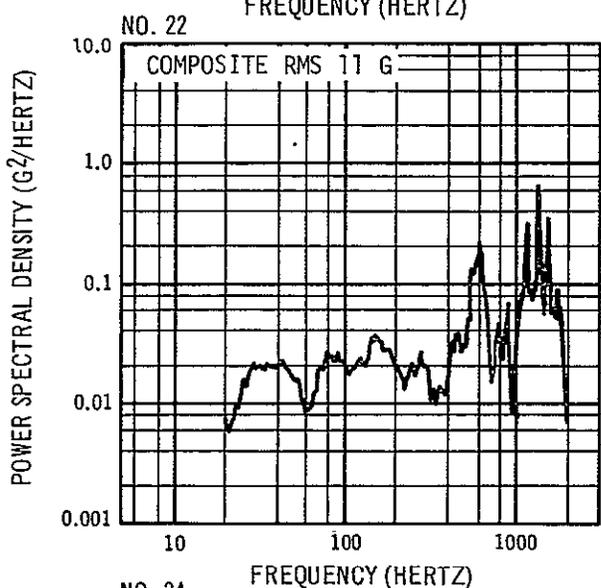
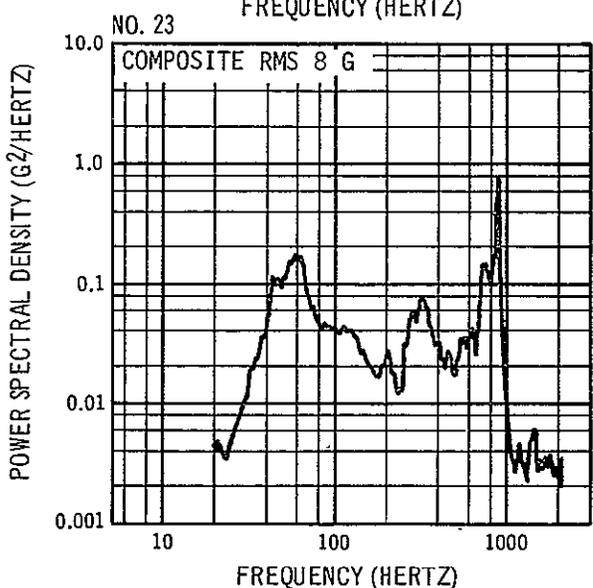
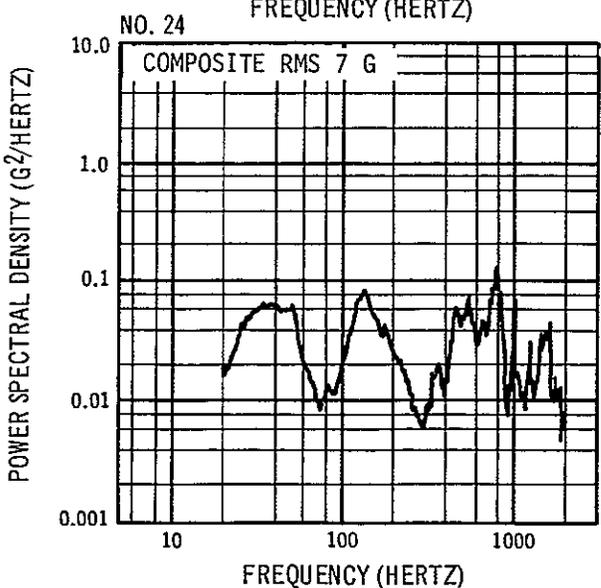
Figure 7-9. Tangential Axis Random Vibration (Sheet 1 of 5)

The test described in paragraph 7.1.2 was repeated in the tangential axis with no malfunction or failure noted during or after the test. Accelerometer data for this test are presented in figure 7-9.

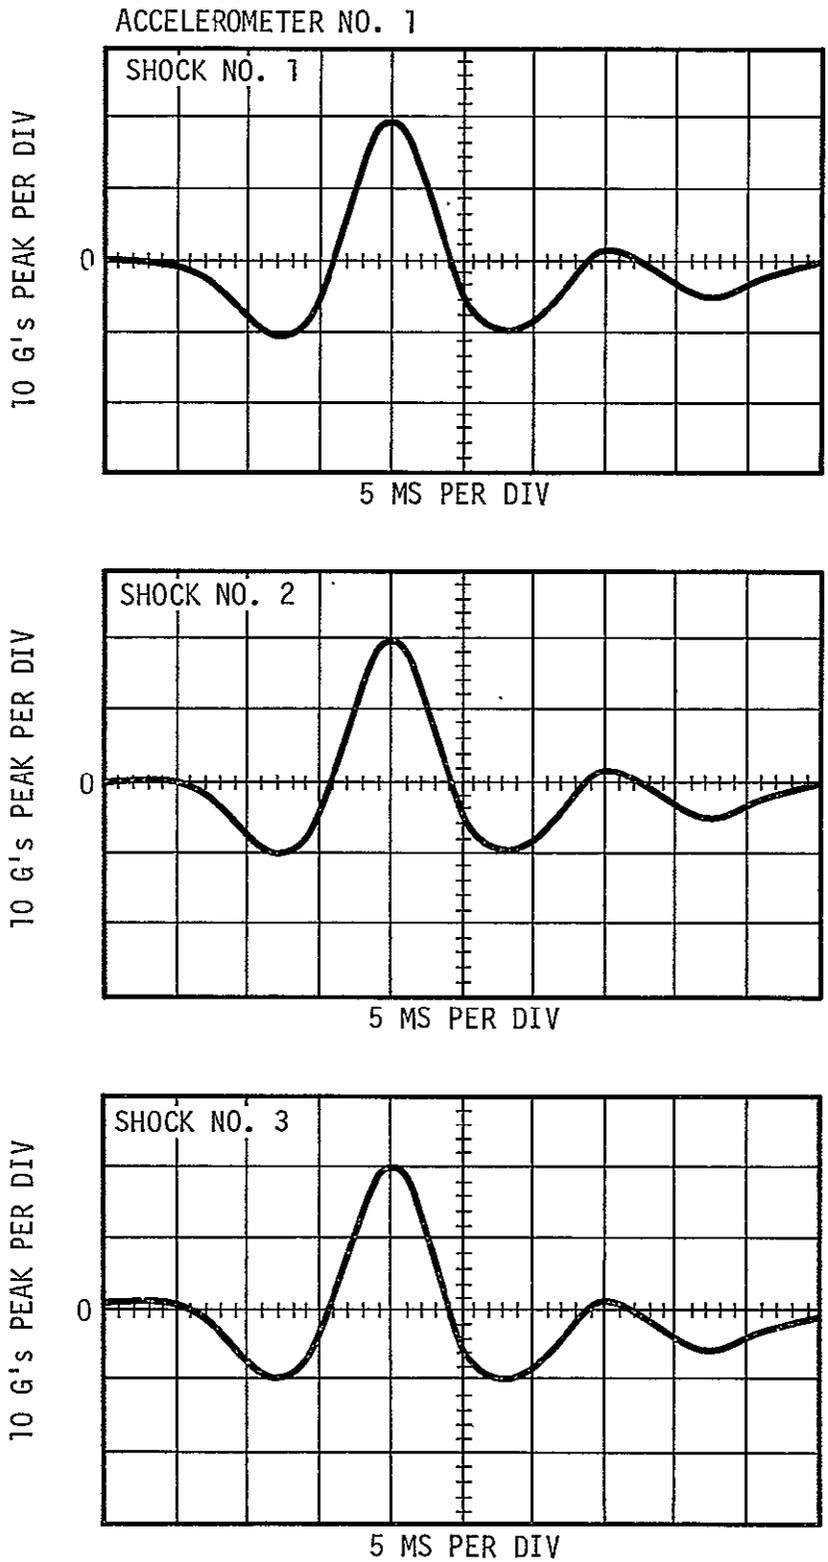
Figure 7-10. Tangential Axis Shock

The test described in paragraph 7.1.3 was repeated in the tangential axis with no malfunction or failure noted before or after the test. Control accelerometer data for this test are presented in figure 7-10. A shock spectrum analysis of shock No. 2 is shown in figure 7-11.

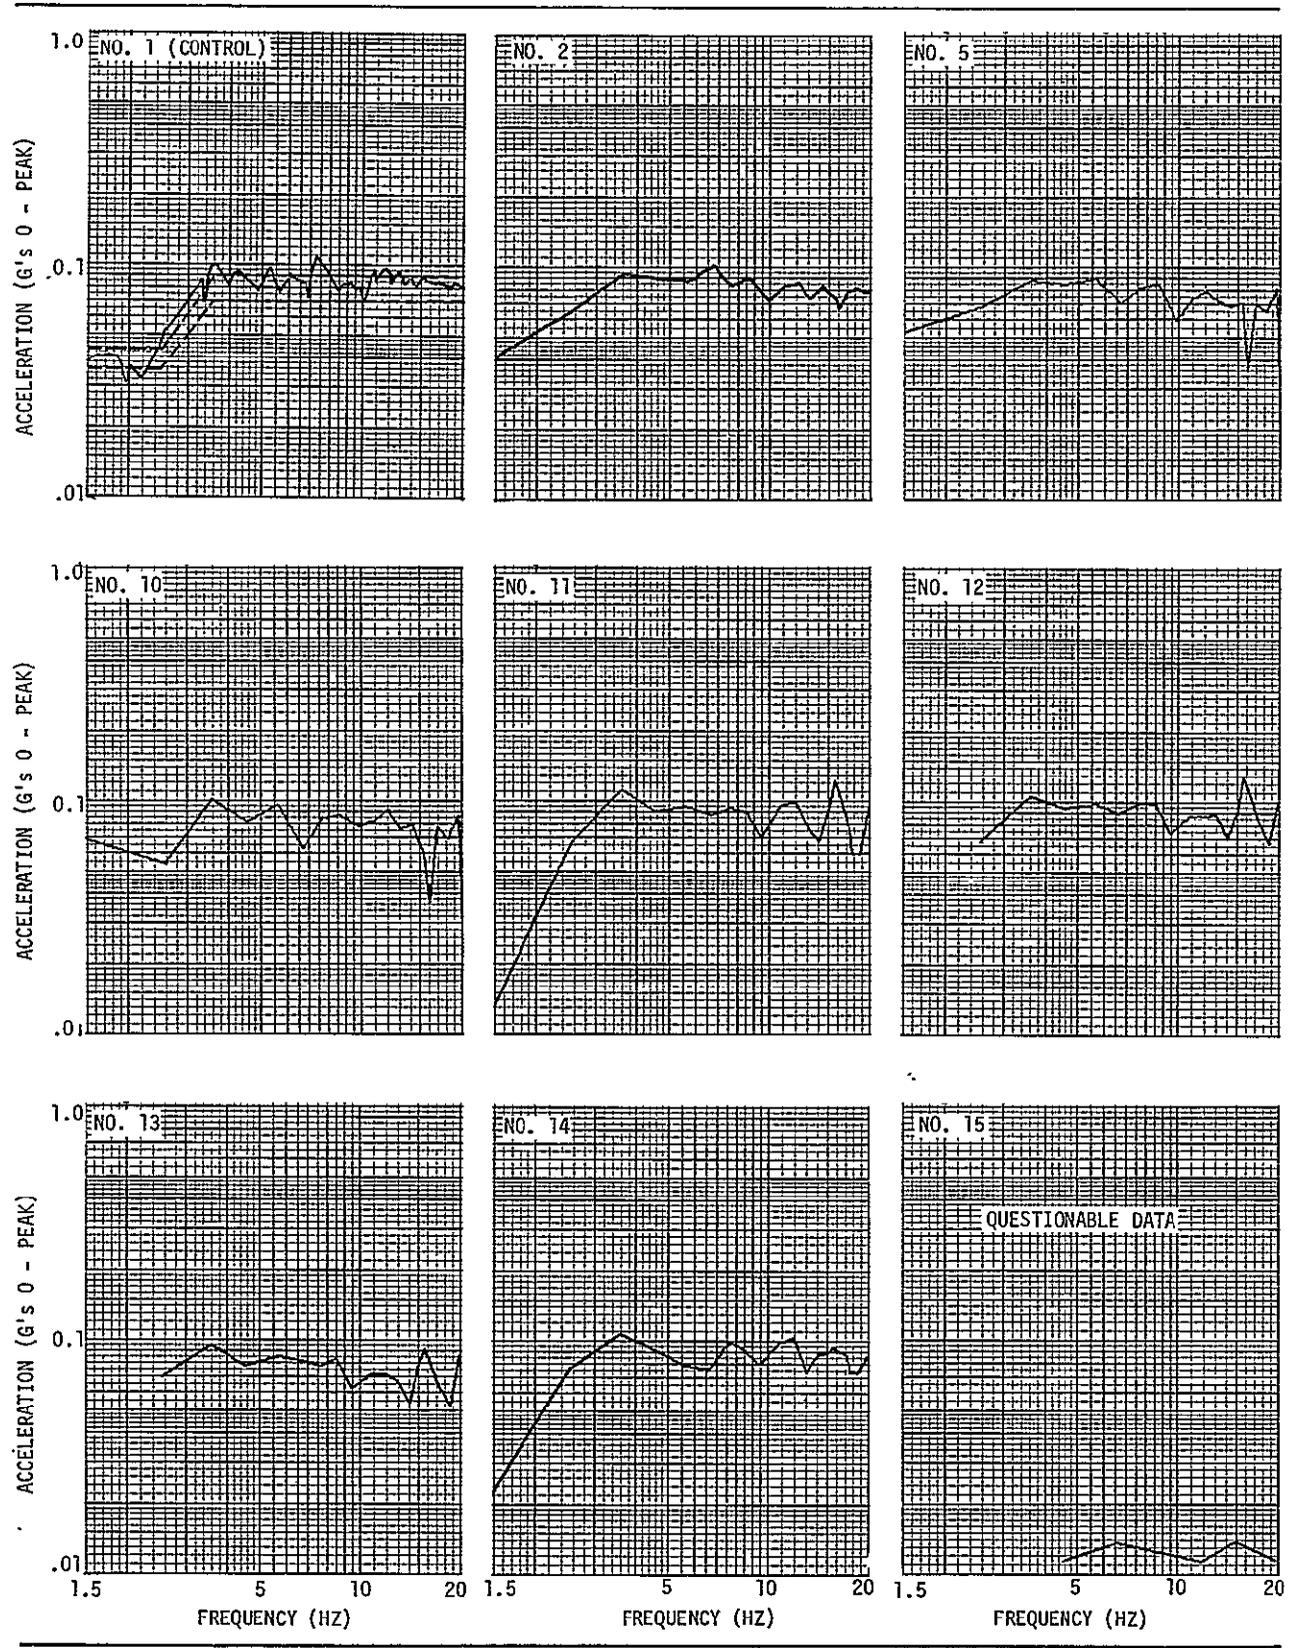
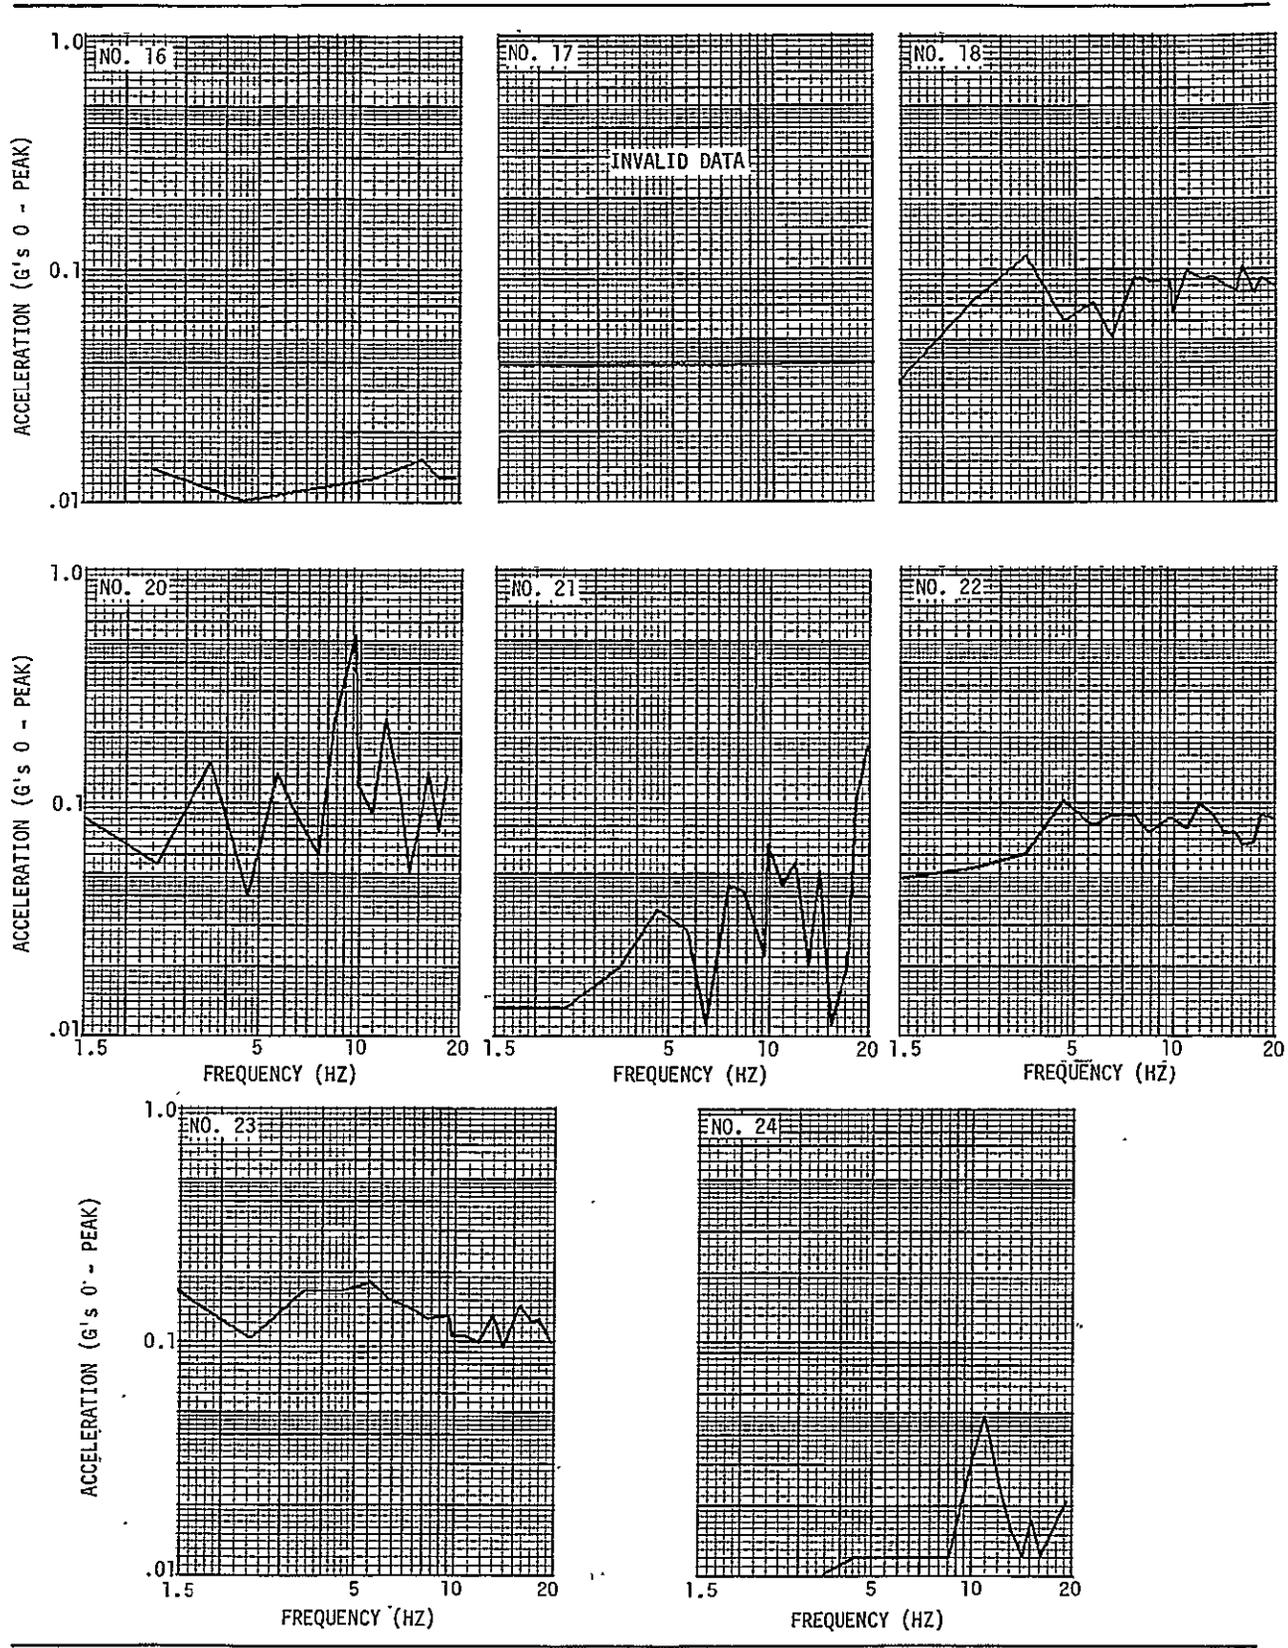
Figure 7-12. Radial Axis Sinusoidal Sweep (Sheet 1 of 2)

acceleration data for this test are presented in figure 7-12. The control data were plotted from the oscillograph trace of the filtered control signal. Response data plots were produced from computer analysis of the unfiltered data. Sixteen data samples were used to generate the curves for each response plot.

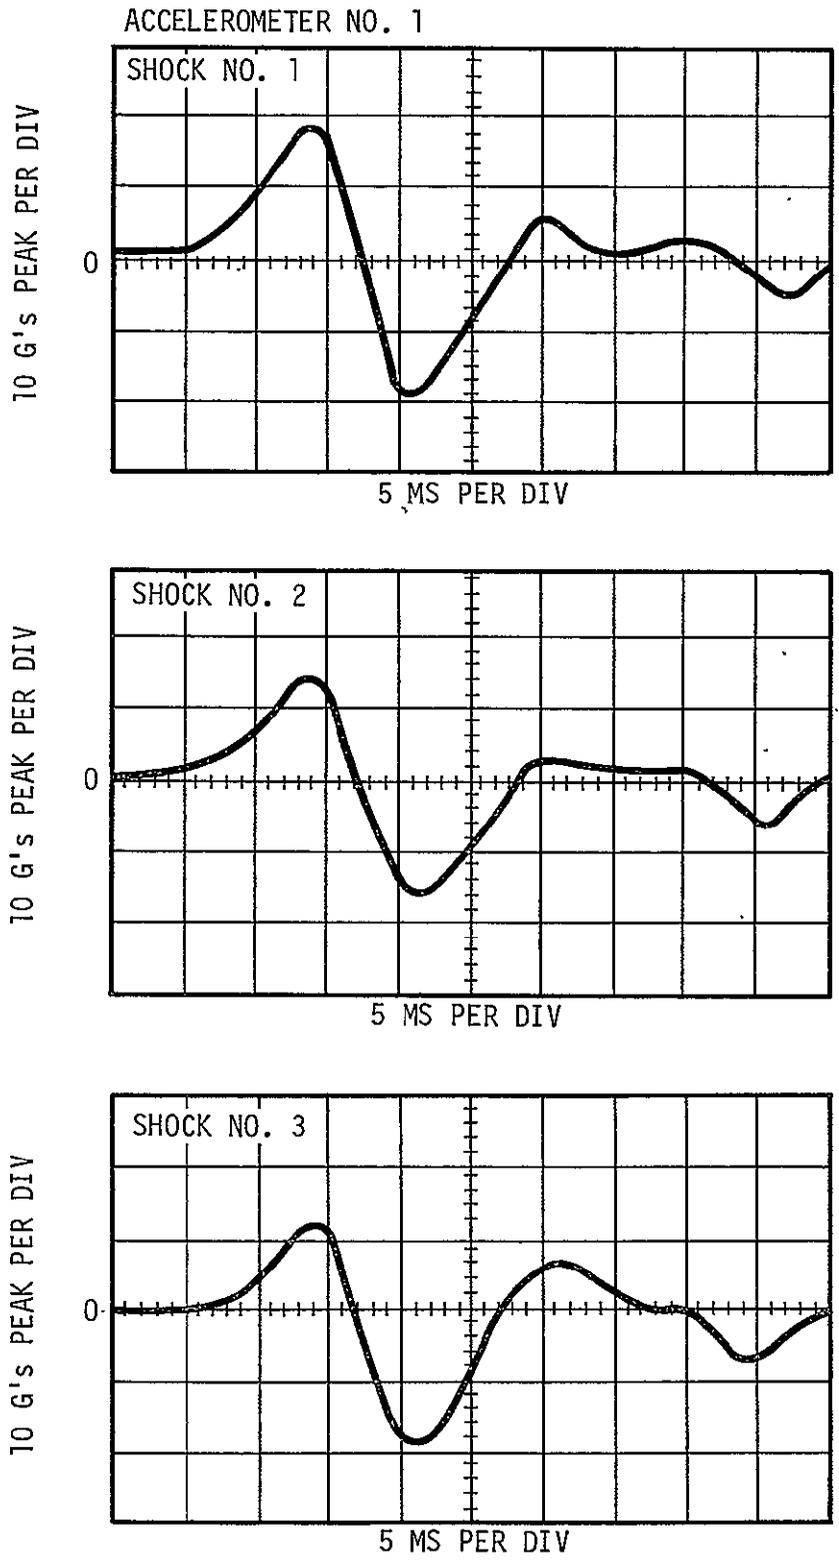
Figure 7-13. Radial Axis Shock

The test described in paragraph 7.1.3 was repeated in the radial axis with no malfunction or failure noted before or after the tests. Control accelerometer data for this test are presented in figure 7-13. A shock spectrum analysis of shock No. 2 is shown in figure 7-14.
