**S-IVB/V AUXILIARY PROPULSION
SYSTEM 90-DAY RECYCLE
CAPABILITY TEST REPORT,
MODULE I**

**DAC-56728
FEBRUARY 1969**

**PREPARED BY:
MCDONNELL DOUGLAS ASTRONAUTICS COMPANY
WESTERN DIVISION
SATURN S-IVB TEST PLANNING
AND EVALUATION COMMITTEE**

**PREPARED FOR:
NATIONAL AERONAUTICS AND
SPACE ADMINISTRATION
UNDER NASA CONTRACT NAS7-101
MODEL DSV-4B**

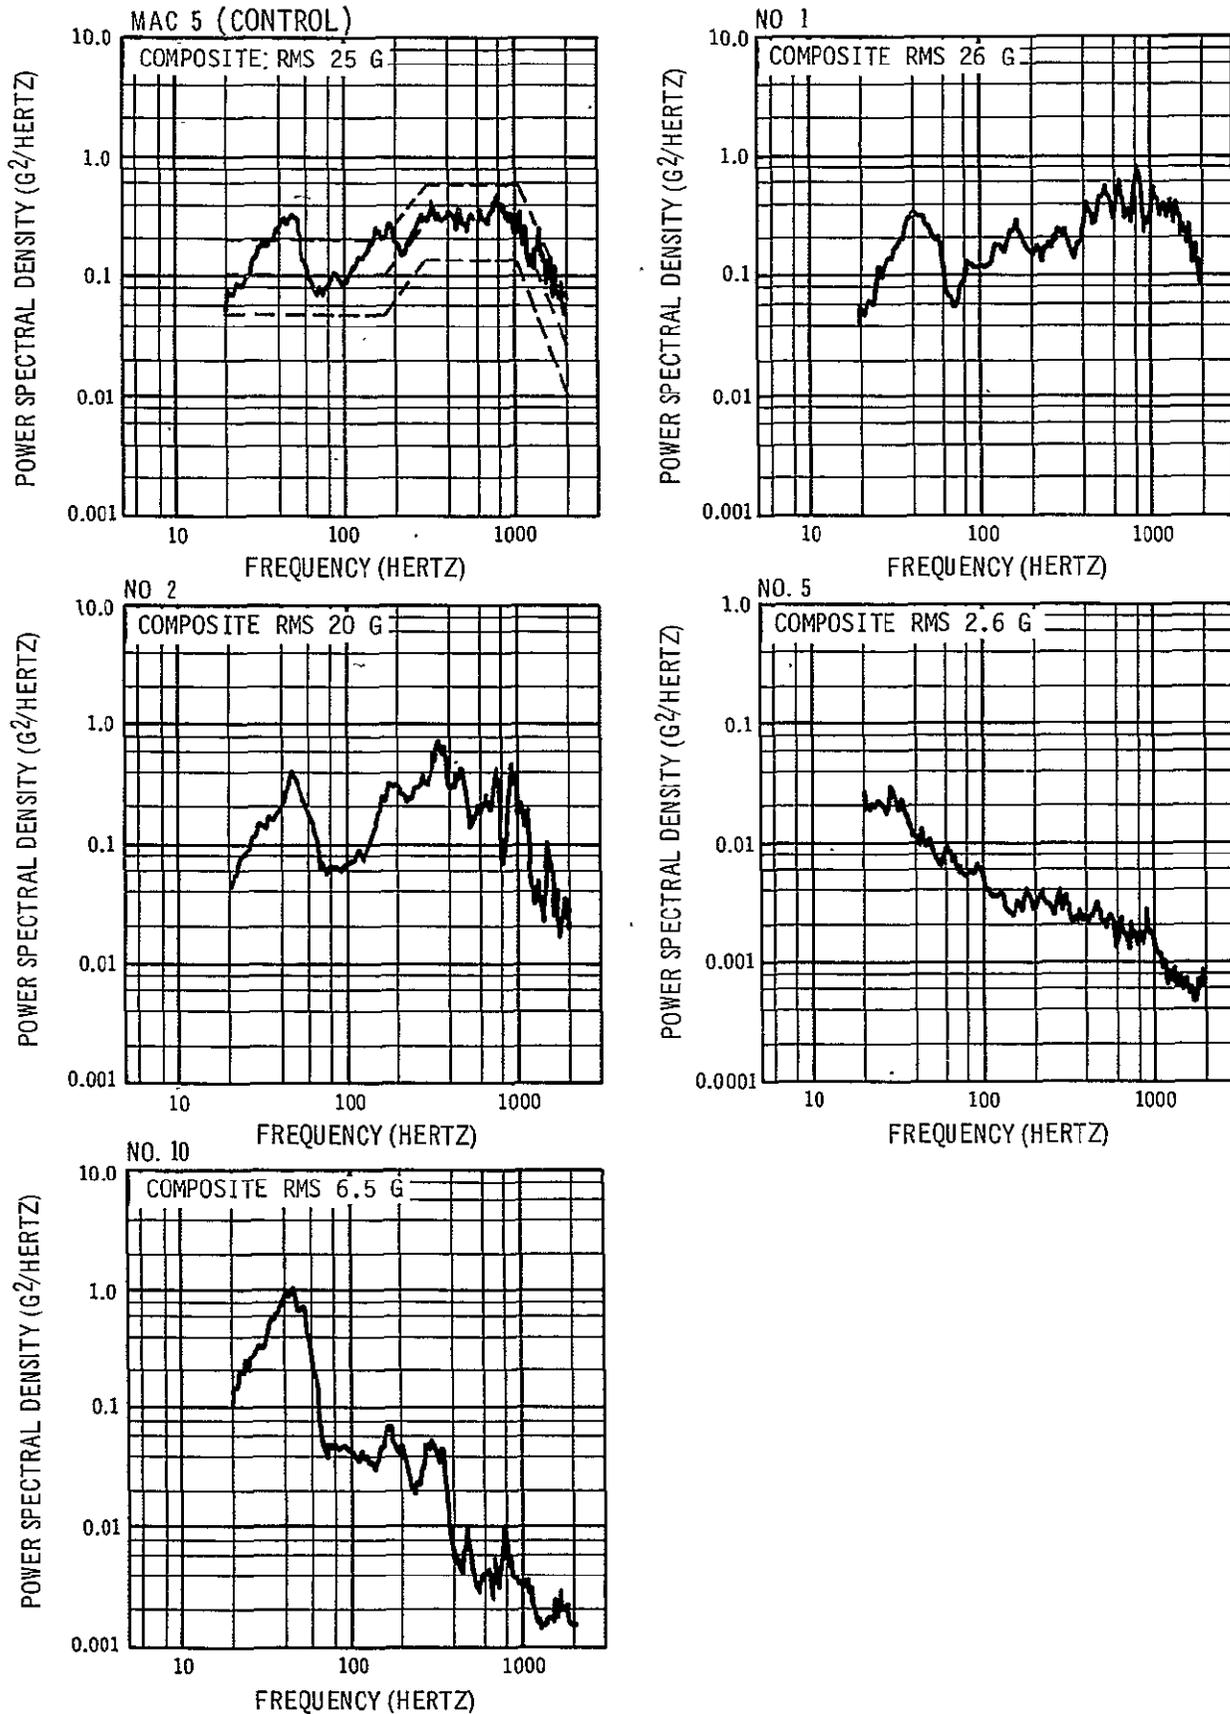
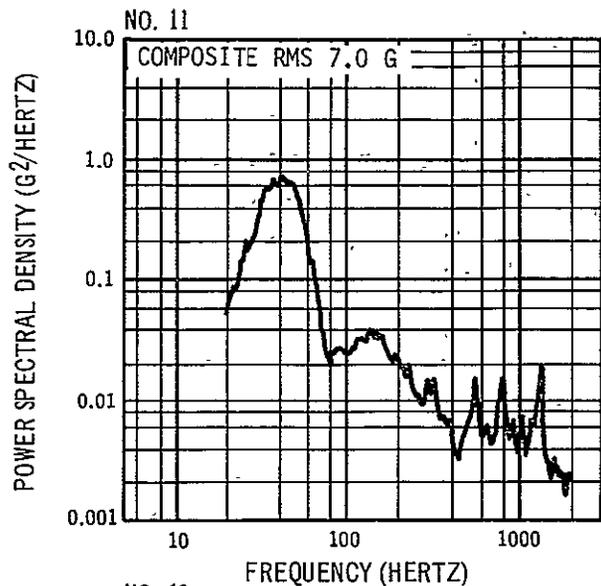
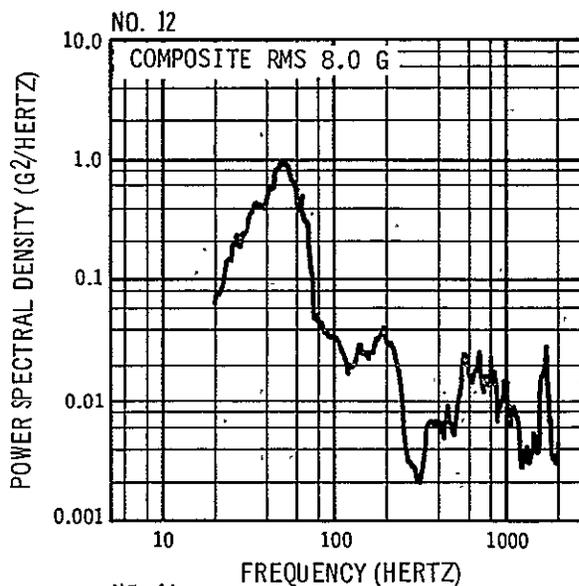
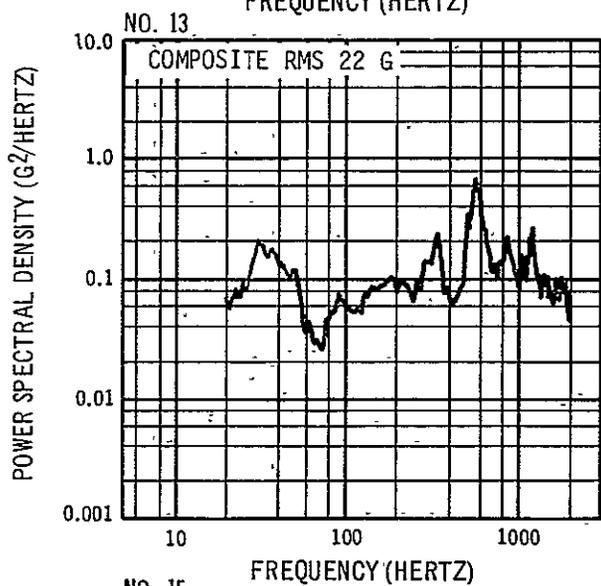
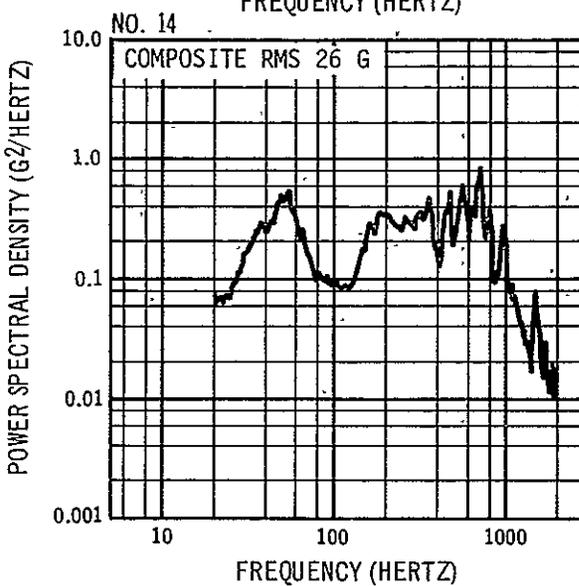
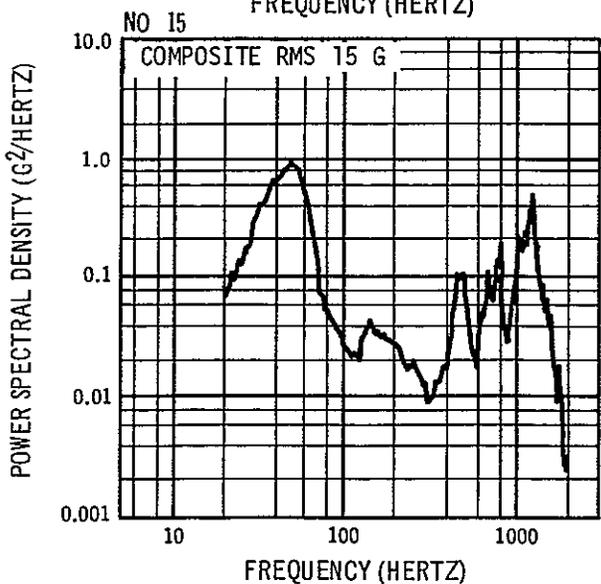
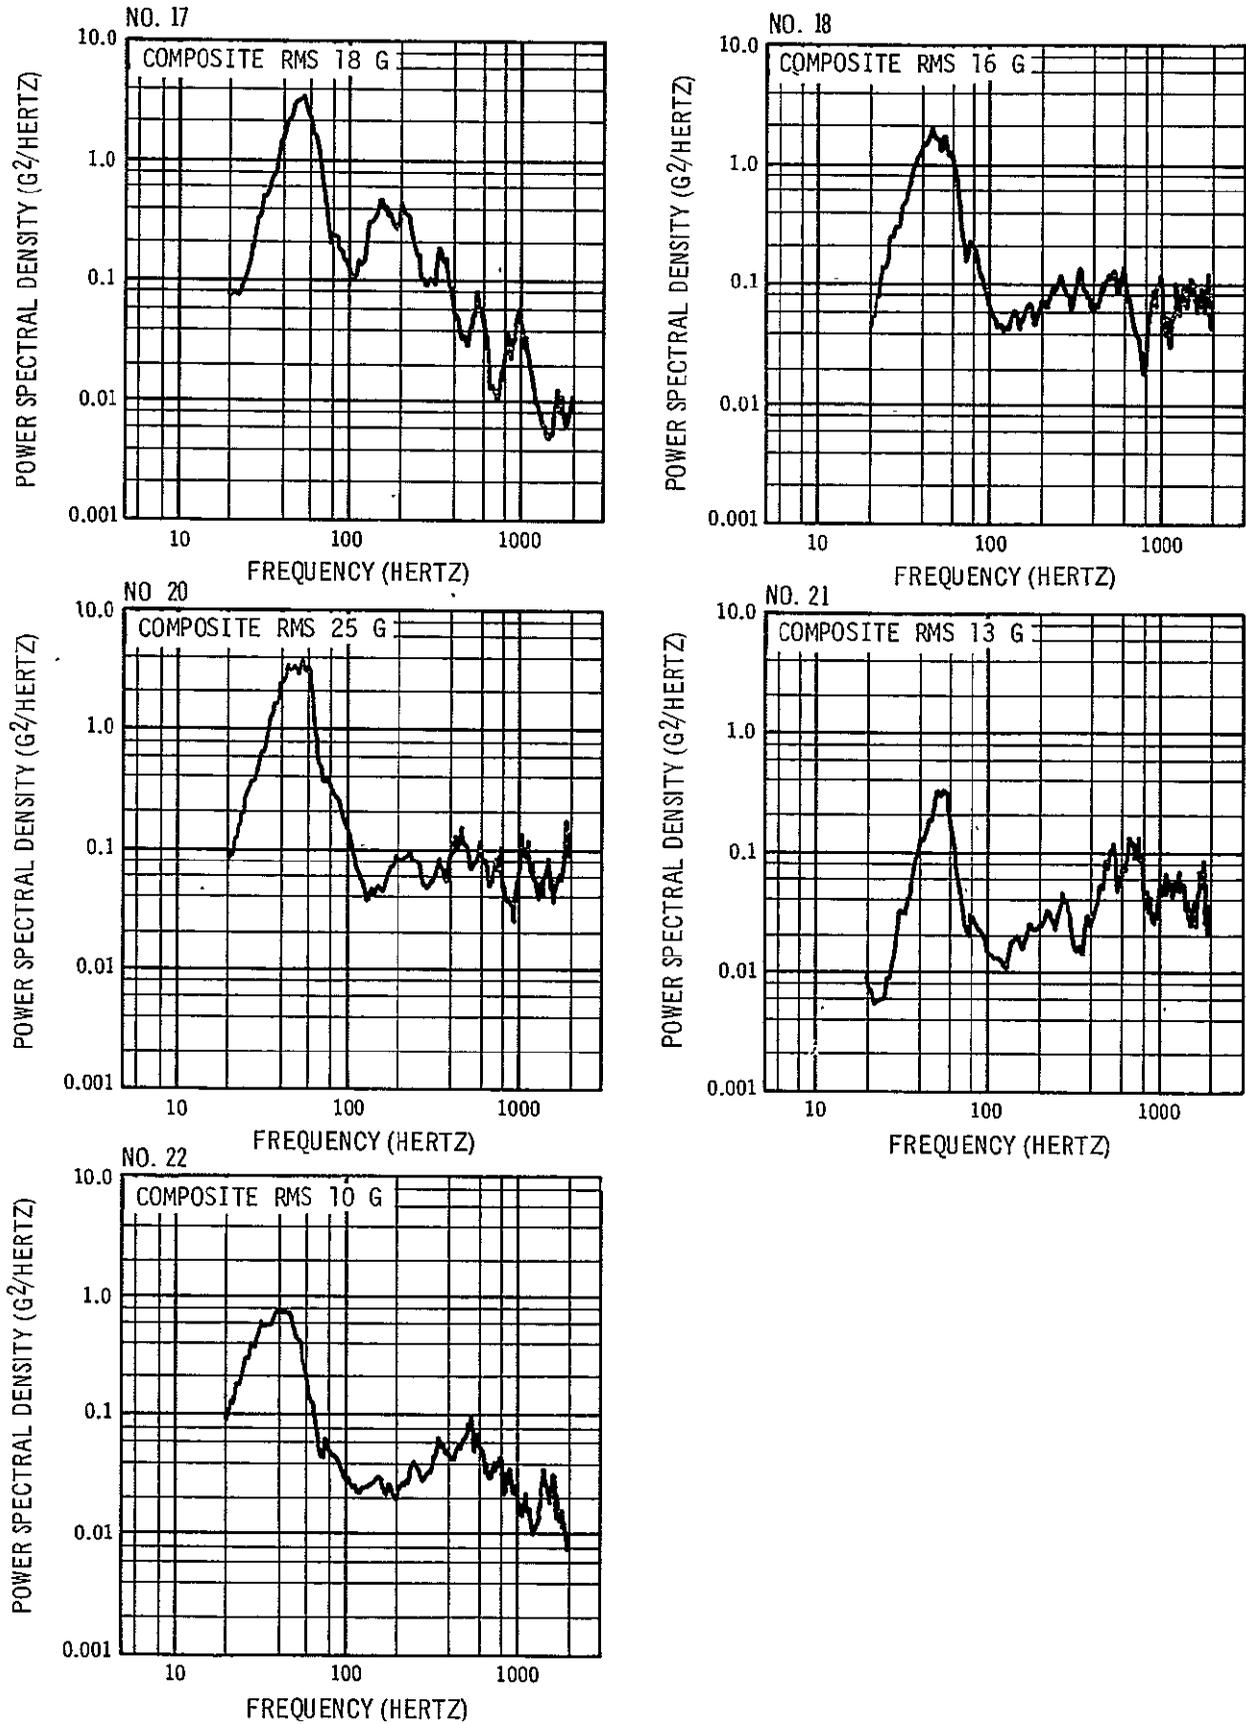
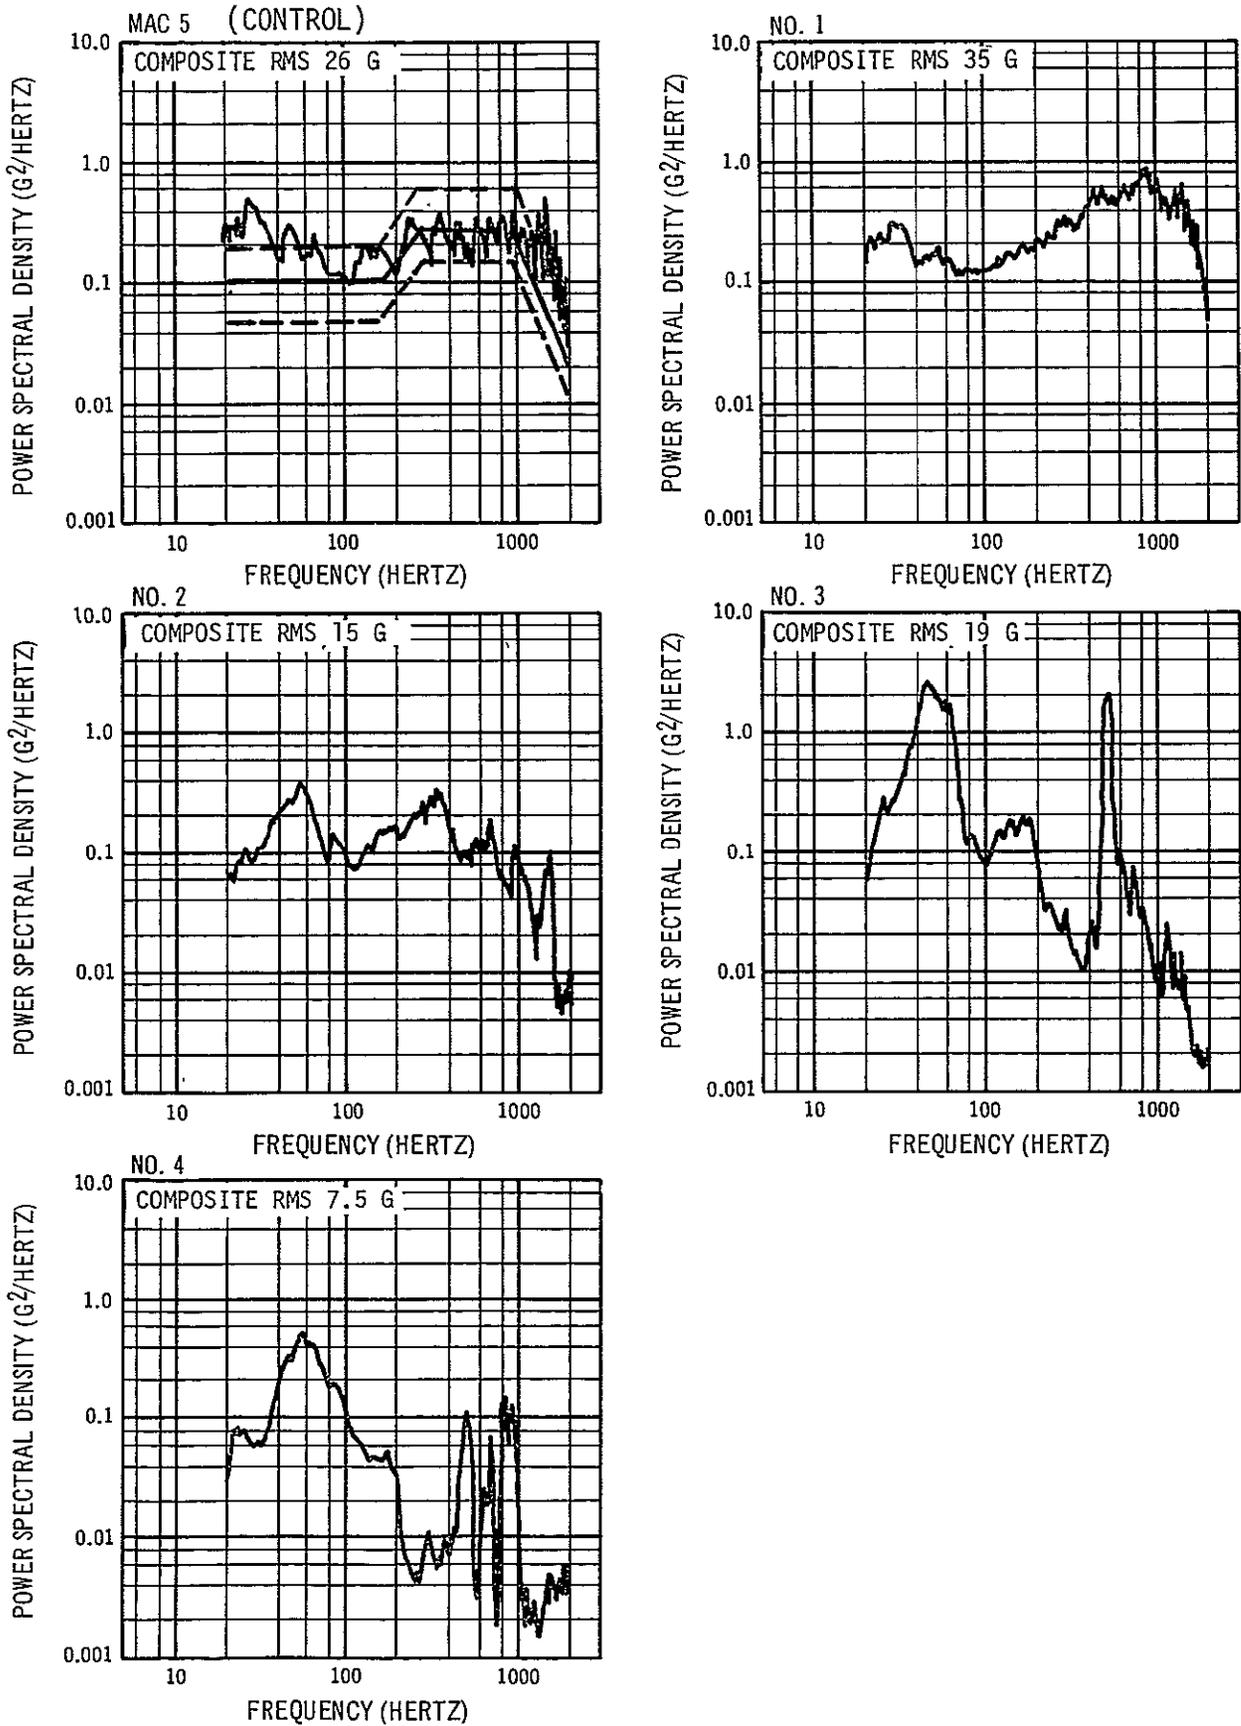
Figure 7-15. Radial Axis Random Vibration (Sheet 1 of 6)

After 2 min of radial axis random vibration testing, a system leak check was performed, which revealed a major leak in the oxidizer tank bladder. Subsequent data evaluation indicated that a pressure fluctuation occurred 63 sec into the run probably due to the bladder failure. Vibration data for this test period are presented in figure 7-15.

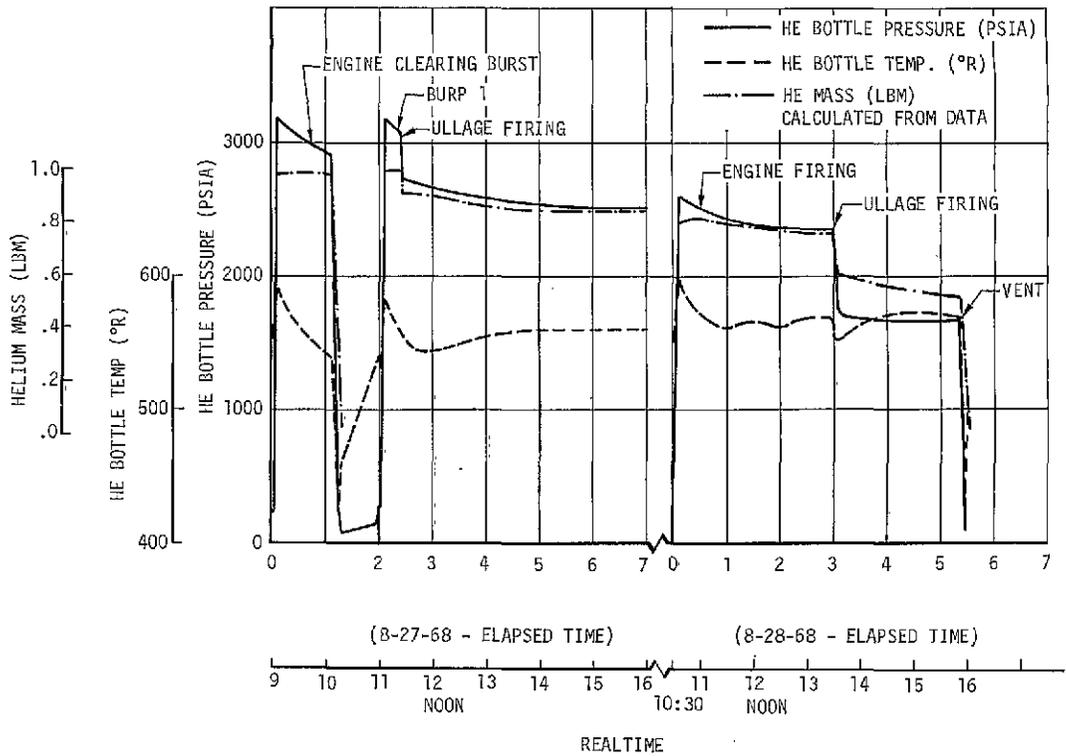
Figure 8-2. LMDC Helium Bottle Data

As shown in figure 8-2, the bottle pressure decreased rapidly between 1127 and 1138 hr. During this time the ullage engine and two attitude control engines were firing, causing the rapid reduction of helium pressure from 3,045 psia to 2,730 psia.

An ullage engine firing from 1329 to 1335 hr accounted for the rapid decrease in bottle pressure from 2,340 psia to 1,775 psia (figure 8-2). Prior to venting the helium bottle at the conclusion of the LMDC, the bottle conditions were 1,670 psia and 569 deg R. This is equivalent to .518 lbm of helium. Thus, .297 lbm of helium was used during the portion of the LMDC conducted on 28 August 1968, and .460 lbm was consumed for the total test.

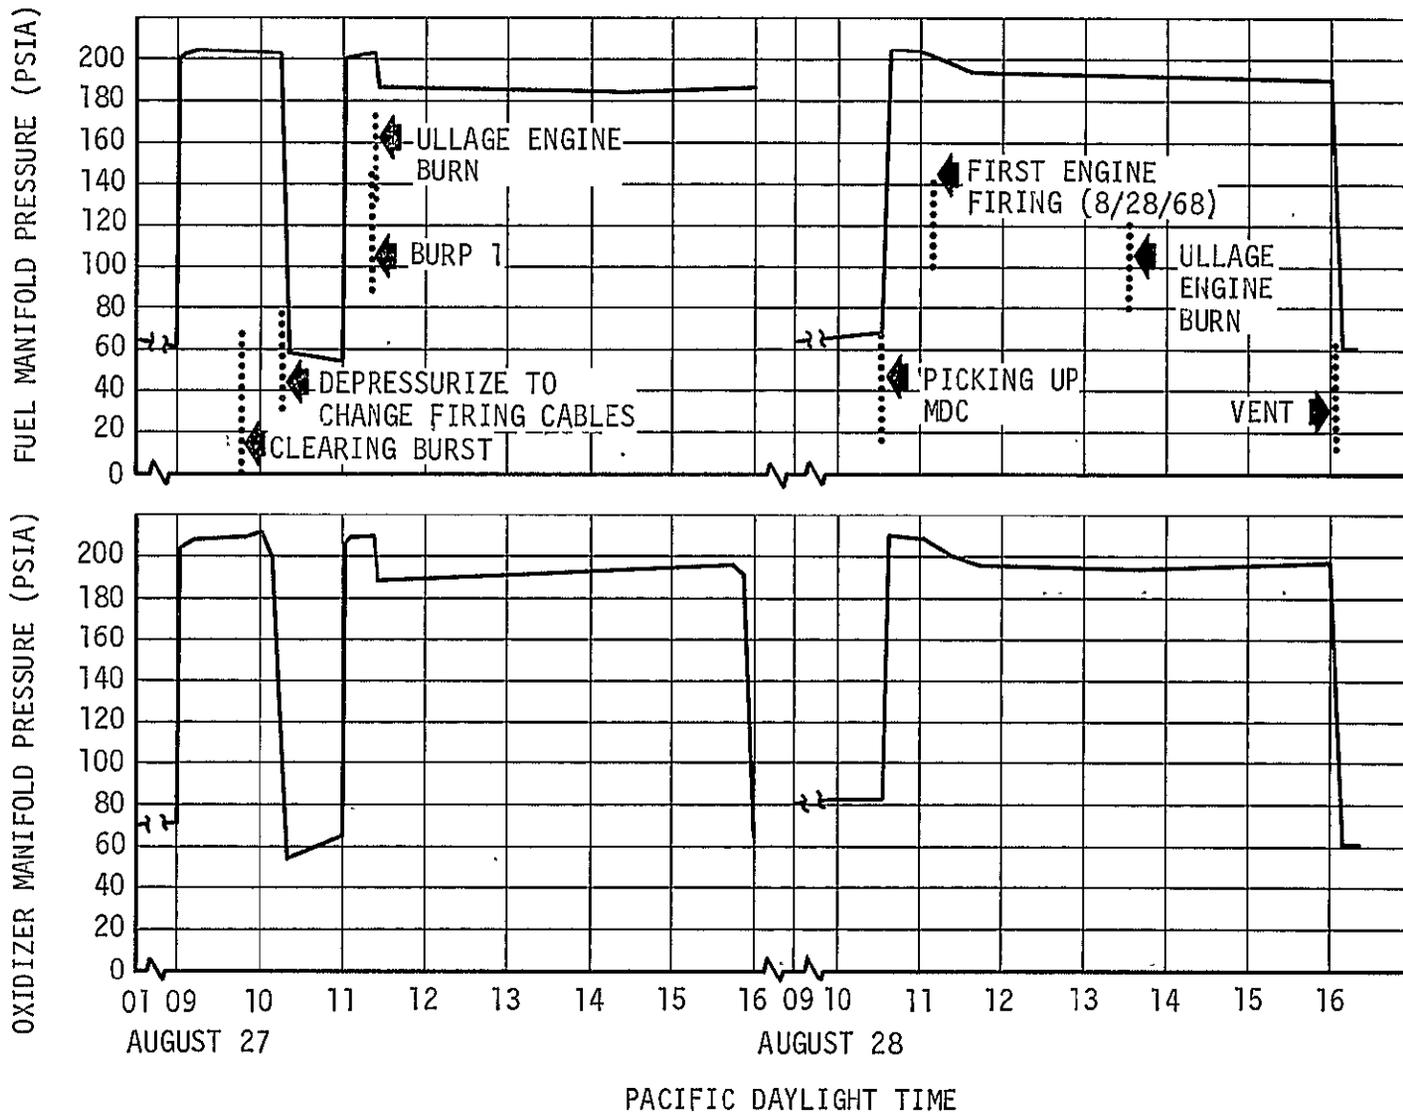
Figure 8-3. LMDC Fuel and Oxidizer Manifold Pressure

Figure 8-3 presents the history of the fuel manifold pressures during the LMDC. The supply manifold pressure remained in the 54 to 65 psia range during the hold periods on 27 August 1968. After system pressurization on 27 August 1968, the range was 201 to 204 psia referenced to ambient, and 185 to 199 psia referenced to vacuum. During hold periods on 28 August 1968, the manifold pressure ranged from 60 to 68 psia. After pressurization on 28 August 1968, the supply manifold pressure was maintained at 200 to 205 psia referenced to ambient, and 190 to 198 psia referenced to vacuum.

Figure 8-3 shows the effect of referencing the regulator to a vacuum. The pressurizations of the helium bottle at 1100 hr on 27 August 1968, and 1030 hr on 28 August 1968, were performed with the regulator referenced to sea level. The regulator was then referenced to a vacuum. As soon as the engines commenced firing and a demand was placed on the regulator, the supply pressures dropped approximately 15 psi. The difference in the rate of the drop was due to the difference in the amount of engine firings.

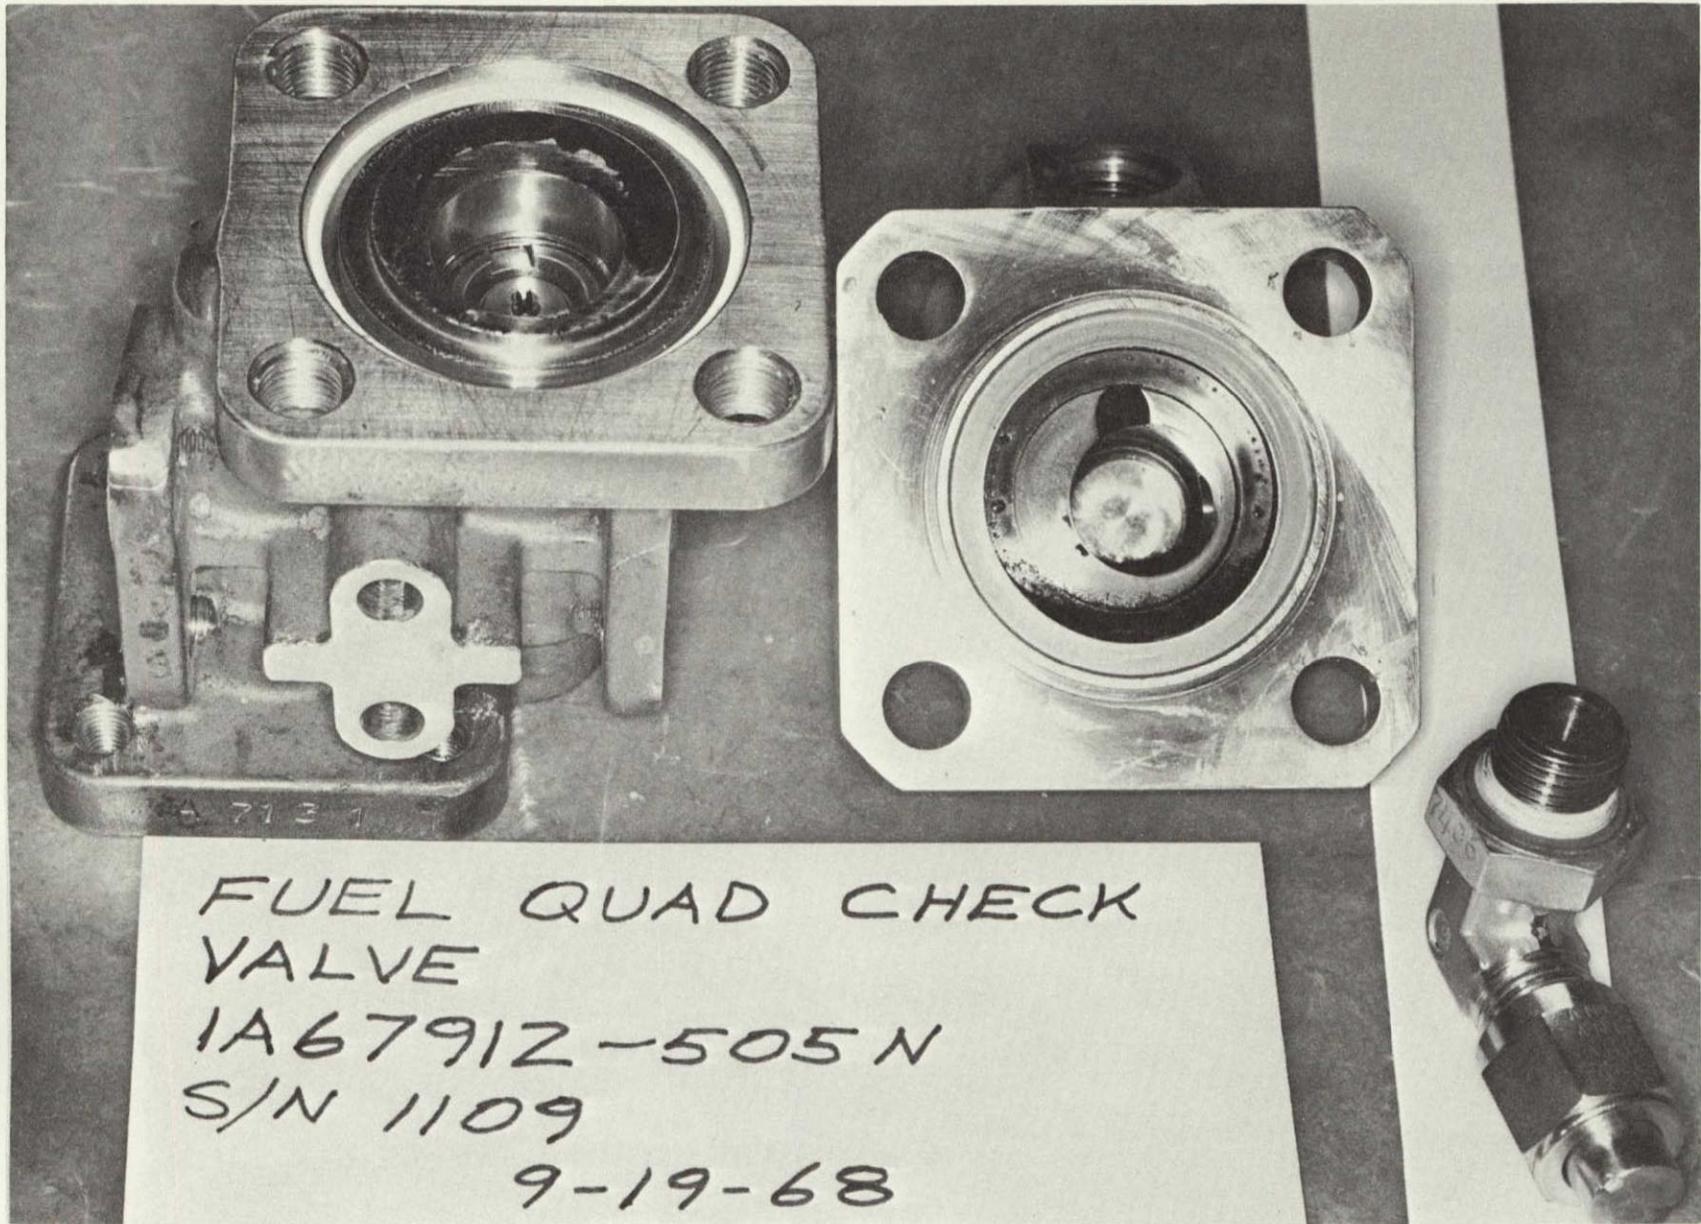
Figure 9-6. Fuel Quad Check Valve

- a. A large quantity of a black liquid substance was found downstream of the upstream check valves between series check valve and in the outlet flange of the valve (figure 9-6). This appeared to be the same type of liquid found in the fuel low pressure helium module and the tube assembly between the fuel quad check valve and the fuel low pressure helium module and was analyzed as a form of MMH.
- b. Two wear rings noted around upstream "A" check valve guide. No metallic particles were found.

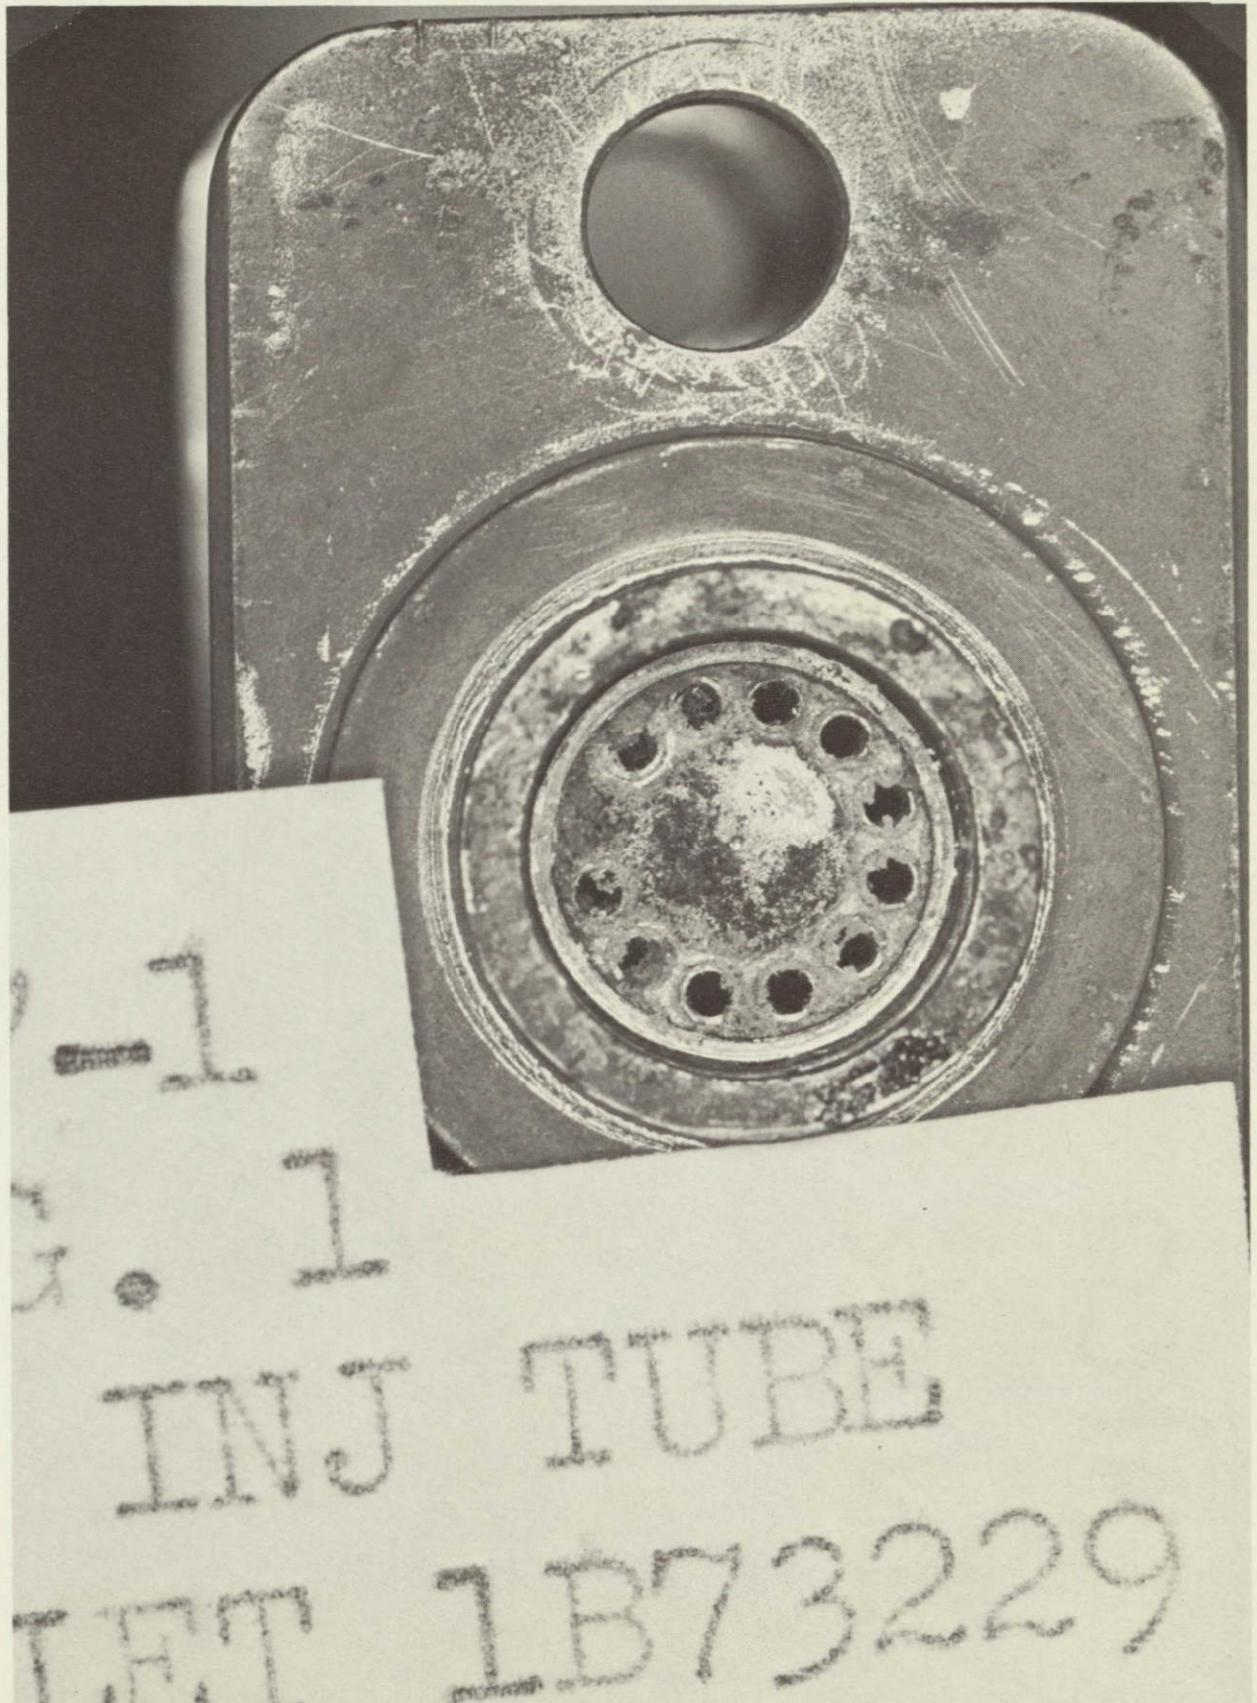
Figure 9-7. Oxidizer Injector Tube Inlet

- a. Oxidizer and fuel valves were clean of contaminants.
- b. A dry green substance was found underneath the oxidizer engine trim orifice at the injector tube inlet (figure 9-7). Analysis of this deposit is reported as a possible complex iron-nickel-nitrate compound. This deposit was similar to that found in engine No. 3, except that it was in a drier condition.
- c. Injector outlets were clean of contaminants.

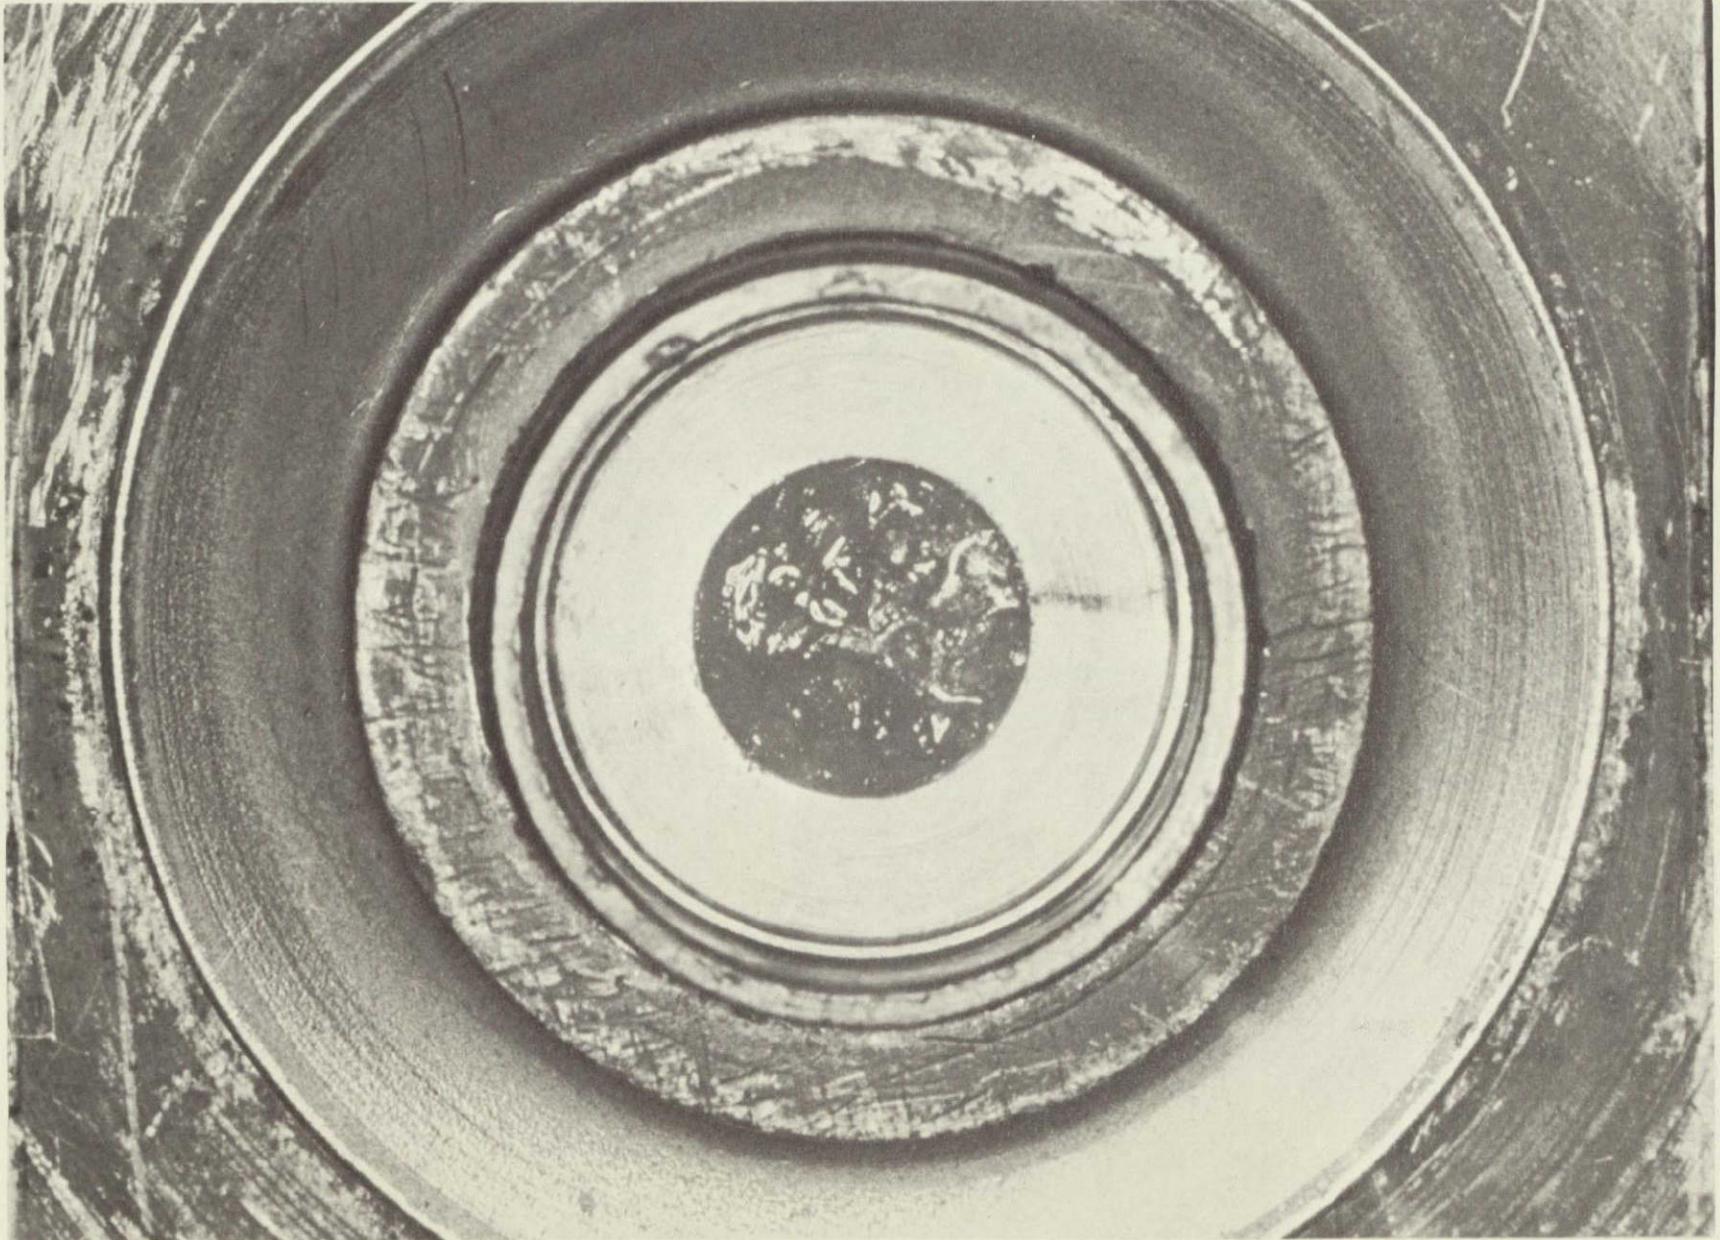
Figure 9-8. Oxidizer Trim Orifice (Sheet 2 of 2)

- c. A small gold-colored particle was noted on the L5 teflon seat.
- d. Several very small particles were imbedded in plunger L6 seal face.
- e. The area under the oxidizer trim orifice was found to have a jelly-like substance that seemed to have completely blocked the 12 oxidizer feed tube inlets (figure 9-8). After removing the trim orifice, which also contained some contamination on the downstream side, it was found that all but two oxidizer tube openings were blocked by a green liquid that appeared to be nickel nitrate - $Ni(NO_3)_2$ (figure 9-9).

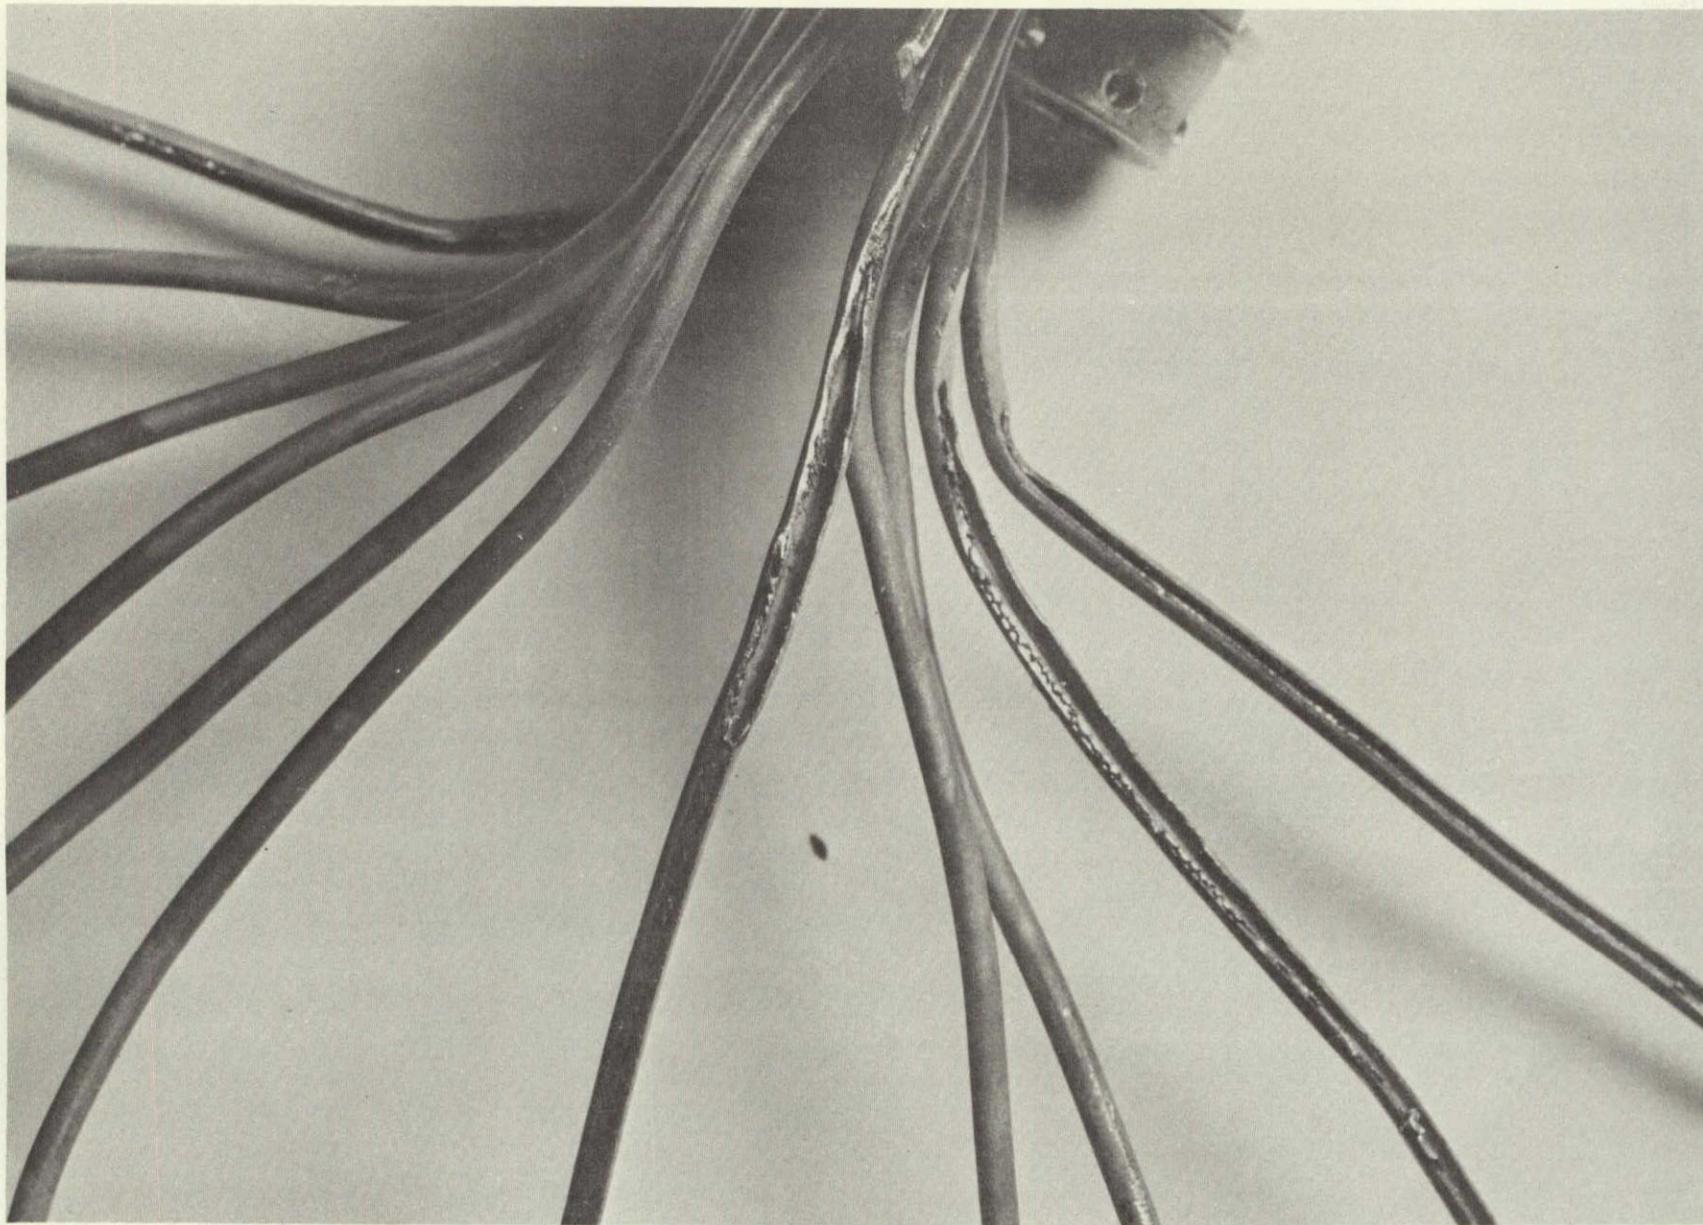
Figure 9-10. Oxidizer Injector Tube (Split)

- f. After removing the silver alloy heat sink and the oxidizer tube and flange assembly, 5 of the 12 oxidizer tubes were split (figure 9-10) with the following results:

- Tube No. 12 - Wet black liquid deposit. A wet chemical test, using Dimethyl Glyoxime, indicated the presence of nickel.
- g. Some deposits were noted at the oxidizer tube to injector interface plates. Figure 9-11 shows four such tubes, ranging from clean to partially blocked.

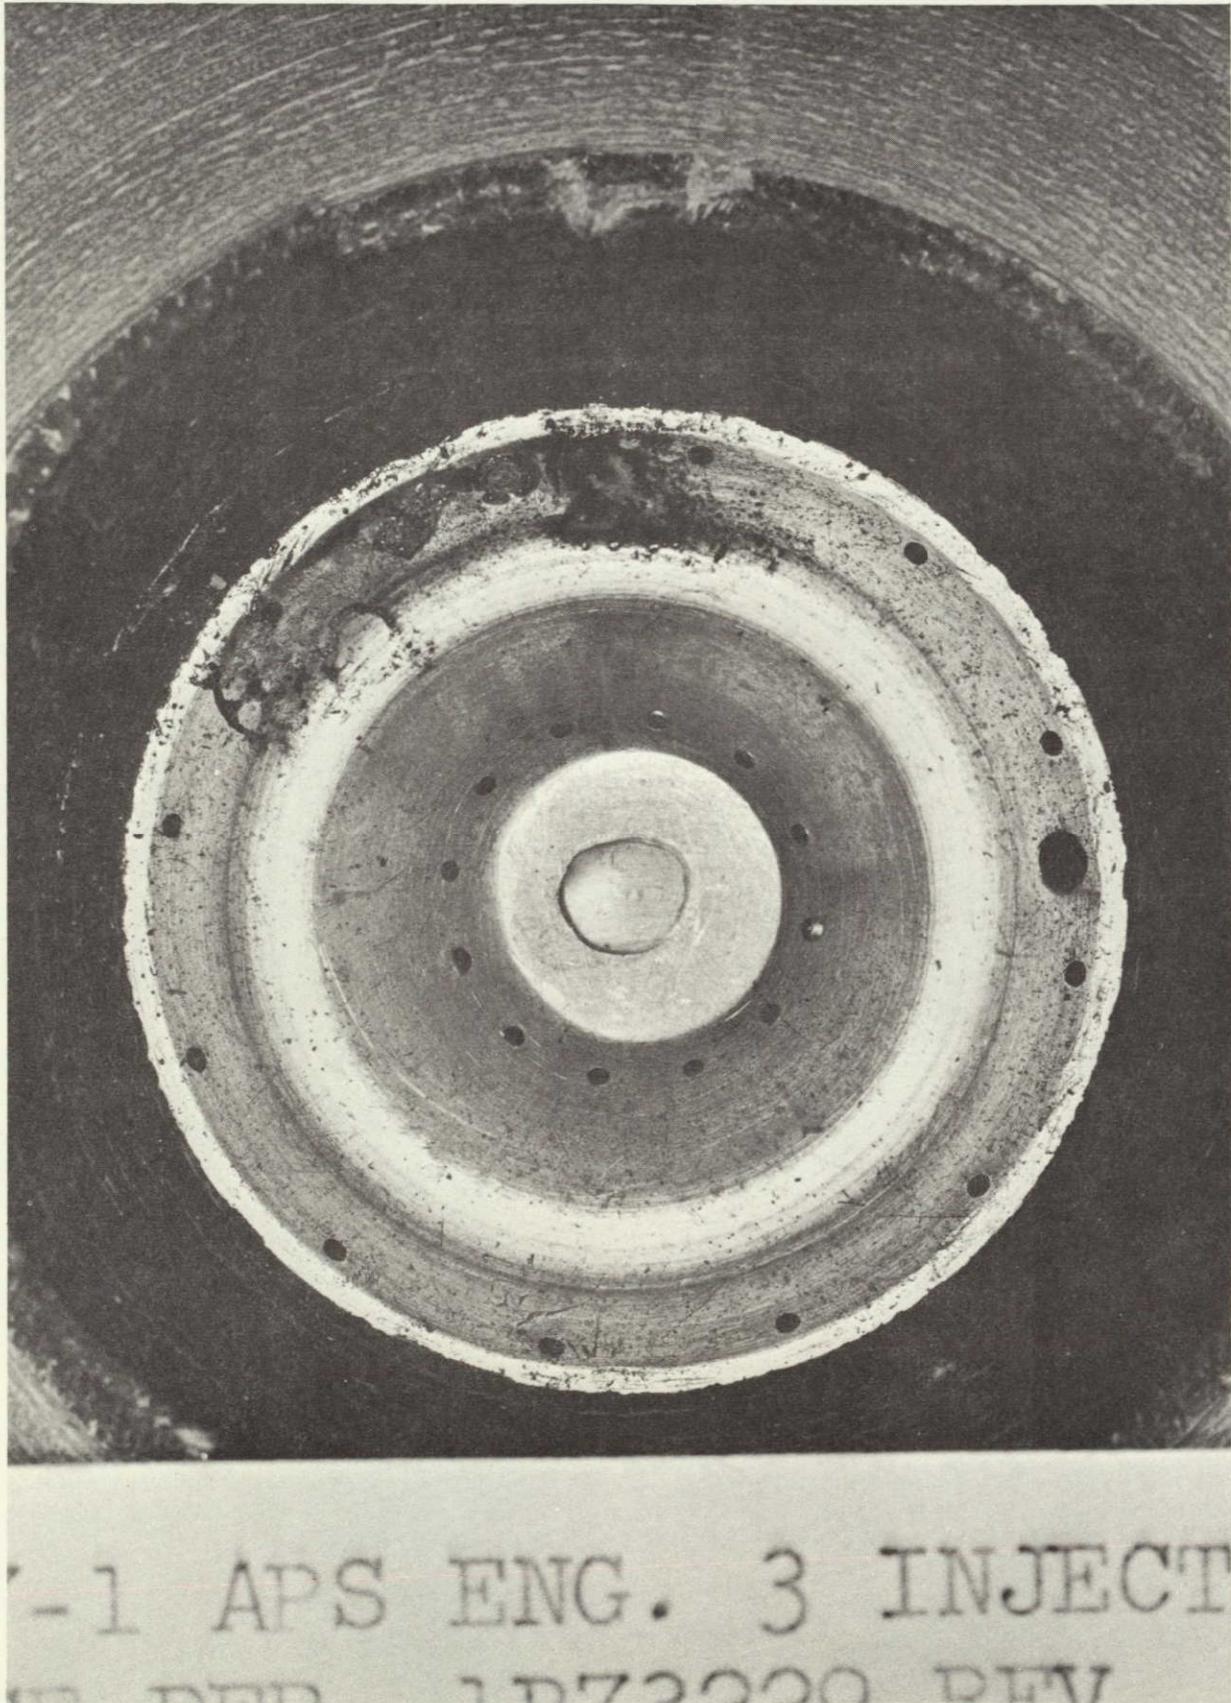
Figure 9-12. Injector Face

- k. A dark, heavy residue was noted on the injector face (figure 9-12).
- l. The combustion chamber and throat insert were free of contamination except injector face, chamber side, showed a black residue at the top and a white residue at the bottom. These were classified as probable combustion products.
