**S-IVB/V AUXILIARY PROPULSION
SYSTEM 90-DAY RECYCLE
CAPABILITY TEST REPORT,
MODULE I**

**DAC-56728
FEBRUARY 1969**

**PREPARED BY:
MCDONNELL DOUGLAS ASTRONAUTICS COMPANY
WESTERN DIVISION
SATURN S-IVB TEST PLANNING
AND EVALUATION COMMITTEE**

**PREPARED FOR:
NATIONAL AERONAUTICS AND
SPACE ADMINISTRATION
UNDER NASA CONTRACT NAS7-101
MODEL DSV-4B**

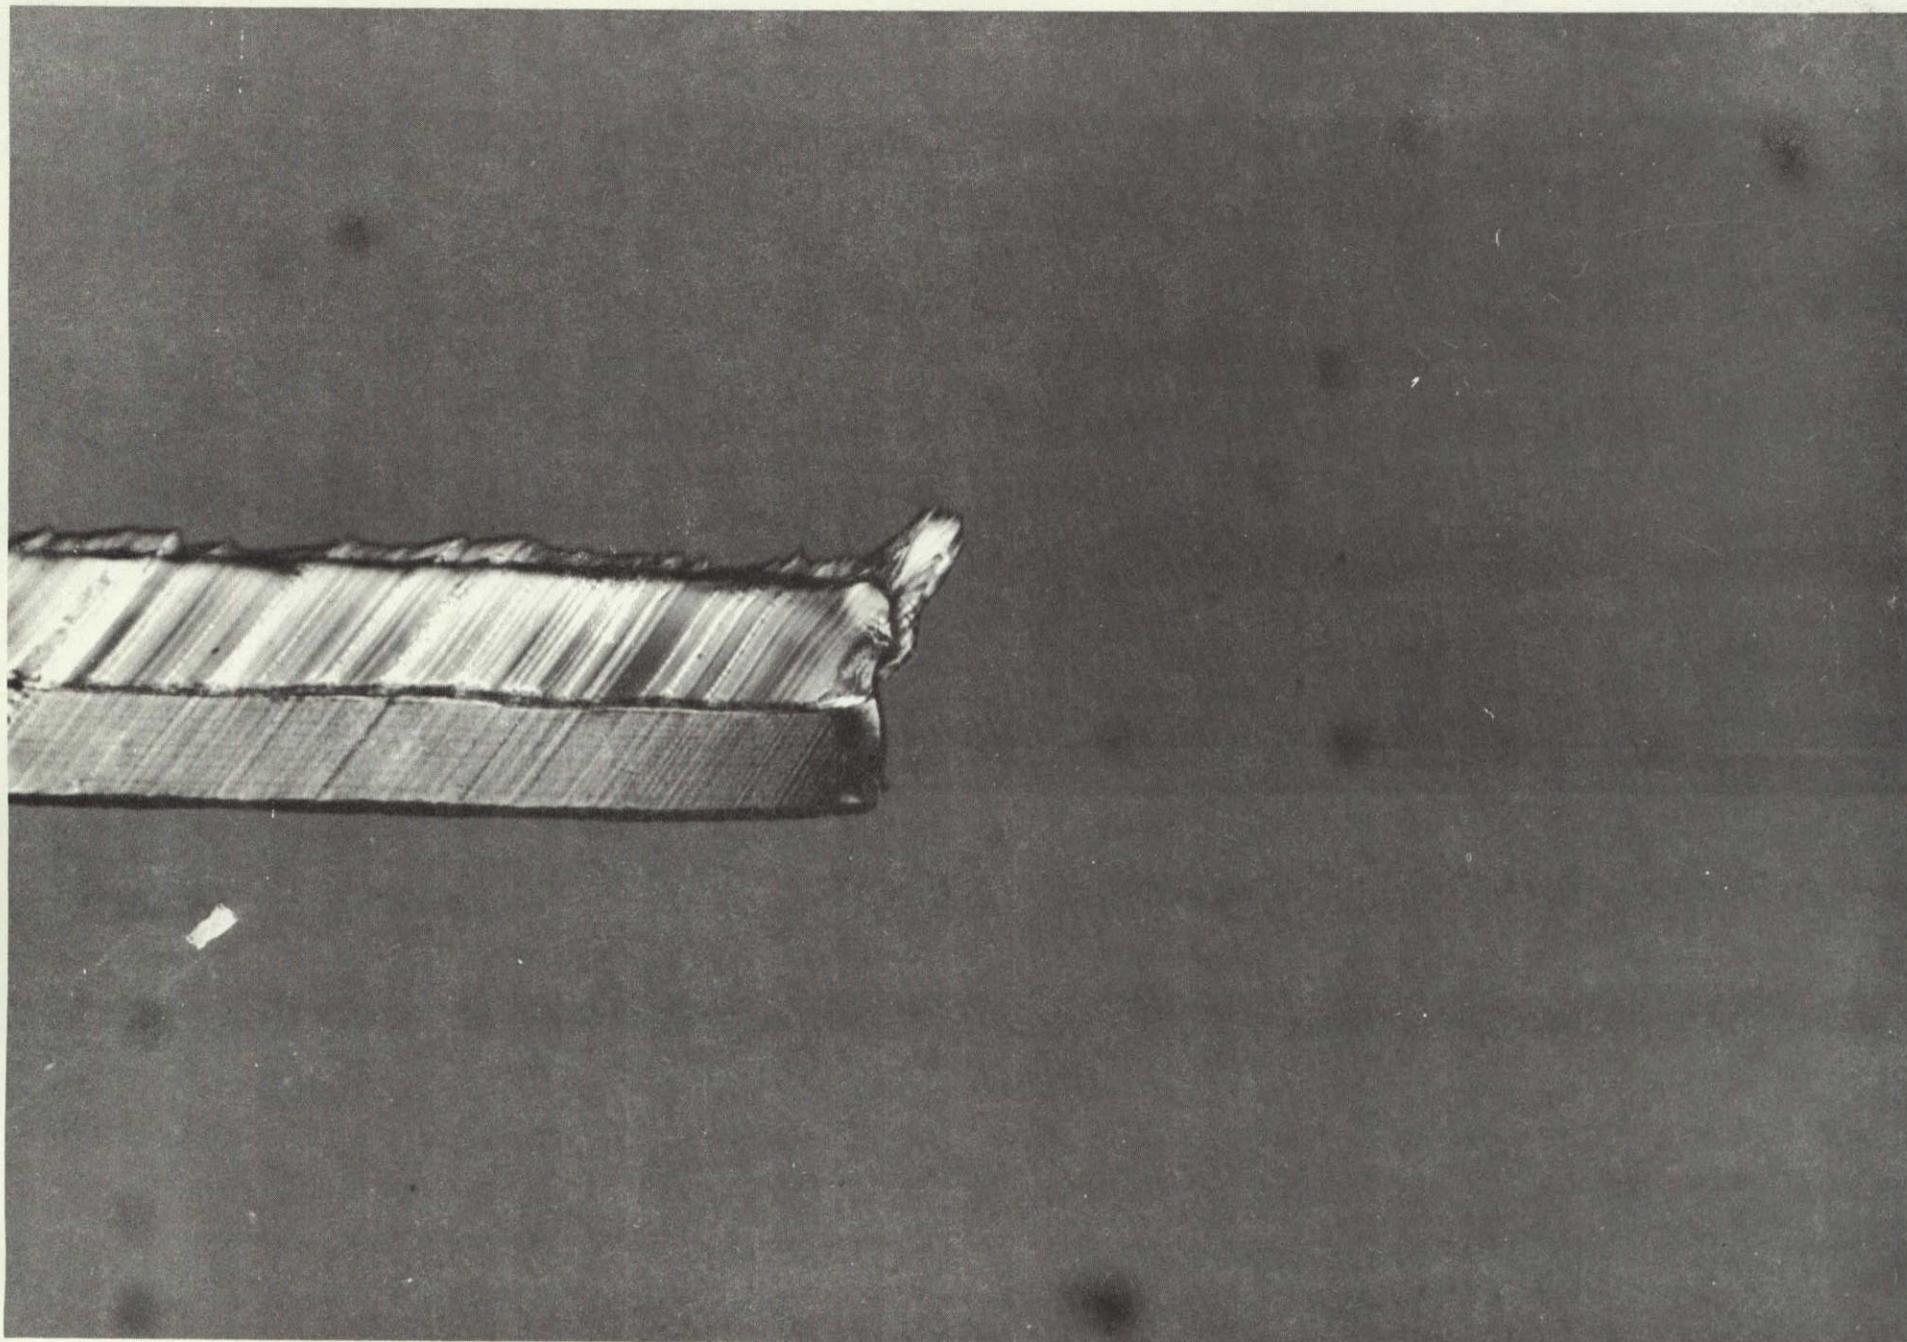
Figures 3 and 4 are typical microscopic cross-sectional views of both failures and are very similar in appearance. All sections taken along the lengths of the failures appeared similar and no failure origin points could be determined.

FIGURE 3 - TYPICAL SECTION, S/N 139-3

MAG: APPROX. 200X

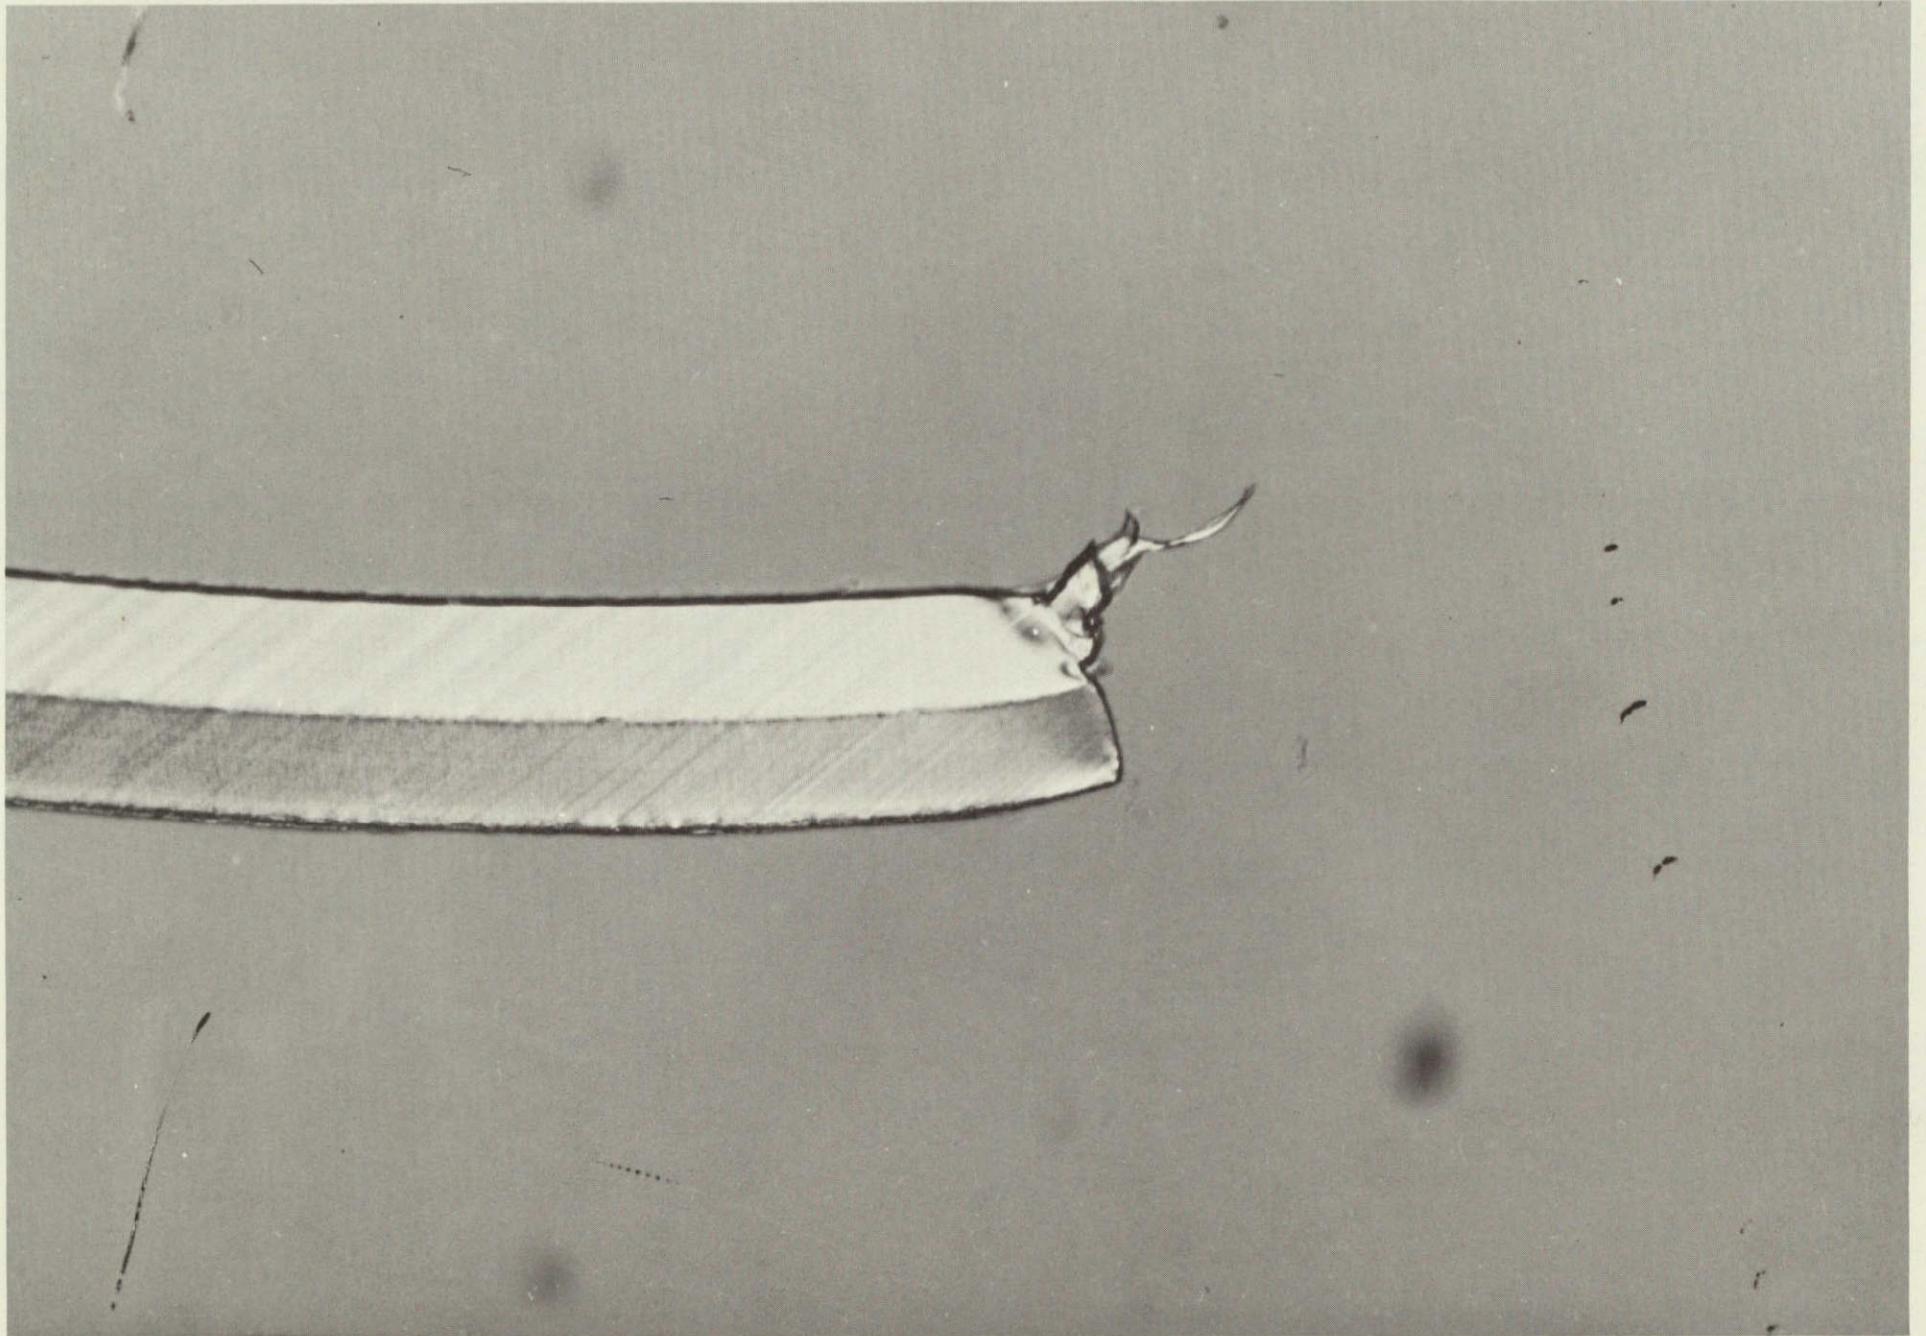
FIGURE 4 - TYPICAL SECTION, S/N 129-3

MAG: APPROX. 200X

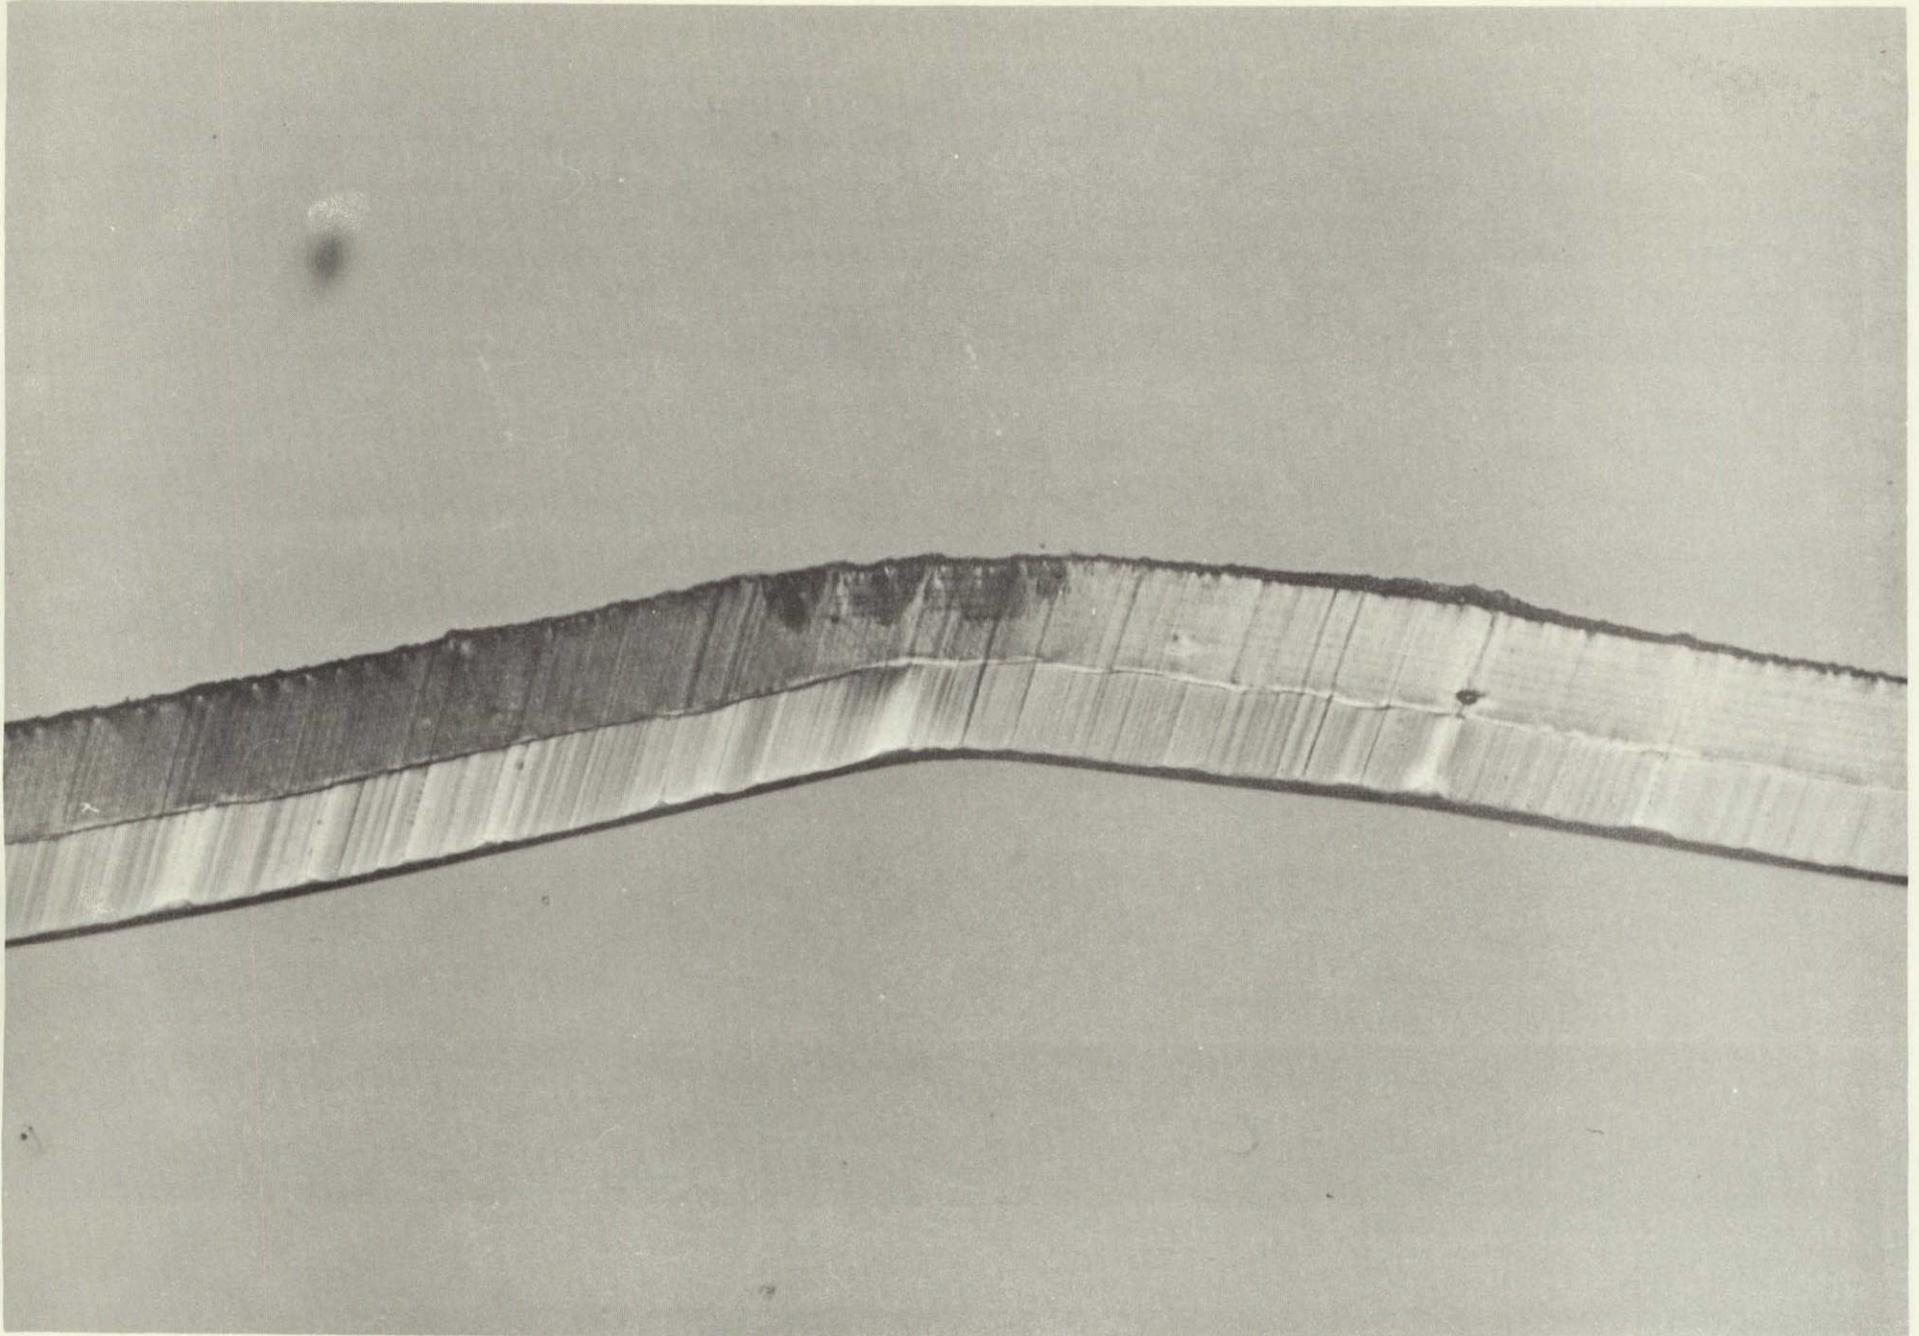
was of interest because of its uniqueness. The crease was cross sectioned and studied. This section (shown in Figure 5) shows little or no damage in the material from the hard crease. Polarized light showed some birefringence which was indicative of some residual stress in the crease.

FIGURE 5 - SECTION THRU HARD CREASE IN S/N 139-3 (QUAD. II)

MAG: APPROX. 170X

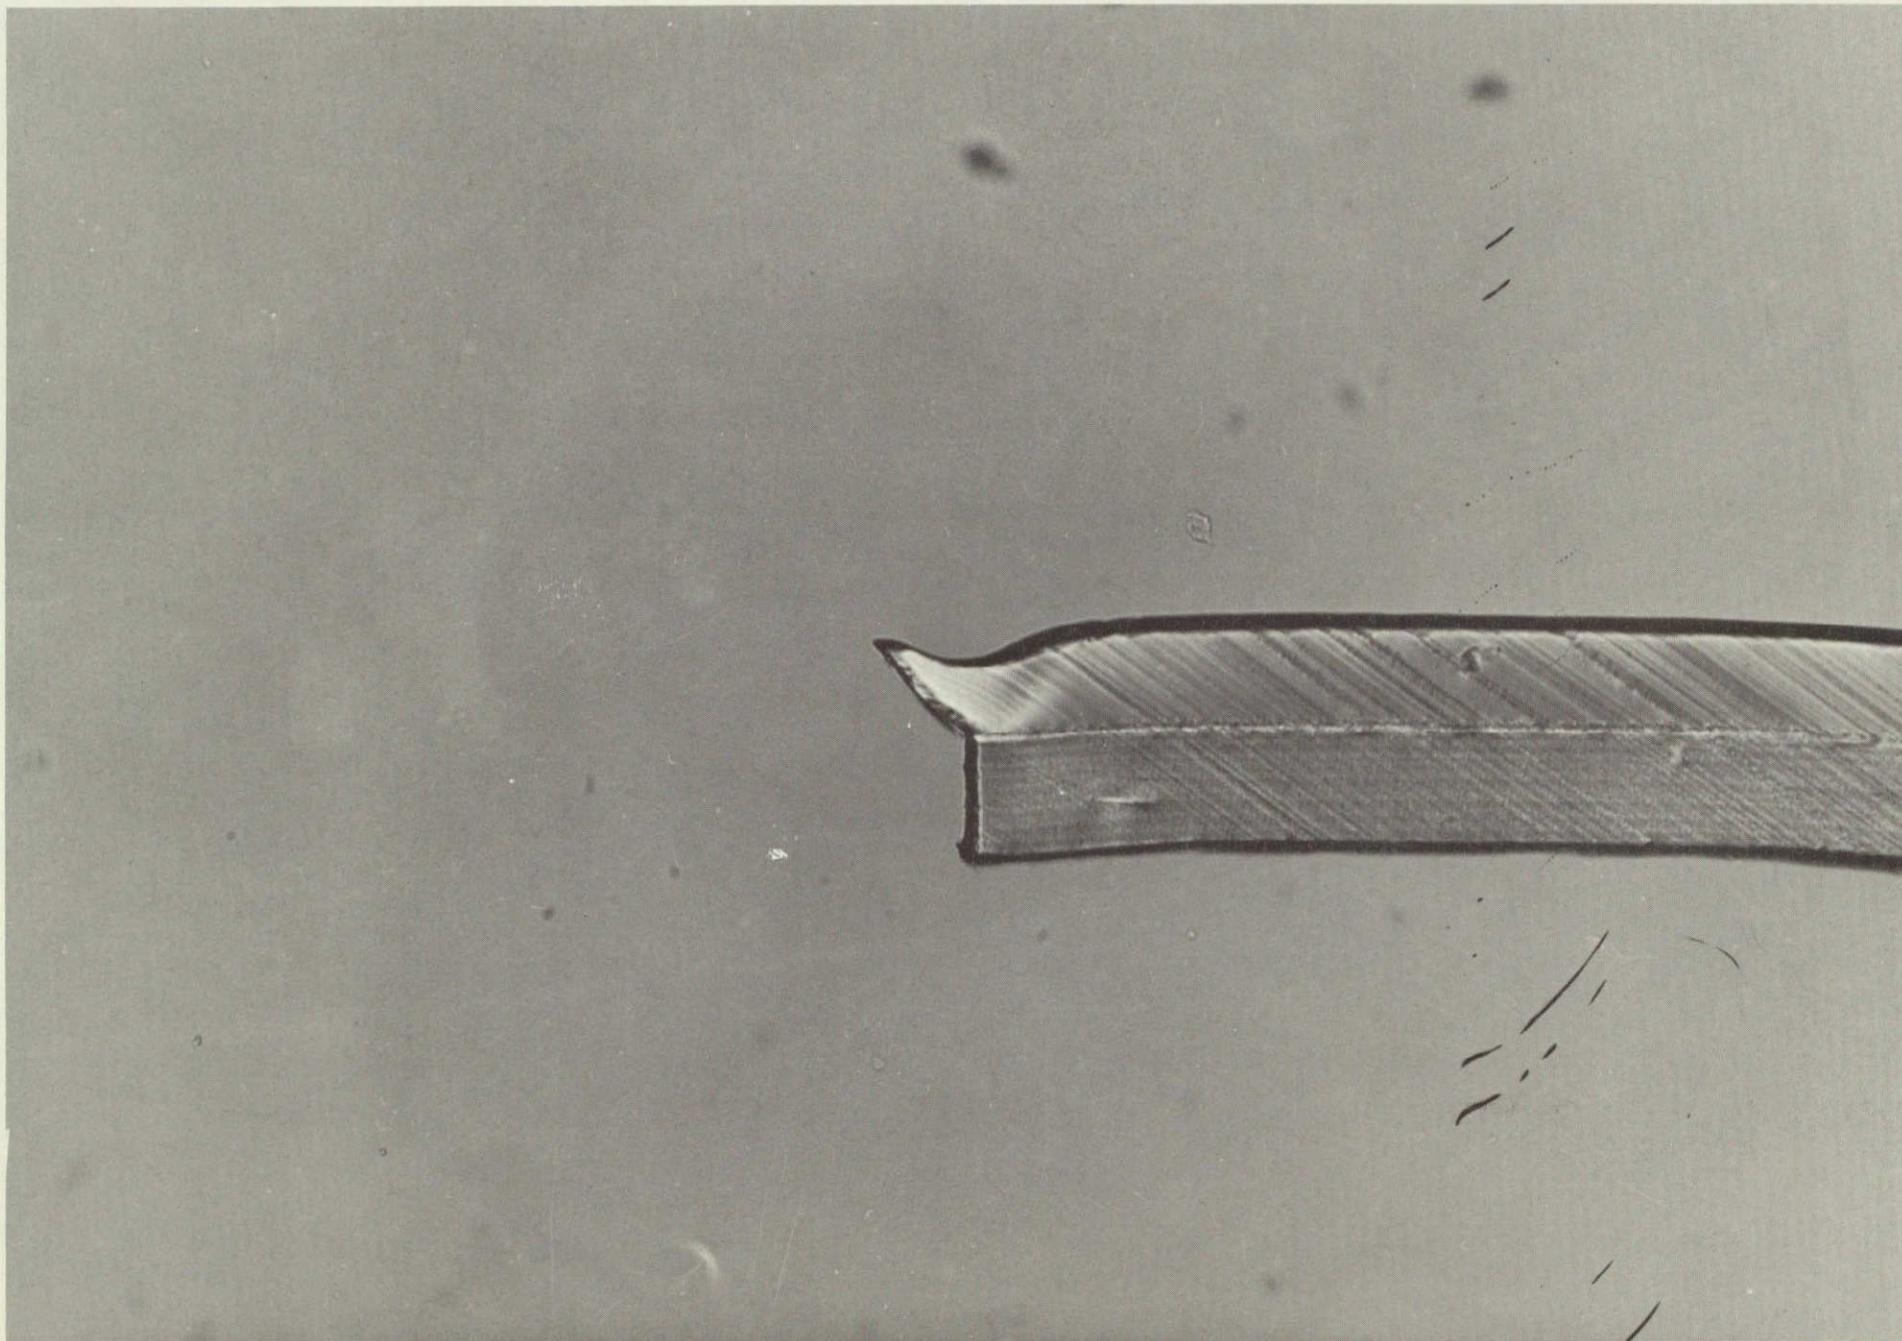
Failure reproduction by shock was performed by connecting a 40-pound weight to one end of a 1/2 inch wide 6-mil laminate specimen which was clamped at the other end. The weight was dropped a distance of one foot. Figure 6 is a microtome section through a shock failure. Note the similarity to the failures shown in Figures 3 and 4 in that there is no TFE elongation, slight FEP elongation, and no

FIGURE 6 - TEFLON LAMINATE (6 MIL)
- SHOCK TEST

MAG: APPROX. 200X

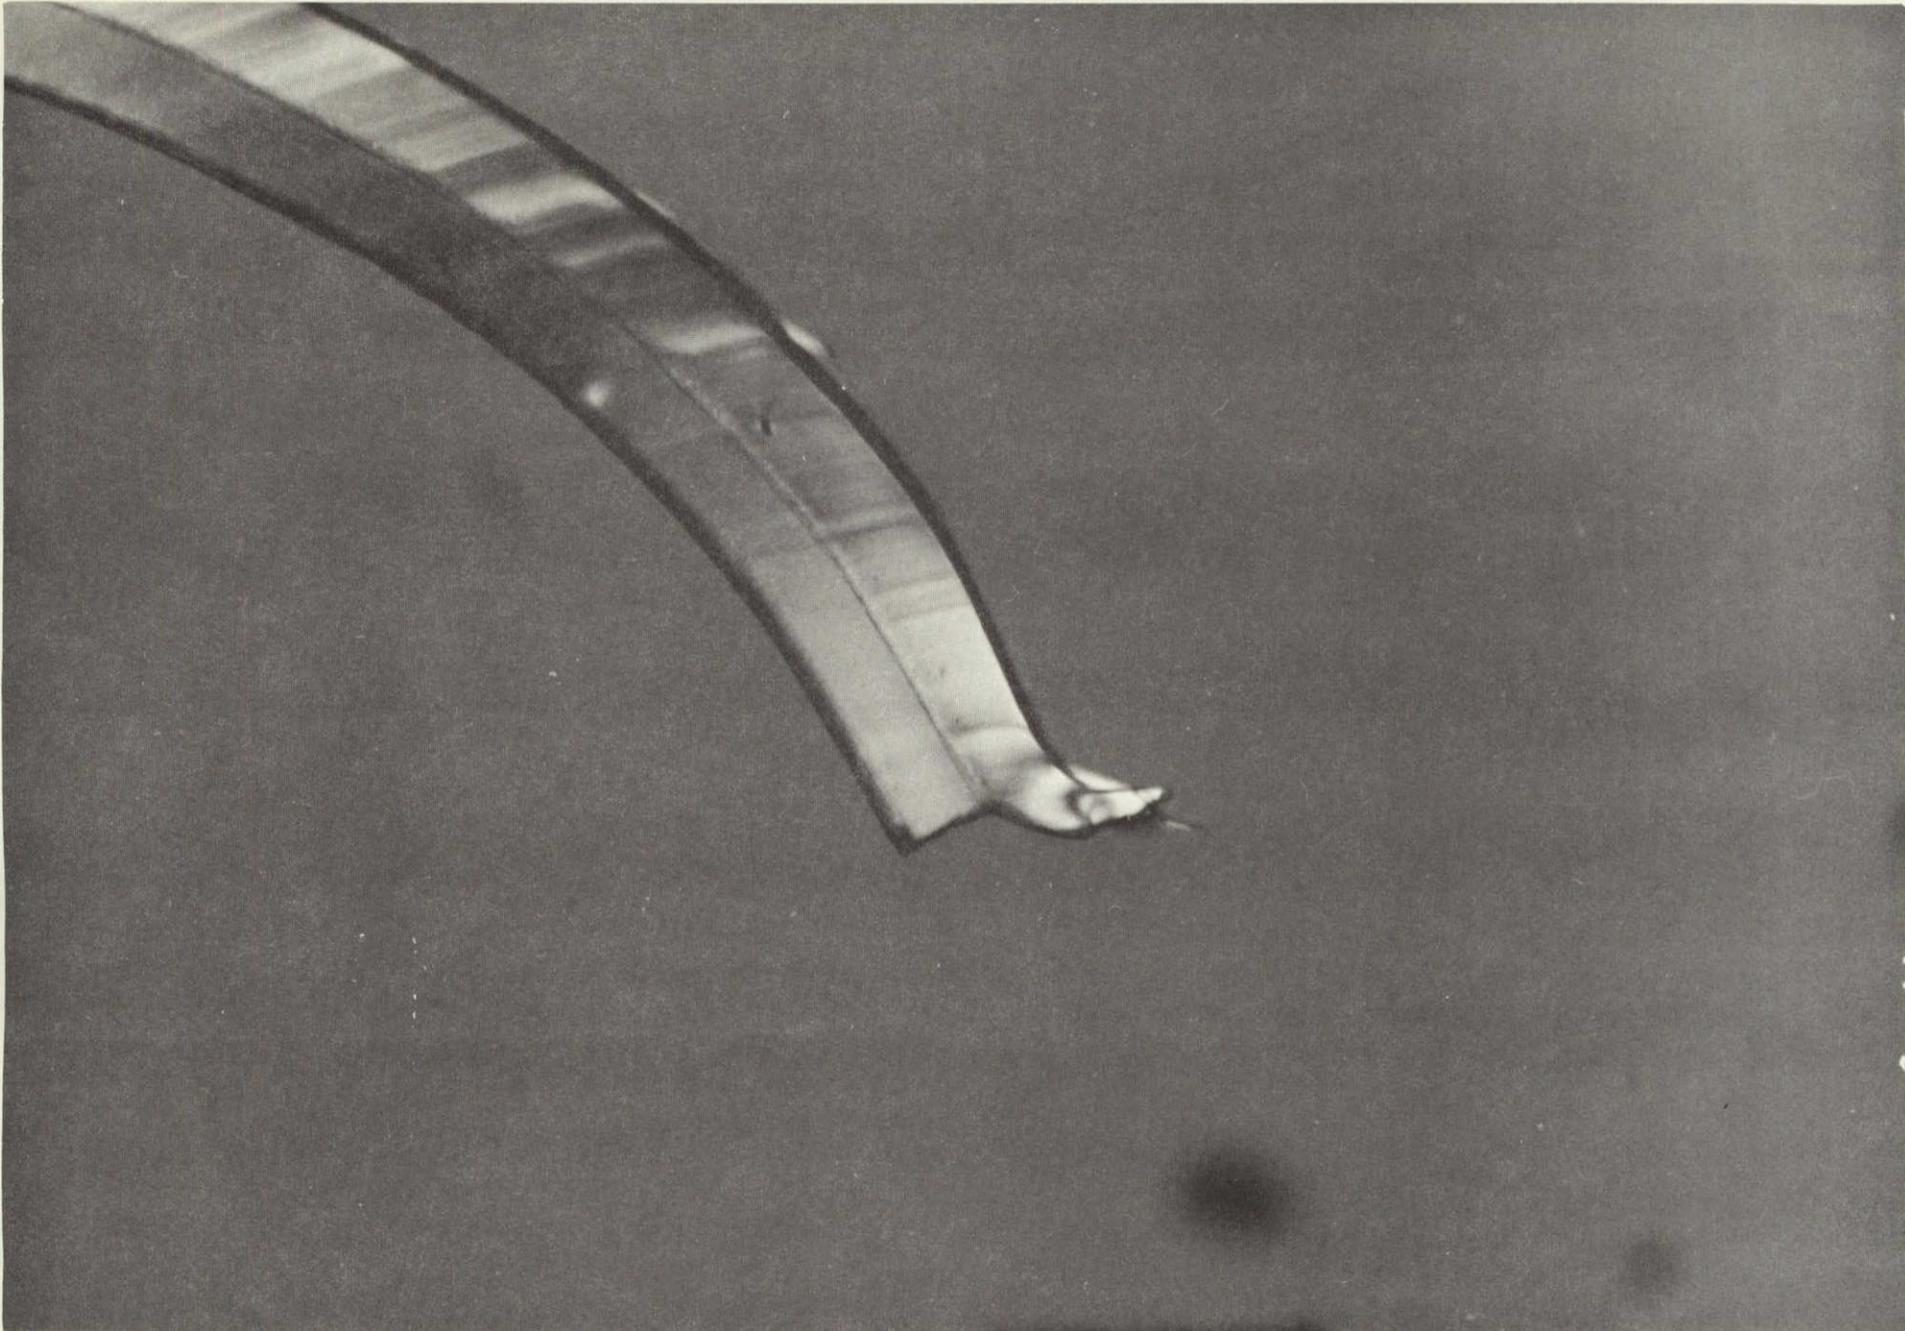
Figure 7 shows a failure produced by a shock load on a 6-mil laminate specimen preconditioned with 25,000 single flexure cycles (unsupported). This is also very similar to that of Figures 3 and 4.

FIGURE 7 - TEFLON LAMINATE (6 MIL)
- FOLD PLUS SHOCK TEST

MAG: APPROX. 200X

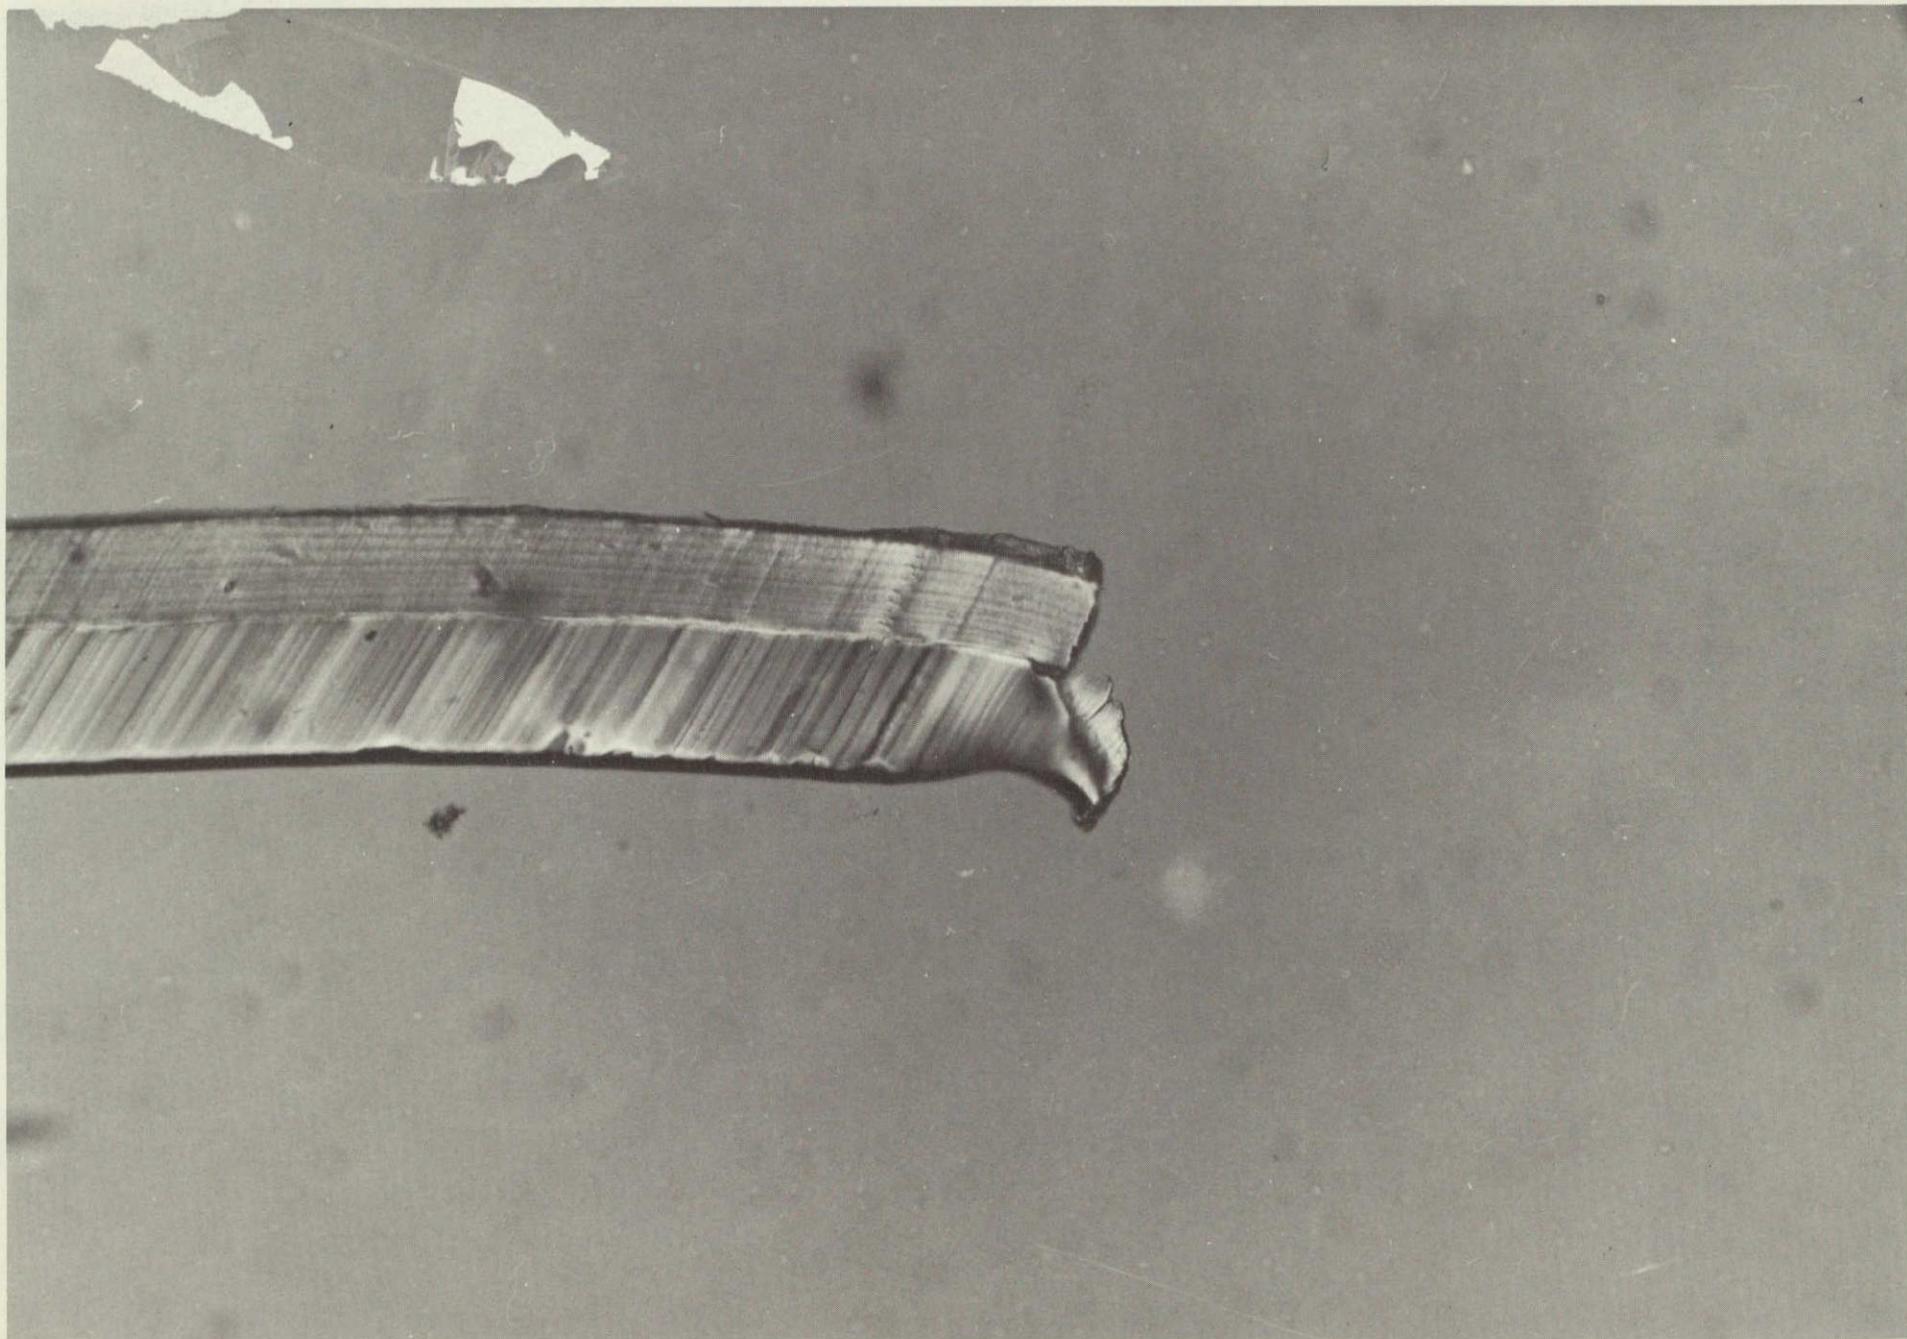
It is thought that a bladder failure once started could propagate by tearing either through handling during removal from the tank or from stress during subsequent testing. Specimens of 6-mil laminate material were notched and then subjected to a steady tearing action. Sections of this tear were microtomed and examined. Figure 8 is a typical photomicrograph of a tear and is also very similar to the actual failures (Figures 3 and 4).

FIGURE 8 - SECTION THRU TEFLON LAMINATE (6 MIL) - TEAR TEST
