THERMAL CYCLING EFFECTS ON SOLAR CELL INTERCONNECTION TABS ON AN OAO-B SAMPLE MODULE

X-761-71-315

Clara M. Vermillion

July 1971

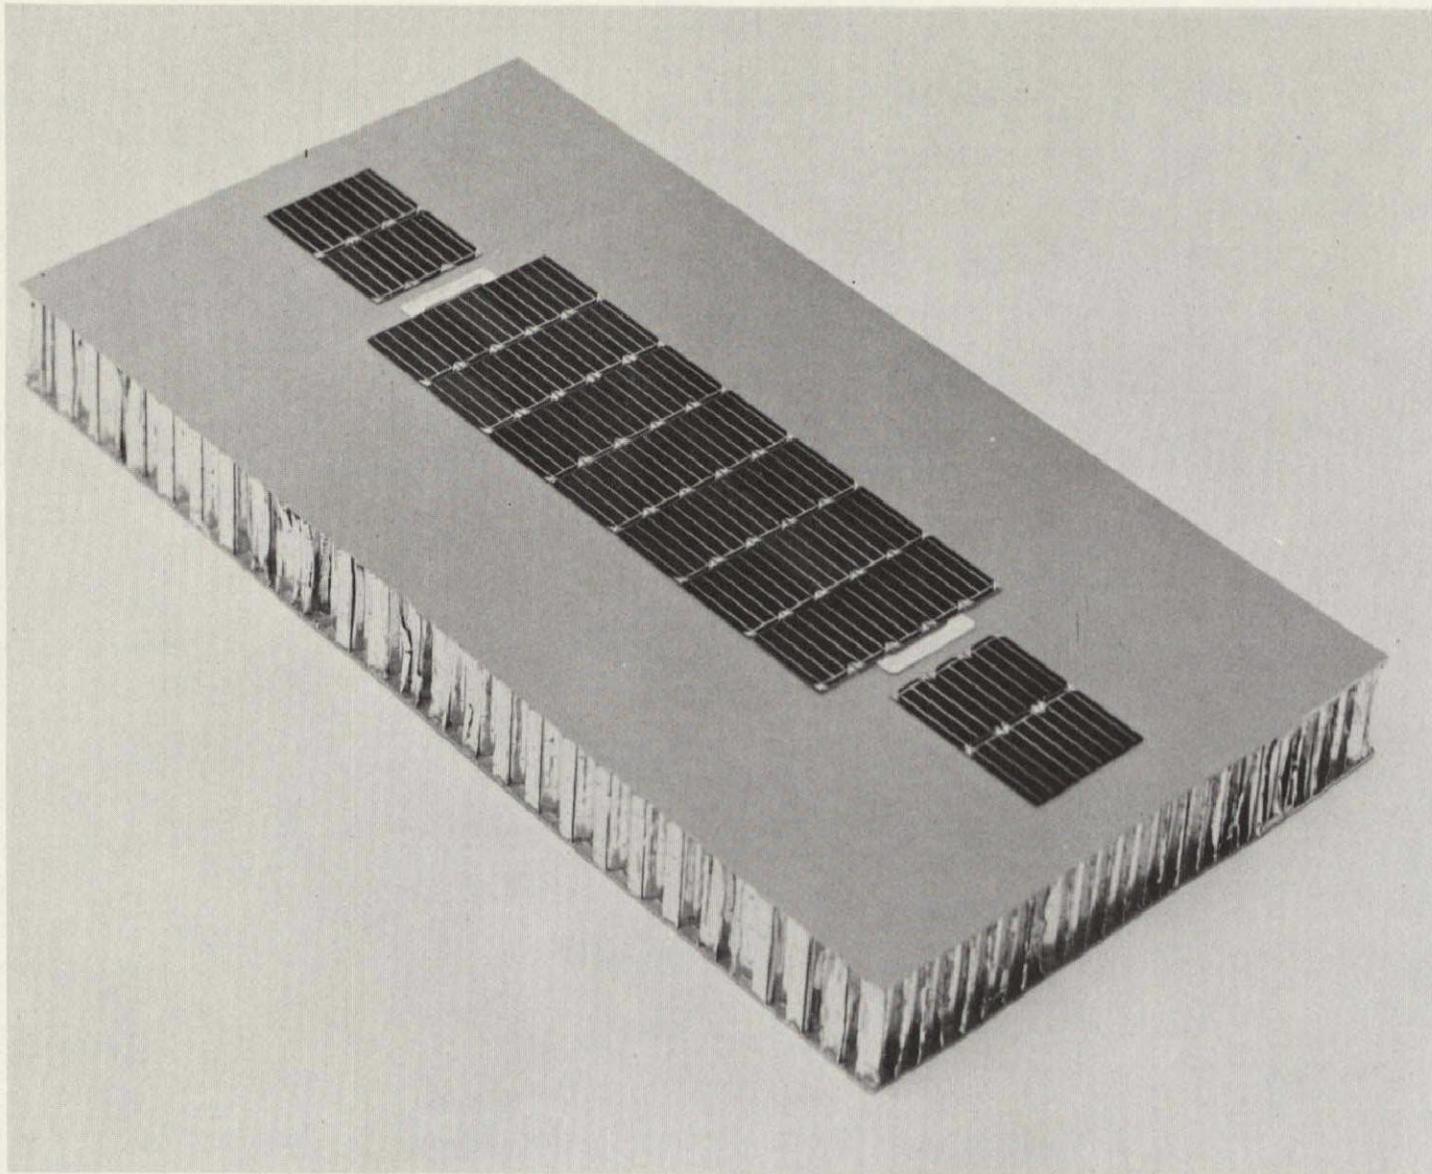
Figure 1. OAO Test Module

A sample module (Figure 1), specified to be of flight quality workmanship and typical of the OAO-B solar array, was obtained from Spectrolab, the manufacture of the OAO-B solar paddles. This module was specified to be of flight quality workmanship but including bent and spliced tabs. It was also specified to consist of a substrate, solar cells, and interconnectors the same as on the S/C #3 paddles.

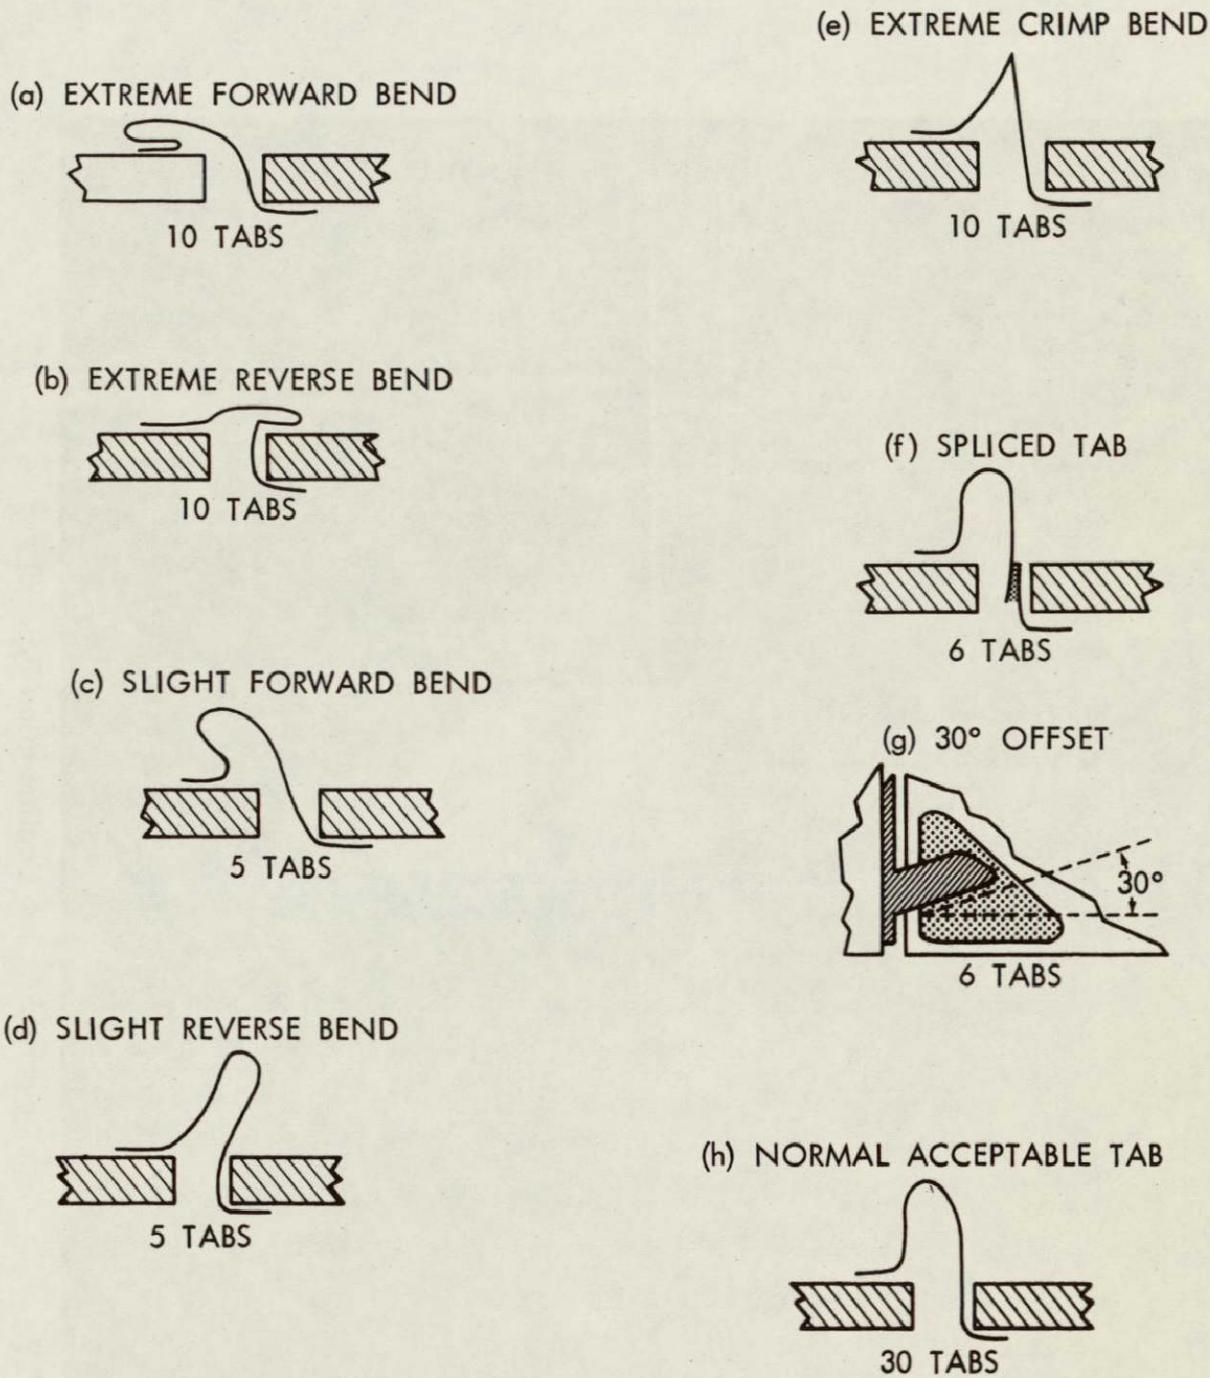
Figure 2. Various Tab Configurations

The overall size of the module substrate is $5\text{-}\frac{3}{4}\text{'}$ x $10\text{-}\frac{3}{4}\text{'}$ x $1\text{-}\frac{1}{4}\text{'}$. The cells used are all 2 x 1 cm corner dart cells with two interconnecting tabs each. The cell configuration consists of three cell groups. Two of the groups have two cells in series and three cells in parallel. One of these is located at the top of the substrate and the other at the bottom. The third group is located in the middle of the substrate. This group is made up of seven cells in series by five cells in parallel. All three groups are bonded to a typical OAO paddle substrate section. After the mounting of the cell groups to the substrate, a number of the tabs were bent into the various configurations as indicated in Figures 2a through 2e. In addition, others were soldered as shown in 2f (spliced) and 2g (soldered out of line). Figure 2h shows the normal tab configuration.

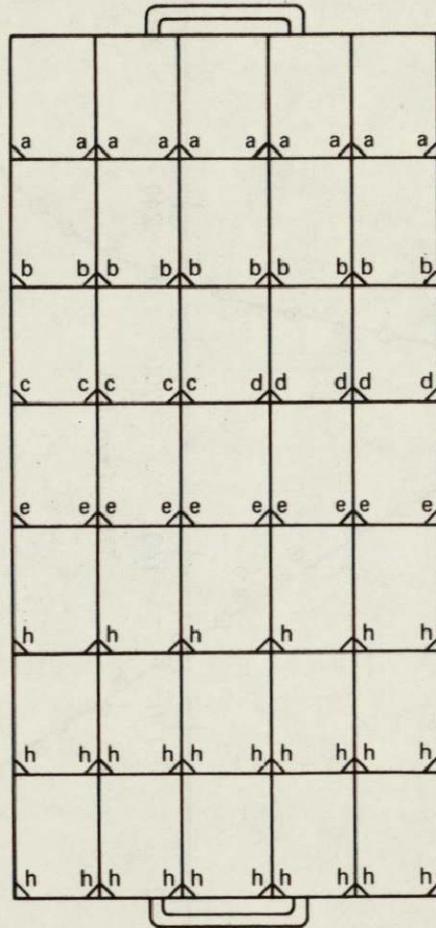
Figure 4. Intended Location of Various Tab Configurations

the location of each type of the sample tabs (Figure 4). The initial inspection was performed using 30 power magnification. The results of this inspection were recorded.

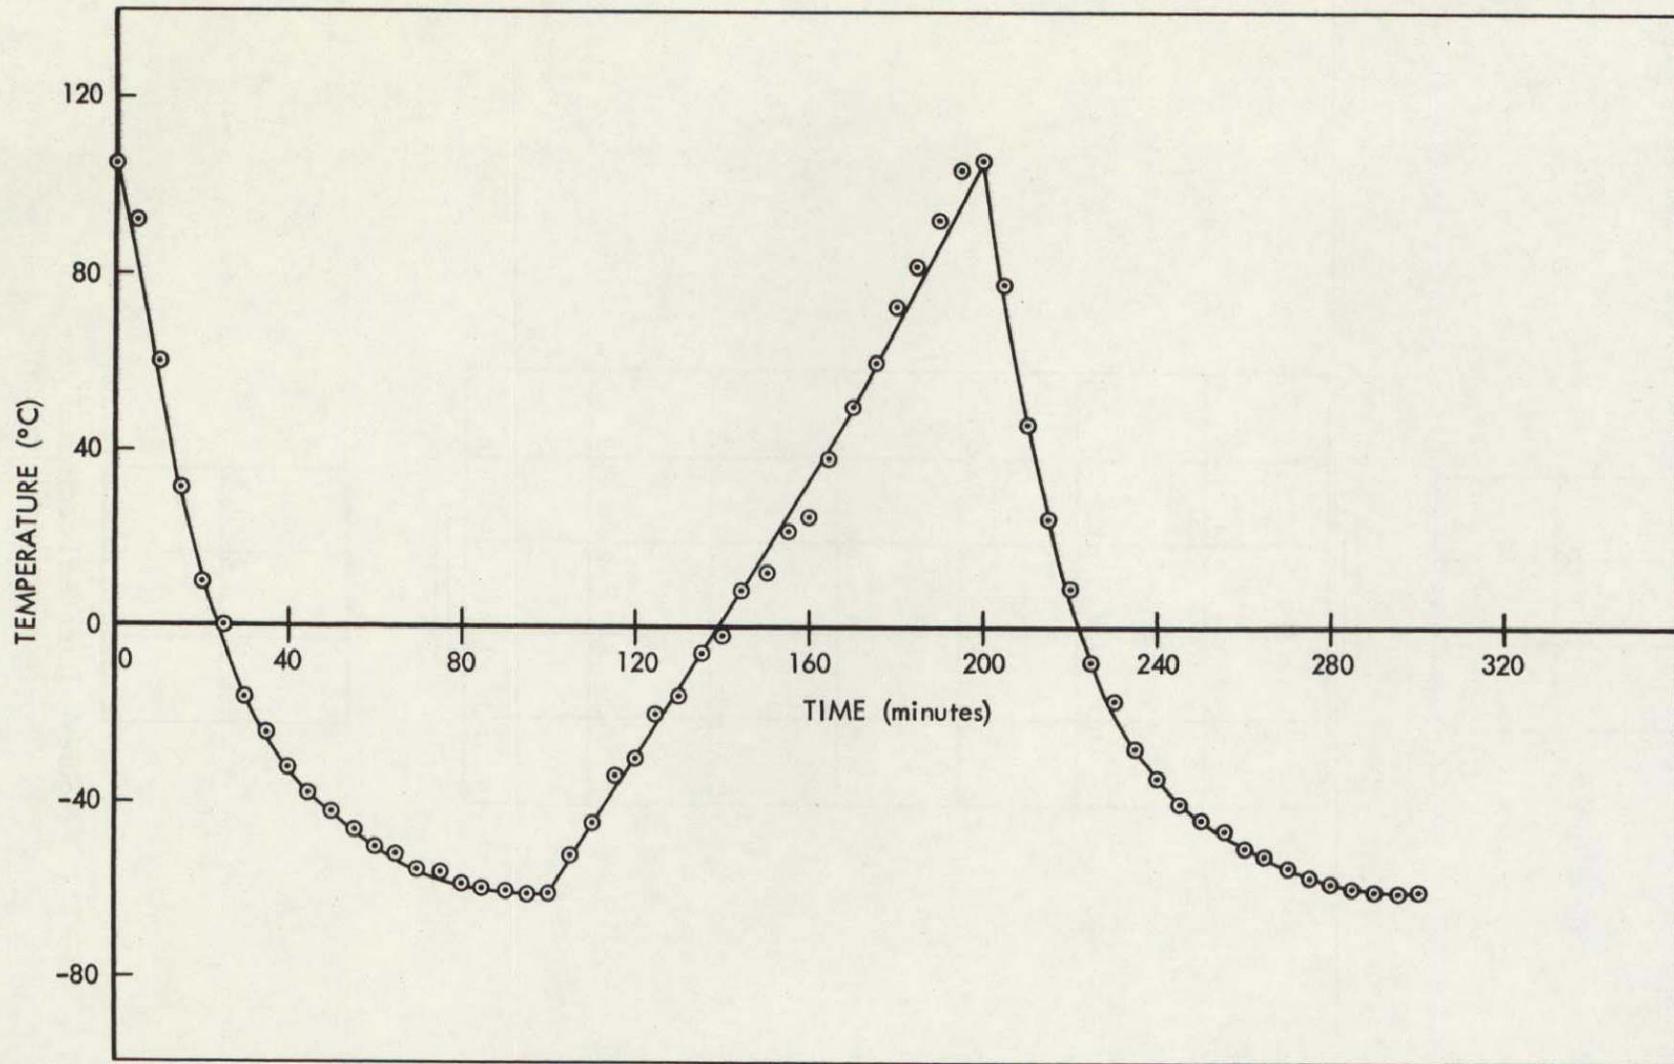
Figure 5. Typical Temperature Cycling (1-1/2 Cycles)

After the initial inspection the sample module was subjected to the thermal cycling test for 50 cycles. This test was performed between the limits of +104° C and -60° C, the temperatures expected in flight. Typical cycle data are shown in Figure 5.
