MSC-05101

APOLLO 14 MISSION  
ANOMALY REPORT NO. 1

FAILURE TO ACHIEVE DOCKING PROBE  
CAPTURE LATCH ENGAGEMENT

MANNED SPACECRAFT CENTER  
HOUSTON, TEXAS  
OCTOBER 1971

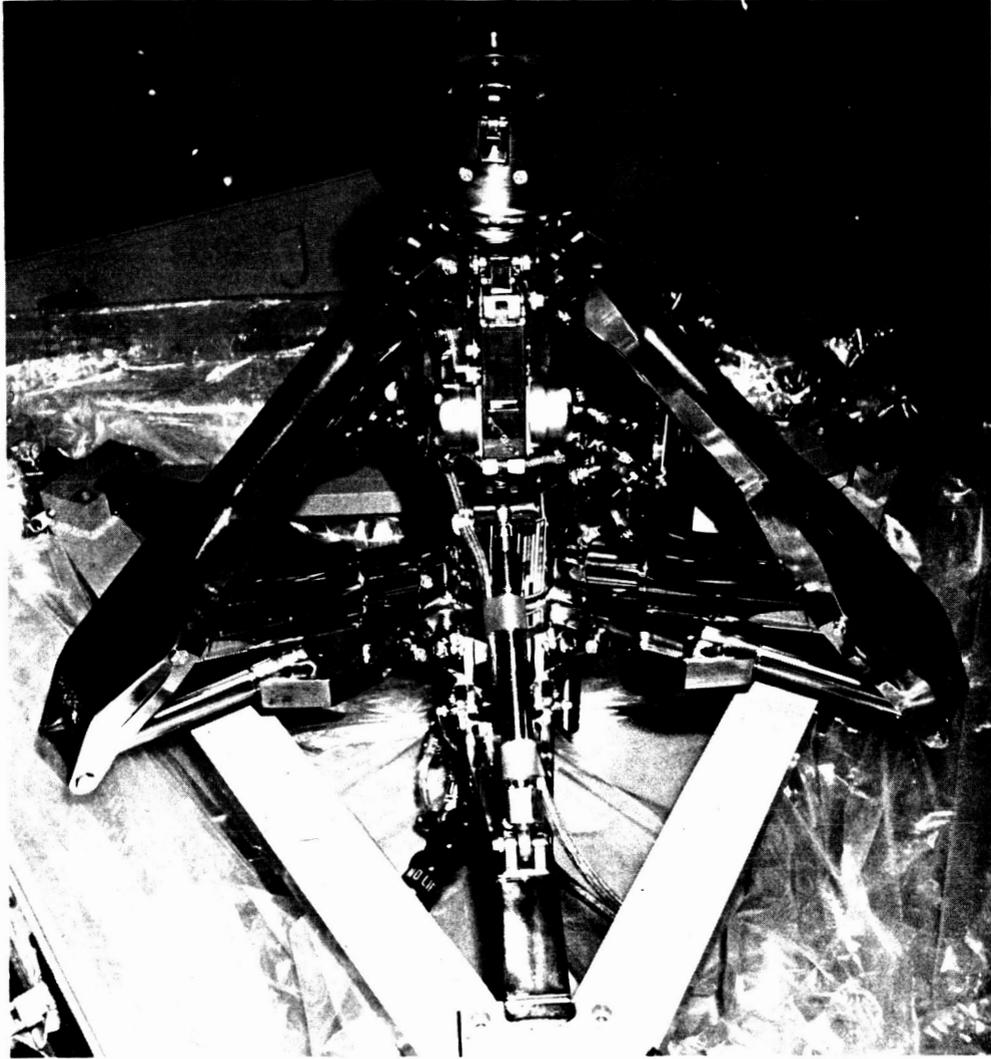
Figure 1.- Apollo 14 probe assembly.

Six docking attempts were required in order to successfully achieve capture latch engagement during the transposition and docking phase following translunar injection. After docking, the probe (fig. 1) and drogue (fig. 2) were examined by the crew. Probe operation appeared normal and radial marks were noted on the drogue. During all subsequent operations, the probe operated properly.

The docking probe (fig. 1) is a tripod-mounted device that serves as the active portion of the docking system. The probe incorporates provisions for the initial capture of the lunar module, energy attenuation, command module/lunar module retraction, relative vehicle alignment, and undocking. The three probe support arms are made of titanium and most of the remaining structure is aluminum with a nickel-plated exterior finish to provide passive thermal control. The structural items (fig. 4) consist of the central cylinder, a piston, a collar, three pitch arms, three shock struts, and the three support arms. The primary subassemblies of the probe consist of the capture latch assembly, the actuator assembly, the capture latch release handle, the nitrogen pressure system, the ratchet-handle assembly, the extend latch/preload assembly, the shock struts, and the attenuators.

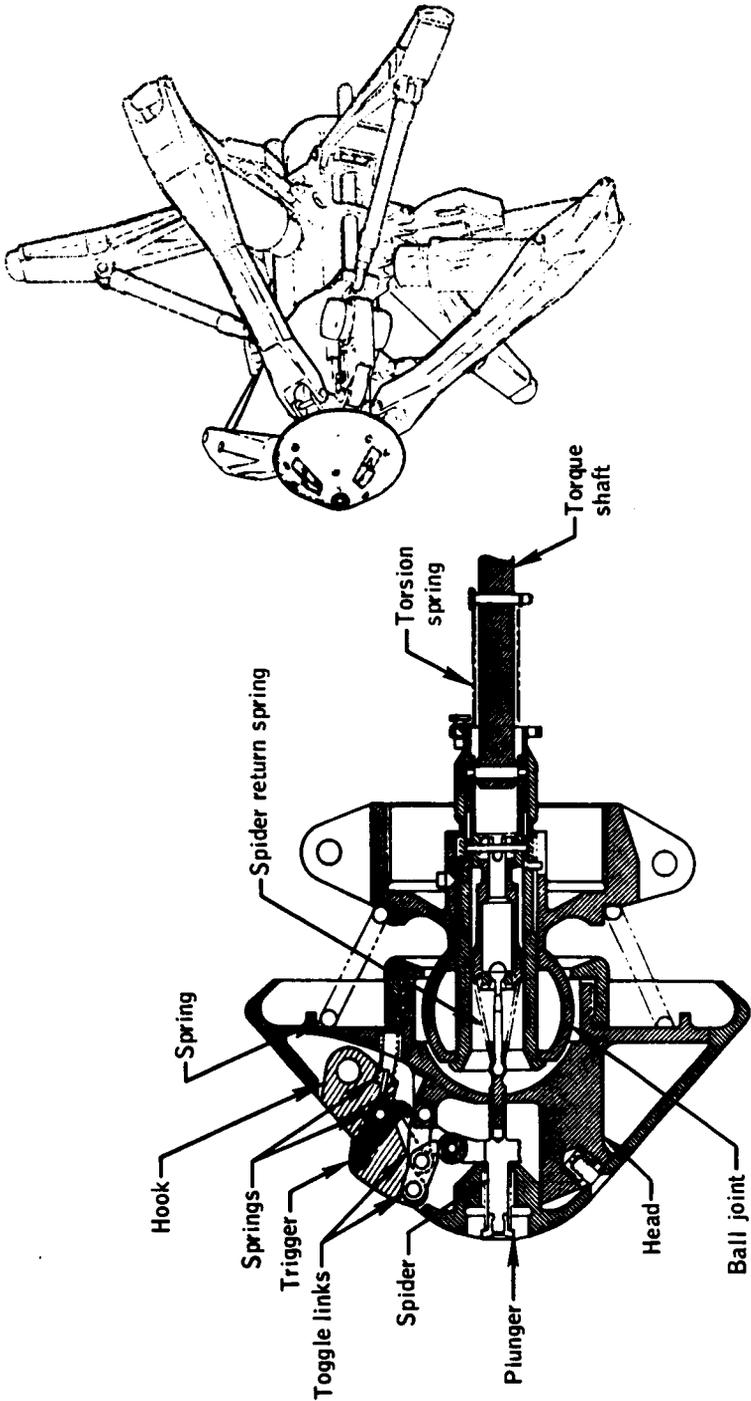
Figure 5.- Probe capture latch assembly shown in locked position.

The probe capture latch assembly (fig. 5) is contained within the probe head and is used for achieving the initial coupling between the command module and lunar module. Figure 6 shows the probe latches locked to a test tool in the same manner as they lock to the drogue. The capture latch assembly consists of three latch hooks (fig. 7) which are pin mounted in the probe head and spring loaded such that the hook protrudes beyond the surface of the probe head. Opposite each of the latch-hook pivot points is a two-piece toggle link (fig. 5) that connects the latch hook to a fixed point on the probe head.

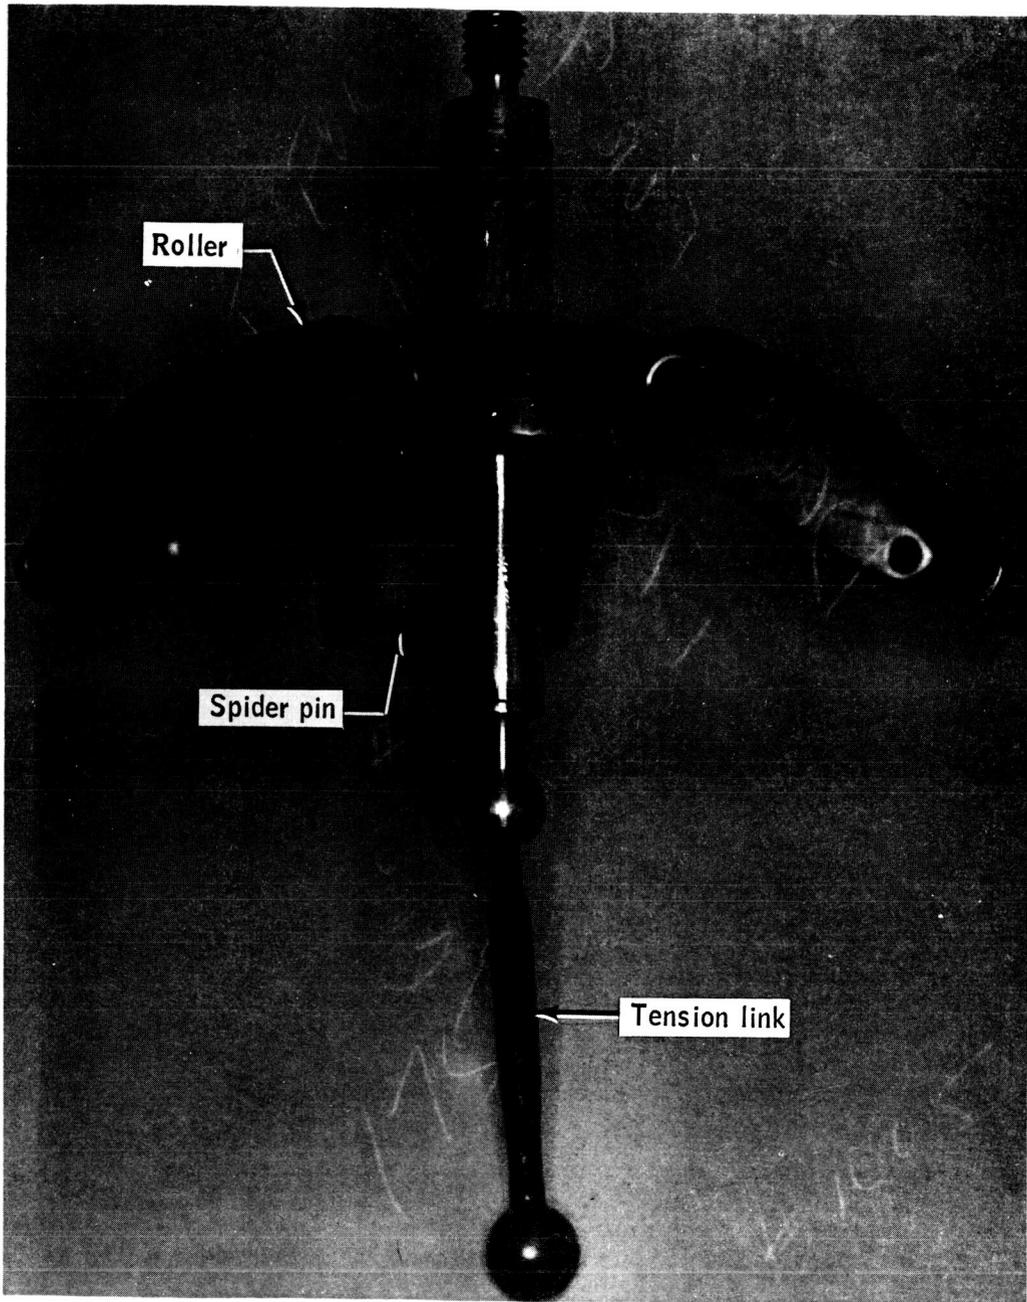
Figure 8.- Spider assembly.

Locking and releasing of the latch hook is determined by the axial position of a single, symmetrical spider (fig. 8) which is spring loaded to the full forward (locked) position (fig. 5). In this position, a roller on the spider (fig. 7) rests beneath each of the latch-hook toggle links such that the latch hooks cannot be depressed. To unlock the latch hooks, the spider must be moved aft and retained until subsequent latch lock is required (fig. 9).

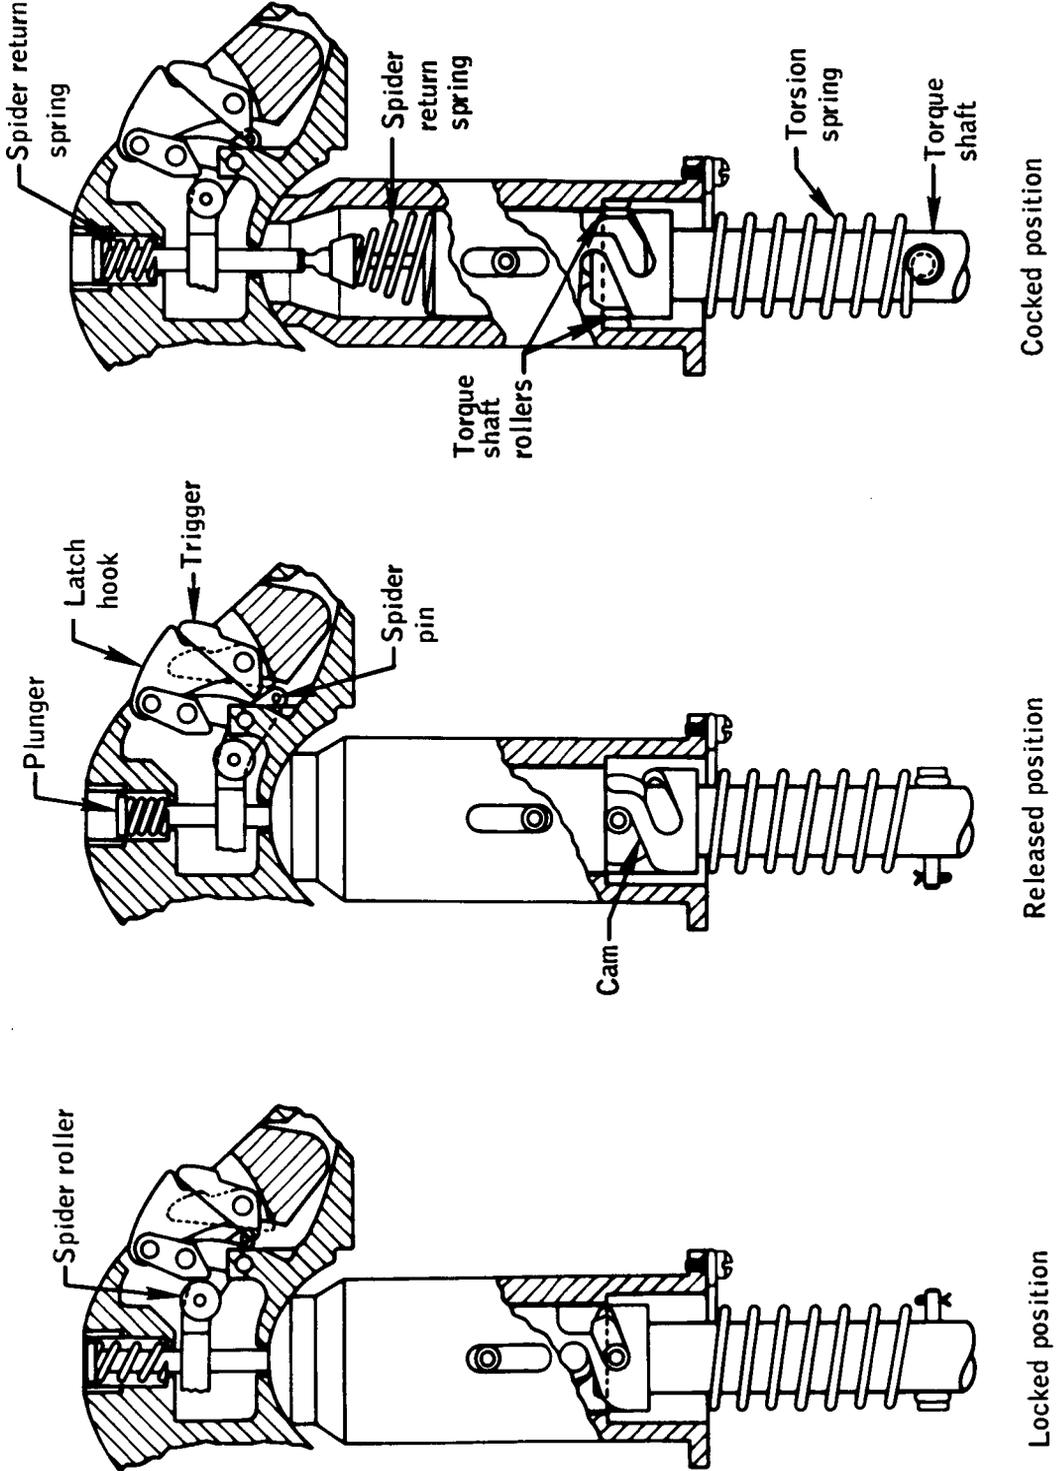
Figure 9.- Relationship of probe latch and cam mechanisms.

Spider retention and release is achieved by triggers located within each of the latch hooks. When the spider is moved aft of the spring-loaded triggers and released, pins located on the outer tip of the spider (fig. 9) bear against the back face of the trigger and thereby prevent forward travel of the spider. To release the spider, all three triggers must be depressed simultaneously since any one of the triggers will retain the spider in the aft position. The spider can be moved from the forward to the aft position by manually depressing the plunger in the probe head or by rotating the torque shaft. The torque shaft has two rollers which ride in helical slots in a cam (figs. 9 and 10). The cam is attached to the spider with a tension link. When the torque shaft is rotated by either manually actuating the capture latch release handle or by powering the torque motors in the actuator assembly (fig. 11), the rollers turn in the cam slots and force the cam and the spider aft (fig. 9). When power is removed from the torque motors, the torsion spring on the torque shaft rotates the shaft back and allows the spider to move forward until cocked, i.e., the spider pins ride against the back of the triggers.

1. The probe status talkback displays functioned properly before and after the unsuccessful attempts, thus indicating proper switch operation and power to the talkback circuits. The talkback displays always indicated that the capture latches were in the cocked position during the unsuccessful attempts (fig. 9). (Note that no electrical power is required to capture the drogue, because the system is cocked prior to flight and the capture operation is strictly mechanical and triggered by the drogue.)

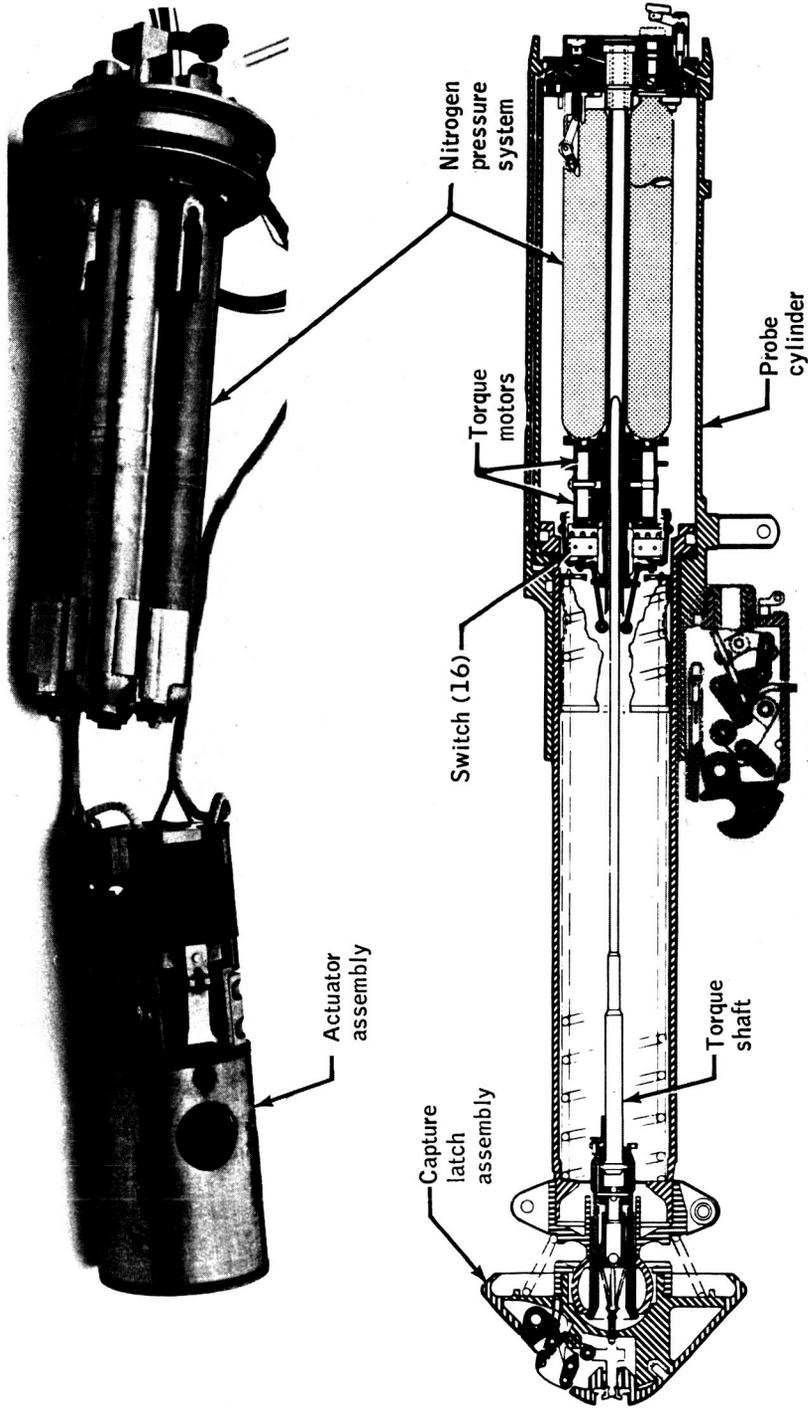
Figure 11.- Cutaway of probe assembly in extended and cocked position.

The actuator assembly (fig. 11) consists of two tandem-mounted dc torque motors, 16 switches, and required electrical circuitry, all located within the probe cylinder. The motor output is such that single-motor operation provides sufficient torque to unlock the capture latches. The drogue (fig. 2), a truncated cone structure that is installed in the lunar module tunnel, and serves as a guide and receiver for the probe head.
