# GENERAL INSTRUMENT CORPORATION

FINAL REPORT

NIMBUS 4/IRLS BALLOON INTERROGATION

PACKAGE (BIP)

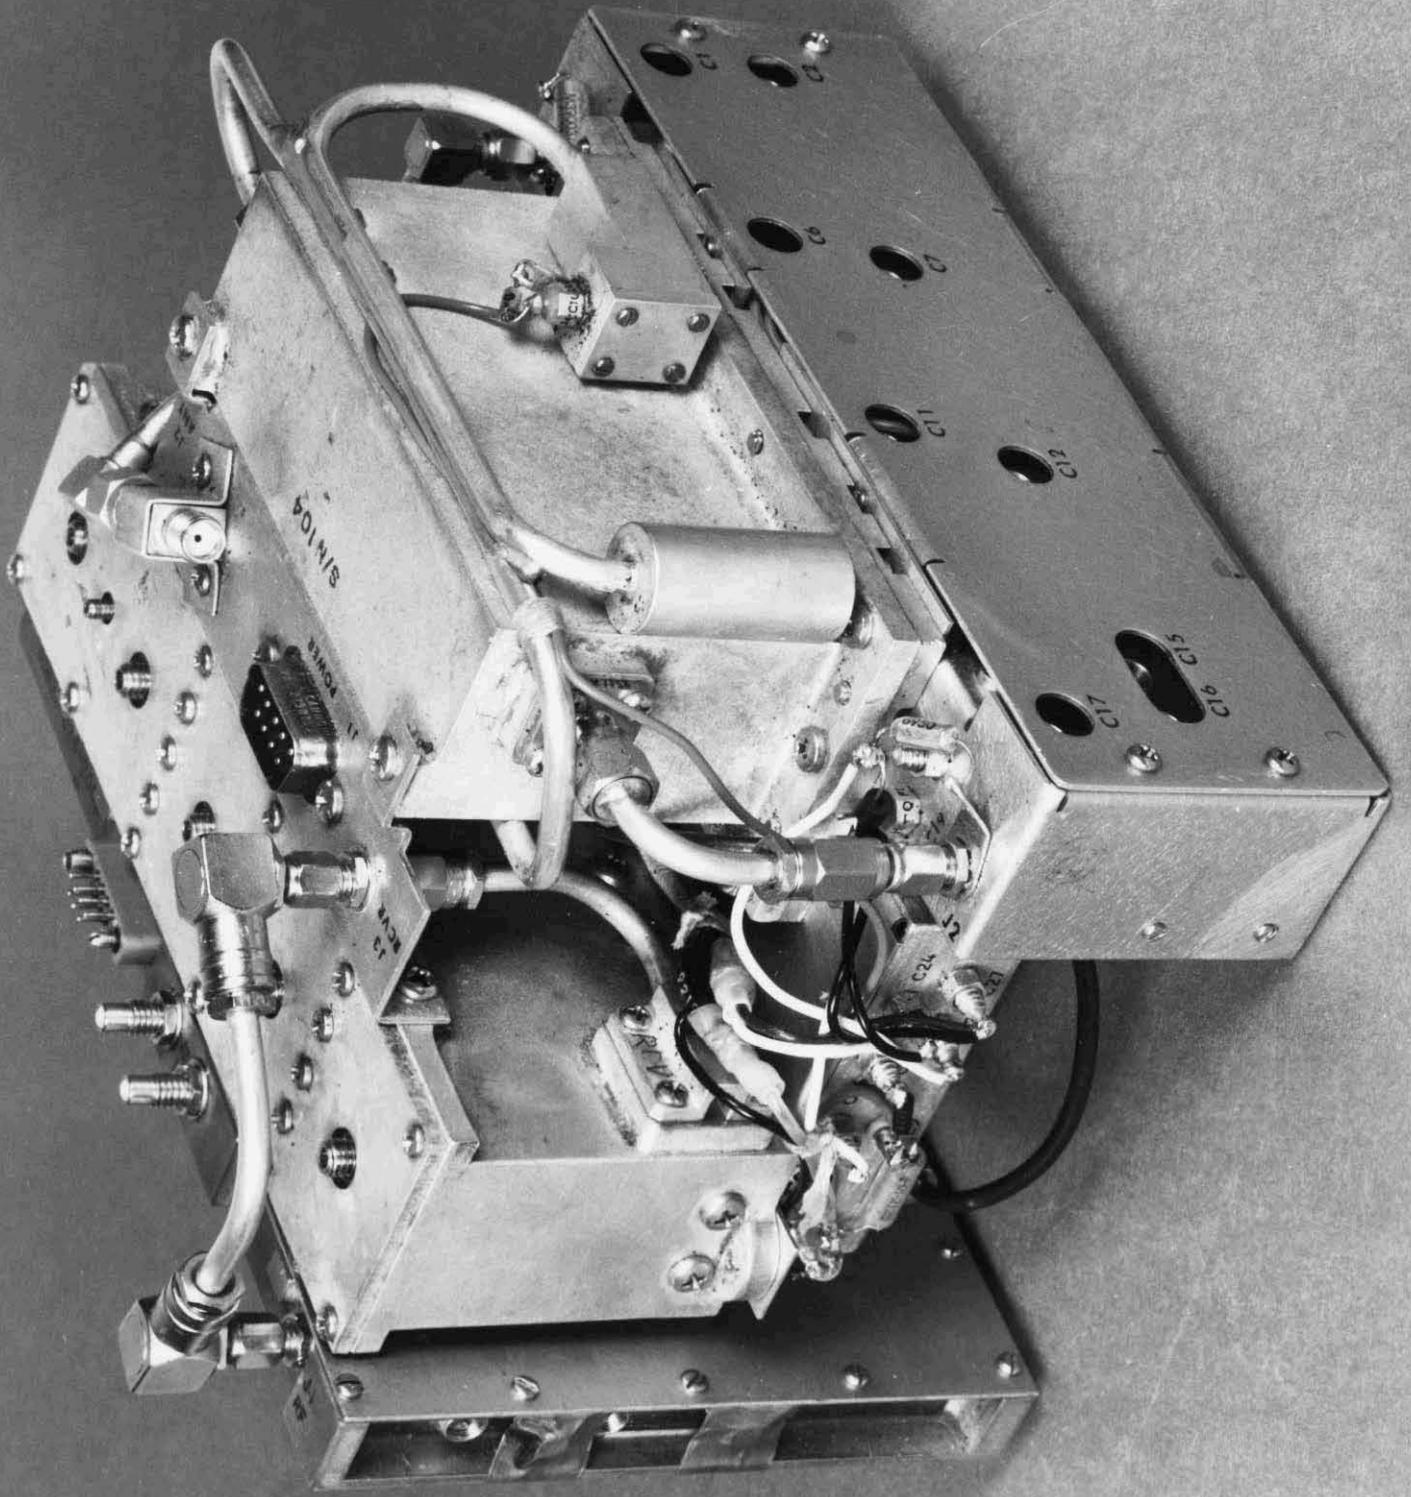
Fig. 2-1

Figure 2-1 is a photograph of the transmitter assembly, the receiver, and interconnection cable. The complete transmitter schematic is shown in Figure 2-2.

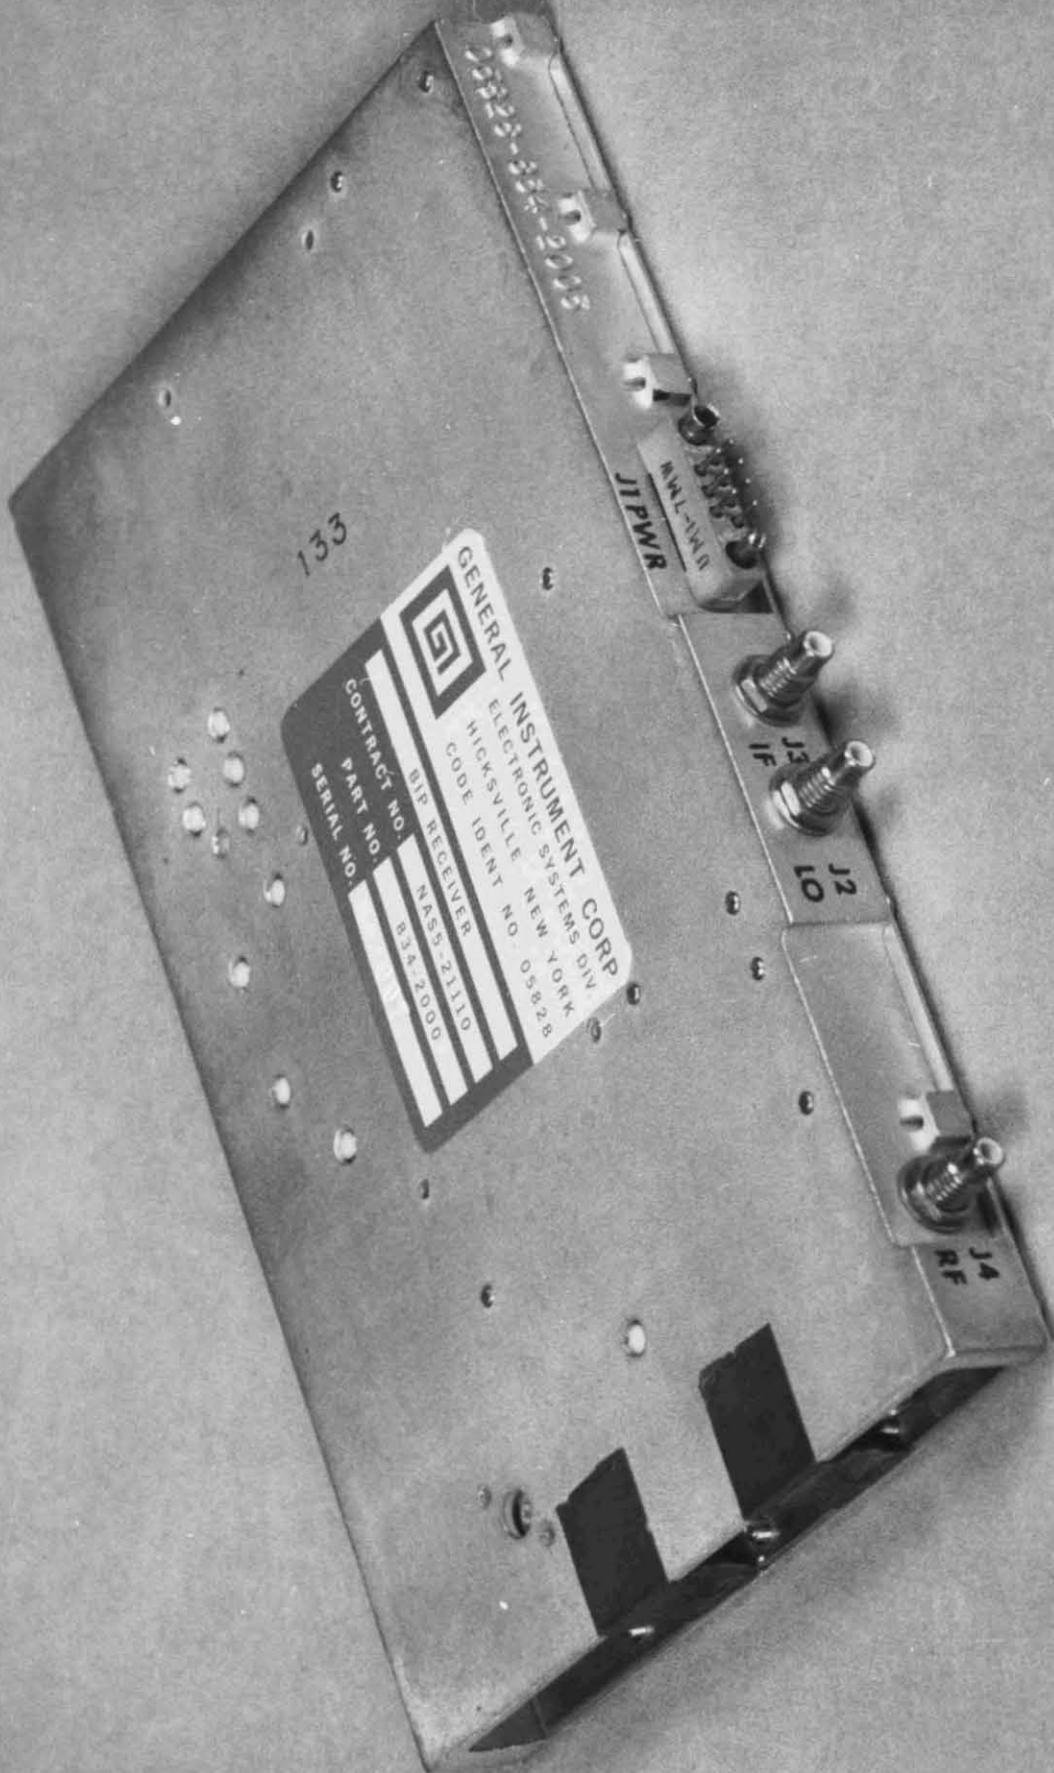
Fig. 3-1

Figure 3-1 and 3-2 are photographs of the BIP receiver. A complete schematic of the BIP receiver is shown in Figure 3-3.

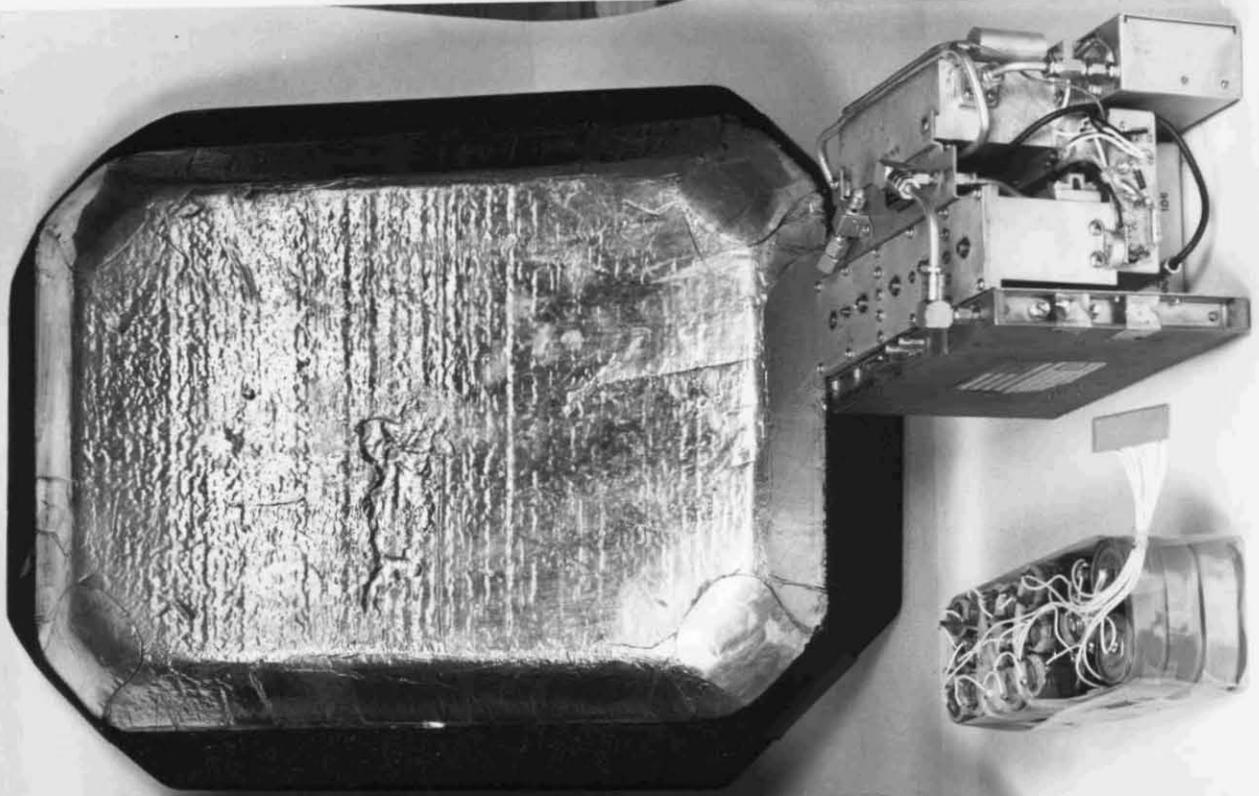
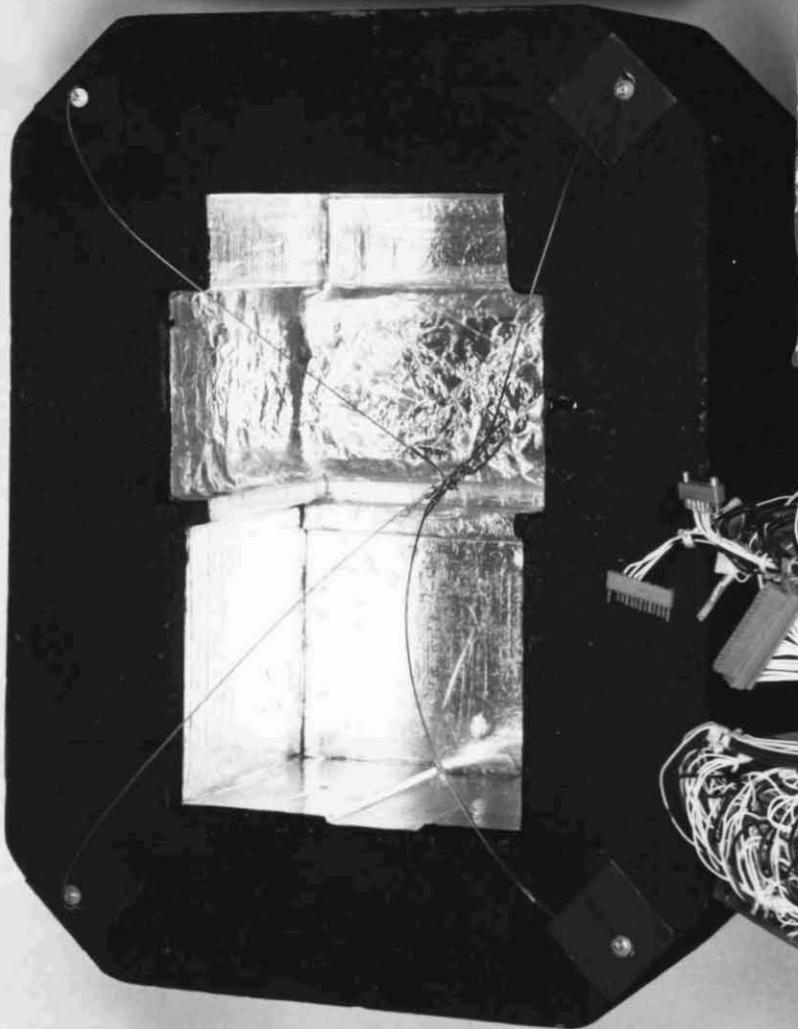
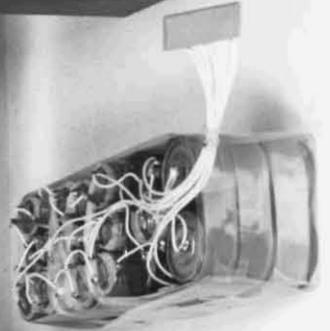
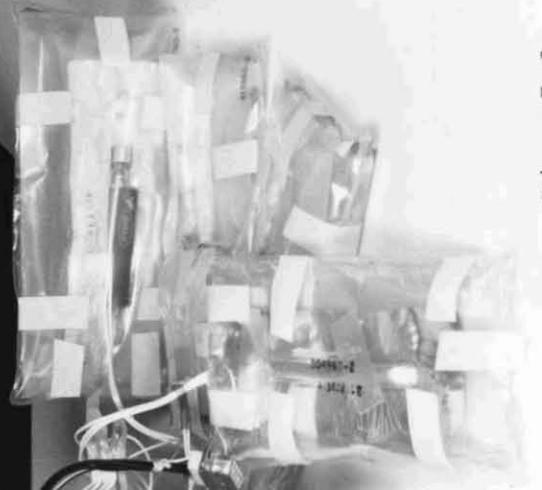
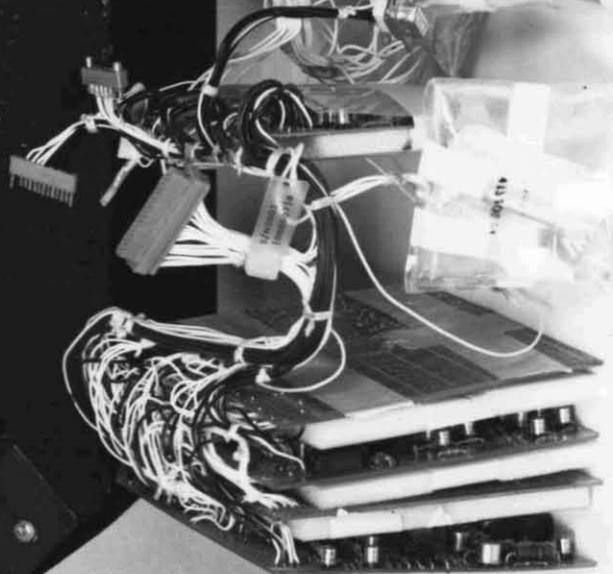
Fig. 5-1

A sub-contract was placed with Radiation, Inc., in November 1969 to provide the electronics sub-assembly (ESA) the water bags, and the battery pack assembly. Figure 5-1 is a photograph which shows the components of the BIP electronics unit. Schematic diagrams of the five printed circuit boards that comprise the ESA are shown in Figures 5-2 to 5-6.

The first test was aborted during the 10 hour day portion of the test due to a failure in the Power Control PC board. The failure burnt away some of the artwork on the board. Radiation's explanation was that the board was not properly cleaned before the protective coating was applied to this section of the board. Moisture caused an electrical short across the artwork causing it to be destroyed. After the concurrence of General Instrument Corporation and NASA a new Power Control board was installed in the electronic sub-assembly.
