NASA TN D-6519

CORROSION STUDY OF BARE AND COATED STAINLESS STEEL

by J. D. Morrison

John F. Kennedy Space Center

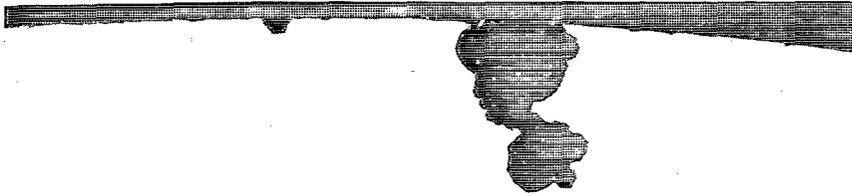
Figure 12. Surface Characteristics and Pit Depth of Type 304L Exposure Sample

VIEW A Magnification: 2X
Exposed Portion

VIEW B Magnification: 2X
Sheltered Portion

VIEW C Magnification: 80X
Cross-Section of Tubing Wall in Deepest Pit Area

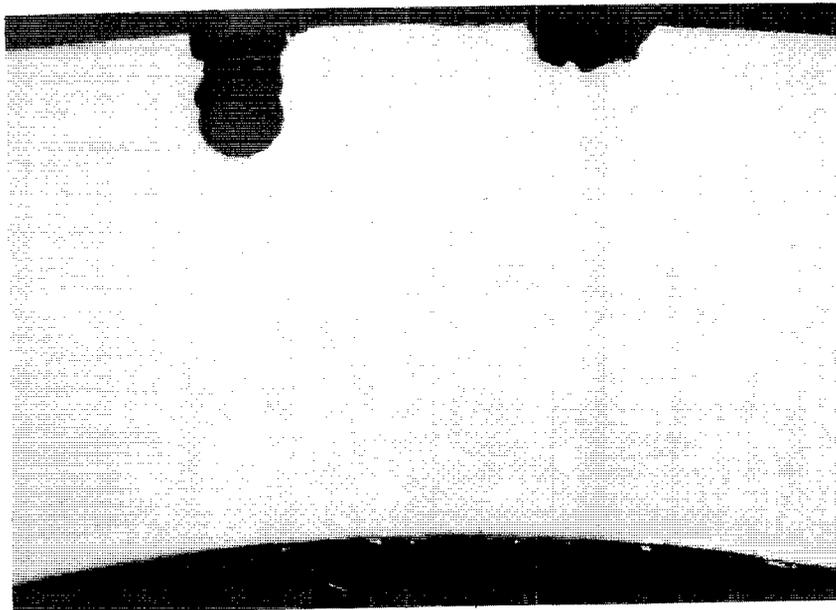
Figure 13. Surface Characteristics and Pit Depth of Type 347 Exposure Sample

Exposed Portion

Sheltered Portion

Cross-Section of Tubing Wall in Deepest Pit Area

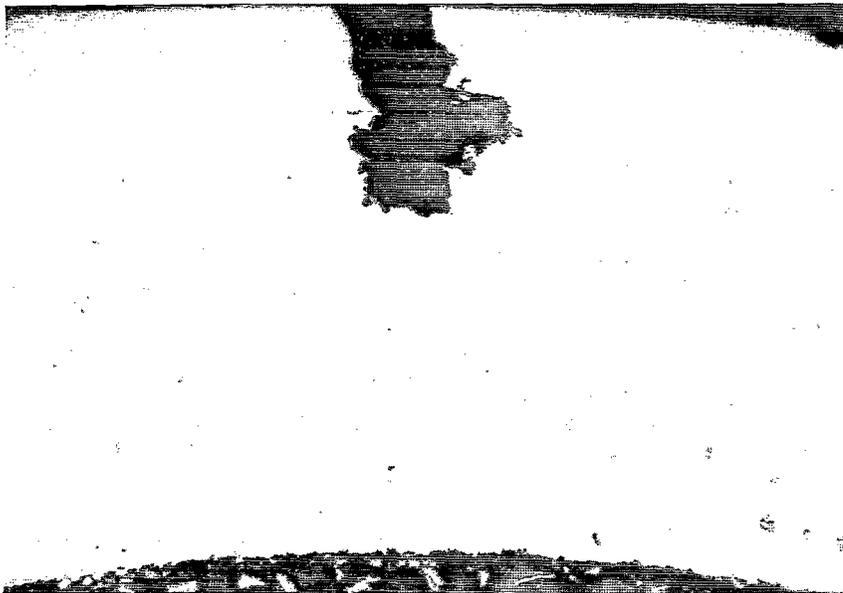
Figure 14. Surface Characteristics and Pit Depth of Type 304 1/8-Hard Exposure Sample

Exposed Portion

Sheltered Portion

Cross-Section of Tubing Wall in Deepest Pit Area

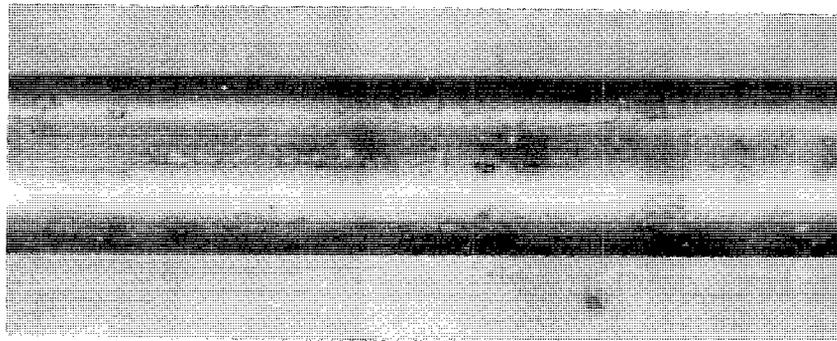
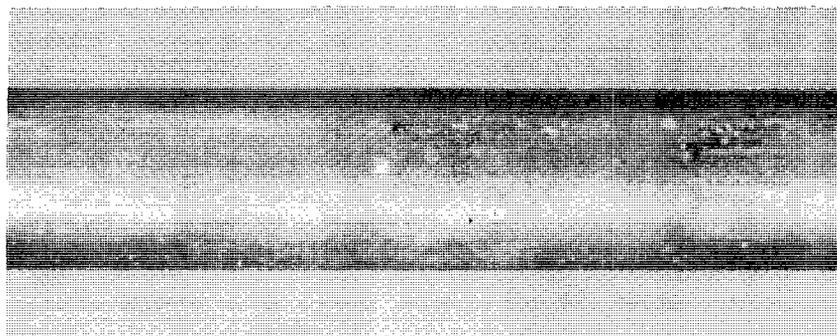
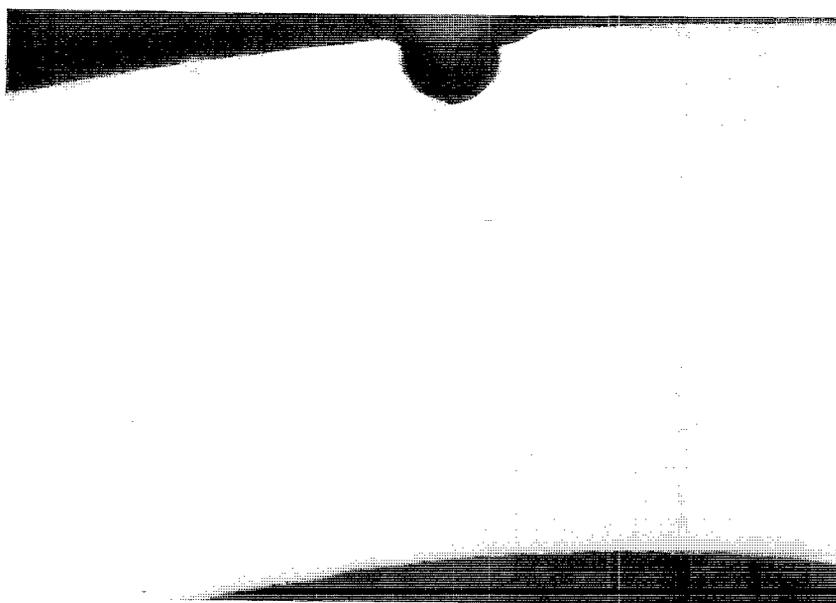
Figure 15. Surface Characteristics and Pit Depth of Type 316 (ASTM-A269) Exposure Sample

Exposed Portion

Sheltered Portion

Cross-Section of Tubing Wall in Deepest Pit Area

Actually, the deepest pits found to date in any of the samples have been in Type 316L and in the Type 316 (MSFC 10M01734), as is shown in Figures 11 and 18. This is not to suggest that Type 316 has a higher pitting rate than the other grades; in another Type 316 sample (Figure 15), no deep pits were found. The evidence cited here does suggest that no single austenitic stainless steel of the grades tested in this program is significantly better than the others for the fluid-systems applications in an environment of the KSC type.

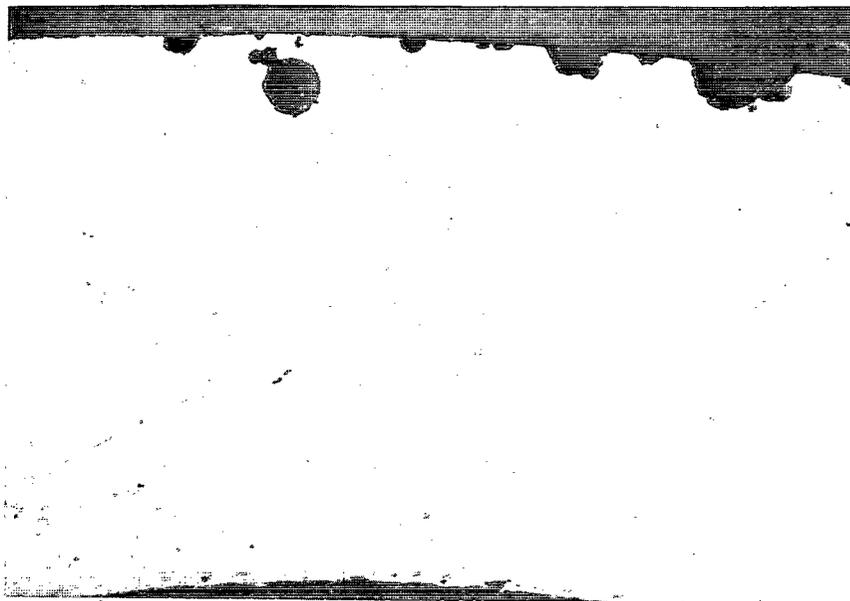
Figure 16. Surface Characteristics and Pit Depth of Type 321 Exposure Sample

Exposed Portion

Sheltered Portion

Cross-Section of Tubing Wall in Deepest Pit Area

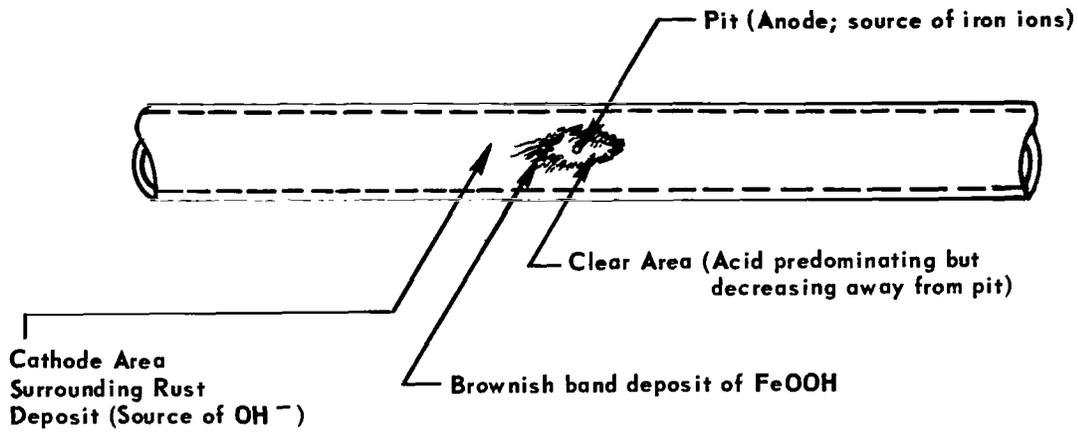
Figure 22. Surface of Tubing in Pit Area

For amplification of the previous references to the mechanisms of pitting corrosion, the following discussion is submitted. In pursuing these points, reference is made to Figures 22 and 23 which depict schematically the morphological and electrochemical conditions prevailing in the pitting corrosion of a section of stainless steel tubing. Figure 22 shows the tubing surface in the vicinity of an active pit, operating in a film of moisture in which there is a dissolved electrolyte. In the KSC area, this is usually sodium chloride, although various other compounds can serve as "solution-type" (ionic) conductors. Chloride ion, as pointed out by Fontana, (References 1 and 2) has the apparently unique ability to penetrate the normally protective complex oxide layer on the stainless steel to cause pitting initiation. In the absence of the chloride ion, pitting is usually initiated at points where mechanical breakage of the oxide layer has occurred, or at non-metallic inclusions present at the metal surface.

Pitting, once initiated, usually continues whenever moisture is available (whether from condensation, salt fog, or other source). The center of the site, the pit itself, is the anode, within which are generated iron ions (ultimately Fe^{+++}) and hydrogen ions (H^+). At some distance from the pit but in the moisture film, is located the cathodic site which is a relatively large area of the unbroken oxide layer on the tubing surface. With this condition, there is a large driving force for enlargement of the pit, since the limiting factor in the electrochemical current generated by the cell is the area of the anode. The cell potential for the pitting of stainless steel is of the order of 0.7 volt. This type of electrochemical activity is called an "active-passive" cell. Hydroxide ions (OH^-) generated in the cathodic area surrounding the pit, and iron ions generated in the pit migrate toward the opposite electrodes and meet in a ring-shaped area around the pit. In this area, the brownish corrosion product identified many times by X-ray diffraction analyses as consisting mainly of iron oxyhydroxide (FeOOH), is deposited on the stainless steel surface. Figure 23 shows the same basic pitting mechanism occurring in a cross-sectional view of the tubing wall. It should be noted that hydrogen ions tend to accumulate within the pit itself, so that the pH may commonly be of the order of 1.
