FATIGUE EXPERIENCE FROM TESTS CARRIED OUT WITH FORGED
BEAM AND FRAME STRUCTURES IN THE DEVELOPMENT
OF THE SAAB AIRCRAFT VIGGEN

By S. E. Larsson
Saab-Scania Aktiebolag
Linköping, Sweden

SUMMARY

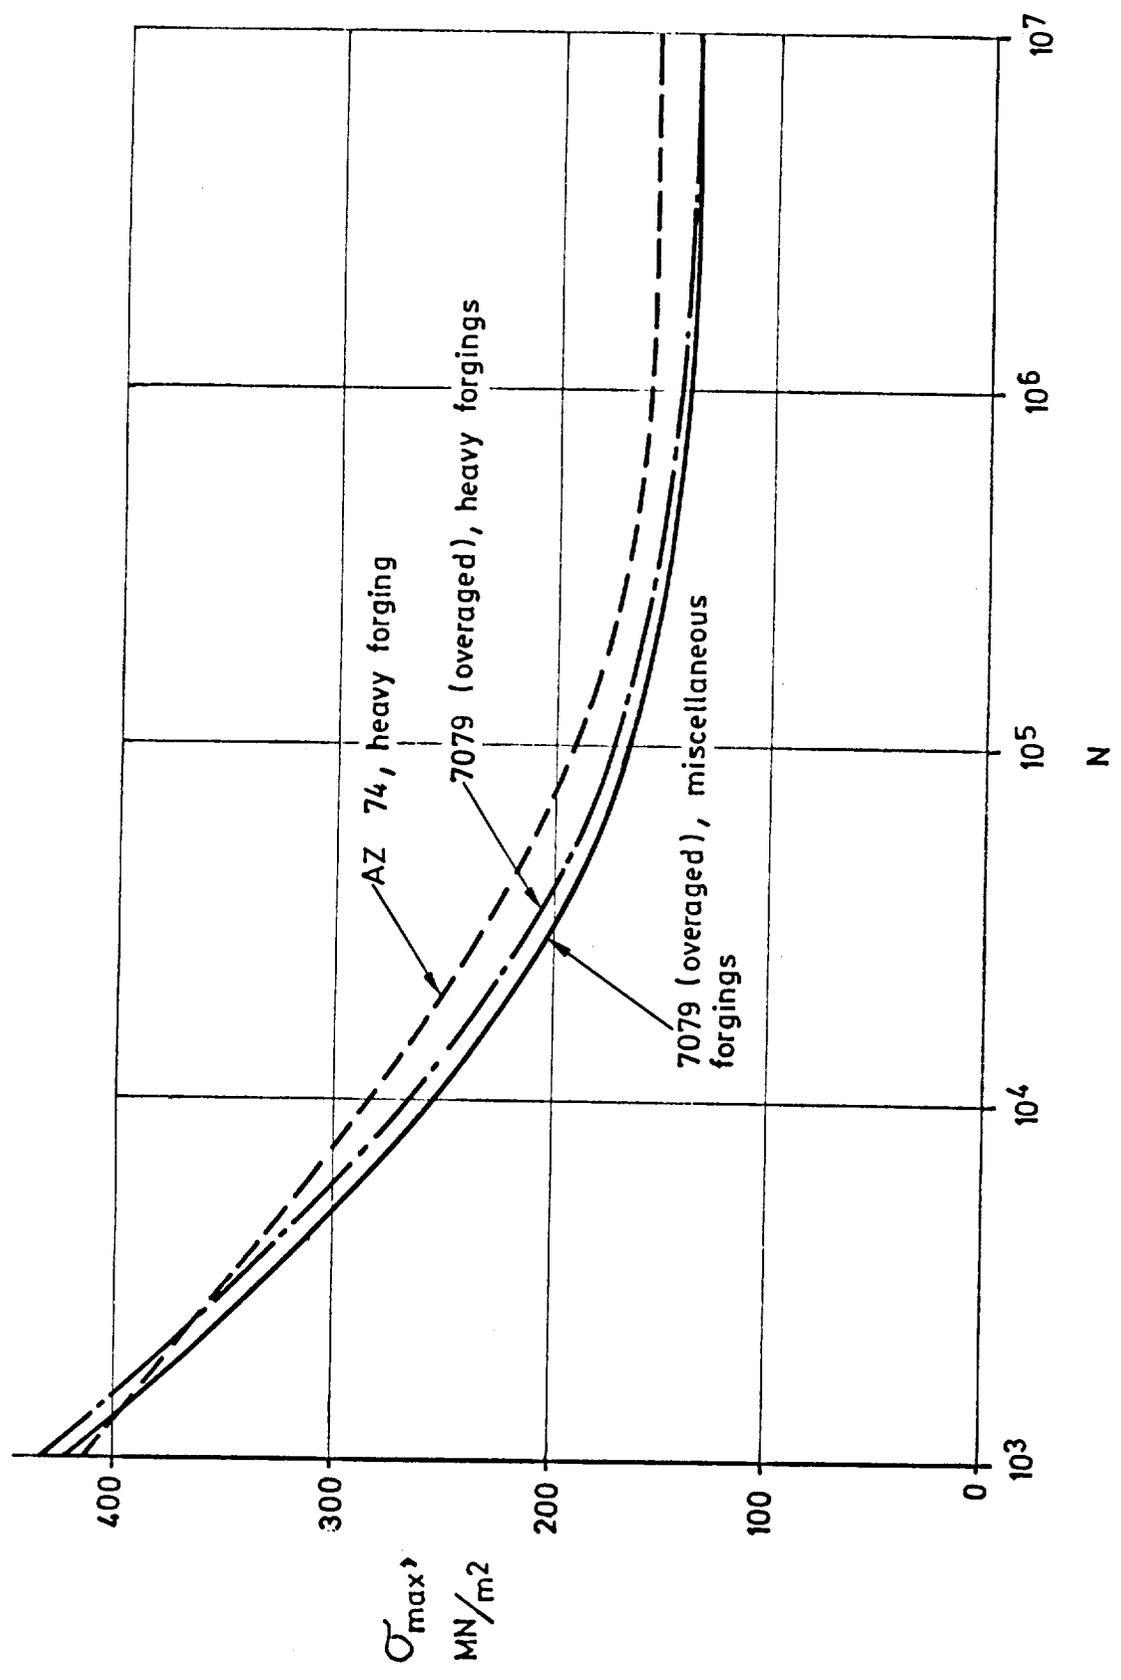
Figure 19.- Results of axial-load fatigue tests on notched round specimens. $K_t = 2.5$; $\sigma_{min} = 0$.

From the fatigue data in figure 19, which are for constant-amplitude tests, it can be seen that AZ 74 has about 10 percent higher fatigue strength than 7079 (overaged). These tests were carried out with small round specimens with diameter $d = 8.5$ mm and notch radius $r = 0.65$ mm.

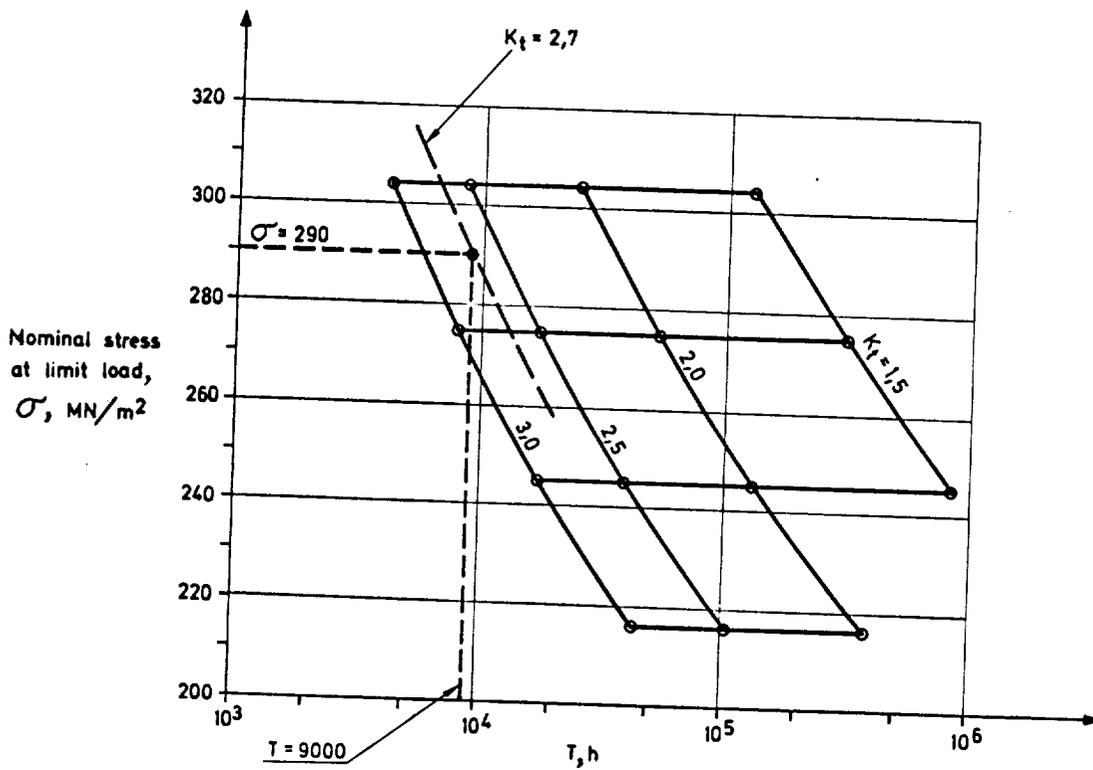
Figure 21.- Results of a cumulative damage calculation for specimen A material, AZ 74.

A recently developed computer method for fatigue calculations based on the linear cumulative damage theory was tested on specimens A and B and their fatigue-test results. The diagram in figure 21 shows calculated S-N curves for various K_t values based on the constant-amplitude fatigue data from figure 19, slightly reduced. The curves in figure 21 are for the specimen A material, AZ 74, the test load spectrum, and $\Sigma(n/N) = 1$. The nominal stress at limit load is plotted against calculated equivalent flying hours. The fatigue test result, $\sigma = 290 \text{ MN/m}^2$ and $T = 9000 \text{ h}$, is plotted and found to correspond to $K_t = 2.7$. (The chosen time, 9000 h, corresponds to a 5-mm fatigue crack in the flange notch, according to the mean curve in figure 20. This time, however, is also supposed to be representative for the bolt-hole cracks.)

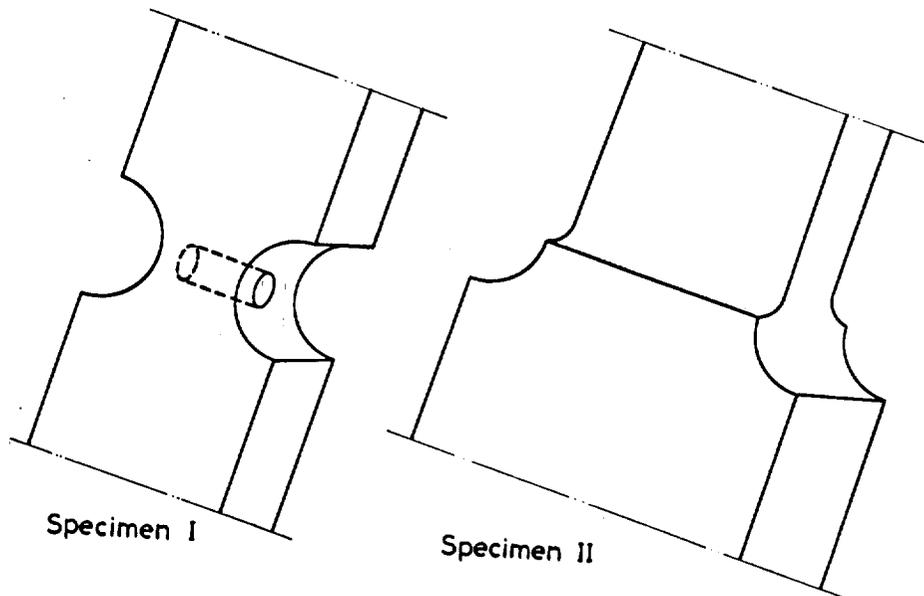
Figure 22.- Examples of interacting stress concentrations.

In order to get a better collection of data as a basis for design and for making up some estimation rules, fatigue testing has been performed and is planned to progress with specimens of various shapes. Figure 22 shows two typical configurations, representing the problem of a hole in a radius (bolt hole in a part with variable cross section) and the problem of simultaneous area variation in perpendicular planes.
