NASA CR-72850

# EVALUATION OF HIGH TEMPERATURE ELECTRICAL MATERIALS AND COMPONENTS

**Westinghouse Electric Corporation  
Aerospace Electrical Division  
Lima, Ohio**

1. Report No. NASA CR-72850	2. Government Accession No.	3. Recipient's Catalog No.	
4. Title and Subtitle Evaluation of High Temperature Electrical Materials and Components.		5. Report Date April 1970

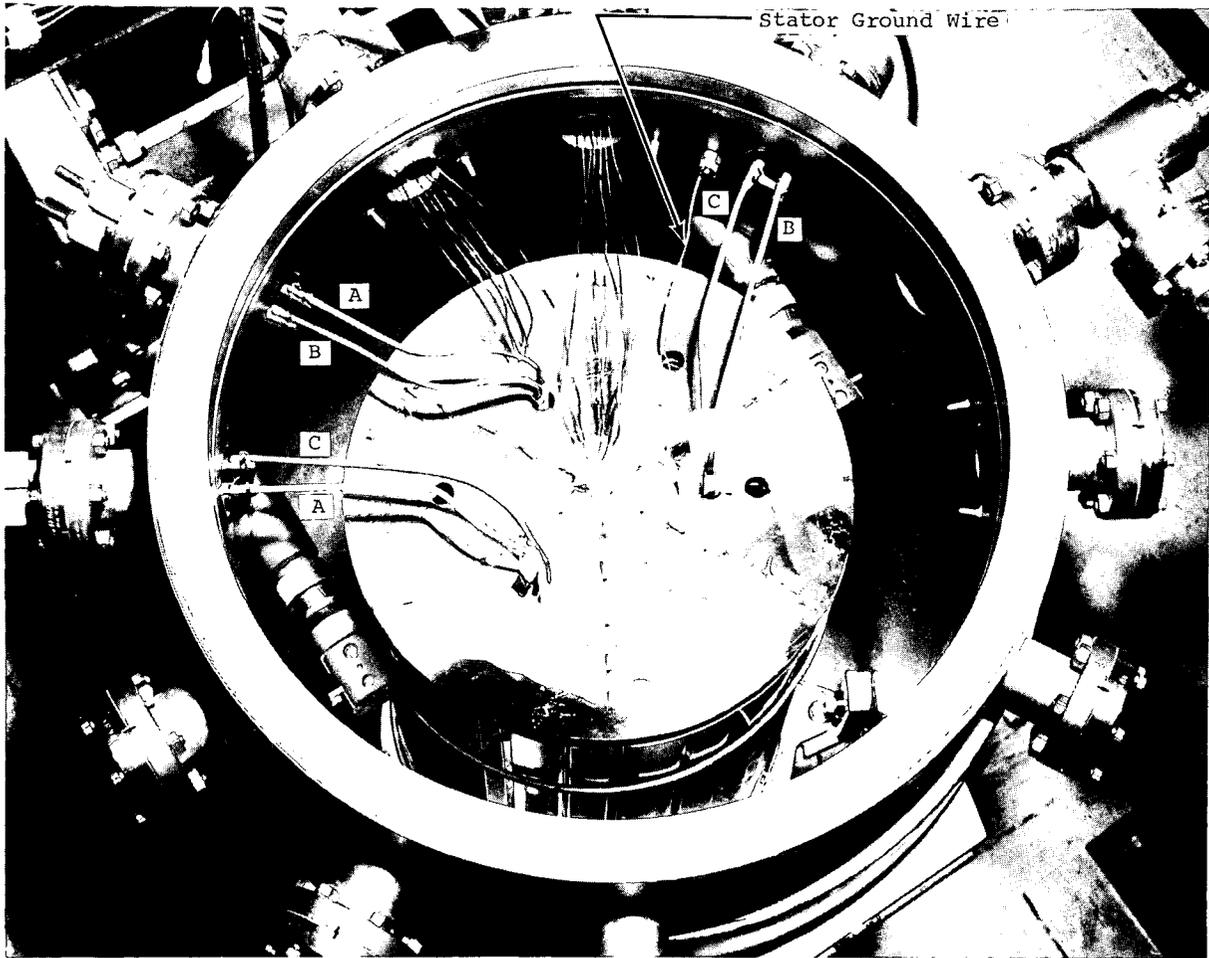
After all room temperature data in vacuum had been obtained, the chamber pressure was raised to room ambient pressure using dry nitrogen as the cover gas. Figure 12 is a photograph of the top of the test chamber after removal of the chamber cover. Two groups of eight thermocouples can be identified in the picture. The three-phase winding leads are identified as A, B, and C. The stator ground wire is also indicated. Winding leads were brought through the top heat shields in rectangular alumina sleeves.

Figure 12. - Photograph of the Stator Test Chamber After 10,000-Hour, 1300° F Ultrahigh Vacuum Endurance Test With the Top Cover Removed. Phase Winding Leads are Identified.

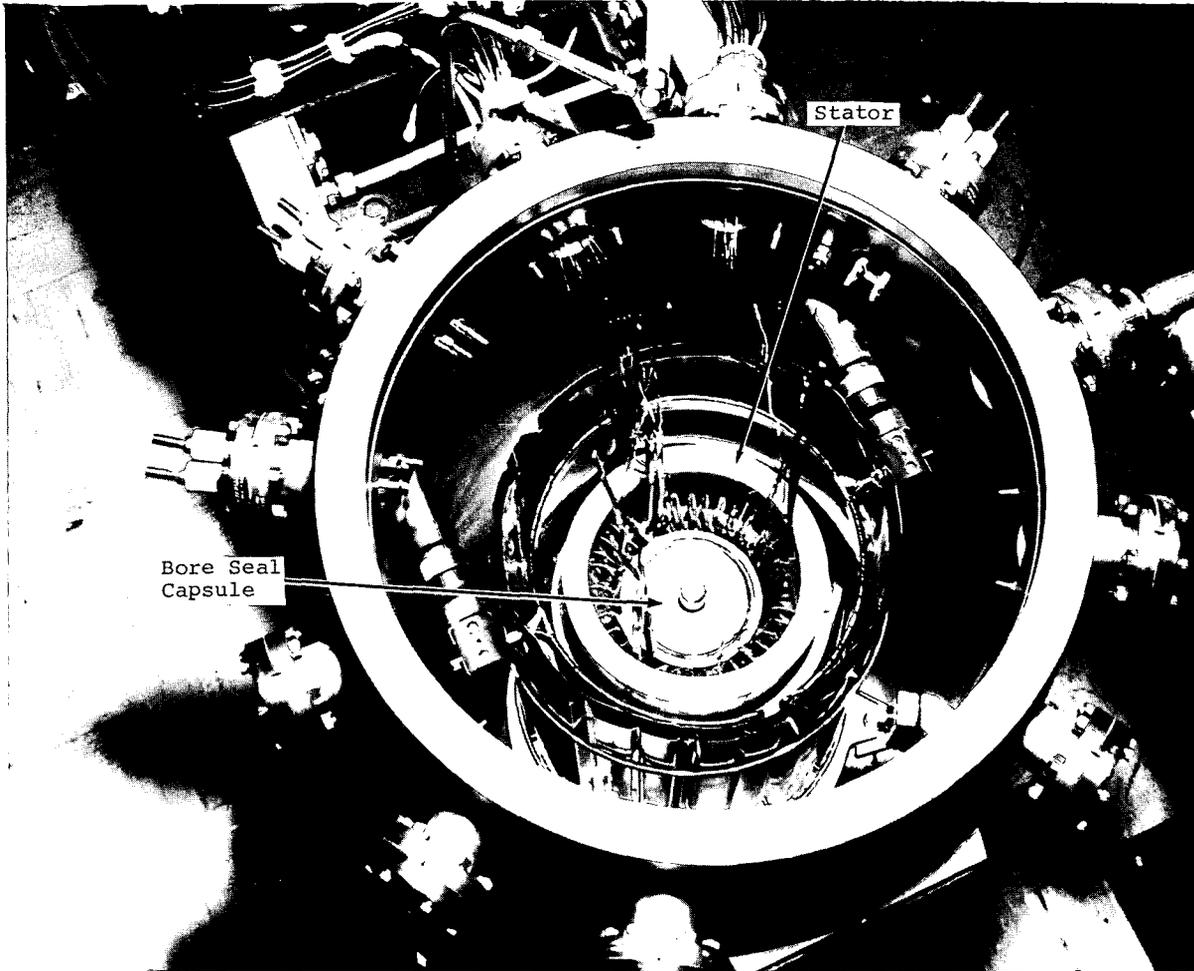
Figure 13 is a view of the chamber interior with top heat shields removed showing the stator and the bore seal capsule. Figure 14 shows the chamber with the stator and bore seal capsule removed. The general cleanliness of the test volume can be noted by the stator support post reflections on the chamber heating element. Figure 15 shows the stator and bore seal capsule on a laminar flow clean bench after removal from the chamber. Figure 16 is a photograph of the bore seal capsule and support pedestal. No evidence of potassium leakage was noted as the stator and bore seal capsule were removed from the test chamber. A stator lamination, slot wedge, and winding end turn stain pattern was evident around the capsule outside diameter. (See figure 2 for pretest appearance of the capsule.) The source of these stains was determined as part of the post-test evaluation. Figure 17 is a view into the stator stack and winding cavity. Anadur "S" conductor insulation on the winding end turns had split when the windings were initially formed. After completion of the Anadur cure cycle, the insulation was

Figure 13. - Photograph of the Stator and Bore Seal Capsule in the Test Chamber After Removal of the Top Heat Shield and After the 10,000-Hour, 1300° F Ultrahigh Vacuum Endurance Test.

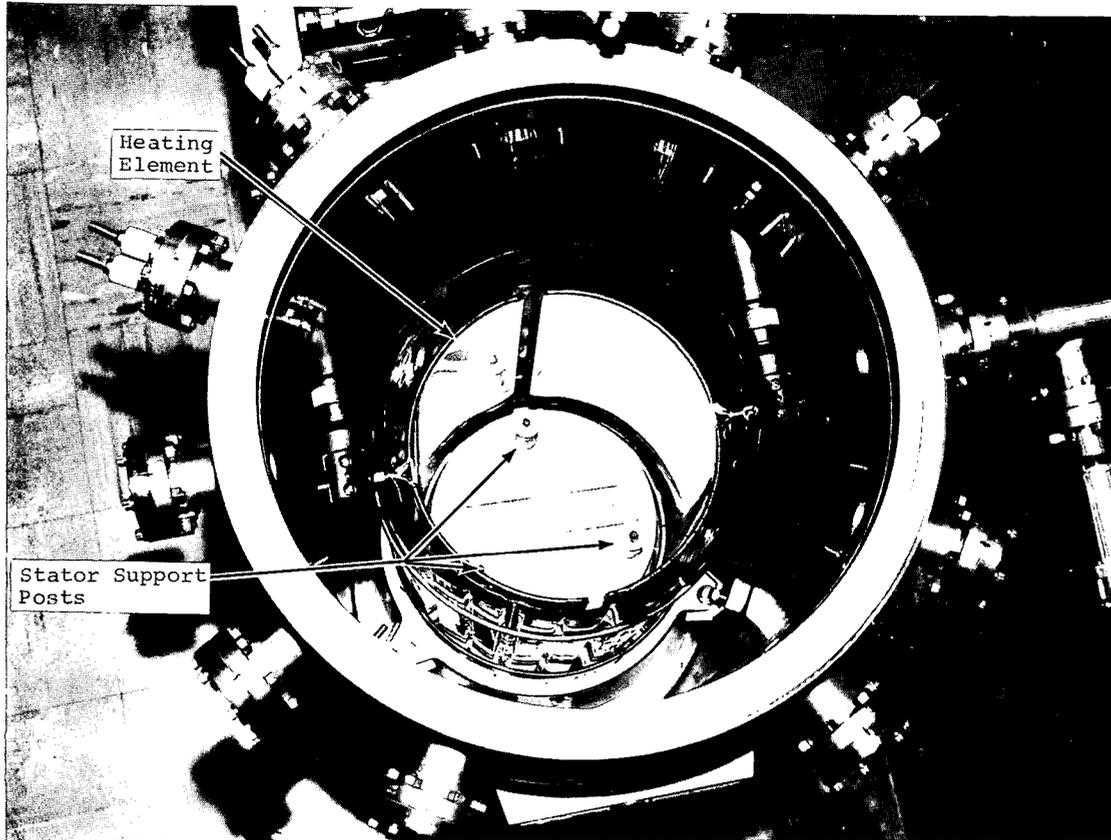
Figure 14. - Photograph of the Interior of the Test Chamber After Removal of the Stator and Bore Seal Capsule After the 10,000-Hour, 1300° F Ultrahigh Vacuum Endurance Test.

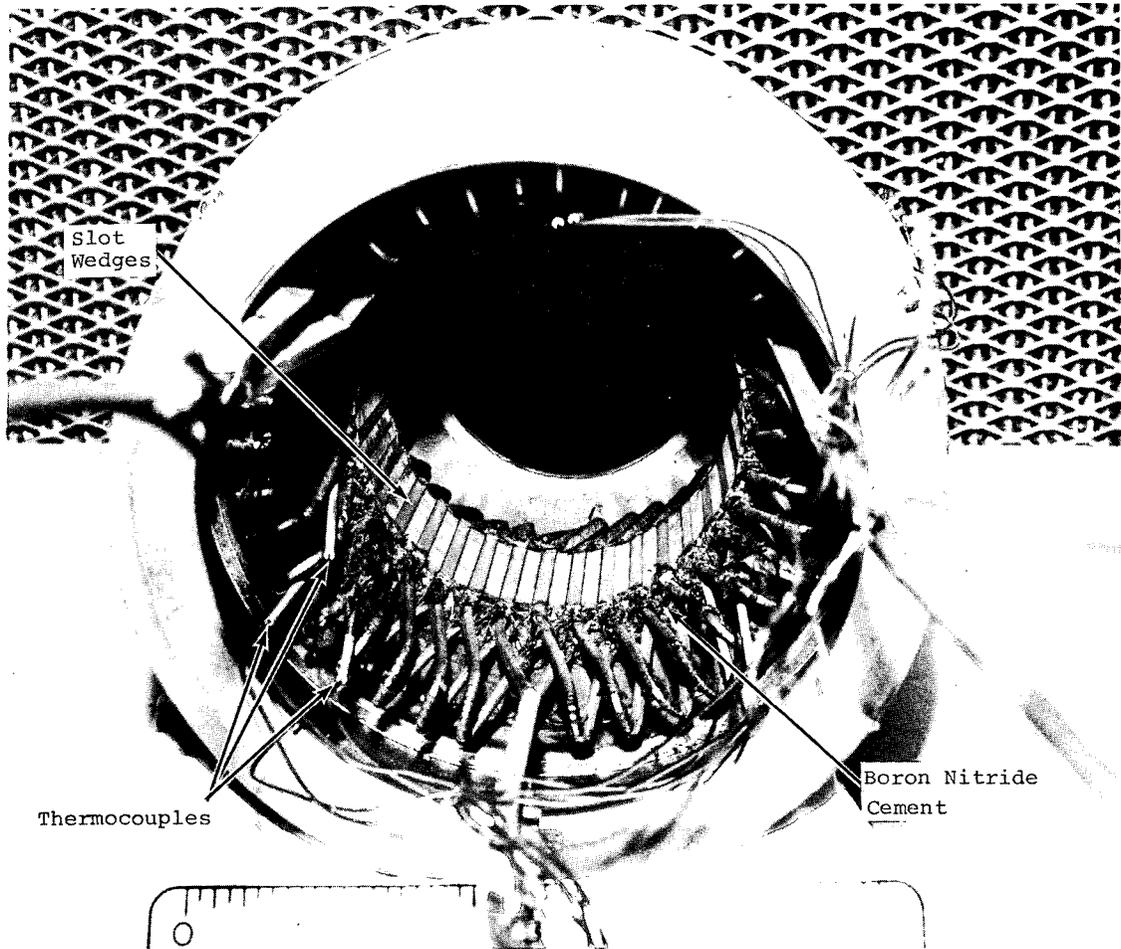
Figure 17. - Photograph of the Stator Interior After Completion of a 10,000-Hour Test at 1300° F in Vacuum.

Visual Examination of the Stator After Removal from the Test Chamber - A visual examination of the stator, performed immediately after removal from the test chamber, revealed some gray discoloration of the insulation materials and a general dulling of the exposed metallic surfaces attributed to deposition of evaporated materials during thermal-vacuum aging. The exposed surfaces of the conductor insulation were gray. Many of the conductor insulation "S" glass fibers on the conductor end turns had been fractured during winding, thereby causing some fraying; but this condition had not progressed further during the aging (see figure 17). The glass fibers were mechanically weak with low interfiber bonding. The adhesion of the wire insulation to the Inconel cladding was also weaker than after firing. The Inconel surface under the insulation was bright and not discolored.

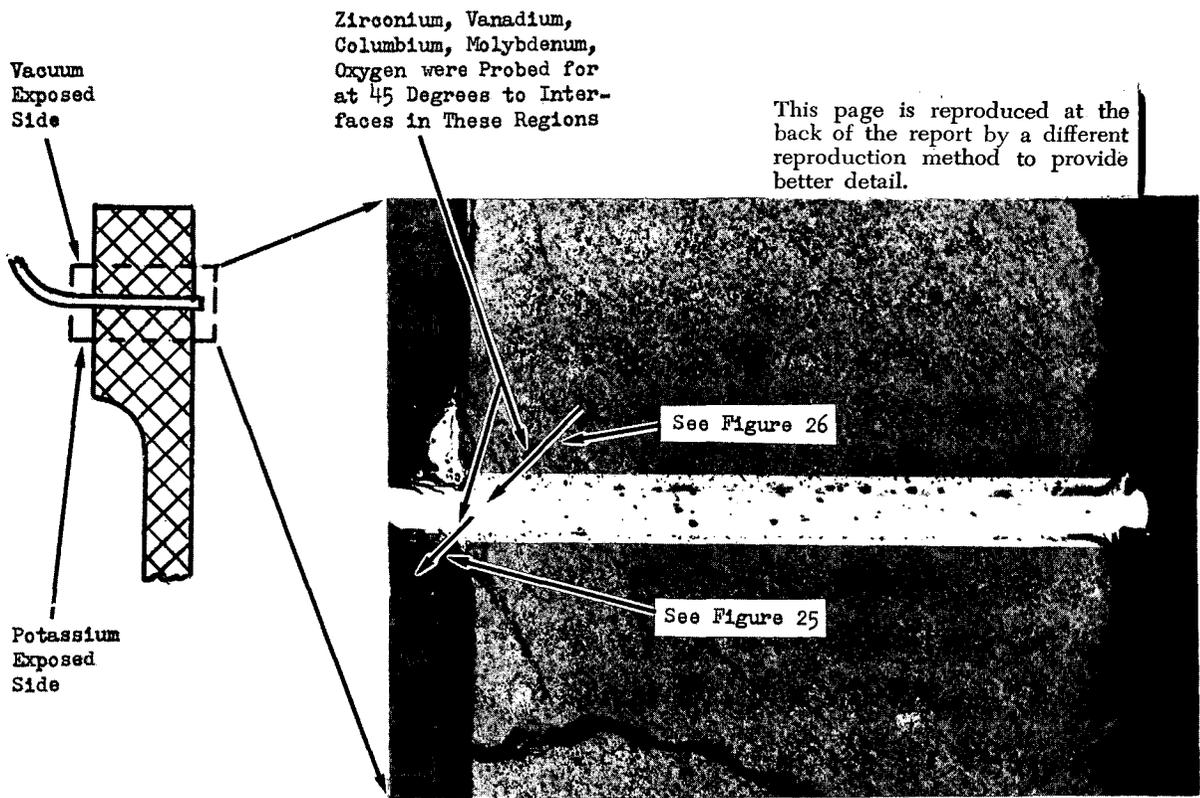
Note: Marked lines and figure numbers correspond to Electron Microprobe Scans

Figure 21. - Photograph Showing Cross Sections of Brazed Joints, From Top of 4-Inch Diameter by 4-Inch High Bore Seal Capsule After Exposure to Potassium at 1300° F For 10,000 Hours. (16X)

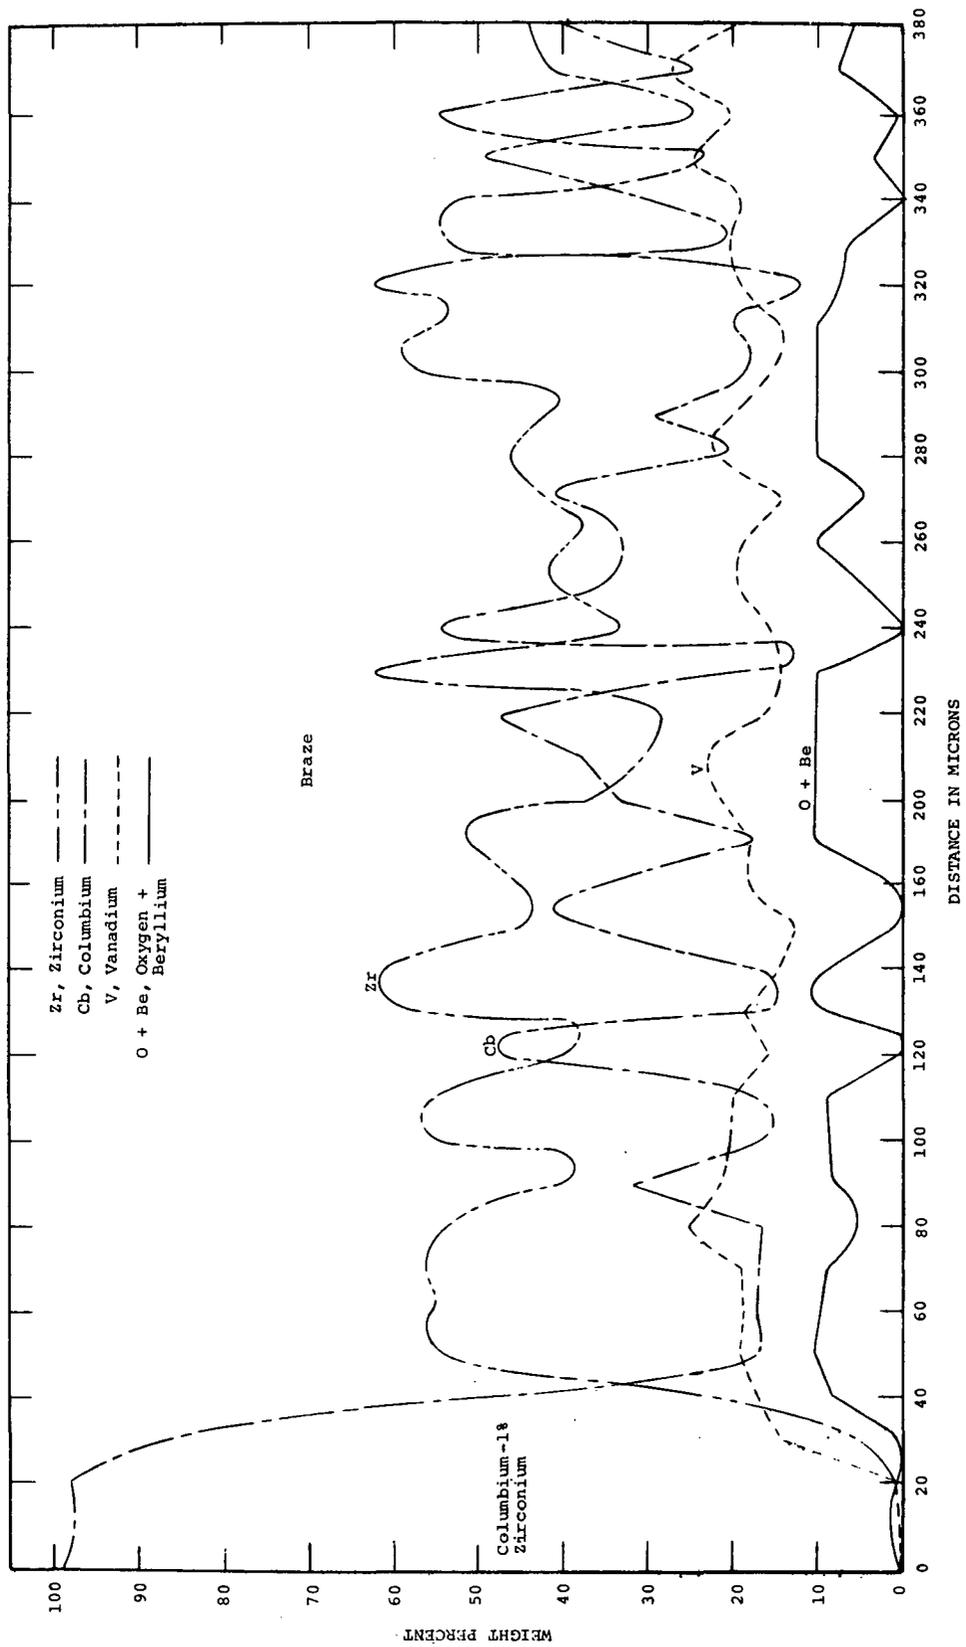
Examination of figures 23, 24, 25, and 26 reveals that the braze alloy joints are not very homogeneous and that each joint structure is somewhat different. The bottom braze alloy structures appear to be less homogeneous than the top braze alloy structures. Most homogeneous of the probed joints is the potassium side of the top seal (figure 25). (It should be noted that this probe trace began in the columbium-1% zirconium end member, crossed a fillet of braze alloy, and terminated at the edge of the fillet.) The probe trace for the other side of the top seal (figure 26) shows this braze alloy to be less homogeneous. Columbium from the columbium-1% zirconium end member appears to have diffused into the braze alloy during the brazing cycle. (This probe trace began in the beryllia, traversed the braze alloy, and terminated in the columbium-1% zirconium.) Comparing figure 24 with figure 26 one can see that the figure 24 braze alloy is much less homogeneous, has narrower zirconium-rich regions, and has substantially more columbium. The columbium content in figure 24 braze changed from 65 percent to 15 percent in ten microns. It appears that the zirconium precipitated, leaving a matrix rich in columbium and vanadium. The figure 24 braze alloy is approximately half the thickness of the figure 26 braze alloy. Figure 23 shows a braze alloy fillet on the other side of the figure 24 brazement. This fillet is less homogeneous than the fillet in figure 25 but more homogeneous than the braze alloy in figure 24. The columbium content in the figure 23 braze alloy is not as high as that in the figure 24 braze alloy. In the top seal braze alloys (figures 25 and 26), the vanadium and columbium seem to be related in that

Figure 23. - Electron Microprobe Analyses Across Potassium Exposed Side of Aged (10,000 Hours at 1300° F) Bore Seal Cap-sule (Columbium-1% Zirconium and 60Zr-25V-15Cb Braze Alloy) Bottom Seal.

both constituents increase and decrease in roughly the same places. This trend does not seem to be as evident in the bottom seal braze alloys (figures 23 and 24).

The probably cause for differences in brazed joint structures is differences in brazing time-temperature relationships for each joint. The generally less homogeneous bottom braze alloy structures (with relatively more columbium present) suggest either high temperature, longer time at temperature, or both, when compared with the top brazes. The relatively lower uniform aging temperature (1300° F), when compared with the apparently non-uniform brazing temperature (in the order of 2500° F), suggests that the brazing cycle established the brazed joint structures, not aging.

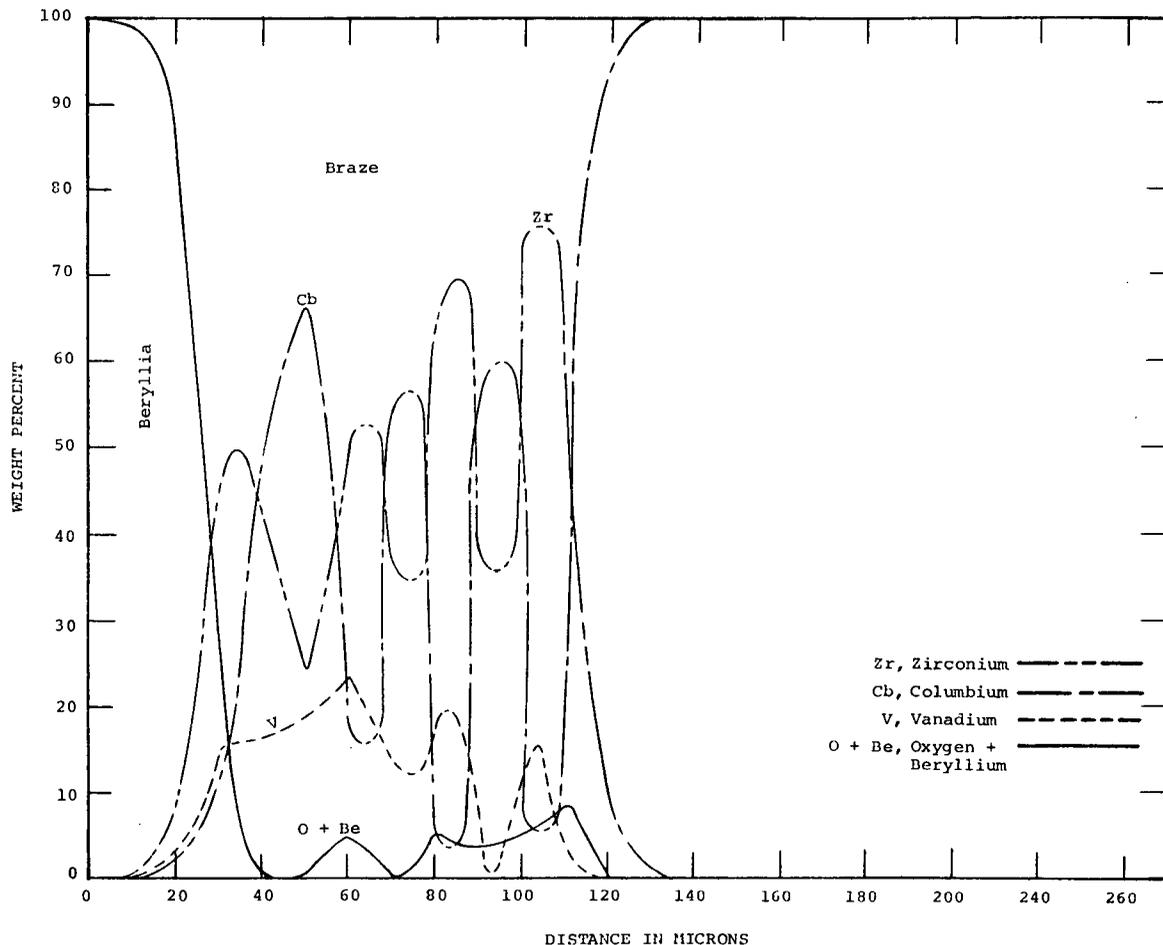
Figure 24. - Electron Microprobe Analyses Across Vacuum Exposed Side of Aged (10,000 Hours at 1300° F) Bore Seal Capsule (Beryllia, 60Zr-25V-12Cb Braze Alloy, and Columbium-1% Zirconium) Bottom Seal.

with 83 weight percent zirconium. The probable composition of the areas referenced in figures 27 and 28 is  $ZrBe_2$ . Another structure identified from microprobe analyses is the zirconium peak shown in both figures 24 and 25 at 55 microns into the braze from the edge of the columbium-1% zirconium. These peaks correspond to the 80Zr-20Cb eutectoid.

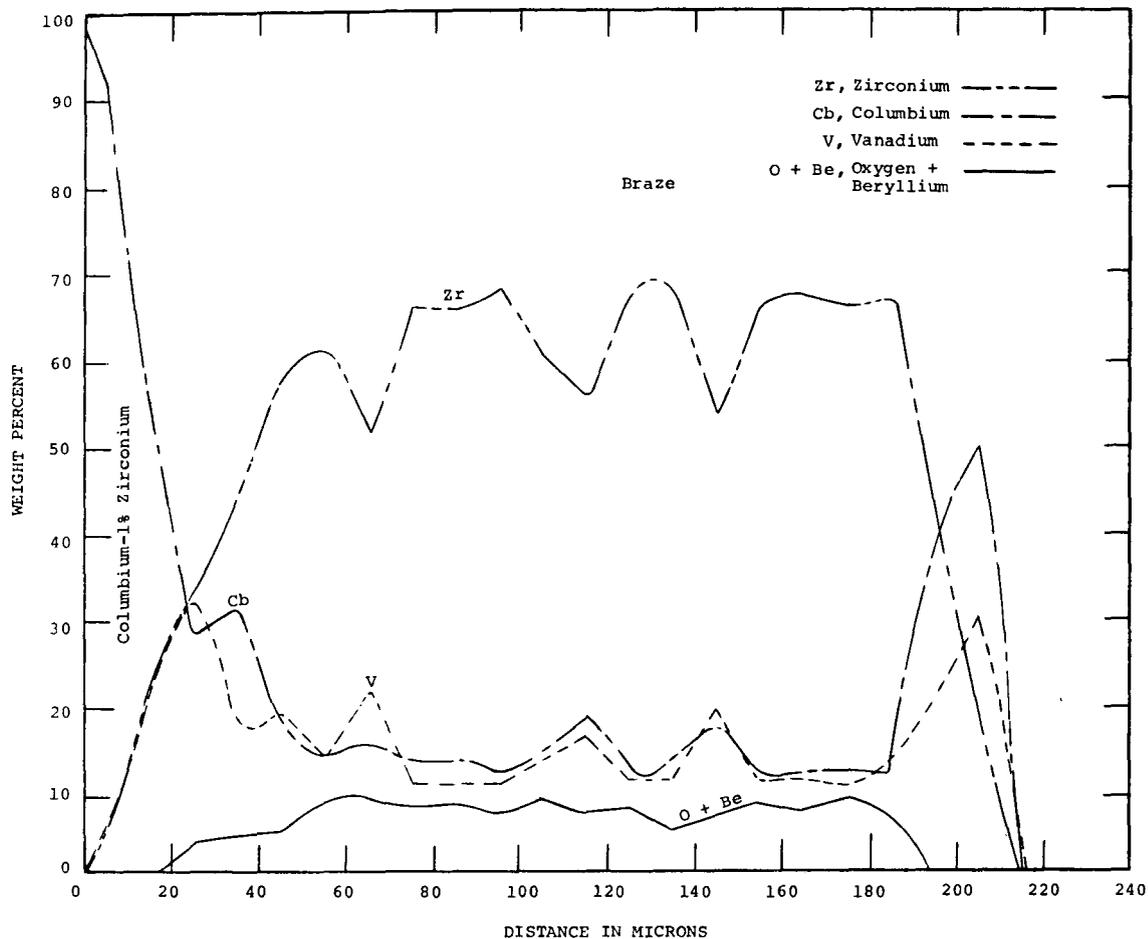
Figure 25. - Electron Microprobe Analyses Across Potassium Exposed Side of Aged (10,000 Hours at 1300° F) Bore Seal Capsule (Columbium-1% Zirconium and 60Zr-25V-15Cb Braze Alloy) Top Seal.

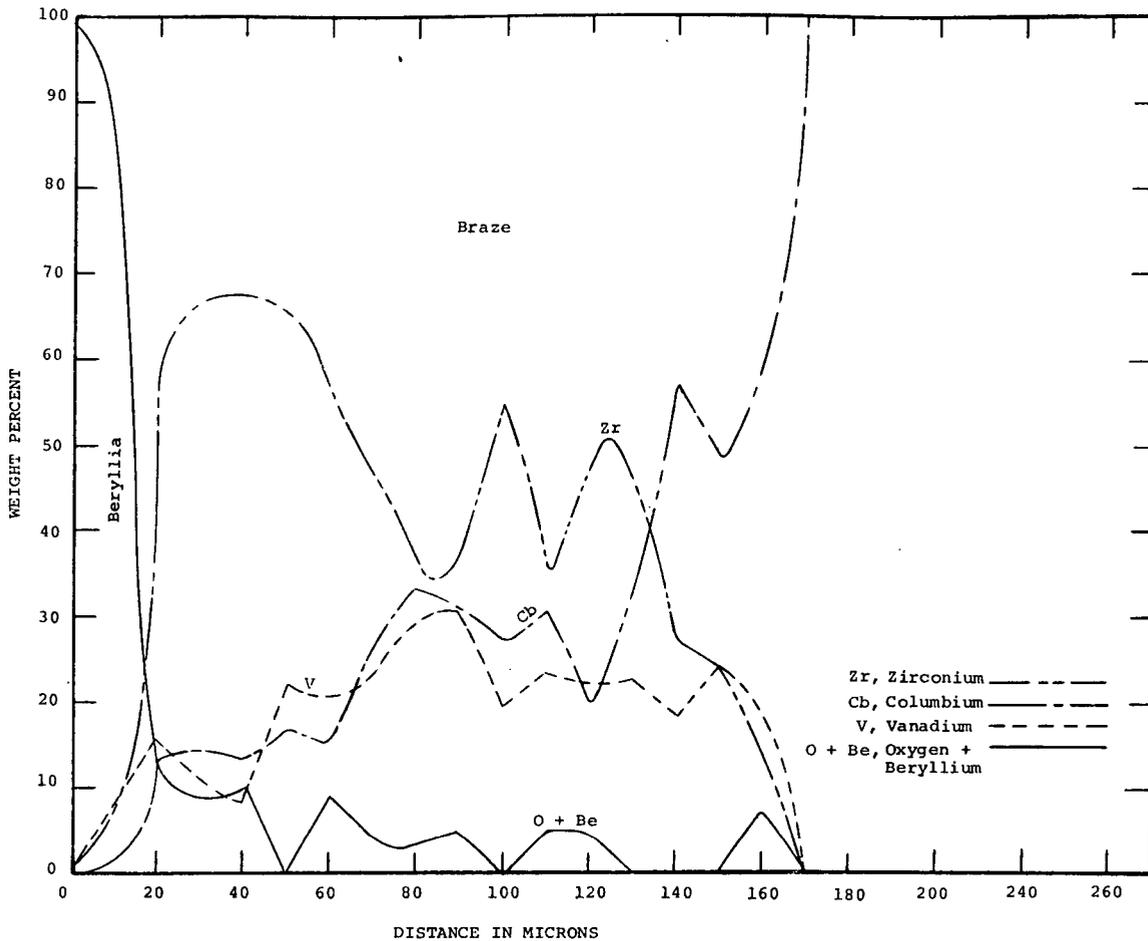
Figure 26. - Electron Microprobe Analyses Across the Vacuum Exposed Side of Aged (10,000 Hours at 1300° F) Bore Seal Capsule (Beryllia, 60Zr-25V-15Cb Braze Alloy and Columbium-1% Zirconium) Top Seal.

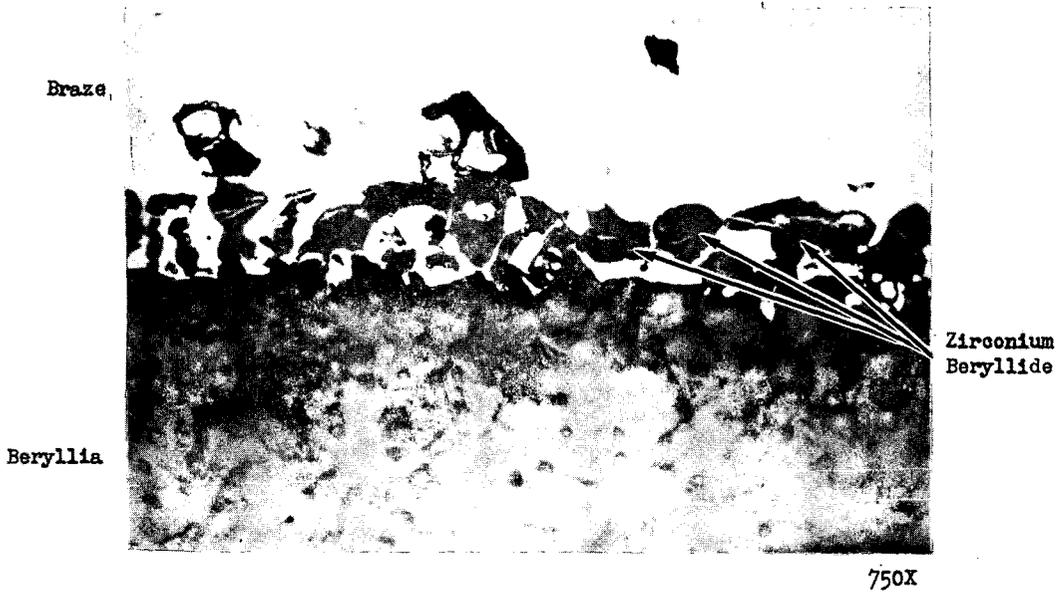
Good wetting characteristics of the braze alloy with respect to both columbium-1% zirconium and beryllia are evident in figures 27 and 29. Joint integrity was retained.

Figure 27. - Photomicrograph of Beryllia/Braze Interface of Bottom Brazed Joint of Bore Seal Capsule After 10,000 Hours at 1300° F Exposure. (750X, Bright Field)

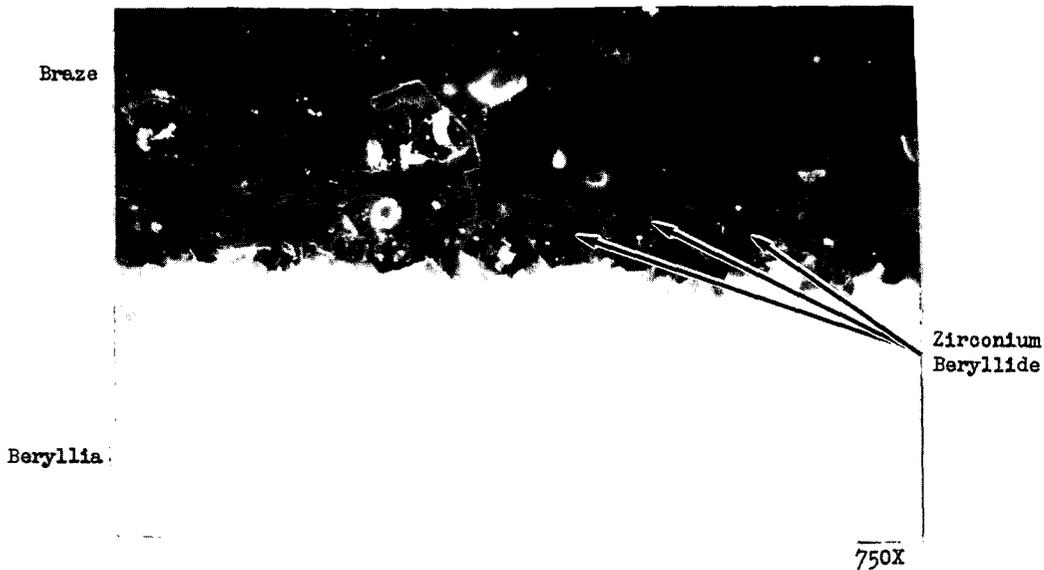
Figure 28. - Photomicrograph of Beryllia/Braze Interface of Bottom Brazed Joint of Bore Seal Capsule After 10,000 Hours at 1300° F Exposure. (750X, Dark Field)

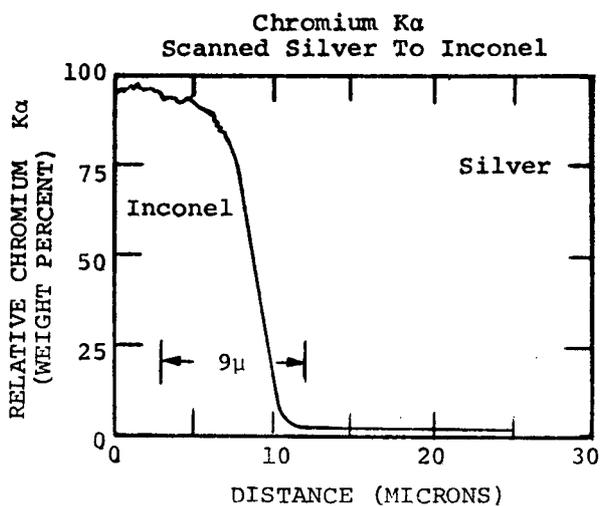
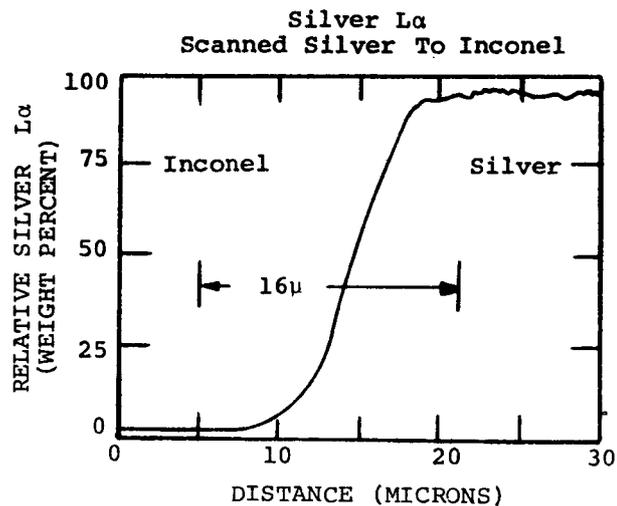
Figure 32. - Electron Microprobe Scans For Silver and Chromium in Aged (10,000 Hours at 1300° F Ultrahigh Vacuum) and Unaged Stator Inconel-Clad Silver Conductors.

indicated as being the interface. Silver could not be detected anywhere in the Inconel cladding nor could chromium be detected in the silver.

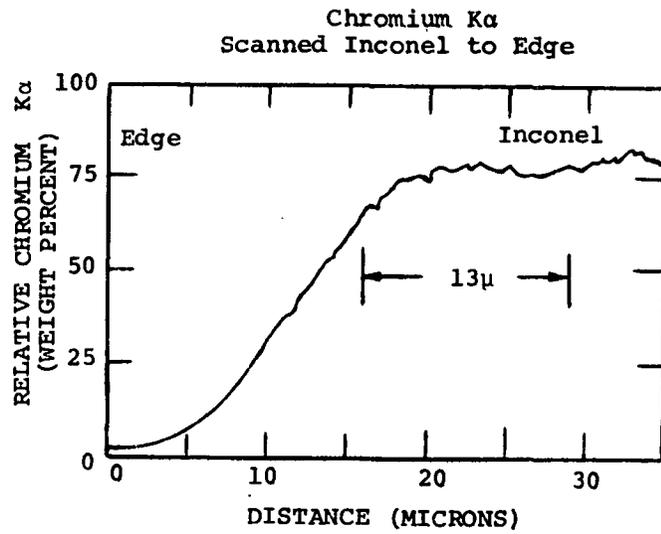
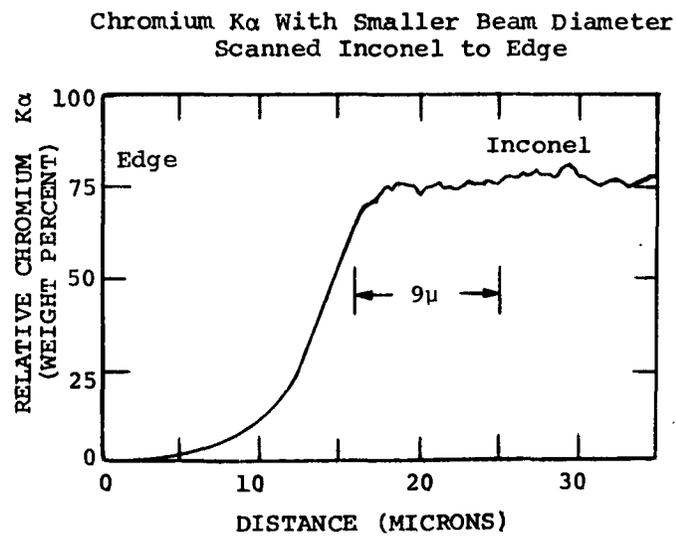
A check was made for possible chromium depletion from the outside of the aged Inconel specimen. A chromium scan was made from the silver interface across the width of the cladding. There was some indication that the chromium content might have decreased from 14 percent to 13 percent in the last 10 microns, but due to edge effects (rounding the specimen in polishing), this is very difficult to confirm. The beam size was reset to a smaller (nearer one micron) diameter and the edge area was re-run. There was even less evidence of any chromium depletion at the vacuum-exposed edge when the smaller beam was used. Figure 33 gives two charts showing these two scans.

Figure 33. - Electron Microprobe Scans For Chromium in Inconel From Aged (10,000 Hours at 1300° F Ultrahigh Vacuum) Stator Conductor Specimen.

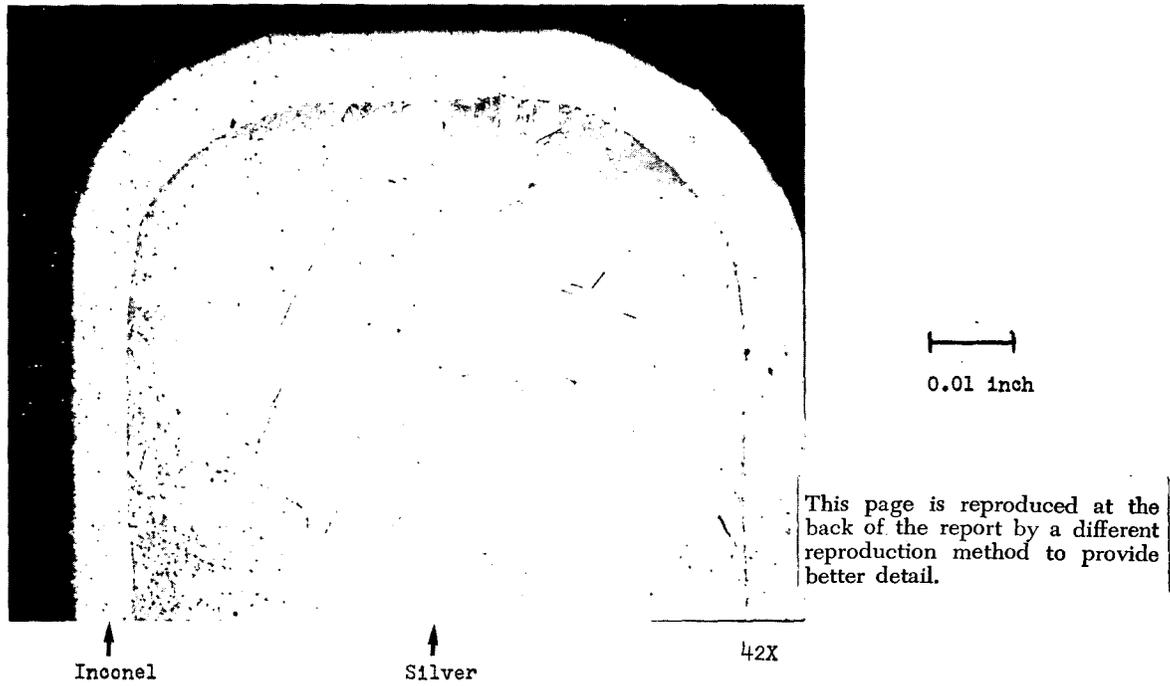
Metallographic Examinations of Inconel-Clad Silver Conductors. - Metallographic examinations were performed on unaged and aged Inconel-clad silver stator conductors from both end turn and slot. Figure 34 is representative of aged conductor from both end turn and slot. No differences were detected between the silver or the Inconel microstructures of the two aged specimens. Figure 35 is a photomicrograph of unaged conductor. A comparison of aged and unaged conductors showed considerably larger grains in the aged Inconel and somewhat larger grains in the aged silver. Grain growth found was considered normal for the aging conditions. There was no evidence of diffusion of silver or chromium in either aged conductor specimen.

Figure 34. - Photomicrograph of Unaged Stator Conductor (42X)

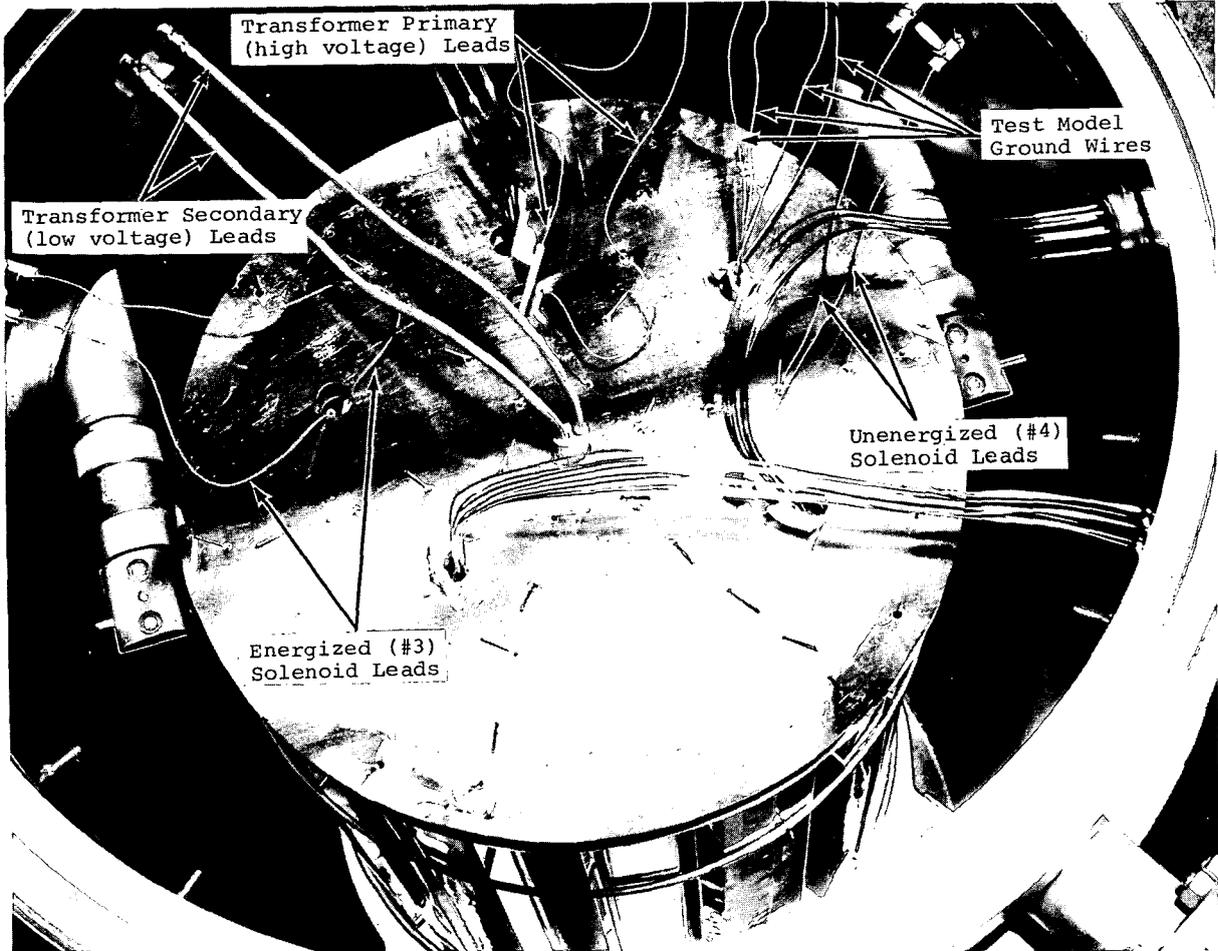
After measurements were completed, the test chamber was raised to ambient pressure using dry nitrogen as the cover gas, and the top cover was removed. Figure 39 is a photograph of the top of the test chamber after cover removal. Thermocouples were brought through the top heat shields in groups of eight. Transformer and solenoid leads are as noted on the photograph. Inspection showed that both lead wires to the energized solenoid were grounded to the top chamber heat shield. The hollow aluminum tubes which were used to insulate the leads as they passed through the heat shields had slipped down, one at a time, until each lead became grounded to the chamber. After the insulators were pulled back into position, the solenoid functioned normally, repeating pre-test bench test values for conductor resistance and insulation performance. Voltage and current values required to pick up and hold the plunger and weight also repeated pre-test bench test values. Thus, the energized solenoid did not suffer an internal failure. The problem was caused by chamber installation procedure and the vibrations that occurred in the test area.

Figure 39. - Transformer and Solenoid Test Chamber with Top Removed After Thermal Vacuum Testing.

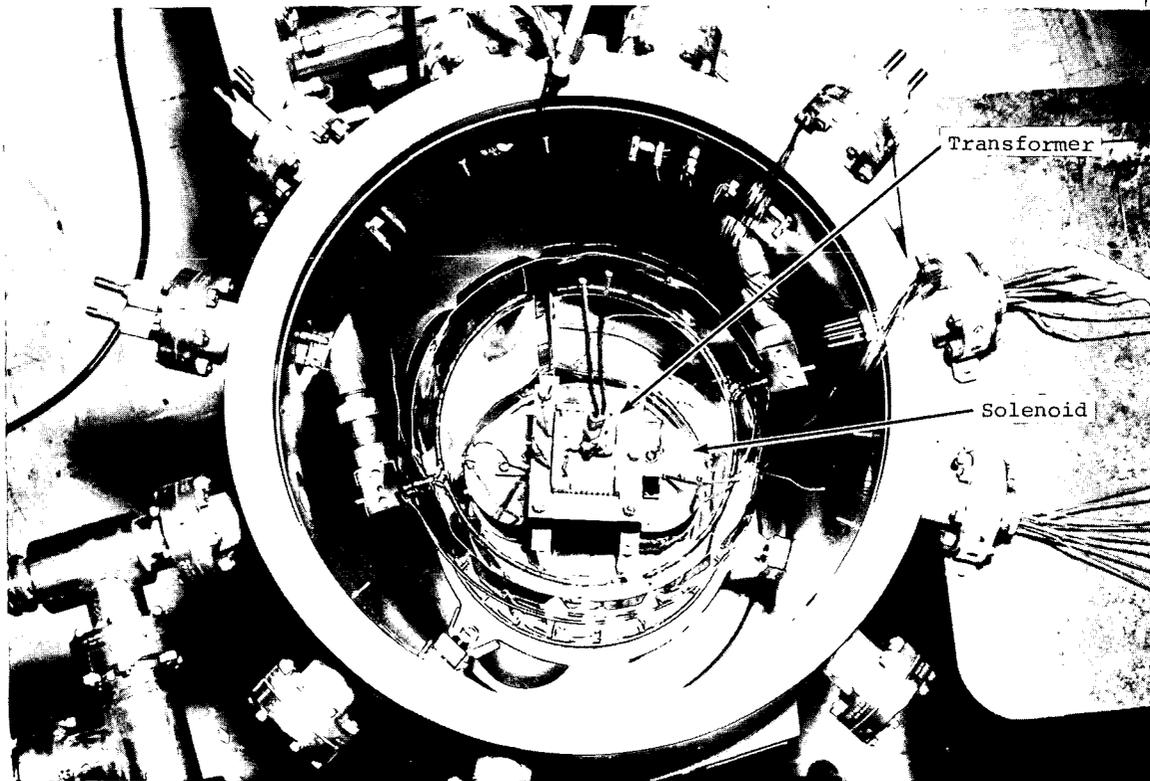
Figure 40 is a view of the chamber with the top heat shields removed. The transformer and two solenoids are shown in position on the model support fixture. Figure 41 is another view of the solenoids with the transformer removed from the chamber. The generally clean condition of the test chamber can be noted by the reflections inside the heating element and on the outside of the outer heat shield. Figure 42 shows the test chamber with the solenoids and support fixture removed.

Figure 40. - Photograph of the Transformer and Two Solenoids in the Test Chamber With Top Heat Shields Removed After Thermal Vacuum Testing.

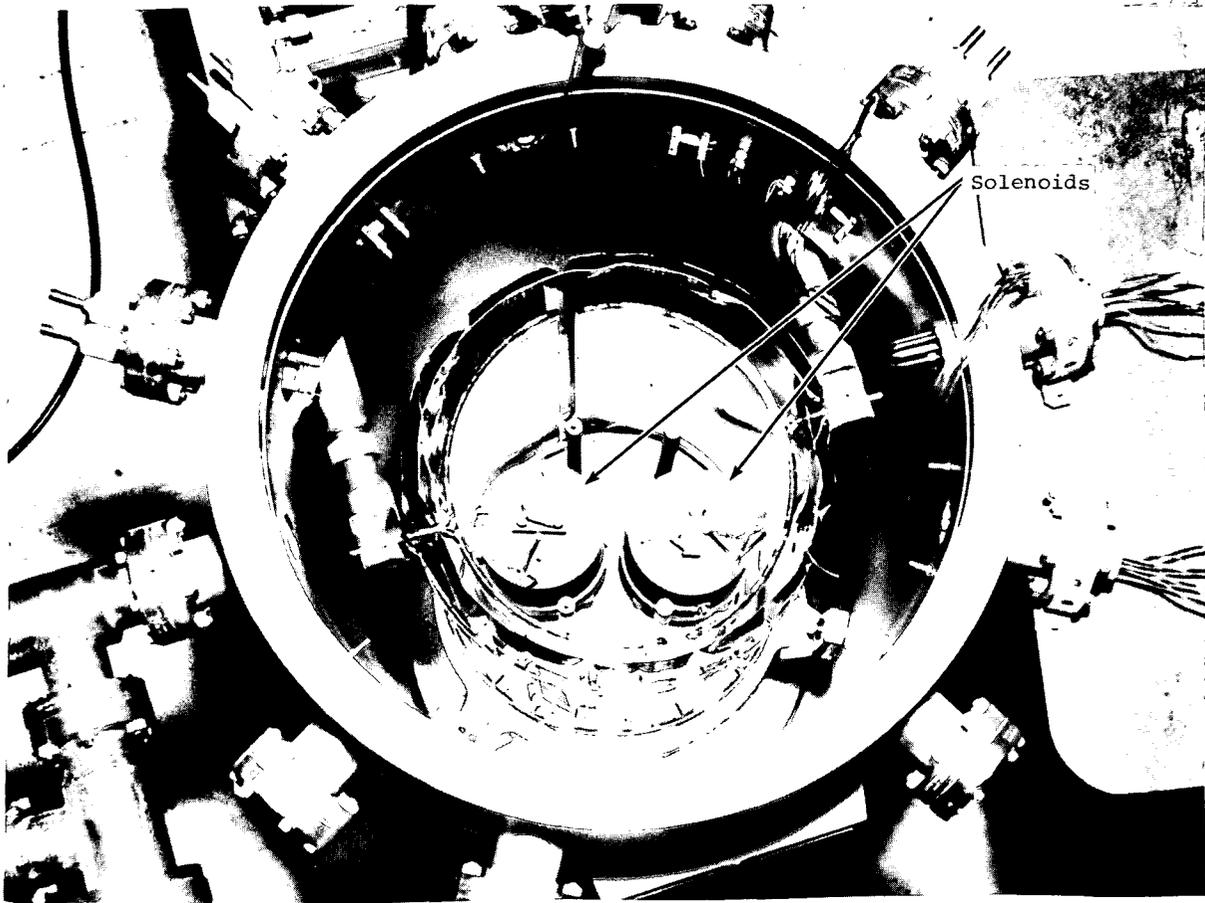
Figure 41. - Photograph Showing the Two Solenoids in the Test Chamber After Thermal Vacuum Testing. Transformer Has Been Removed.

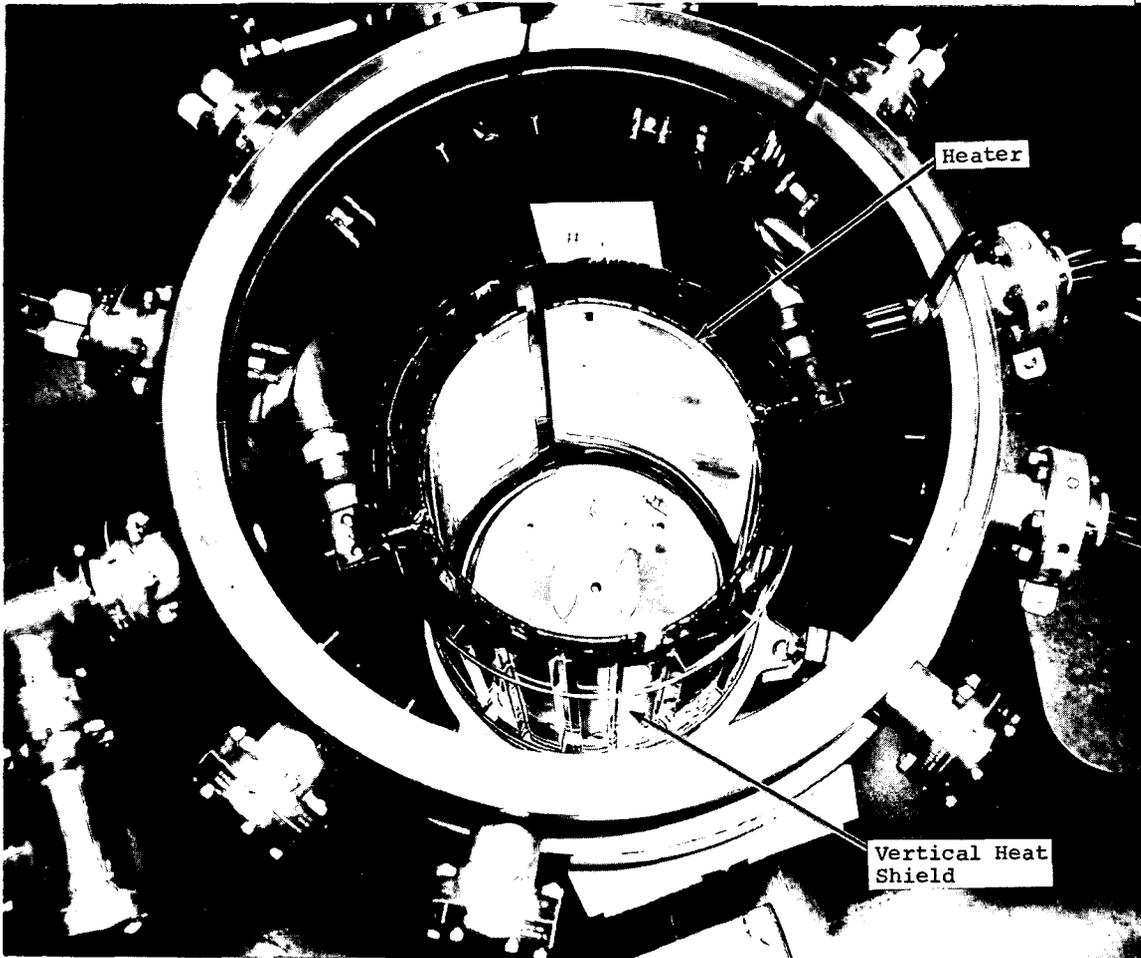
Figure 42. - Photograph of the Interior of the Test Chamber After Thermal Vacuum Testing. Transformer and Two Solenoids Have Been Removed.

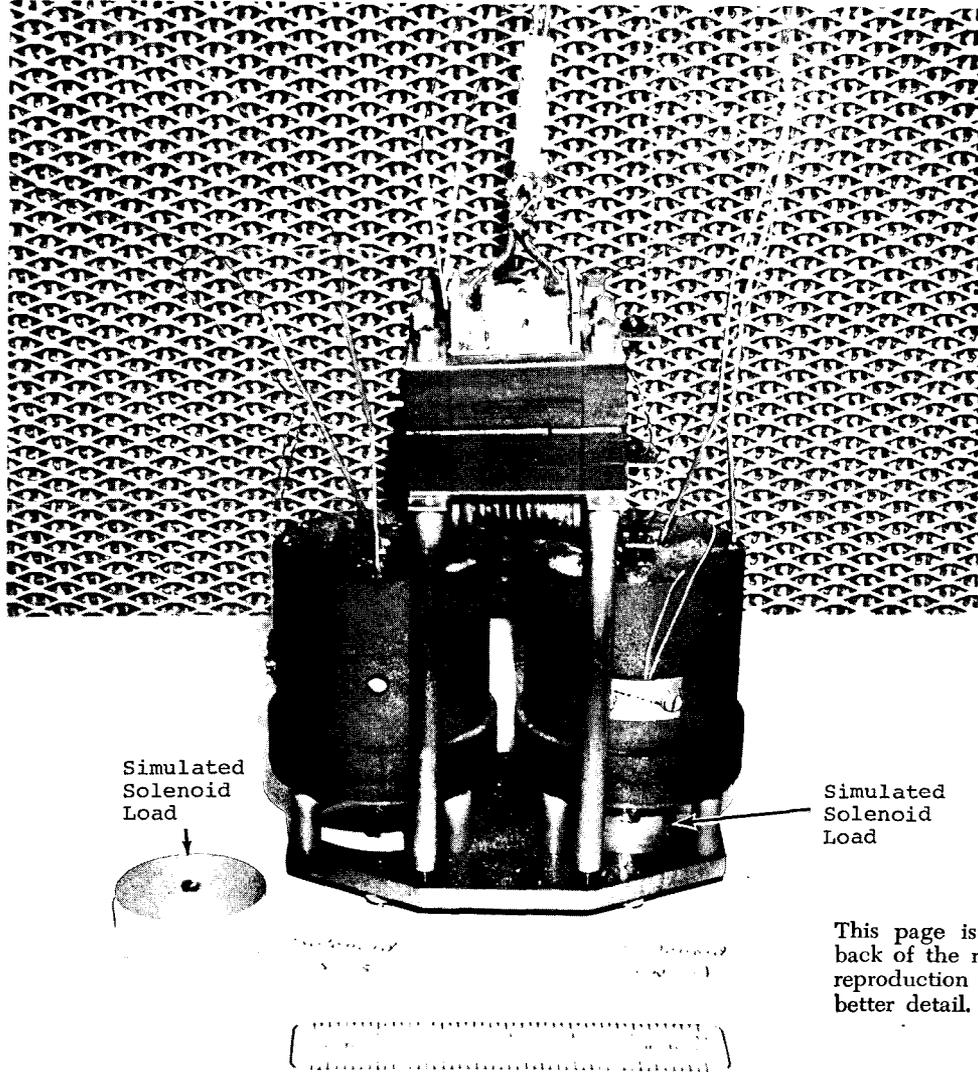
Figure 43 is a photograph of the transformer, solenoids and support fixture. The powdery material seen on the flat surfaces is loose conductor insulation which was disturbed when dry nitrogen was admitted to bring chamber pressure up to ambient pressure. The weight from the continuously energized solenoid is also displayed in the photograph.

Visual Examination. - Visual examination showed all exterior surfaces to be discolored. The normally white insulation and bright metal surfaces had a dull gray appearance, due to the deposition of evaporated materials. The ceramic spool end plates had a pattern of deposits indicating line-of-sight deposition.

Figure 43. - Photograph of the Transformer and Two Solenoids After Thermal-Vacuum Testing.
