NASA CR-72850

# EVALUATION OF HIGH TEMPERATURE ELECTRICAL MATERIALS AND COMPONENTS

**Westinghouse Electric Corporation  
Aerospace Electrical Division  
Lima, Ohio**

1. Report No. NASA CR-72850	2. Government Accession No.	3. Recipient's Catalog No.	
4. Title and Subtitle Evaluation of High Temperature Electrical Materials and Components.		5. Report Date April 1970

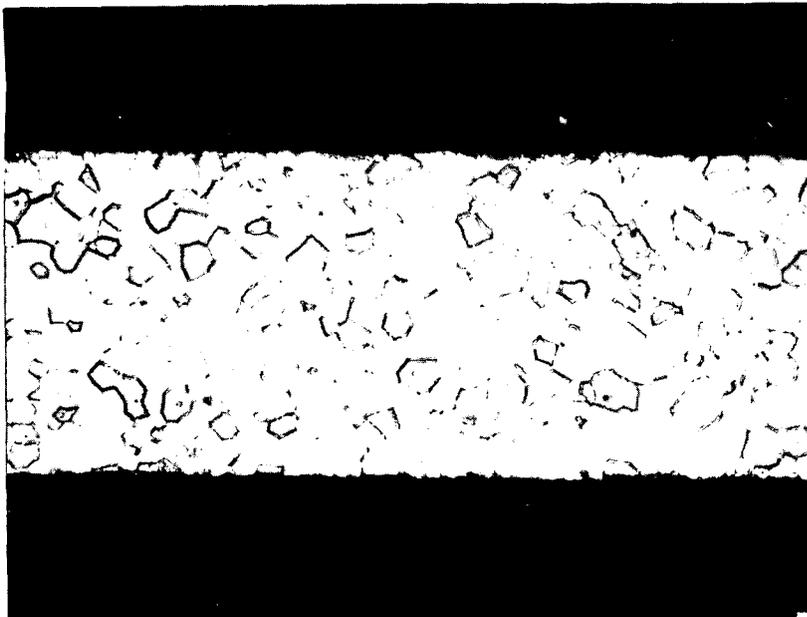
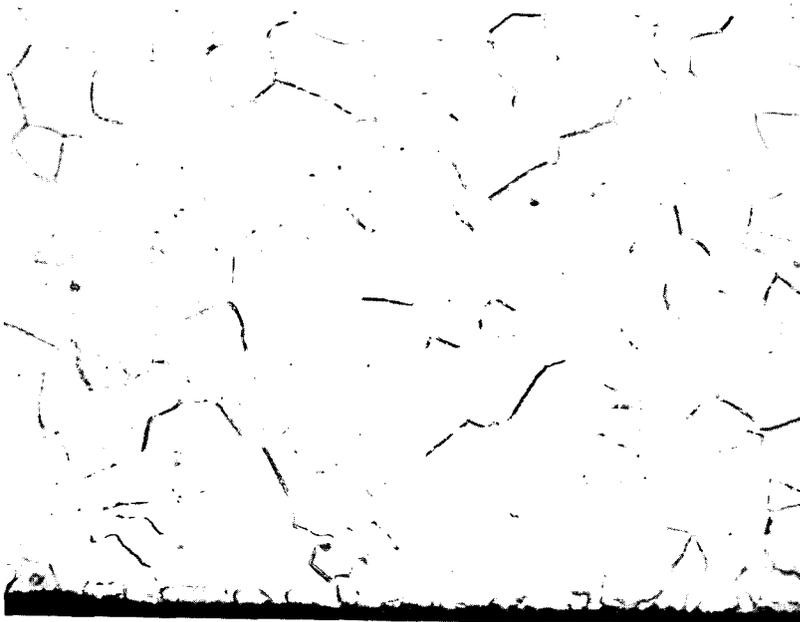
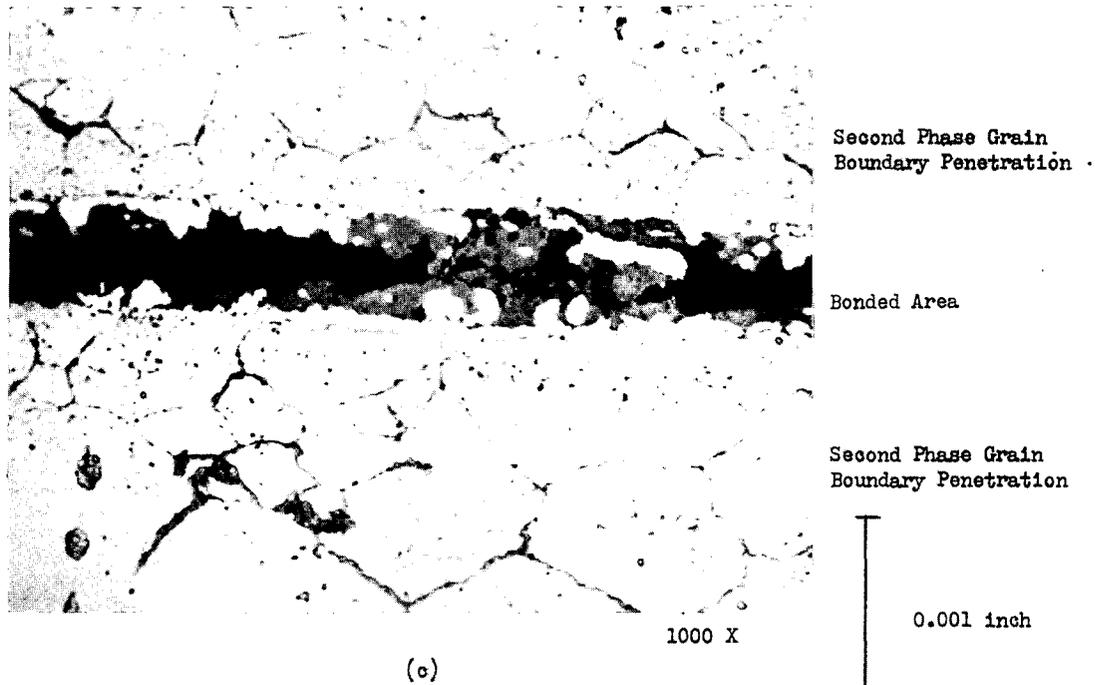
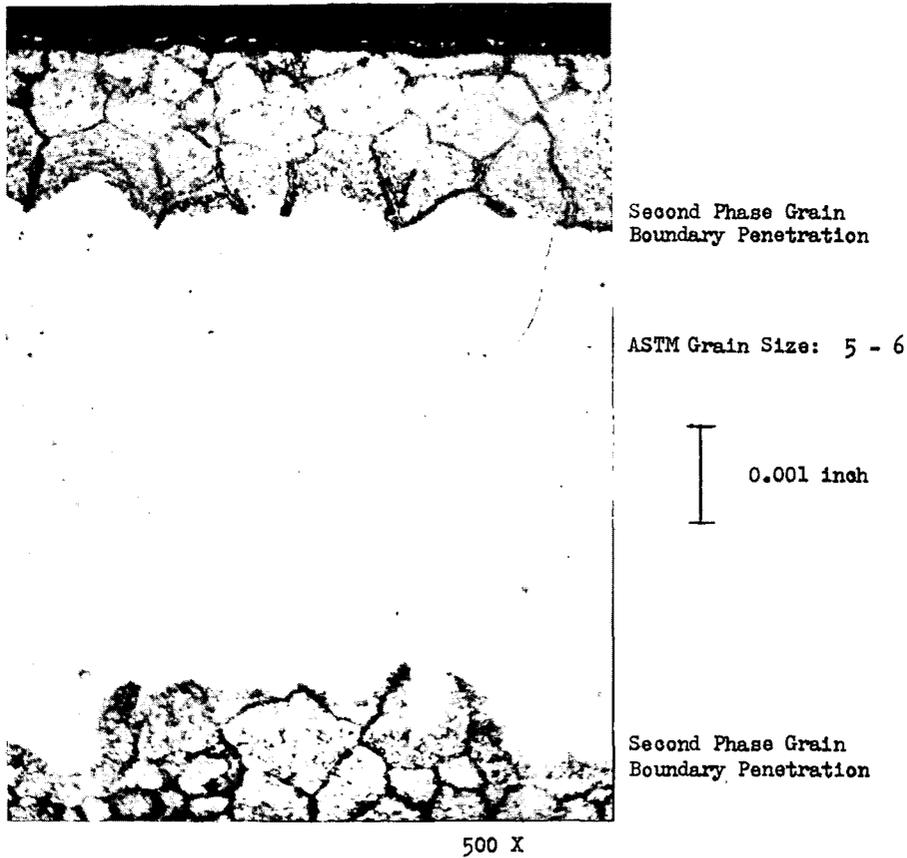
A pair of bonded laminations is shown in figure 46(c). Surface oxide had bridged the spacing between laminations resulting in laminations adhering to each other.

Figure 46. - Photomicrographs of Iron-27% Cobalt Magnetic Laminations from the Transformer Before and After Thermal Aging for 5000 Hours at a Pressure in the  $10^{-9}$  Torr Range.

- (a) Unaged iron-27% cobalt transformer lamination with plasma arc sprayed alumina interlaminar insulation (99.99+%  $Al_2O_3$ ) applied, 200X.  
Etchant: 50HNO<sub>3</sub>, 45CH<sub>3</sub>, COOH, 5H<sub>2</sub>O
- (b) Unaged iron-27% cobalt transformer lamination with plasma arc sprayed alumina interlaminar insulation applied, 500 X.
- (c) Iron-27% cobalt laminations with plasma arc sprayed interlaminar insulation applied, after 5000 hours aging at 1300° F, unetched, 1000X. Note area of "cold-weld" - area between laminations bridged by oxide caused adherence of adjacent laminations.
- (d) See next page.

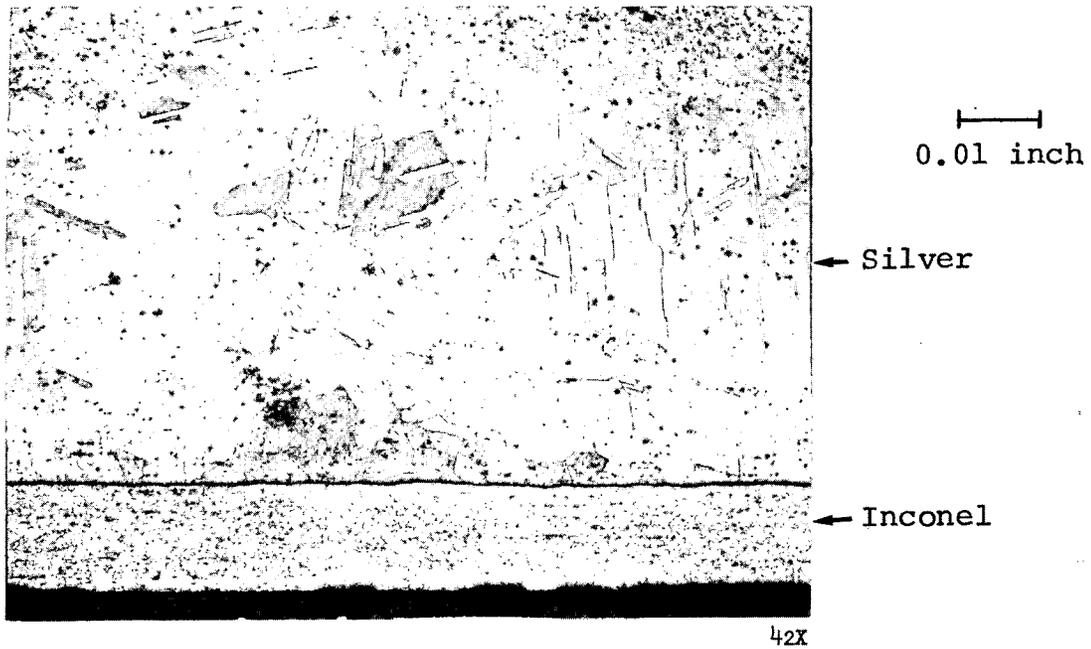
Figure 47. - Photomicrograph of Longitudinal Section of Unaged Transformer Secondary Conductor (42X)

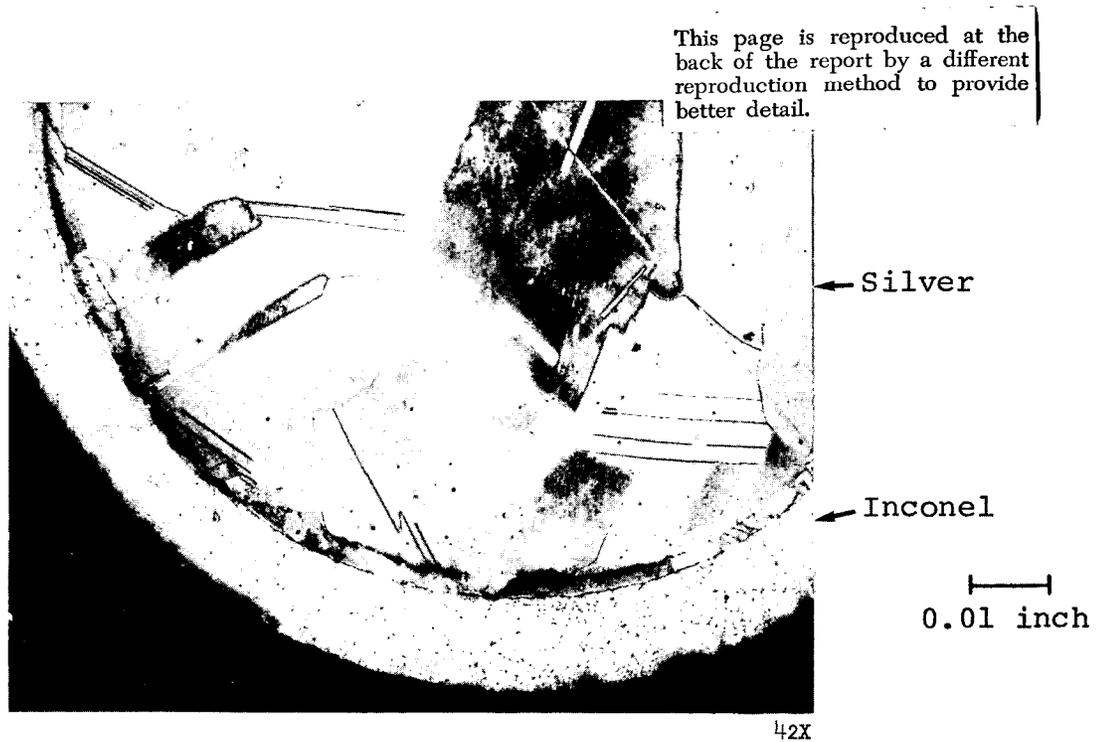
Figure 48. - Photomicrograph of Transverse Section of Transformer Secondary Conductor After 5000-Hour Thermal-Vacuum Exposure (42X)

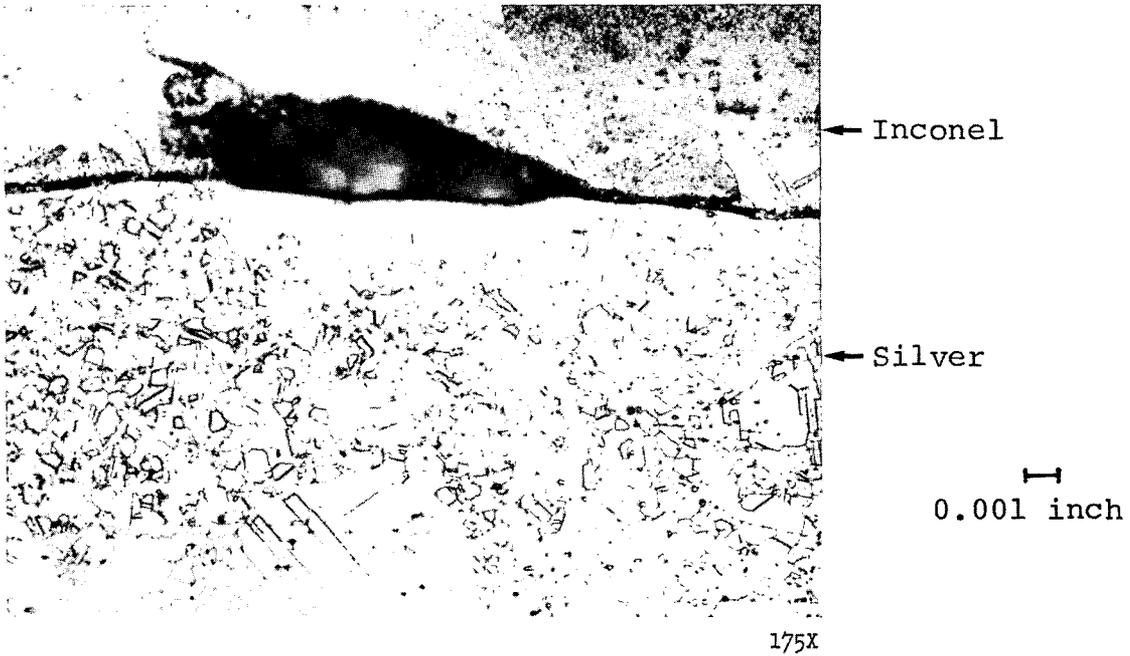
Figure 49. - Photomicrograph of Transverse Section of  
Transformer Secondary Conductor After  
5000-Hour Thermal-Vacuum Exposure  
(175X)

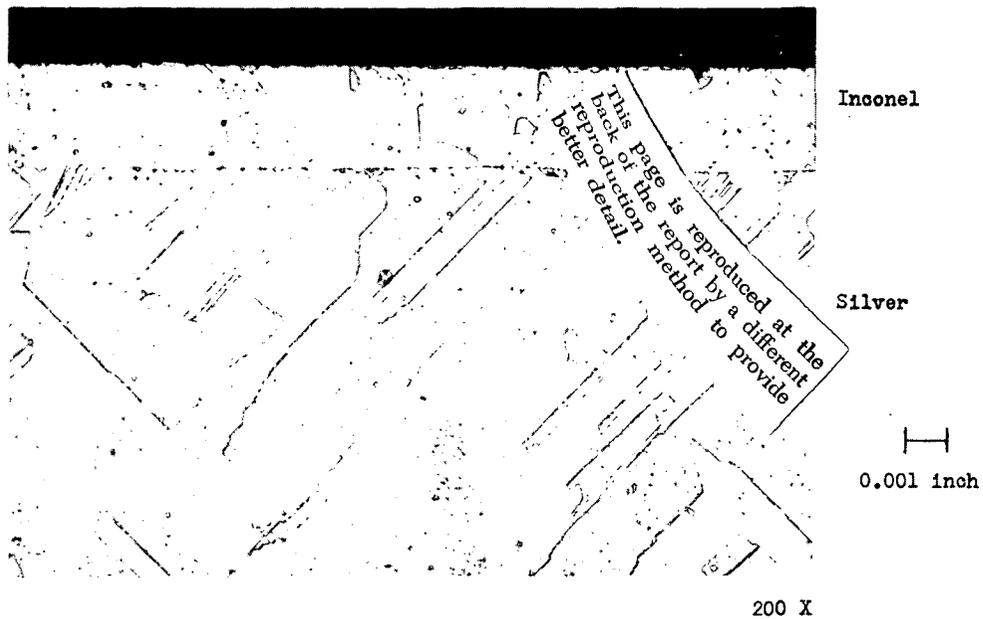
Microstructures of transformer primary conductors are shown unaged in figure 50 and as aged in figure 51. Grain growth due to thermal aging occurred in both the silver and the Inconel. Grain growth was as expected and was similar to that found in the aged secondary conductor. No evidence of voids was found in either aged or unaged primary conductor specimen.

Figure 50. - Photomicrograph of Longitudinal Section of Transformer Primary Conductor After 5000-Hour Thermal-Vacuum Exposure. (200X)

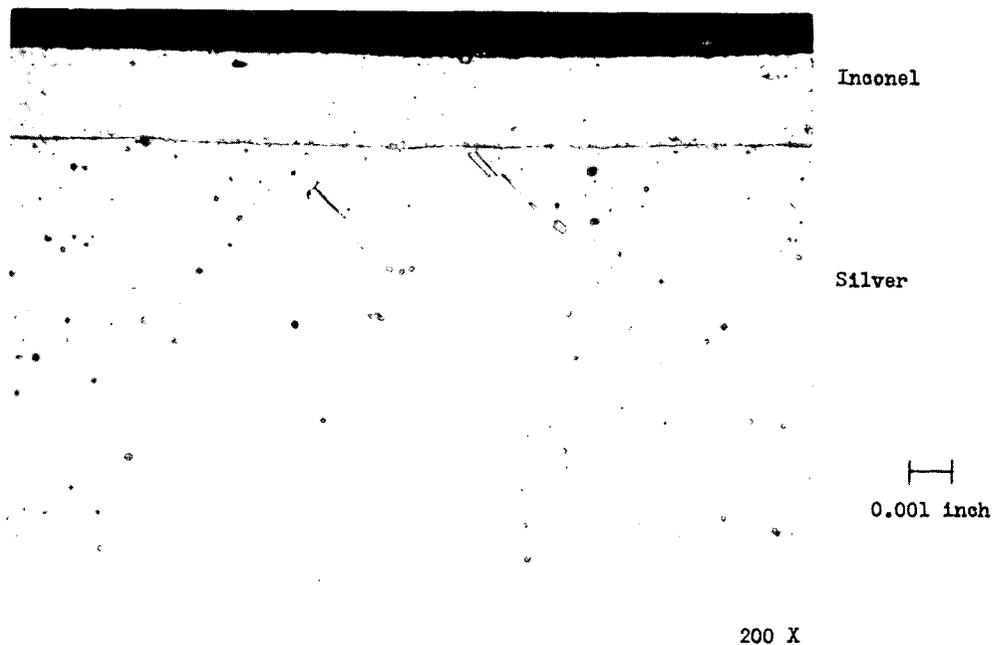
Figure 51. - Photomicrograph of Longitudinal Section of Unaged Transformer Primary and Solenoid Conductor. (200X)

Metallographic Examinations of Electrical Conductors. - Metallographic examinations were performed on Inconel-clad silver conductors, unaged and from each solenoid. The solenoid conductor is the same as that used for the transformer primary. Microstructure of the unaged material is shown in figure 51. Microstructure of the conductor from the intermittently energized solenoid is shown in figure 54. Grain growth occurred in both the Inconel and the silver during aging, as was to be expected. Large random voids in the silver are seen in figure 54. Particles of silver may be seen adhering to Inconel cladding. It is probable that the silver was molten at some time after the beginning of the cladding process (such as in strand annealing between drawing operations). The random distribution of the voids indicates a short time in the molten state (incipient melting) as there was insufficient time for the voids to coalesce. No voids were detected in the unaged conductor (figure 51).

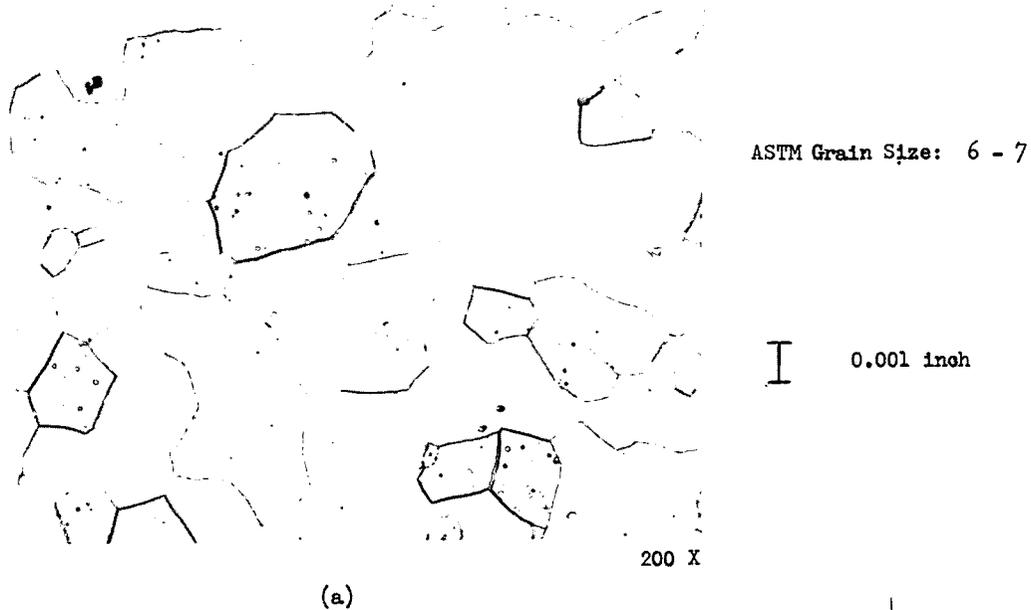
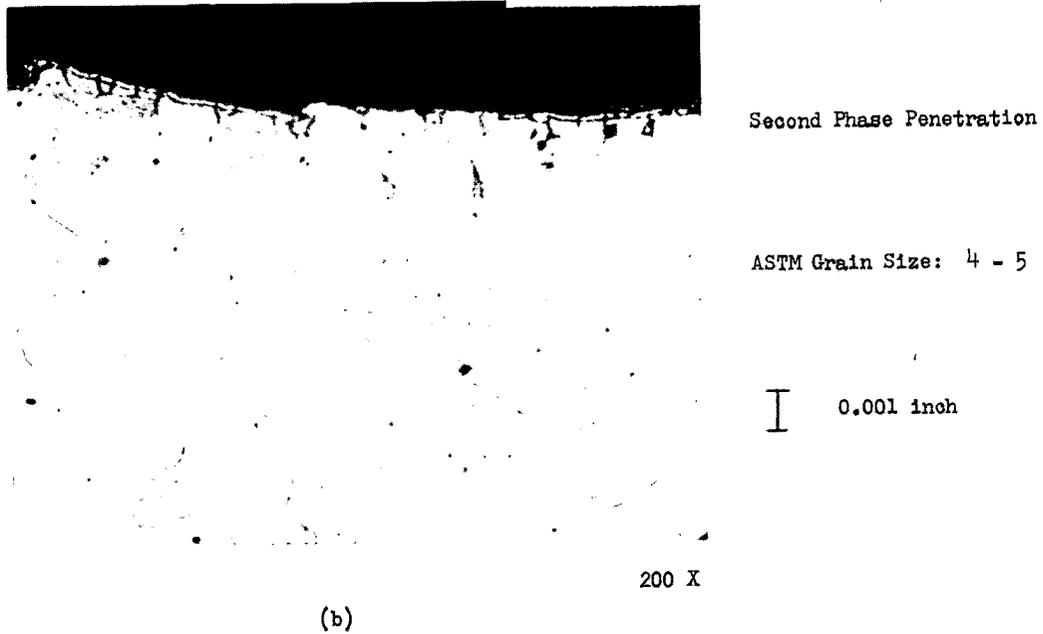
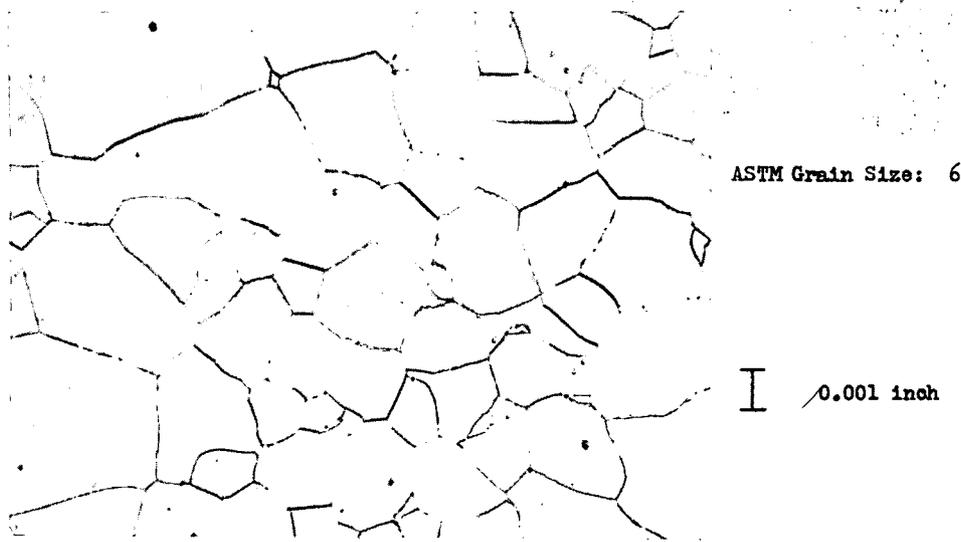
The microstructure of sections from solenoid end bells and plungers were examined and compared with a specimen from the unaged iron-27% cobalt forged bar. Representative microstructures are shown in figures 52 and 53. Some grain growth is evident in the iron-27% cobalt plunger (figure 52(c)) from the continuously energized solenoid, number 3, (aged 5000 hours at

Figure 52. - Photomicrographs of Forged Iron-27% Cobalt Magnetic Alloy from Solenoids Before and After 5000-Hour Thermal-Vacuum Exposure. (200X)

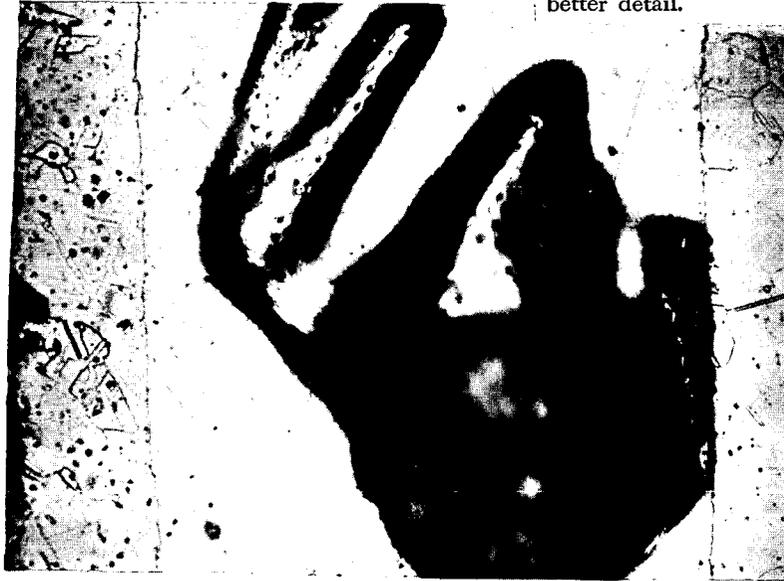
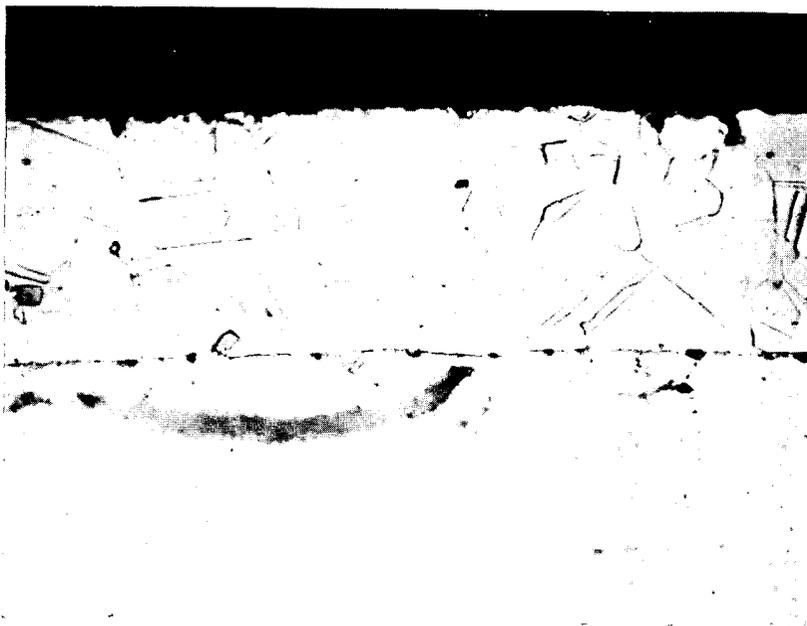
Figure 54. - Photomicrograph of the Electrical Conductor of the Intermittently Energized Solenoid After 5000-Hour Thermal-Vacuum Exposure. (200X)

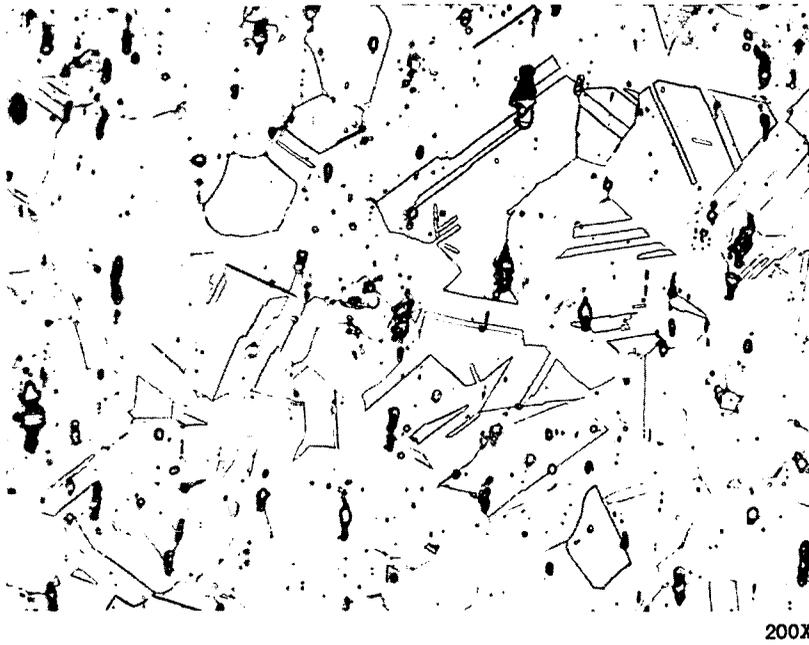
Construction Material Examinations. - Solenoid construction materials were given visual examinations. The stop plate from the continuously energized solenoid and unaged material were subjected to metallographic examinations and were compared. Figures 56 and 57 show microstructures of the unaged and aged materials respectively. The unaged material has the normal annealed face centered cubic structure while the aged material exhibits a face centered tetragonal structure probably mixed with a close packed hexagonal structure. However to verify this, electron diffraction studies will be necessary. Visual examination of the solenoid weights revealed no degradation occurred in thermal aging. No degradation was found in the examination of the 321 stainless steel O-ring.

Figure 56. - Photomicrograph of Unaged Solenoid Stop Plate Material. (200X)
