ABSTRACT

BYPASS CONTROL VALVE  
SEAL AND BEARING LIFE CYCLE TEST REPORT

Project 122

April 1972

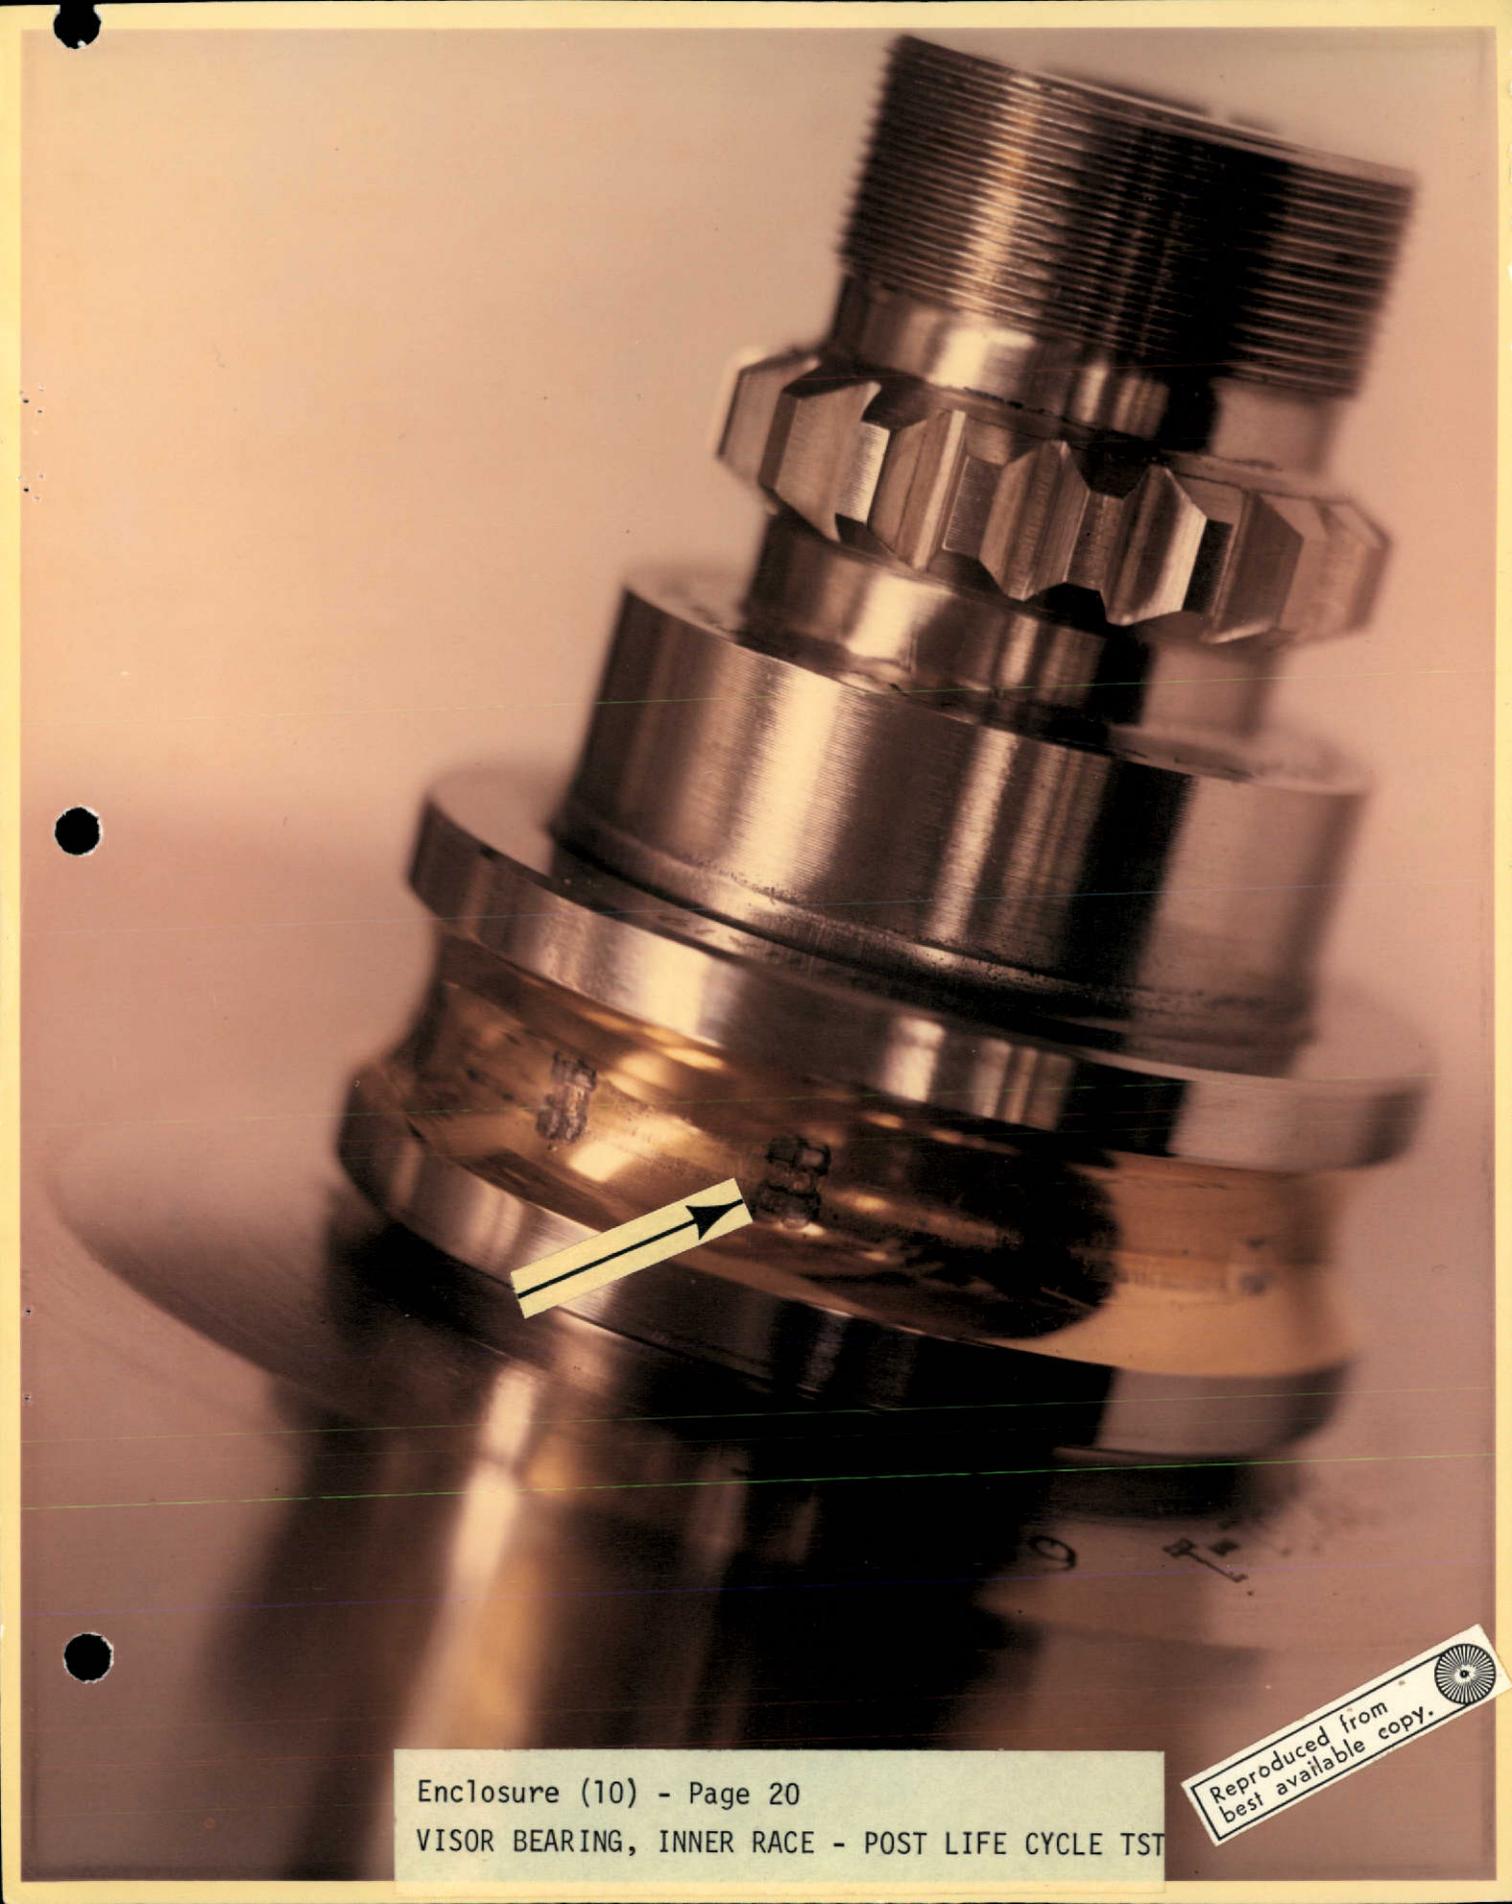
Enclosure (10) - Page 20  
VISOR BEARING, INNER RACE - POST LIFE CYCLE TST

Disassembly of the valve revealed no part failure or galling. Scoring occurred at the seal to visor sealing interface and at points of maximum load where the bearing balls had worn thru the gold plated race surfaces. The wear on all other valve parts was insignificant.

1. Improve the visor fabrication process to obtain a more uniform spherical surface or develop a lapping procedure to assure conformance of the visor seal interface to the visor.
2. Conduct ambient air or GN<sub>2</sub> flow tests to ascertain the correlation between the predicted vs. actual hydrodynamic torque and loss coefficient.
3. Conduct a cryogenic life cycle test at pressures, temperatures flowrates and control positions expected during engine operation. The results of the test should then be correlated with the ambient life cycle tests to determine the extent of further development and redesign if required.
