APOLLO 16 MISSION

ANOMALY REPORT NO. 4

UNEVEN DRIVE RATES OF THE SCANNING TELESCOPE

MANNED SPACECRAFT CENTER HOUSTON, TEXAS NOVEMBER 1972

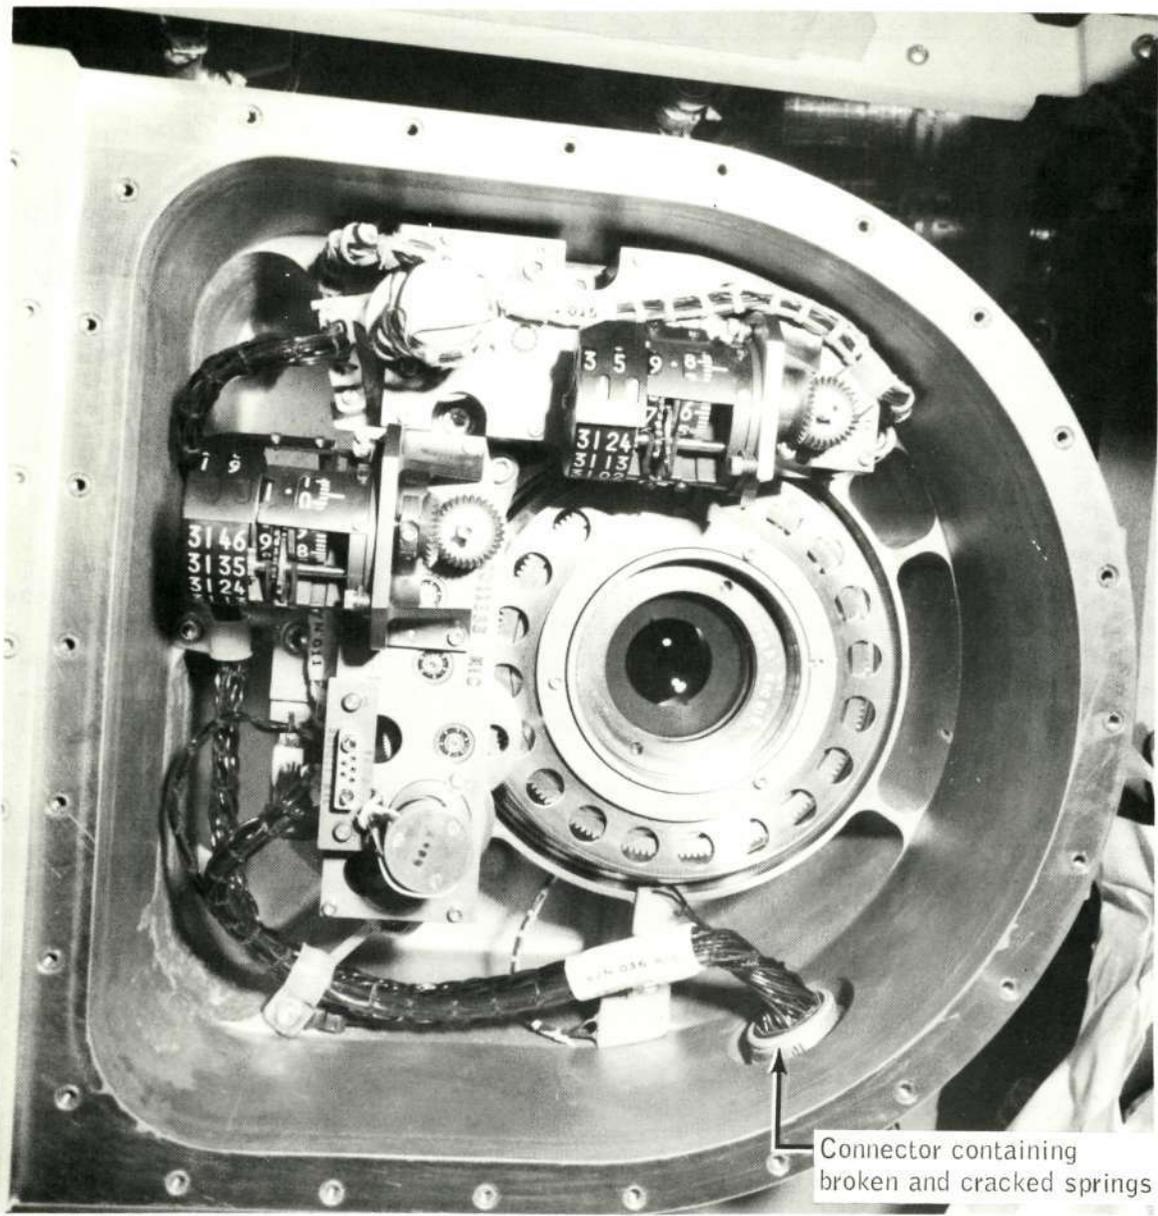
Figure 1.- Scanning telescope.

The sextant and the scanning telescope are mounted in the optical unit assembly that is fixed to the guidance system navigation base. These optical instruments are in an unpressurized cavity (fig. 1) and exposed to the external spacecraft environment. The electrical signals and voltages necessary to reposition the optics are routed to the optical instruments through two feed-through connectors on the pressure bulkhead behind the optics panel.

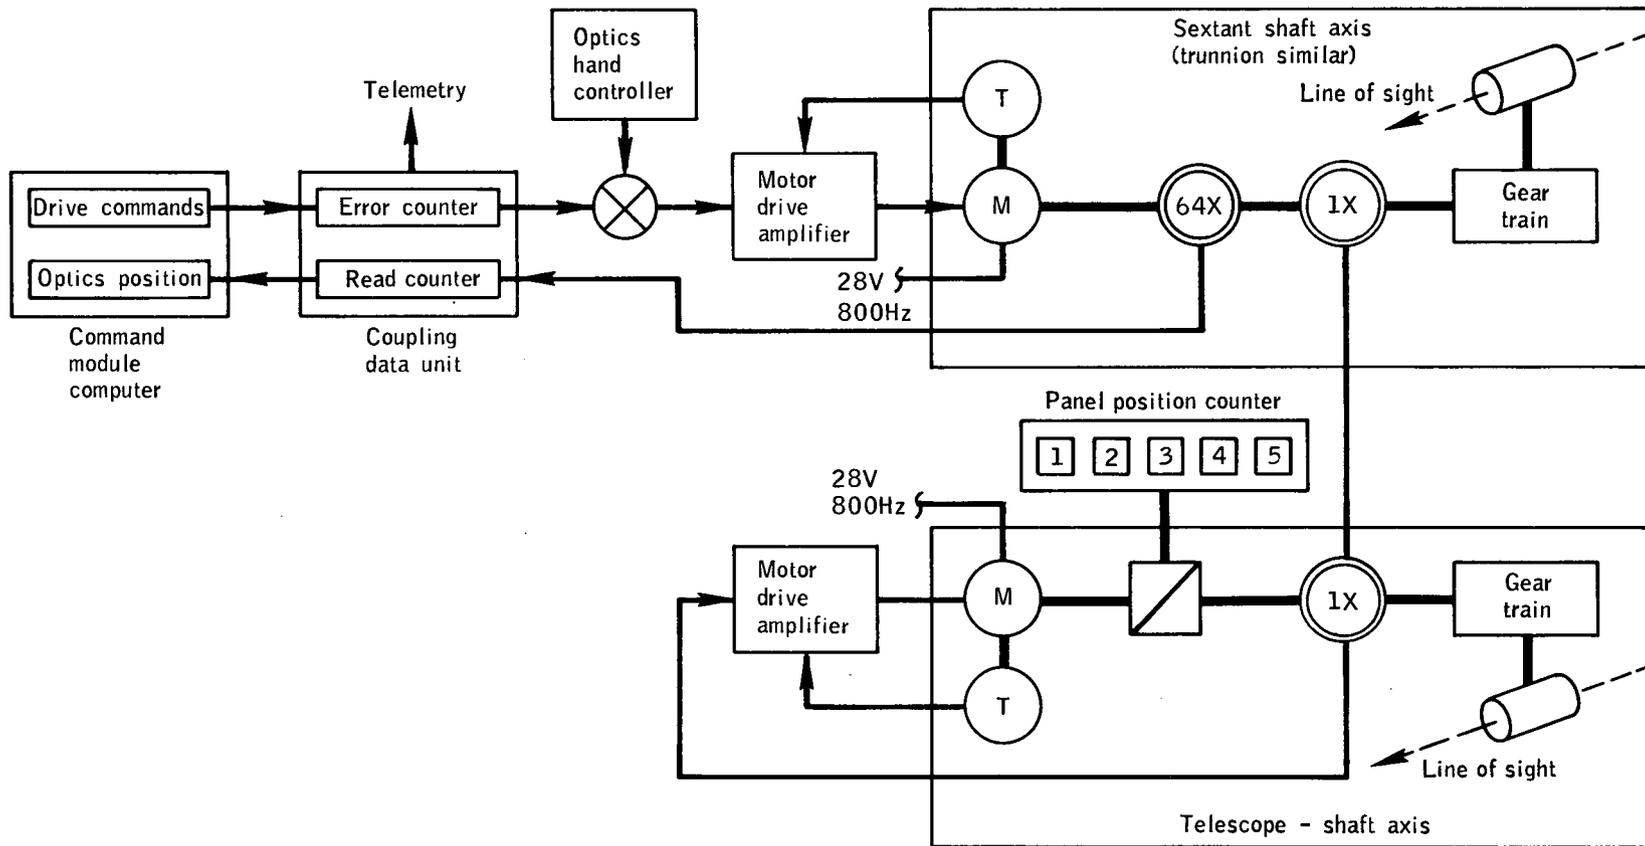
Figure 2.- Functional drawing of optical unit assembly.

The optics can be repositioned by three methods: First, manual drive commands can be generated by using the optics hand controller; second, the computer can be used to generate automatic drive commands; and third, the optics can be commanded to zero position by selecting the zero optics mode. Figure 2 is an electrical block diagram of the optical subsystem. As shown in the figure, all drive commands are sent to the sextant, and the telescope is slaved to the sextant through LX resolvers.

Telemetry data did not reveal any abnormalities in optics drive commands. The telemetry pick-off for the drive commands is located in the coupling data unit digital-to-analog converter section, and erratic positioning of the optics downstream of the telemetry pick-off (fig. 2) would not have been detectable in the data. Further, since there was no problem with the sextant, the source of the erratic drive rates must have been downstream of the sextant LX resolver.
