# FIELD REPAIR OF COATED COLUMBIUM THERMAL PROTECTION SYSTEMS (TPS)

## FINAL REPORT

MDC E0681

15 SEPTEMBER 1972

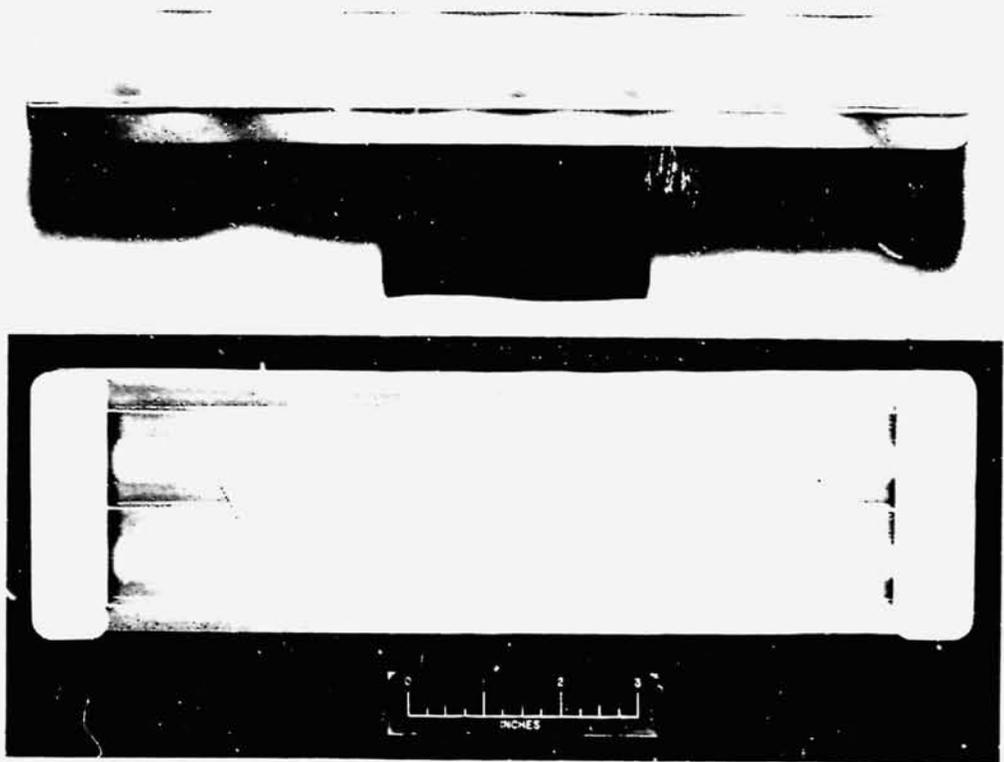
457-1693

The fusion welding of the skin to the ribs caused a noticeable amount of distortion. Typical examples of this distortion are shown in figure 3-3. The longitudinal bowing of the panels produced a nominal deflection of 0.07 inch in the center of the span and a series of ripples, or buckling of the skin, between the ribs. The maximum depth of the buckles, 0.08 inch occurred in the center of the panel and the buckling of the skin was not noticeable on the unsupported edges.

The undesirable skin distortion was caused by shrinkage of the electron beam fusion weld which joined the ribs to the skin. The rib thickness was 0.022 inch and the skin was 0.012 inch thick. Because the 0.012-inch skin was not of sufficient strength and stiffness, it buckled between the ribs. The problem of producing distortion-free rib stiffened panels was attacked using two simultaneous approaches. The first approach was to prevent distortion during welding by altering the welding

Showing Skin Distortion

The second approach, creep forming the rib stiffened panels after welding, was investigated. Experiments were conducted in which rib stiffened skins were straightened by placing machined molybdenum bars between the ribs to provide dead weight loading while the part was heated in a vacuum. Results from the first experiments were good and it was established that 1 hour at 2700°F with a normal pressure of 0.6 lb/in<sup>2</sup> was sufficient to remove the bow in the ribs and the waviness of the skin. A tool (shown in figure 3-4) of sufficient size to creep straighten a 20 by 20-inch rib stiffened panel was constructed of TZM alloy molybdenum. The tool was used to straighten eight 3 by 12-inch panels and four 4 by 10-inch panels. All of these panels were successfully straightened without cracks or other damaging effects and were flat and distortion free. Figure 3-5 shows a full size panel before creep straightening, and figures 3-3, 3-7 and 3-8 show panels after creep straightening.

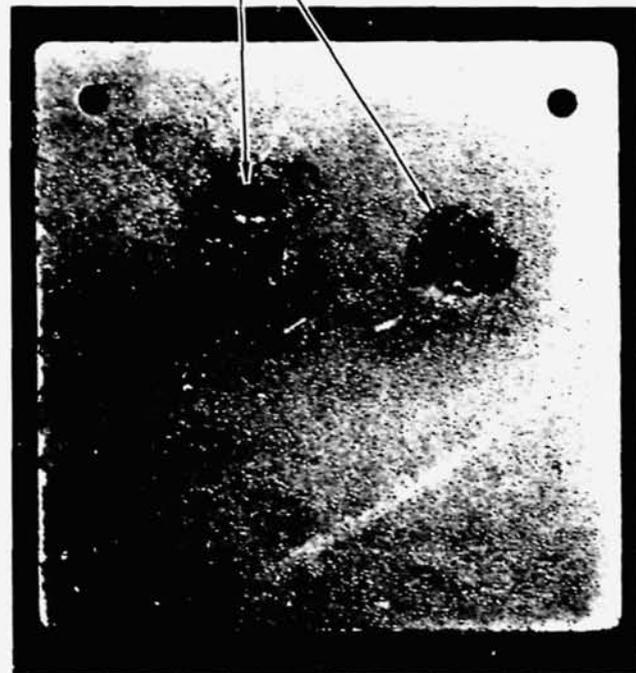
145 FT SEC IMPACT

AFTER OXIDATION TESTING

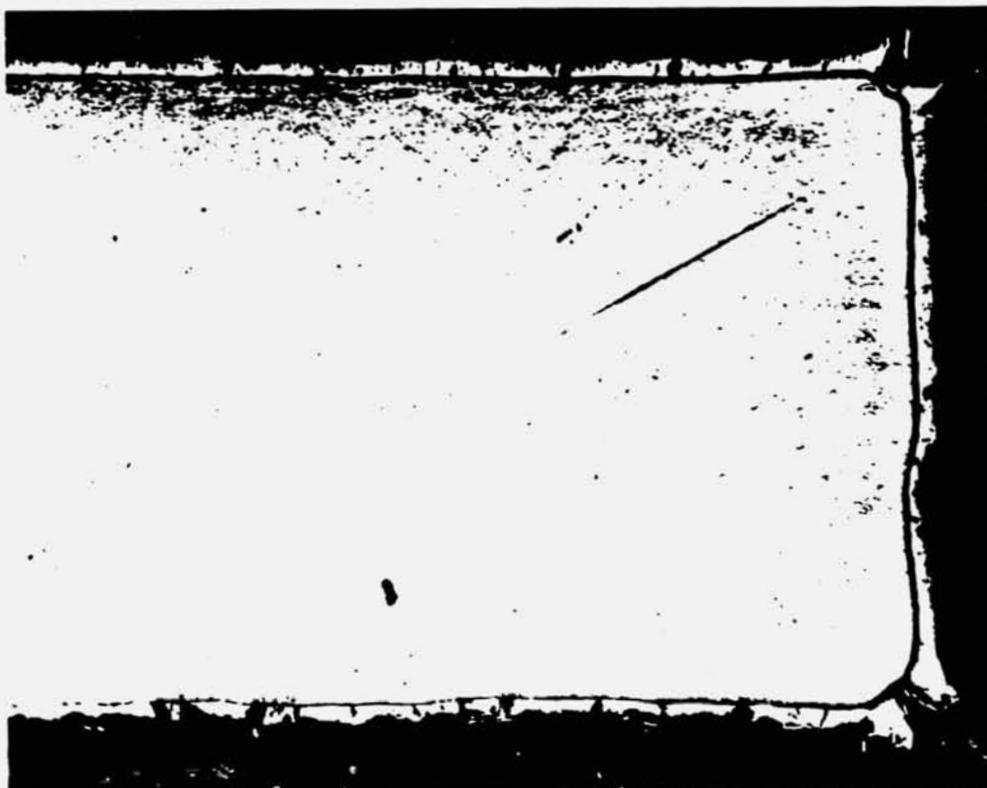
FIGURE 5-6

5.3.1 Coated Refractory Metal Experience - Past experience has shown that the most common cause of coating damage is impact on edges. Edges are more susceptible than surfaces to collision damage during handling and installation. The susceptibility of an edge to impact damage is related to the quality of the coating at the edge as well as to the angle of impact and the kinetic energy at impact. Figure 5-6 shows a poorly coated edge and figure 5-7 shows an adequately coated edge.

EXAMPLE OF POOR QUALITY EDGE COATING

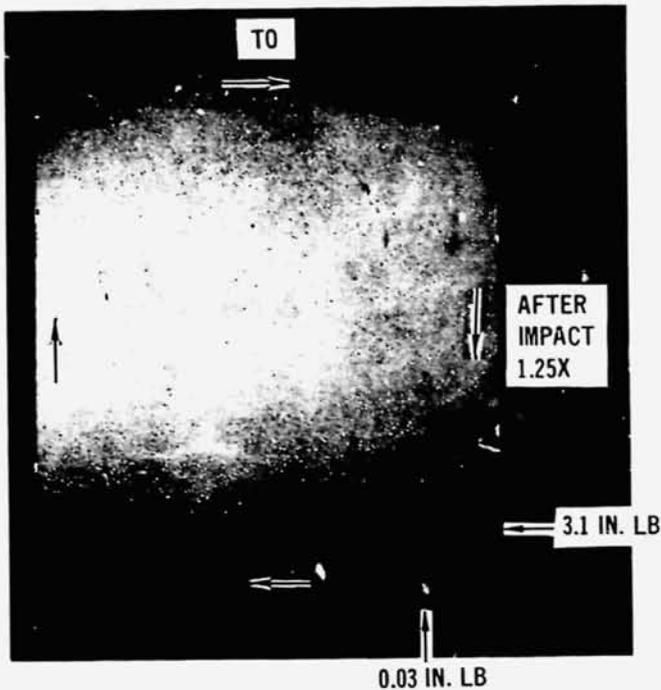
Figure 5-8

clamped to hold the edge perpendicular to the free fall patch of the pendulum arm. The impact energy was taken to be the product of the weight of the pendulum arm and the change in height of the center of gravity of the arm during the impact swing. Coupons of R-512E coated Cb-752 and VH-109 coated C-129Y were damaged at various levels and oxidation tested for 25 hours at 2400°F or until failure occurred. Table 5-2 presents the edge impact data and oxidation test results. Examples of edge impact specimens are shown in figures 5-8 and 5-9.

SYLVANIA R-512E EDGE IMPACT SPECIMENS

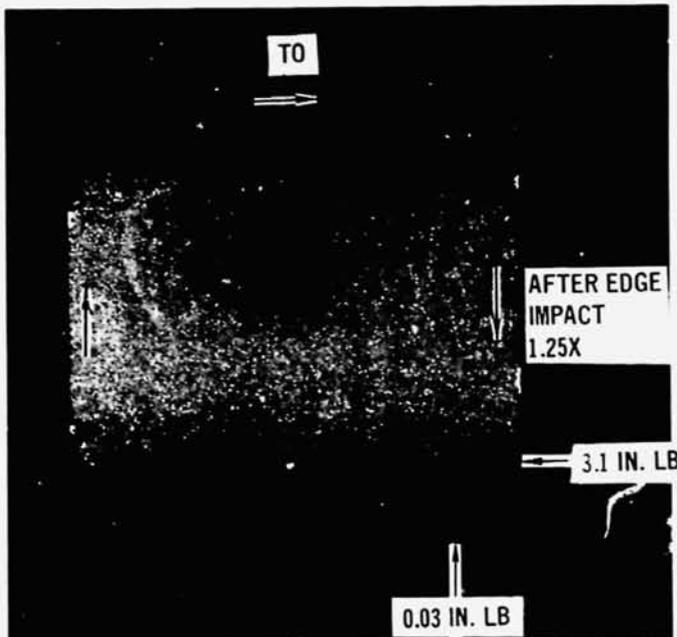
VAC-HYD VH-109 EDGE IMPACT SPECIMENS

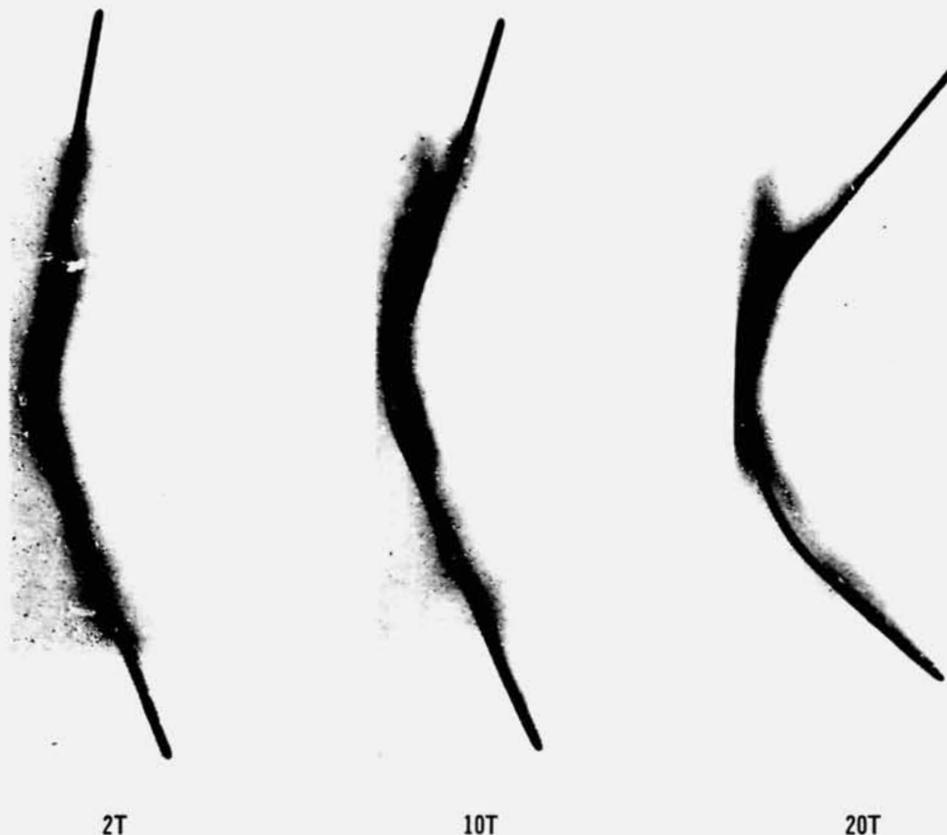
Figure 5-10

TYPICAL SYLVANIA R-512E/Cb-752 BEND SPECIMENS

The distortion test results are presented in table 5-3 and typical bends for both coatings are shown in figures 5-10 and 5-11. The bend testing produced three types of coating defects. Spalling of the coating on the compression surface and chipping of the edges occurred first as illustrated in figure 5-12. The third and least detrimental type of defect was cracking of the coating on the tension side, illustrated in figure 5-13. Coating damage on the compression surface was found to be the most detrimental with the R-512E and VH-109 coatings showing early failure when bent at 10 T to more than 18 and 9 degrees, respectively. It was found that the compression spallation posed a serious problem when the coating sheared at the substrate, thus producing a total loss of coating in the damaged area (figure 5-12). The tension cracking proved to be much less critical, and repair coatings had to be applied to compression surface damage areas to test the tension cracking condition. The VH-109 coating was bent to a 66-degree permanent set at 2 T and to a 98-degree permanent set at 20 T. Seven hours were required to

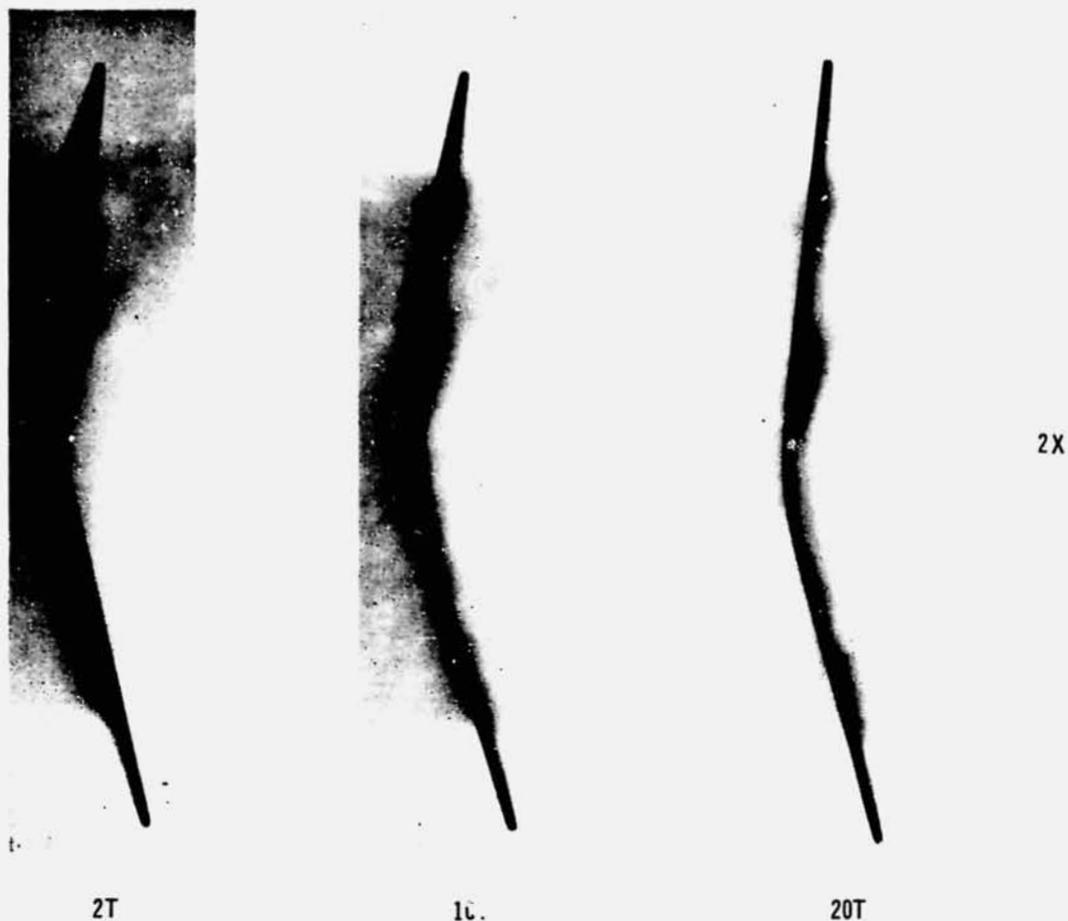
TYPICAL VAC-HYD VH-109/C-129Y BEND SPECIMENS

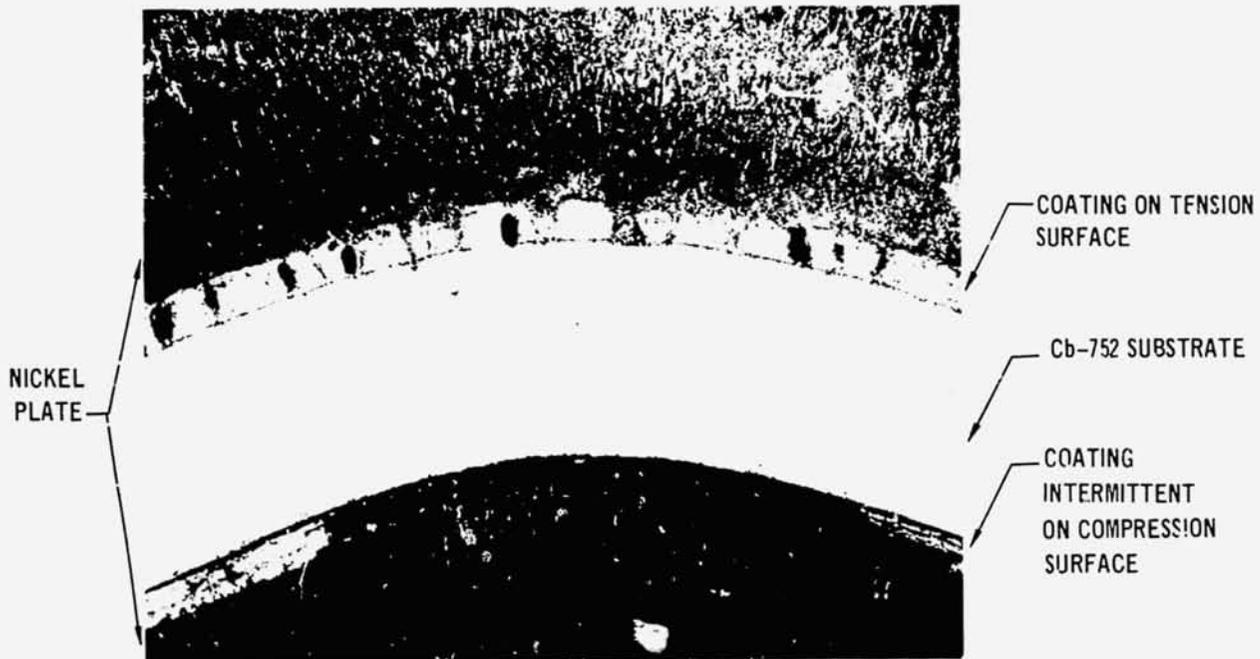
Figure 5-14

initiate oxidation failure on the tension side. The R-51E coating was bent to a 50-degree permanent set at 2 T and to a 90-degree set at 20 T; it did not fail even after 25 hours at 2400°F. The difference in type of damage sustained on the compression and tension side is shown in cross section in figure 5-14. The coating on the compression surface was sheared at the substrate, leaving a substantial area of unprotected columbium. On the tension surface, the tension crack simply opened up and the coating remained in place. The small area exposed, and the proximity of coating (producing an oxide and closing up the crack), accounts for the great difference in oxidation performance between the surfaces. Figure 5-15 shows typical examples of the oxidation failures which were experienced.

R-512E BEND SPECIMEN-- 150X

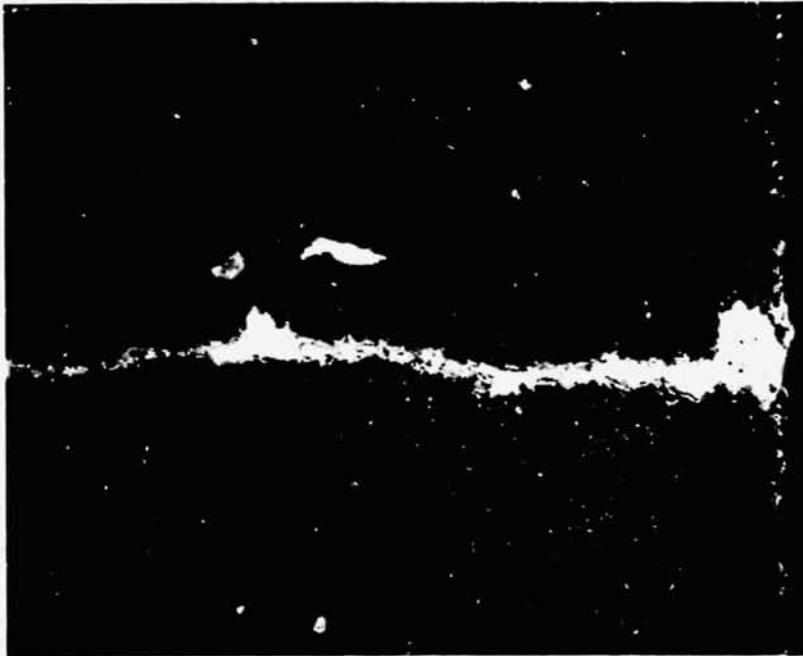
1 HOUR FAILURE IN COMPRESSION DAMAGE

7 HOUR FAILURE IN TENSION DAMAGE

EXAMPLES OF TYPICAL OXIDATION FAILURES EXPERIENCED IN BEND SPECIMENS

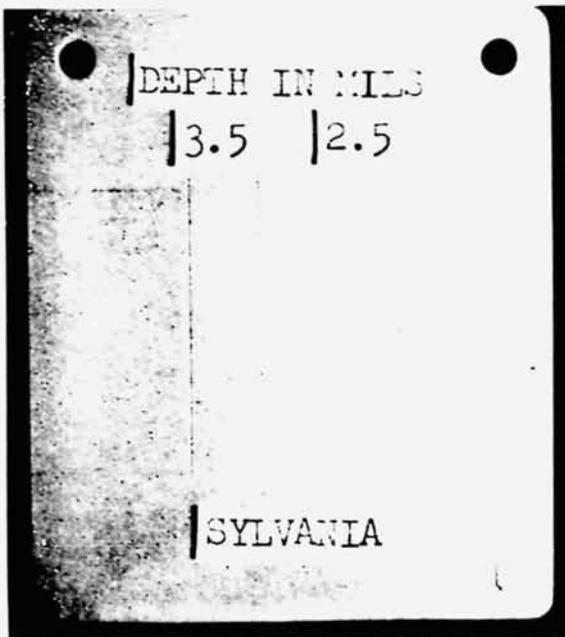
5.5.3 Scratching Damage Testing and Results - For this study, a scratch was defined as damage to the coating caused by a hard, sharp object penetrating and cutting the coating to a measurable depth. Line deposits from softer objects or superficial disturbances of the surface were not considered. The scratches were cut into the coatings with a 60-degree tungsten carbide tool mounted in a milling machine. The specimen surface was located perpendicular to, and just touching, the tool over the desired length of stroke. The tool then was pushed into the coating to the desired depth and the machine table driven to produce the desired depth of cut. In an initial set of specimens scratch defected, the Sylvania R-512E coating was cut to a depth of 1/2, 1, 1-1/2, and 2 mils (figure 5-16) and the VAC-HYD VH-109 coating was cut to a depth of 1/2, 1, 1-1/2, 2, and 3 mils (figure 5-17). After oxidation testing at 2400°F for 25 1-hour cycles at one atmosphere, the scratches had produced no oxidation failure in either coating (see figures 5-16 and 5-17).

BEFORE OXIDATION TESTING 1.4X

AFTER OXIDATION TESTING 25 HOURS AT 2400°F 1.4X

SYLVANIA R-512E SCRATCH TESTS BEFORE AND AFTER OXIDATION TESTING

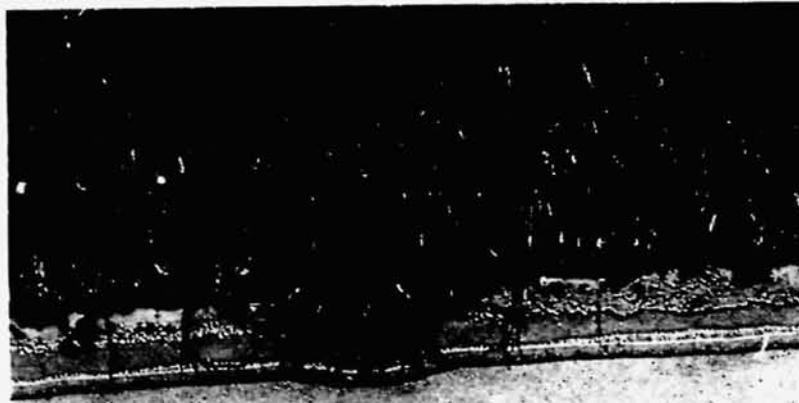
Figure 5-20

SCRATCH DEPTHS OF 2 MILS BEFORE AND AFTER OXIDATION TESTING

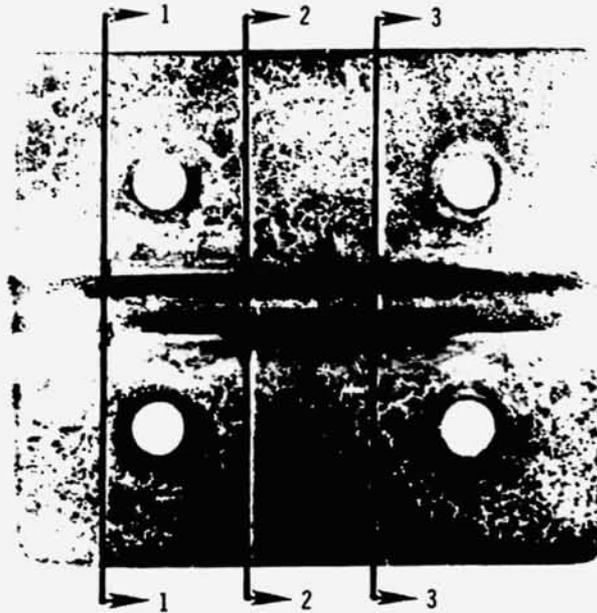
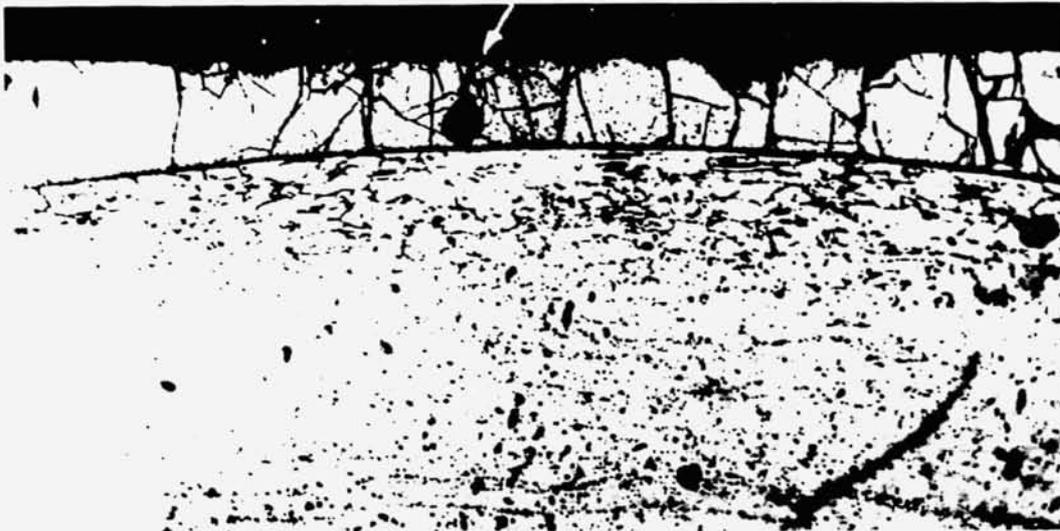
5.6.1 Coated Refractory Metal Experience - MDAC has considerable experience with abrasion in the production of the ASSET and BGRV flight systems. Abrasion has occurred in low cycle/low load applications, such as thread interaction in fasteners, spring clips, panel seals, etc. Although abrasion was considered carefully, it has never been a problem. The BGRV program employed coated columbium in a flare seal application and in a special monoball bearing. In these applications the LB-2 aluminide coating was applied to Cb-752 columbium alloy, which proved to be very satisfactory. Figure 5-21 shows a sliding seal test specimen after 6,000 cycles of 8 lb/in loading, with a 1-inch stroke length and a frequency of 47 cycles per minute. A photomicrograph through the area of highest wear is shown in figure 5-21.

PHOTOMICROGRAPH OF COATING IN WEAR AREA  
250X

RESULTS OF BGRV SLIDING SEAL TEST

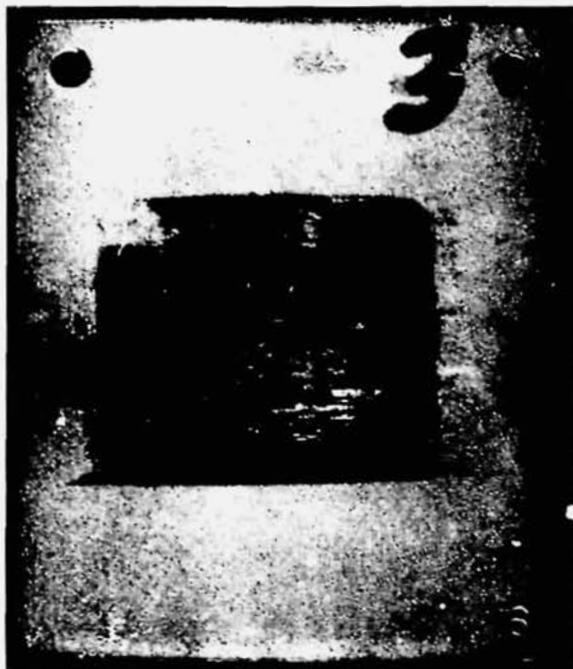
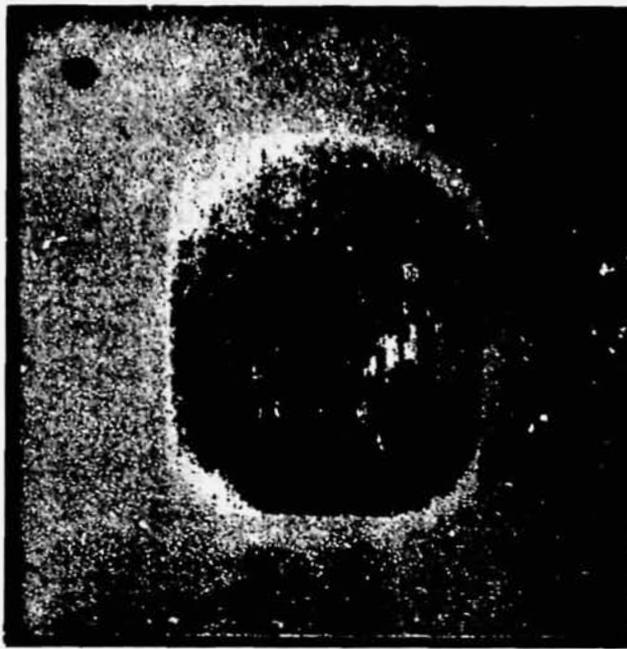
The specimens after testing are shown in figure 5-24. Oxidation testing was not conducted, since the specimens would have failed immediately in the areas in which galling had occurred and the underlying substrate had been disturbed.

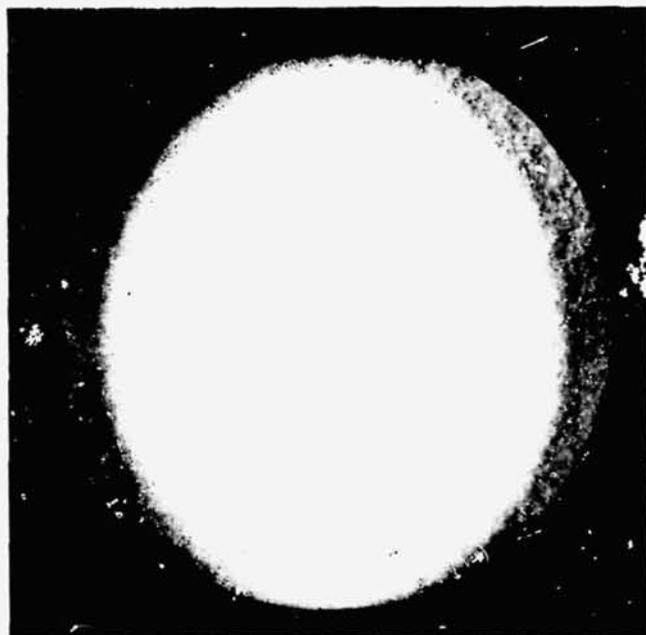
Figure 5-25

The dimensional change coating thickness was determined to be 2.2 mils per surface for the Sylvania R-512E and 2.6 mils per surface for the VAC-HYD VH-109. A careful examination for edge cracking revealed very little edge cracking in the R-512E and a moderate amount in the VH-109, with the differences noted attributable to differences in coating thickness. The specimens were tested for 25 hours at 2400°F. The VH-109 specimens did not show any oxidation failures in the 25-hour test. One of the holes in the R-512E series showed an oxidation failure after 20

hours at 2400°F. Figures 5-25 and 5-26 show these specimens before and after oxidation testing.

Judging from the quality of the edges after coating, it was not surprising that these specimens performed reasonably well in oxidation. However, edge cracking is clearly a potential point for early coating failures and should be avoided. It is believed that the fused slurry silicide process has a tendency to produce better edge quality than coatings available in the past. Assuming there is adequate slurry present on the edges, the chemical reactions at the coating temperatures are so aggressive that areas such as sharp edges are consumed at an increased rate by the slurry. This smooths out the edges, reducing the tendency of the coating to crack on the edges. Coating thickness is an important factor in edge quality, and must be closely controlled to yield optimum edge coating quality.

AFTER OXIDATION TESTING 20 HOURS - 2400°F 4.2X

TYPICAL SYLVANIA R-512E COATING ON EDGE TEST COUPONS

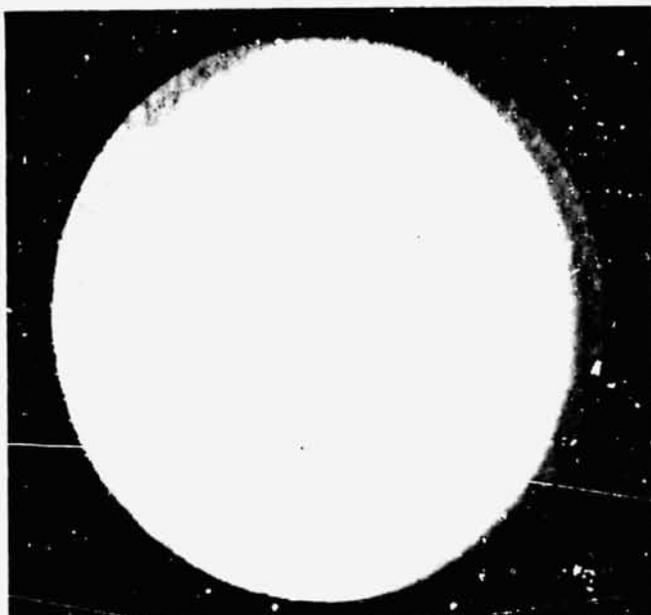
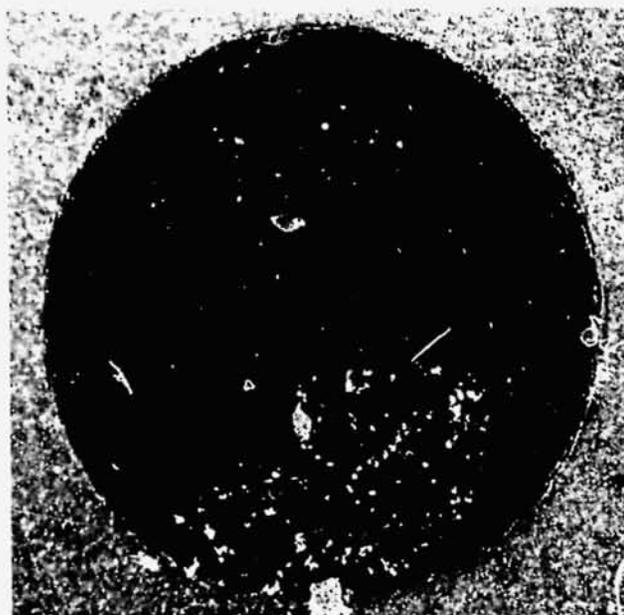
AFTER OXIDATION TESTING 25 HOURS - 2400<sup>o</sup>F

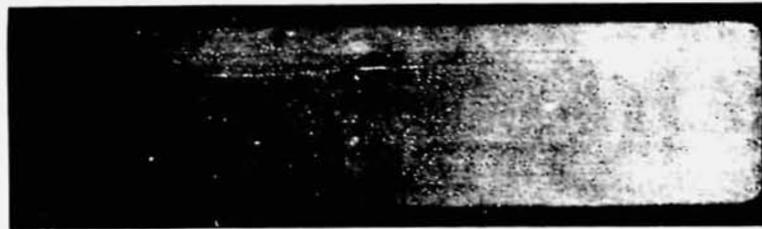
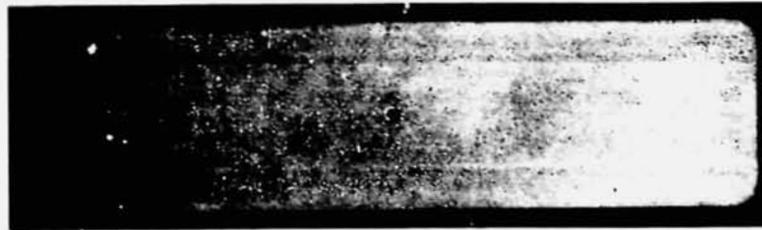
6.1 SPECIMEN PREPARATION - The rib stiffened panel specimens described in paragraph 3 were intentionally damaged after protective coating. All defects were located on the exterior skin side of the panels to simulate damage which would be repairable in the field. Two sizes of defects were employed, 0.12 and 0.06 inch in diameter. The coating was completely removed to the columbium substrate by gritblasting. A Porta-blast gritblaster was used to remove the coating from the 0.12-inch diameter defects and a Micro-blaster was employed to produce the 0.06-inch diameter defects. The defects were placed in the center of the panels (2 inches from each end) to match the center of the maximum bending moment area on the specimen. Two defect locations were investigated - on the skin over the rib and on the skin midway between the ribs. Defects on the edges of the skin were not tested because previous testing has shown that the edges are the least critical area (reference 1). Figure 6-4 illustrates the defected specimens prior to testing.

DEFECTS IN COATED RIB STIFFENED PANEL SPECIMENS PRIOR TO TESTING

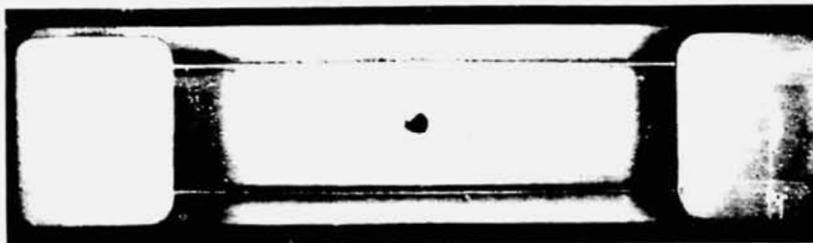
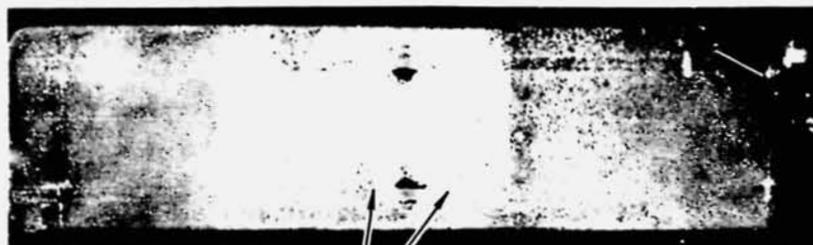
Figure 6-5

The initial set of 4 specimens was given 10 profile cycles. In the case of both the Cb-752 and C-129Y panels, a hole was oxidized through the skin. The holes associated with the defects located between the ribs were equal in diameter to the 0.12-inch diameter coating defect. In the case of the defects located in the skin over the ribs, the additional volume of columbium restricted the oxidation hole area to one small hole through the skin on each side of the rib (see figure 6-5).

6.3. The time selected was 900 seconds, equivalent to ten 90-second boost duration periods. Cracks were observed in two specimens at approximately 270 seconds, and testing was terminated at 400 seconds, with three of the four specimens having experienced cracking. Typical failures are shown in figure 6-6 with the crack initiating from the inside edge of the load pad and progressing into the rib. Of the eight possible ribs in the initial series, five ribs cracked in a similar manner. One panel, C-129Y panel number 12, did not show any cracking after the 400-second test. These failures were not associated with the damage spots intentionally put into the coating. There was, however, one crack in Cb-752 panel number 5 which initiated in the coating damage area and progressed parallel to the rib, through the electron beam weldment on both sides of the damage site area. This failure is shown in figure 6-5.

CRACKS

TYPICAL RIB STIFFENED PANEL SPECIMENS WITH  
.12 INCH DEFECTS AFTER 10 PROFILE CYCLES

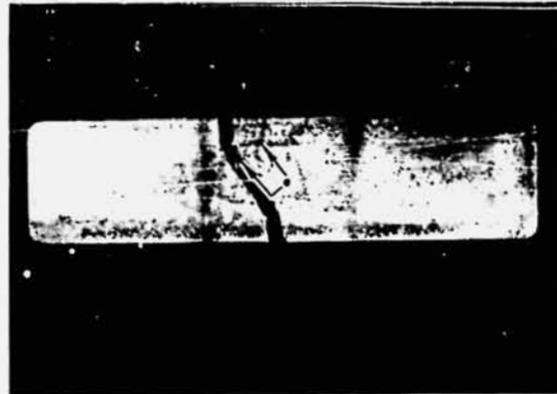
PANEL SPECIMEN FAILED FROM ACCIDENTAL OVERLOADING -  
FAILURE NOT THROUGH DEFECT

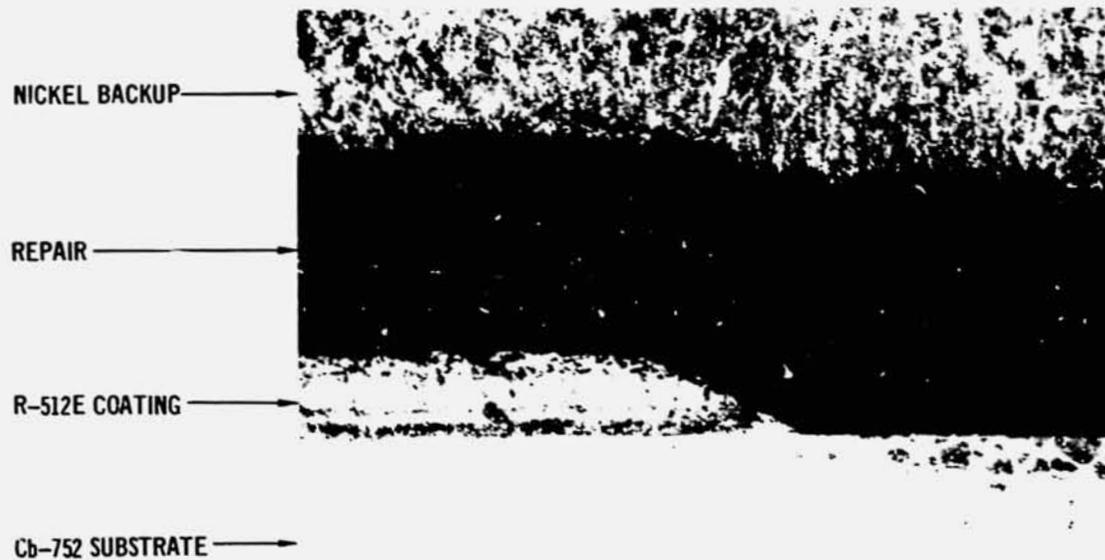
The experiments indicated that for R-512E composition A was acceptable without the flame-sprayed aluminum oxide for up to 80 reentry profile cycles. Figure 7-1 shows the results of 1 atmosphere and Figure 7-2 shows the effects of aluminum oxide flame spray in the low pressure reentry profile testing.

NOTE: REPAIR WITHOUT FLAME SPRAYED  $Al_2O_3$

REPAIR OF R-512E COATED Cb-752 WITH COMPOSITION A  
AFTER 25 HOURS AT 2400°F

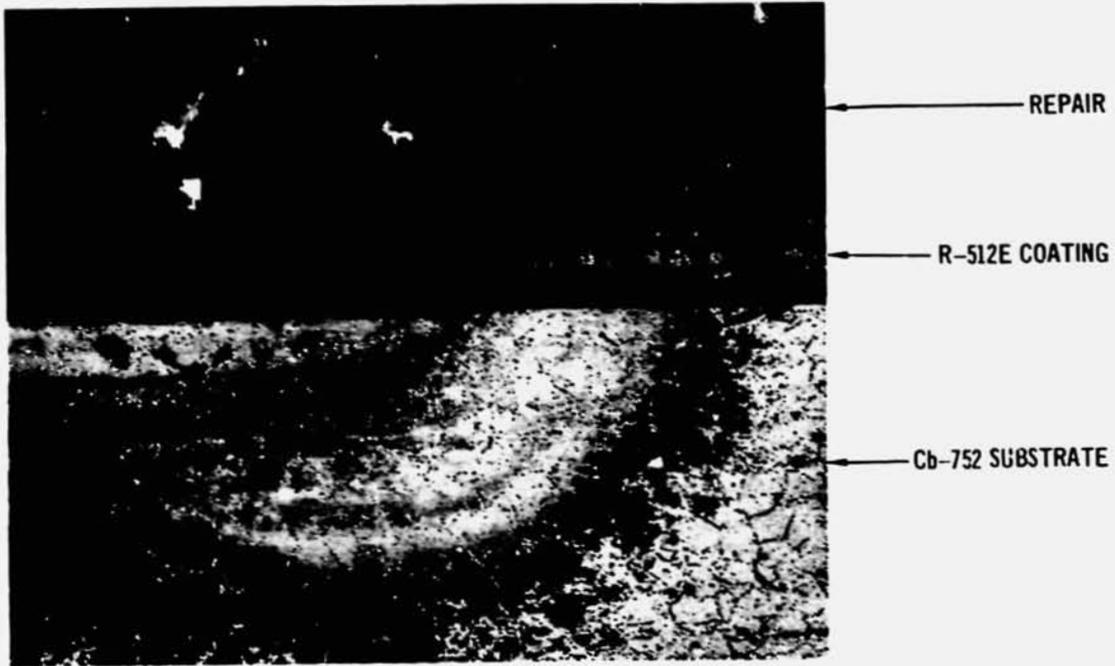
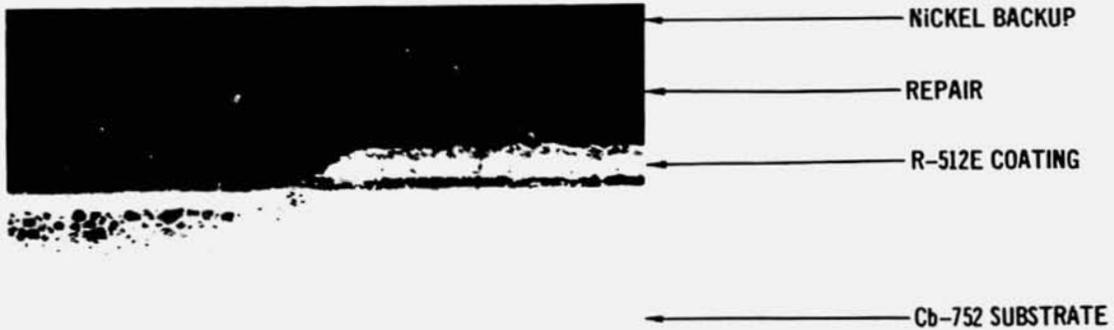
WITH  $Al_2O_3$  FLAME SPRAY

WITHOUT  $Al_2O_3$  FLAME SPRAY

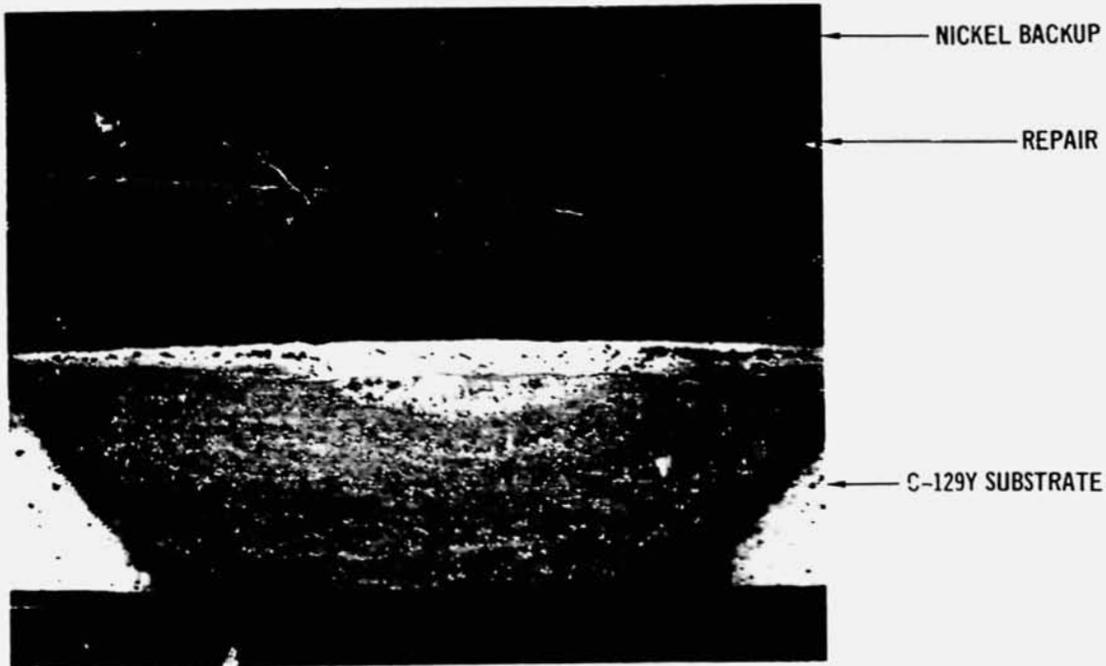
Figure 7-2

GROSS CONTAMINATION ASSOCIATED WITH  
FLAME SPRAYED  $Al_2O_3$  UNDERCOATING

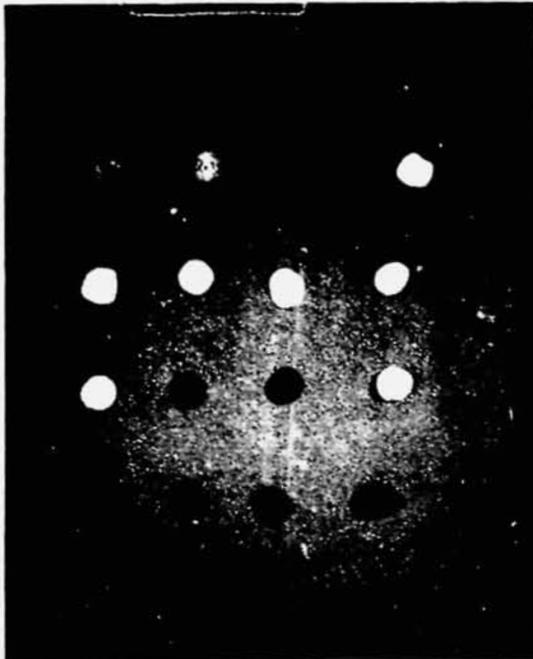
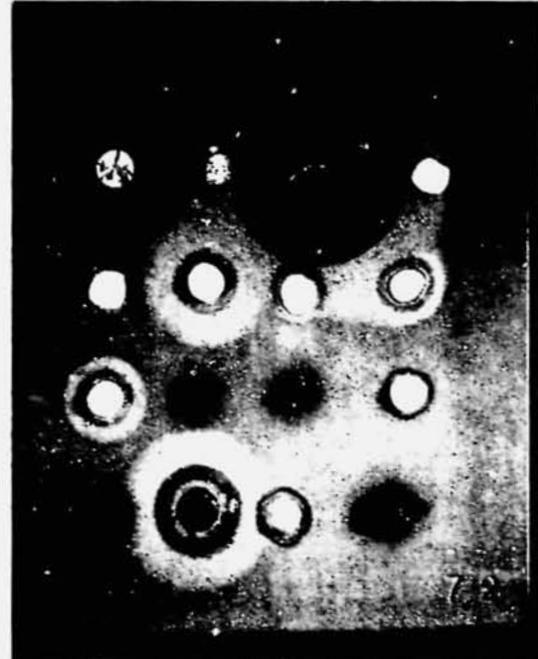
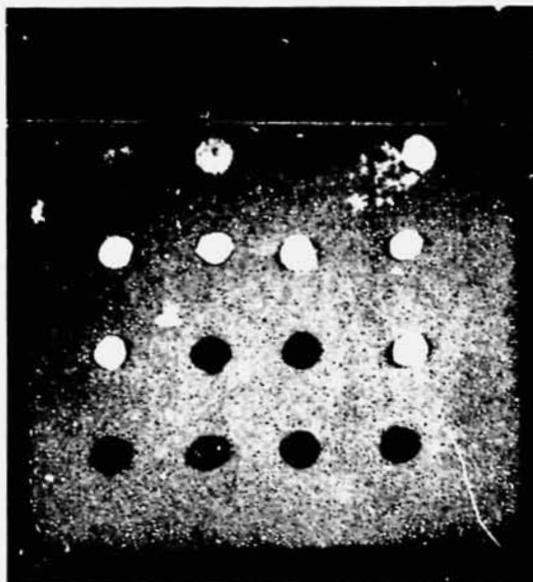
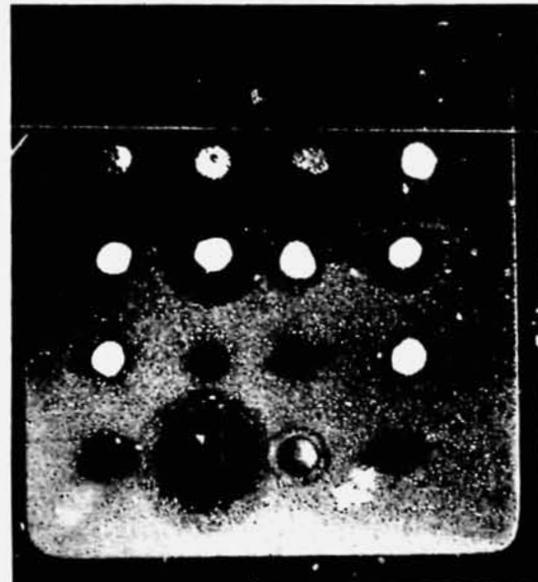
COMPATIBILITY TESTING OF REPAIR MATERIALS AND FUSED SLURRY SILICIDE COATINGS  
(See Table 7-2)

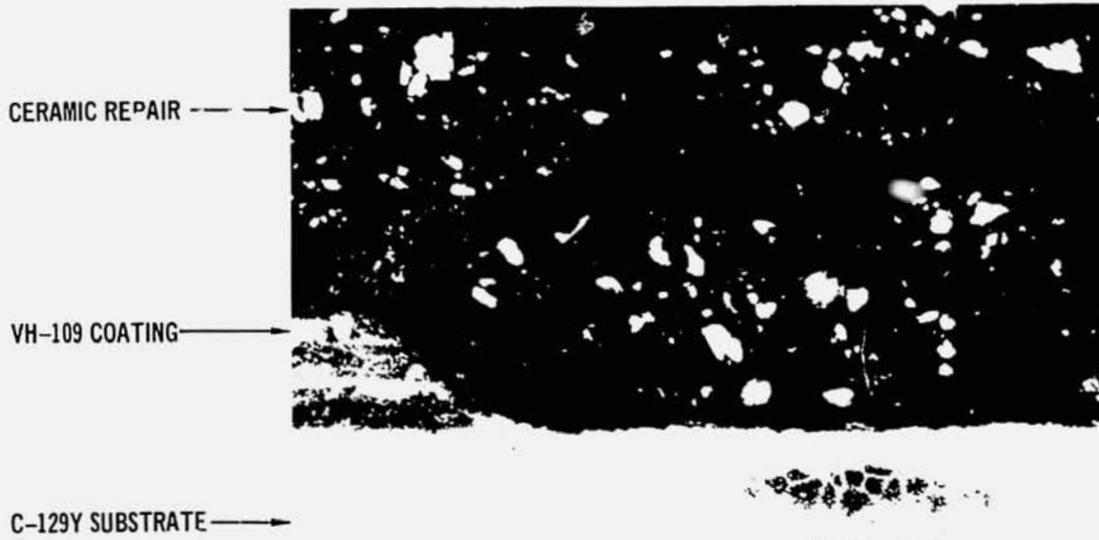
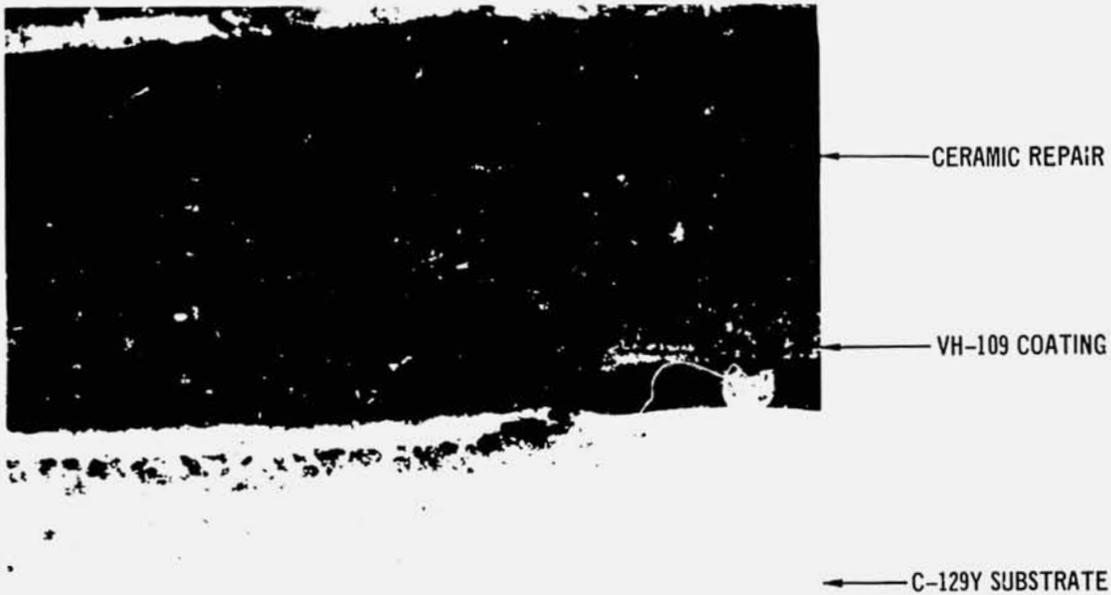
Composition P-1

Composition U-1

CERAMIC REPAIR COMPOSITIONS FOR VH-109 COATING  
AFTER 25 HOURS AT 2400°F

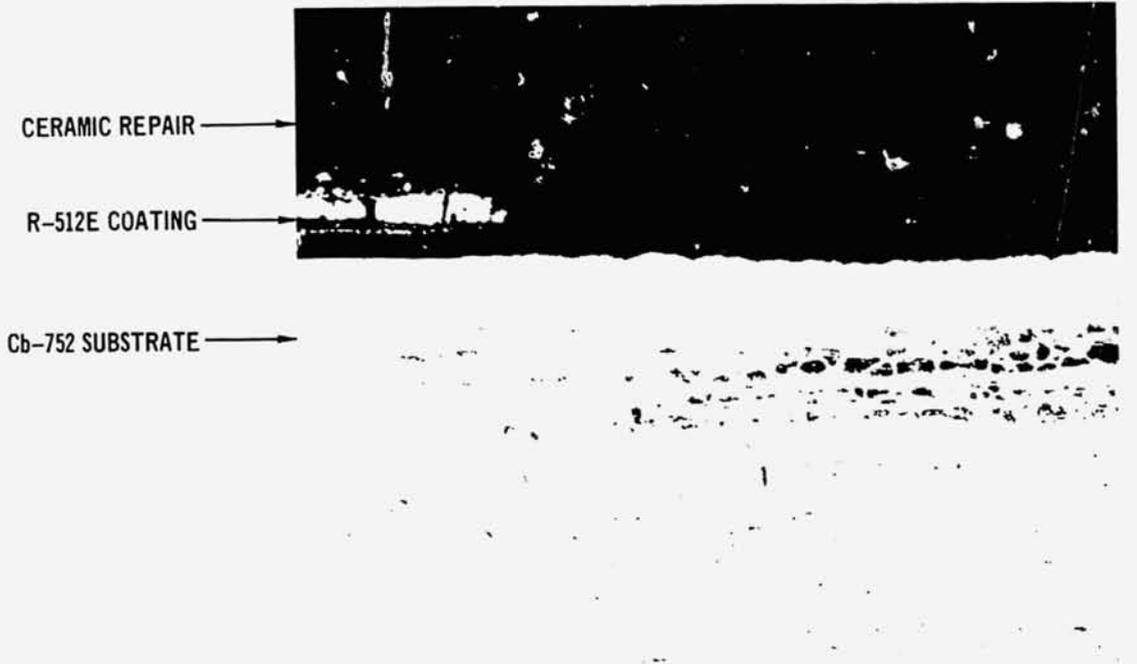
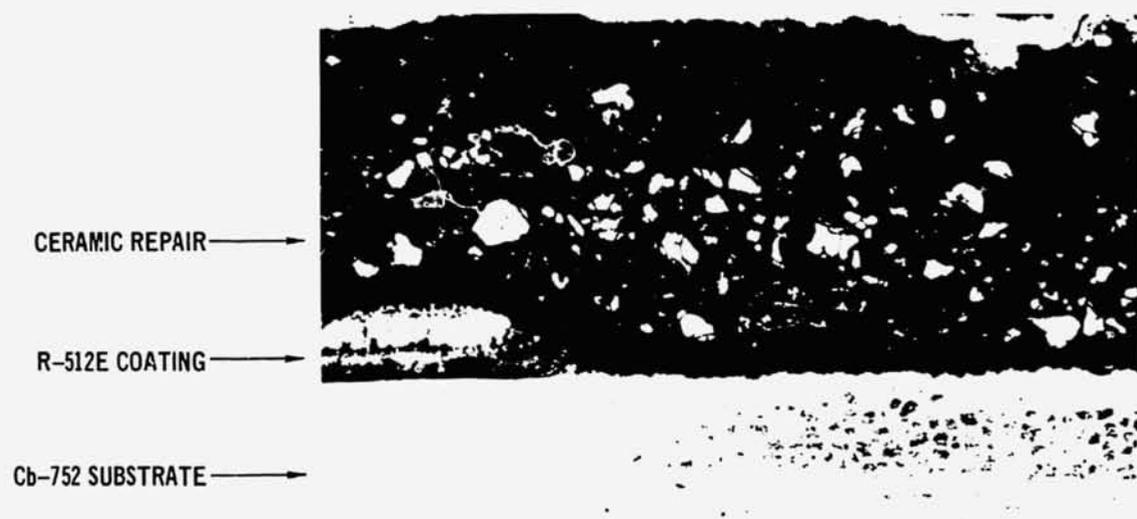
Figure 7-6

A metallographic examination was performed to determine the degree of contamination associated with each of the repairs which passed the one atmosphere screening test. Typical results are shown in figure 7-6. In the case of each of the compositions, with the exception of T-1, the degree of contamination was minimal, and the compositions were considered to have passed the air atmosphere screening test and to be ready for reentry profile evaluation.

CERAMIC REPAIR COMPOSITIONS ON R-512E COATING AFTER 25 HOURS AT  
2400°F IN AIR

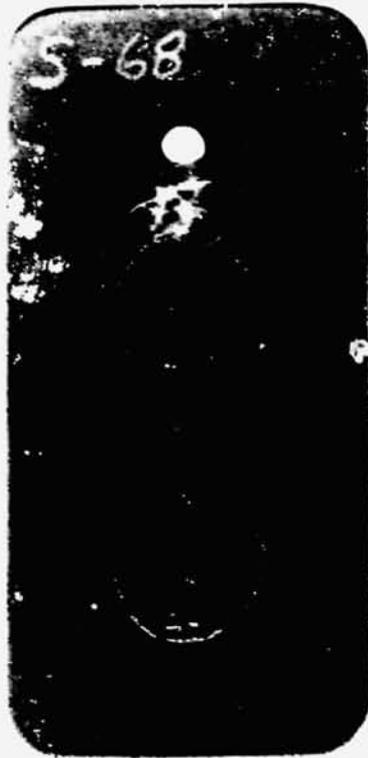
Figure 7-8

than either A-1 or U-1 compositions, but this depth was not considered excessive. The U-1 repaired coupons before and after testing are shown in figure 7-8 with a metallographic cross-section. The U-1 repair proved to be a dense uniform material which allowed minimal oxygen to pass into the Cb-752 substrate. The P-1 repairs were the least effective, permitting oxidation failures to occur in the repair area within 30 to 60 profile cycles.

U-1 REPAIR OF R-512E COATING

CROSS SECTION OF U-1 REPAIR OF R-512E COATING AFTER  
100 SIMULATED REENTRY CYCLES

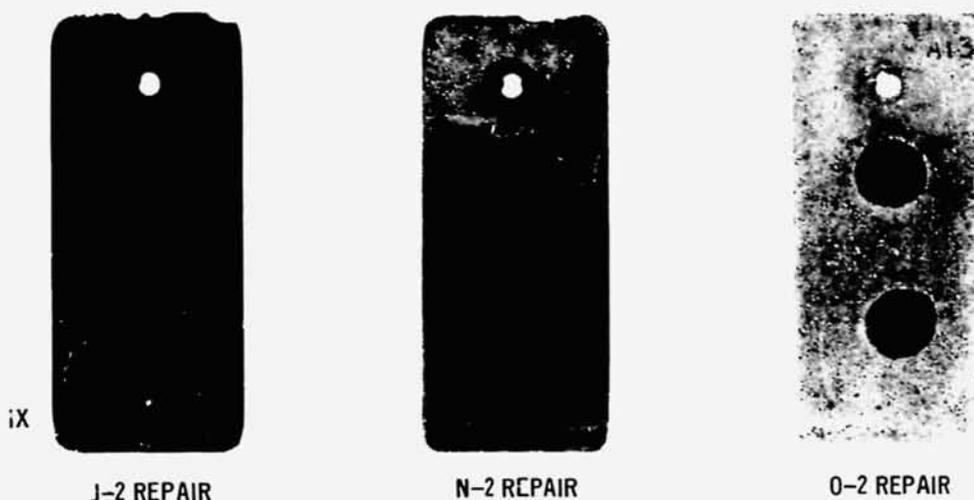
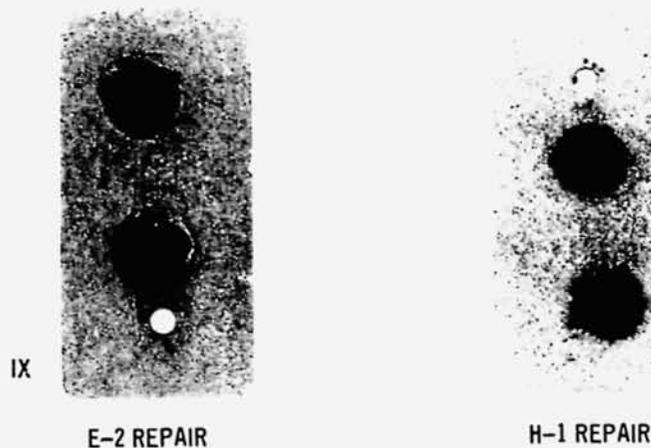
Figure 7 - 10

The improved versions of the ceramic compositions have in common a substantially improved surface texture and physical appearance. Figure 7-10 shows the final improved composition having no significant surface porosity after 110 reentry profile cycles. The physical microstructure has been substantially improved, as shown in figure 7-11. Improved ceramic repair compositions were ready for evaluation on 3 by 12-inch rib stiffened panels under reentry flight simulation in order to prove adequacy of the repairs under structural strains and acoustics.

CERAMIC COMPOSITION REPAIRS WITH IMPROVED VEHICLE  
SYSTEM AFTER 110 REENTRY PROFILE CYCLES
