# FIELD REPAIR OF COATED COLUMBIUM THERMAL PROTECTION SYSTEMS (TPS)

## FINAL REPORT

MDC E0681

15 SEPTEMBER 1972

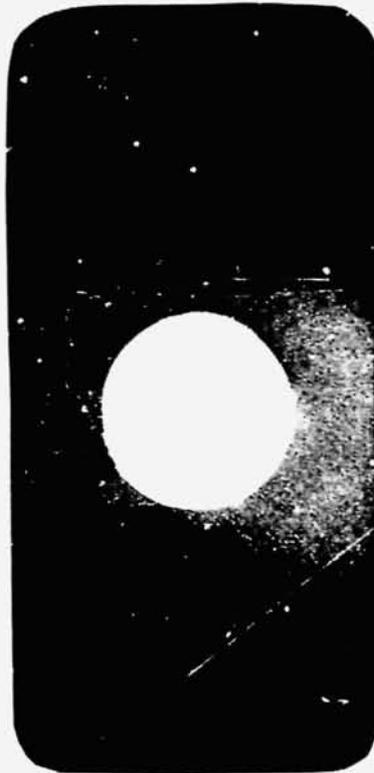
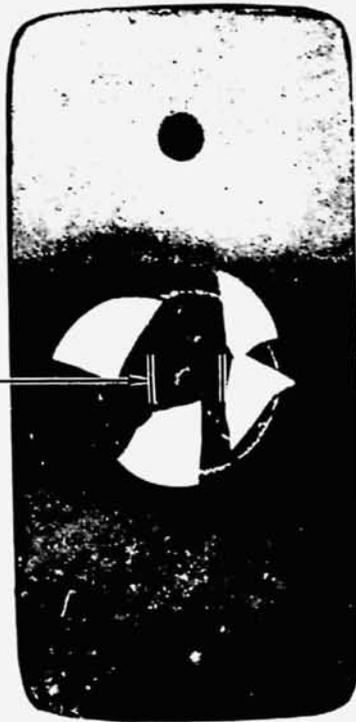
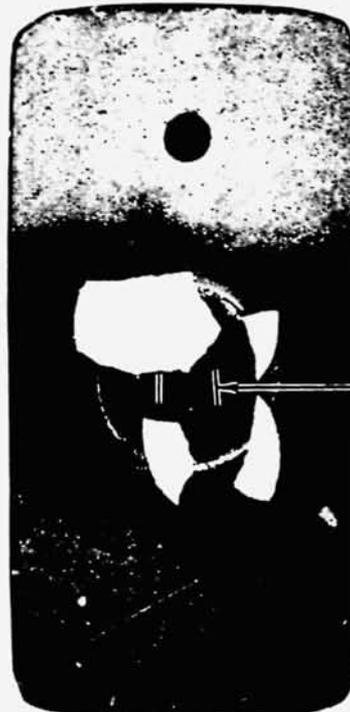
incompatibility and thermal expansion mismatch contributed to the failure. The R-512E fused slurry silicide coating beneath the oxide repair in the overlap area spalled off with the oxide repair down to the Cb-752 substrate. Profile exposures resulted in the same type of failures for the sprayed oxides.

PLASMA SPRAYED OXIDE REPAIRS SHOWING SPALLING TYPE FAILURE  
(Photographs 2X)

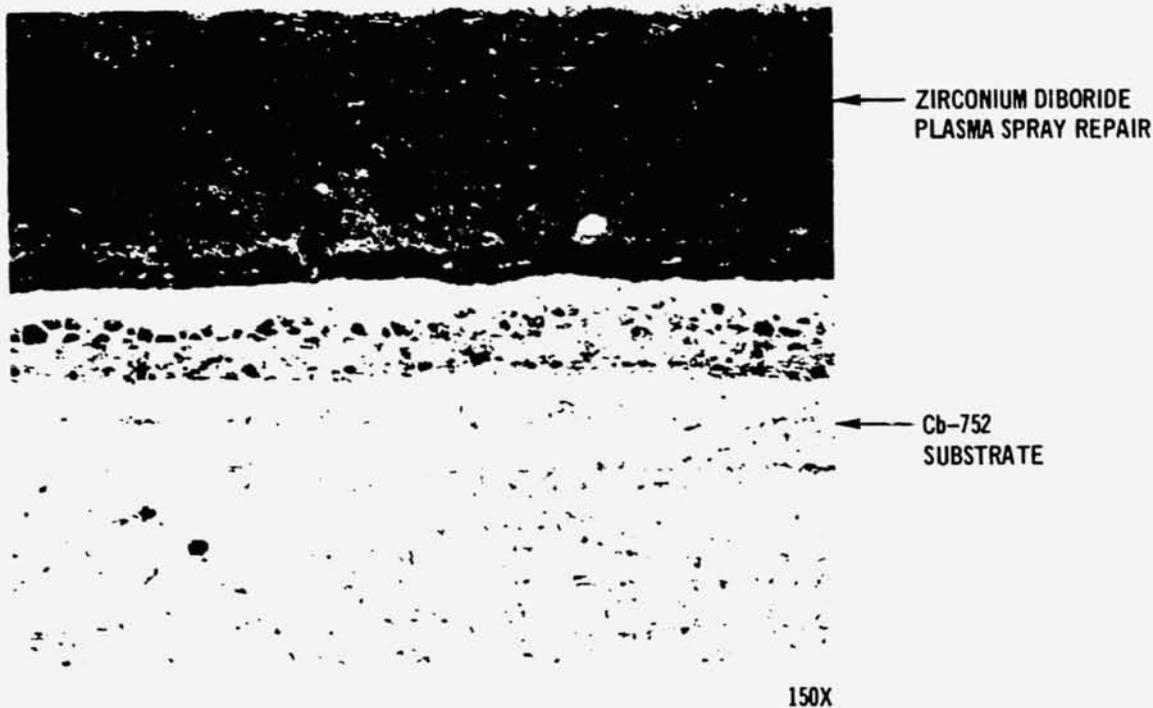
A series of intermetallic plasma sprayed repairs were evaluated which showed promise as reliable repairs. The first intermetallic material evaluated was zirconium diboride. The 1 atmosphere screening test coupon failed at 22 hours at 2400°F by a small oxidation spot on the periphery of the repair area. The sample which was profile tested experienced the same conditions at 10 profile cycles. In both cases it was concluded that a subtle compatibility problem was present since the oxidation failures were in the overlap area of the R-512E coating. Figure 10-2 shows a cross section of the zirconium diboride repair area after 22 hours at 2400°F. The amount of contamination of the columbium substrate below the repair was minimal. The porosity of the plasma sprayed coating appears to be the greatest of the three intermetallic materials sprayed.

PHOTOMICROGRAPH OF PLASMA SPRAYED ZIRCONIUM DIBORIDE  
REPAIR AFTER 22 HOURS AT 2400°F

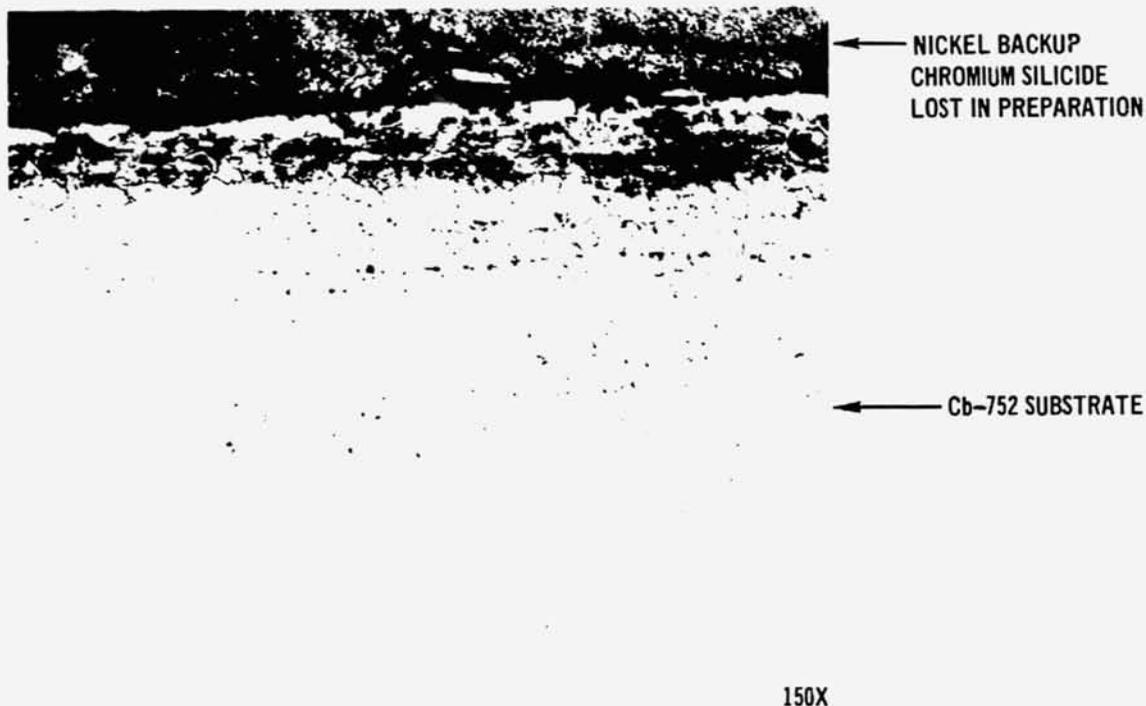
The second intermetallic material evaluated was chromium silicide. Table 10-1 summarizes the results of the evaluation. The air atmosphere oxidation test produced oxidation failures within the repair area after 22 hours at 2400°F. Part of the repair thickness spalled off by failing cohesively after thirteen 1-hour cycles, reducing the remaining coating thickness to approximately 2.5 mils. The profile test specimen similarly spalled a portion of the repair thickness at 20 cycles and general oxidation failures occurred after 30 profile cycles (see figure 10-3). A metallographic examination of the air atmosphere test specimen revealed that the contamination below the repair was minimal, as shown in figure 10-3. It was concluded that a repair thickness of 6.6 mils was too thick to prevent cohesive spalling of the exterior of the repair. Oxidation testing indicated that a lesser thickness (approximately 4 mils) would be sufficient for oxidation resistance.

PHOTOMICROGRAPH OF CHROMIUM SILICIDE REPAIR AFTER 22 HOURS AT 2400°F

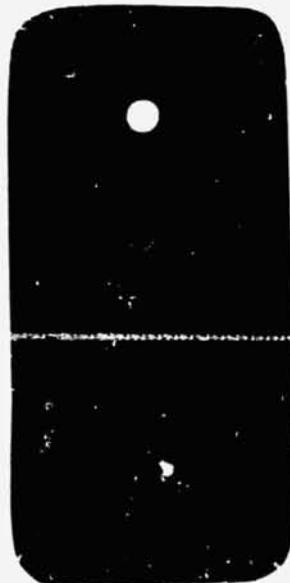
MOLYBDENUM DISILICIDE PLASMA SPRAYED REPAIRS OF R-512E OF Cb-752

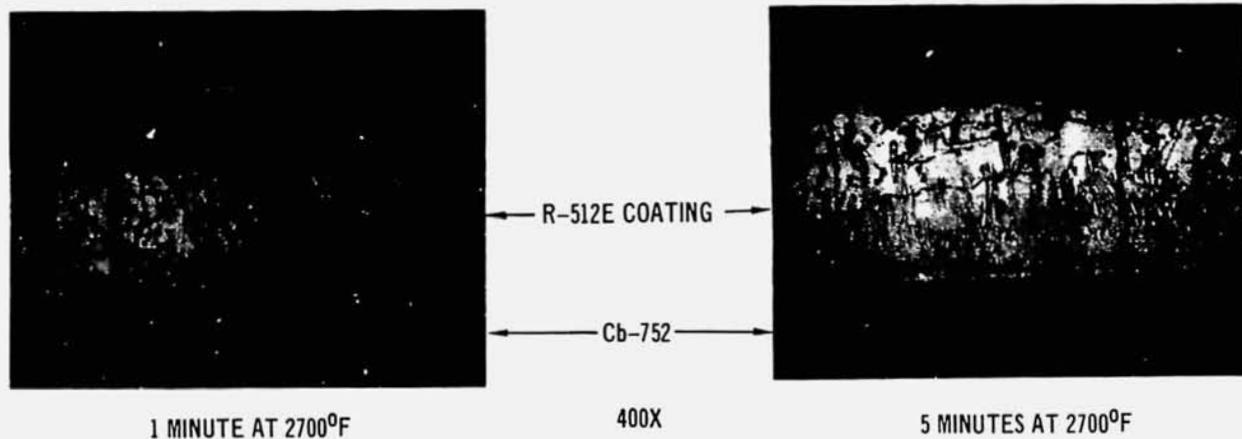
Figure 11-3

Each of the eight processing conditions was examined metallographically to determine if the coating was structurally the same as that formed during a standard processing cycle (1 hour at 2580°F). Figures 11-3 and 11-4 show the microstructures observed. The microstructures for the 1-minute processing show normal coating structures at 2700 and 2800°F. Incomplete reaction is indicated at 2600°F with excessive reaction and coarse columnar structure at 2900°F. The 5-minute processing specimens show a normal coating structure at 2600 and 2700°F, with excessive reaction indicated at 2800° and 2900°F. Triplicate coupons were oxidation tested to the reentry time-temperature-pressure conditions shown in figure 4-1, and the results are presented in figure 11-5. It can be seen that the 1-minute processing at 2600, 2700 and 2800°F produced a coating with a cyclic profile life

### PHOTOMICROGRAPHS OF RAPID COATING FORMATION STUDY

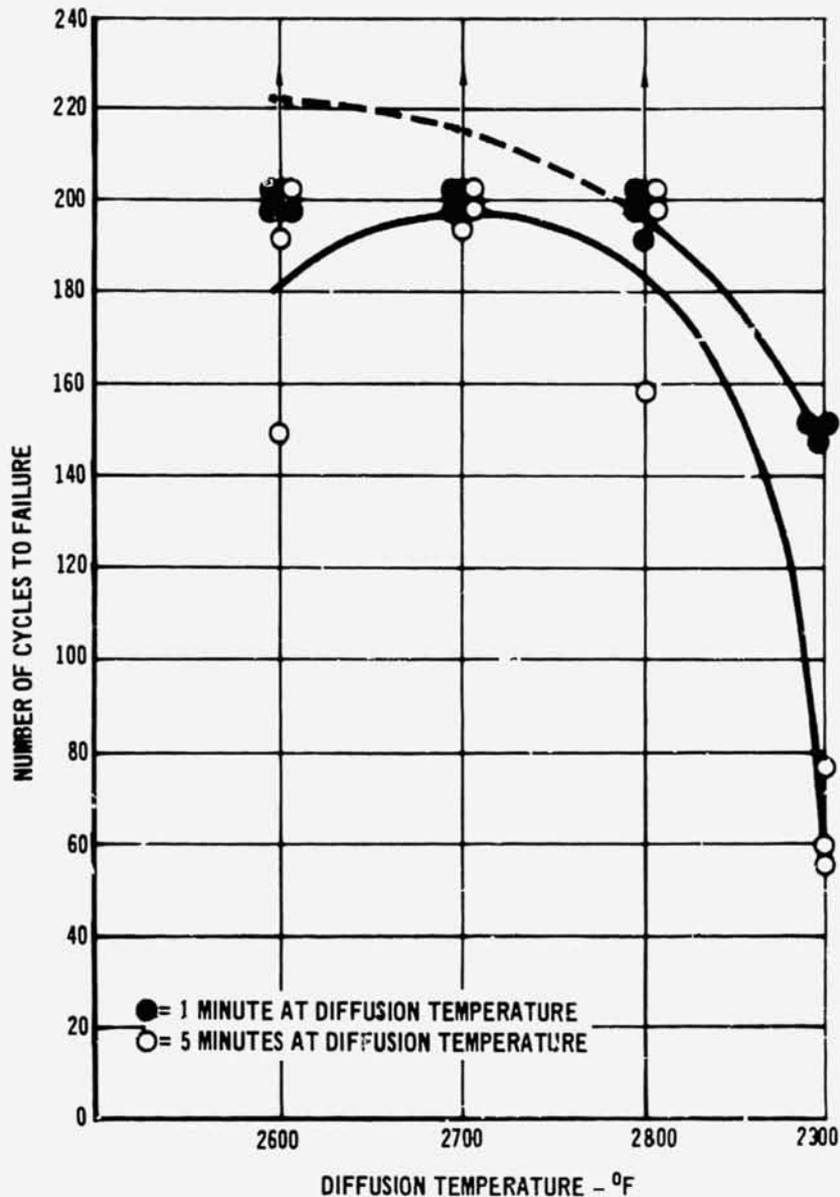
Figure 11-5

of 200 or more cycles. The 5-minute processing gave an optimum life at 2700°F, which is in excess of 200 reentry profile cycles. It was concluded that processing at 2700°F would produce a coating of satisfactory quality, with temperature variations of 100°F not being of significant concern. A processing time of 1 minute was shown to be sufficient, with up to 5 minutes being satisfactory at 2700°F. These results were considered very encouraging as the potential appeared good for developing a rapid coating repair method with wide processing tolerances and broad

REENTRY PROFILE OXIDATION TEST RESULTS OF R-512E COATINGS  
PRODUCED IN RAPID COATING FORMATION STUDY

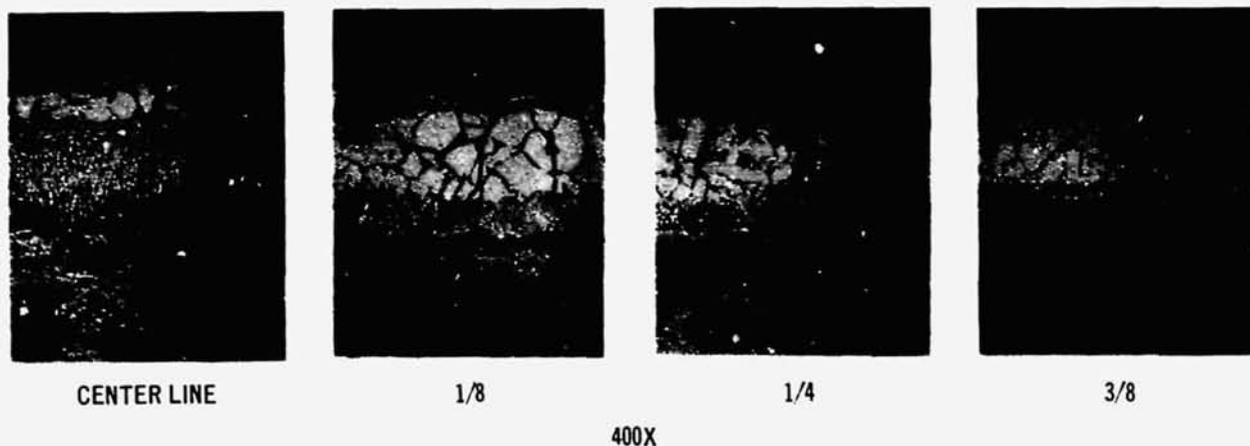
Figure 11-8

EFFECT OF DISTANCE FROM CENTERLINE OF REPAIR ON R-512E COATING STRUCTURE

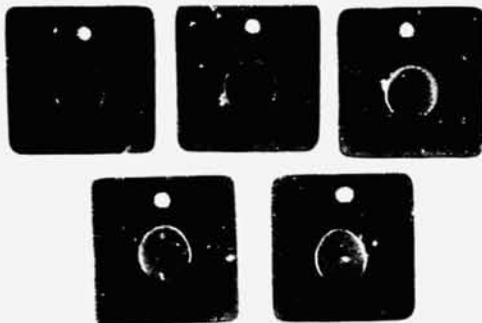
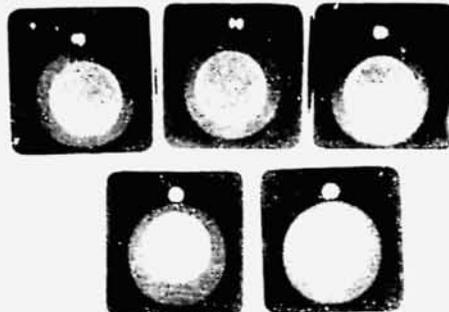
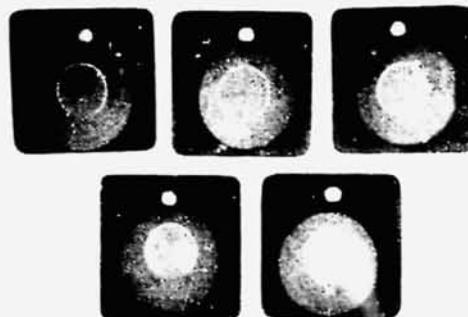
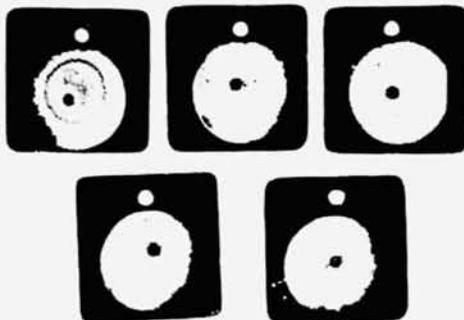
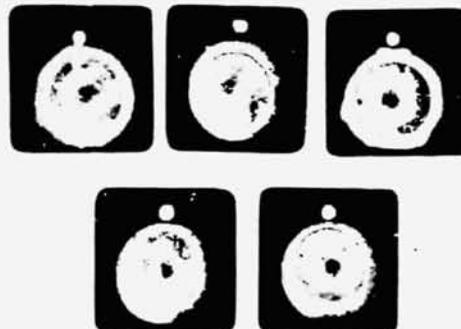
3/8 INCH DEFECT SPECIMENS

1/2 INCH DEFECT SPECIMENS

AFTER DEFECTING

REMOVAL OF OXIDES SURROUNDING THE DEFECT

REPAIR OF DEFECT

AFTER OXIDATION TESTING

RESULTS OF REPAIRING 3/8 AND 1/2 INCH DEFECT AREAS

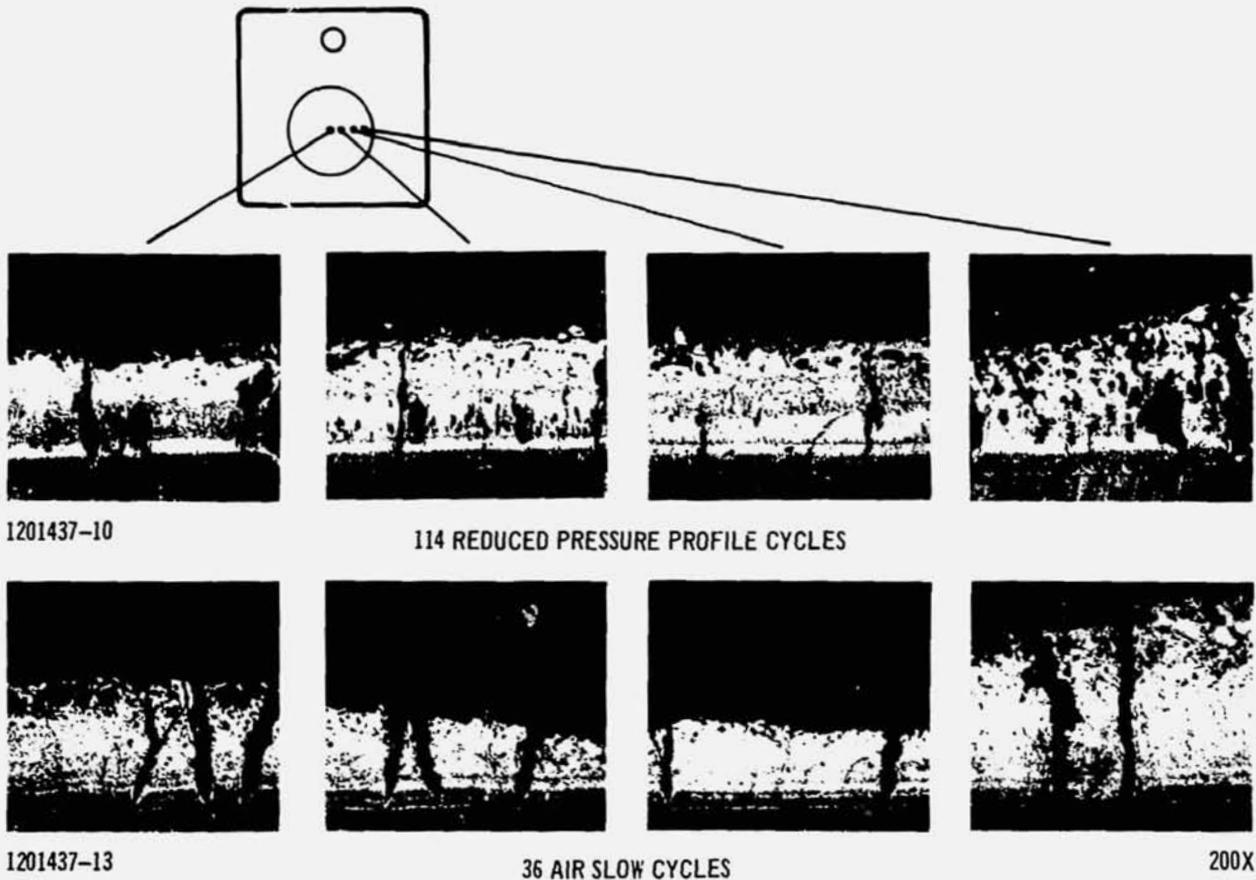
457-2872

PHOTOMICROGRAPHS OF 1/2 INCH DIAMETER DEFECT SPECIMENS  
AFTER REPAIR AND TEST

concluded that defects up to 1/2 inch in diameter could be satisfactorily repaired using the radiant spot heater.

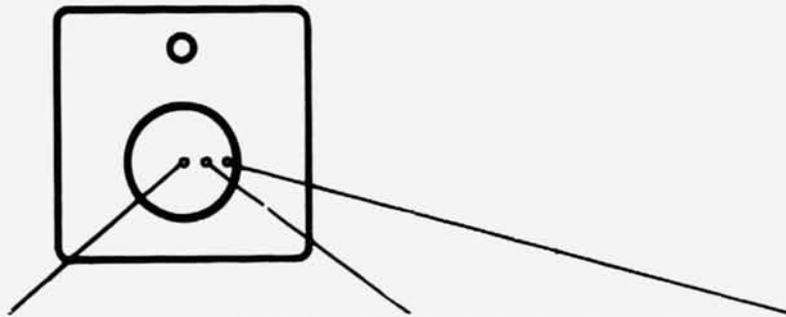
114 REDUCED PRESSURE PROFILE CYCLES

36 AIR SLOW CYCLES

PHOTOMICROGRAPHS OF 3/8 INCH DIAMETER DEFECT SPECIMENS  
AFTER REPAIR AND TEST

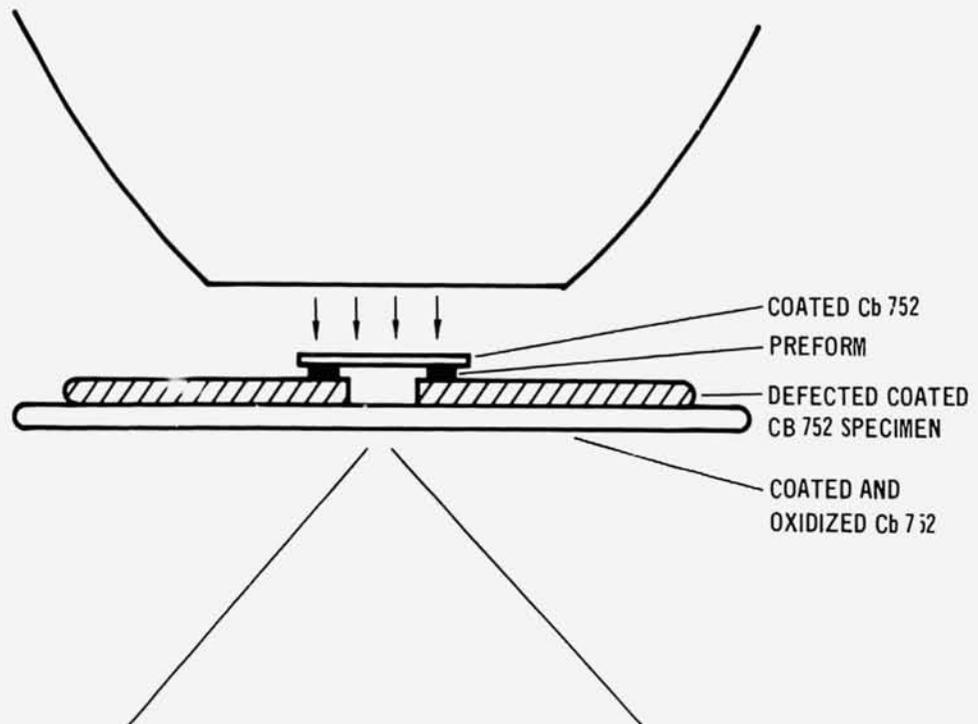
SECTIONS THROUGH REPAIRED HOLE EDGE  
AFTER EXPOSURE TO 14 SLOW CYCLES

REPAIR OF DRILLED HOLE EMPLOYING RADIANT LAMP SPOT HEATER

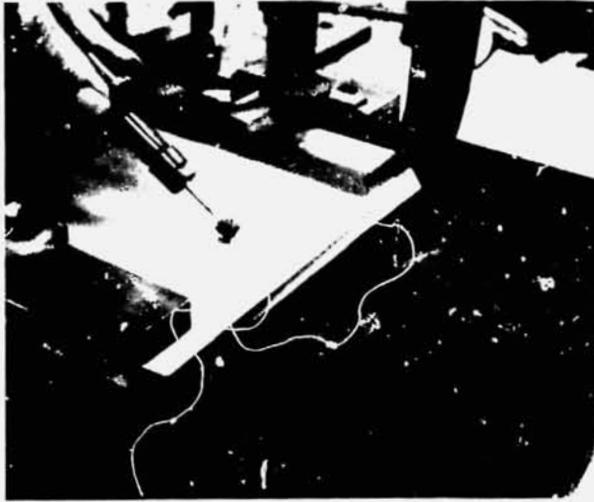
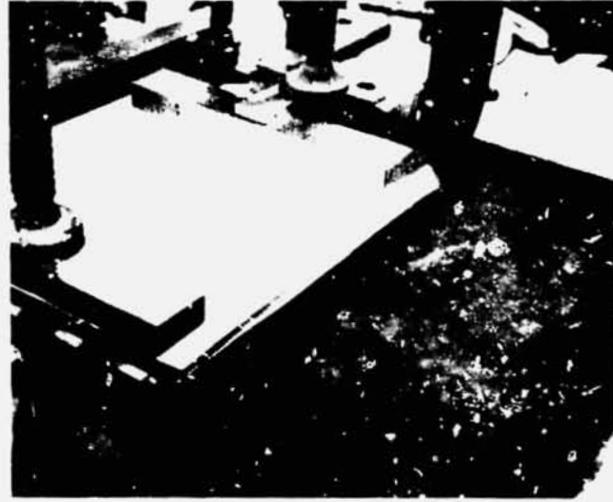
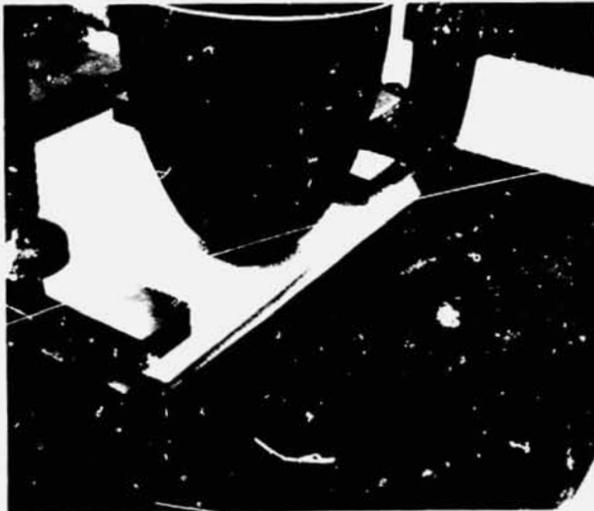
The panel was defected by grinding through the coating approximately 3 mils into the substrate. An R-512E preform was placed over the defect and the standard C-2 heat cycle was applied with the spot heater. This procedure is illustrated in figure 11-14. Dial gauge readings were taken at numerous points on the panel face before and after the repair procedure, with the panel unrestrained (lightly taped to surface plate). Three separate repair cycles were performed. The first repair caused an average depression between the welds of 5 mils with a maximum displacement of 13 mils. The second repair attempt produced similar, but slightly less, distortion. During the third repair sequence, an average inward displacement of 7 mils occurred with a maximum distortion being 30 mils. In most cases the displacement was below the plane of the skin between the corrugations.

PANEL REPAIR SEQUENCE

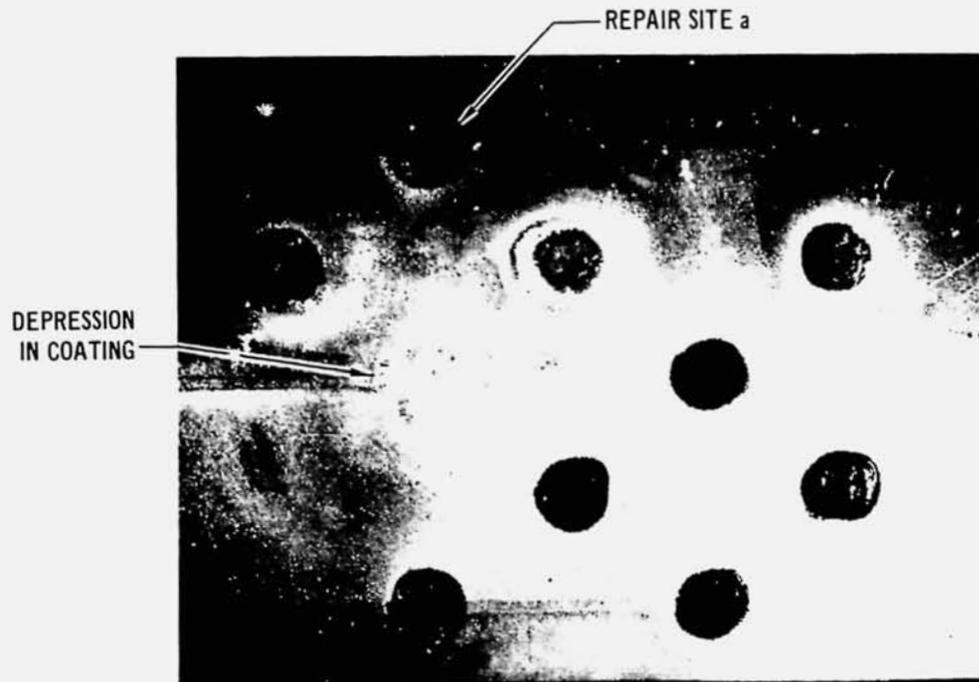
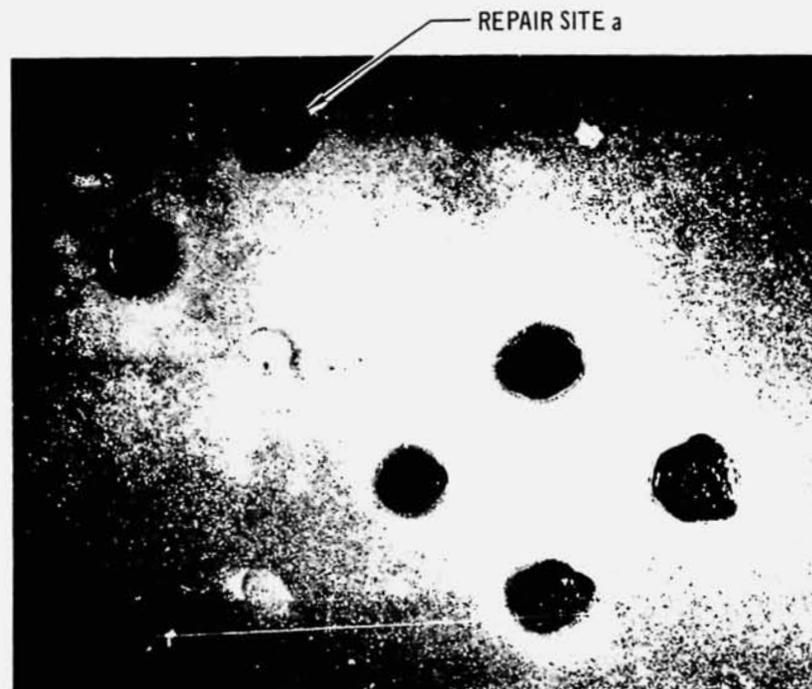
and VAC 10 were left with the single repair cycle. The appearance of the Sylvania lamp repairs before testing is shown in figure 12-6. The physical appearance was considered good. One panel, SYL 6, had a small depression in the coating located 0.2 inch from the defect area and on the outer periphery of the overlap area, as noted in figure 12-6.

TYPICAL APPEARANCE OF FIELD REPAIR COATED  
PANELS PRIOR TO TESTING

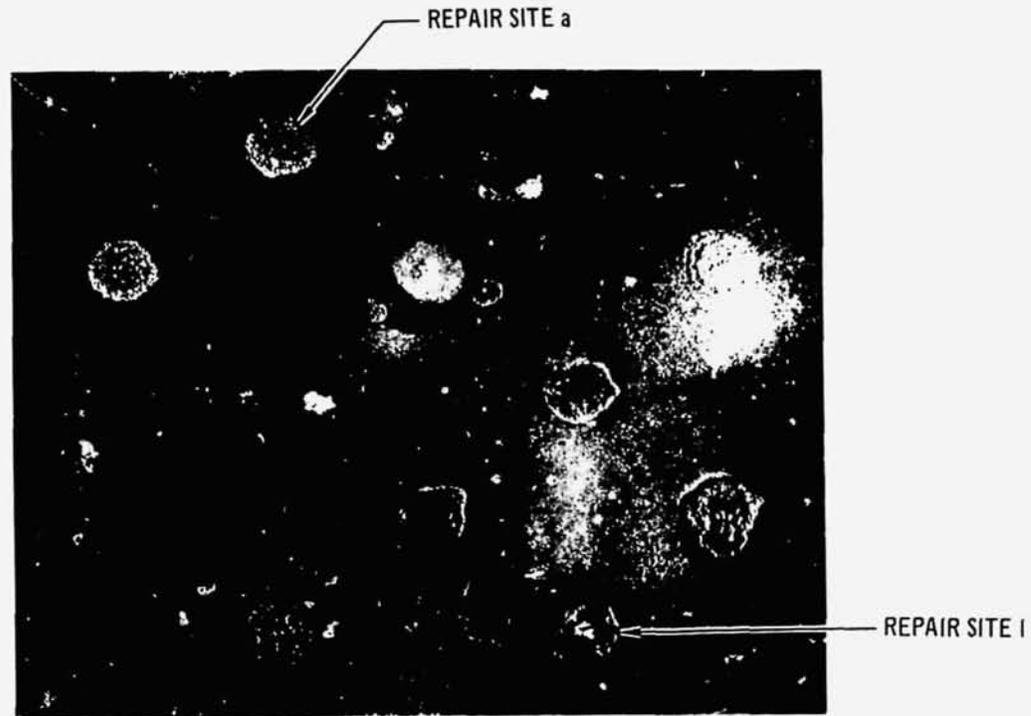
Figure 12-8

The repair area prior to testing is shown in figure 12-6, while the repair area after 80 flight simulation cycles is shown in figure 12-8. Ceramic repair compositions A-1 and P-1, applied over and between the ribs, did not experience any oxidation failures through the 80 reentry profile cycles. The U-1 ceramic repairs located between the ribs did not fail in oxidation through the 80 profile cycles. The second U-1 site (located over a rib) failed after 40 profile cycles. The failure initiated in a chipped area of the repair, which occurred during the acoustic exposure after 30 profile cycles, and is the only case noted in which a ceramic repair was damaged during acoustic exposure. Each of the oxidation

REPAIR AREA OF PANEL SYL-6 A AFTER 80 PROFILE REENTRY CYCLES

failures was repaired with the U-1 ceramic composition to provide oxidation protection during subsequent testing of unfailed repairs. The H-1 ceramic composition proved to be the poorest, with 1 repair site failing after 20 profile reentry cycles, and the second site failing after 70 profile cycles.

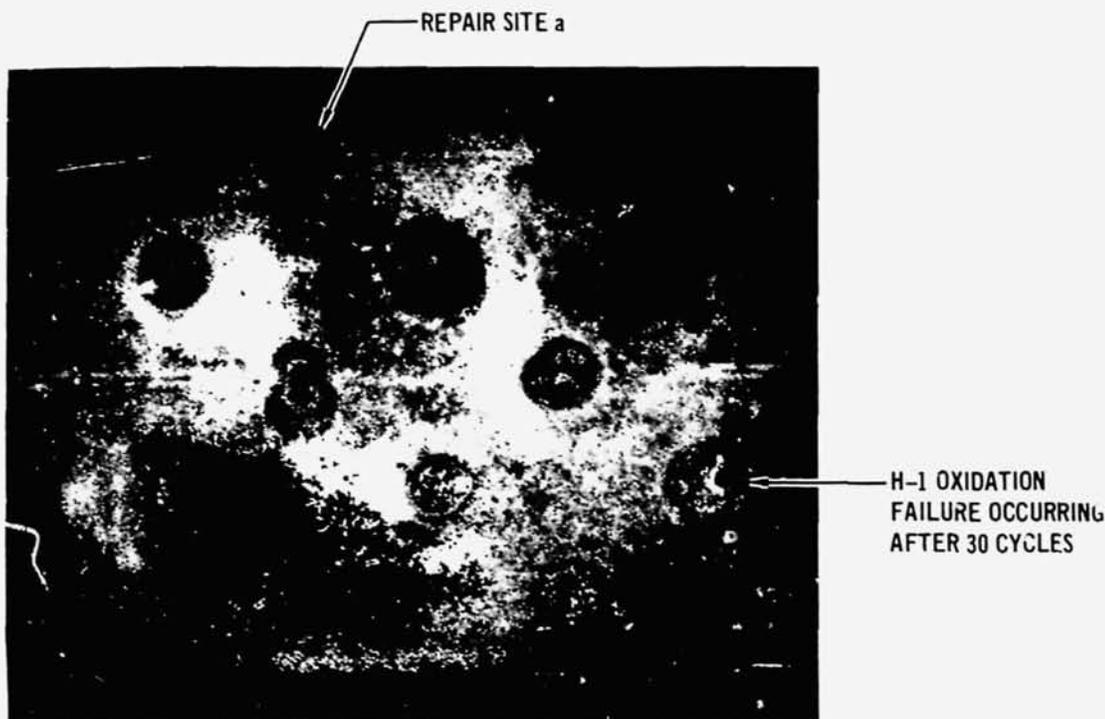
The performance of the repair sites was considered very good. Figure 12-10 shows the repair area of panel VAC-11 after 100 cycles. The only repair oxidation failure was a ceramic H-1 composition at repair site i, which failed between exposure cycles 20 and 30. A small hole was oxidized through the skin, forming the assumption that the oxidation failure occurred during or shortly after the twentieth cycle. The second H-1 repair site, as well as the U-1 and P-1 ceramic repairs and the two lamp repairs, performed satisfactorily through 100 cycles.

PANEL VAC-11 AFTER 100 PROFILE CYCLES SHOWING  
GOOD REPAIR PERFORMANCE

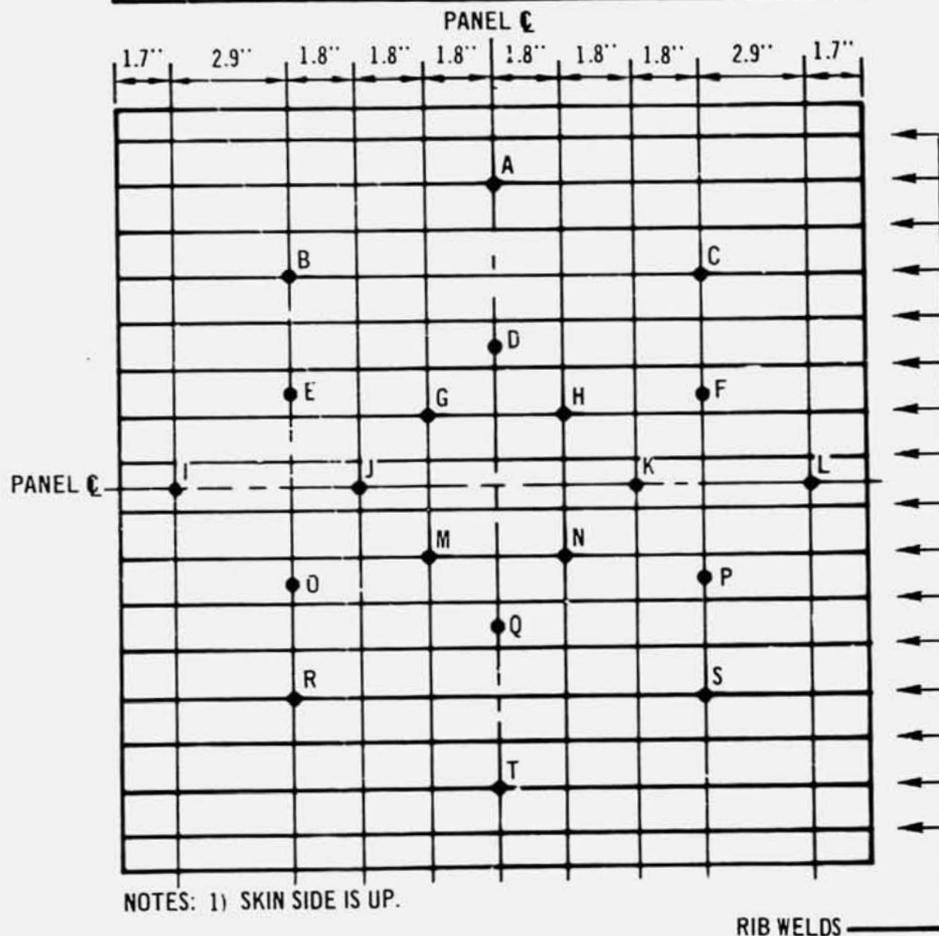
The design of the 20 by 20-inch rib stiffened panels was described in section 4 and the fabrication and coating are covered in section 3. It was decided to apply 4 different types of repairs to a total of 20 different sites on the panel skin. Figure 13-1 shows the repair site locations and type of repair. The defects to be repaired were formed by gritblasting the coating from the skin in the desired locations using 220 mesh aluminum oxide at a pressure of 40 lb/in<sup>2</sup>. The defects for the R-512E replacement repairs with the spot heater and the defects for molybdenum disilicide plasma spray were 1/8 inch in diameter. The defects for repair with the ceramic compositions were 1/4 inch in diameter.

REPAIR SITE LOCATIONS FOR 20 BY 20-INCH PANELS

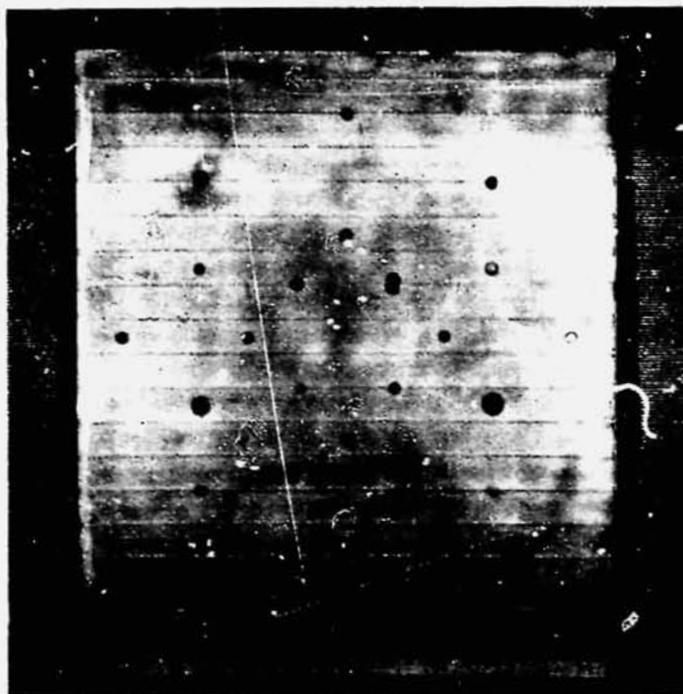
Figure 13-2

The repairs were applied by the methods derived on this program and described in the appropriate sections of this report. (Lamp replacement of R-512E is described in section 11, the plasma spraying in section 10, and the ceramic repairs in section 7 and appendix C.) As a final proof inspection, each of the panels was heated to 2200°F for 10 minutes in an air atmosphere furnace. Each of the 40 repair sites was fully protective and functioning normally. The physical handling involved in defecting, repairing, and inspecting 20 separate areas on each panel produced a general soiling of the skin surface. The panels were cleaned by alumina gritblasting at 15 lb/in<sup>2</sup> pressure. The surface removal was not measureable by micrometer but is nominally 0.1 to 0.2 mil. The panels in general had a good appearance and are shown in figures 13-2 and 13-3.

FULL SIZE Cb-752/R-512E RIB STIFFENED PANEL WITH  
FIELD REPAIR COATINGS

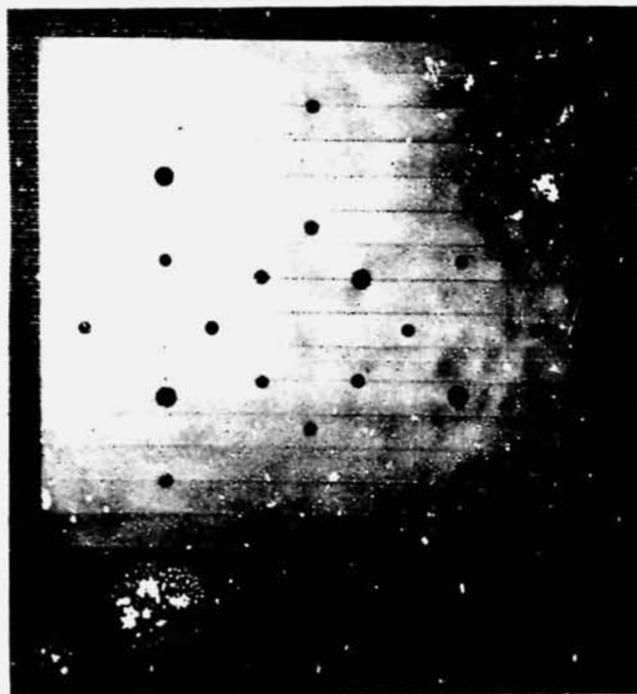
FULL SIZE C-129Y/VH-109 RIB STIFFENED PANEL WITH  
FIELD REPAIR COATINGS
