NASA TM X-68284

A 9700-HOUR DURABILITY TEST OF A
FIVE CENTIMETER DIAMETER ION THRUSTER

by S. Nakanishi and R. C. Finke
Lewis Research Center
Cleveland, Ohio 44135

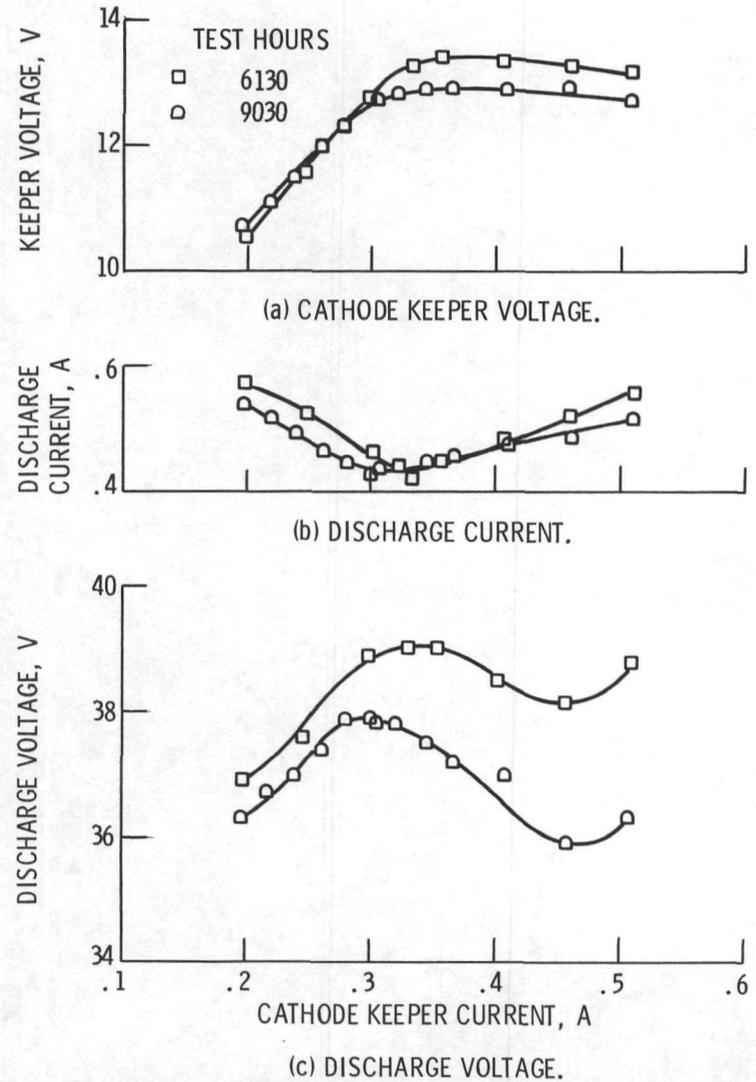
Figure 6. - Effects of varying cathode keeper current at 25 mA beam current and no heater power.

Cathode keeper current. The effects of varying the cathode keeper current while maintaining a constant beam current of 25 mA is shown in figure 6. The levels and trends in the keeper voltage (fig. 6(a)) and the ion chamber discharge current (fig. 6(b)) at 6130 and 9030 hours were similar. The cathode keeper voltage reached a maximum at a keeper current between 0.35 and 0.4 A. A corresponding minimum in the discharge current occurred at a slightly lower value of keeper current.

The discharge voltage shown in figure 6(c) was generally lower at the 9030 hour point. Because discharge voltage was inversely very sensitive to propellant flow rate, it is apparent that the flow was higher at the later time. At both times, however, the trends in discharge voltage as a function of keeper current were similar. The maxima in the discharge voltage corresponded to the minima in the discharge current. Because the beam current was held constant, it follows that the minimum discharge current was required where the discharge voltage, and hence the ionization, was a maximum.

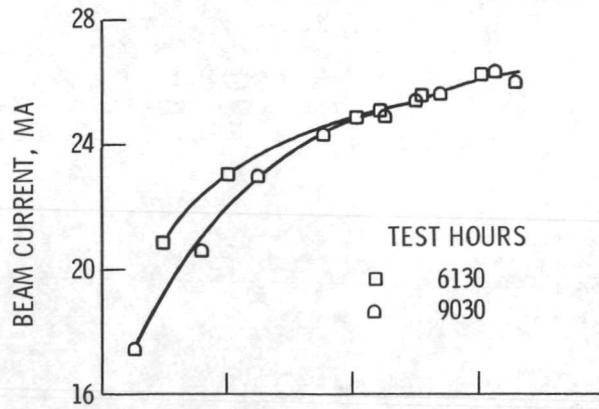
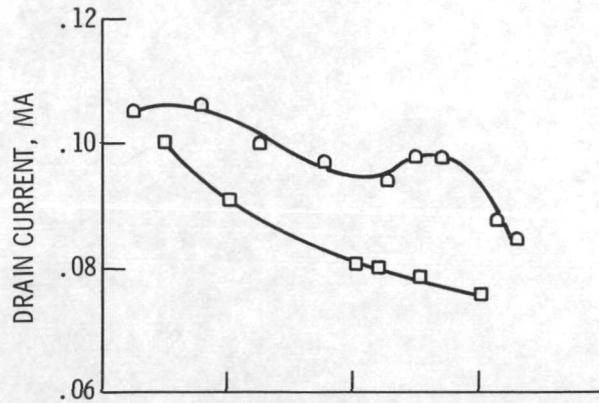
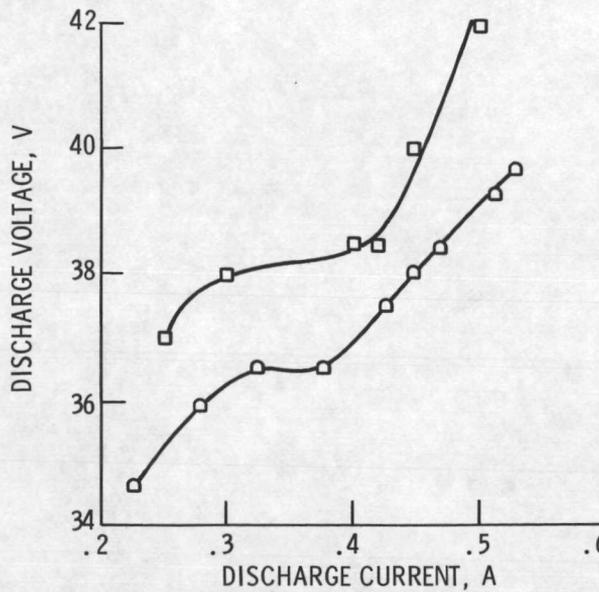
Figure 7. - Effects of varying ion chamber discharge current. Cathode keeper current, 0.3 A.

Discharge current. The effects of varying discharge current are shown in figure 7. The cathode keeper current was maintained at 0.3 A. No cathode heater power was used. The beam current characteristic curves (fig. 7(a)) at 6130 and 9030 hours were almost identical except for a more rapid fall-off in the later curve at discharge currents below 0.4 A.

The accelerator drain current shown in figure 7(b) decreased with increasing discharge current. This effect is attributable to less charge exchange ions as beam current and propellant utilization efficiency increased. The higher drain current at 9030 hours was probably due to a slightly higher propellant flow rate.

The discharge voltage shown in figure 7(c) was about 1.5 volts lower at the 9030 hour point be-

cause of the higher propellant flow rate. At discharge currents less than 0.4 A, the drop in discharge voltage below 37 volts and the loss in ionization probably caused the rapid fall-off in beam current (fig. 7(a)). In contrast, the discharge voltage at the 6130 hour point was 37 volts or higher for discharge currents as low as 0.25 A.

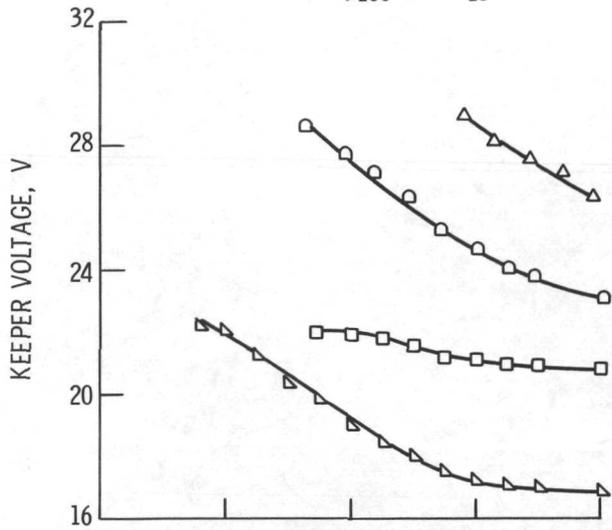
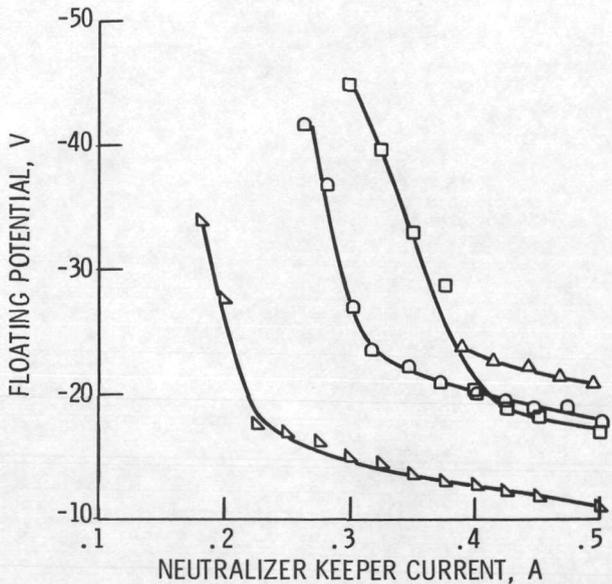
Figure 8. - Effects of varying neutralizer keeper current.

Neutralizer keeper current. The gradual rise with time in keeper voltage and neutralizer floating potential for fixed point operation has been shown in the test history (fig. 3). The effects of varying neutralizer keeper current are shown in figure 8. The keeper voltage generally decreased as keeper current was increased (fig. 8(a)). Increasing the heater power also reduced the keeper voltage, but the effects were dependent on the number of operating hours. At 6130 hours, the neutralizer could be operated with no heater power. At 9030 hours, this was no longer possible. At 7100 hours, 10 watts of heater power reduced the keeper voltage below the 6130 hour values. With 10 watts of heater power at 9030 hours, the keeper voltage was still higher than at 6130 hours with no heater power.

The corresponding variations in neutralizer floating potential are shown in figure 8(b). The floating potential increased rapidly as keeper current was reduced below a critical "knee" value. The "knee" value of keeper current was also dependent on heater power level and operating time. Higher heater power moved the knee to lower values of keeper current. For most of the test, the keeper current was held at 0.45 A which was well above the critical value for all conditions. In general, the combination of heater power level and operating time which affected keeper voltage had similar effects upon the floating potential.

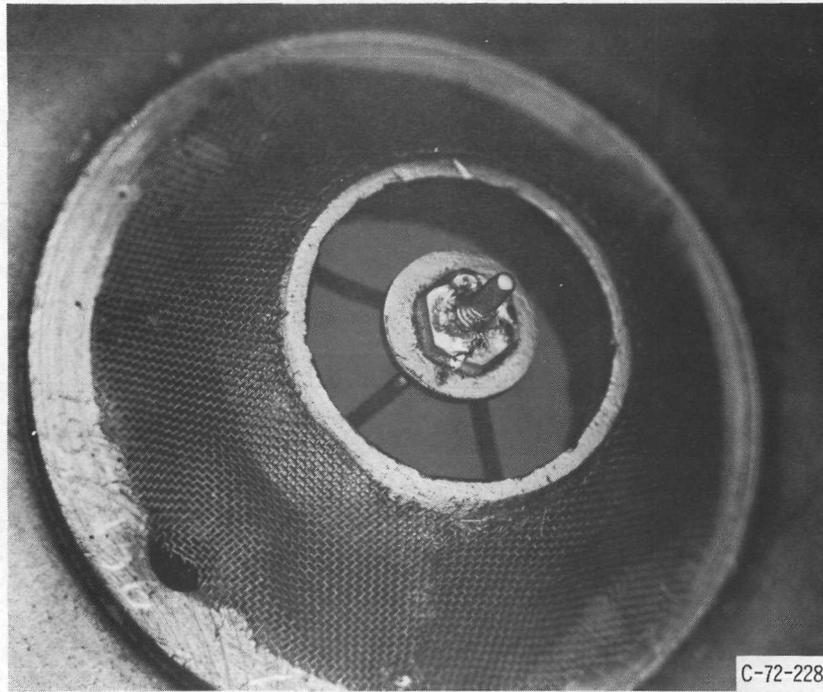
Figure 17. - Cathode pole assembly after 2027 hours.

Cathode pole assembly and thruster back plate. A photograph of the cathode pole assembly and thruster back plate which were exposed to the ion chamber plasma is shown in figure 16. The extent of erosion can be seen by comparison with figure 17 which is a photograph of the same component after 2027 hours of operation. The magnification was higher so that the initial stages of erosion could be seen around the screw threads and the hexagonal corners of the nut.
