SKYLAB MISSION REPORT
SECOND VISIT

PREPARED BY
Mission Evaluation Team

NATIONAL AERONAUTICS AND SPACE ADMINISTRATION
LYNDON B. JOHNSON SPACE CENTER
HOUSTON, TEXAS
January 1974

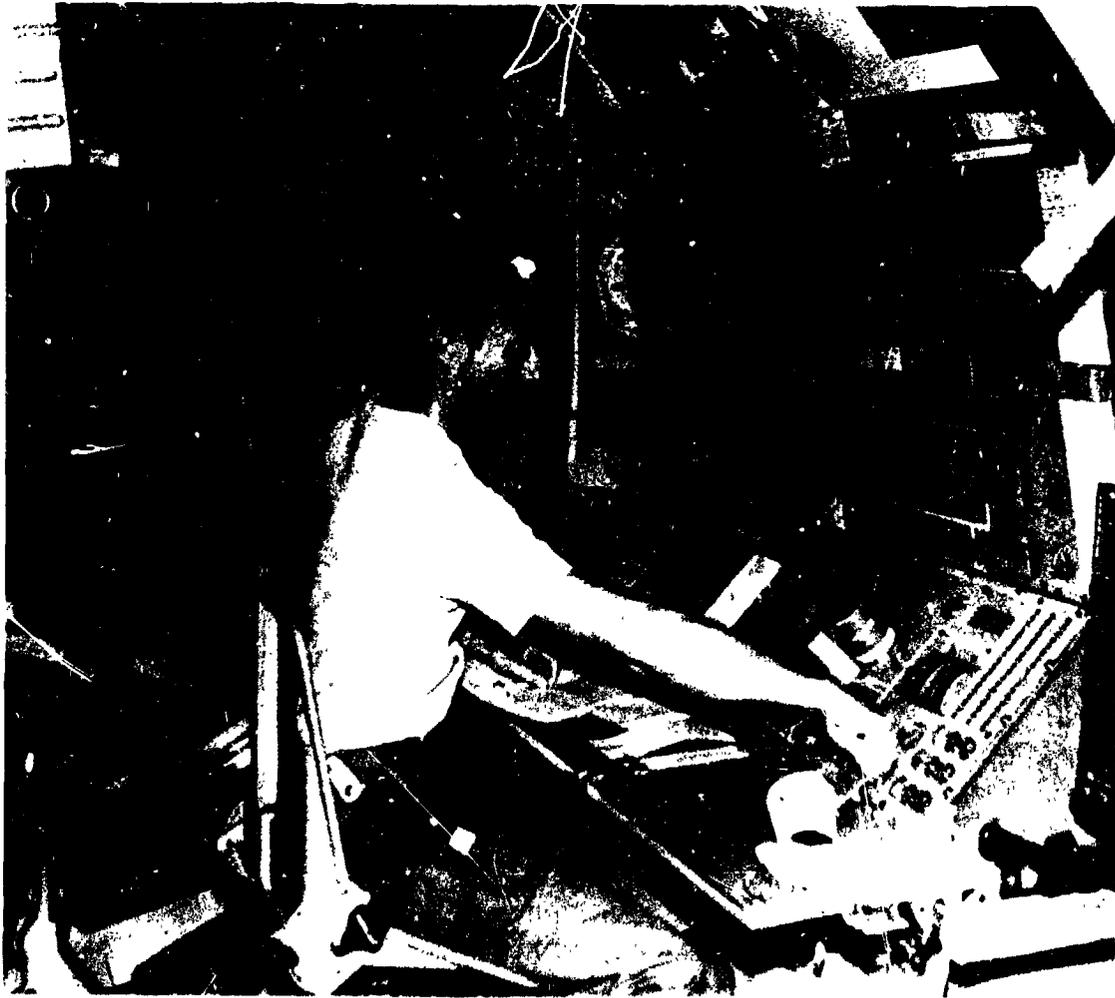
Figure 10-9.- Crewman at Apollo Telescope Mount control and display panel.

The chair at the Apollo Telescope Mount control and display panel is an unsatisfactory feature which should be considered in future spacecraft designs. The chair is locked to the grid structure and it was intended that the operator strap himself to the seat so that his position would be much the same as a man sitting at a desk. Although the chair was tried on several occasions by all crewmen (fig. 10-9), the chair was not satisfactory because the operator had far more flexibility and a much greater reach simply by locking his feet into the gridwork and then extending or bending his legs, either together or one at a time, to reach from top to bottom or side to side. Operations were much more comfortable without the chair, and the crew believes that these comments apply to a much broader category of human factors design than simply the chair evaluated at the Apollo Telescope Mount control and display panel.

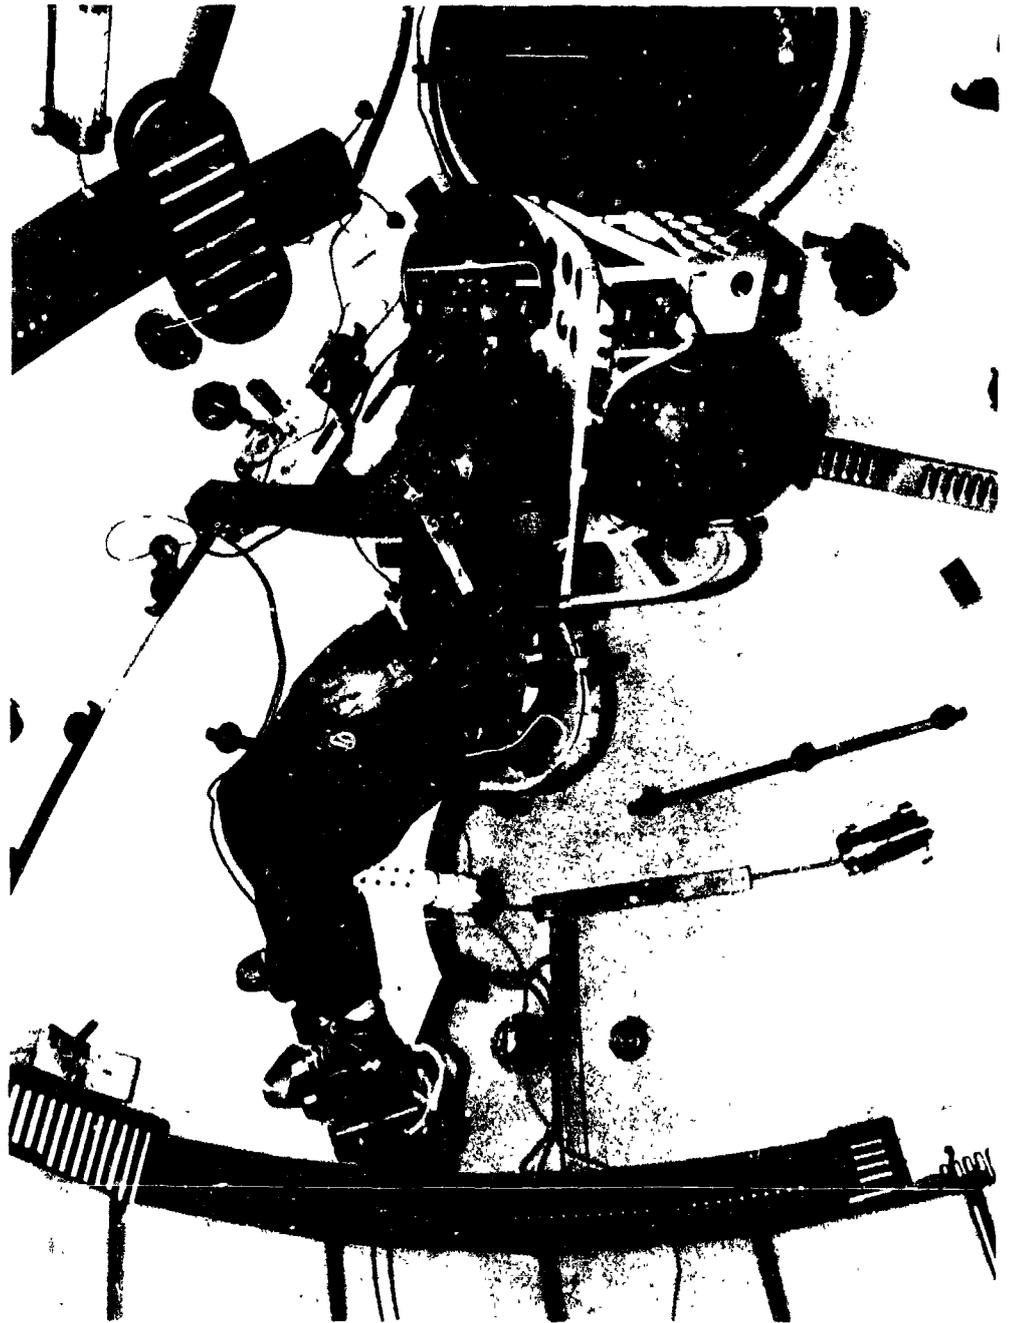
Figure 10-14.- Foot-controlled maneuvering unit in operation.

Evaluation of experiment T020 (fig. 10-14) revealed two major deficiencies. One, the experimental unit lacked 6-degree-of-freedom operation, so that it was frequently impossible to go where one wanted, and two, precise control with the feet, particularly in the suited mode, was not possible.

The lack of six degrees of freedom, with the capability of translating only toward the head or toward the feet, was most frustrating. The only way that a target could be reached was to start when almost completely stationary with the feet pointed at the target. If the initial thrust were not exactly toward the target, some lateral translational velocity was introduced. The lateral translational velocity could not be removed before missing the target in about one third of the attempts. Further, the lack of 6 degrees of freedom made stopping at any desired place within the Workshop completely impossible once any motion had been introduced. Rotational or translational corrections to null a velocity would result in other translations or rotations about the same or other axes which then had to be corrected. Consistently stationkeeping or flying to a desired destination was just not possible with the foot-controlled maneuvering unit.

Because of the impossibility of being able to stationkeep or fly to the desired destination consistently, the crew believes that the T020 foot-controlled maneuvering unit embodied design principles that are unsafe for use during extravehicular operations.

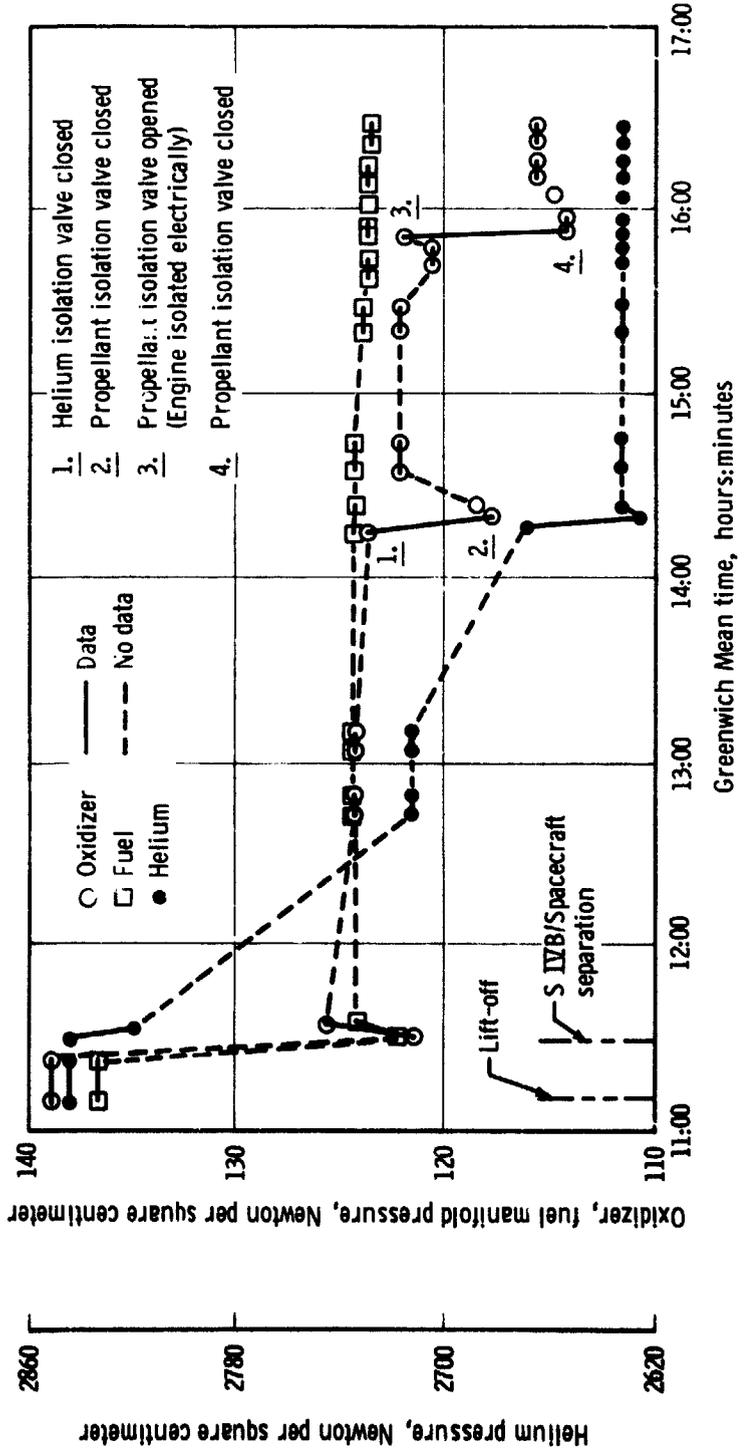
Figure 17-1.- Service module reaction control system quad B propellant data.

About an hour and a half later, a troubleshooting procedure was conducted that involved electrically isolating the quad B engines, then opening the propellant isolation valves with the helium valves closed (fig. 17-1). Data from this troubleshooting procedure, and from the final three-minute period at 14:18 G.m.t., established that the oxidizer leak rate was about 0.035 kilogram per second through the engine oxidizer valve. The flow rate through a fully open valve is approximately 0.16 kilogram per second. The data prior to 14:15 G.m.t indicated that the leakage started sometime following the first usage of the B-3 engine.

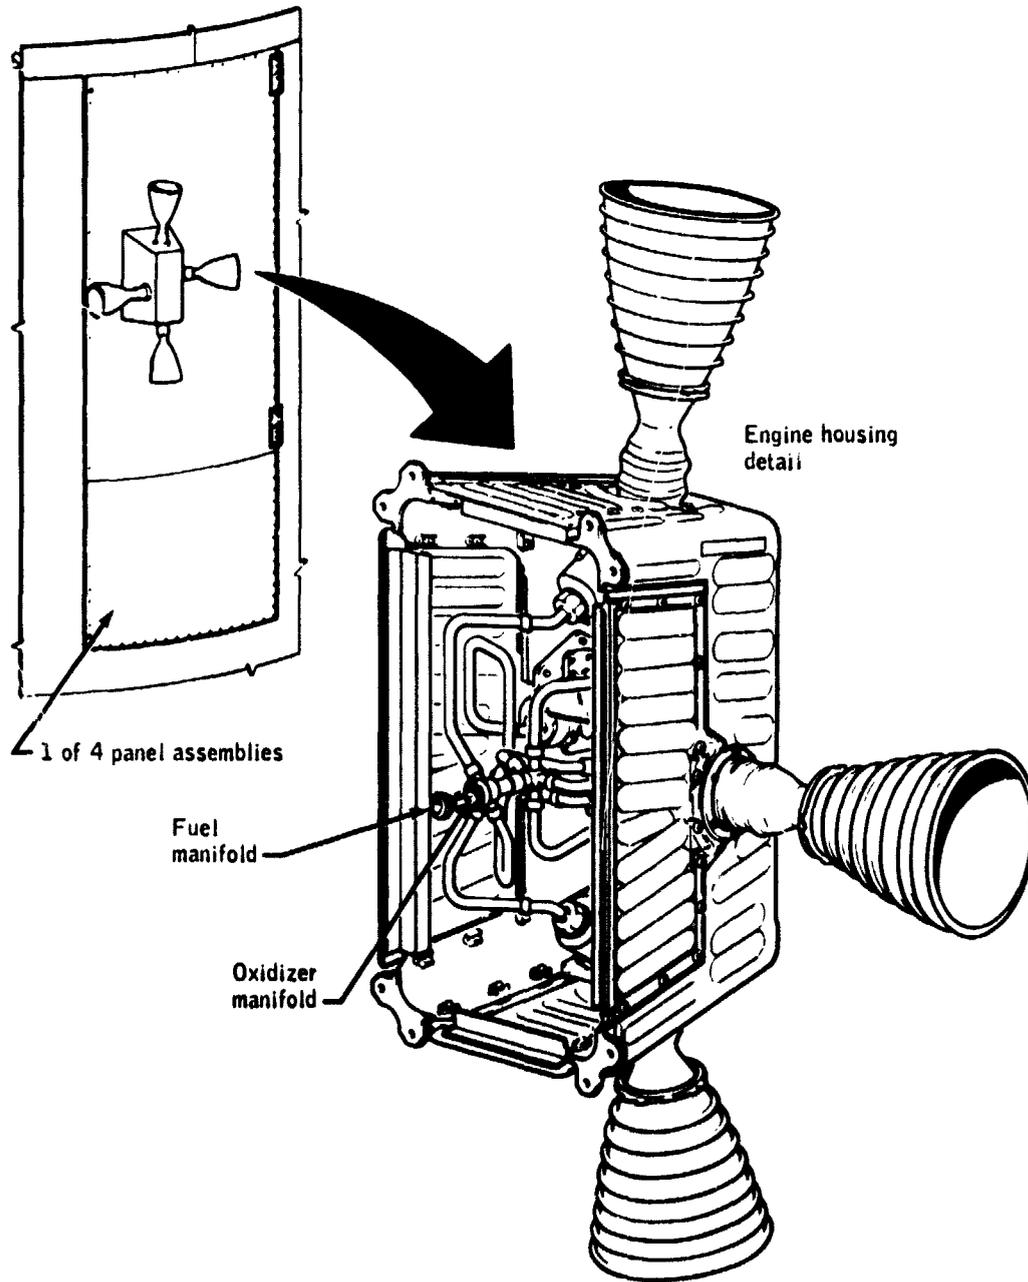
Figure 17-3.- Service module reaction control system.

The service module reaction control system consists of four individual quad panel assemblies and a propellant storage module. Each assembly (fig. 17-3) has a separate propellant feed system and four engines. The engines are mounted in an engine housing that also encloses an oxidizer and a fuel manifold that feeds propellant to the thruster solenoid valves.

Data analysis indicates that the leak originated in the engine housing area. The probable flow path of the leak, including key temperature changes along that path, is shown in figure 17-4. Equipment in the engine housing from which the leak could have originated includes the four engine assemblies, the Dynatube connectors between the engines and the oxidizer manifold, one machined tee, ten brazed joints, and five lengths of tubing.

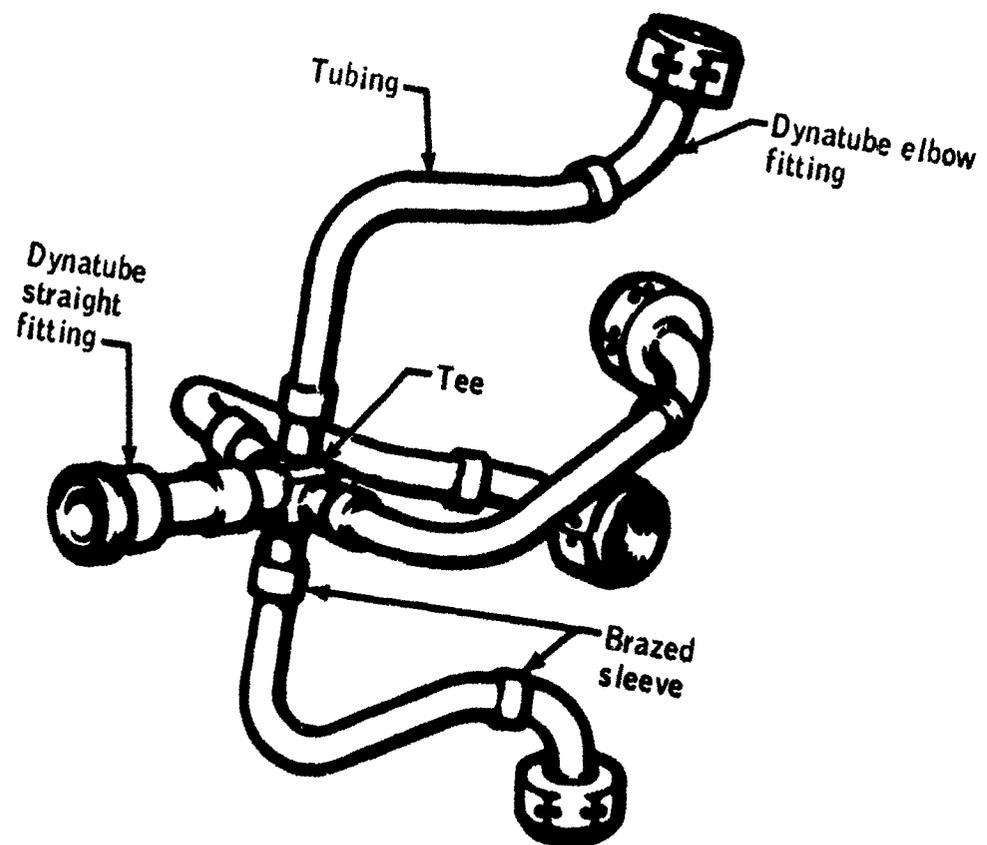
Figure 17-5.- Oxidizer manifold configuration.

The only condition that will match the timeline of events and leakage rates experienced on quad D is an improperly torqued Dynatube connector. Each oxidizer manifold (fig. 17-5), has five Dynatube connectors.

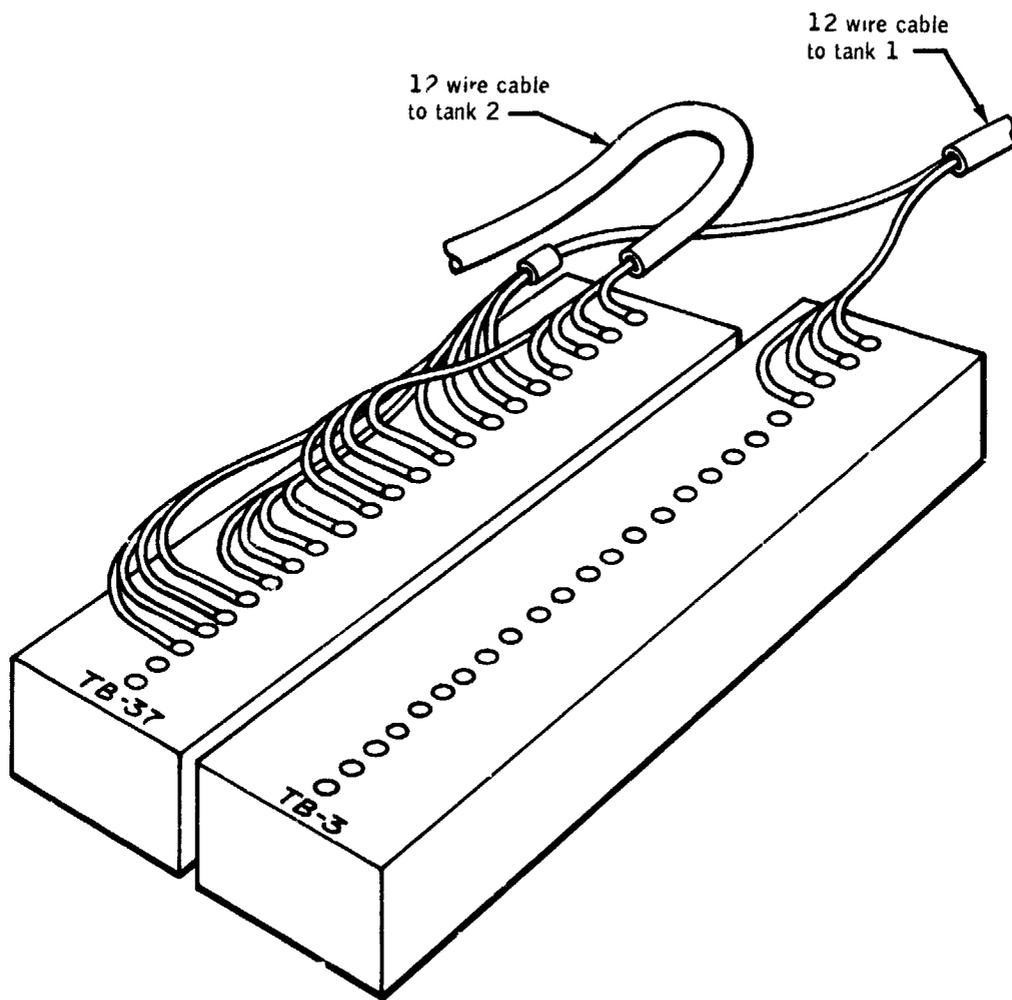
Figure 17-8.- Cryogenic hydrogen tank wiring at terminal boards.

On visit day 2, the cryogenic hydrogen tanks were configured with the tank 1 fans and heaters off and tank 2 fans and heaters in automatic for increasing the tank 2 depletion rate. However, pressurization cycles were noted in tank 1 and the tank began to deplete at a faster rate than tank 2. On visit day 11, the tanks were reconfigured with the tank 1 fans and heaters in automatic and the tank 2 fans and heaters off. Pressure cycles and faster depletion rates resulted in tank 2.

During installation of the cryogenic shelf on the second visit spacecraft, the cryogenic oxygen instrumentation wiring for tanks 1 and 2 and the hydrogen reactant valve wiring were reversed. These wire reversals were corrected at the spacecraft manufacturing facility during preflight checkout for proper connection. The only wiring in the command and service module that was not verified at the launch site or the spacecraft manufacturer's facility for connection to the proper tank was the vendor-supplied wiring from the tank interface to the spacecraft terminal board interface for the fans and the heaters. The wiring for both tanks is color coded identically and both terminal boards are located side by side (fig. 17-8). The hydrogen tank fans and heaters were tested at Kennedy Space Center for proper functioning, but not for proper connection.

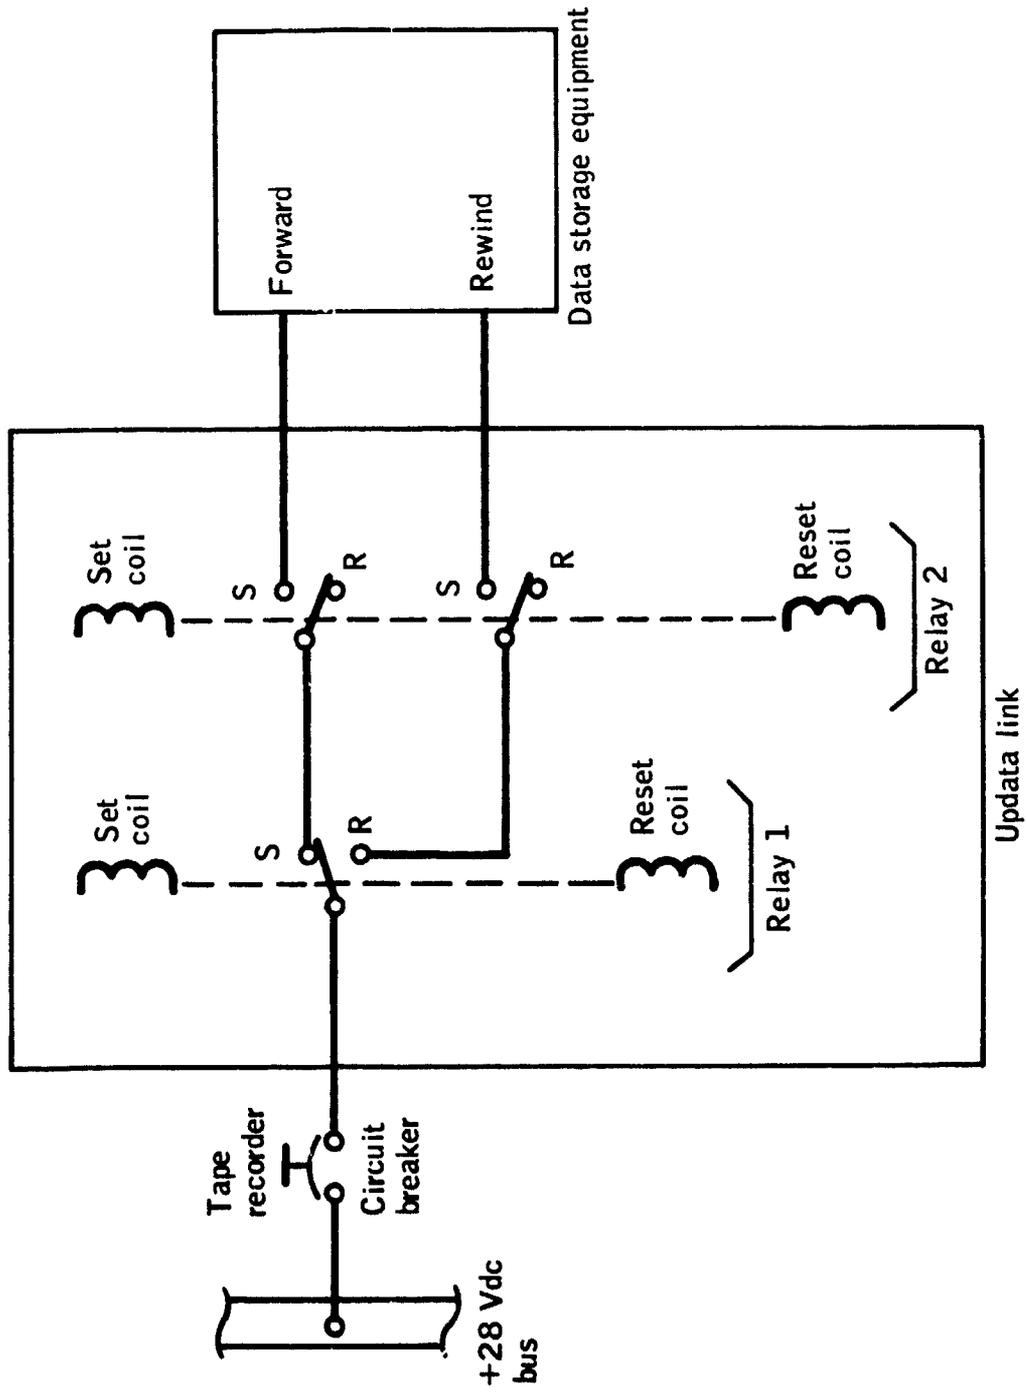
Figure 17-9. - Data storage equipment control.

The data storage equipment stops when both the forward and rewind commands are absent. Latching relays 1 and 2 (fig. 17-9) are controlled by uplink commands and configured to provide the proper commands to the data storage equipment. When both relays are latched in the set position, the forward command is given. When relay 1 is reset and relay 2 is set, the rewind command is given. The stop command, then, corresponds to relay 2 reset. During the flight, the problem was that relay 2 could not be reset. However, during postflight testing, the system operated properly.

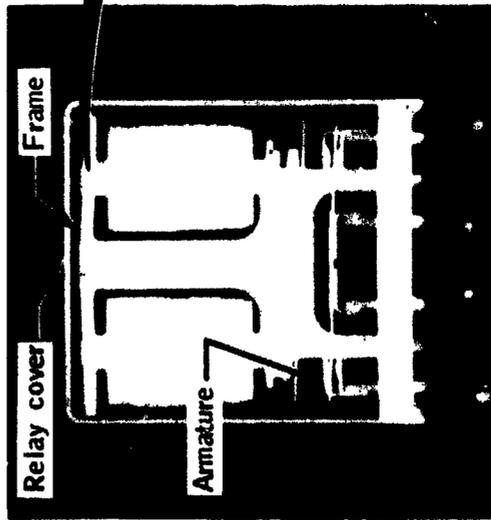
Figure 17-10.- X-rays of relay with loose solder ball.

Postflight X-rays of relay 2 (fig. 17-10) showed that a solder ball large enough to jam the relay armature and prevent contact transfer was trapped between the relay cover and frame. The solder ball must have been dislodged from the armature gap by the spacecraft landing shock and became trapped where it was subsequently found.

Metallic particle between armature and pole

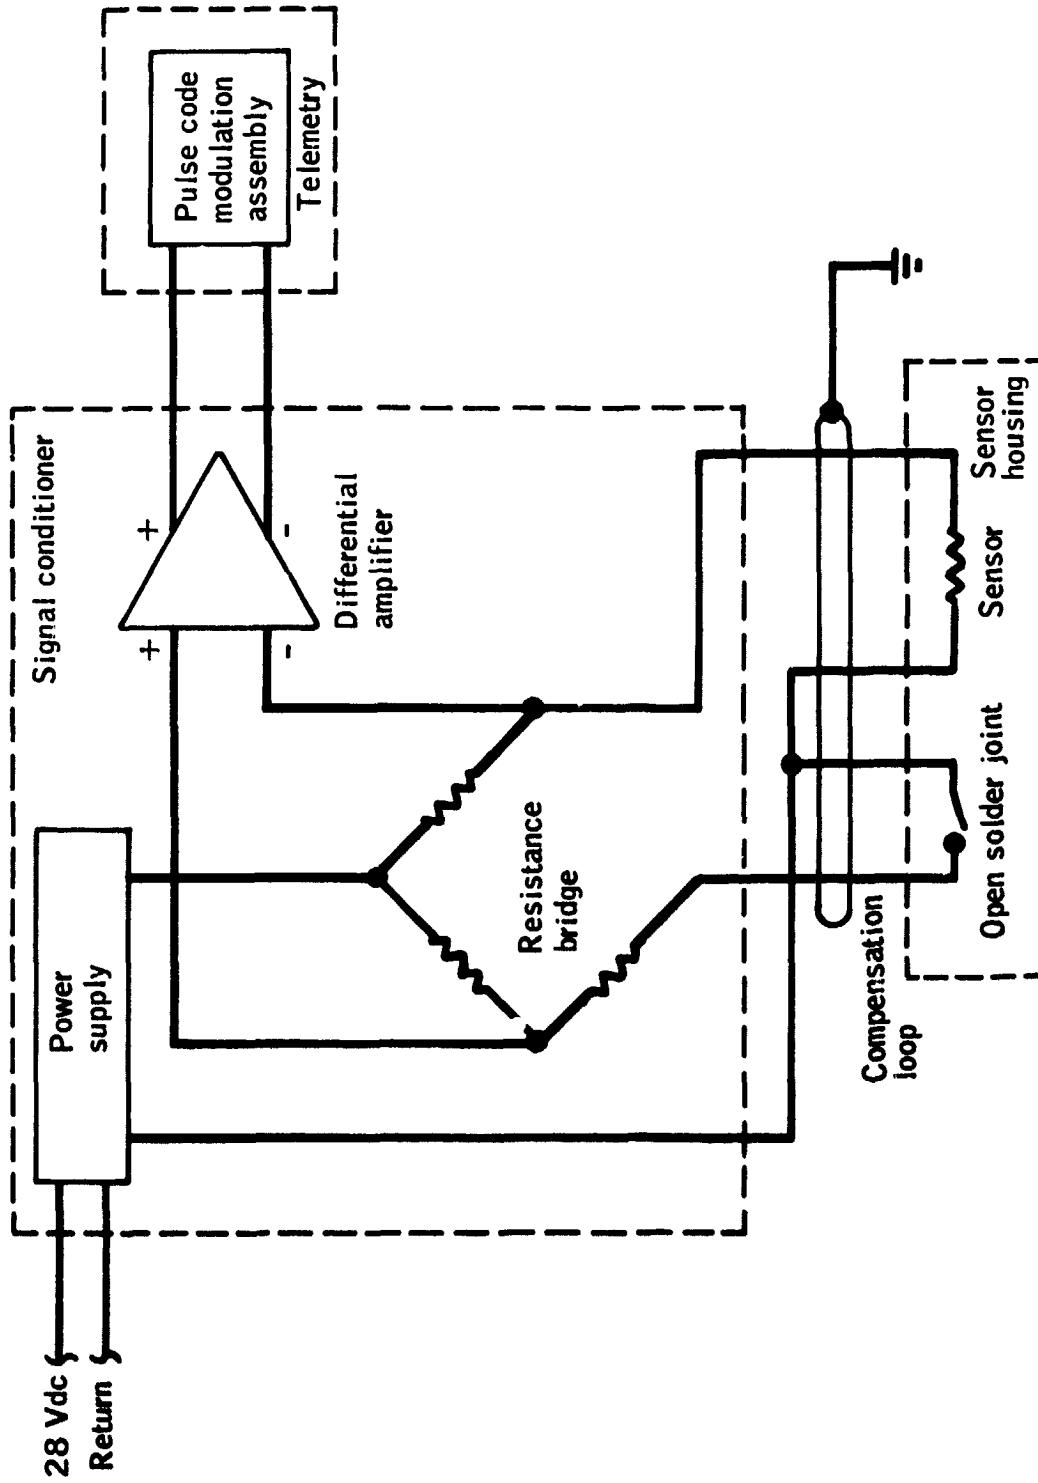
Figure 17-12. - Engine package temperature measurement circuit.

The engine package temperature sensor is located in the quad B housing (fig. 17-11). The sensor is a platinum resistance thermometer that operates in a resistance bridge as shown in figure 17-12. The transducer is connected to the signal conditioner by a shielded four-wire cable. Two of the four wires are connected to the resistance thermometer, and the remaining two wires are shorted together to compensate for errors introduced by wiring resistance. The bridge output is amplified and fed to the pulse code modulation assembly in the telemetry system.

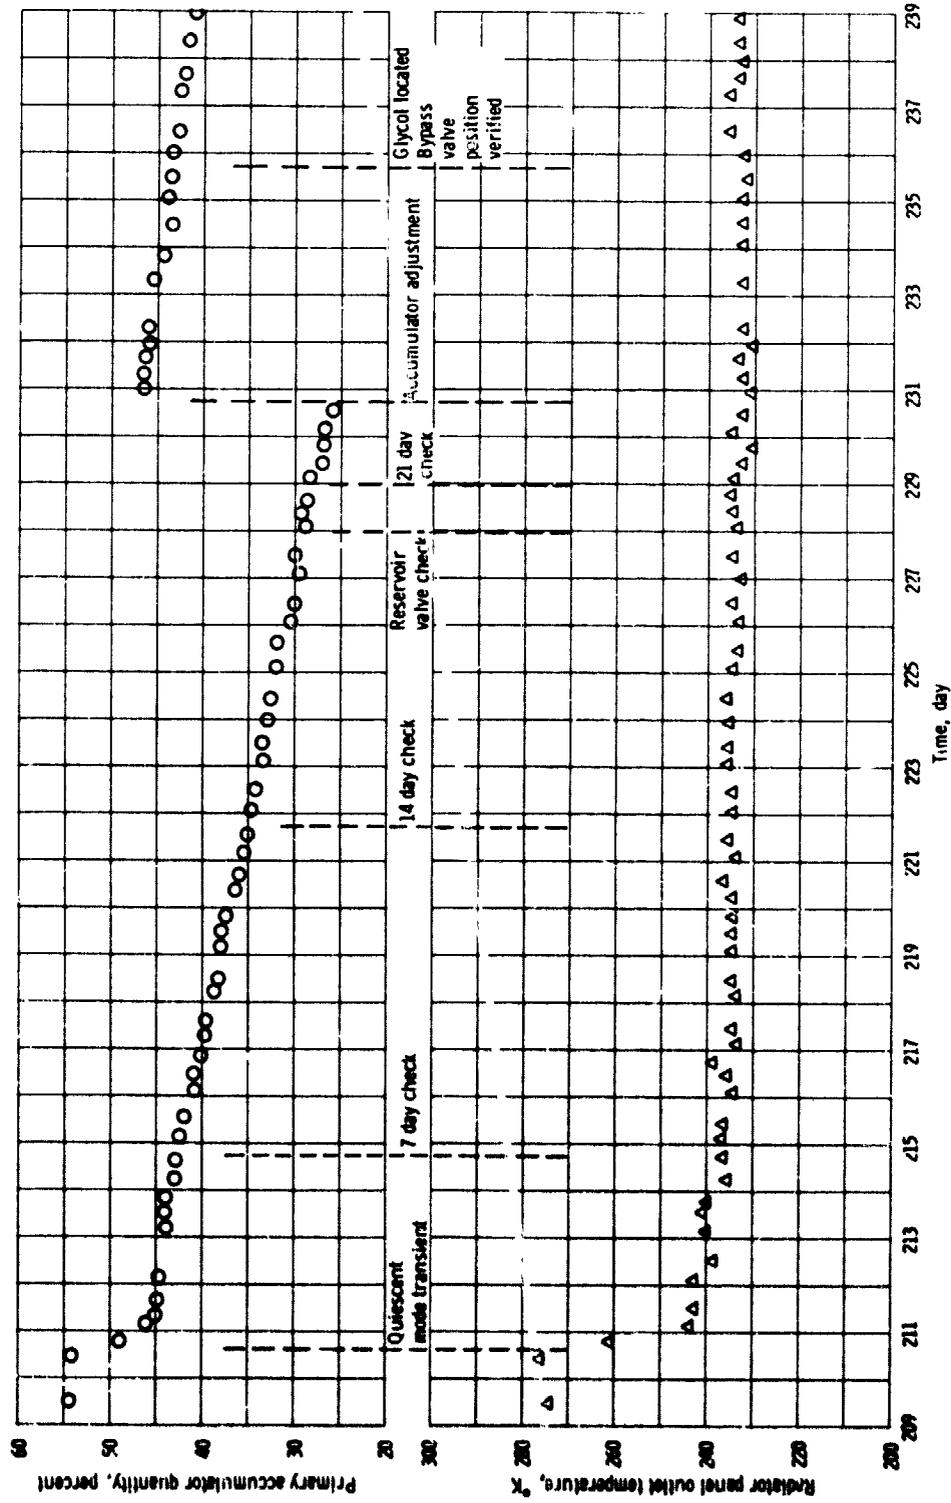
Figure 17-13. - Coolant quantity and temperature history.
(Representative cyclic minimums)

After insertion into earth orbit, the primary water/glycol (coolant) accumulator quantity was adjusted to about 50 percent and the water/glycol reservoir was isolated in accordance with the checklist. After the coolant loop temperatures stabilized, the coolant accumulator quantity decreased at a rate of approximately one percent per day (fig. 17-13). On visit day 19, the crew verified that the reservoir inlet and outlet valves and the accumulator fill valve were fully closed. On visit day 22, the crew confirmed that coolant fluid was not leaking back into the reservoir by cycling the inlet valve and noting that ullage existed in the reservoir. The primary accumulator quantity was increased to about 50 percent (46 percent at the coldest orbit point) on this same day by transferring coolant from the reservoir into the accumulator. The accumulator quantity continued to decrease, but at the reduced rate of about one-half percent per day.

The water/glycol accumulator quantity continued to decrease at the reduced rate until visit day 31, when the quantity stabilized and remained at about 40 percent until the end of the visit.

A postflight leak check was made on the primary coolant system. No leakage was noted with the suit heat exchanger coolant bypass valve in either the flow or bypass position, but leakage was observed when the valve was in an intermediate position. No evidence of leakage was noted in any other area of the vehicle.

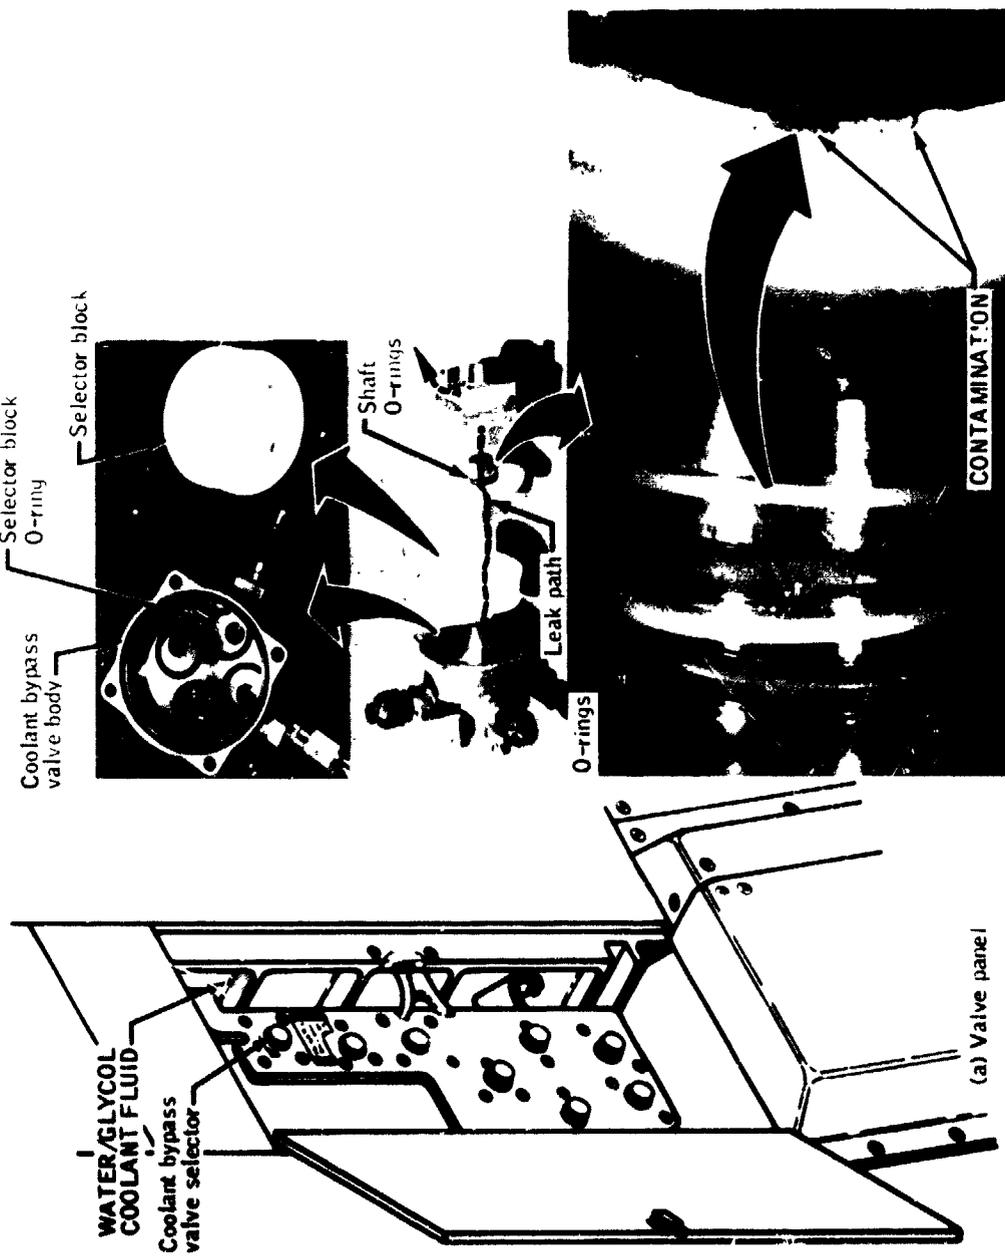
Figure 17-14.- Suit heat exchanger coolant bypass valve.

(b) Disassembled view of valve showing area of contamination

The leaking valve was removed from the command module and disassembled. The selector block O-rings (fig. 17-14), which form the primary seals in the selector block and valve housing assembly, were in good condition. A small amount of contamination was evident on and around the redundant O-rings on the shaft (fig. 17-14). Analysis indicated that the contamination was gray paint, similar to that used on the command module panels. Contamination on the shaft seals could cause leakage when the valve is in an intermediate position because, in an intermediate position, the primary seal O-rings which encircle the ports in the valve block may not encircle the selector block ports, and the redundant shaft O-rings must perform the sealing function for the valve. However, since the crew verified that the valve was not in an intermediate position, and since the valve was not actuated for four days prior to the leak stoppage, the cause of the leakage is unknown.

Preflight primary coolant system leak tests will be performed on subsequent command modules with the suit heat exchanger coolant bypass valve in the bypass position. In addition, manual positioning of the valve will be used during the mission to ensure positive positioning.

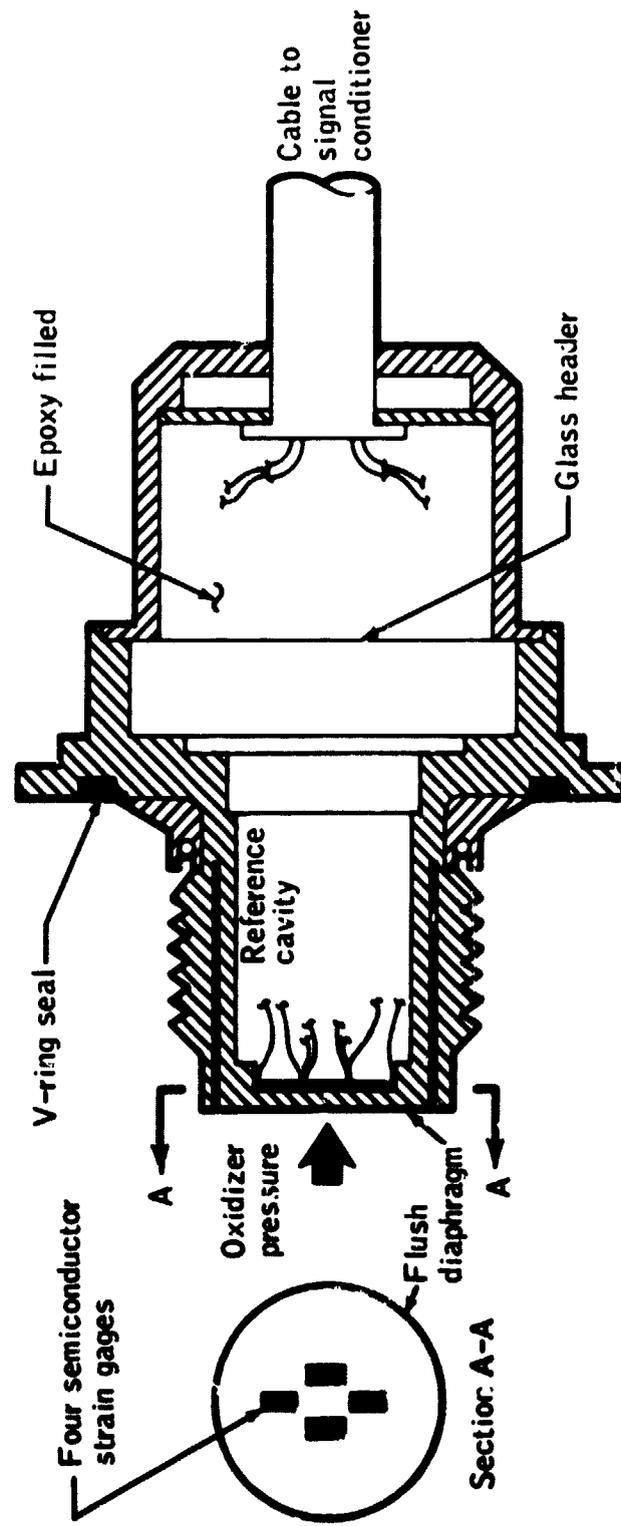
Figure 17-15.- Cutaway view of oxidizer pressure transducer.

The pressure transducer sensing element is a steel alloy diaphragm that is flexed by the differential pressure between the oxidizer and the 10 newtons per square centimeter reference cavity pressure as shown in figure 17-15. Four small silicon semiconductor strain gages are cemented directly to the inside surface of the diaphragm. They are connected as the four active elements in a resistance measurement bridge.

Analysis shows that the failure must have been in the transducer. Similar malfunctions in the past were caused by separation of a strain gage from the diaphragm because of the failure of the cement. This failure causes a change in the transfer function between the pressure and the output voltage.

If this measurement should fail on a future mission, other measurements may be used to determine the service propulsion system performance.

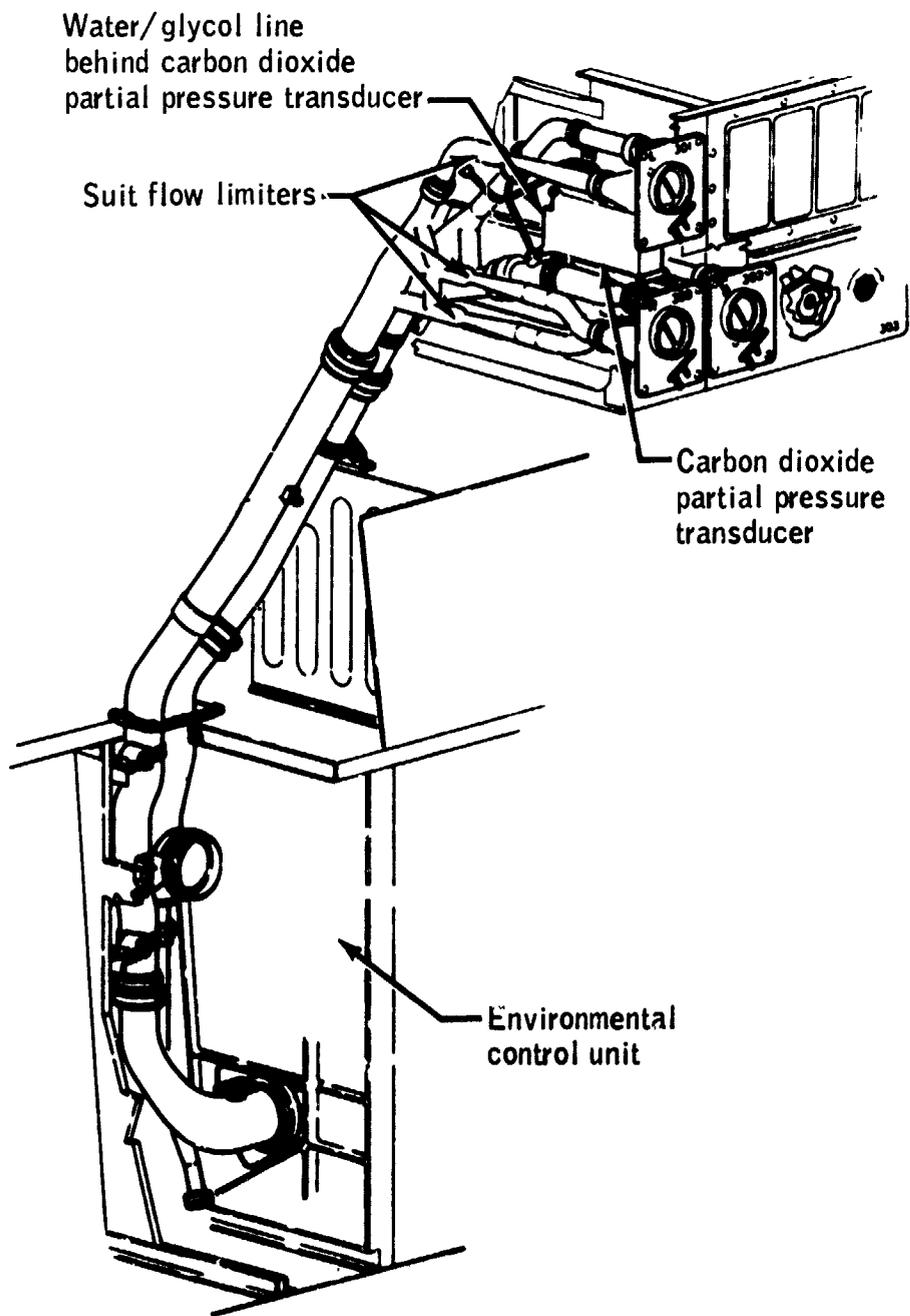
Figure 17-19.- Carbon dioxide partial pressure transducer location in left-hand equipment bay.

The carbon dioxide transducer is located in the left-hand equipment bay, above the environmental control unit (fig. 17-19). A water/glycol coolant line runs behind the unit. Previous failures similar to those noted in this transducer have occurred when the transducer was chilled below the dew point of the gas passing through the transducer, causing condensation within the transducer.

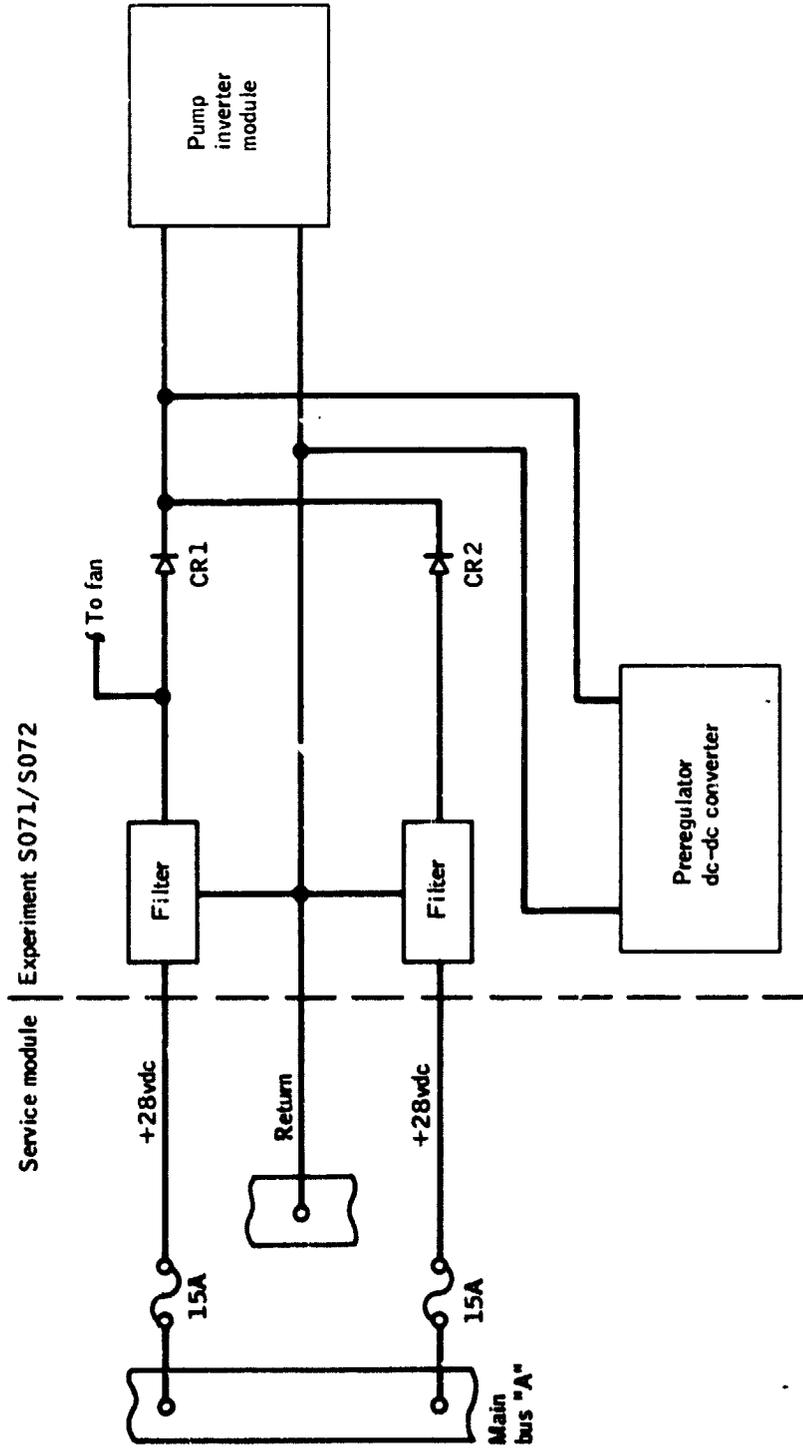
Figure 17-20.- Experiment S071/S072 power distribution and conditioning.

The equipment for these two experiments consists of a complete environmental system for the pocket mice and vinegar gnats, plus sensors and telemetry. Electrical power is supplied through two parallel branches. Each branch contains a 15-ampere fuse, an input power filter, and a steering diode (fig. 17-20), and is capable of supplying the normal operating current of 5 amperes. The 28-volt power is fed to the glycol pump power inverter and the voltage regulator network.

The electrical short causing the power failure could not have occurred on the bus side of diodes CR1 and CR2. A short to ground in either branch would have blown the fuse protecting that branch. Normal power of 5 amperes would then be supplied through the remaining branch.

Poor packaging and wire routing are believed to be the cause of this failure. Ames Research Center will publish the detailed results of this failure. The experiments are not scheduled for the remainder of the Skylab program. Therefore, no corrective action is required.

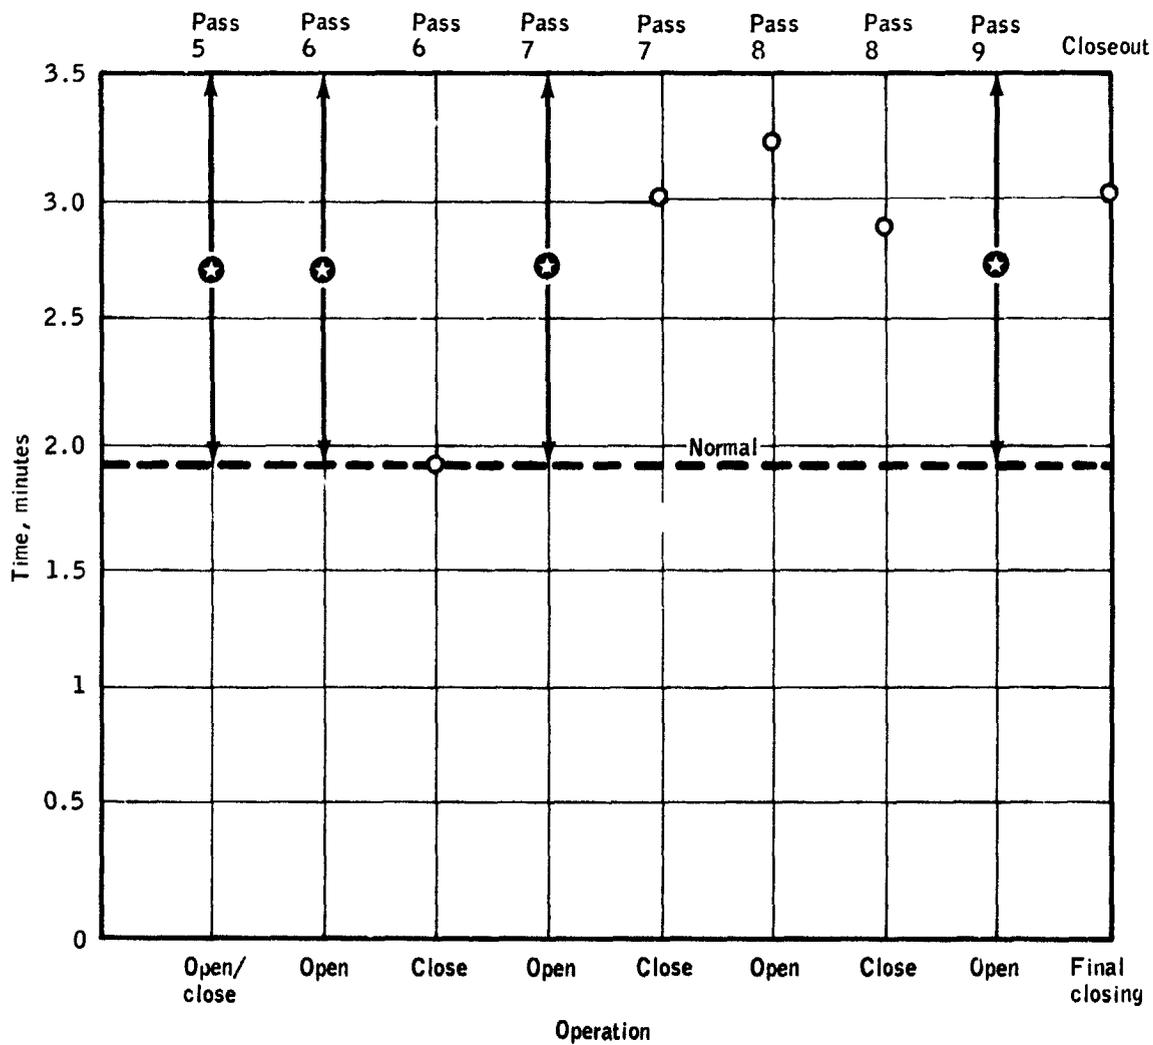
Figure 17-26.- Experiment S191 door actuation times.

The normal opening or closing time of the door is about 2 minutes. The door operation became slow and erratic during the fifth Earth Resources Experiment Package pass on visit day 12. Figure 17-25 shows the door and figure 17-26 plots the actuation time of the door, beginning with that event. The closing time of the door for the seventh Earth Resources Experiment Package pass shows a step increase above the normal time. From that event until the end of the second visit, there was no significant increase in door operation time. The times for the seventh and eighth pass and the final closing show that the door situation, although not normal, was consistent.

Ground tests have shown two conditions that could cause the slow and erratic operation. The first condition is that the mechanical load increases to approximately the motor stall torque. This possibility can be discounted because the motor will run at synchronous speeds until the load is near the stall torque. It is unlikely that the load would increase to that level and no further. The second condition is interruption of the drive voltage to one of the motor windings. This possibility fits the flight indications since the speed did not continue to decrease with operating time.

Action will be taken to reduce the number of door actuations to a minimum. The door was closed prior to the departure of the second visit crew. The door will be opened after docking on the third visit and left open until the end of the mission to minimize the probability of door failure. General optical contamination as a result of this door being open is acceptable. Mission planning adjustments have been made to manage the thermal differences caused by operations with the door open.

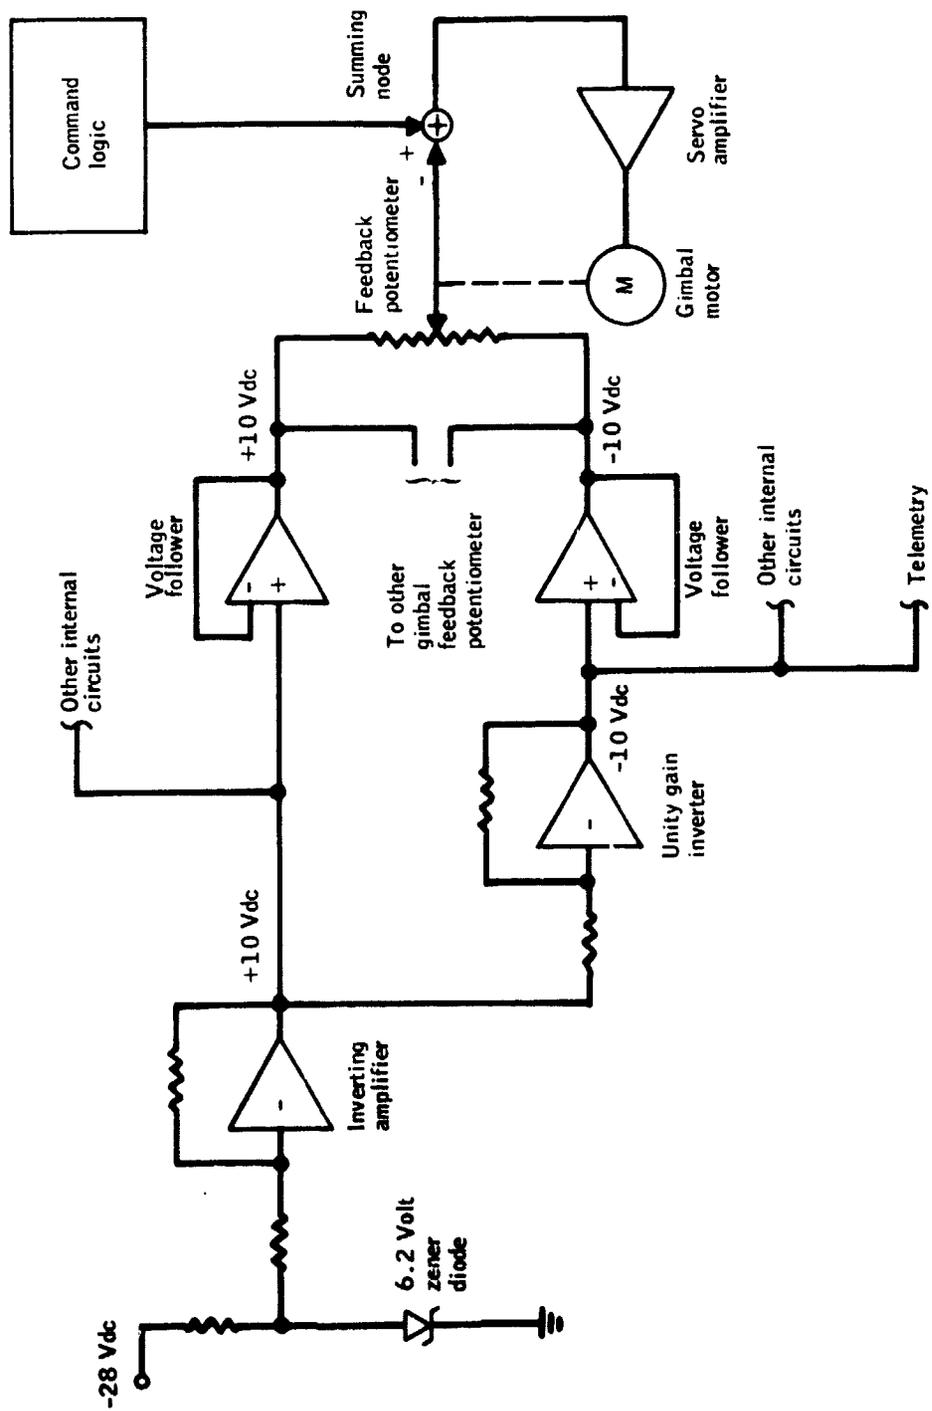
Figure 17-30.- Antenna gimbal servo loop.

The measurement of the minus 10 volt supply indicated that the supply voltage was minus 0.99 volt. Ground tests have shown that if the output of the voltage follower supplying minus 10 volts to the servo potentiometers was shorted to ground, the voltage follower input voltage would be held at minus 0.99 volt and all of the improper indications (and no others) would result. The fault, therefore, must have been a short to ground somewhere on the output of the minus 10 Vdc voltage follower.

to plus 0.84 radian for the next data-taking scan.) At the time, the roll gimbal was commanded to a fixed position (0 radian). The problem then cleared and the operation was normal through the next antenna data-taking scan. The fault again occurred at the end of the second antenna pitch retrace (plus 0.84 radian). Thereafter, the minus 10 volt output varied from minus 1 to minus 1.22 Vdc for a period of about 15 seconds and then steadied at a value of minus 0.99 Vdc. This operation is symptomatic of a mechanical-type short circuit somewhere in the antenna or its flexible harness, and not a component short circuit.
