SKYLAB MISSION REPORT
SECOND VISIT

PREPARED BY
Mission Evaluation Team

NATIONAL AERONAUTICS AND SPACE ADMINISTRATION
LYNDON B. JOHNSON SPACE CENTER
HOUSTON, TEXAS
January 1974

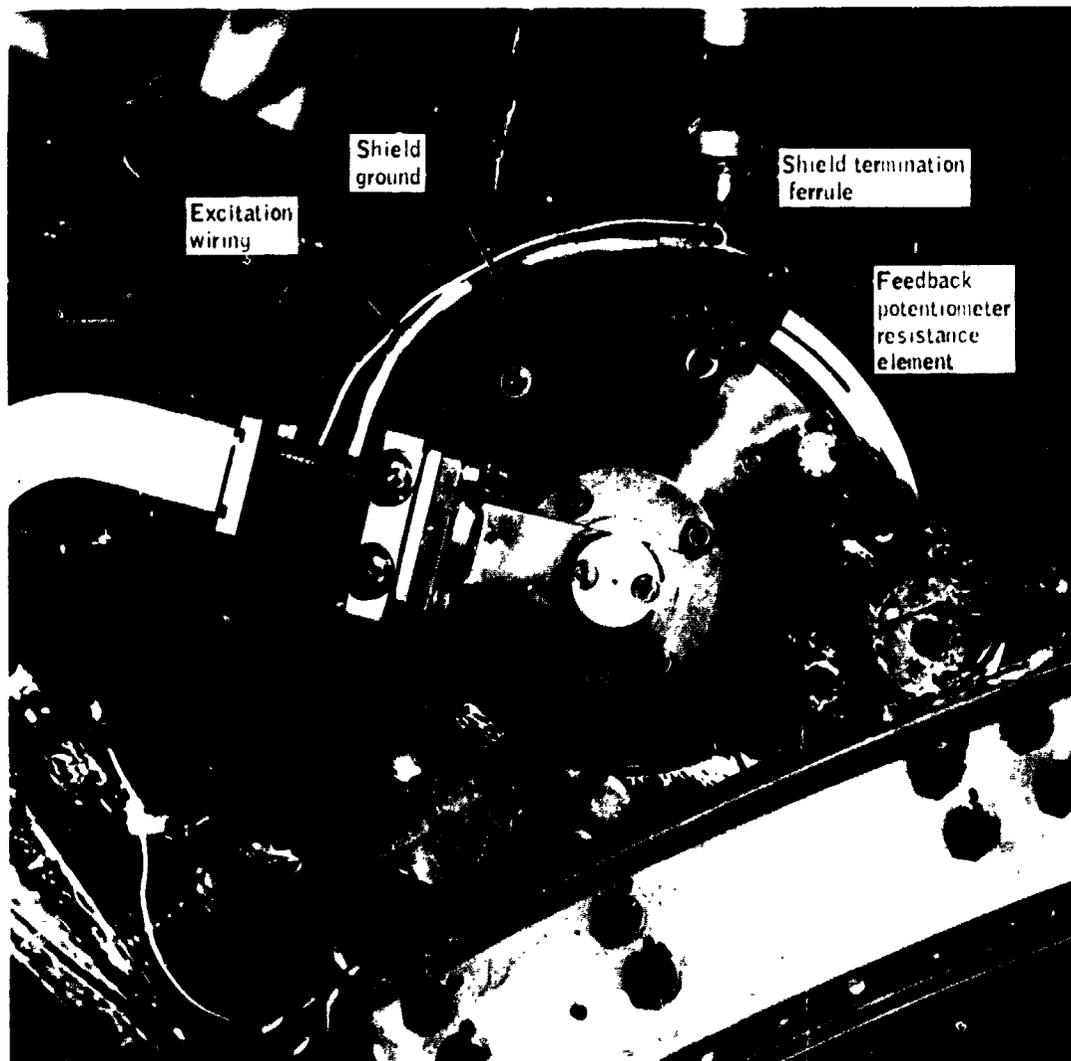
Figure 17-32.- Experiment S193 antenna pitch gimbal.

The antenna (fig. 17-31) is driven in two axes - pitch and roll. Each axis uses a feedback potentiometer to supply antenna position information to the gimbal servo loop as shown in figure 17-30. The potentiometer (fig. 17-32) consists of a 2.13-radian circular segment resistance element that is bonded to the antenna housing. The potentiometer wiper is attached to the axis shaft which turns within the housing. The resistance element is partially exposed and conductive contamination could have shorted the minus 10 Vdc end of the element to ground. In addition, since the excitation voltages are supplied to the resistance element by a twisted shielded pair cable, the shield termination ferrule may have cut through the minus 10 volt conductor insulation and grounded the conductor.

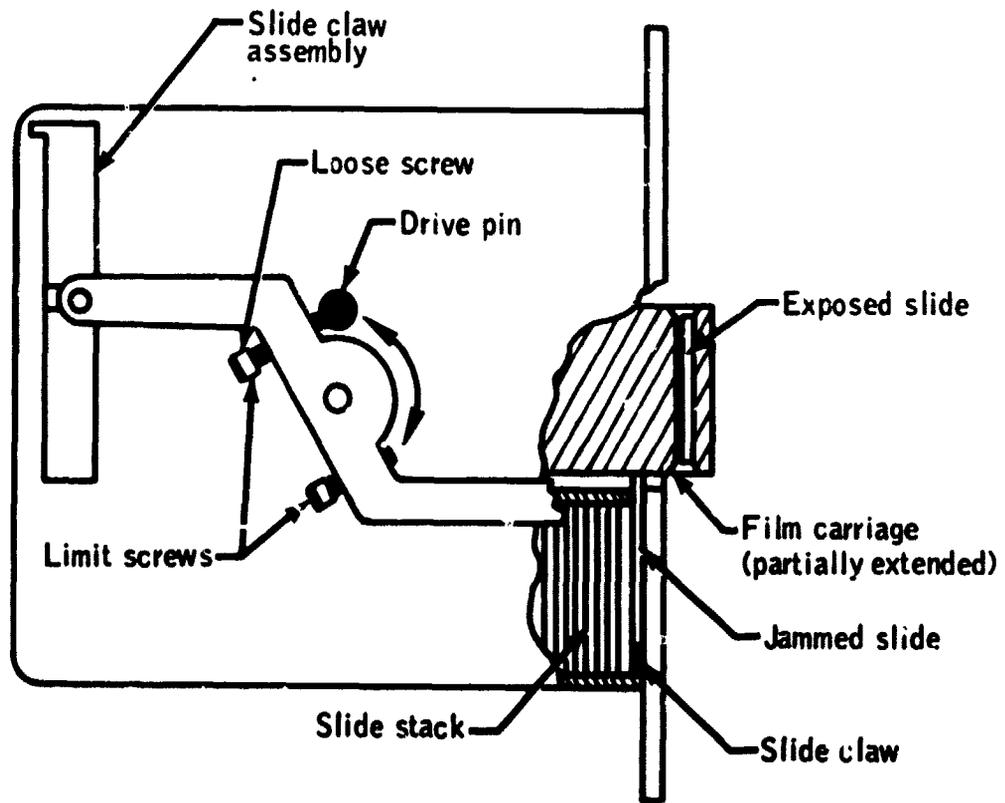
Figure 17-33.- Experiment S019 film canister.

On visit day 56, the film advance/shutter control crank on film canister 005 jammed at the carriage-retracted position and would not continue to rotate on to the slide-retracted position. Therefore, a new slide could not be transferred into the carriage from the supply stack nor could the exposed slide be ejected into the takeup stack.

Examination of the returned film canister showed that the slide pickup sequence was initiated before the carriage retraction was completed. As a result, the slide that was being transferred from the supply stack for insertion into the carriage had jammed against the carriage slide guide.

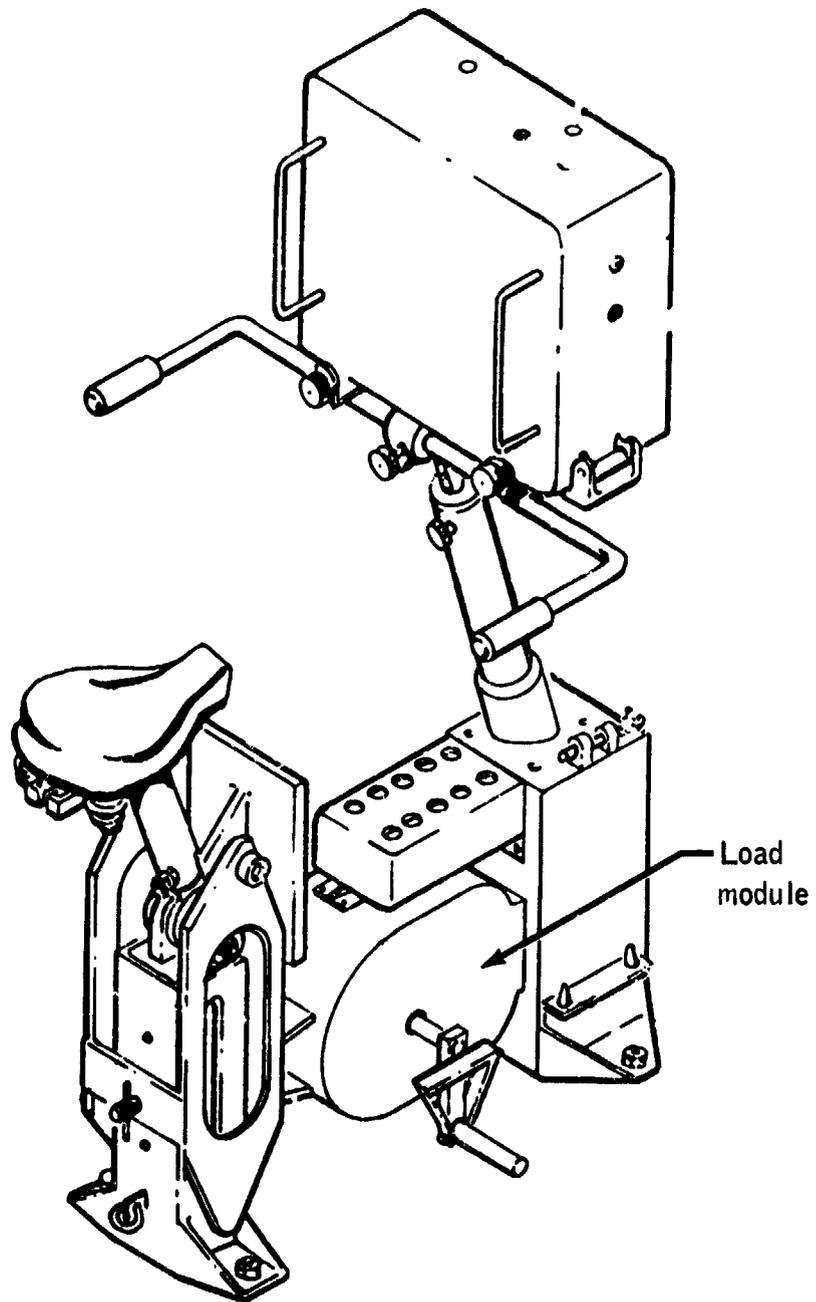
Figure 17-34.- Bicycle ergometer.

The experiment M171 ergometer load module began making excessive noise and eventually began free wheeling (no load) during the visit day 20 exercise period. After a 1-hour cooling period, the ergometer functioned properly and continued to operate normally for the remainder of the visit.

Two types of ergometer failures occurred during ground tests that resulted in excessive noise followed by free wheeling. The first was rotor thermal expansion, resulting from operating at excessive power levels, and causing the rotor to mechanically rub against the stator. When this occurred, sufficient force was coupled into the force transducer to break one of the strain gages. A failure of this type, however, is permanent, and could not have occurred to the flight unit as that unit operated normally after cooling down.

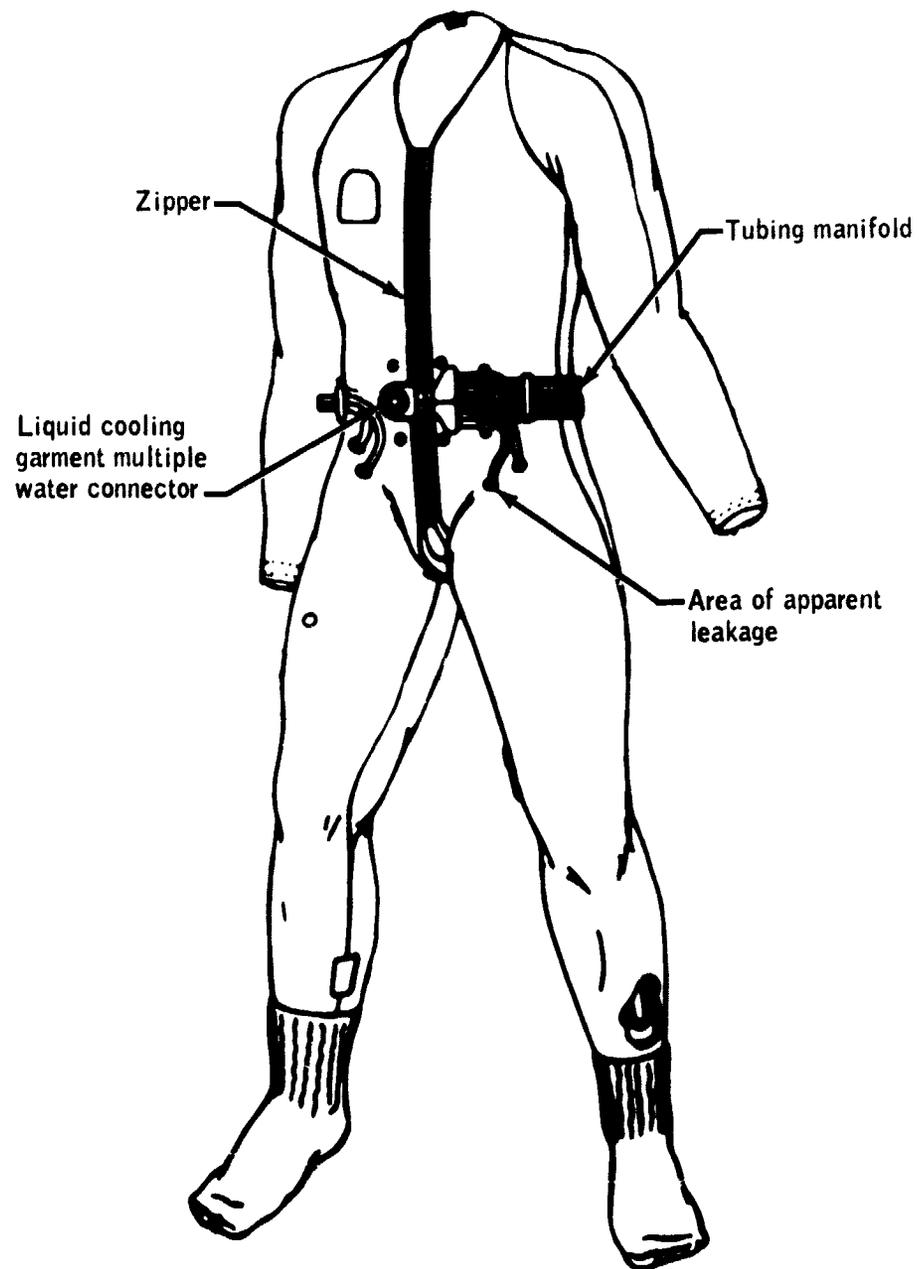
Figure 17-39.- Liquid cooling garment.

Upon removal of the liquid cooling garment after the second extravehicular activity, the crewman reported that liquid leakage was occurring and had dampened the garment in the area between the multiple water connector and the junction at the first manifold (fig. 17-39). The Commander also stated that this leakage had occurred after the suited run with experiment M509 and that efforts to detect the location of the leak by squeezing the liquid cooling garment tubes were unsuccessful.

The garment was returned and leak tests were performed; however, no leak was found.

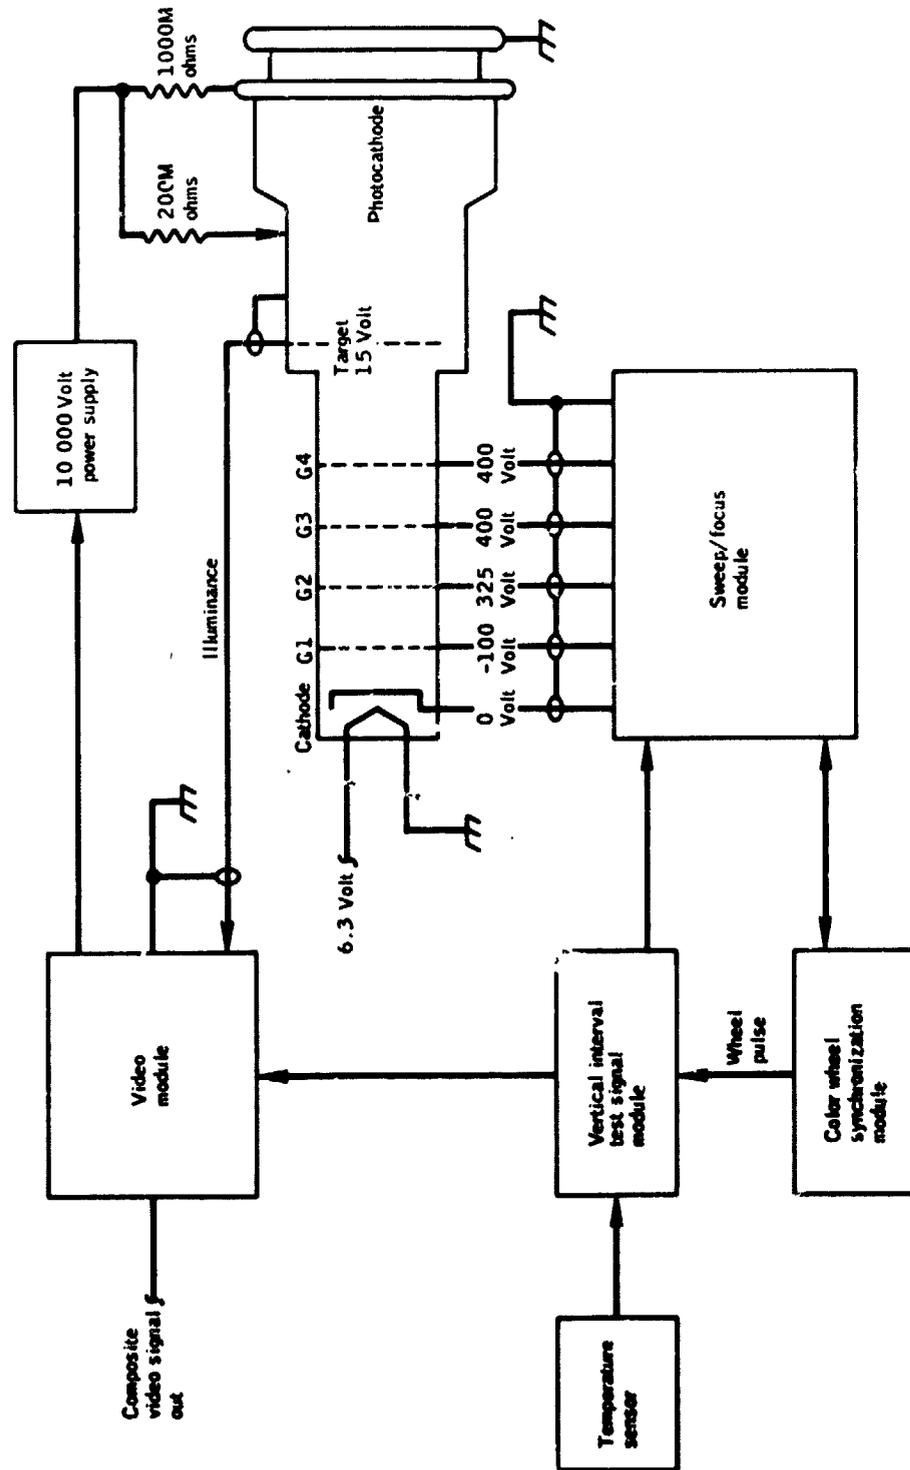
Figure 17-40.- Television camera network block diagram.

The illuminance component of the composite video signal was lost. In place of the video signal was a pattern of noise that gave the appearance of horizontal streaks on the television display. The synchronizing

signals, vertical interval test signal, and temperature information were still being transmitted to the ground. The failures which result in loss of illuminance, but permit the remainder of the composite video to be present, are grounding or shorting of the image tube electrodes (fig. 17-40).

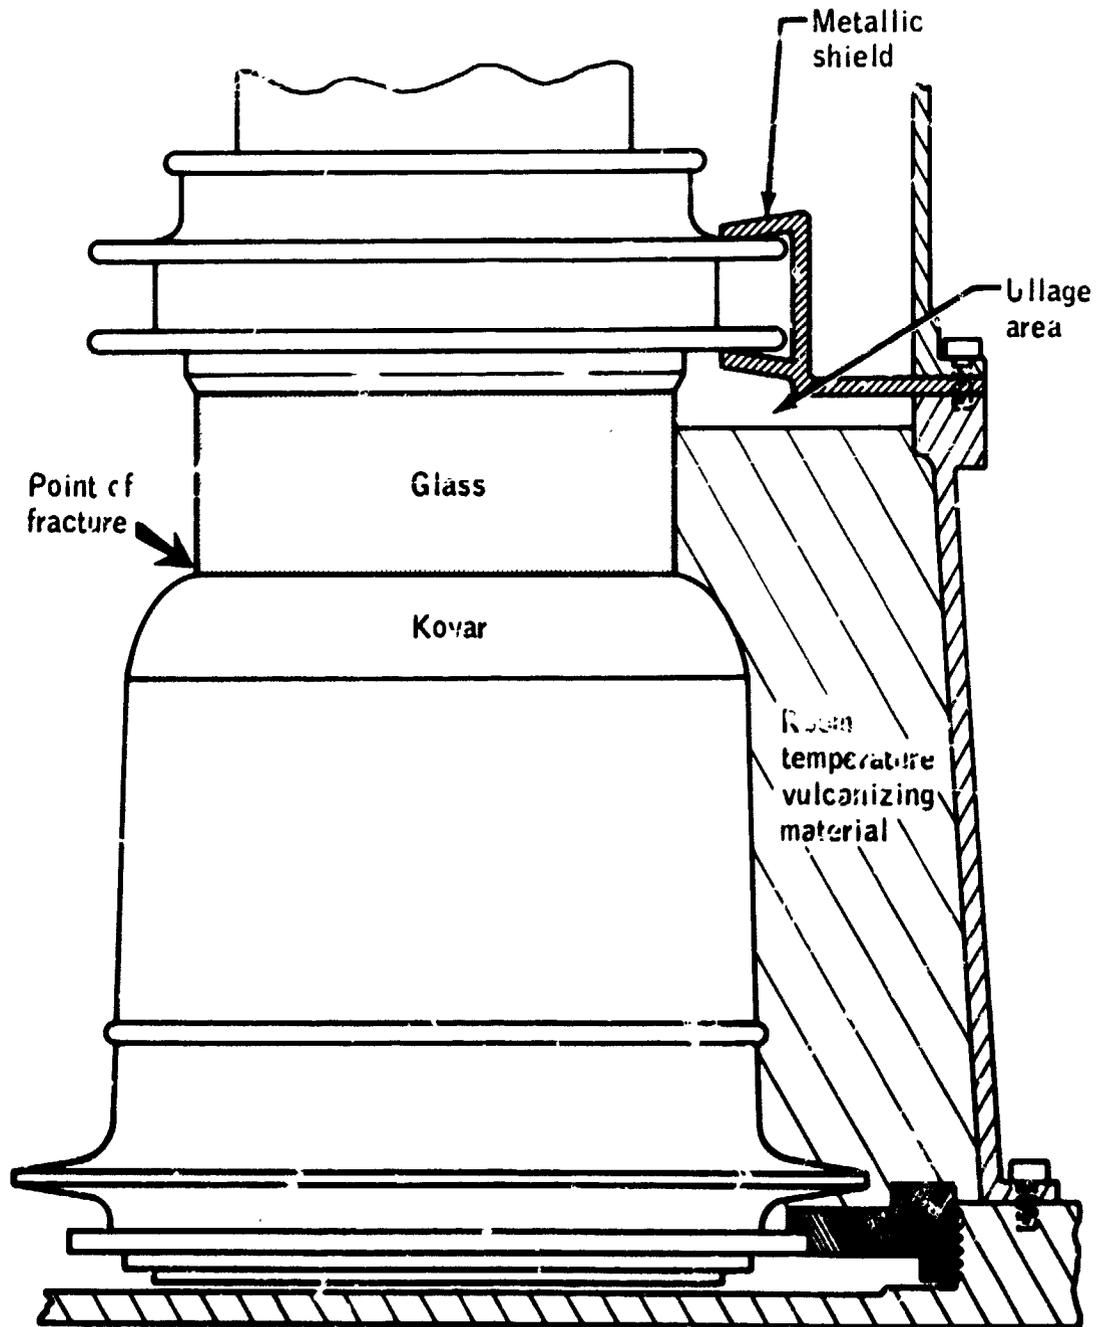
Figure 17-41.- Objective portion of television image tube.

Figure 17-41 is an enlarged drawing of the objective portion of the image tube. During high temperature vacuum testing to flight qualify the television camera, an image tube failed. The failure was caused by room temperature vulcanizing material expanding and filling the small ullage volume of the image tube, thus exerting a tension force at the glass-to-Kovar junction, and fracturing the glass. The test temperature was 343° K, but the temperature at which the fracture occurred was not known.

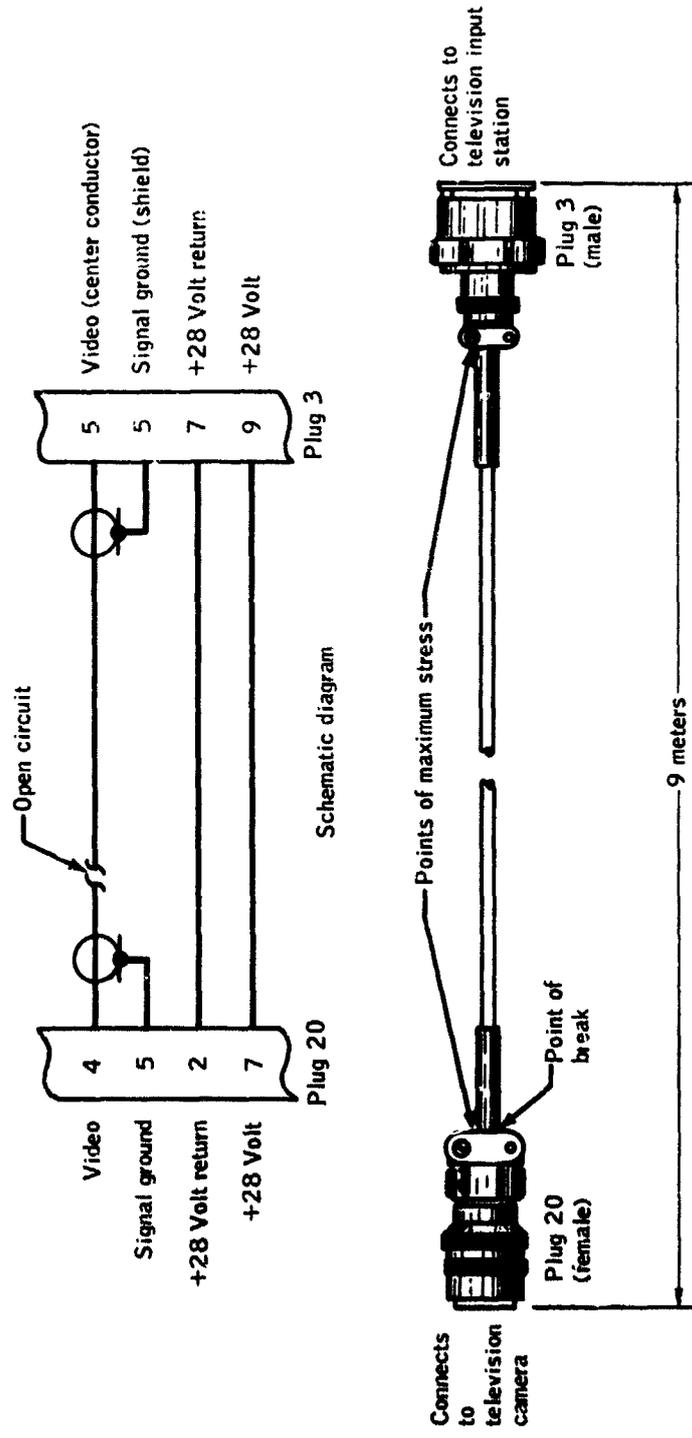
Figure 17-43.- Television power cable.

The single channel of data from the downlink diagnostic unit is transmitted by a television power cable (fig. 17-43) to television input station 133. The television power cable may be disconnected from the downlink diagnostic unit and connected to the portable television camera. The downlink diagnostic unit is only used with the Multiple Docking Adapter television input station, whereas the portable television camera may be connected through the television power cable to any television input station.

The crew checked the television power cable, and found that the coaxial center conductor that carries the video signal was open. Ground testing verified that the break was located as shown in figure 17-43.

The Apollo Telescope Mount transmissions are not carried by the television power cable and therefore were not interrupted. The open coaxial conductor probably caused the intermittent bit stream in the downlink diagnostic unit data, and four days later, the total loss of the portable television camera video signal.

A replacement television power cable will be carried on the third visit.

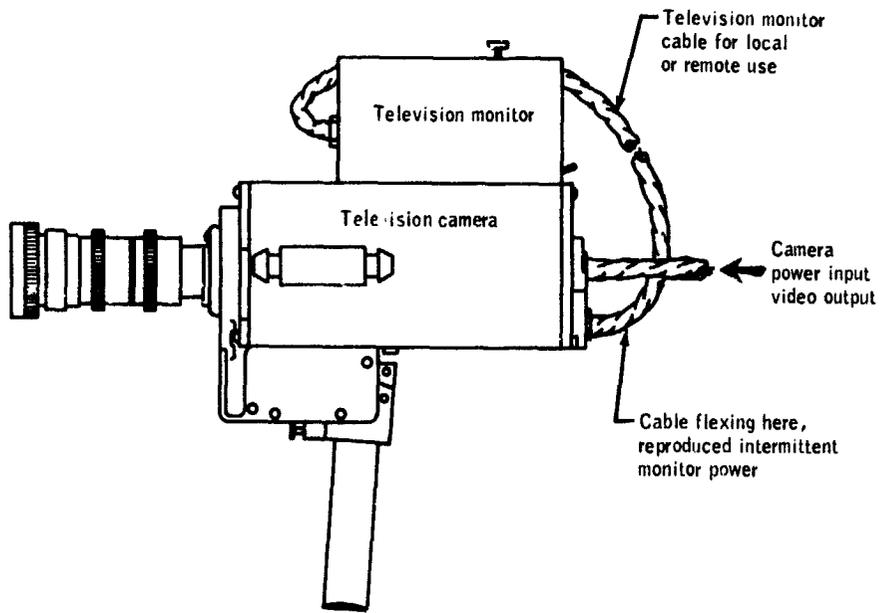
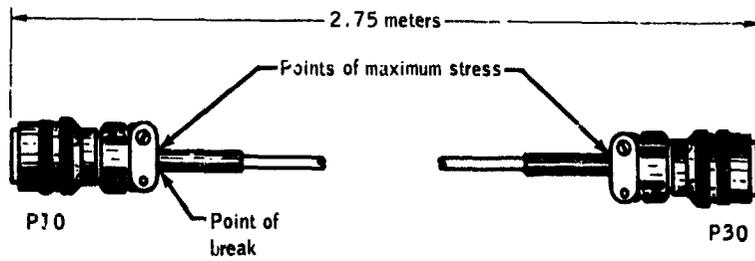
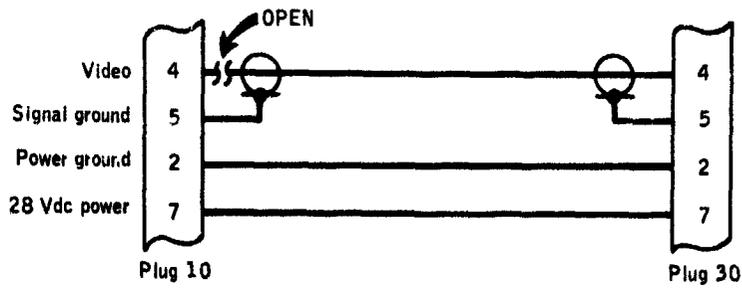
Figure 17-44.- Television monitor cable.

The camera has two isolated video outputs, one of which is transmitted through the television power cable to the input station for transmission to the ground, and the other is transmitted to the onboard television monitor through a television monitor cable (fig. 17-44). The television monitor cable also provides electrical power from the camera to the monitor.

On visit day 51, the crew checked out the television monitor cables. The monitor cable in use produced an intermittent monitor picture when it was flexed near the plug where the cable connects to the camera body. Testing this cable with the replaced monitor produced the same collapsing picture condition, but both monitors operated satisfactorily with the spare monitor cable.

An open in the coaxial cable center conductor was found in the returned monitor cable.

The gray raster condition was caused by the open in the monitor cable. The collapsing picture problem may have been caused by an internal problem which may still exist, but was not evident after the exchange of cables.

A replacement television monitor cable will be carried on the third visit along with an additional monitor.

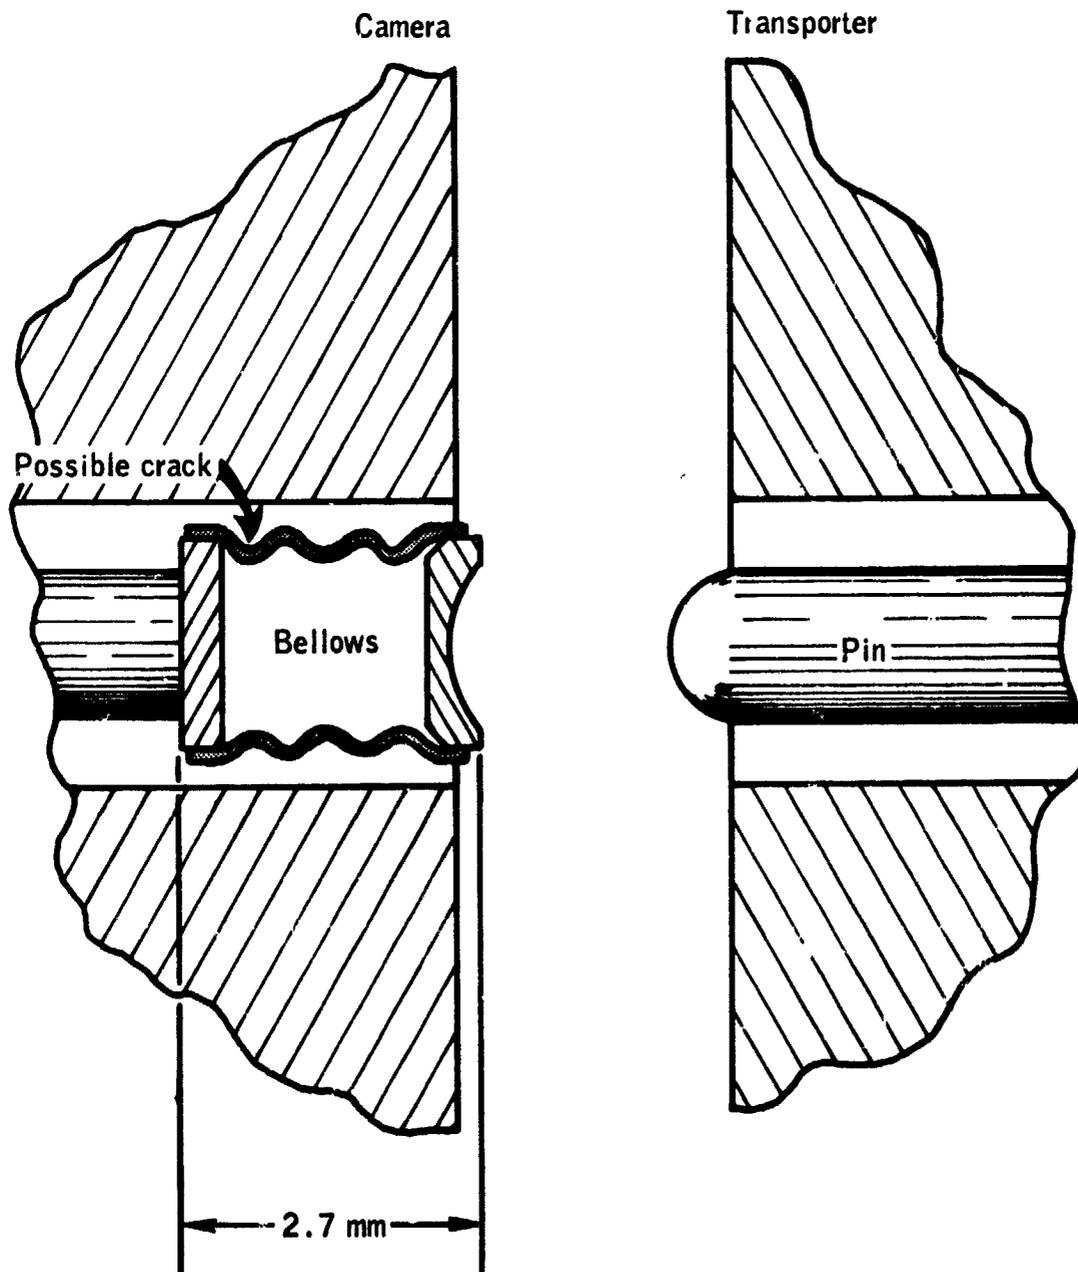
Figure 17-45.- Camera and transporter electrical interface contacts.

The camera supplies plus 28 Vdc power to the film transporter through an electrical interface. The interface consists of two bellows contacts on the camera and mating pin contacts on the transporter. When a transporter is mounted on a camera, the transporter pins depress the camera contacts (fig. 17-45), providing electrical connections.

During ground testing, camera failures occurred in which one or more bellows cracked and lost return force. This type of failure would cause the failure seen in flight.

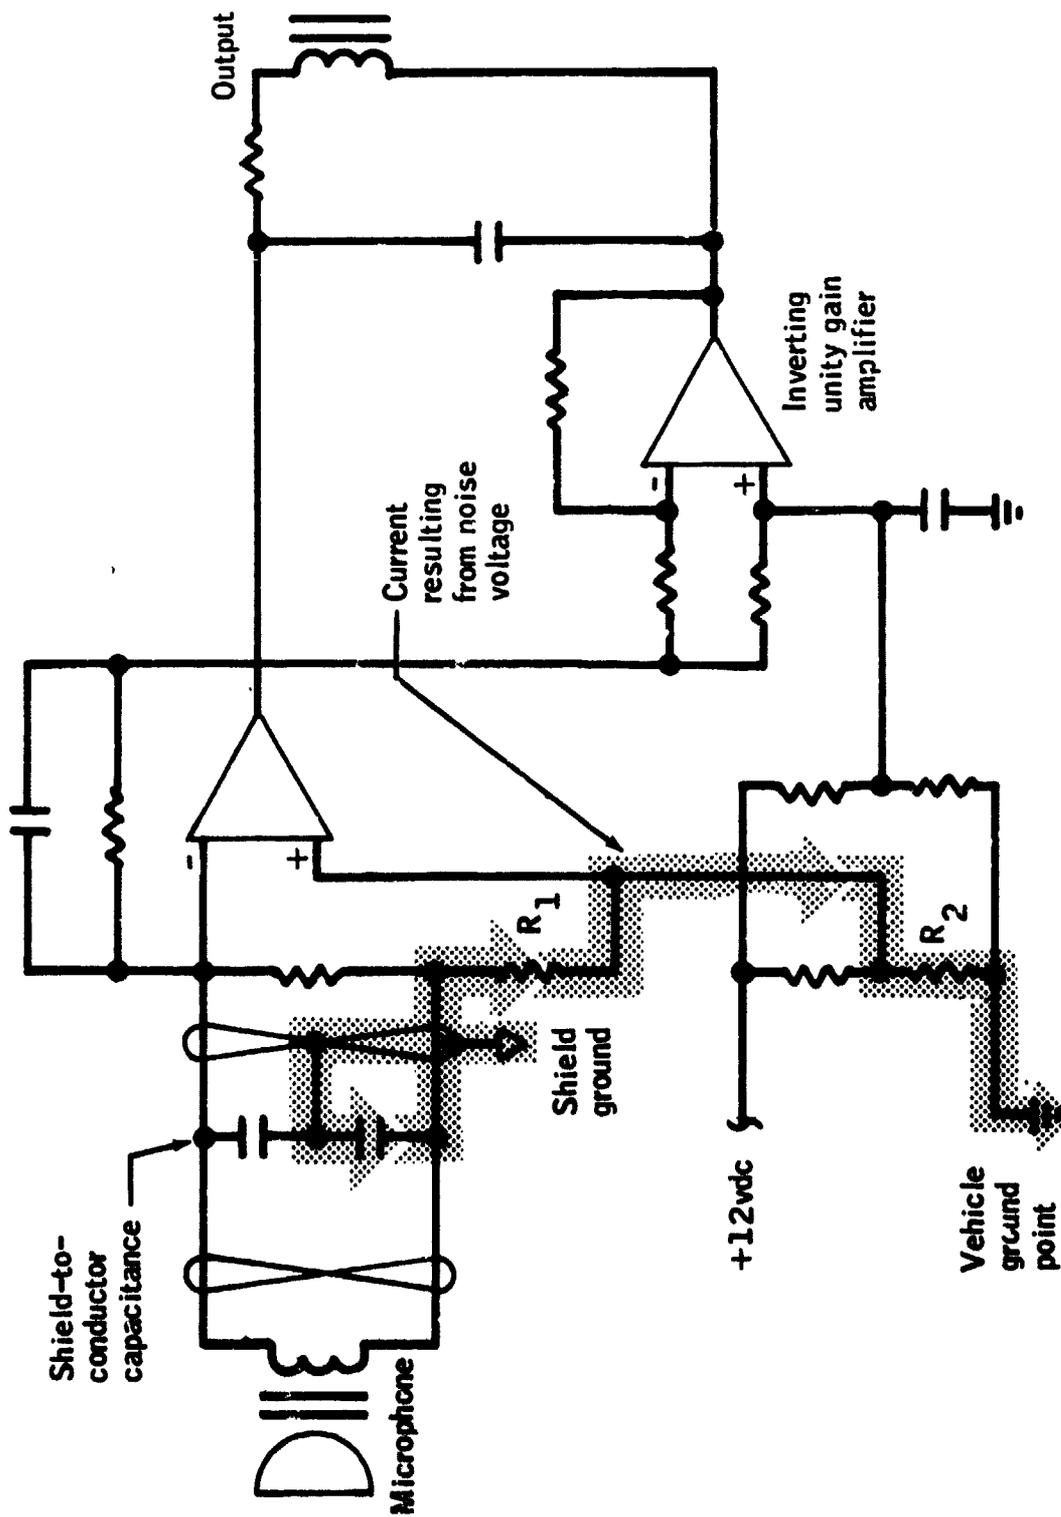
Figure 17-47.- Microphone and amplifier assembly.

In the hand-held microphone application, the microphone output was connected across one of the two series resistors as shown in figure 17-47. The microphone cable shield was grounded at a point different from the vehicle ground point. A ground loop voltage between the two ground points was then coupled from the cable shield to the cable conductors through the shield to conductor capacitance and a noise current resulted as shown in figure 17-47. Since the noise current flowed through resistors R1 and R2, a voltage was developed across resistor R1 in series with the microphone output and was connected between the amplifier inverting and noninverting inputs (noncommon mode). Tests showed that this noise voltage input resulted in the high amplifier output noise level.

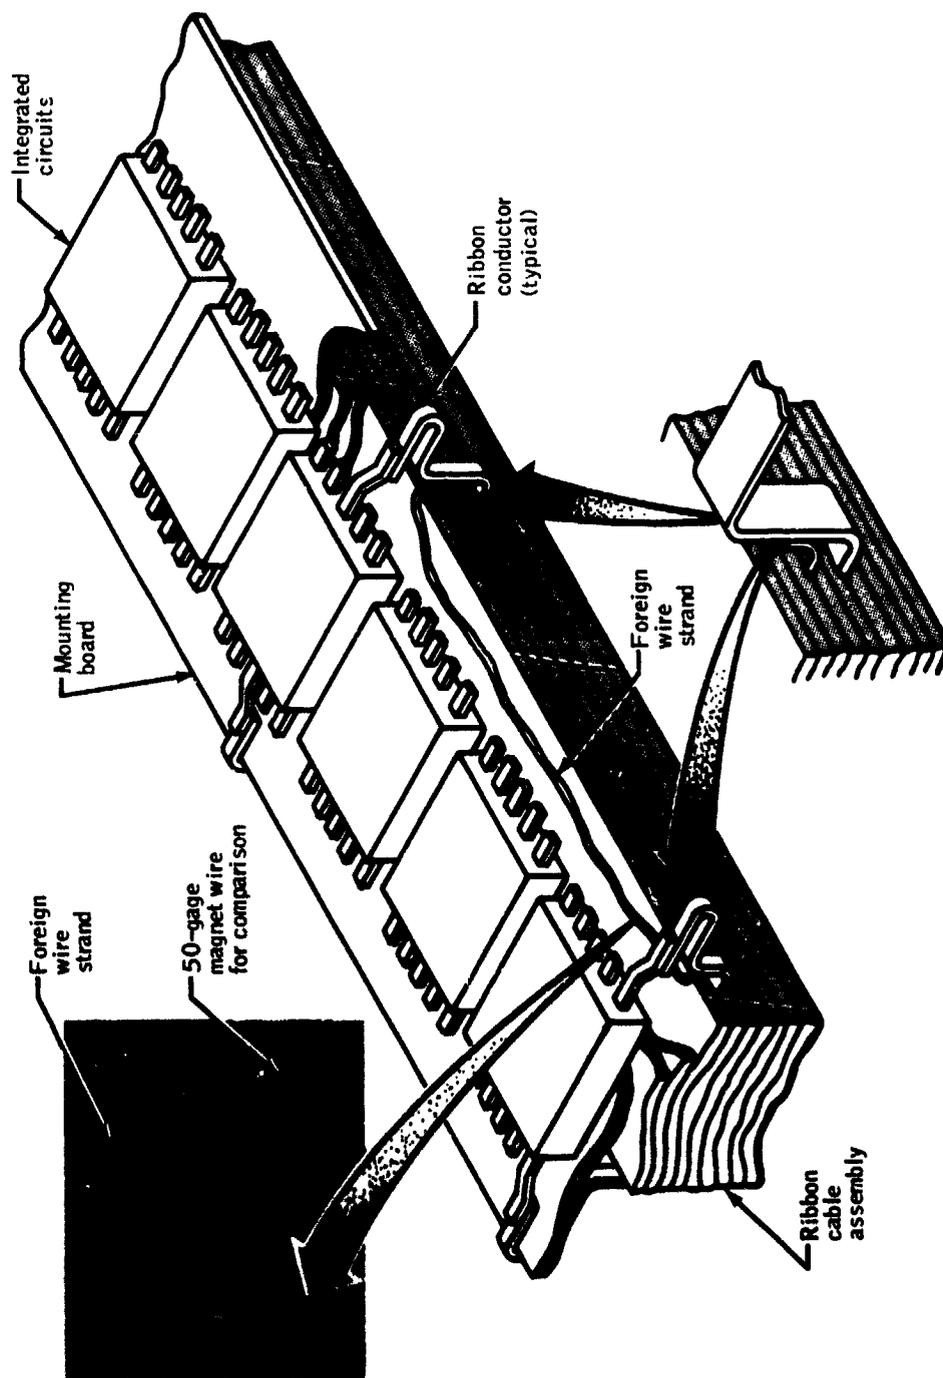
Figure 17-50.- Read counter short circuit.

The read counter wiring assembly was disassembled, layer by layer, by removing the strips of mylar tape. A 2-centimeter-long segment of enameled copper wire was found included in the third layer of conductors (fig. 17-50). Each end of the wire projected from the side of the wiring assembly immediately adjacent to an interconnecting pin of one of the integrated circuits. When the two wire ends shorted the two different integrated circuit pins, the output of the master flip-flop circuit that multiplies one of the read counter stages was connected to the counter output that feeds the command module computer (fig. 17-49). The master flip-flop then supplied 20-microsecond duration pulses at the rate of 12 800 pulses per second to the read counter computer output (normal pulses are 3 microseconds long and occur at 6400 pulses per second). Tests showed the longer pulses at the higher pulse rate would cause the computer register to change at the 0.698 radian per second rate experienced during the mission.

Acceptance tests performed on the coupling data unit and its components during manufacturing are considered adequate. There is no known non-destructive test which would have detected the presence of the wire segment; therefore, no corrective action can be taken.
