SHUTTLE ACTIVE THERMAL CONTROL SYSTEM
DEVELOPMENT TESTING

VOLUME VIII

TUBE ANOMALY INVESTIGATION

Report No. T169-28

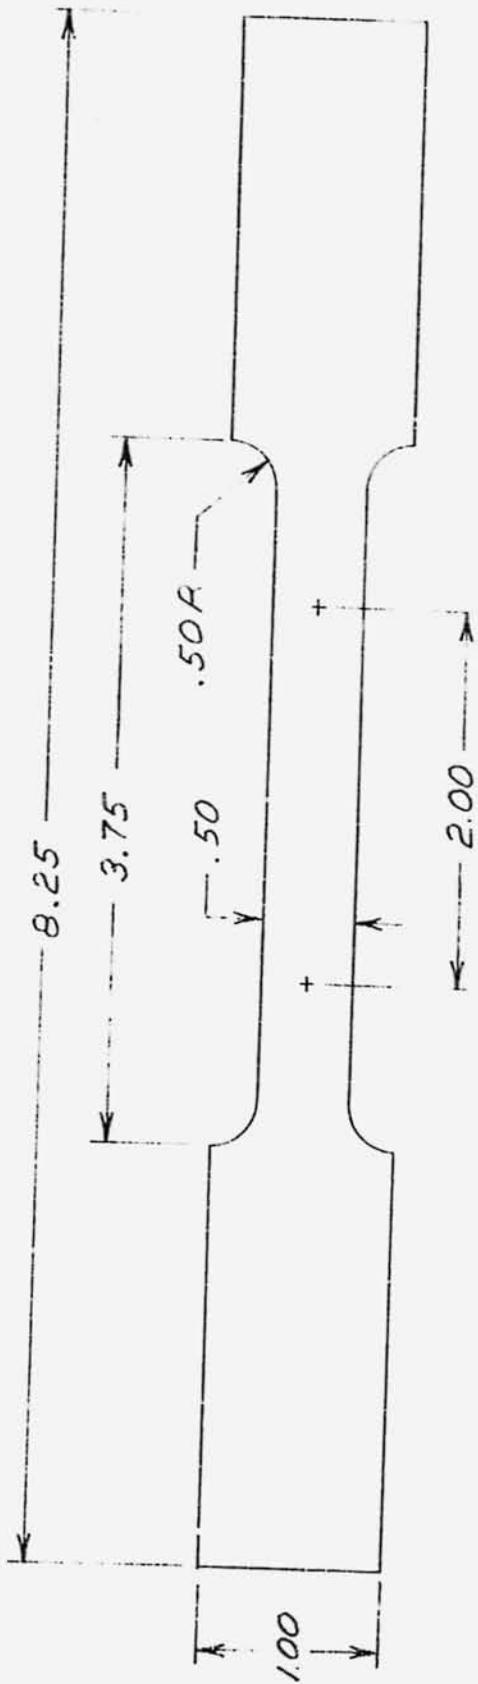
FIGURE 14
TENSILE SPECIMEN ORIENTATION

Mechanical properties of the extruded tubing were determined in both longitudinal and transverse directions. Tensile specimen orientation and dimensions are shown in Figures 14 and 15. The results of the mechanical tests are given in Table 1. Considering the abnormal size of the test specimens, there was relatively little scatter in the data, with all specimens meeting the requirements for the -T42 condition.

LONGITUDINAL TEST SPECIMEN

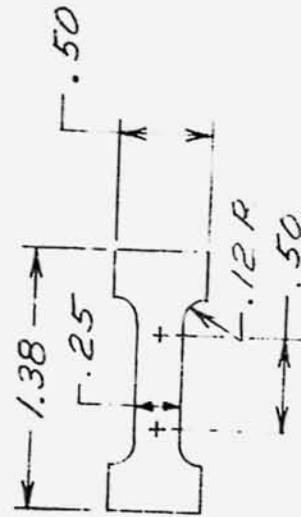
FIGURE 15

TRANSVERSE TEST SPECIMEN
