NASA TM X-71867

OH-58 HELICOPTER TRANSMISSION FAILURE ANALYSIS

by D. P. Townsend, J. J. Coy,* and B. R. Hatvani
Lewis Research Center
Cleveland, Ohio 44135
January, 1976

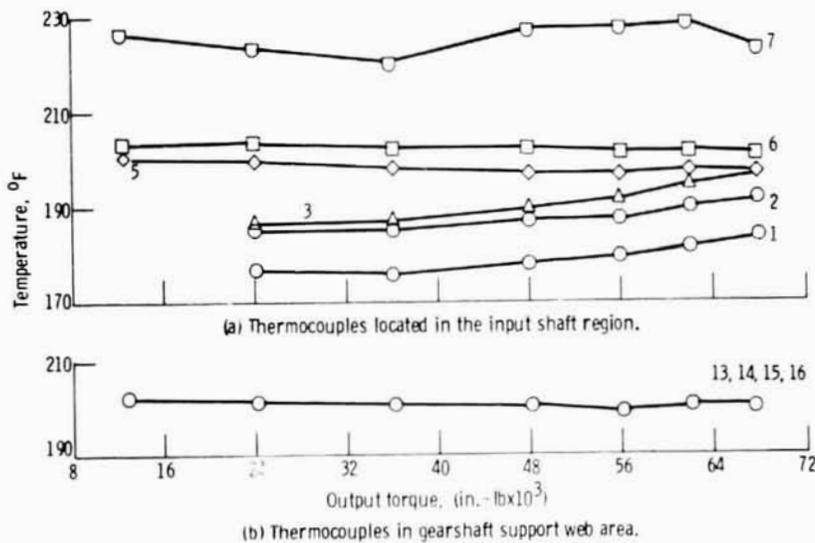
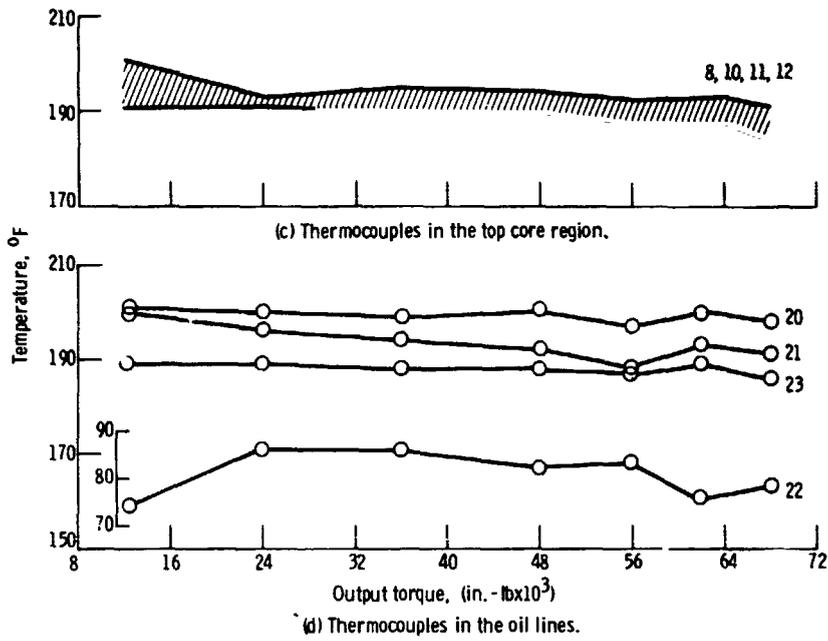
Figure 6. - OH-58 transmission stabilized temperatures as a function of output torque. Input speed, 6200 rpm; oil-out temperature, 200° F.

Figure 6 contains the temperatures of the various transmission components as a function of output torque. The respective numbers in the figure indicate the location of the thermocouples in figure 2(a). The oil-out temperature was maintained at 200° F and the input speed was 6200 rpm. The temperature recorded for the 67 000 inch-pound torque (140 percent power rating) was not stabilized due to the short time at which this overload condition (140 percent torque) was maintained. The highest temperature was recorded for the pinion seal which was 228° F at an output torque of 62 400 inch-pounds (130 percent power rating).

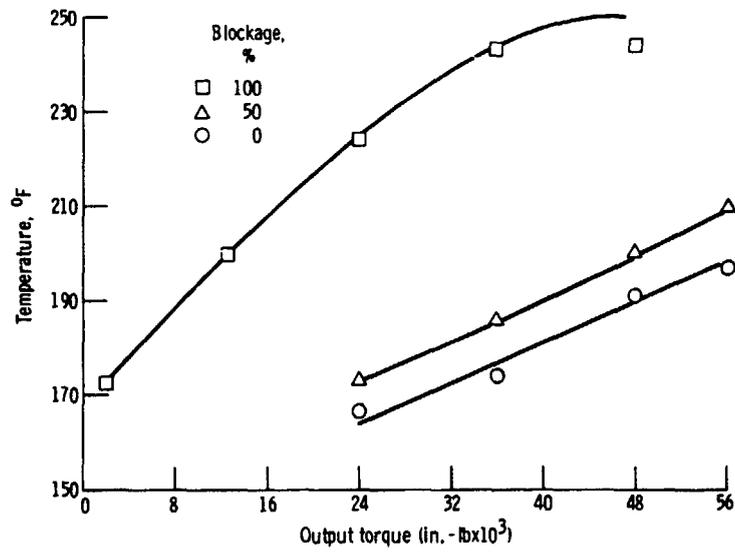
Figure 7. - Stabilized oil-out temperatures as a function of output torque for different amounts of oil cooler blockage. Input speed, 6200 rpm.

In order to determine the transmission oil-out stabilization temperature, the transmission was run with different output torque conditions while the oil cooler was either completely blocked, partially blocked or completely open. The results of these tests are summarized in table I and shown in figure 7. The maximum oil-out temperature obtained for zero percent and 50 percent oil cooler

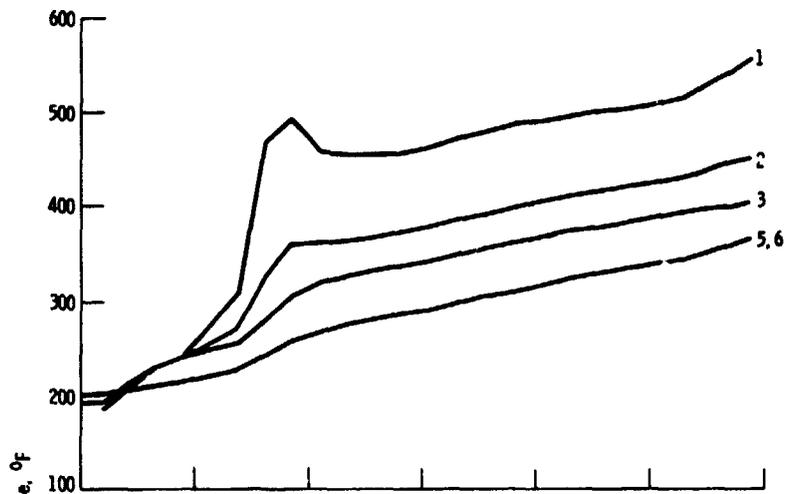
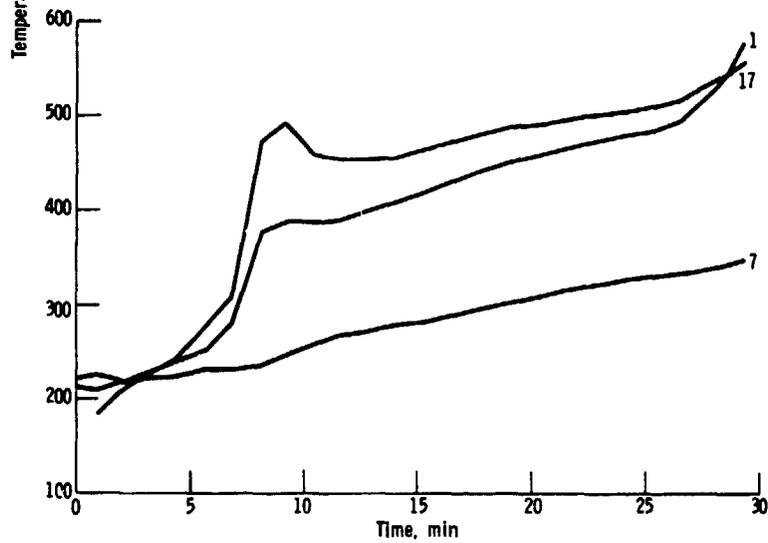
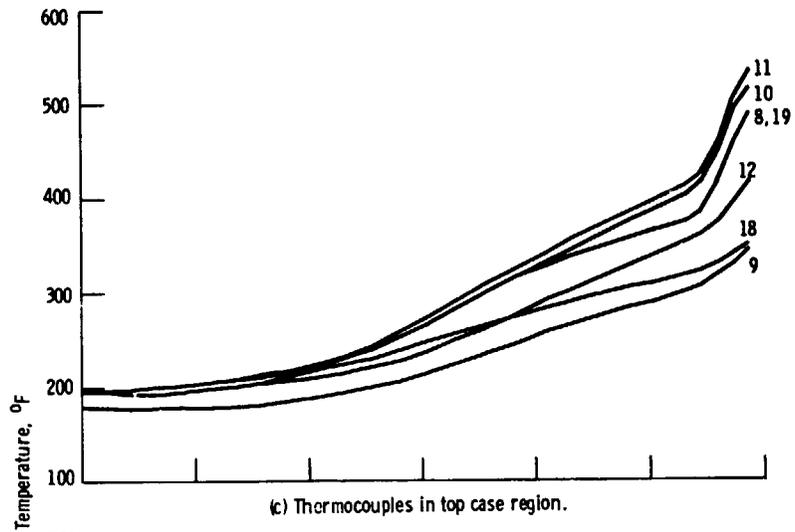
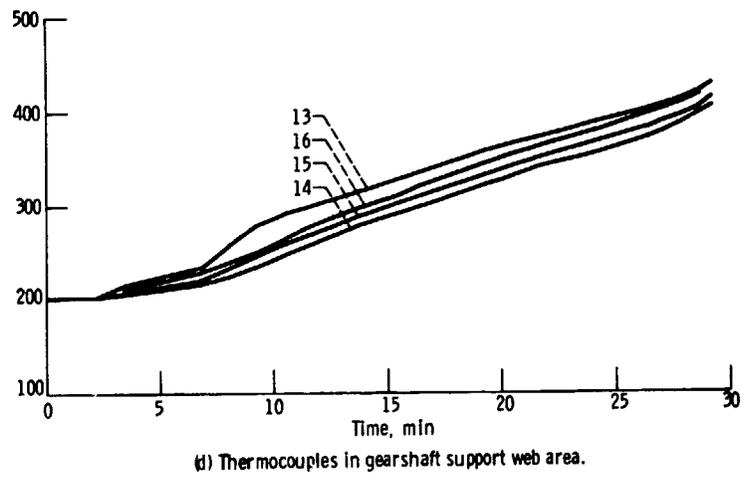
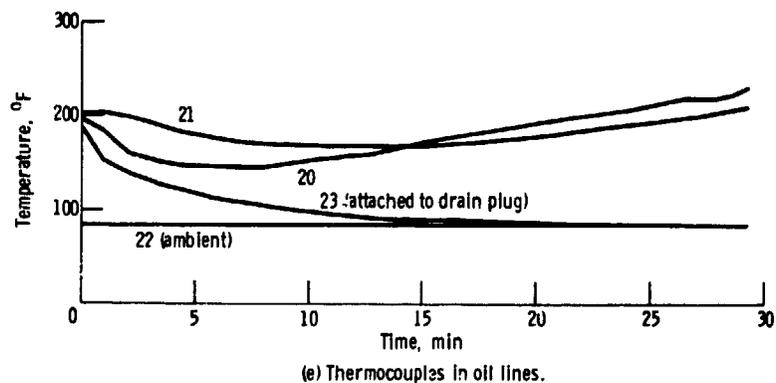
Figure 8. - Temperature as a function of time for survivability test of OH-58 transmission. Input speed, 6200 rpm; output torque, 36 000 in.-lb.

At a torque level of 36 000 inch-pounds and a speed of 6200 rpm the drain plug at the bottom of the transmission housing was removed and the oil in the transmission was allowed to drain out. The results of this test are shown in figure 8 wherein the component temperatures are shown as a function of time. Time zero is the time at which the oil drain plug was removed.

Figure 8(c) shows an increase in temperature in the planet gear area at approximately 13 minutes.

The rate of increase of the pinion temperatures slowed until at approximately 14 minutes the rate began to increase again (figs. 8(a) and (b)). These increases in temperature were caused by additional planet bearing cages melting which allowed the spherical rollers in the planet gear bearings to tumble and slide within the bearings (fig. 11).

At approximately 27 minutes there is an additional increase in the rate of temperature rise as seen in the planet and (fig. 8(c)), the pinion area (figs. 8(a) and (b)) and to a lesser extent in the bevel gear bearing area (fig. 8(d)). At this point in time the gearbox is approaching complete failure. At these temperatures, the planet gears have very little strength. The lock nut on the planet bearing was being machined by the bevel gear bolt heads (fig. 12). The pinion

Temperatures in the oil system were measured and are shown in figure 8(e). A thermocouple placed near the transmission recorded the ambient temperature of the test cell. It was $84 \pm 1^{\circ}$ F for the duration of the test. The thermocouple attached to the oil drain measured the slow temperature decay to ambient conditions from the time the drain plug was removed. The two thermocouples in the oil line measured the initial reduction in temperature that resulted from the disappearance of hot oil in the lines. The temperature later rose again in response to the heating by conduction from the hot gearbox.
