NASA TN D-8301

**APOLLO EXPERIENCE REPORT -
COMMAND AND SERVICE MODULE
CONTROLS AND DISPLAYS SUBSYSTEM**

Aaron B. Olsen and Robert J. Swint

Lyndon B. Johnson Space Center

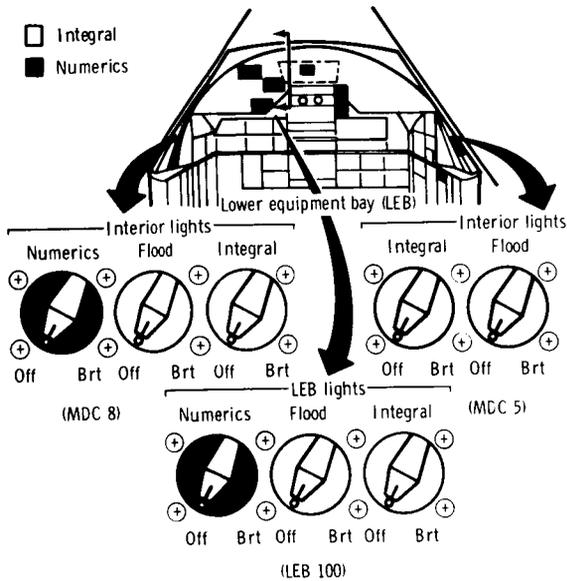
Figure 3.- The command module integral and numerics illumination system.

Lamp tube. - Other than problems caused by poor handling, the greatest cause of tube failure was an inadequate amount of mercury injected into the tube. Manufacturing procedures were changed to prevent recurrence of this discrepancy.

Lamp moisture absorption. - To prevent failures caused by moisture absorption, improved procedures were implemented for the application of the potting sealant to tube ends and epoxy surfaces.

Silicon-controlled rectifier. - Although no failure was directly attributed to the failure of a silicon-controlled rectifier, the following additional screening was implemented to preclude this possibility.

1. A burn-in for 100 hours at 1 ampere at 373 K (100° C)
2. A test for the minimum gate turn-on current

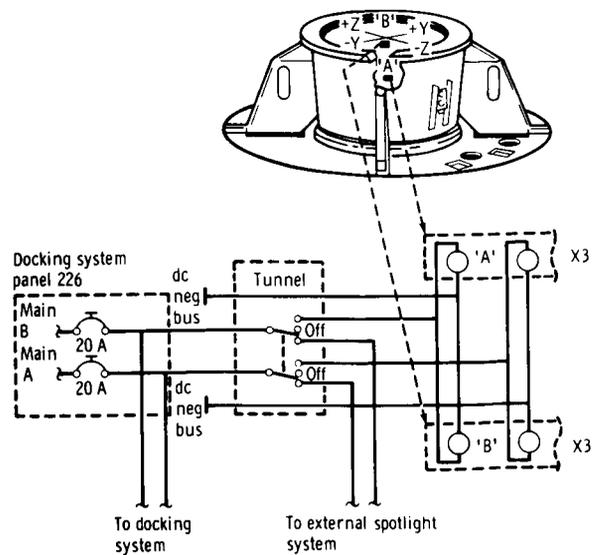
Figure 4.- Tunnel lighting schematic.

Other lighting. - Lighting for the tunnel area was provided by six incandescent fixtures, each containing two miniature 28-volt dc lamps (fig. 4). Exterior lighting (fig. 5) consisted of a docking spotlight, eight orientation or identification lights (four amber, two red, and two green), a rendezvous flashing beacon, and a white floodlight for EVA's. The docking spotlight was electrically deployed on a spring-mounted door and projected a light beam 21.3 meters (70 feet) in diameter at a range of 61 meters (200 feet). The orientation lights were small lamps spaced around the service module (SM) for position identification by other vehicles. The rendezvous flashing beacon, located in the forward section of the SM, used a xenon tube that flashed at a rate of 1 flash/sec for a duration of 20 milliseconds and was visible by telescope for 297 kilometers (160 nautical miles). The beacon was used for long-distance identification by the lunar module (LM) crew when approaching the CM. The white floodlight (EVA light), also located in the forward section of the SM, was spring loaded to deploy when the boost protective cover was jettisoned. The floodlight was used to illuminate the hatch area and the side of the CM during EVA. The tunnel lighting and all exterior lighting were relatively trouble free during the entire program.

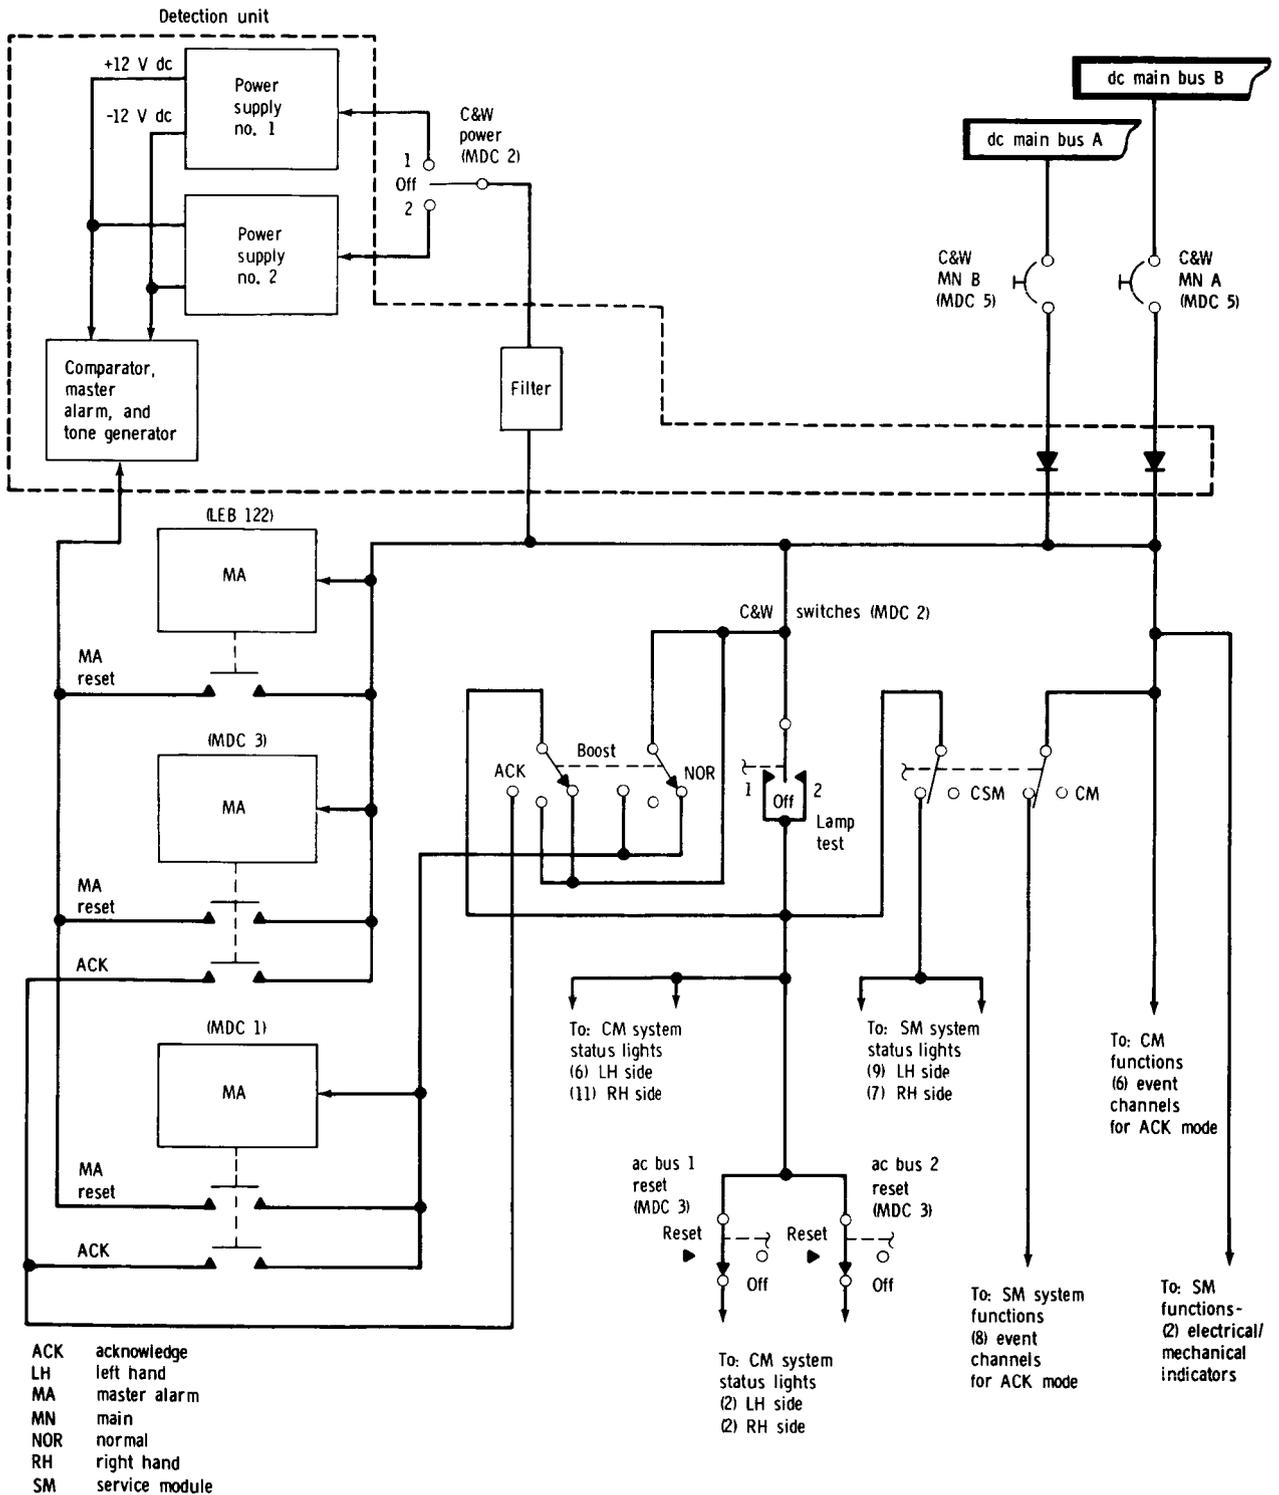
Figure 6. - Schematic of C&WS power distribution.

The caution and warning subsystem (C&WS) (figs. 6 and 7) monitored critical parameters of most of the spacecraft operational systems and alerted the crewmembers to malfunctions or out-of-tolerance conditions when they occurred in any of these systems. The C&WS was composed of the CDU, system status light matrices, master alarm (MA) switches, and associated control switches. The CDU, the major component in the C&WS, was located behind panel 3. The CDU contained two redundant regulated ± 12 -volt dc power supplies, high- and low-limit comparators, logic circuitry, level detectors, lamp drivers, and a two-level-output tone generator. When a malfunction or out-of-tolerance condition occurred, the alarm limits (reference voltages) were exceeded. These alarm-limit signals triggered voltage comparators that activated logic and lamp driver circuits. These circuits activated the MA, the tone generator, and the appropriate system status light on panel 2. The MA light and the bilevel (750 to 2000 hertz) tone were reset when the MA pushbutton switch was depressed. However, the status lights on panel 2 remained lighted as long as the malfunction or out-of-tolerance condition existed. The status lights could be prevented from lighting when there was an out-of-tolerance condition by positioning the "normal/boost/acknowledge" switch to "acknowledge." When a malfunction occurred with the switch in this position, only the MA and the tone generator were energized, but the status light was lighted only while the MA was depressed. When the switch was placed in the "boost" position, the MA light adjacent to the red "abort" light on panel 1 was disabled to prevent possible confusion between the two lights. Thirty-three of the available 48 matrix status lights on panel 2 were used as system inputs; some of the lights had as many as 7 separate inputs to indicate malfunctions. If there was more than one parameter to a status light, the first malfunction to occur triggered the tone, the MA light, and the status light. As long as the malfunction existed, the tone and MA circuits could not be reset for that particular channel, and any of the other parameters in the channel that went out of tolerance were unable to indicate the out-of-tolerance situation through the C&WS. This condition, known as masking, was very undesirable. However, by the time this condition was recognized as a problem, correction would have required a major redesign and redevelopment program on the CM C&WS. The main reason for not correcting the masking problem was that all parameters in question could be monitored elsewhere during this period.

No known vehicle test failures and only one reported flight anomaly occurred in the C&WS. The reported anomaly occurred approximately 0.45 second after final ring-latch closure during the initial transposition and docking maneuver of the Apollo 9 (CSM 104) mission. Analog and bilevel data did not indicate any out-of-tolerance condition at the time. The fact that the alarm occurred during the hard docking rather than at physical contact ruled out static discharge between the two vehicles and indicated a shock-sensitive condition. The C&WS MA circuit was a latching system that could respond to transients of 10 microseconds in duration, and a transient on any of the 69 inputs could trigger the alarm. Analysis of CSM 104 flight data revealed no system anomaly; thus, the specific cause remains unknown.

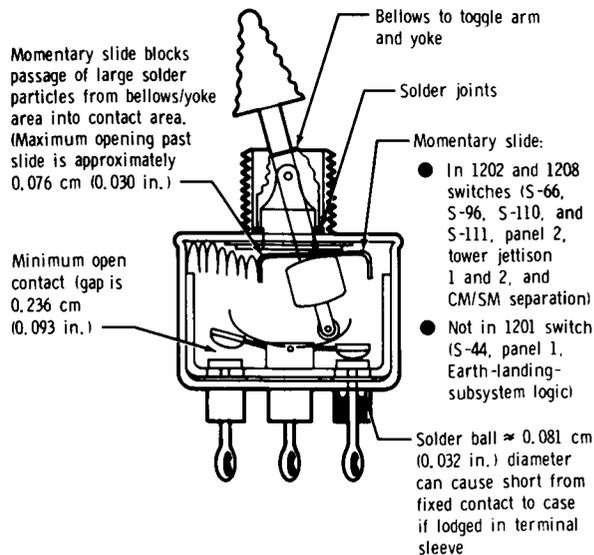
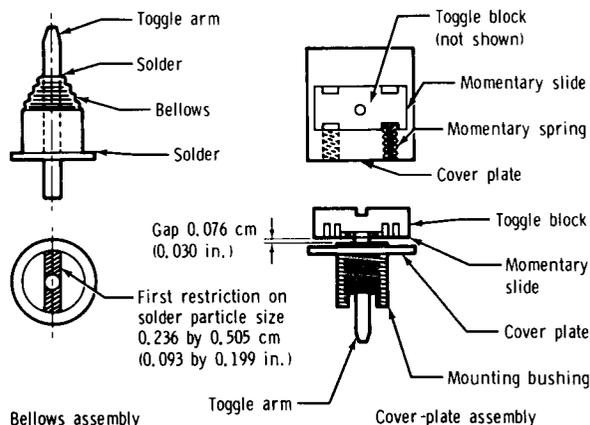
Figure 14.- Toggle switch.

Toggle switches, used as manual control elements on the CM, were configured in one to four poles and in two or three positions and were of a maintained, momentary, or lock type, depending on the use. The block I toggle switch was an environmentally sealed unit with a low failure rate. After the block II requirements were established for a hermetically sealed switch, it was determined that the block I vendor did not manufacture one and did not choose to manufacture one. Consequently, the initial block II toggle switch was a hermetically sealed plunger-type unit with an unsealed toggle mechanism for switch actuation. Early in the block II program, switch problems became apparent. Failures caused by high contact resistance, by mechanical lockup, and by nonfunction at high or low pressure resulted in a change to the present completely hermetically sealed switch. This switch had many serious problems (figs. 12 to 14), such as internal solder balls, extra parts and pieces inside switches, contact buttons welded to a terminal post in an inverted position, defective contact-button welds, auxiliary contact-plate welds, momentary shorting of contact arm with spring, cracked toggle block assembly and bellows, annealing and displacement
