Paper No. 10

**LIGHTNING TESTS OF THE ORBITER PYROTECHNIC ESCAPE SYSTEM**

R. Cohen, *Johnson Space Center, Houston, Texas*  
E. H. Schulte, *McDonnell Aircraft Company, St. Louis, Missouri*

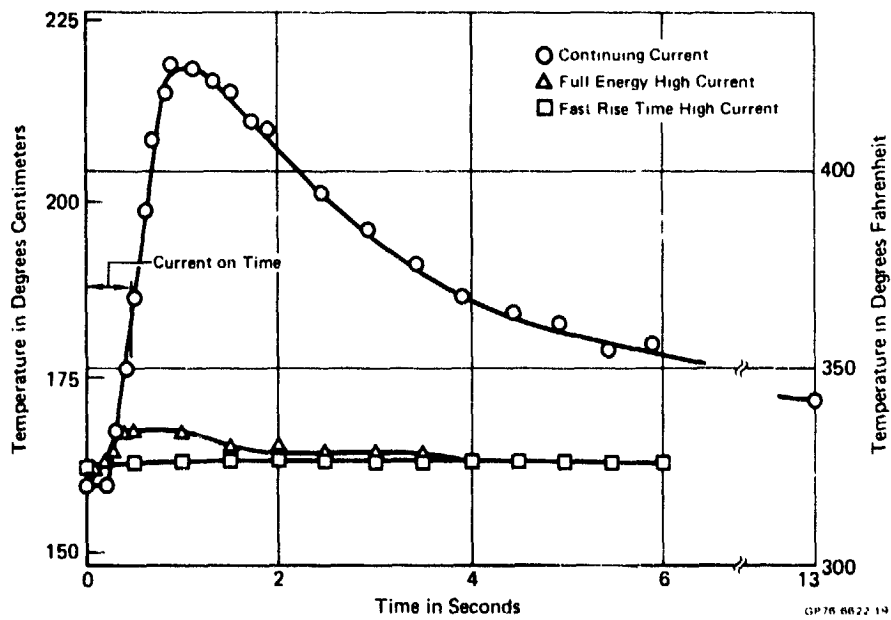
was then scraped away to reveal the exact location of the pyro as shown in Figure 18. Radiographs of the panel at the burn thru area showed that the thermocouple junction was approximately 0.13 - 0.19 CM (0.050 - 0.075 inch) away from the edge of the hole. Temperatures measured during the various lightning tests are shown in Figure 19 and show that the heat energy input to the pyros was small.

**FIGURE 19 – TEMPERATURES AT PYROS DURING SIMULATED LIGHTNING STRIKES**
