NASA Technical Memorandum 79227

THE EROSION/CORROSION OF SMALL  
SUPERALLOY TURBINE ROTORS  
OPERATING IN THE EFFLUENT  
OF A PFB COAL COMBUSTOR

G. R. Zellars, S. M. Benford, A. P. Rowe,  
and C. E. Lowell

July 30, 1979

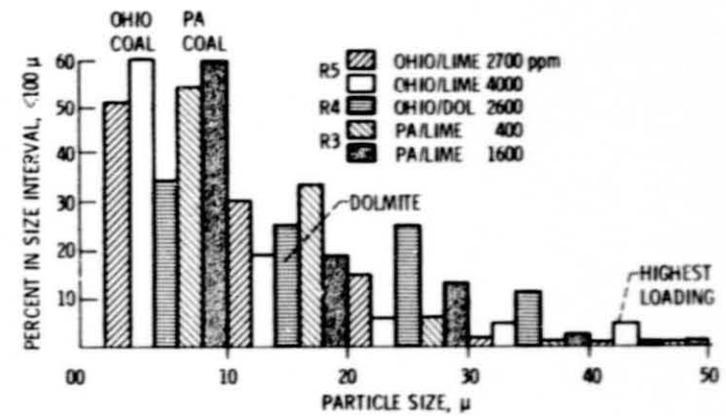
Nonadiabatic burning of Ohio coal and dolomite generated the greatest amount of solids carryover from the bed. In addition, the particle size distribution appears to be significantly different from that of the other coal/sorbent combinations. Figure 7 shows the particle size distribution of samples taken at 3-8 hour intervals in the three tests. In comparison with Ohio coal and limestone solids at 2600 ppm, Ohio coal and dolomite solids contain more particles in the potentially erosive 20-40  $\mu$  range. Within the range of measurement error, there appears to be little difference in particle size distribution between Ohio and Pennsylvania coal with limestone, despite the wide range of loadings. The number of particles with size greater than 30  $\mu$  does appear to be enhanced at the highest loading. These size distributions are a function of both off-the-bed particulate size and cyclone separation characteristics. The Ohio/dolomite size distribution may reflect a lower cyclone efficiency in the 20-40  $\mu$  range as a result of excessive carryover.

Figure 7. - Typical size analysis of solids loading into the turbine during 3 to 8 hour collection times.

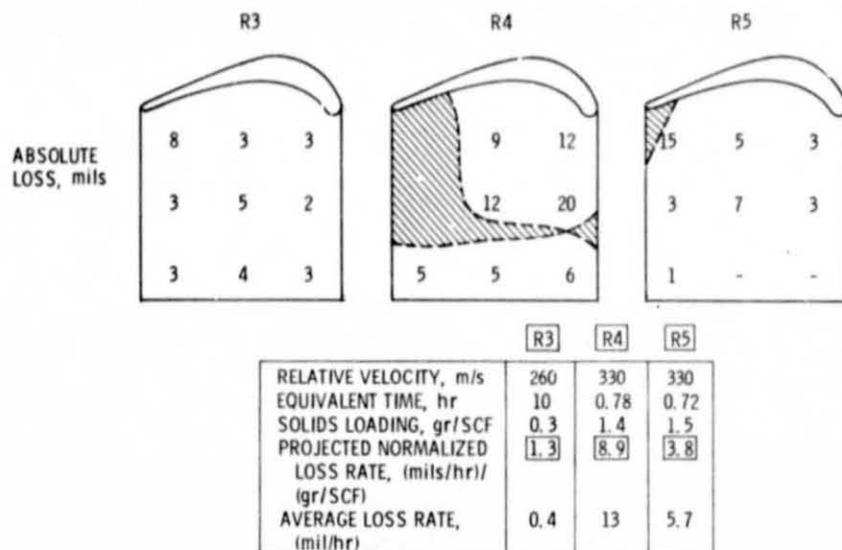
A comparison of surface loss rates projected for full admission is shown in Figure 12. At 6% partial admission, the exposure times are equivalent to 10 hours for R3 and about 0.75 hours for R4 and R5. In these times, the average loss rate ranged from 10 to 300 u/hr (0.4 to 12 mil/hr). Both R3 and R5 rotors were exposed to limestone sorbent effluent. The normalized erosion rate of R5 (45 cm/yr/1000 ppm, 3.8 (mils/hr)/(gr/SCF)) is three times greater than that of R3 (15 cm/yr/1000 ppm, 1.3 (mils/hr)/(gr/SCF)). If erosion varies as the cube of velocity, the erosion rate should be only twice as great at the higher velocity. The additional factor may reflect a larger proportion of heavy particles at higher solids loading, a slight difference in particle composition, or a difference in the erosion resistance of the oxide or metallic surfaces.

Figure 12. - Projected surface erosion loss rate at full admission.

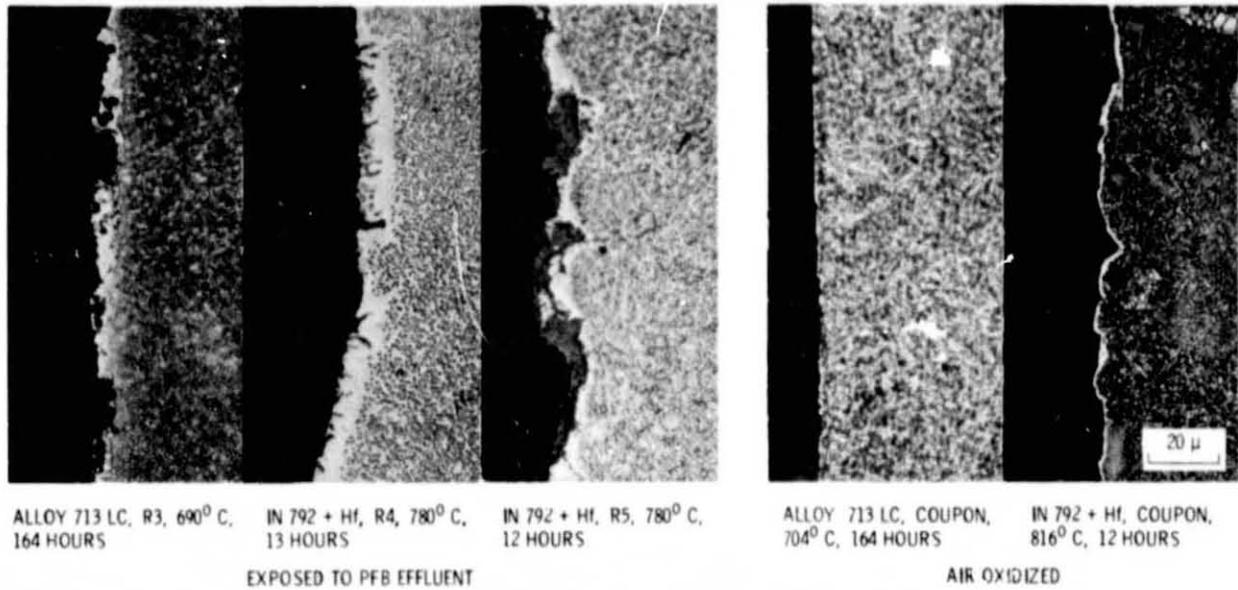
Figure 13. - Suction side oxidation compared with furnace oxidized coupons.
