**737 GRAPHITE COMPOSITE FLIGHT SPOILER
FLIGHT SERVICE EVALUATION**

**BOEING COMMERCIAL AIRPLANE COMPANY
SEATTLE, WA**

AUG 78

1. Report No. NASA-CR-158933	2. Government Accession No. N79-77914	3. Recipient's Catalog No.	
4. Title and Subtitle 737 GRAPHITE COMPOSITE FLIGHT SPOILER FLIGHT SERVICE EVALUATION		5. Report Date August 1978

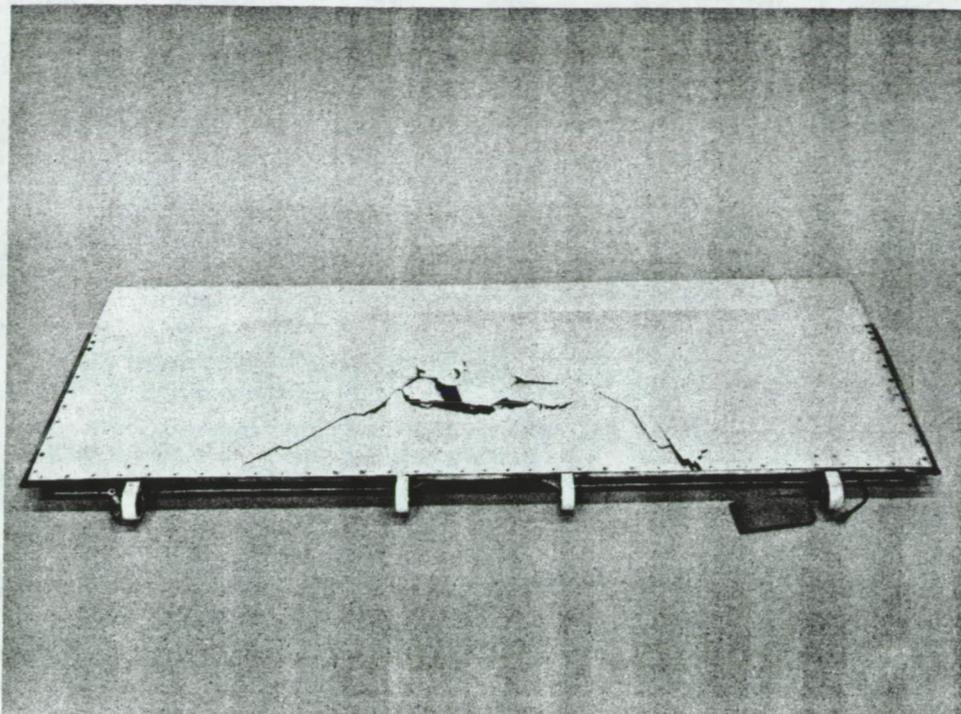
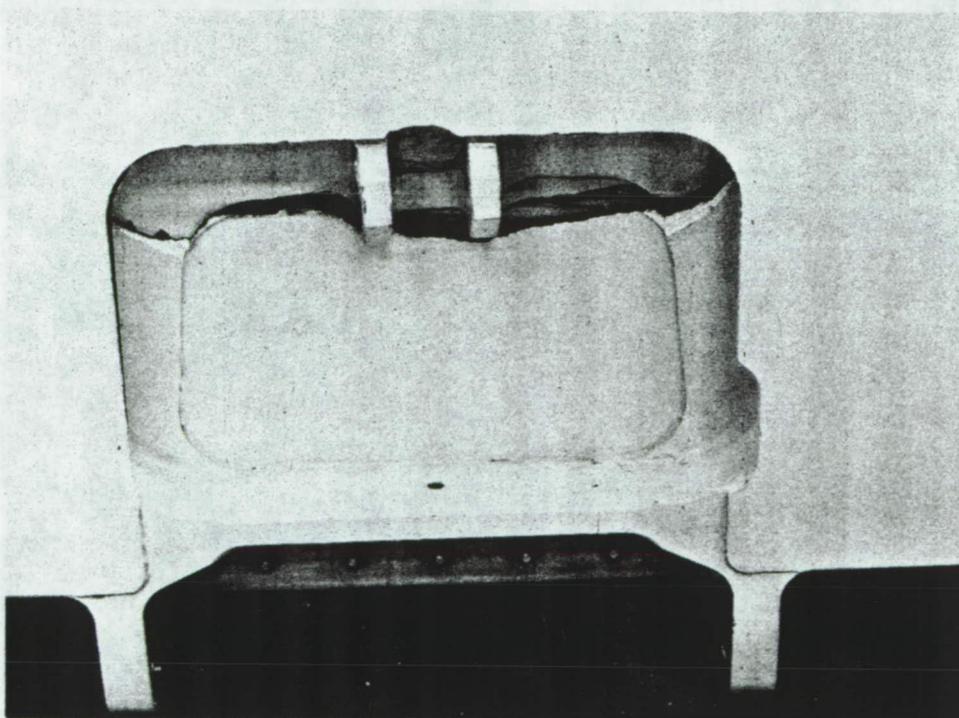
Figure 3.—Spoiler S/N 0071 Static Test

During this reporting period, a total of six spoilers were removed from the flight service program for evaluation and test. All removed spoilers (except S/N 0111 which has not yet been processed) were re-inspected using the ultrasonic through-transmission C-scan and the results compared to the records made at the time of original fabrication. No detectable differences were noted in this comparison. The sixth third-year spoiler S/N 0027, previously unreported, was processed through the ultrasonic inspection and returned to revenue service. Three of the fourth-year spoilers (S/N 0016, 0071, and 0107) were then selected to be destructively tested to measure residual static strength following the specified calendar period of exposure. Table 5 contains the residual strength and stiffness data relative to the fourth-year removals. Table 6 is repeated from reference 1 to complete the third year data. Figures 2, 3, and 4 show the spoiler panels after static testing. Figures 5, 6, and 7 are plots of the load-deflection data for these three panels.

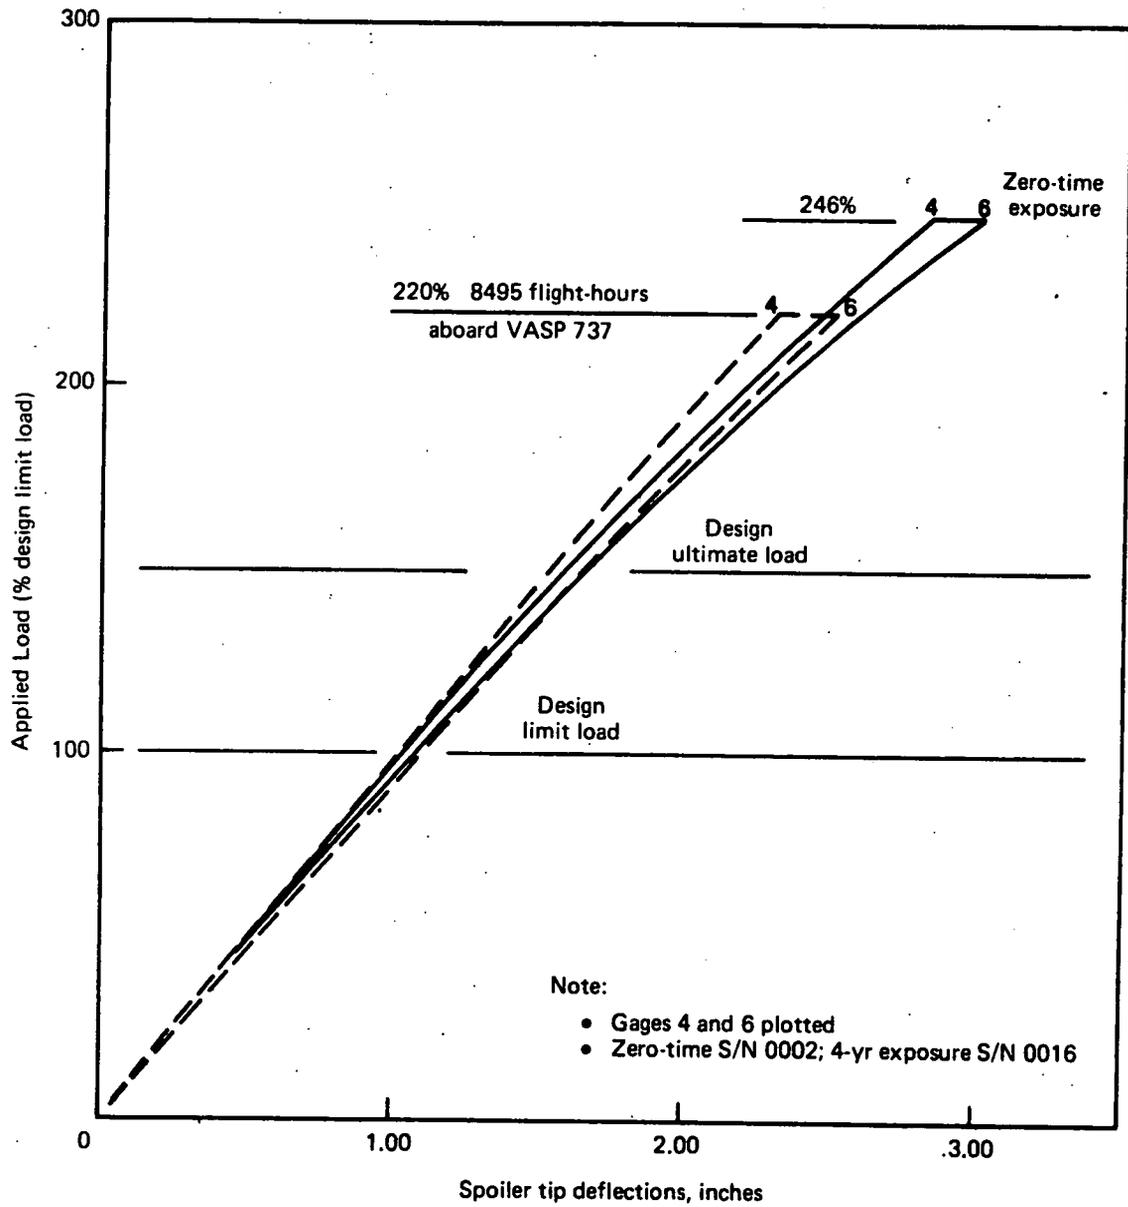
Figure 5.—Load-Deflection Curves—Zero-Time and 4-Year Exposure
(Union Carbide T300/2544 Material System)

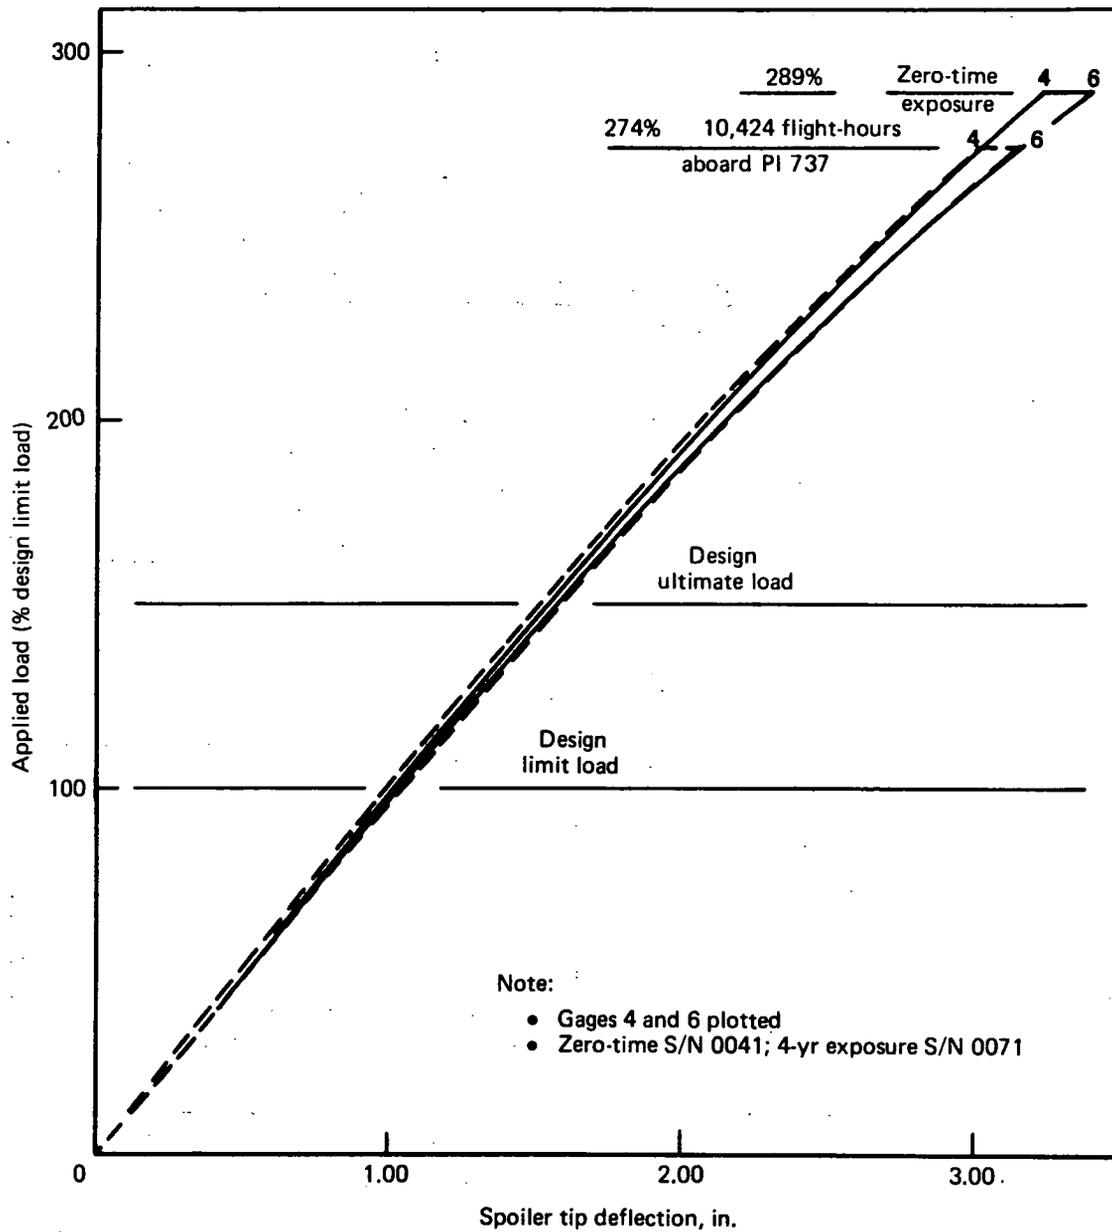
Figure 6.—Load-Deflection Curves—Zero-Time and 4-Year Exposure
(Narmco T300/5209 Material System)

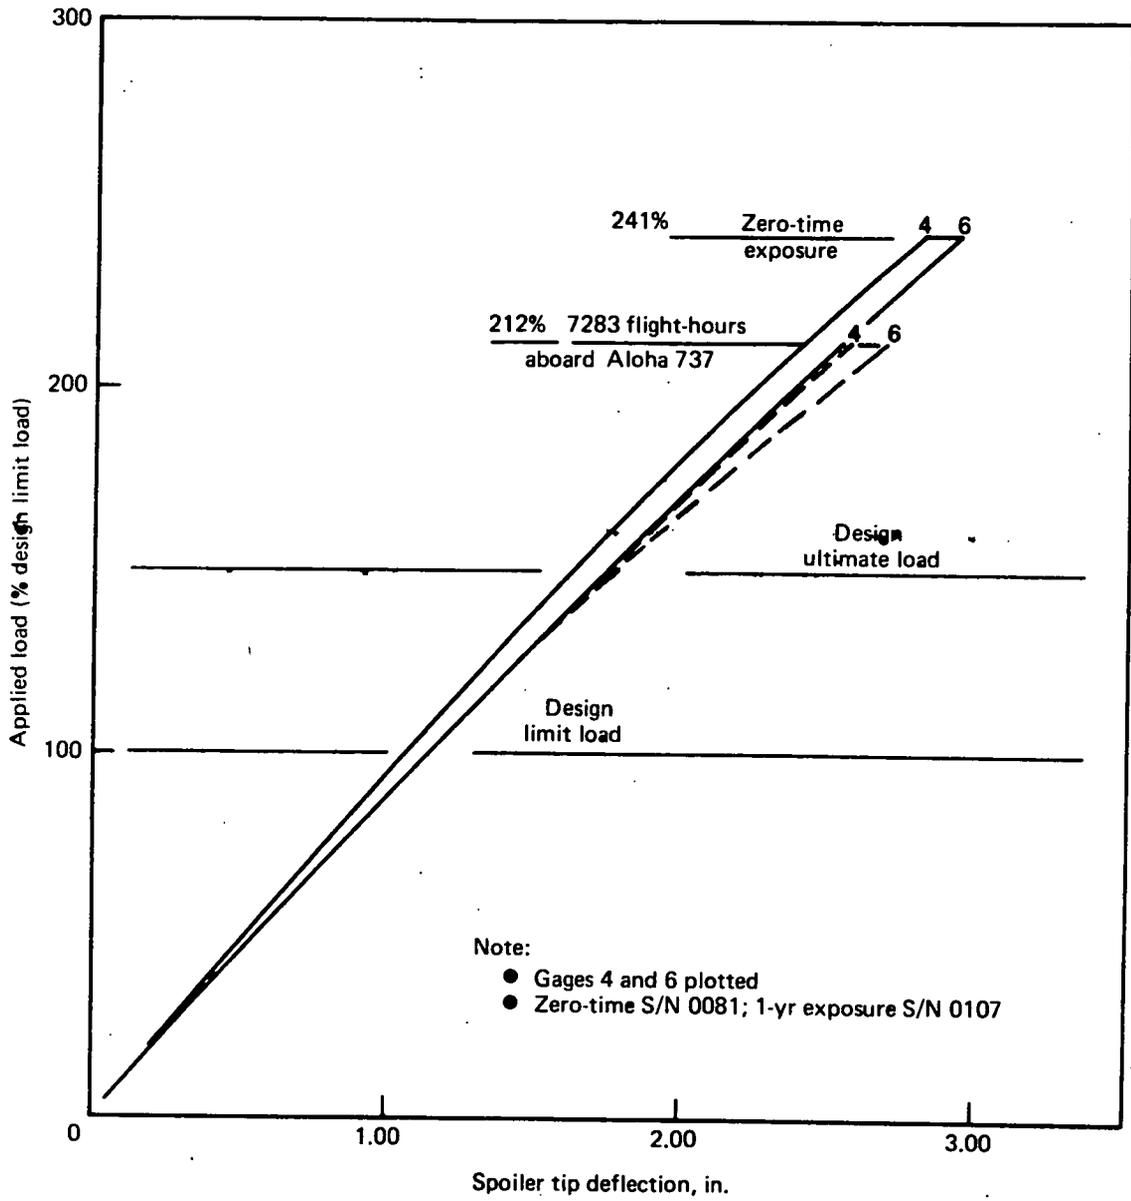
Figure 7.—Load-Deflection Curves—Zero-Time and 4-Year Exposure (Hercules AS/3501 Material System)

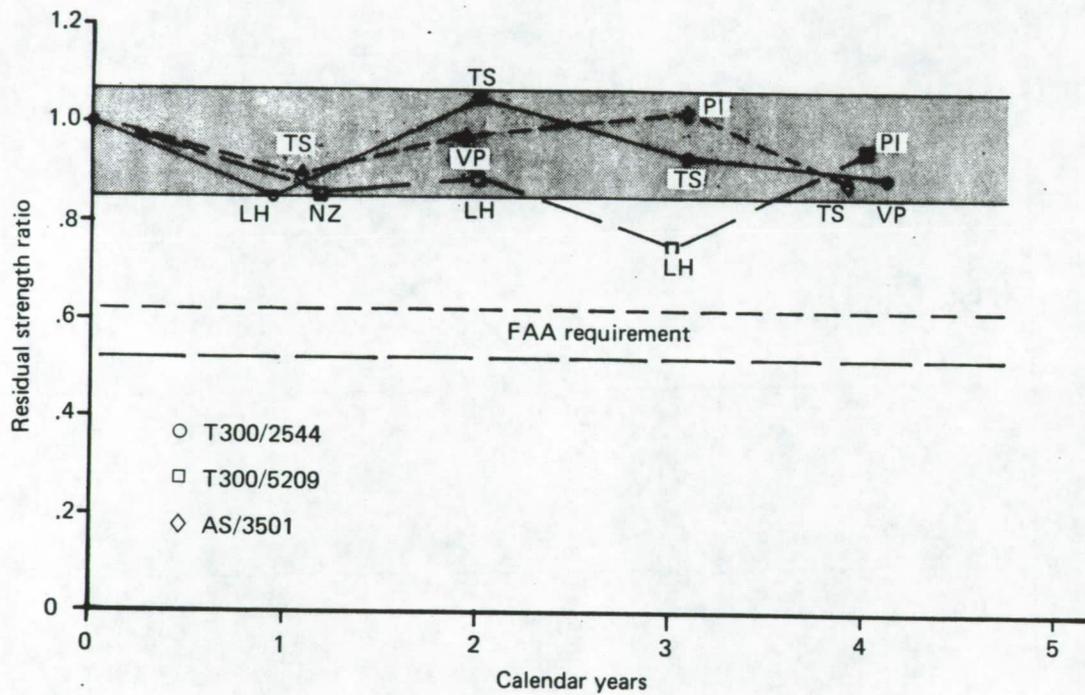
A plot of the residual static strength data accumulated to date appears in figure 8, plotted as a function of time. This data continues to illustrate the data scatter previously discussed in ref. 1, while at the same time showing a significant reversal of the downward trend previously identified for the 250°F curing resin system. Based on the available data, continued retention of static strength levels can be anticipated.

Figure 8.—Residual Strength After Exposure

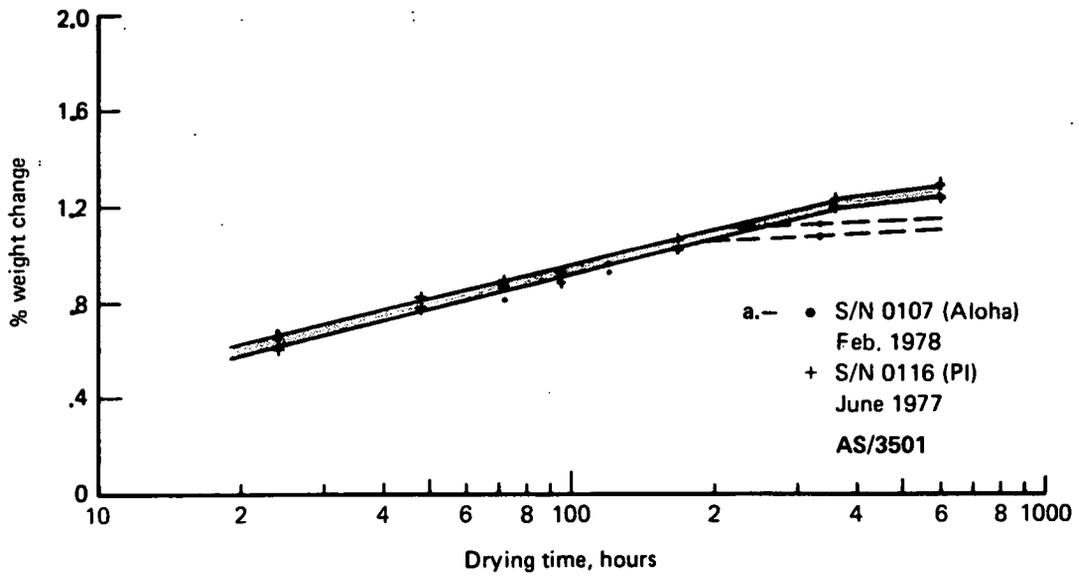
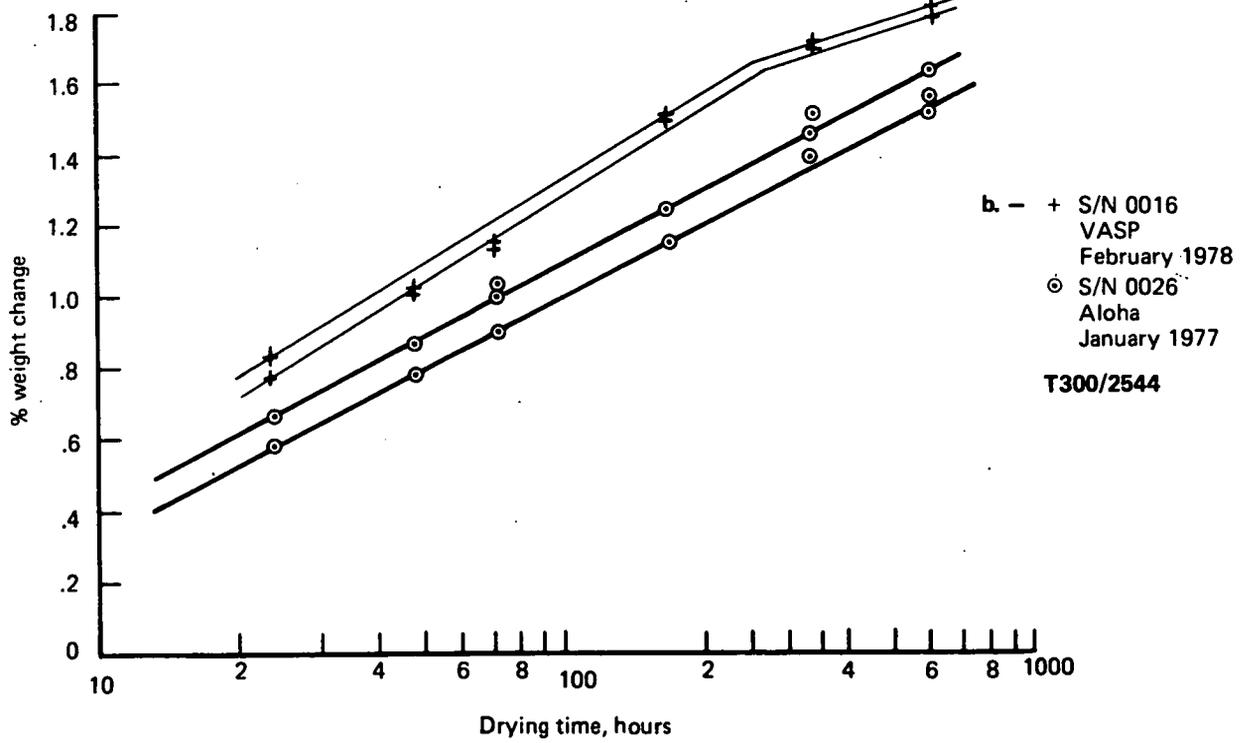
As a continuation of the moisture sampling technique initiated and described in ref. 1, additional core samples were obtained from two of the spoiler panels which were static-tested for residual strength (ref.: Static Test Results). Spoilers S/N 0016 (VASP) and 0107 (Piedmont) each had 3 core samples removed prior to static test. These six specimens were oven-dried at 160°F, with periodic measurement of weight changes. Plots of the weight changes as a function of time are shown in figure 9. This data, in conjunction with the previous core-sample data in reference 1, will be consolidated with other moisture-absorption data as it becomes available.

Comparable data from the third-year static test spoiler S/N 0116, unreported in last year's documentation due to unavailability, is also shown in fig. 9.

Figure 9.—Moisture Weight Change

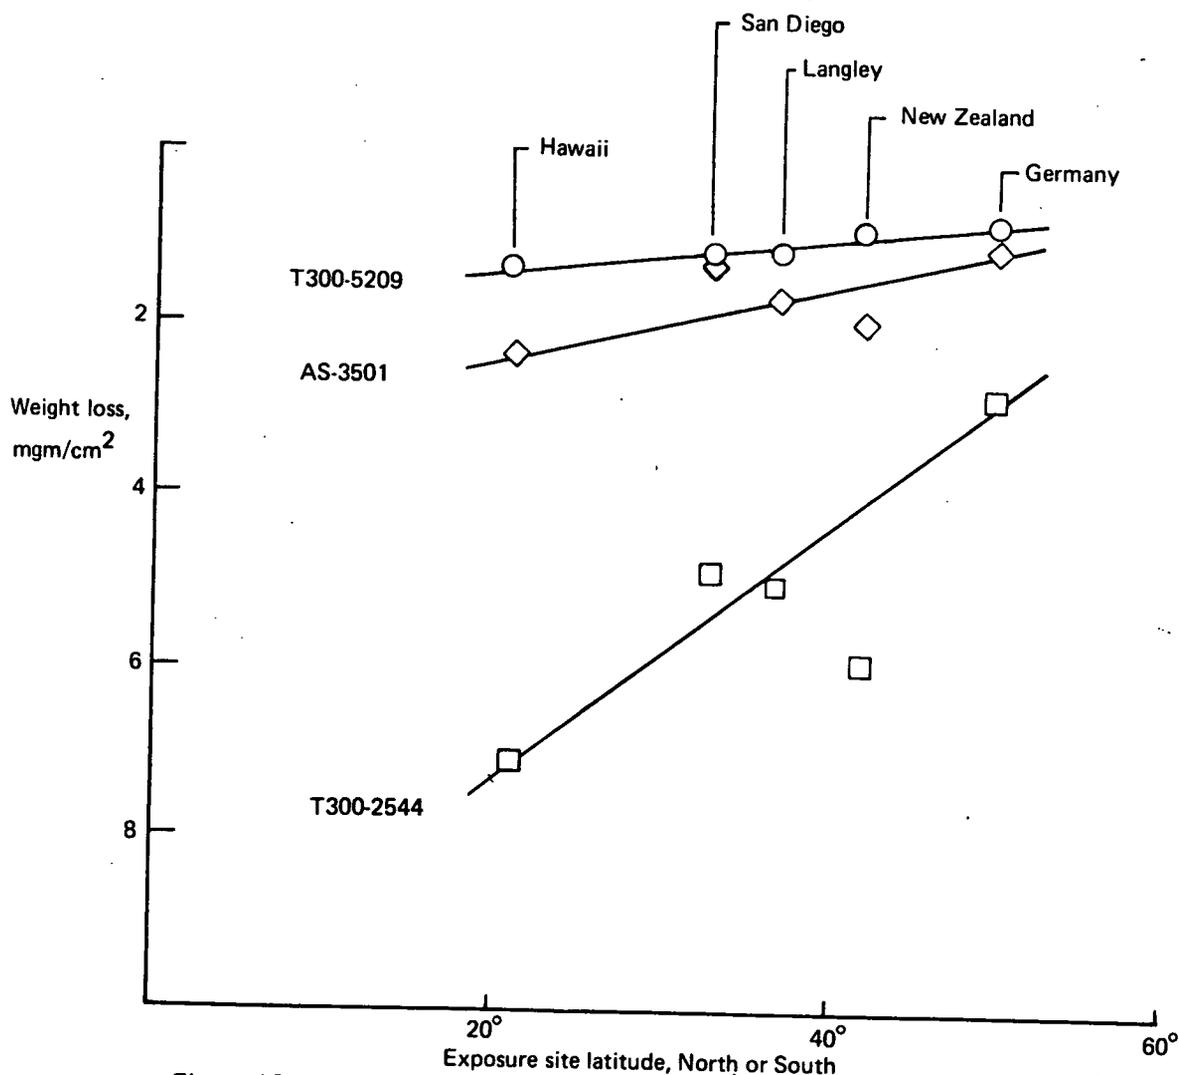
Similar data are not generated for the shear specimens because of their small size, nor for compression specimens because of the glass/epoxy tabs bonded to the specimens. Figure 16 is a plot of the weight loss data resulting from three years outdoor ultraviolet exposure for all exposure sites except Sao Paulo. The Sao Paulo specimens are still being dried after testing. The weight loss data are presented as a function of exposure site latitude. The limited data obtained to date indicates that weight loss due to ultraviolet exposure is approximately inversely proportional to the distance of the exposure site from the equator. It should be pointed out that all specimens had bare surfaces.

Figure 16.—Weight Loss From Environmental Exposure (Three Years)

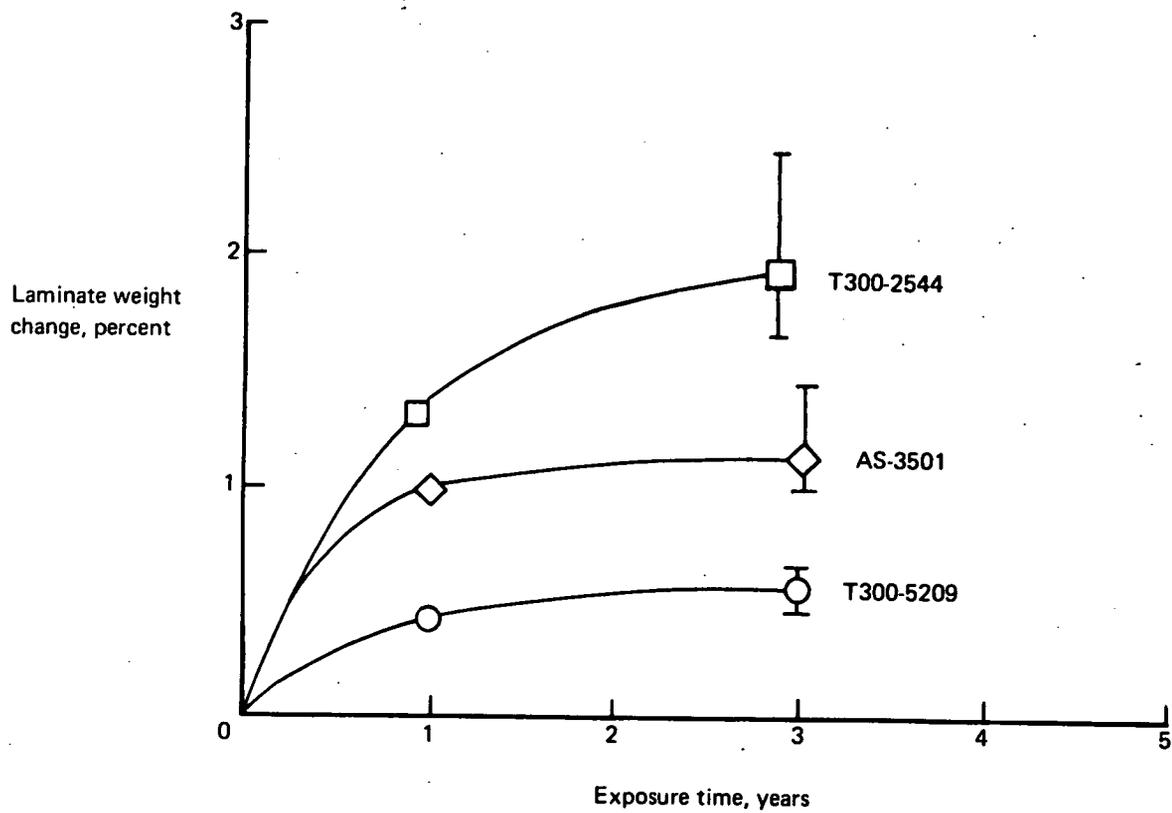
The amount of moisture absorbed by the several graphite-epoxy materials is shown in figure 18. These results represent the determinations made on flexure specimens after their worldwide outdoor exposures for times up to three years.

Figure 18.—Moisture Pickup for Composites After Worldwide Ground-Based Exposures
