NASA Contractor Report 172383

Advanced Manufacturing Development of a Composite Empennage Component for L-1011 Aircraft

Phase III — Final Report
Production Readiness Verification Testing

LOCKHEED-CALIFORNIA COMPANY
BURBANK, CALIFORNIA 91520

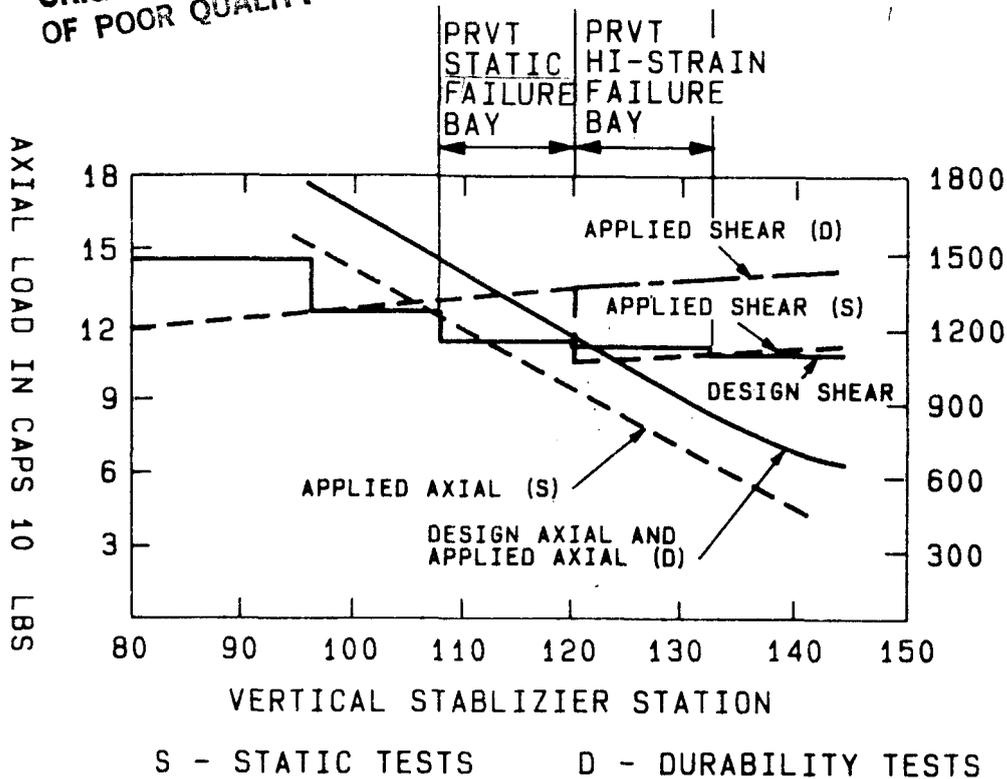
Figure 70. - PRVT spar loads.

The design ultimate loads and the applied test loads are shown in figure 70 for both the static and the durability tests. The stress analyses predicted that the most critical location in the front spar due to the design loads was in the bay between VSS 97.199 and VSS 121.45, with a margin of safety at 0.05. The caps had considerably higher margins of safety. Based on the H23 test which failed at 129 percent DUL, the analysis was considered to be conservative. The lowest margin between VSS 121.45 and the VSS 145.71 was 0.16. Assuming this was equally conservative, the PRVT spars should be capable of withstanding in excess of 120 percent DUL at any location. Because the durability spars are to be static tested after completion of durability testing the cap reinforcement plates were identical for both set-ups. These

plates were designed to give the best match of web loads and cap loads in the critical bay during durability testing. The static test set-up employs two jacks, one at the tip and one at VSS 121.45, and gives a good match of design shears for the full length of the specimen, but the cap loads are lower than the design loads. The durability test set-up could not employ two jacks because of limited number of computer control channels available. Also the long-term control of two jacks operating together in fully reversed load cycling presented an overload hazard.

The single load point setup for durability testing, while matching loadings well below VSS 121.45, caused a 20 percent higher shear to be applied above VSS 121.45. The upper access hole was not included in any of the PRVT spars as a precaution against failure due to uneven load introduction across the spar web. The access hole just above VSS 121.45 was not considered to be a problem for the basic spars where the highest load in that bay would be 80.4 percent DUL. However, in the high strain spars this bay would see 120 percent DUL. Based on the static test results, where failures occurred between 124.8 percent and 149.4 percent, the cycle at 120 percent was not anticipated to cause a problem.
