**MATERIALS FOR ADVANCED TURBINE ENGINES  
PROJECT COMPLETION REPORT  
PROJECT 4**

**OXIDE-DISPERSION-STRENGTHENED  
TURBINE BLADES**

**VOLUME II**

(NASA-CR-179561-Vol-2)

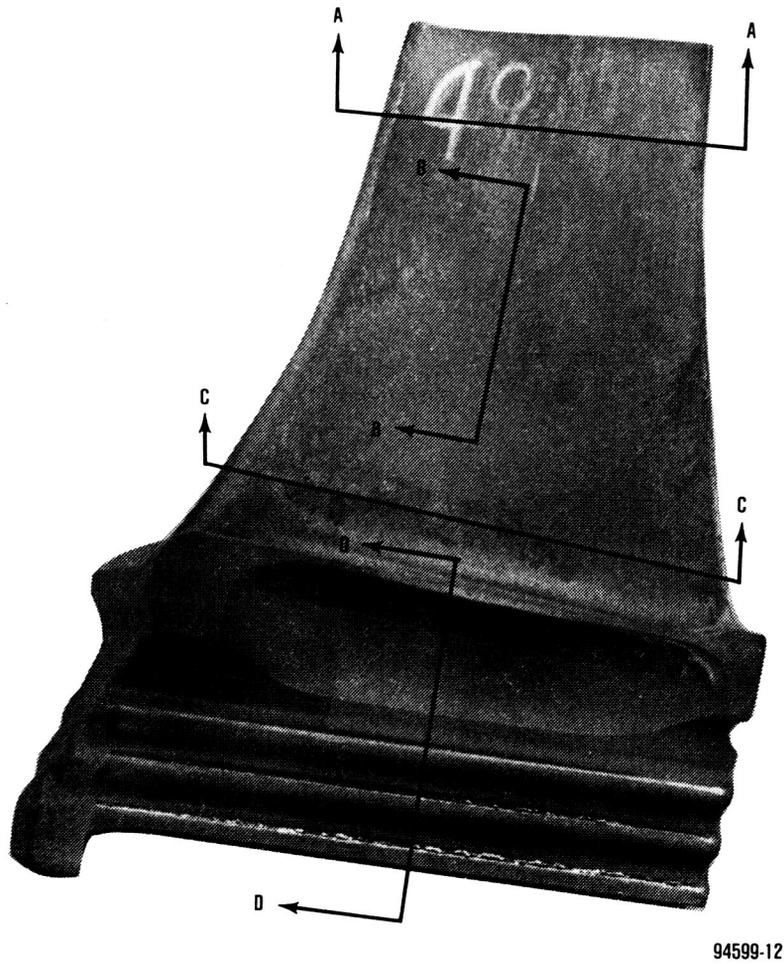
Figure 11. Metallurgical Sectioning Scheme of MA6000 Blade.

**4.2 Metallurgical Evaluation.** Metallographical sectioning of representative MA6000 turbine blades following the completion of the testing is shown in Figure 11. To provide a baseline comparison, an unexposed blade was similarly sectioned and studied. Results of the examination focusing on macro- and microstructural morphology, firtree fretting, and blade oxidation condition are discussed in detail below.

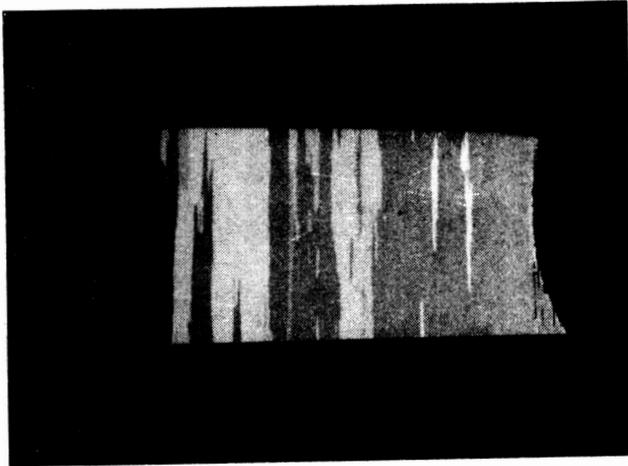
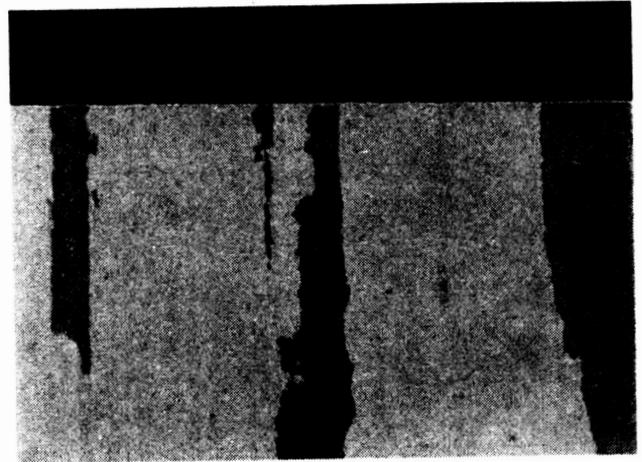
Figure 12. Typical Macrostructure of MA6000 Blade Used in 200-Hour Endurance Engine Test.

**4.2.1 Macro- and Microstructure.** The typical macrostructure of the blades revealed highly textured directionally recrystallized grains characteristic of MA6000, as shown in the photomicrographs in Figure 12. The regions between large grains were inhabited by small high aspect ratio grains, also characteristic of the recrystallized alloy.
