**VOLUME II
MATERIALS FOR ADVANCED TURBINE ENGINES
(MATE) - PROJECT 4
EROSION RESISTANT COMPRESSOR AIRFOIL COATINGS
FINAL REPORT**

**UNITED TECHNOLOGIES CORPORATION
Pratt & Whitney
Engineering Division**

**Prepared for
National Aeronautics and Space Administration
Lewis Research Center
Contract NAS3-20072 - Project 4**

1. REPORT NO. CR- 179645		2. GOVERNMENT AGENCY		3. RECIPIENT'S CATALOG NO.	
4. TITLE AND SUBTITLE MATE PROGRAM Erosion Resistant Compressor Airfoil Coating - Volume II			5. REPORT DATE November 1986

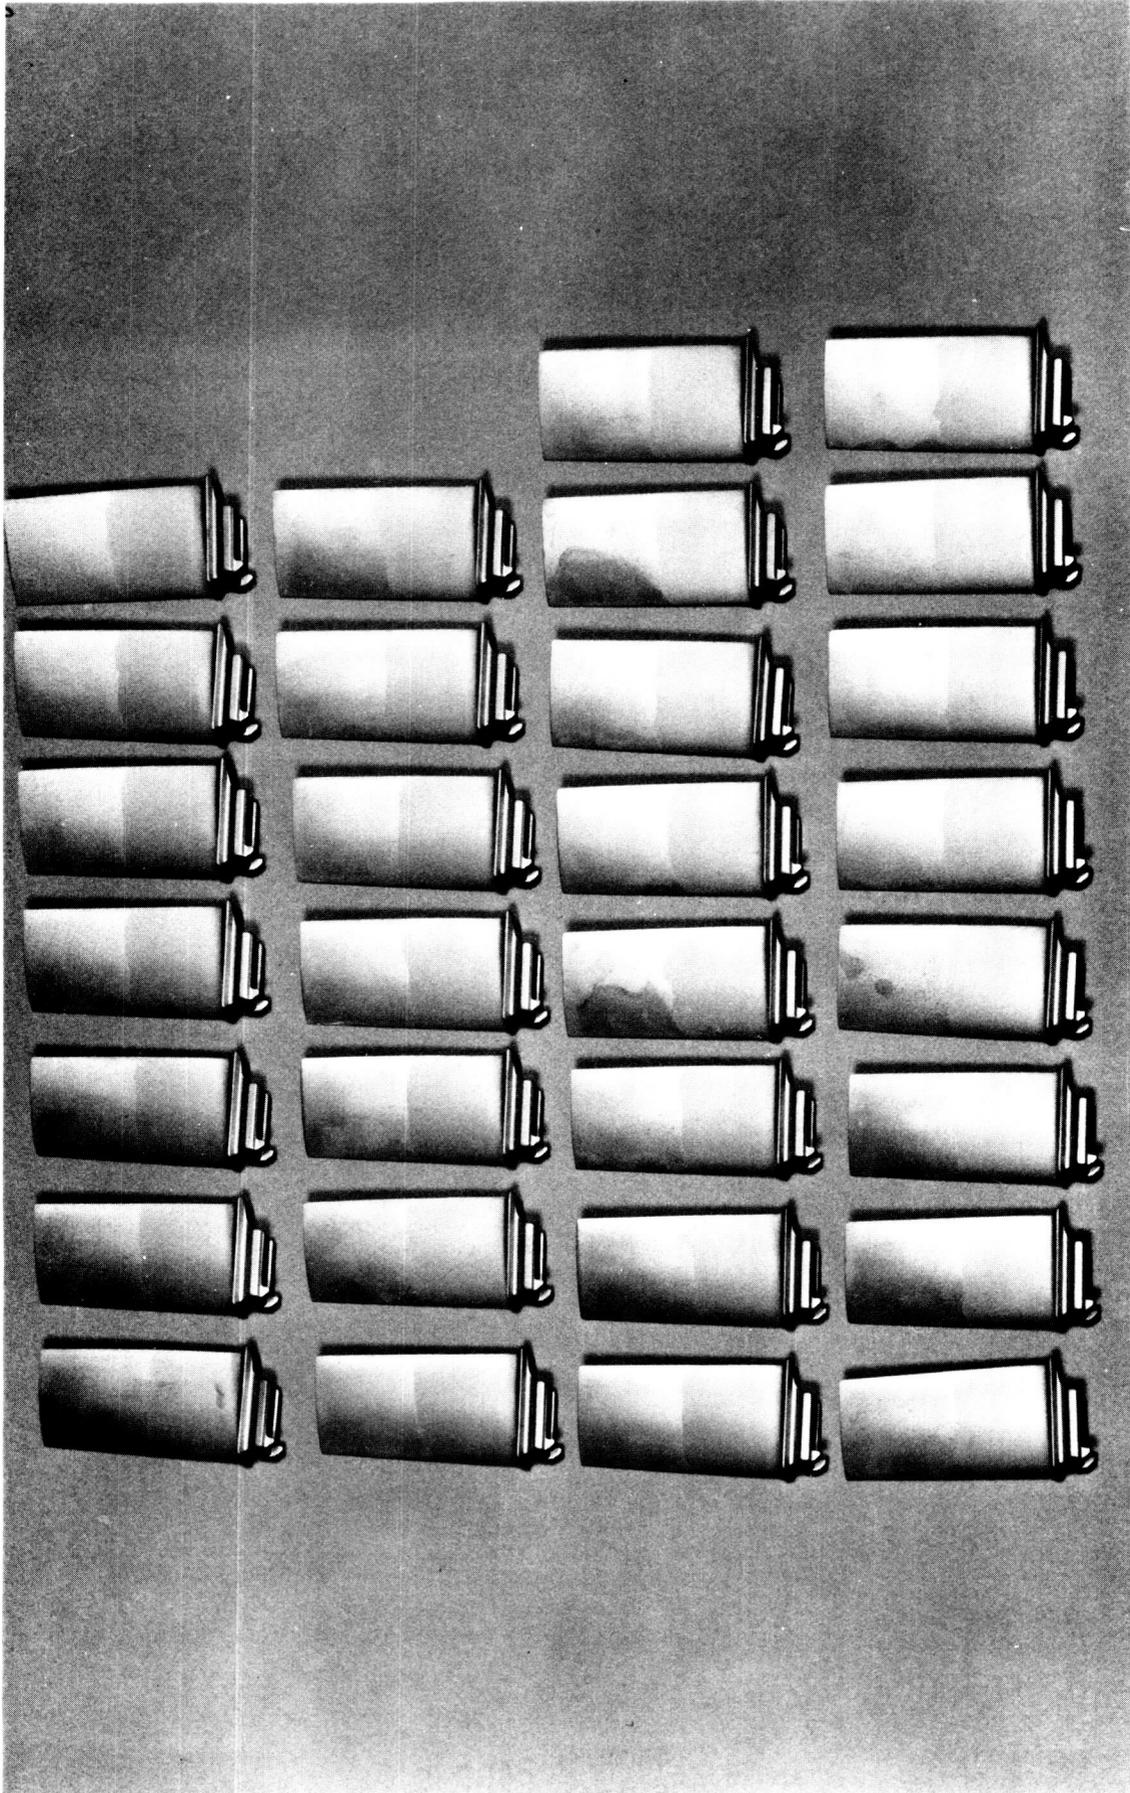
Figure 1 JT8D AMS 4928 8th Stage Compressor Airfoils Gator-Gard Plasma Spray
Coated with 88WC-12Co and Media Finished

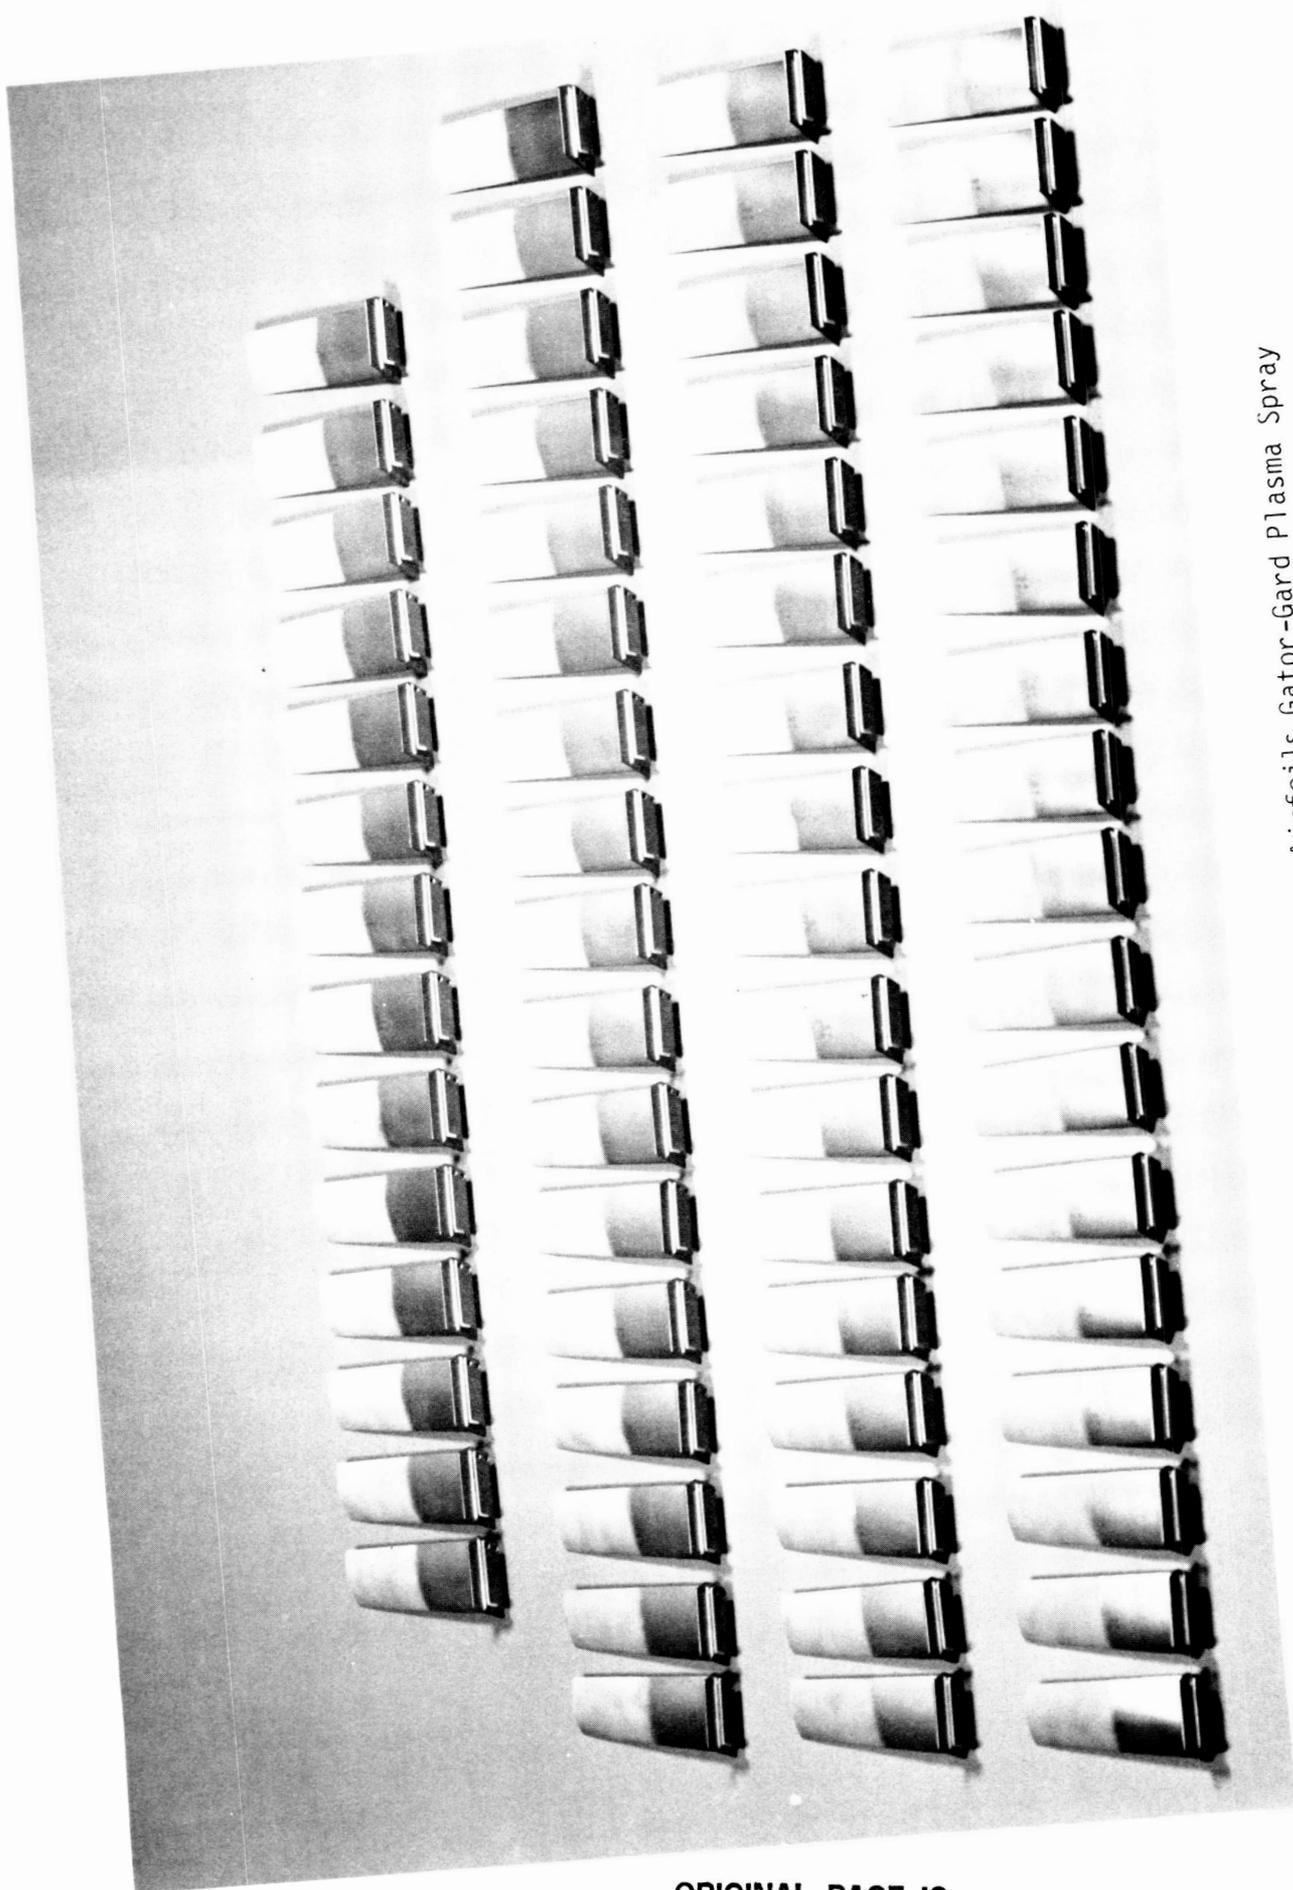
Figure 2 JT9D AMS 4928 7th Stage Compressor Airfoils Gator-Gard Plasma Spray
Coated with 88WC-12Co

One Gator-Gard plasma spray coated 88WC-12Co seventh stage AMS 4928 compressor blade fractured through the airfoil approximately 2 5/8" above the root platform (Figure 10).

Binocular and scanning electron fractographic examination of the JT9D seventh stage airfoil fracture surface revealed high cycle fatigue (HCF) which had progressed for approximately 7/8" from an origin at the trailing edge surface, and for approximately 5/32" from an origin in vicinity of the leading edge (Figures 11 and 12); rubbed leading edge fracture surface precluded identification of the exact origin location. Fracture terminated in tensile overload between the extremities of the two HCF progressions.

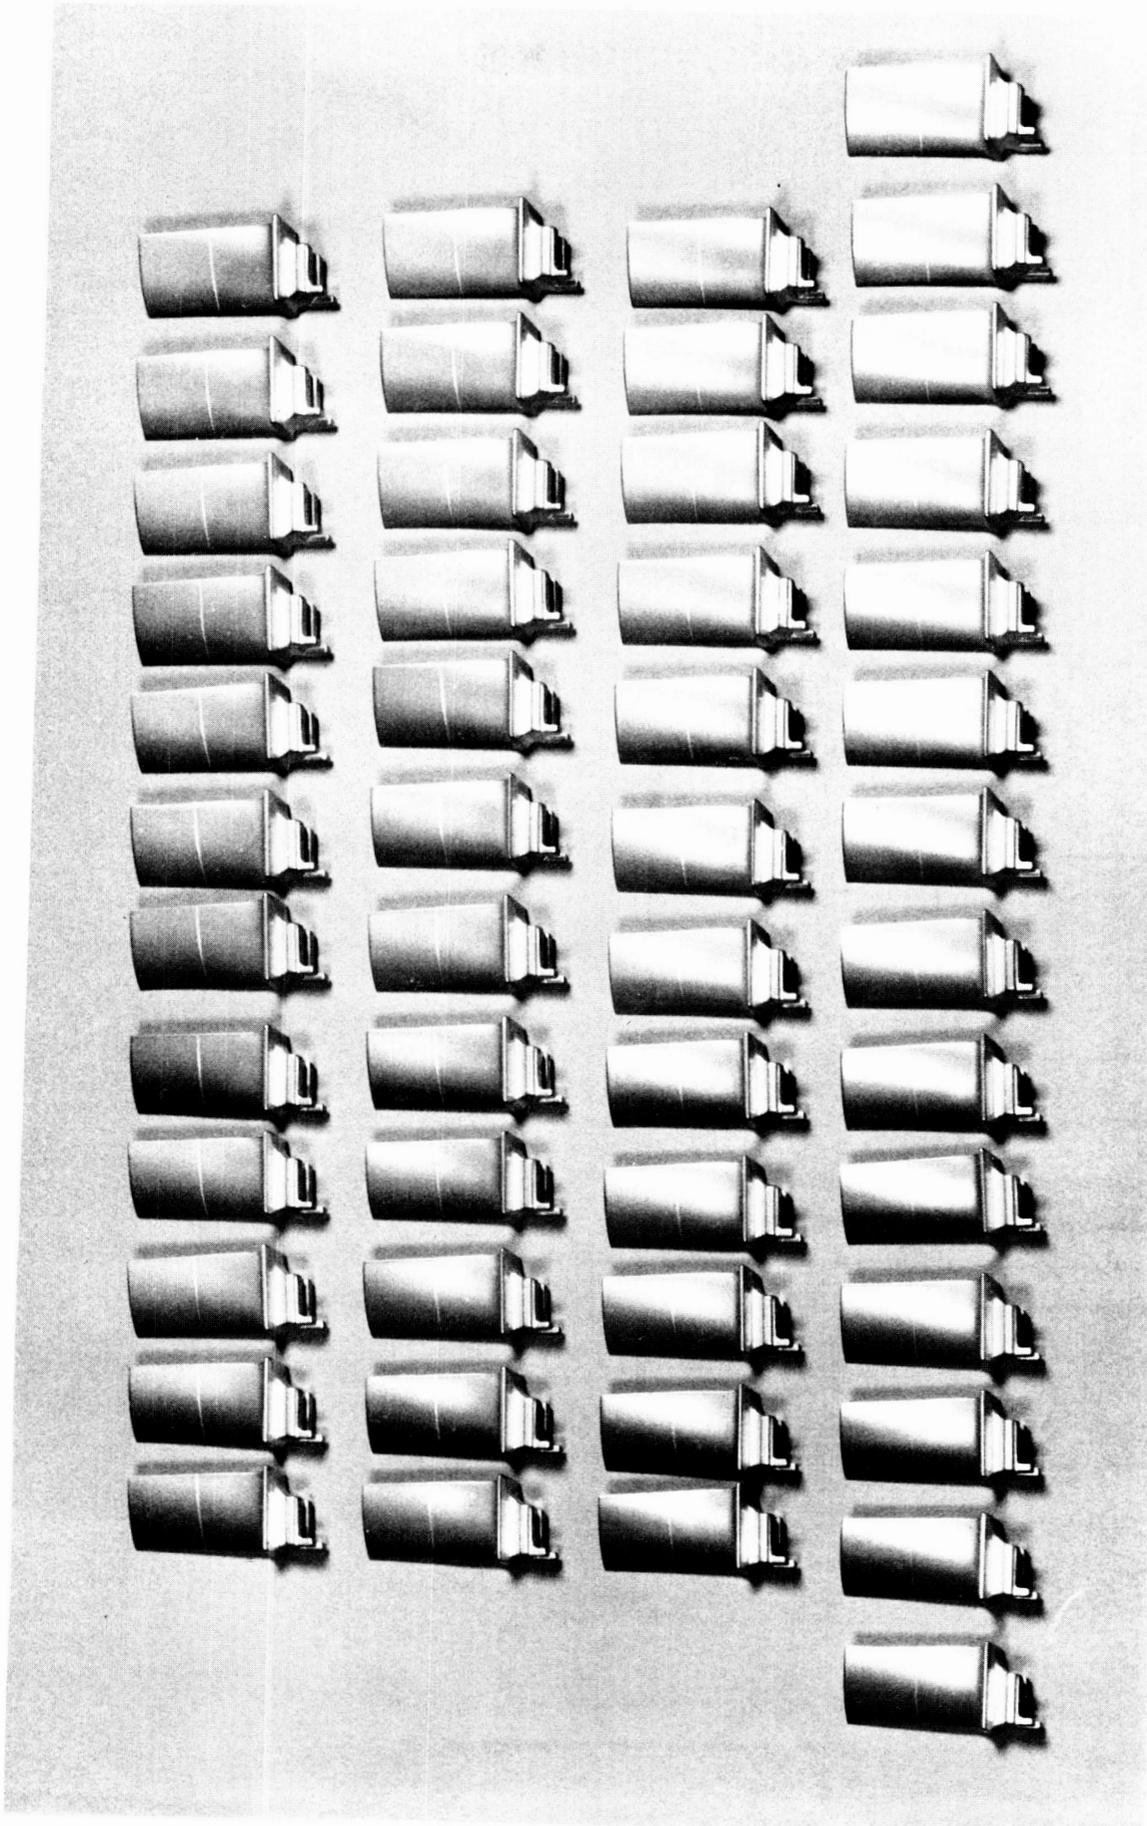
Figure 3 JT8D AMS 5616 12th Stage Compressor Airfoils 60 Kw Plasma Spray
Coated with 88WC-12Co and Overcoated with SermeTel 5380

Post test inspection of the twelfth stage AMS 5616 airfoils, plasma spray coated with 83WC-17Co, using the 60 KW process, indicated no evidence of cracks. All of these airfoils were still acceptable for engine operation.

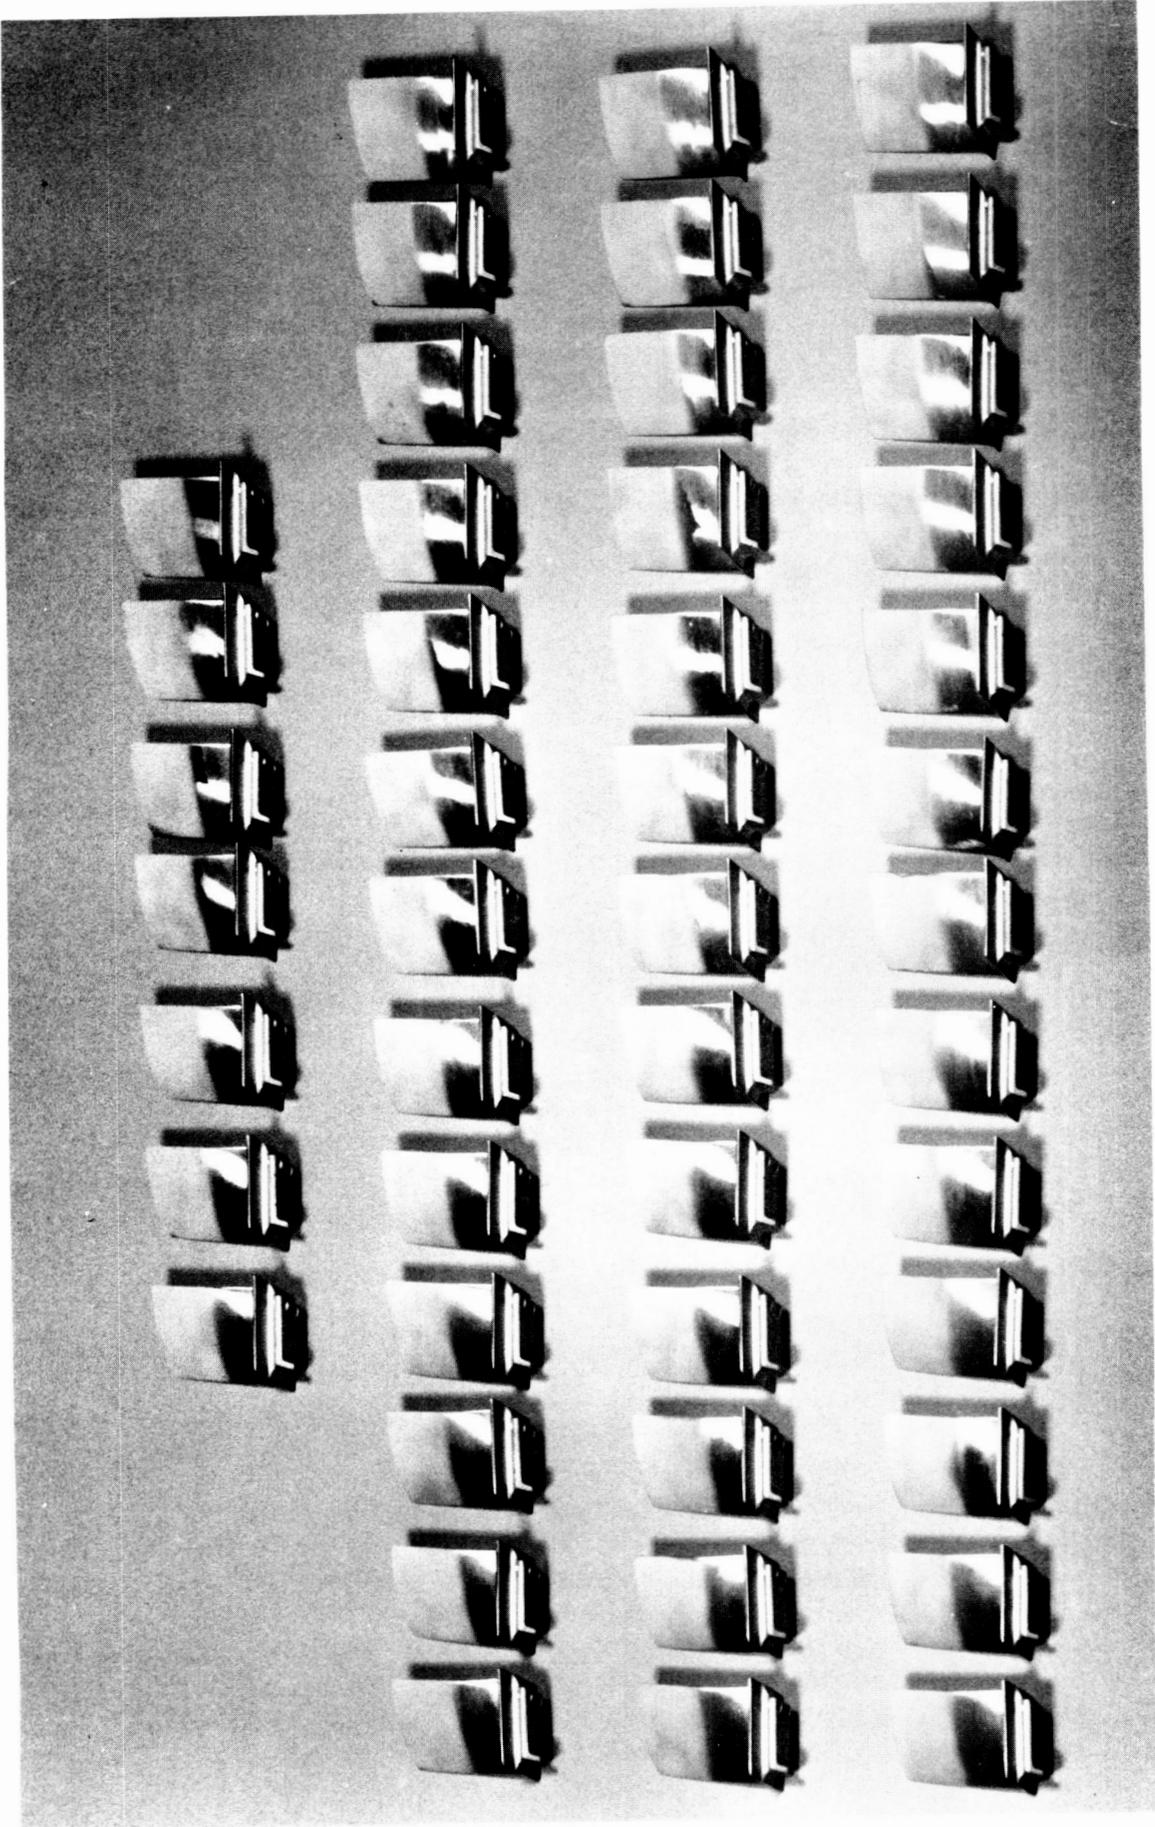
Figure 4 JT9D Incoloy 901 14th Stage Compressor Airfoils Gator-Gard Plasma Coated with 88WC-12Co

Incoloy 901 fourteenth stage airfoils coated with either Gator-Gard plasma spray 88WC-12Co on pack diffusion applied Cr+B did not exhibit any detrimental conditions which would have precluded additional engine testing.

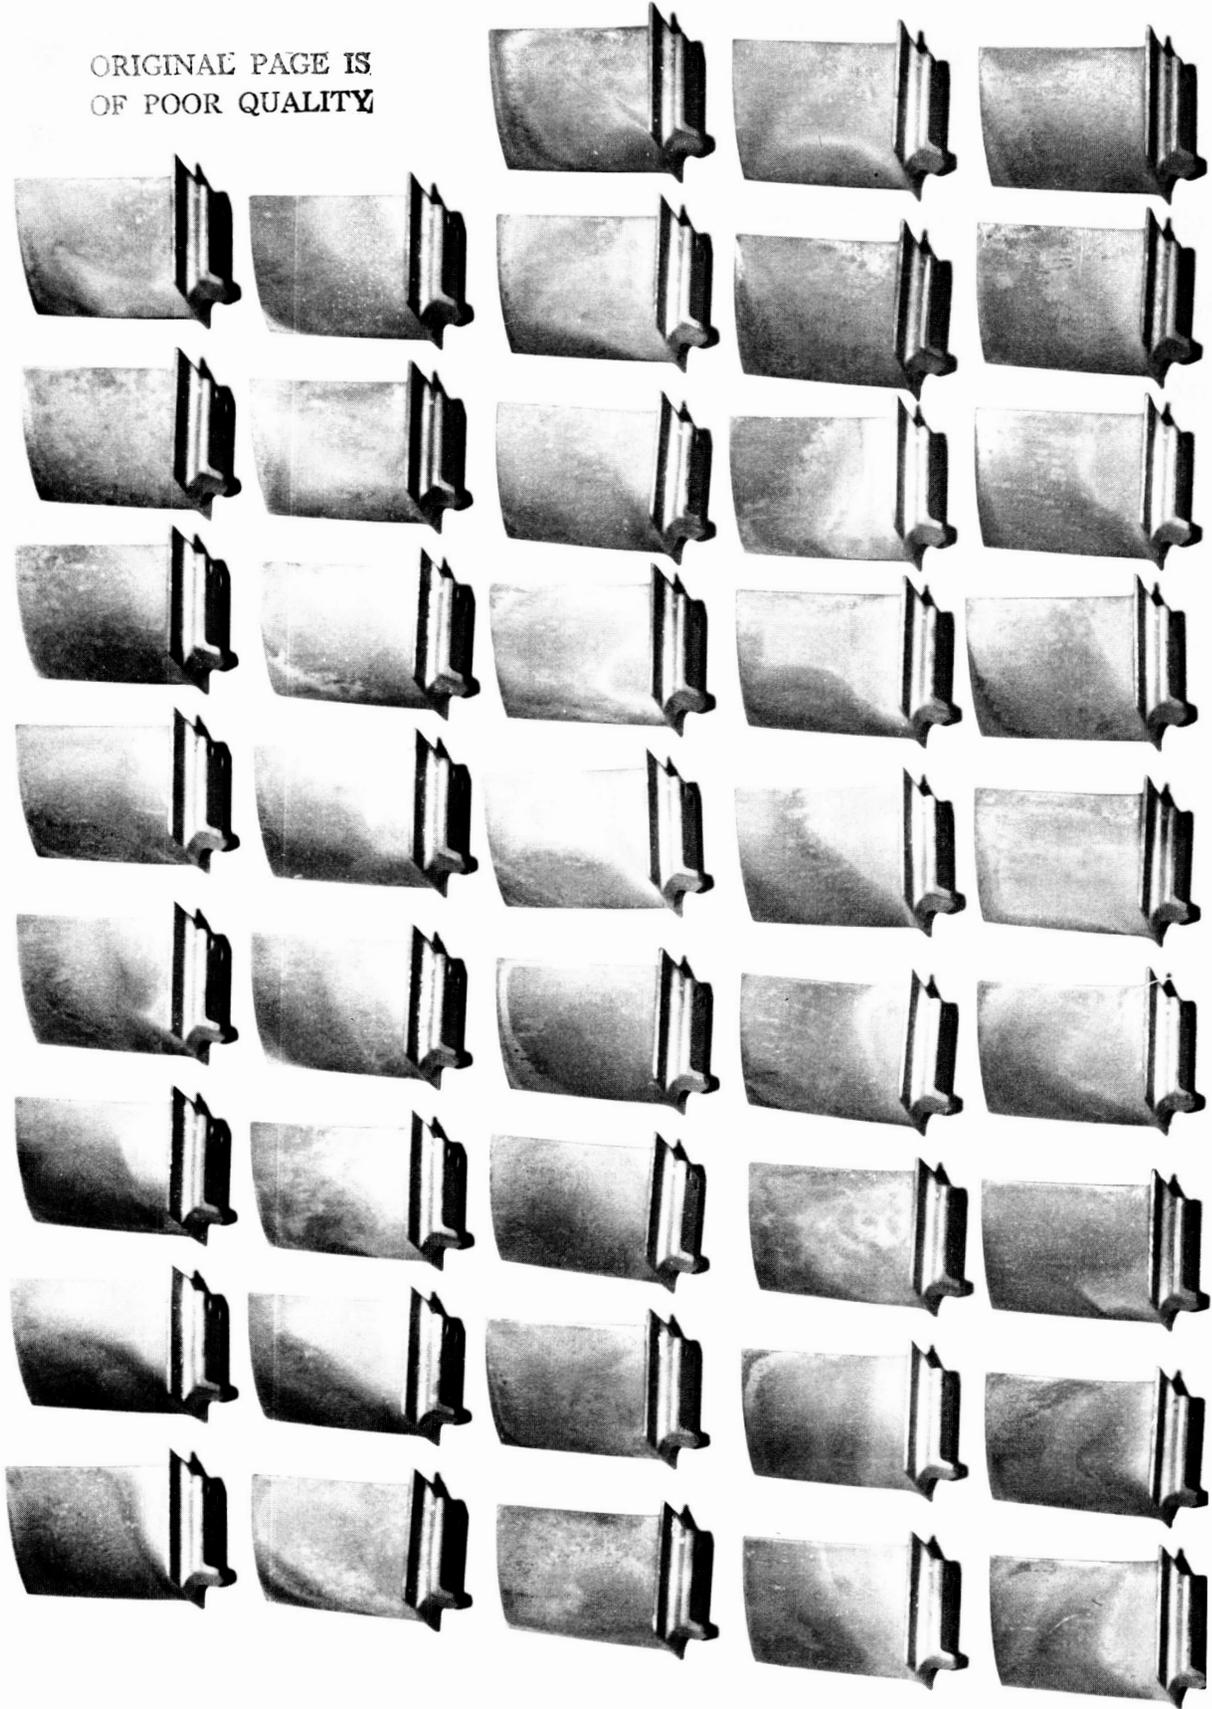
Figure 5 JT9D Incoloy 901 14th Stage Compressor Airfoils Pack Diffusion Coated With Cr+B
