FULL SCALE TECHNOLOGY DEMONSTRATION OF A MODERN COUNTERROTATING UNDUCTED FAN ENGINE CONCEPT

ENGINE TEST

December 1987

by
GE Aircraft Engines
GE36 Project Department
Cincinnati, Ohio 45215

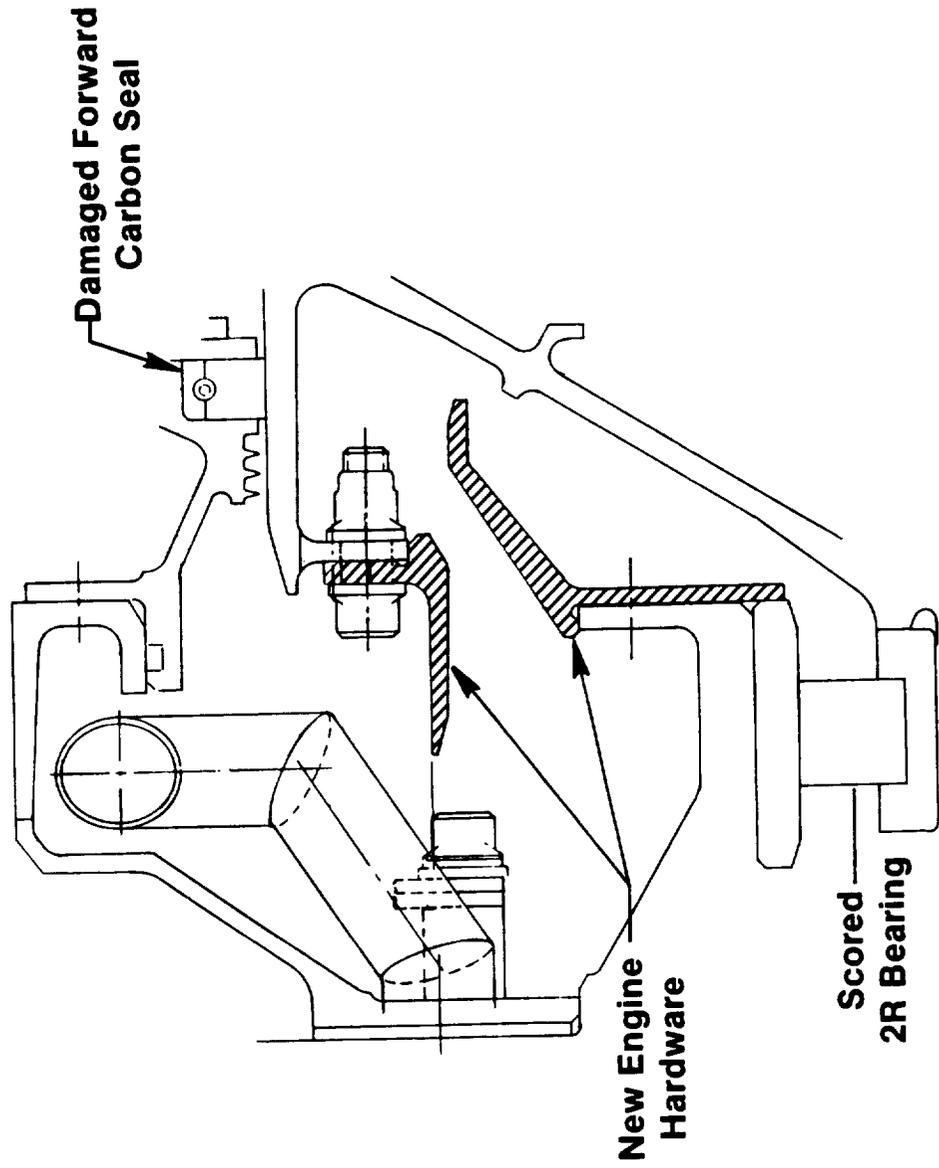
Figure 3-1. Carbon Seal Assembly Fix.

After the first engine start, the engine was shut down due to a low oil level warning. Carbon seal pieces were found in the propulsor scavenge screens. The engine was removed from the test site, and the propulsor was separated from the gas generator. After separation, it was found that the forward stationary carbon seal was damaged. It was determined that the seal was damaged during assembly. The 2R bearing was also found damaged, this due to carbon seal debris. New hardware was added to the engine to help guide the propulsor rotors together to avoid any damage to the seal (Figure 3-1), which was completely replaced with new hardware, along with the 2R bearing. The propulsor was remated with the gas generator with no problems, and the engine was put back on test. There were no oil leaks when the engine tests resumed.

While running the engine with the damaged carbon seal, the resulting internal oil leak caused an unbalance in the rotors. This unbalance caused the Stages 7, 9, and 11 propulsor turbine blades to rub hard against the inner 6-11 spool. Twenty-two Stage 11 blades were found to have cracks in the root. It was decided to not replace these blades but to closely monitor their stress levels.

- Added New Engine Hardware To Guide Rotor

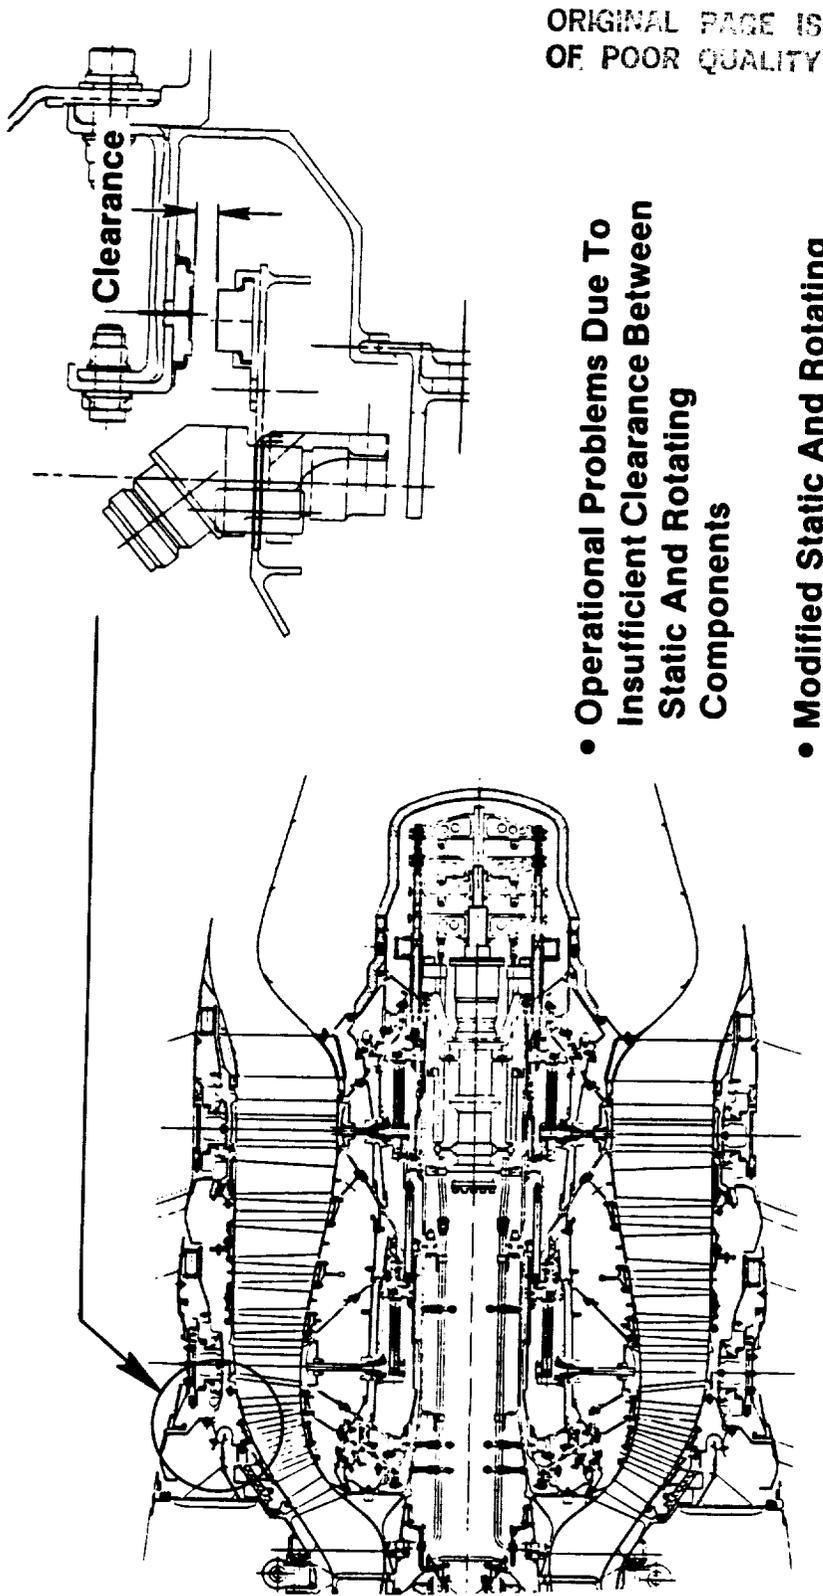
Operational problems with the forward telemetry system were caused by insufficient clearance between the static and rotating forward telemetry antenna components. These components were modified to increase the cold running clearance from 0.135 to 0.250 inch, as diagrammed in Figure 3-2.

- **Operational Problems Due To Insufficient Clearance Between Static And Rotating Components**
- **Modified Static And Rotating Support Structures**
- **Increased Cold Running Clearance - From: 0.135 To: 0.250**

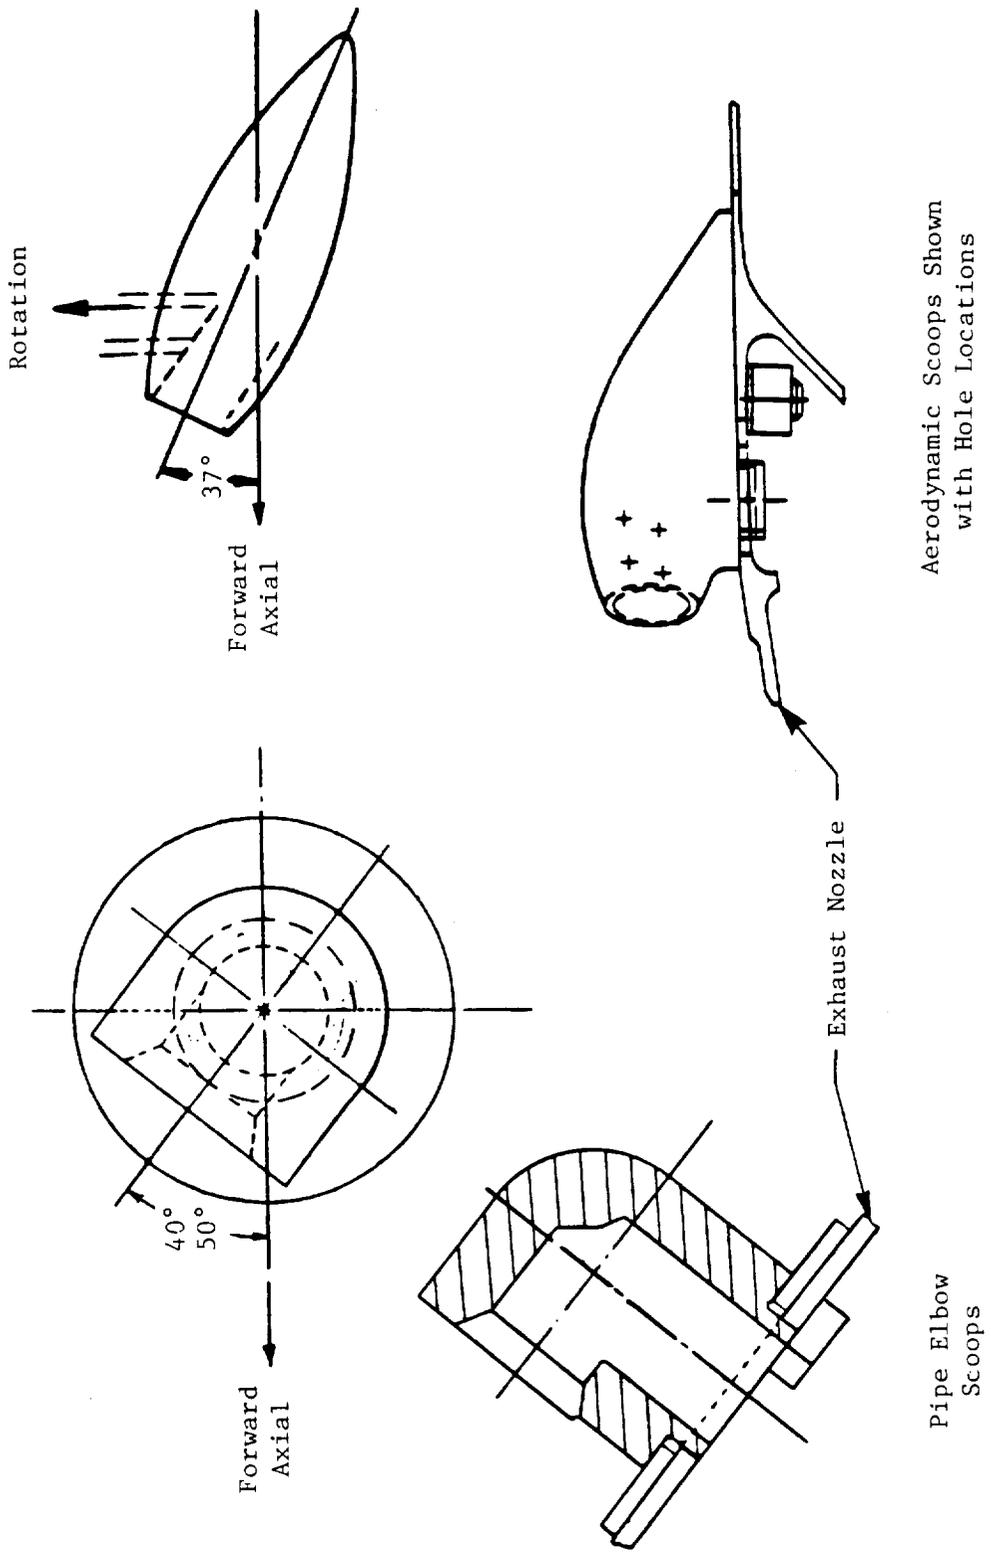
Figure 3-4. Telemetry System Scoop Designs.

Problems with the telemetry system, due to high temperatures, resulted in design changes to increase cooling. Cooling scoops were added to the rotating exhaust nozzle to bring in additional ambient air to cool the telemetry system (especially that of Stage 2). Prior to the addition of cooling scoops, there were flush vent holes in the exhaust nozzle. The following summarizes the design changes:

The addition of four holes to the side of the scoops were an attempt to increase flow to the telemetry system during static ground testing. Sixty of the modified aerodynamic scoops will be used for flight test. Figures 3-3 and 3-4 illustrate the telemetry system and cooling scoop designs.

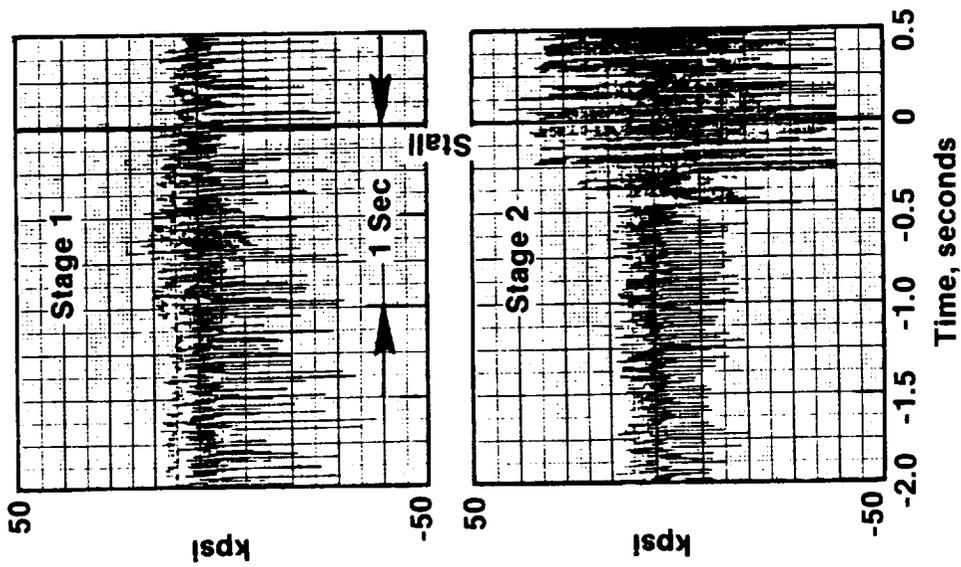
Figure 3-13. History of Turbine Blade Response, Run to Thrust and Stall.

During testing, prior to the stall, significant first flexural vibratory response had been observed on all stages of power turbine blading (Figures 3-12 and 3-13). Teardown revealed significant damage to Stage 1. Several blades had large leading edge root cracks and were leaning aft toward Stage 2. One local segment of blades was buckled aft into Stage 2. All Stage 2 leading and trailing edges, as well as all Stage 3 leading edges, were bent circumferentially and severely rubbed. Stages 1, 7, 9, and 11 exhibited severe tip rub. While Stages 7, 9, and 11 had rubbed previously during Build No. 1 due to oil leakage past a broken carbon seal, the poststall rubs were more severe. Stage 4 had very light tip rub only at the trailing edge. Stages 2, 3, 6, and 8 exhibited no tip rub. Stage 10 rubbed only one blade, which was bent at the platform. Stages 7, 9, and 11 had several bent airfoils. The rotor inner

- Morning Run Similar To 9-19-85 And 9-27-85 Runs
- Accel To 1200 - Back Off For Stage 1 20 Per Rev/1F
- Accel To 1300 - Back Off For Stage 7 8 Per Rev/1F
- Accel To Thrust - Back Off For T46
- Accel To Thrust And Stabilize
- Stress Stable Until 0.5 - 1 Second Before Stall

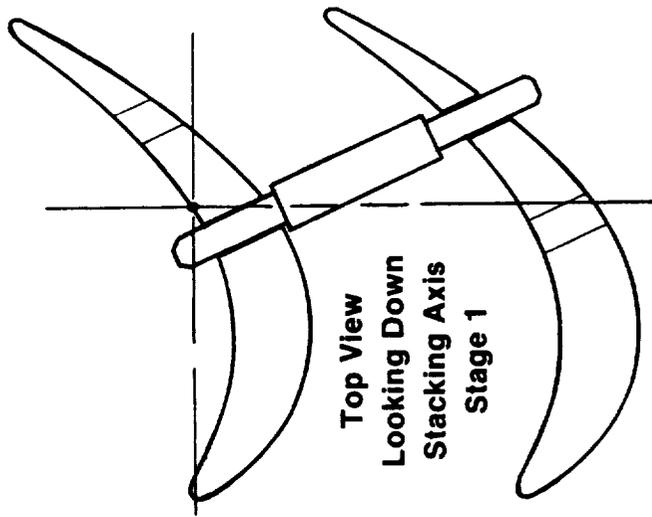
Figure 3-14. Turbine Blade Fix.

All power turbine blades were replaced for Build 2. Spanning across adjacent blades, coulomb dampers (in the form of René 41 pins) were designed for all stages of blading as illustrated in Figure 3-14. Effectiveness of the damper design has been substantiated by component rig spin ("whirligig") and bench wear tests. Although no evidence of fatigue was indicated for the power frames, dampers were also added to Stage 12 as a precaution due to a predicted first flexural response with the outlet guide vane passing frequency. Strain gages have also been added to the Stages 5 and 12 power frame airfoils for Build 2.

- **Blade-To-Blade Damper Pins**
- **Increased Tip Clearance**
 - + 0.050 Inch Stages 1, 3, 7, 9, 11
 - + 0.030 Inch Stages 2, 4, 6, 8, 10
- **Reduced Tip Thickness**
(0.030 → 0.015)

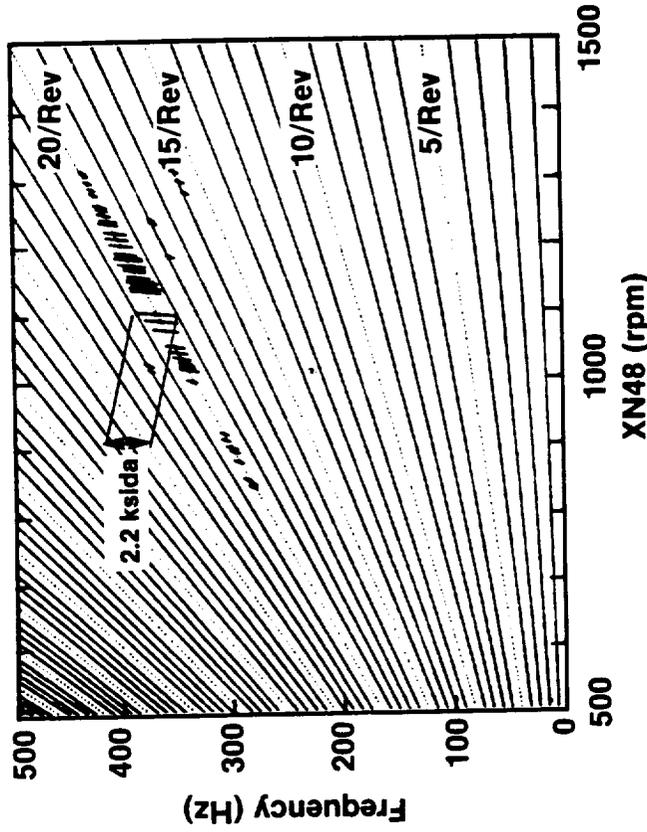
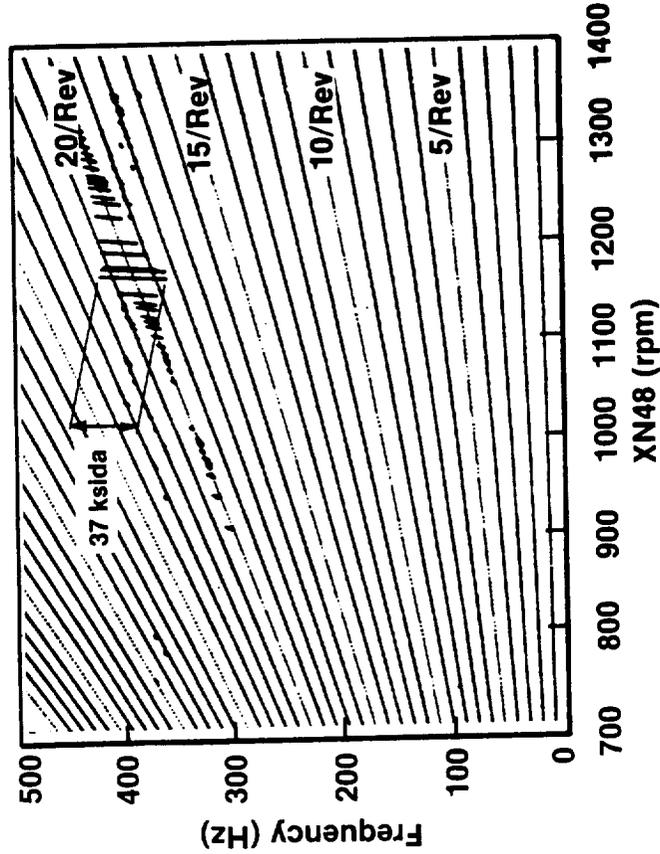
Figure 3-15. Power Turbine Blade Vibratory Response, Damper Effectiveness - Stage 1.

Coulomb damper pins were added to all turbine blade stages (1-4, 6-11) and to Stage 12 power turbine frame airfoils (Section 3.4 and Figure 3-14). Figure 3-15 demonstrates the Stage 1 turbine blade vibratory-stress reduction resulting from the addition of the damper pins. Figure 3-16 shows the Stage 1 vibratory stress in relation to the scope limits before and after addition of the dampers. Figures 3-17 through 3-26 illustrate the vibratory stress for all turbine blade stages after installation of the dampers. Data are from an accel to 25,000 lbf, except for Stage 11 blades data (bad telemetry signal) which is from an accel to 22,000 lbf. Section 3.11 contains stress data for the turbine frame blades.

Dampers Highly Effective

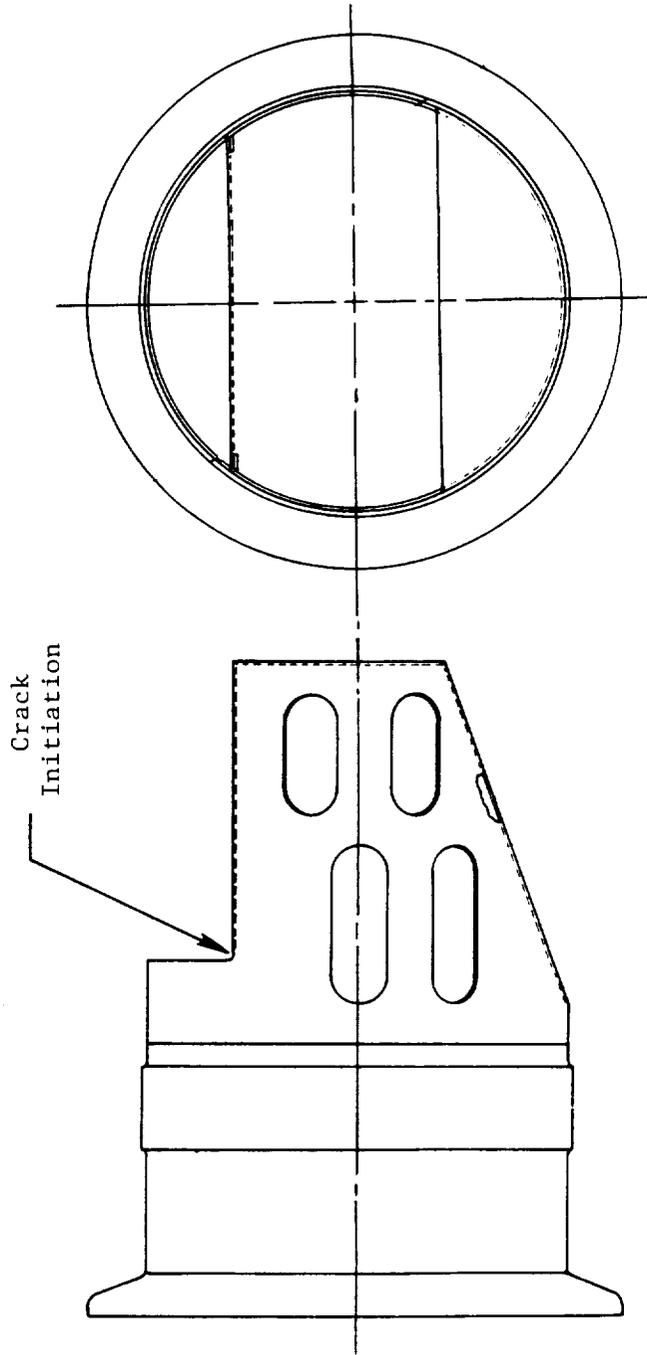
Figure 3-29. Bypass Bleed Valve Diffuser.

During Build 2, the fan bypass bleed valve diffuser failed in high cycle fatigue (Figure 3-29). Until a redesigned diffuser (Figure 3-30) could be

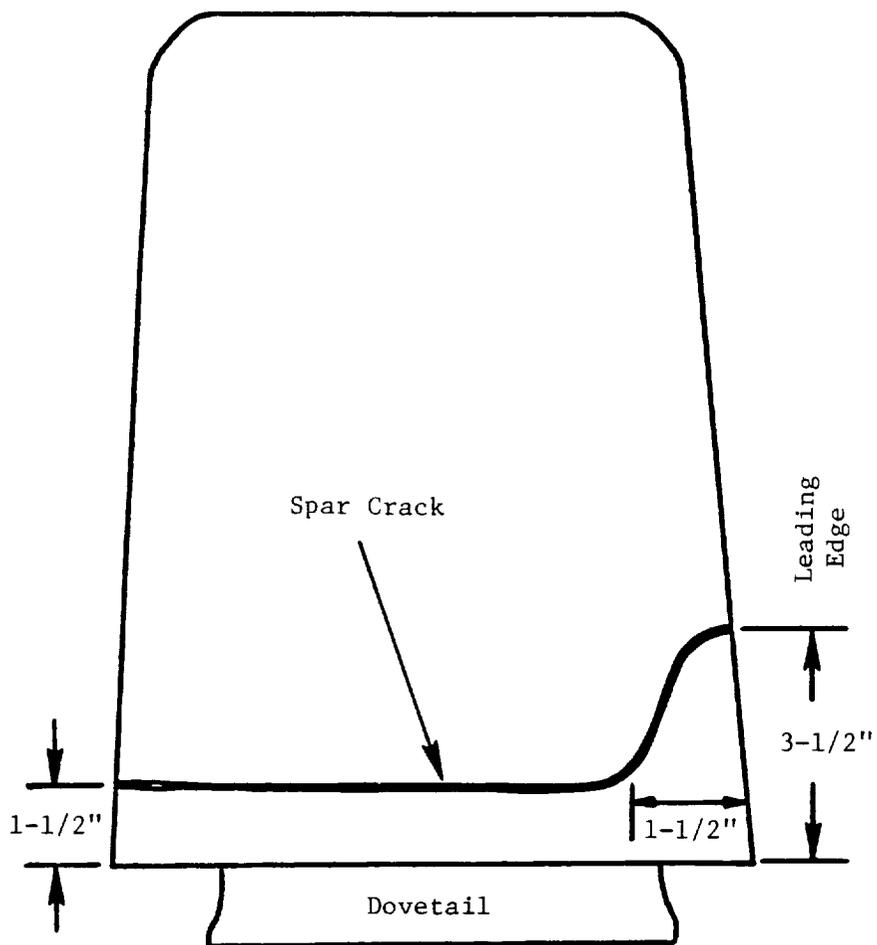
Figure 3-31. Spar Schematic.

Inspection of the spar following shutdown indicated the titanium had cracked at the EB (electron beam) weld line the entire width of the spar. The EB weld crack was clearly visible over the midspan of the blade (Figure 3-31).

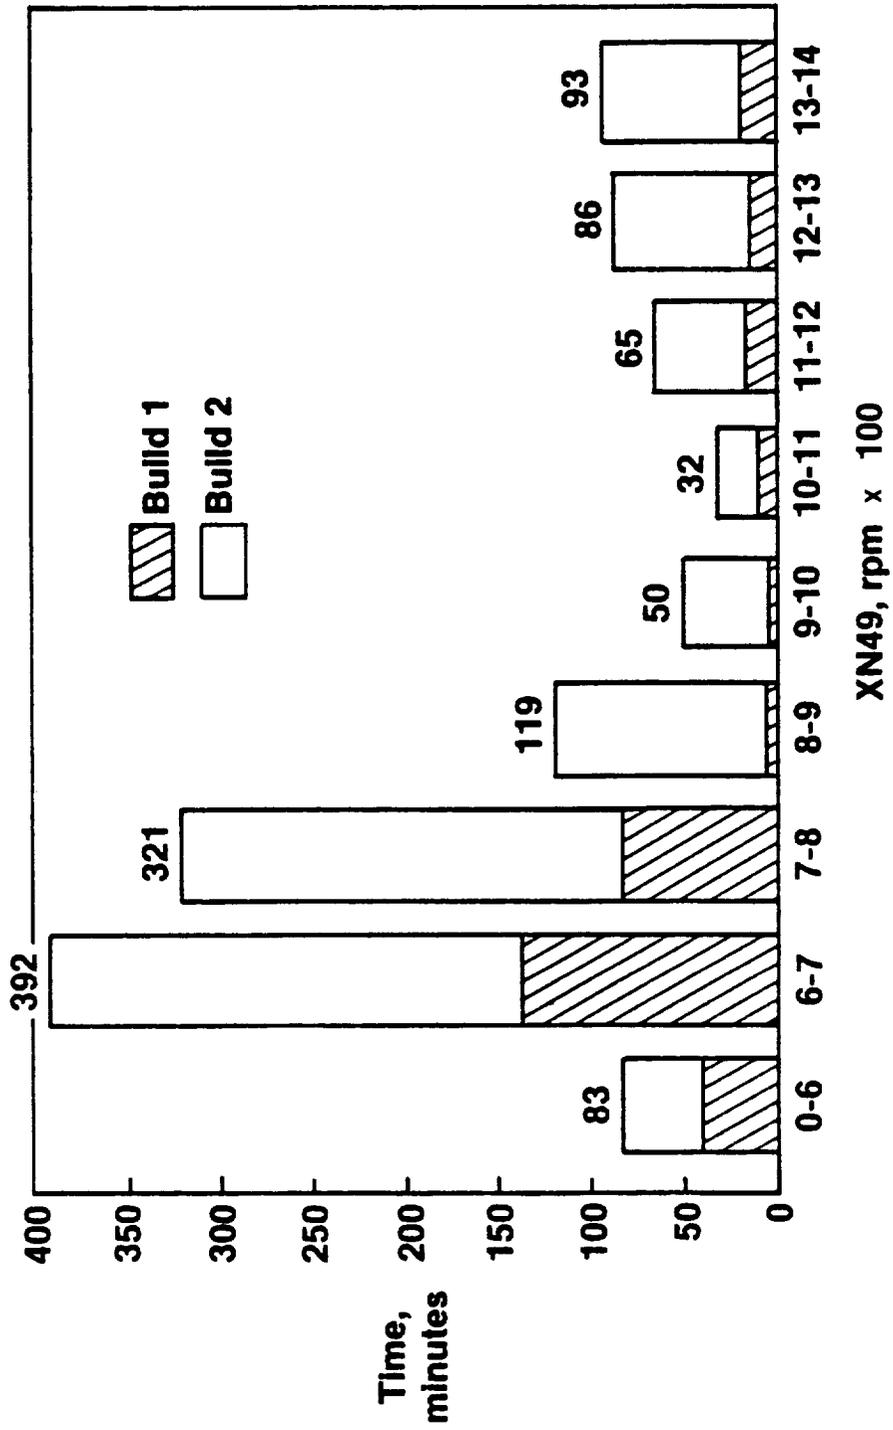
Figure 3-32. Total Run Until Fan Failure.

The blade that failed had been run 20:40 hours prior to the failure. A breakdown of run time versus propulsor fan speed is provided in Figure 3-32.

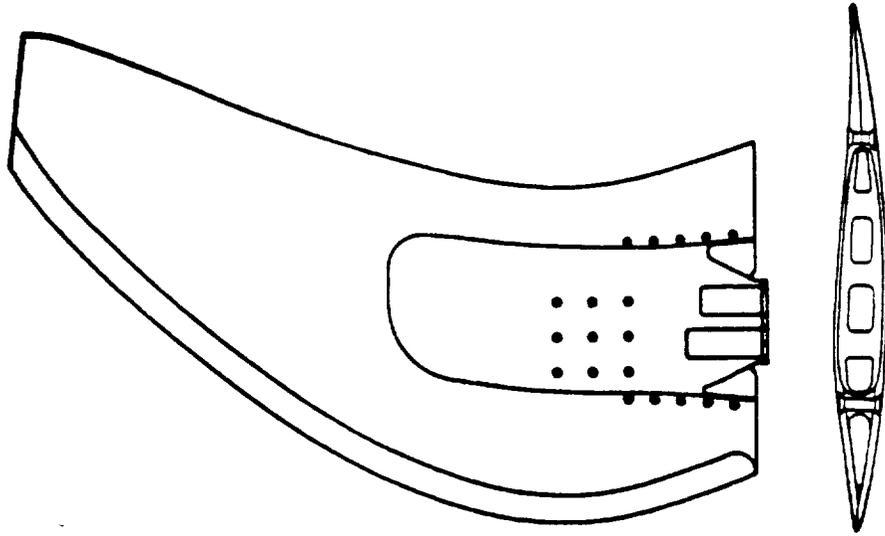
Figure 3-34. Improved Fan Blade Mechanical Design.

None of the original design Stage 1 fan blades had to be replaced due to failure or debonding. After Build 2, the blades were replaced with redesigned blades with mechanical retention features. Figures 3-33 and 3-34 compare the original and redesigned fan blades. All of the redesigned Stage 1 fan blades ran through Build 3 without problems.

- **Solid Spar with EDM Pockets (2 Plugs)**
 - **Same Ply Lay-Up Pattern**
 - **Add One 0.005" Adhesive Layer on Spar Surface**
 - **Positive Shell Retention**
 - **New Foam Material, Rohacell, Replaces Syntactic Foam**
 - **Composite Channel Sections at Spar LE to Reinforce Spar/Shell Bond Joints**
 - **Composite Close Out at Airfoil Base**
 - **Wider LE Lap Joints**
 - **Solid Composite in TE Cavity**
 - **Improved Shell Taper Pattern at Root**
- Full Ply Length on the Spar Surface

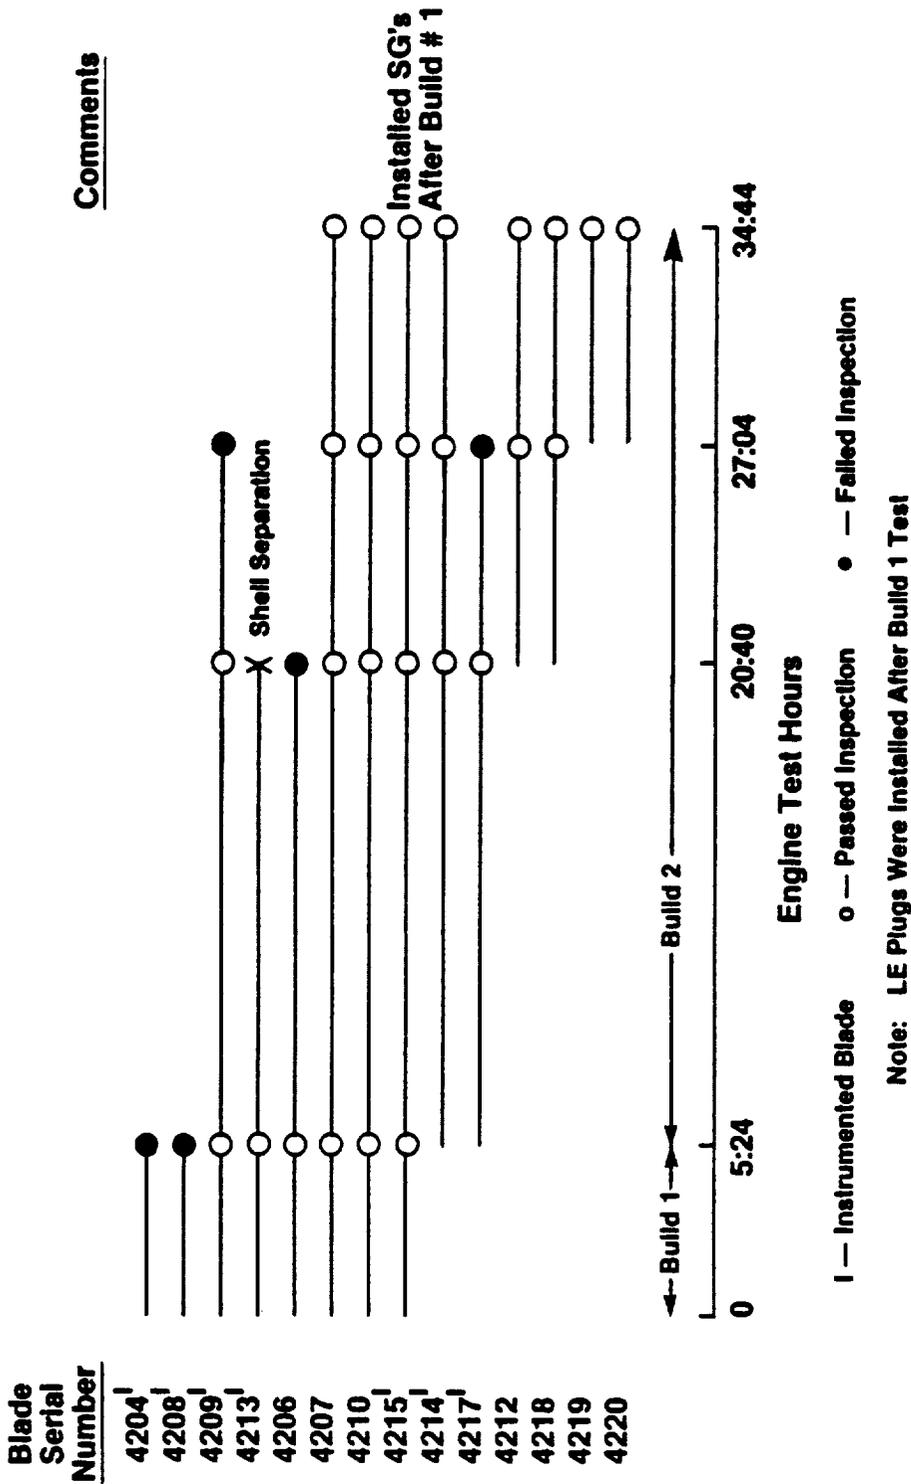
Figure 3-35. Stage 2 Fan Blades Engine Test History.

Some of the original design Stage 2 fan blades failed inspection during Builds 1 and 2 due to debonding. These were replaced once any discrepancy was found. Figure 3-35 depicts the history of the Stage 2 blades during Builds 1 and 2. Investigation into the two debonded blades found after Build 1 determined that the probable cause of debonding was from propagation from cracks in the foam inside the blades. This foam filled the cavity between the composite shell and the titanium spar. Cracks in the foam during manufacturing propagated into the shell/spar bond. A design change was made (Figure 3-36) to try to prevent this from happening.

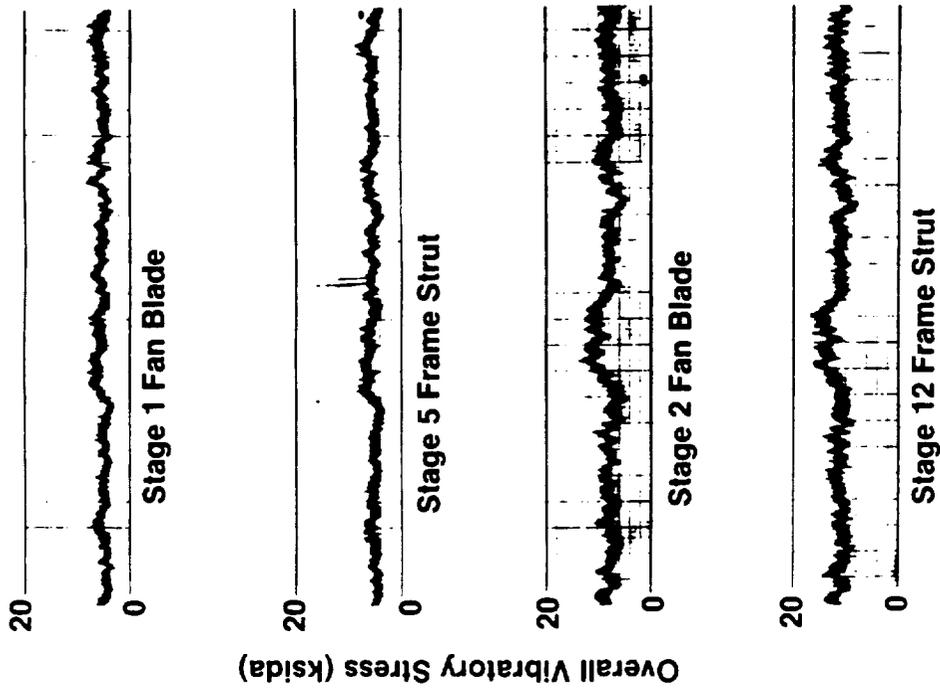
During Build 2, power turbine frame vibratory stresses were higher than predicted. The stresses were found to be predominantly 2/rev forced response. This was caused from the fan Rotor 2 nodal, first flex mode (note that the turbine frame and the fan blade rotor are mechanically linked). This causes the frame stress to track the fan blade stress. Figure 3-45 provides a stress comparison.

● **Build 2 Observations**

- Higher Than Expected Vibratory Stress
- Predominantly 2/Rev Forced Response
- Frames Track Fan Blades

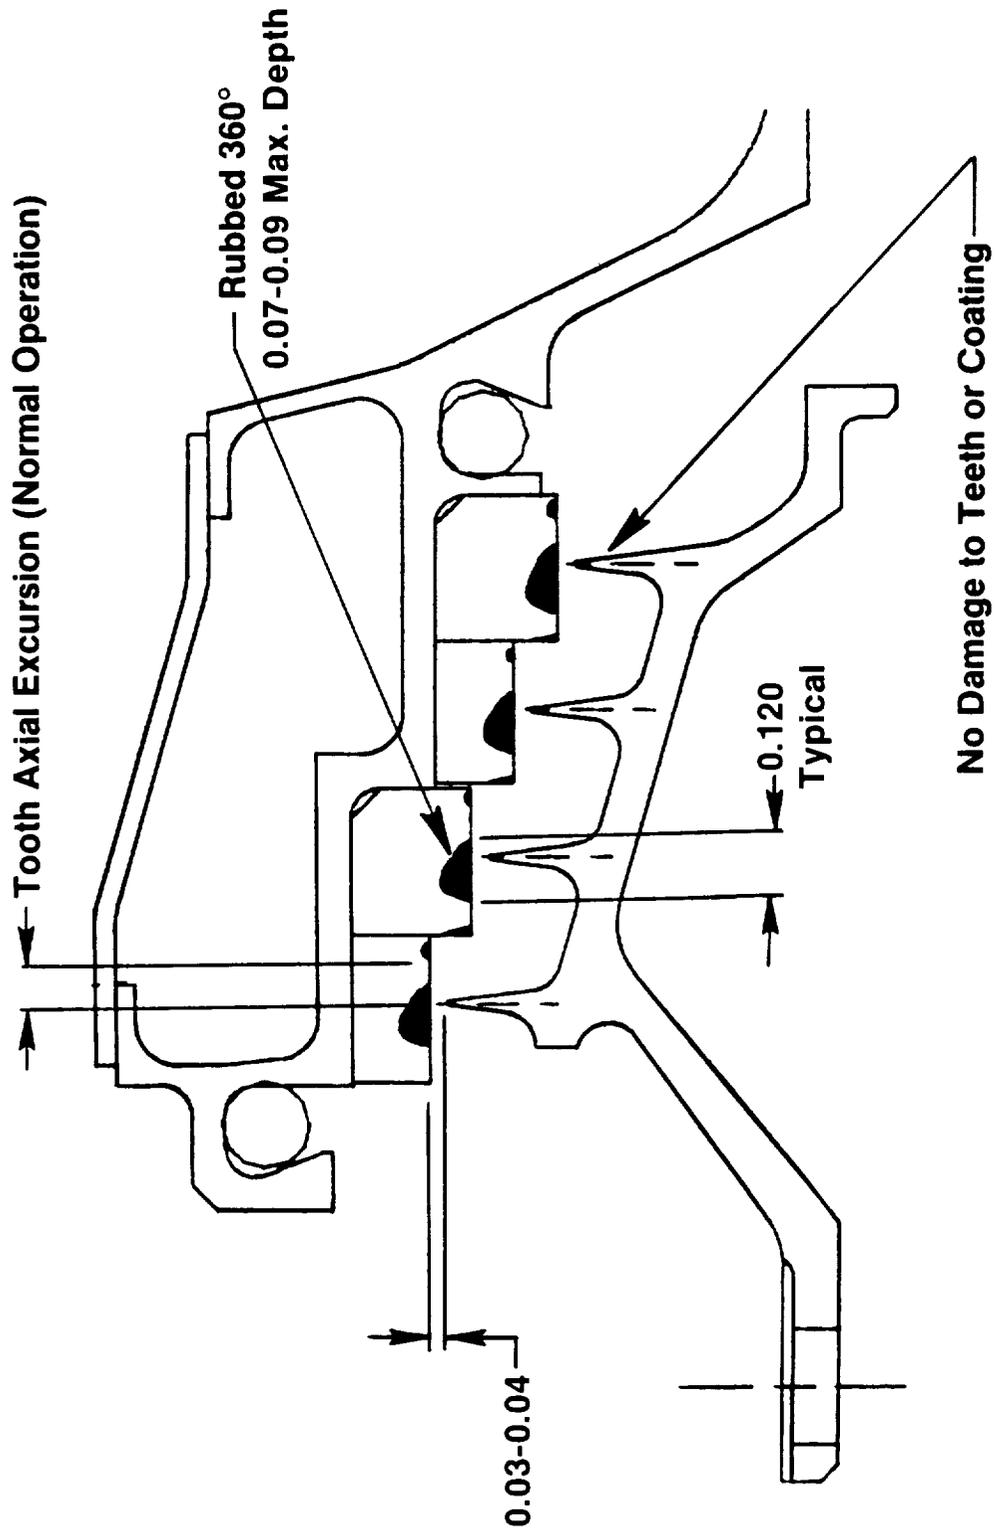
Figure 3-60. Aft Outer Flowpath Seals.

The Stage 2 polygonal ring was removed, followed by the outer seal. The seal teeth had no damage, and coating wear was normal for the engine run time. A cross-sectional view of the seal is shown in Figure 3-60.

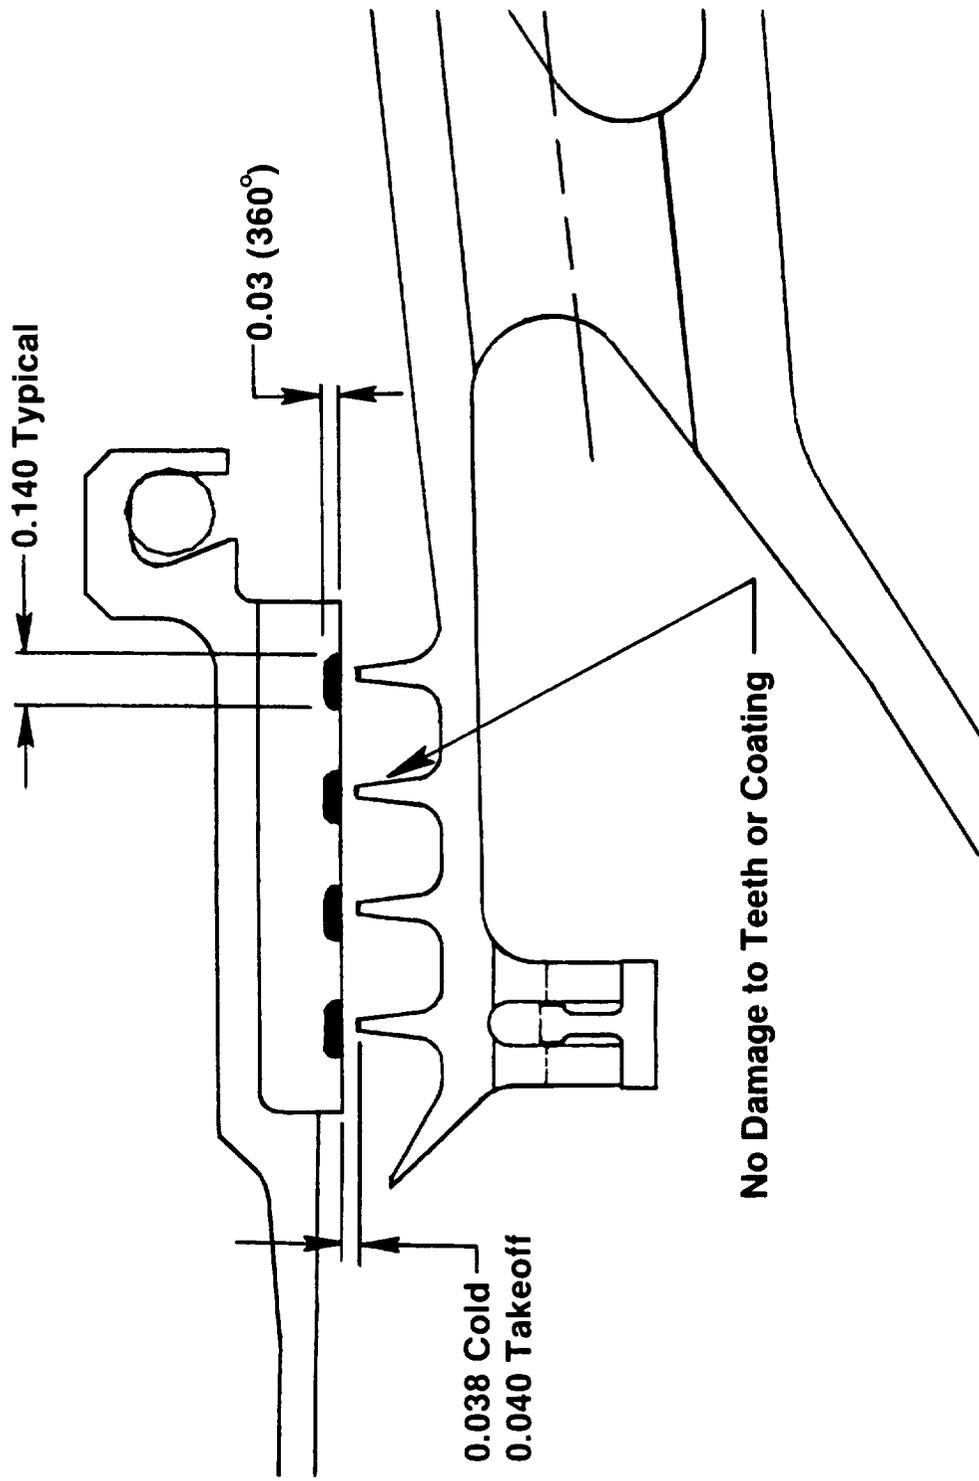
Figure 3-61. Midsump Seals.

Because the carbon seal aft of the 1R bearing, sealing the cavity, was in remarkably good condition and repairable, the seal was removed for inspection, the carbon segments were replaced, and the seal assembly installed. The mid-sump seal aft of the carbon seal had rubbed grooves about 0.14-inch long × 0.04-inch deep in the honeycomb. As shown in Figure 3-61, the honeycomb and seal teeth were all serviceable and reused.

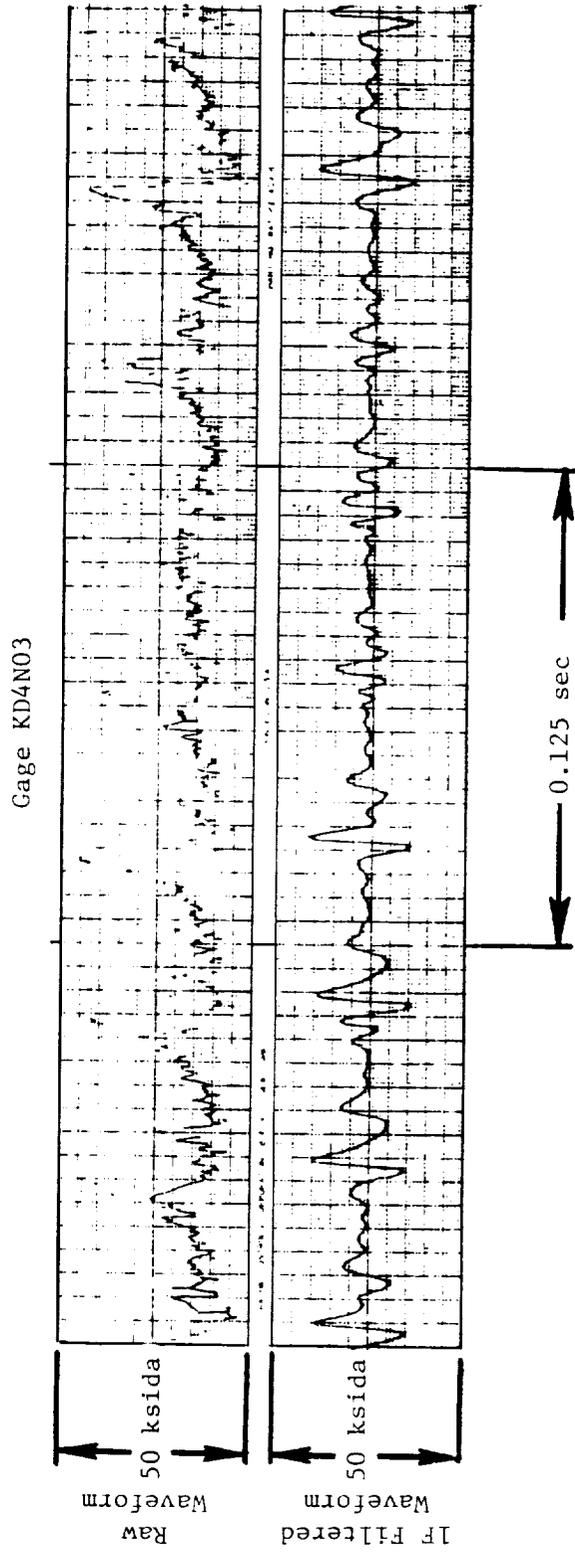
Figure 3-62. Suspected Stage 11 Rub.

All Stage 11 blades were heavily rubbed, and Stage 10 was lightly rubbed (Figure 3-62); 3 Stage 11 blades were discovered with cracks in the leading edge root, and the inner spool had evidence of a hard rub. The outer spool (odd rotor) aft stages are cantilevered from the Stage 5 power frame. If the 1R bearing were not providing adequate radial support, it would account for a rub at the aft stages of the outer spool. The 3 cracked Stage 11 blades were replaced prior to rebuild. Table 3-3 summarizes the results of the turbine blade inspection.

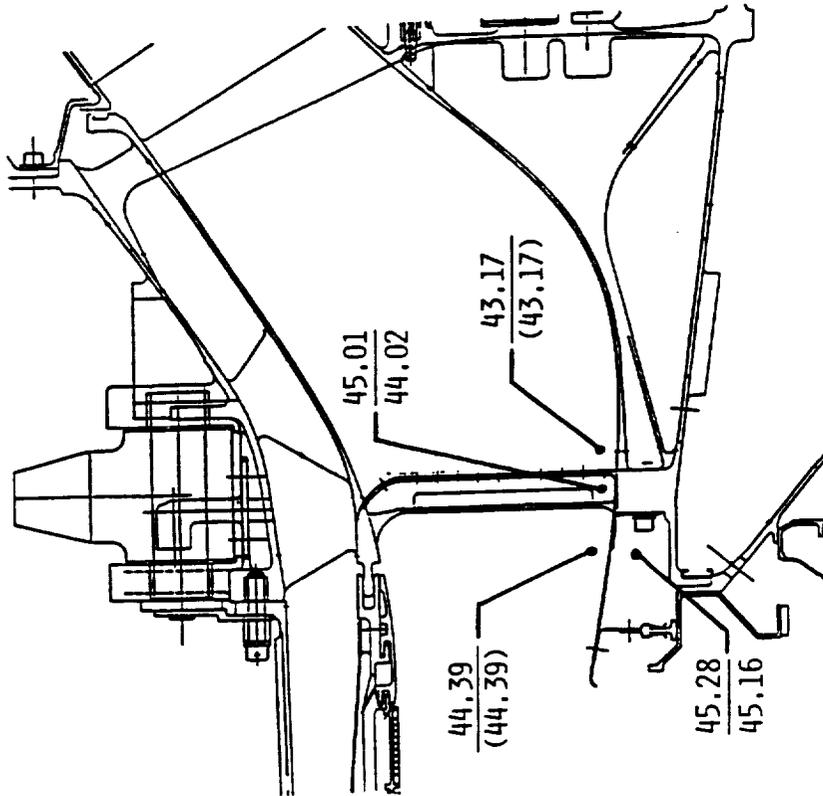
Figure 4-4. Mixer Frame Backflow Margin - Build 01 Engine.

The total pressure drop available to the frame film holes is very low, making BFM (backflow margin) a concern. The regions of minimum BFM are the inner flowpath fairing upstream of the strut leading edge and strut leading edge cavity at the root. A comparison of predicted and measured pressures for engine Build 1 is shown in Figure 4-4. While the BFM across the inner flowpath fairing film holes is slightly less than predicted, the BFM across the strut leading edge cavity film holes is much higher than predicted.

- INNER BAND BACKFLOW MARGIN IS 2.0% VS 1.7% PREDICTED.
- STRUT LEADING EDGE BACKFLOW MARGIN IS 4.3% VS 2.0% PREDICTED.
- BACKFLOW MARGIN IS HIGHER IN ALL OTHER REGIONS.
- MIXER FRAME ANALYTICAL FLOW MODEL HAS BEEN MODIFIED TO REFLECT TEST RESULTS.

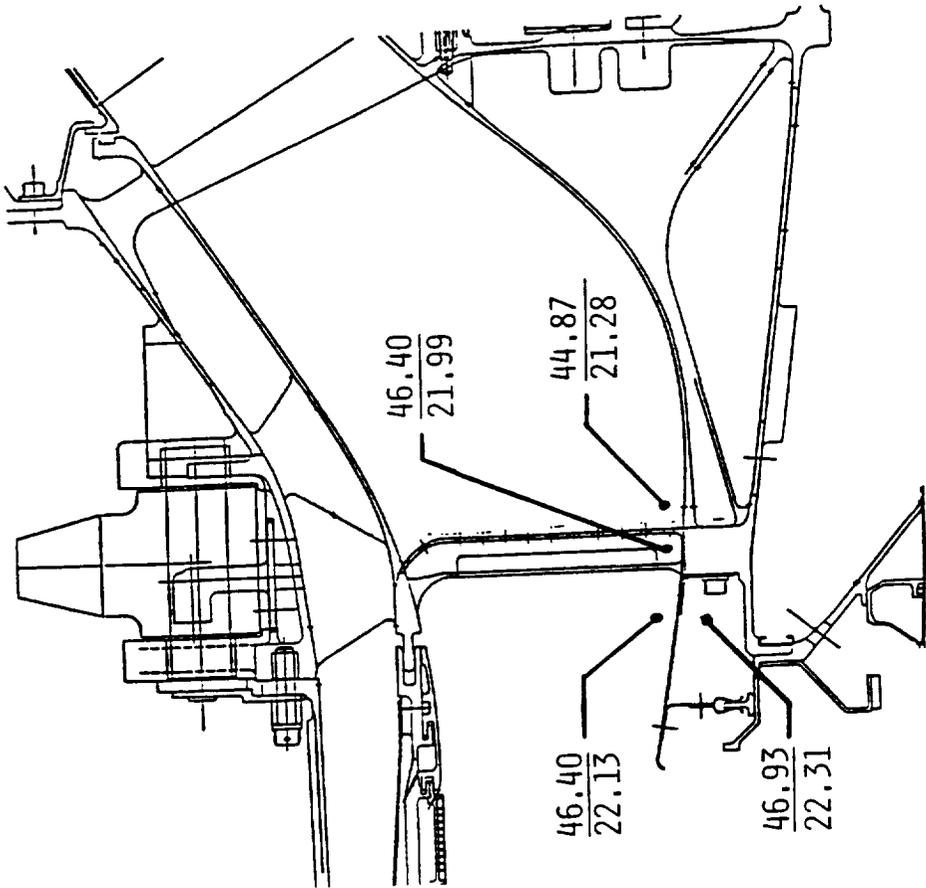
Figure 4-5. Mixer Frame Backflow Margin - Build O2 Engine.

Installation of power turbine blade dampers for engine Build 2 resulted in a lower level BFM. The inner flowpath fairing pressures for engine Build 2 are shown in Figure 4-5 for takeoff and maximum cruise, the minimum backflow condition. Takeoff pressures are taken from test data, and the maximum cruise pressures are predictions based on test results. The 0.79% BFM at maximum cruise condition is low, but it is in a very localized region. The BFM in all other regions is significantly higher.

- BFM = 1.1% AT TAKEOFF.
- BFM = .79% AT MAXIMUM CRUISE CONDITION.
- LOWER BUILD O2 BACKFLOW MARGIN IS RESULT OF LOWER POWER TURBINE FLOW FUNCTION.
- INSTALLATION OF POWER TURBINE BLADE DAMPERS.

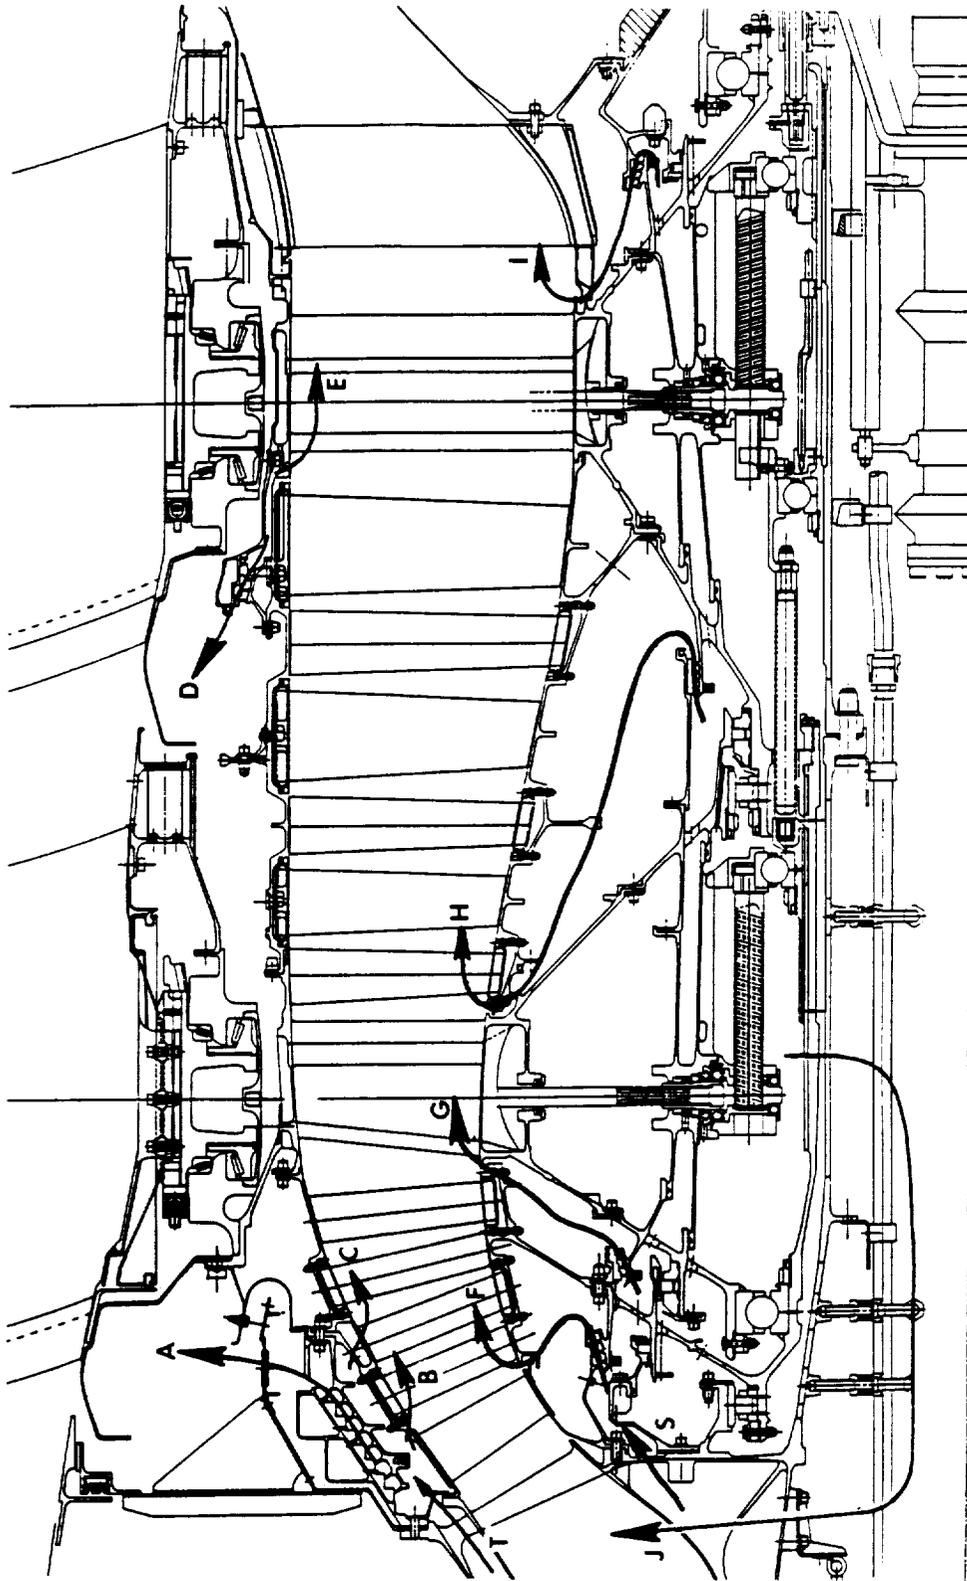
Figure 4-7. Power Turbine Secondary Flow Circuit.

Figure 4-7 illustrates the power turbine secondary flow system. The flow rates, predicted and actual, are tabulated in Table 4-1. Although the total secondary flow for engine Build 1 neared prediction, the Stage 1 inner flowpath purge flow was significantly lower than predicted. This redistribution of flow is a result of a mixer frame supply hole flow coefficient that is lower than predicted and shafting hole flow coefficients that are greater than predicted. The increased pressure drop across the mixer frame supply holes, combined with reduced pressure drop through the shafting annular holes, serves to lower the supply pressure to the forward seal. Also, the sump vent flow was higher than predicted due to large carbon seal leakage areas. This additional vent flow results in a further decrease in Stage 1 purge flow.

During Build 3 engine testing, rubs occurred on two middle inner flowpath seals (G and H). There is an increase in the flows of these two seals, but because the system is metered for the most part by the supply hole and the shafting holes, the total secondary flow increases only slightly (Figure 4-7).

Extrapolation of the test data indicates that for Build 1 testing, backflow could occur at maximum power. To maintain positive flow in all cases, the mixer frame supply hole area was increased from 5.4 in² to 5.84 in². The resulting increase in forward seal ΔP from Build 1 testing to Build 2 testing is significant (Figure 4-8); however, the impact of this area increase on the remaining purge flows is negligible. The aft labyrinth seal flow increased significantly from Build 1 to Build 2 testing, presumably due to an increased seal clearance, indicated by a reduction in pressure drop across the seal.

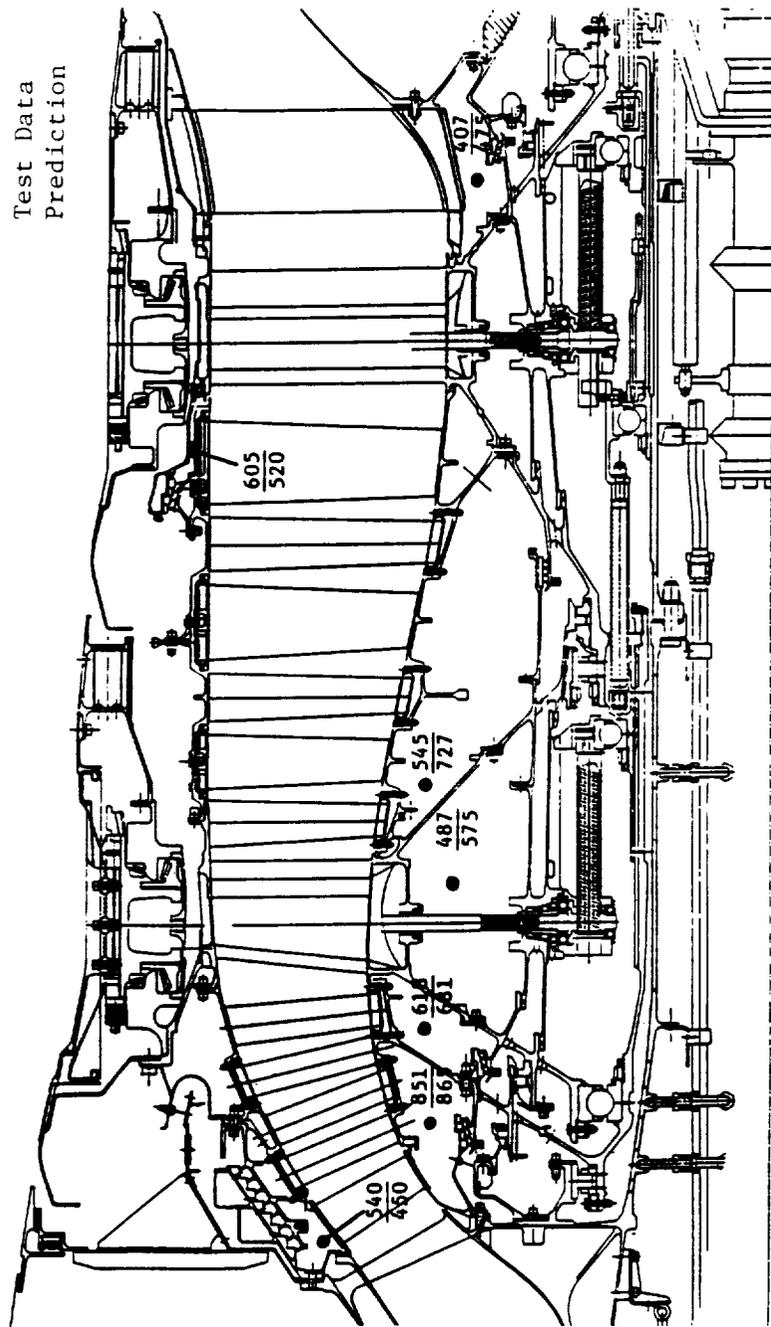
Figure 4-9. Rotor Cavity Temperatures at Takeoff Power.

According to thermocouple data, all cavities are adequately purged. A comparison of predicted and actual temperatures is presented in Figure 4-9.

- Test Data Corrected to Hot Day Takeoff
- Inner Cavity Temperatures Are Below Prediction
- Outer Flowpath Seal Packing Air Temperature Is Above Predicted
- No Evidence of Gas Ingestion.
