FULL SCALE TECHNOLOGY DEMONSTRATION OF A MODERN COUNTERROTATING UNDUCTED FAN ENGINE CONCEPT

ENGINE TEST

December 1987

by
GE Aircraft Engines
GE36 Project Department
Cincinnati, Ohio 45215

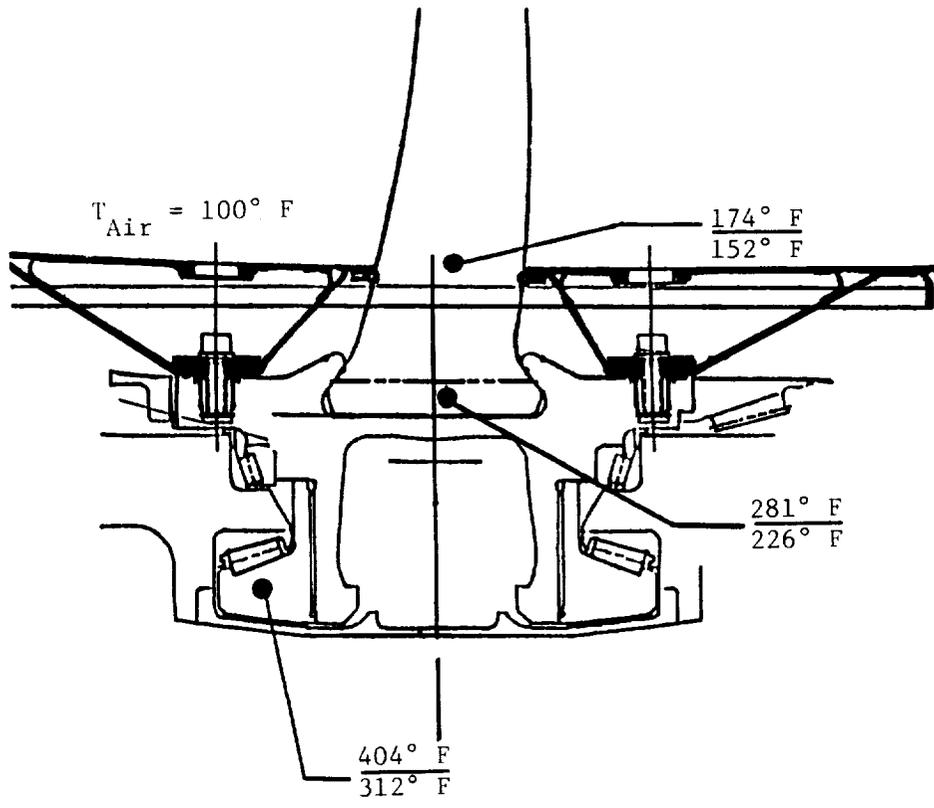
Figure 4-13. Forward Fan Blade Hub Temperatures; Hot Day Takeoff, Mach = 0.0, Full Thrust.

Figure 4-13 gives a breakdown of the forward fan blade hub temperatures for hot day takeoff. The 404° F trunnion temperature is taken from thermocouple data. All other temperatures are determined by rebalancing the heat transfer model on the basis of the trunnion temperature. All temperatures are higher than predicted, but are still within allowable limits.

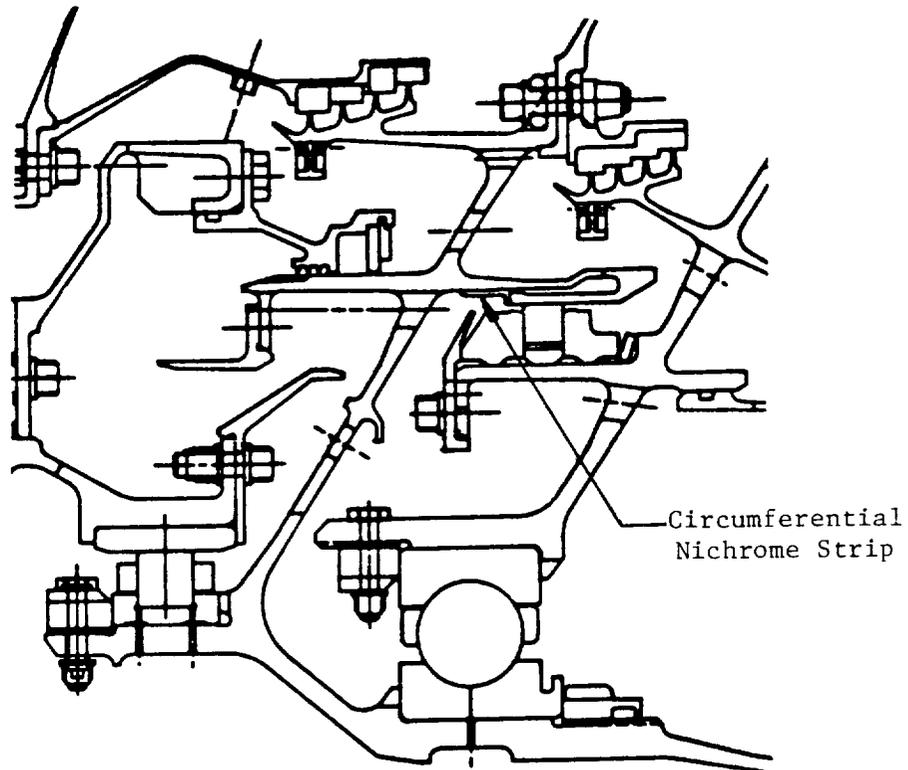
Figure 6-1. Seal Cavity Closure.

The two roller bearings were replaced twice during ground testing when they were exposed at disassembly. They were replaced because debris damage had scored some of the rollers. The debris was comprised almost exclusively of 0.007-inch-diameter steel shot particles, with some other manufacturing and wear debris present in very small quantities. Prior to engine teardown, oil sample analysis had identified the possibility of a debris problem.

Causing extensive scoring of the rollers, the shot became imbedded in the soft silver plate of the rolling element retainer of the bearing. This would cause both a breakdown of the hydrodynamic lube film because of the high loads and low rotational speeds and a diminished fatigue life. However, no surface distress due to rubbing was observed.

To prevent further debris damage, the blind cavity was ultrasonically cleaned and sealed closed with a nichrome strip (Figure 6-1). This was fairly successful, although one or two pieces of shot were still found in subsequent oil samples.

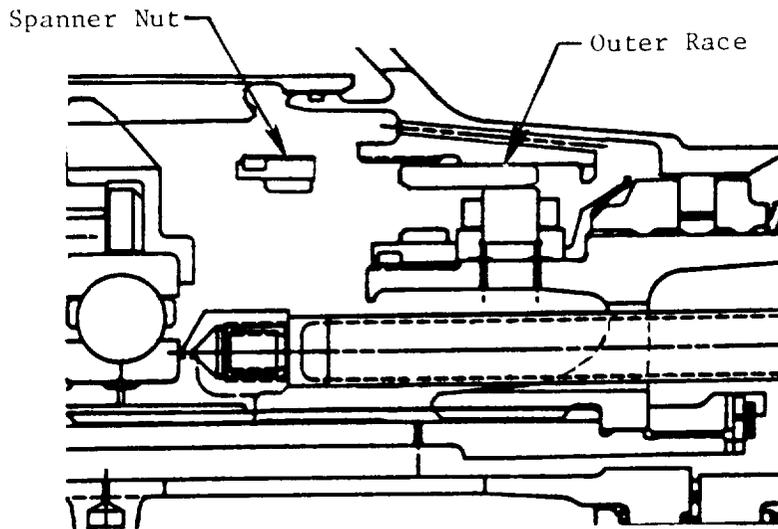
Figure 6-2. Possible Running Condition with 1R Spanner Nut Loose.

The outer ring retention nut of the 1R intershaft bearing came loose and completely disengaged during the final stage of ground testing; this permitted axial movement of the outer ring.

The nut is believed to have jammed the actuation system preventing blade-angle adjustment. On teardown, forward and aft rotors could not be separated in the normal disassembly sequence. This was caused by the rollers no longer being in contact with the outer raceway. Borescope inspection prior to disassembly had shown the rollers still engaged, so running in this disengaged condition had not occurred. When the rotors were separated, the bearing was found to be in remarkably good condition, except for the damage to the roller corners caused when the rollers dropped into the region of the outer shaft, from which the ring had moved, and hung up on the shaft shoulder (Figures 6-2 and 6-3).

Examination of the spanner nut indicated no obvious thread damage, and the Vespel insert retention feature appeared undamaged. The appearance of the raceway did not indicate any running off the normal roller path; however, some coning was indicated. The shaft coning was in the direction to move the shaft radially away from the nut, and the wedge effect would exert an axial force on the nut in the direction to promote untorquing. There was no damage from ring spinning on either the outer ring OD or the shaft bore.

For subsequent engine testing, a hole was line-drilled axially in the thread, and a roll-pin was mechanically locked in the thread to prevent the nut becoming untorqued (Figure 6-4).

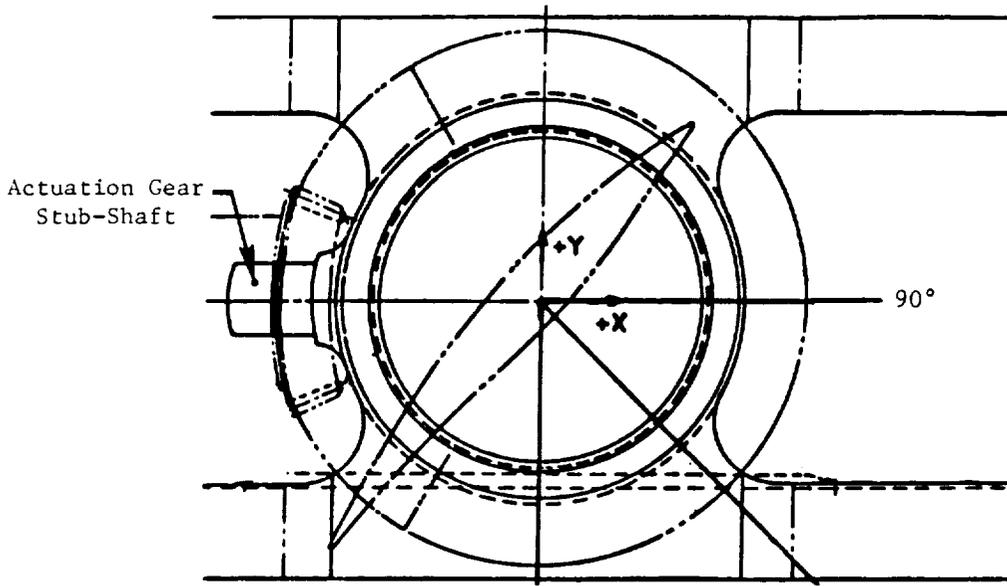
Figure 6-6. Bearing Housing Deflection.

The roller wear paths on the raceway of the cup and cone showed evidence of bearing distortion due to the unsymmetrical loads caused by the housings deflecting, as was predicted by finite element analysis. The bearing cone had been made more flexible to compensate; however, even the cone bending was not enough to provide an even loading. Deflection analysis was performed using a lighter blade weight than we currently have (Figures 6-6 and 6-7).

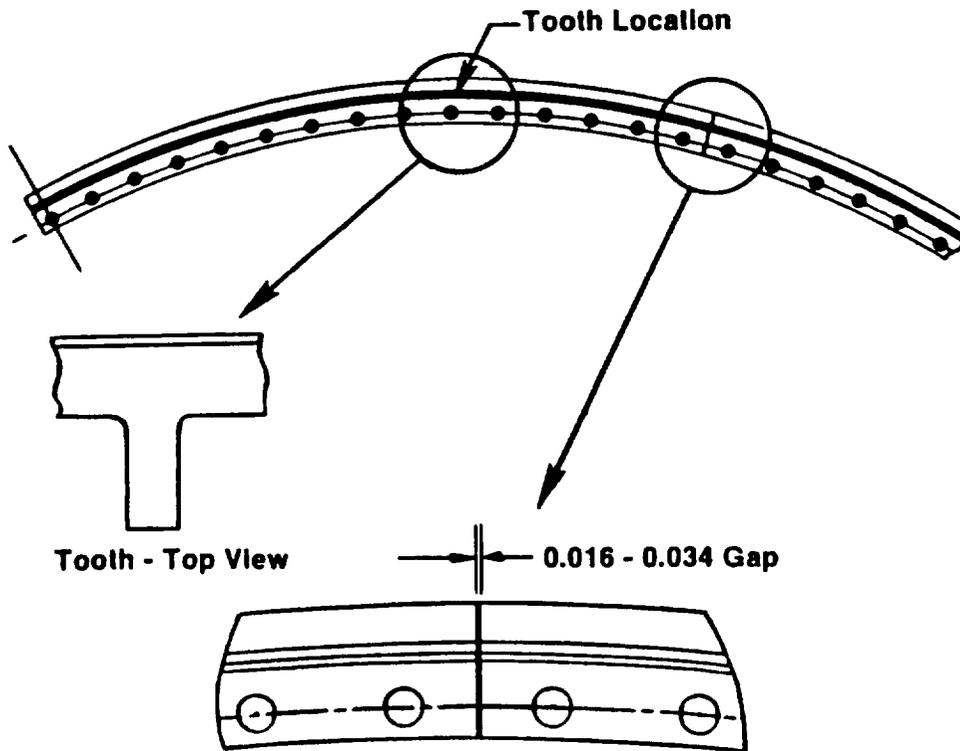
Figure 9-1. Fan Speed Sensor Segments.

During Build 1 testing, it was discovered that the speed being sensed by the control for the forward propulsor rotor (XN48) was incorrect. A further study as to the cause showed that the gaps in the target wheel, which was divided into eight segments, were inducing a superfluous signal onto the magnetic speed-sensing pickups (Figure 9-1). This caused a higher sensed speed, up to two times actual. The situation was initially corrected by a change in speed signal processing. A more elegant solution was identified for implementation on Build 2. This solution consisted of locating the teeth on the target wheel directly at the segment gaps (Figure 9-2).

- Original Design
- **8 Segments Total**
- **1 Tooth Centered In Each Segment**

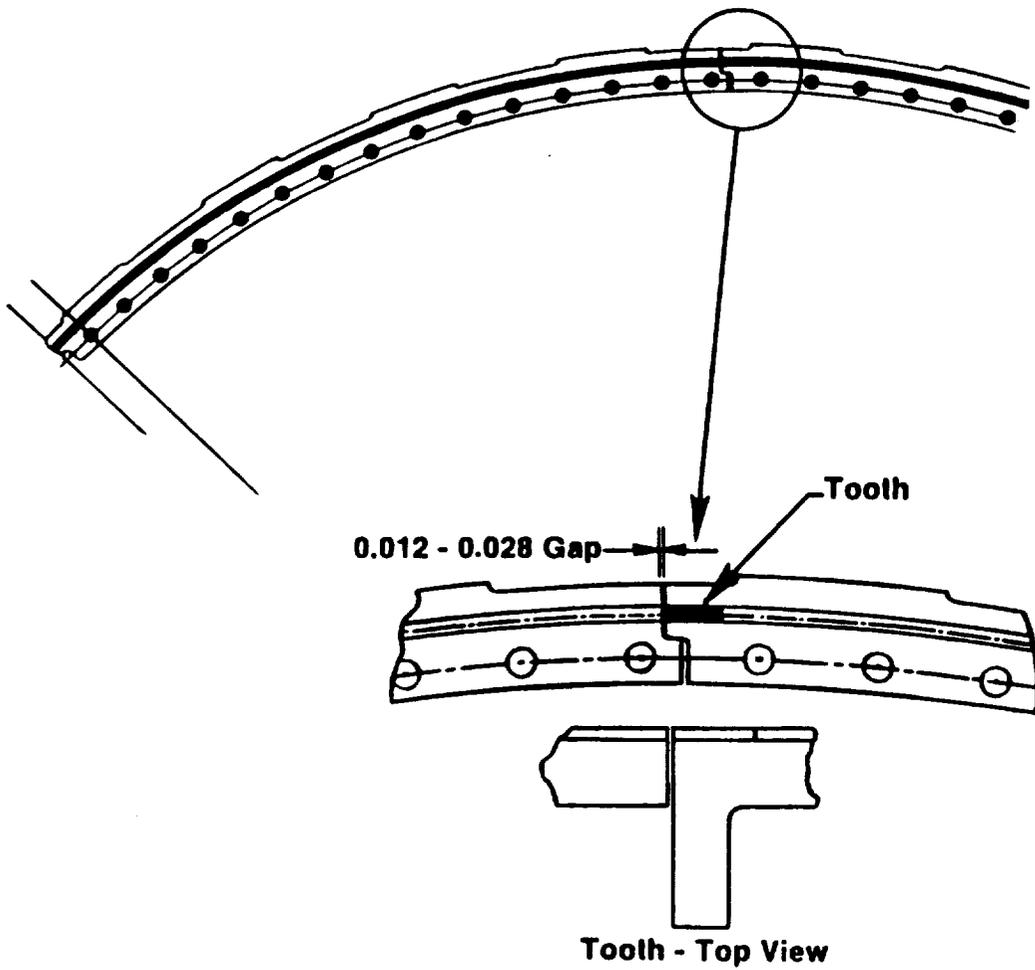
Figure 9-2. Fan Speed Sensor Segments.

- Redesign
- **8 Interlocking Segments**
- **1 Tooth Per Segment**
- **Tooth Positioned On End**
- **Gap Width Reduced**

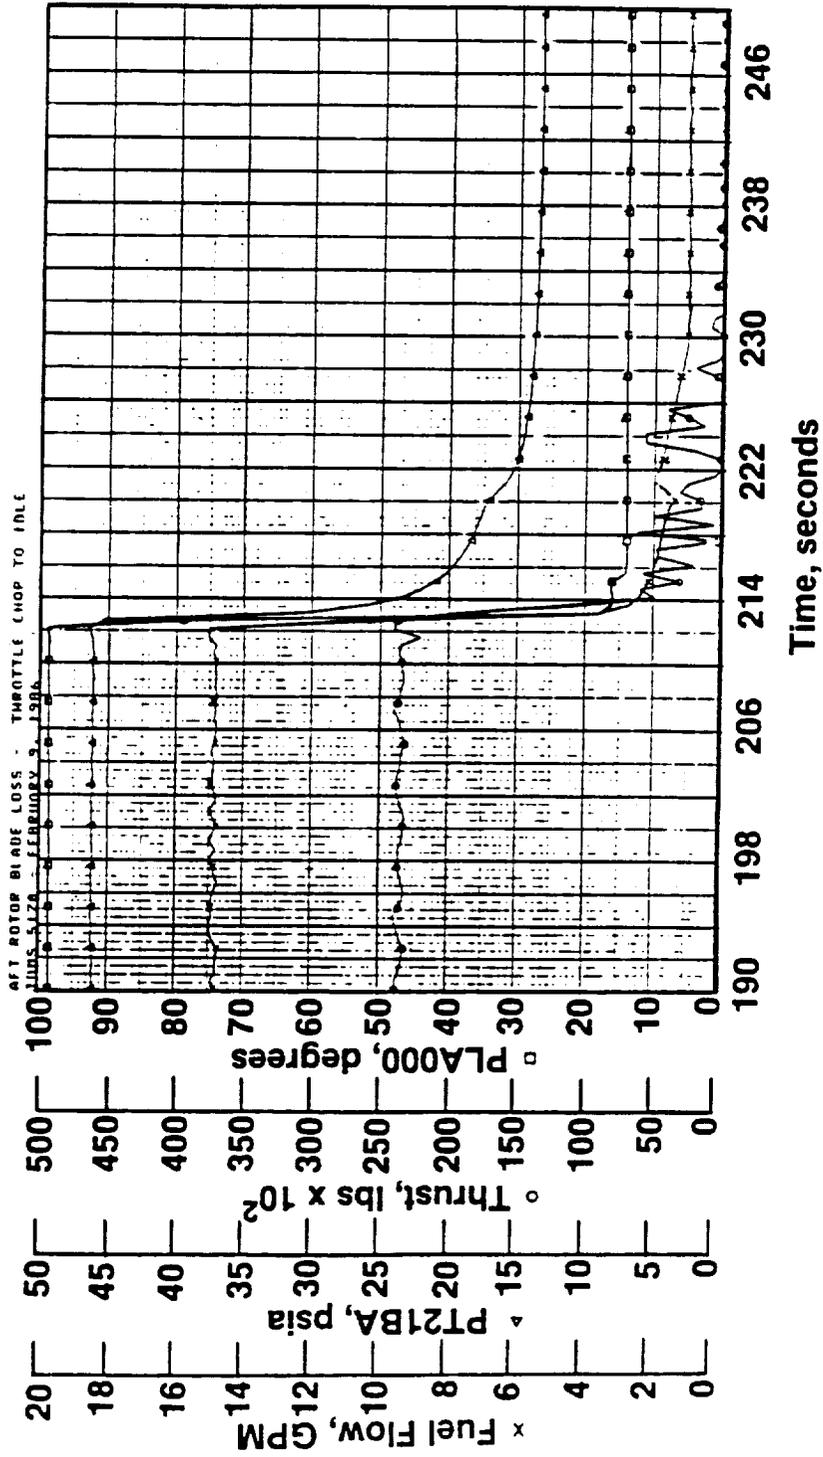
Figure 9-4. Throttle Chop Decels.

As a result of the blade-out incident, the engine was chopped from 24,000 corrected thrust to idle, then stopcocked approximately 10 seconds later. As illustrated in Figures 9-4 through 9-8, the control system maintained complete control during the blade-out, chop to idle, and subsequent stopcock.

- 24,000 F_N/∂ to Idle
- Blade Out Incident

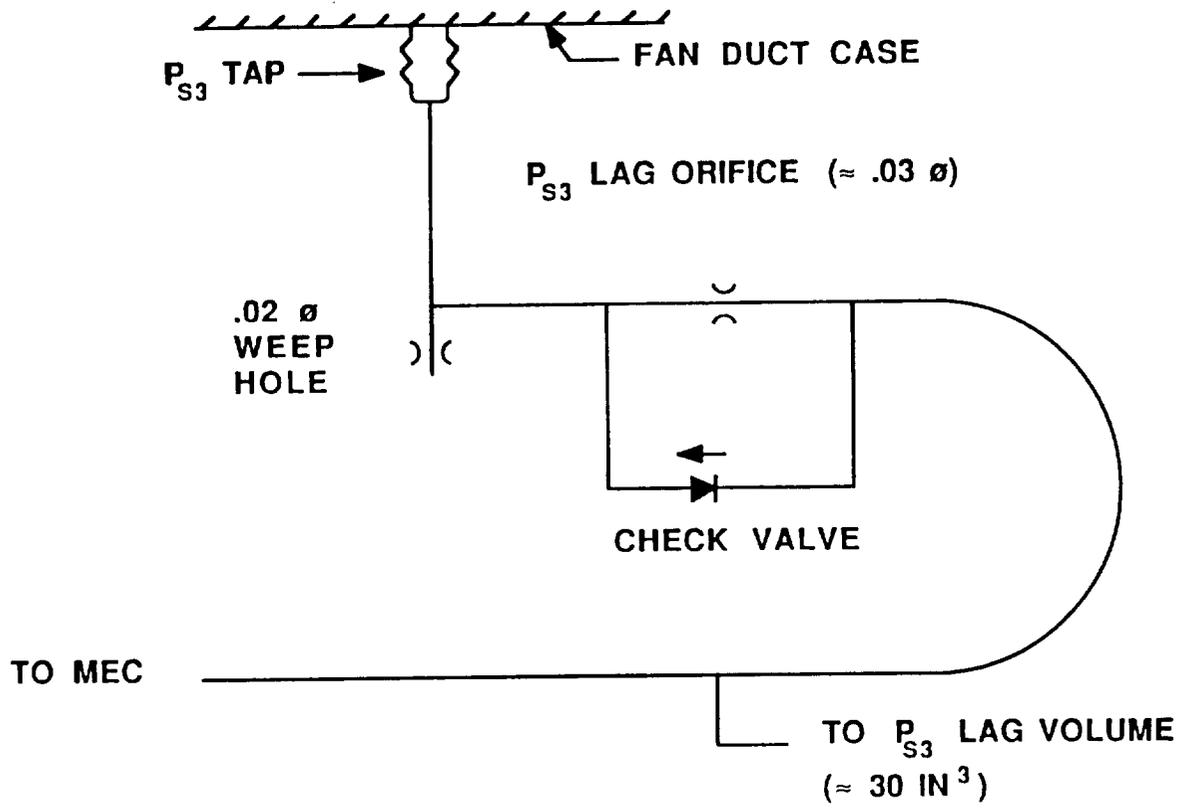
Figure 9-13. P_{S3} Accumulator Configuration.

A limited number of small, part, and full power throttle chops and small part power accelerations were performed. During a throttle burst from idle to 1150 rpm, an overspeed incident occurred. It was determined to have been caused by the fan pitch actuator becoming force-limited due to a too rapid response time of the gas generator. A fix was identified to slow down the accel rate of the core by putting an accumulator on the CDP (compressor discharge pressure) sensing line to the HMU. A preliminary fix was installed on the engine which adequately slowed the core accel rate. A more polished design was used on Build 3.

The gas generator response time was reduced with an orifice/accumulator system (Figure 9-13) in the CDP (compressor discharge pressure) line to the HMU (hydromechanical unit) and a control rate control. This modification was due to an overspeed incident caused by a force-limited actuator. The orifice/accumulator was sized to give an 8-second idle-to-rated-thrust response.

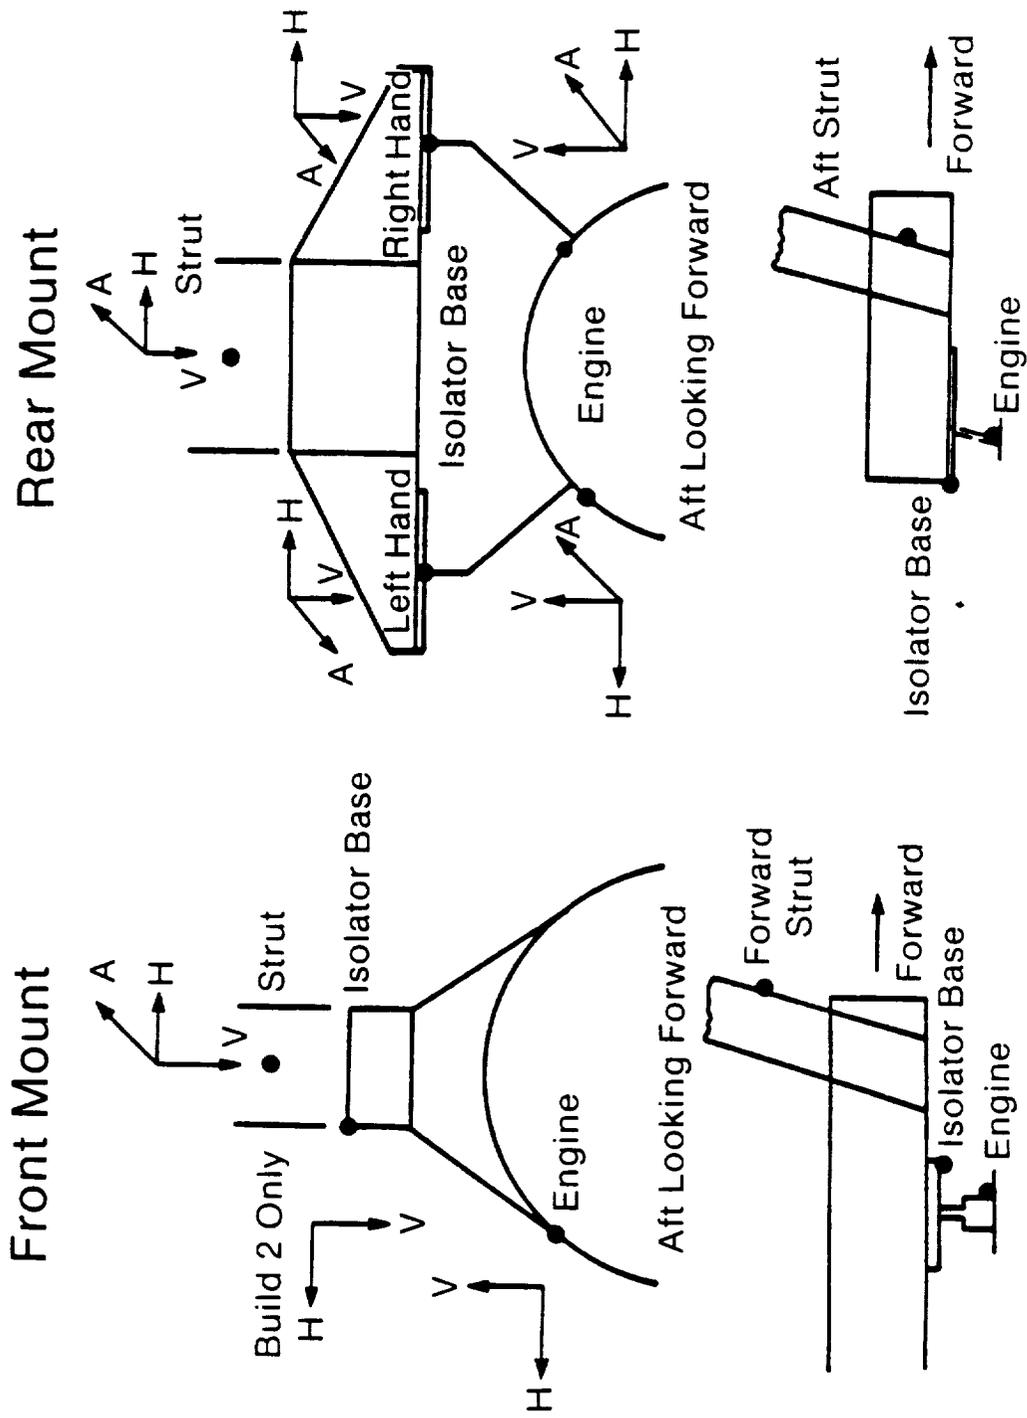
Figure 10-1. UDF™ Engine 082-001 Accelerometer Definition.

The fan blade airfoil loss incurred on February 9, 1986 caused a 262,000 gm-inch (577 lb-inch) unbalance load. This failure occurred at a fan speed of 1371 rpm and a thrust level of 24,000 pounds. Engine, isolator, mount beam, and strut accelerometers were located as shown in Figure 10-1.

At blade-out, the rear-mount horizontal vibration level reached 200 mils double amplitude, while its normal level is 10 mils. The front mount along the horizontal axis reached 95 mils, while its normal level is 15 mils. The engine was then chopped to idle (680 rpm) in 1.23 seconds, where it remained for 9.0 seconds before being shut down. Vibration levels of the vertical axes of the front and rear mounts reached 200 mils DA (double amplitude) from their normal levels of 2 mils each. As attested in Table 10-1, the maximum vibration levels occurred in the rigid body modes during coast down.
