**NASA**  
**Reference**  
**Publication**  
**1239**

# Failure Behavior of Generic Metallic and Composite Aircraft Structural Components Under Crash Loads

Huey D. Carden  
and Martha P. Robinson

Huey D. Carden  
and Martha P. Robinson  
*Langley Research Center  
Hampton, Virginia*

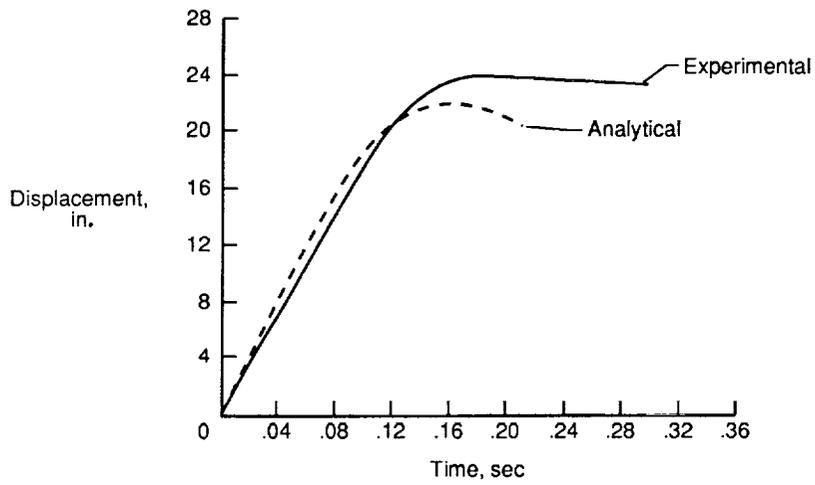
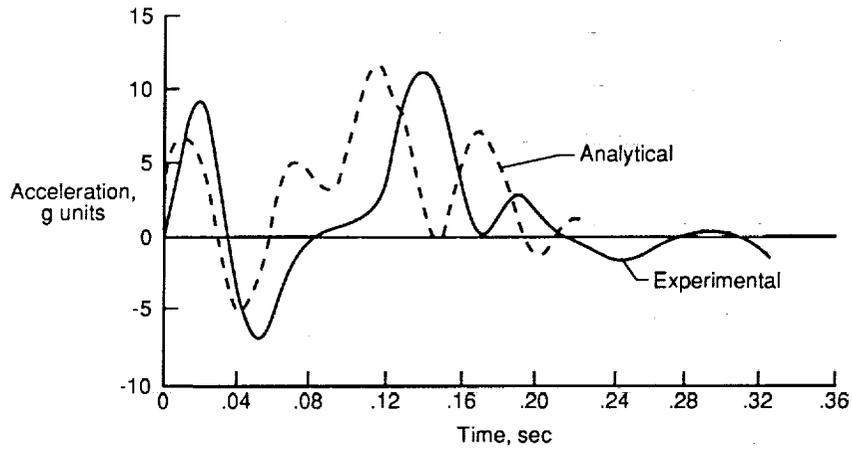
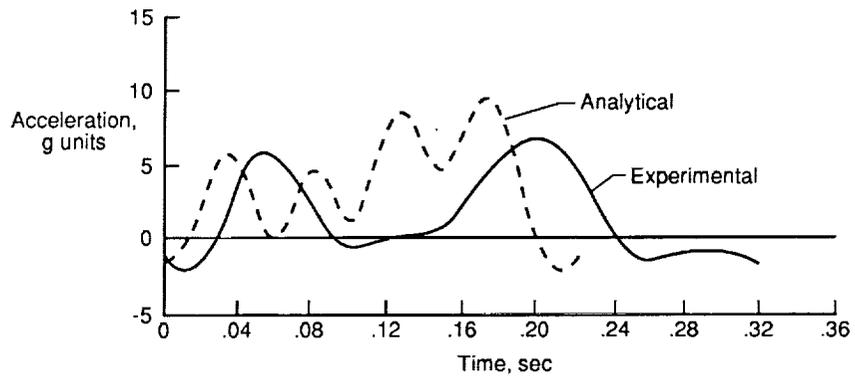
A comparison of the analytical predictions of the two-frame model and full-section experimental responses is shown in figure 13. As shown in the figure, the correlation of vertical displacements and wall/floor and dummy pelvis accelerations are considered good. Figure 14 shows the deformation pattern of the two frame model. As may be noted, the overall impression from the analytical model deformation pattern is quite similar to the behavior seen in the experiment with the full-section shown in figure 11. Thus, the full-section behavior was basically contained in the two-frame model.

Figure 13. Comparison of experimental and analytical fuselage crushing and accelerations of metal transport section.

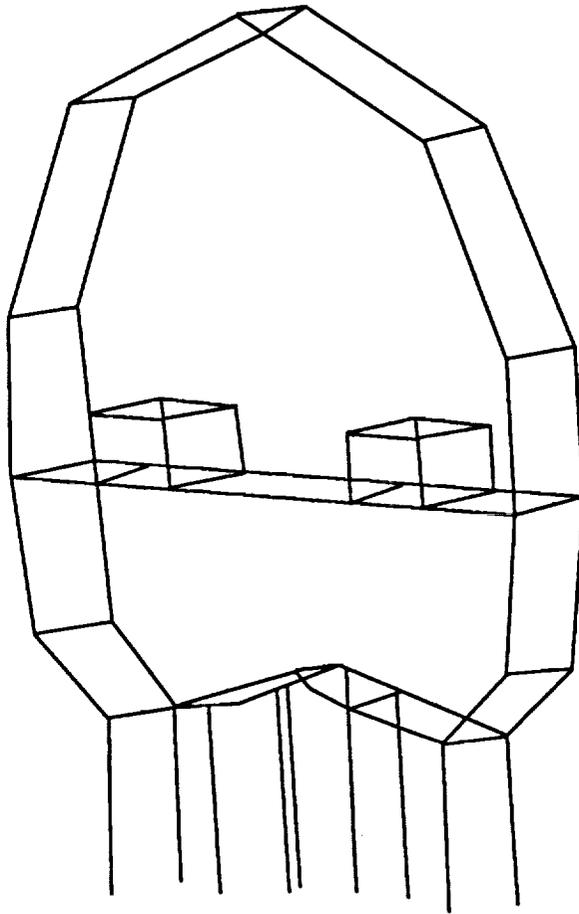
Figure 14. Deformed model showing analytical failure of metal transport section.

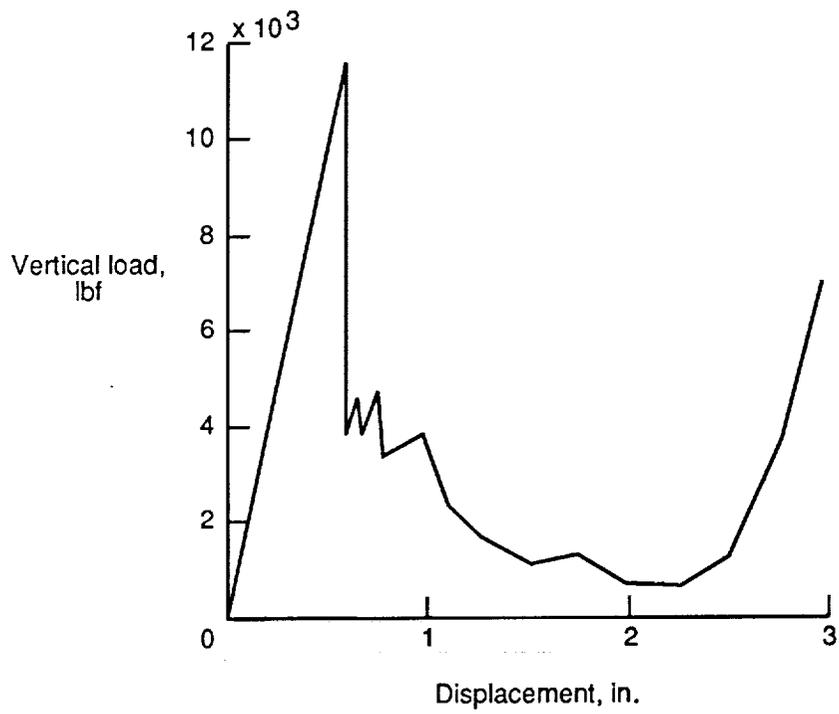
(a) Load deflection of composite panel.

Figure 15 shows the failure behavior and the static load displacement data for the corrugated frame/skin specimen from the ACEE program. Figure 15(a) indicates that the load increased linearly to failure, whereupon the load dropped substantially as a result of fracturing of the corrugated frames at locations ( $0^\circ$  and  $6.2^\circ$ ) near the center (loading region) of the panel. Additionally, some delamination of the frame caps occurred during the loading. Once the panel was removed from the test apparatus, the snap-through condition of the skin was reversed, as may be noted in figure 15(b). The fractures of the corrugated frame and some delamination of the frame caps, mentioned above, are the only visible damage to the structure.

Figure 15. Static results for composite frame/skin panel studies.

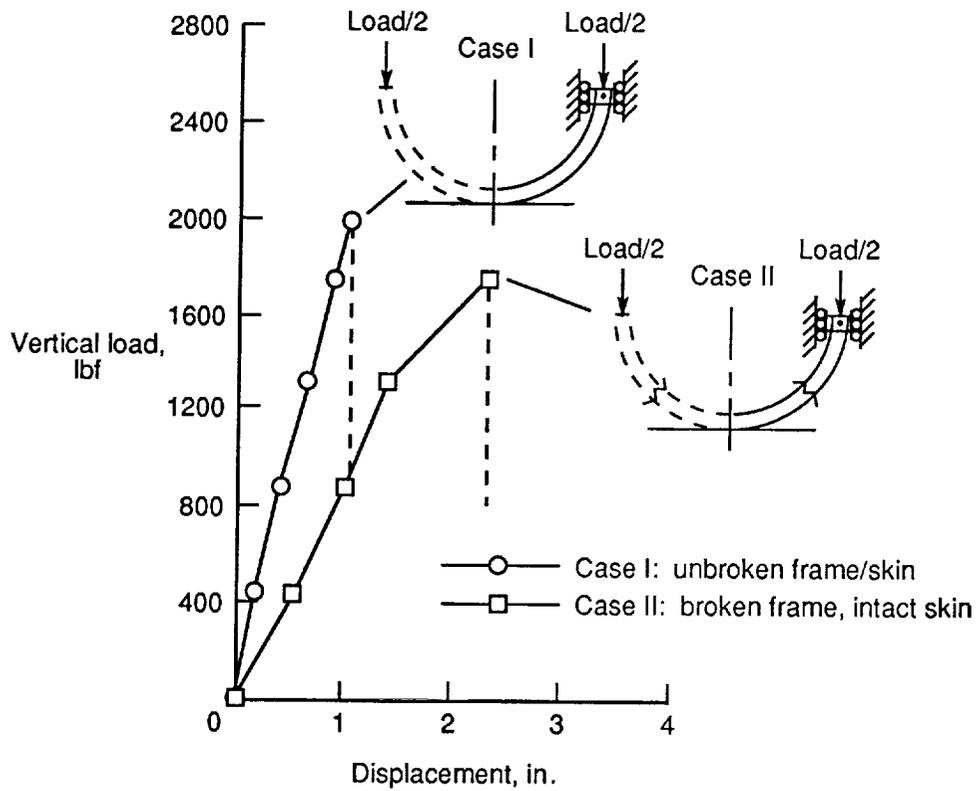
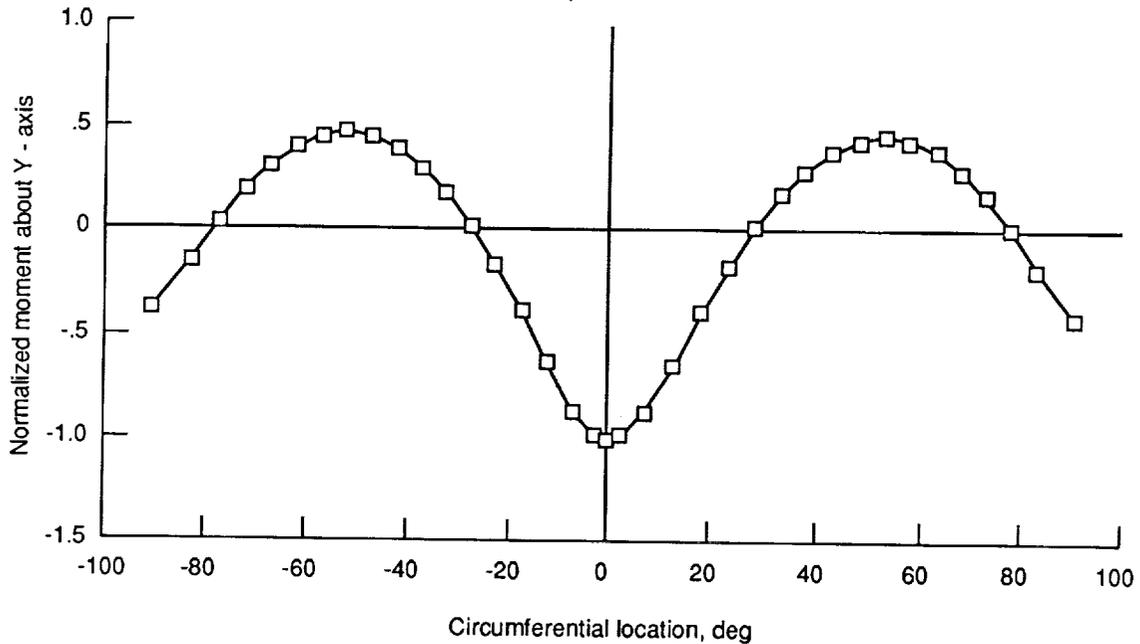
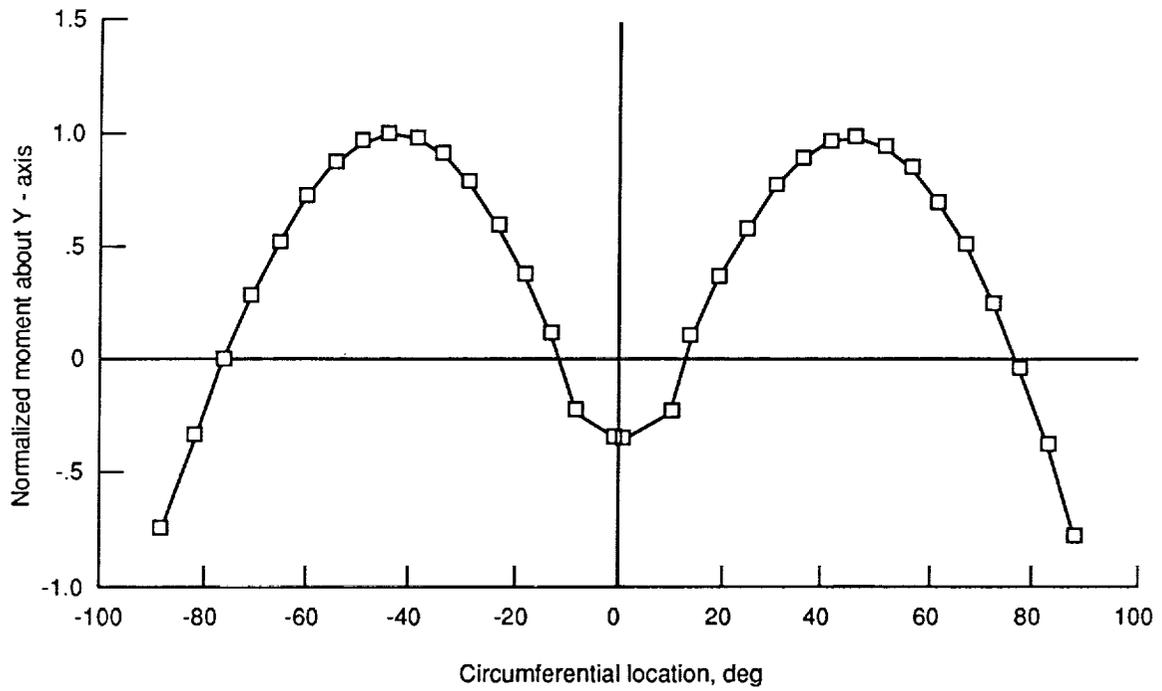
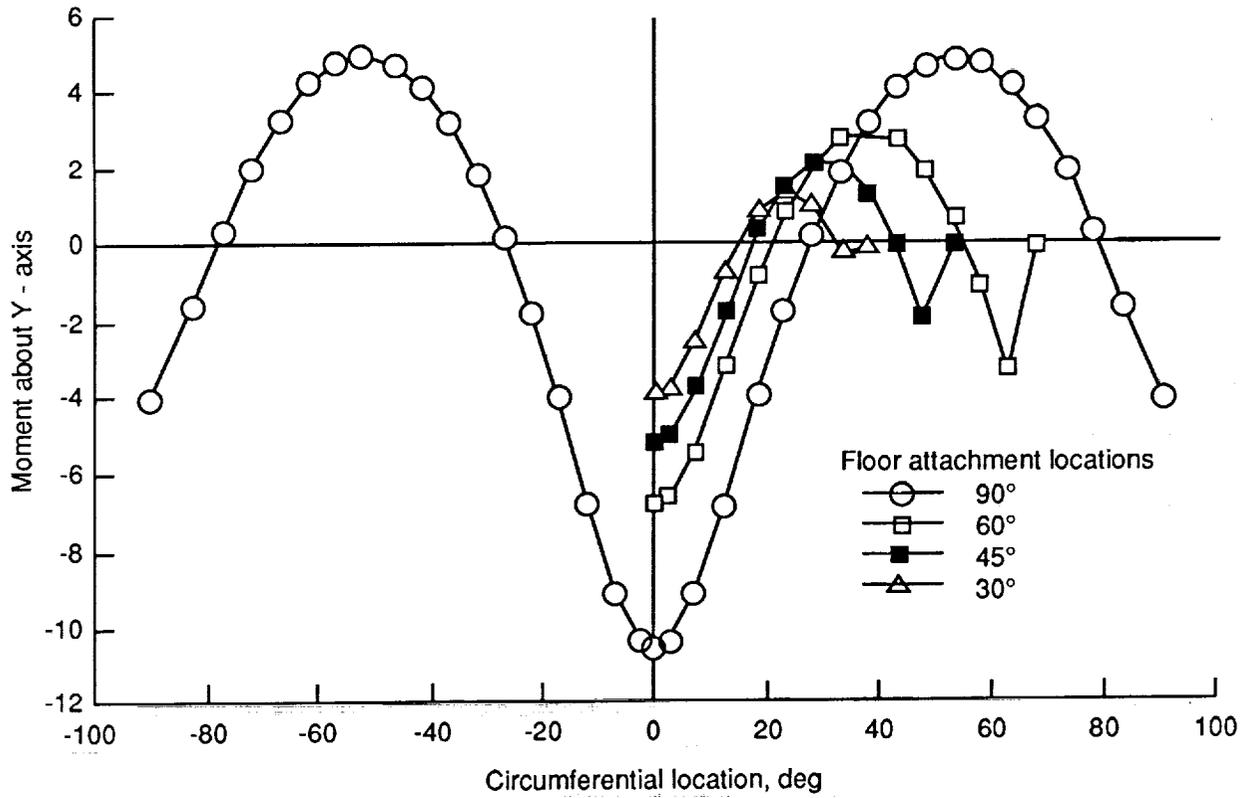
Figure 17. Typical analytical results for composite skinned frame using I-section frame for ease of analysis.

Figure 17. Concluded.

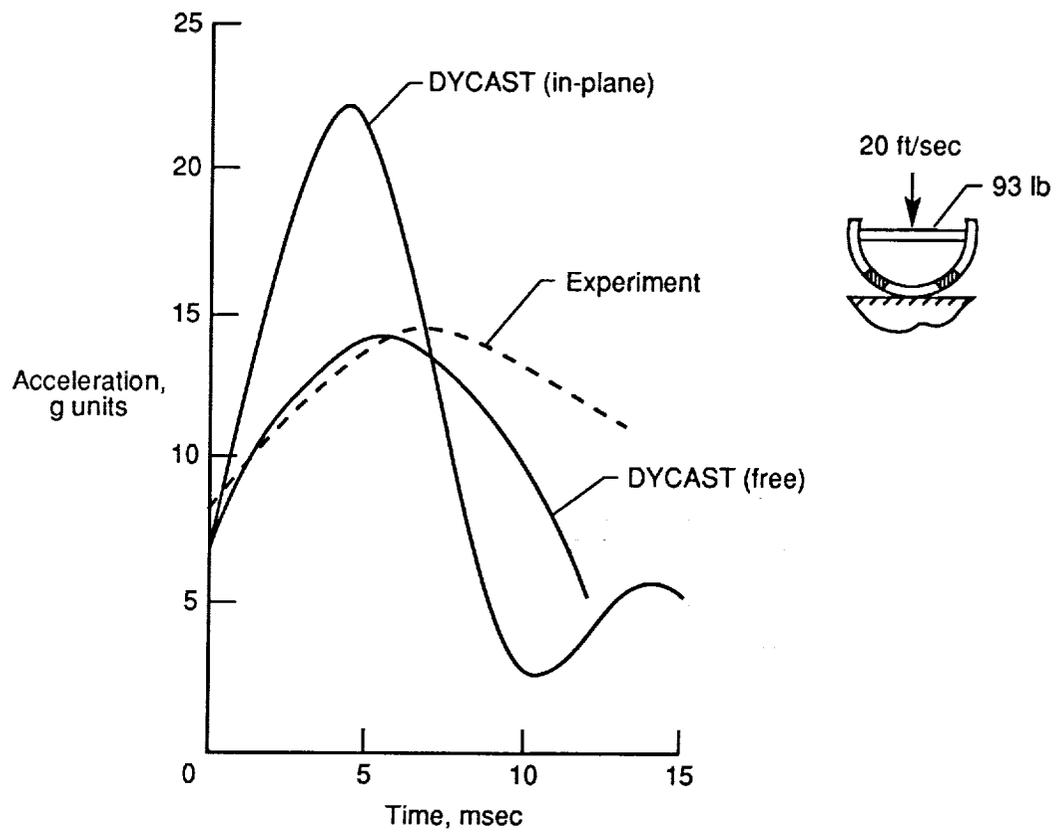
Figure 19. Comparison of experimental and analytical composite Z-frame accelerations.

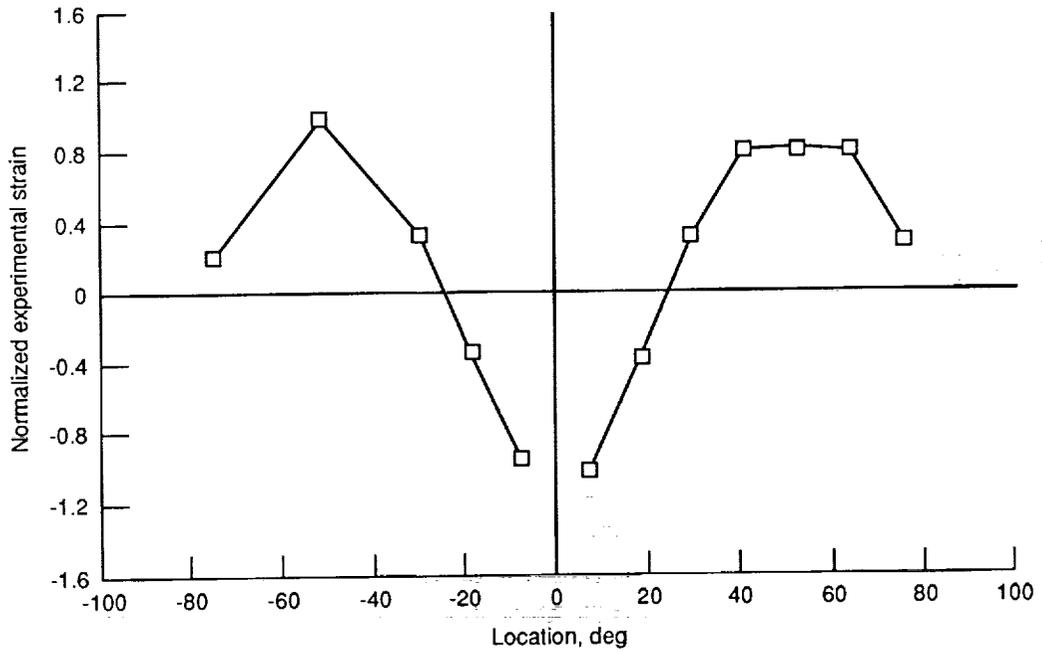
(c) Normalized circumferential strain distribution. Frame A.

Figure 21. Concluded.

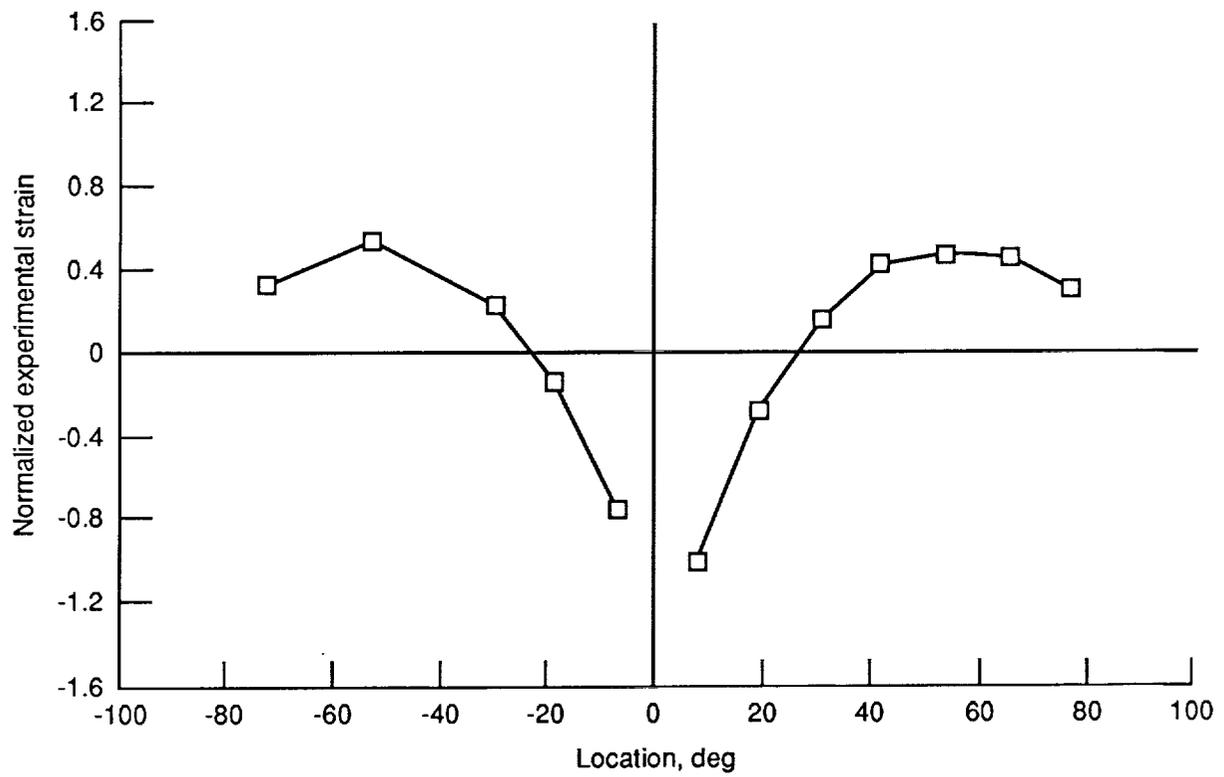
(c) Normalized circumferential strain distribution. Frame A.

Figure 22. Concluded.

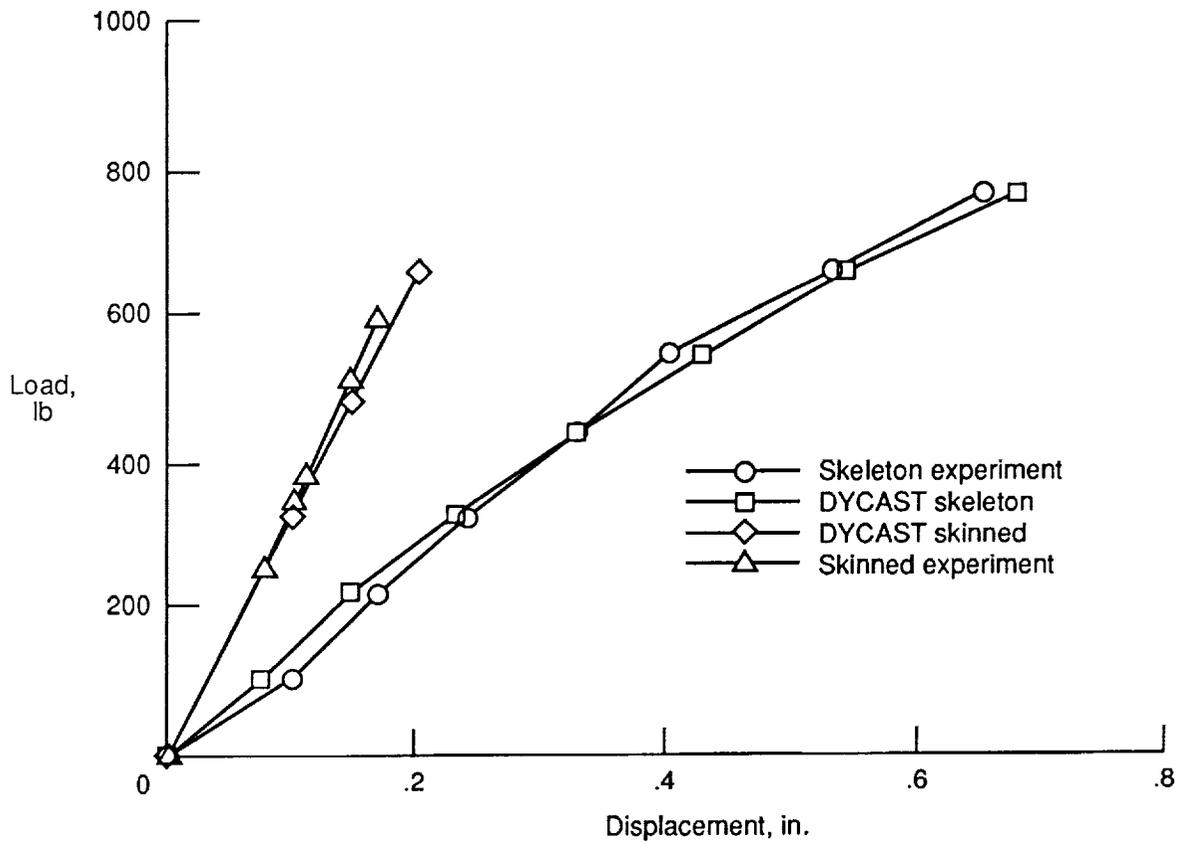
Figure 23. Comparison of experimental and analytical stiffnesses of skeleton and skinned composite subfloors.

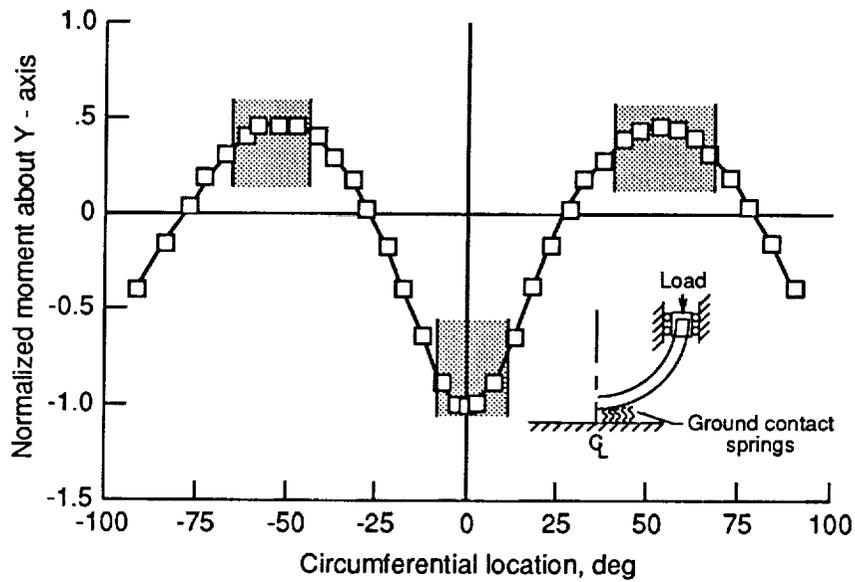
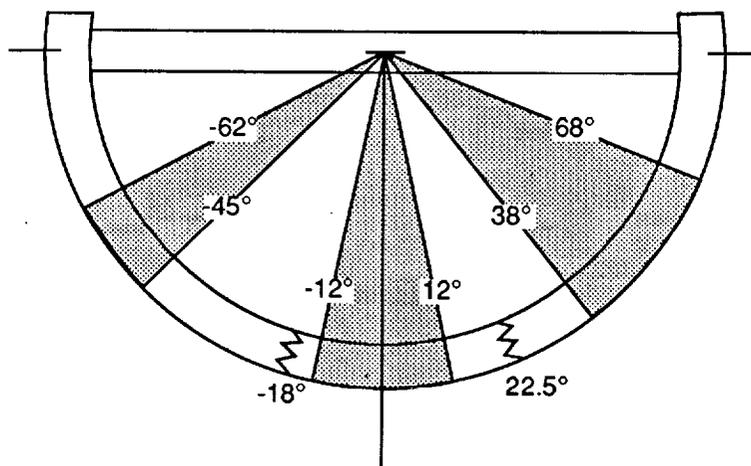
Figure 24. Comparison of nondimensional analytical moment distribution predicted by finite element frame model and observed failure locations (indicated by shaded regions) on metal and composite fuselage components and structures.
