Debris/Ice/TPS Assessment And Photographic Analysis For Shuttle Mission STS-37

April 1991

Gregory N. Katnik
NASA/Kennedy Space Center

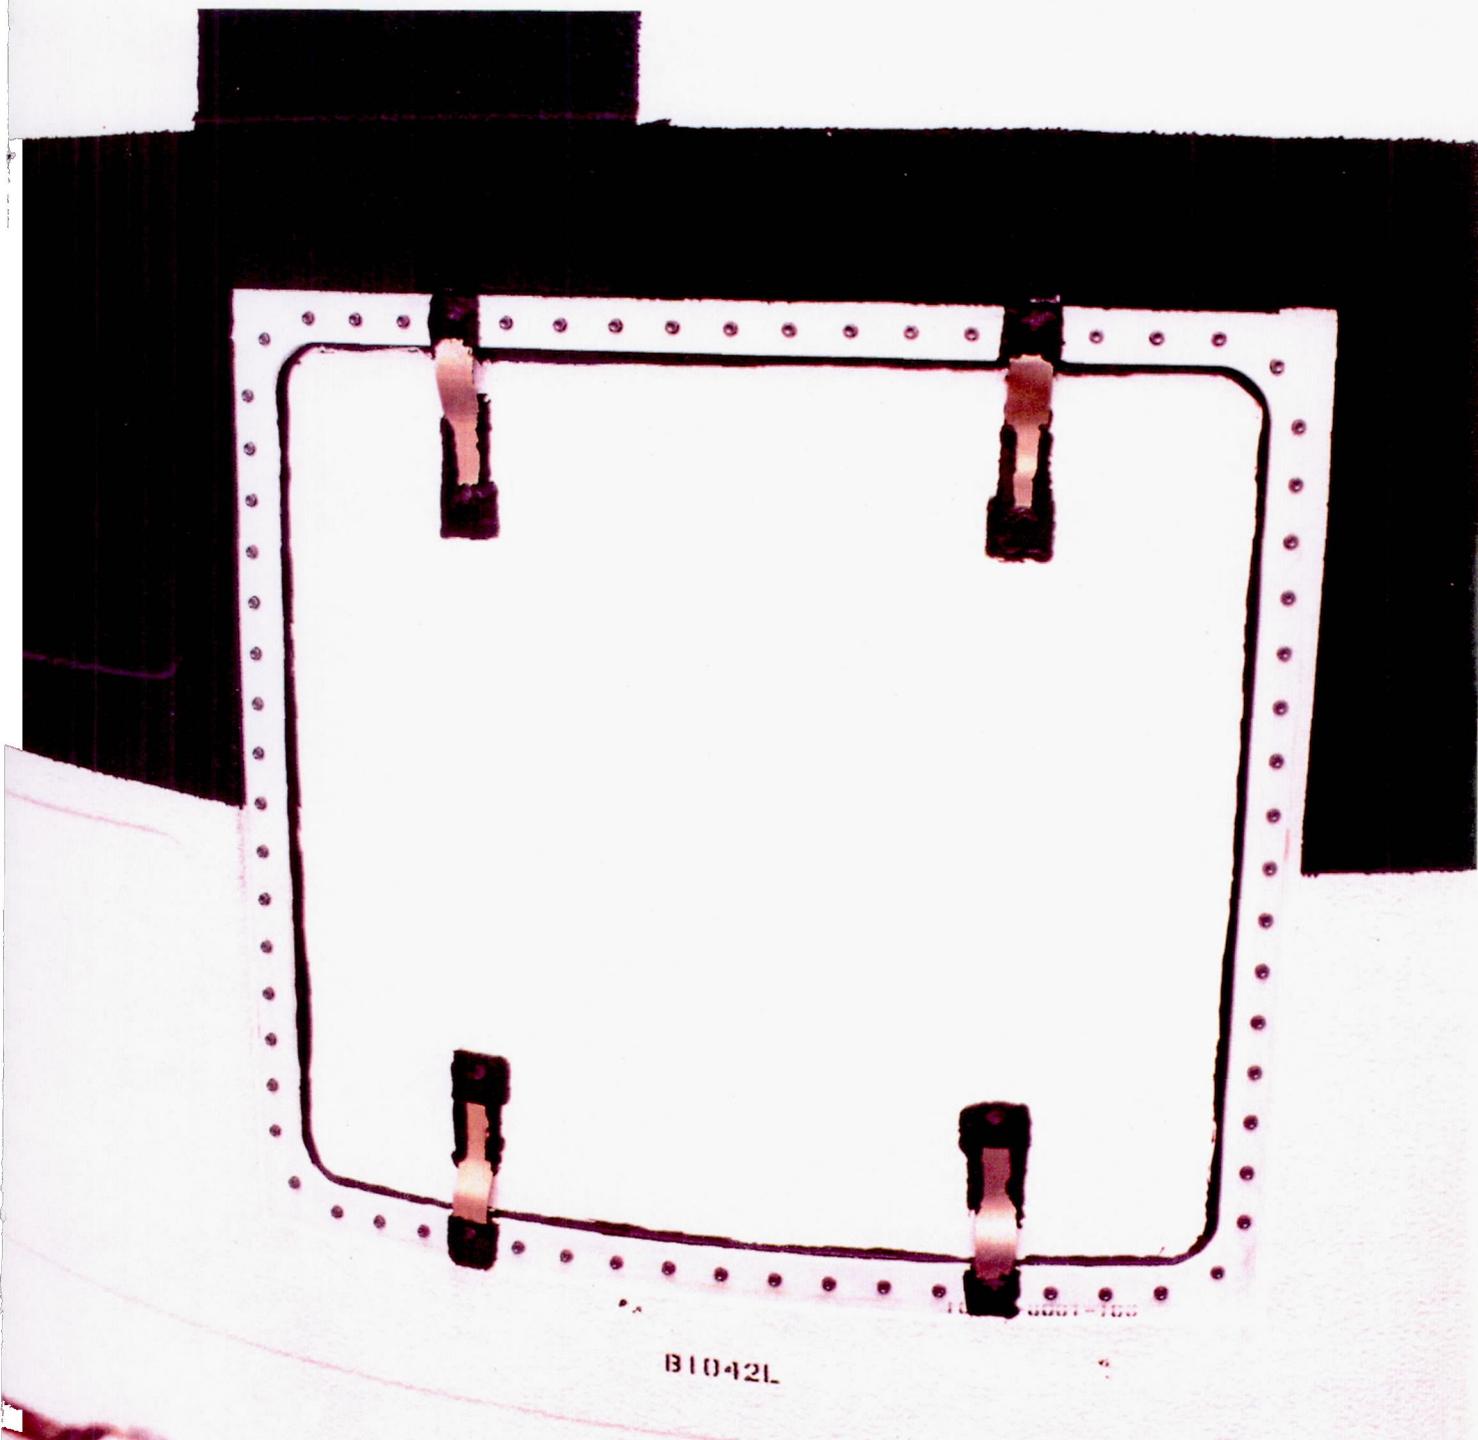
First flight with new grounding straps attached to SRB forward skirt flight door

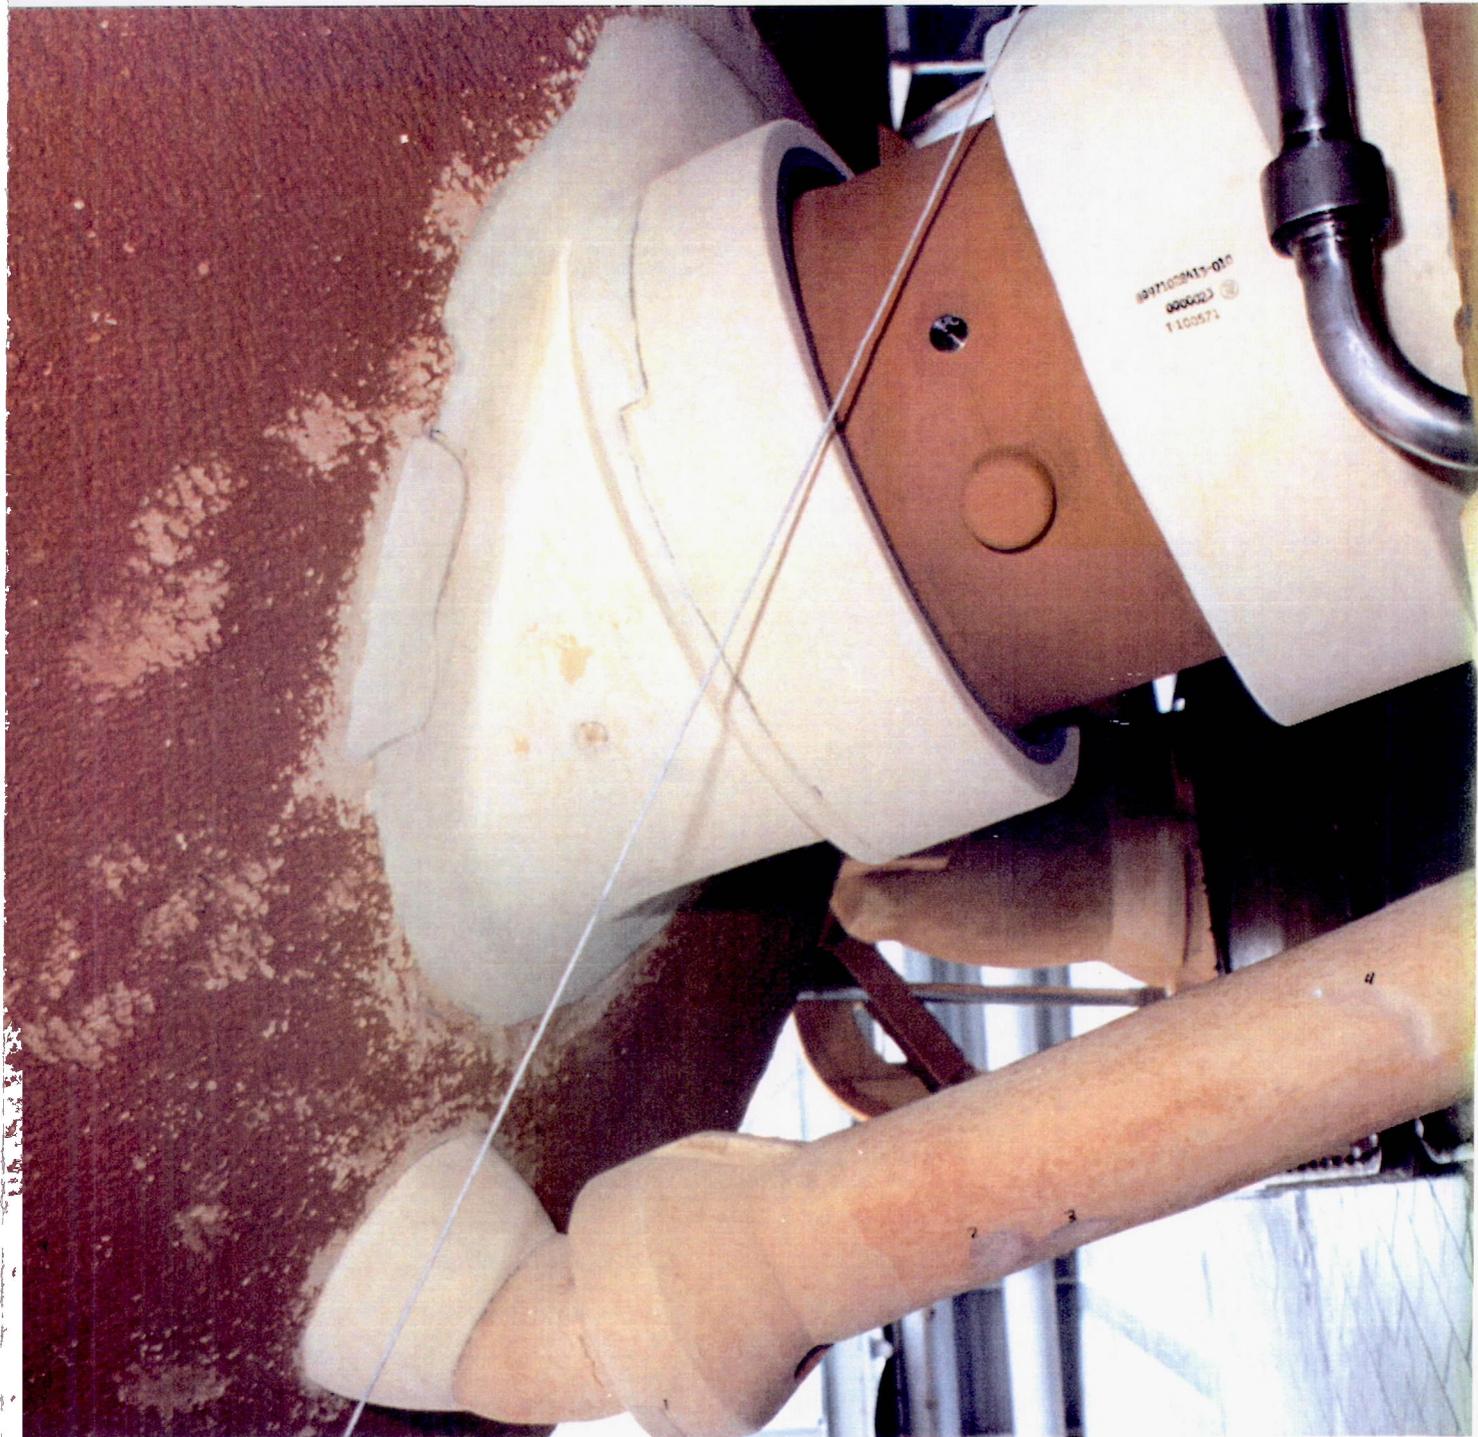
Pre-cryo load condition of foam repairs on the LH2 feedline
and recirculation line-to-tank interfaces

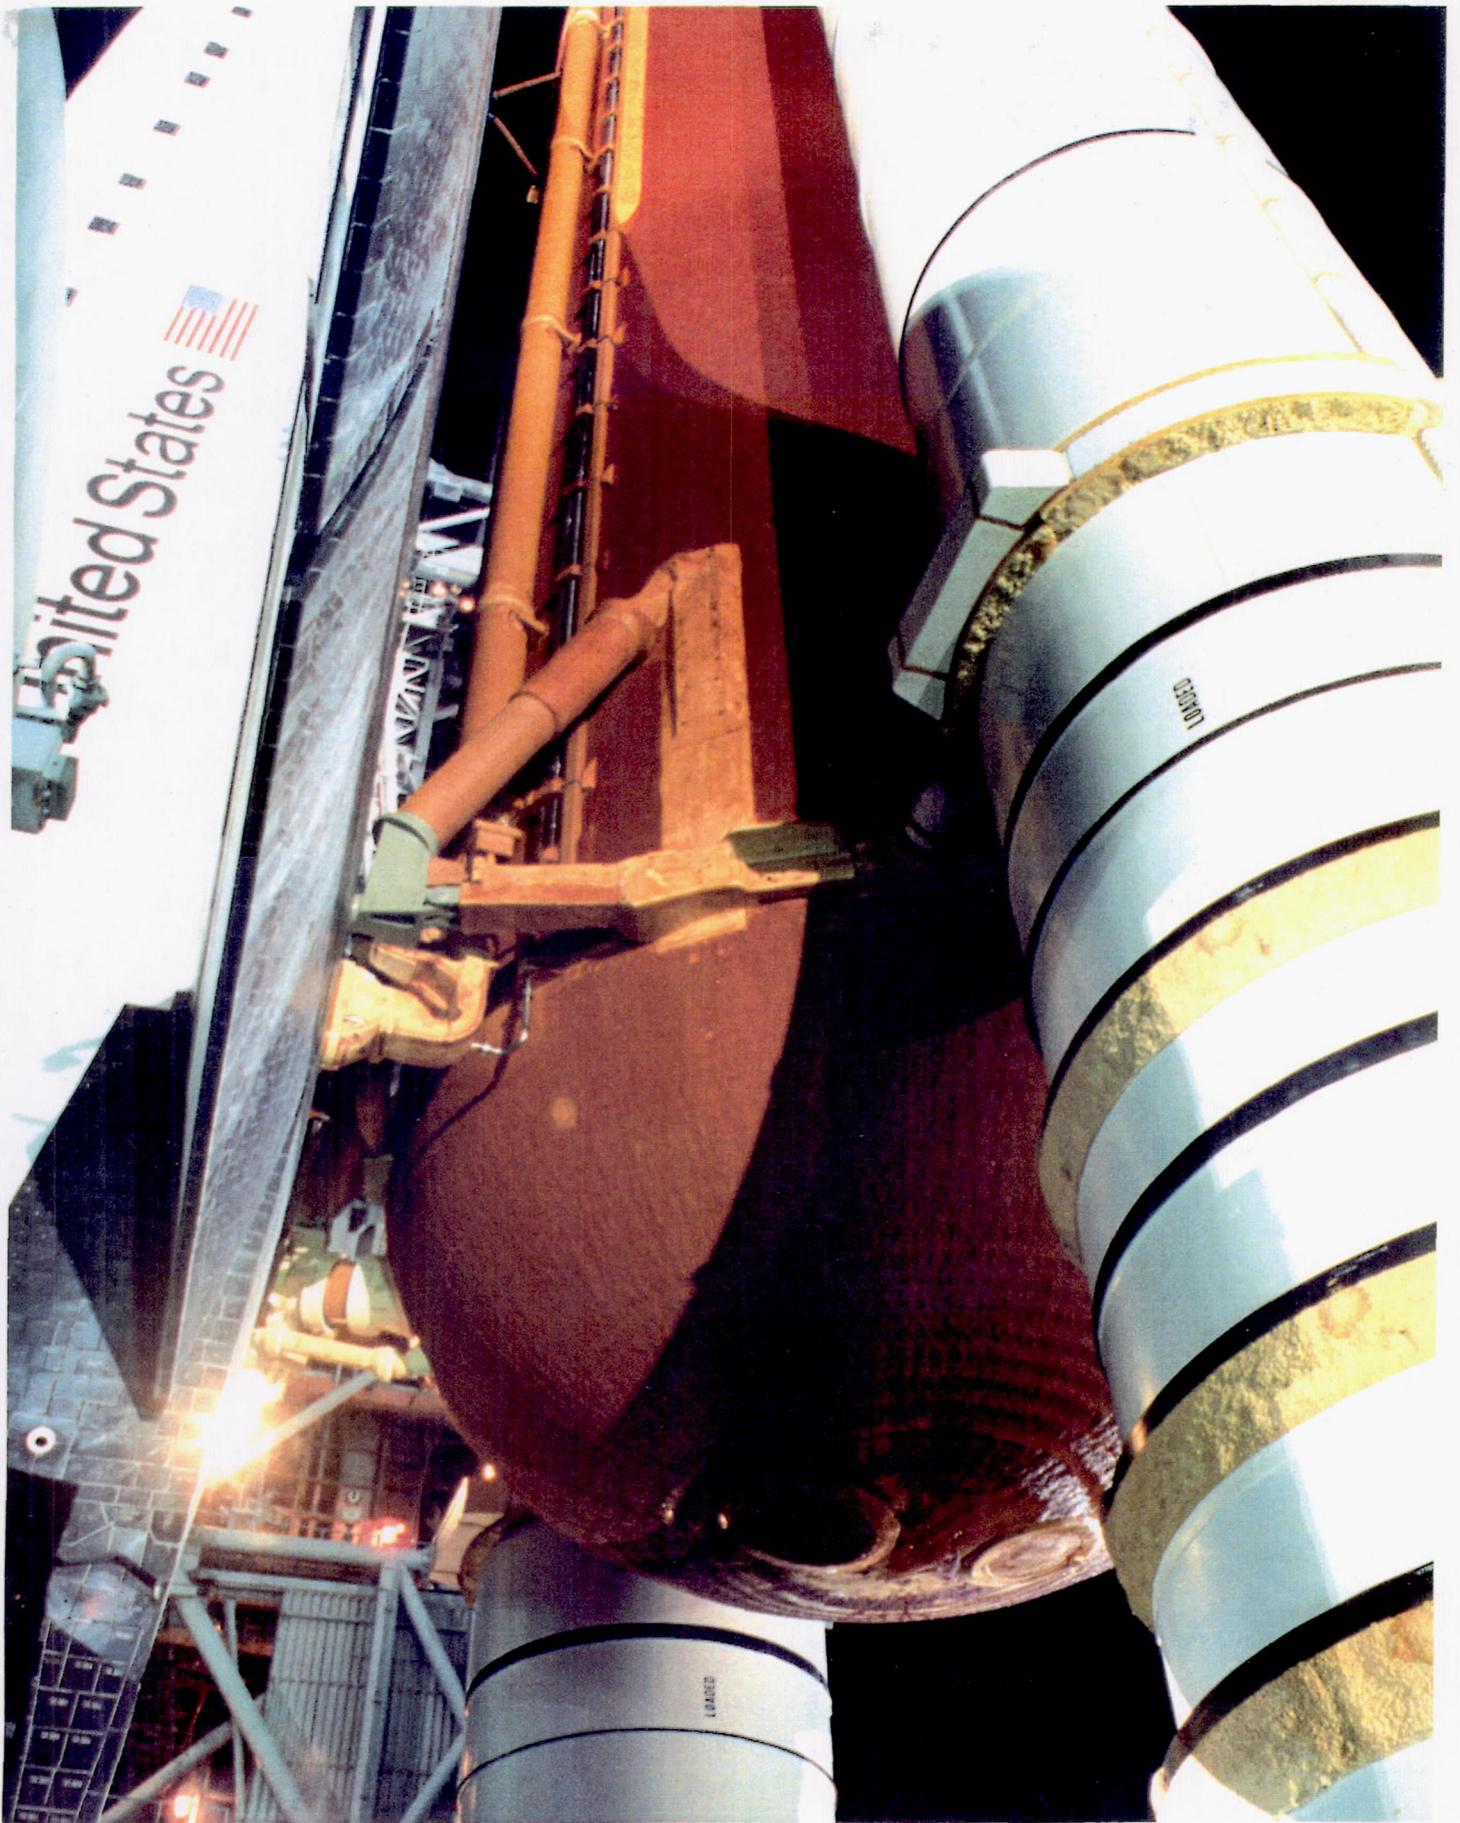
No ice or frost had formed on the LH2 tank TPS acreage area

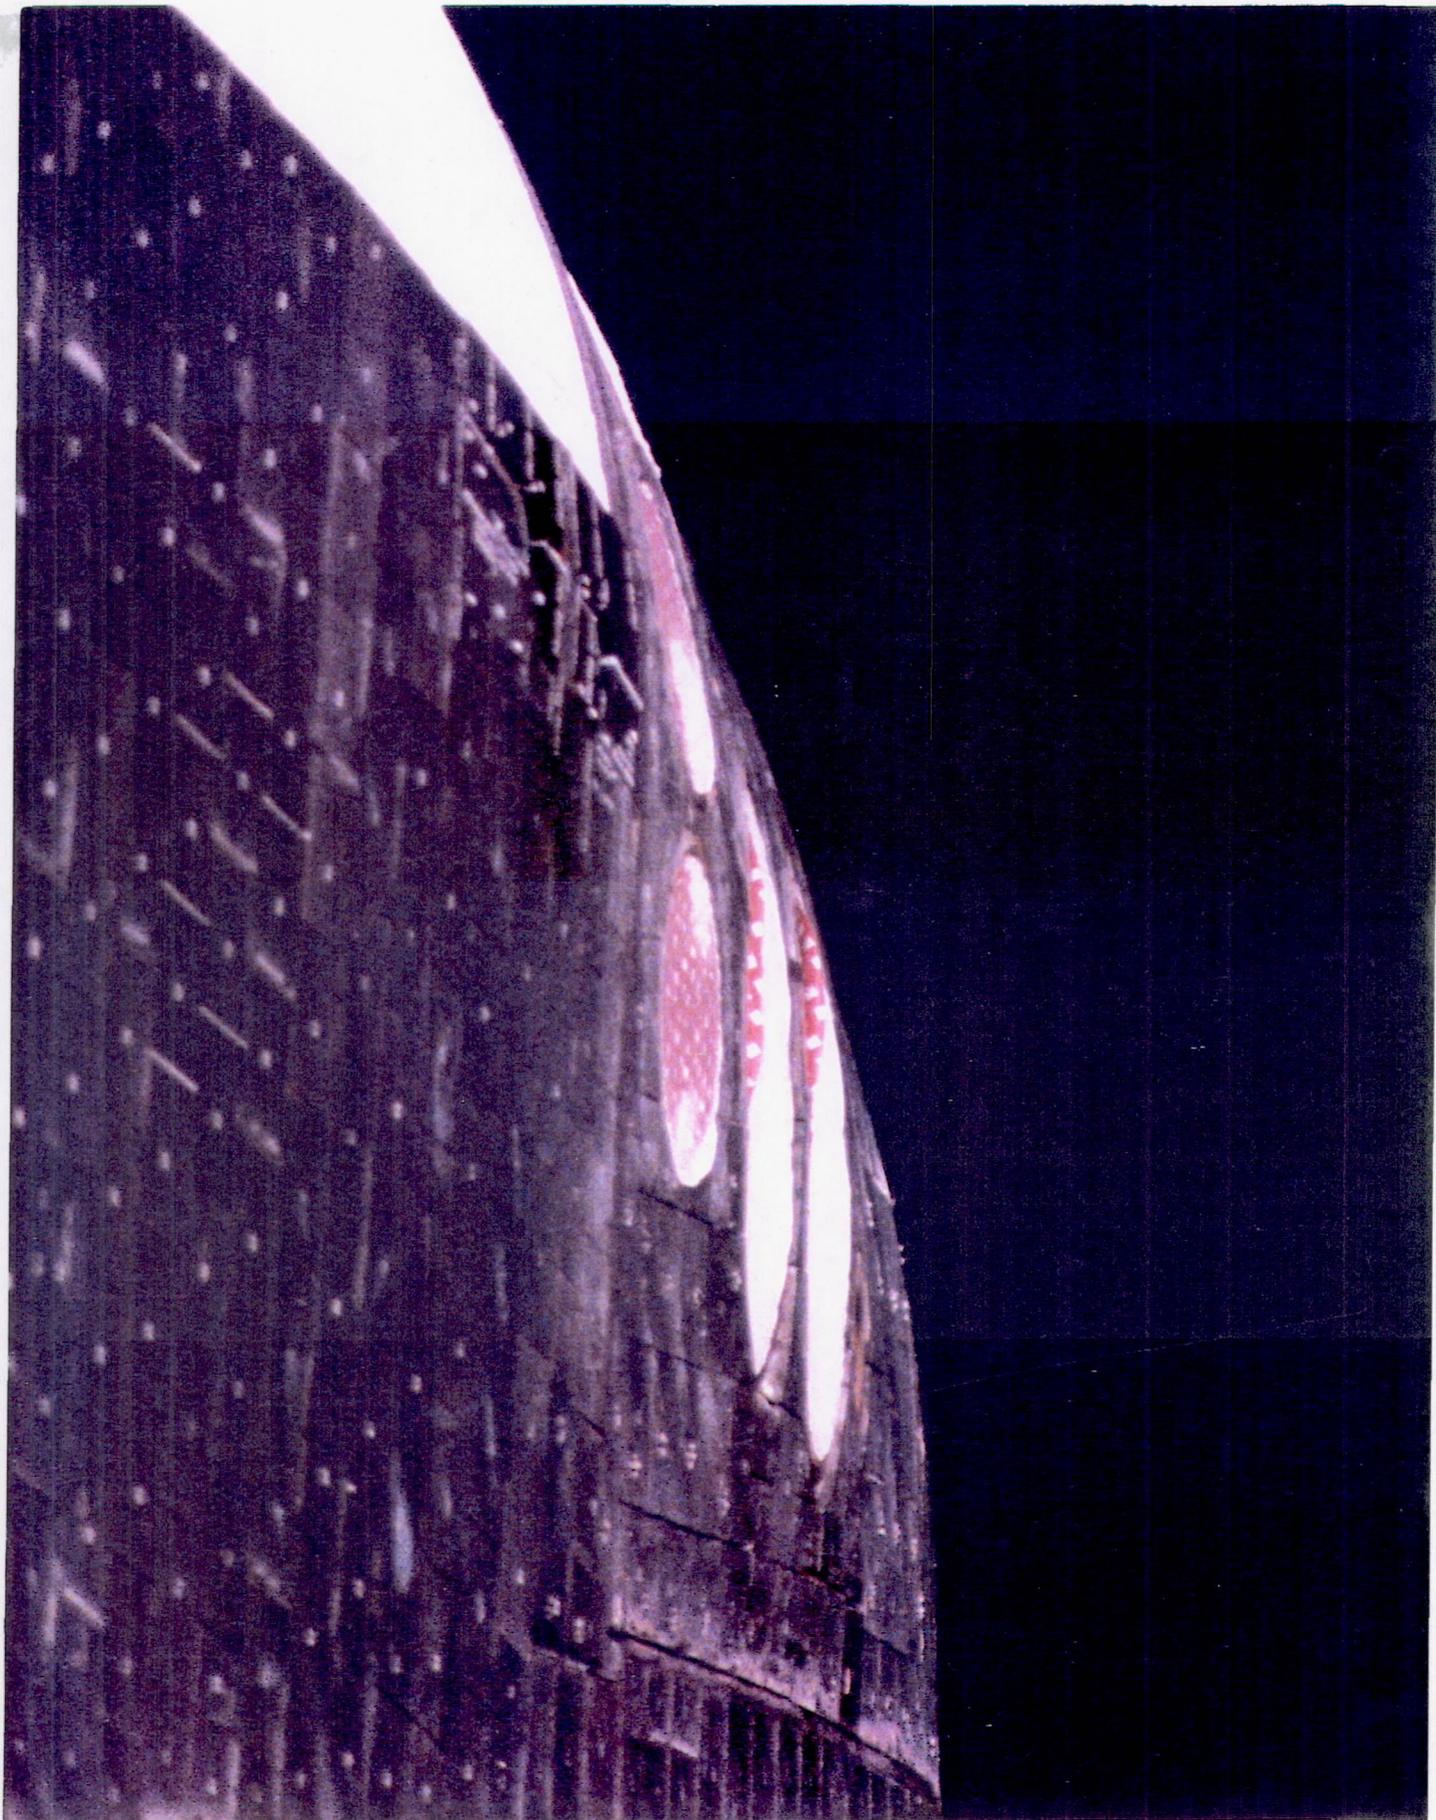
View (from the MLP deck) of Orbiter RH FWD RCS paper covers.
Discoloration of the covers was due to recent rainfall.

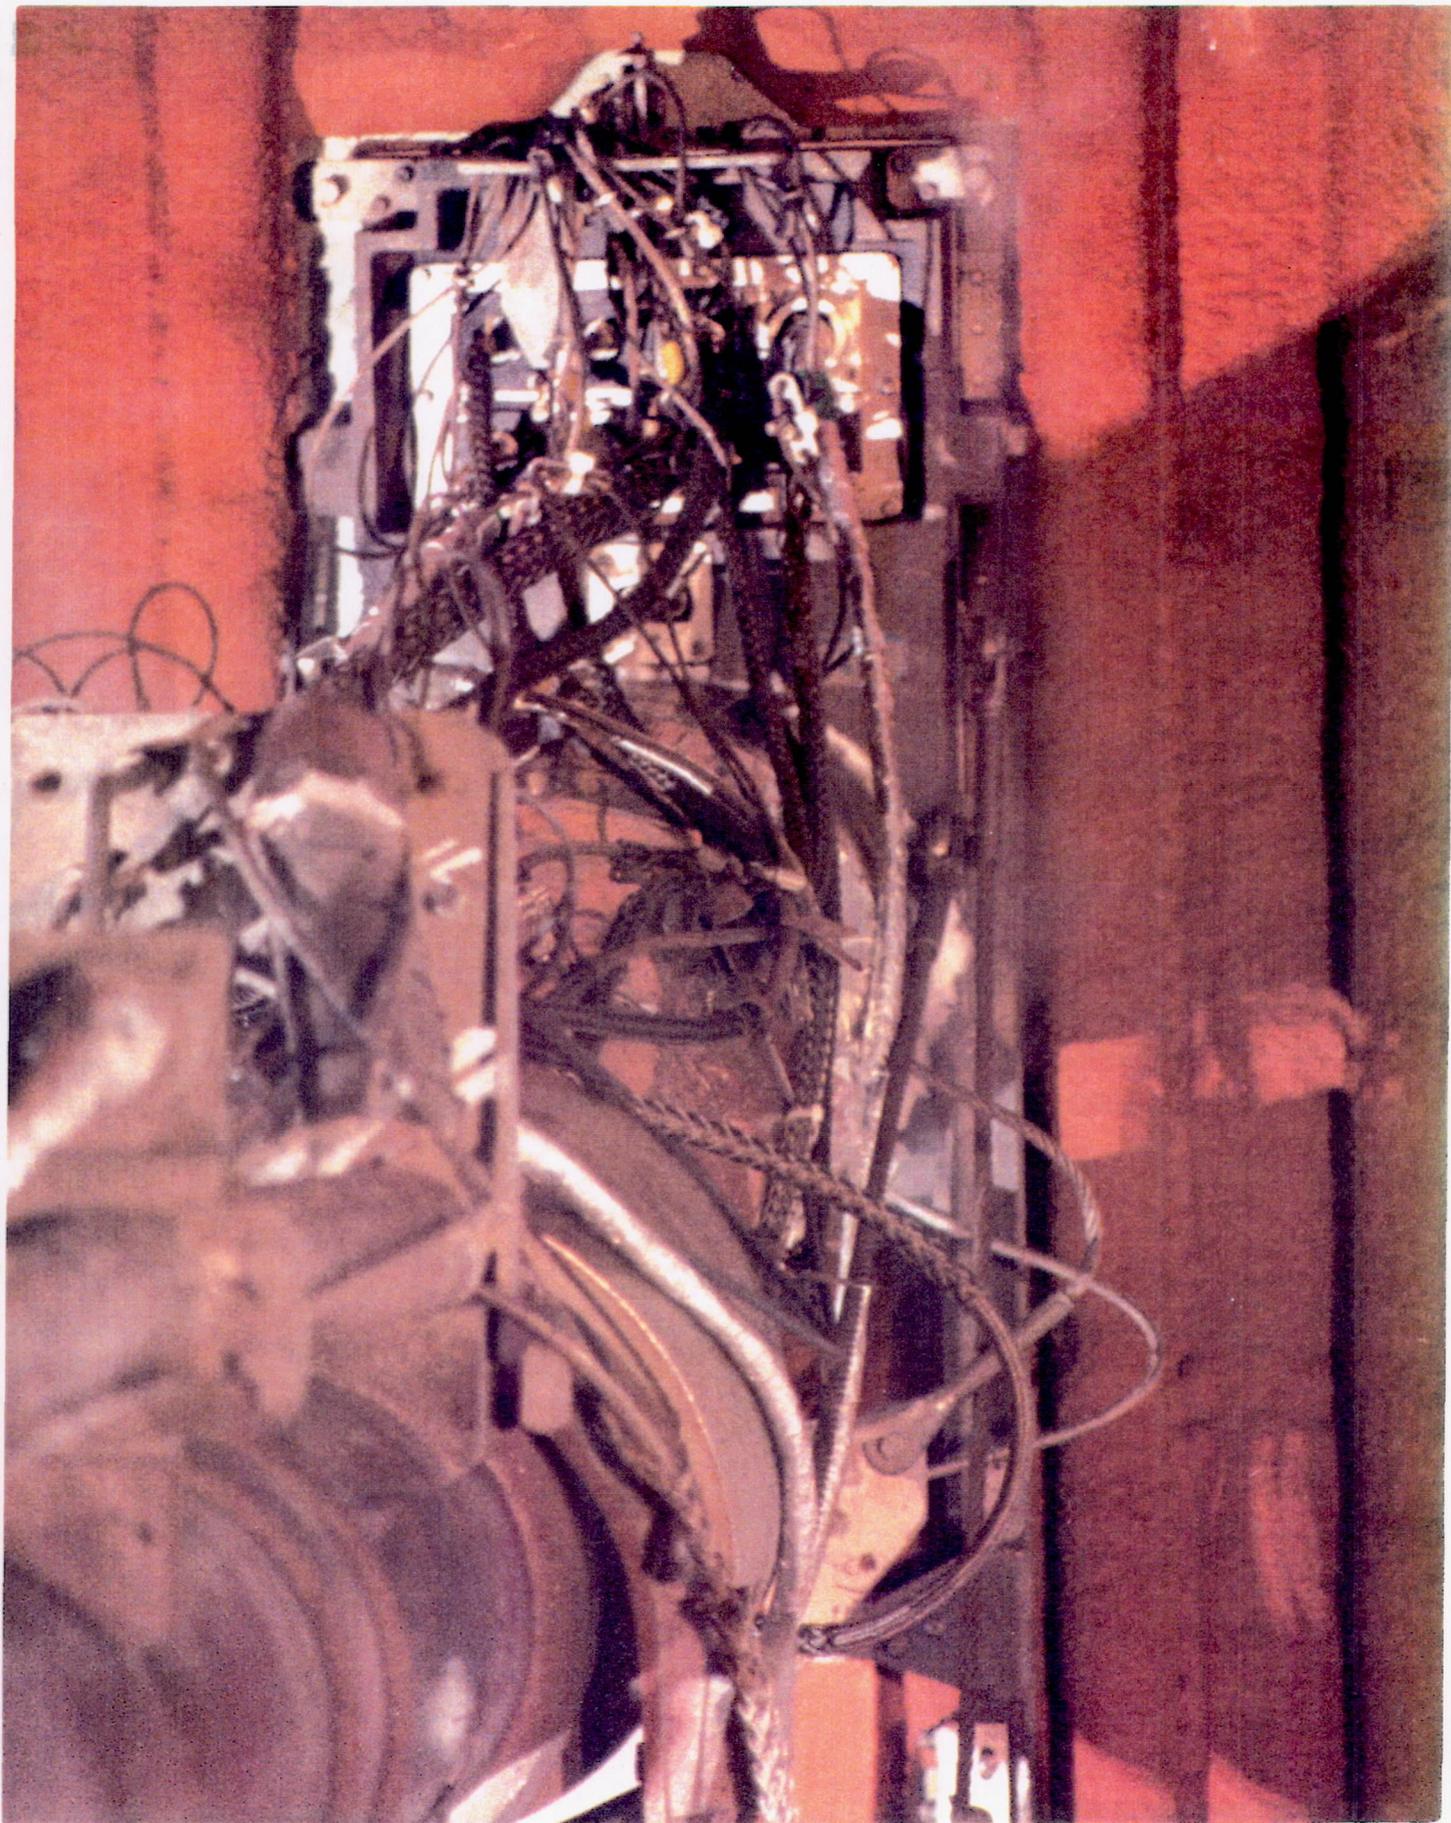
Typical accumulations of ice/frost were present on the GUCP legs and TPS cutout area below the GH2 vent line

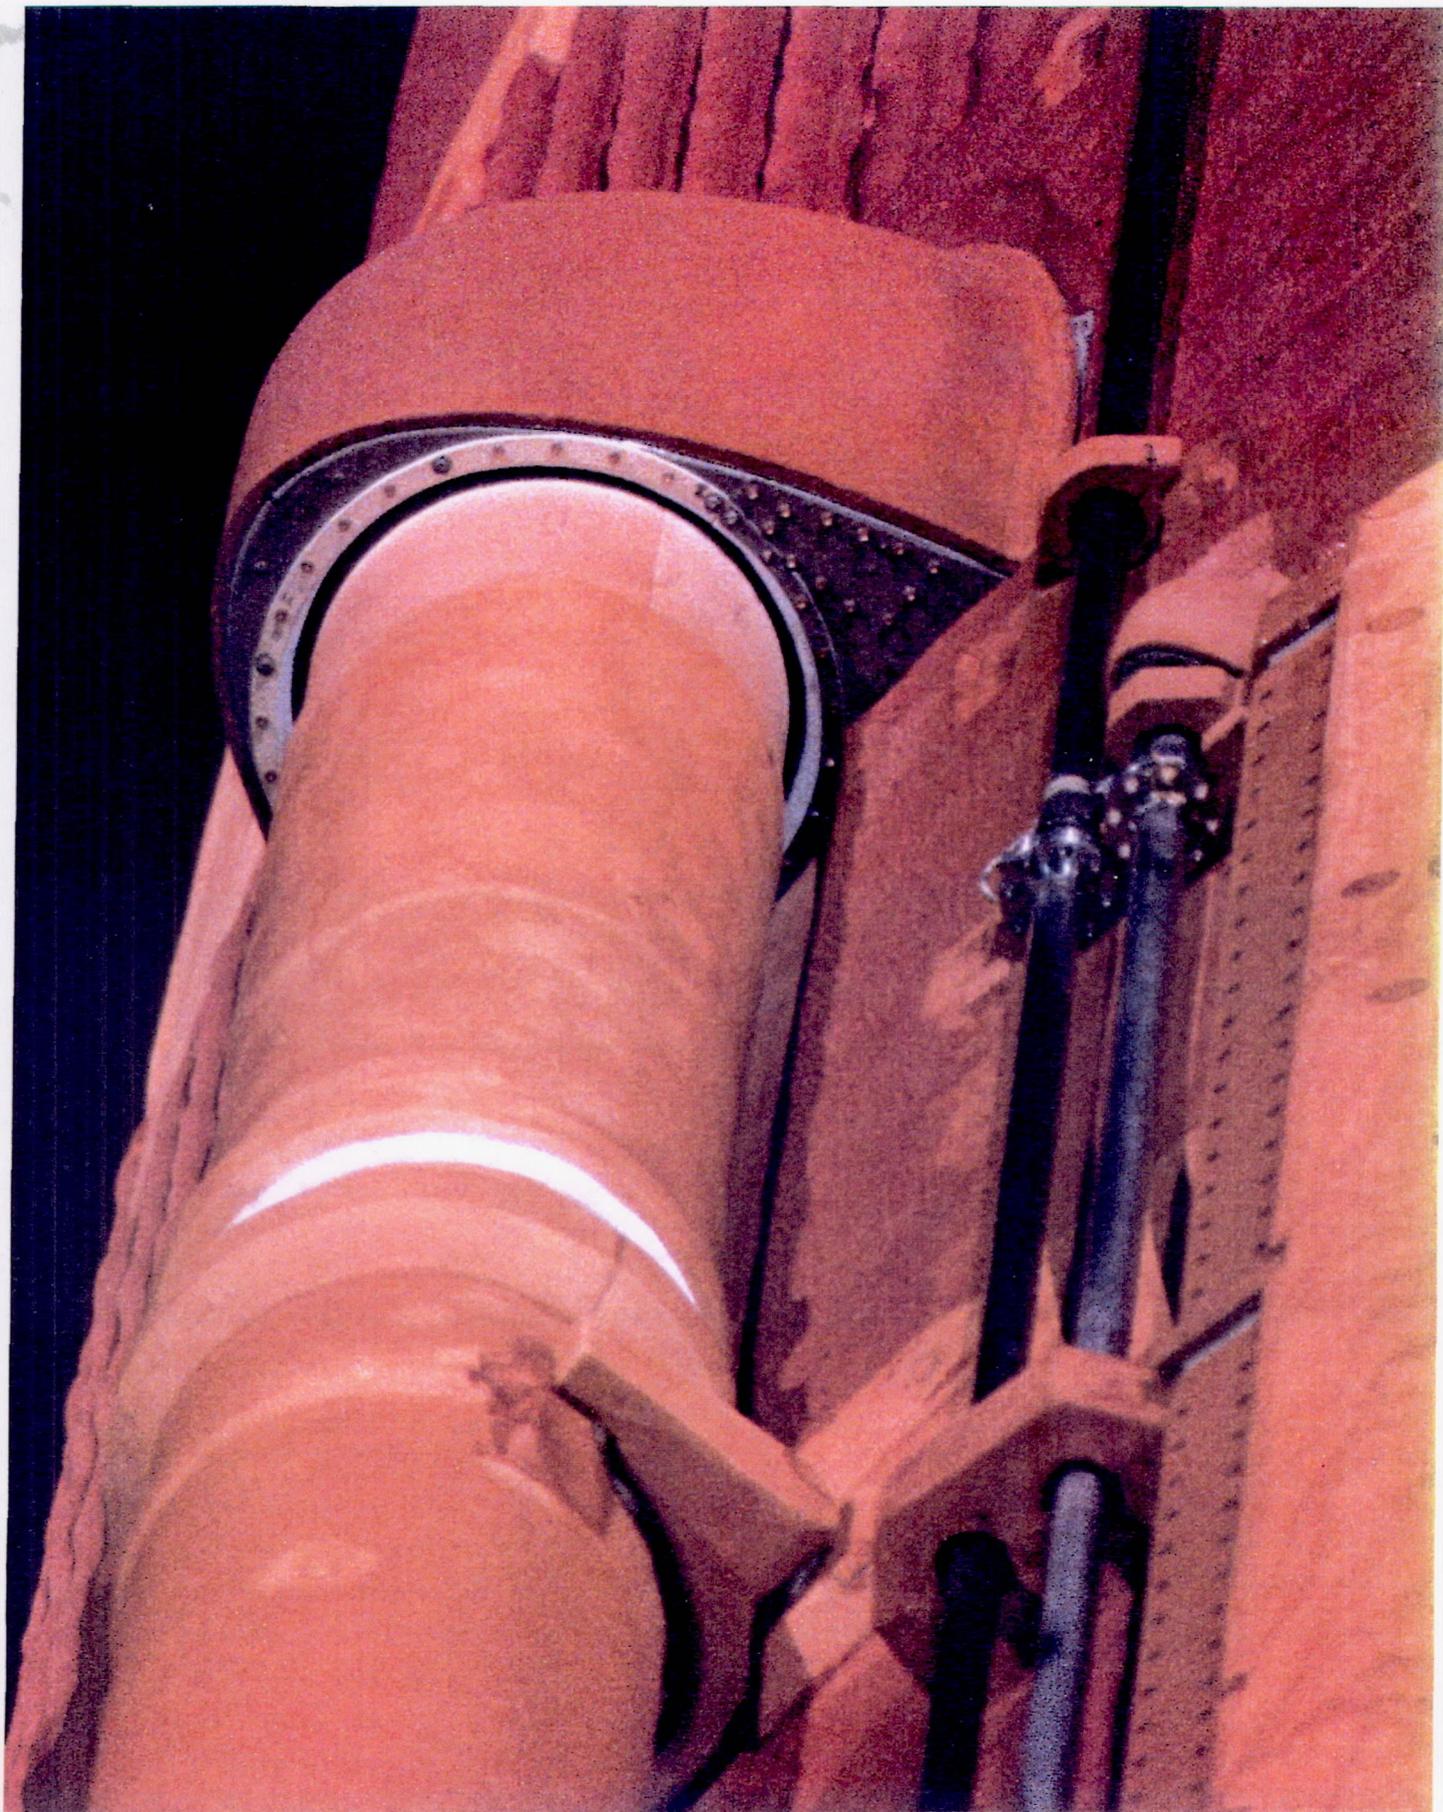
Typical ice/frost had accumulated in the L02 feedline upper bellows and support brackets

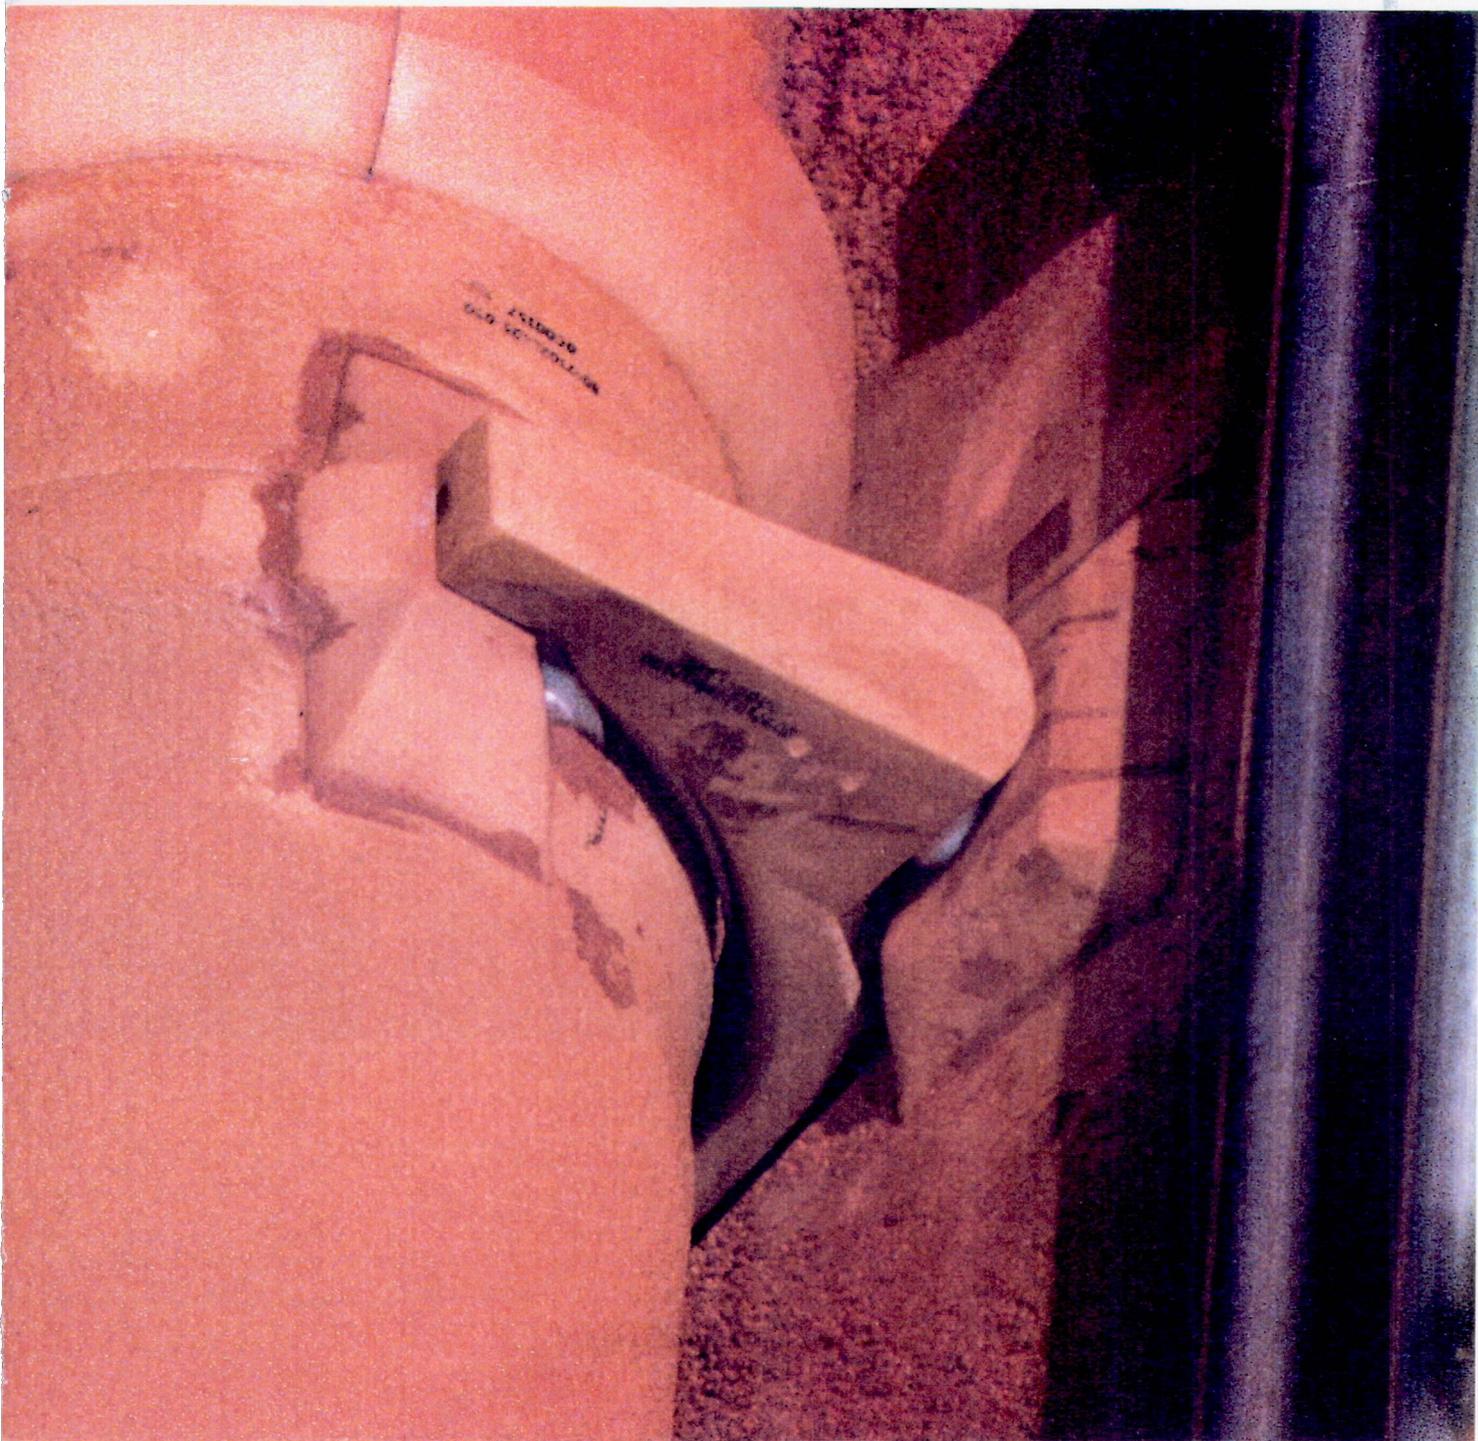
Ice/frost formations were visible in the LO2 feedline support brackets

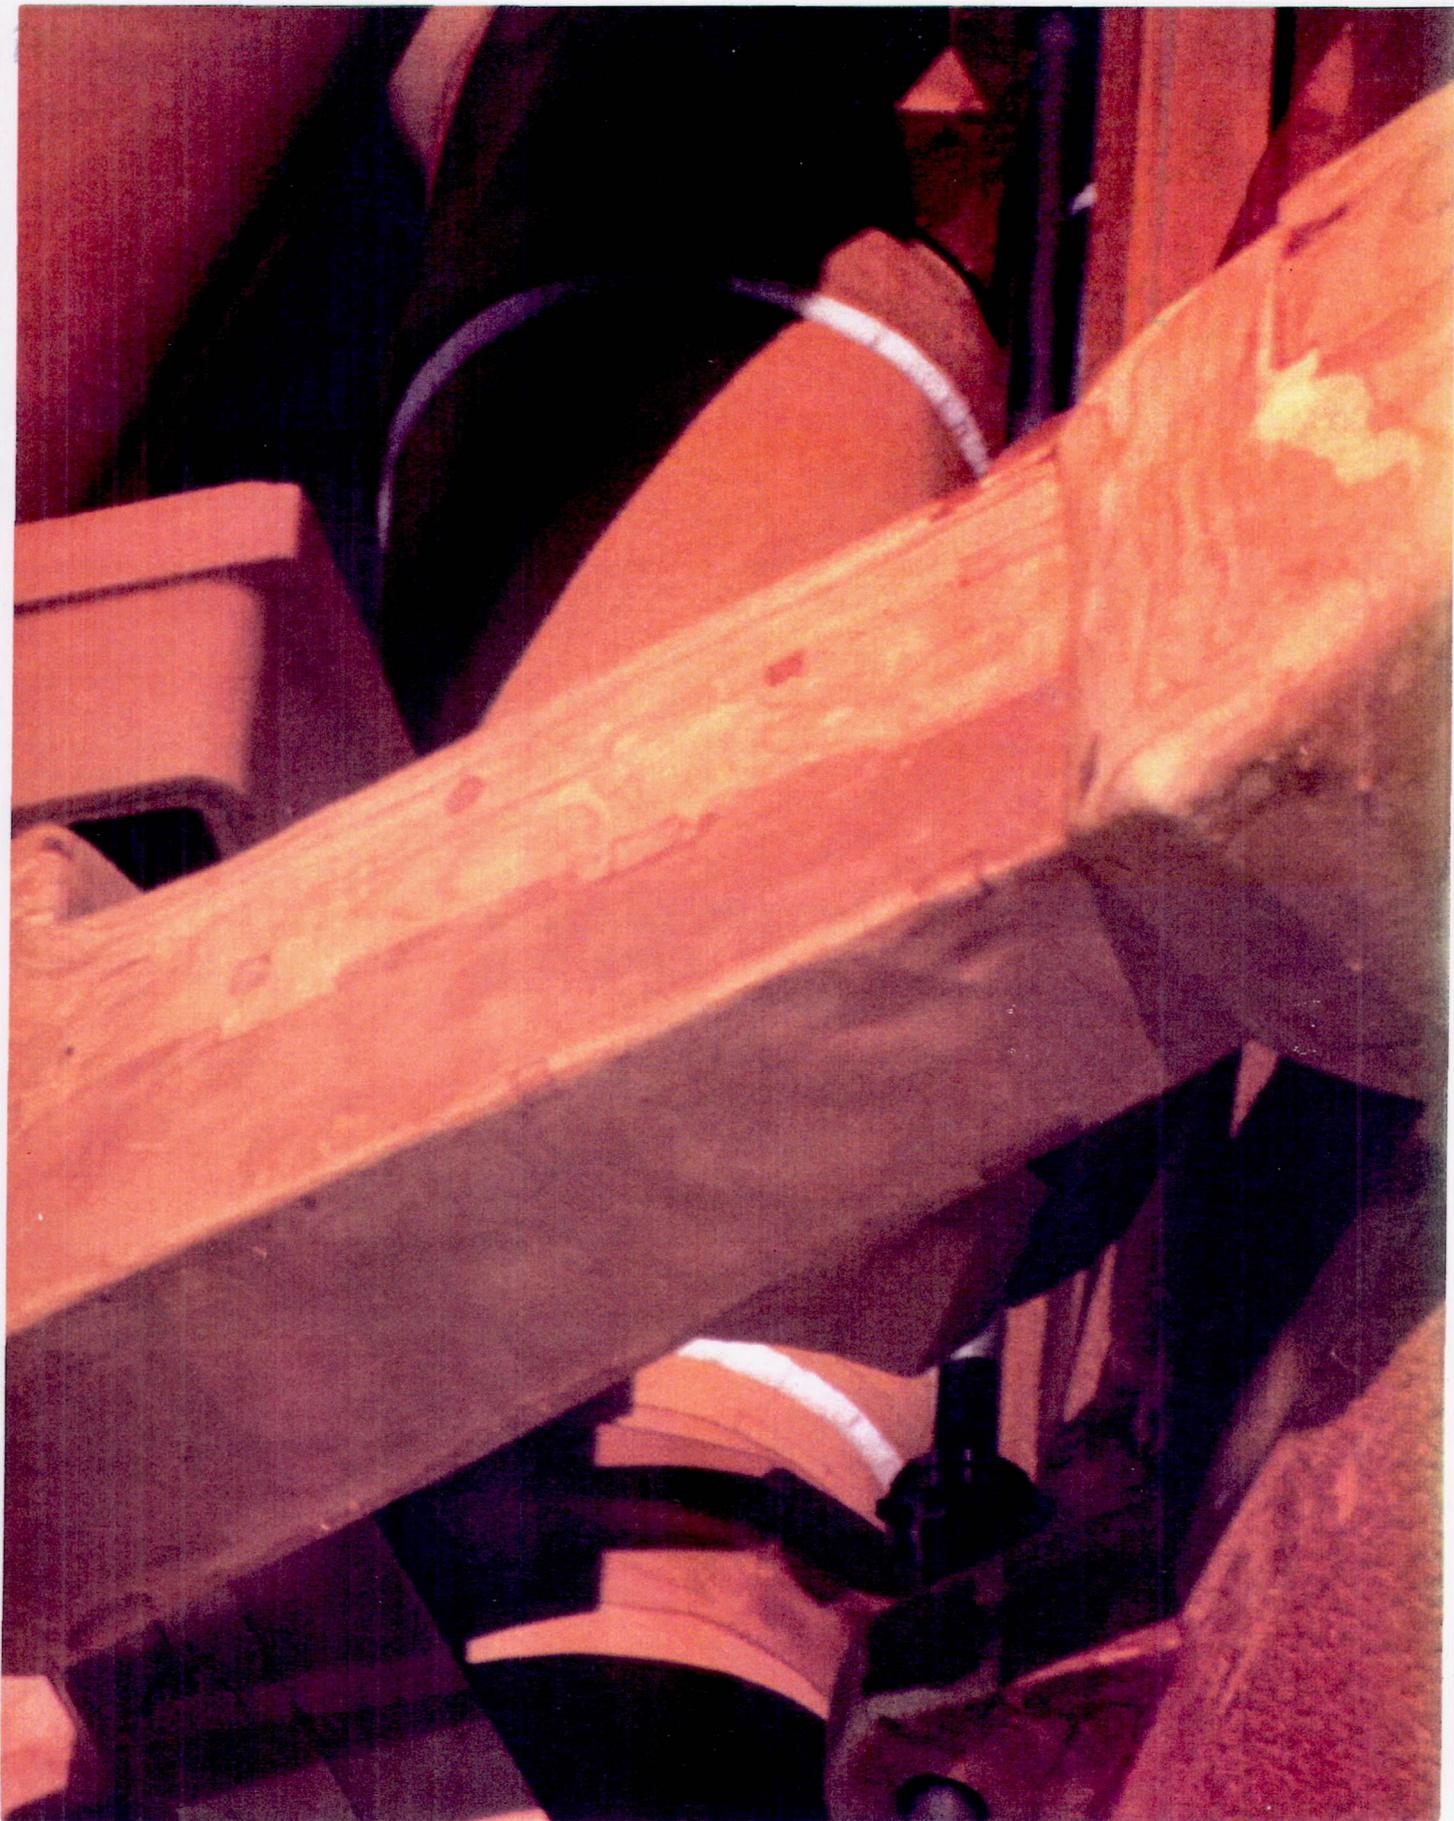
Typical ice/frost had accumulated in the L02 feedline lower bellows

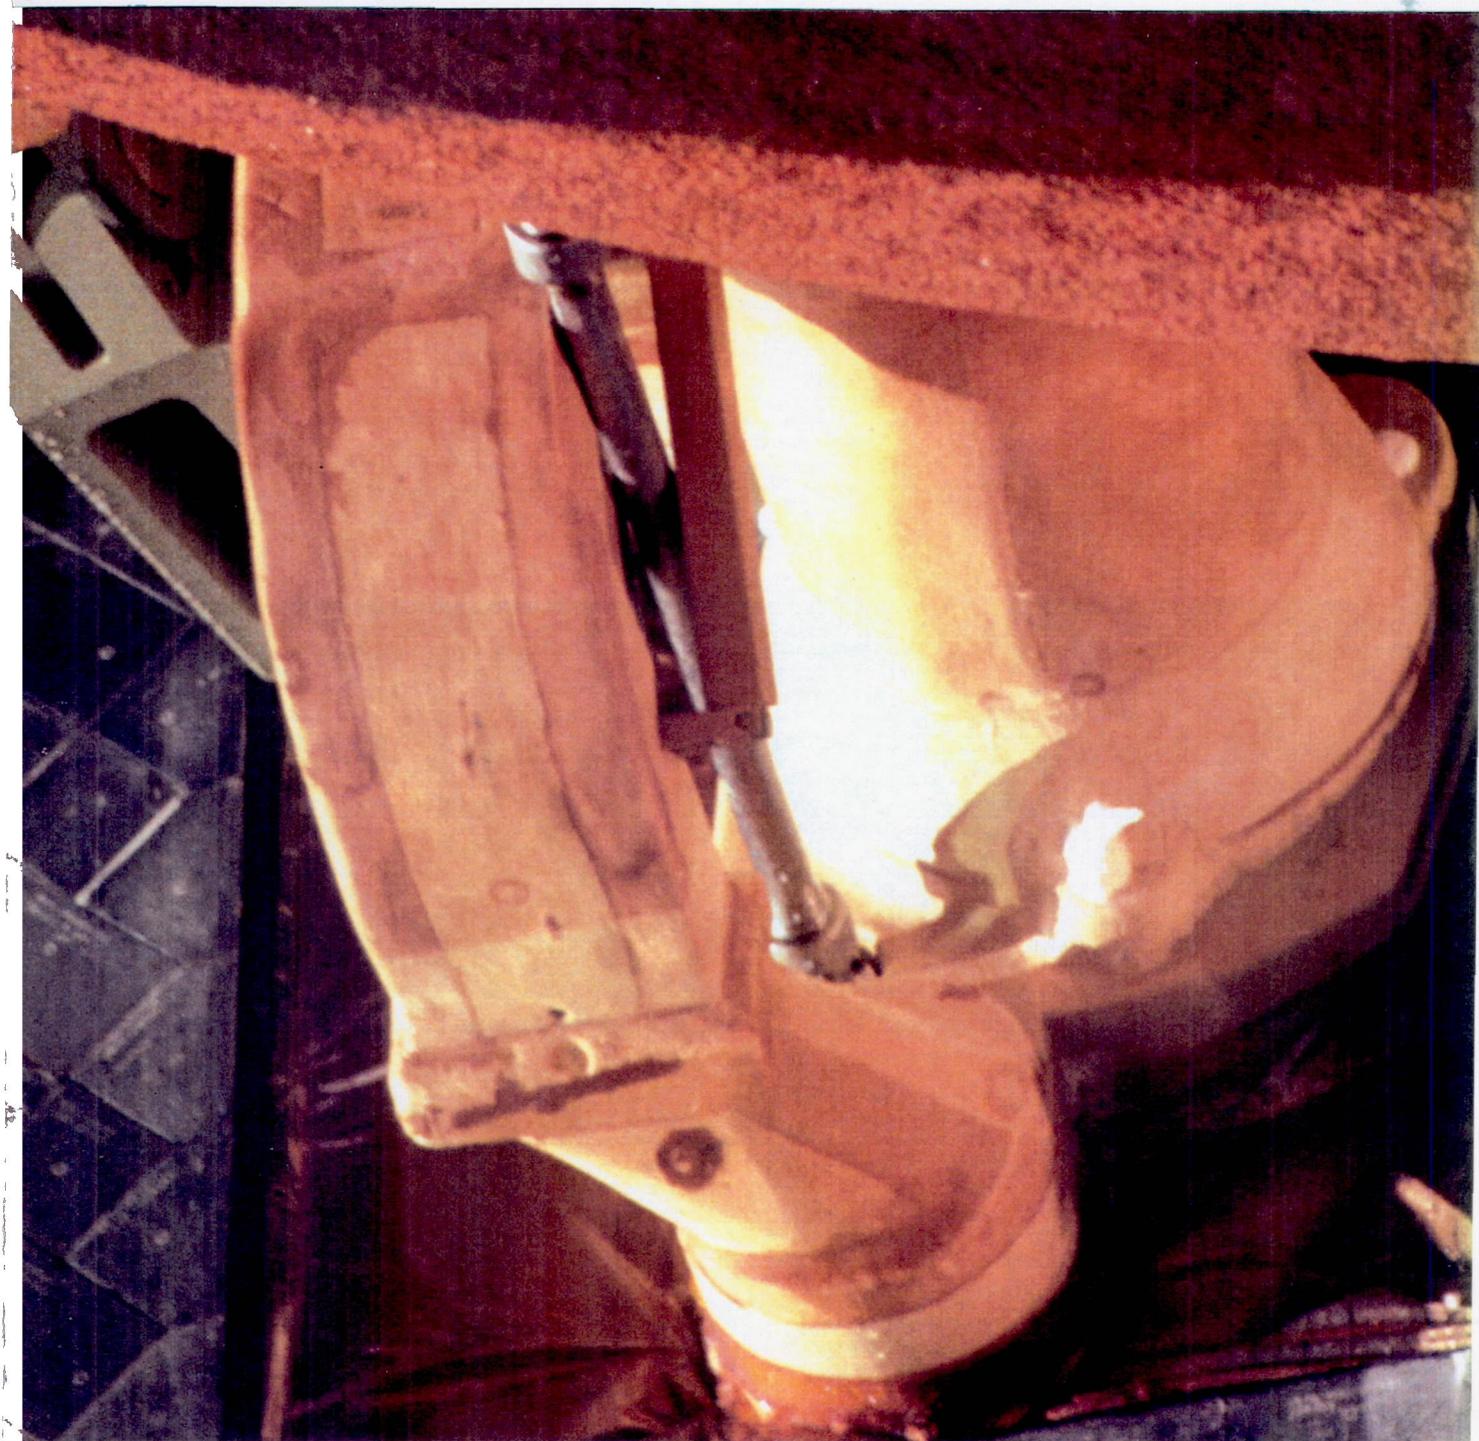
Typical ice/frost fingers had formed on the L02 ET/ORB umbilical pyrotechnic canister purge vents. Very little ice/frost accumulated on the purge barrier (baggie).
