Debris/Ice/TPS Assessment And Photographic Analysis For Shuttle Mission STS-37

April 1991

Gregory N. Katnik
NASA/Kennedy Space Center

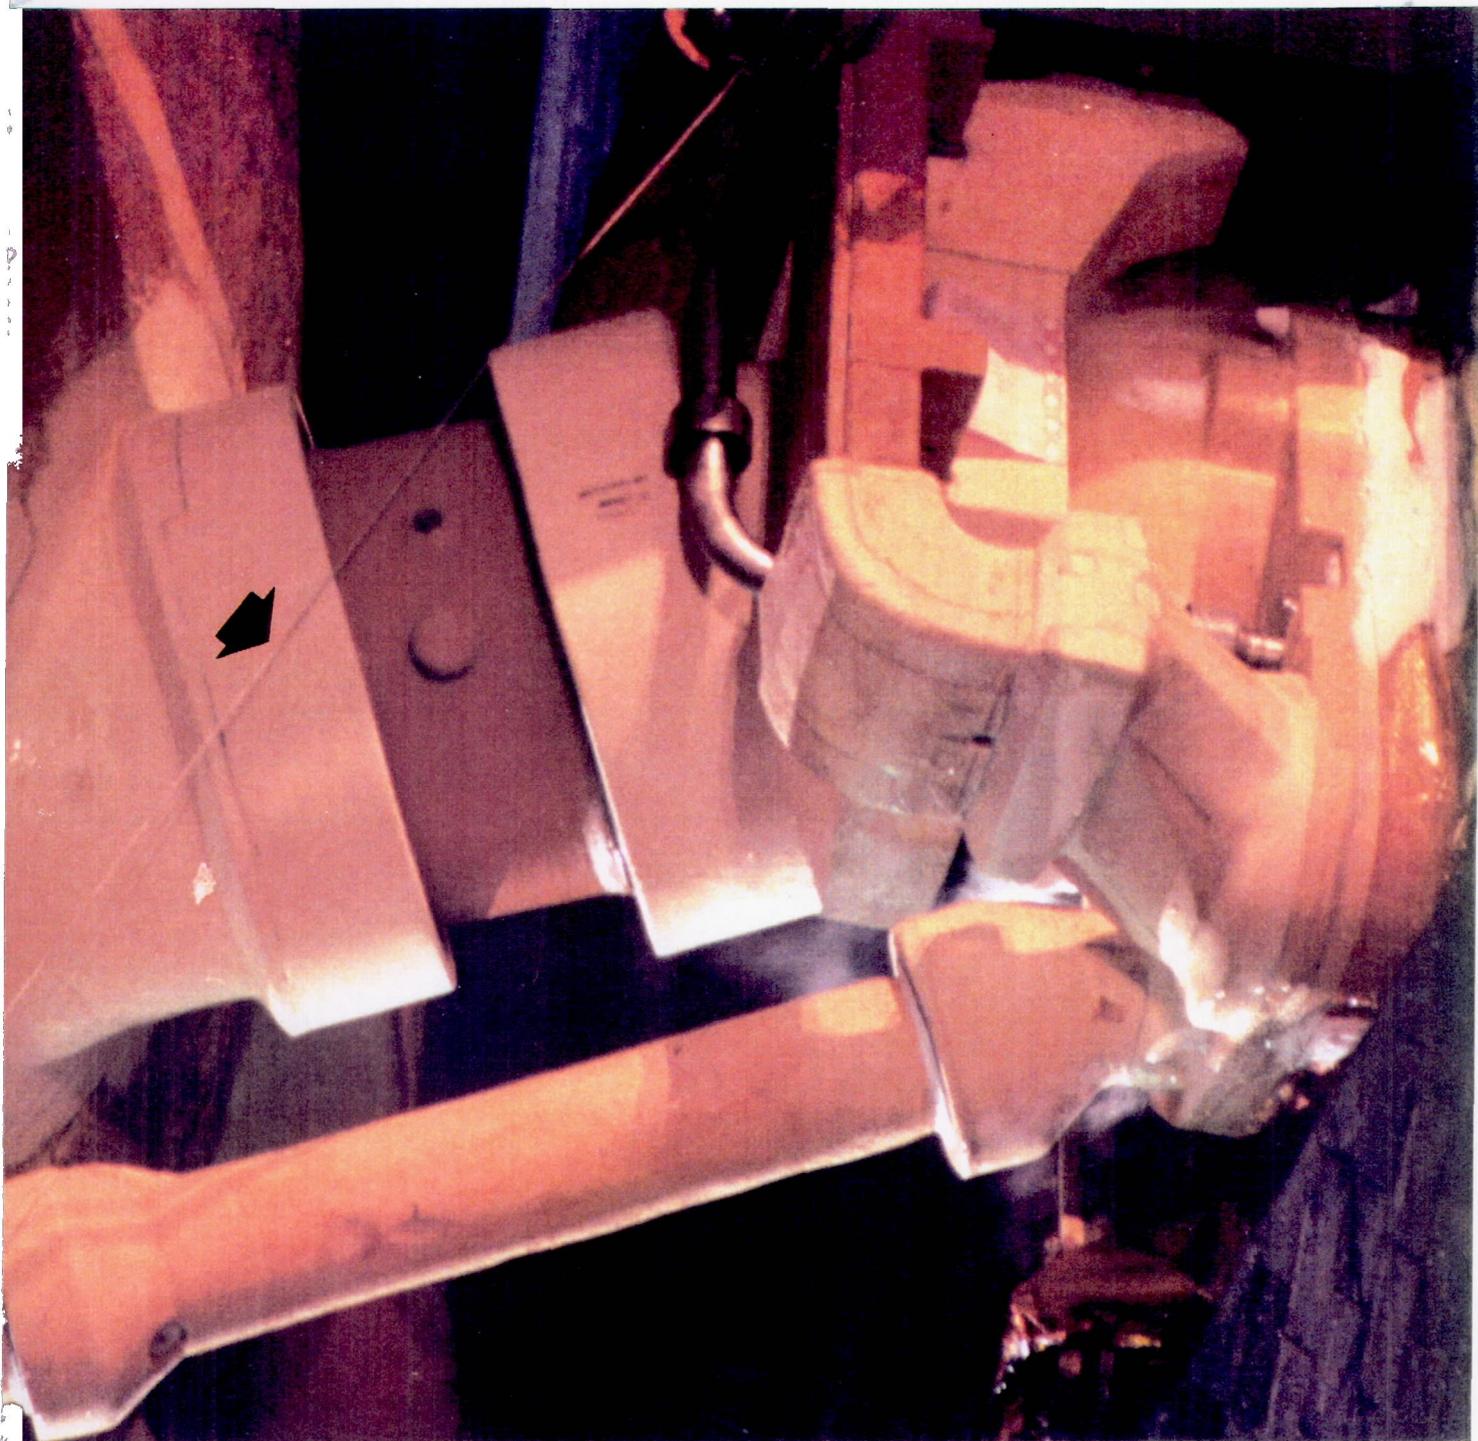
Typical ice/frost accumulations were present on the LH2 ET/ORB umbilical pyrotechnic canister purge vents, plate gap purge vents, and purge barrier (baggie). No ice/frost accumulated on the LH2 feedline and recirculation line-to-tank interface foam repair areas. Note pull-down line for LD 54/55 tygon tubes.

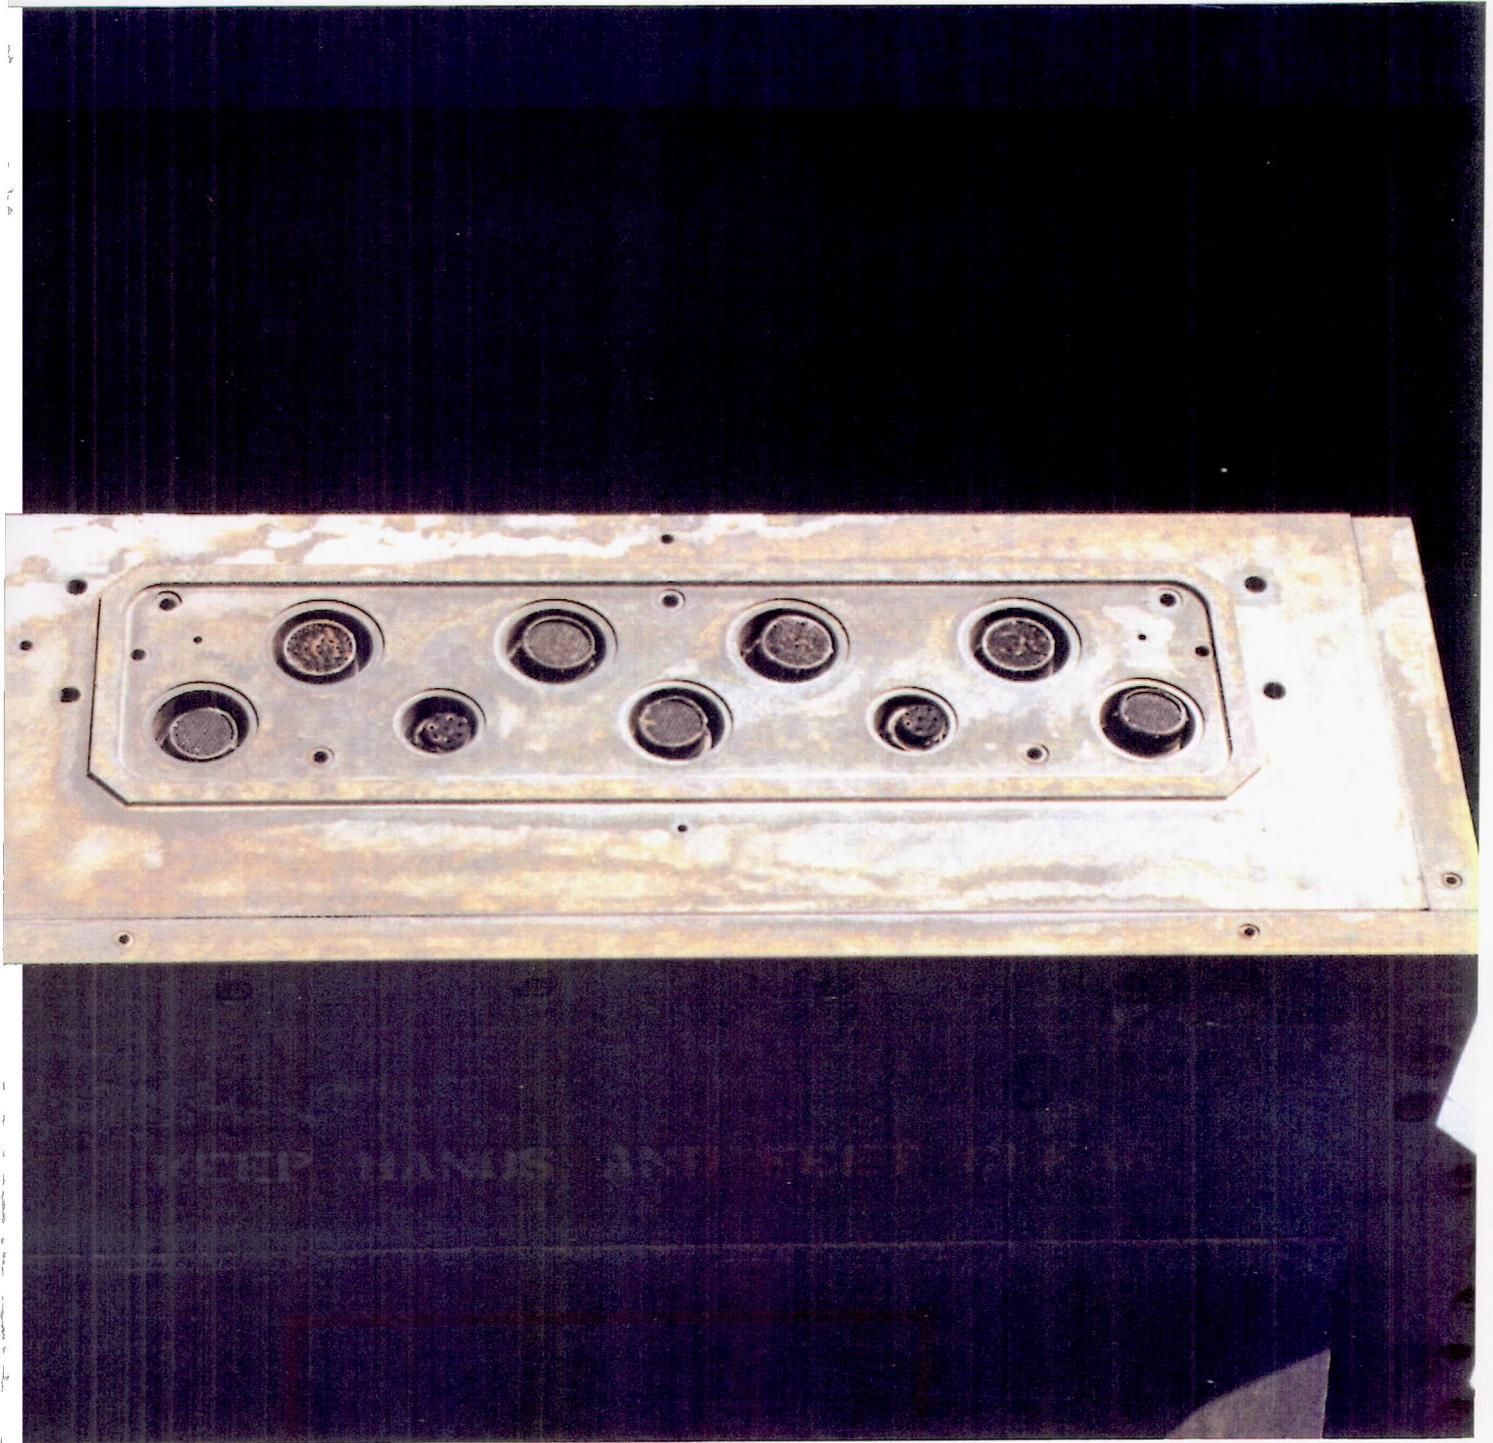
New electrical connector savers (sacrificial pieces) on the SRB joint heater T-0 umbilicals were intact after launch

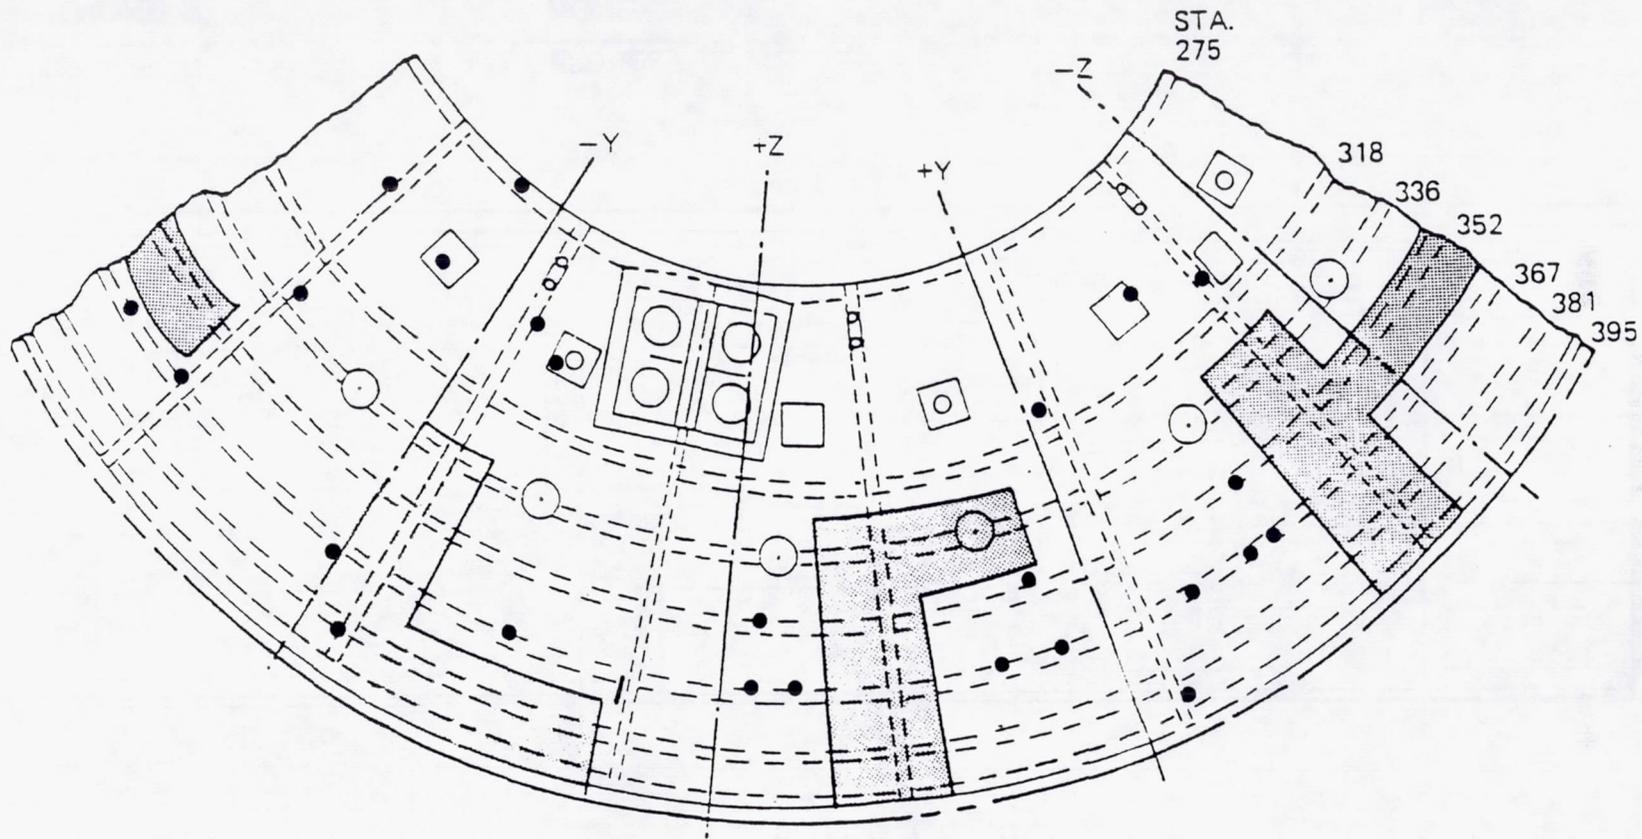
FIGURE 5. RIGHT SRB FRUSTUM

The nose cap was not recovered. The RH frustum had no areas of missing TPS but had 26 MSA-2 debonds over fasteners (Figure 5). All four BSM covers were in the open position, but had been bent by parachute riser entanglement.

MISSING TPS
NONE

DEBONDS
• 26 MSA-2
DEBONDS OVER
FASTENERS

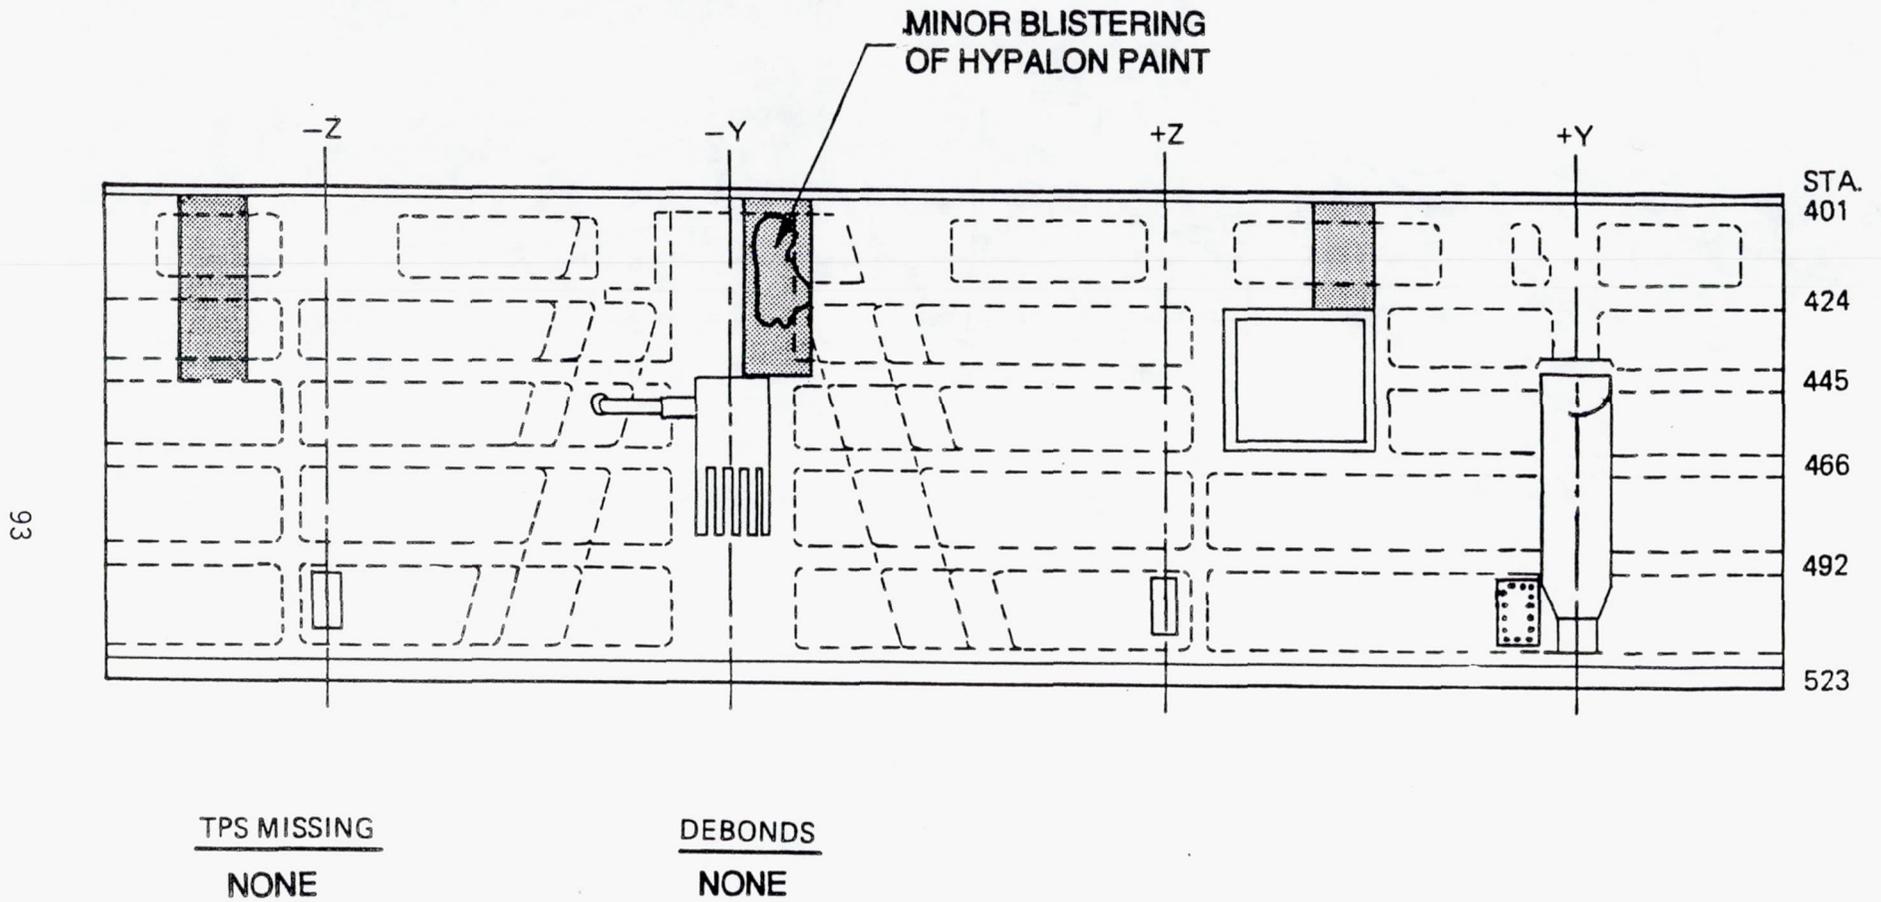
FIGURE 6. RIGHT SRB FWD SKIRT

The RH forward skirt exhibited no debonds or missing TPS. Minor blistering of the Hypalon paint occurred forward of the attach point (Figure 6). The phenolic plates on both RSS antennae were intact. The forward separation bolt and electrical cables appeared to have separated cleanly. No pins were missing from the frustum severance ring.

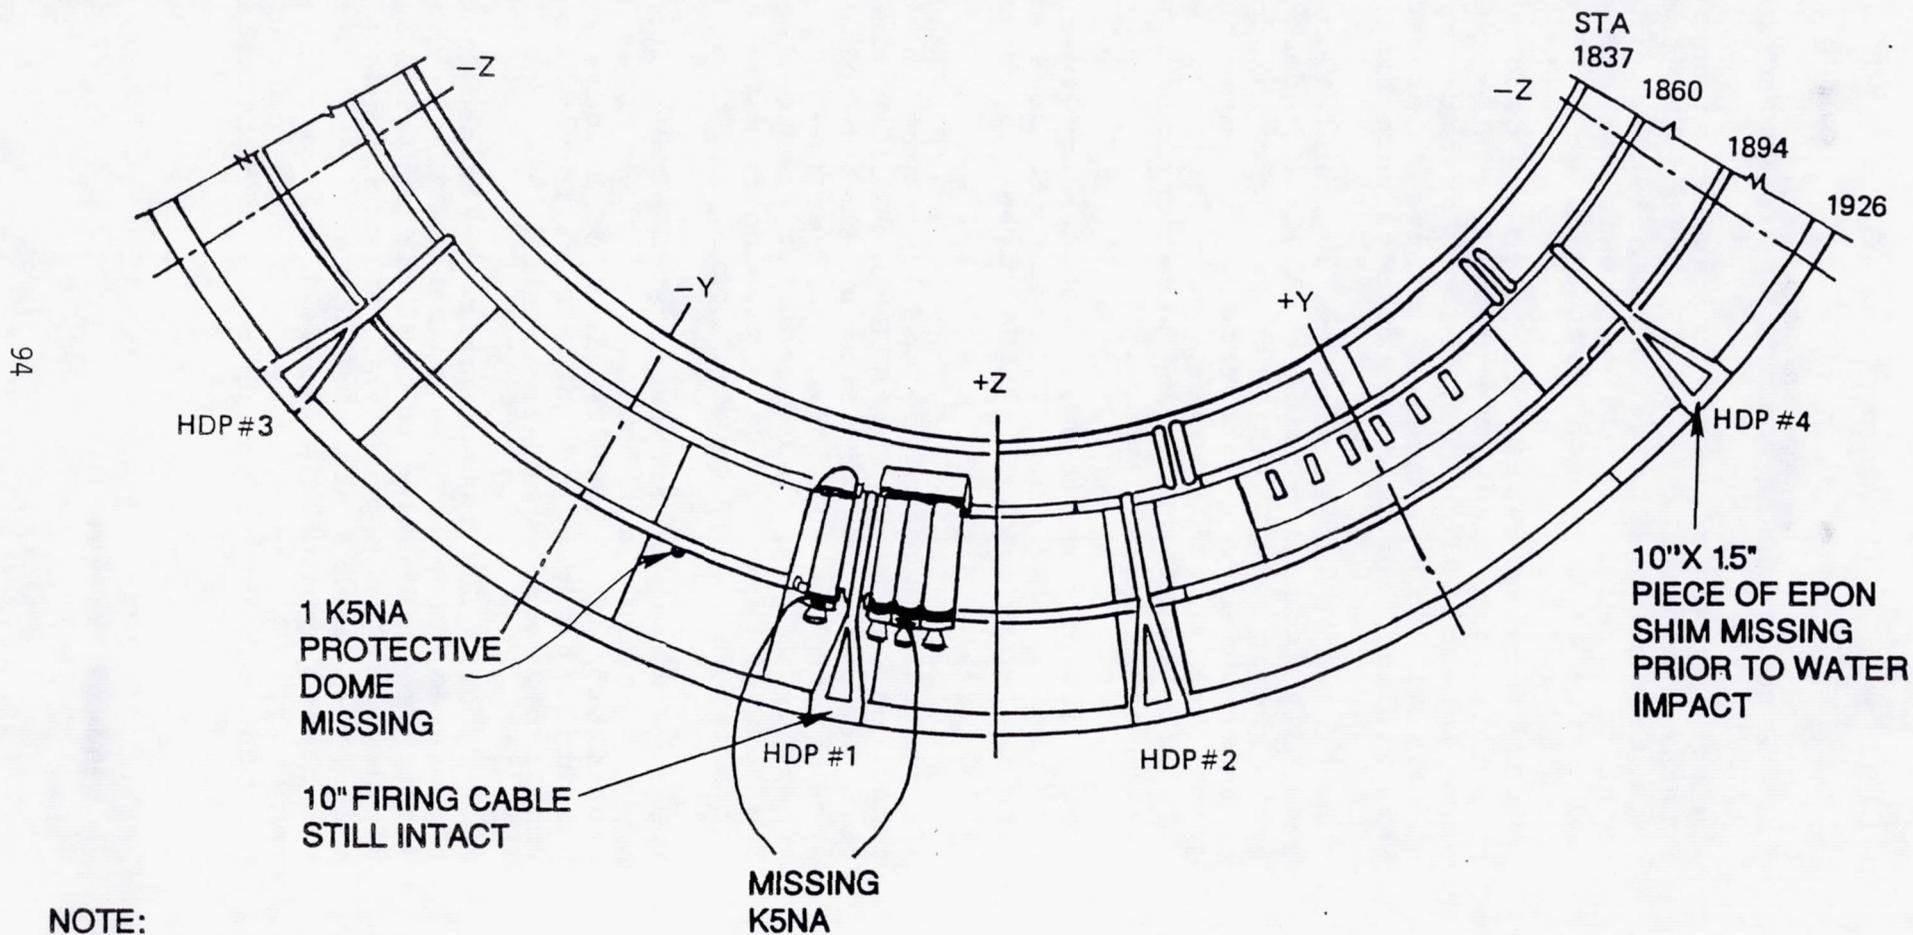
FIGURE 7. RIGHT SRB AFT SKIRT EXTERIOR TPS

The phenolic material on the kick ring delaminated in some locations. One of the K5NA protective domes was lost from the aft side of the phenolic kick ring prior to water impact. The aft skirt TPS acreage was in good condition with localized blistering of the Hypalon paint (Figure 7). K5NA was missing from all four aft BSM nozzles. Instafoam was missing from the aft ring around the aft skirt feet, HPU exhaust horns, and the SRB T-0 umbilical.

All four Debris Containment System (DCS) plungers were seated properly. Approximately 10 inches of pyrotechnic cable was still attached to HDP #1. A 10"x1.5" piece of EPON shim material was missing from HDP #4 prior to water impact.

NOTE:
ALL FOUR DCS PLUNGERS
WERE SEATED

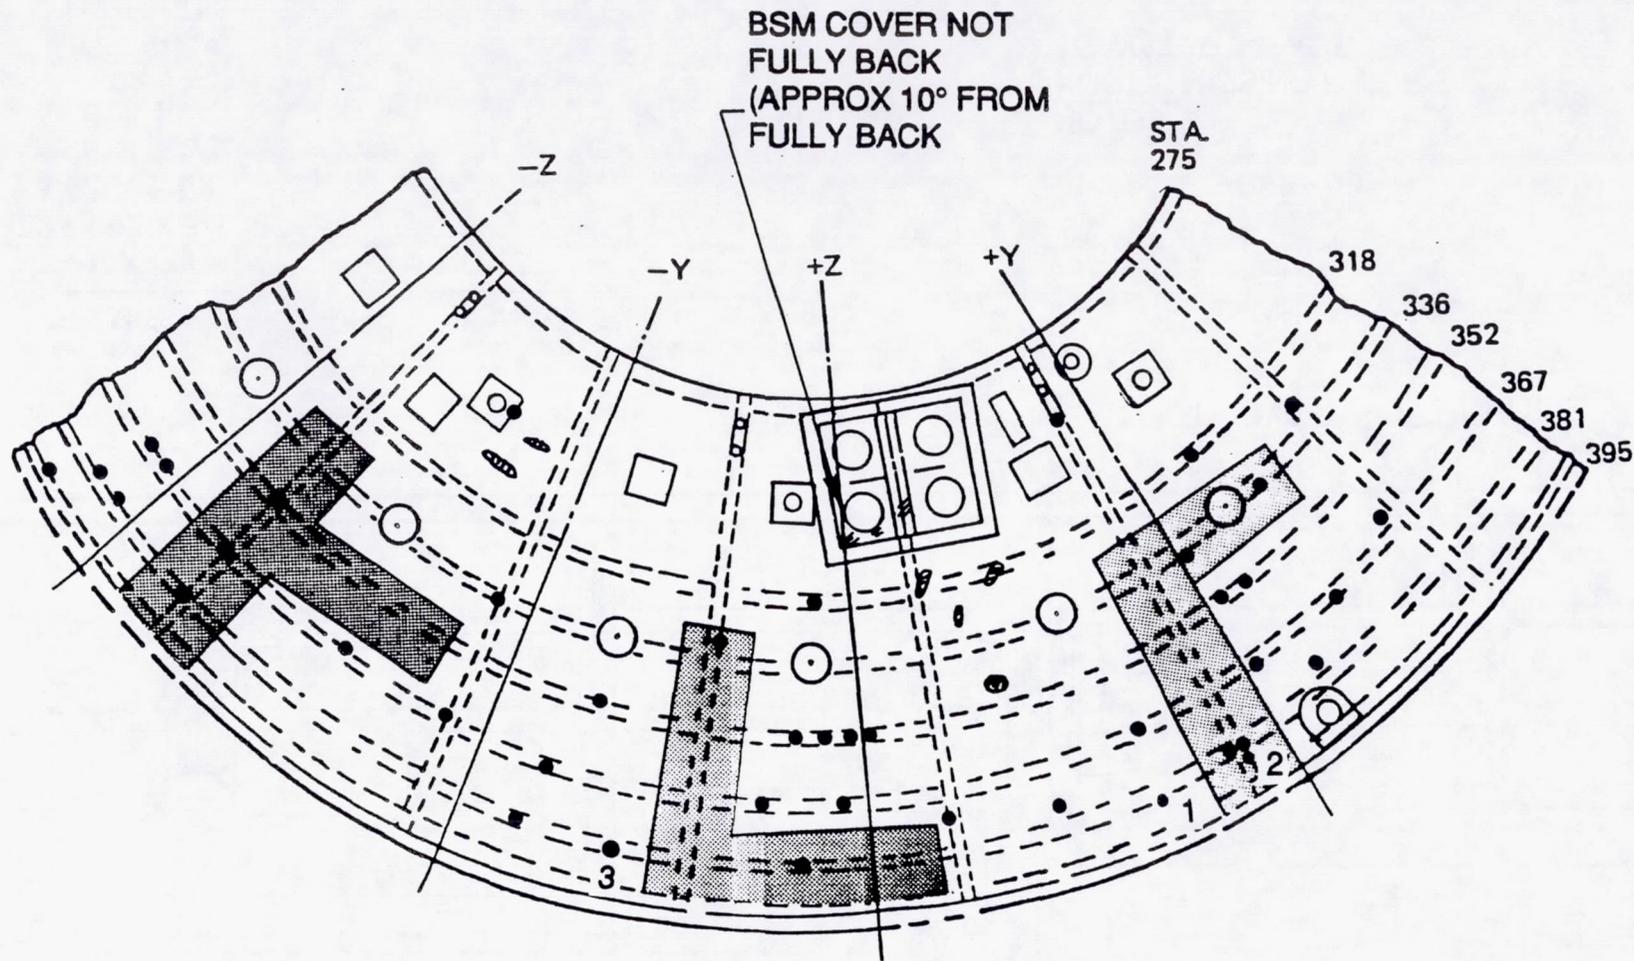
FIGURE 8. LEFT SRB FRUSTUM

The nose cap was recovered and showed no unusual damage. The LH frustum exhibited 2 areas of missing TPS and 41 MSA-2 debonds over fasteners (Figure 8). Minor blistering of the Hypalon paint occurred in localized areas. The BSM covers were intact and in the fully opened position.

MISSING TPS

- 1 - 3/16 X 3/8
- 2 - 3/8 X 5/8
- 3 - 1 X 1 1/4 (HANDLING DIVOT)

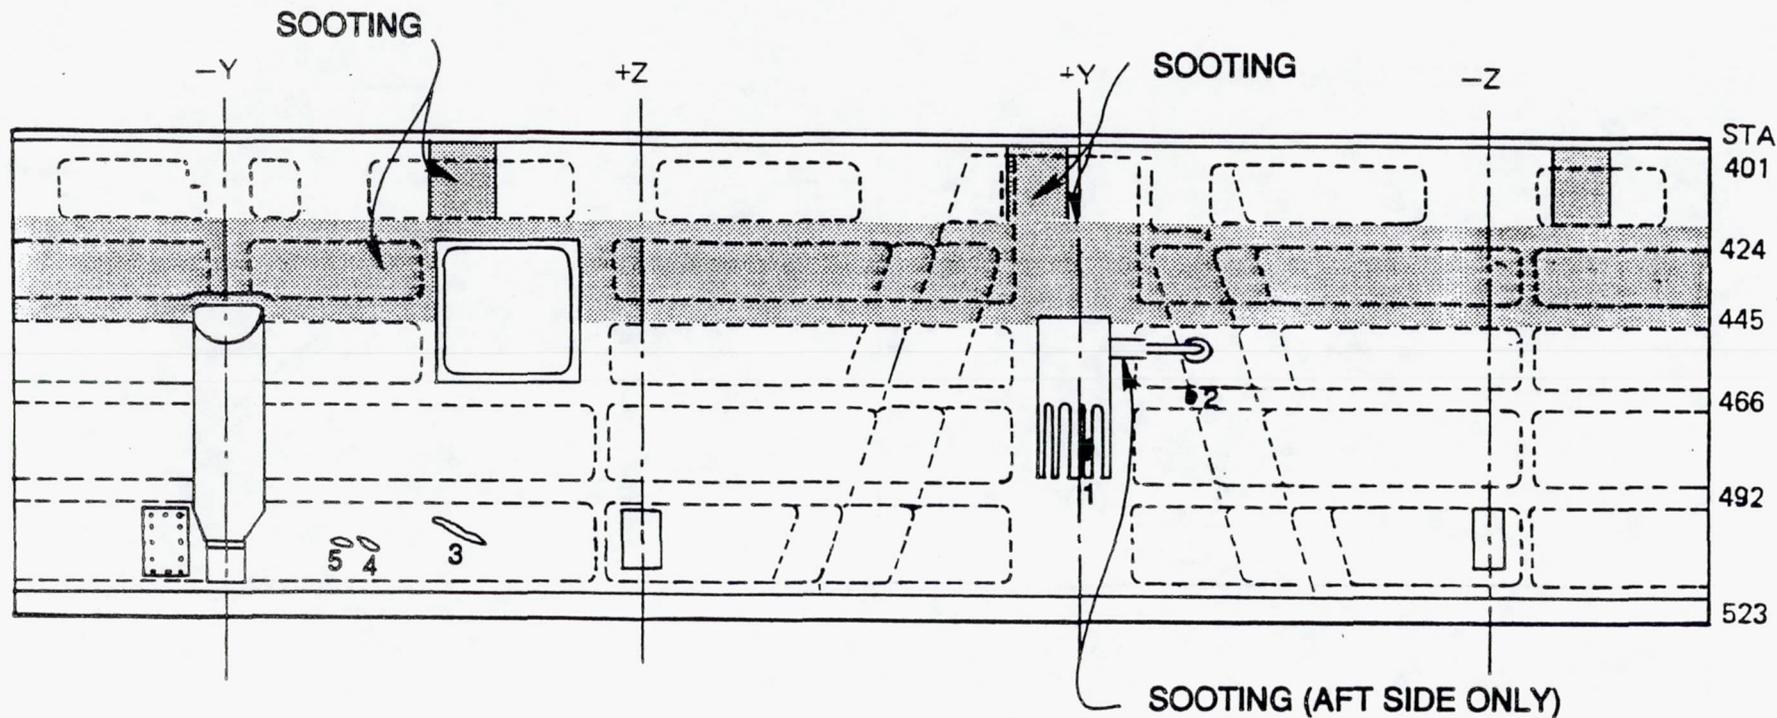
FIGURE 9. LEFT SRB FWD SKIRT

The LH forward skirt exhibited no debonds (see note about structural buckling). The phenolic plates on both RSS antennae were intact (Figure 9). The forward separation bolt and electrical cables appeared to have separated cleanly. No pins were missing from the frustum severance ring.

NOTE: The LH SRB forward skirt sustained damage in the area of the system tunnel. TPS (K5NA and MSA) was cracked and the metal substrate was buckled on both sides of the systems tunnel. Some of the Hypalon topcoat was missing. Initial assessment indicates the forward skirt damage was not a source of debris nor was caused by a debris problem. The most likely causes, according to MSFC, were unusual loads induced by water impact 'slapdown' loads or parachute deployment side loads.

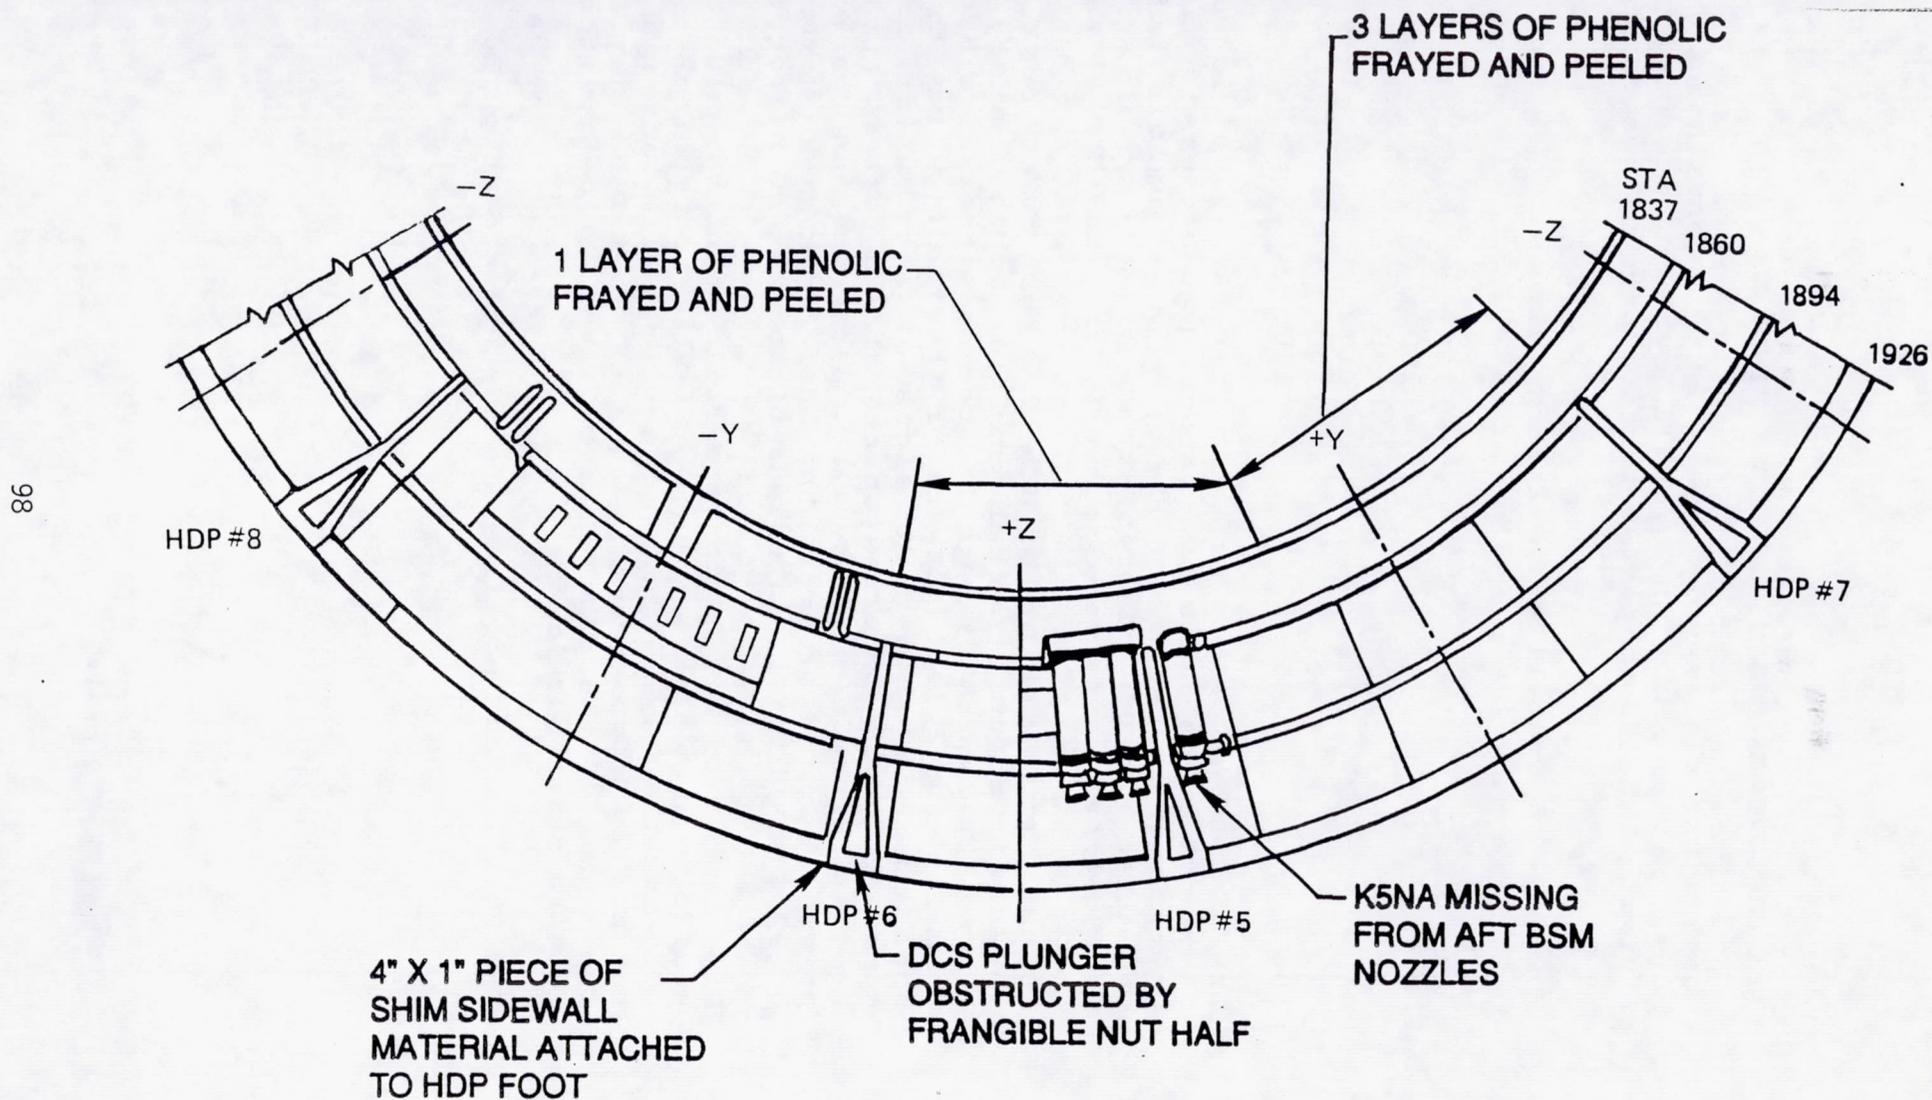
FIGURE 10. LEFT SRB AFT SKIRT EXTERIOR TPS

The phenolic material on the kick ring delaminated in several locations. None of the K5NA protective domes were lost from bolt heads on the aft side of the phenolic kick ring during ascent (Figure 10). The TPS over the aft skirt acreage was generally in good condition. K5NA was missing from all four aft BSM nozzles. Instafoam was missing from the aft ring around the aft skirt feet, HPU exhaust horns, and the SRB T-0 umbilical.

NO TPS MISSING PRIOR TO WATER IMPACT

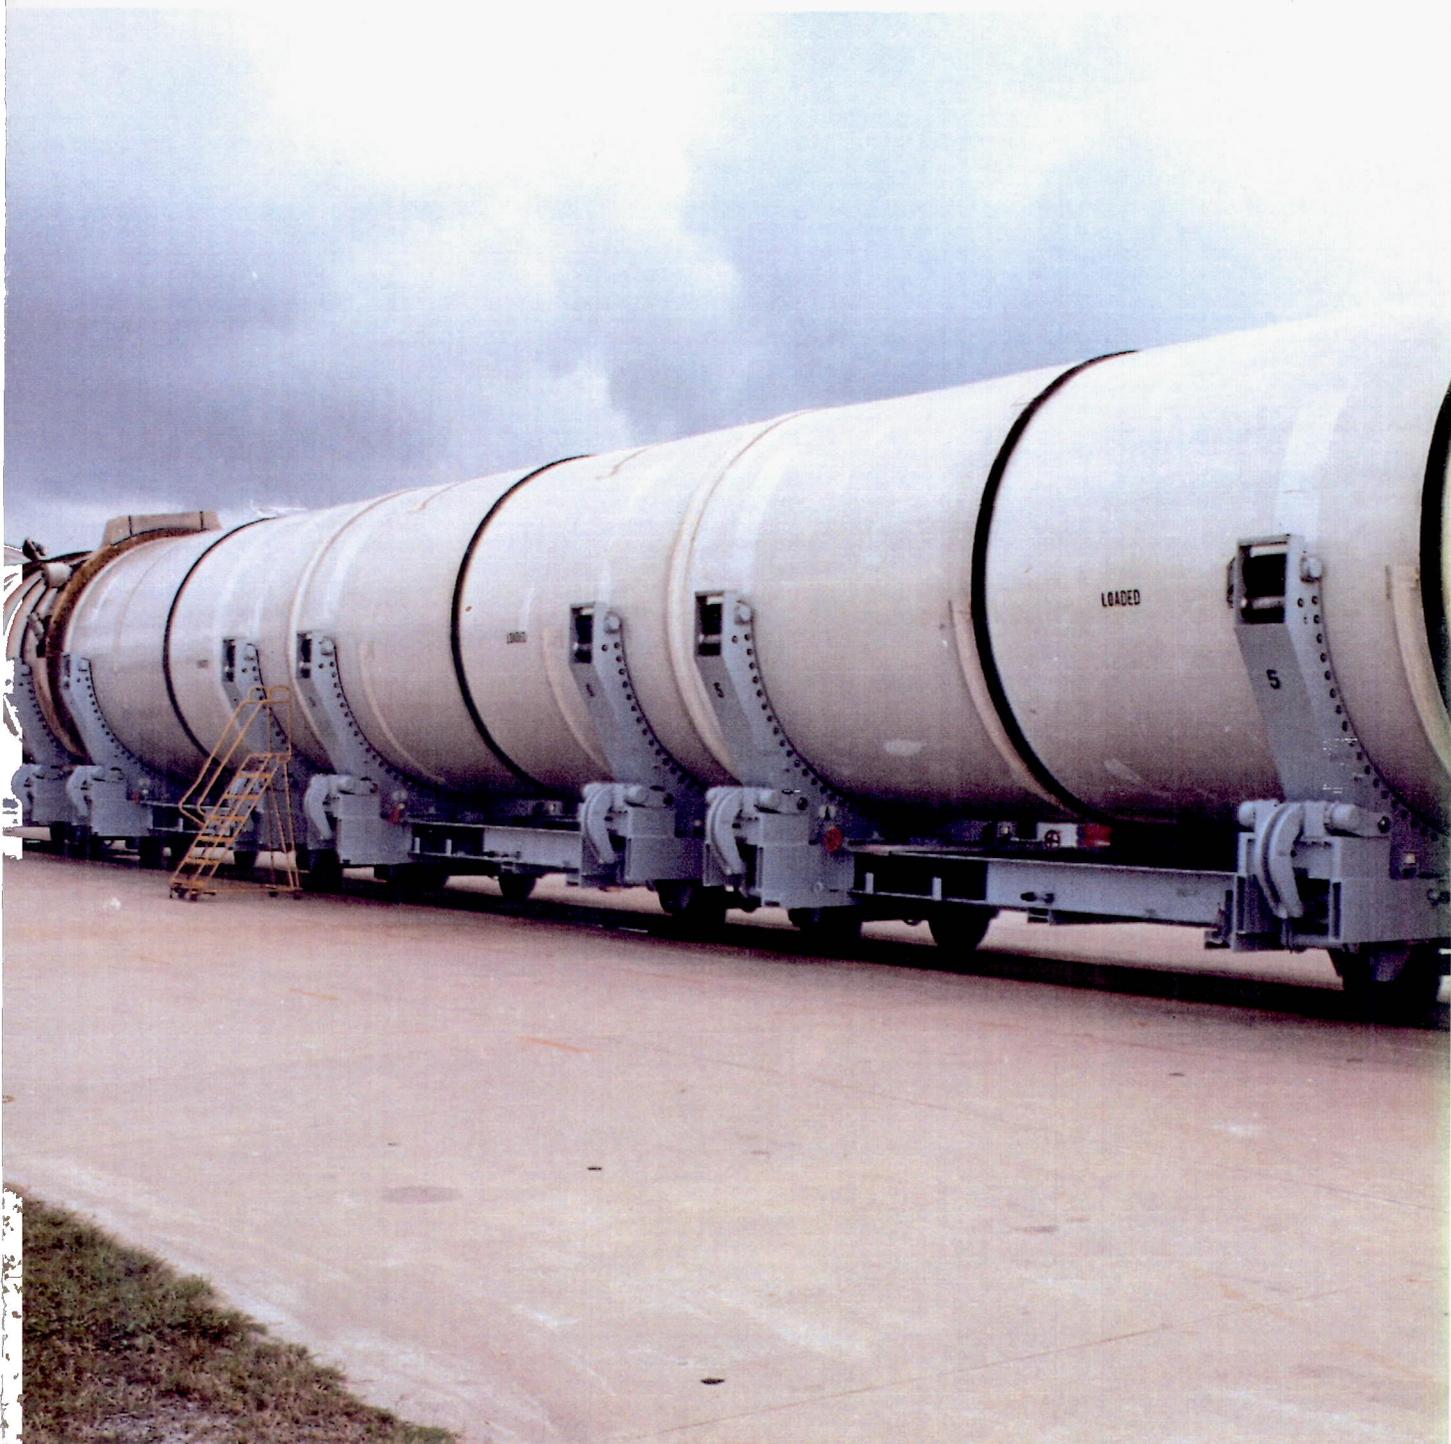
Post launch condition of the LH FWD skirt. There were no TPS debonds, areas of missing TPS, or other damage on the ET side of the FWD skirt (opposite side of the buckling damage).

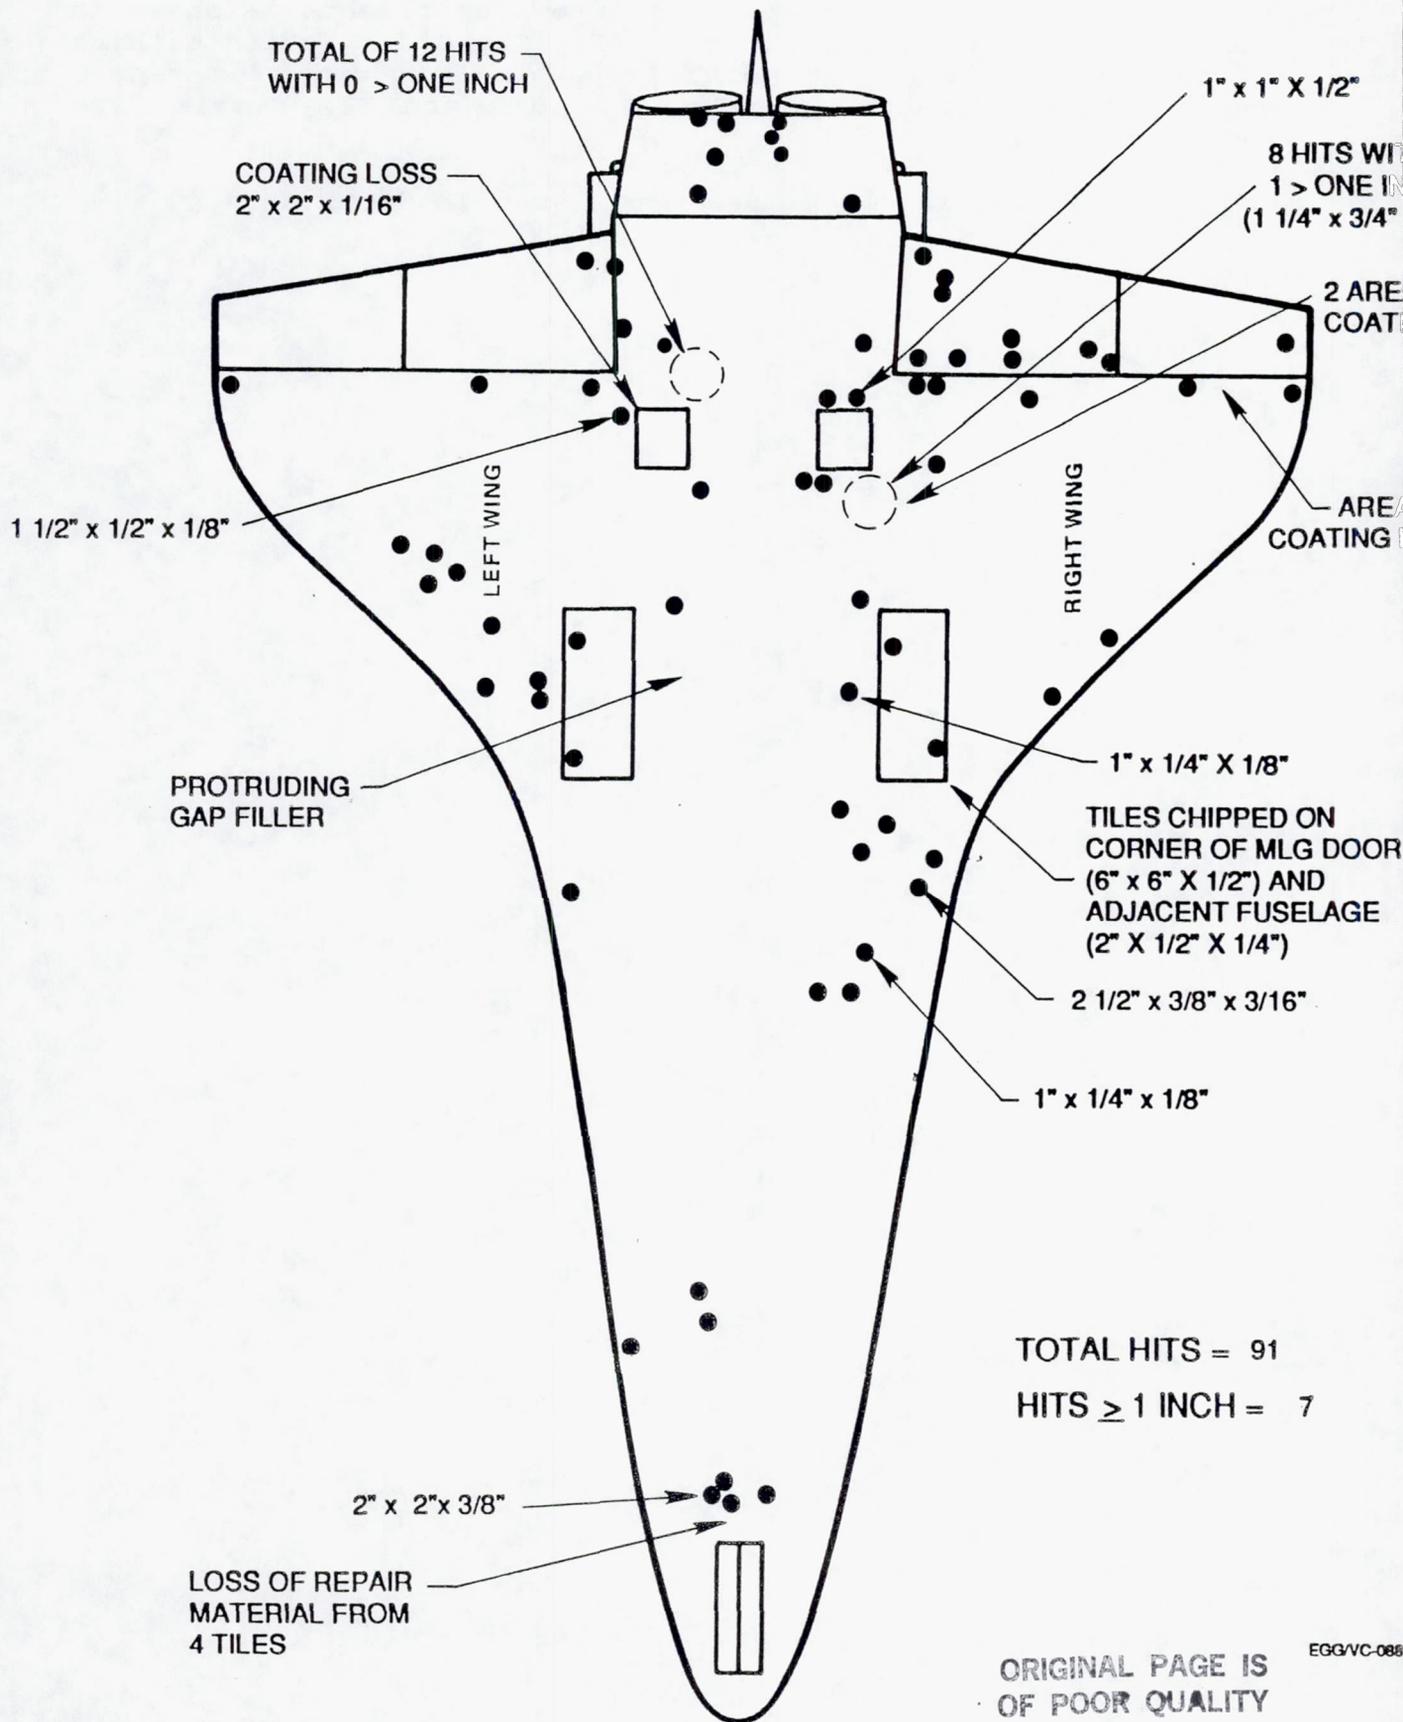
FIGURE 11. DEBRIS DAMAGE LOCATIONS

The Orbiter lower surface had a total of 91 hits of which 7 had a major dimension of one inch or greater. A comparison of these numbers to statistics from 25 previous missions of similar configuration (excluding missions STS-24, 25, 26, 26R, 27R, and 30R which had damage from known debris sources), indicates the total number of hits on the lower surface was greater than average, but the number of hits with a major dimension of 1" or larger was less than average. Figures 11-14 show the TPS debris damage assessment for STS-37. Figure 15 indicates the sites where samples were taken for laboratory chemical analysis.

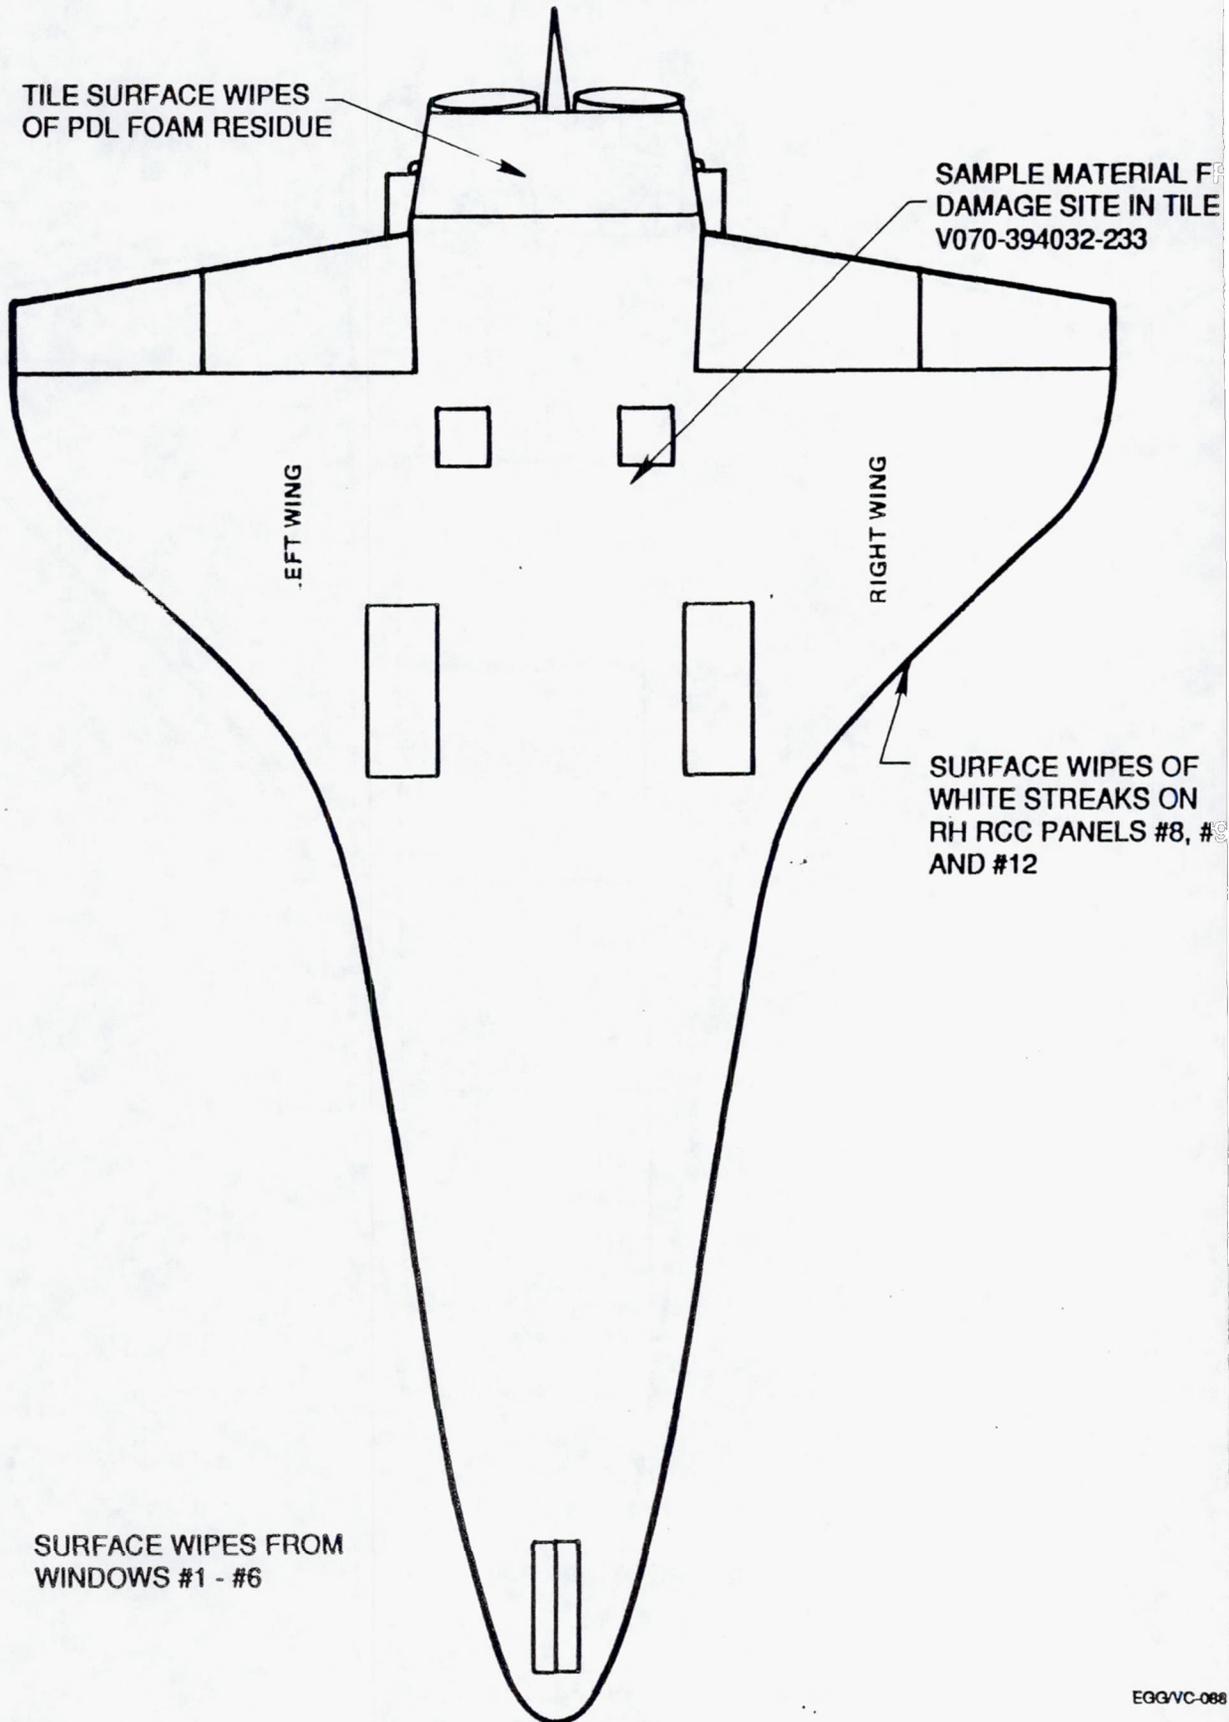
FIGURE 15. CHEMICAL SAMPLE LOCATIONS

A larger than usual quantity of white streaks were present on the RH wing leading edge RCC panels #5 through #17. The largest streak, on panel #8, was approximately 24" long by 4" wide. Only a few very small white streaks were present on the LH wing RCC panels. Samples of selected streaks were taken for laboratory analysis (reference Figure 15).
