Debris/Ice/TPS Assessment And Photographic Analysis For Shuttle Mission STS-37

April 1991

Gregory N. Katnik
NASA/Kennedy Space Center

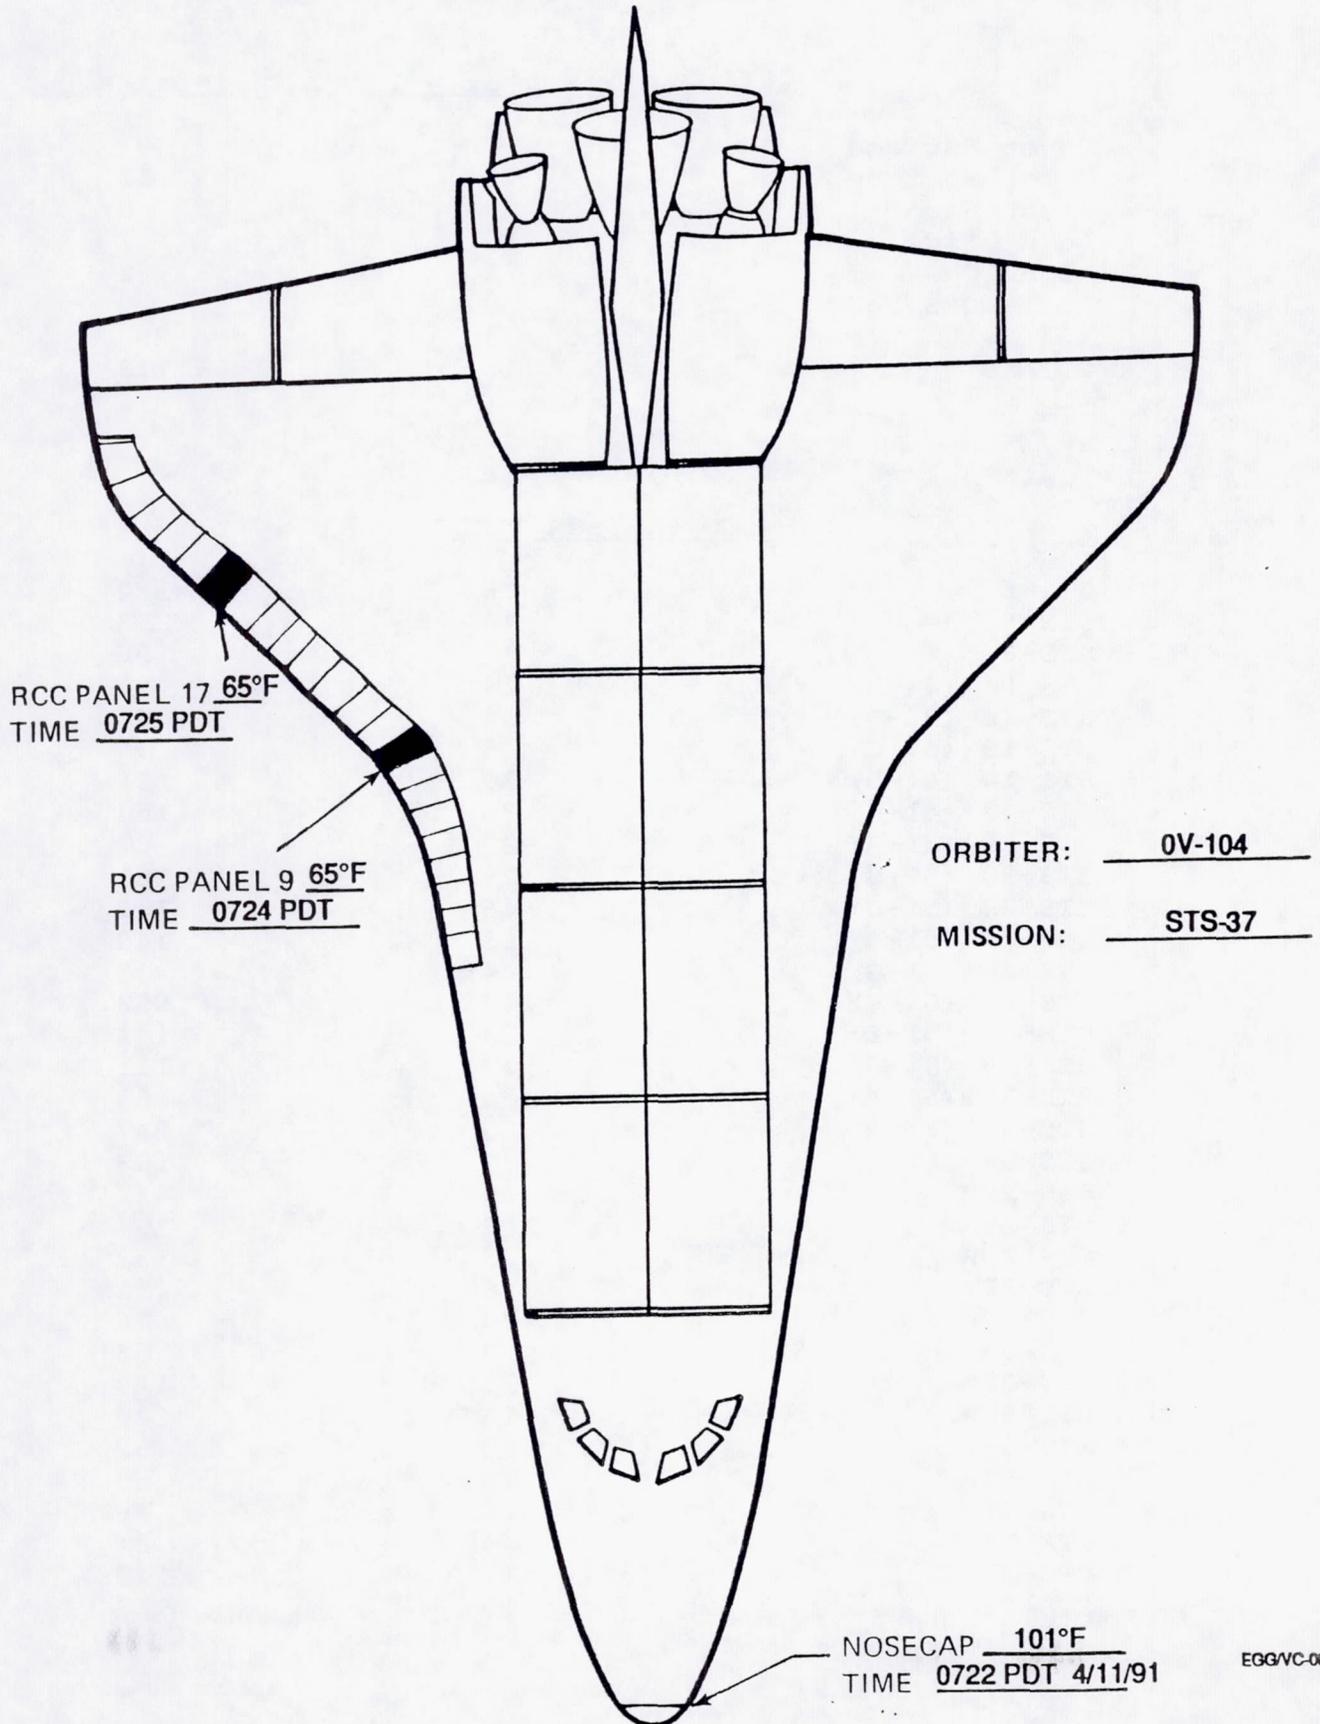
FIGURE 16. **STS-37 RCC TEMPERATURE MEASUREMENTS AS RECORDED BY THE SHUTTLE THERMAL IMAGER TEMPERATURE MEASUREMENTS**

The KSC Shuttle Thermal Imager (STI) was used to measure the surface temperatures of several areas. Twenty-seven minutes after landing the Orbiter nose cap RCC was 101 degrees F and both the RH wing leading edge RCC panels #9 and #17 were 65 degrees F (reference Figure 16). These temperatures were lower than usual due to the low ambient temperature and high winds.

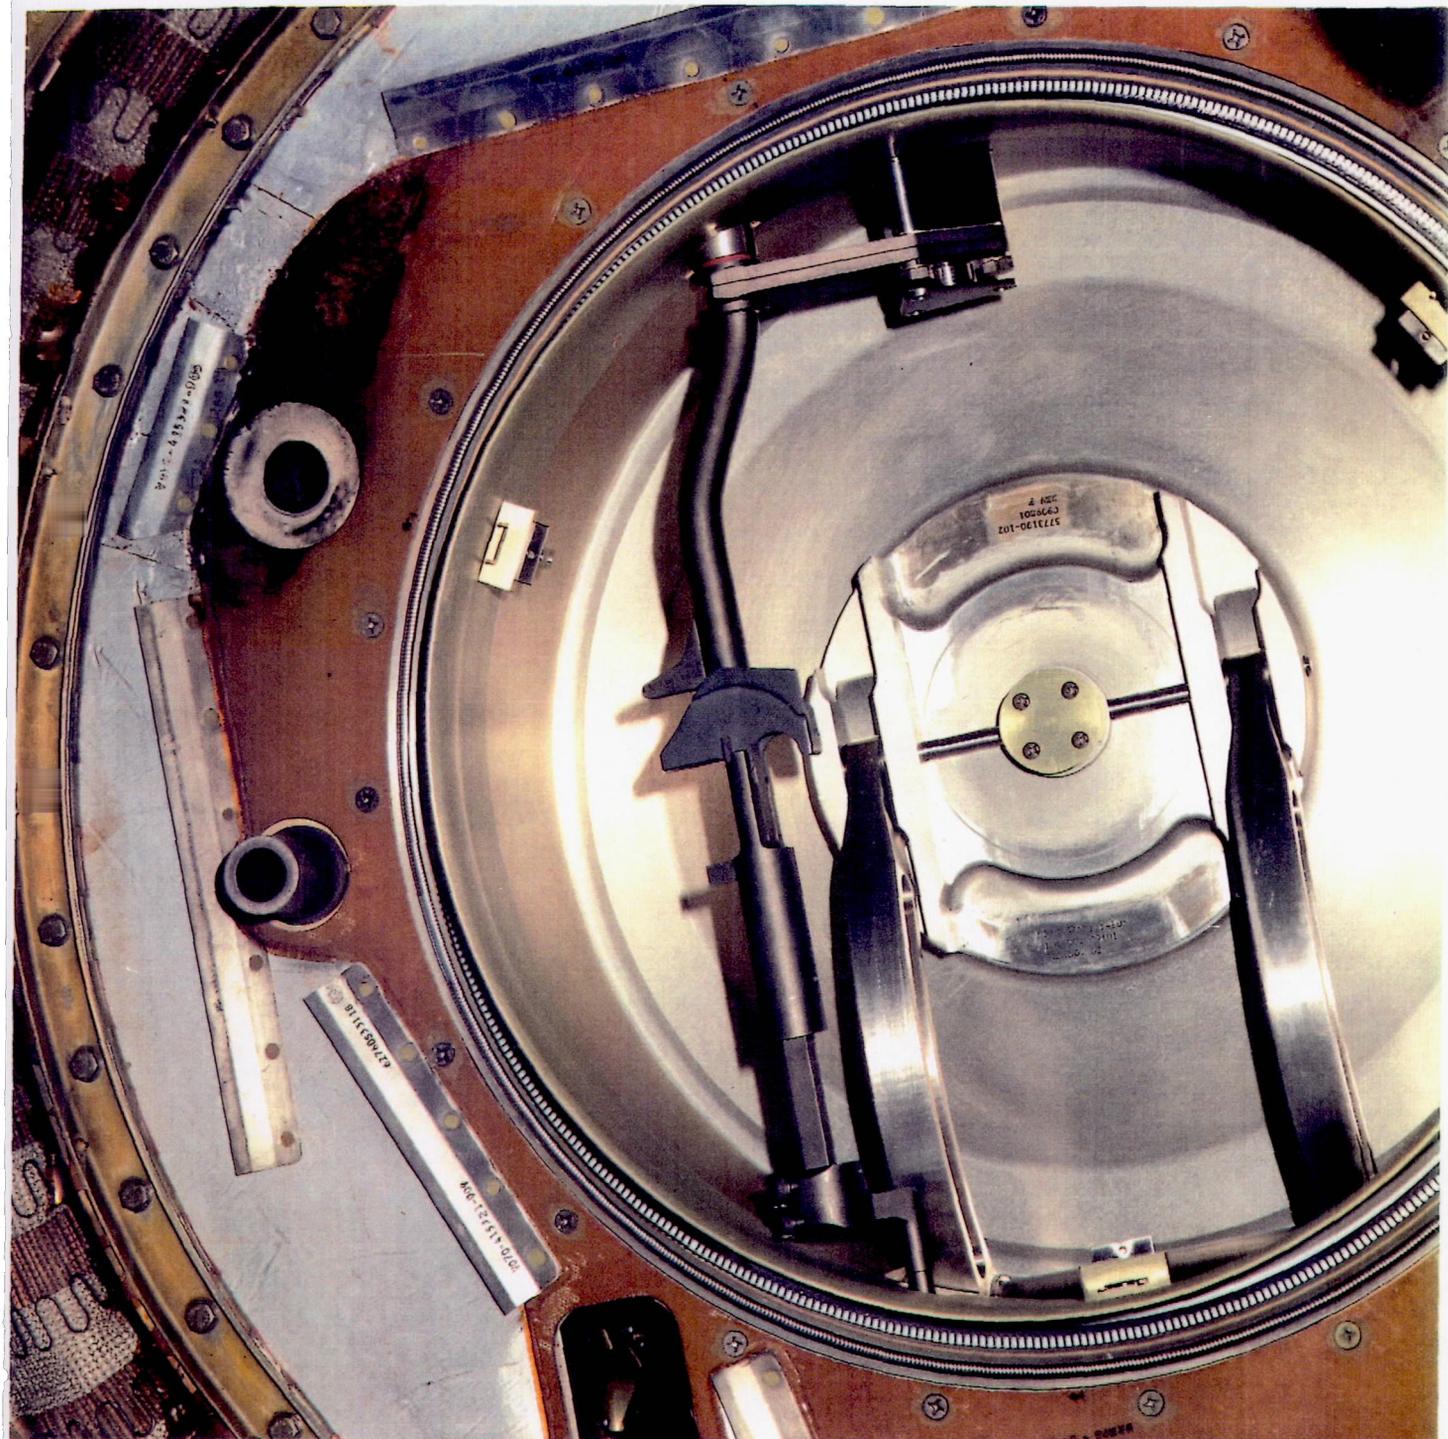
A lightning protection contact fell onto the runway when the LH2 ET/Orbiter umbilical door was opened. This contact, which is approximately 17.5" long by 2.5" wide, is normally bonded to the ET half of the LH2 umbilical and should have stayed with the ET after separation. Subsequent laboratory analysis revealed adhesive failure with very little adhesive present on the inner surface (bonding side of the part to the umbilical). There was no evidence of foam material or contaminants. The

polyurethane adhesive had been poorly cured. The cause of the bonding problem is unknown, but the use of self tapping screws to secure the lightning contact is under review. The new 14 inch disconnects were designed with fastened lightning protection contacts.

Lightning protection contact that fell onto the runway when the LH2 ET/ORB umbilical ET door was opened. The contact is normally bonded to the ET half of the umbilical and should have stayed with the ET after separation.

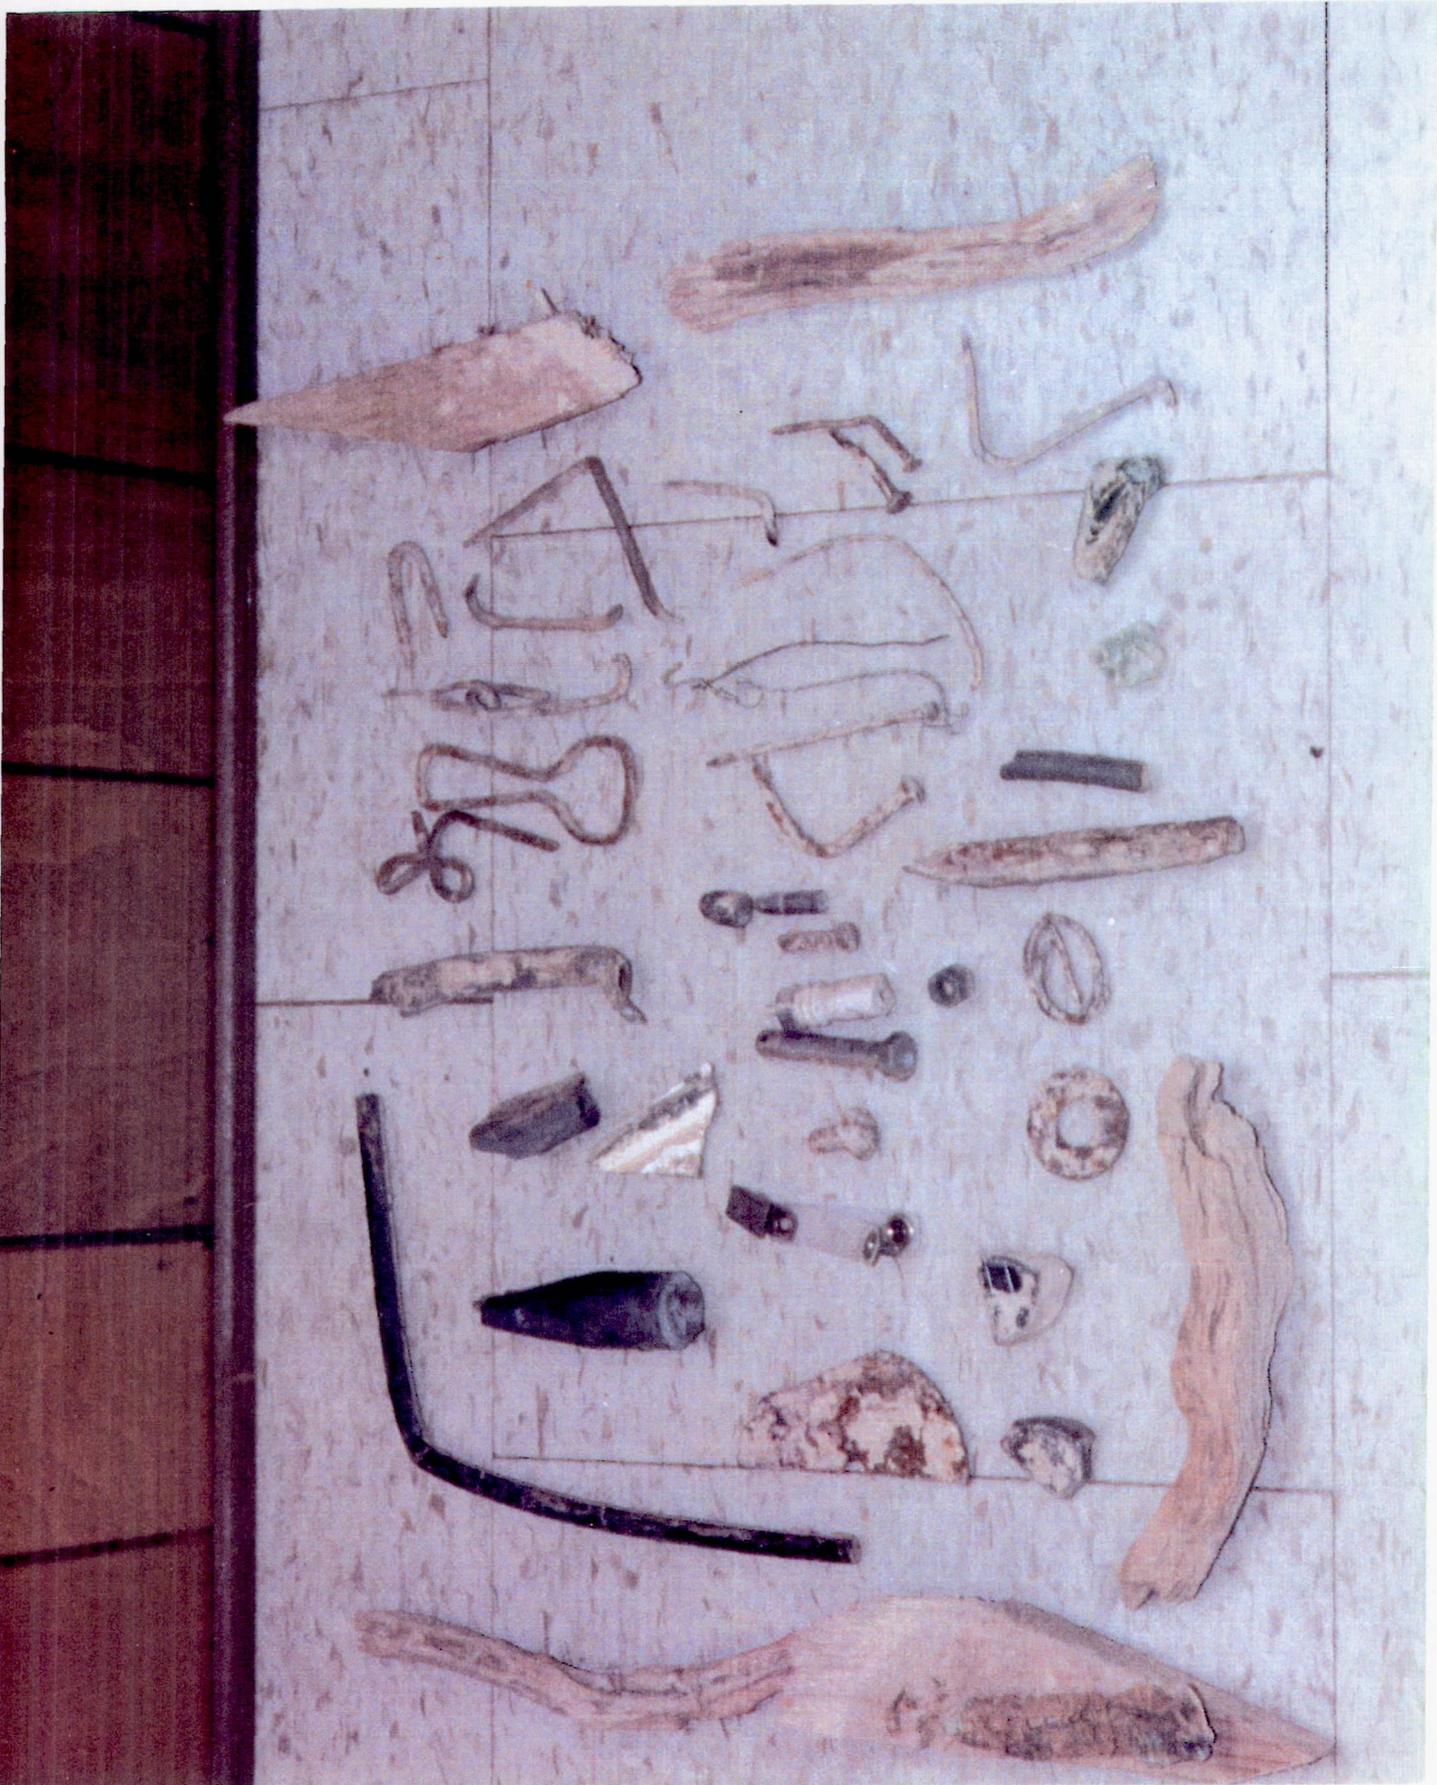
The only flight hardware found on the runway were pieces of the broken tile from the RH main landing gear door

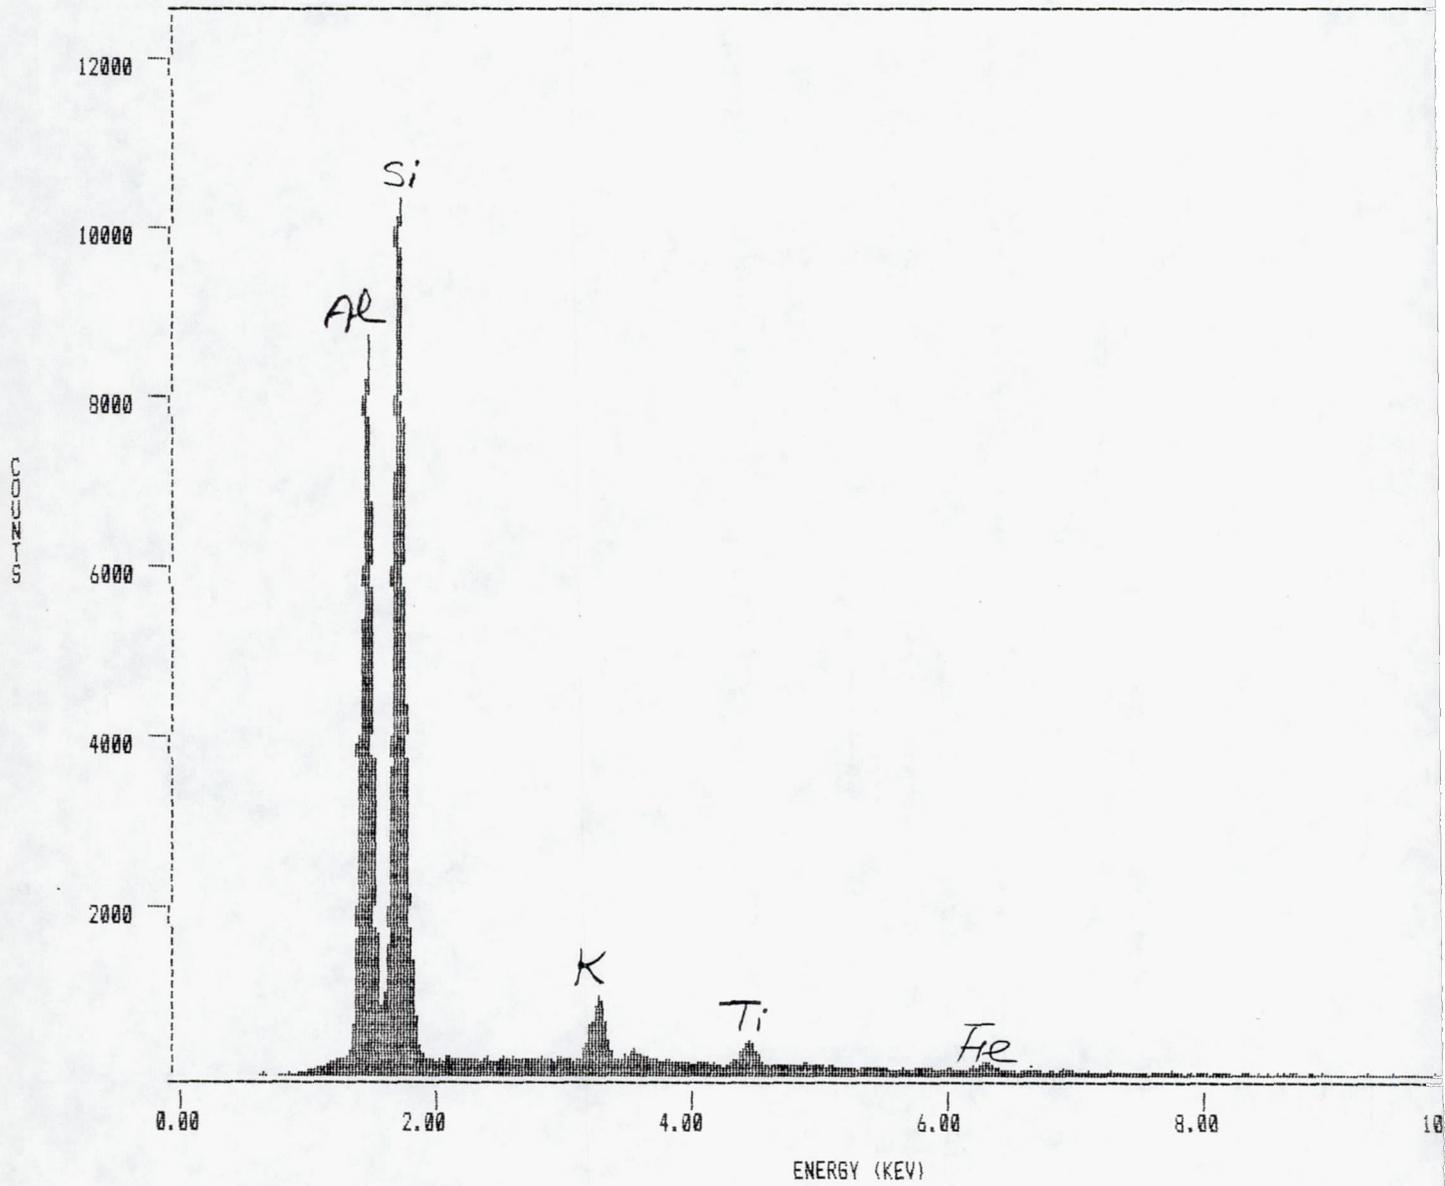
Figure 4. HYPALON, AS RCVD, 988-90

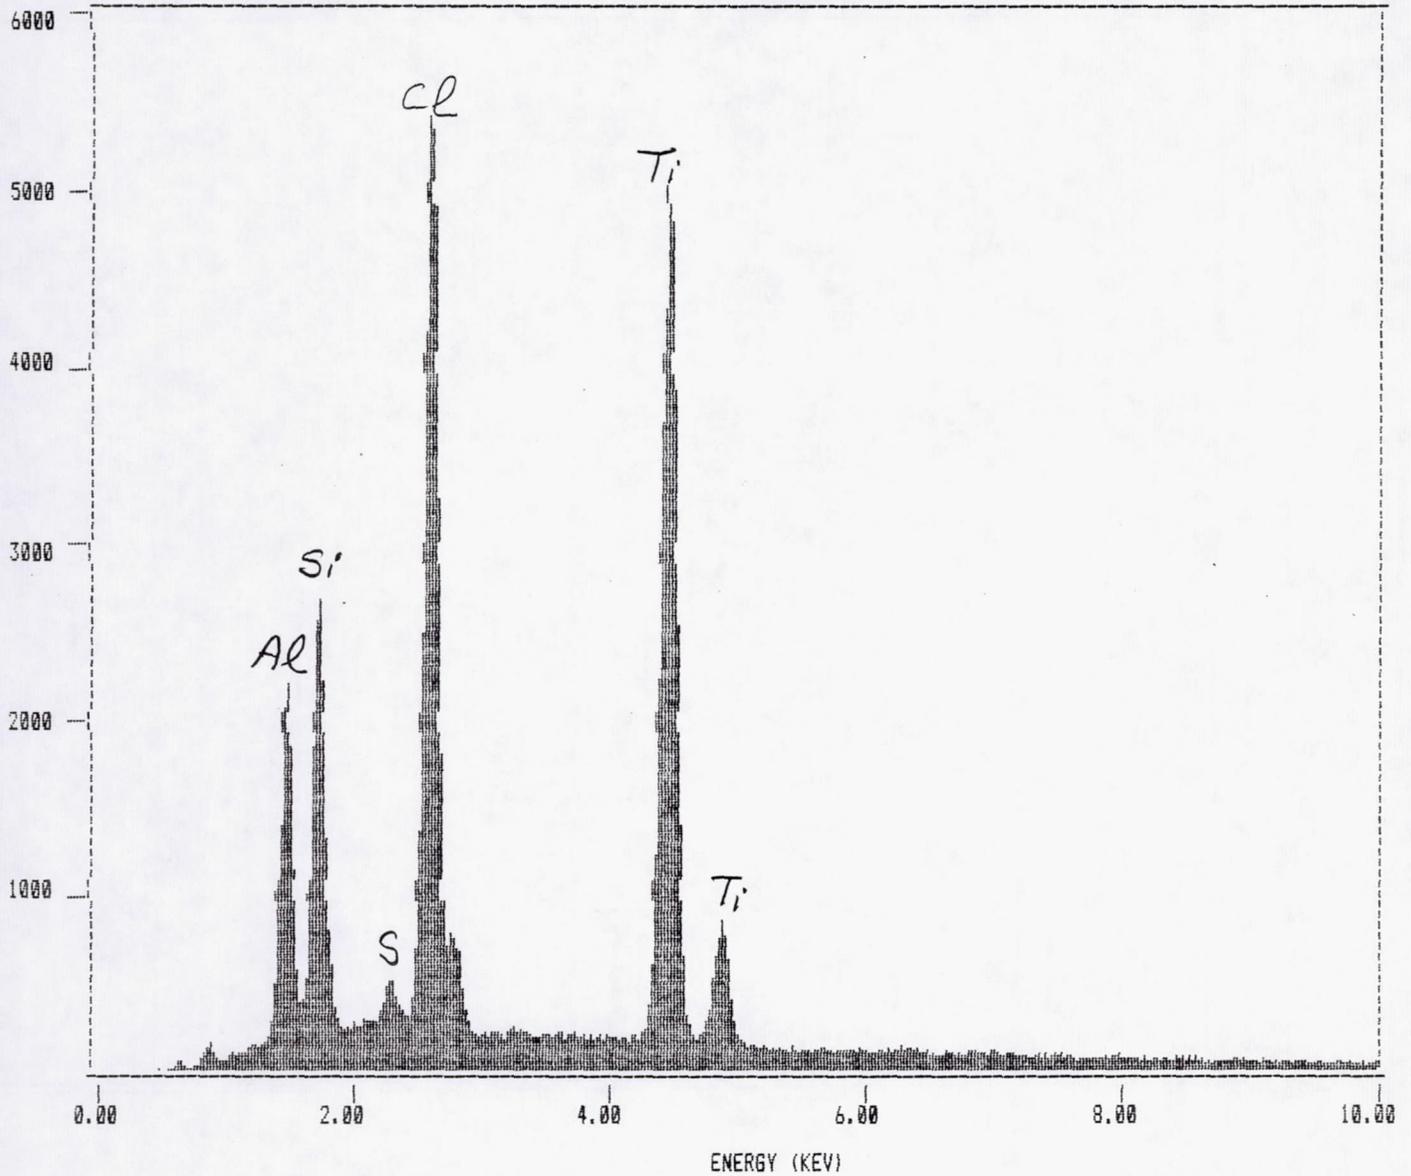
Figure 5, HYP, 2600F, 1HR, 988-90
