# Debris/Ice/TPS Assessment And Photographic Analysis For Shuttle Mission STS-40

DEBRIS/ICE/TPS ASSESSMENT  
AND  
PHOTOGRAPHIC ANALYSIS  
OF  
SHUTTLE MISSION STS-40

June 5, 1991.

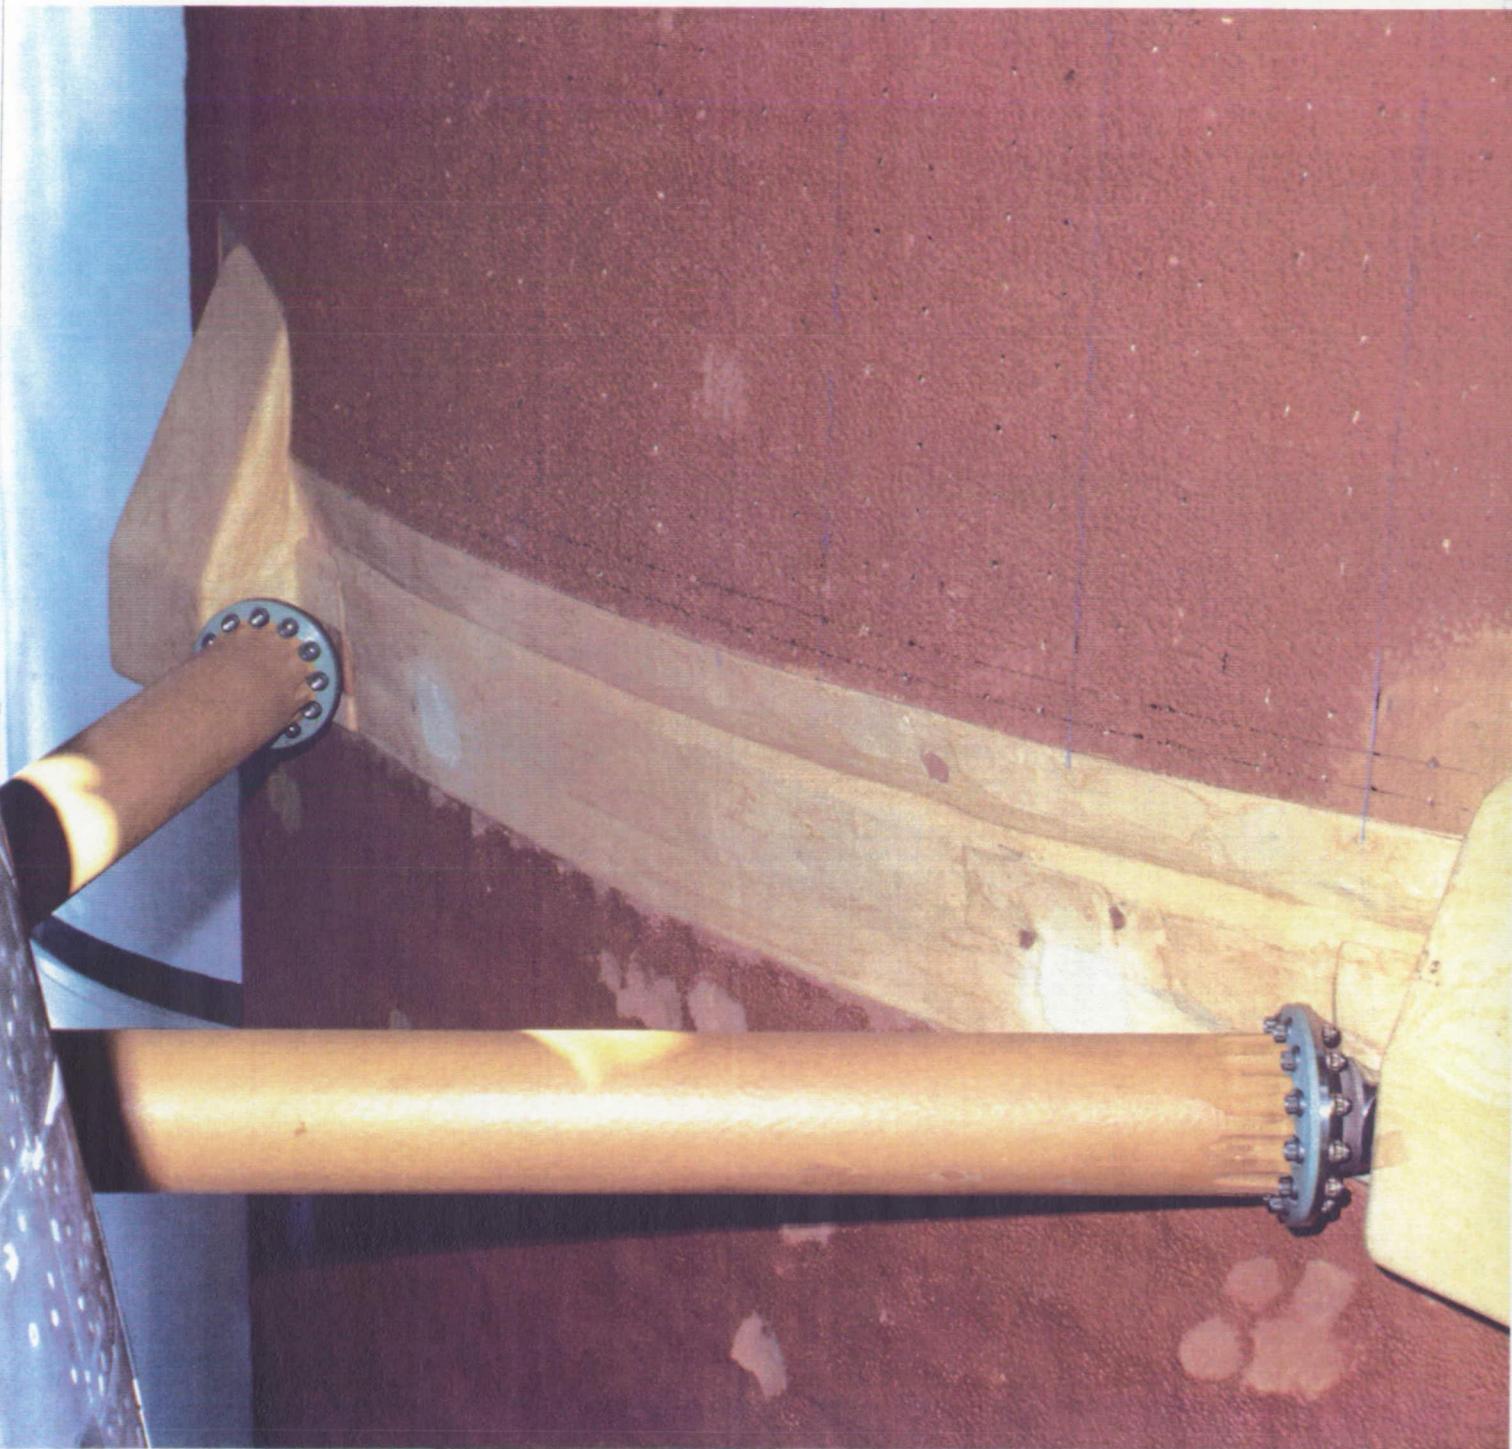
View of the External Tank forward attach point bipods, +Z side of the intertank and upper LH2 tank prior to cryoload. No anomalies were visible on the bipod jack pad closeouts.

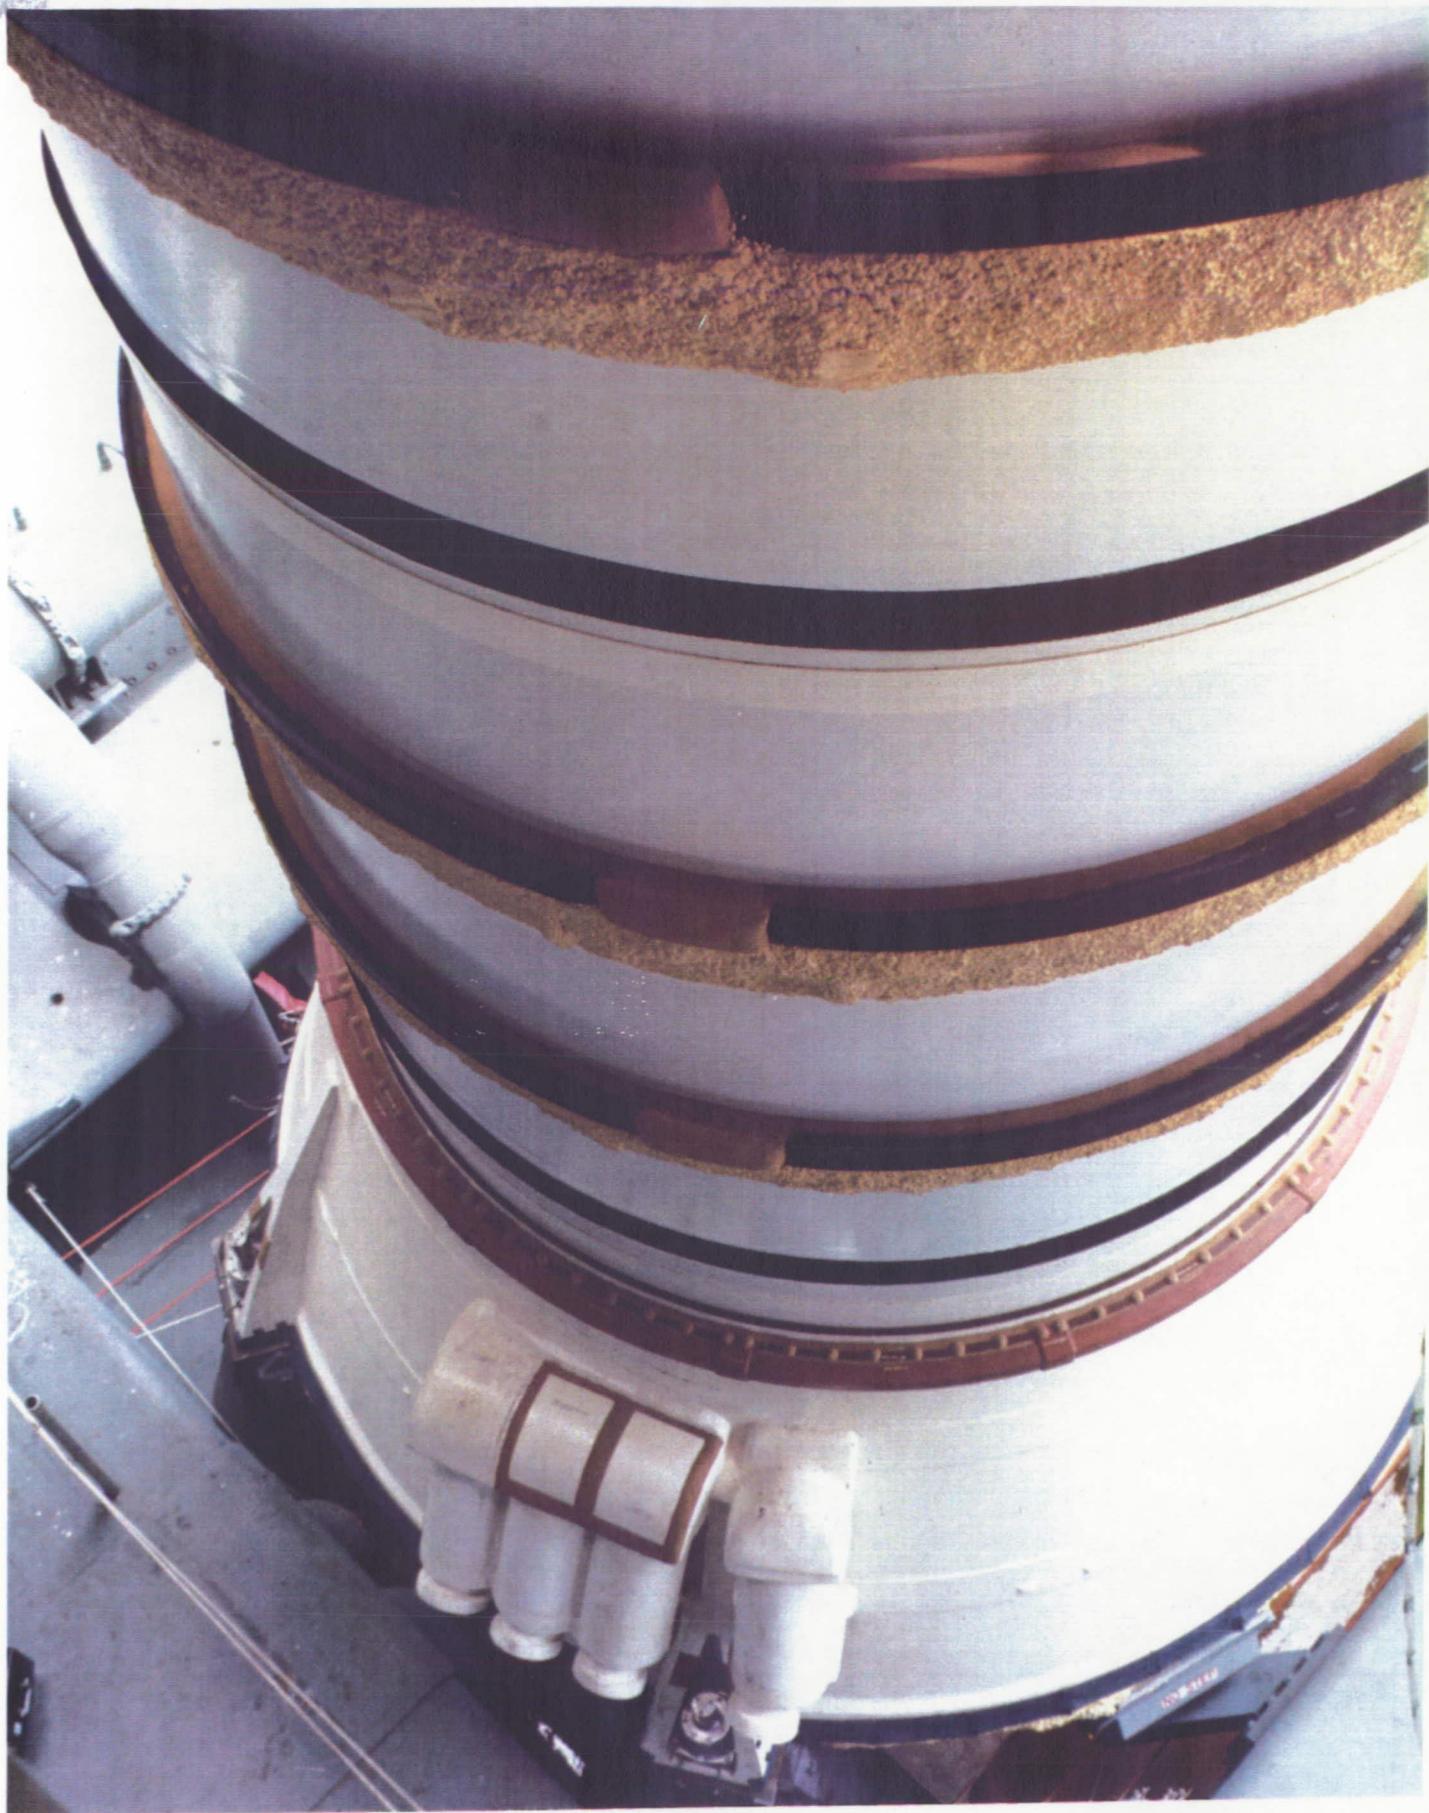
Aft booster stiffener ring splice plate K5NA closeouts were intact on the LH Solid Rocket Booster

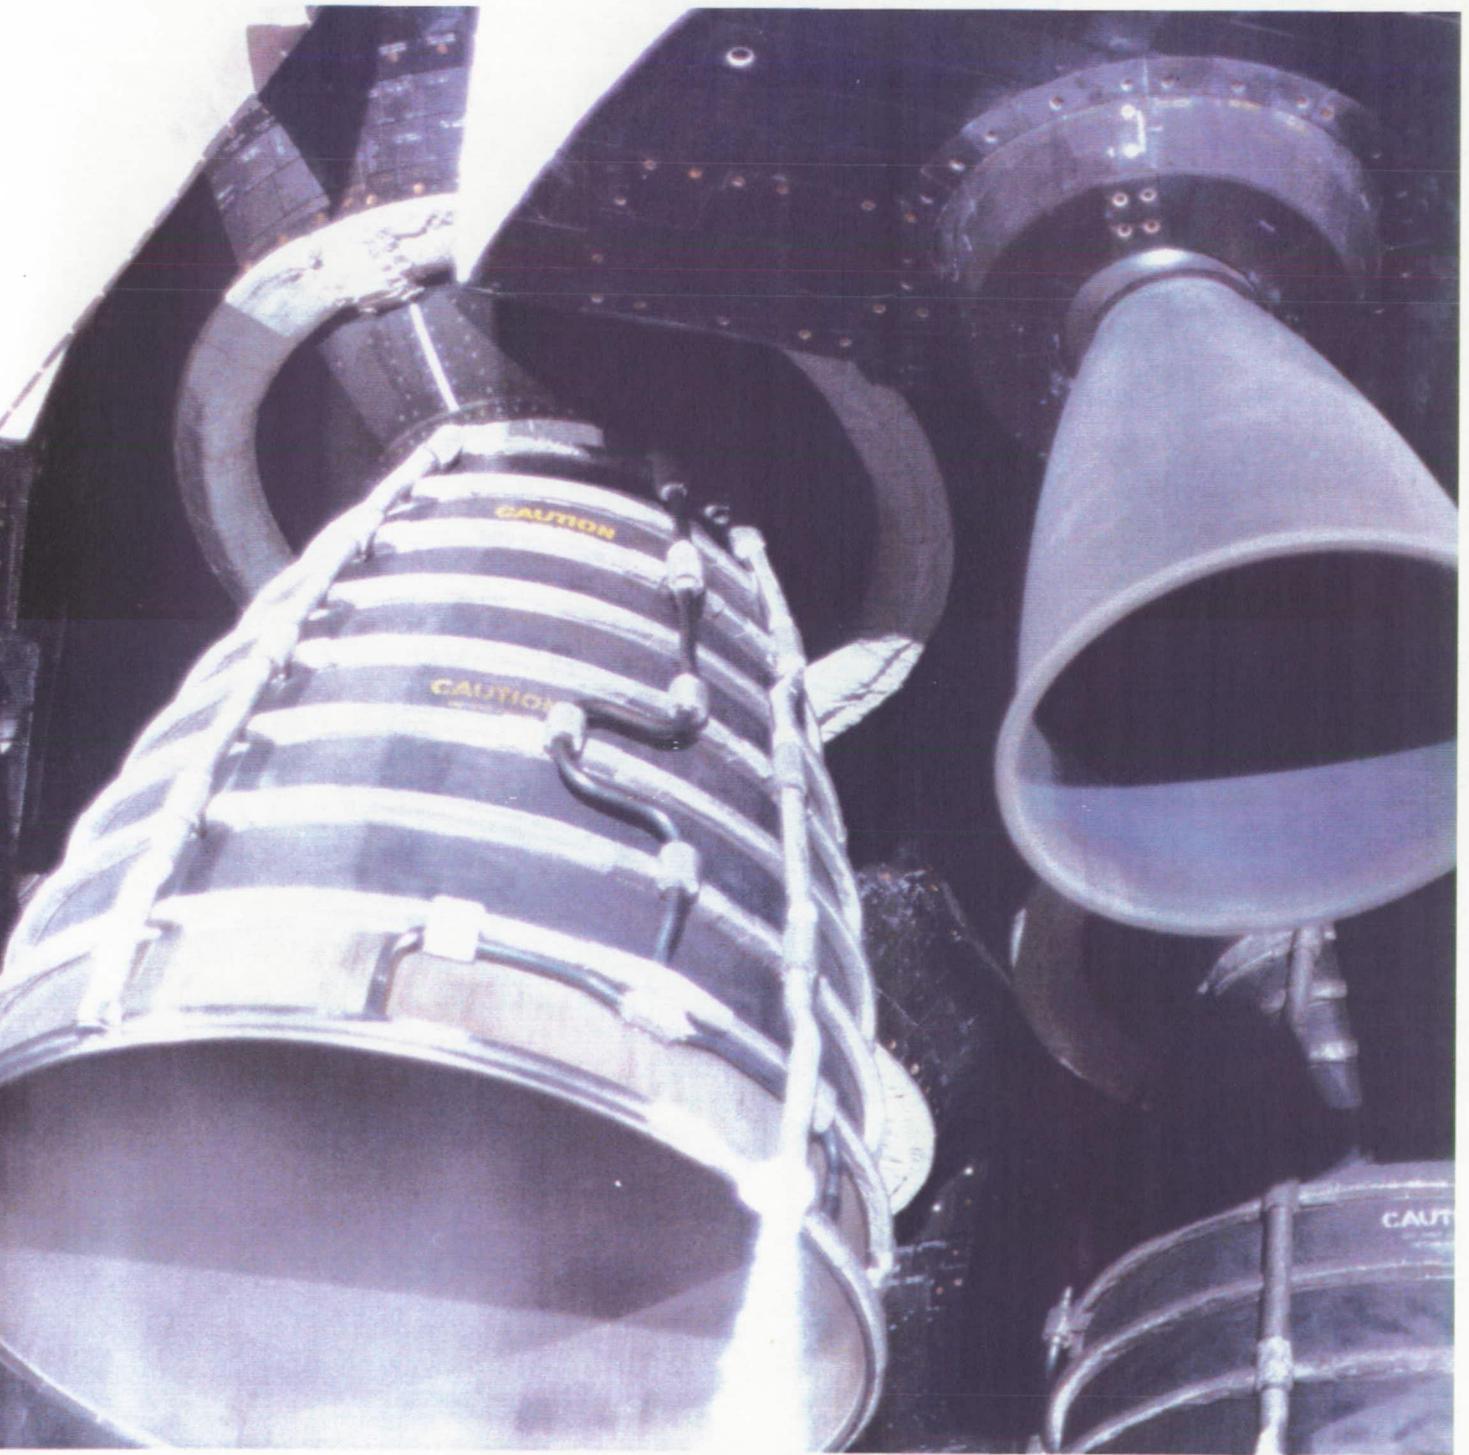
Light condensate was present on the SSME engine mounted heat shields. Light ice/frost had accumulated on the SSME #1 and #2 heat shield-to-nozzle interfaces.

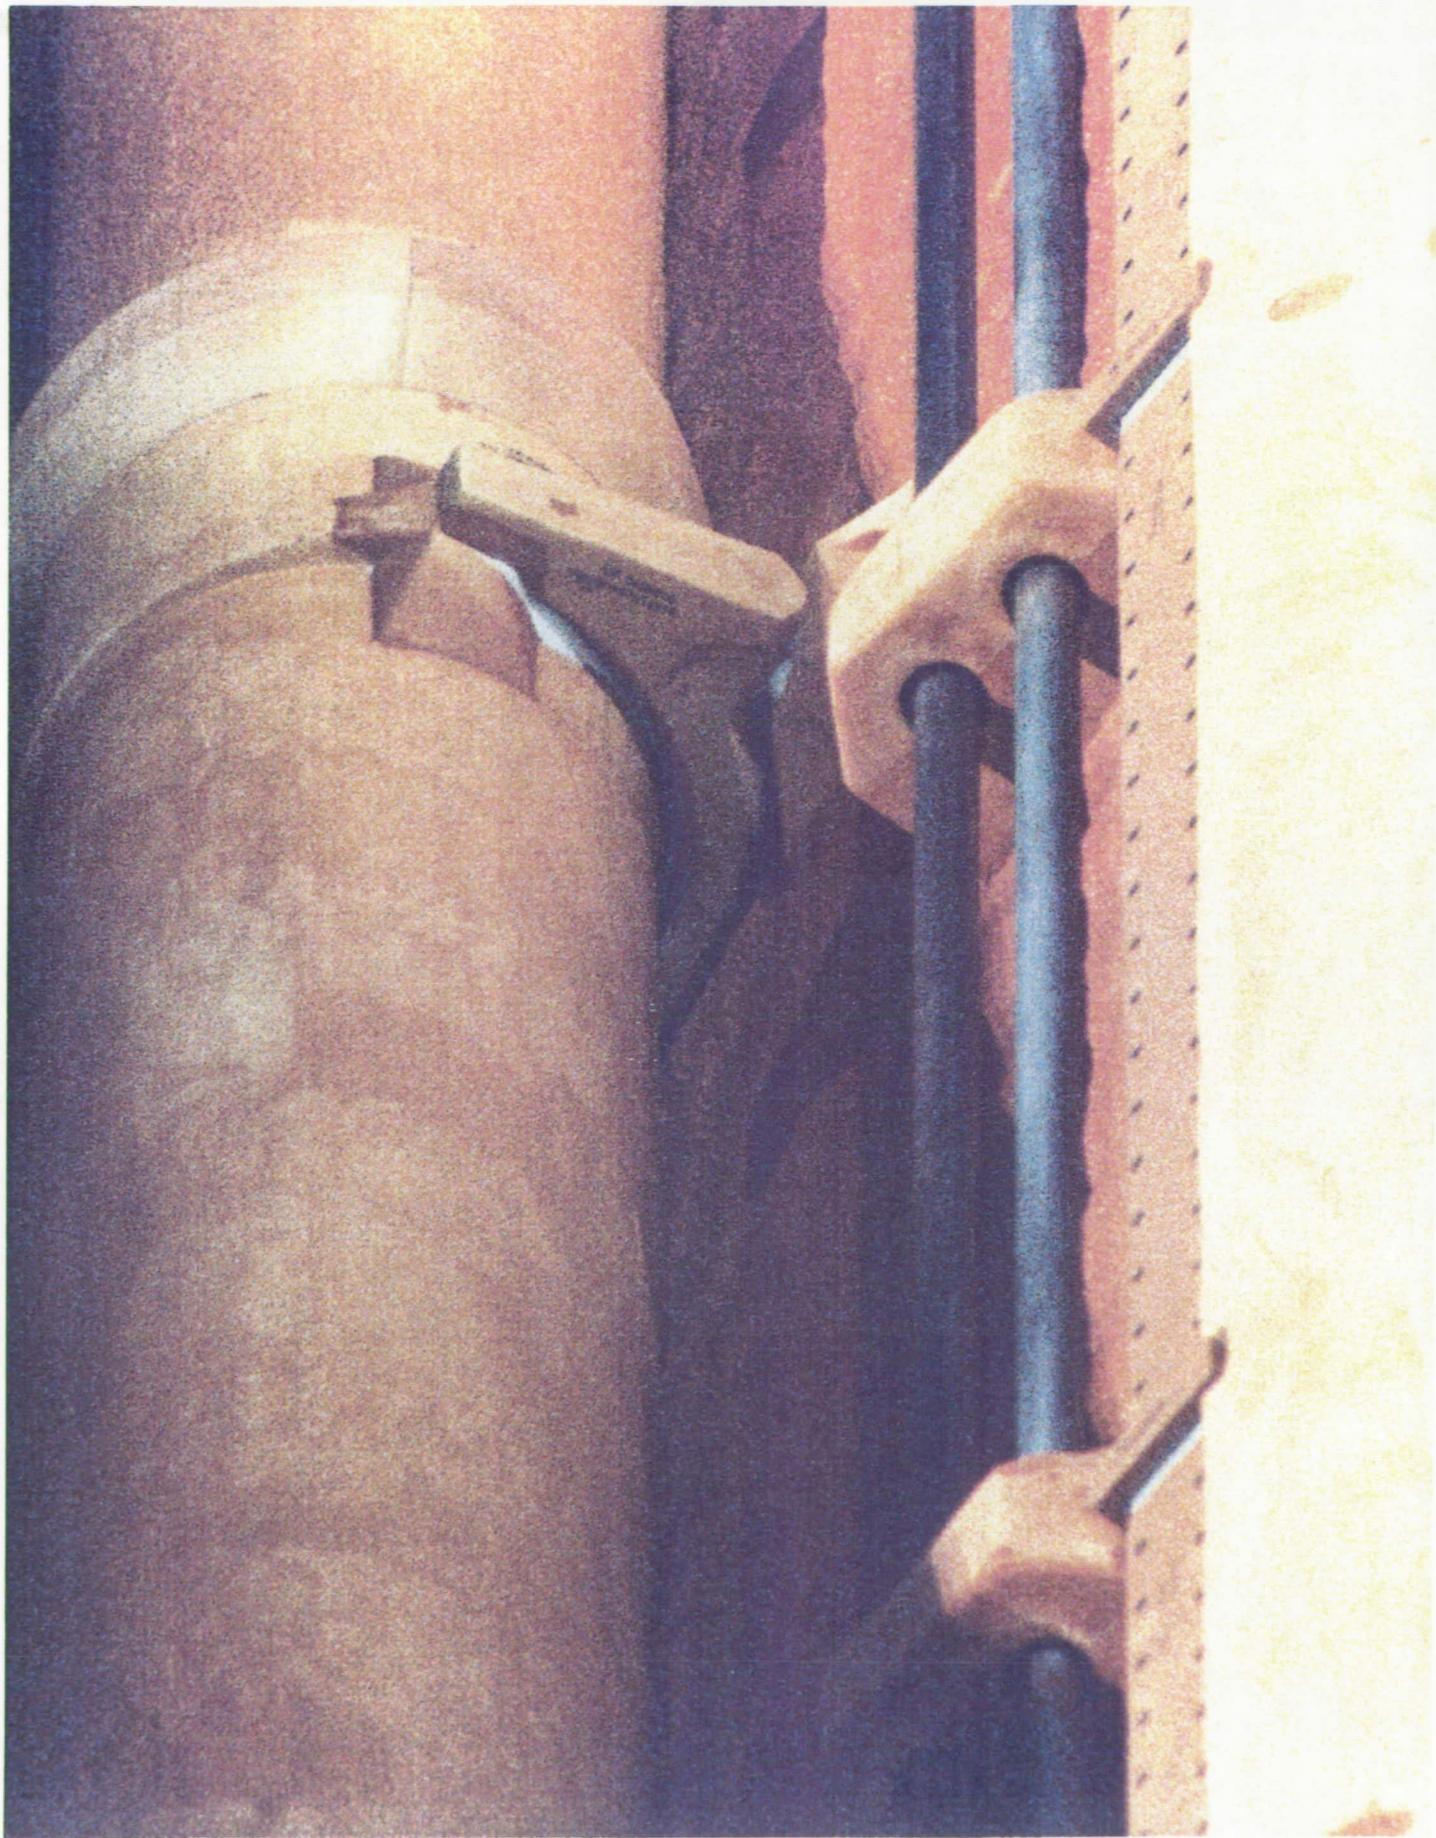
Typical amounts of ice/frost had accumulated in the upper L02  
feedline support brackets

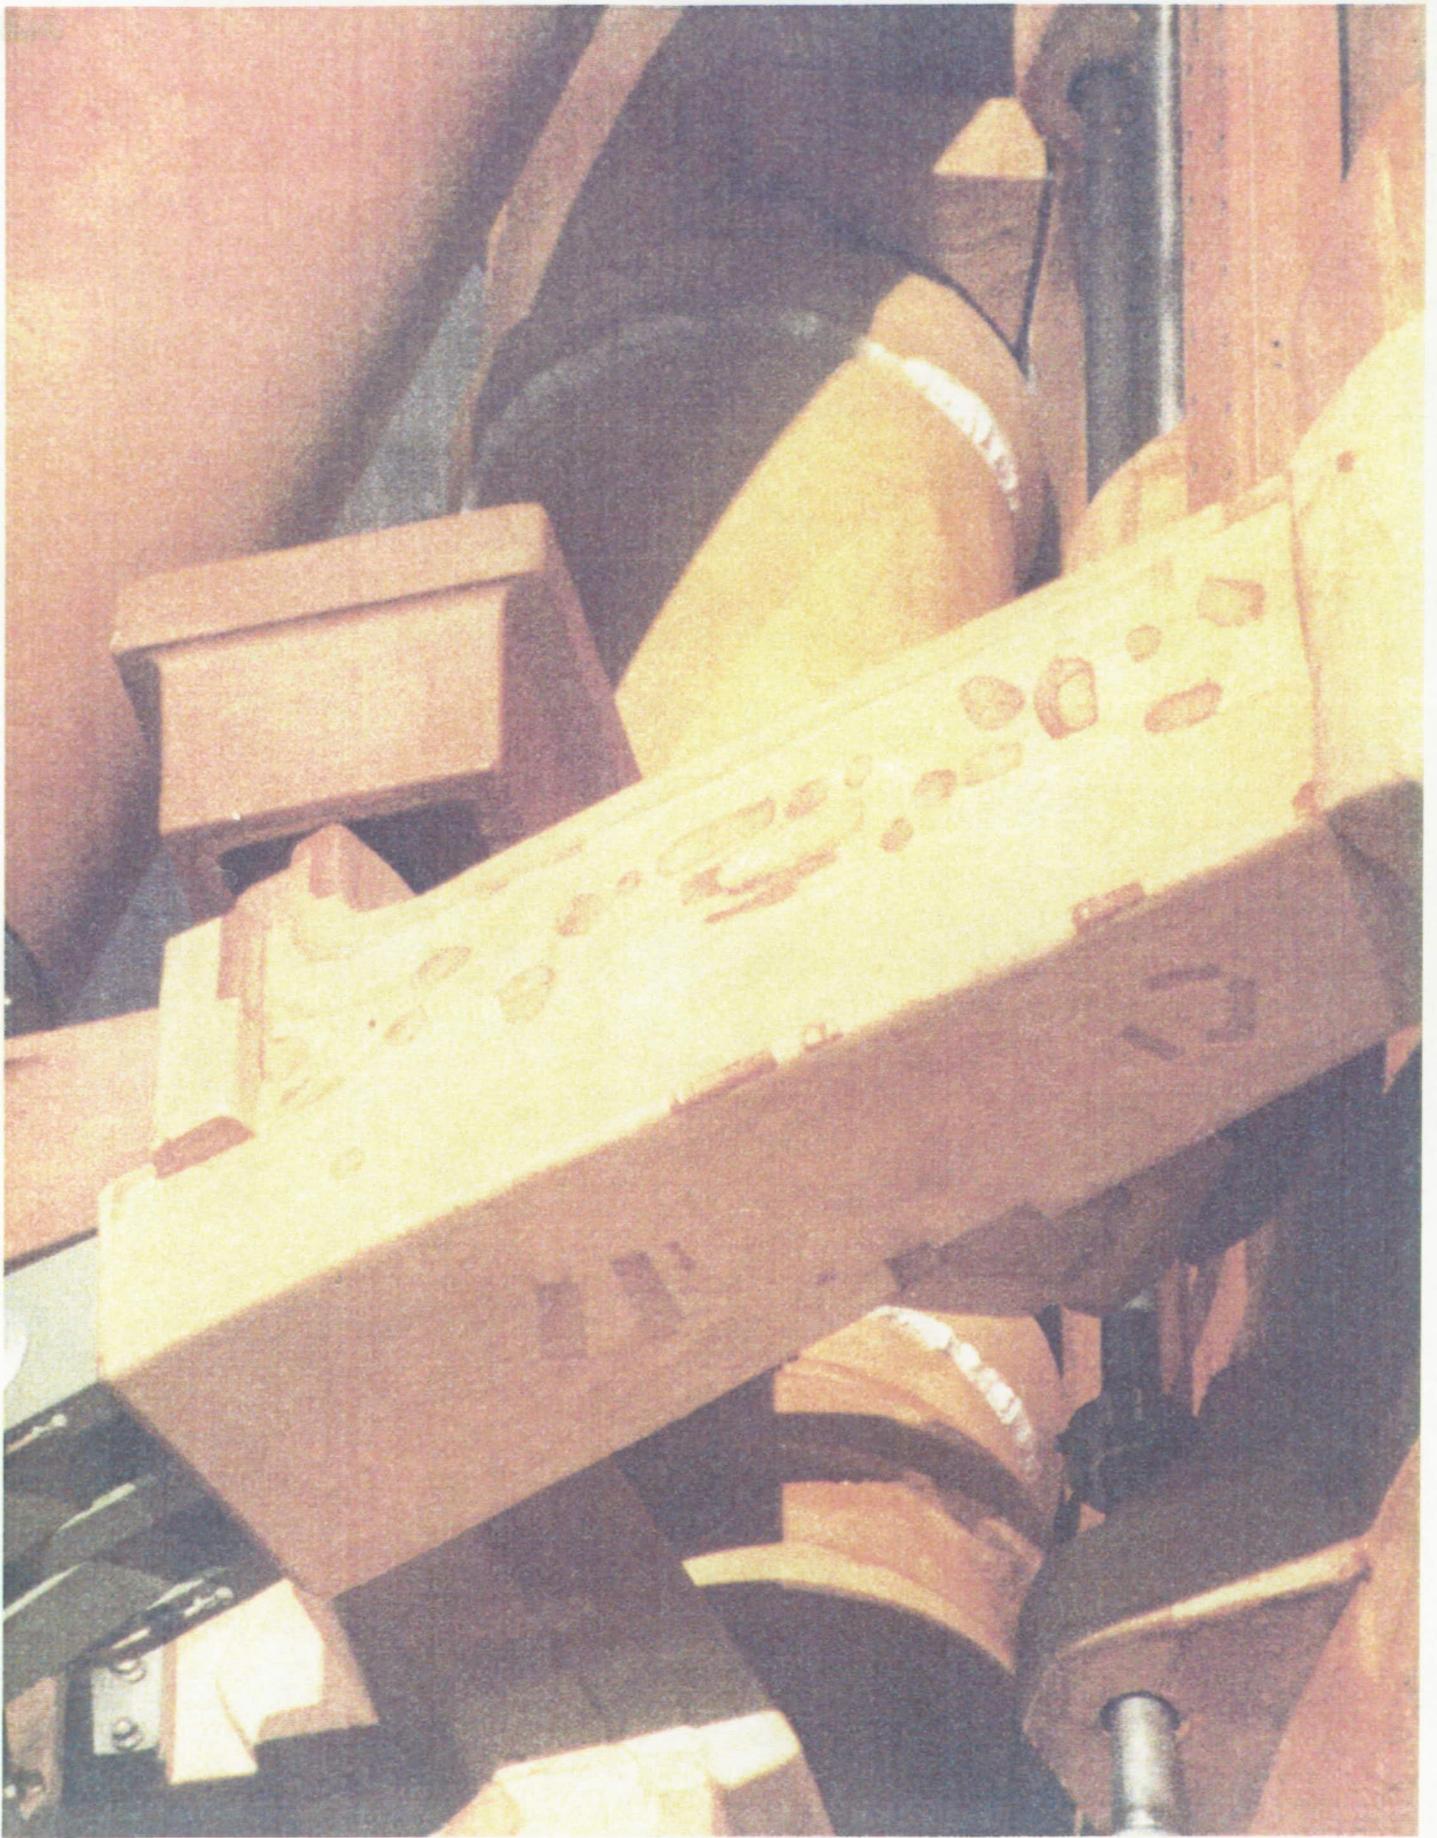
Typical ice/frost was present in the lower L2 feedline bellows  
and support brackets

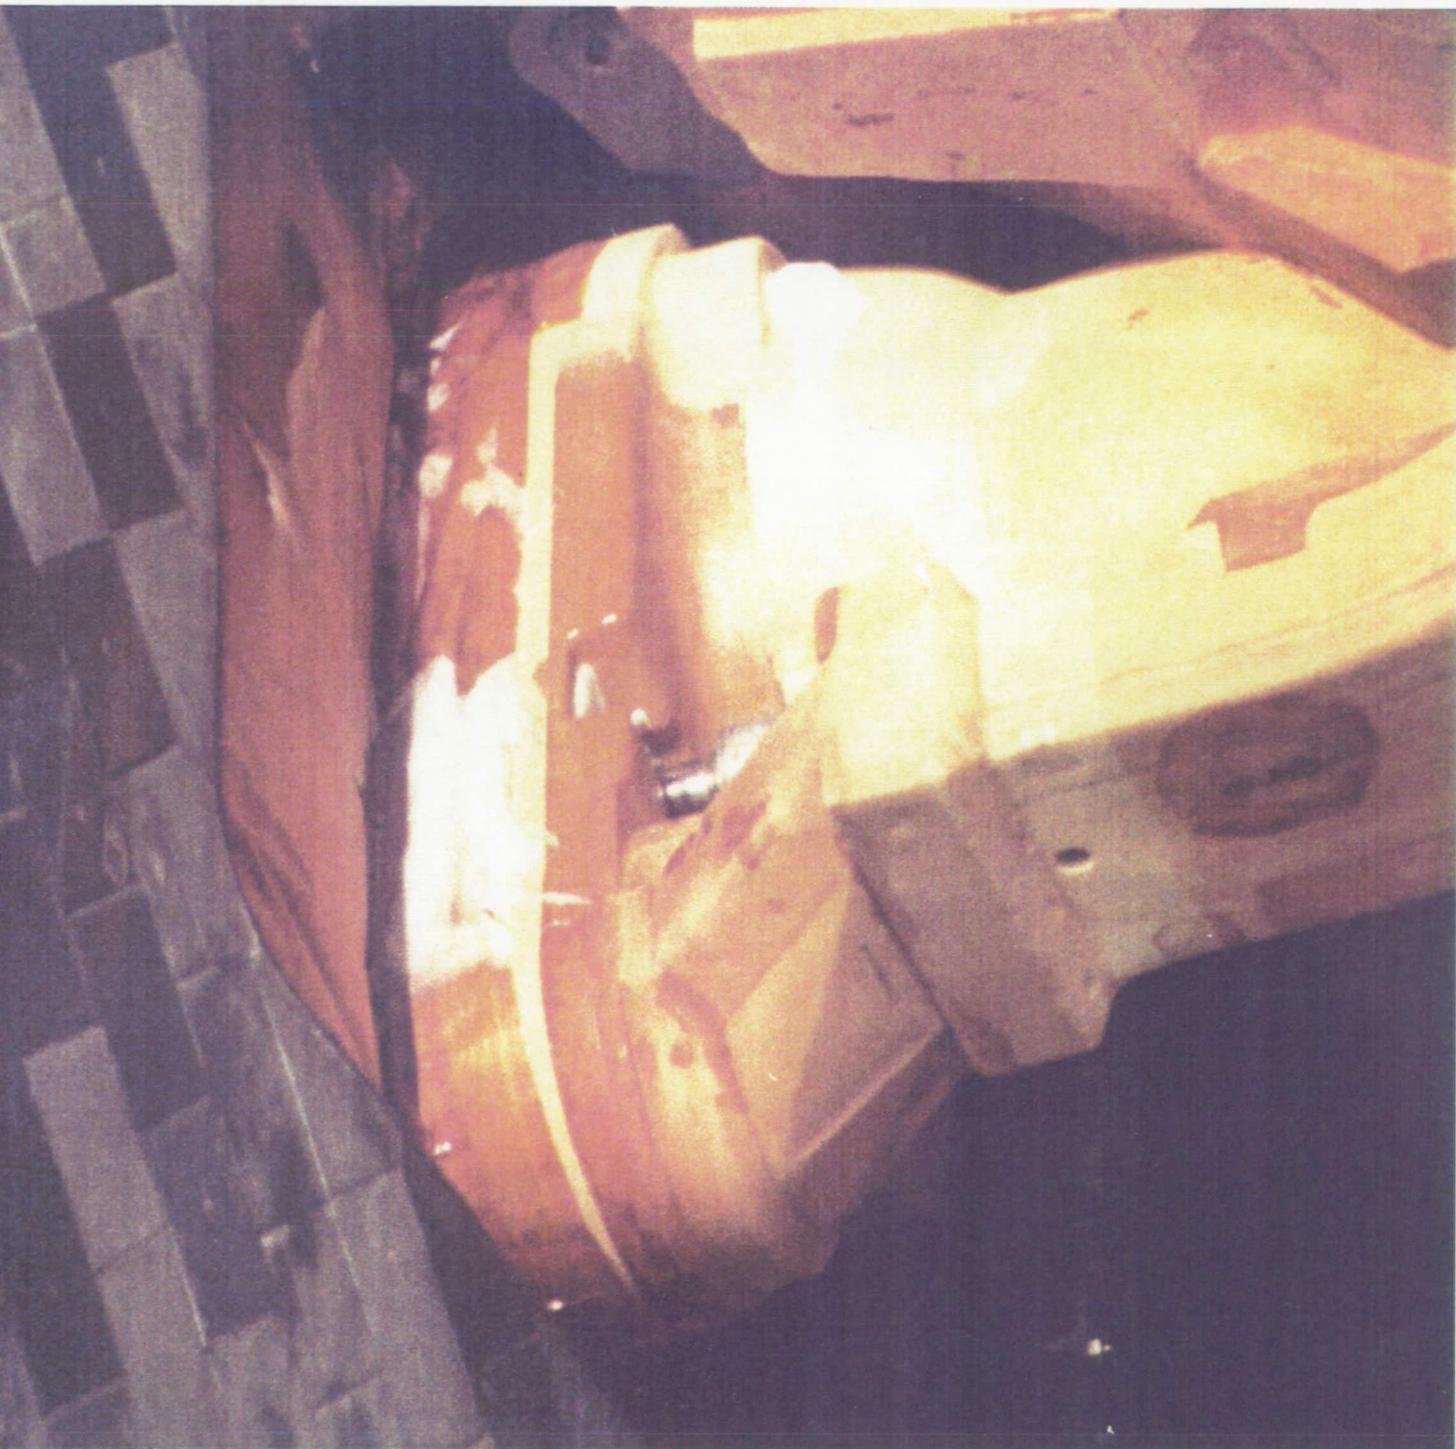
Ice/frost accumulations on the LO2 ET/ORB umbilical forward outboard pyrotechnic canister purge vent and outboard side of the purge barrier (baggie) were acceptable.

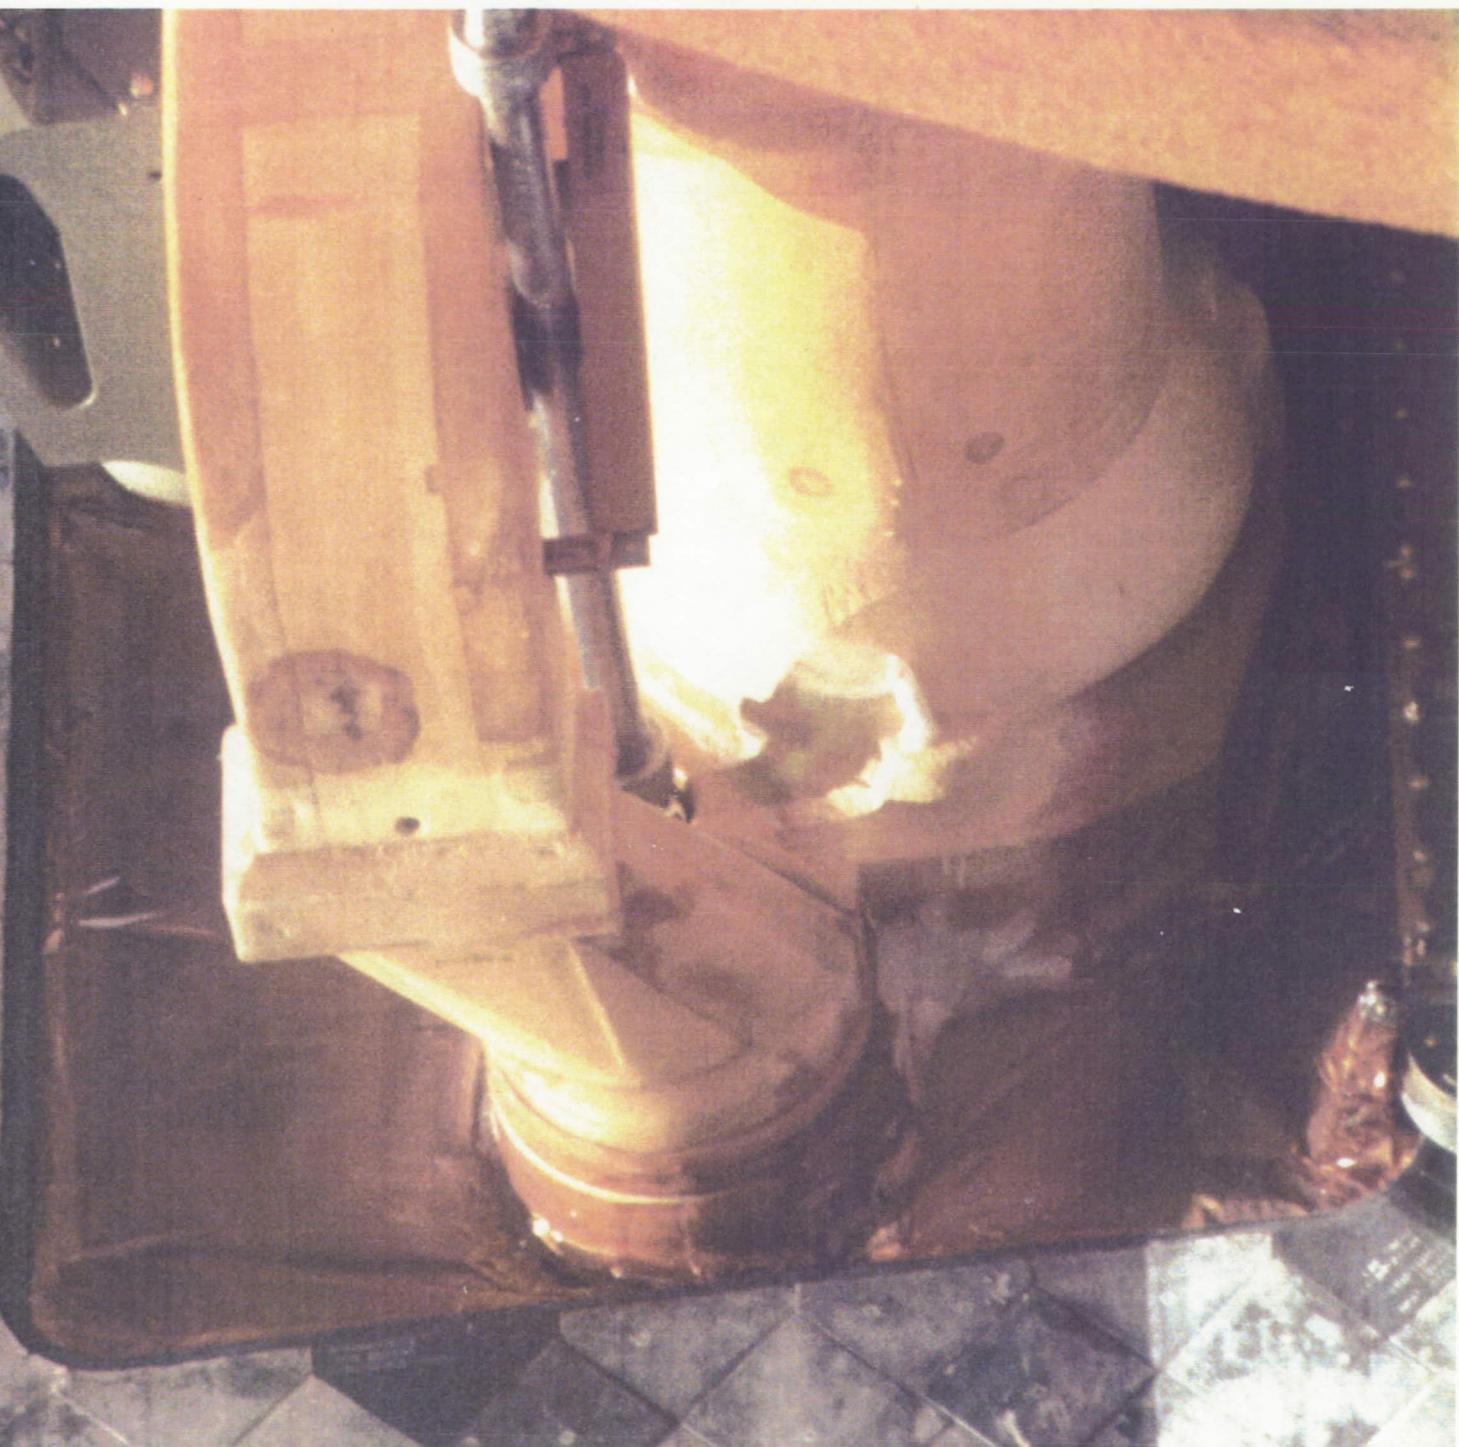
Ice/frost accumulations on the LO2 ET/ORB umbilical purge barrier (baggie) aft and inboard sides and the aft pyrotechnic canister purge vent were acceptable. Venting of nitrogen purge gas was normal.

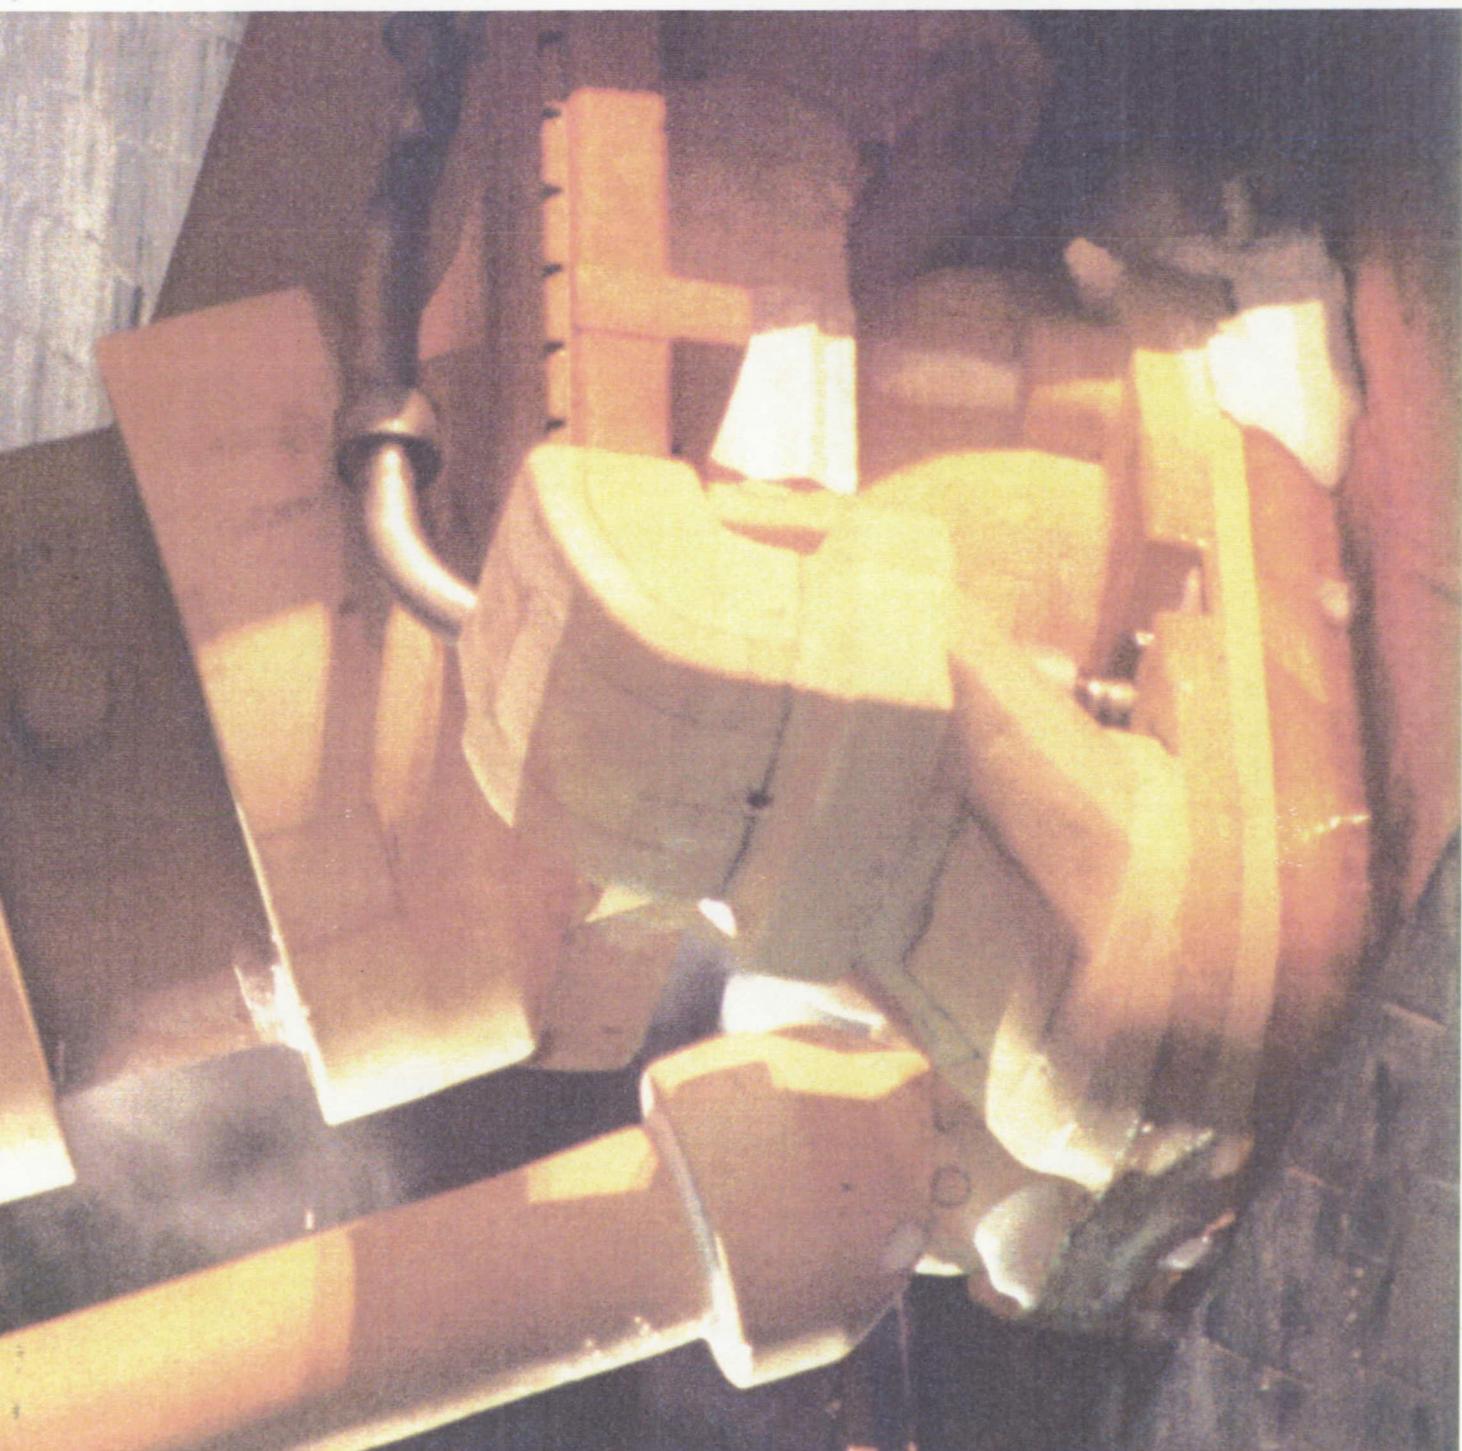
Ice/frost accumulations on the LH2 ET/ORB umbilical purge barrier (baggie) top, outboard, and aft sides were somewhat less than usual. Ice/frost fingers on the pyrotechnic canister purge vents and the umbilical disconnect plate gap purge vents were typical.

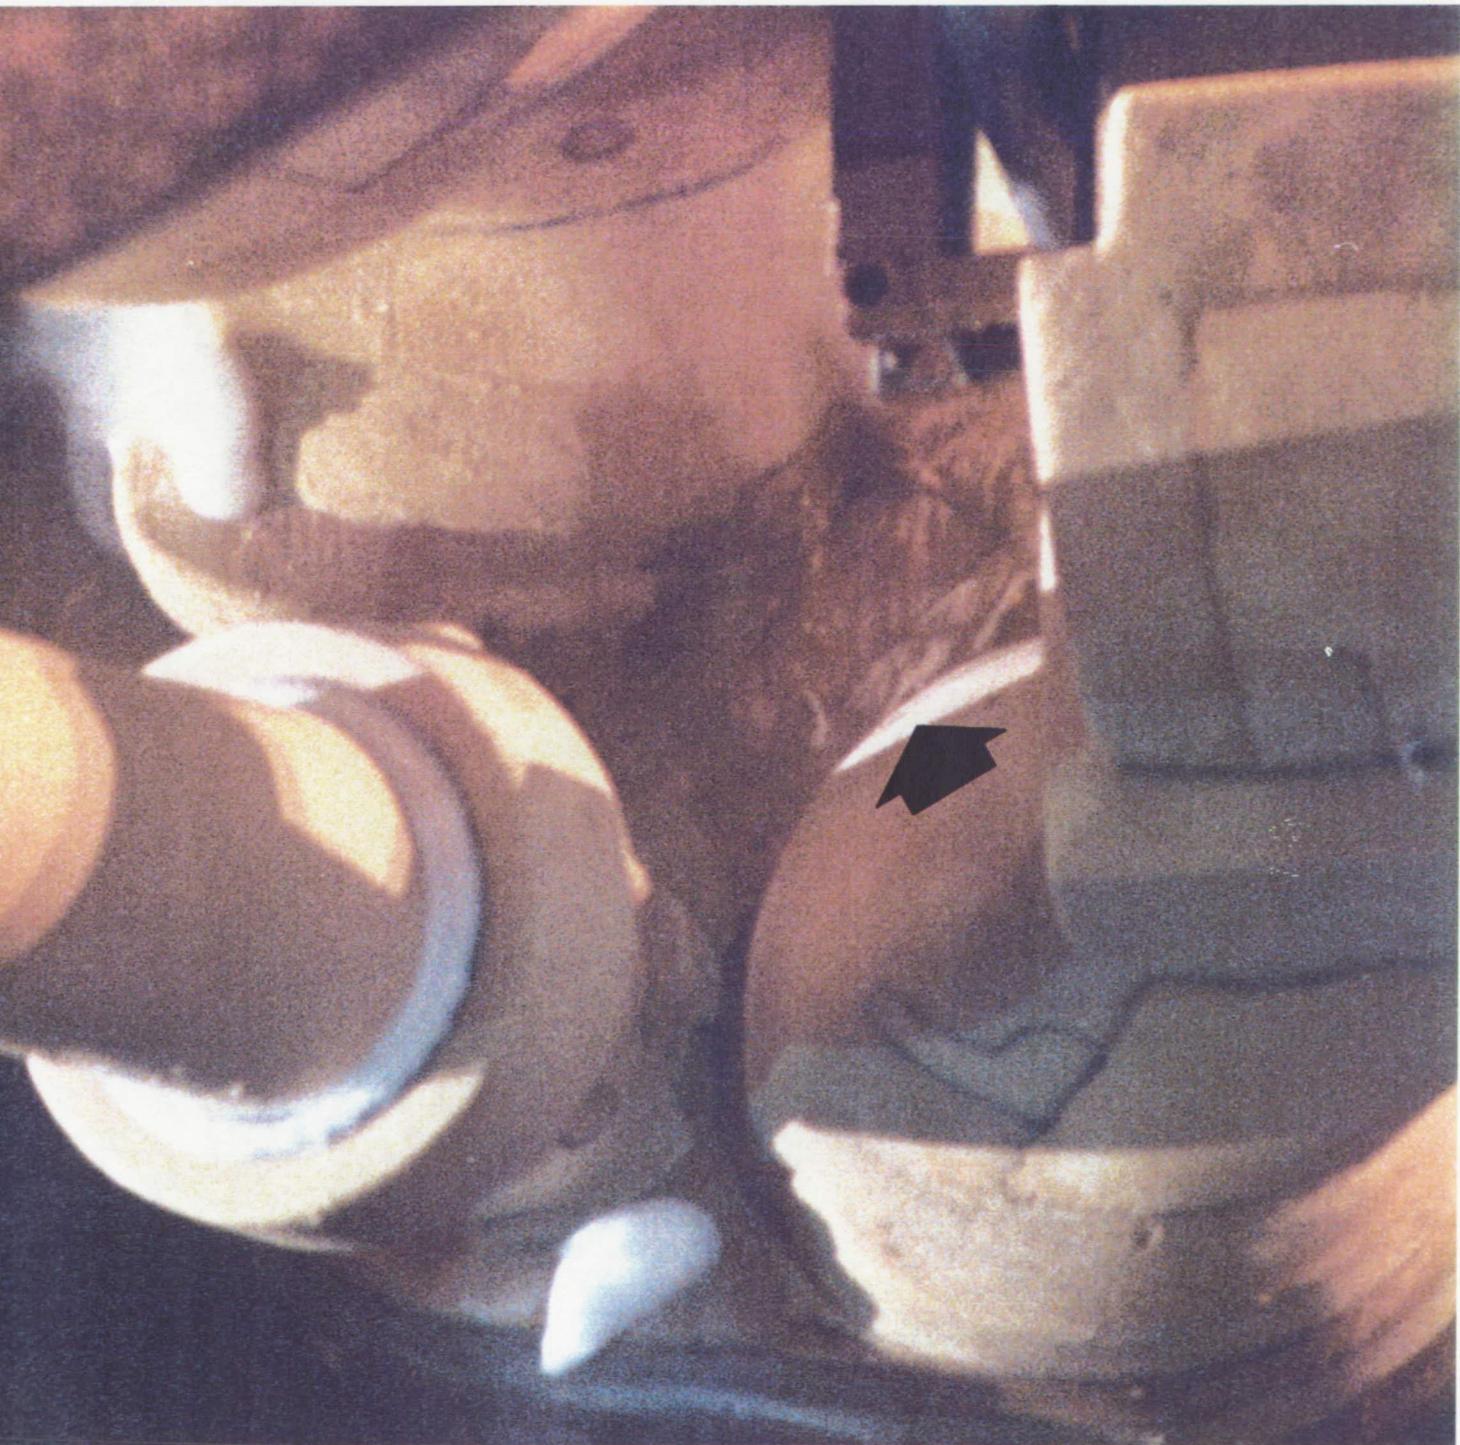
Ice/frost accumulations on the LH2 ET/ORB umbilical aft plate gap purge vent, aft pyrotechnic canister purge vent, and in the LH2 recirculation line upper bellows was typical. Venting of helium purge gas vapors was normal. No ice or frost had formed on the bondline of the 17-inch flapper valve actuator access port foam closeout.

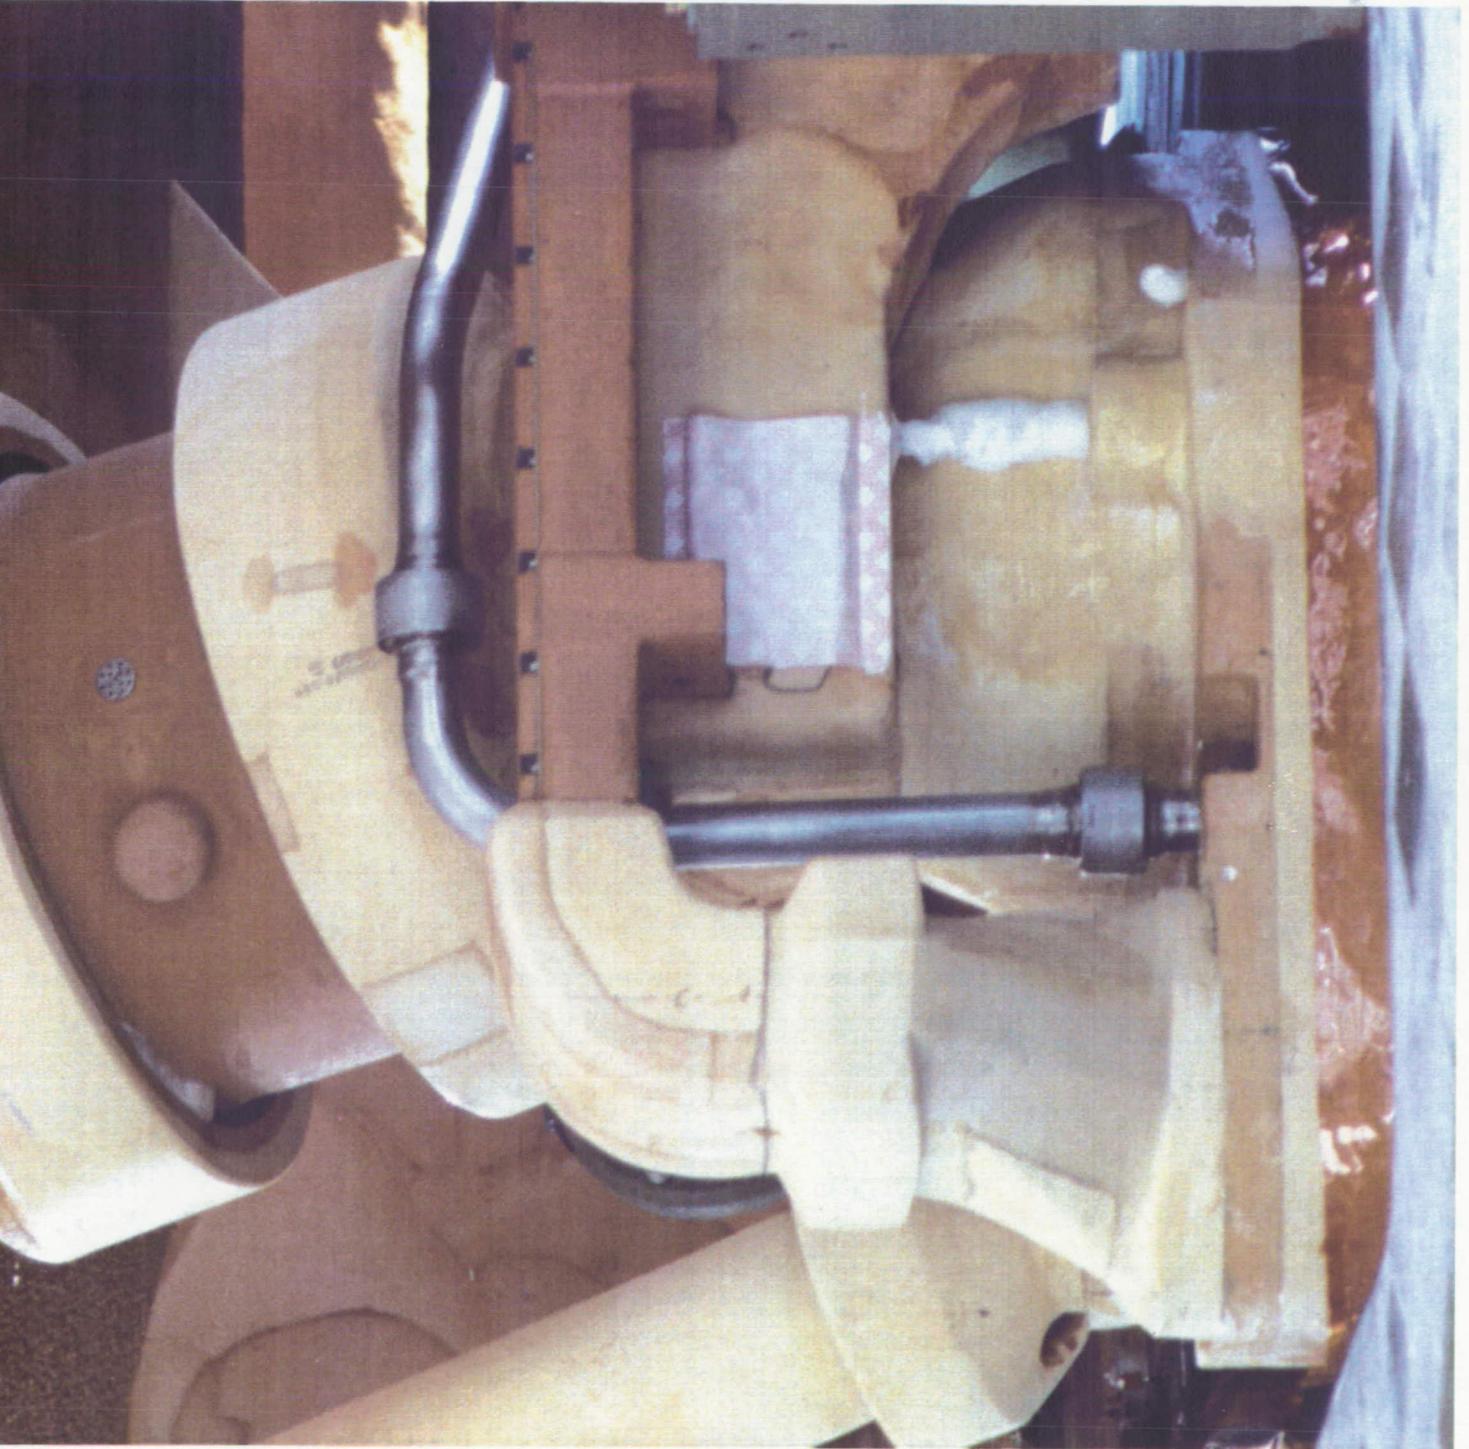
Post drain inspection of the LH2 ET/ORB umbilical revealed no anomalies. Some ice remained on the forward plate gap purge vent, forward outboard pyrotechnic canister purge vent, and LH2 feedline lower bellows - an expected occurrence.
