# Debris/Ice/TPS Assessment And Photographic Analysis For Shuttle Mission STS-40

DEBRIS/ICE/TPS ASSESSMENT  
AND  
PHOTOGRAPHIC ANALYSIS  
OF  
SHUTTLE MISSION STS-40

June 5, 1991.

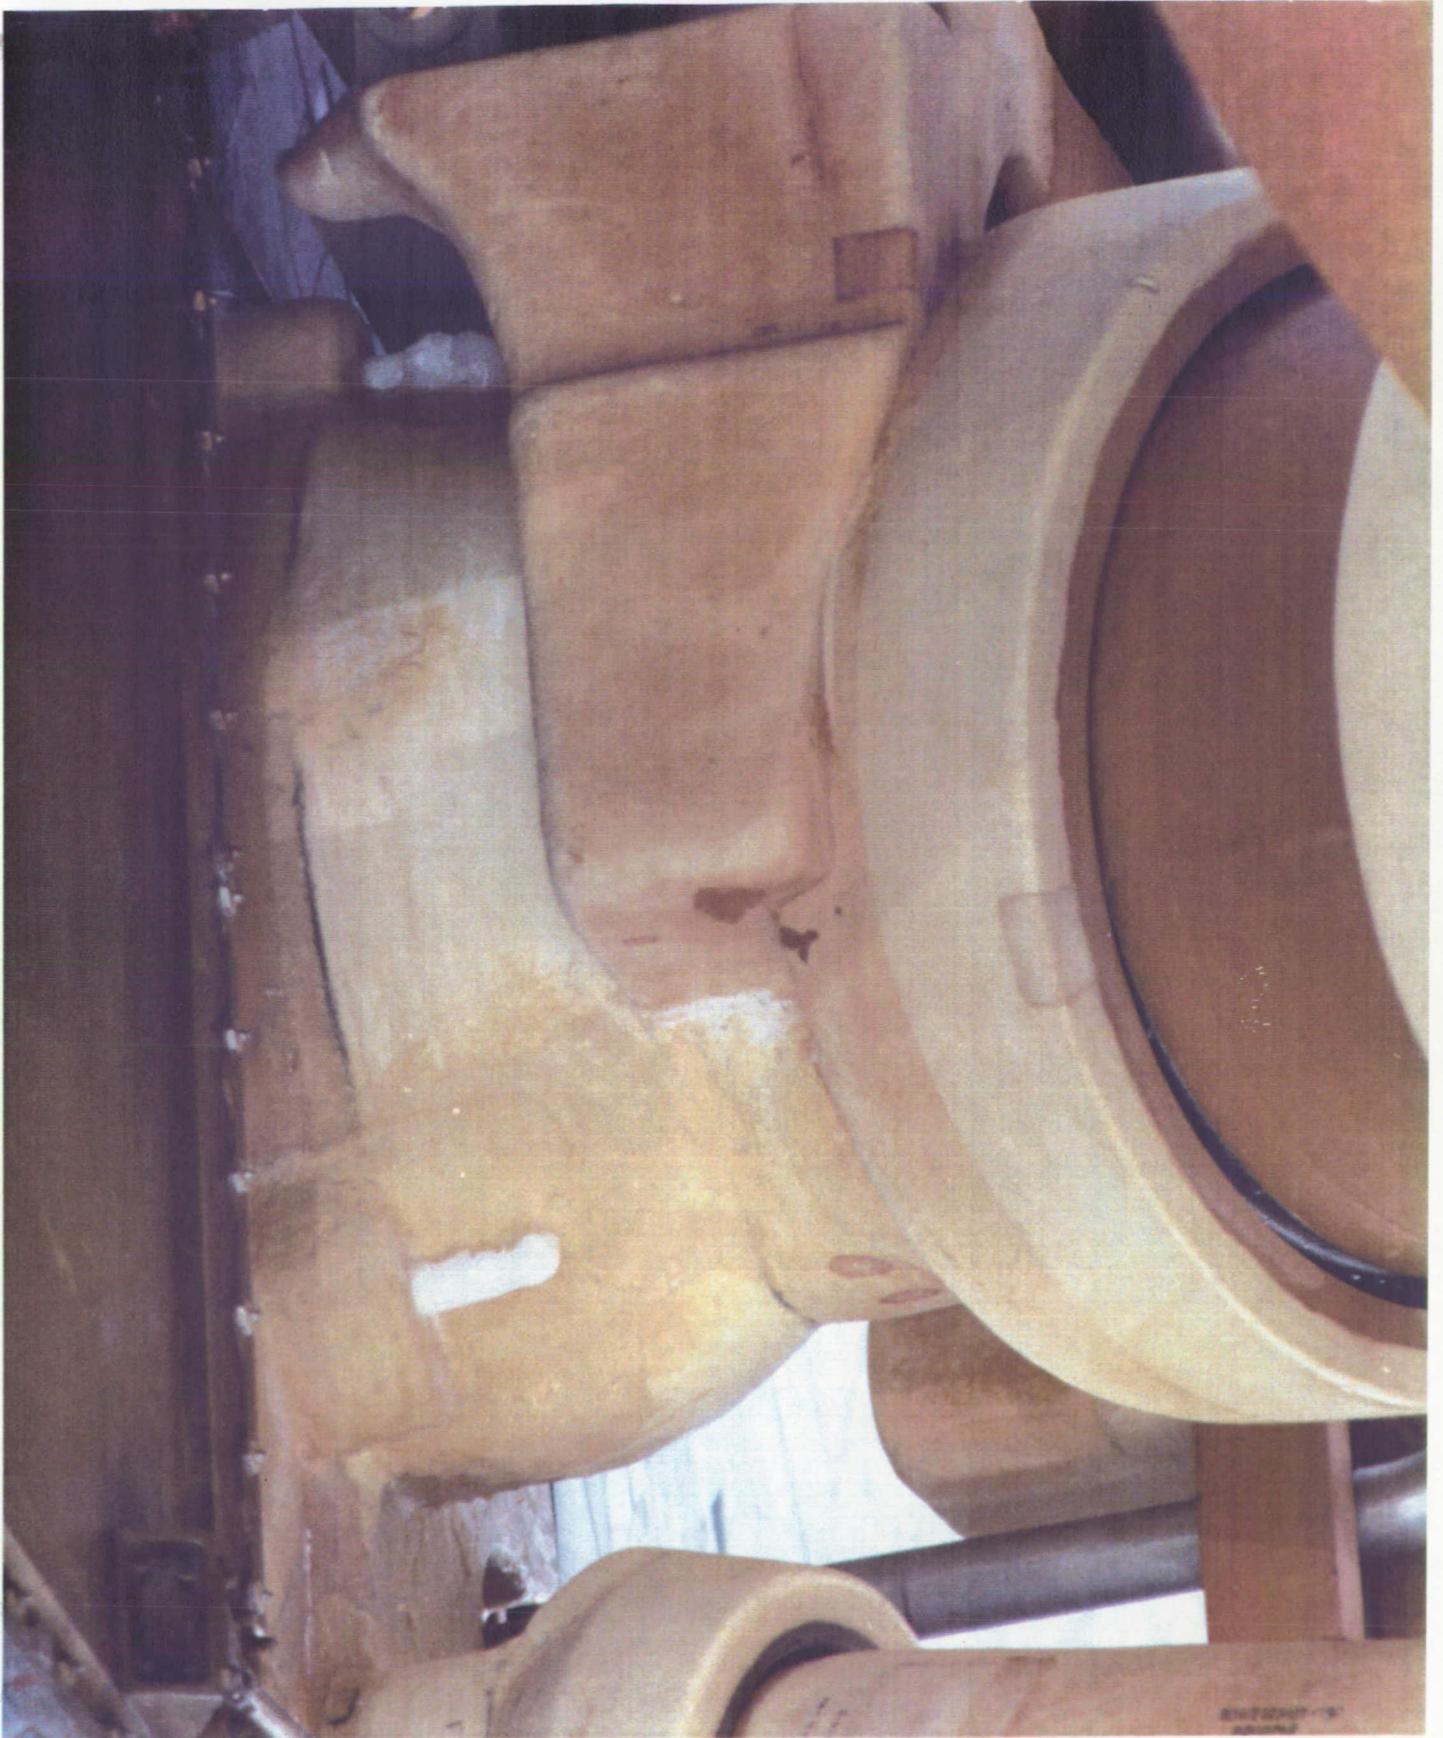
No anomalies were visible on the inboard side of the LH2 ET/ORB umbilical. Ice fingers were still present on the forward inboard and aft pyrotechnic canister purge vents.

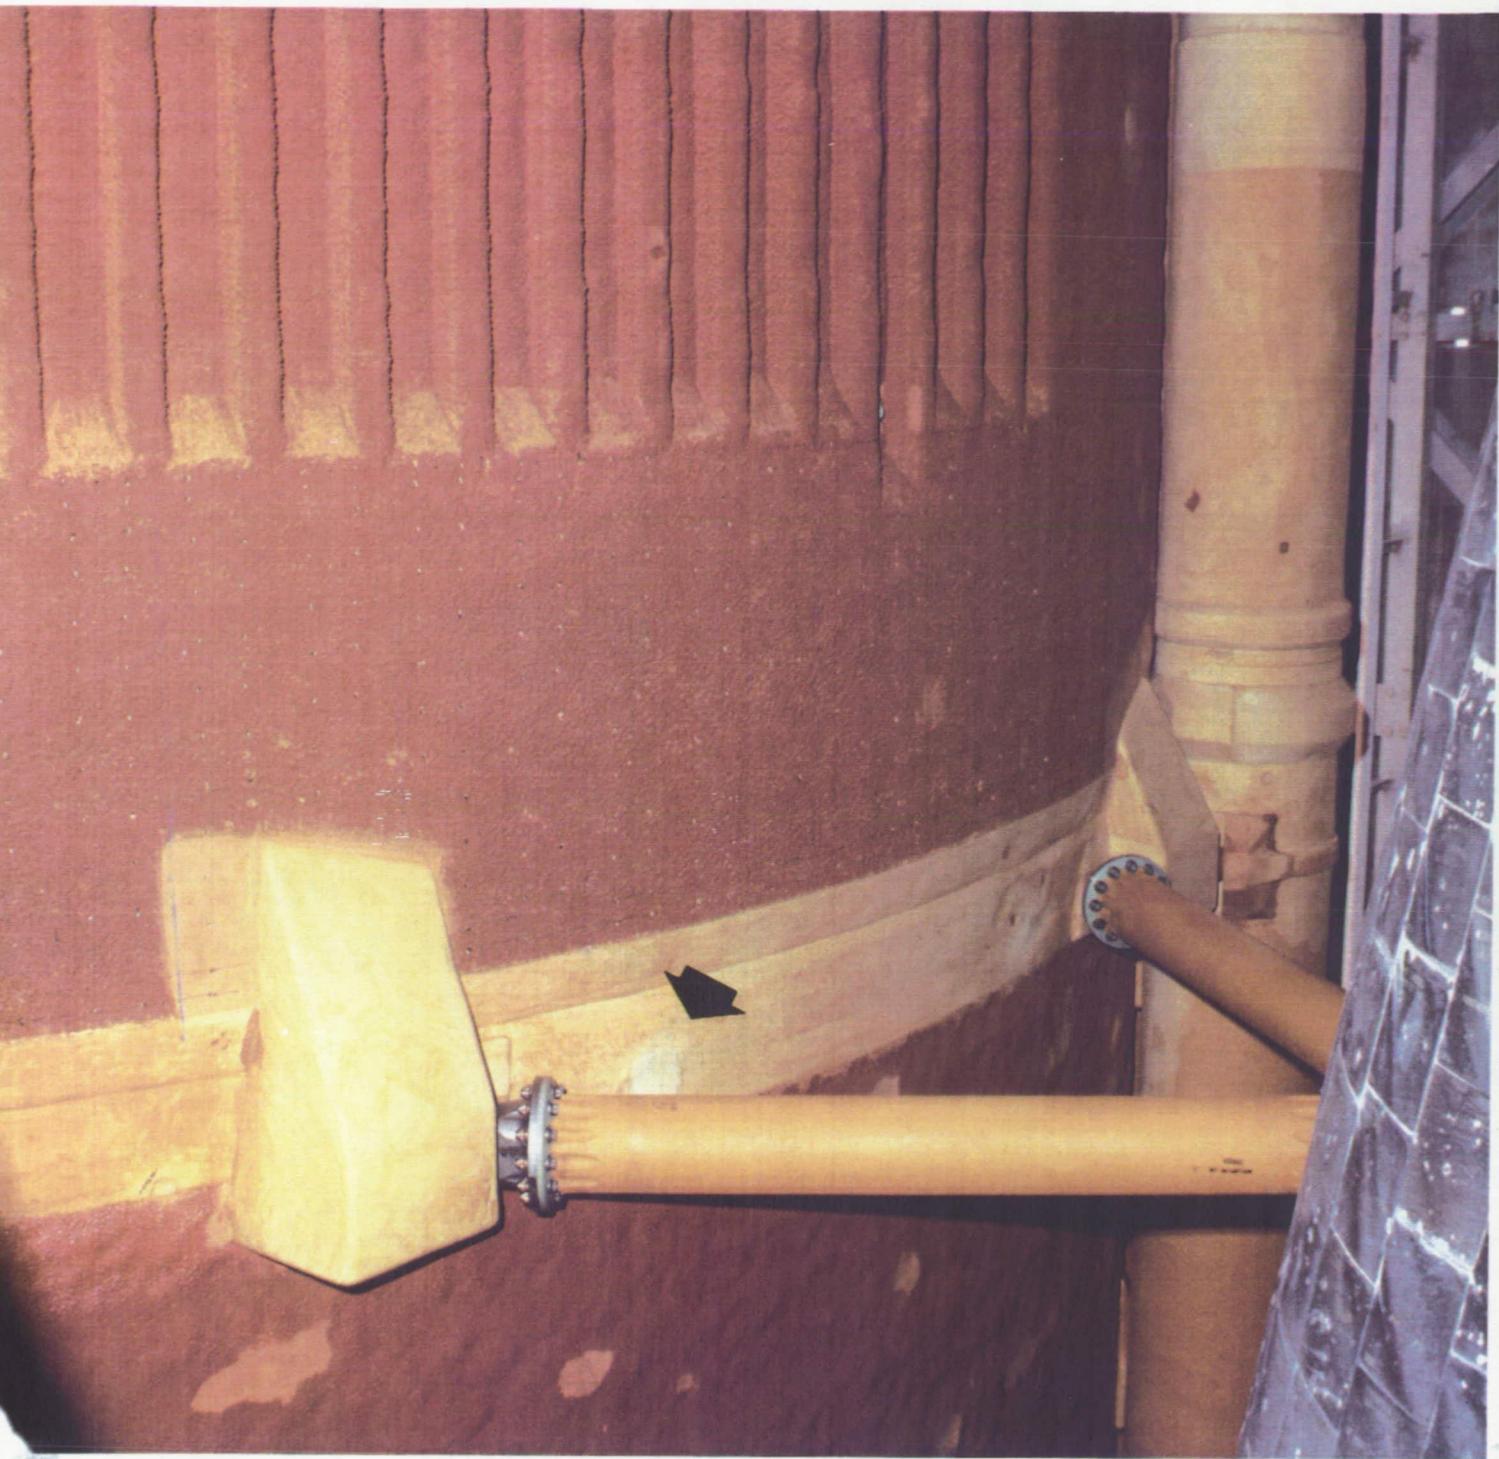
View of the External Tank forward attach point bipods, +Z side of the intertank and upper LH2 tank. Pre-launch inspection revealed a debond of the -Y bipod jack pad closeout, though the debond was not visible from this side of the vehicle.

The PDL repair to the ET -Y jack pad closeout was intact after cryogenic loading. The repair was flush with the surrounding foam. No ice or frost was present on the TPS or adhesive bond line. There was no venting of vapor.

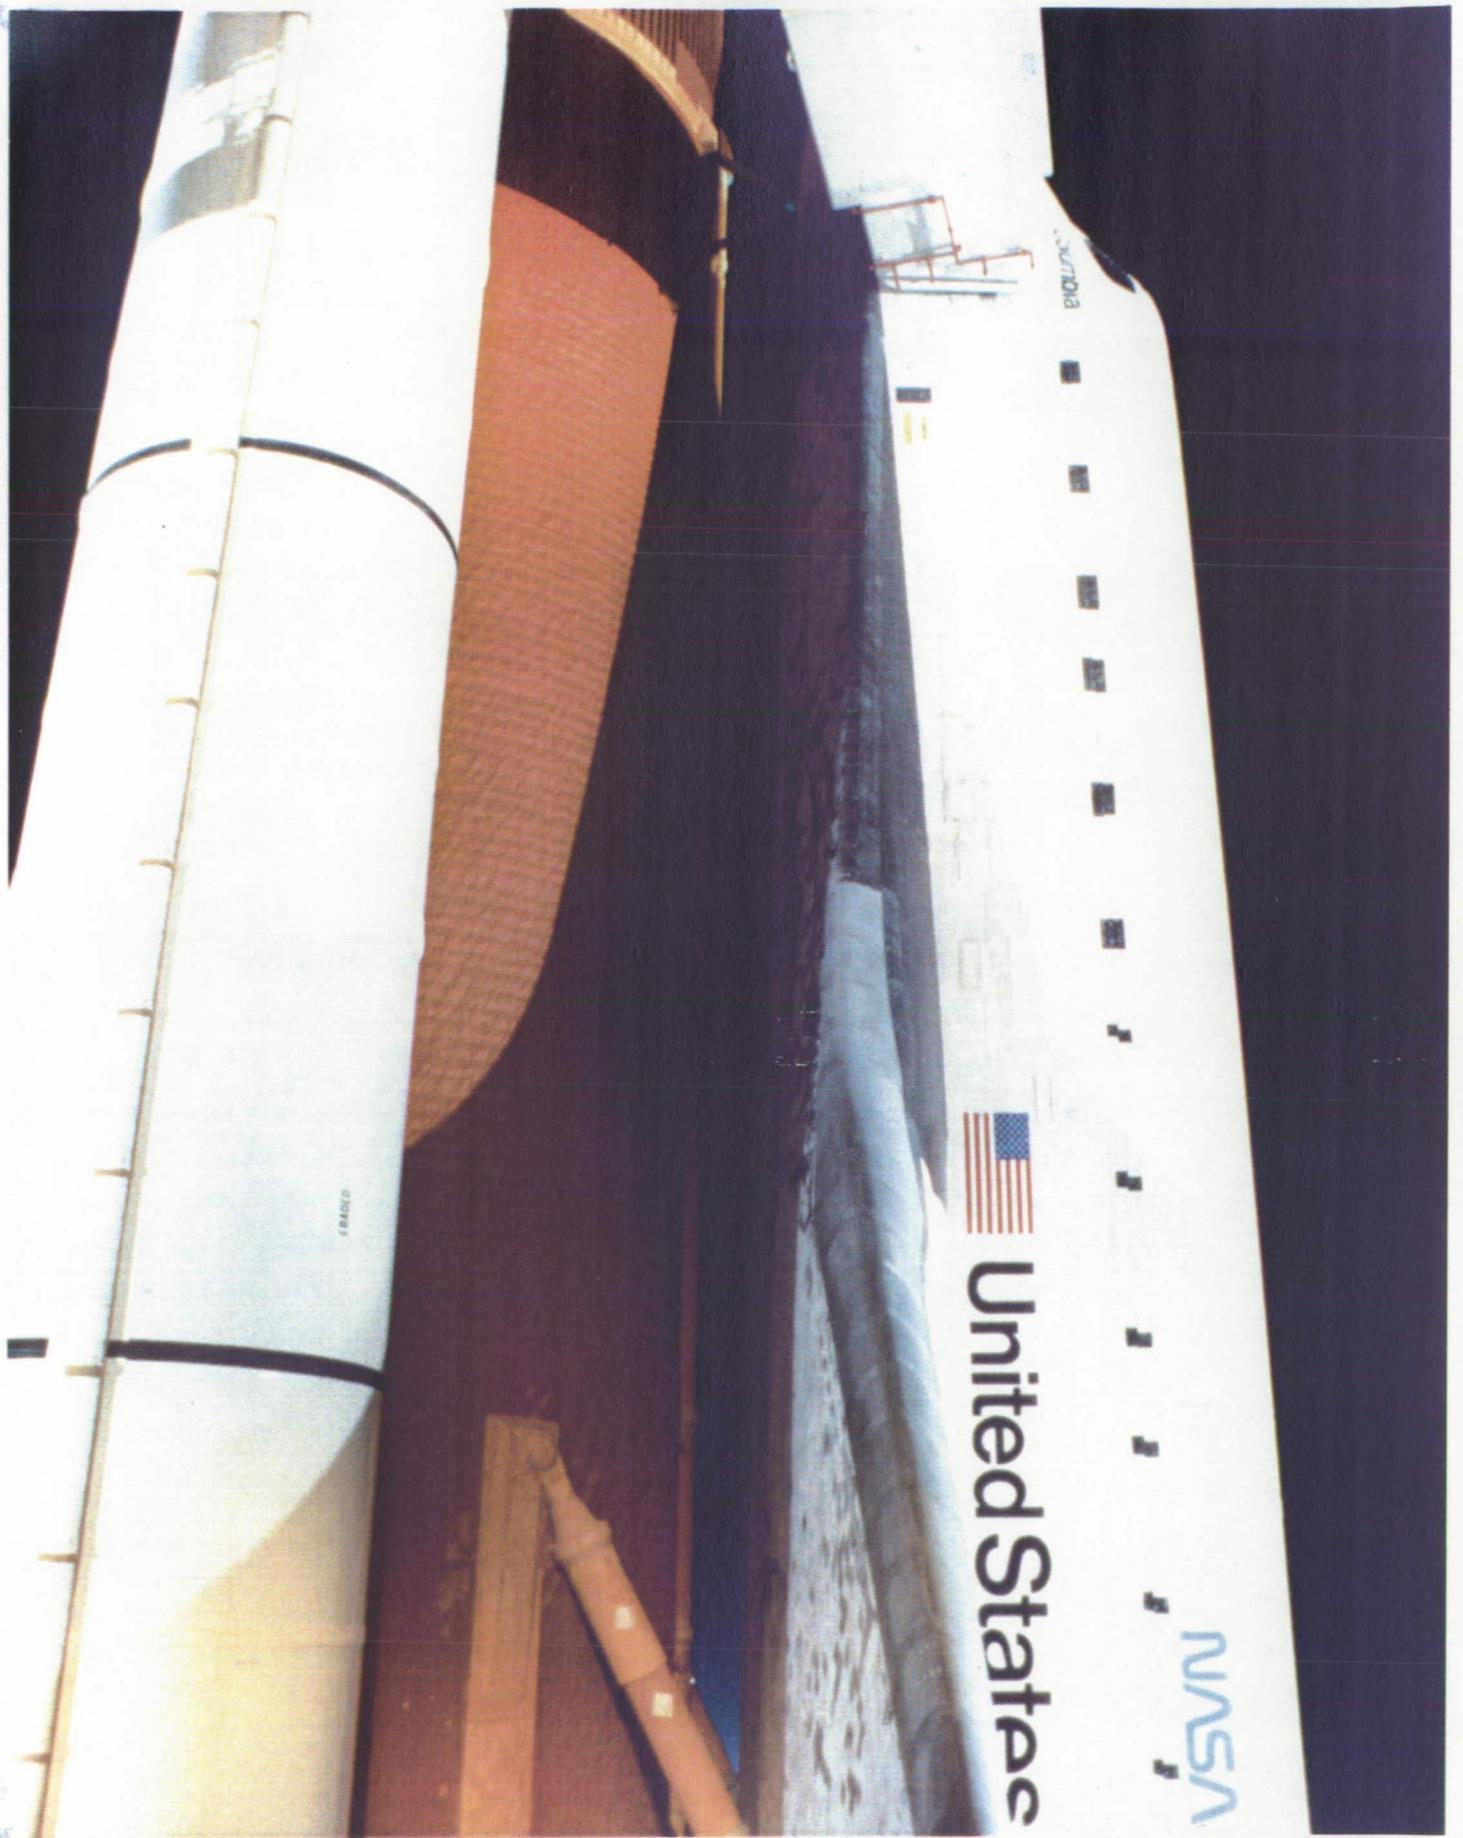
A moderate amount of condensate, but no acreage ice or frost, was present on the +Z side of the External Tank

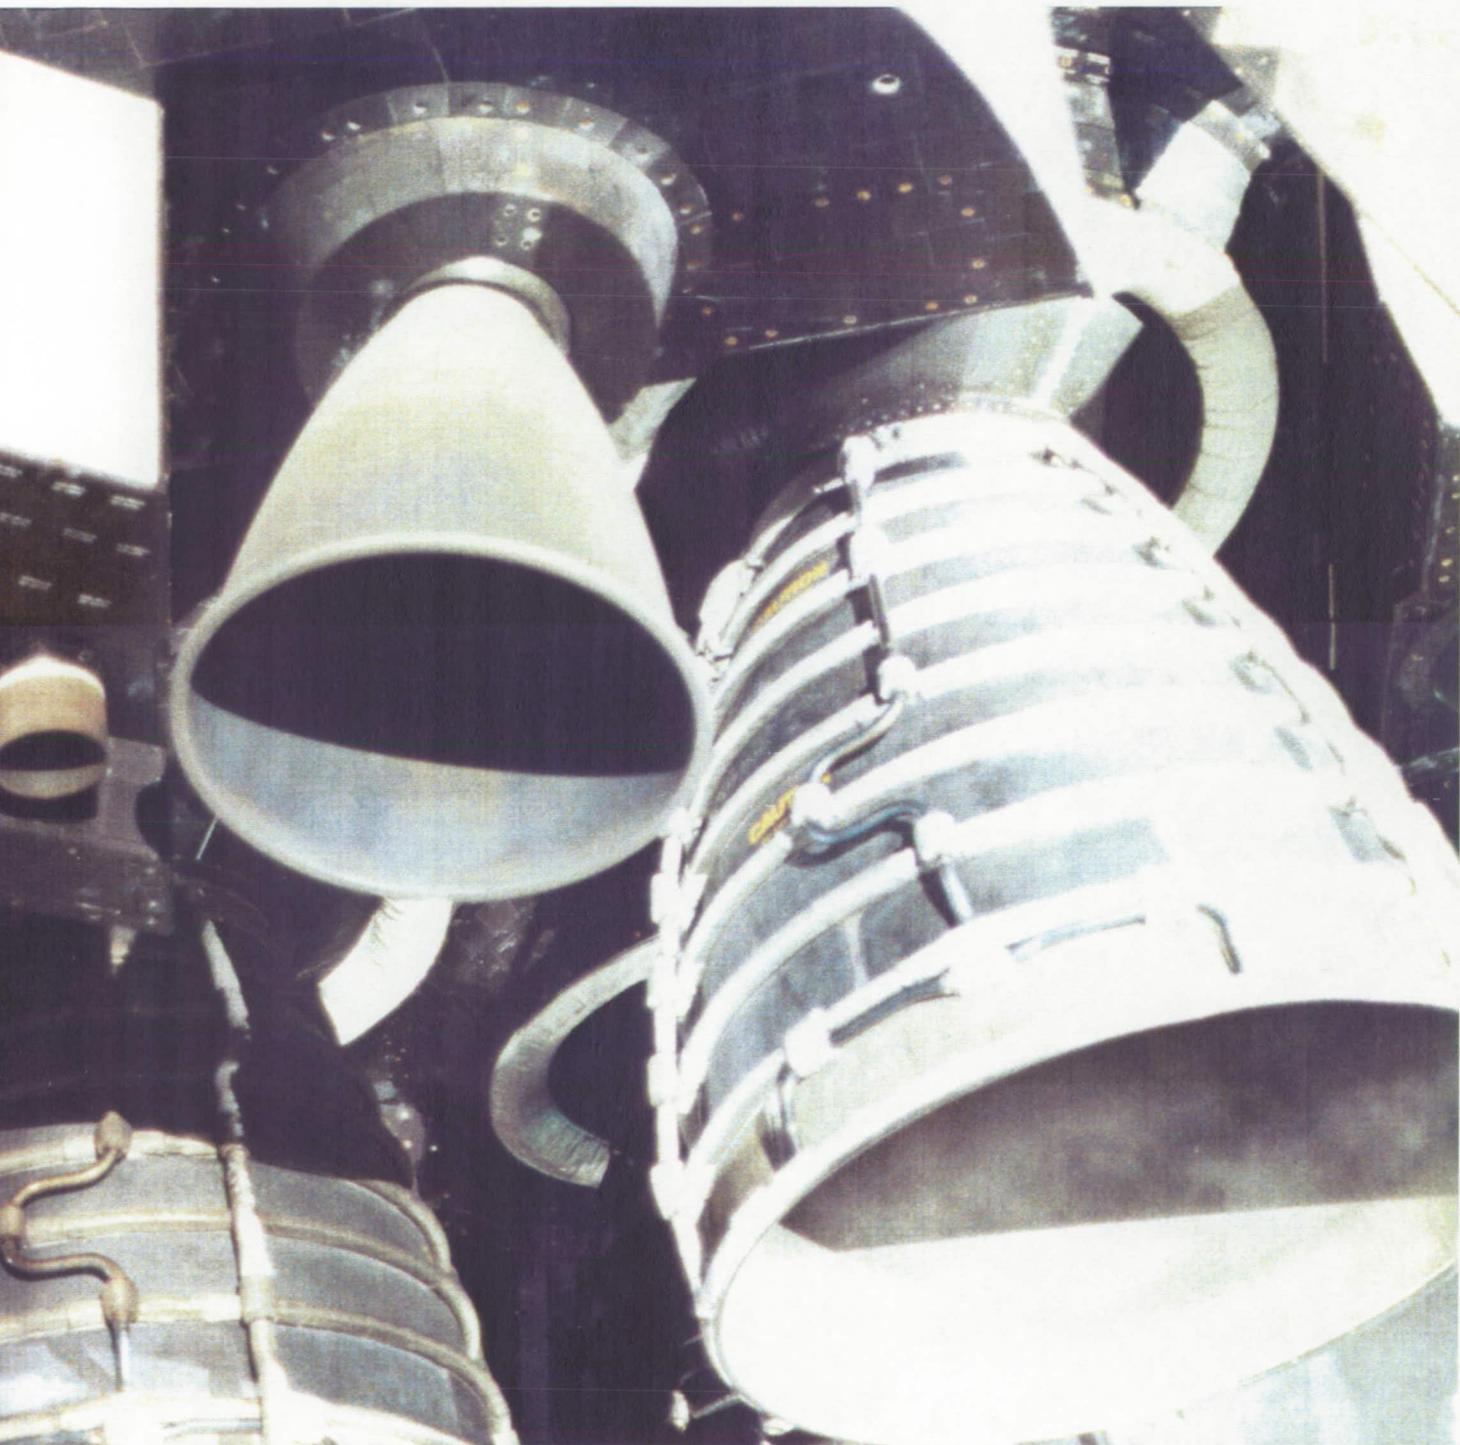
Light condensate was present on the SSME engine mounted heat shields. Light frost had accumulated on the SSME #1 and #2 heat shield-to-nozzle interfaces.

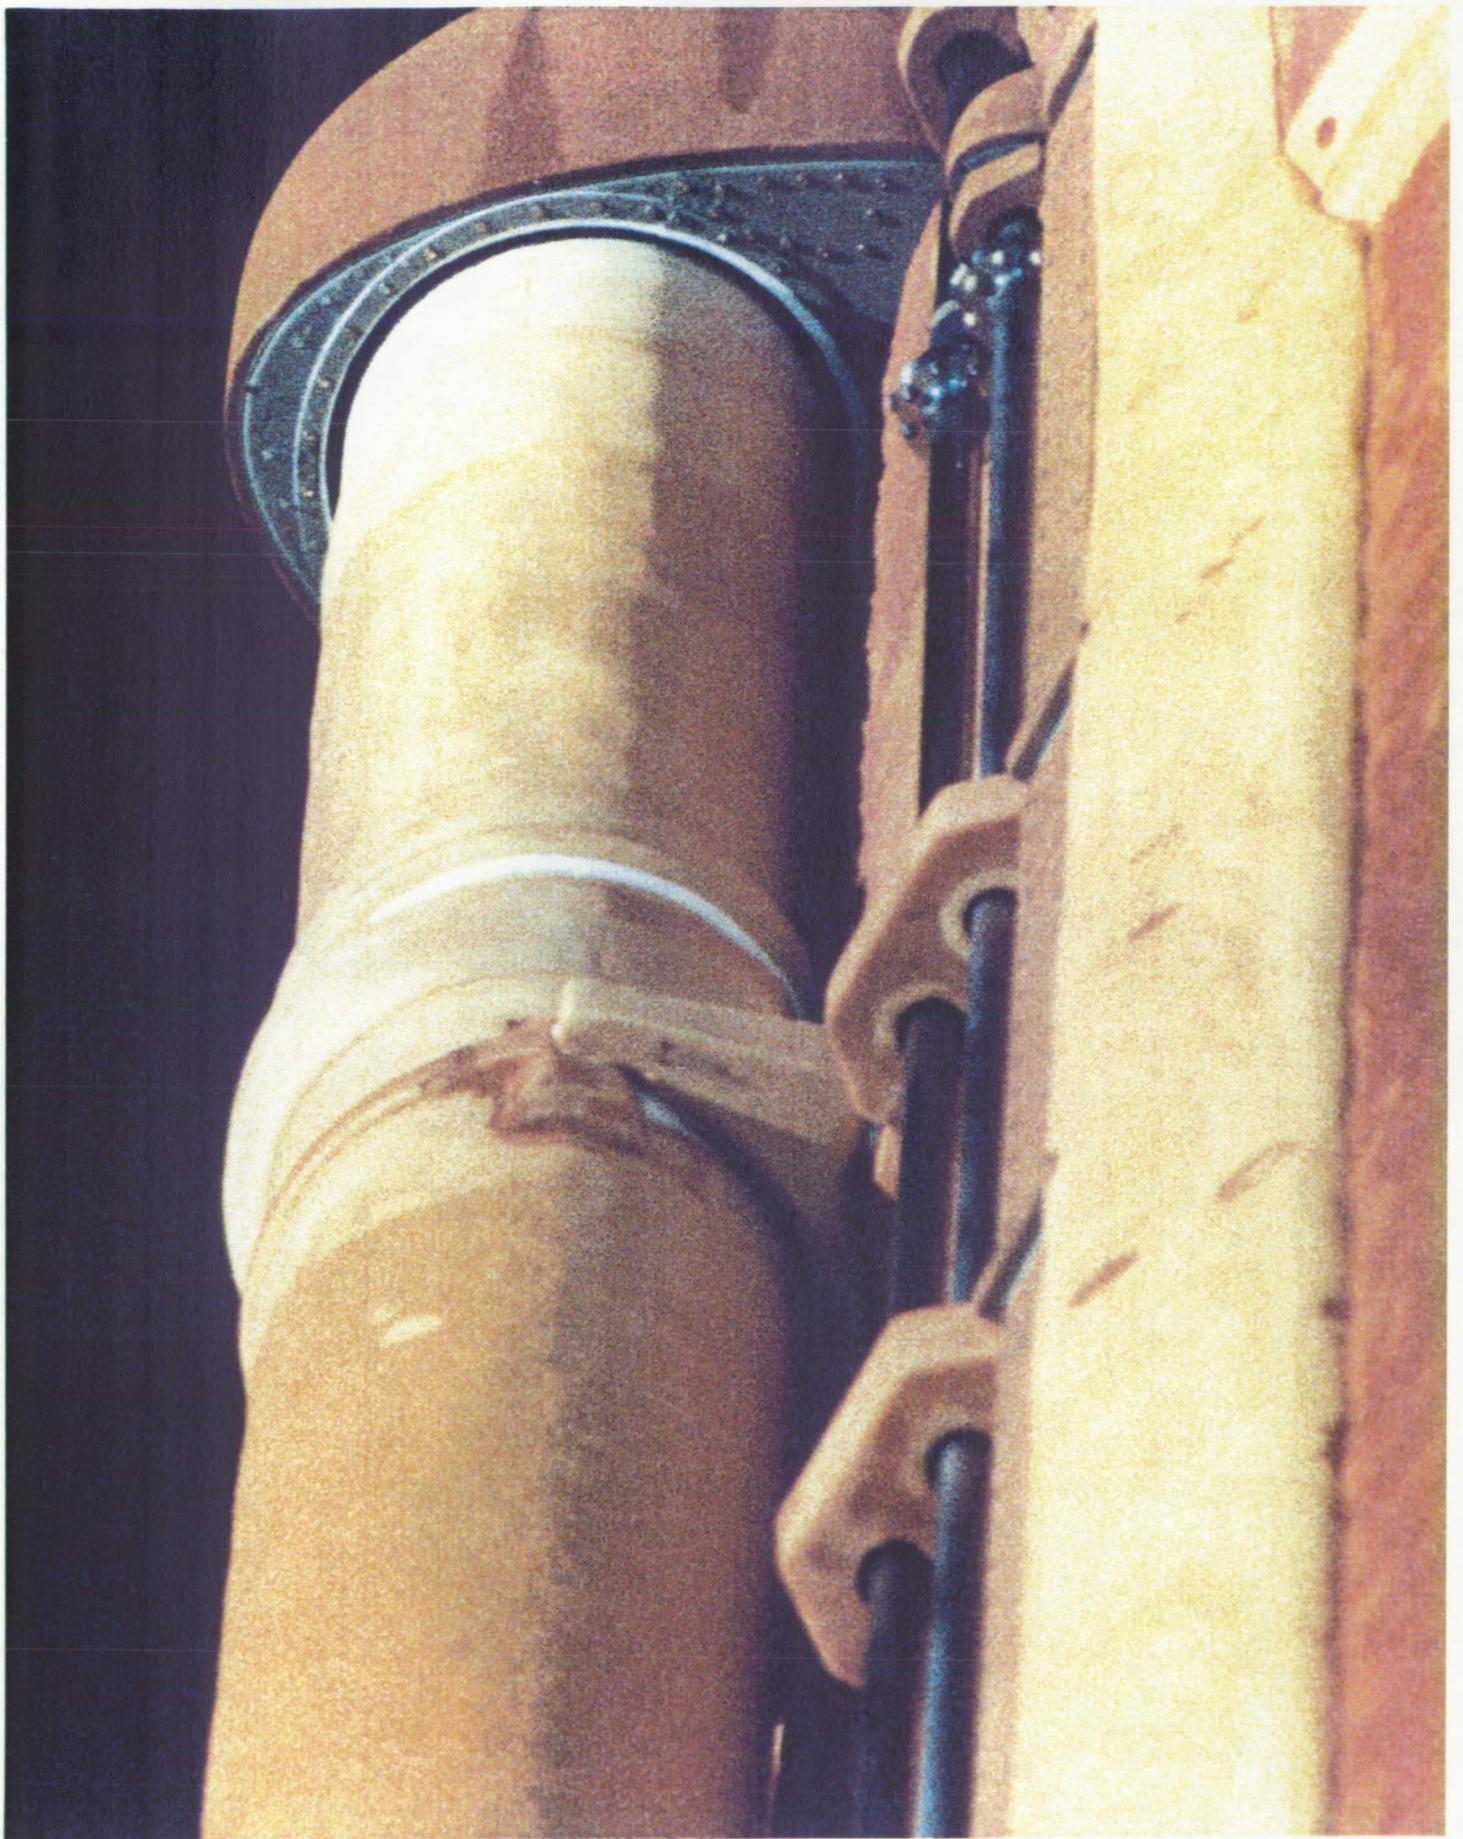
Typical amounts of ice/frost had accumulated in the L02  
feedline upper bellows and support brackets

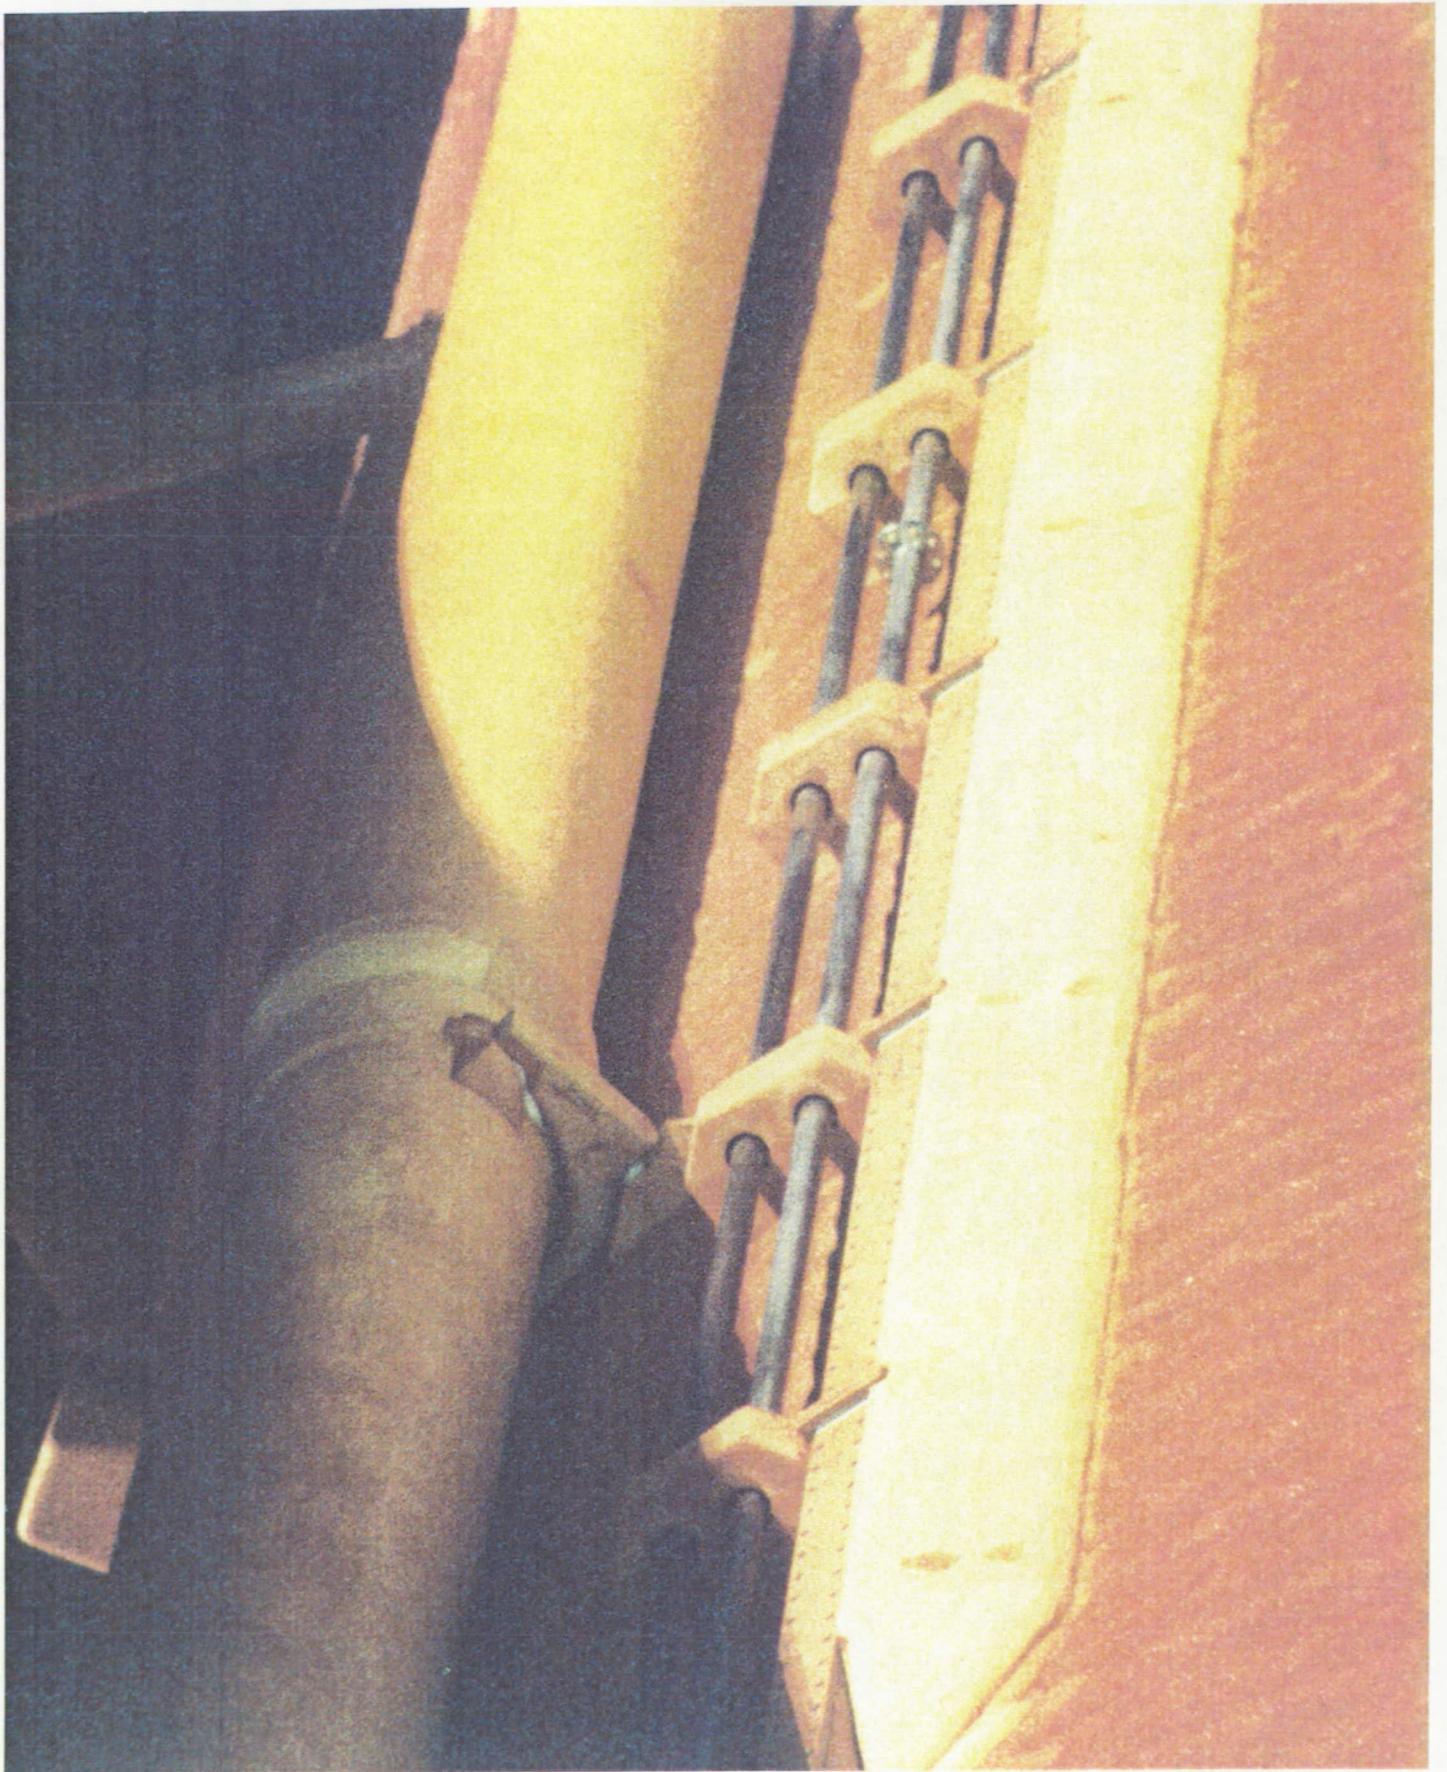
Typical amounts of ice/frost had accumulated on the L02 feed line support brackets. There were no anomalies on the PAL ramps, cable tray, or pressurization line ramps.

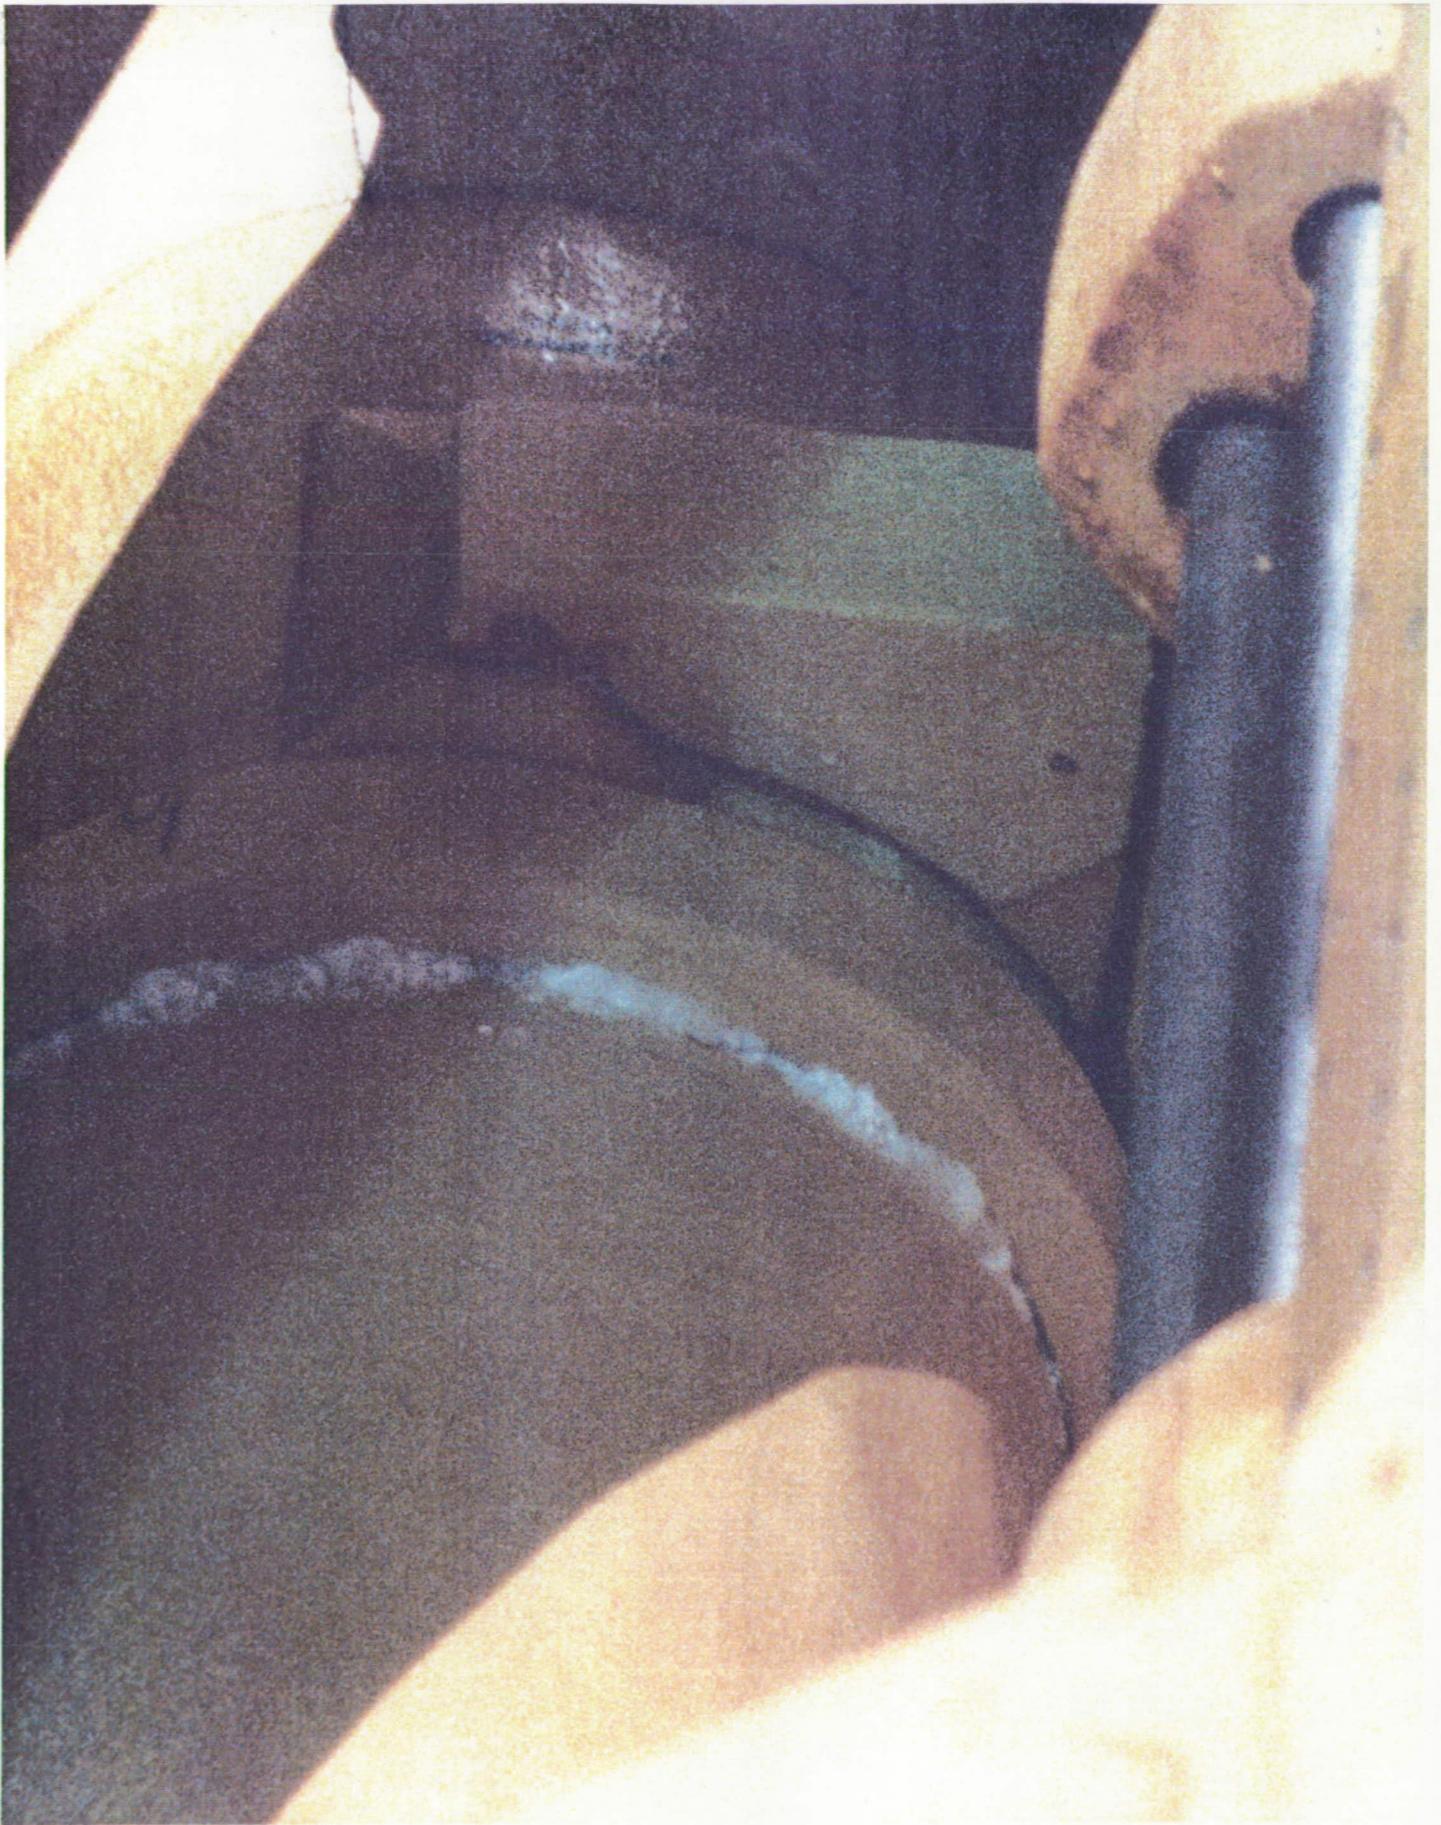
Typical amounts of ice/frost were present in the LO2  
feedline lower bellows and support brackets

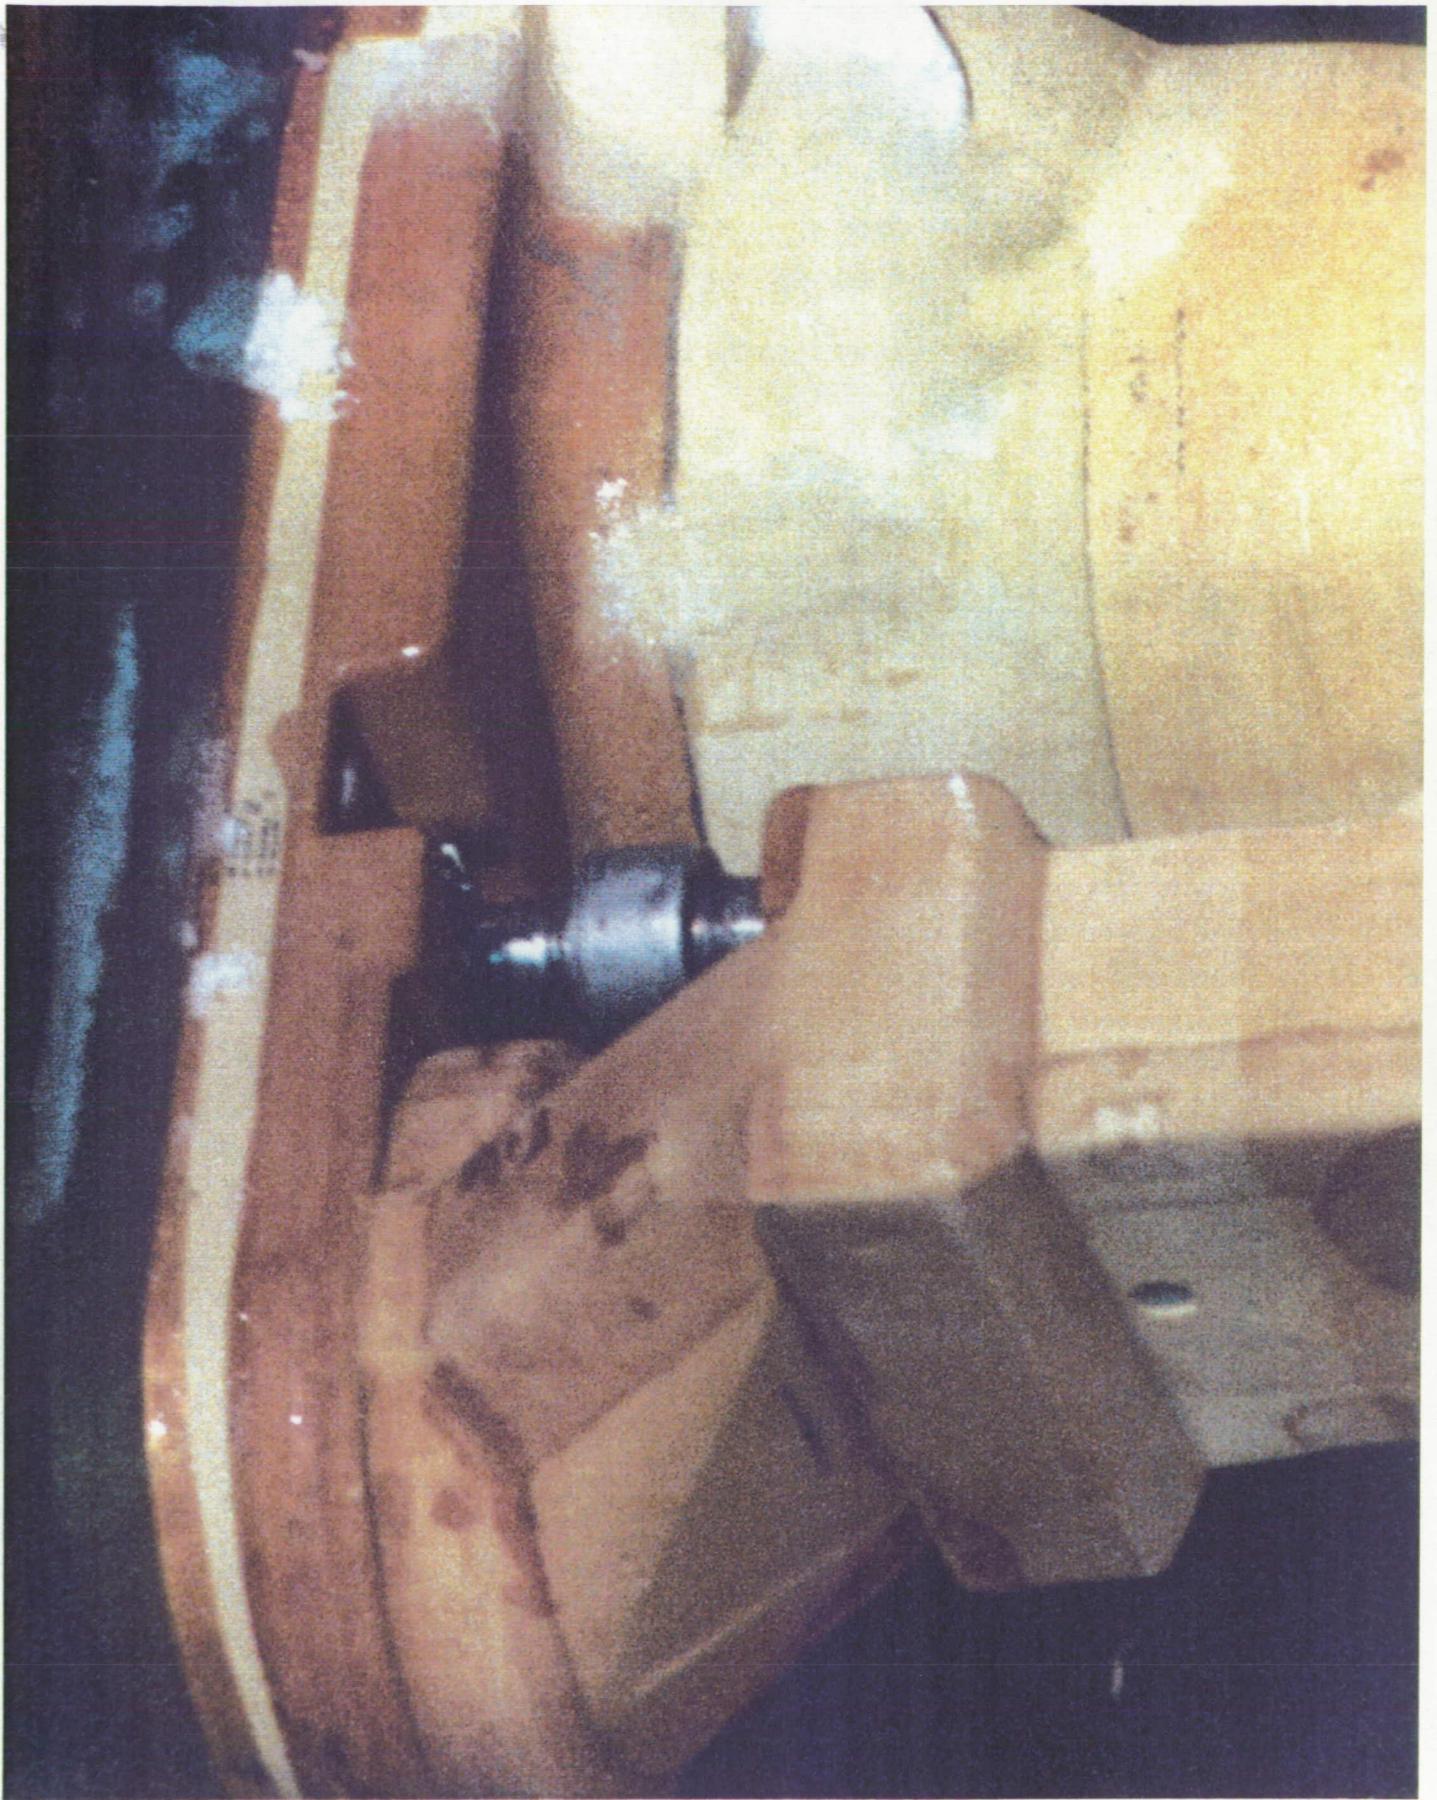
Ice/frost accumulations on the LO2 ET/ORB umbilical forward outboard pyrotechnic canister purge vent and outboard side of the purge barrier (baggie) were typical.

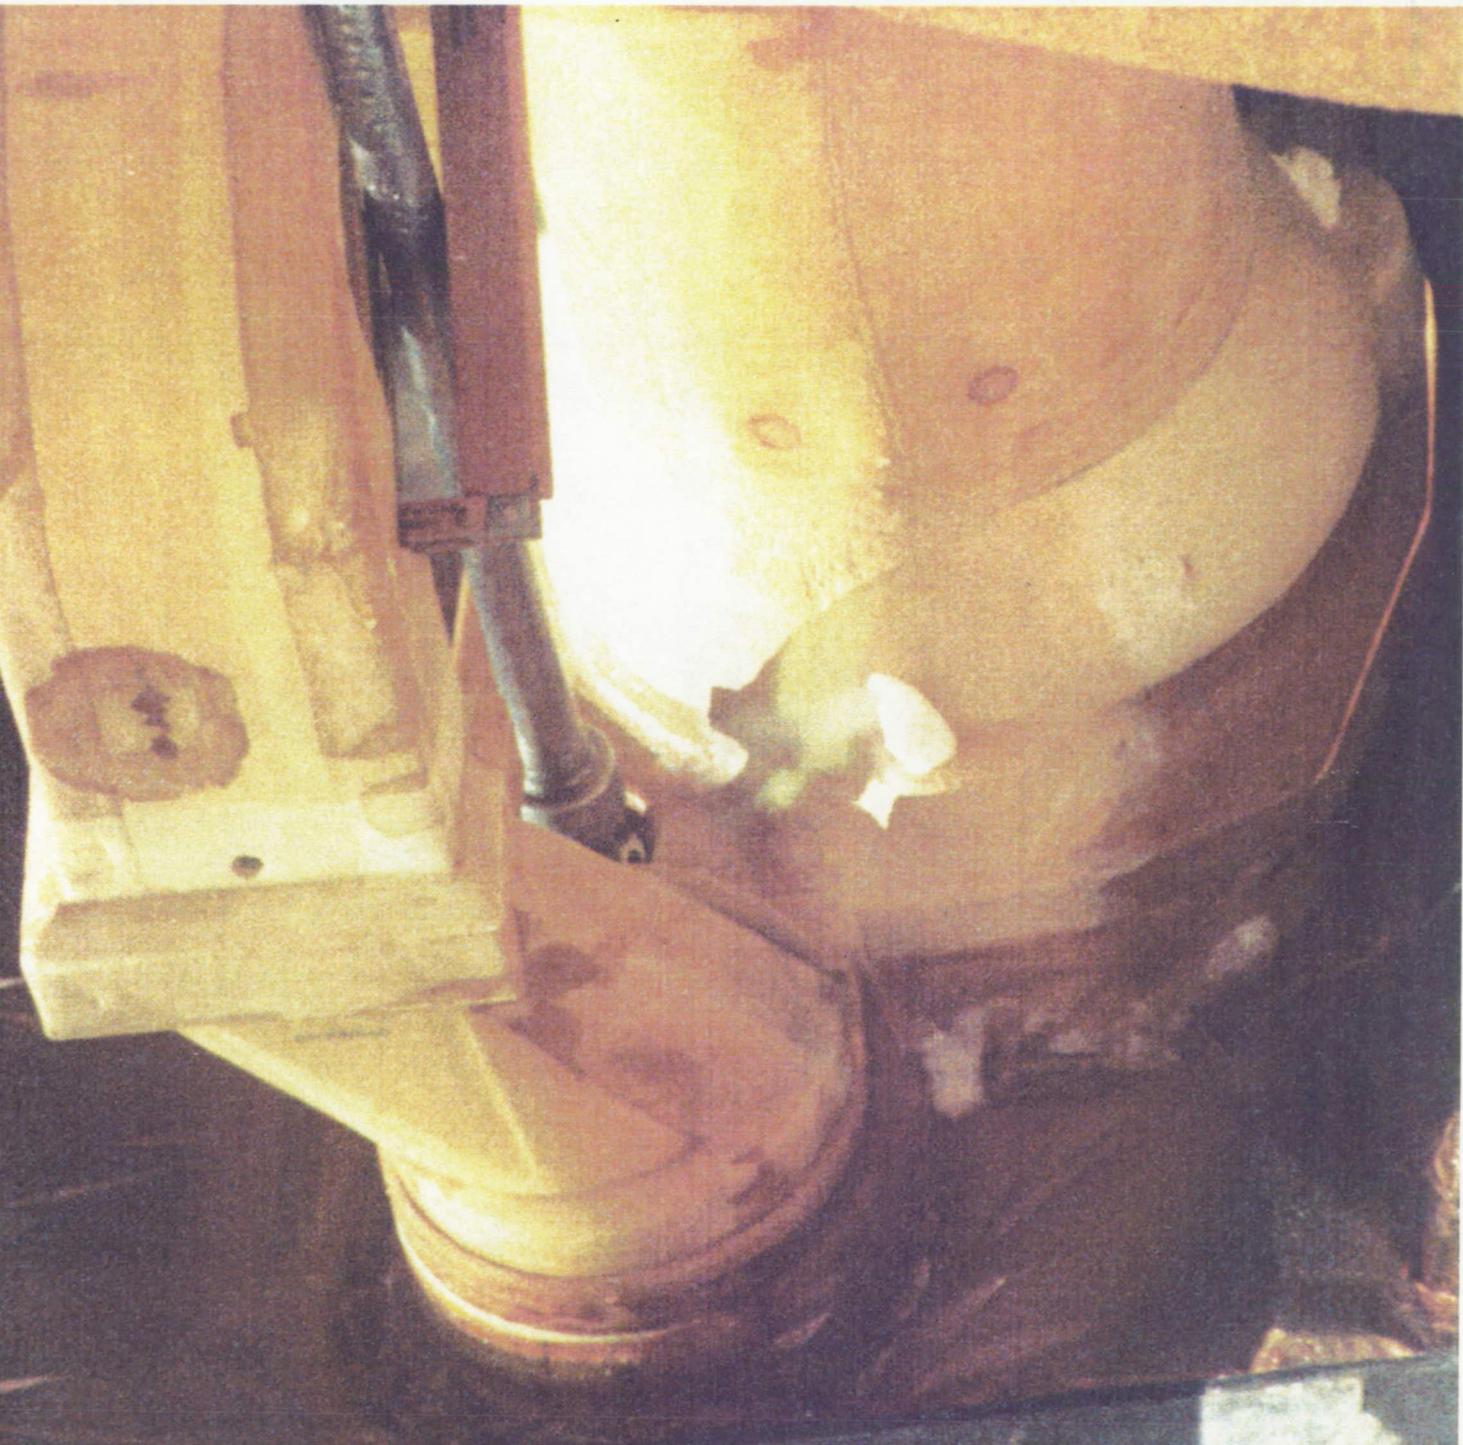
Ice/frost accumulations on the L02 ET/ORB umbilical purge barrier (baggie) aft side and the forward inboard and aft pyrotechnic canister purge vents were typical. Venting of nitrogen purge gas was normal.
