# Debris/Ice/TPS Assessment And Photographic Analysis For Shuttle Mission STS-40

DEBRIS/ICE/TPS ASSESSMENT  
AND  
PHOTOGRAPHIC ANALYSIS  
OF  
SHUTTLE MISSION STS-40

June 5, 1991.

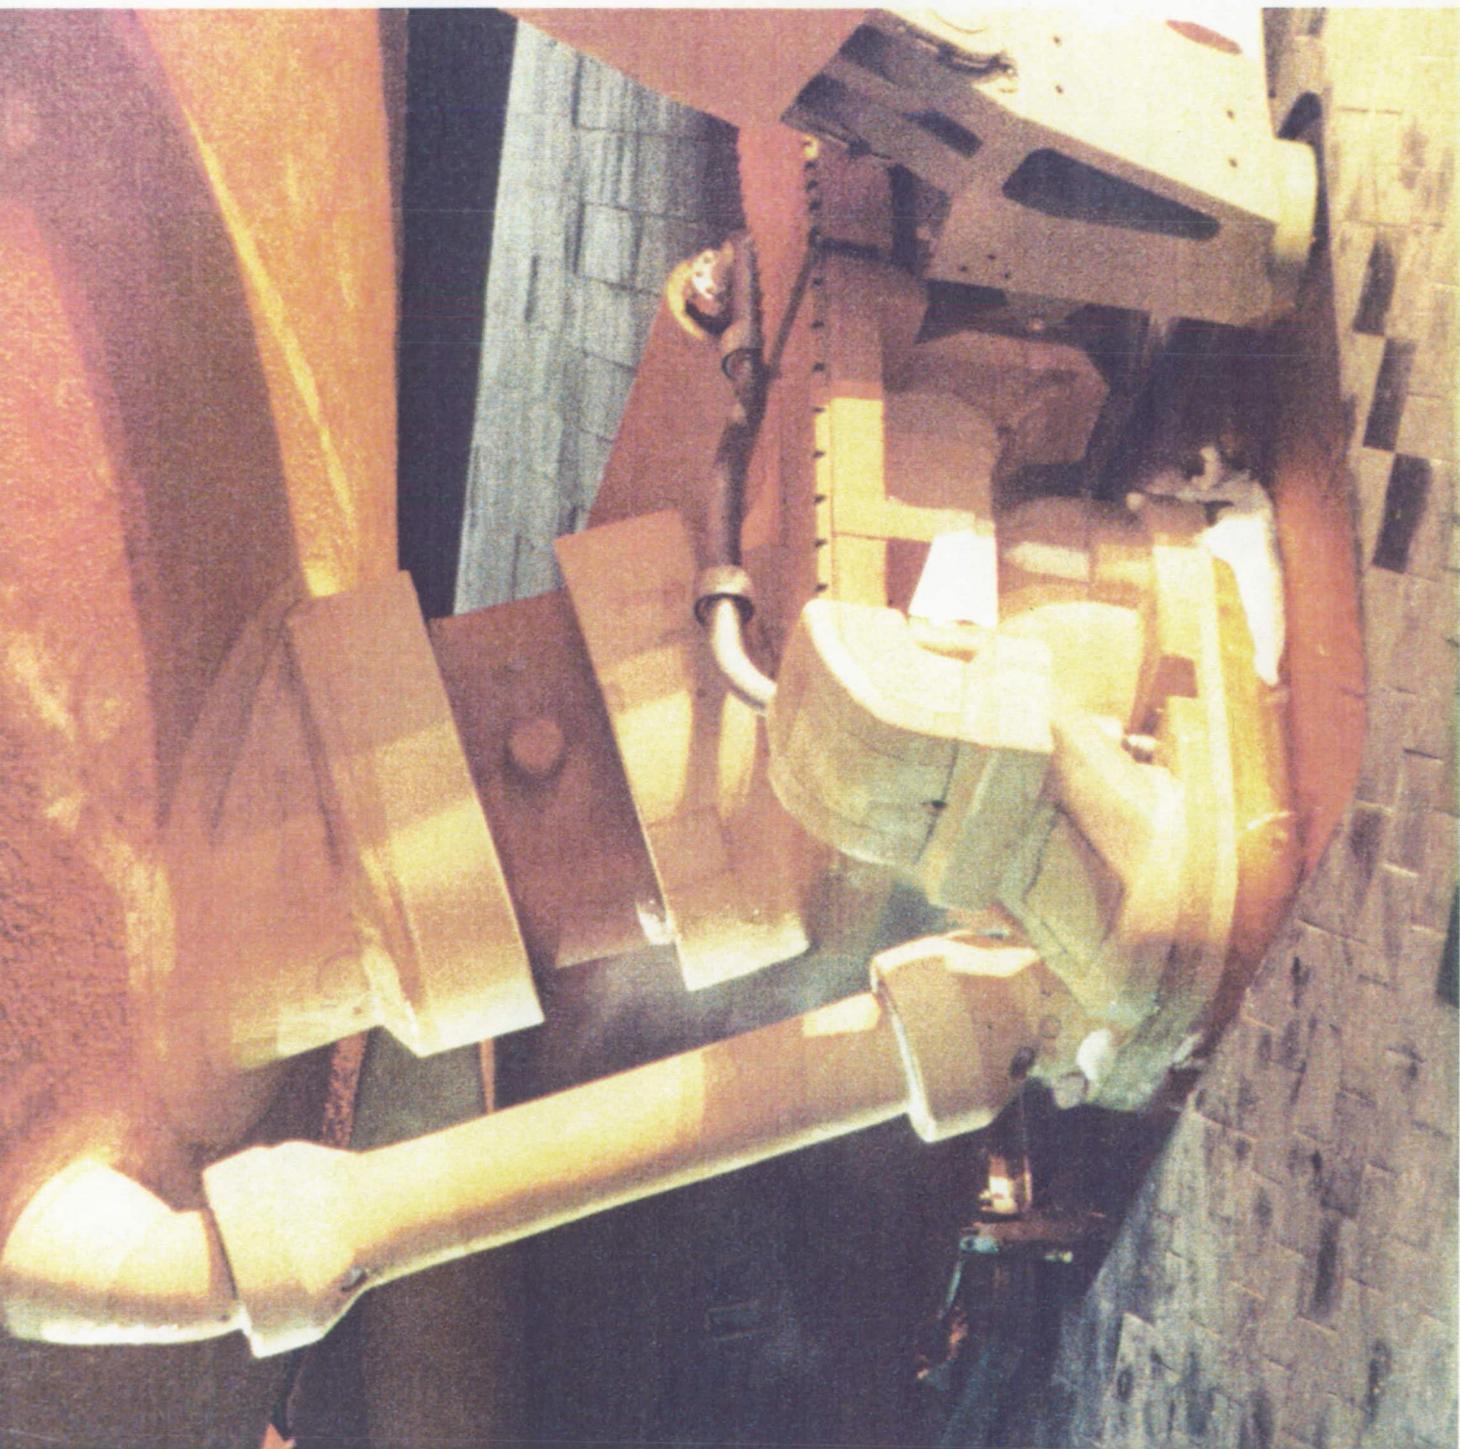
Ice/frost accumulations on the LH2 ET/ORB umbilical purge barrier (baggie) top, outboard, and aft sides were somewhat less than usual. Ice/frost fingers on the pyrotechnic canister purge vents and the umbilical disconnect plate gap purge vents were typical. There were no unusual vapors or cryogenic drips.

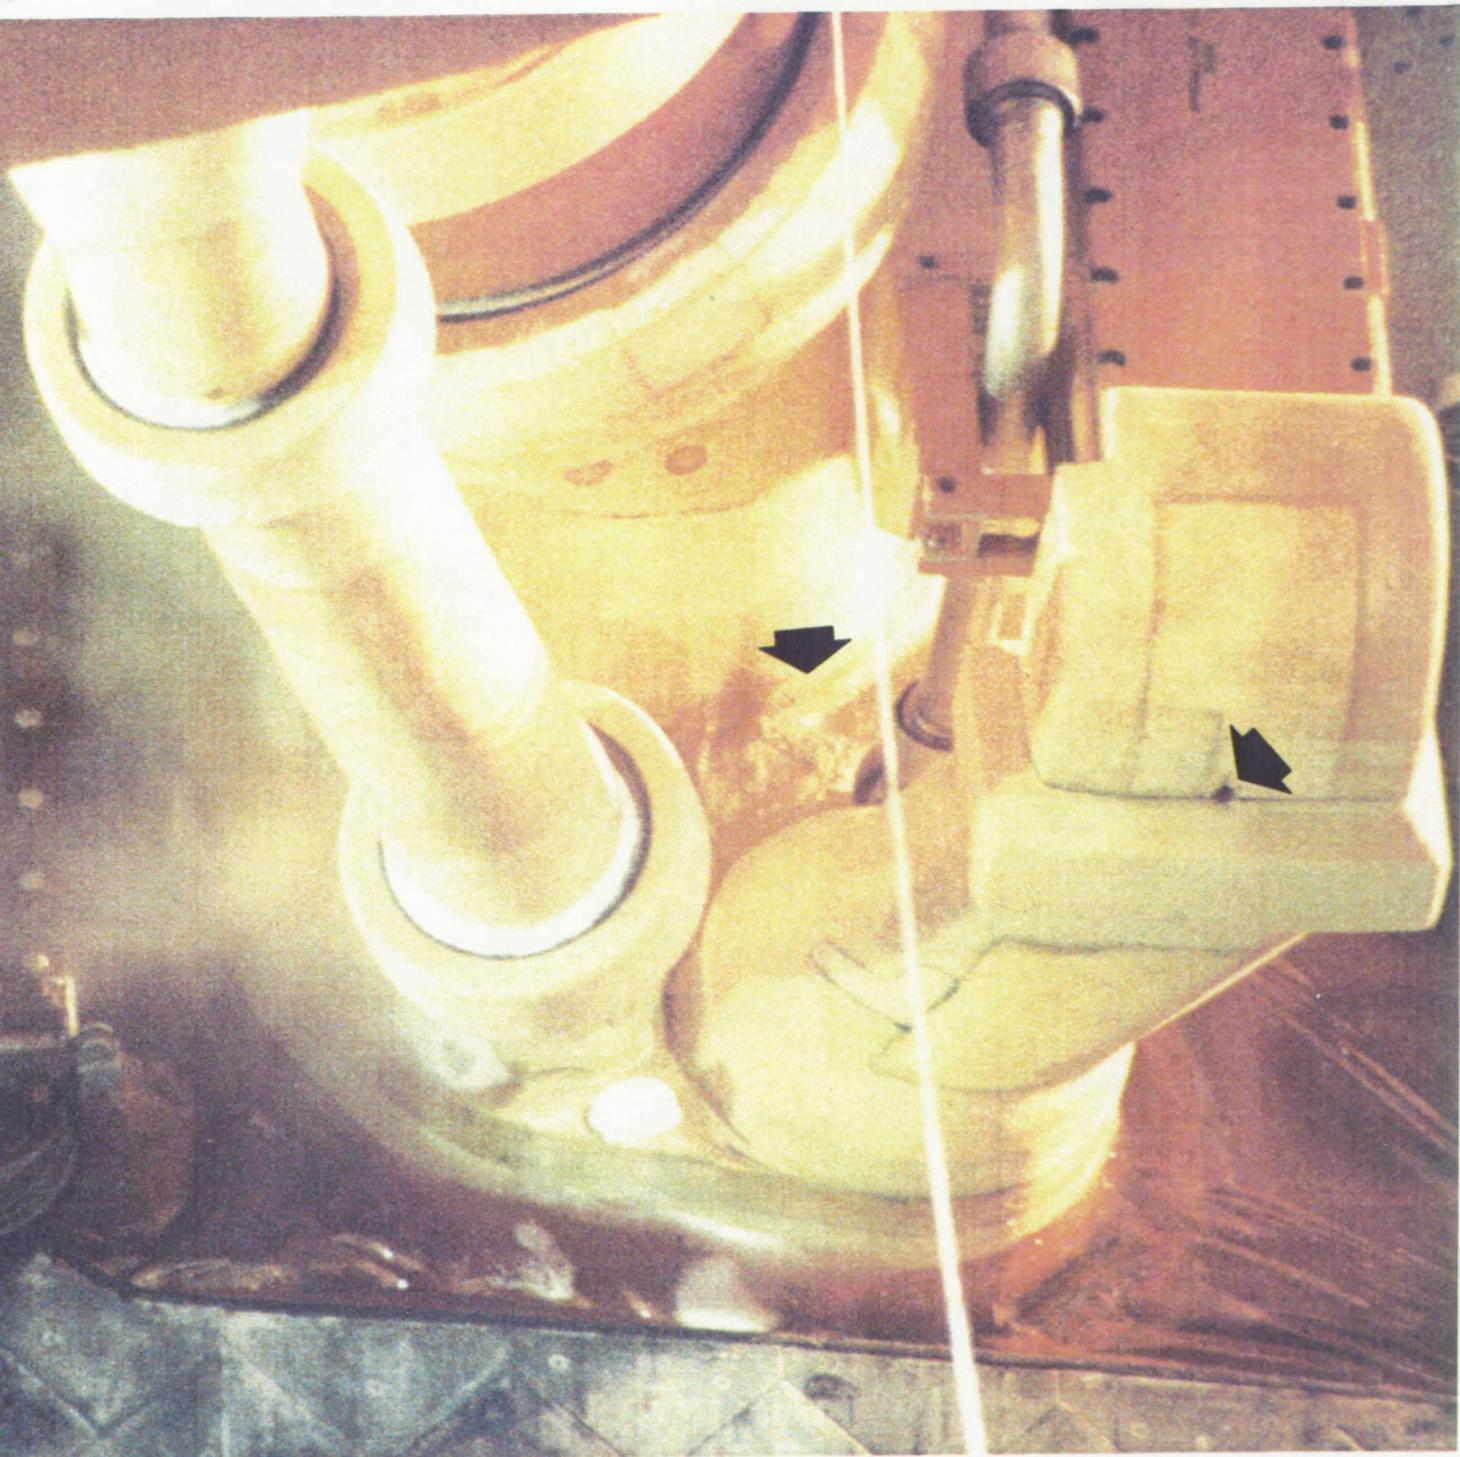
Ice/frost accumulations on the LH2 ET/ORB umbilical aft plate gap purge vent and in the LH2 recirculation line bellows were acceptable. Venting of helium purge gas vapors was normal. No ice or frost had formed on the bondline of the 17-inch flapper valve actuator access port foam closeout or on the cable tray vent hole. Note light-colored pulldown cord for the LD54 and LD55 leak detector tygon tubes.

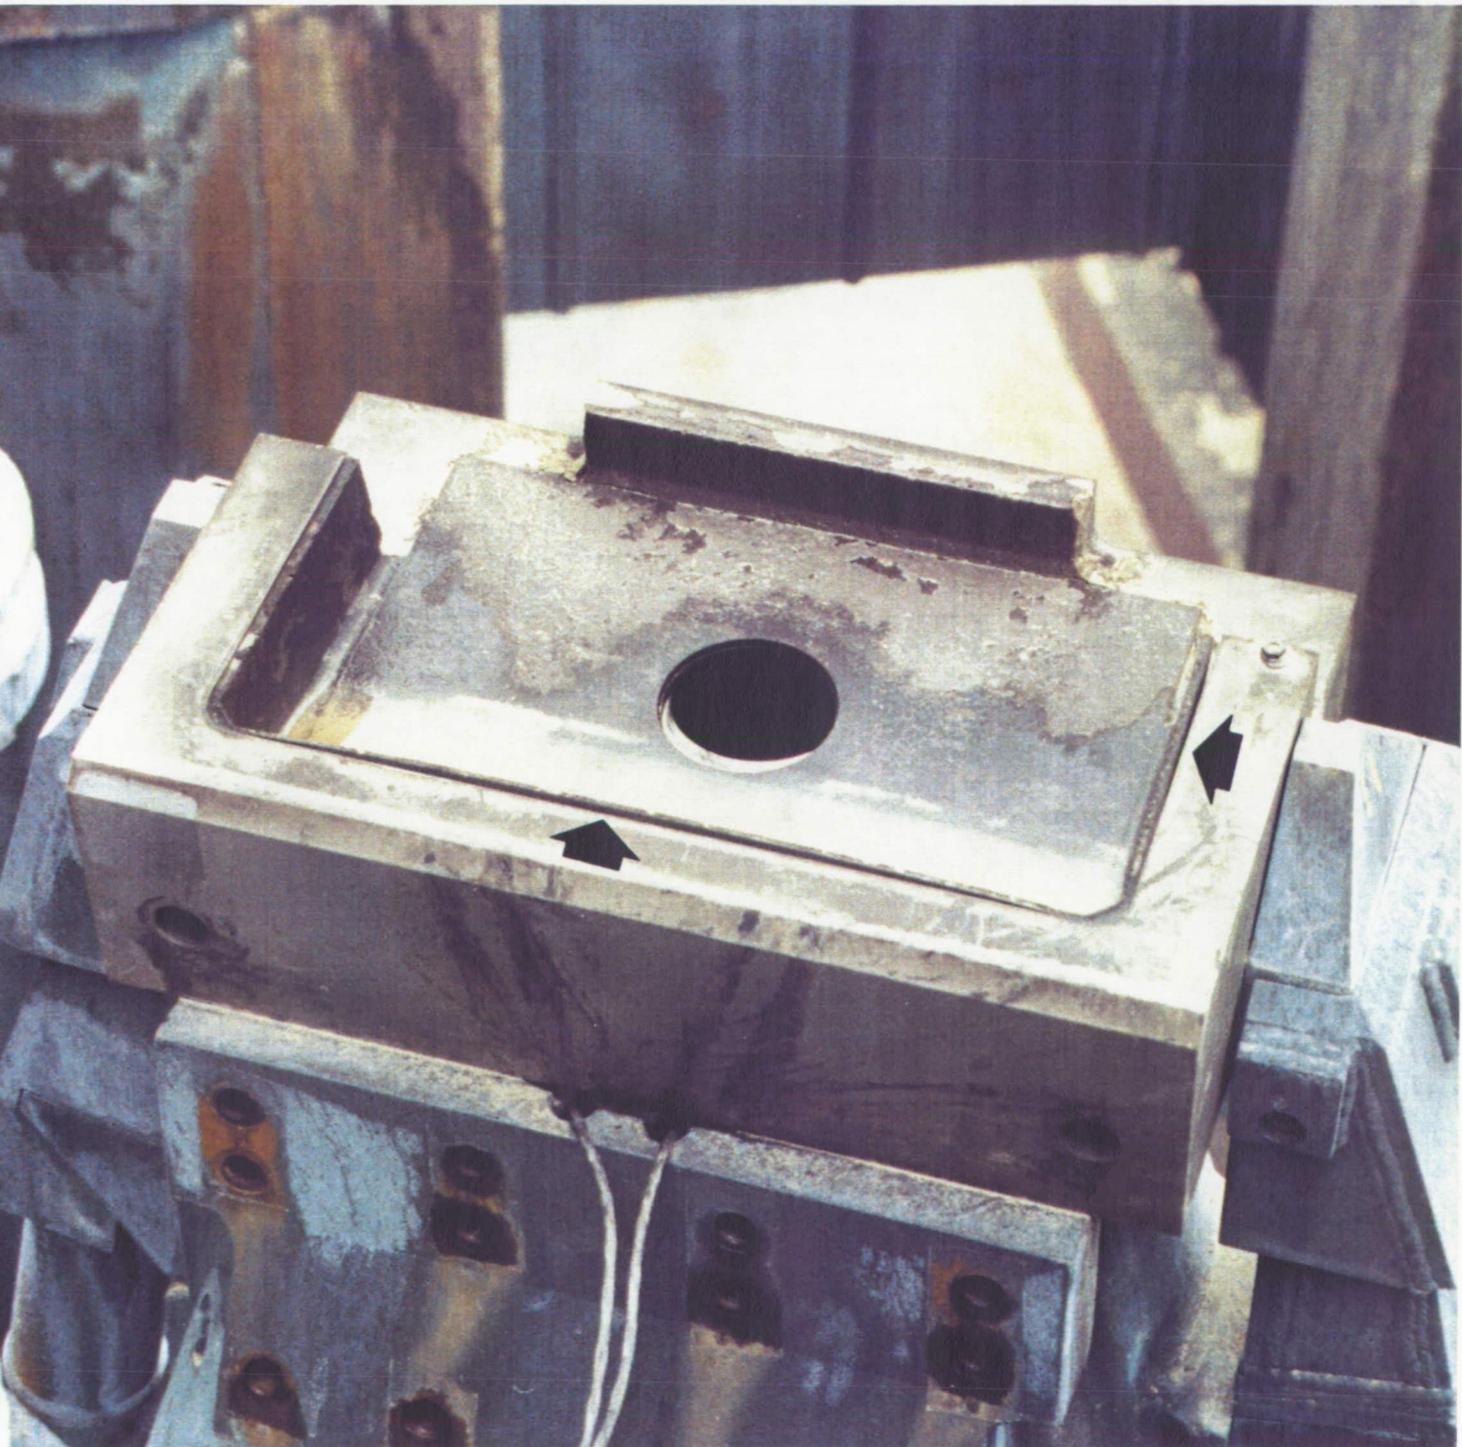
EPON shim material on the south holddown posts was intact, but the sidewall material was debonded to various degrees.

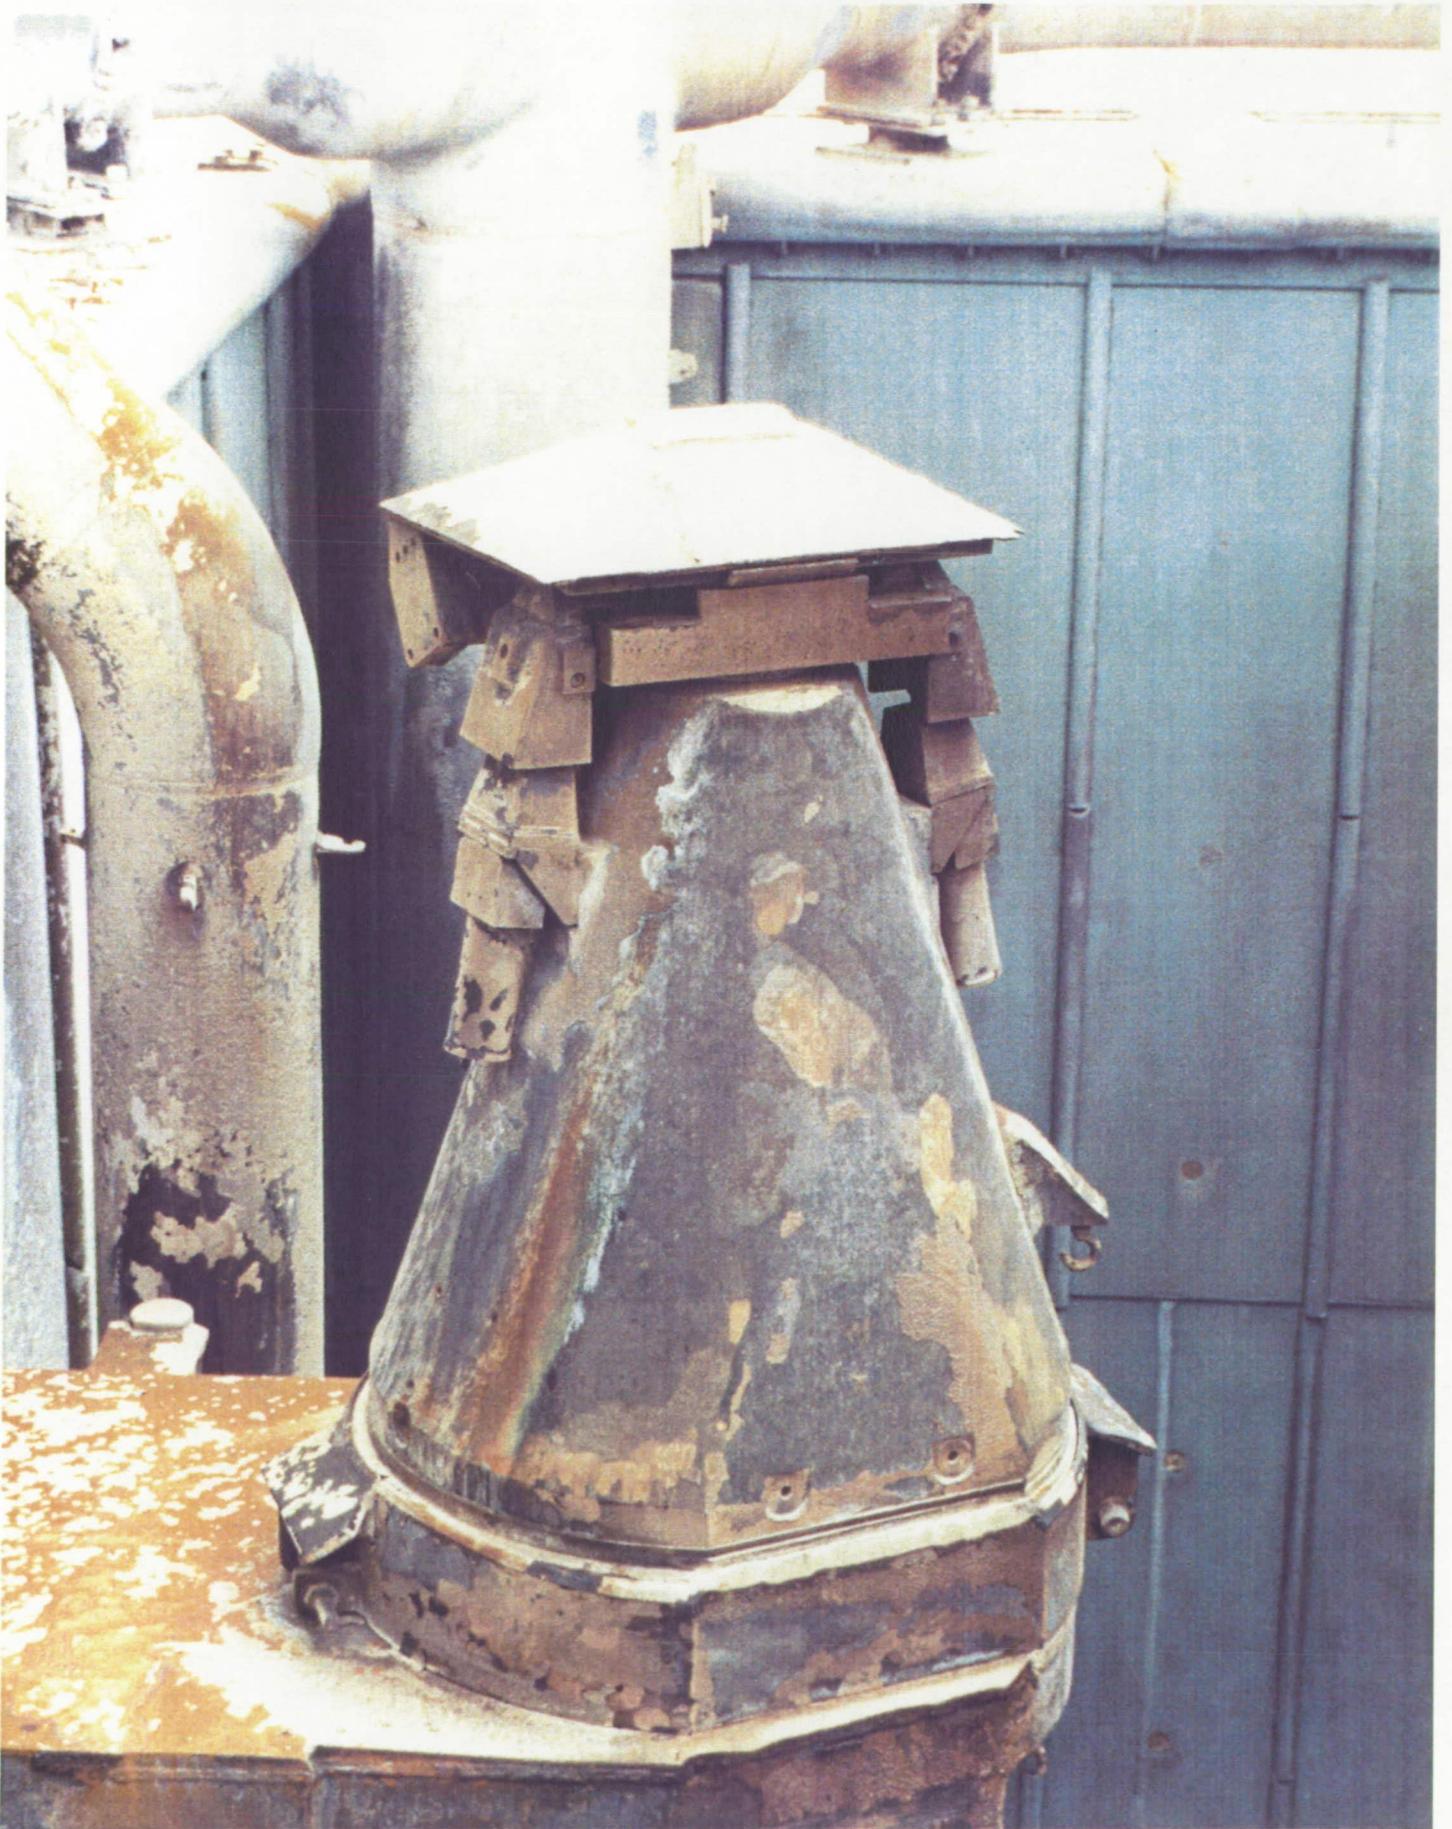
North holddown post doghouse blast covers were in the closed position and exhibited less than usual SRB plume erosion

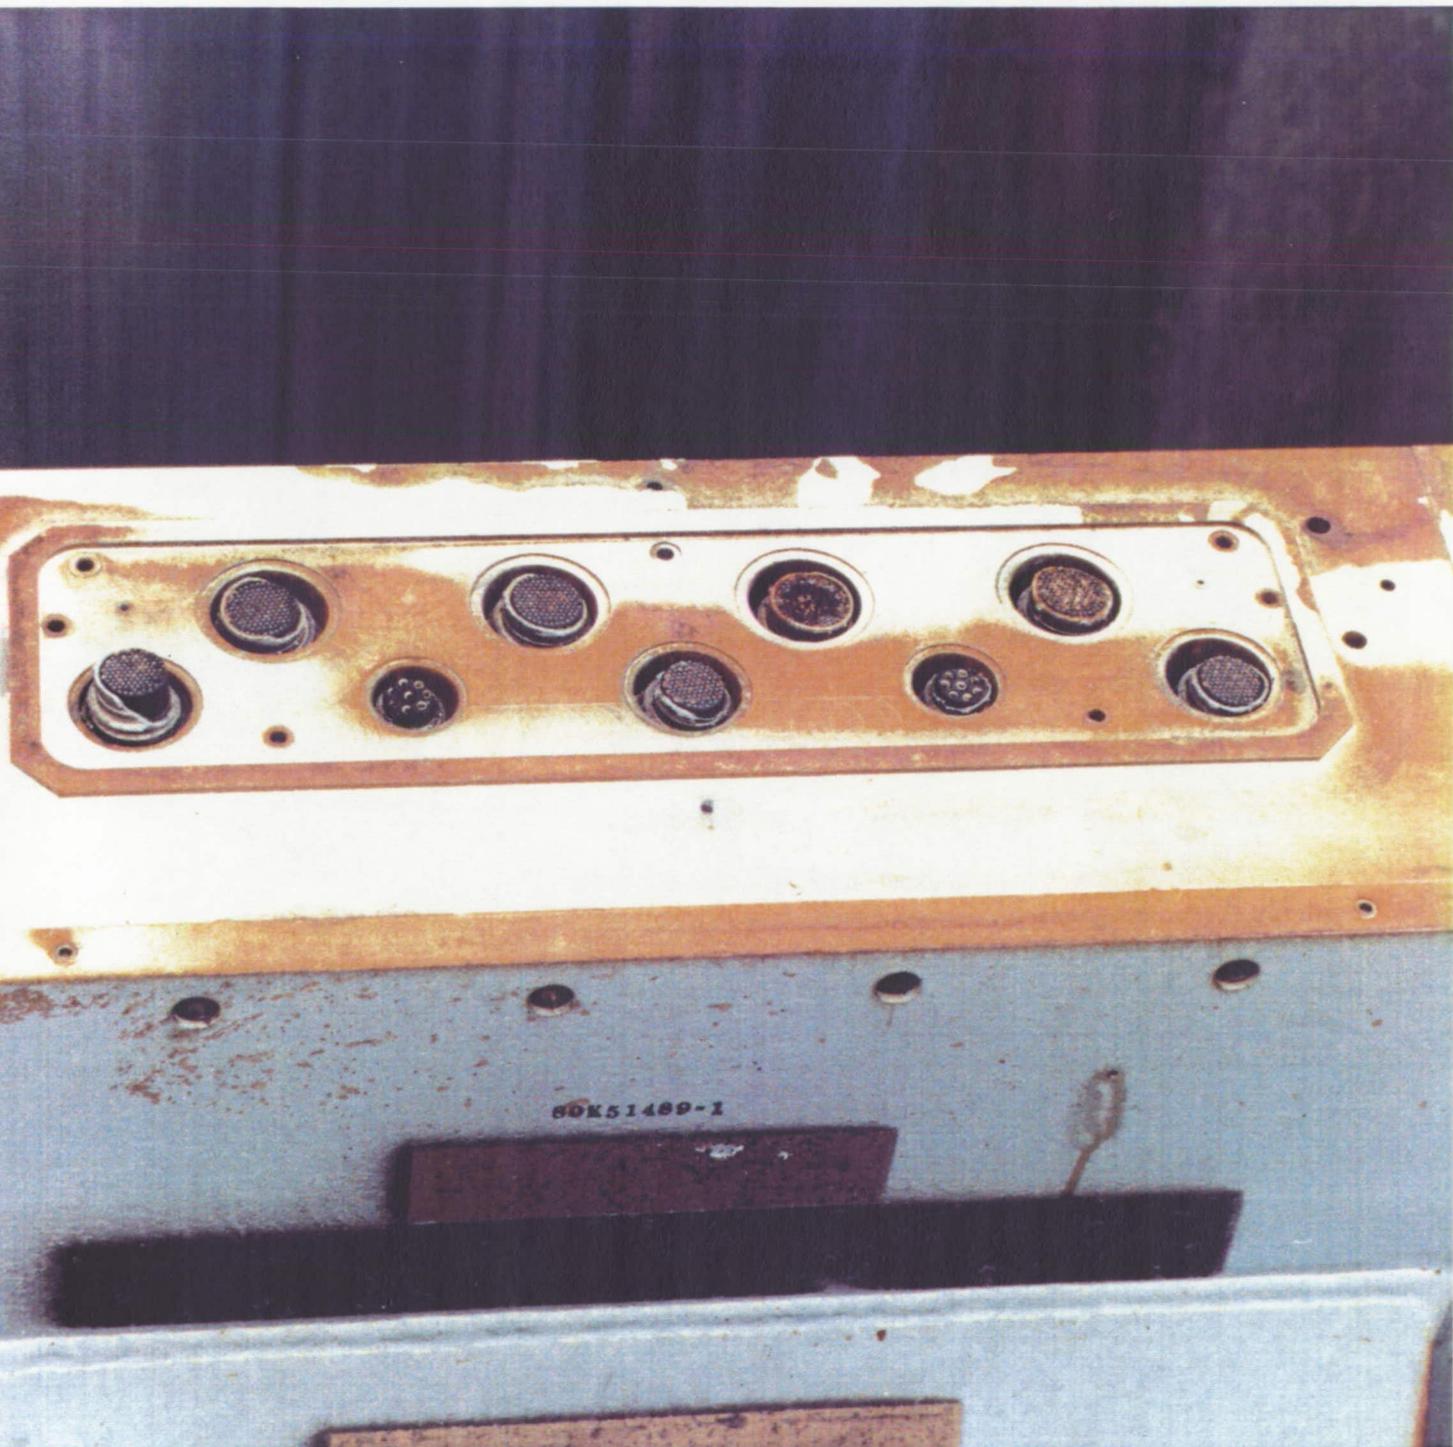
The cable connector savers (sacrificial pieces) on both SRB T-0 umbilicals showed typical plume impingement effects

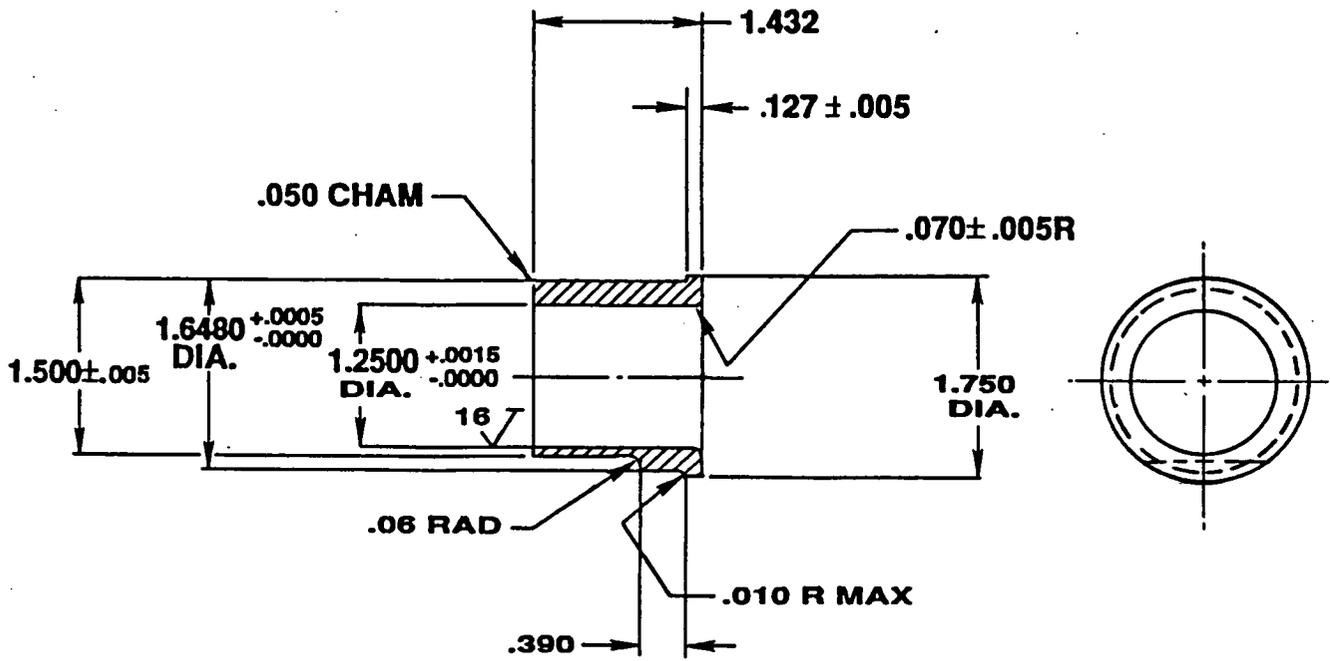
FIGURE 8.

Shortly after ET separation, the 16mm film showed a metallic cylinder drifting past the LH2 ET/ORB camera and moving away from the Orbiter. Inspection of OV-102 ET/ORB umbilicals after landing revealed no missing hardware. KSC identified the object as the outboard shear pin bushing from the ET half of the LH2 ET/ORB umbilical. Dimensions of the bushing are shown in Figure 8. On-orbit umbilical photography confirmed the inboard bushing on the LH2 umbilical and the two bushings on the LO2 umbilical were still in place after ET separation. KSC inspected the bushings on ET-47 prior to OV-104 umbilical mate. No anomalies were found. Presence of the bushings on ET-47 after separation from the Orbiter (STS-43) can not be confirmed due to lack of umbilical cameras on OV-104. The Flight Problem Report is summarized in Appendix A.

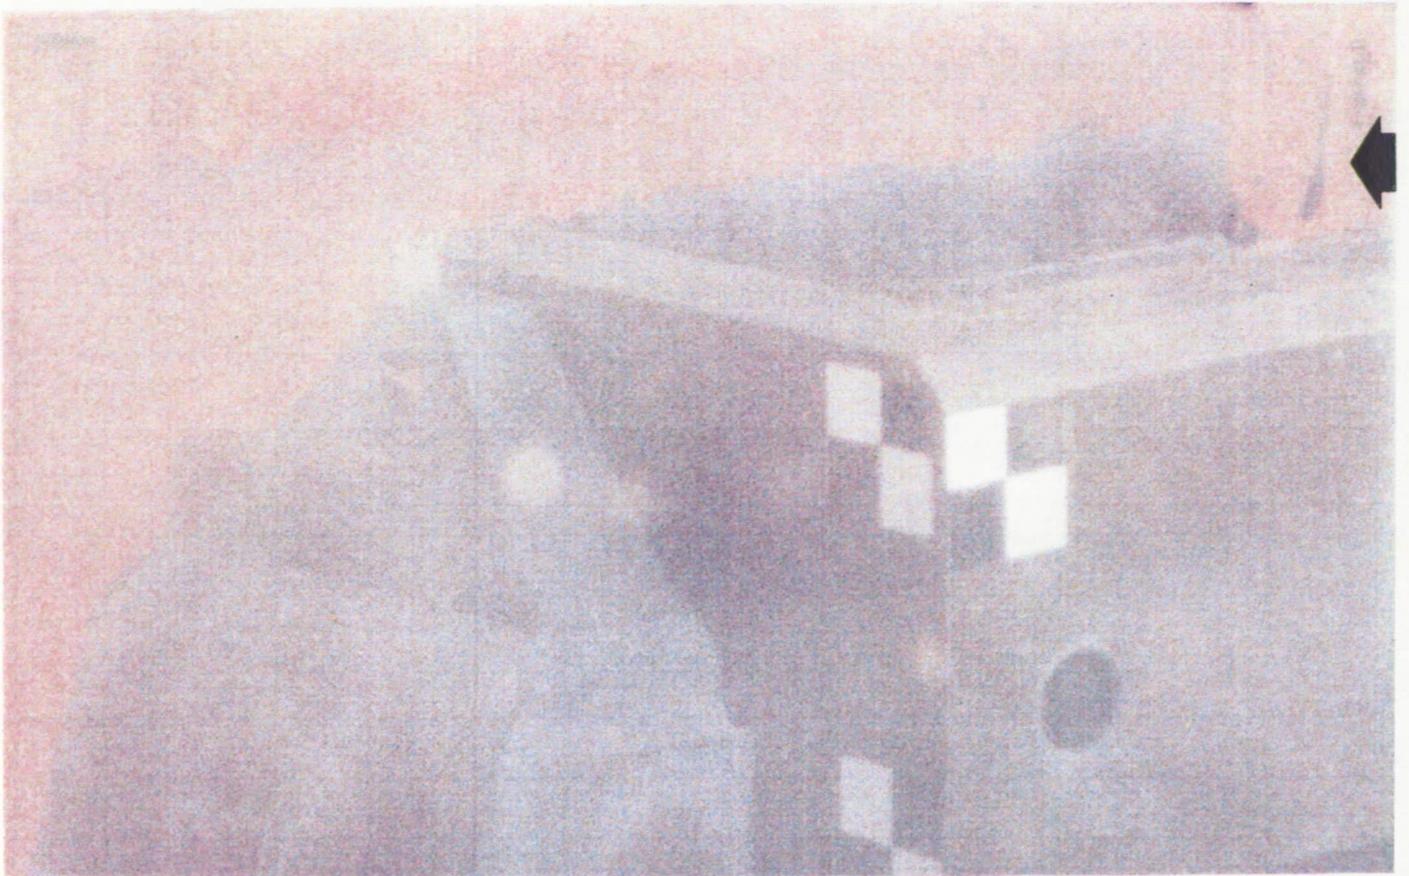
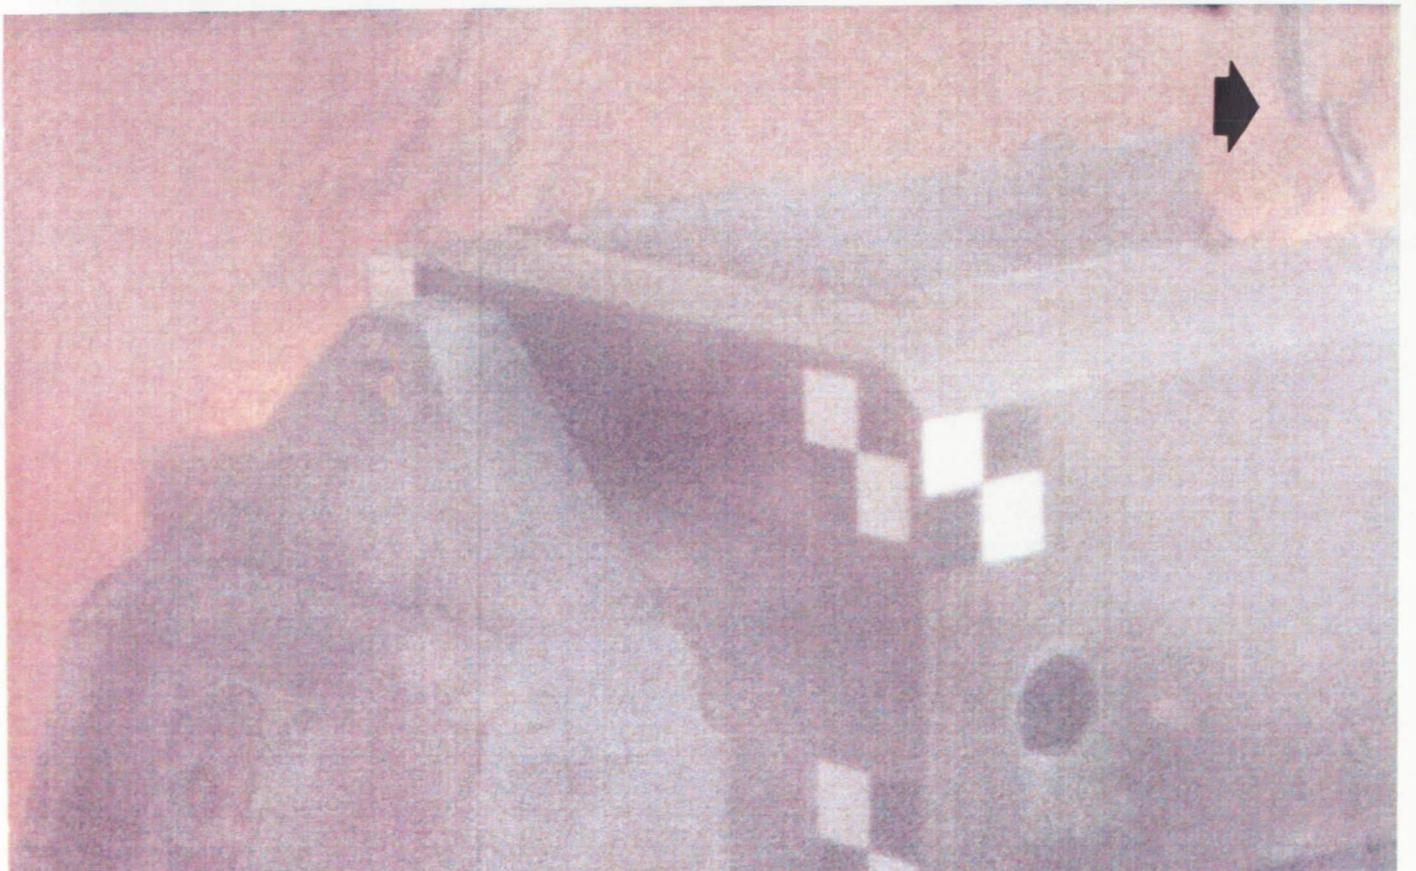
Three pieces of frangible nut and one NSI cartridge fragment fell from the HDP #5 DCS/stud hole shortly after liftoff

The largest frangible nut fragment measured 3.25" x 1.0" x 0.5" and was found on the MLP deck under the sound suppression water pipe just east of HDP #5 during the post launch pad inspection.

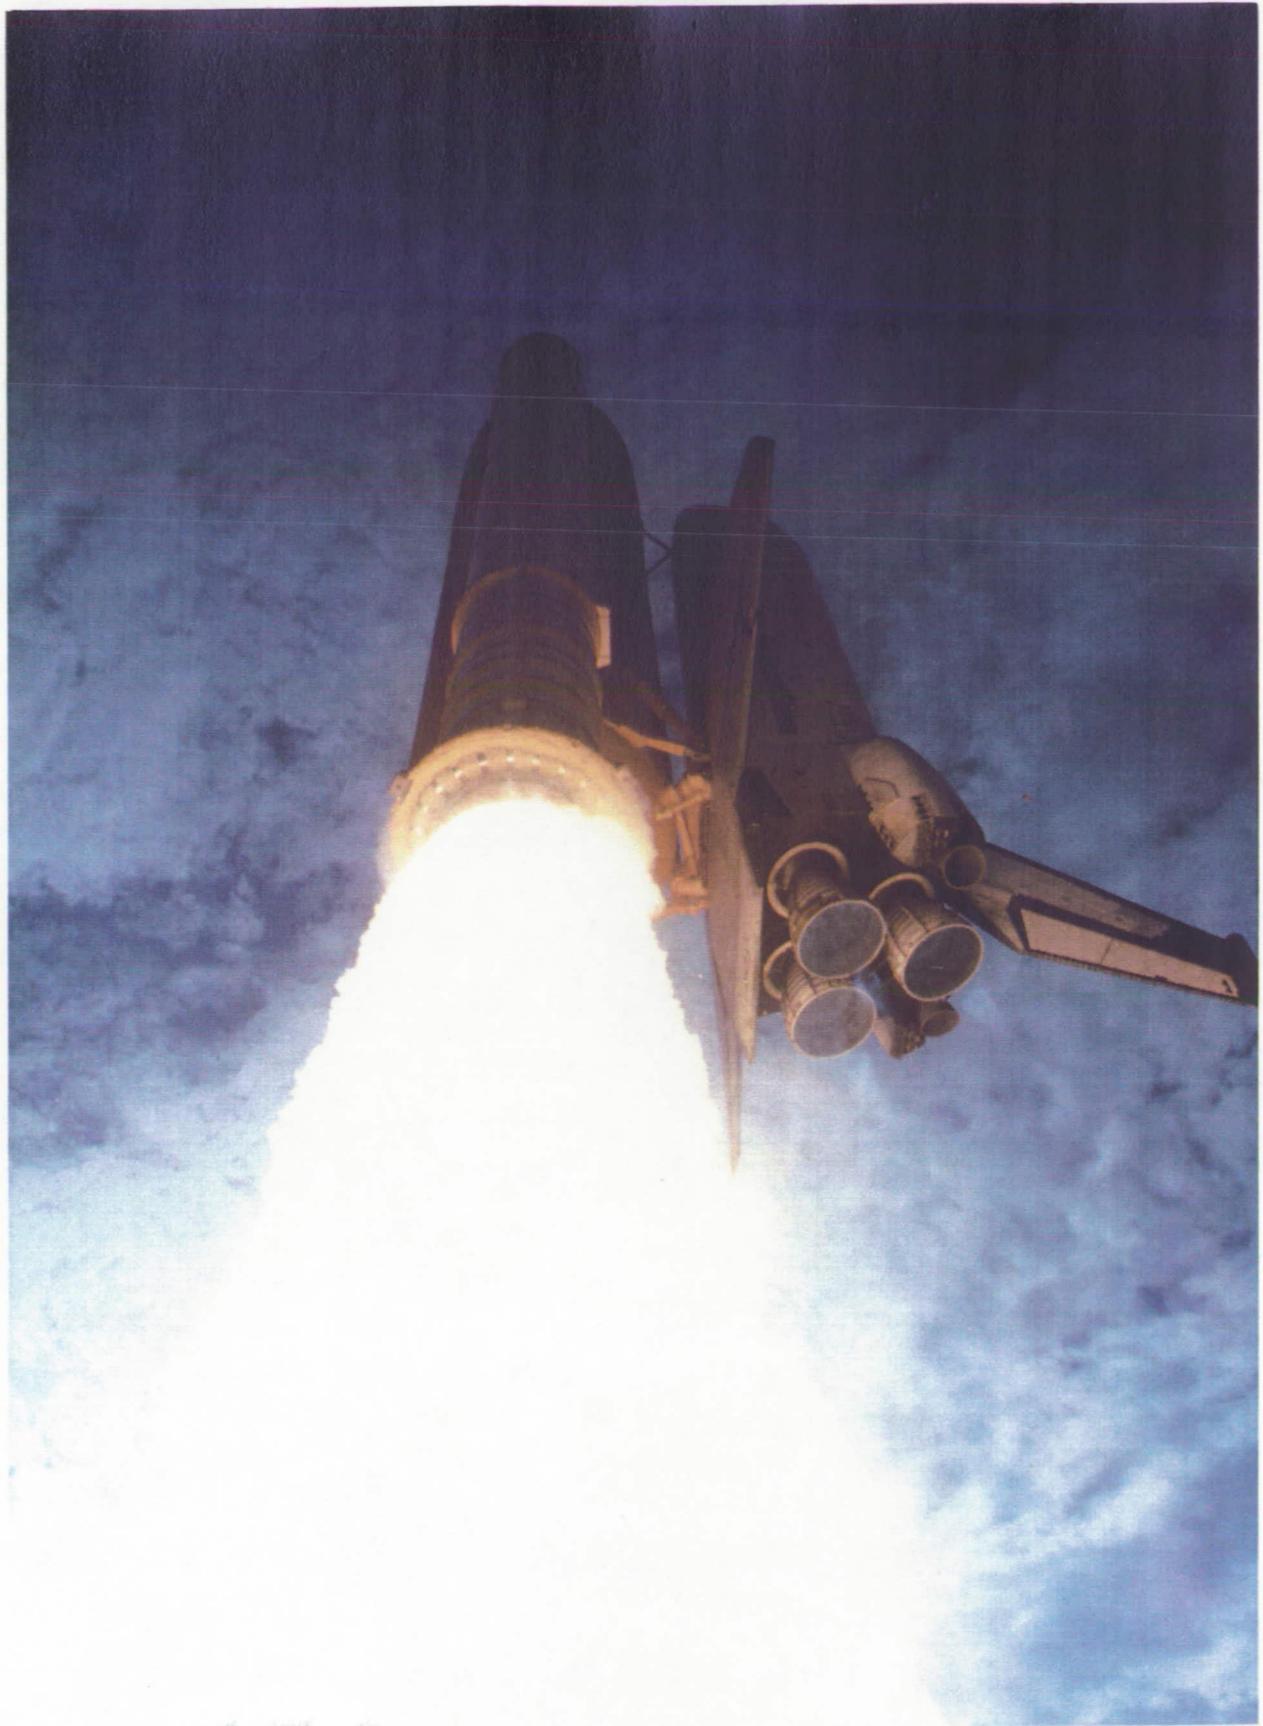
Ice continued to fall from the ET/ORB umbilicals as the vehicle cleared the tower. There were no unusual vapors or cryogenic drips in the area of the umbilicals. No anomalies were visible on the LH SRB aft skirt. Thermal curtain tape was intact.

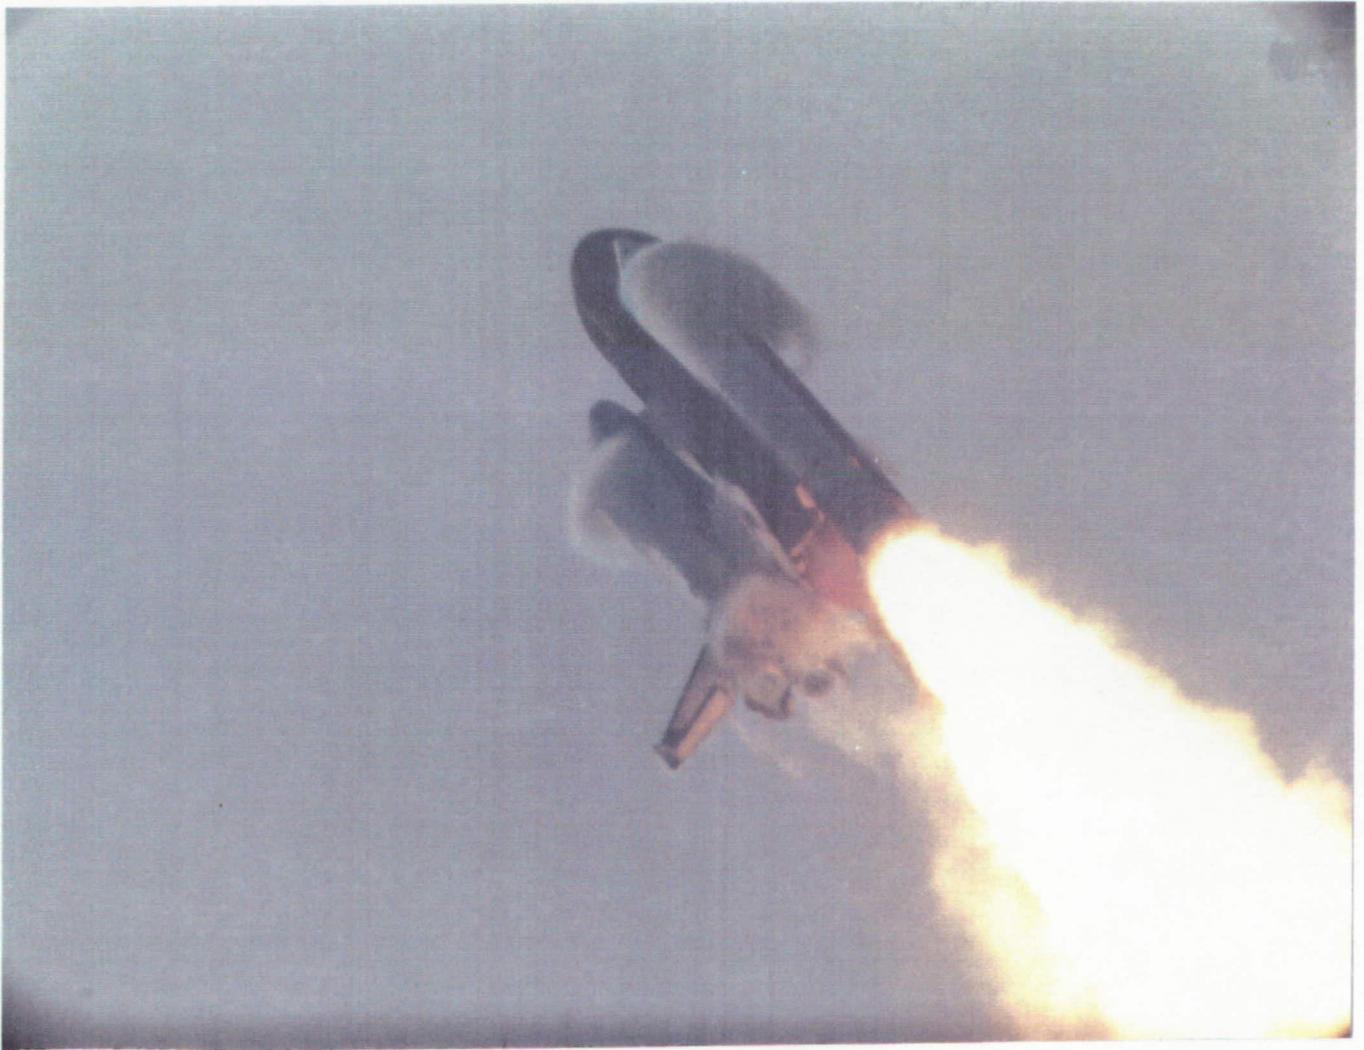
Shock wave formation caused localized flow condensation to become visible on the forward ET/SRB attach points, SRB ETA rings, ET/ORB forward attach point, bipods, Orbiter forward fuselage, wing tips, OMS pod leading edges, and SILTS pod on the vertical stabilizer.

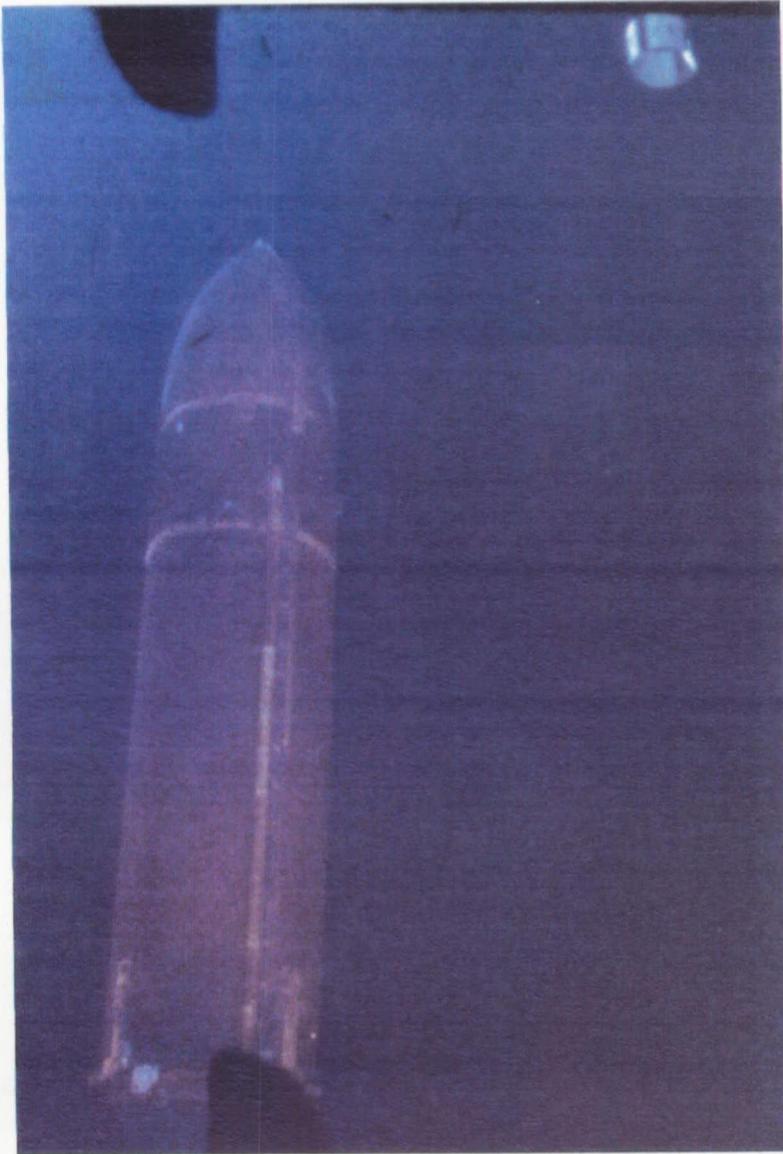
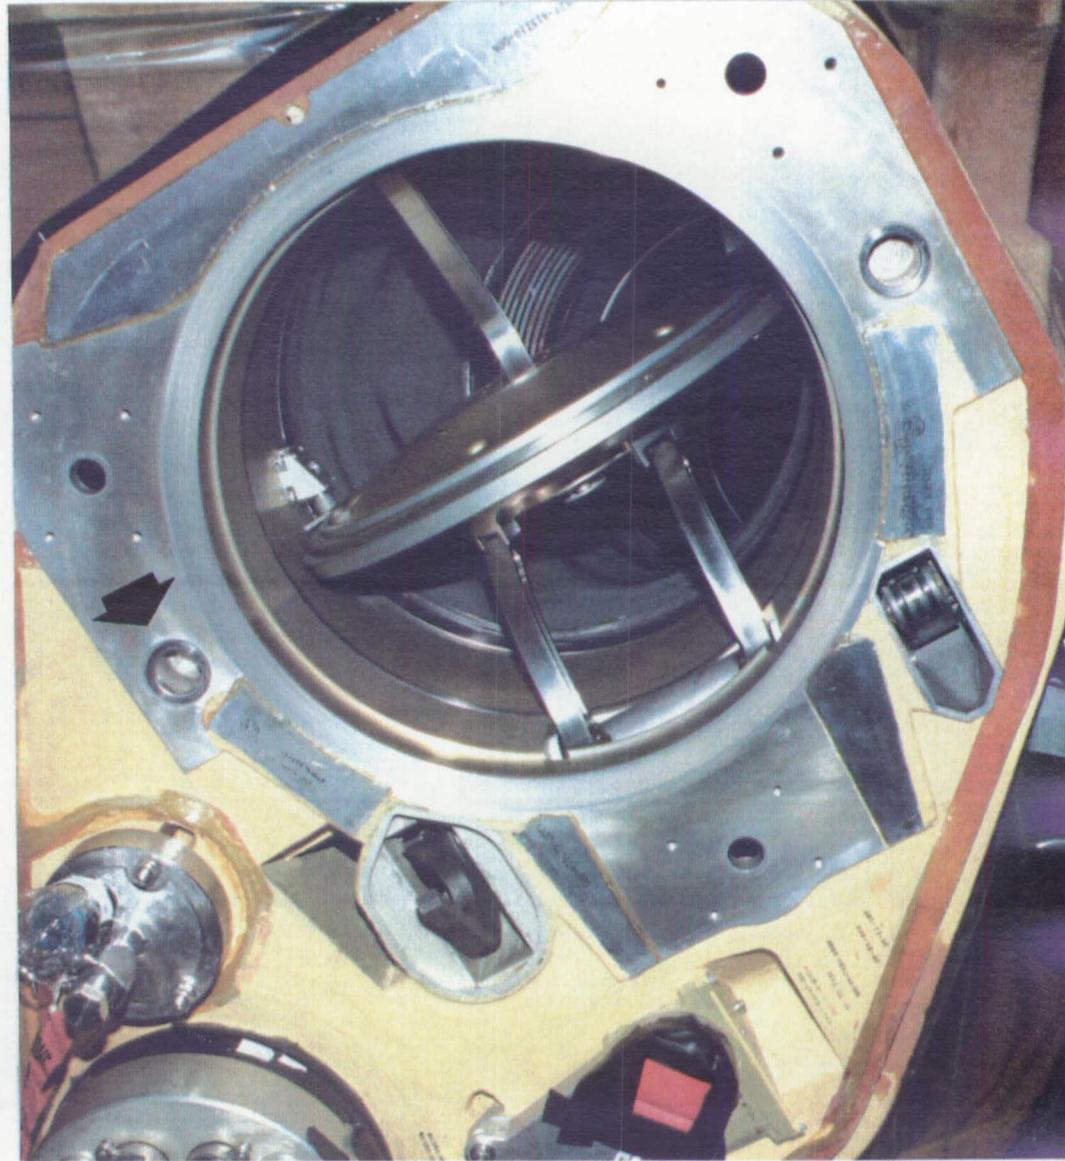
16mm camera in the LH2 ET/ORB umbilical recorded the presence of the outboard shear pin bushing/sleeve from the ET half of the LH2 umbilical. Pre-flight closeout photo shows the bushing (arrow) in the umbilical disconnect plate near the LH2 17-inch feedline.

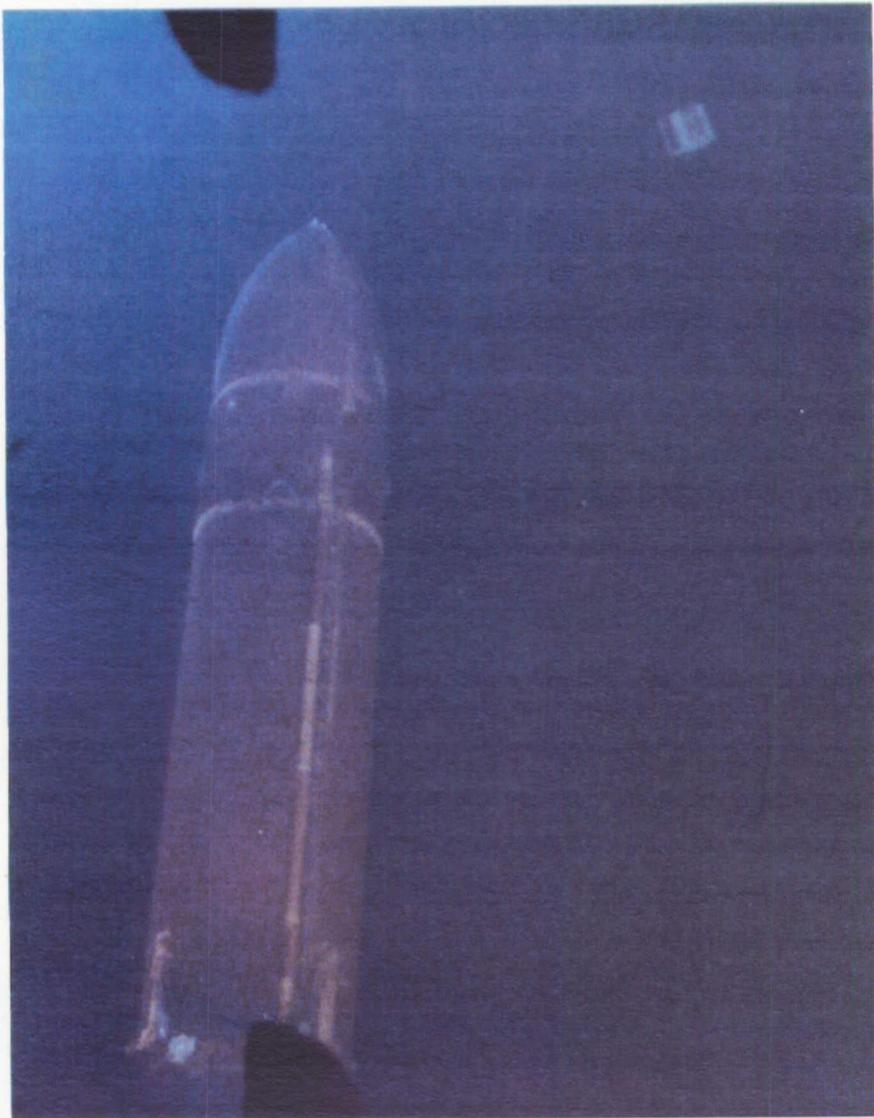
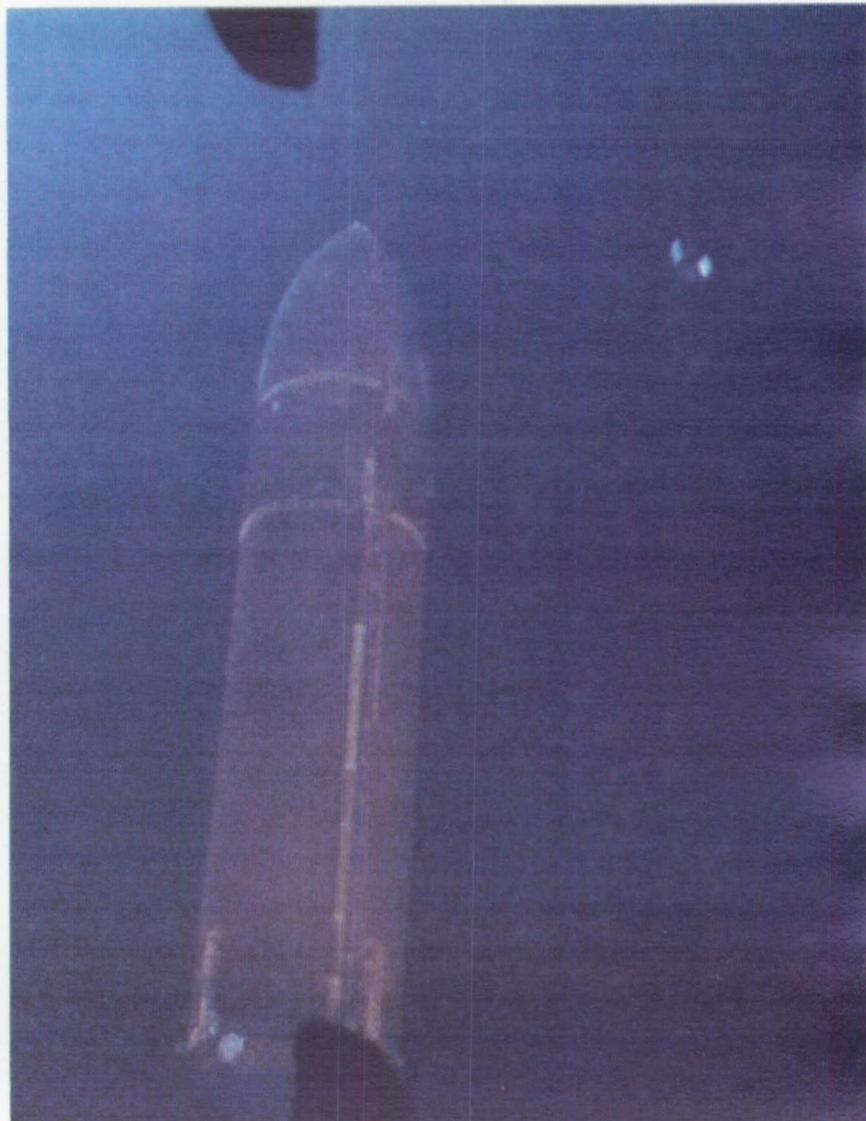
The Inconel-718 shear pin bushing from the ET half of the LH2 ET/ORB umbilical drifted past the camera lens approximately 44 seconds after separation and was visible for 2.5 seconds. The bushing measured 1.432 inches long with an outer diameter of 1.750 inches and an inner diameter of 1.250 inches.
