# Debris/Ice/TPS Assessment And Photographic Analysis For Shuttle Mission STS-40

DEBRIS/ICE/TPS ASSESSMENT  
AND  
PHOTOGRAPHIC ANALYSIS  
OF  
SHUTTLE MISSION STS-40

June 5, 1991.

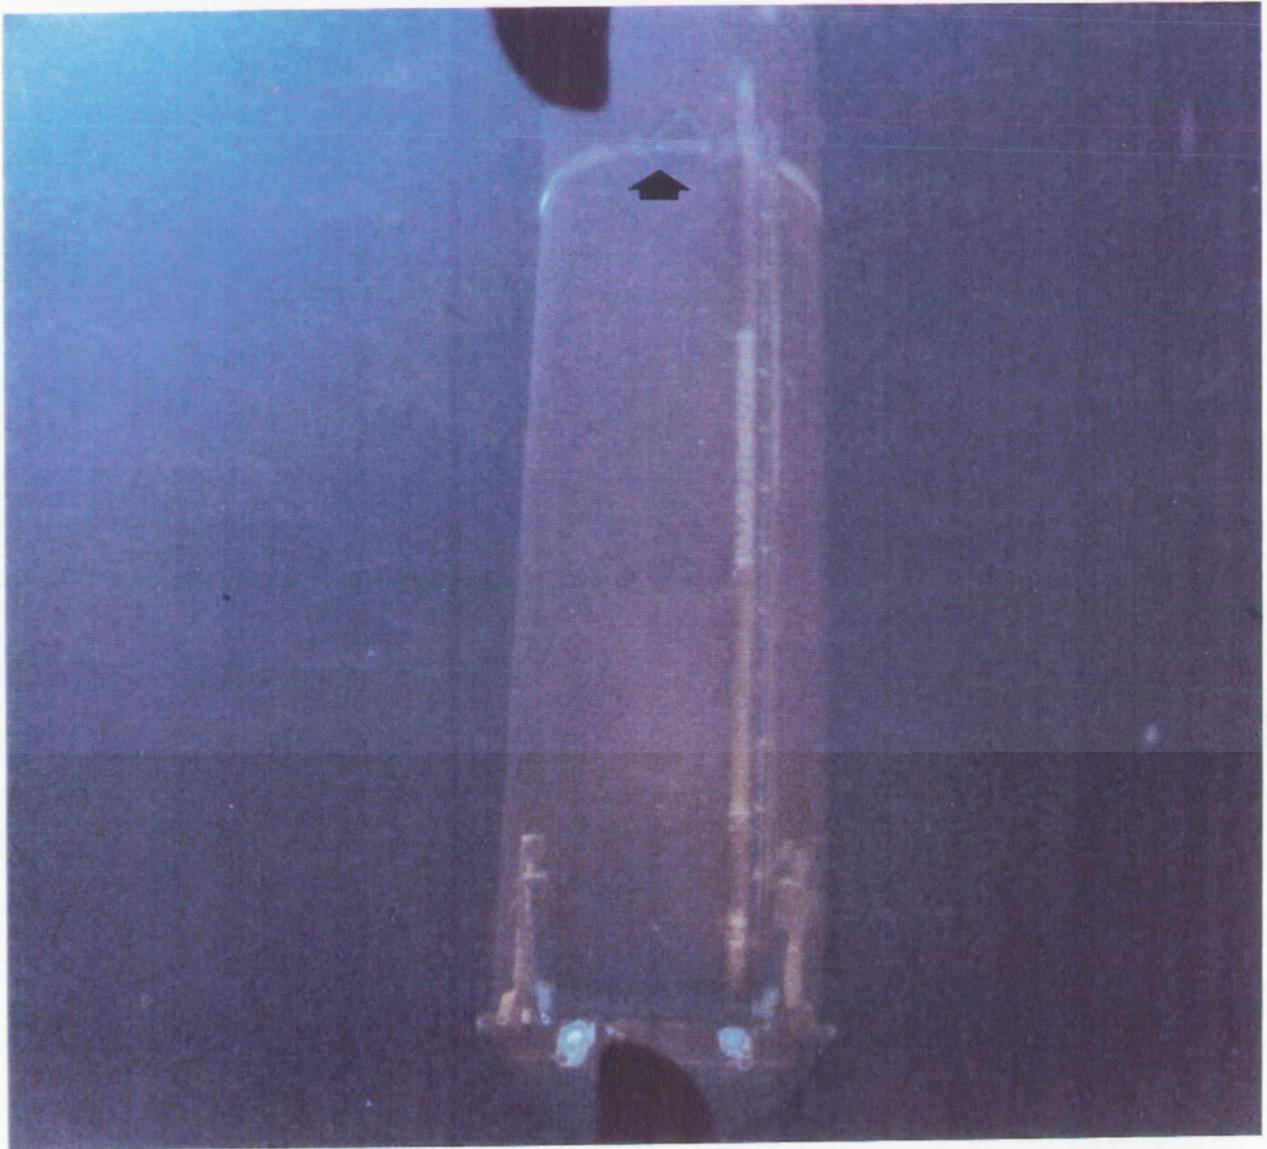
There were no significant TPS divots on the LH2 tank acreage. No anomalies were visible on the LO2 feedline, PAL ramp, and pressurization lines/ramps. Top-coated crossbeam and thrust struts have been charred by ascent aeroheating - an expected occurrence. PDL repair to the -Y jack pad closeout was in place and intact (arrow).

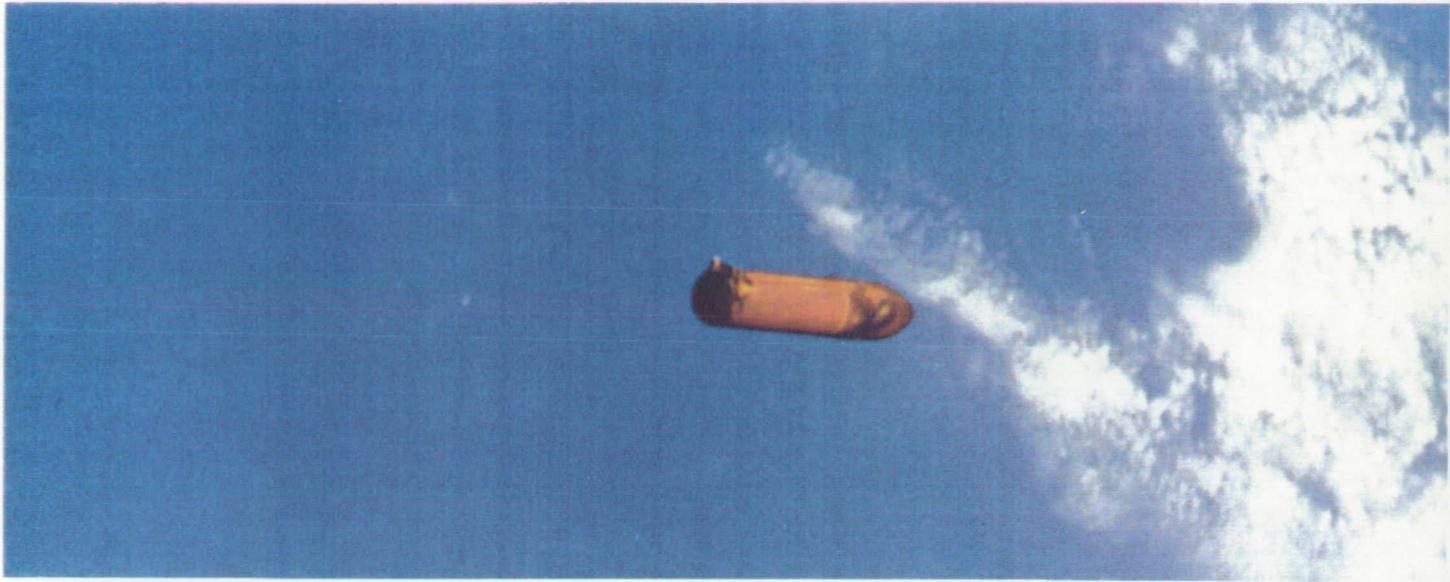
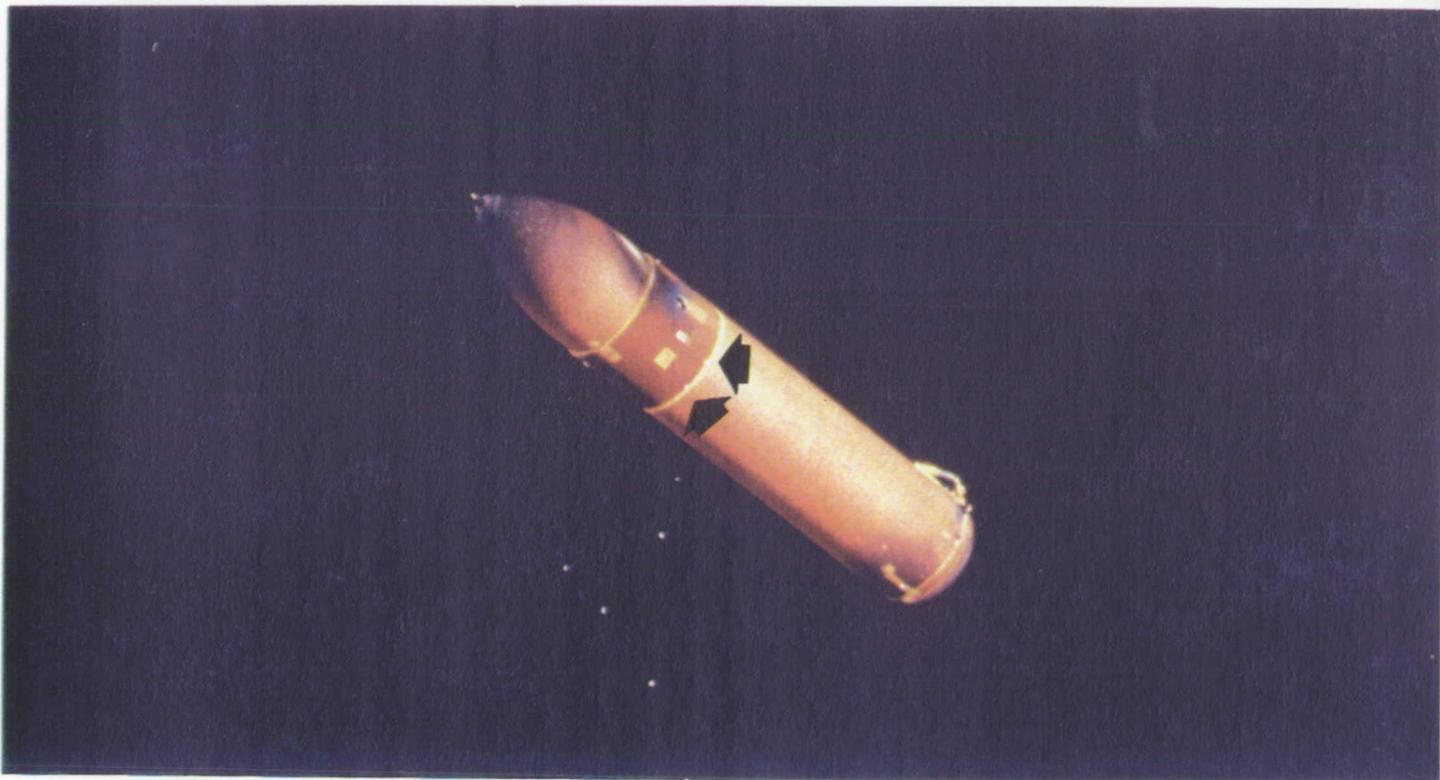
Two TPS divots, approximately 8-10 inches in diameter, were located on the LH2 tank-to-intertank flange below the intertank access door and GH2 vent line QD. There were no visible anomalies on the TPS acreage. Pieces of MPS ice reflected sun light as the ET drifted away from the Orbiter.

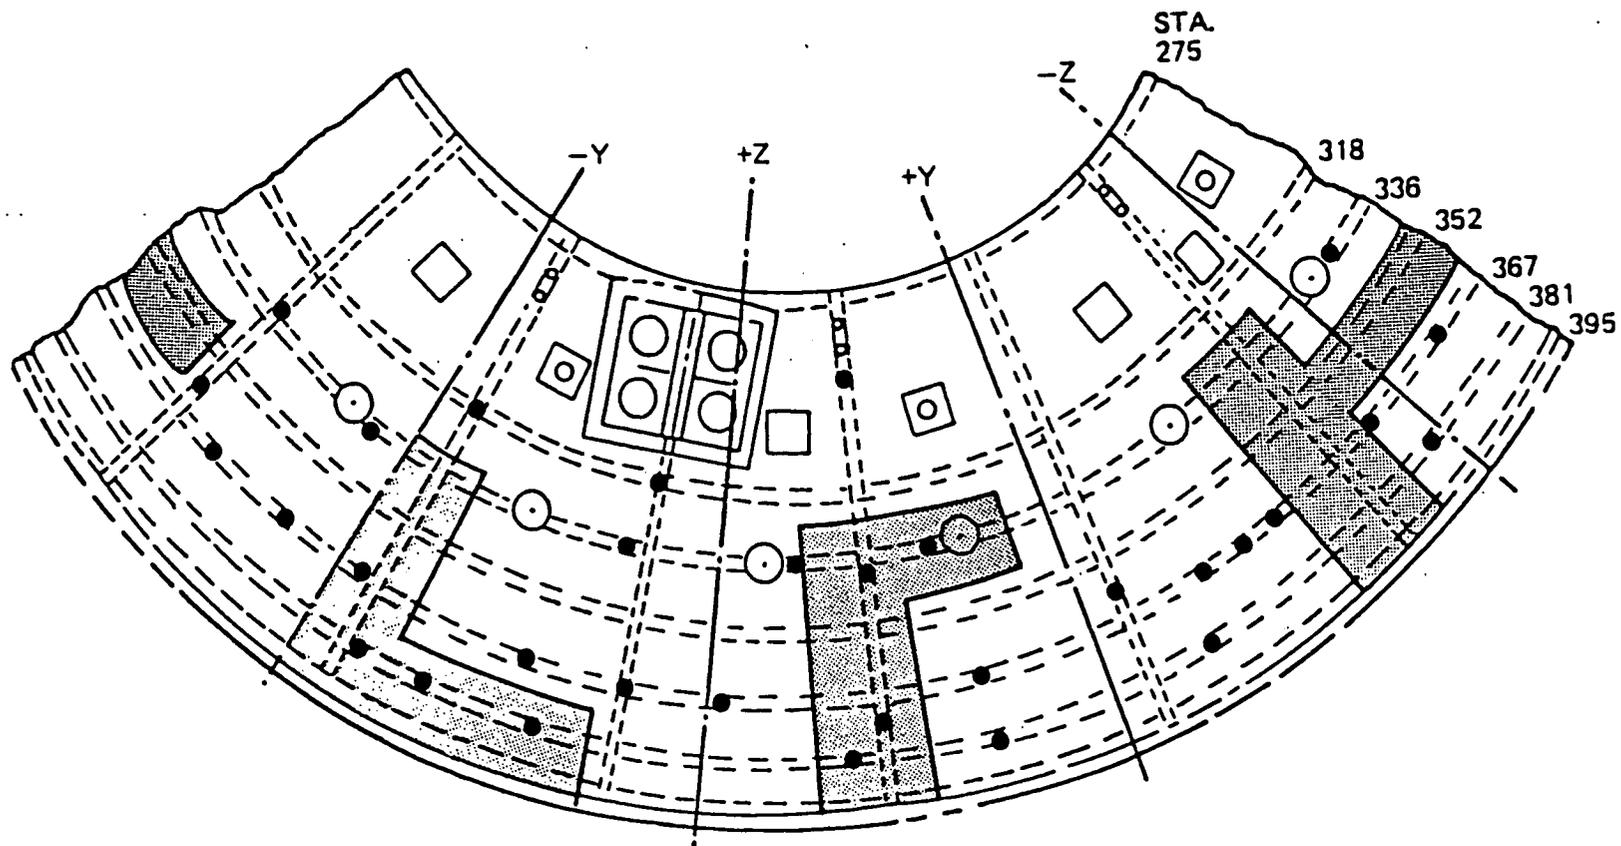
FIGURE 9. RIGHT SRB FRUSTUM

The nose cap was not recovered. The RH frustum was missing no areas of TPS but had 32 MSA-2 debonds over fasteners. There was minor blistering of the Hypalon paint (Figure 9). The BSM covers were locked in the open position, but the two RH covers were bent upward by parachute riser entanglement.

2 RIGHT BSM COVERS WERE IN  
THE LOCKED OPEN POSITION  
BUT WERE BENT UPWARD BY  
PARACHUTE RISER ENTANGLEMENT

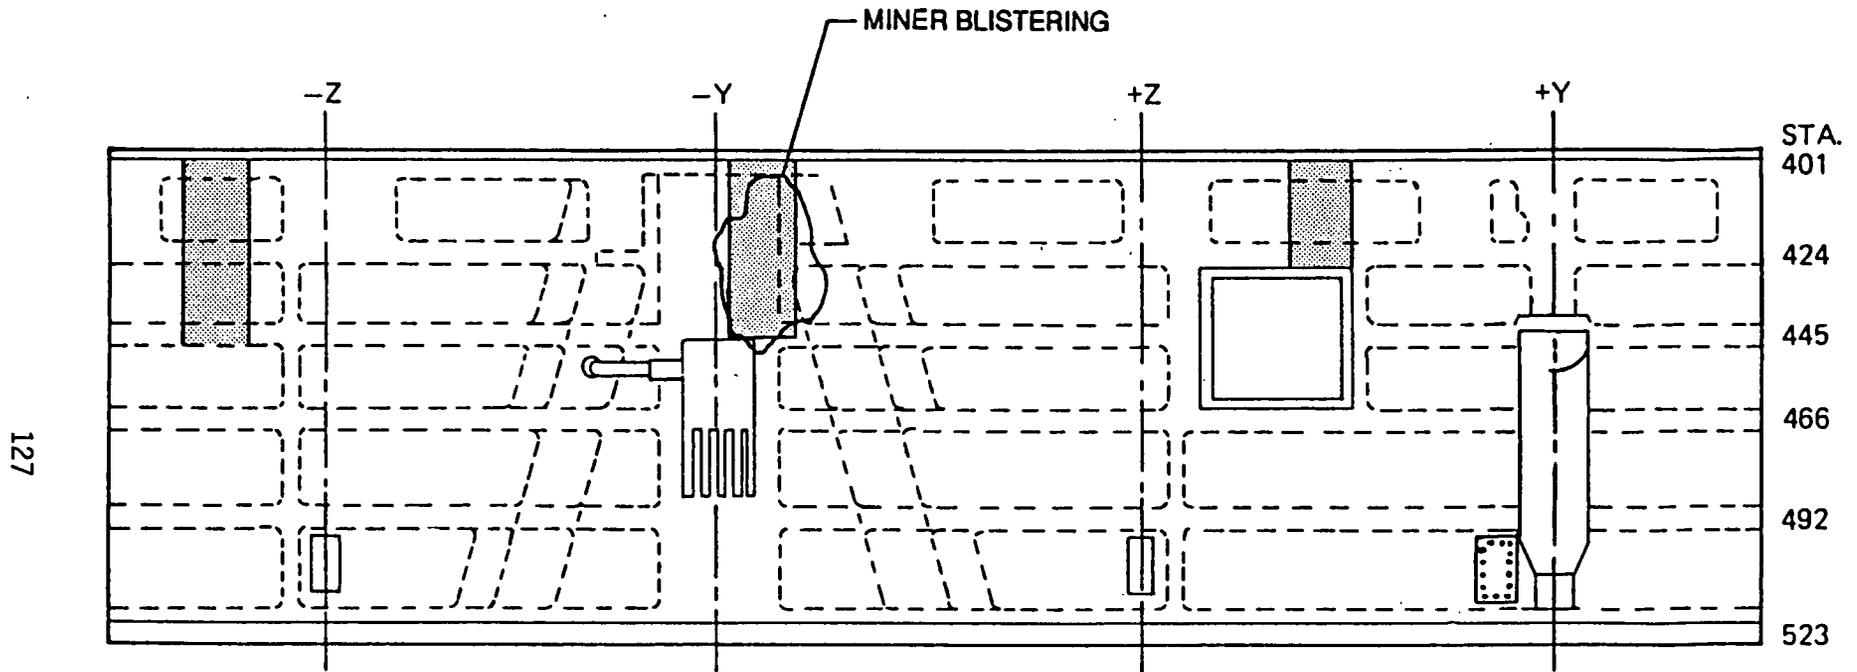
FIGURE 10. RIGHT SRB FWD SKIRT

The RH forward skirt exhibited no debonds or missing TPS. The phenolic plates on both RSS antennae were intact (Figure 10). The forward separation bolt and electrical cables appeared to have separated cleanly. No pins were missing from the frustum severance ring. Minor blistering of the Hypalon paint occurred forward of the ET/SRB attach point.

BLISTERING OF HYPALON  
PAINT WAS MINIMAL.  
RSS ANTENNA PHENOLIC  
PLATES WERE INTACT.

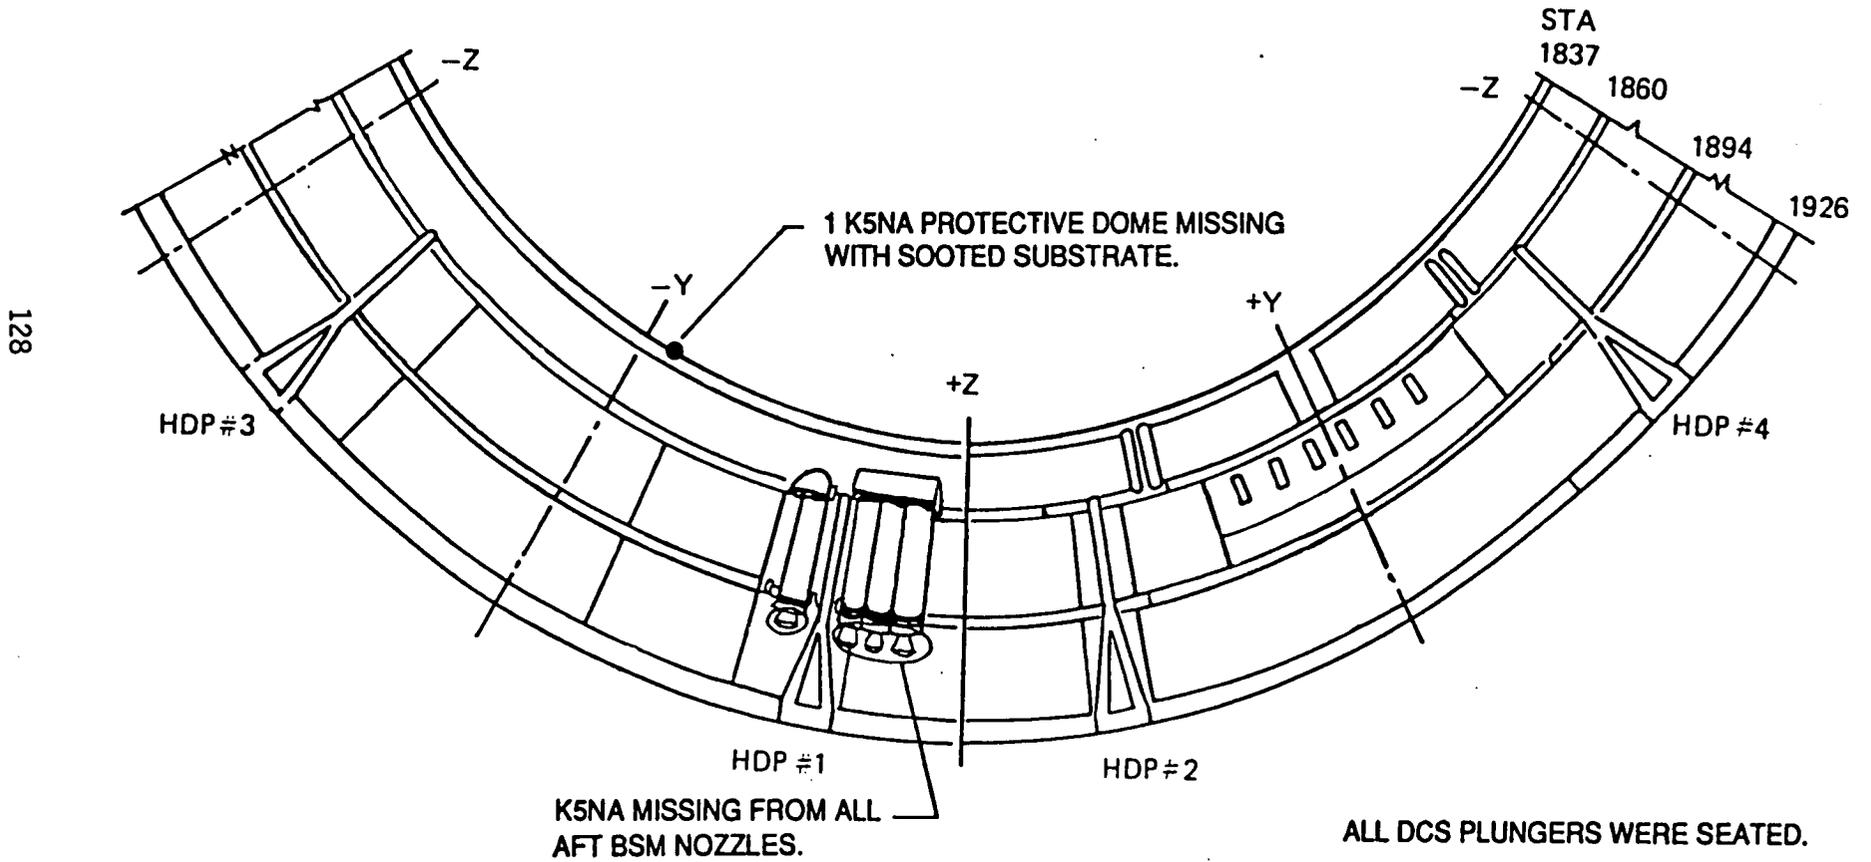
FIGURE 11. RIGHT SRB AFT SKIRT EXTERIOR TPS

The phenolic material on the kick ring delaminated in only a few locations. One of the K5NA protective domes was lost from a bolt head on the aft side of the phenolic kick ring prior to water impact since the substrate was sooted. The aft skirt TPS acreage was in good condition. K5NA was missing from all aft BSM nozzles (Figure 11).

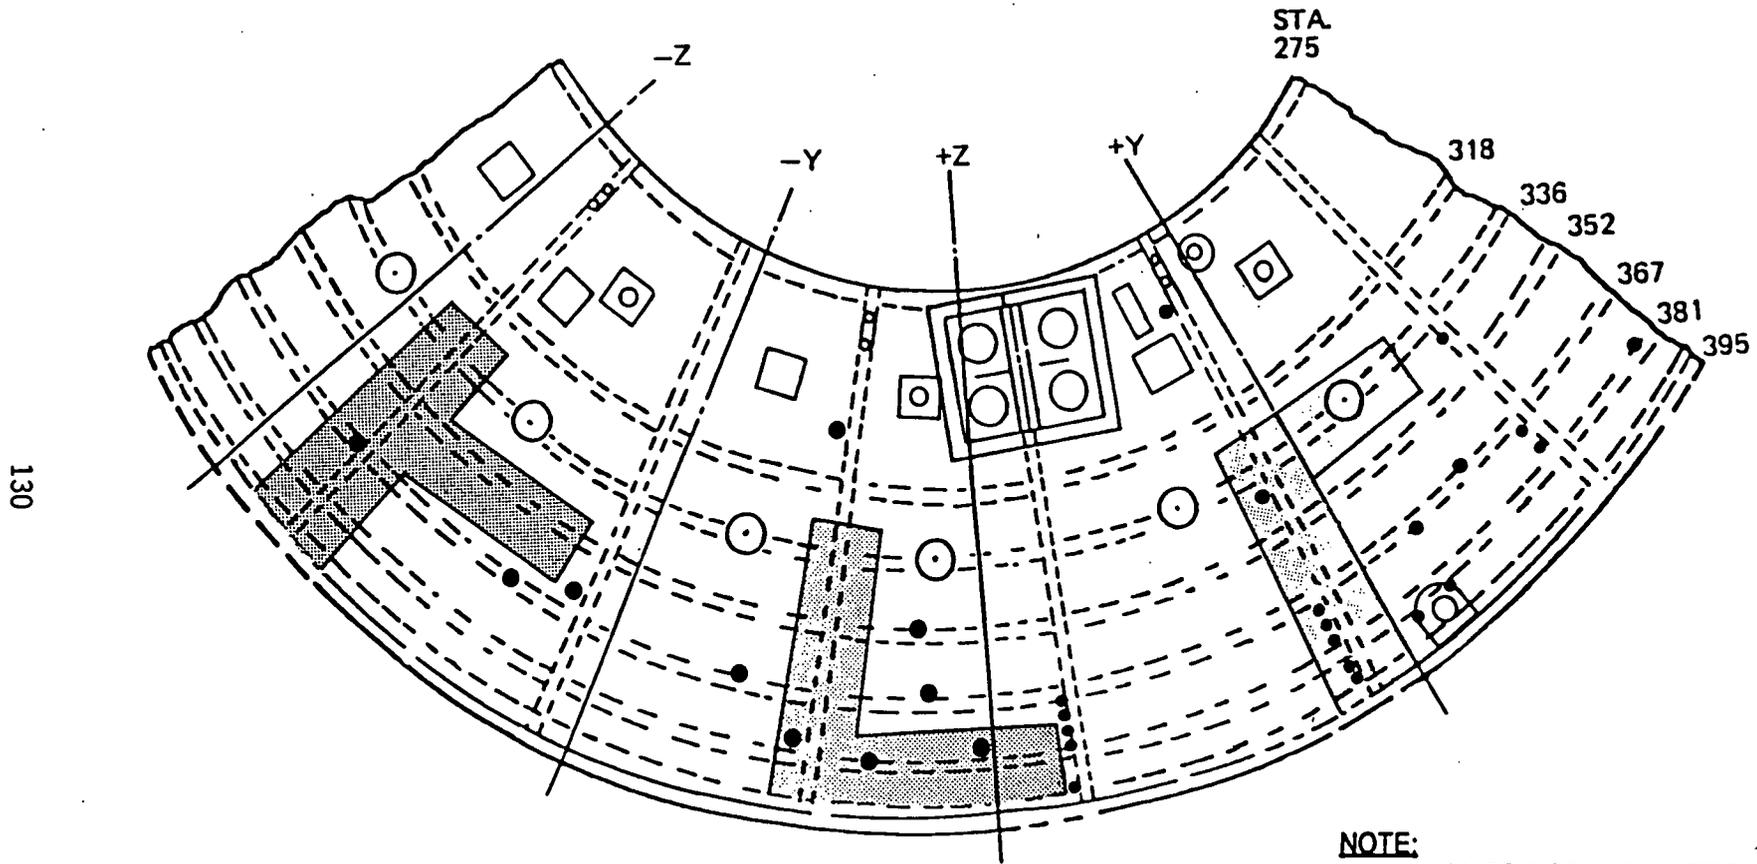
FIGURE 12. LEFT SRB FRUSTUM

The nose cap was not recovered. The LH frustum was missing no TPS but had 30 MSA-2 debonds over fasteners (Figure 12). Minor blistering of the Hypalon paint occurred at three locations. All BSM covers were locked in the fully opened position.

ALL BSM COVERS WERE  
LOCKED IN THE OPEN  
POSITION.  
BLISTERING OF HYPALON  
PAINT WAS MINIMAL.

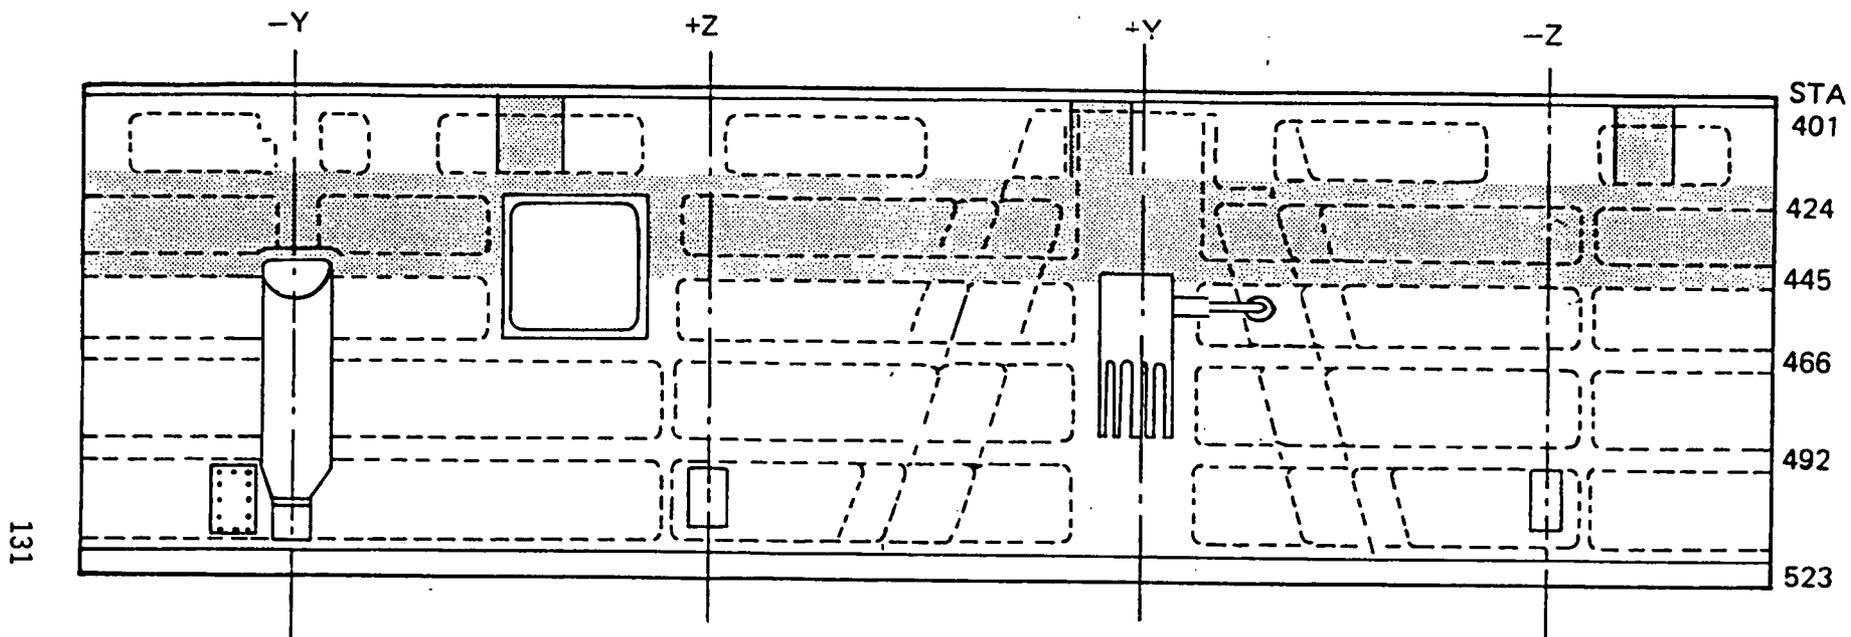
FIGURE 13. LEFT SRB FWD SKIRT

The LH forward skirt exhibited no debonds or missing TPS. The phenolic plates on both RSS antennae were intact (Figure 13). The forward separation bolt and electrical cables appeared to have separated cleanly. No pins were missing from the frustum severance ring. Minor blistering of the Hypalon paint occurred forward of the ET/SRB attach point.

BLISTERING OF HYPALON  
PAINT WAS MINIMAL.  
PHENOLIC PLATES ON RSS  
ANTENNAE WERE INTACT.

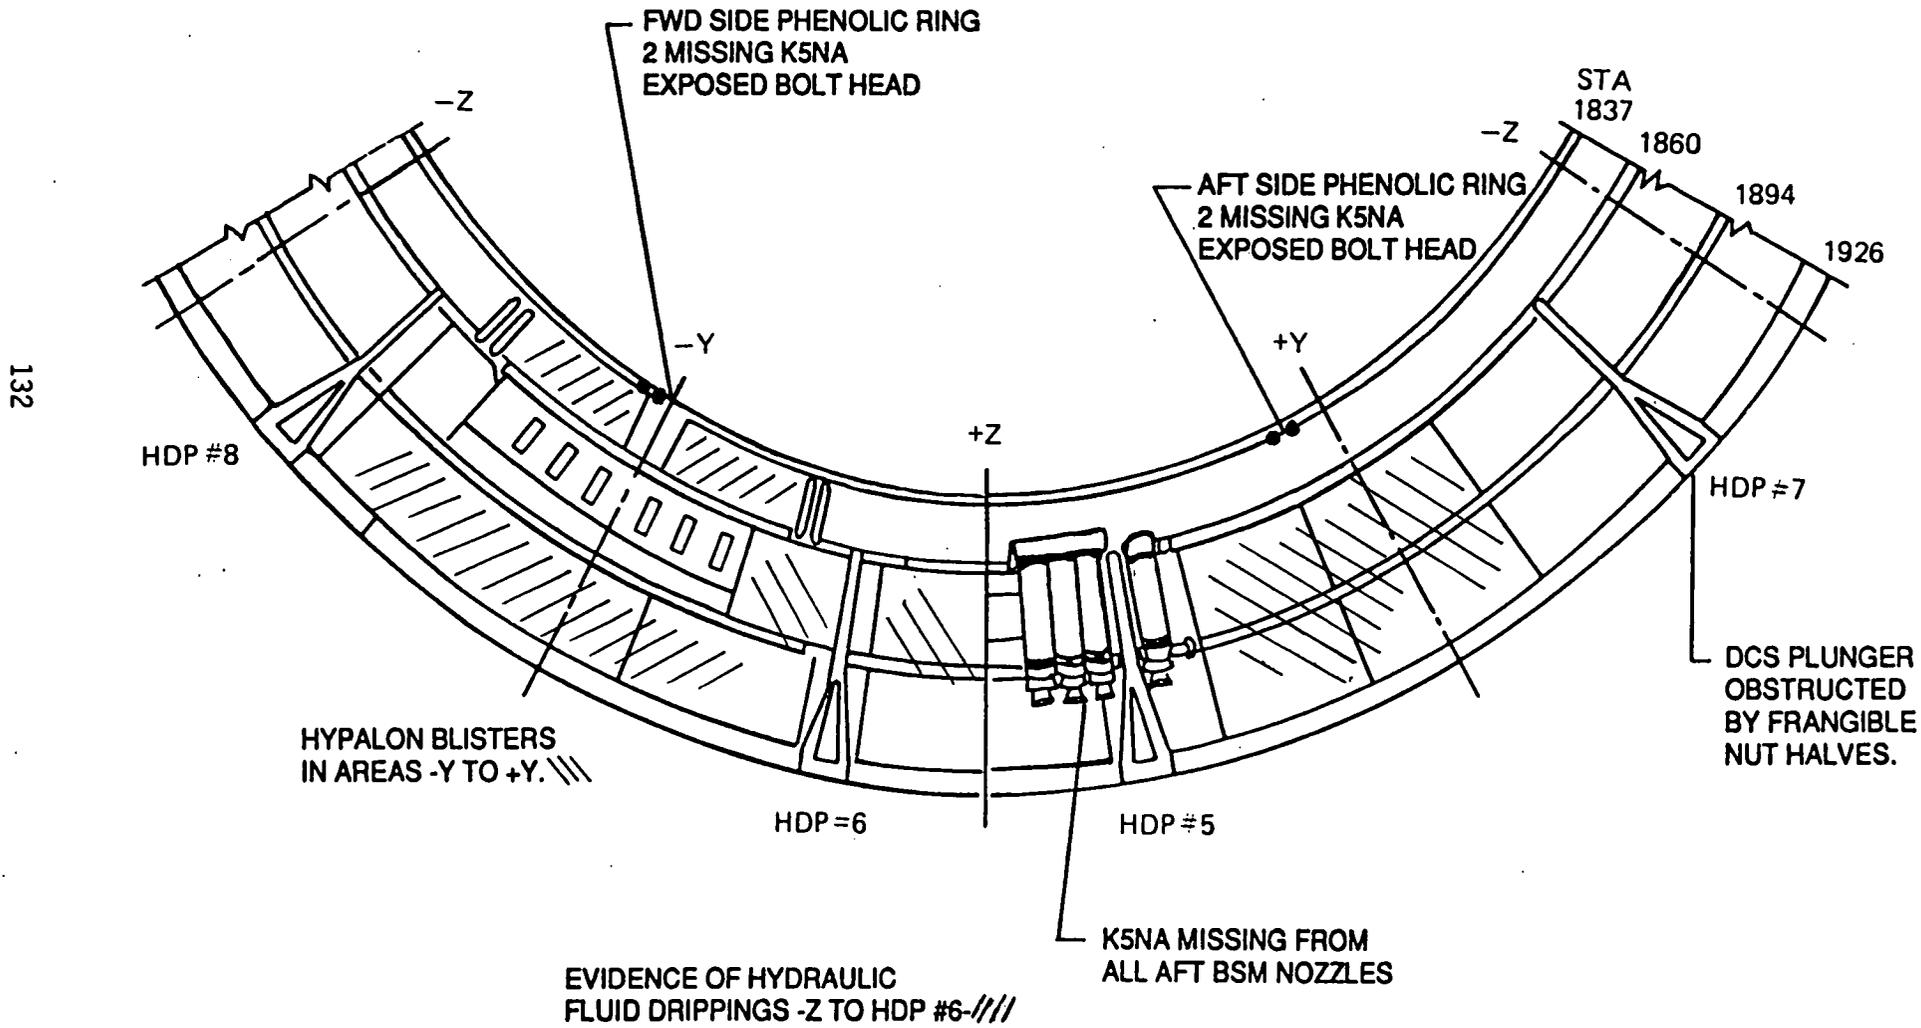
FIGURE 14. LEFT SRB AFT SKIRT EXTERIOR TPS

The phenolic material on the kick ring delaminated in only a few locations. Some K5NA protective domes were lost from bolt heads on the aft side of the phenolic kick ring prior to water impact. The aft skirt TPS acreage was in good condition. K5NA was missing from all aft BSM nozzles (Figure 14).

The HDP Debris Containment System (DCS) plungers were seated with the exception of HDP #7, which was obstructed by frangible nut halves. EPON shim material was missing from the aft skirt after water impact, but none of the substrate was charred.

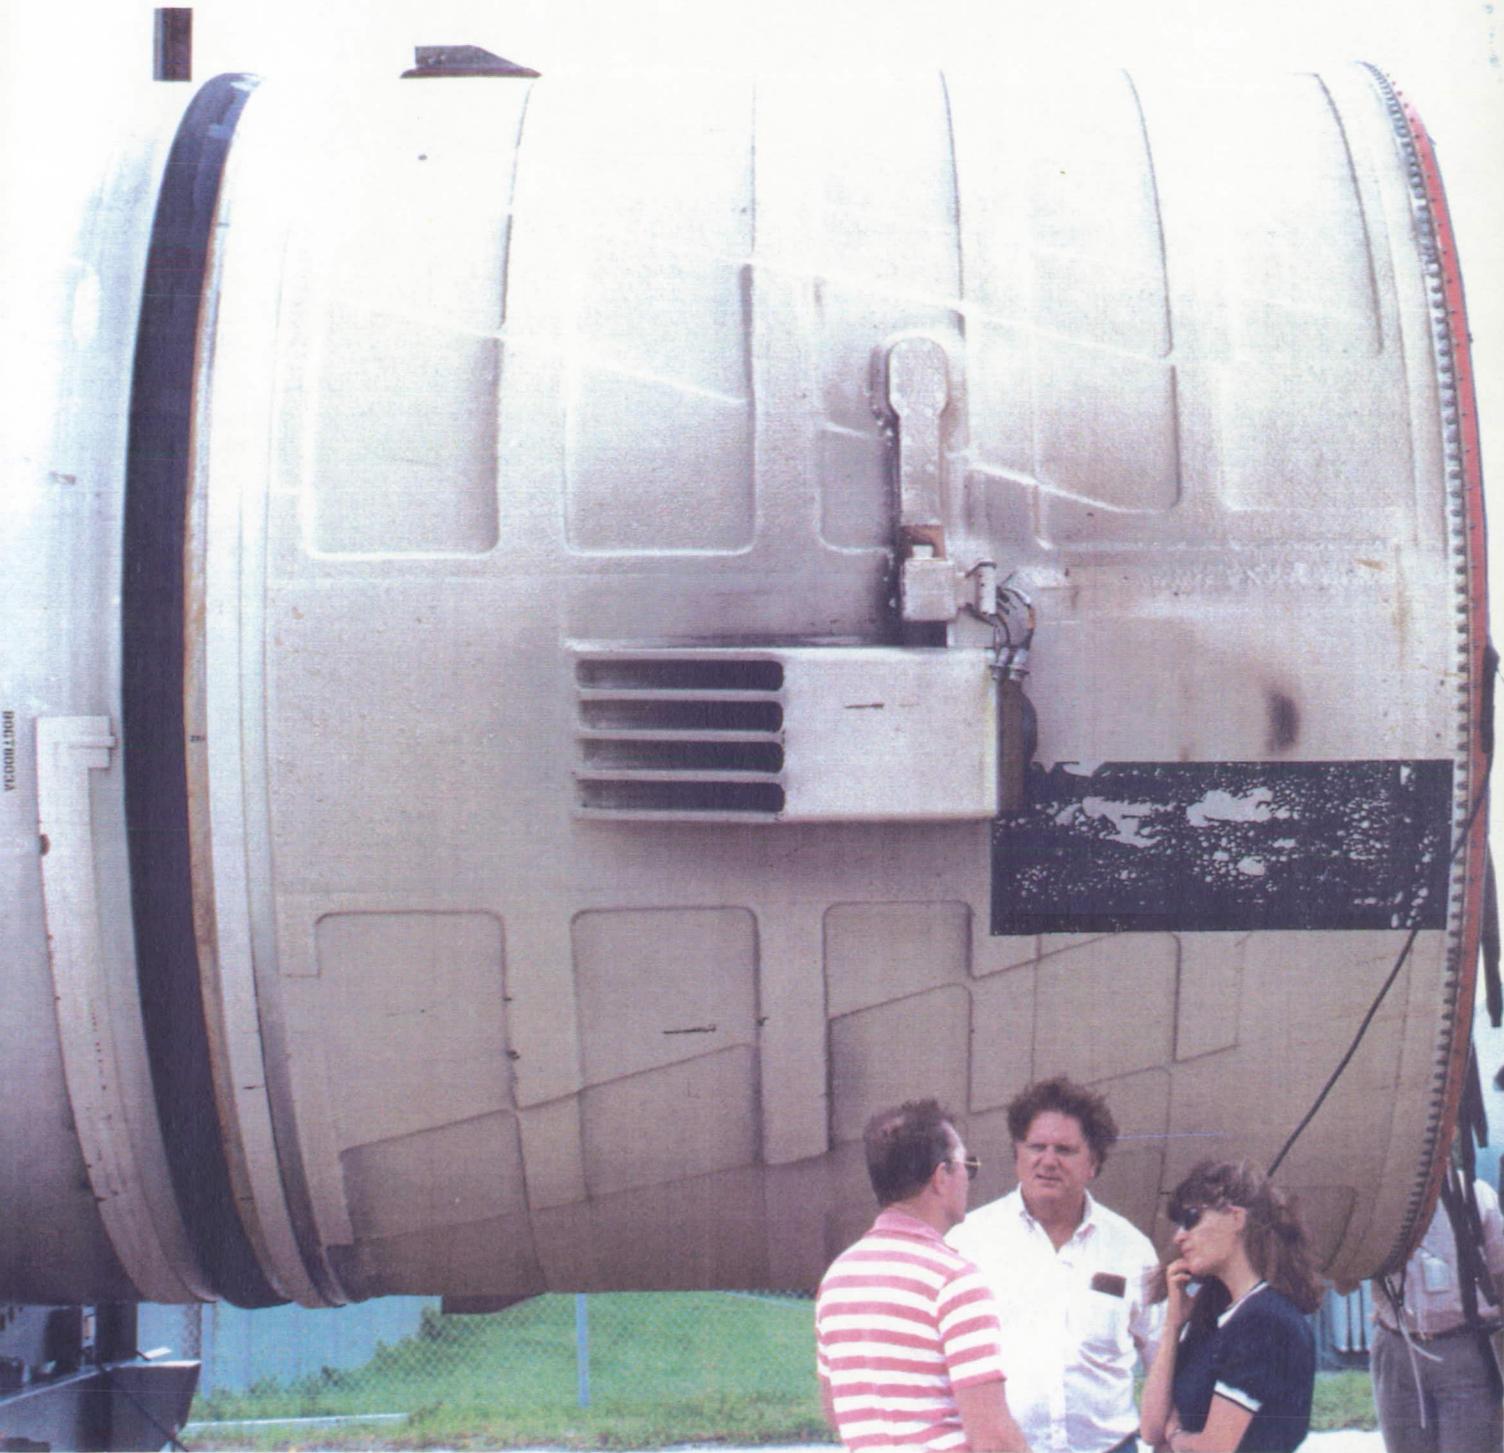
The BSM covers were locked in the open position, but two covers were bent upward by parachute riser entanglement.

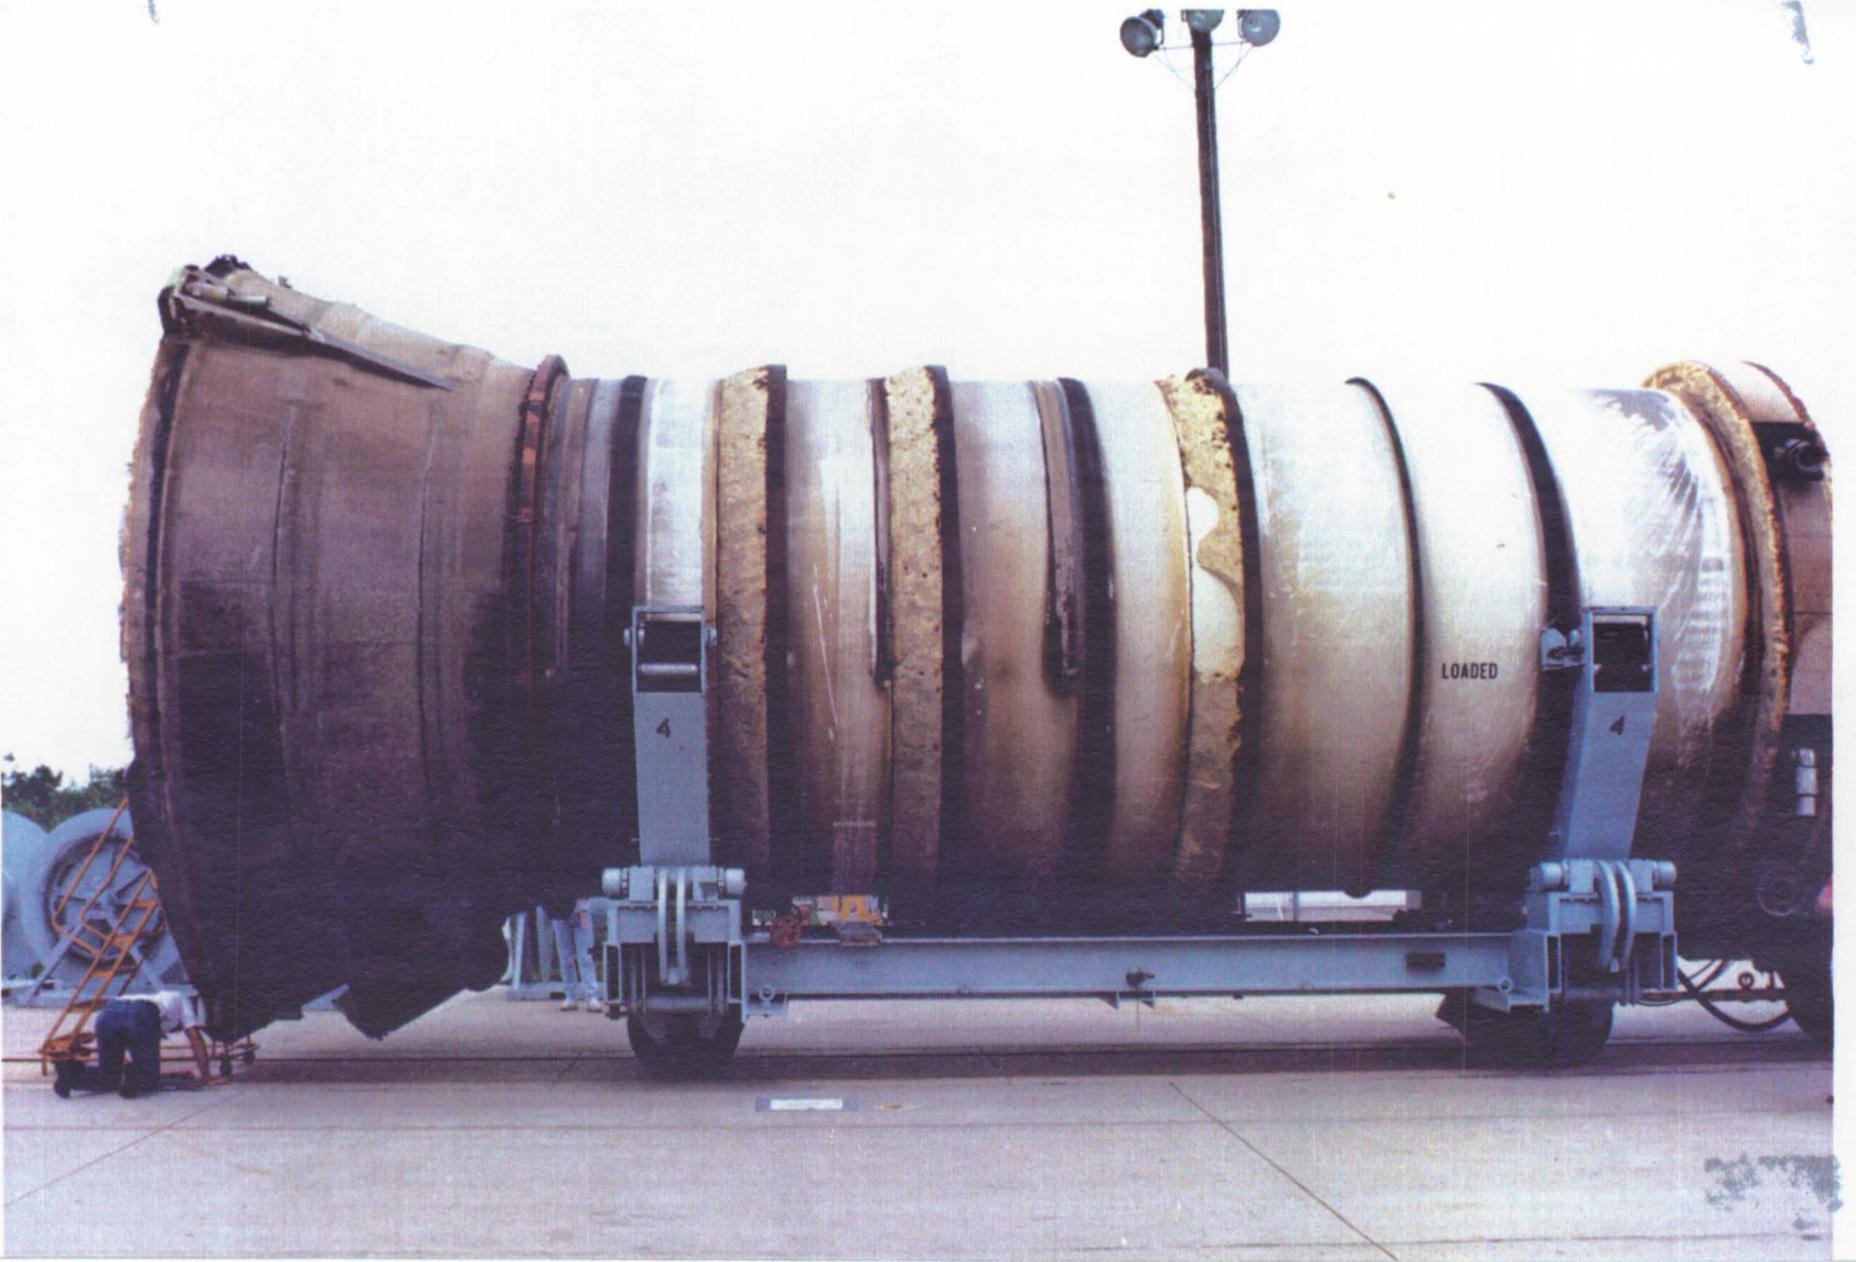
Overall view of the RH SRM segment cases. The field joint protection system closeouts were generally in good condition.

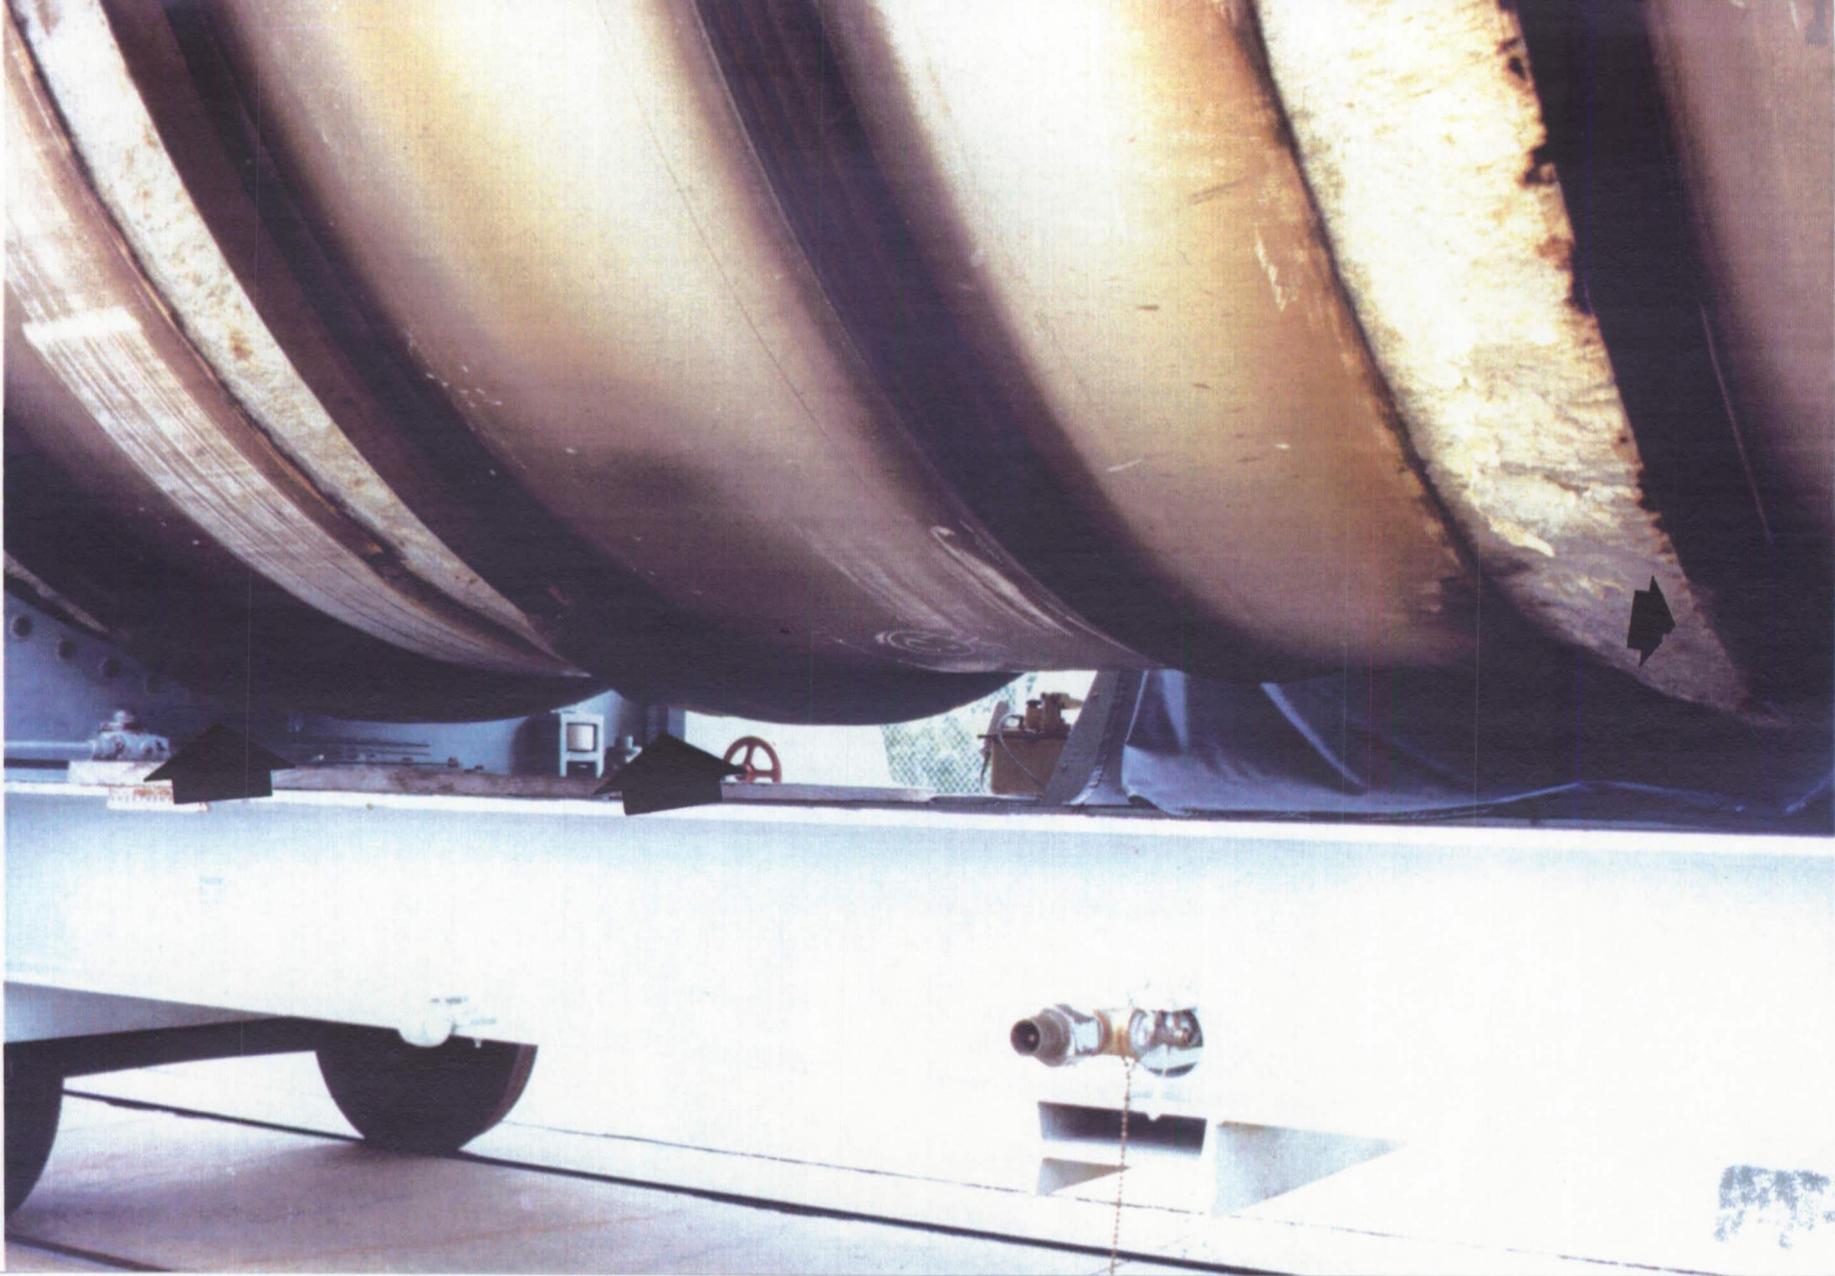
Post flight condition of the RH aft booster and aft skirt

The RH aft booster stiffener ring splice plate closeouts were intact and no K5NA material was missing

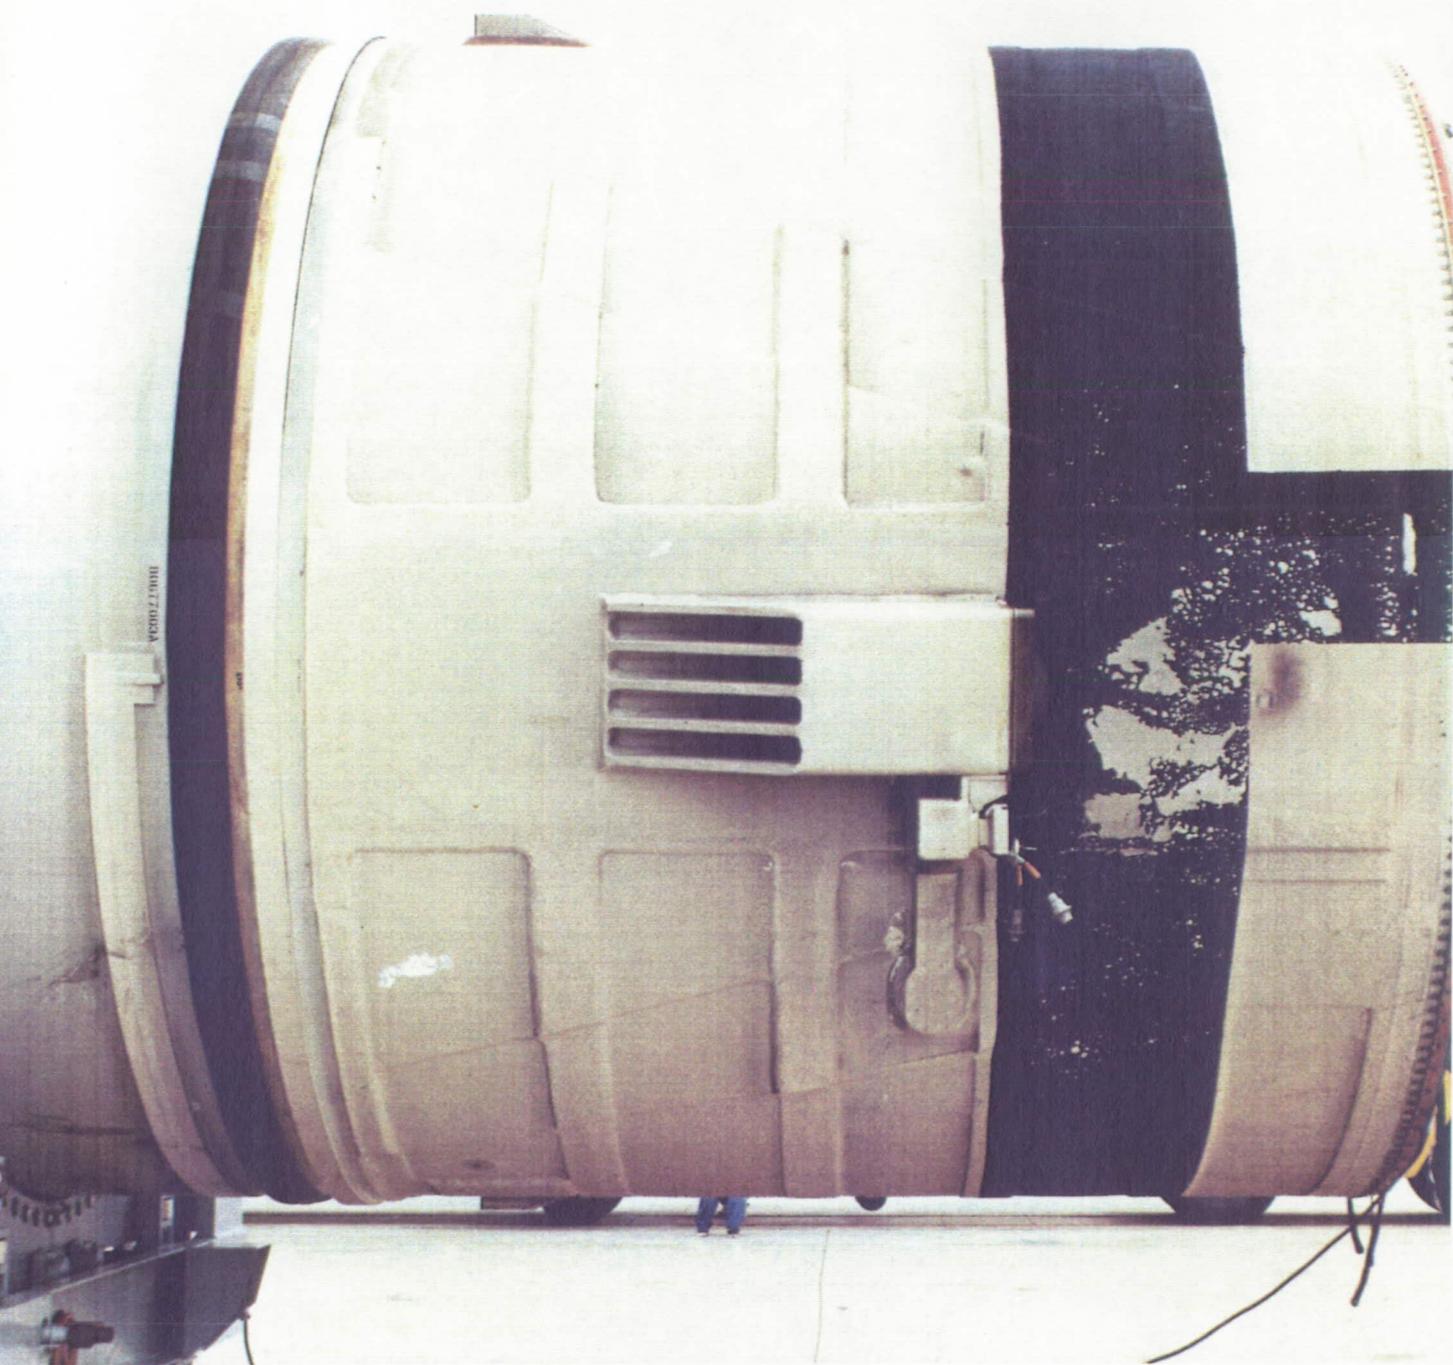
The LH frustum was not missing any TPS but had 30 MSA-2 debonds over fasteners
