# Debris/Ice/TPS Assessment And Photographic Analysis For Shuttle Mission STS-40

DEBRIS/ICE/TPS ASSESSMENT  
AND  
PHOTOGRAPHIC ANALYSIS  
OF  
SHUTTLE MISSION STS-40

June 5, 1991.

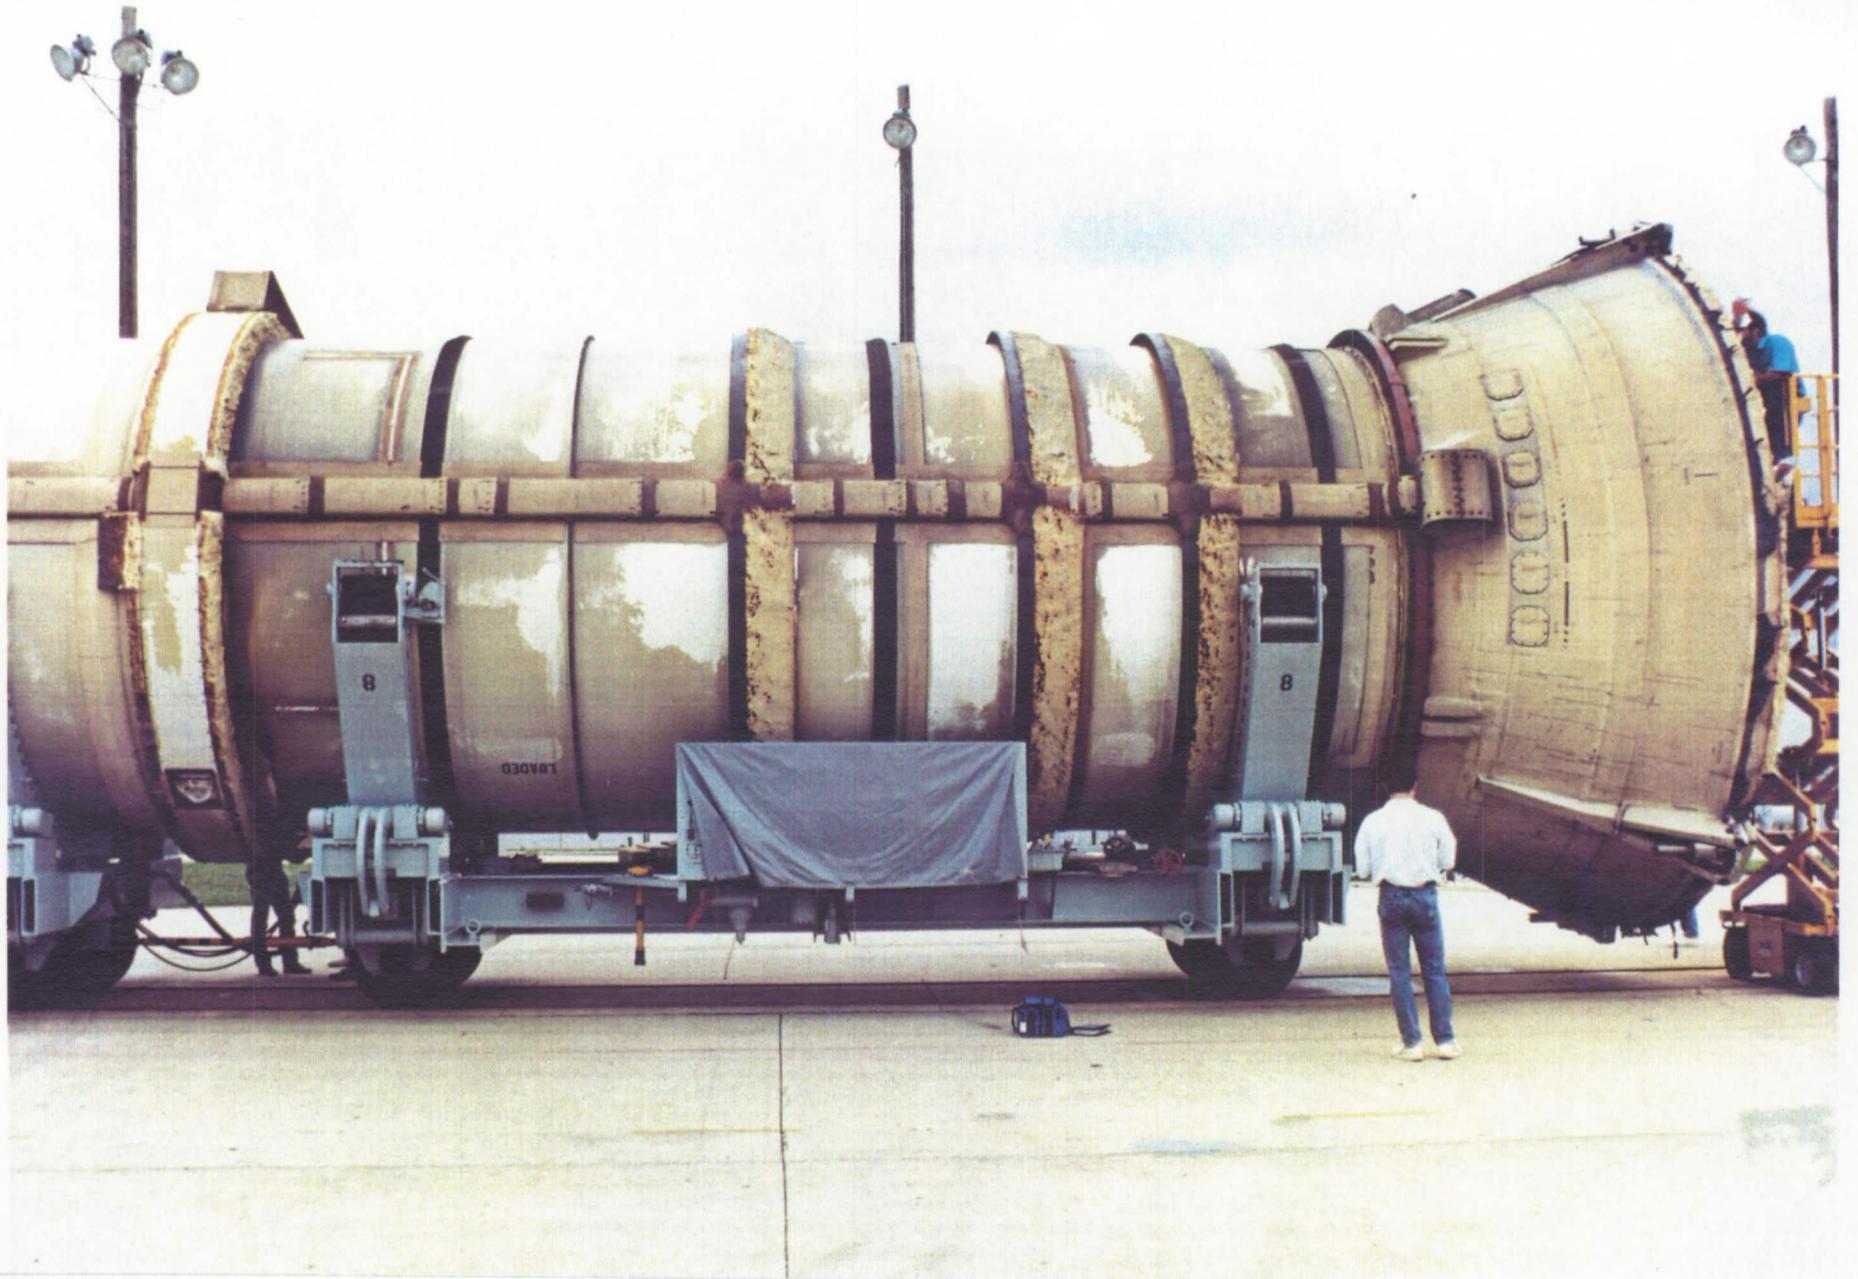
Overall view of the LH SRM segment cases. The field joint protection system closeouts were generally in good condition.

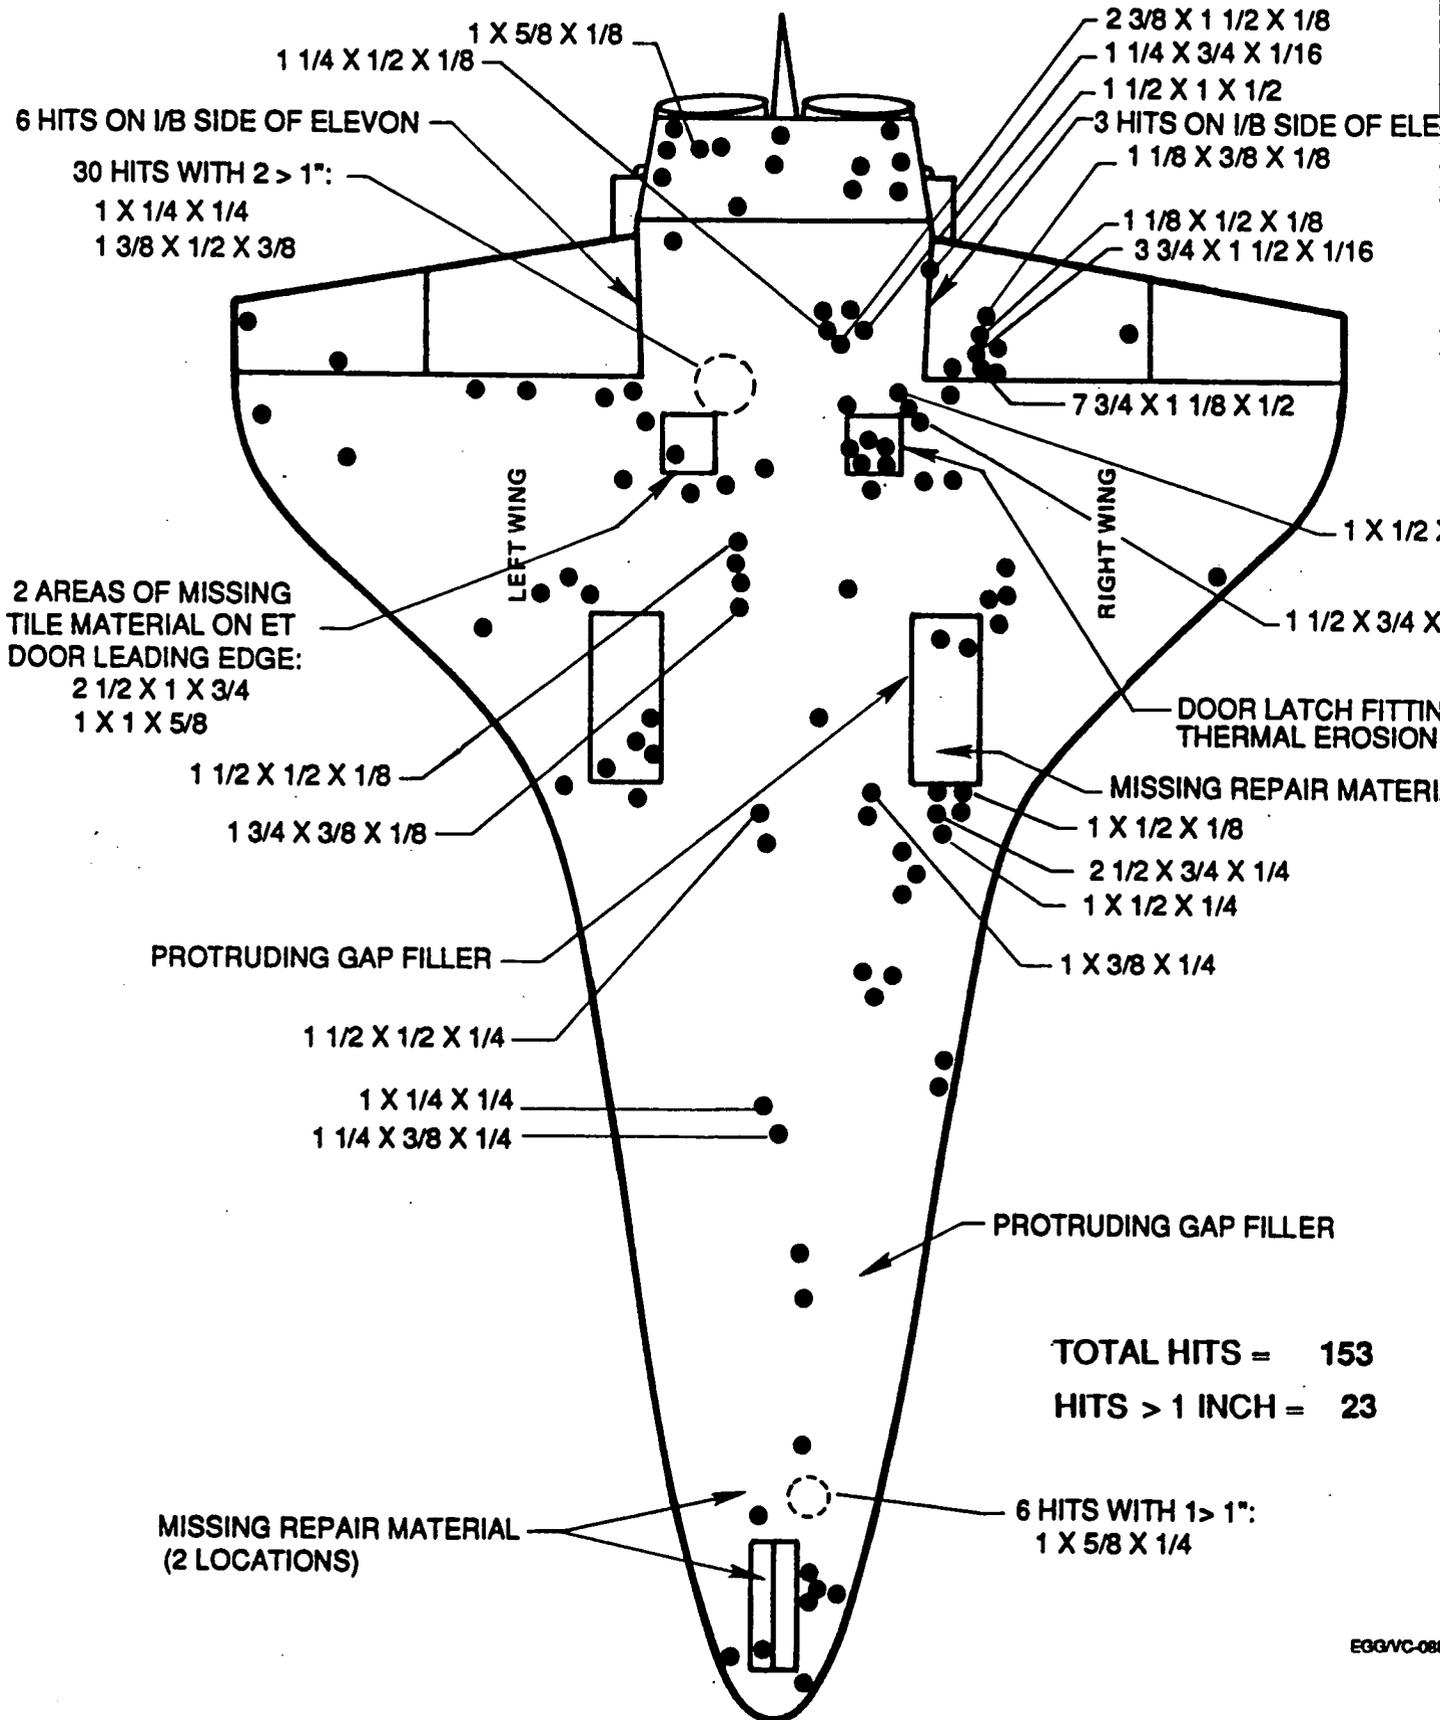
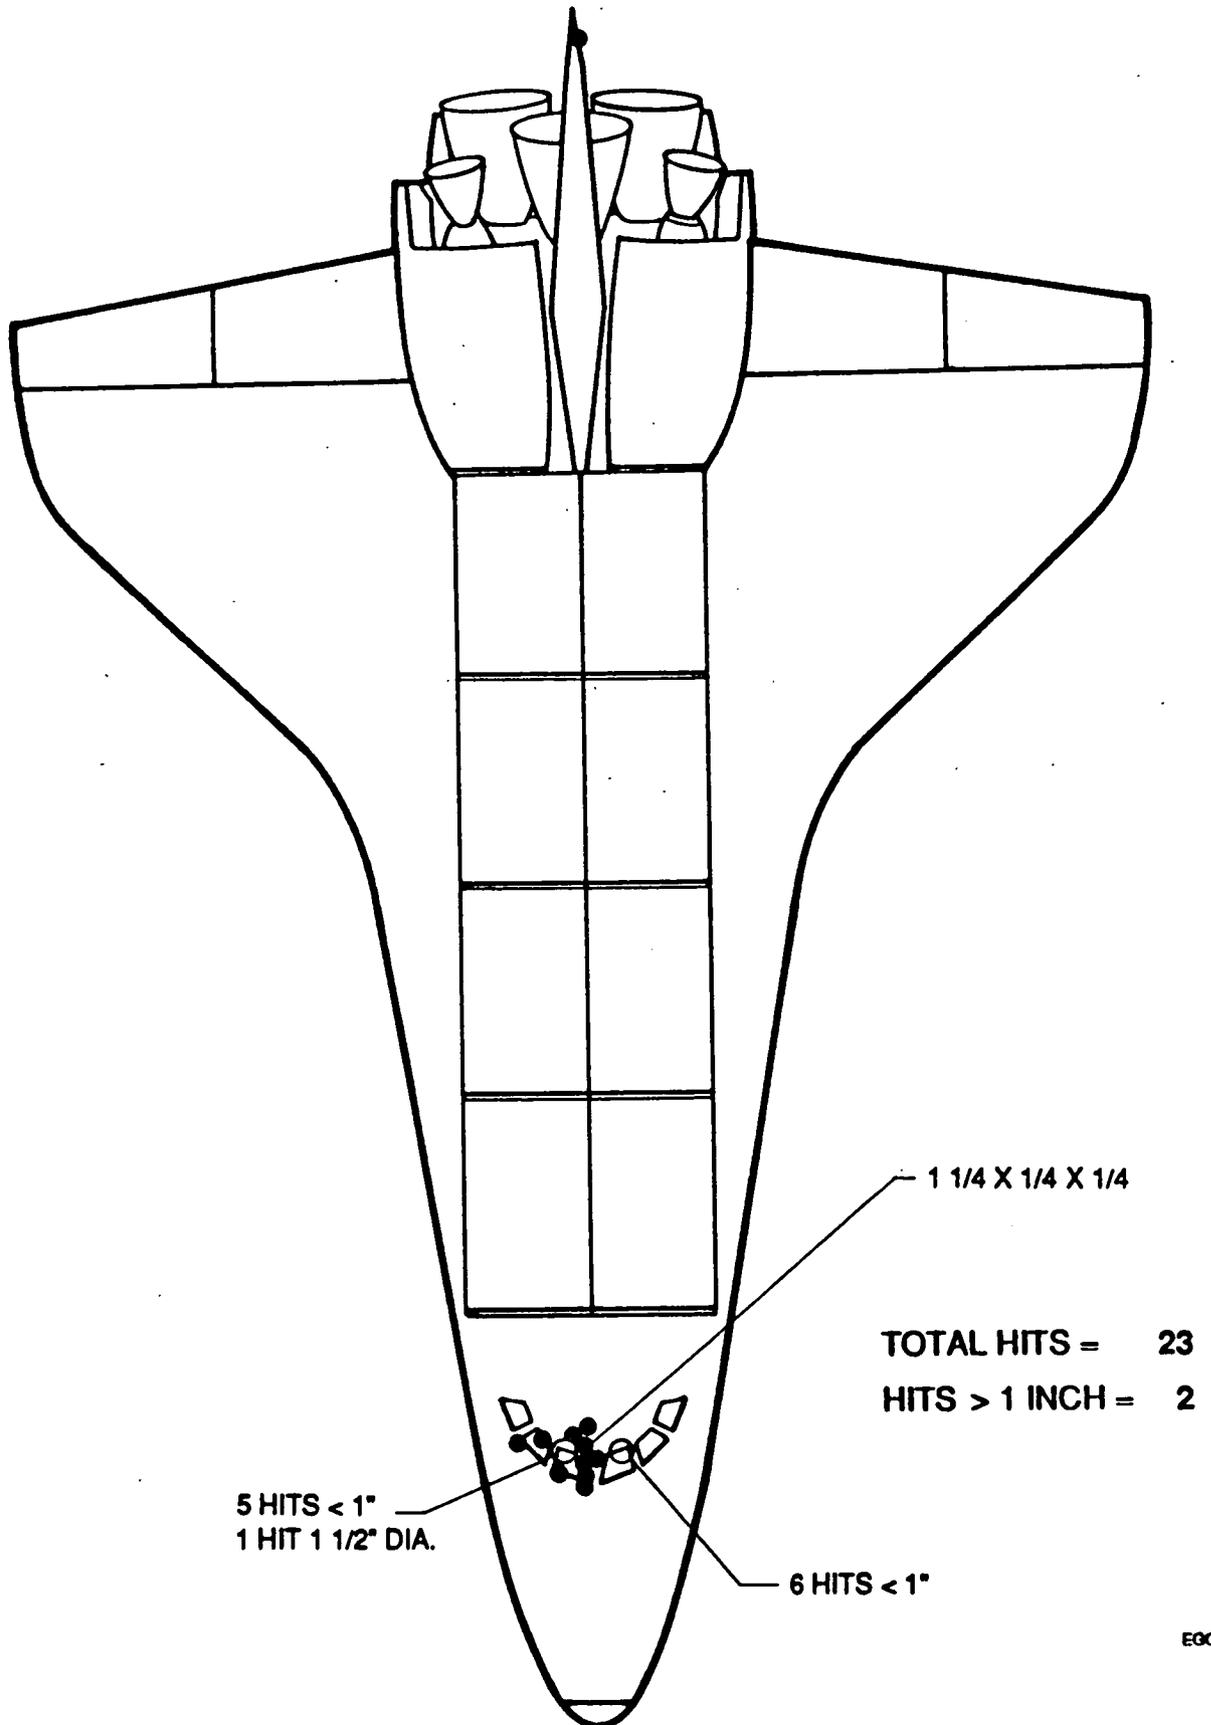
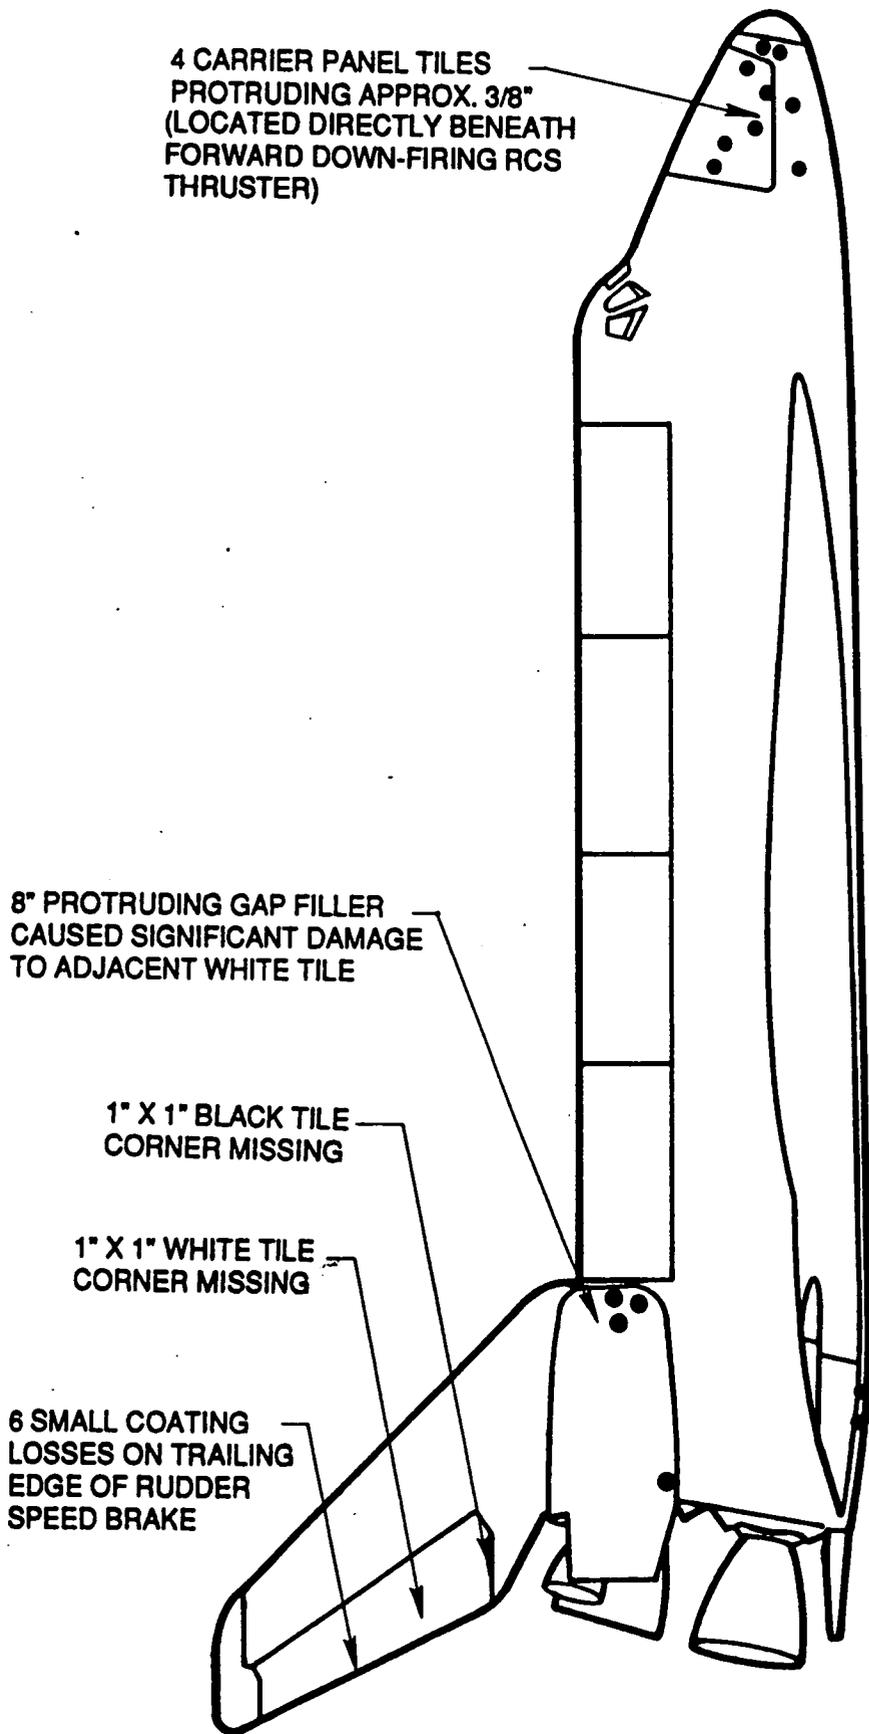
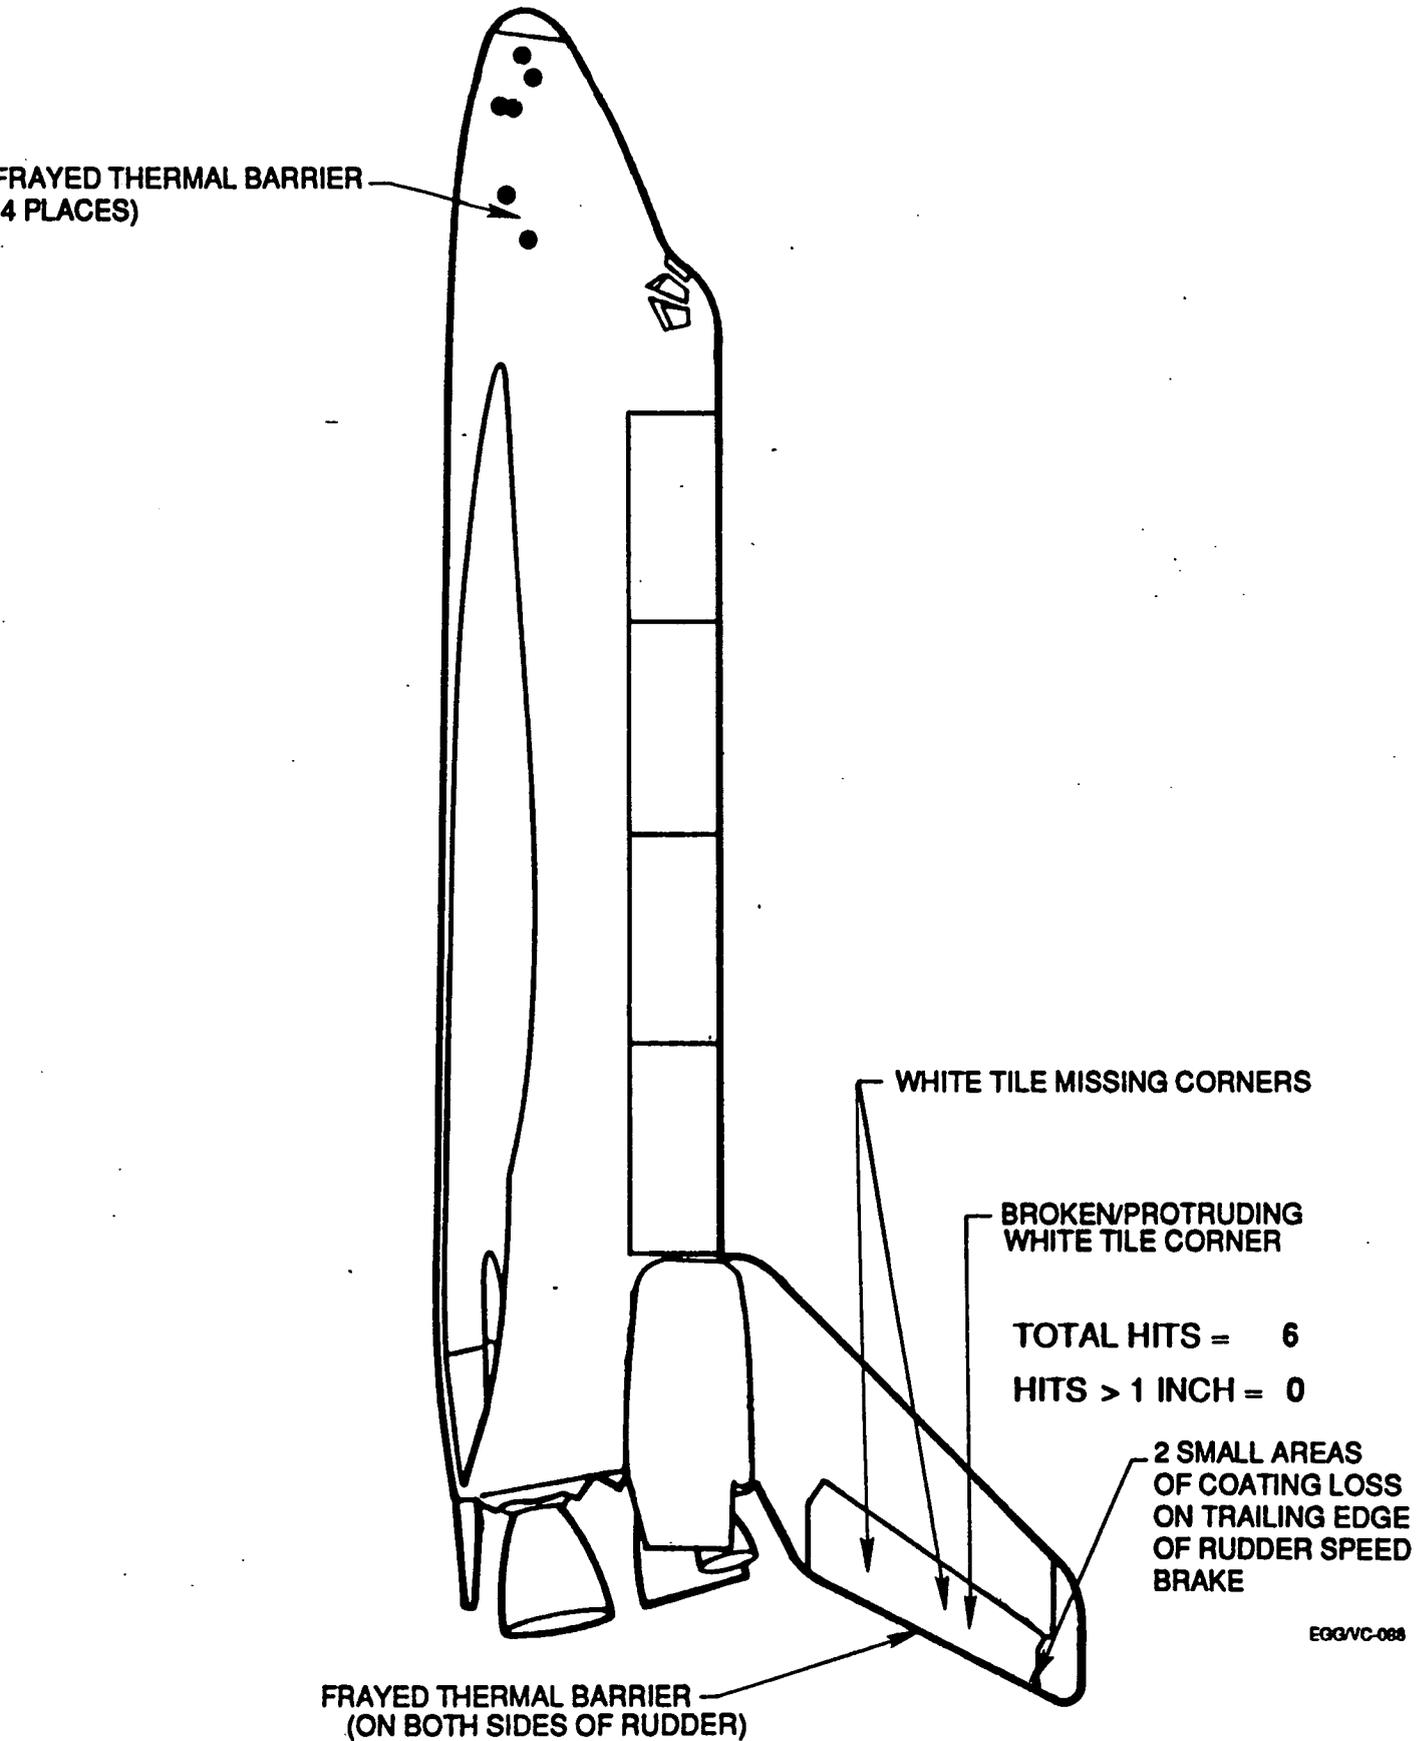
# FIGURE 15. STS-40 DEBRIS DAMAGE LOCATIONS

The Orbiter lower surface had a total of 153 hits of which 23 had a major dimension of one inch or greater. A comparison of these numbers to statistics from 27 previous missions of similar configuration (excluding missions STS-24, 25, 26, 26R, 27R, and 30R which had damage from known debris sources), indicates both the total number of hits and the number of hits with a major dimension of 1 inch or larger on the lower surface was greater than average. Figures 15-18 show the TPS debris damage assessment for STS-40. Figure 19 indicates the sites where samples were taken for laboratory chemical analysis.

TOTAL HITS = 15  
HITS > 1 INCH = 0

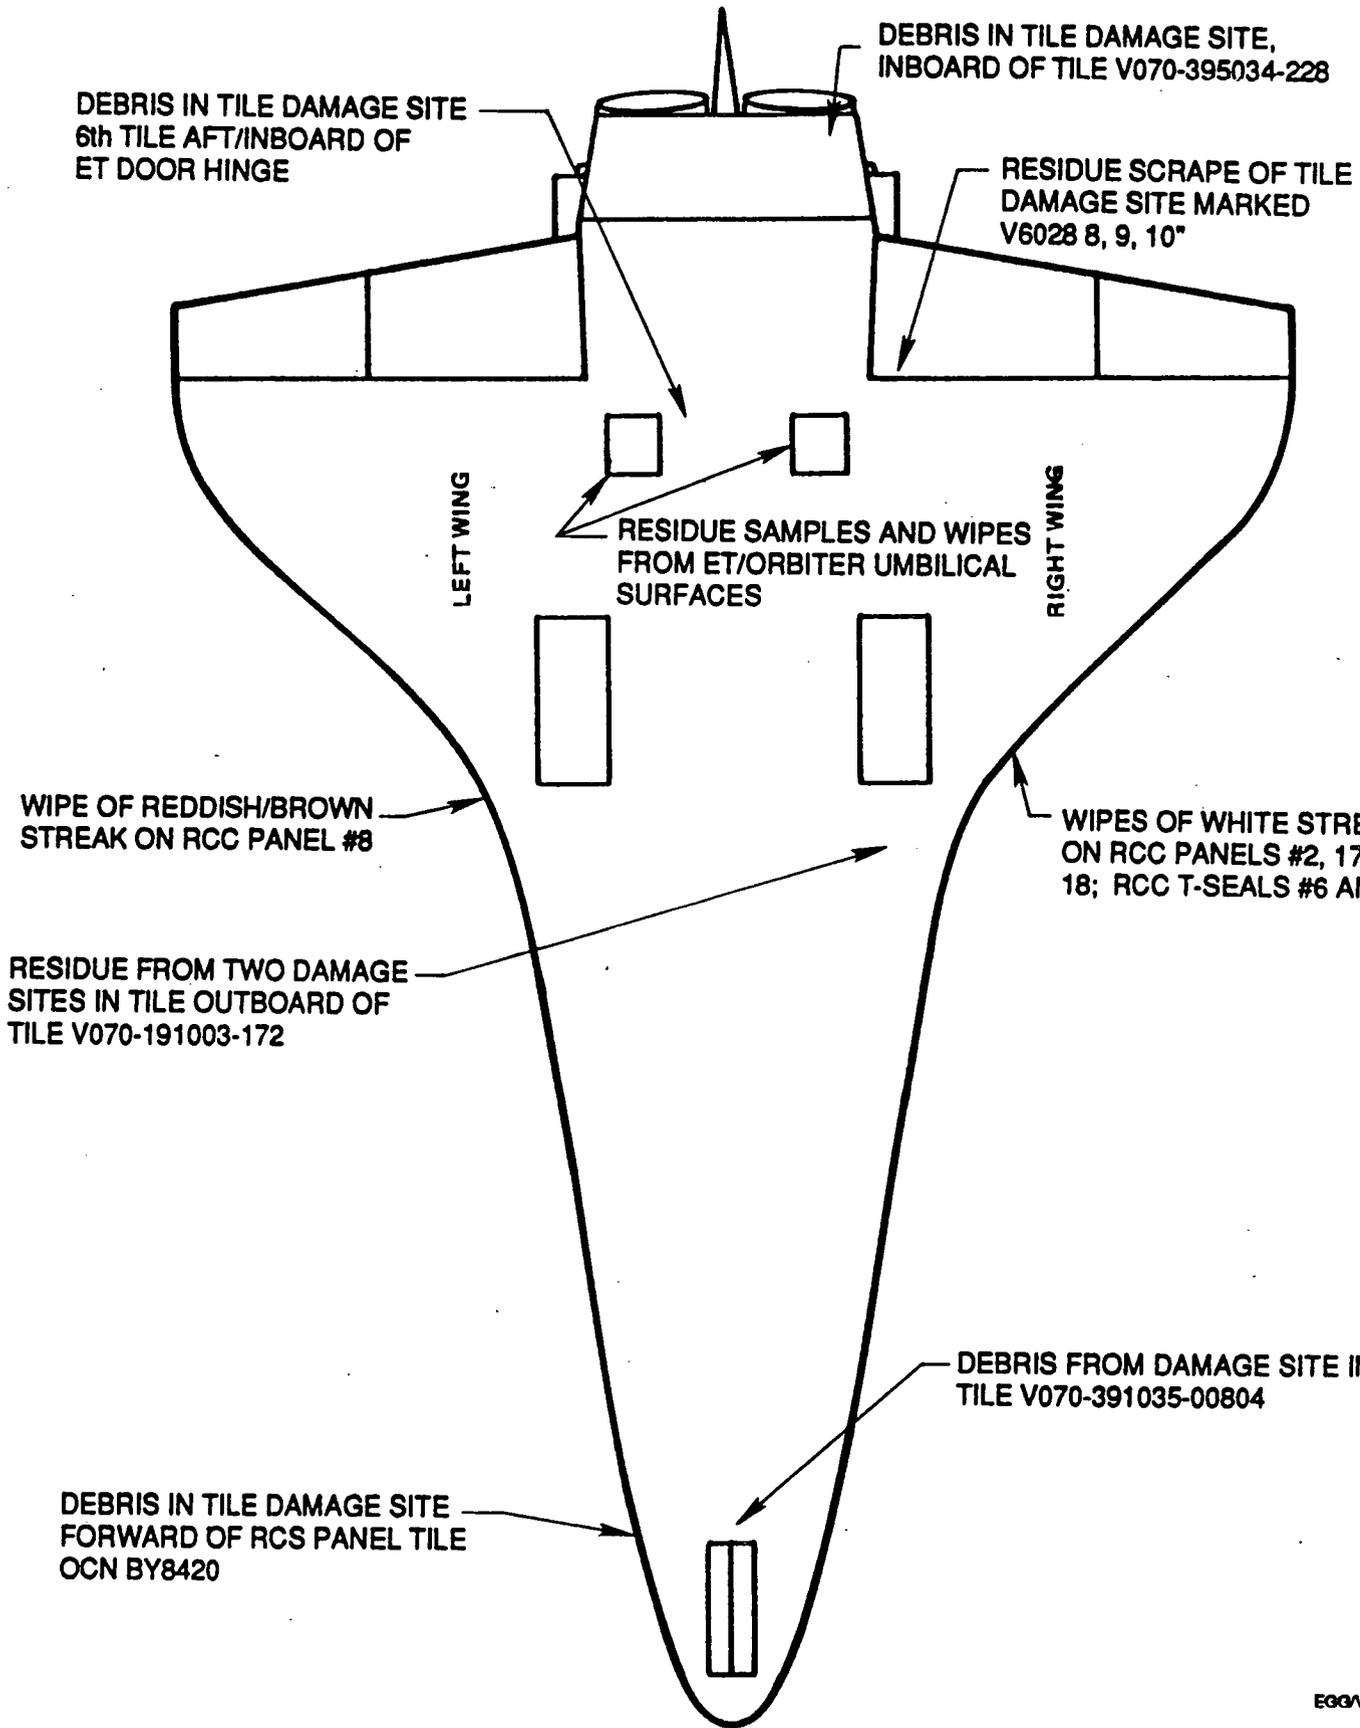
# FIGURE 19. STS-40 CHEMICAL SAMPLE LOCATIONS

White streaks were present on the RH wing leading edge RCC panels #2, 17, and 18; and T-seals #6 and 11. A reddish-brown streak was present on the LH wing leading edge RCC panel #8. Samples of selected streaks were taken for laboratory analysis (Figure 19).

A total of 24 samples were obtained from Orbiter OV-102 during the STS-40 post landing debris assessment at Ames-Dryden Flight Research Facility (ADFRF), California (Figure 19). The 24 submitted samples consisted of 8 Orbiter window wipes (W 1-8), 6 wing leading edge RCC samples (5RH, 1LH), 7 tile residue samples, and 3 ET-ORB umbilical wipes (1LH2, 2LO2). The samples were analyzed by the NASA KSC Microchemical Analysis Branch (MAB) for material composition and comparison to known STS materials. The specific elemental analysis is shown in the appended MAB report. Debris analysis involves the placing and correlating of particles with respect to composition, thermal (mission) effects, and availability. Debris sample results and analyses are listed by Orbiter location in the following summaries.

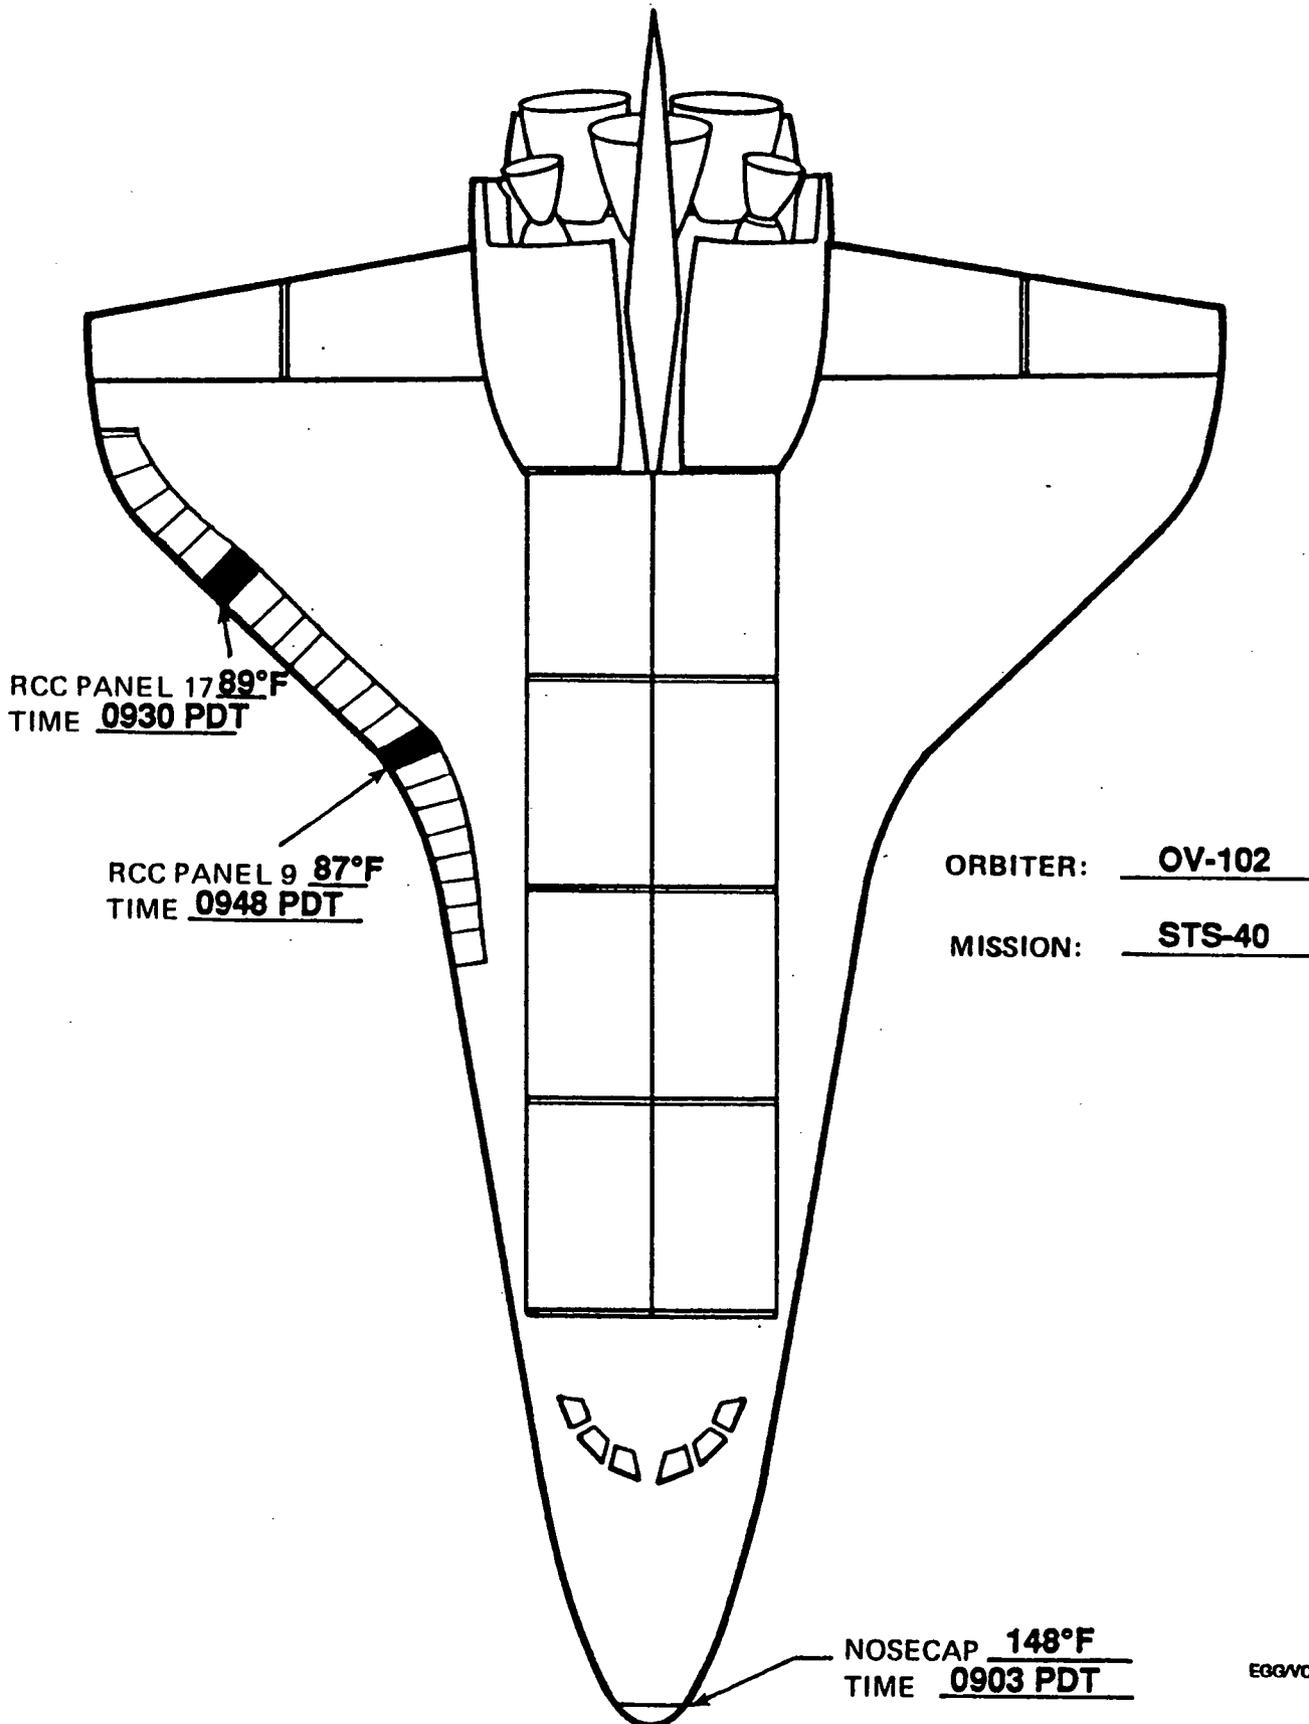
FIGURE 20. **STS-40 RCC TEMPERATURE MEASUREMENTS AS  
RECORDED BY THE SHUTTLE THERMAL IMAGER  
TEMPERATURE MEASUREMENTS**

The KSC Shuttle Thermal Imager (STI) was used to measure the surface temperatures of several areas. Twenty-four minutes after landing, the Orbiter nose cap RCC was 148 degrees F. The RH wing leading edge RCC panel #9 was 87 degrees F sixty-nine minutes after landing. Fifty-one minutes after landing the RH wing panel #17 was 89 degrees F (Figure 20).

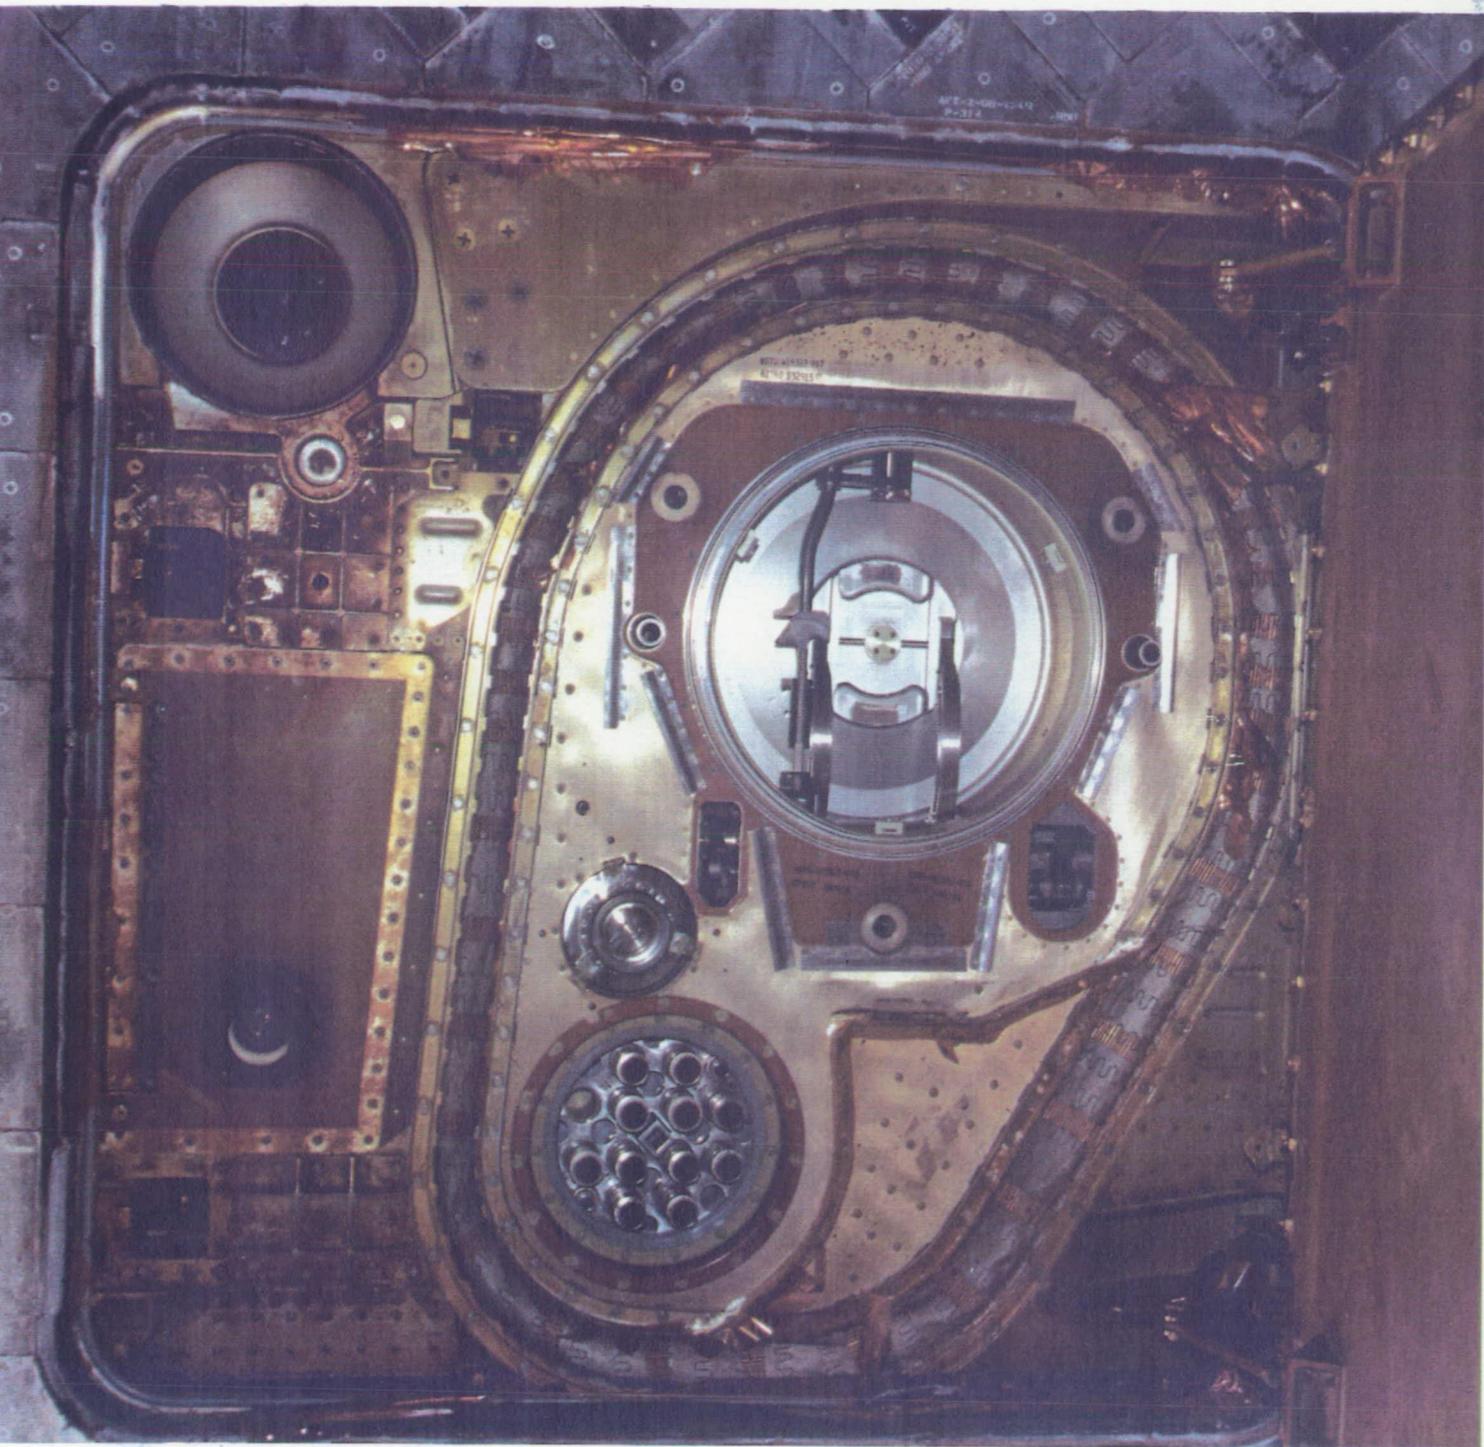
The RH ET/Orbiter (LO2) umbilical door centerline forward outboard latch fitting and adjacent tile sustained hot gas intrusion and exhibited significant melting/erosion due to the lack of or degradation of the RTV seal.
