METEOROID AND DEBRIS IMPACT FEATURES DOCUMENTED ON THE LONG DURATION EXPOSURE FACILITY

A Preliminary Report

Compiled by Members
of the LDEF Meteoroid
and Debris Special
Investigation Group

August 1990

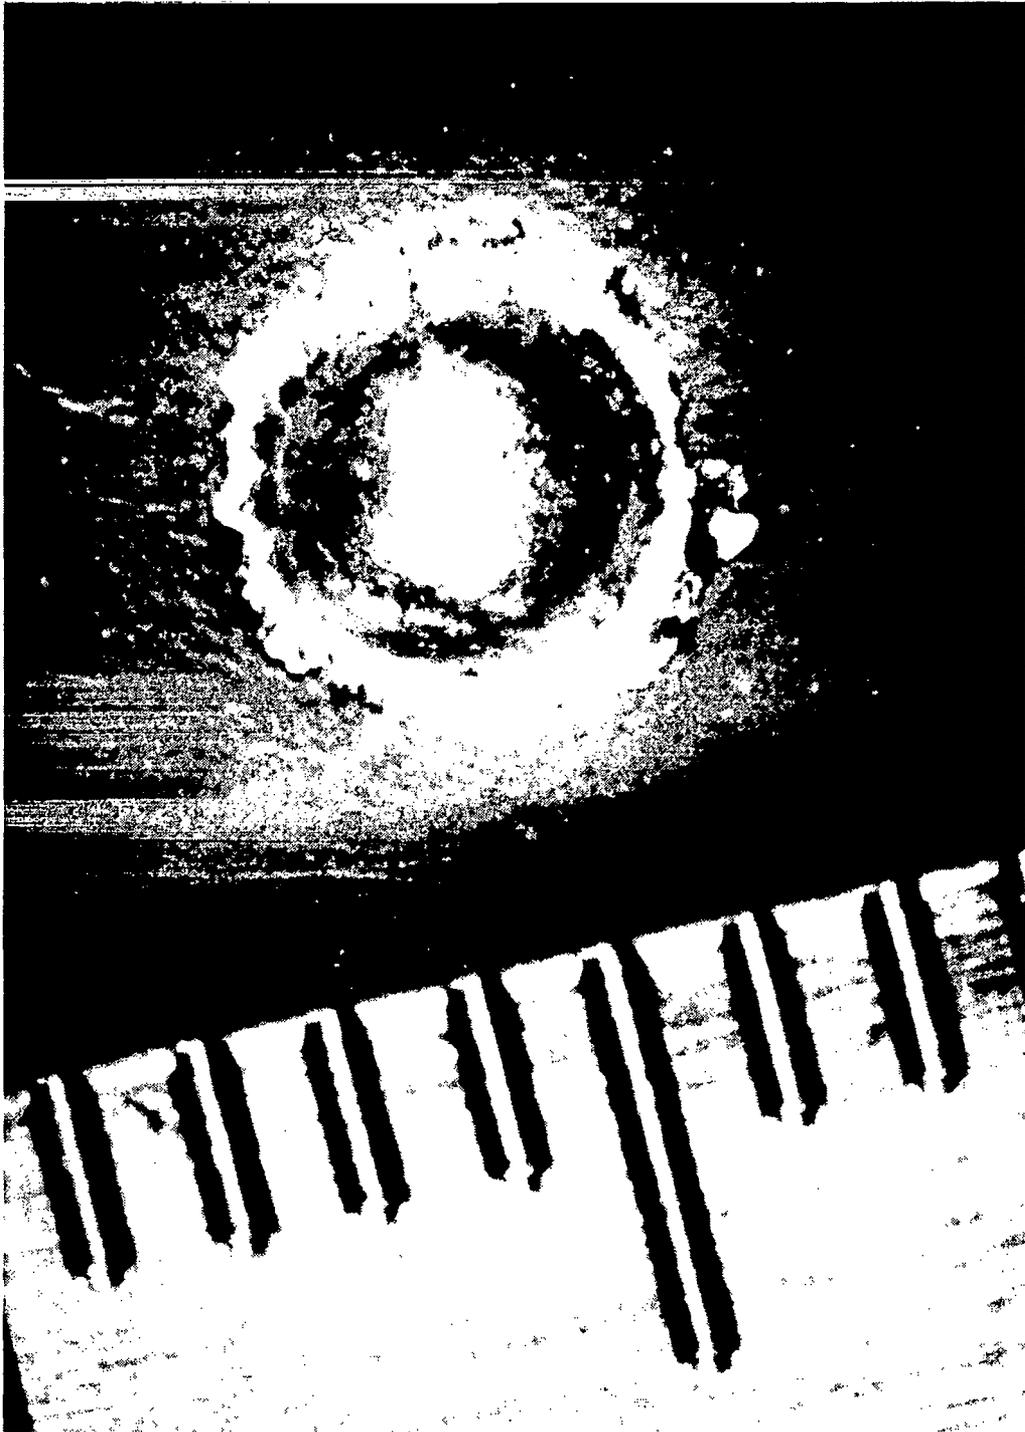
Figure 2. Photograph of a symmetrically-shaped crater in an aluminum surface. Most features on LDEF were of this type. Small divisions on scale are in millimeters.

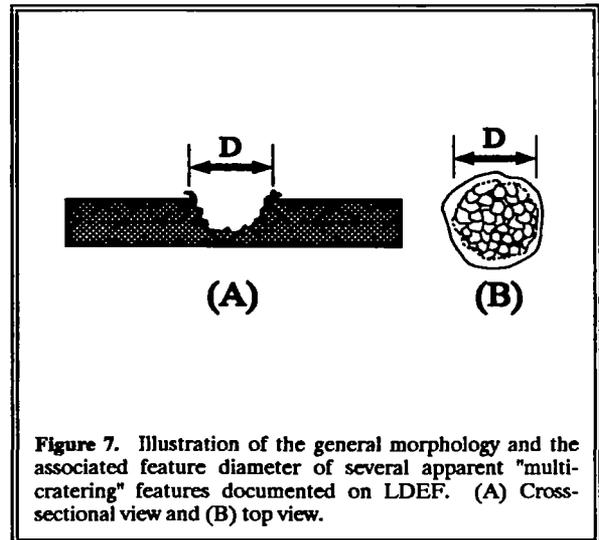
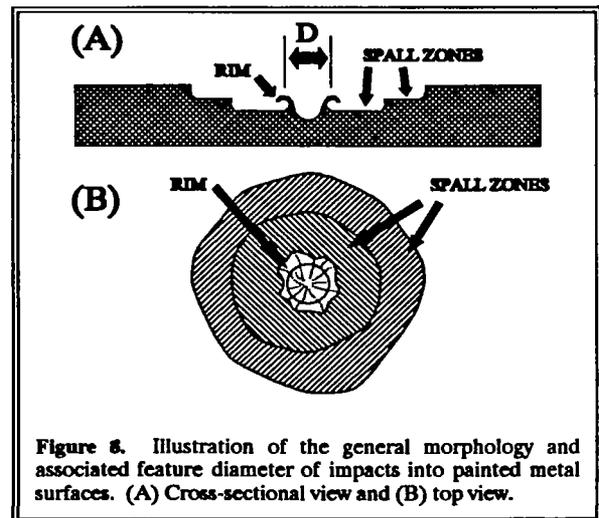
Impacts >0.5 mm in diameter into painted metal surfaces generally produced associated spall zones in the paint which extended for several crater diameters around the standard-shaped crater in the underlying metal surface (Figures 8 and 9). On thin aluminum panels coated with several layers of paint there were frequently large, front-surface delamination zones extending tens of crater diameters around the impact sites. In these instances, the top layer of paint was apparently blown off of the surface by acoustic forces propagating through the thin panel. In many cases, diameters for these zones were measured and recorded in the comments field of the digitized image files.

Figure 9. Impact into one of the paint specimens on an experiment-tray clamp. This particular feature was the largest impact feature found on the numerous tray clamps. View measures approximately ~6.5 cm across.

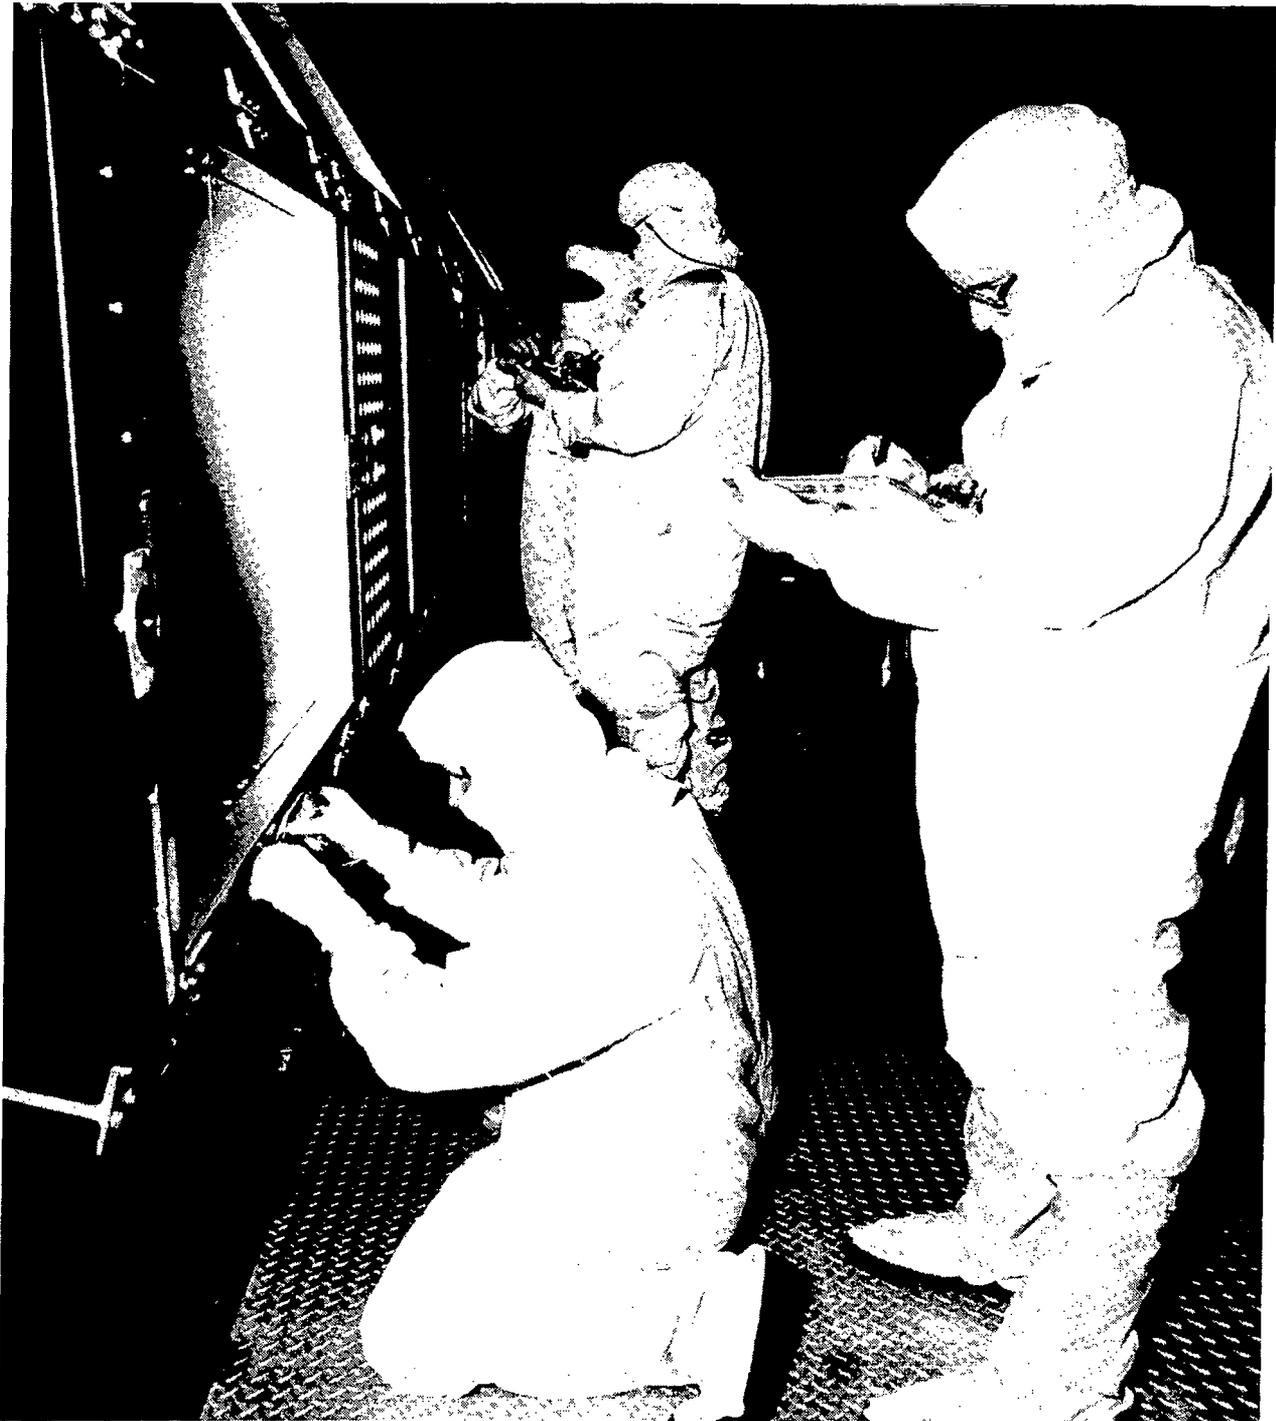
Figure 21. Members of the M&D SIG performing the BOLTS, CLAMPS, SHIMS, AND EXPERIMENT TRAY FLANGES/LIPS INSPECTION AND BOLT ORIENTATION SURVEY prior to the commencement of the deintegration operations.

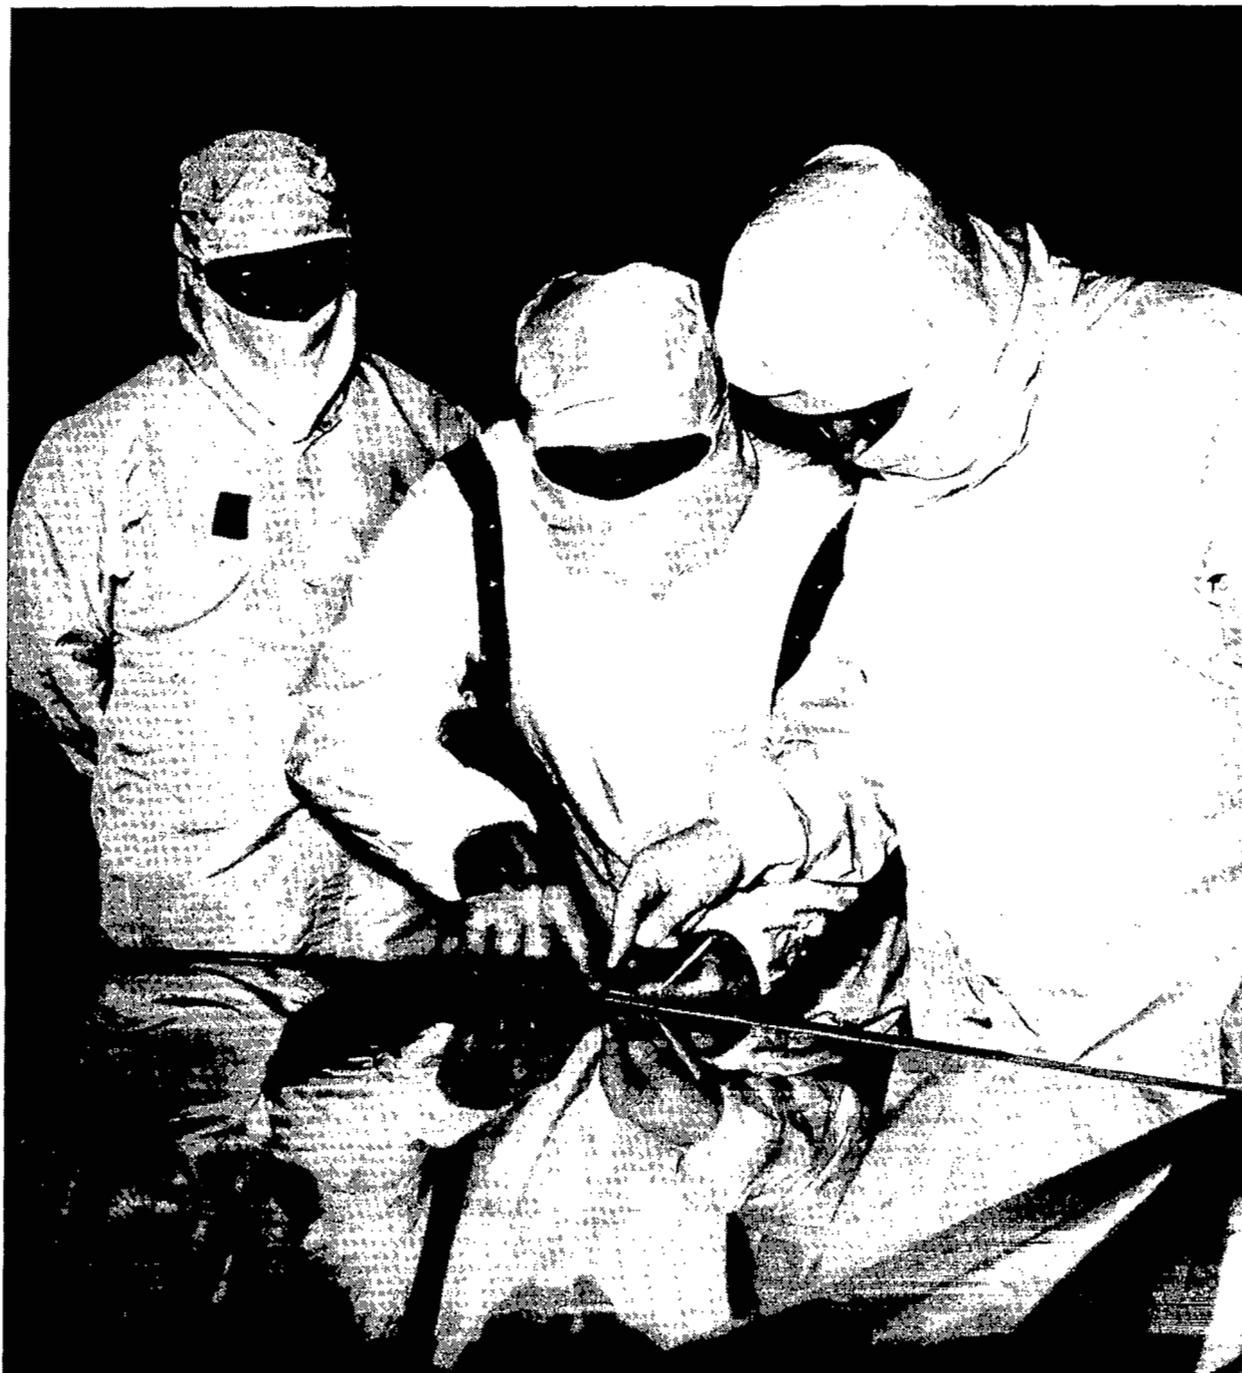
Figure 23. M&D SIG and Ground Operations personnel removing small sections of the experiment-tray cover gasket to prevent damage and contamination to features residing on the experiment-tray flanges.

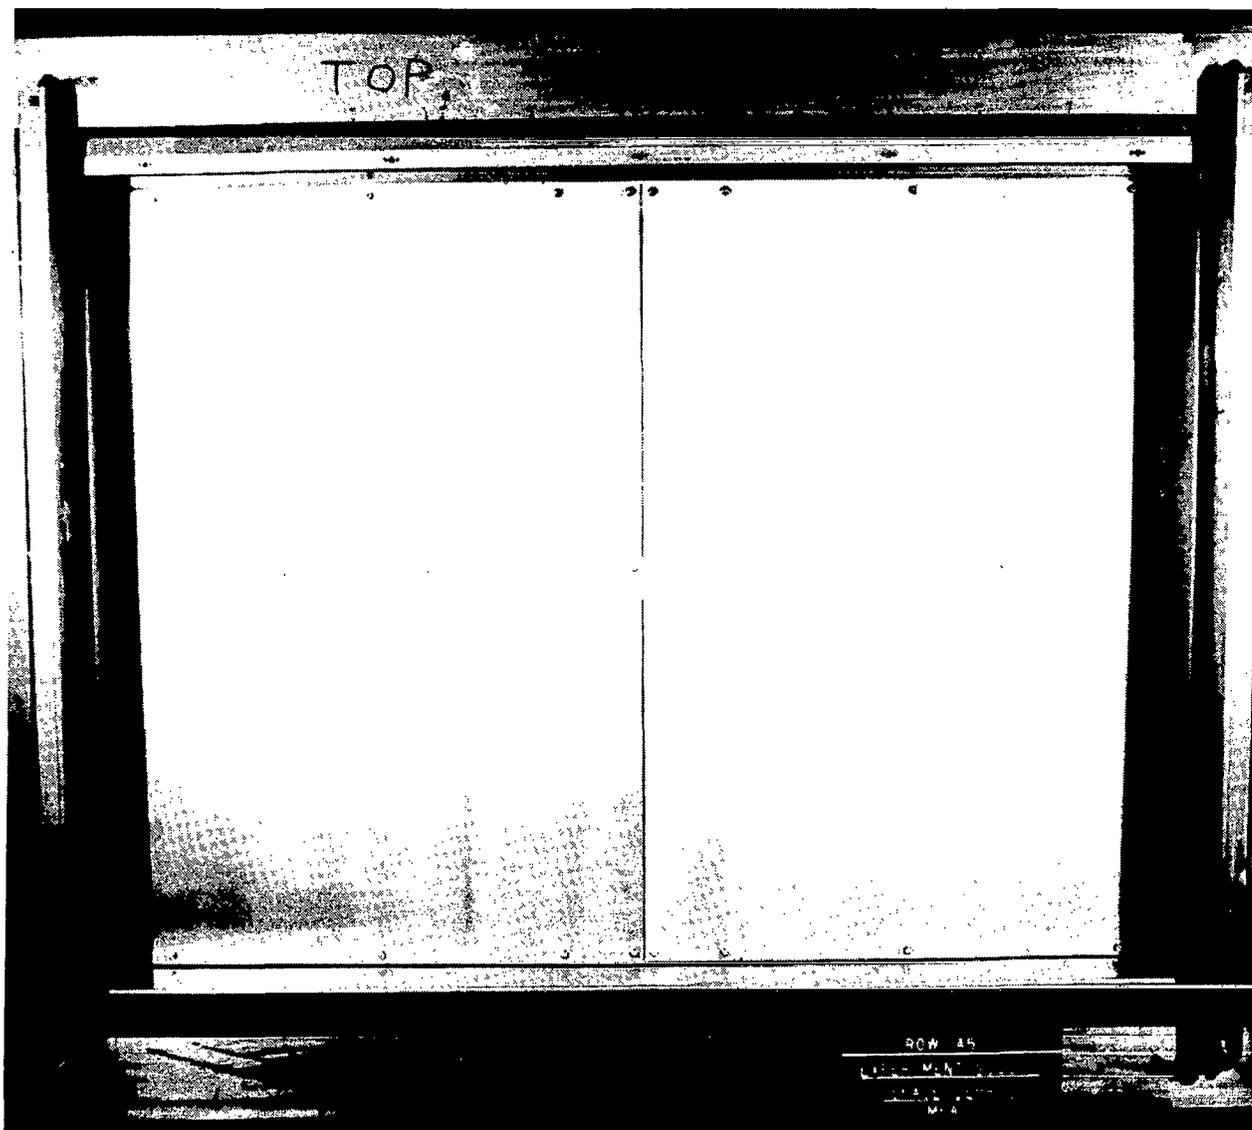
Figure A05-1. This post-deintegration view shows the front of the entire A05 experiment tray.

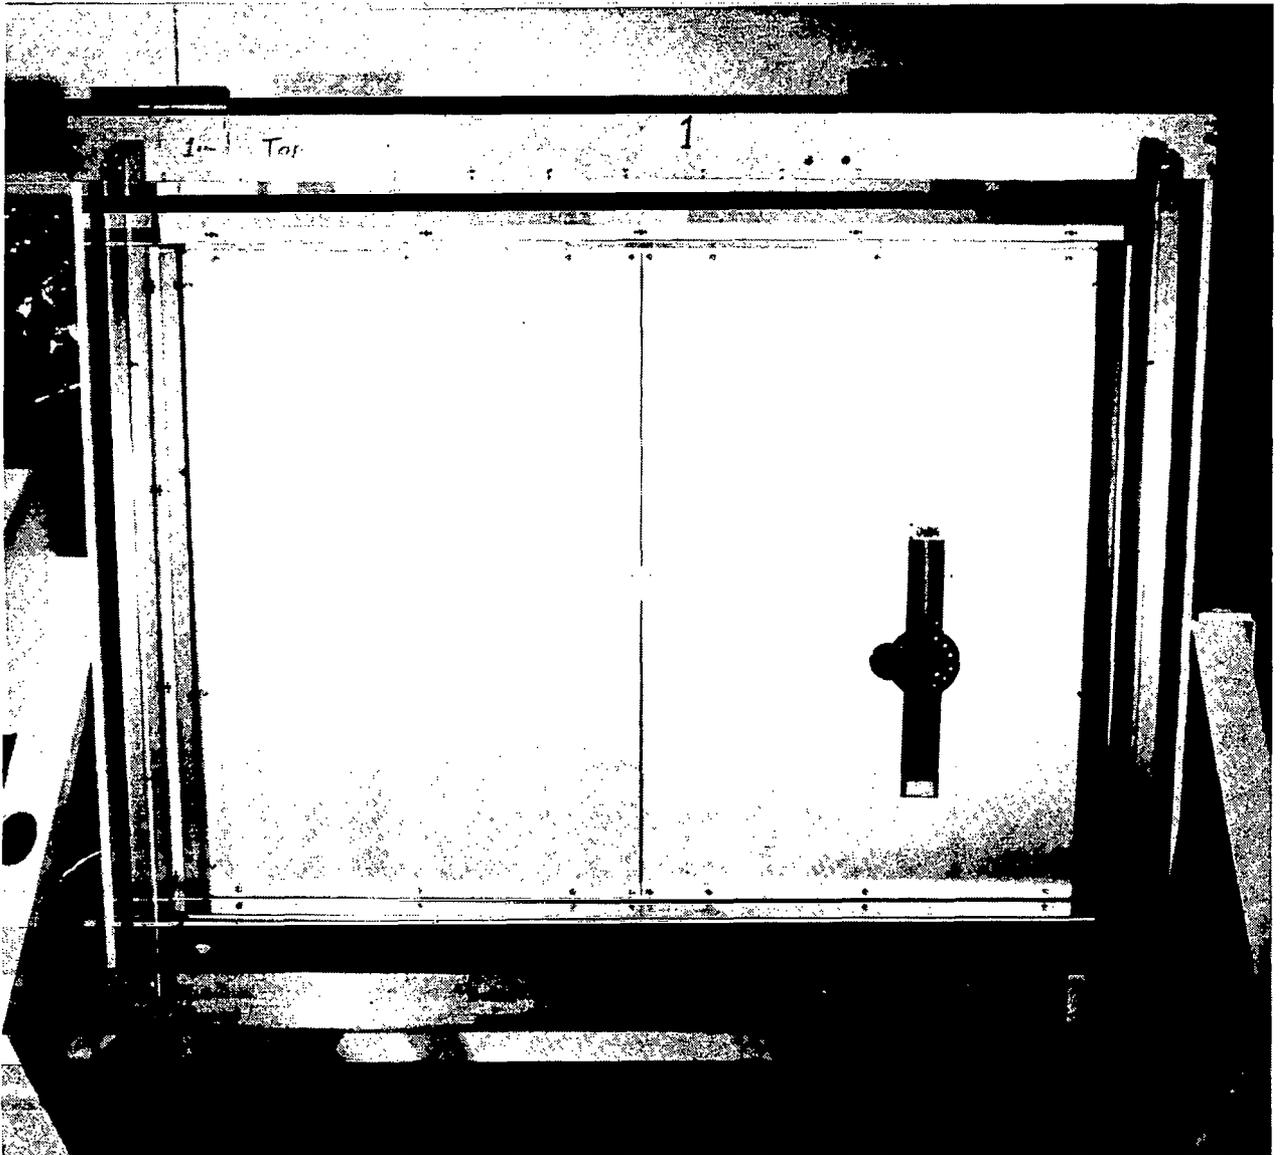
Figure A06-1. This post-deintegration view shows the front of the entire A06 experiment tray. The navigational target is located on the right side of the aluminum tray.

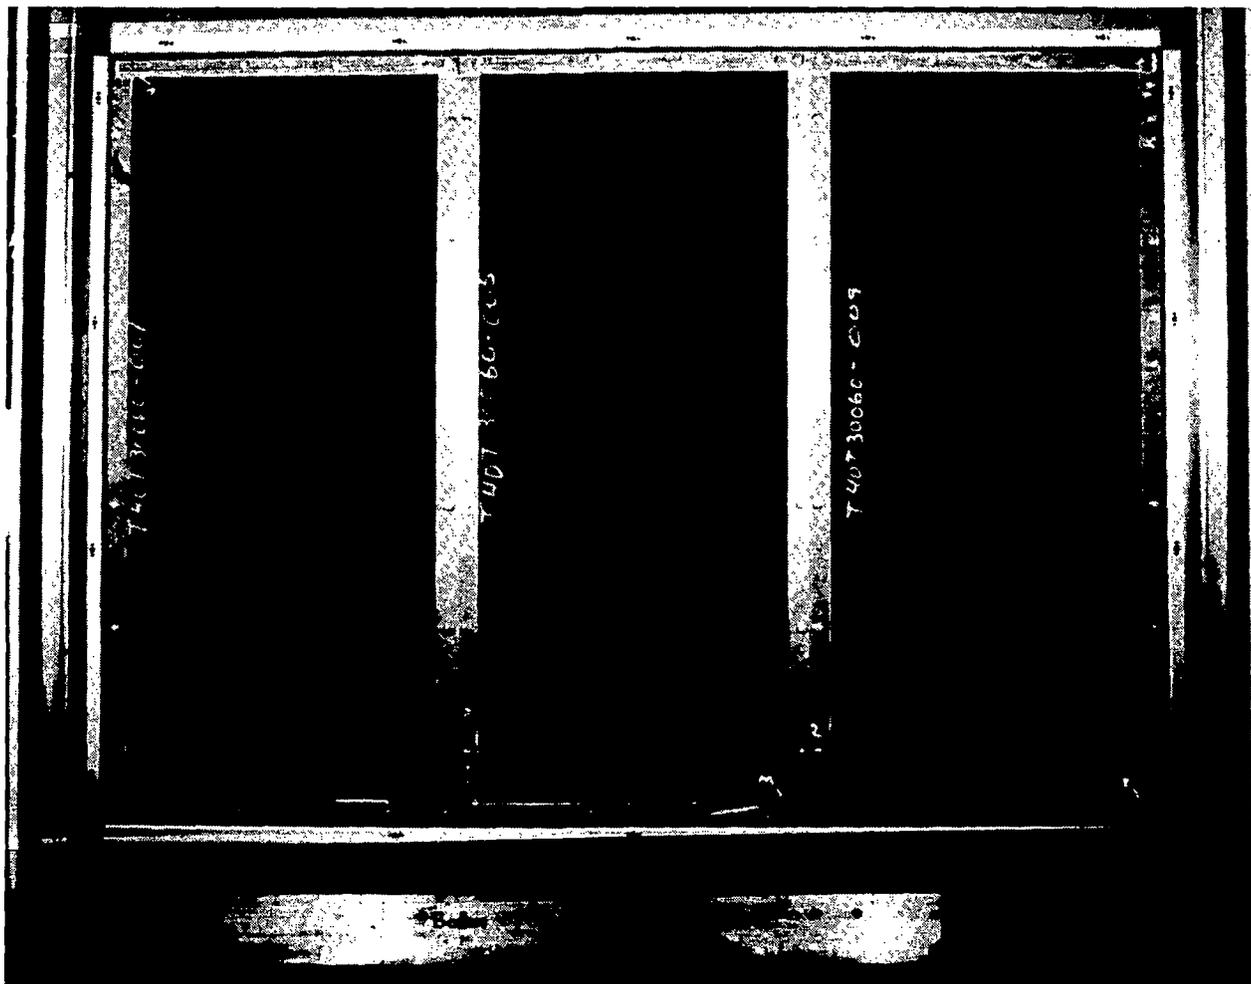
Figure A07-1. This post-deintegration view shows the front of the entire A07 experiment tray, showing the large sheets of graphite composites.

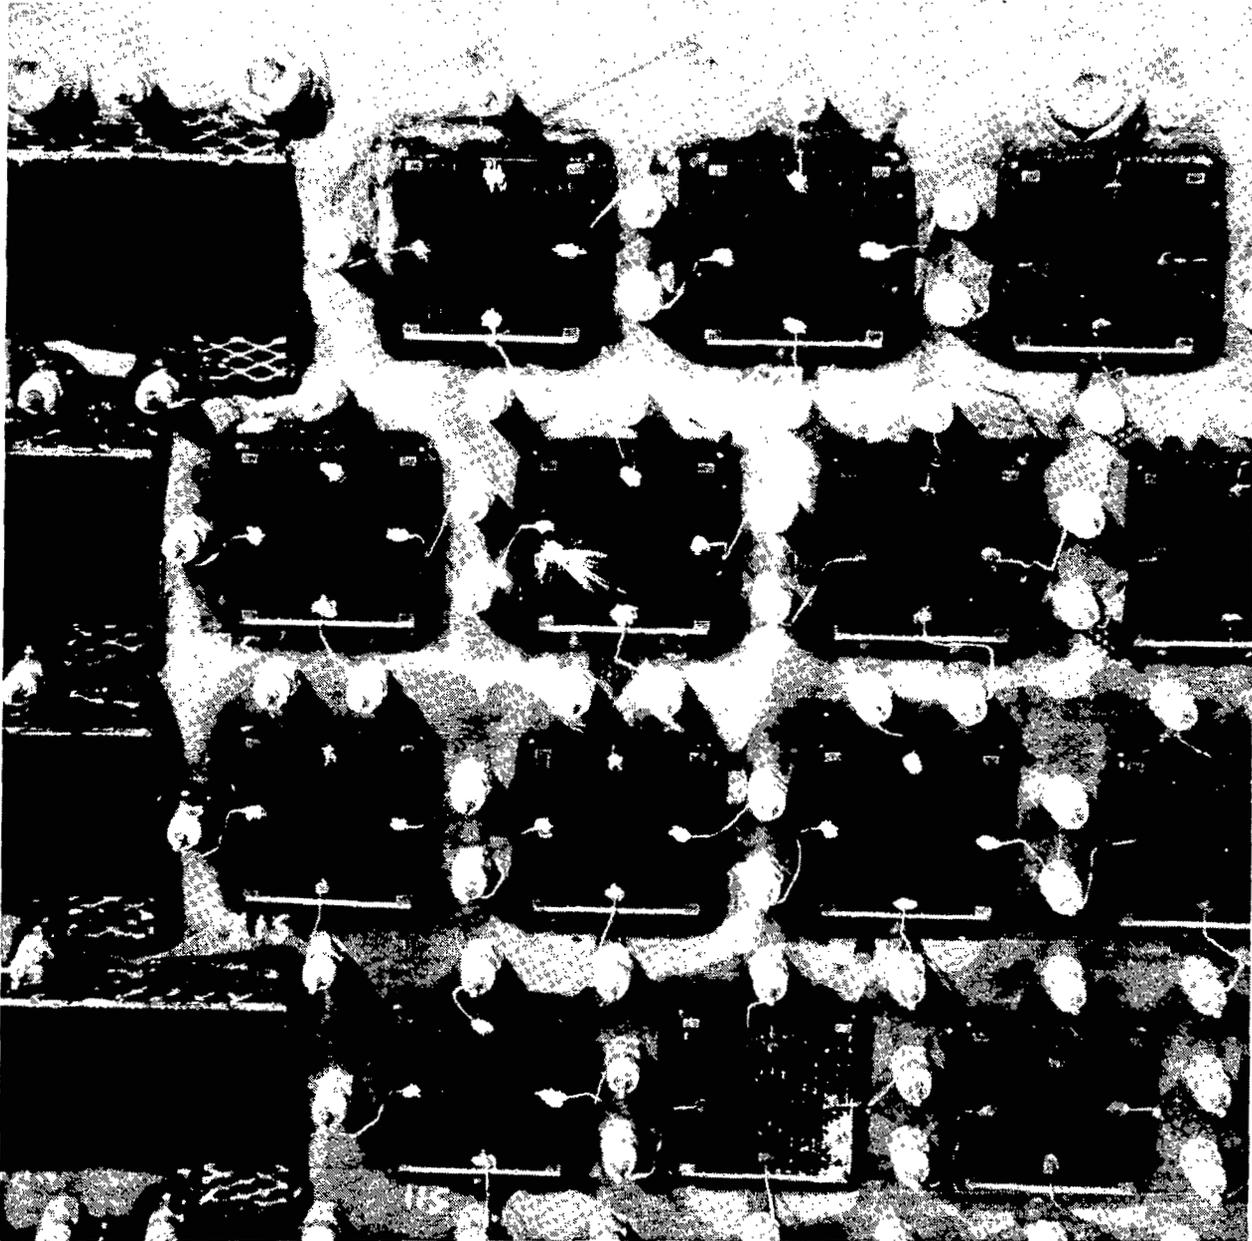
Figure A08-2 - This is a close-up of the sub-tray in the lower left of tray A08, showing an impact feature on a solar cell. This view measures approximately 13 cm across.

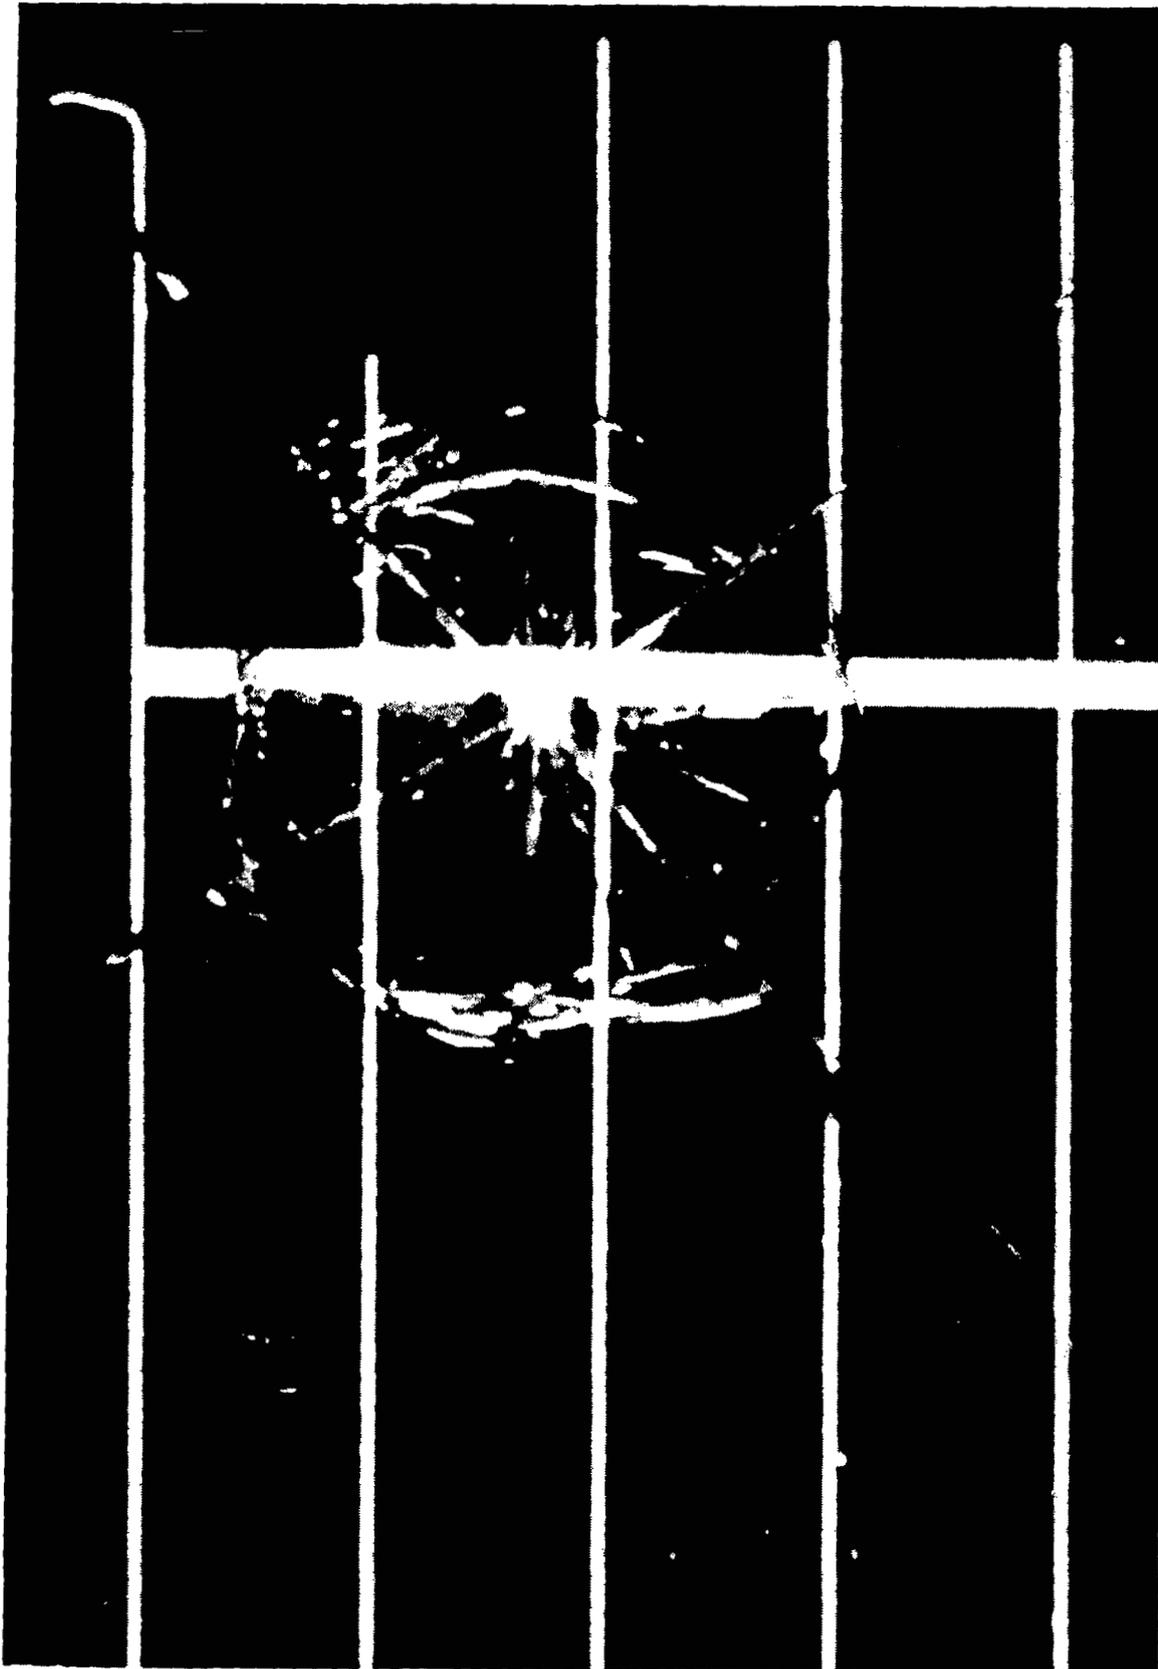
Figure A08-3. This is a close-up on an impact into a solar cell, showing accompanying shattering, and measures approximately 3 cm across.

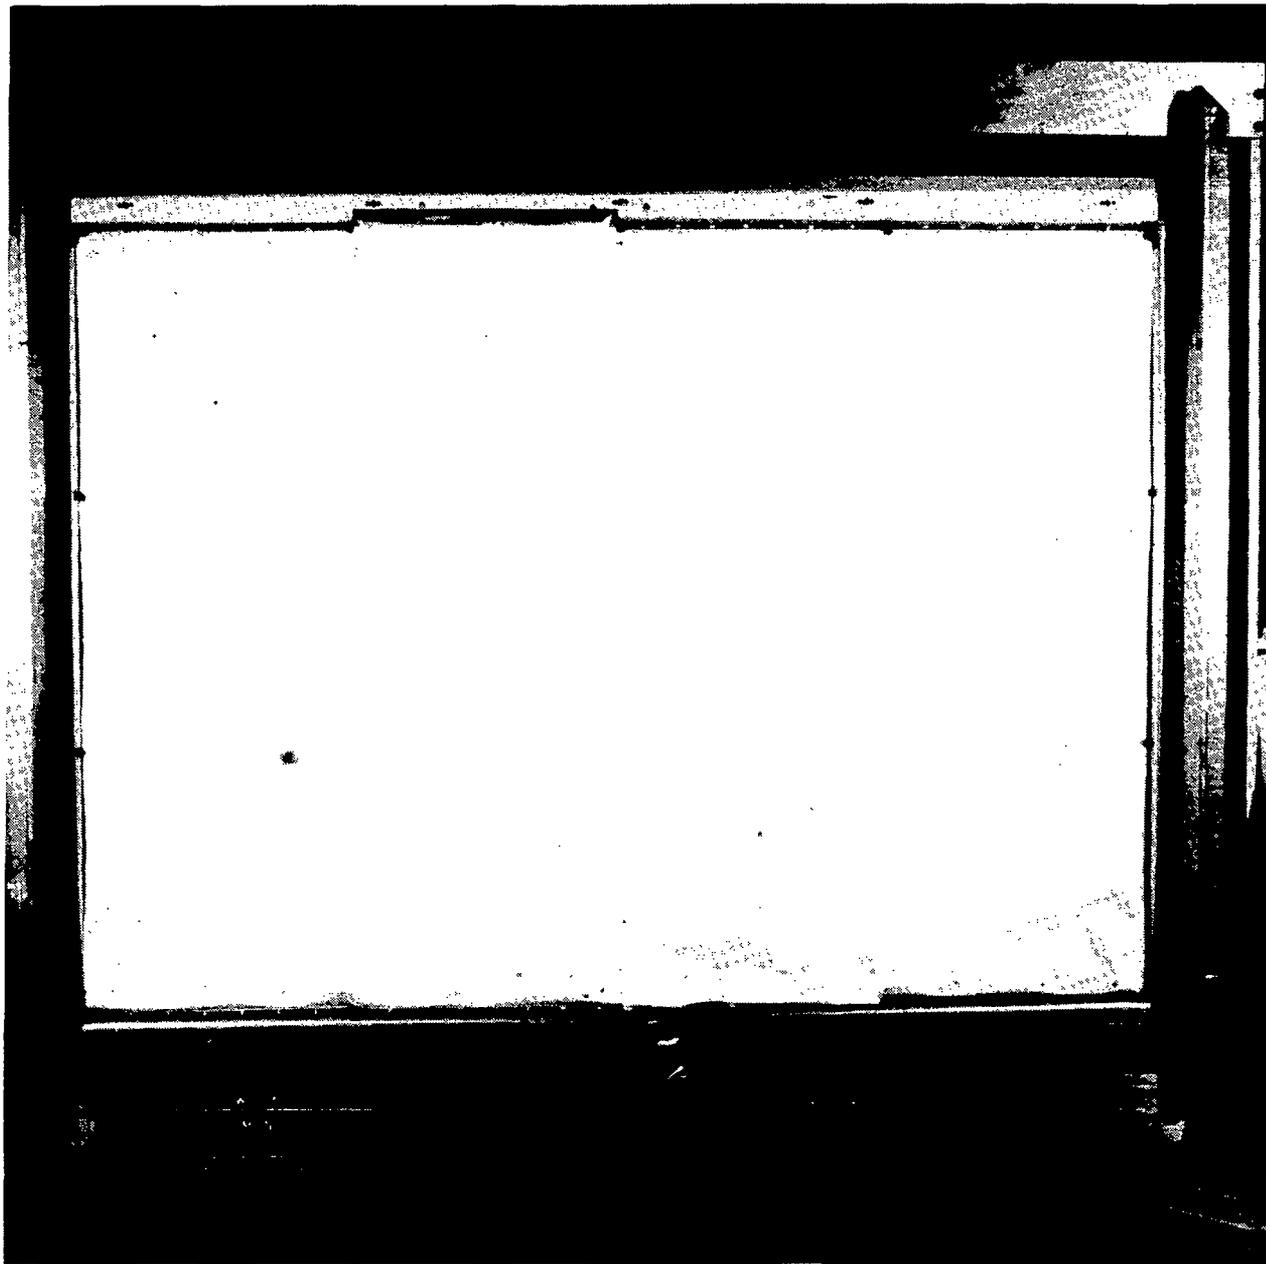
Figure A10-1 - This post-deintegration view shows the front of the entire A10 experiment thermal blanket. *Fleur-de-lis* patterns across the blanket are surface expressions of the velcro attachment points to the underlying aluminum frame. Many impact features are apparent across the blanket surface. The large impact feature in the lower left is also shown in Figure A10-2.

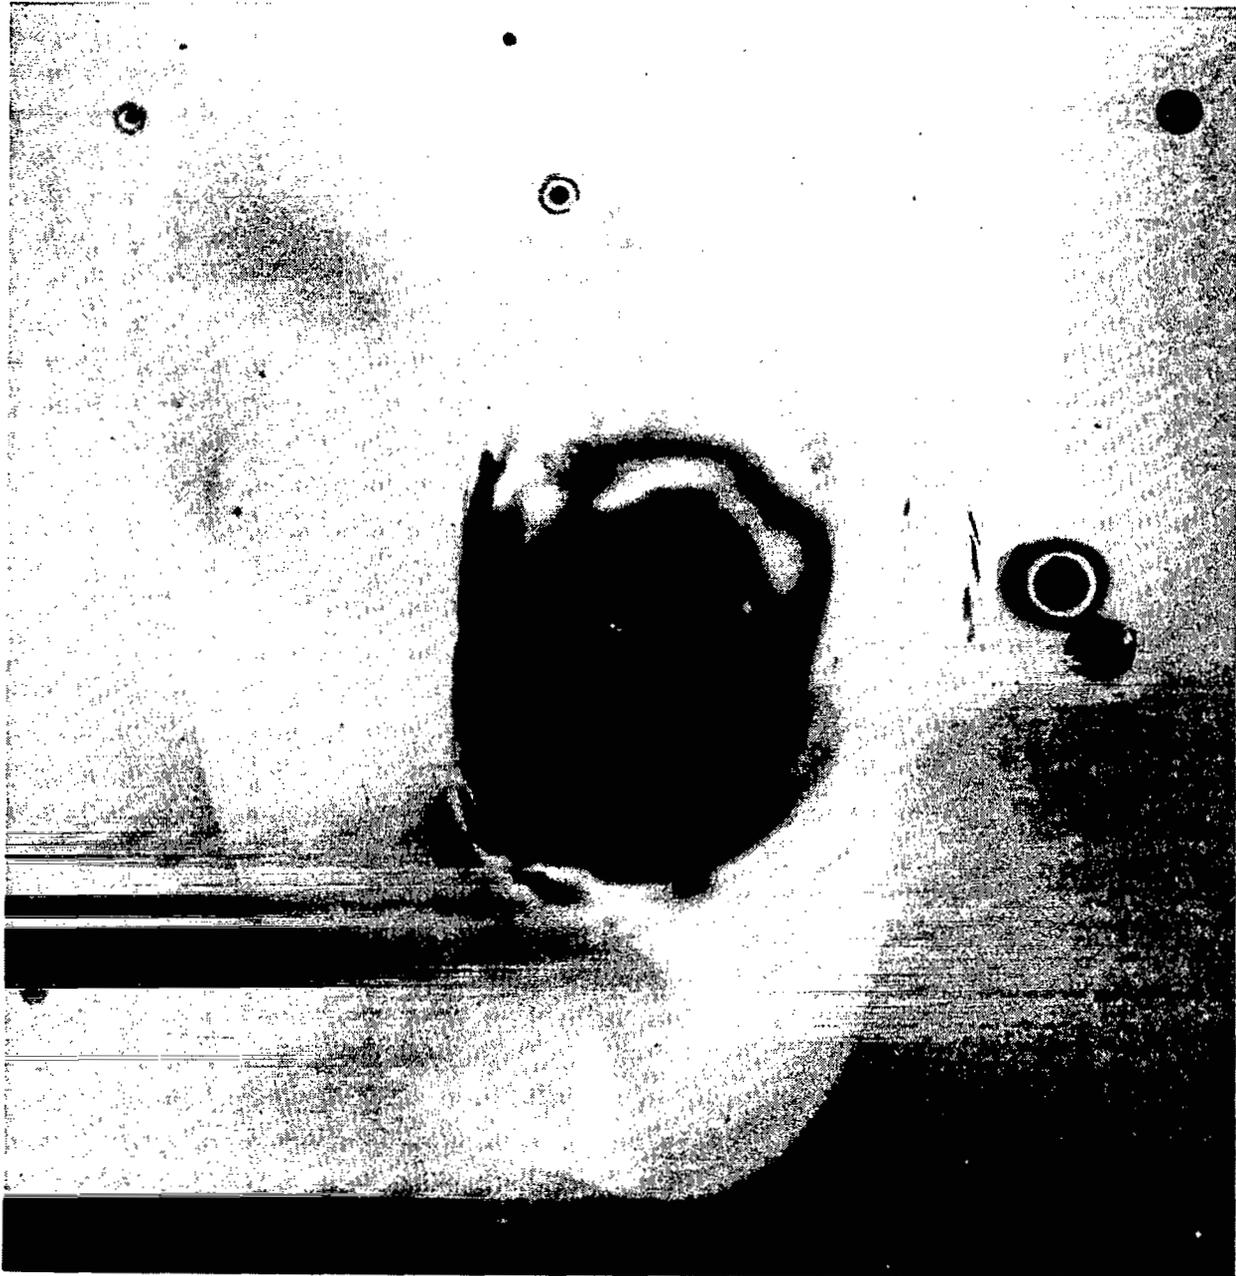
Figure A10-2. This is a view of large impact features on the A10 thermal blanket. Dark rings encircle many of the features. Some rings are incomplete. Rounded delamination areas surround most impact features shown here. View measures approximately 10 cm across.

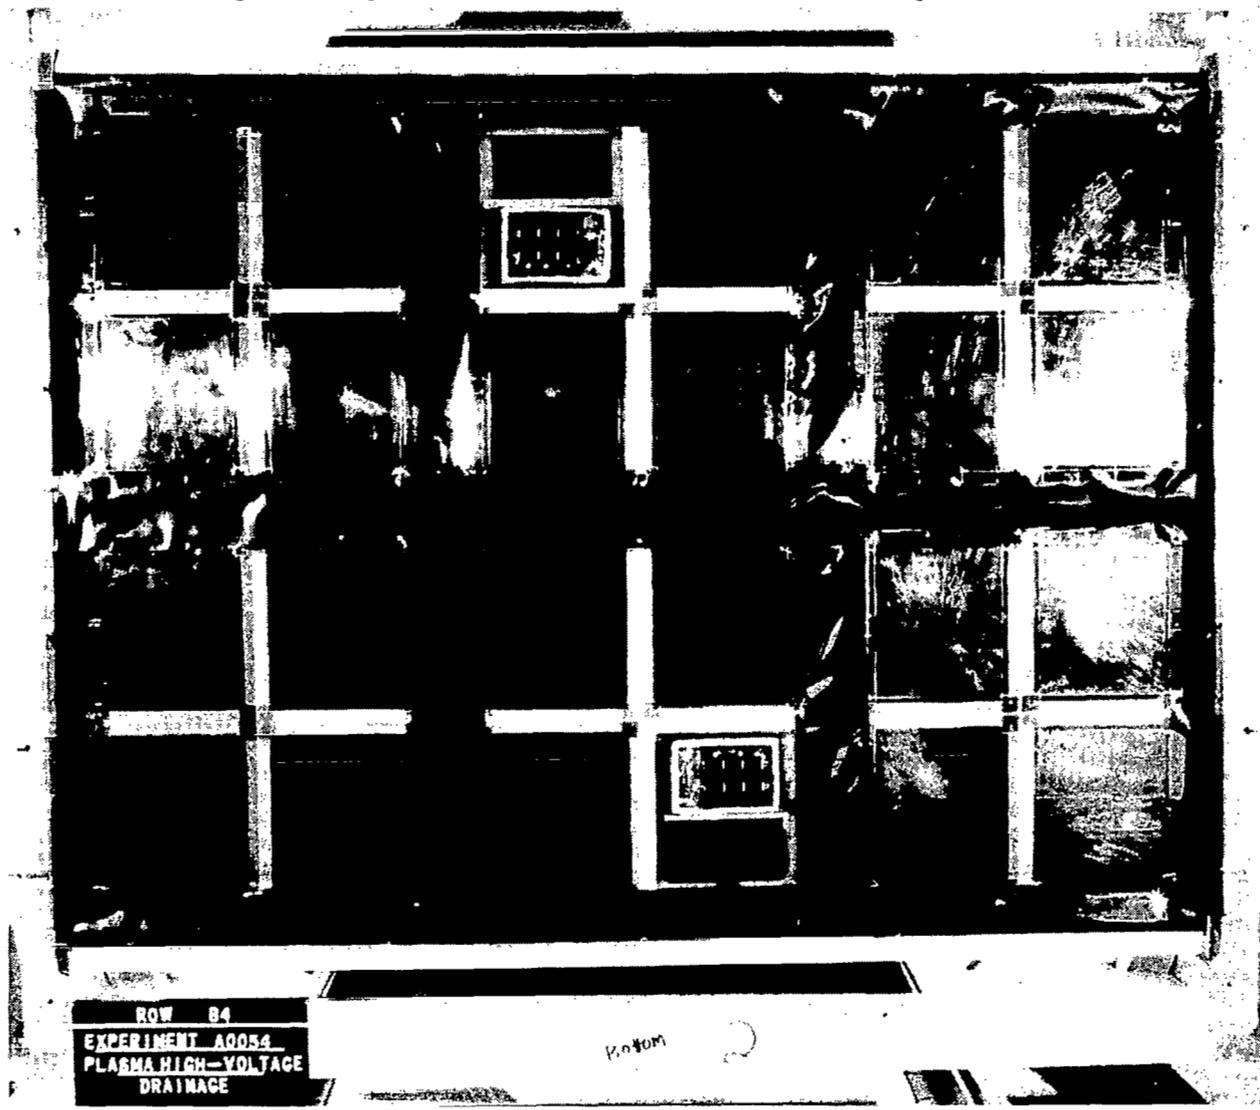
Figure B04-1. This post-deintegration view shows the front of the entire B04 experiment tray.

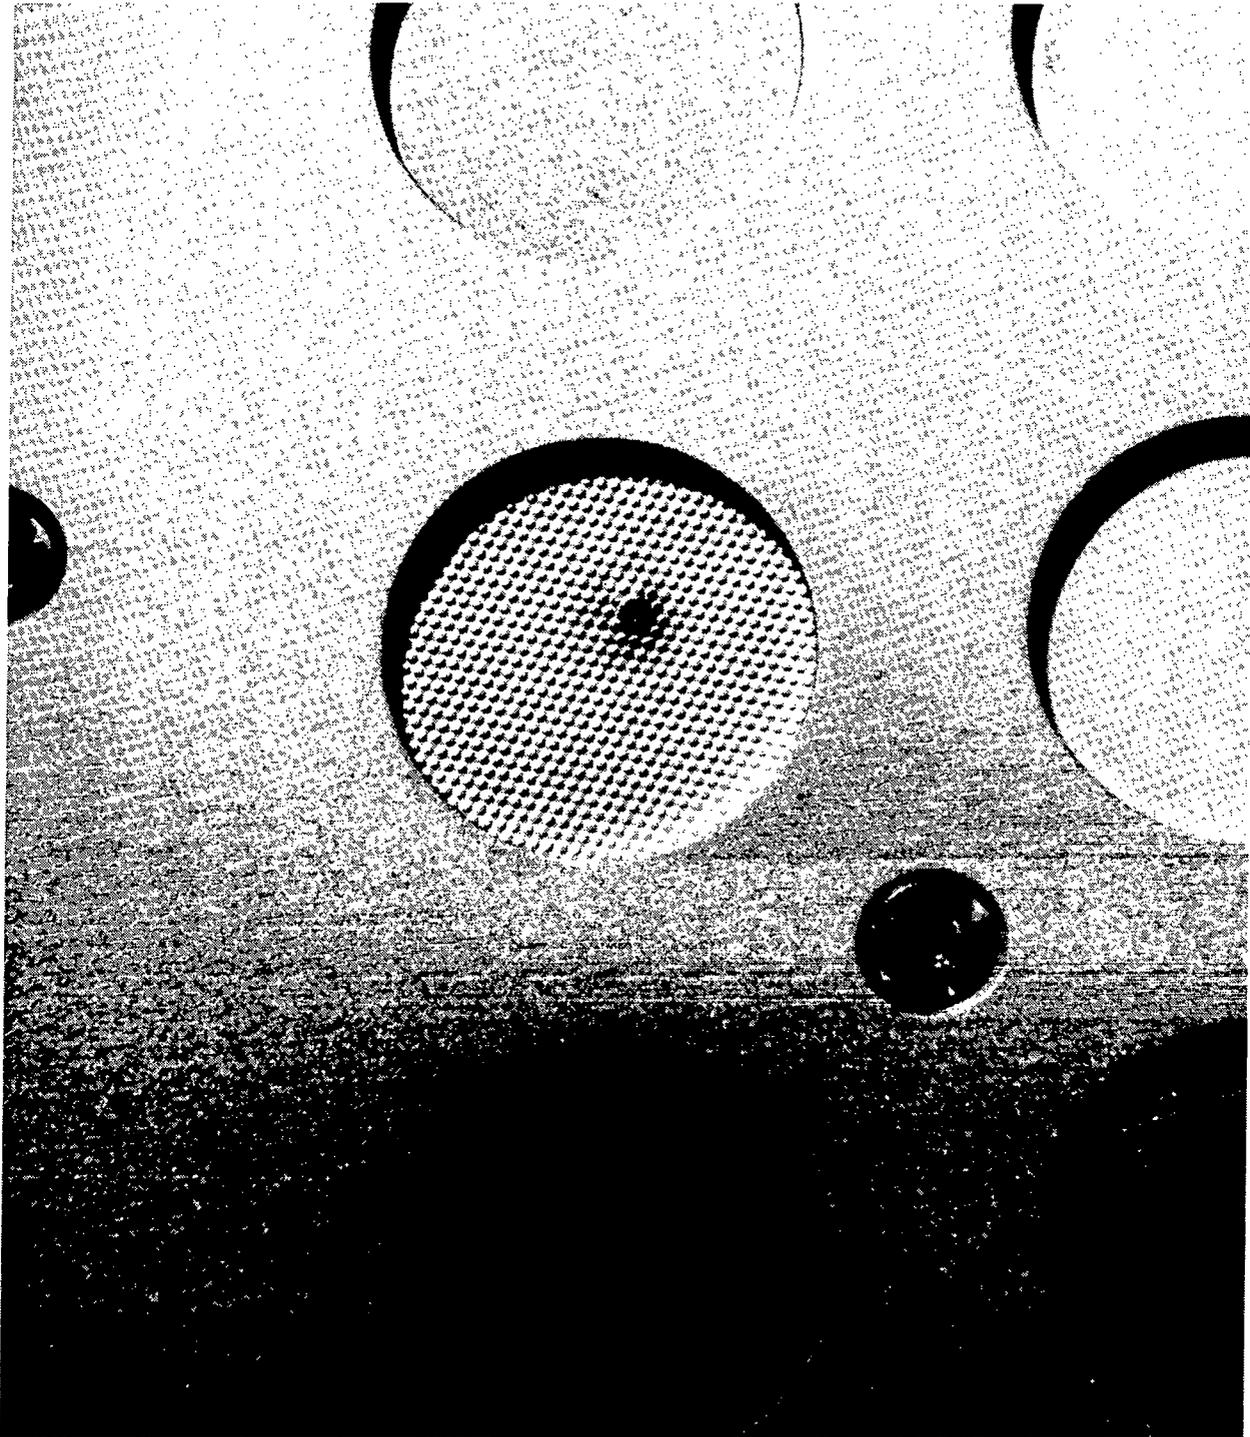
Figure B09-3. This view illustrates impact features in two materials from the bottom of Tray B09. View measures approximately 4 cm across.

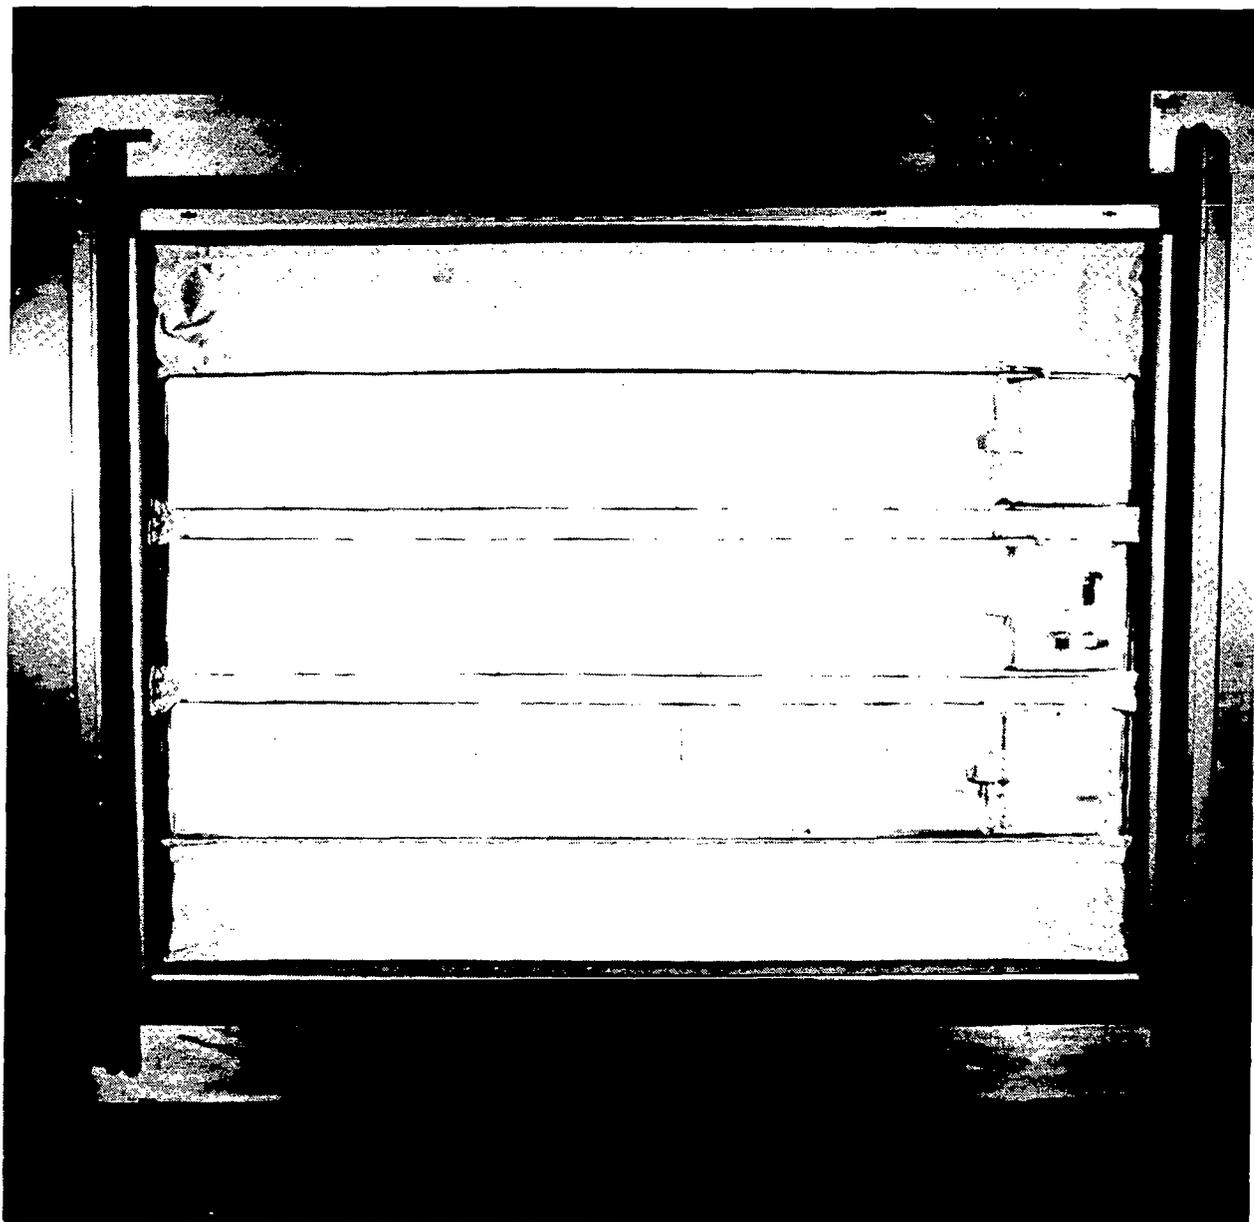
Figure B10-1. This post-deintegration view shows the front of the entire B10 experiment tray.
