METEOROID AND DEBRIS IMPACT FEATURES DOCUMENTED ON THE LONG DURATION EXPOSURE FACILITY

A Preliminary Report

Compiled by Members
of the LDEF Meteoroid
and Debris Special
Investigation Group

August 1990

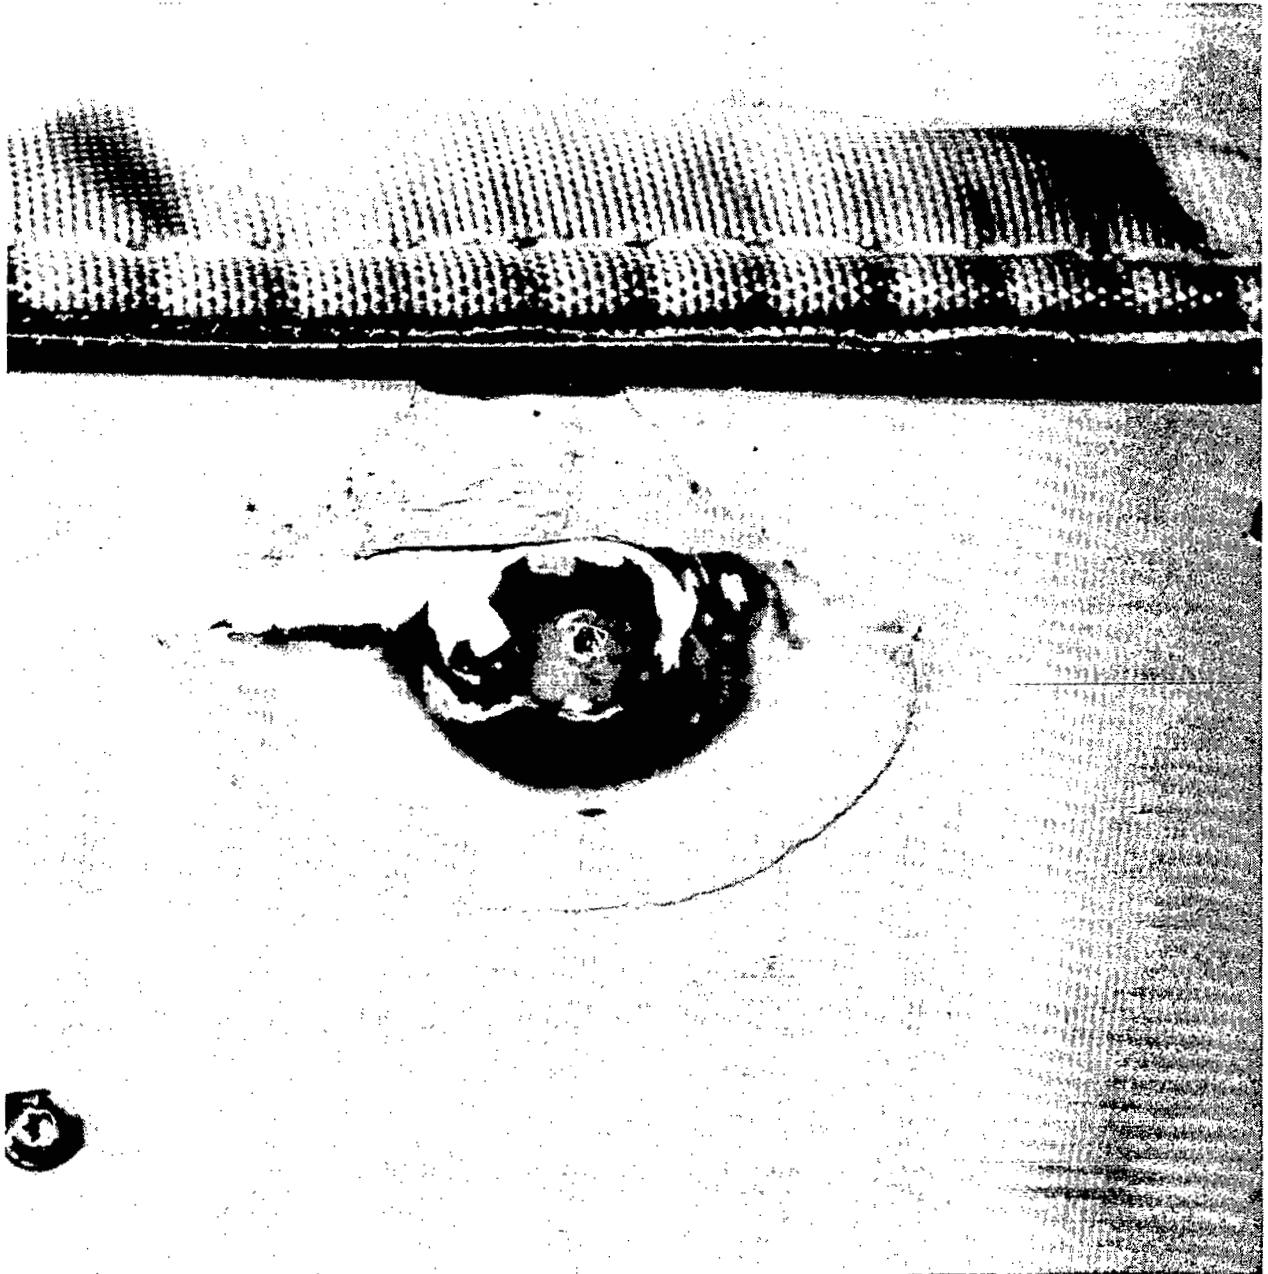
Figure B10-2. This is a view of a large impact with spall across one of the heat-pipe covers. View measures approximately 4 cm across.

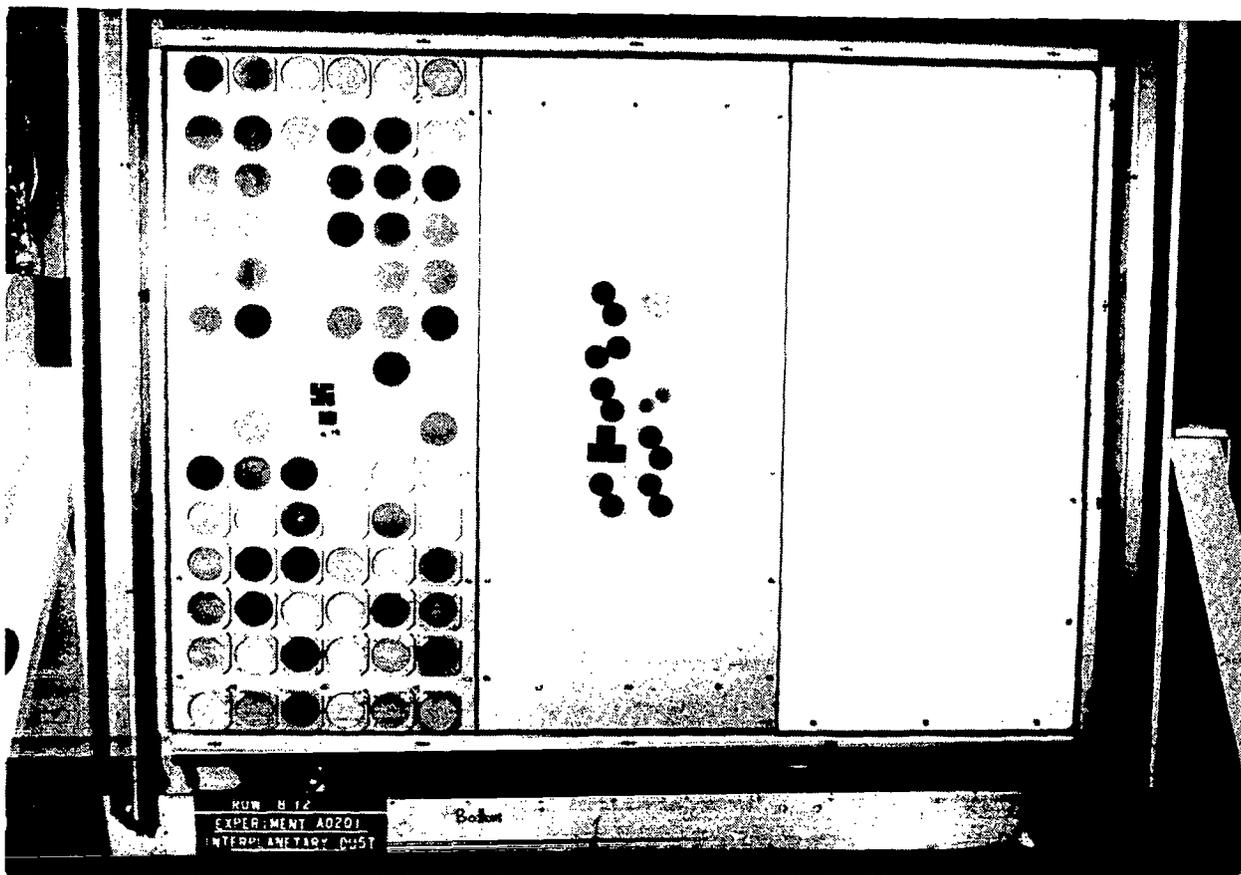
Figure B12-1. This post-deintegration view shows the front of the entire B12 experiment tray.

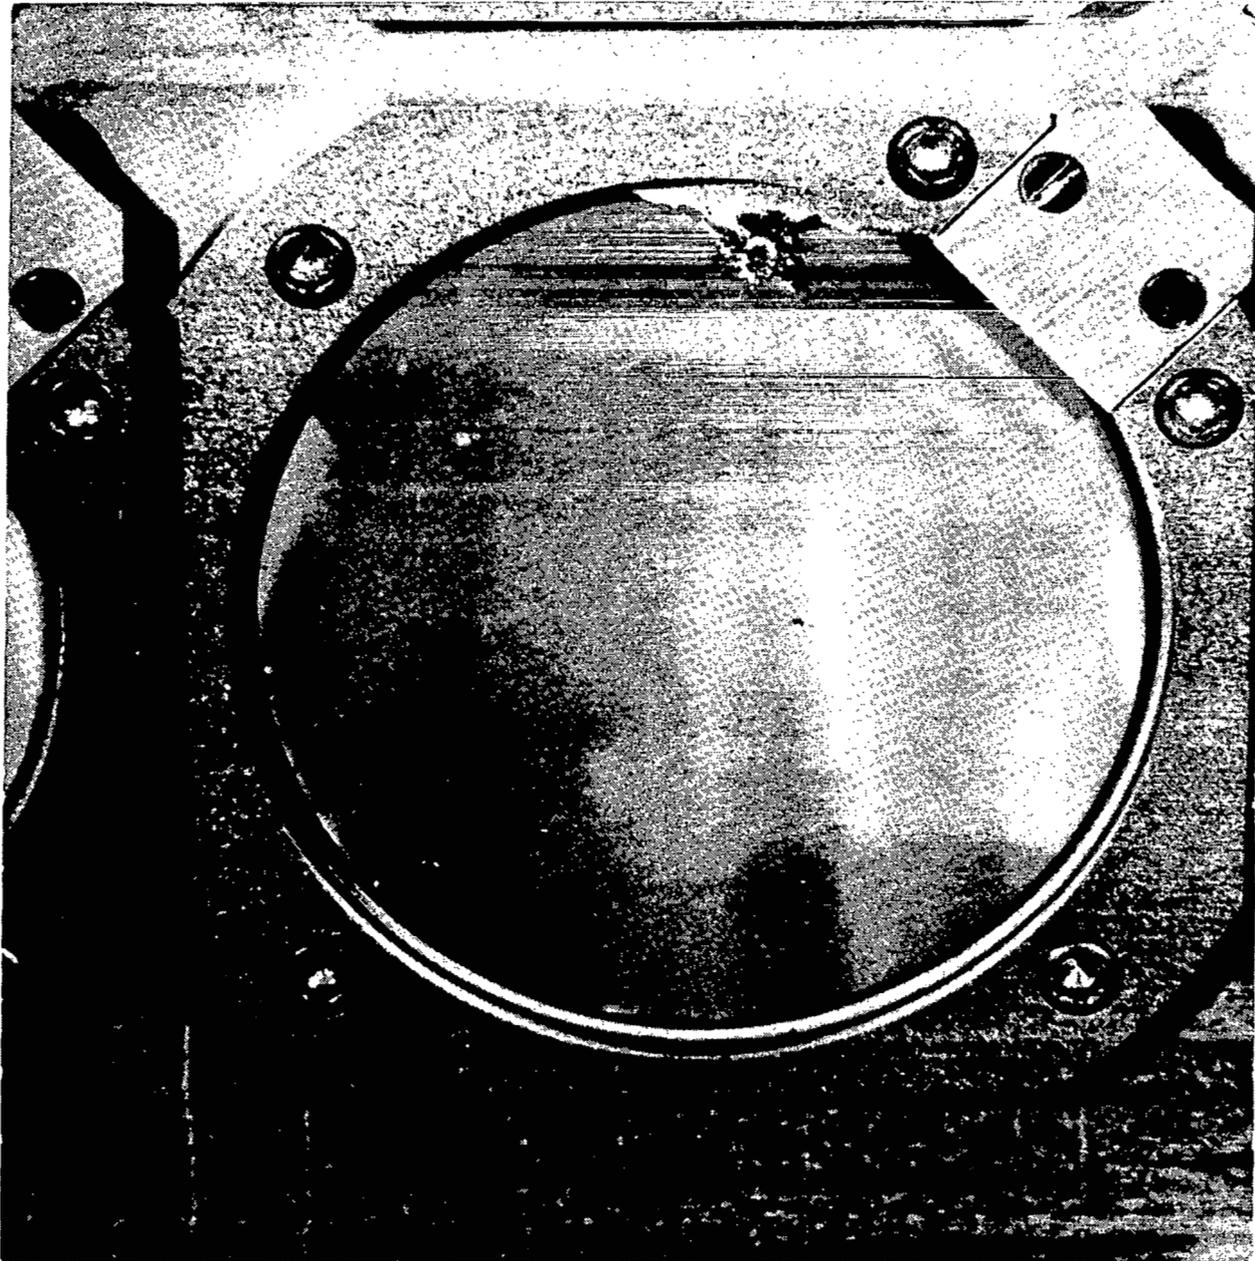
Figure B12-2. This is a view of impact feature #17, with associated shattering, onto a MOS detector. View measures approximately 9 cm across.

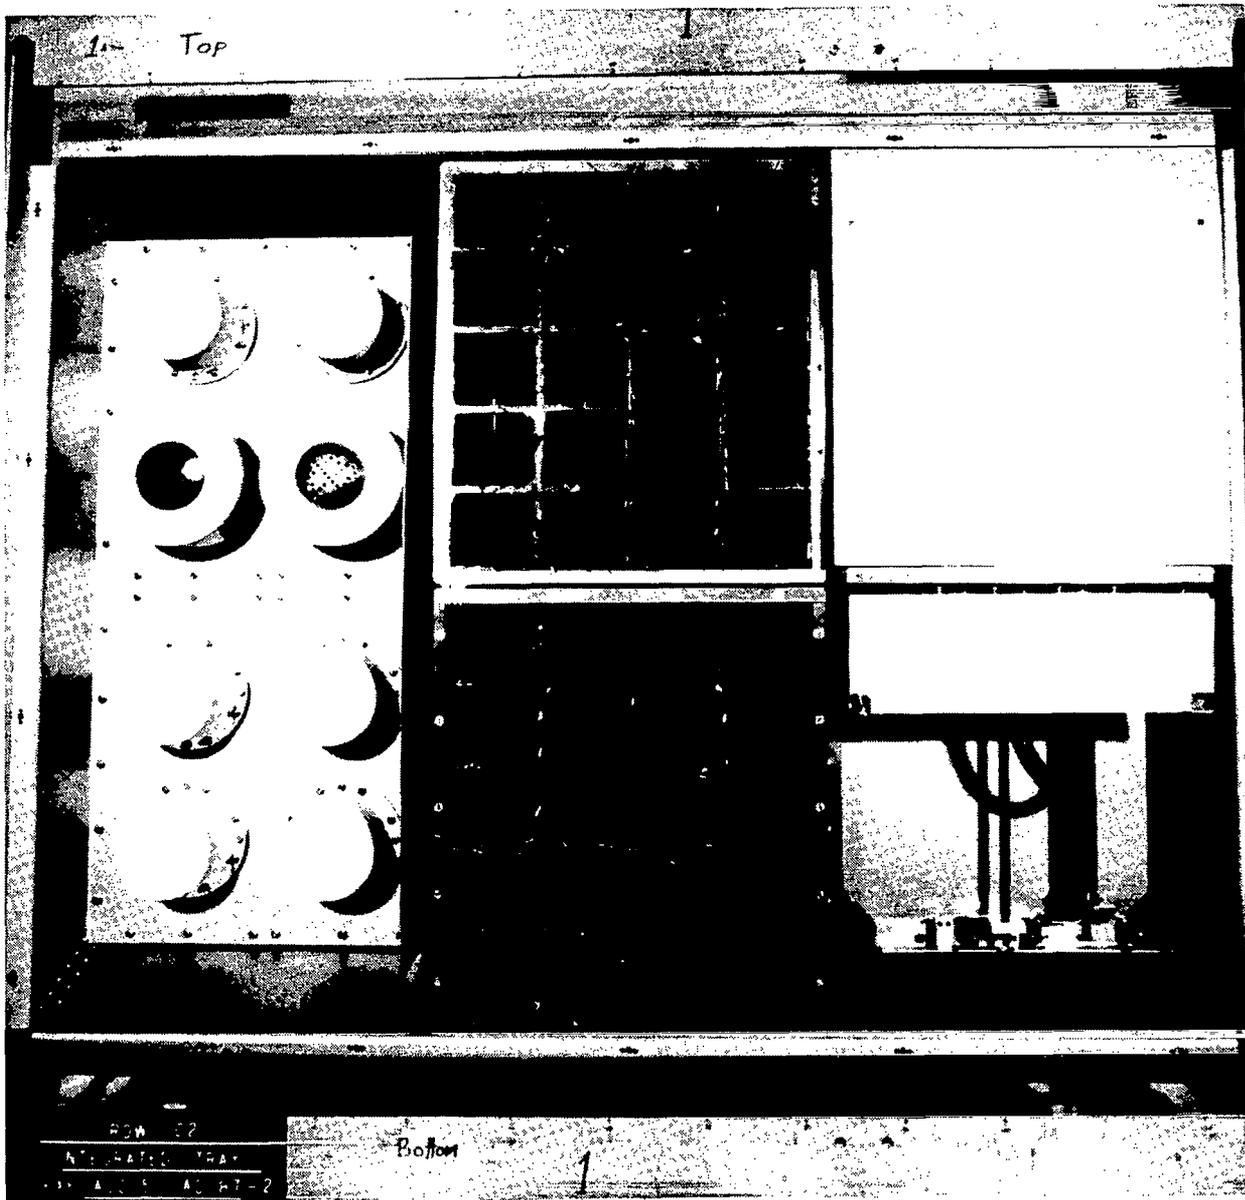
Figure C02-1. This post-deintegration view shows the front of the entire C02 integrated experiment tray. The active canister is present on the right.

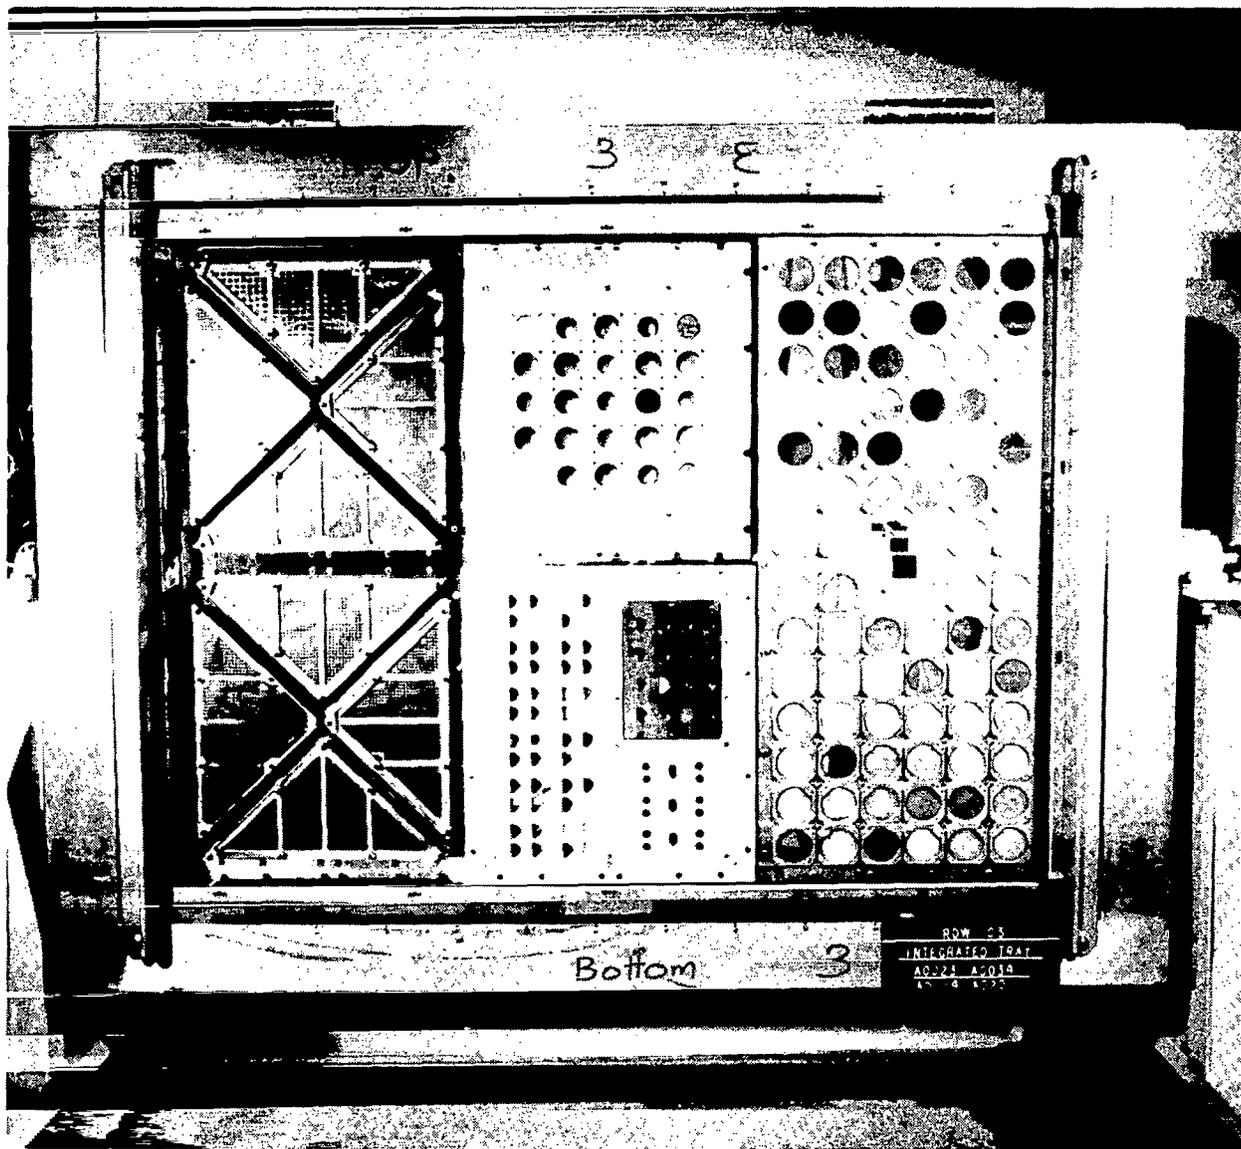
Figure C03-1. This post-deintegration view shows the front of the entire C03 integrated experiment tray.

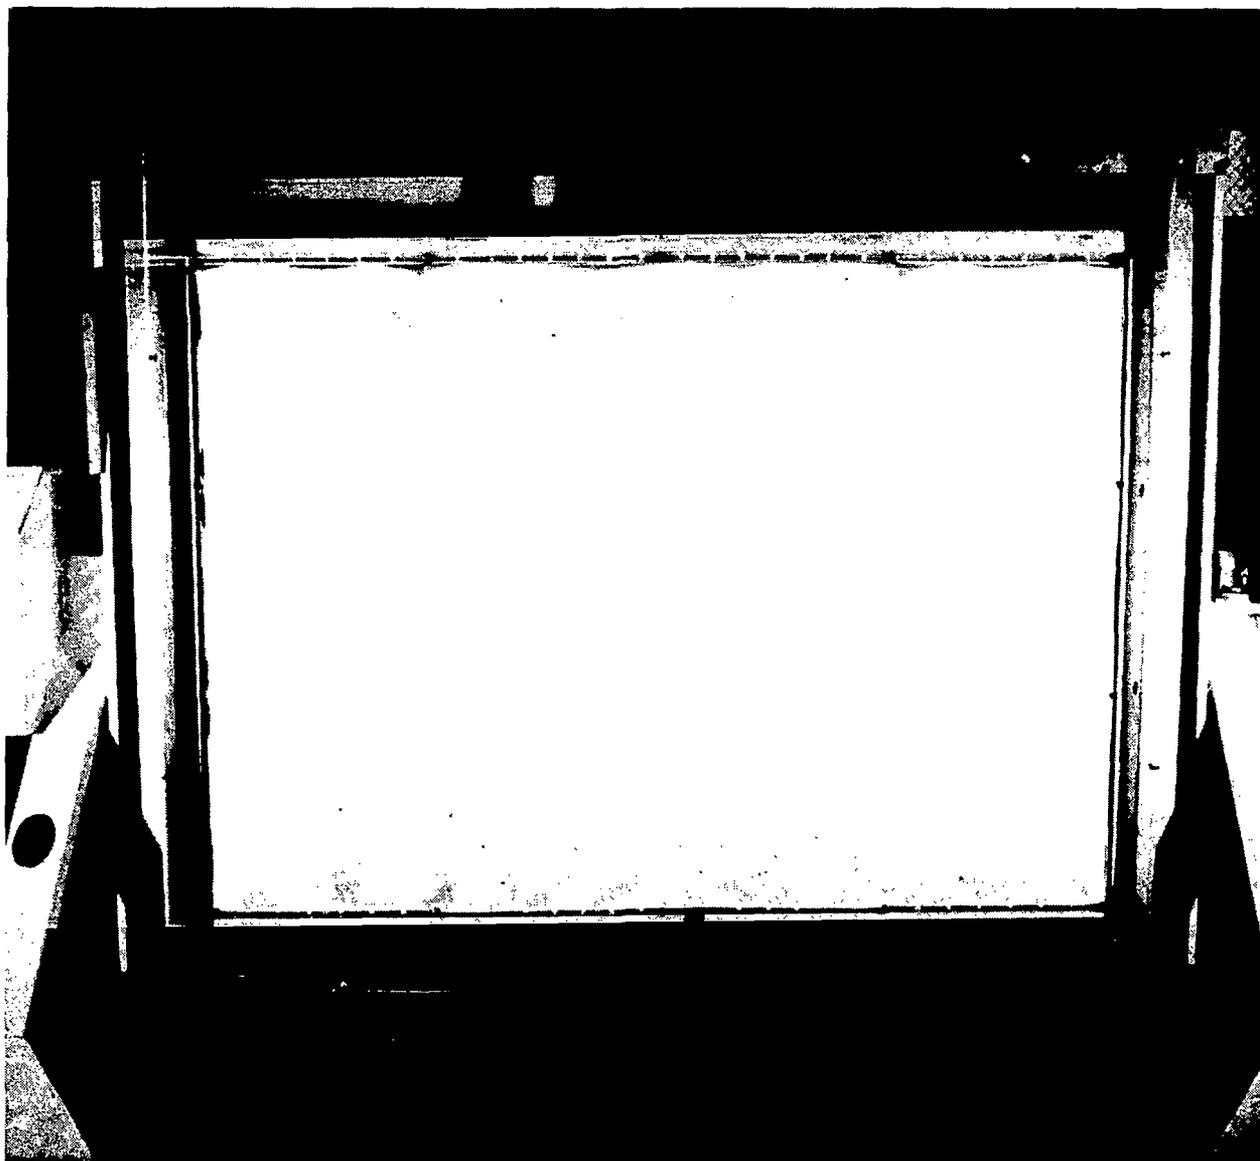
Figure C08-1. This post-deintegration view shows the front of the entire C08 experiment thermal blanket. Oxygen erosion has given this blanket a frosted appearance. The large impact (#94, with a streak) on the lower right is shown in Figure C08.

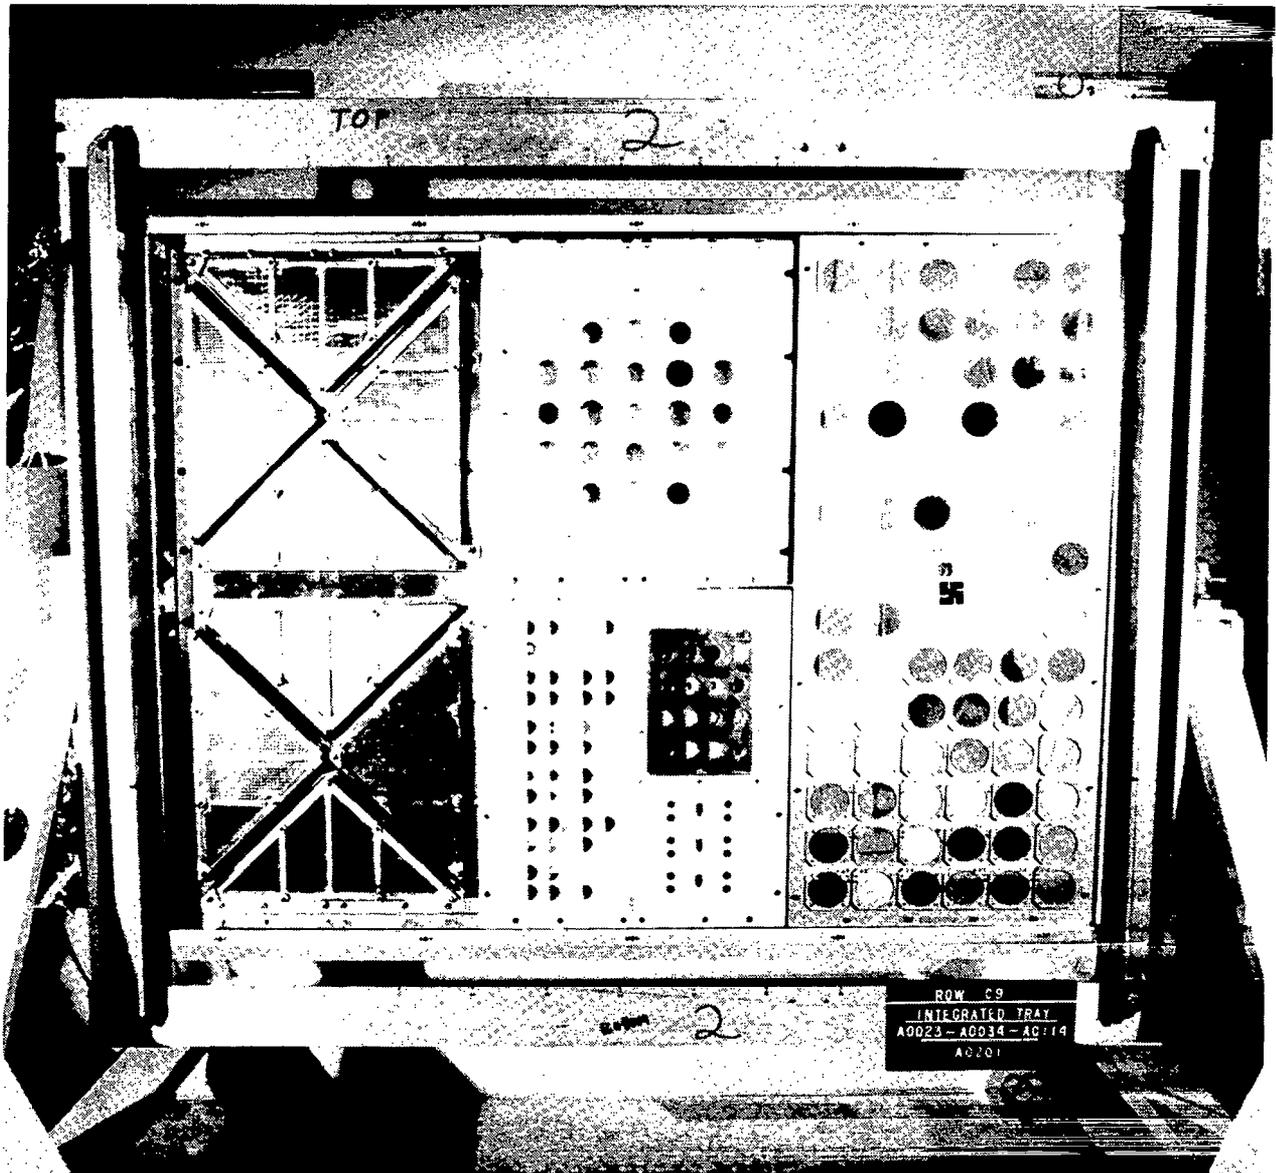
Figure C09-1. This post-deintegration view shows the front of the entire C09 integrated experiment tray.

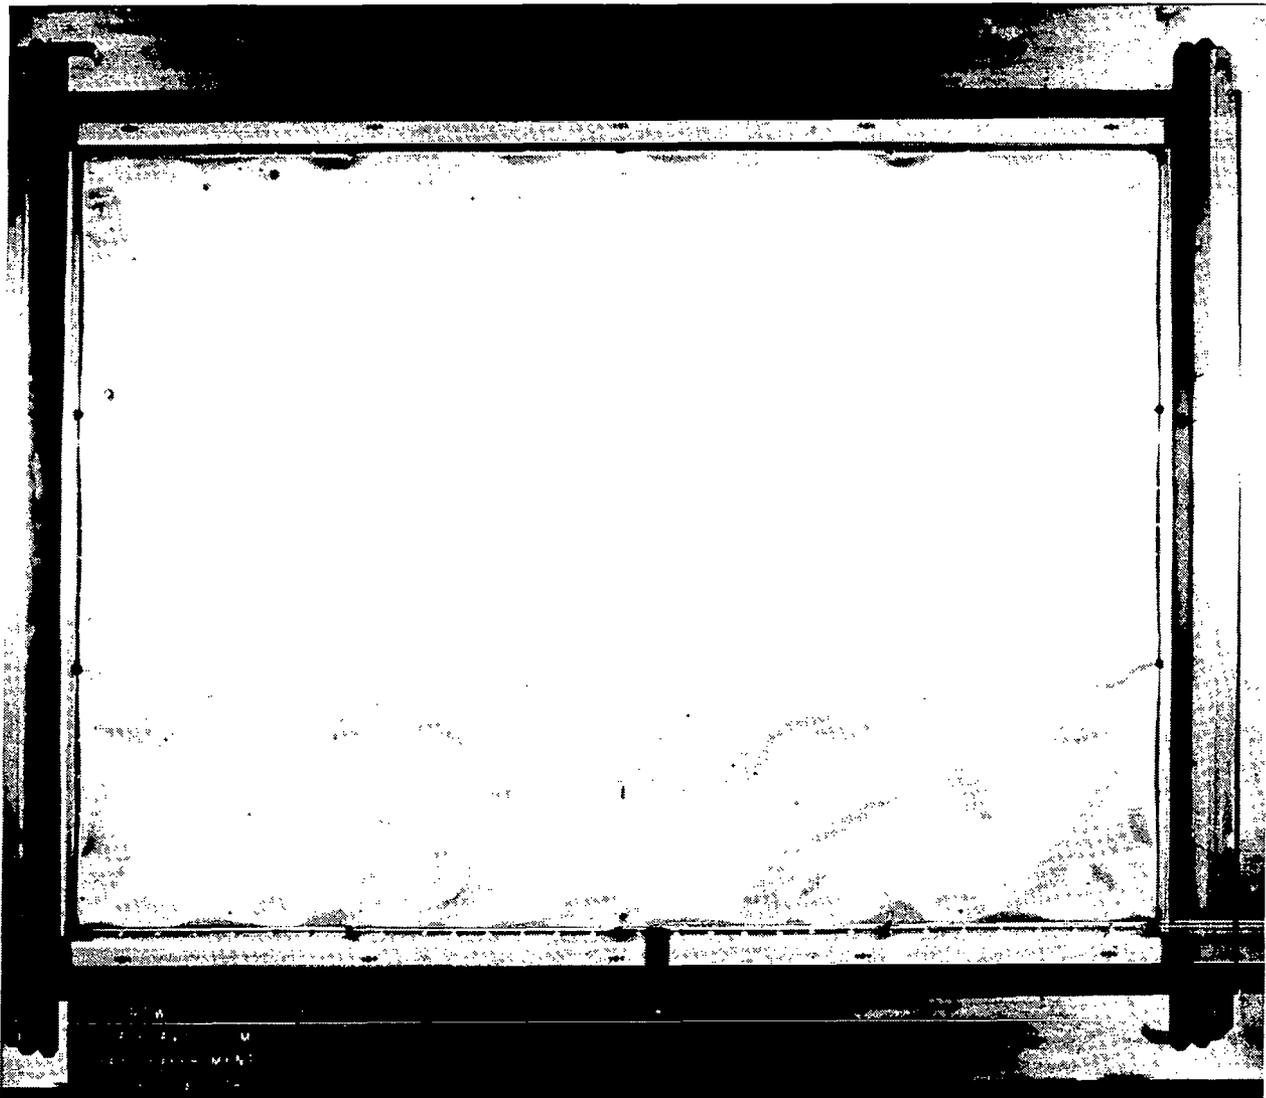
Figure C11-1. This post-deintegration view shows the front of the entire C11 experiment thermal blanket. Oxygen erosion has given the blanket a frosted appearance. The double impact feature in the center of the blanket is shown in Figure C11.

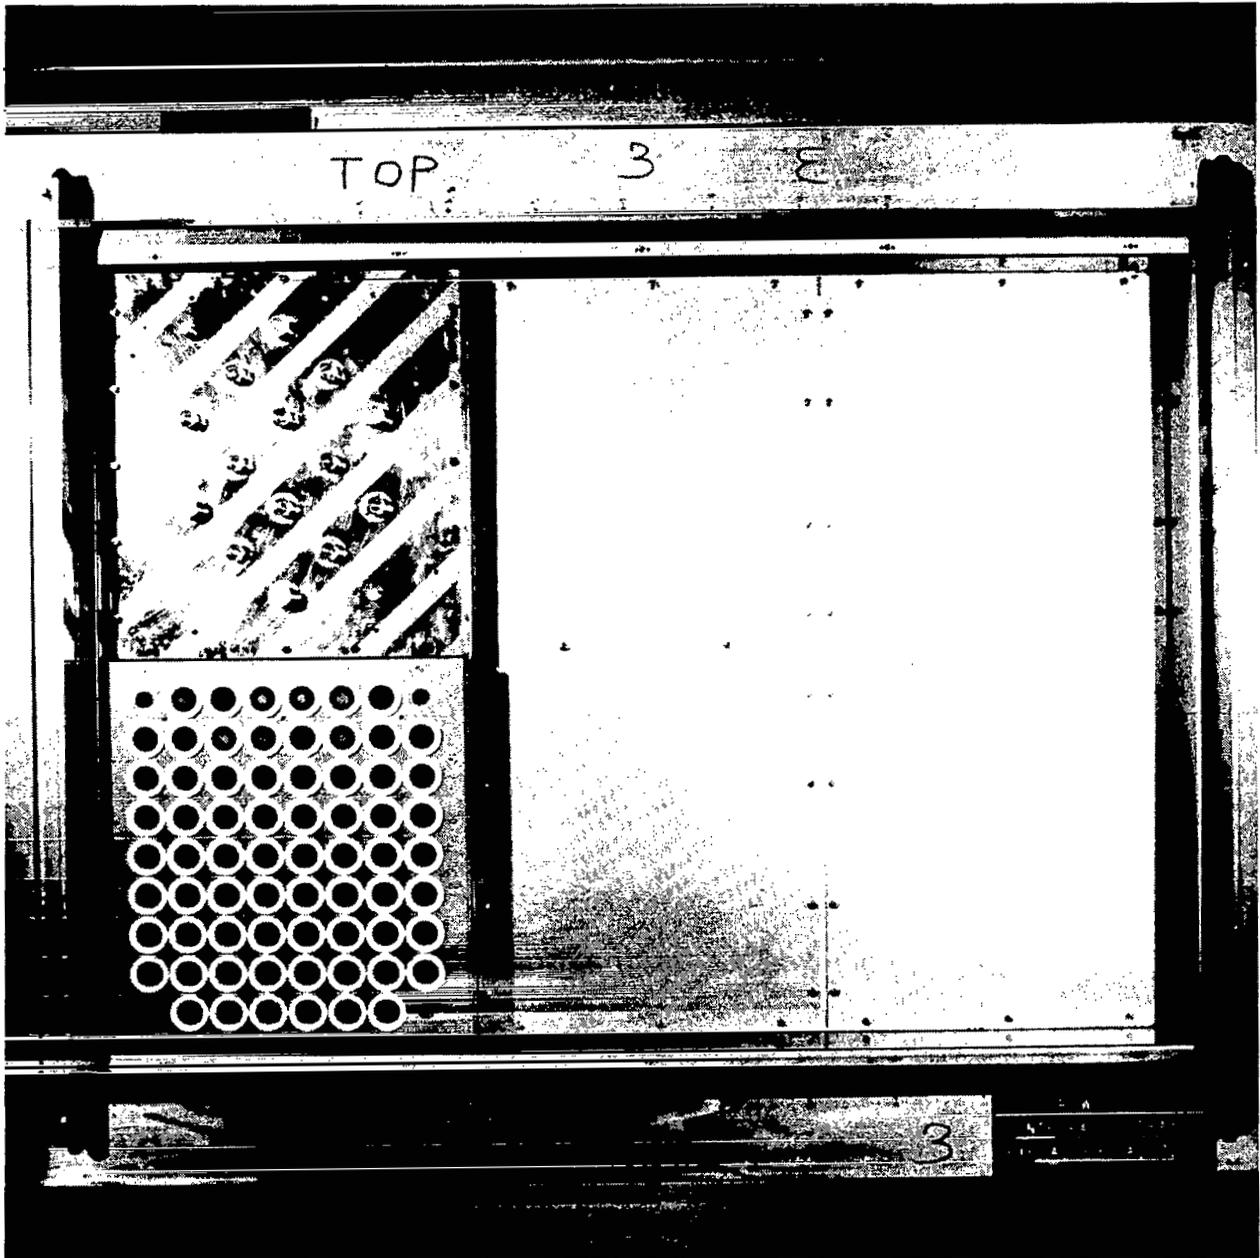
Figure D02-1. This post-deintegration view shows the front of the entire D02 integrated experiment tray.

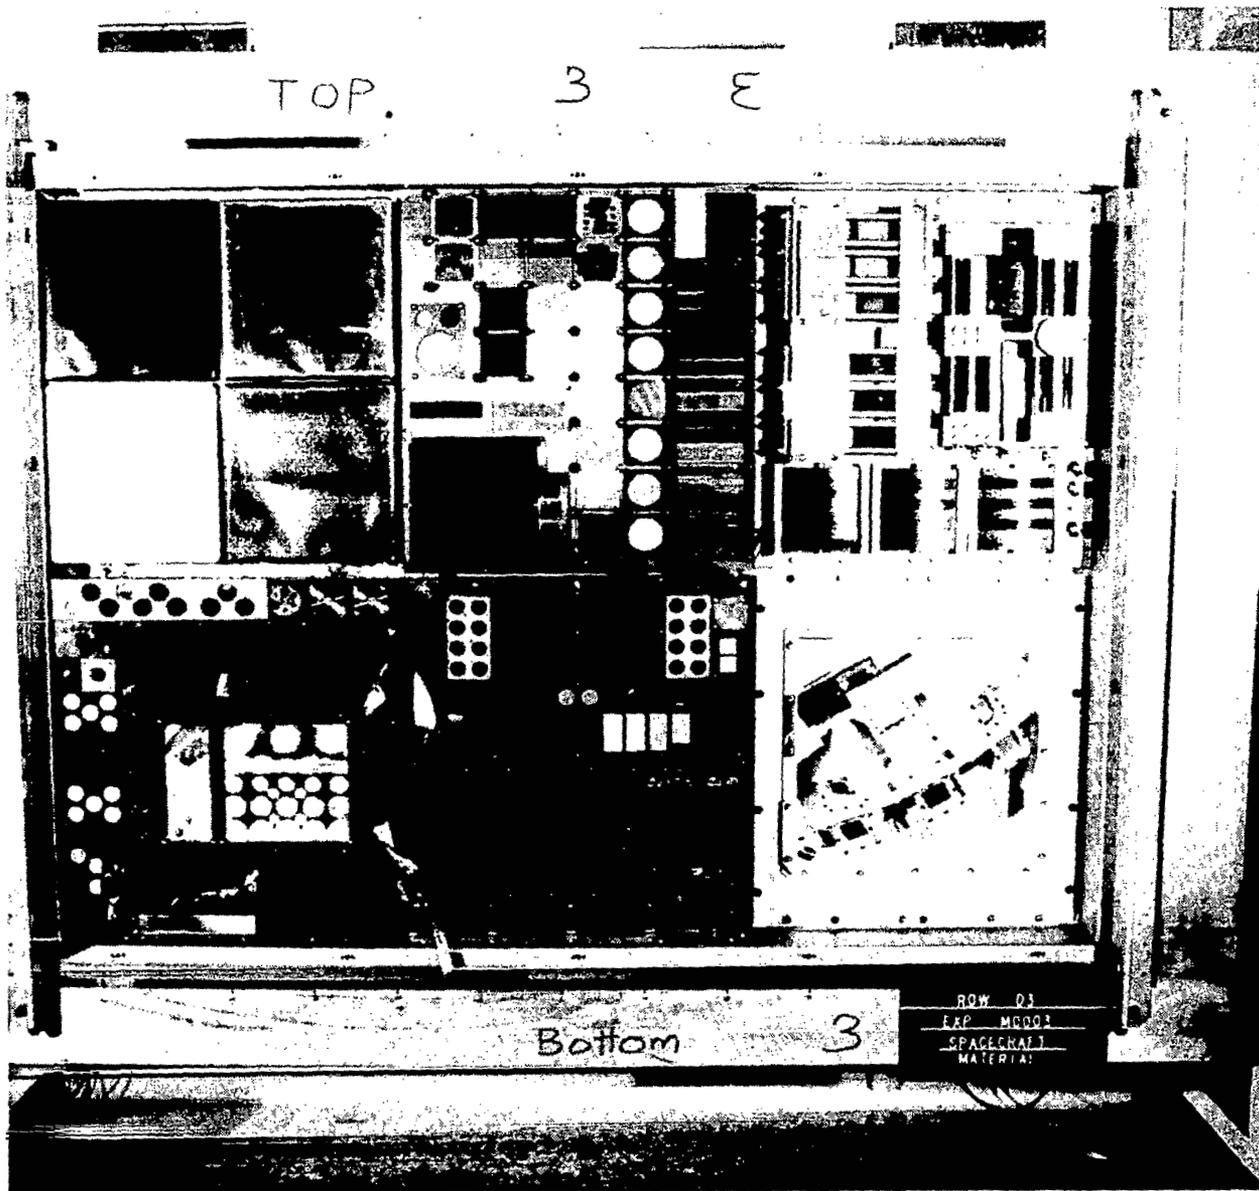
Figure D03-1. This post-deintegration view shows the front of the entire D03 experiment tray.

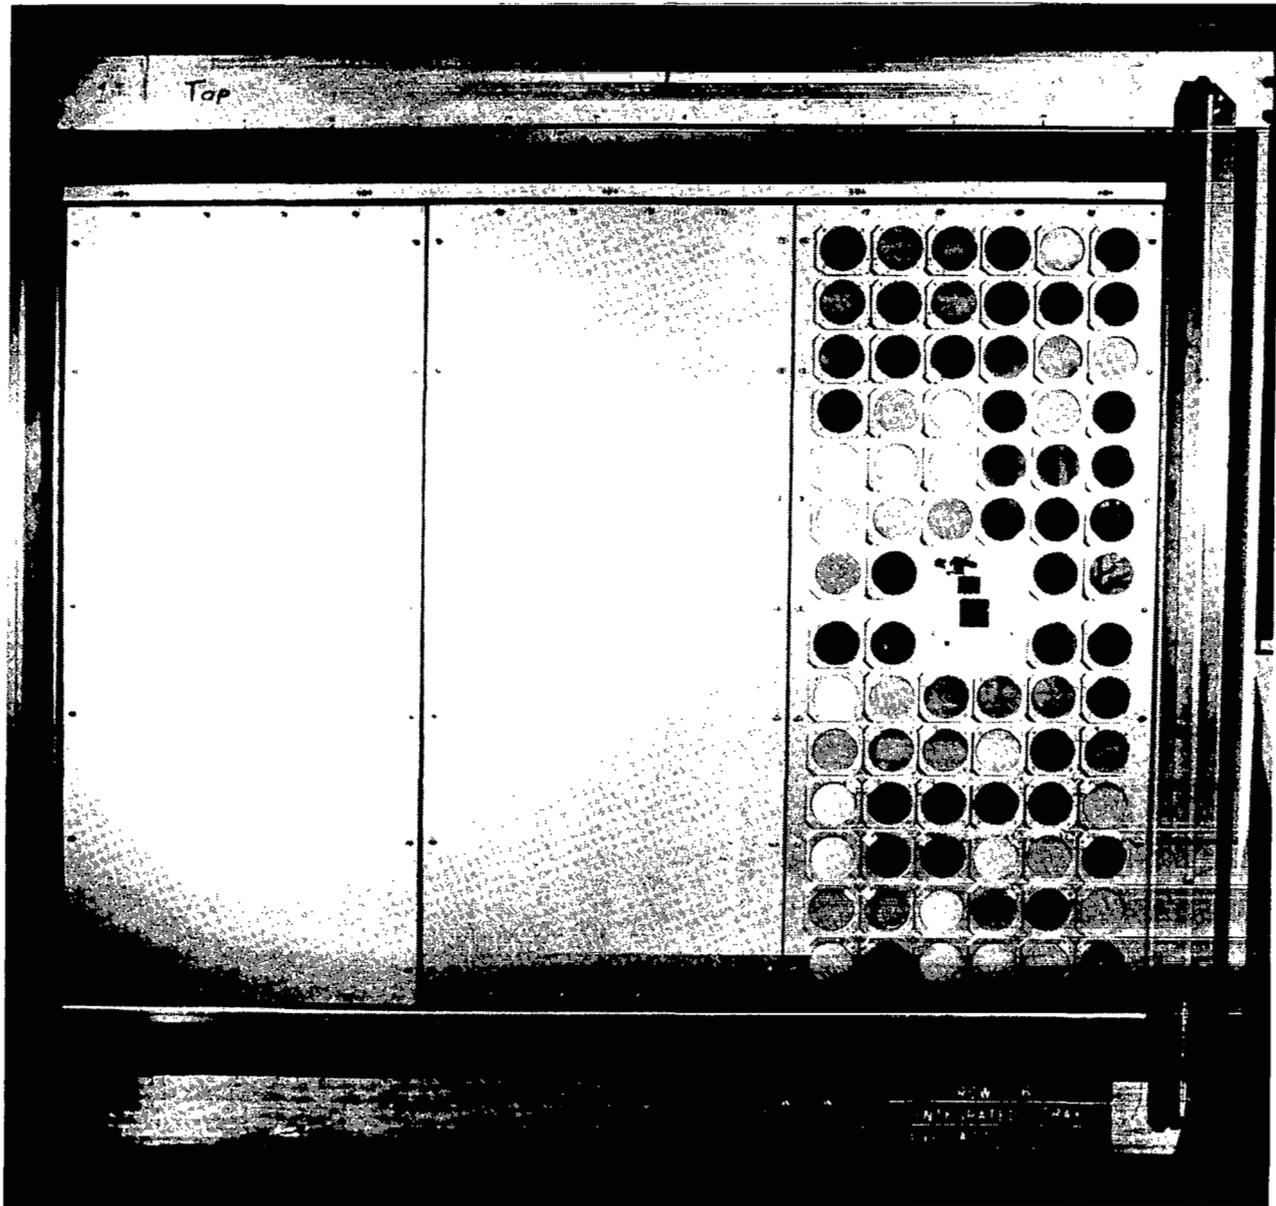
Figure D06-1. This post-deintegration view shows the front of the entire D06 experiment tray.

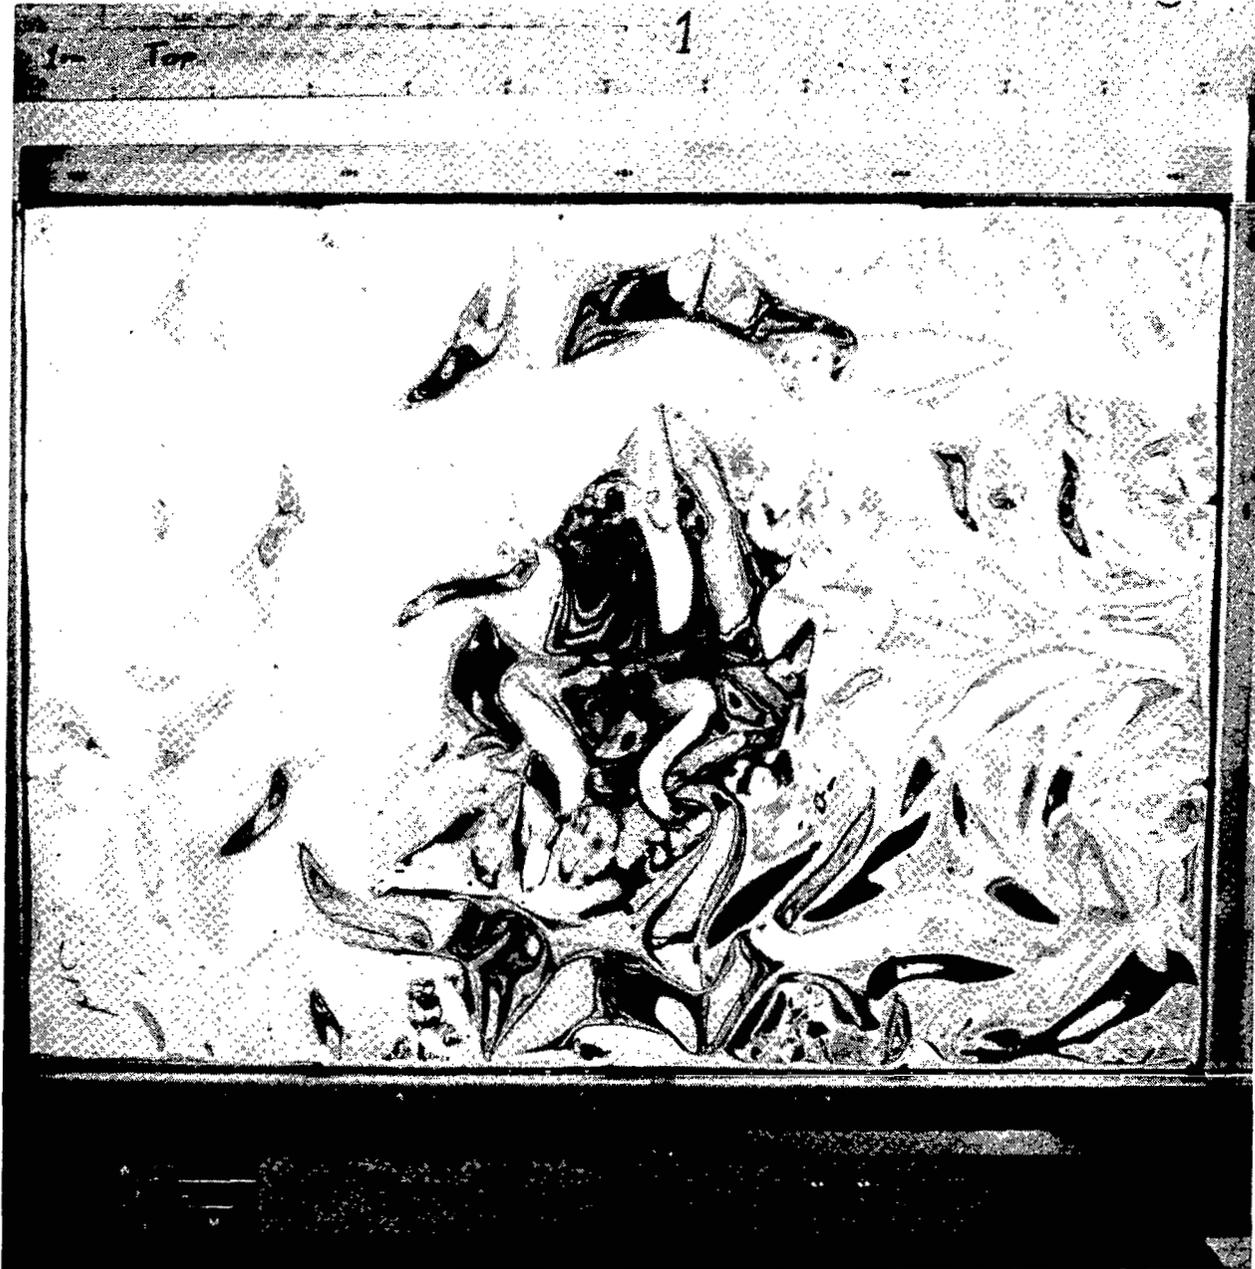
Figure D07-1. This post-deintegration view shows the front of the entire D07 experiment thermal blanket.

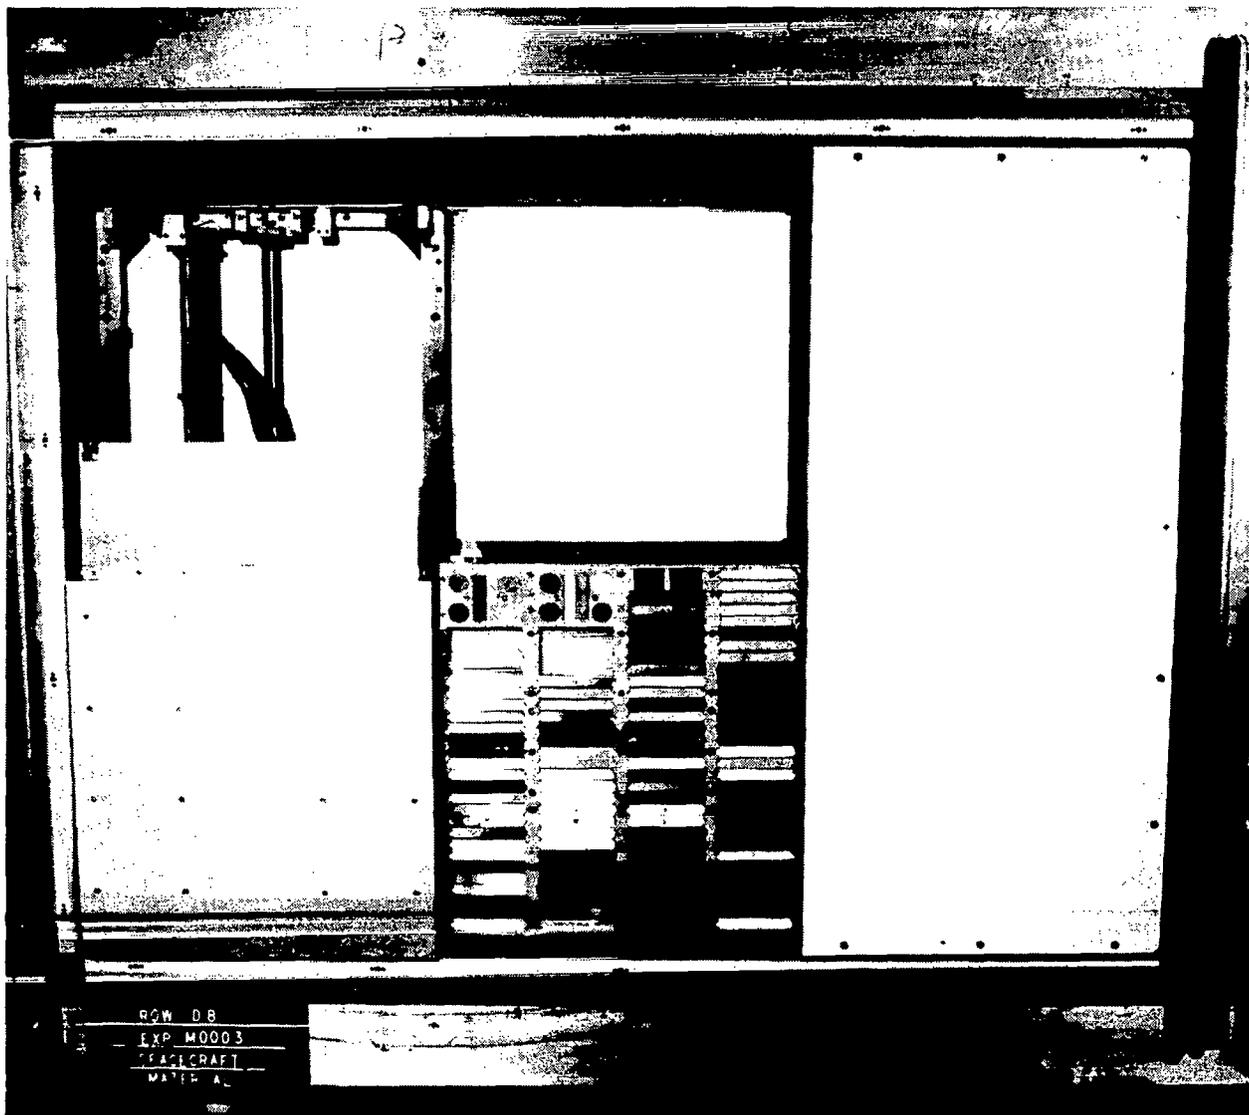
Figure D08-1. This post-deintegration view shows the front of the entire D08 experiment tray. The active canister is located on the left.

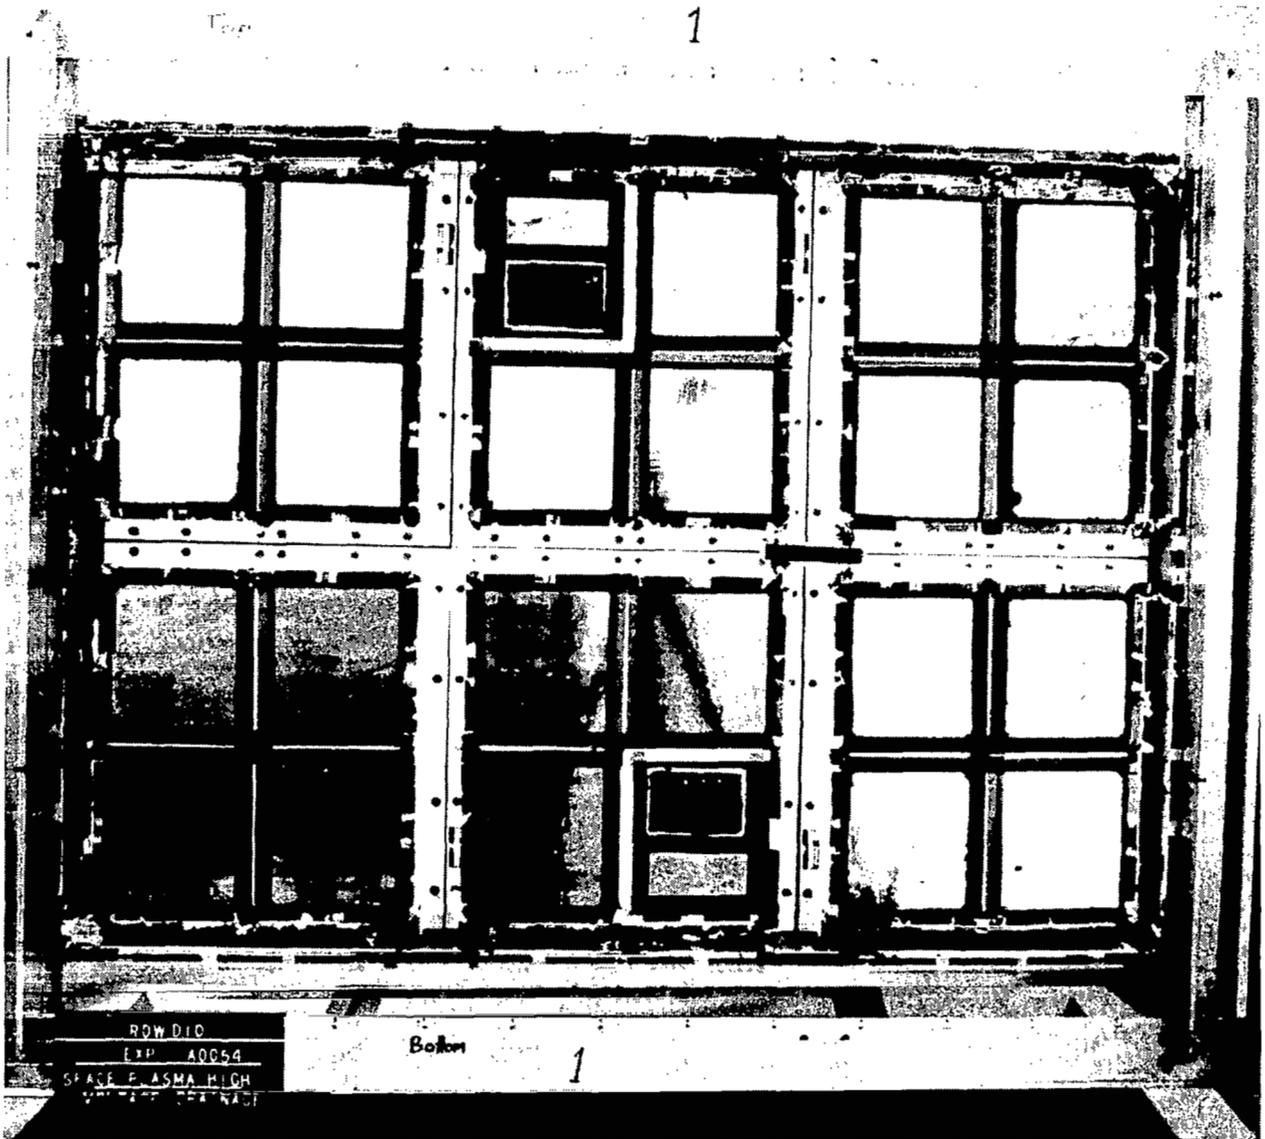
Figure D10-1. This post-deintegration view shows the front of the entire D10 experiment tray.

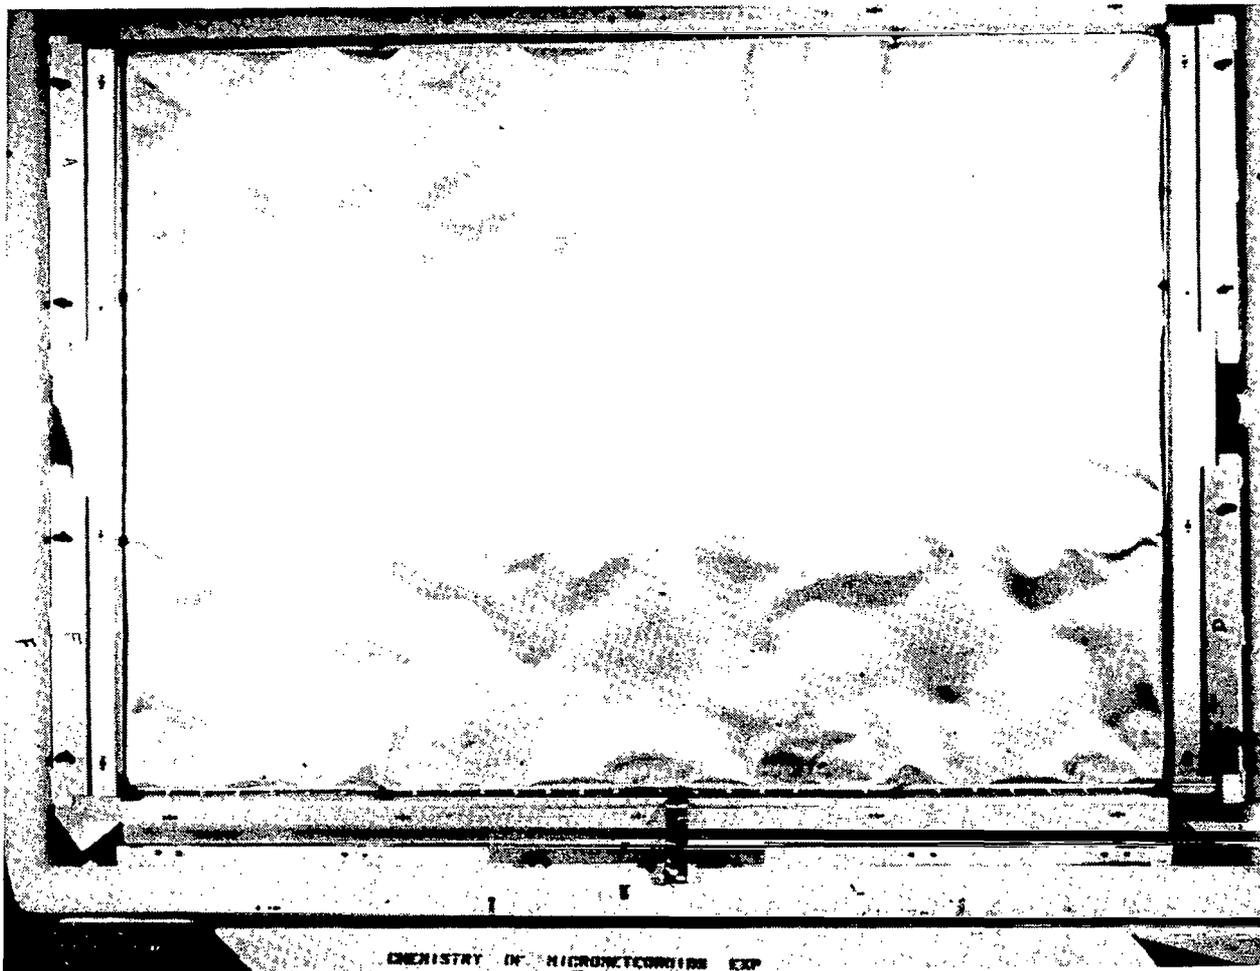
Figure D11-1. This post-deintegration view shows the front of the entire D11 experiment thermal blanket. Some impact features are apparent.
