METEOROID AND DEBRIS IMPACT FEATURES DOCUMENTED ON THE LONG DURATION EXPOSURE FACILITY

A Preliminary Report

Compiled by Members
of the LDEF Meteoroid
and Debris Special
Investigation Group

August 1990

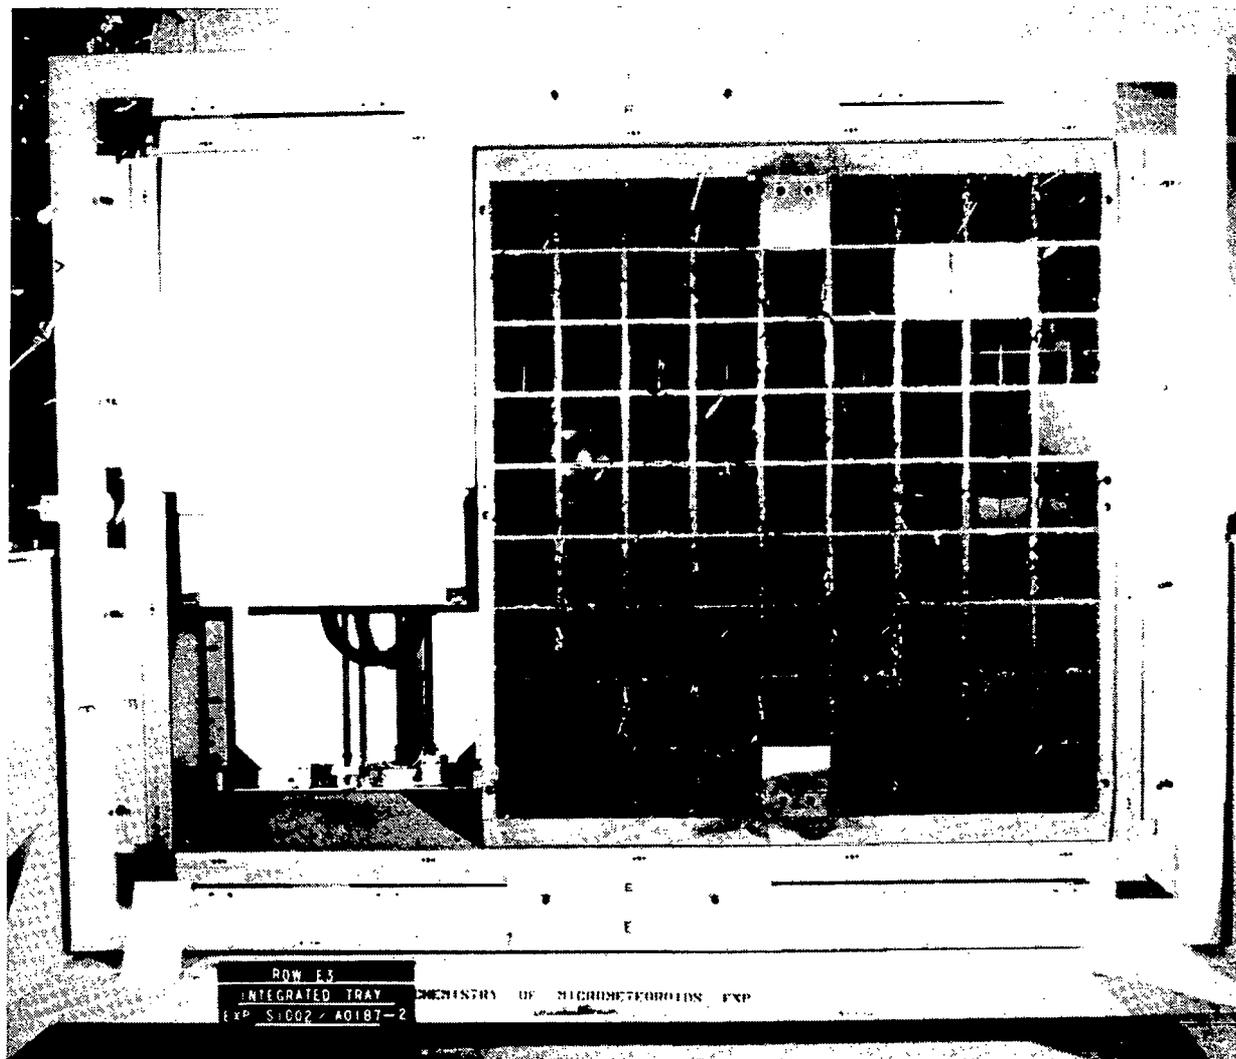
Figure E03-1. This post-deintegration view shows the front of the entire E03 experiment tray.

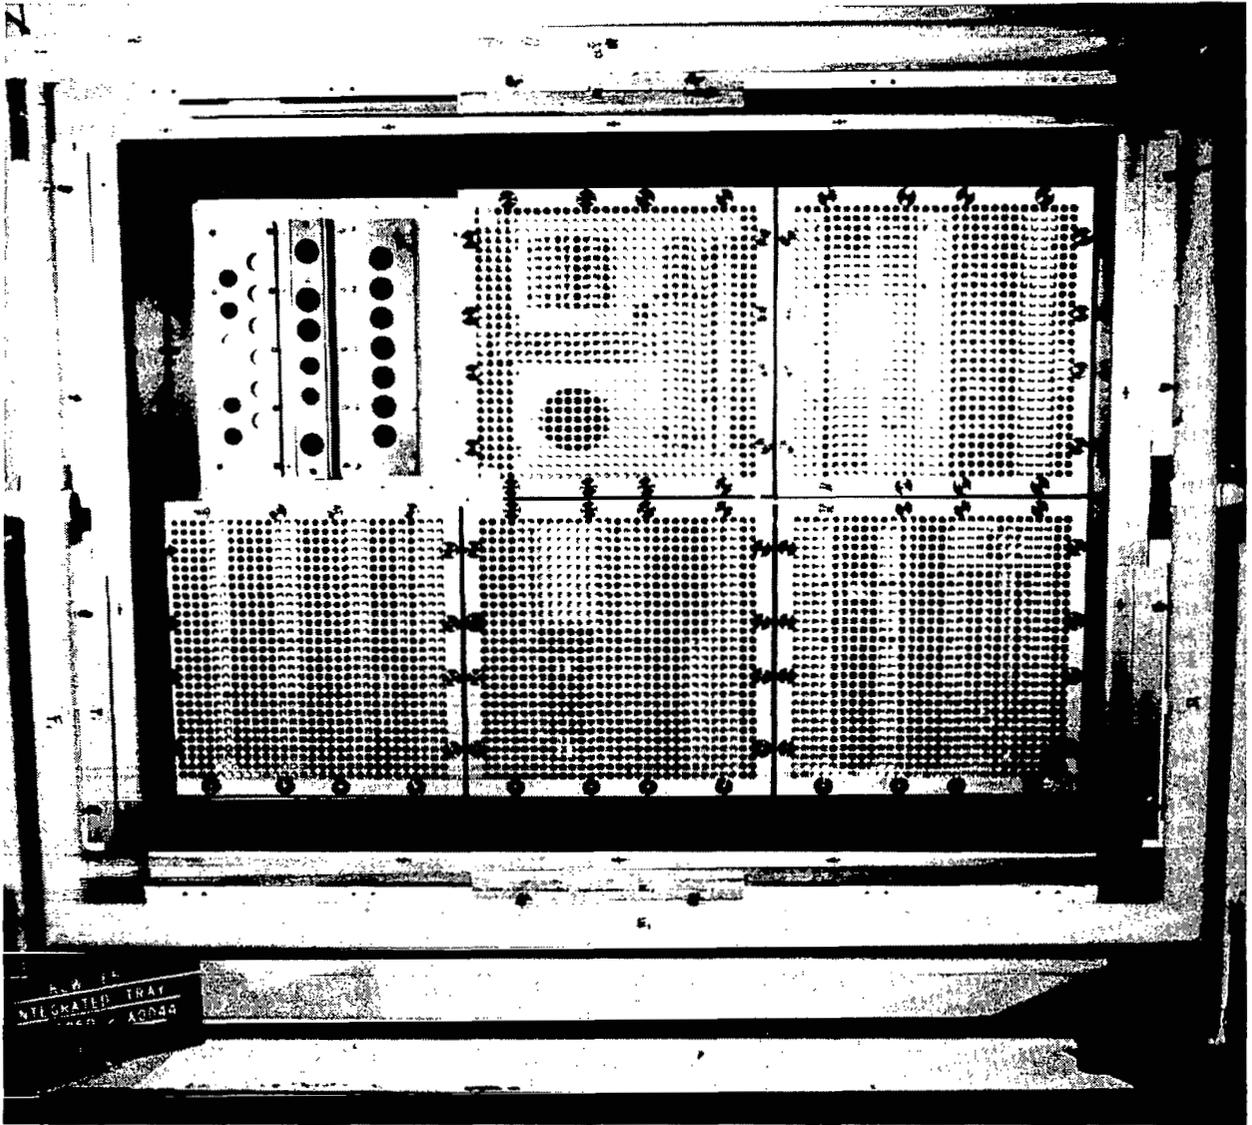
Figure E05-1. This post-deintegration view shows the front of the entire E05 experiment tray. Partially transparent aluminum "sunscreens" cover five-sixths of the tray. The tray elements below these sunscreens were not surveyed by the M&D SIG at KSC in 1990.

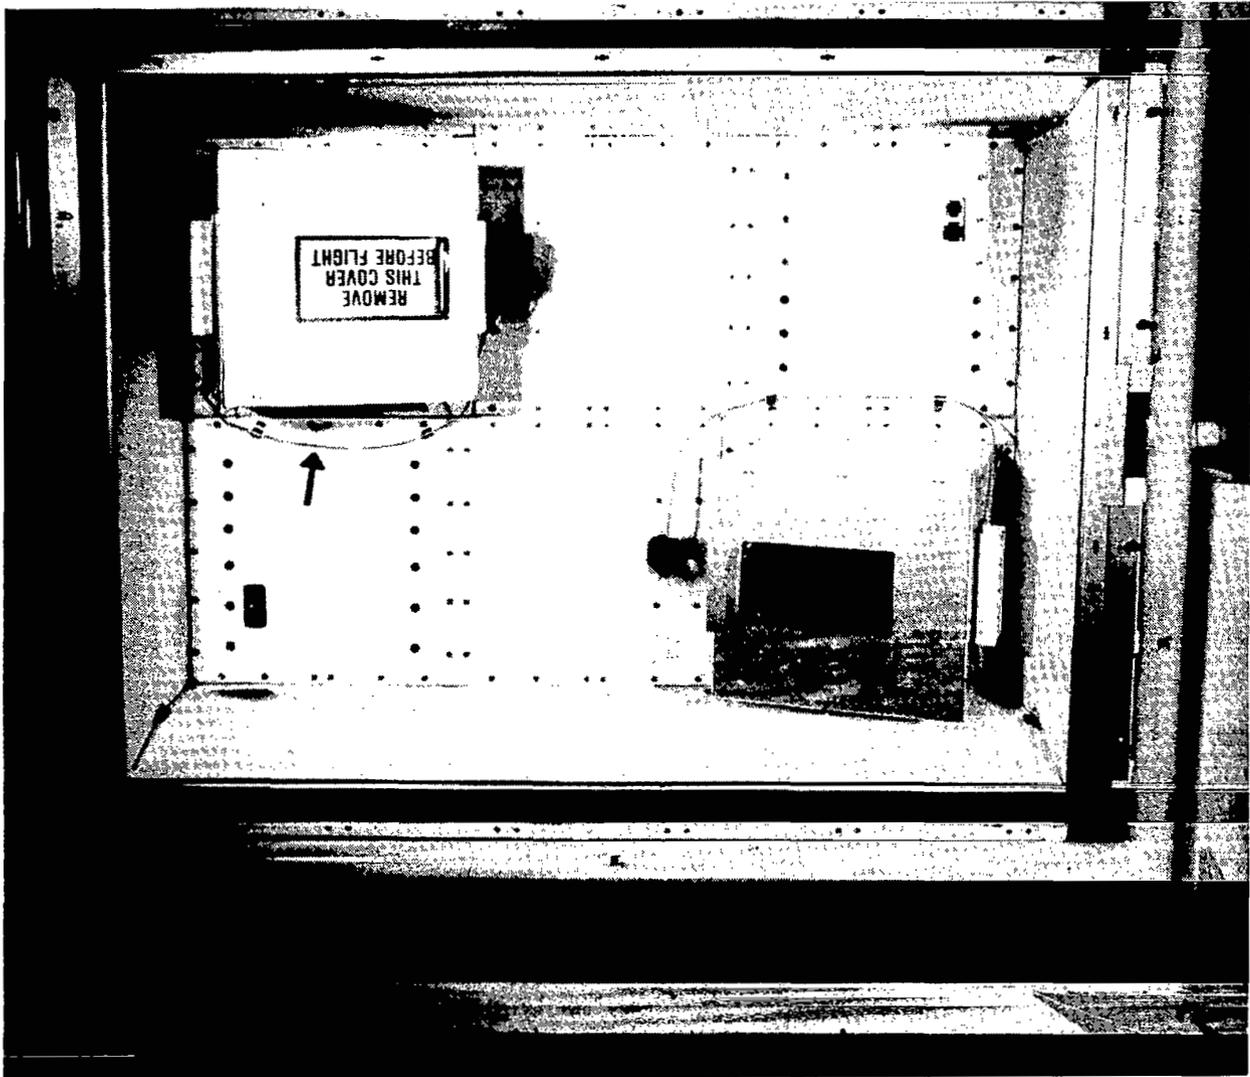
Figure E12-1. This post-deintegration view shows the front of the entire E12 experiment tray. The space-exposed interstellar gas collector foils have been covered in this view. An arrow points to the impact feature (#8) shown in Figure E12-2.

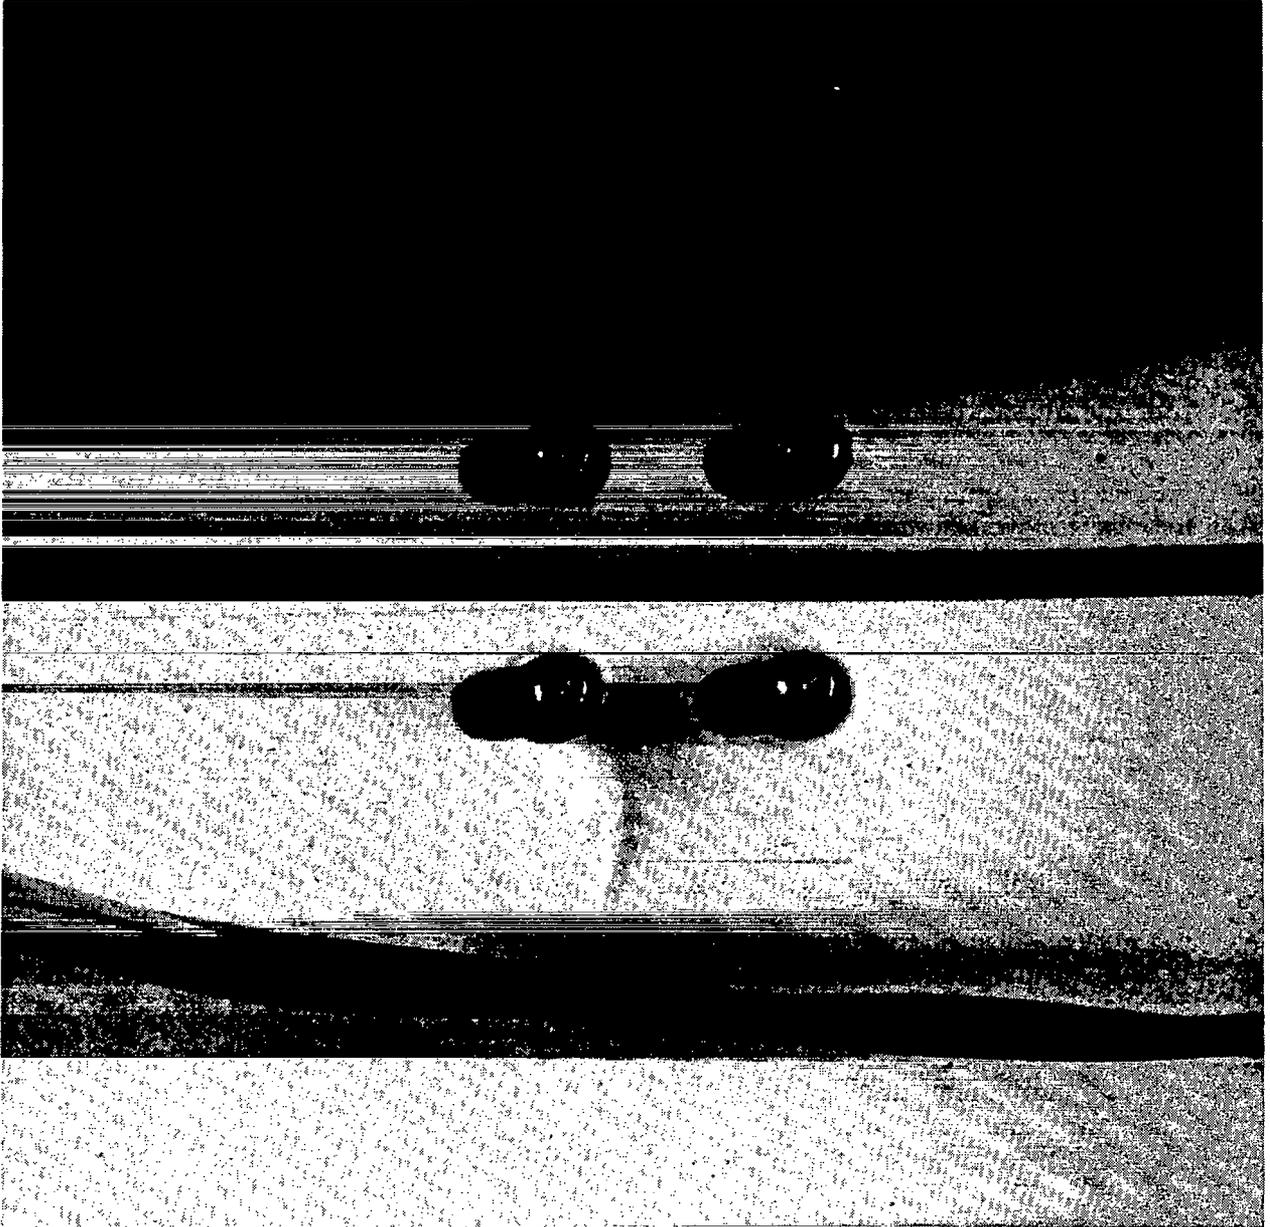
Figure E12-2. This view shows an ejecta spall pattern resulting from an impact (#8) into the lower left bolt head. View measures approximately 11 cm across.

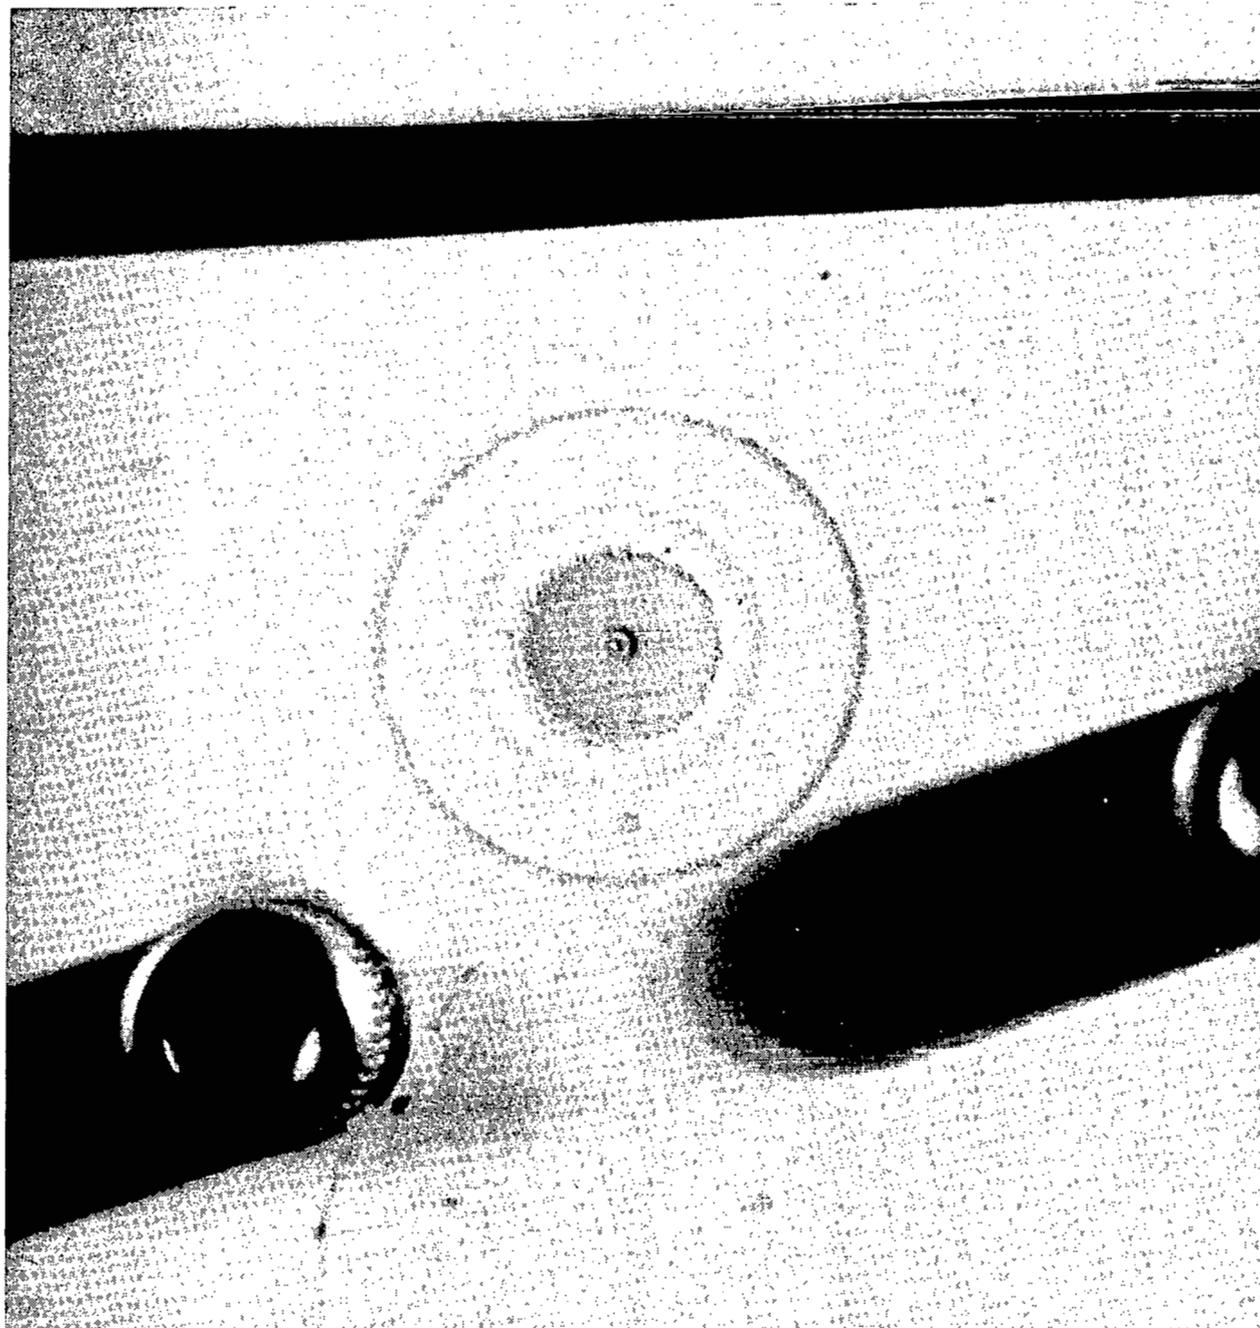
Figure F08-3. A concentrically-ringed impact feature into the white-painted aluminum surface. View measures approximately 4 cm across.

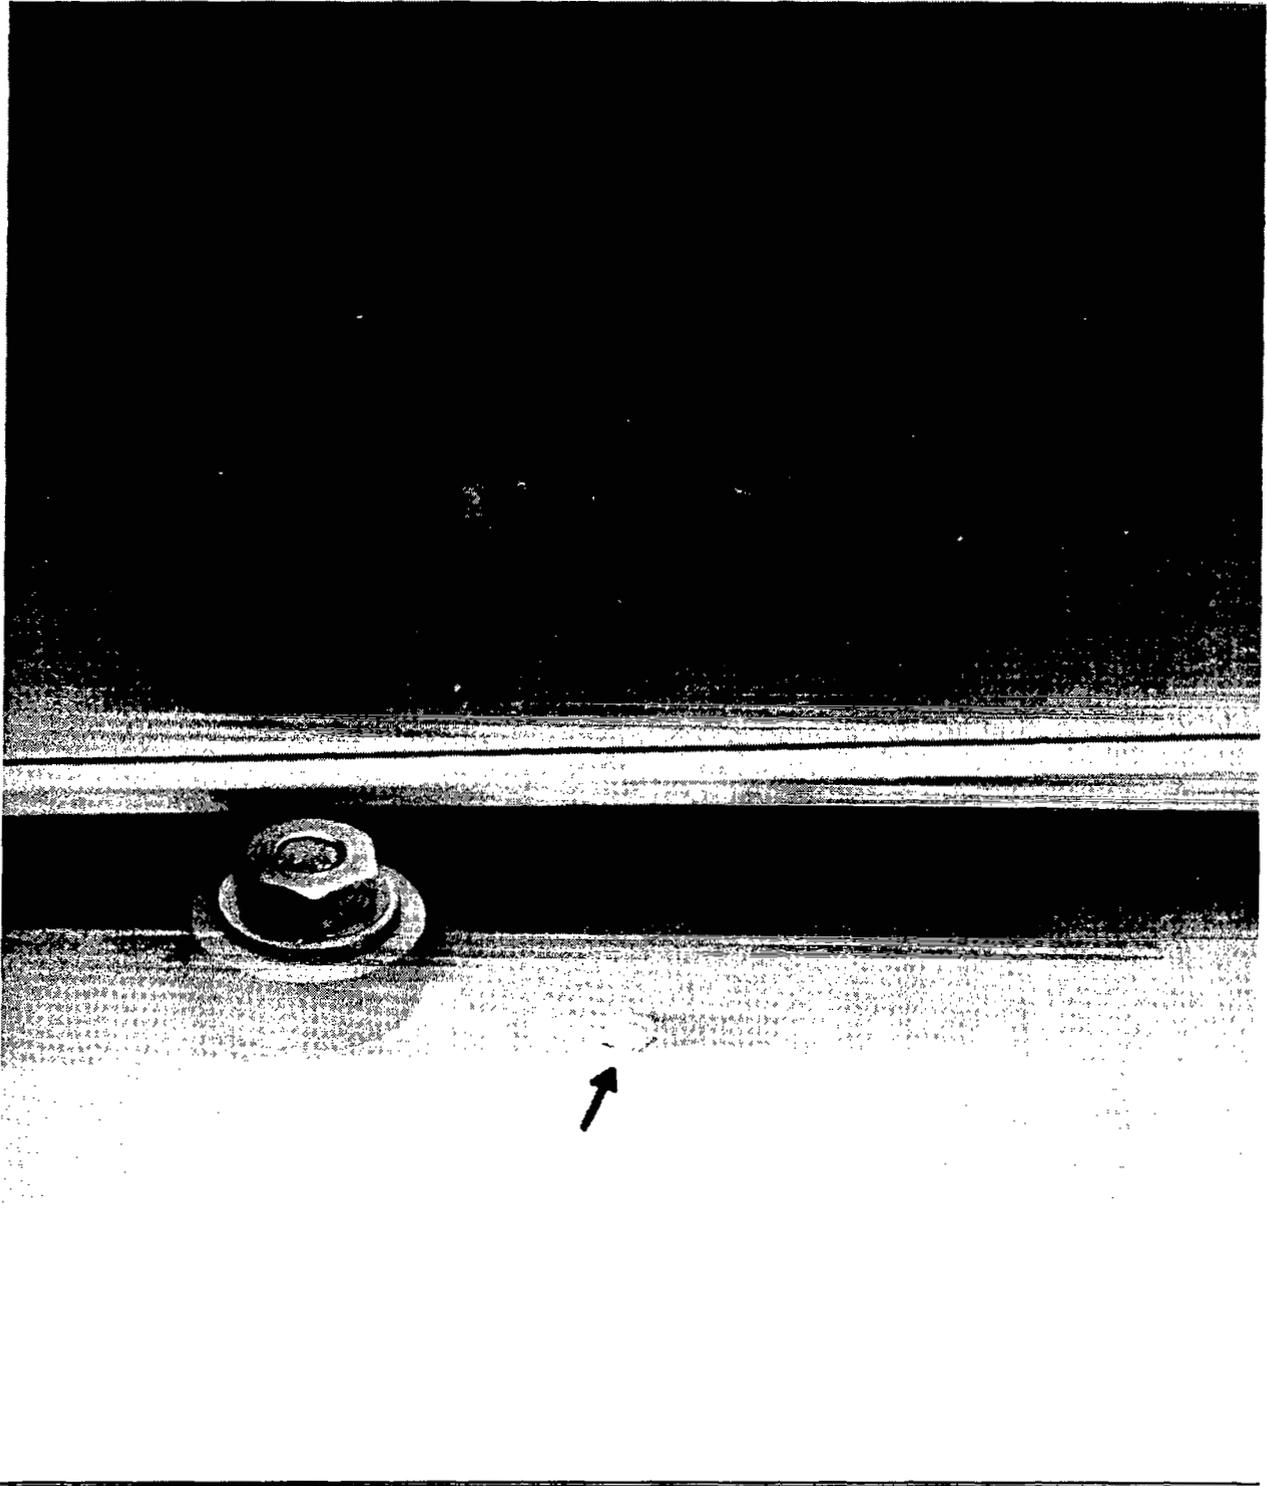
- Figure H09-1. This post-deintegration view shows the front of the entire H09 experiment tray. The space-exposed interstellar-gas collector foils have been covered in this view.
- Figure H09-2. View of a crater (indicated by arrow) located in aluminum with a large adjacent ejecta pattern. The feature was located inside one of the detector housings. This view measures approximately 12 cm across.

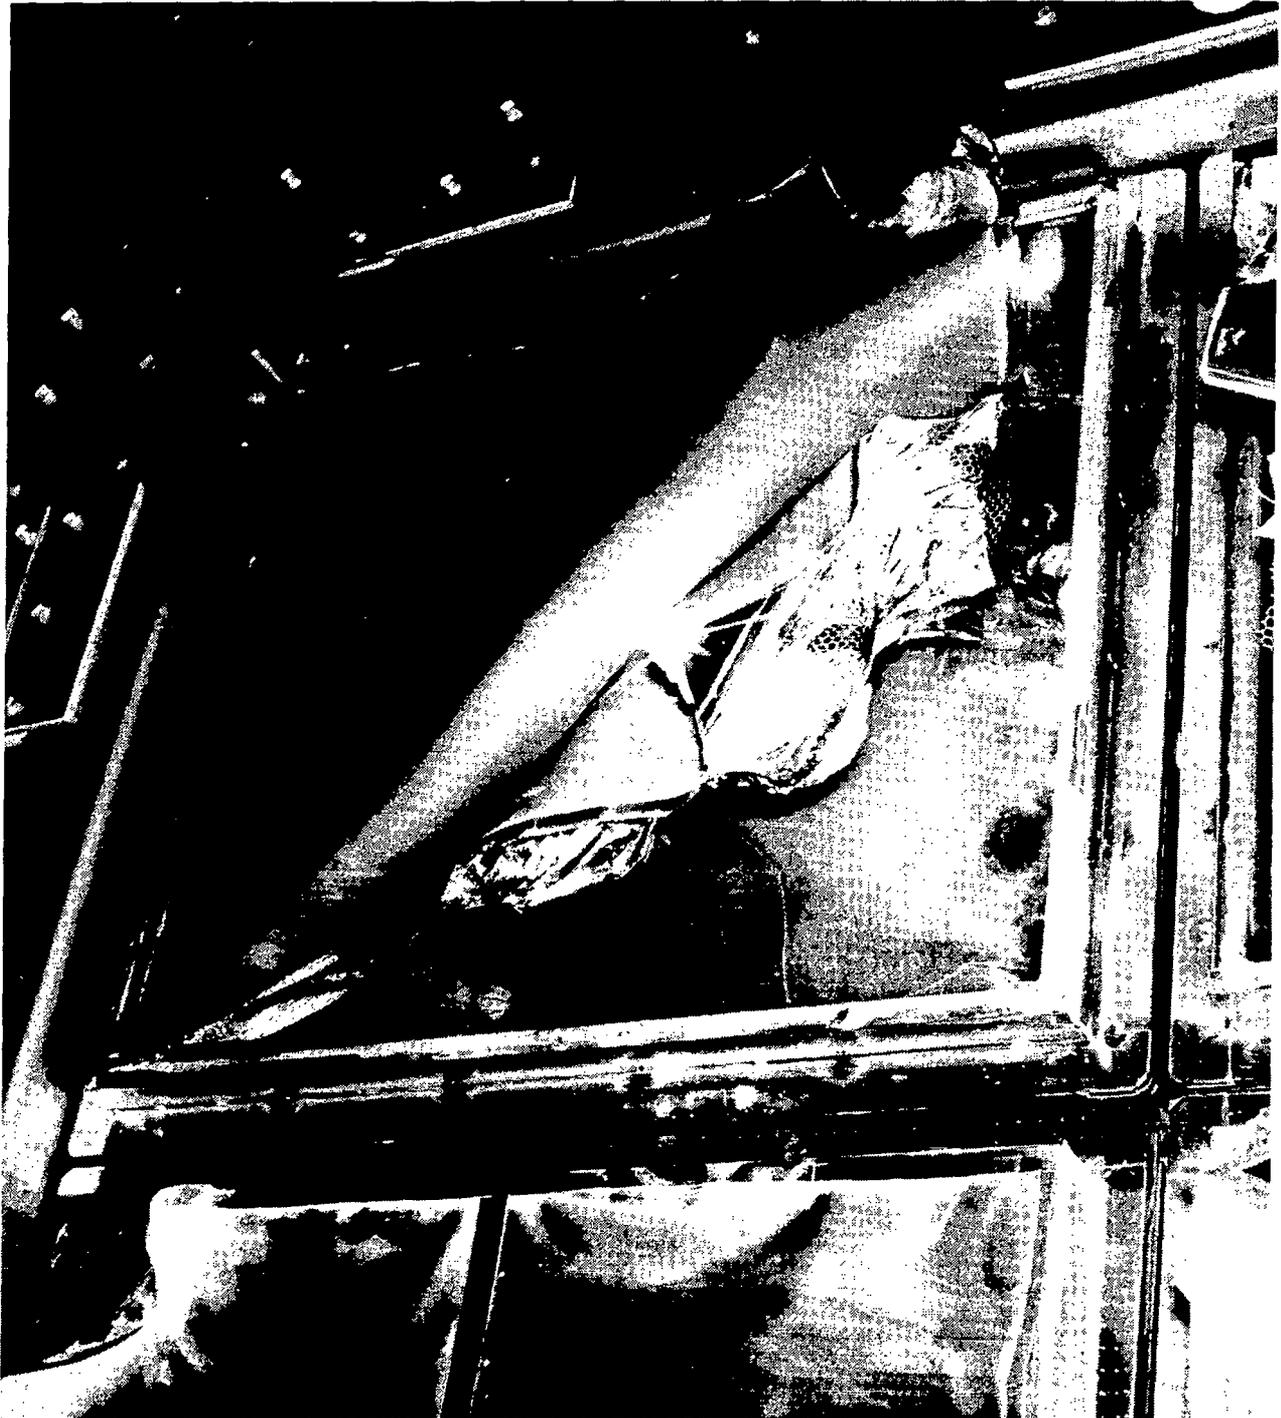
Figure H12-2. This pre-deintegration view shows one module of tray H12 with the thermal blanket partially peeled back exposing the lexan detector stack below.
