# Debris/Ice/TPS Assessment And Integrated Photographic Analysis For Shuttle Mission STS-47

November 1992

**Gregory N. Katnik**  
**NASA/Kennedy Space Center**

DEBRIS/ICE/TPS ASSESSMENT  
AND  
PHOTOGRAPHIC ANALYSIS  
OF  
SHUTTLE MISSION STS-47

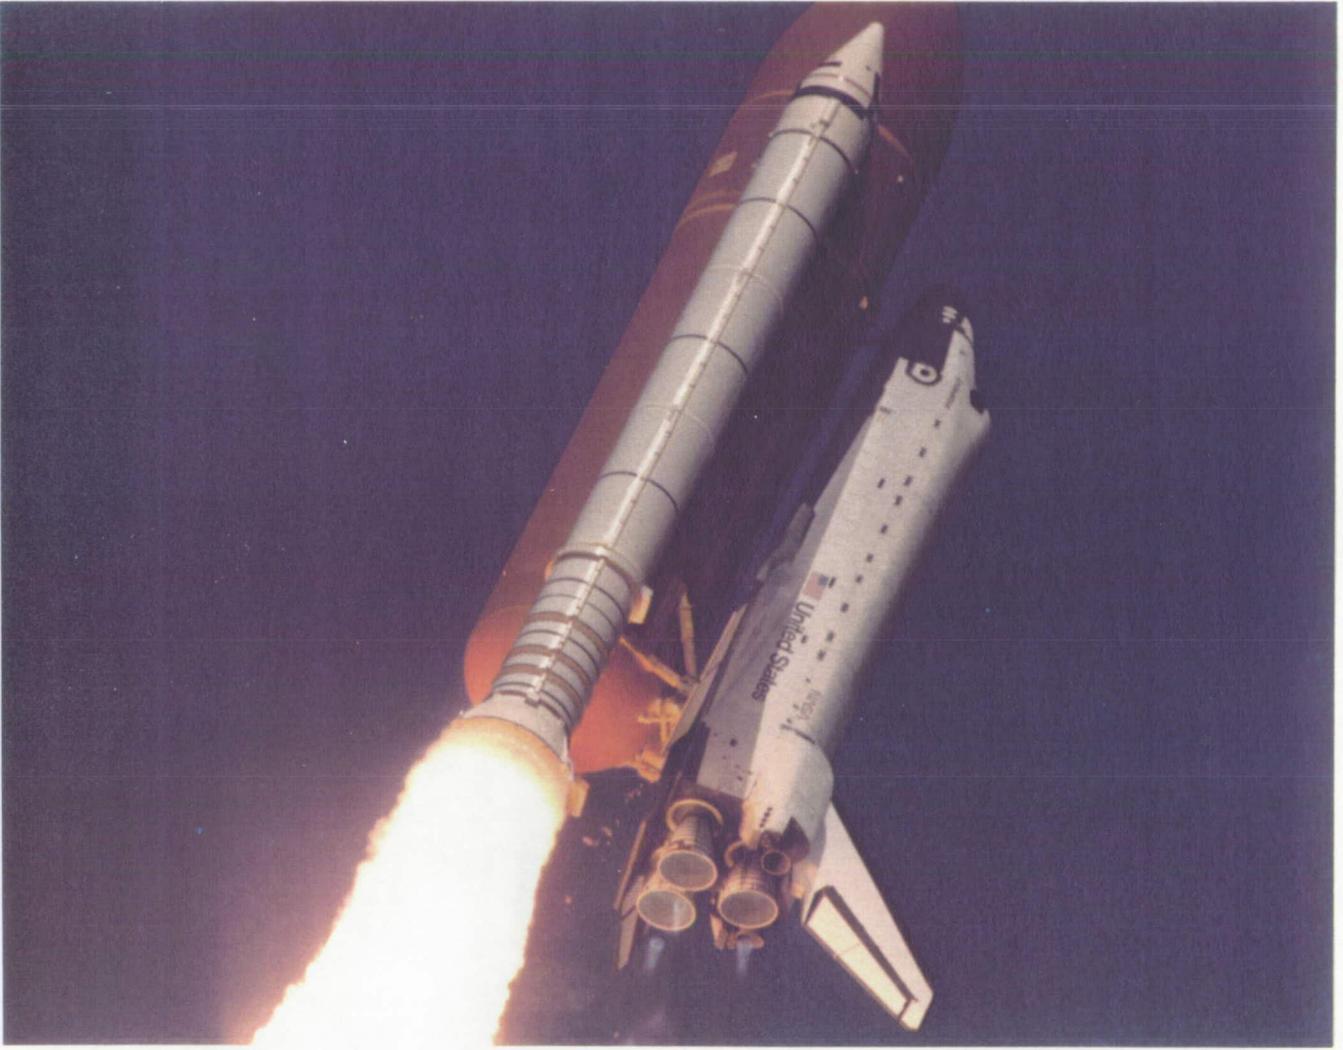
Clusters of particles falling aft of the Orbiter shortly after completion of the roll maneuver were pieces of the LH2 and L02 ET/ORB umbilical purge barrier (baggie) material. Loss of the purge barrier during flight is a common and expected occurrence

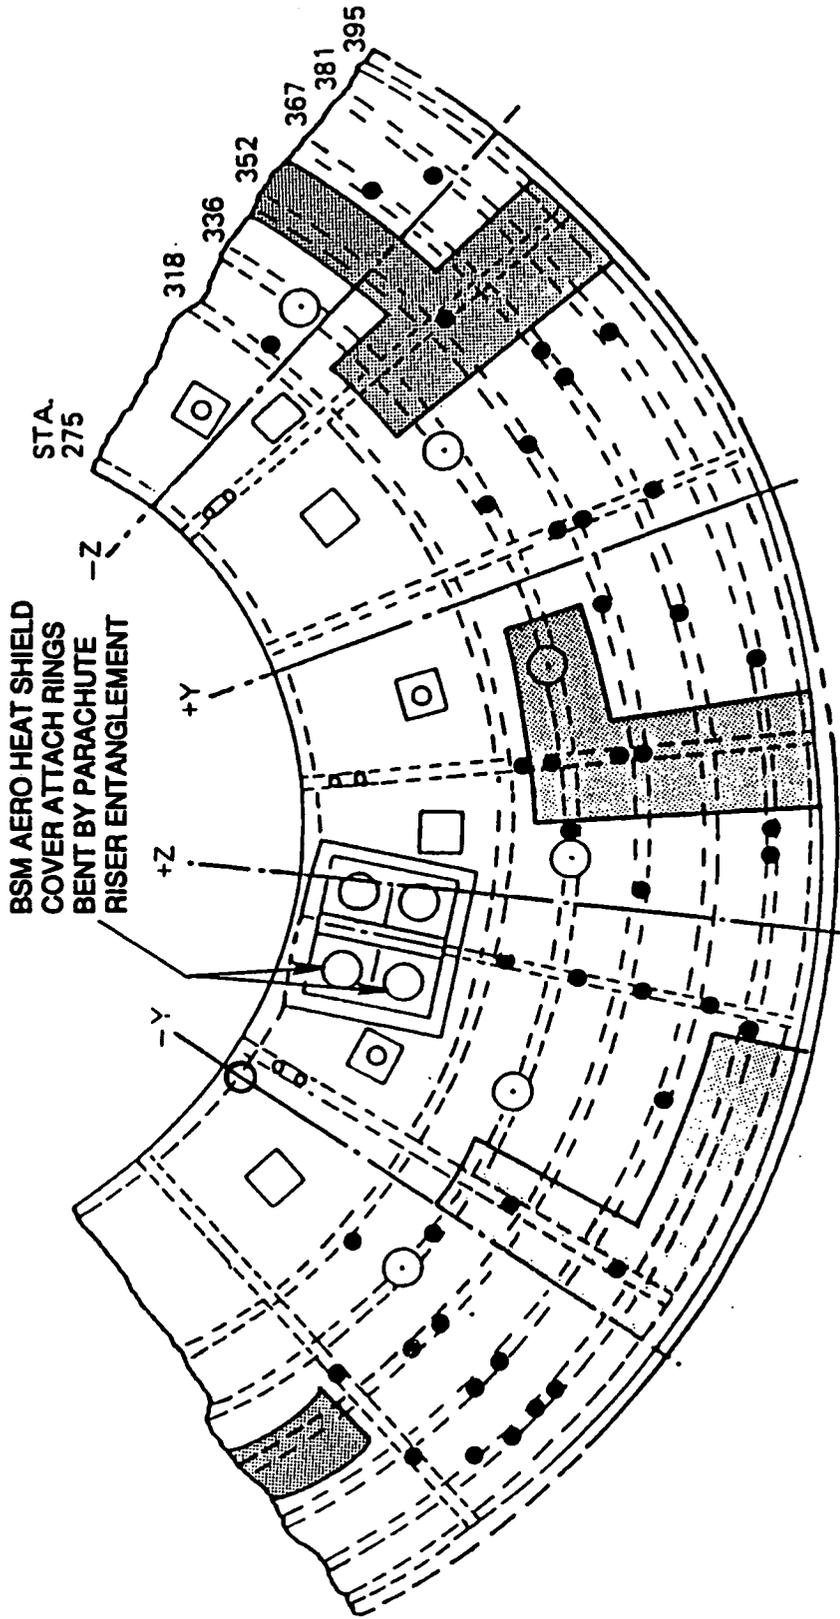
Figure 4. RIGHT SRB FRUSTUM

The Solid Rocket Boosters were inspected at Hanger AF after retrieval. The RH frustum had 42 MSA-2 debonds over fasteners and one 2-inch diameter area of missing TPS on the -Y axis at the 275 ring frame. The LH frustum had 25 MSA-2 debonds over fasteners and was missing MSA-2 (1.5-inch diameter) from one location between the +Y and +Z axes on the 381 ring frame. A 6" x 3" piece of K5NA was missing from the aft stiffener ring. Though the remaining material showed signs of delamination, the surfaces were not sooted indicating the material was most likely lost at water impact. All Debris Containment System (DCS) plungers were seated properly. Pieces of EPON shim were missing from HDP #4 and HDP #7. The material was lost prior to water impact and exhibited a sooted/charred substrate.

MINOR LOCALIZED BLISTERING  
OF HYPALON PAINT ALONG 395 RING

MISSING TPS

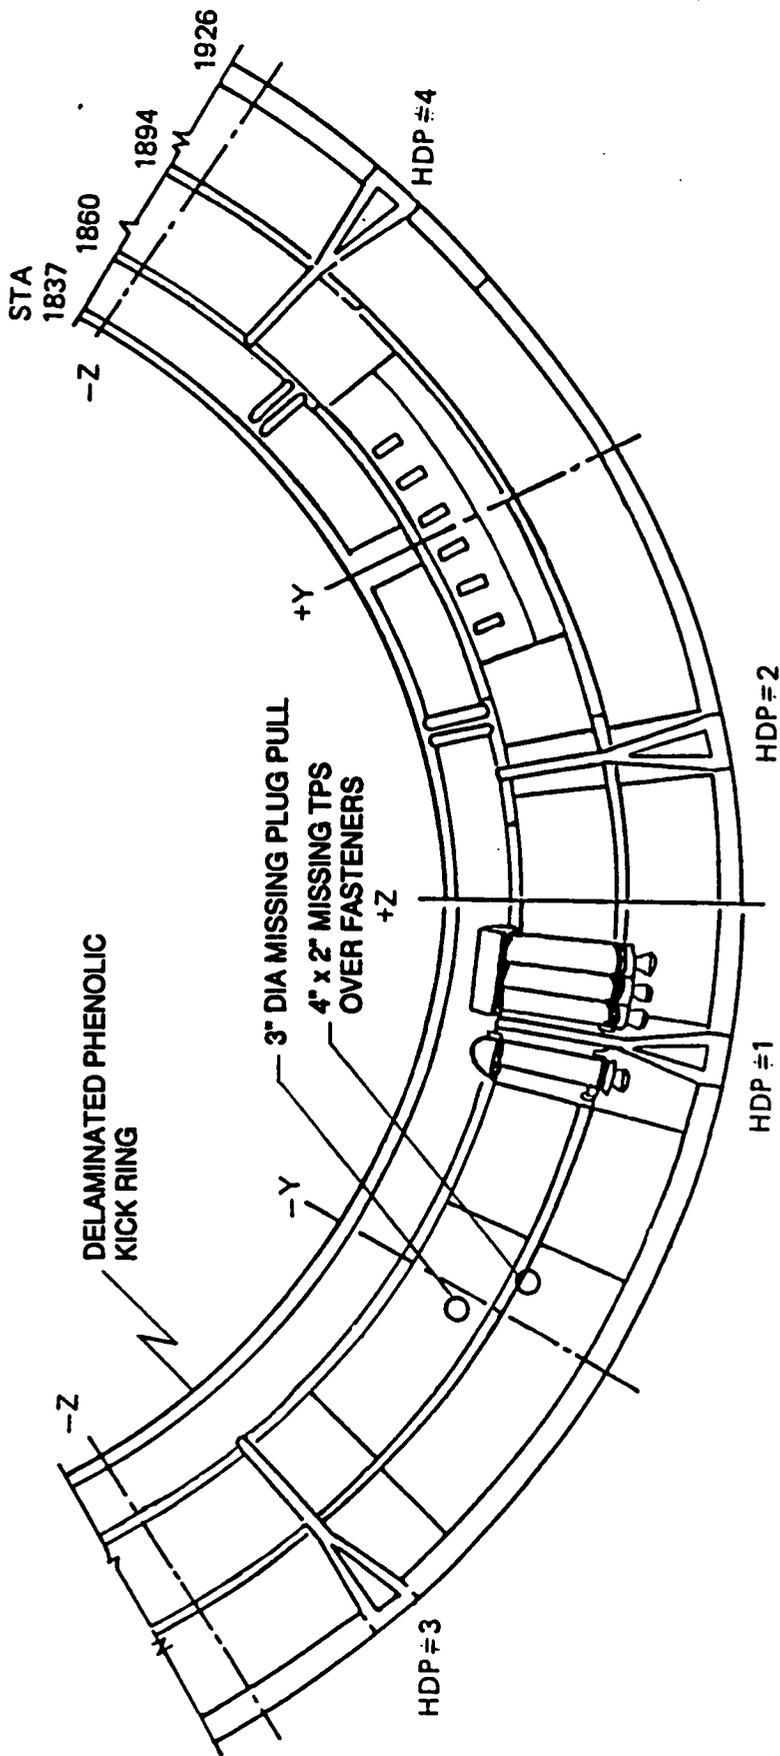
Figure 6. RIGHT SRB AFT SKIRT EXTERIOR TPS

The phenolic material on the kick ring was delaminated. The K5NA closeouts (protective domes) on the kick ring forward and aft fasteners had been eliminated. RTV-133 replaced the K5NA over the forward fasteners. Three divots, measuring 3" in diameter, 4"x2", and 4"x2", had occurred on the aft skirt TPS (Figure 6).

All Debris Containment System (DCS) plungers were seated properly. This was the tenth flight utilizing the optimized link. Pieces of EPON shim were missing from HDP #4 (3-inch diameter) and HDP #3 (2-inch diameter). The material was lost prior to water impact (sooted/charred substrate).

ALL DCS PLUNGERS  
PROPERLY SEATED

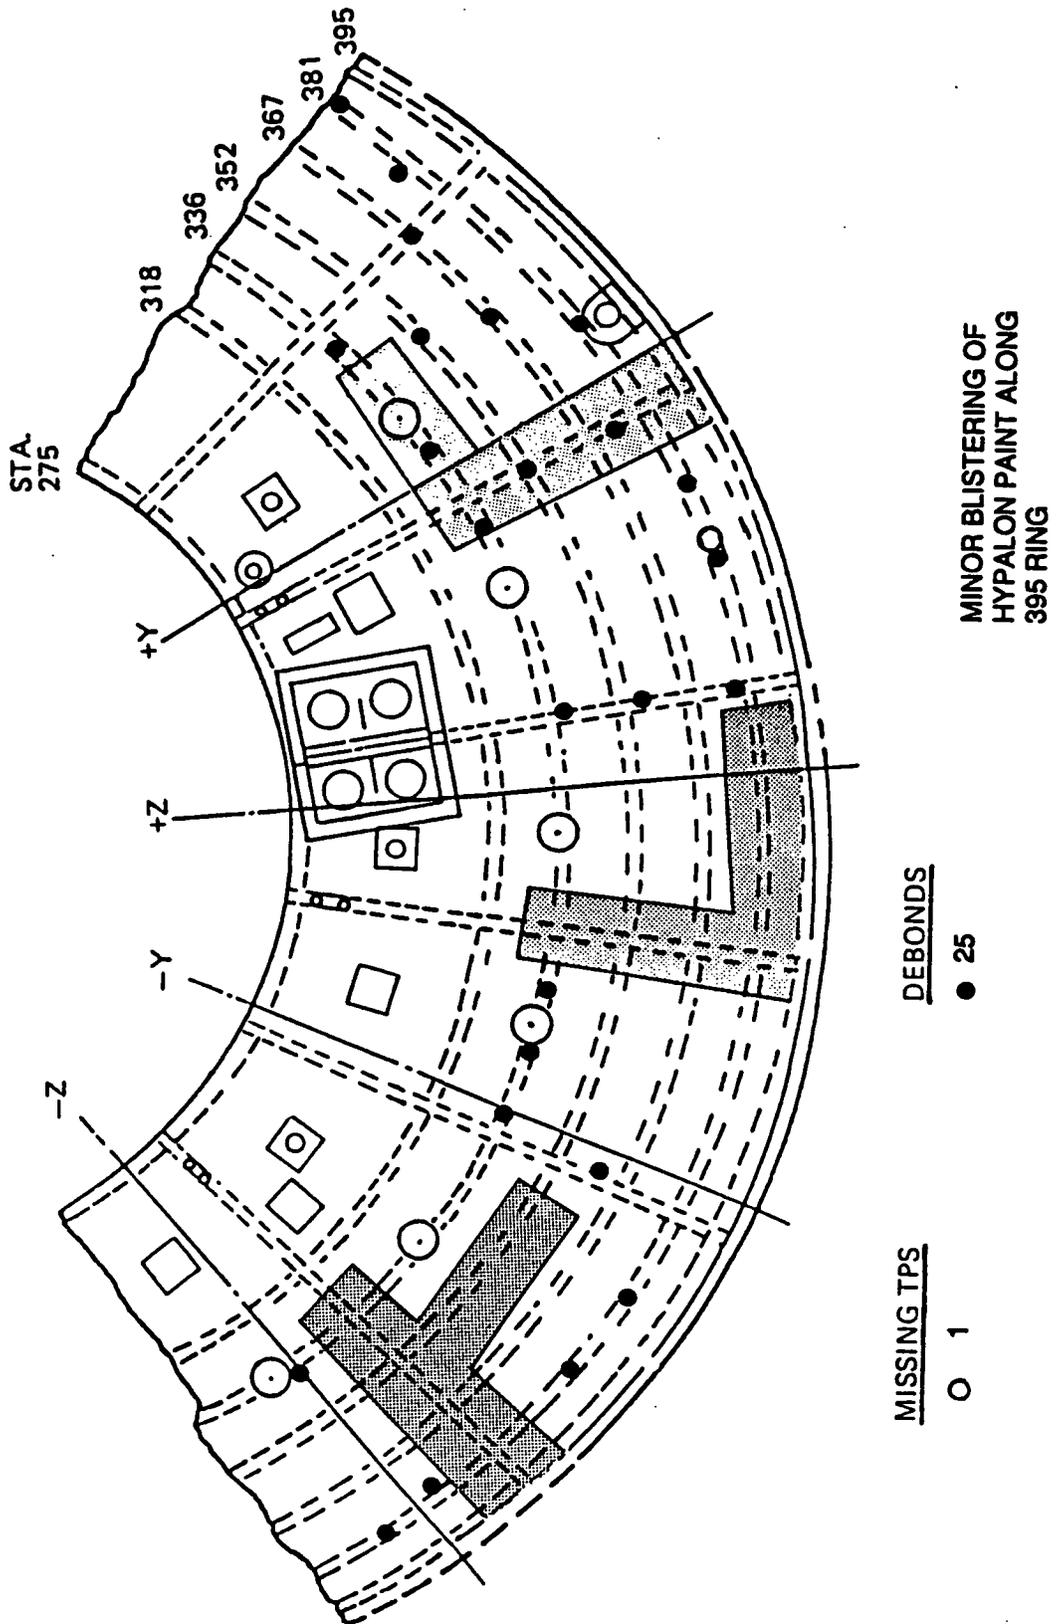
Figure 7. LEFT SRB FRUSTRUM

All four Debris Containment System (DCS) plungers were properly seated. This was the tenth flight utilizing the optimized link. Pieces of EPON shim material were missing from HDP #7 prior to water impact (sooted/charred substrate).

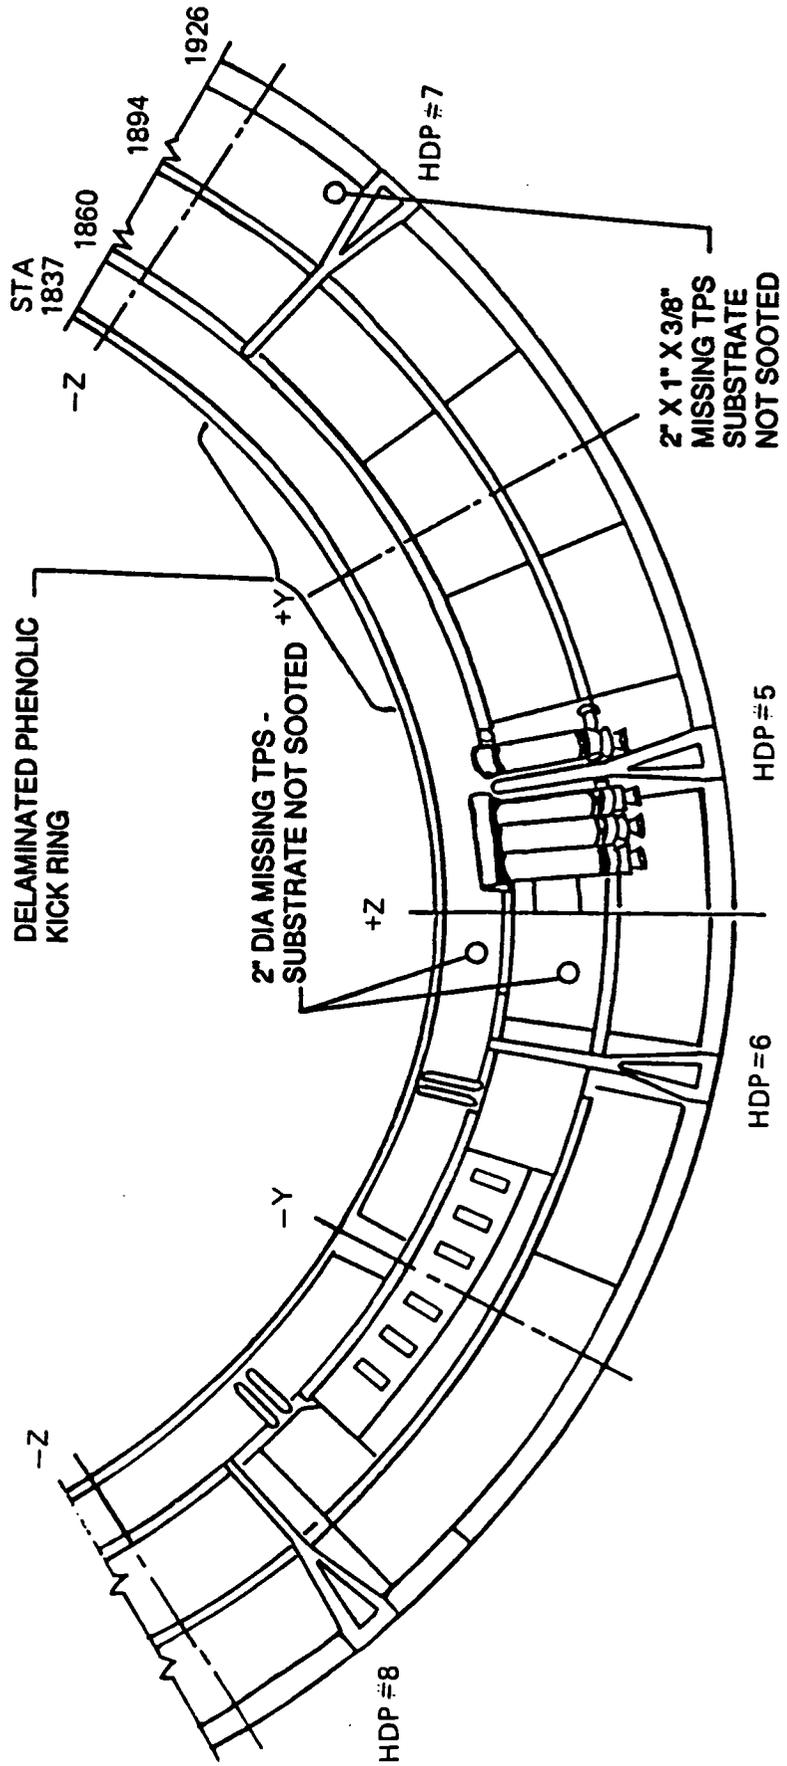
Figure 9. LEFT SRB AFT SKIRT EXTERIOR TPS

TPS MISSING  
NONE

DEBONDS  
NONE

MINOR BLISTERING OF  
HYPALON PAINT ON  
SYSTEMS TUNNEL COVER  
AND ET/SRB ATTACH FITTING

ALL DCS PLUNGERS  
PROPERLY SEATED

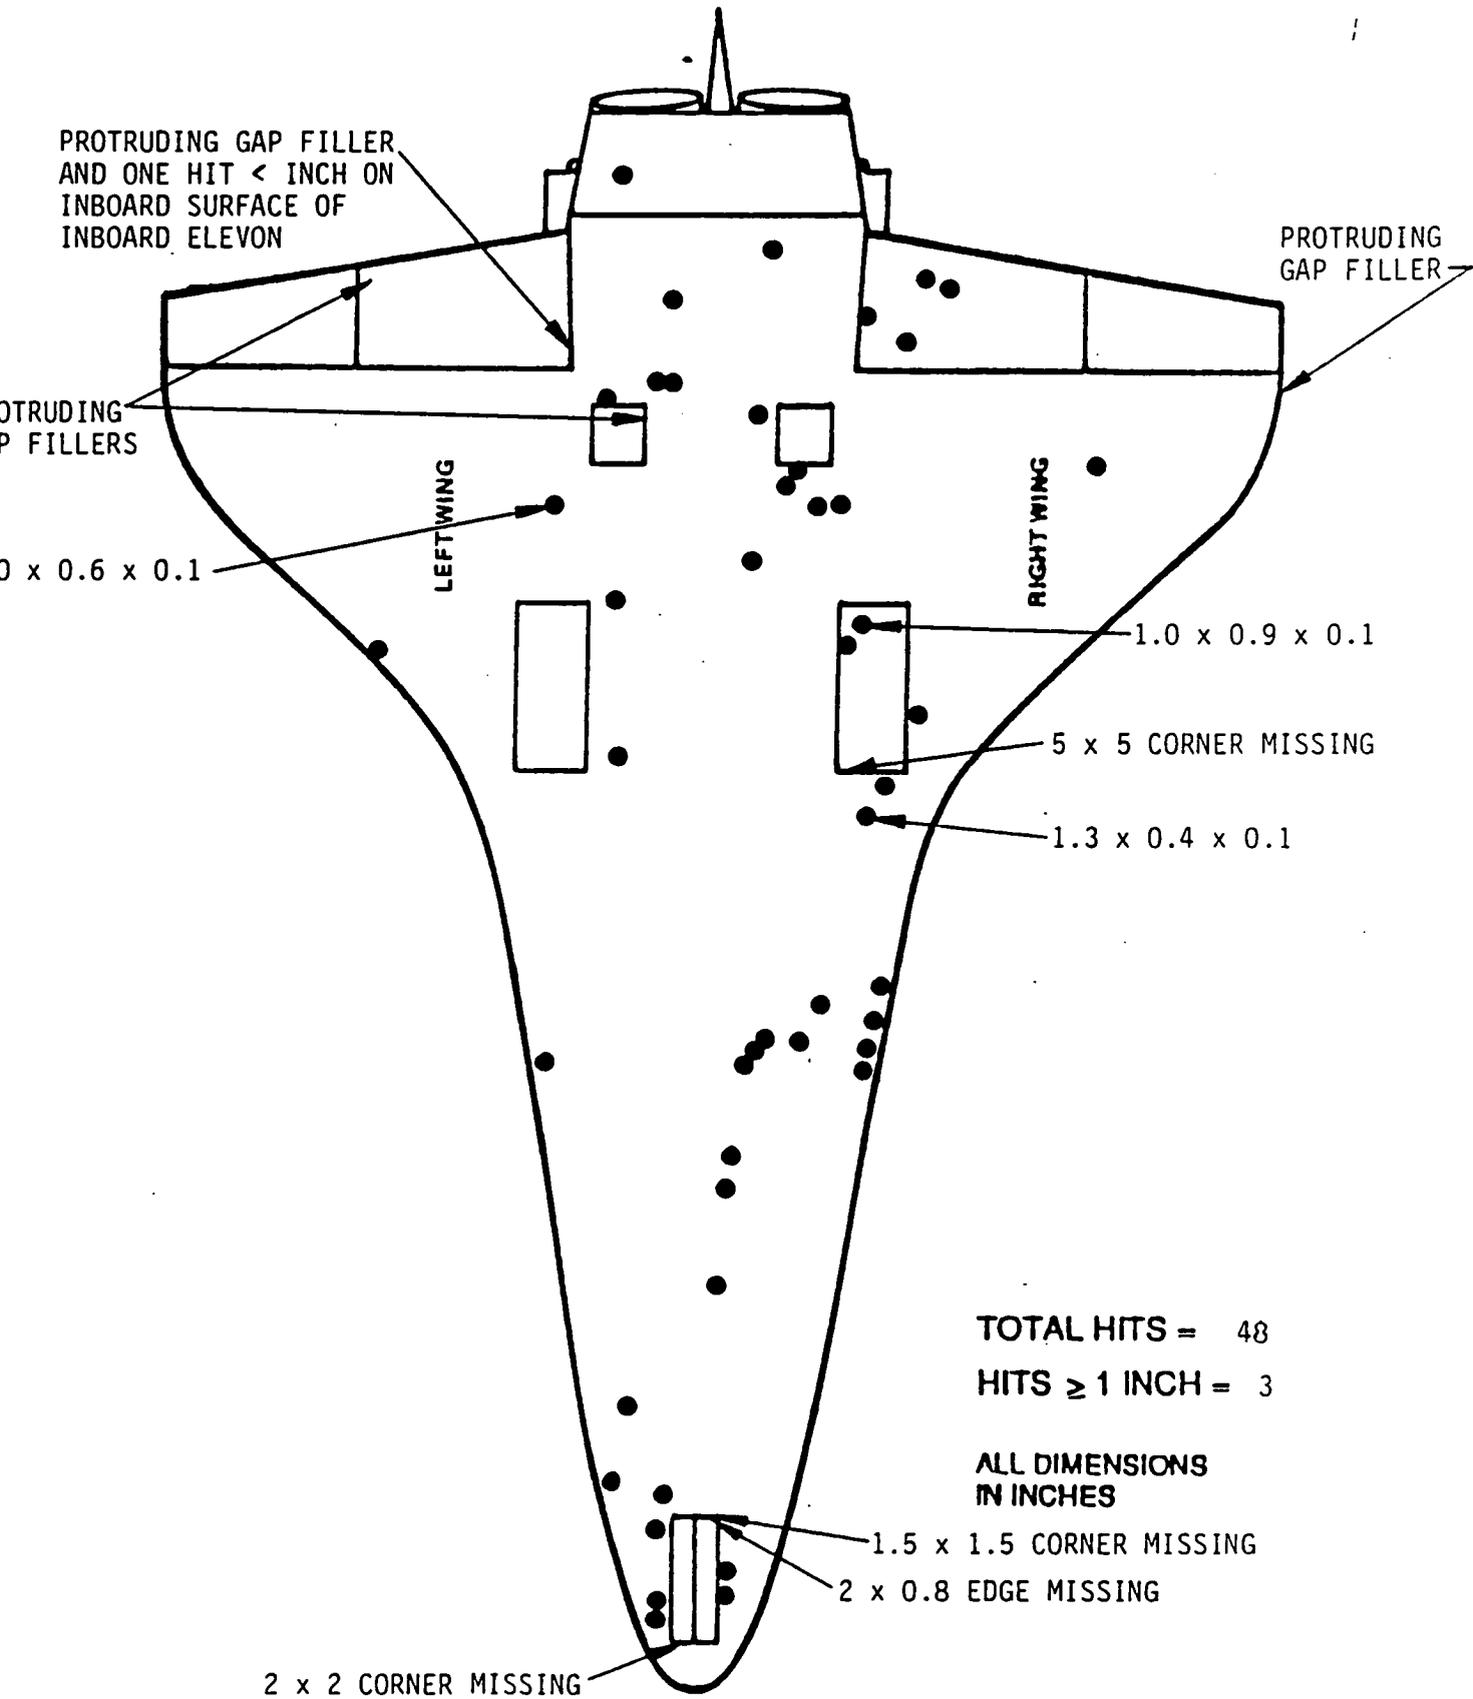
Figure 10. **DEBRIS DAMAGE LOCATIONS**

The Orbiter lower surface sustained a total of 47 hits, of which 3 had a major dimension of one inch or greater. These figures are much less than average (reference Figure 17). The distribution of hits on the lower surface does not suggest a single source of ascent debris, but indicates a shedding of ice and Thermal Protection System (TPS) debris from random sources.

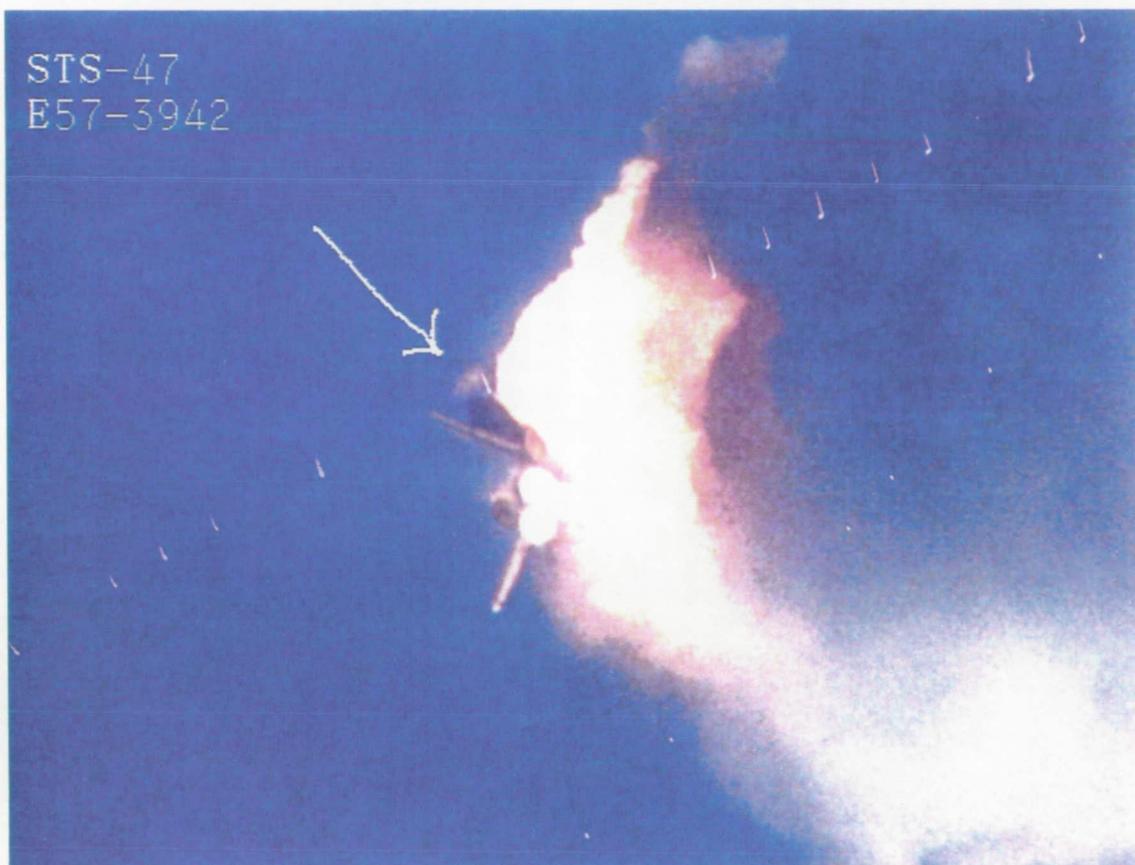
**Figure 2.1.3.2a** Large Debris Appeared between the Right Wing and the External Tank and Traveled Aft at 29 Seconds MET

On camera E-57 a large piece of light colored debris was seen moving towards the right wing and traveled aft at approximately 29 seconds MET (Figure 2.1.3.2a). The object appeared to move towards rather than away from the orbiter/plume area. This indicates that it was probably not vehicle related and may have been a bird. The object did not appear to strike the vehicle.

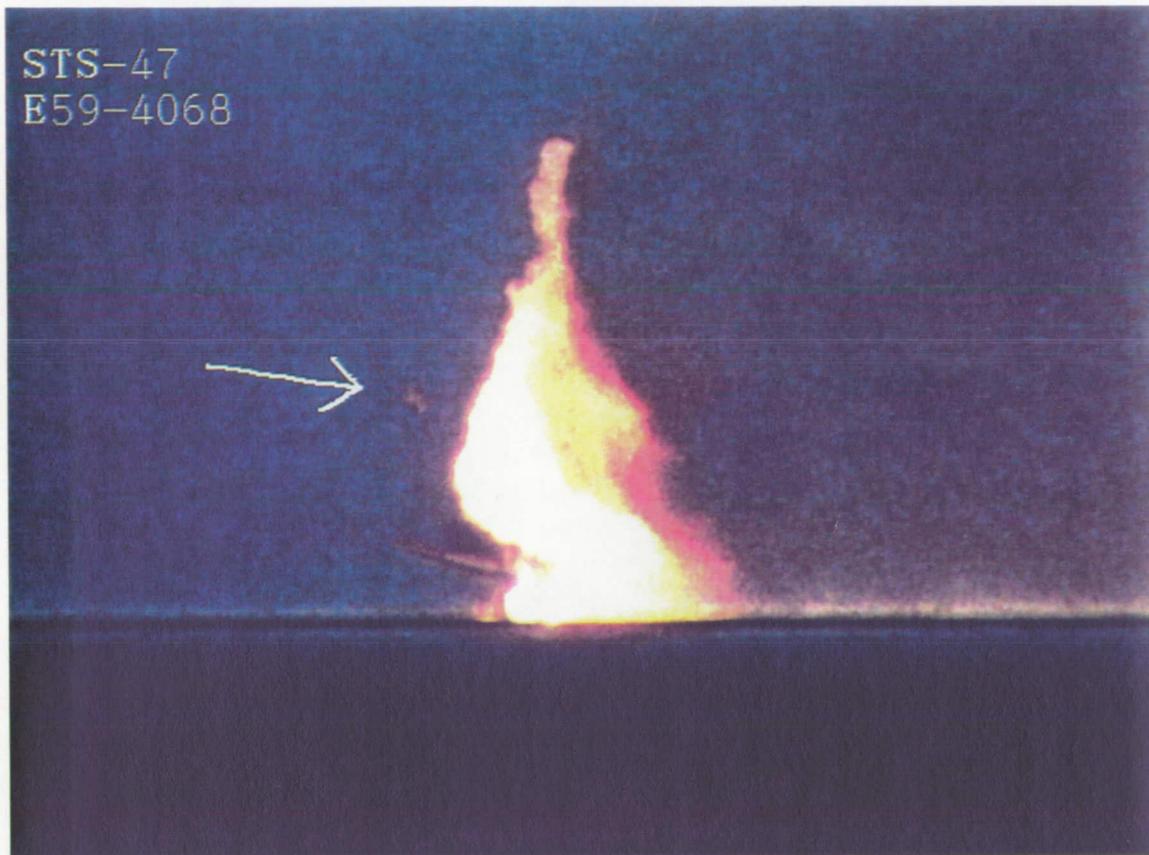
**Figure 2.1.3.2b Large Piece of Dark Debris Moving Aft Along the Right SRB Exhaust Plume Boundary at 32 Seconds MET**

On camera E-59, a large piece of dark debris was seen traveling aft along the right SRB exhaust plume boundary at 32 seconds MET (Figure 2.1.3.2b). Like the object seen on camera E-57, it appeared to move towards the vehicle and was probably not vehicle related. Again this was probably a bird. The object did not appear to strike the vehicle.

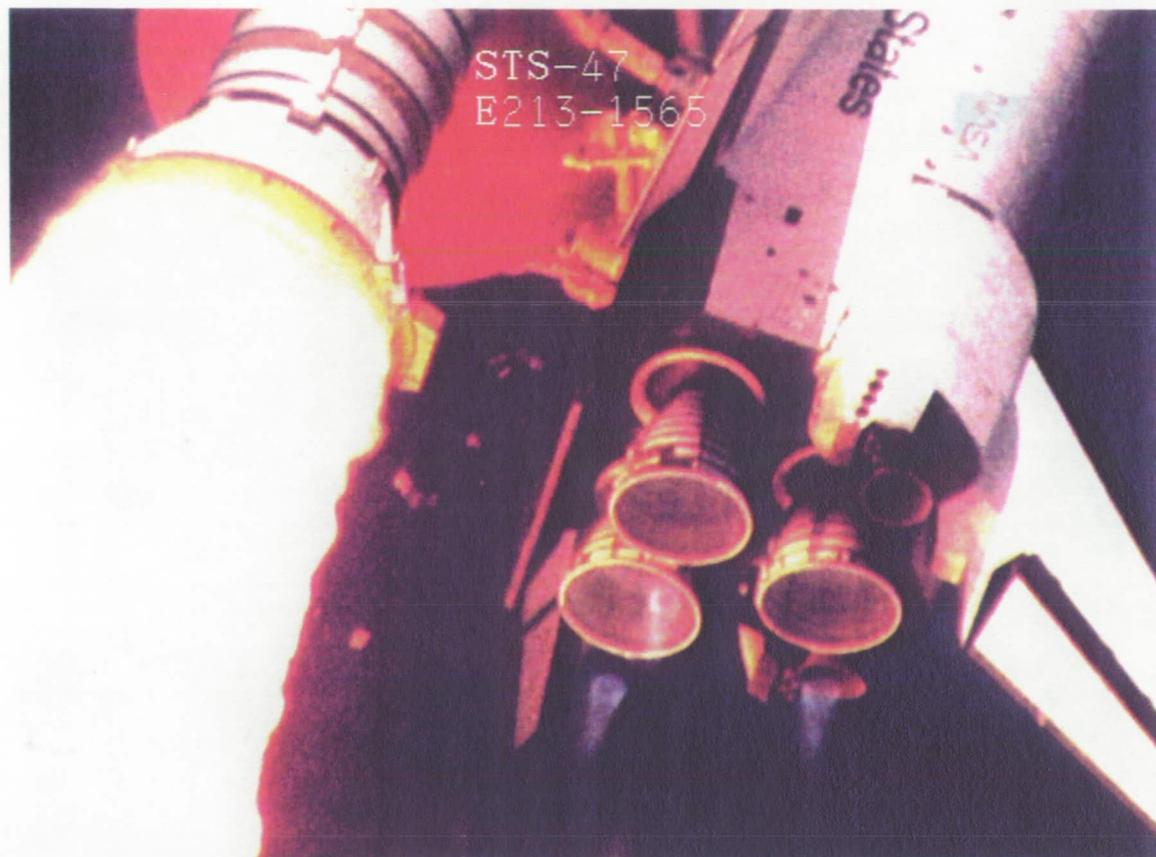
**Figure 2.1.3.2c Multiple Pieces of Baggie Material from ET/Orbiter Umbilical Area at 19.4 Seconds MET**

On camera E-213 multiple pieces of baggie material were seen to originate from the ET/Orbiter umbilical area and travel aft after the roll maneuver. Approximately 3 seconds later, a piece of orange debris, possibly baggie material, was seen to travel from the RSRB exhaust plume area toward the SSME exhaust plume.

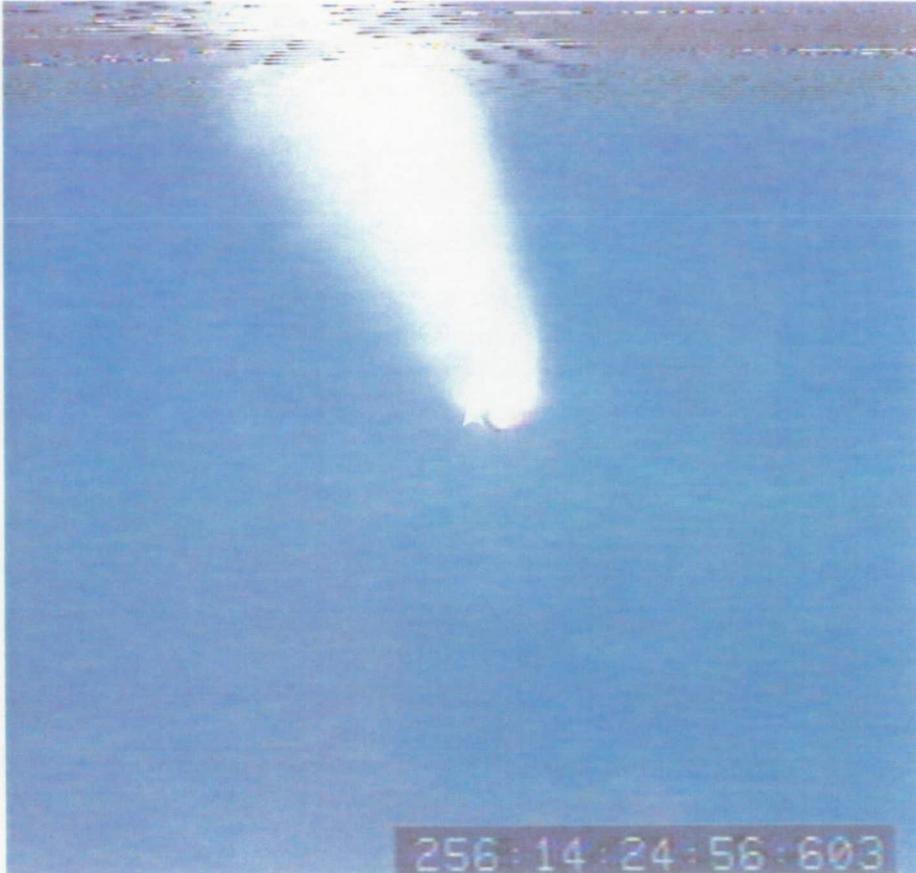
**Figure 2.3.5 Dark Puff in SSME Exhaust Plume**

A dark puff was noted in the SRB plume at approximately 116.6 seconds MET (immediately before plume brightening). No follow up action has been requested.

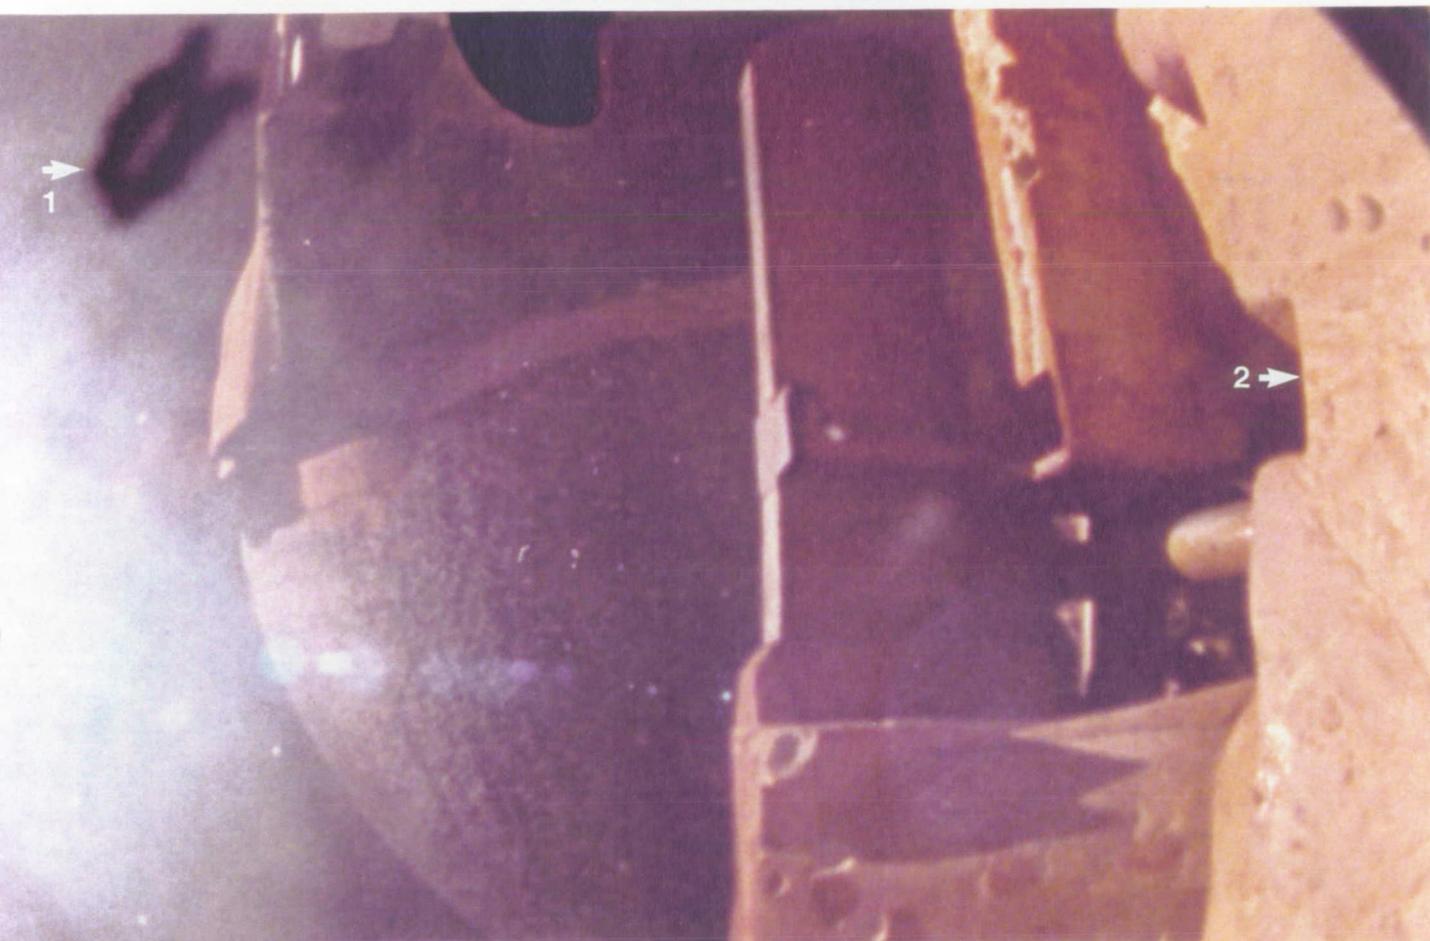
**Figure 2.4.1.4 Clip Shaped Debris at ET Separation**

A clip shaped object was seen on the film from the 16 mm hydrogen umbilical well camera with the 5mm lens at ET separation (arrow 1). The object first moved to the top of the frame, disappeared for 459 frames and then reappeared. The object then moved downward and disappeared from the FOV. MSFC pointed out that the object appeared to be within the camera housing. The film was rescreened and it was confirmed that indeed the object appeared to be within the camera housing, since the object was seen to pass between the camera lens and the edge of the camera housing.

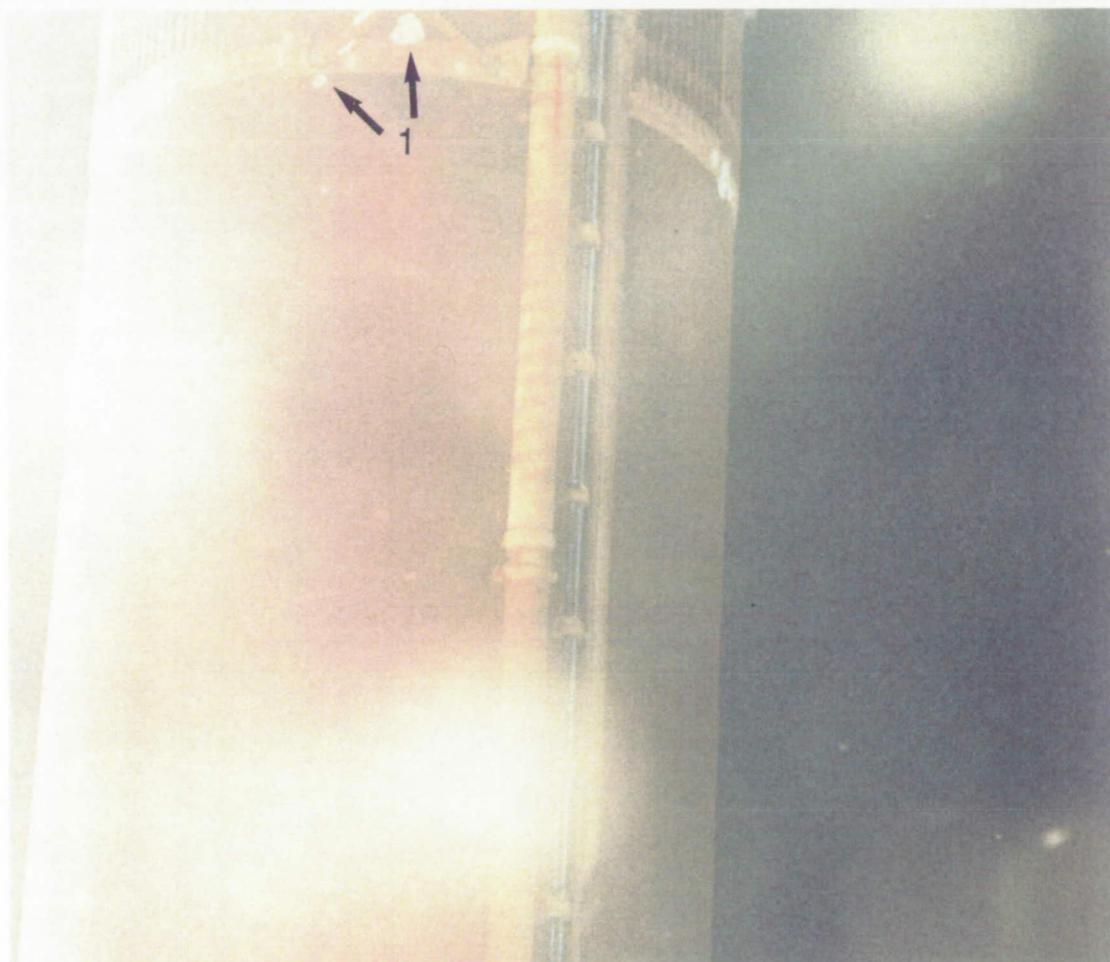
of the external tank. Several divots were seen near the forward ET/Orbiter attach bipod (arrow 1). Shortly after the initial review of the films the divot(s) were declared an inflight anomaly (IFA) by the manager of the JSC Space Shuttle Engineering Integration Office. Divots have been seen near the forward ET/Orbiter attach bipod, along the intertank close-out, and on the intertank TPS on previous mission films. Since reflight, divots in these same regions were reported seen on STS-28R, STS-29R, STS-32R, STS-41R, STS-35, STS-37, STS-40, STS-42, and STS-45 (Reference JSC Space Shuttle Photographic and Television Analysis Project Mission Final Reports). Similar divots were also seen on films from several missions prior to reflight including STS-51F, STS-61A and STS-61C.

**Figure 2.4.1.5a Divots near Forward ET/Orbiter Attach Bipod (from the 35 mm Umbilical Well Camera)**

Measurements were made of the large divot visible between the legs of the forward bipod located partially on the intertank close-out and partially on the ET intertank TPS using the 35mm umbilical well camera film (Mag 55). The divot measured 0.65 mm x 0.60 mm on the film. Using the known distance between the forward bipod legs of 85.530 inches, the divot was scaled to be 16.35 x 15.09 inches in size. Some shadow is visible inside the divot indicating depth. Under stereoscopic examination, the divot also appeared to have detectable depth. A second divot near the left leg of the forward bipod was measured to be 0.25 mm x 0.25 mm or 6.29 inches in size.

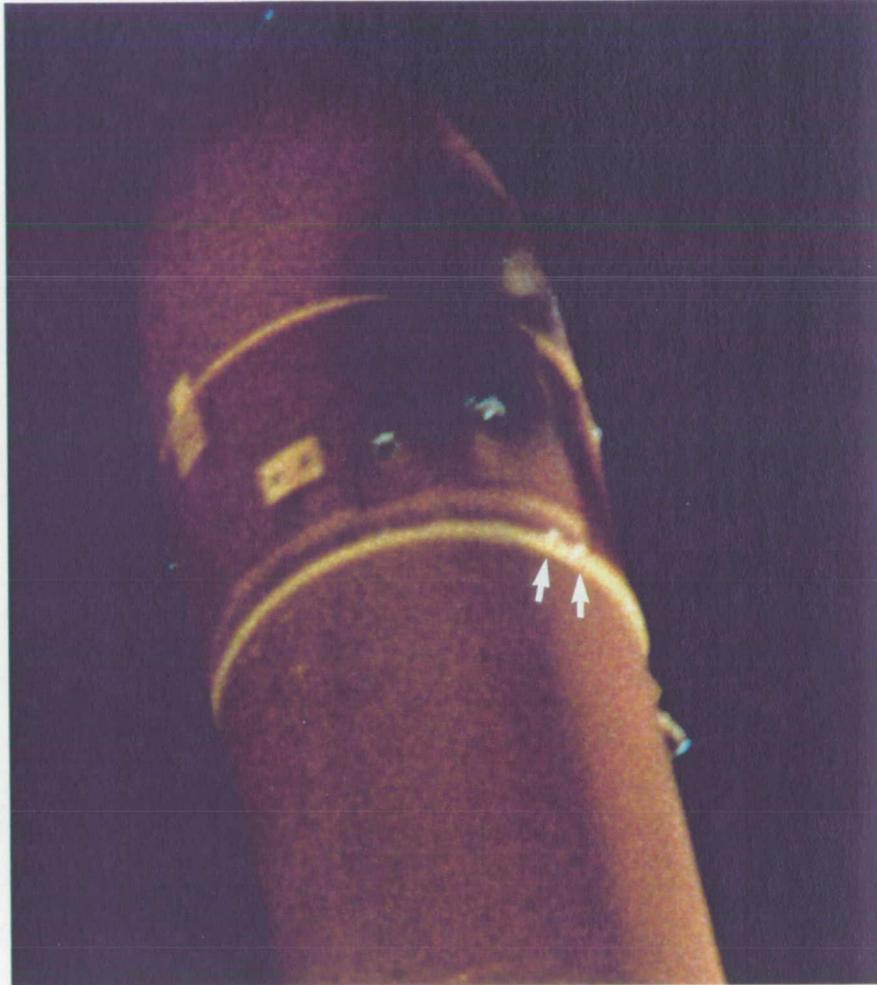
**Figure 2.4.1.5b** Divots seen on ET Intertank (70 mm Handheld Hasselblad Film, Frame STS-47-71-006)

The two divots visible on the intertank close-out and TPS shown on the handheld Hasselblad photograph above taken by astronaut Mark Lee were measured to be approximately 14 inches (left) and 13 1/2 inches (right) in size along their major axis.

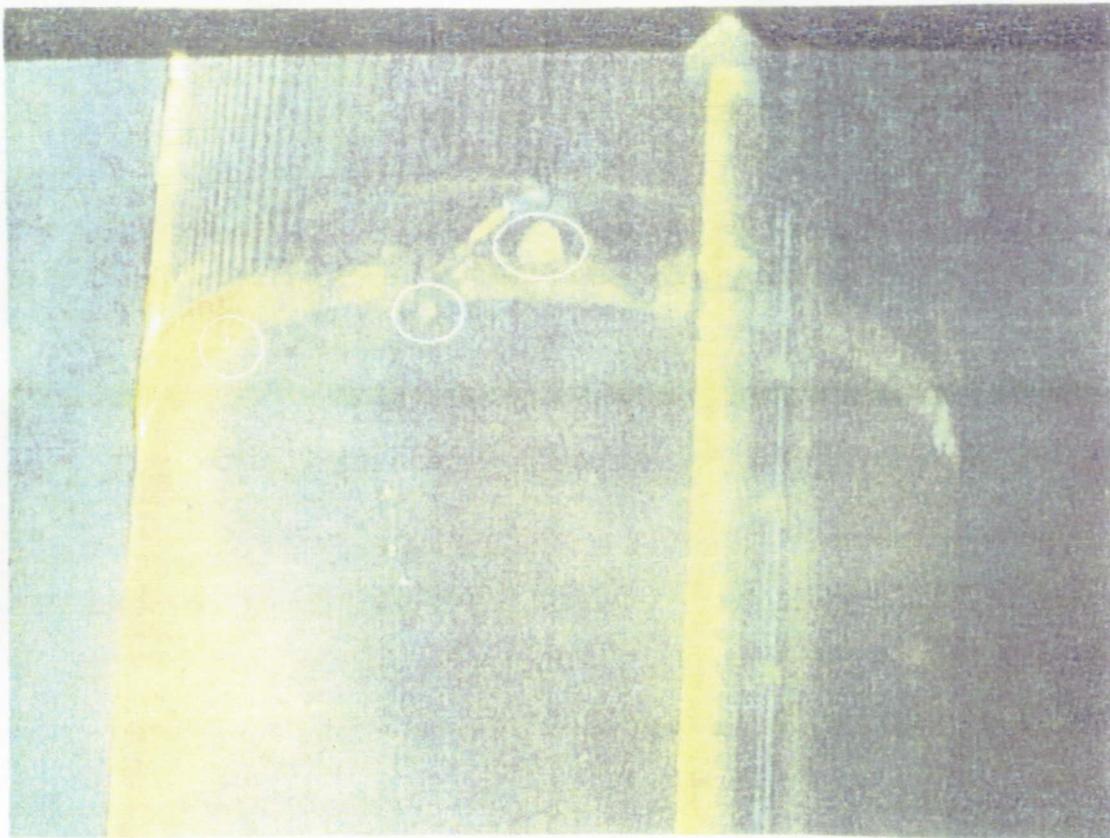
Figure One

Divots Noted at LH2 Intertank Scarf Joint and Bipod Strut
