Debris/Ice/TPS Assessment And Integrated Photographic Analysis For Shuttle Mission STS-52

December 1992

DEBRIS/ICE/TPS ASSESSMENT
AND
PHOTOGRAPHIC ANALYSIS
OF
SHUTTLE MISSION STS-52

October 22, 1992

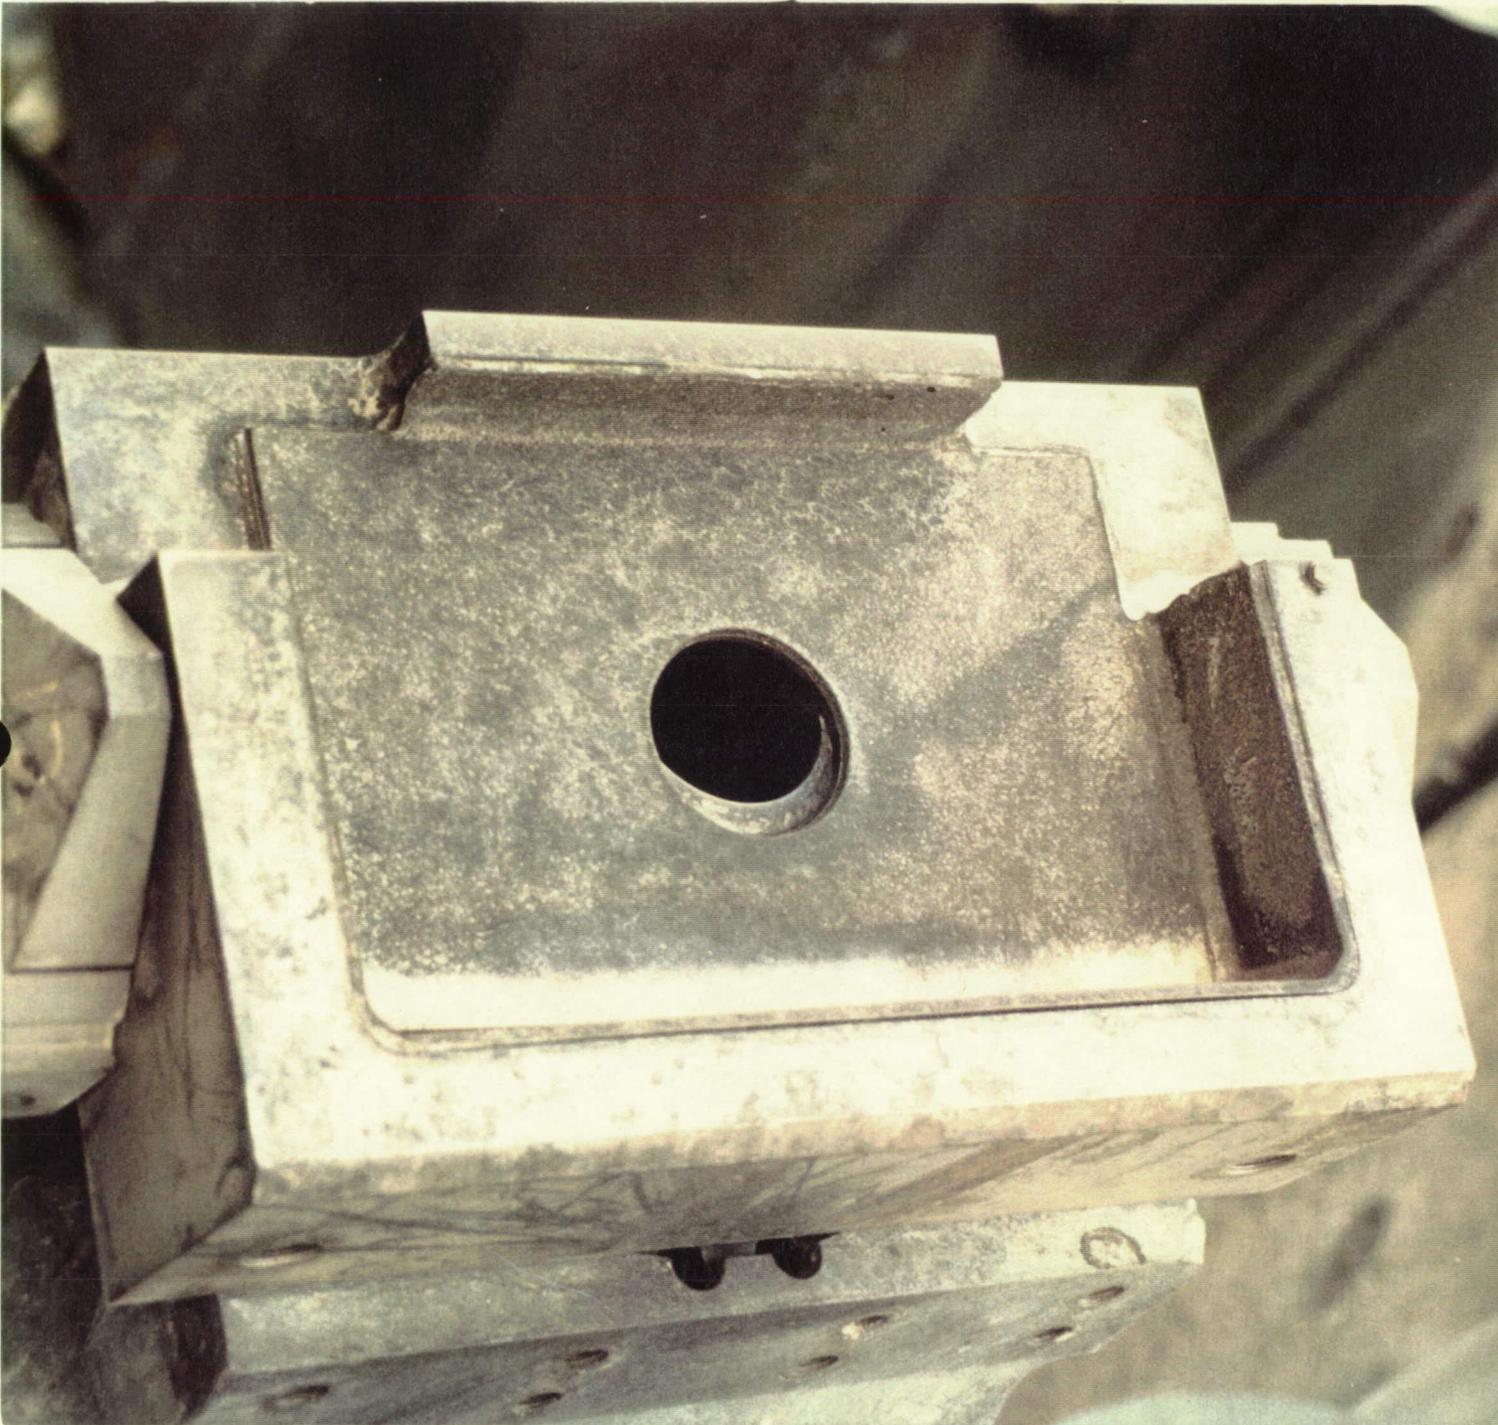
Plume erosion of the south SRB holddown posts was typical. EPON shim material was intact but slightly debonded from the holddown post shoes.

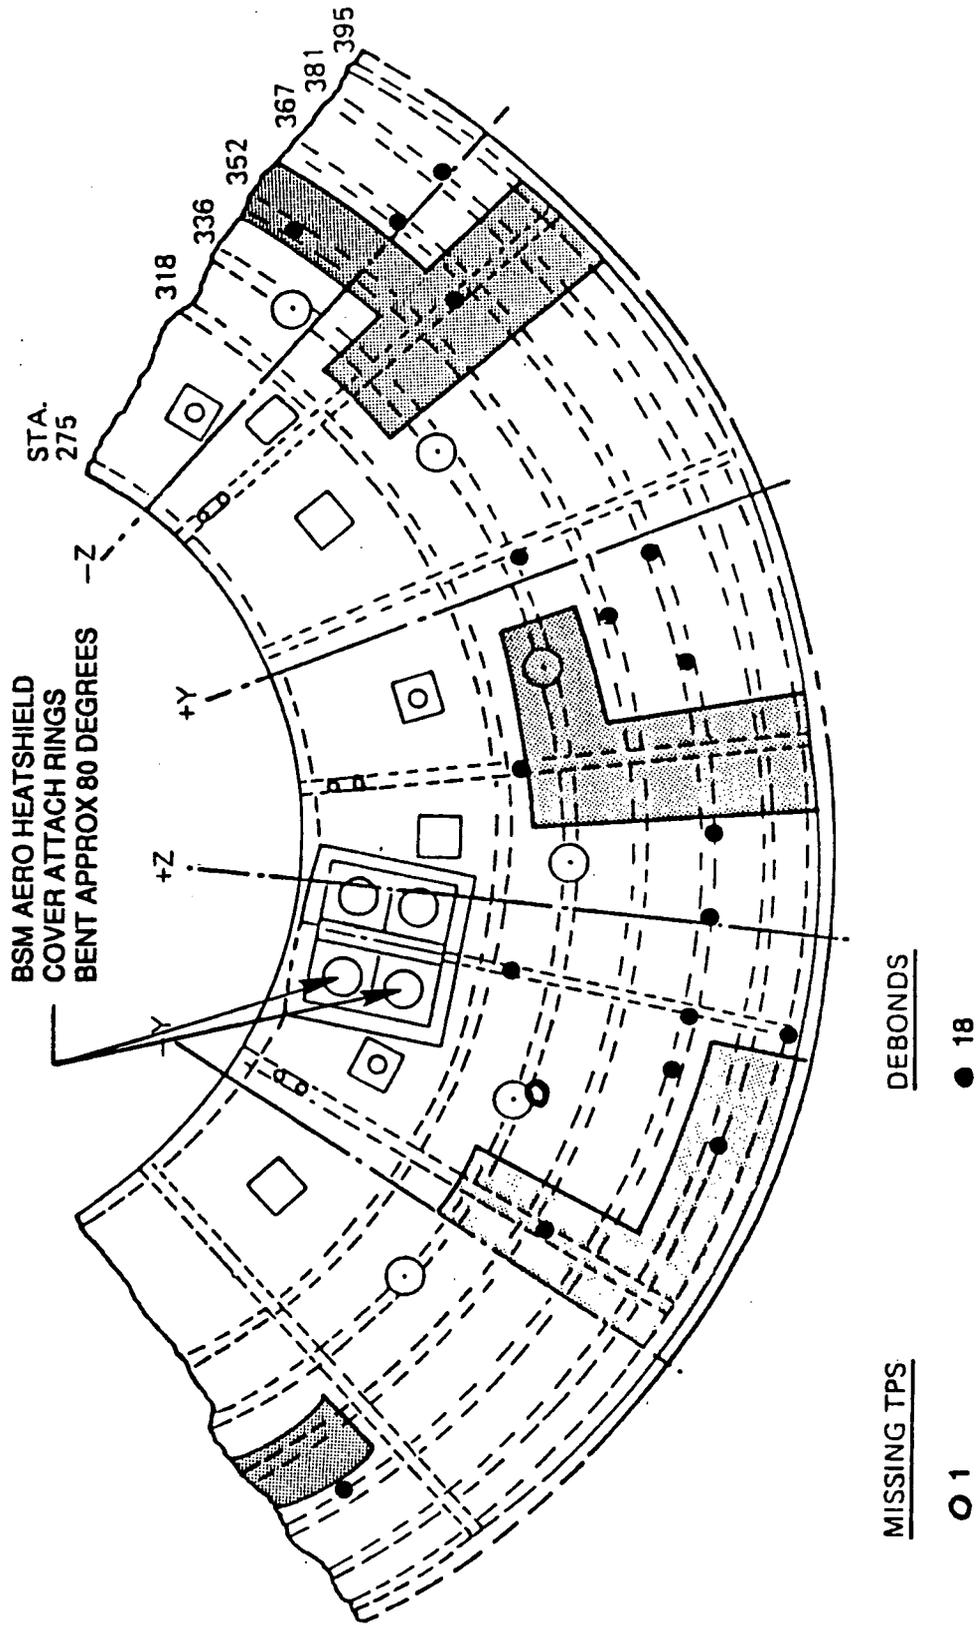
Figure 4. **RIGHT SRB FRUSTUM**

The RH frustum had 18 MSA-2 debonds over fasteners and one 1.5" diameter area of missing TPS in the -Y+Z quadrant at the 336 ring frame. Minor localized blistering of the Hypalon paint had occurred predominantly along the 395 ring (Figure 4). All BSM aero heat shield covers were locked in the fully opened position though the left two cover attach rings had been bent by parachute riser entanglement.

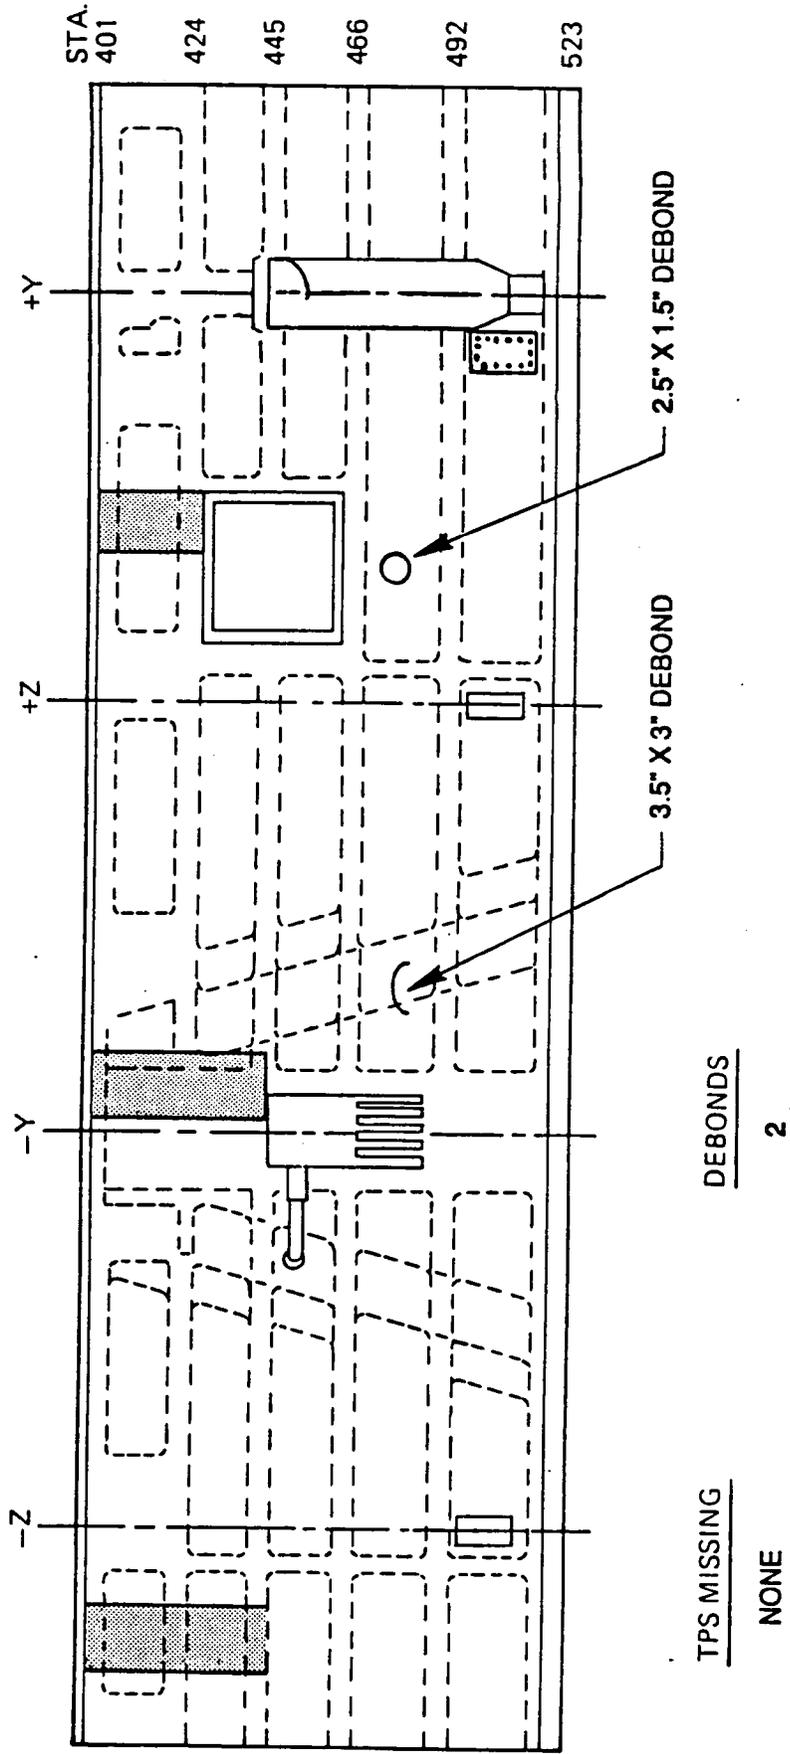
Figure 5. RIGHT SRB FWD SKIRT

The RH forward skirt exhibited no missing TPS, but did have two debonds. The first debond was located at approximately 240 degrees, station 480, and measured 3.5" x 3" in size. The second debond was located at approximately 150 degrees, station 470, and measured 2.5" x 1.5" in size. Both RSS antennae covers/phenolic base plates were intact and undamaged. Minor blistering of the Hypalon paint occurred on the forward ET/SRB attach point (Figure 5). No pins were missing from the frustum severance ring. The forward separation bolt and electrical cables appeared to have separated cleanly.

MINOR BLISTERING OF HYPALON
PAINT AT ET/SRB FORWARD
ATTACH POINT

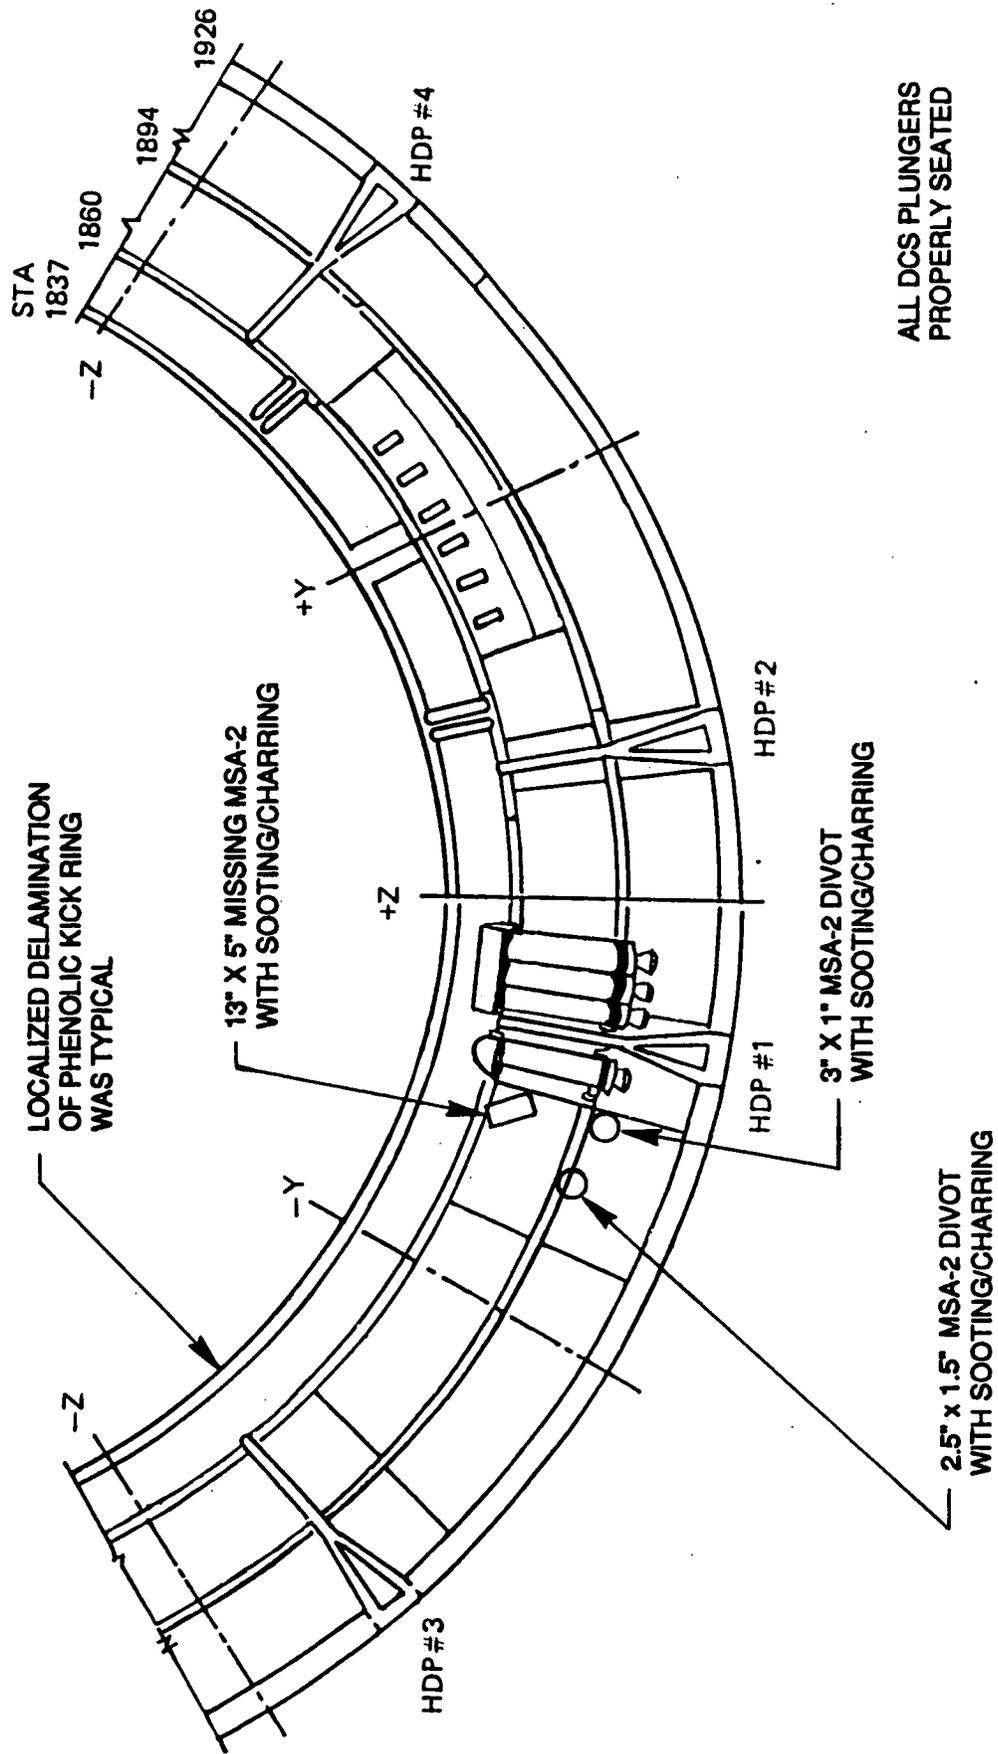
Figure 6. RIGHT SRB AFT SKIRT EXTERIOR TPS

The phenolic material on the kick ring was delaminated. Two divots, measuring 13" x 5" and 3" x 1", had occurred on the aft skirt acreage TPS just to the -Y side of the single BSM. Some of the material along the aft edge of the divots appeared sooted/charred. A third divot, measuring 2.5" x 1.5", had occurred between the single BSM and the -Y axis at station XB-1894 partially exposing two fastener head covers (Figure 6). Samples were taken from all three locations for laboratory analysis. K5NA was missing from all BSM nozzles.

Approximately 50 percent of the EPON shim was missing from HDP #3 aft skirt foot. The substrate was sooted/charred indicating that the shim material was lost prior to water impact. All Debris Containment System (DCS) plungers were seated properly. This was the eleventh flight utilizing the optimized link.

ALL DCS PLUNGERS
PROPERLY SEATED

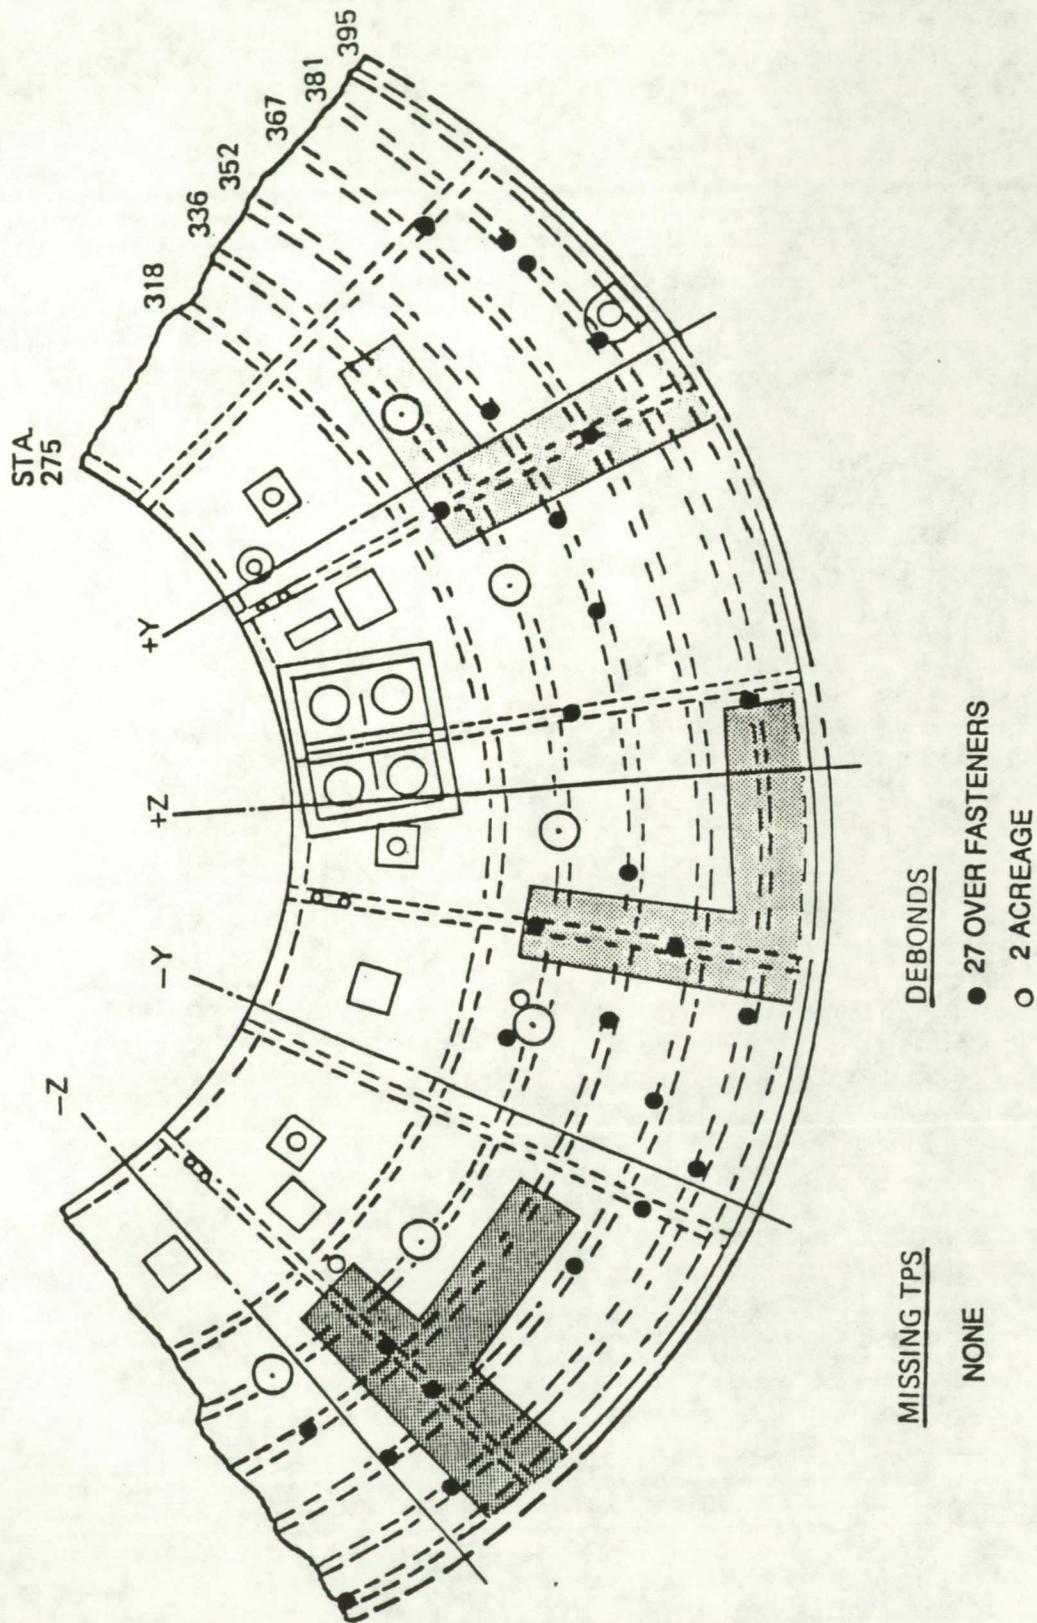
Figure 7. LEFT SRB FRUSTRUM

The LH frustum was missing no TPS, but had 27 MSA-2 debonds over fasteners and two MSA-2 acreage debonds. There was minor localized blistering of the Hypalon paint along the 395 ring frame (Figure 7). The BSM aero heatshield covers were locked in the fully opened position.

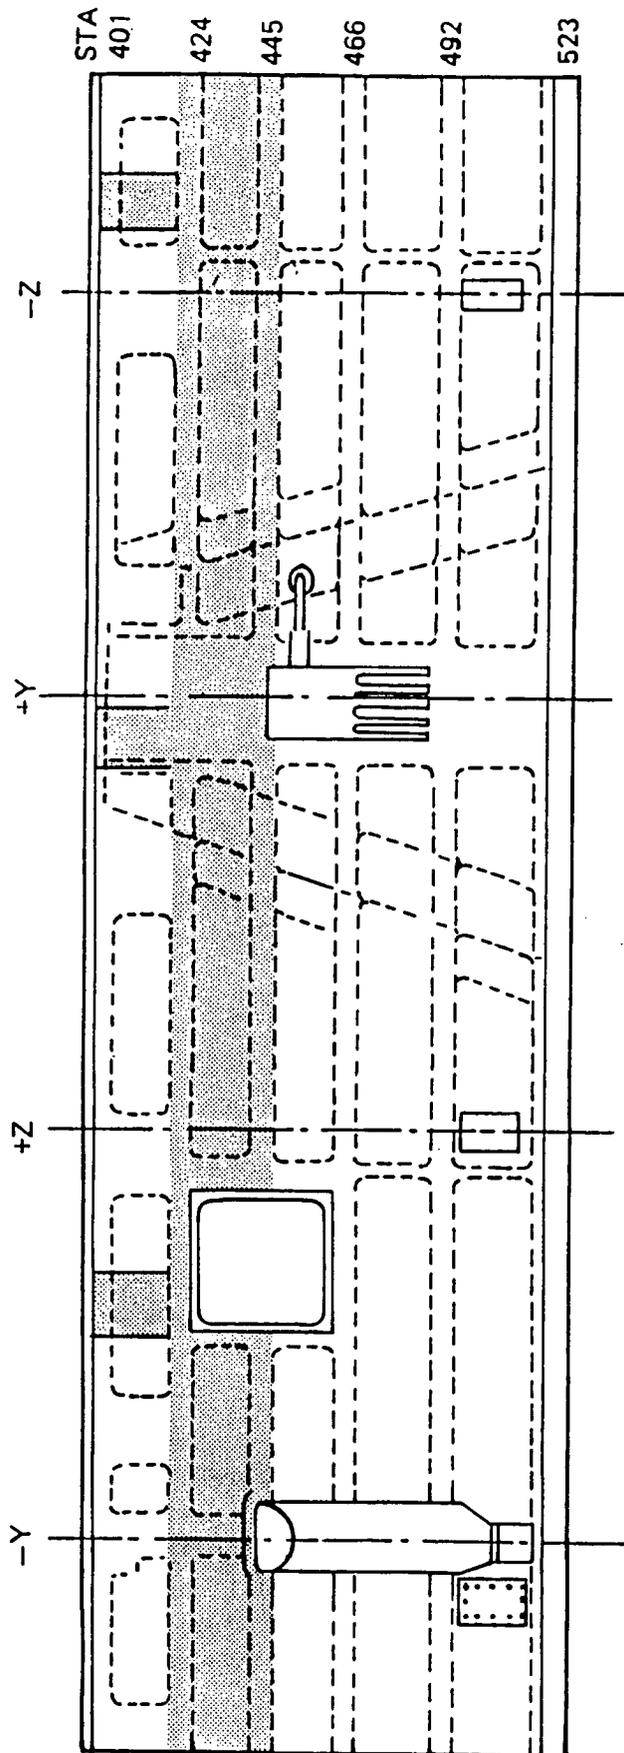
Figure 8. LEFT SRB FWD SKIRT

The LH forward skirt exhibited no debonds or missing TPS. The phenolic plates on both RSS antennae were intact and undamaged (Figure 8). The forward separation bolt and electrical cables appeared to have separated cleanly. No pins were missing from the frustum severance ring. Minor blistering of the Hypalon paint occurred near the ET/SRB attach point.

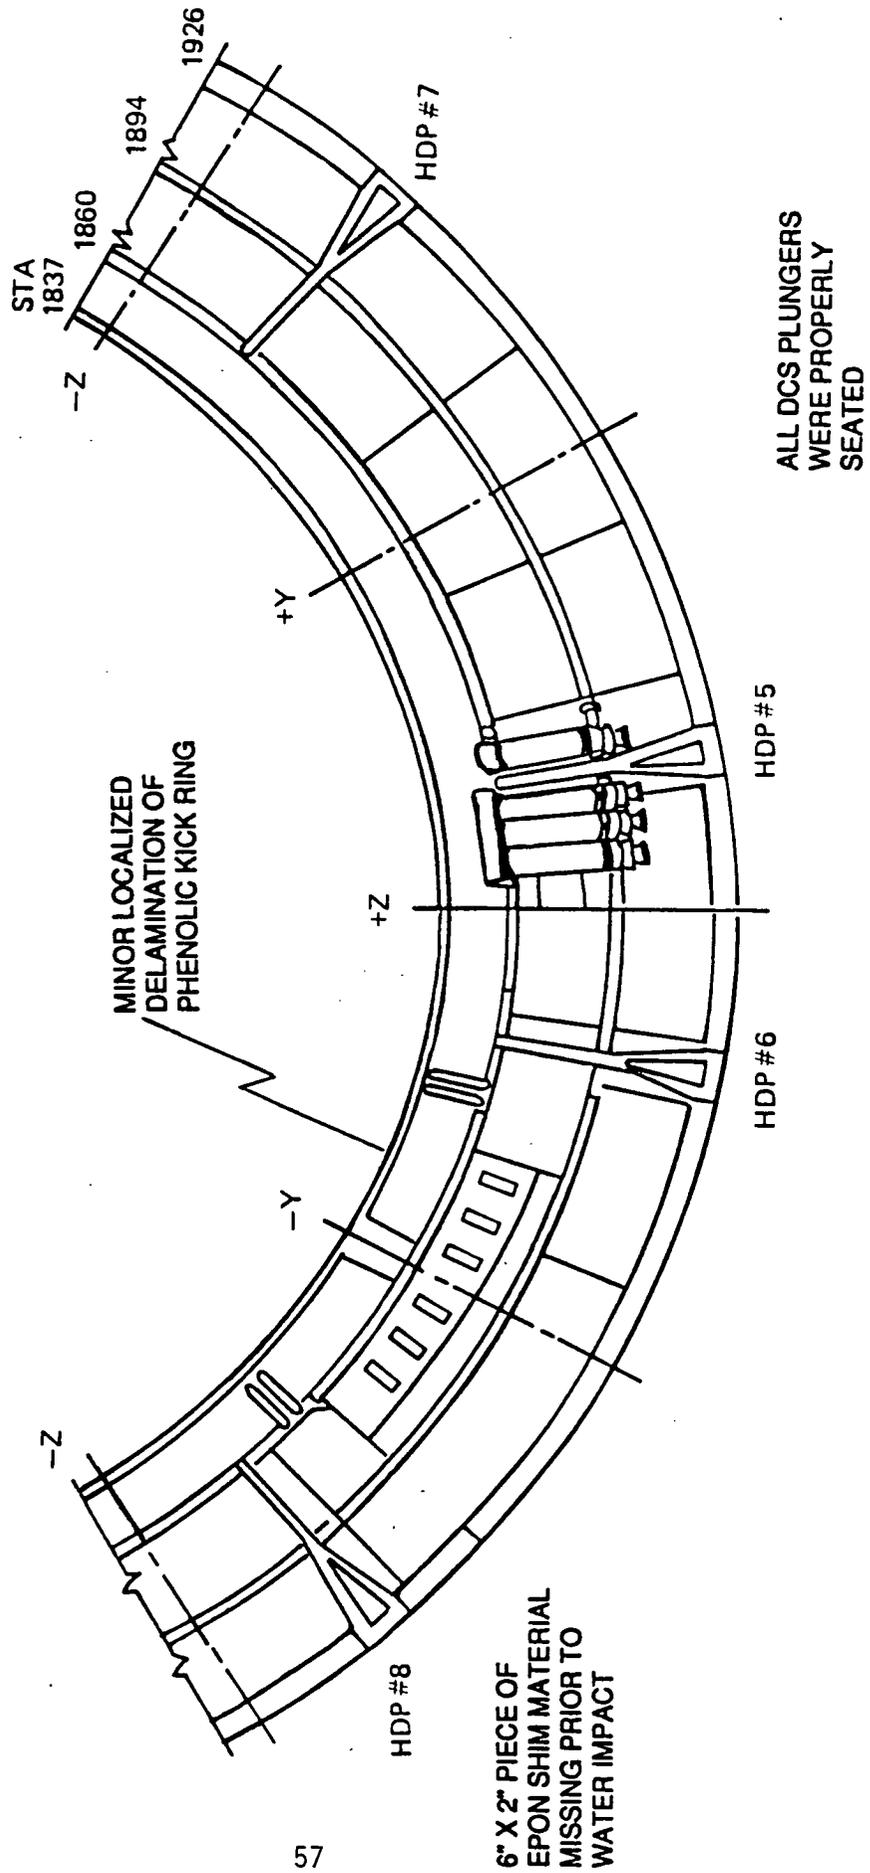
Figure 9. LEFT SRB AFT SKIRT EXTERIOR TPS

The phenolic material on the kick ring exhibited localized delamination. The acreage TPS on the aft skirt was generally in good condition (Figure 9).

A 6" x 2" piece of EPON shim was lost from HDP #8 aft skirt foot prior to water impact. All four Debris Containment System (DCS) plungers were properly seated. This was the eleventh flight utilizing the optimized link.

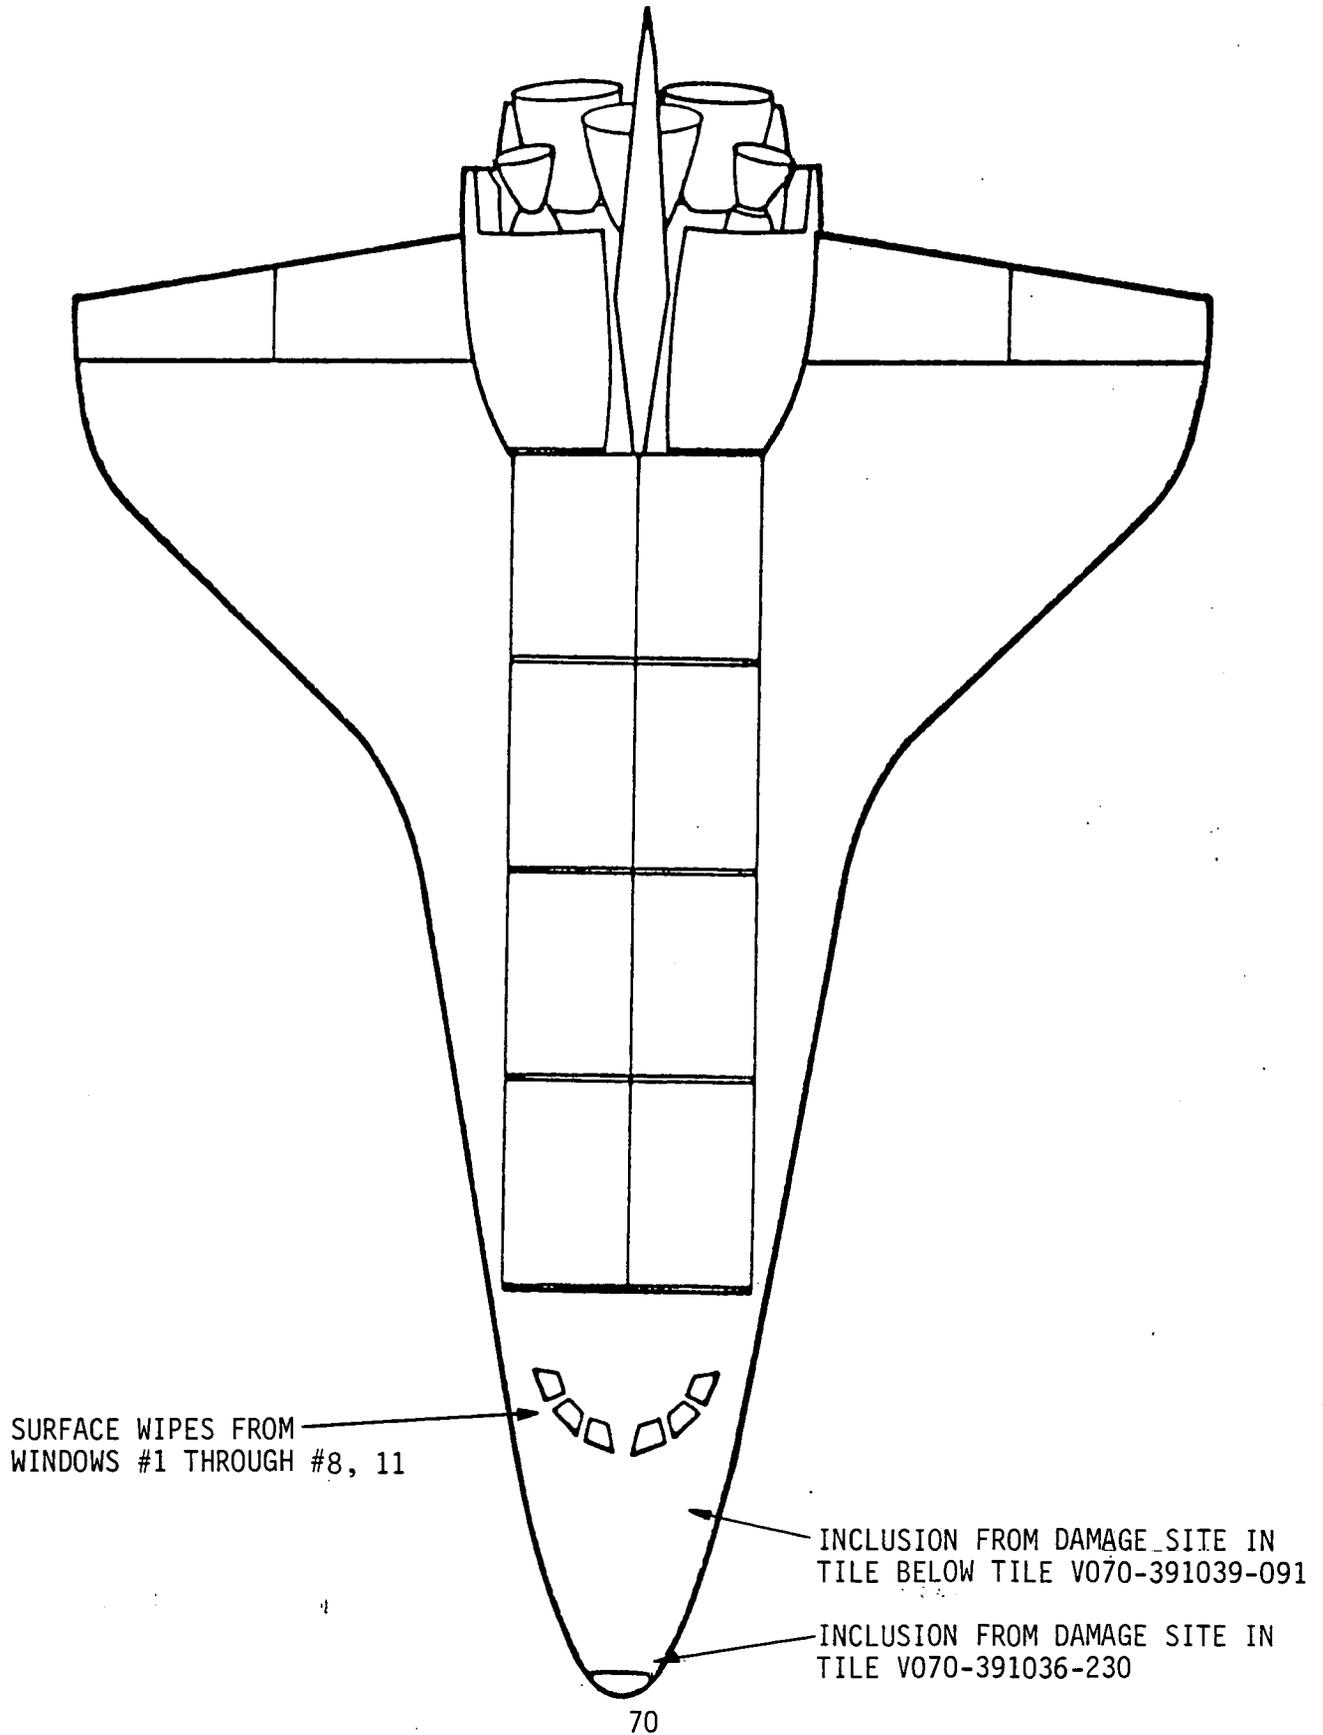
Figure 14. **CHEMICAL SAMPLE LOCATIONS**

Samples of inclusions found in two tile damage sites on the Orbiter nose were taken for laboratory analysis (reference Figure 14 for sample locations and section 8.0 for analysis results).

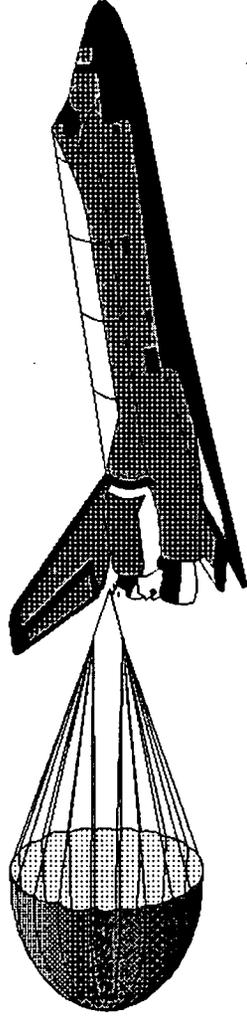
Figure 15.

This flight marked the fourth use of the Orbiter drag chute. The drag chute appeared to have functioned nominally. However, a tile on the aft end of the vertical stabilizer stinger was damaged by the chute risers during deployment. Another tile, on the lower (-Z) RH edge of the drag chute compartment opening, was slightly damaged by separation of the chute compartment door. Similar damage has been observed after every previous use of the drag chute. All drag chute hardware was recovered and showed no signs of abnormal operation (reference Figure 15 for recovery locations).

RECOVERY LOCATIONS OF DRAG CHUTE COMPONENTS

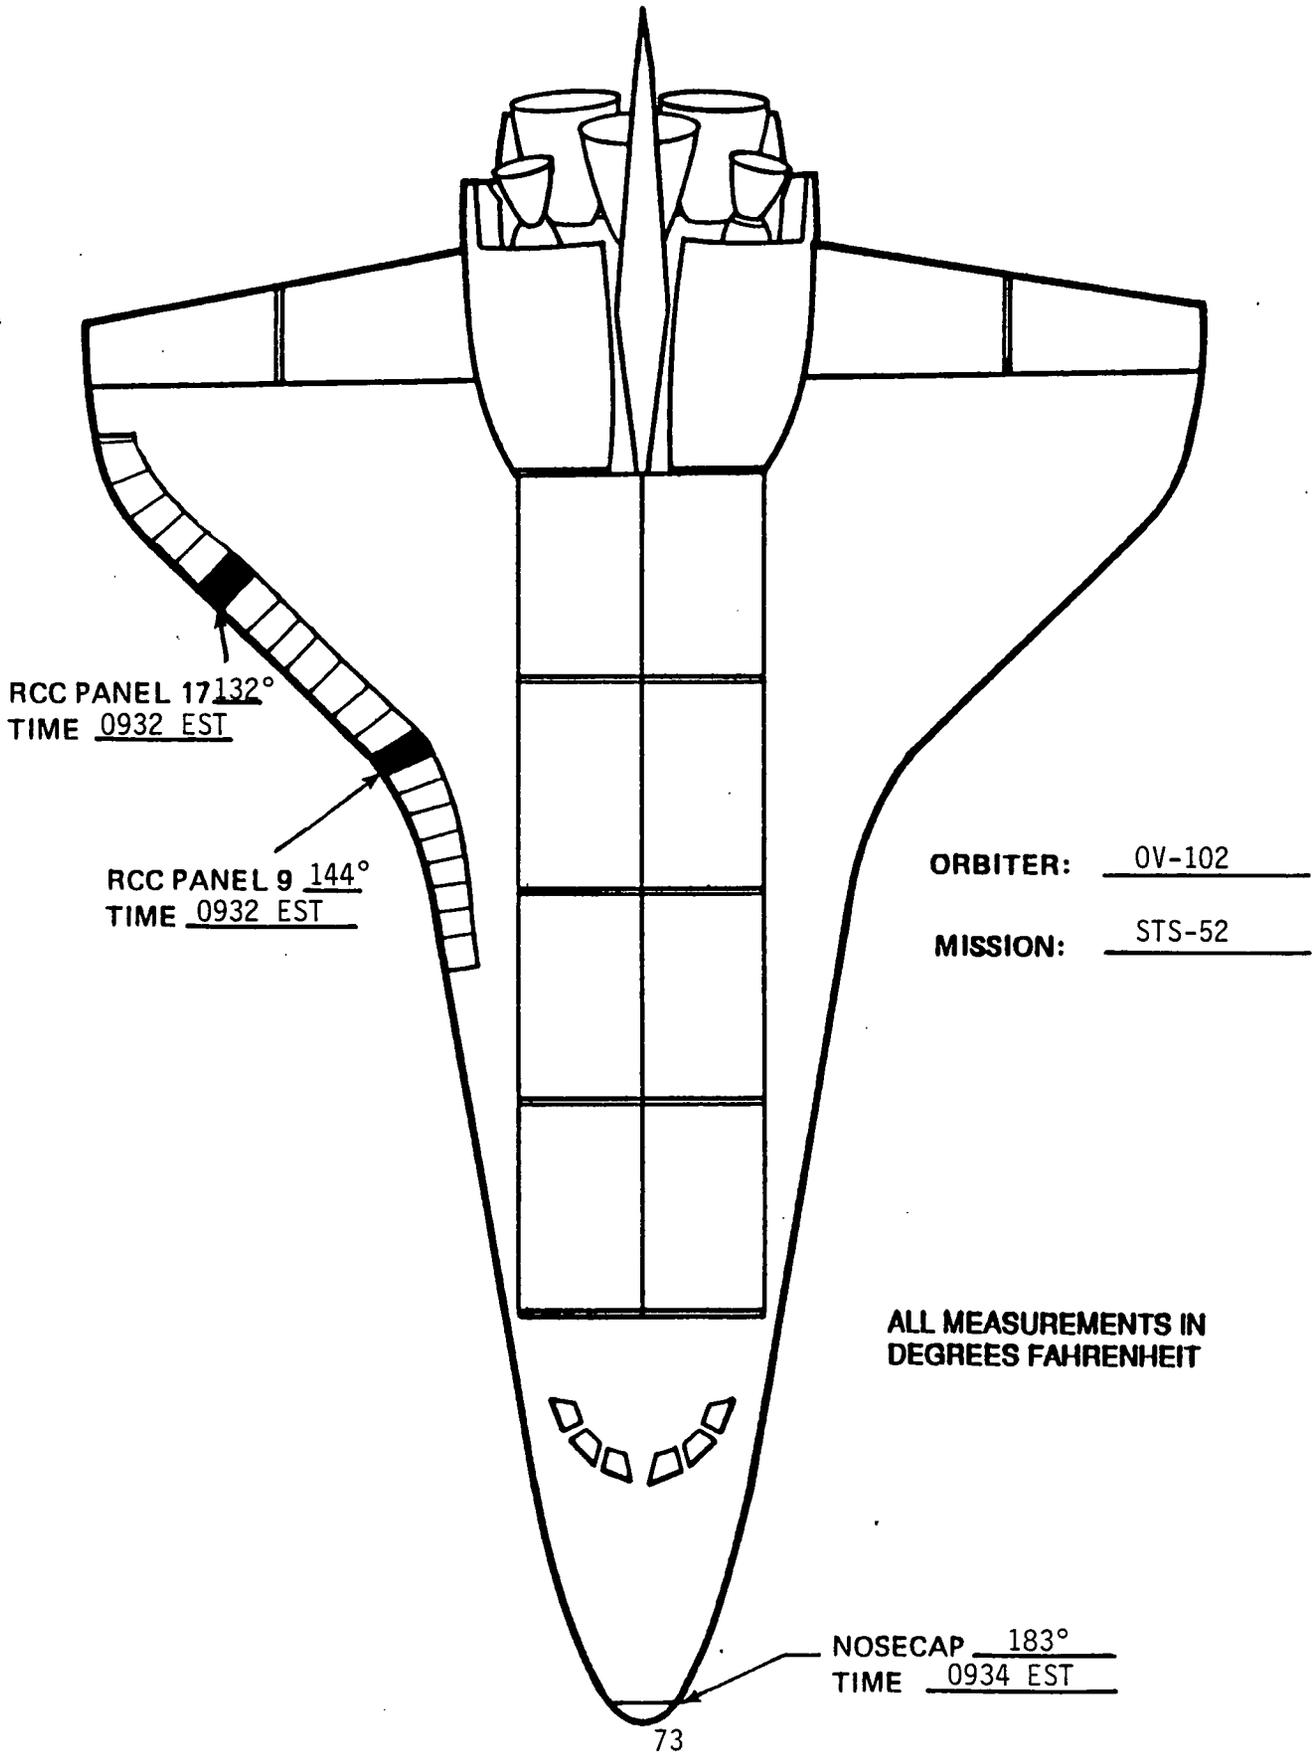
Figure 16. **STS-52 RCC TEMPERATURE MEASUREMENTS AS RECORDED BY THE SHUTTLE THERMAL IMAGER**

A portable Shuttle Thermal Imager (STI) was used to measure the surface temperatures of three areas on the Orbiter (per OMRSD V09AJ0.095). Twenty-eight minutes after landing the Orbiter Reinforced Carbon-Carbon (RCC) nose cap was 183 degrees Fahrenheit (F). Twenty-six minutes after landing the RH wing leading edge RCC panel #9 was 144 degrees F, and panel #17 was 132 degrees F (reference Figure 16).

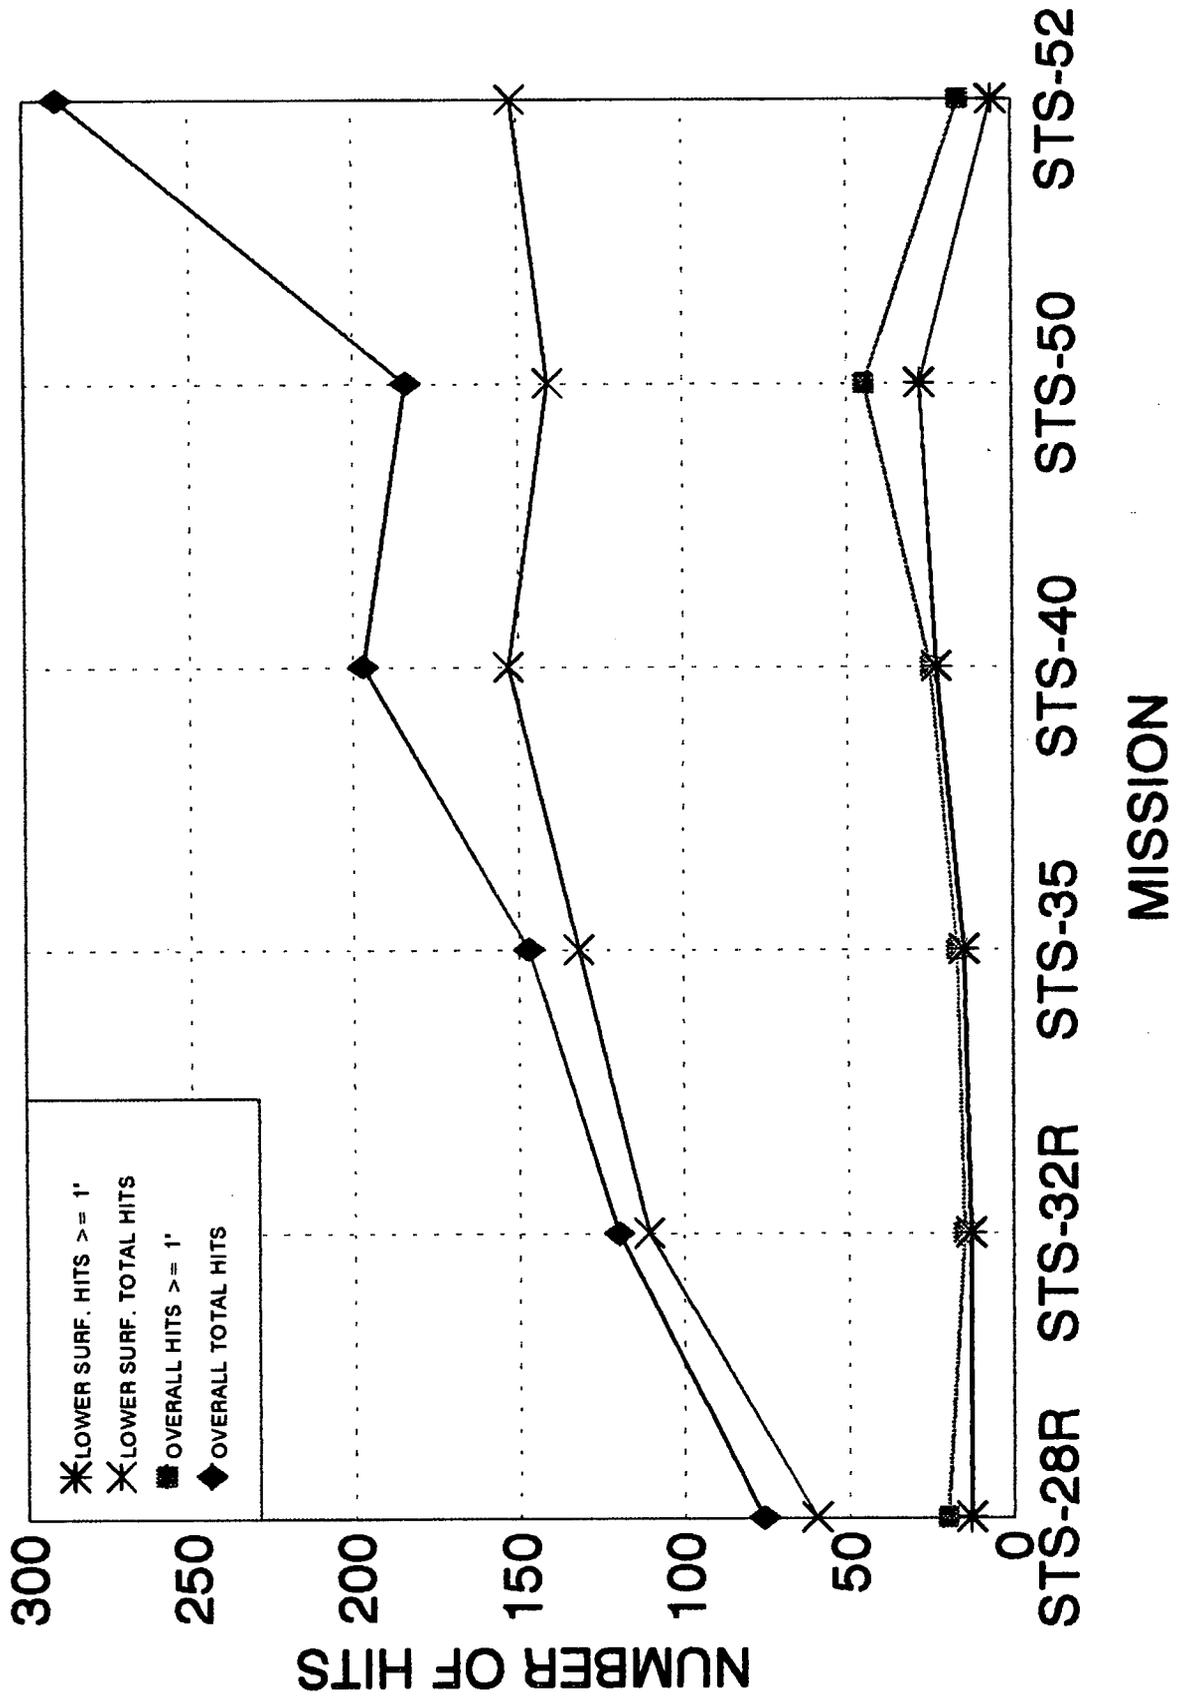
One factor that may be contributing to Orbiter debris damage is vehicle age. OV-102 has shown an increasing trend in the total number of debris hits sustained during each flight. This upward trend may be due to the effects of age on Orbiter TPS materials. Original and repaired TPS materials may become weak/loose due to the effects of thermal cycling and exposure to vibration/loading, creating potentially damaging debris. Post landing debris damage sustained by OV-102 during the last six flights is shown in Figure 20.

OV-102 POST LANDING DEBRIS DAMAGE

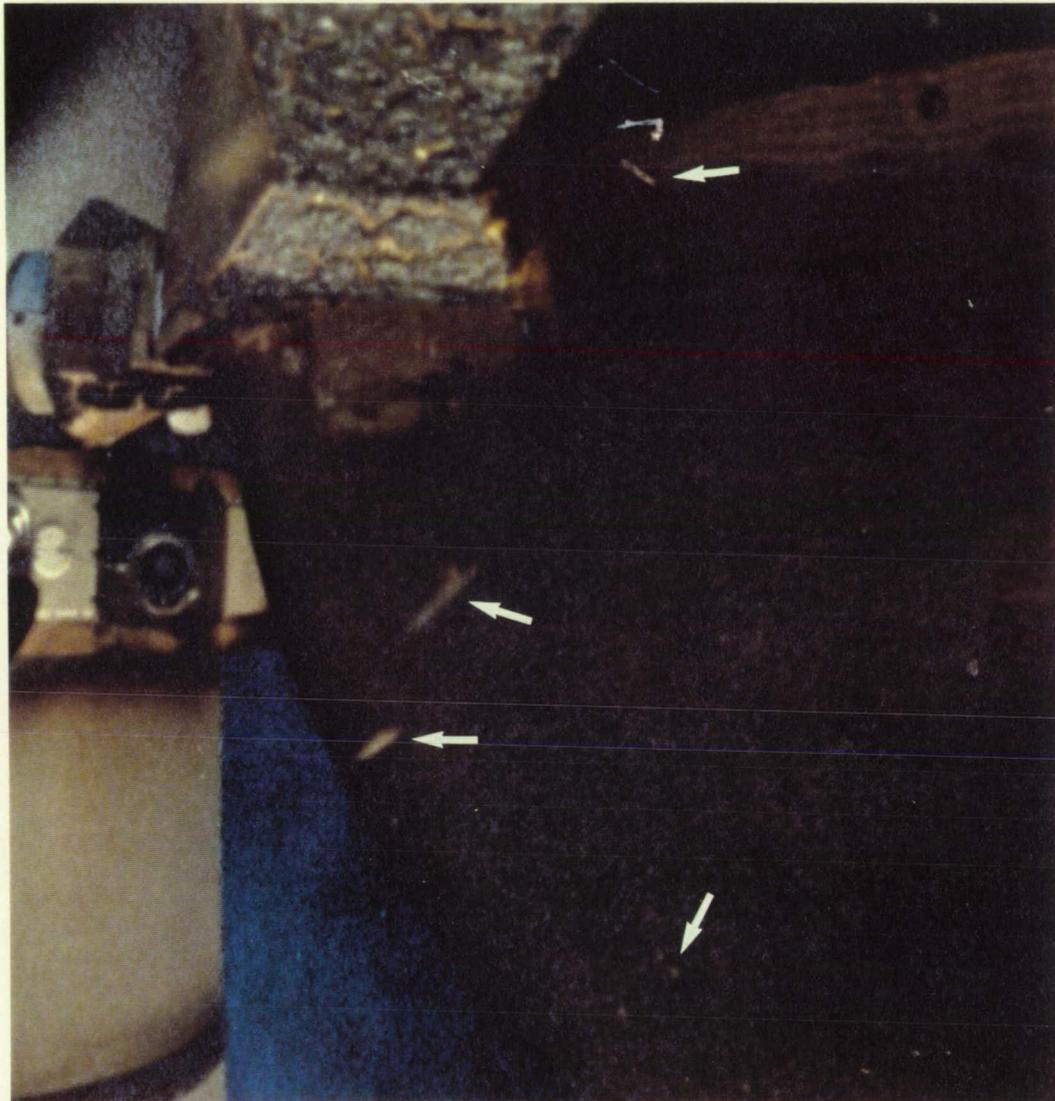
Figure 2.4.1.1 16 mm View (10 mm Lens) of LSRB Separation

Numerous pieces of small debris were seen in the 16 mm umbilical camera film views of the LSRB before, during, and after SRB separation. The debris appeared to be small pieces of TPS that had ablated off the external tank.

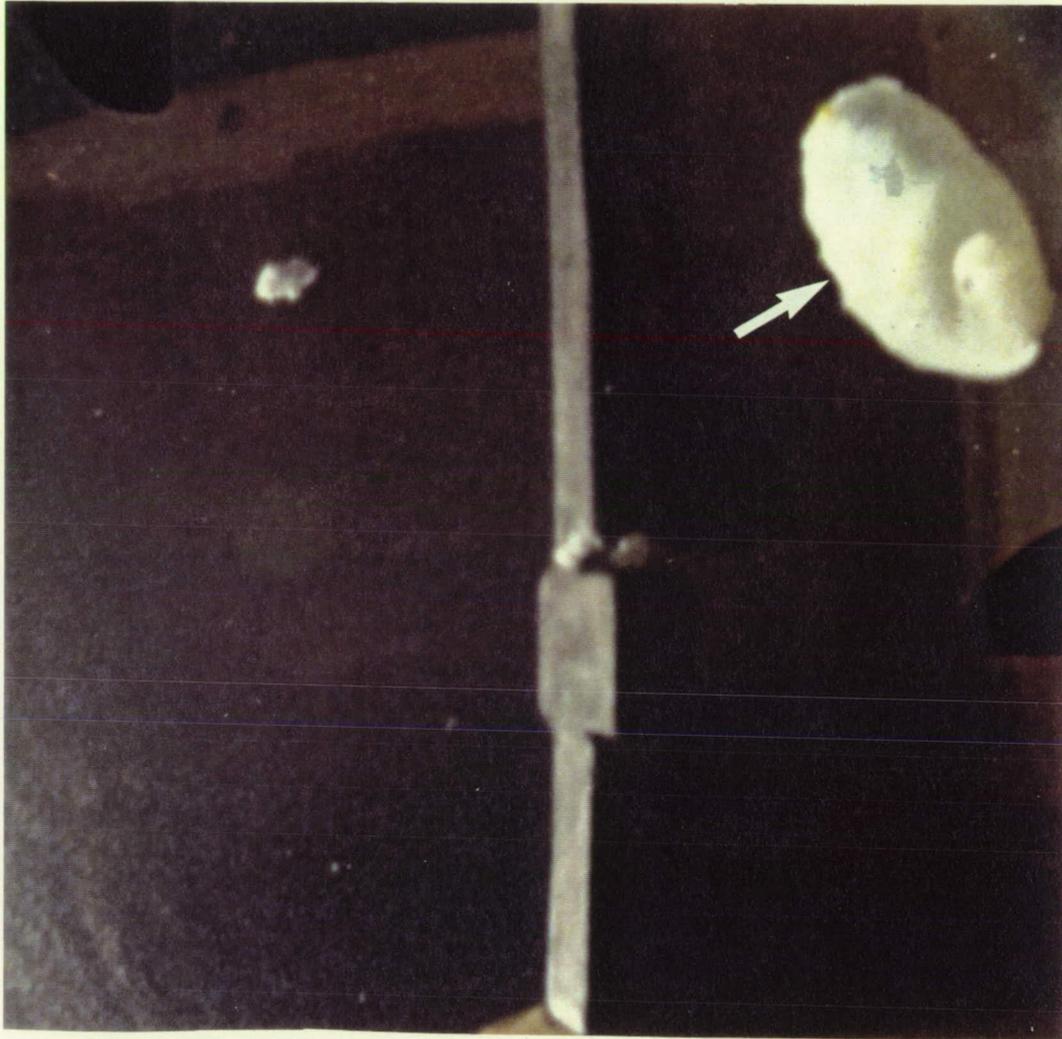
Figure 2.4.1.2 (A) Ice from Forward Purge Vent Tube Visible at ET Separation

A single, large, white cylindrical-shaped piece of debris was seen to travel across the FOV just before ET separation. KSC reported that this debris was an ice finger from a forward purge vent tube.

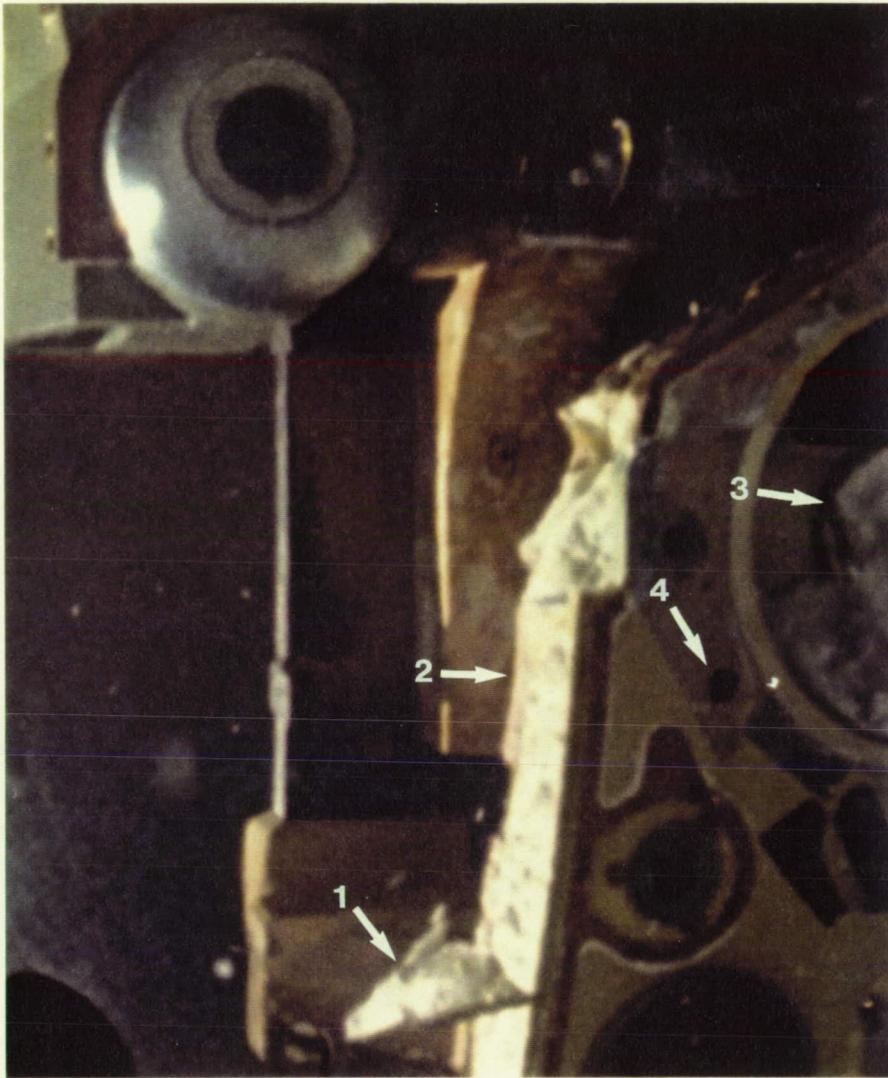
Figure 2.4.1.2 (B) LH2 ET Umbilical at ET Separation

A small piece of foam like material moved across the ET LH2 umbilical just after ET separation (1). A blistered appearance to the TPS on the left side of the LH2 umbilical was visible as the ET began to move away from the Orbiter (2). Ice was visible in the orifice of the LH2 17 inch line as the LH2 umbilical came into full view (3). The bushing sleeves appeared to be present in their proper positions (4). (The cylindrical-shaped debris object seen on the STS-40 umbilical well film was believed to have been a dislodged bushing sleeve).
