Debris/Ice/TPS Assessment And Integrated Photographic Analysis For Shuttle Mission STS-52

December 1992

DEBRIS/ICE/TPS ASSESSMENT
AND
PHOTOGRAPHIC ANALYSIS
OF
SHUTTLE MISSION STS-52

October 22, 1992

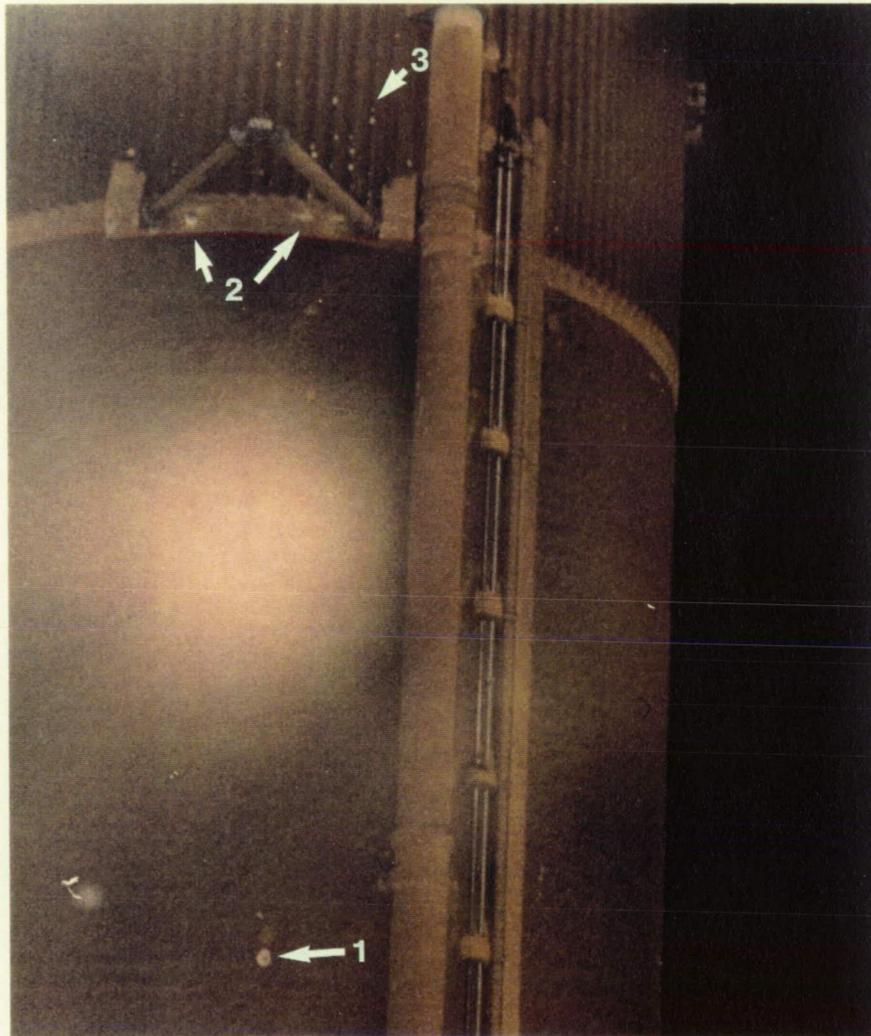
Figure 2.4.1.3 Small White Marks/Divots seen on ET +y TPS

A divot was seen on the LH2 tank TPS approximately ten feet below the intertank closeout line (+Z axis to the left of the LO2 feedline). The divot was estimated to be approximately six inches in size (1).

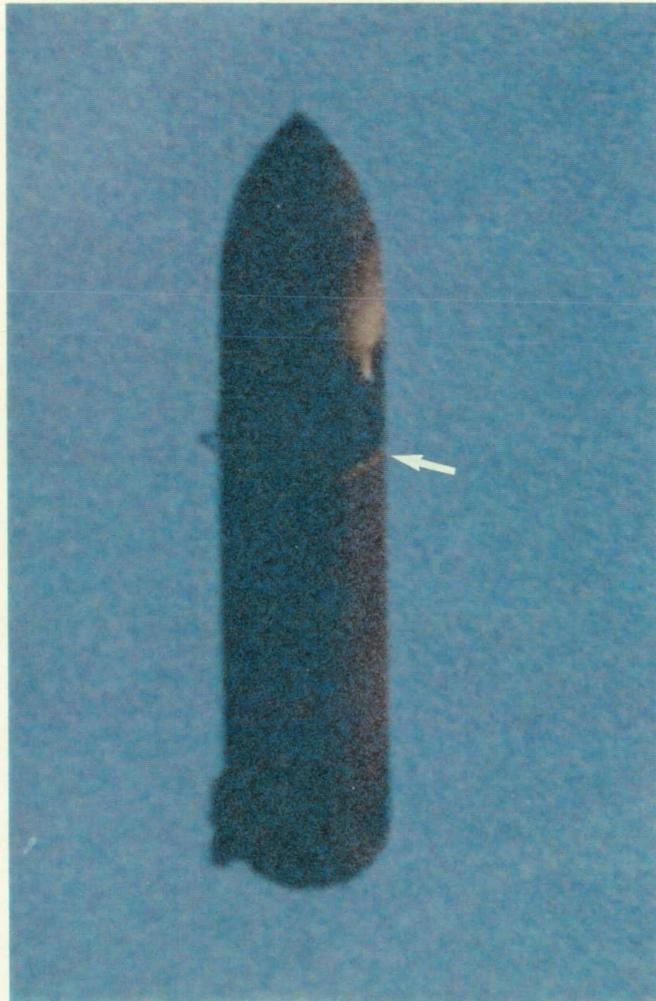
Figure 2.4.2 Possible Divots on the LH2/Intertank Interface

The detailed screening revealed two possible divots in the LH2 intertank interface on the +Y axis. The ET tumbled at approximately 0.124 revolutions per minute about a plane which intersected the optic axis. Updates to the DTO-0312 have been incorporated into the next mission's procedures that should increase the quality of the photography.

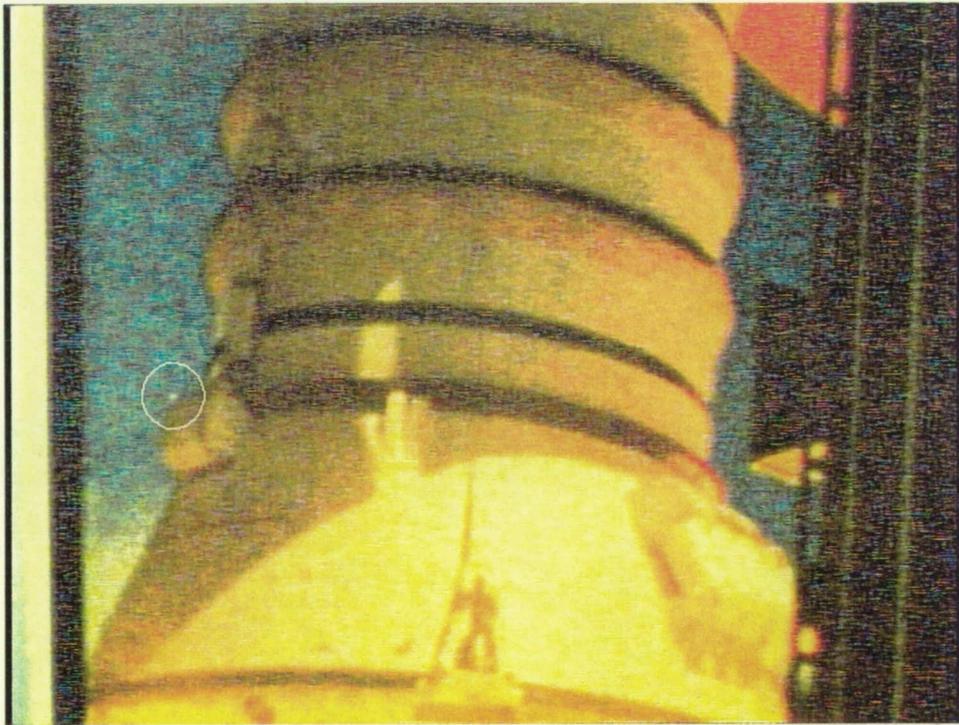
Figure 4

Pad Debris Noted From SRB Blast Hole

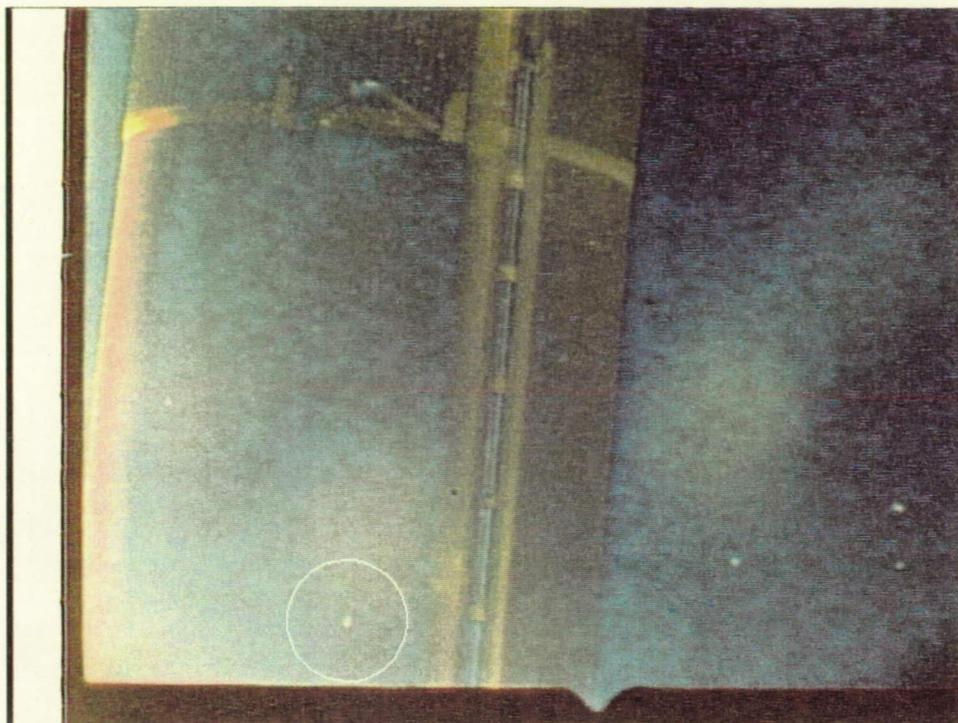
Figure 5

Divot Noted Towards Center of the LH2 Tank Near the LOX Line

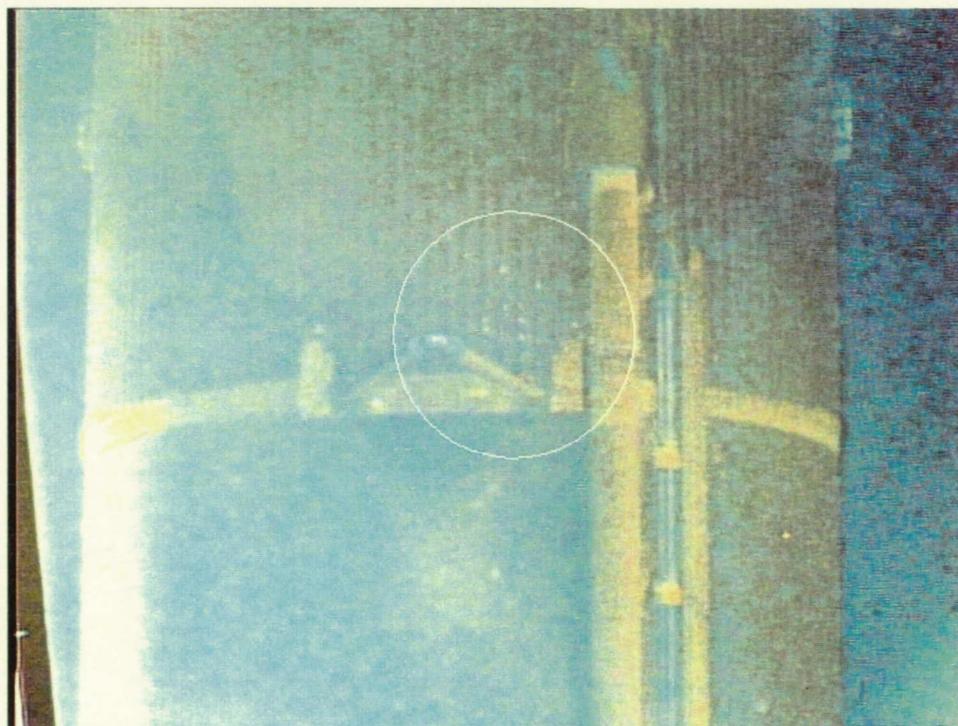
Figure 6

Several Small Divots Noted on Right Side of the Bipod on the Intertank
