NASA-CR-192522

Final Report on the SRB Frustrum "Smiley" Cracking Phenomenon Study

February 6, 1993

Thomas A. Cruse, Ph.D.
401 Bowling Ave. #6
Nashville, TN 37205
(615) 343-8727; (615) 343-8730 (fax)

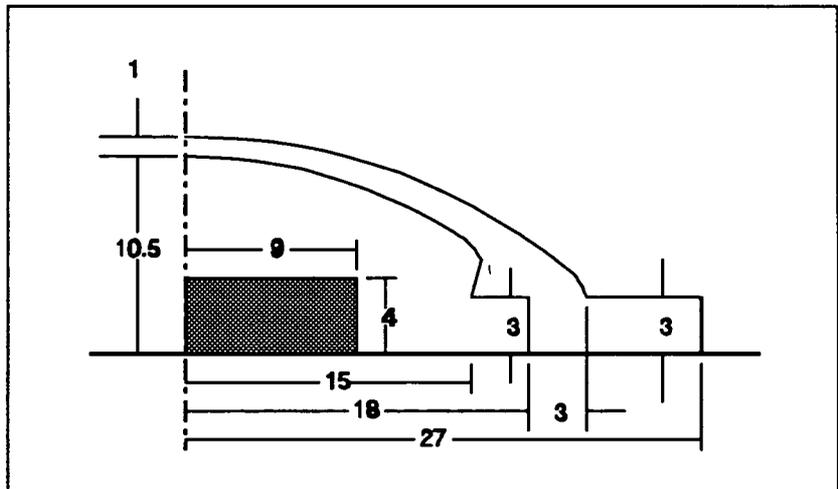
Figure 3: Nominal Dimensions of FEM Model (mm.)

The nominal geometry defined for analysis is shown in Figure 3, where the dimensions are given in millimeters. The configuration is taken to be axisymmetric, and only the right-hand side of the geometry is shown. The nominal geometry has been taken to have a large amount of excess PR-1422 material, taken to be 3 mm thick and extending to the edge of the low profile cap, which has been removed. The right hand edge of the indicated geometry is taken to be a surface with no normal motion of the MSA-2 material, thereby approximating the restraint of the surrounding MSA-2 material. The slight undercut of the low profile cap has been simplified by using an angle to the interface. The volume occupied by the fastener is indicated by the shaded region. The MSA-2 material is shown with a 1 mm thickness at the centerline, and a 3 mm thickness away from the fastener.

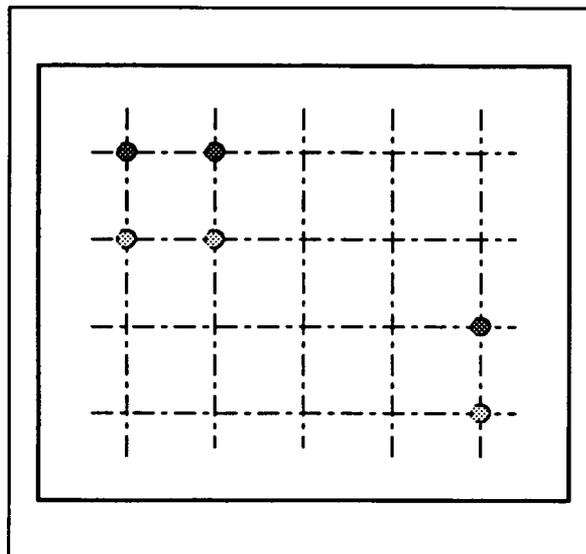
Figure 5: Proposed Test Panel

The test panels should be prepared in a fashion similar to that shown schematically in Figure 5. Each test panel of 0.125" thick aluminum contains four rows of five simulated fastener locations. The figure indicates typical locations for each of the 20 simulated fasteners, which are arranged in alternate rows of five with overfill, five without, etc. The simulated fastener locations were located on centers approximately 10x the size of the raised region which includes the PR-1422 material, and the raised MSA-2 material covering the sealant. The distance is to provide space sufficient to isolate each test location from all others, and for cutting each test specimen such that the 2"x 2" test specimen is large enough to minimize the influence of edge failures during tensile testing.

Test pull blocks were fabricated for each of the 20 simulated fastener specimens cut from each test panel. Each block was of sufficient size that it could be bonded over the raised MSA-2 material for a bonded diameter approximately equal to the anticipated failure zone, as shown schematically in Figure 5.

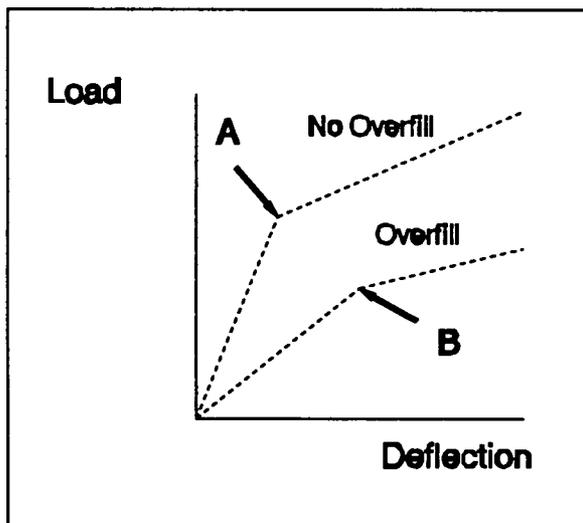
Figure 7: Schematic of the Load-Deflection History for the Pull Test

The pull test for no overfill of the PR-1422 material will show less compliance than for the test with overfill. The reason is that there is more MSA-2 material between the pull bar and the aluminum panel, to resist the applied loading. At a critical load level, the MSA-2/aluminum bond will fail (indicated in Figure 3 as point A). The loading will shift more toward the MSA-2/PR-1422 interface centered over the simulated fastener location. This load path is much more flexible than the original load path prior to bond failure and the load deflection curve will likely show a significant increase in compliance. Failure at the indicated failure site in Figure 6 will likely occur at point A in the load history.

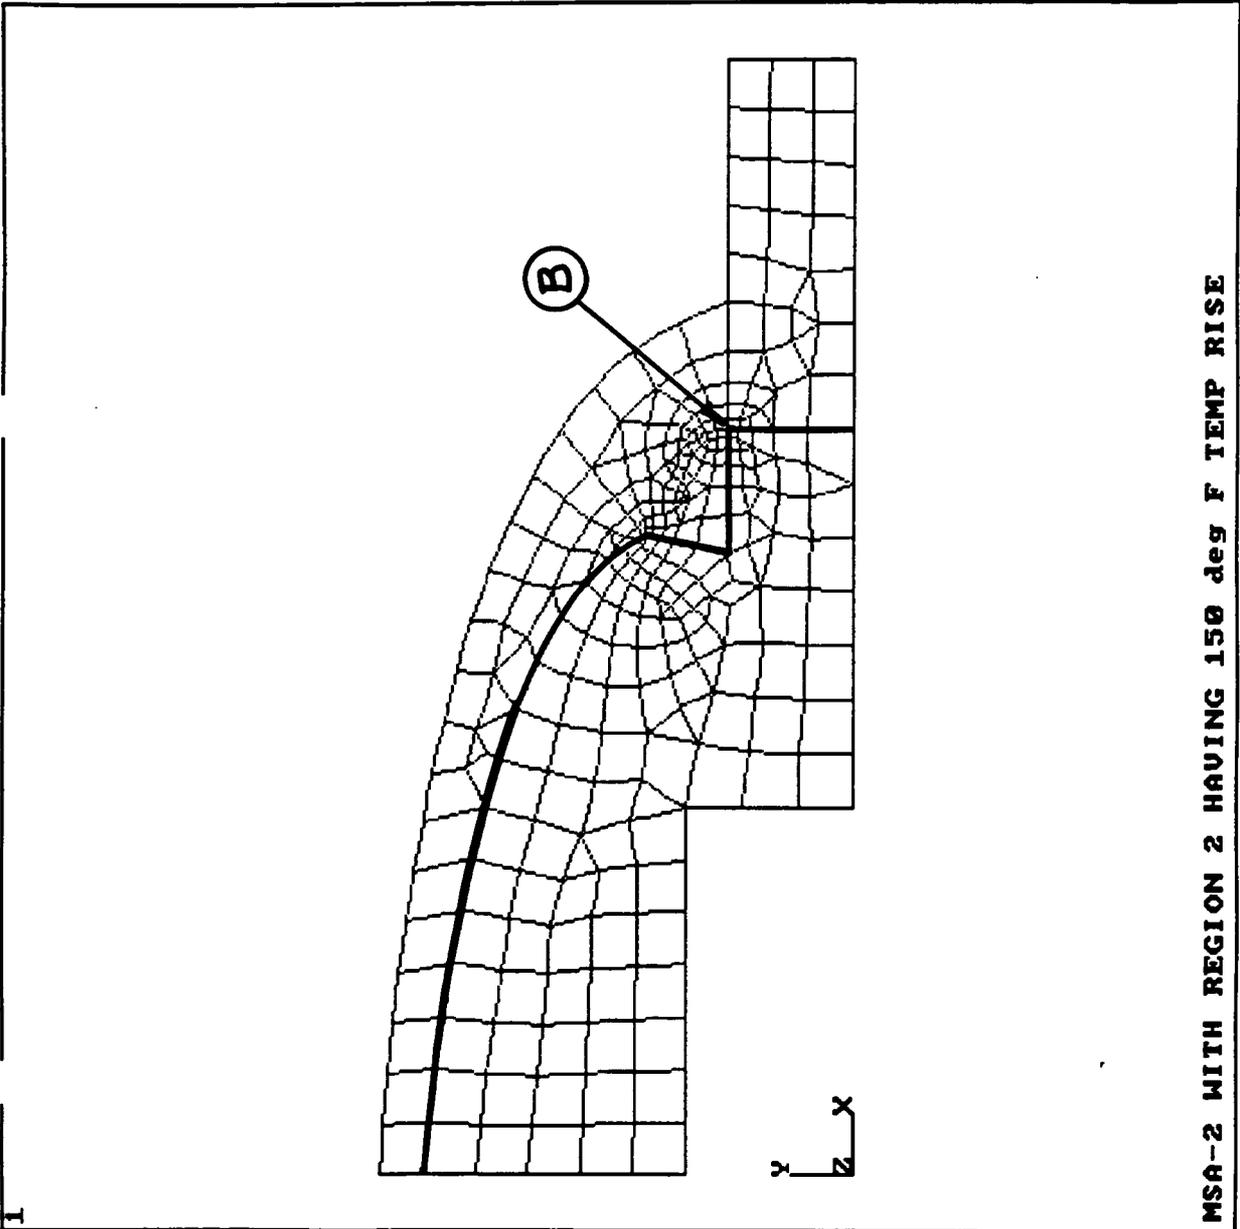
CASE 3

MSA-2 WITH REGION 2 HAVING 150 deg F TEMP RISE

ANSYS 4.4
 OCT 10 1992
 14:24:16
 POSI=1 STRESS
 STRES=1
 ITER=1
 SIGE (AUG)
 DMX =0.029864
 SMN =0.331712
 SMXB=47.1422
 SMXB=77.765

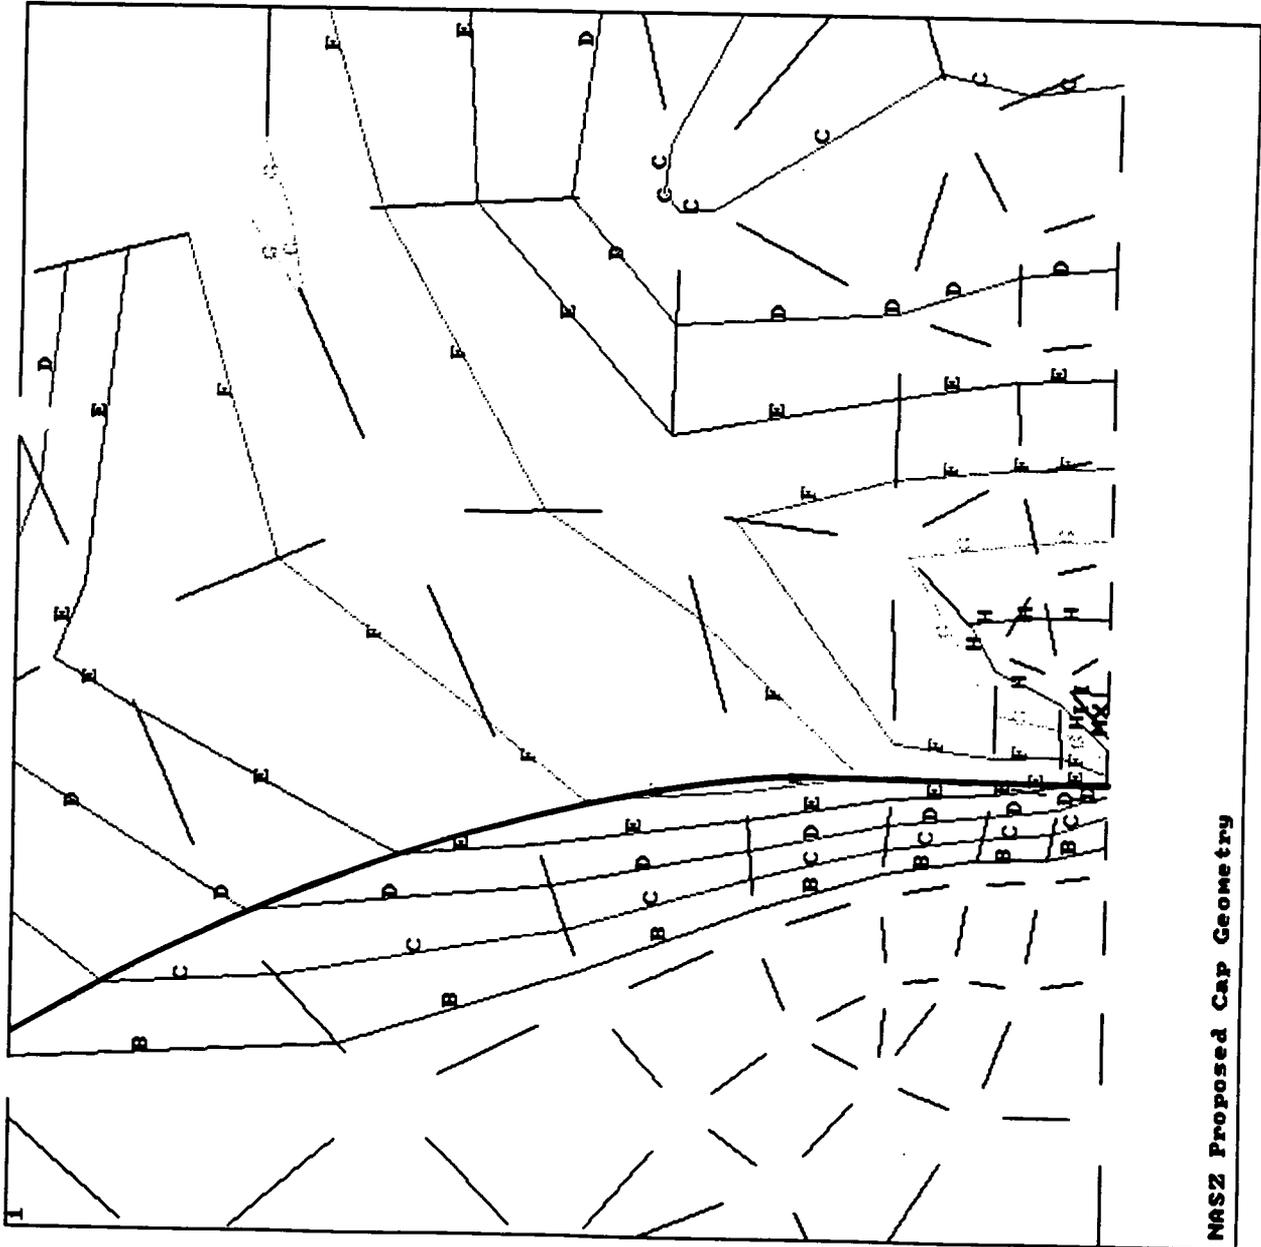
CASE - 2

NASZ Proposed Cap Geometry
