**NASA
Technical
Paper
3190**

**External Stress-Corrosion
Cracking of a
1.22-m-Diameter Type 316
Stainless Steel Air Valve**

Thomas J. Moore,
Jack Telesman,
Allan S. Moore,
Dereck F. Johnson,
and David E. Kuivinen

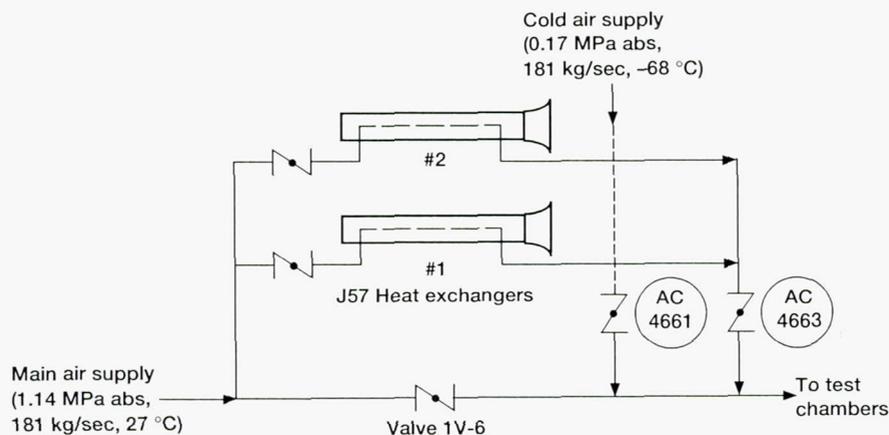
Figure 2.—Piping for the combustion air supply system.

In one mode of operation, ambient combustion air is delivered to the test cell at a maximum delivery rate of 181 kg/sec at 1.14 MPa absolute (fig. 2). In another mode, ambient combustion air is blended with air chilled to -68°C . This chilled air is discharged from valve AC4661 at 181 kg/sec at 0.17 MPa absolute. In a third mode, valve 1V-6 can be used to divert ambient combustion air through the J57 heat exchangers (where nonvitiated air can be heated to 400°C). This heated air is then discharged through valve AC4663 and is mixed with ambient air. In the highest operating temperature variation of the third mode, valve 1V-6 is closed. As seen in figure 2, all of the combustion air is forced through the heat exchangers. The air temperature at the upstream face of valve 1V-6 is at about 27°C and at the downstream face is from 340 to 370°C . The high-temperature mode of operation was used in about 20 of the 100 annual runs made over the past 18 years. In a typical run, the time at the maximum operating temperature was about 3 hr, and the pressure on the upstream face of the valve (about 1.14 MPa abs) was only slightly higher than the pressure on the downstream face.

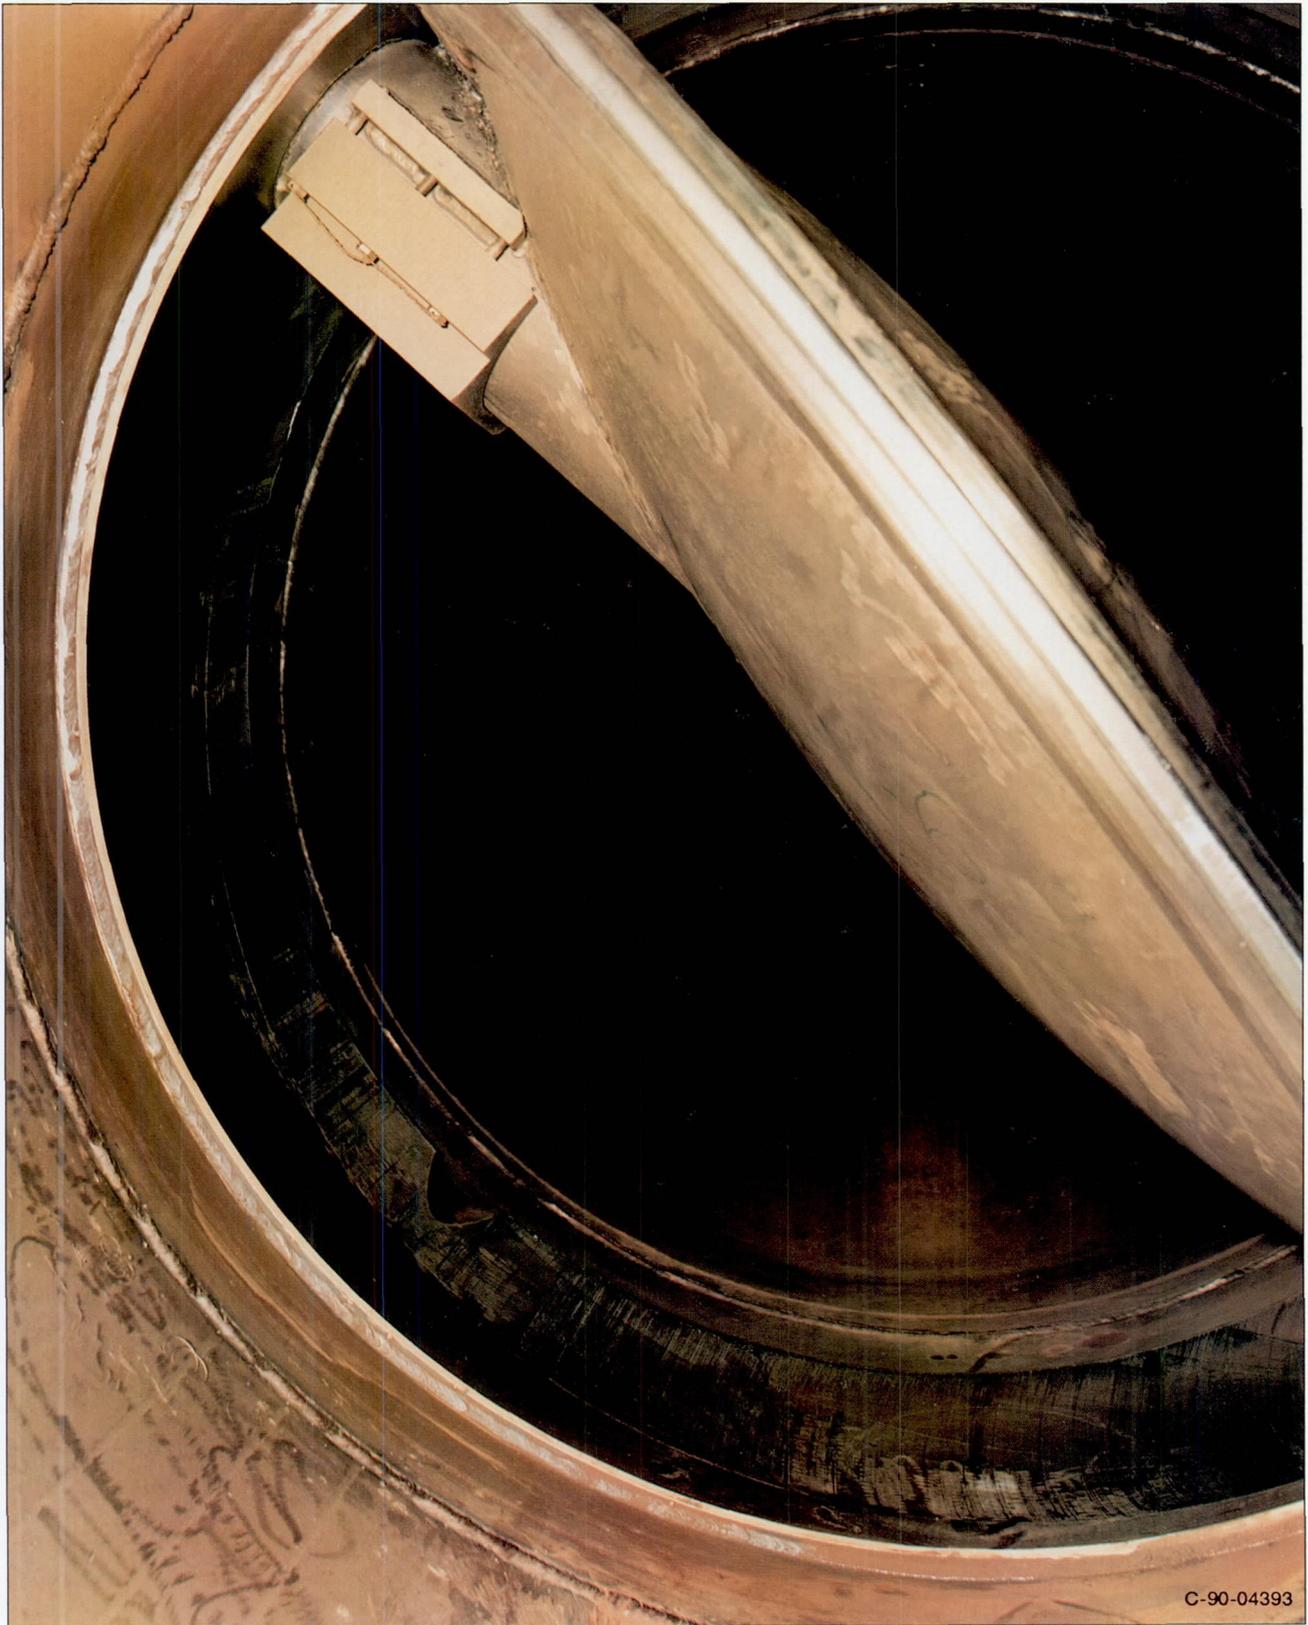
An internal view of the valve in the open position (looking upstream) is shown in figure 4. An identical view in the closed position is shown in figure 5. Through-the-wall cracking was present in the weld HAZ for about half the

circumference of the butt joint on the south and north sides. Figure 5 also shows the locations from which 21-mm-diameter metallographic plug samples W, X, and Y were taken from the butt joint and the region from which sample Z was taken from the T-joint. Figures 6 and 7 are external views showing the plug holes, which were centered at the butt joint cracks. The plugs included weld metal, HAZ, and unaffected base metal. Figure 6 also shows that the area of sample Z (which was cut out later) included a portion of the support ring. The internal view in figure 8 shows the plug holes of samples X and W and a portion of the through-the-wall toe crack from the external ring-to-skirt T-joint. This toe crack, which was evident along the inner circumference, was parallel to the circumferential butt joint crack. These cracks were only about 25 mm apart. Sample Z (shown in fig. 9), which contains the toe crack, was obtained by manual plasma arc cutting. The downstream support ring was included with a 10- by 26-cm portion of the skirt. Cross sections of sample Z were taken transverse to the support ring for both macro- and micro-examination.

Figure 4.—Internal view (looking upstream) of valve 1V-6 in the open position.

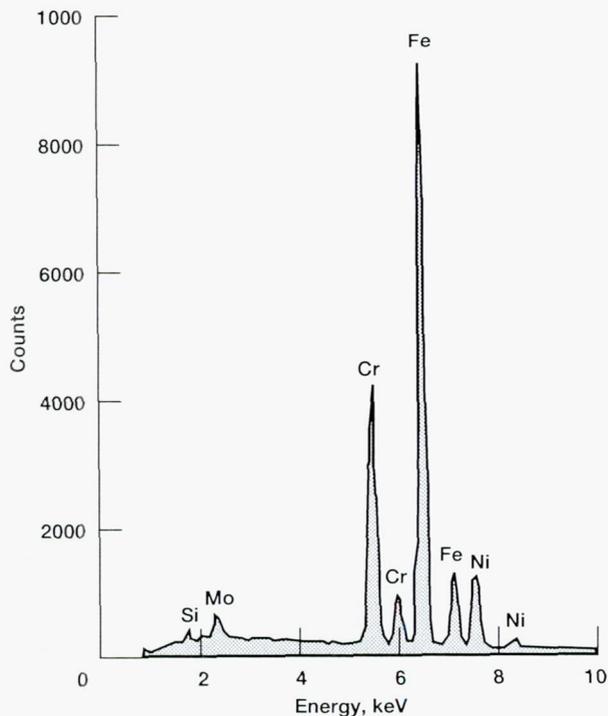
The base metal support ring spectra are shown in figure 15. A comparison of the support ring analysis as determined by XEDS and conventional methods can be made using the data in table I. This comparison shows general agreement except for the lower molybdenum (Mo) content in the XEDS analysis.

Figure 15.—Type 316 stainless steel matrix spectra.

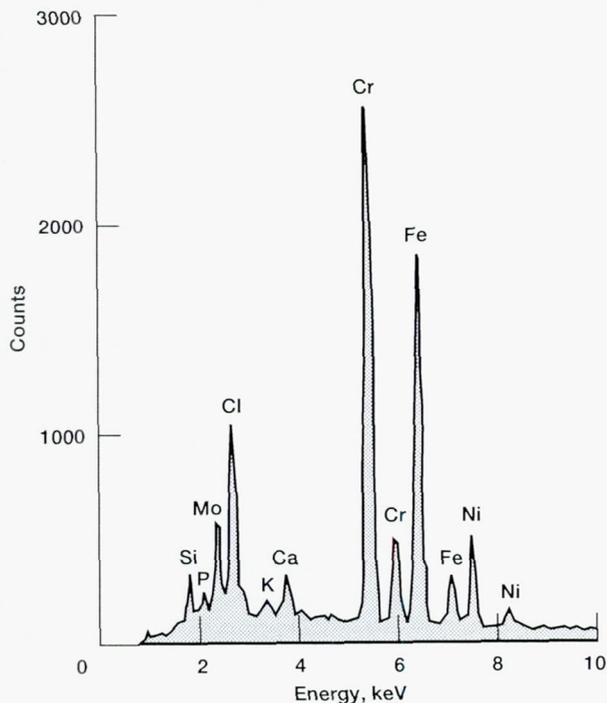
Perhaps the most important information was obtained from the analysis of the intergranular layer, 150 μm below the surface of the cracked ring (fig. 14). The profile for this spectra is shown in figure 16. These data are given in table I. A comparative XEDS analysis of the base metal and the intergranular layer showed increased quantities of Cr (18.5 to 31.1 percent), Cl (0.1 to 7.9 percent), and P (0.4 to 1.3 percent). The high Cr indicates the presence of chromium carbides at the grain boundaries (i.e., a sensitized condition). In this condition, the grain boundary regions adjacent to the

Figure 16.—Intergranular, stress-corrosion crack spectra.
