# Debris/Ice/TPS Assessment and Integrated Photographic Analysis for Shuttle Mission STS-56

May 1993

DEBRIS/ICE/TPS ASSESSMENT  
AND  
PHOTOGRAPHIC ANALYSIS  
OF  
SHUTTLE MISSION STS-56

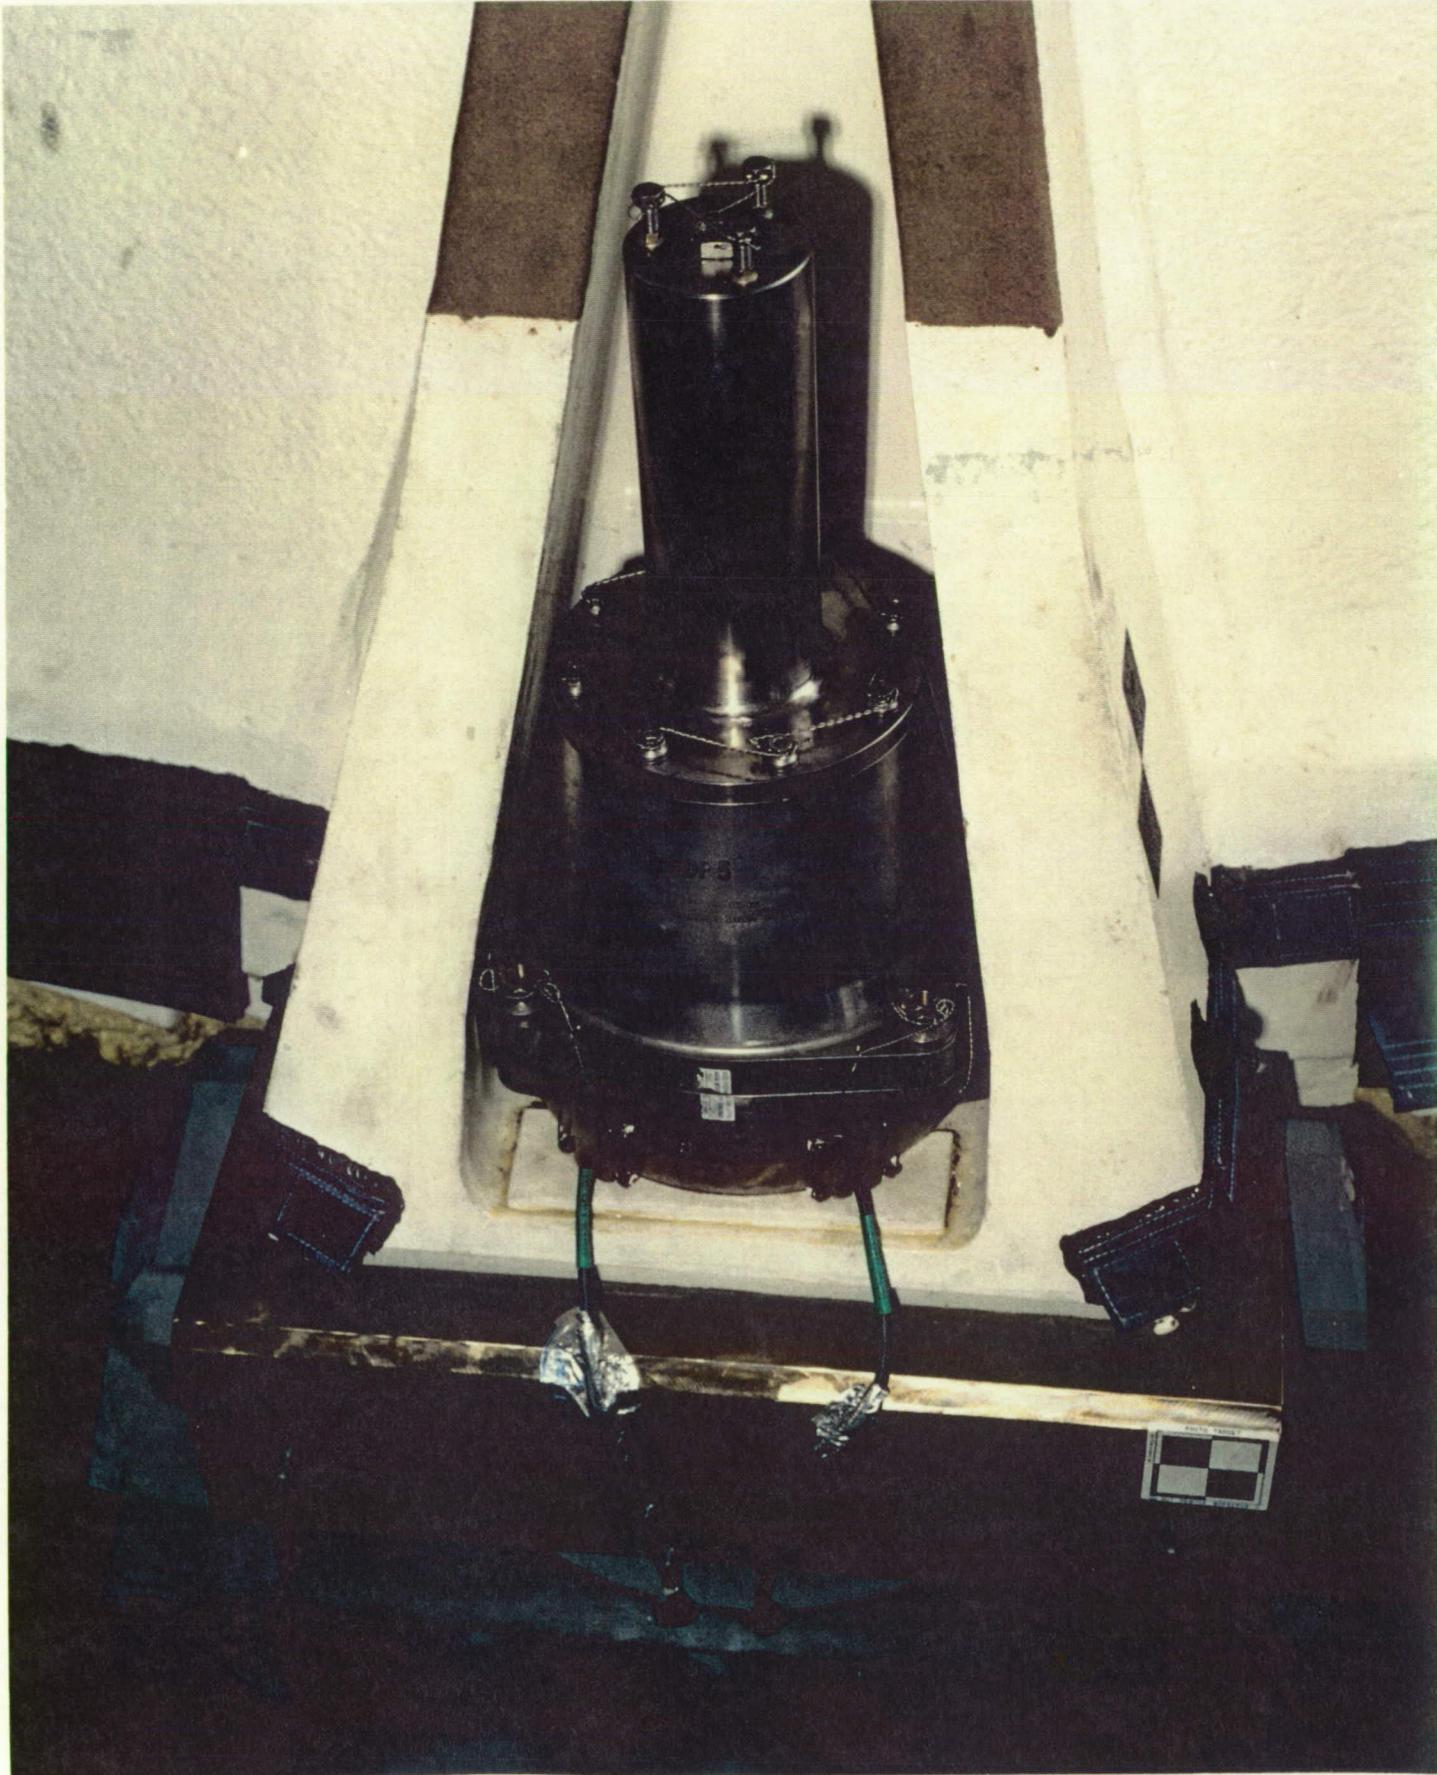
Pre-launch configuration of the Holddown Post (HDP) #5  
Debris Containment System (DCS)-exterior view

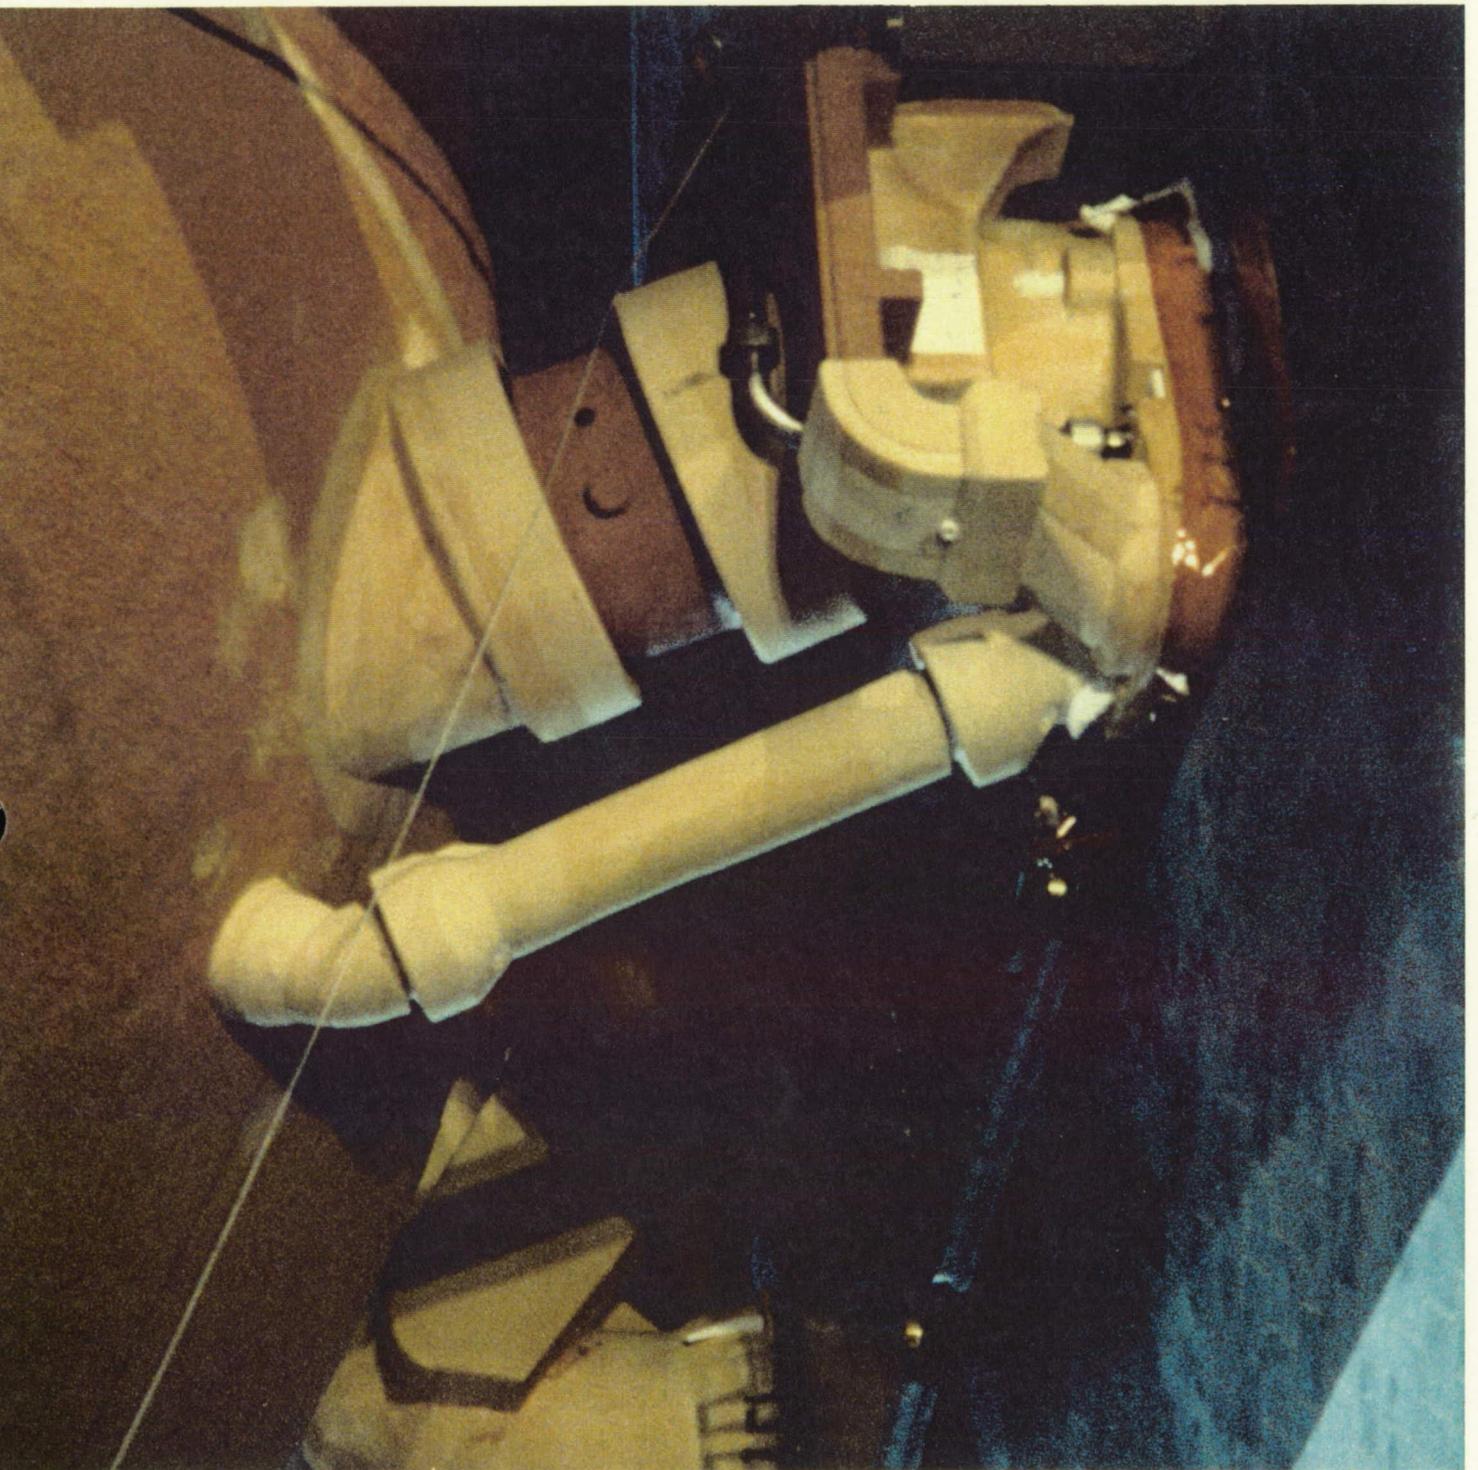
A 10-12 inch long crack occurred in the -Y vertical strut cable tray forward surface TPS near the longeron closeout interface. The 1/4-inch wide crack exhibited no offset and was not filled with ice or frost. The condition was acceptable for flight.

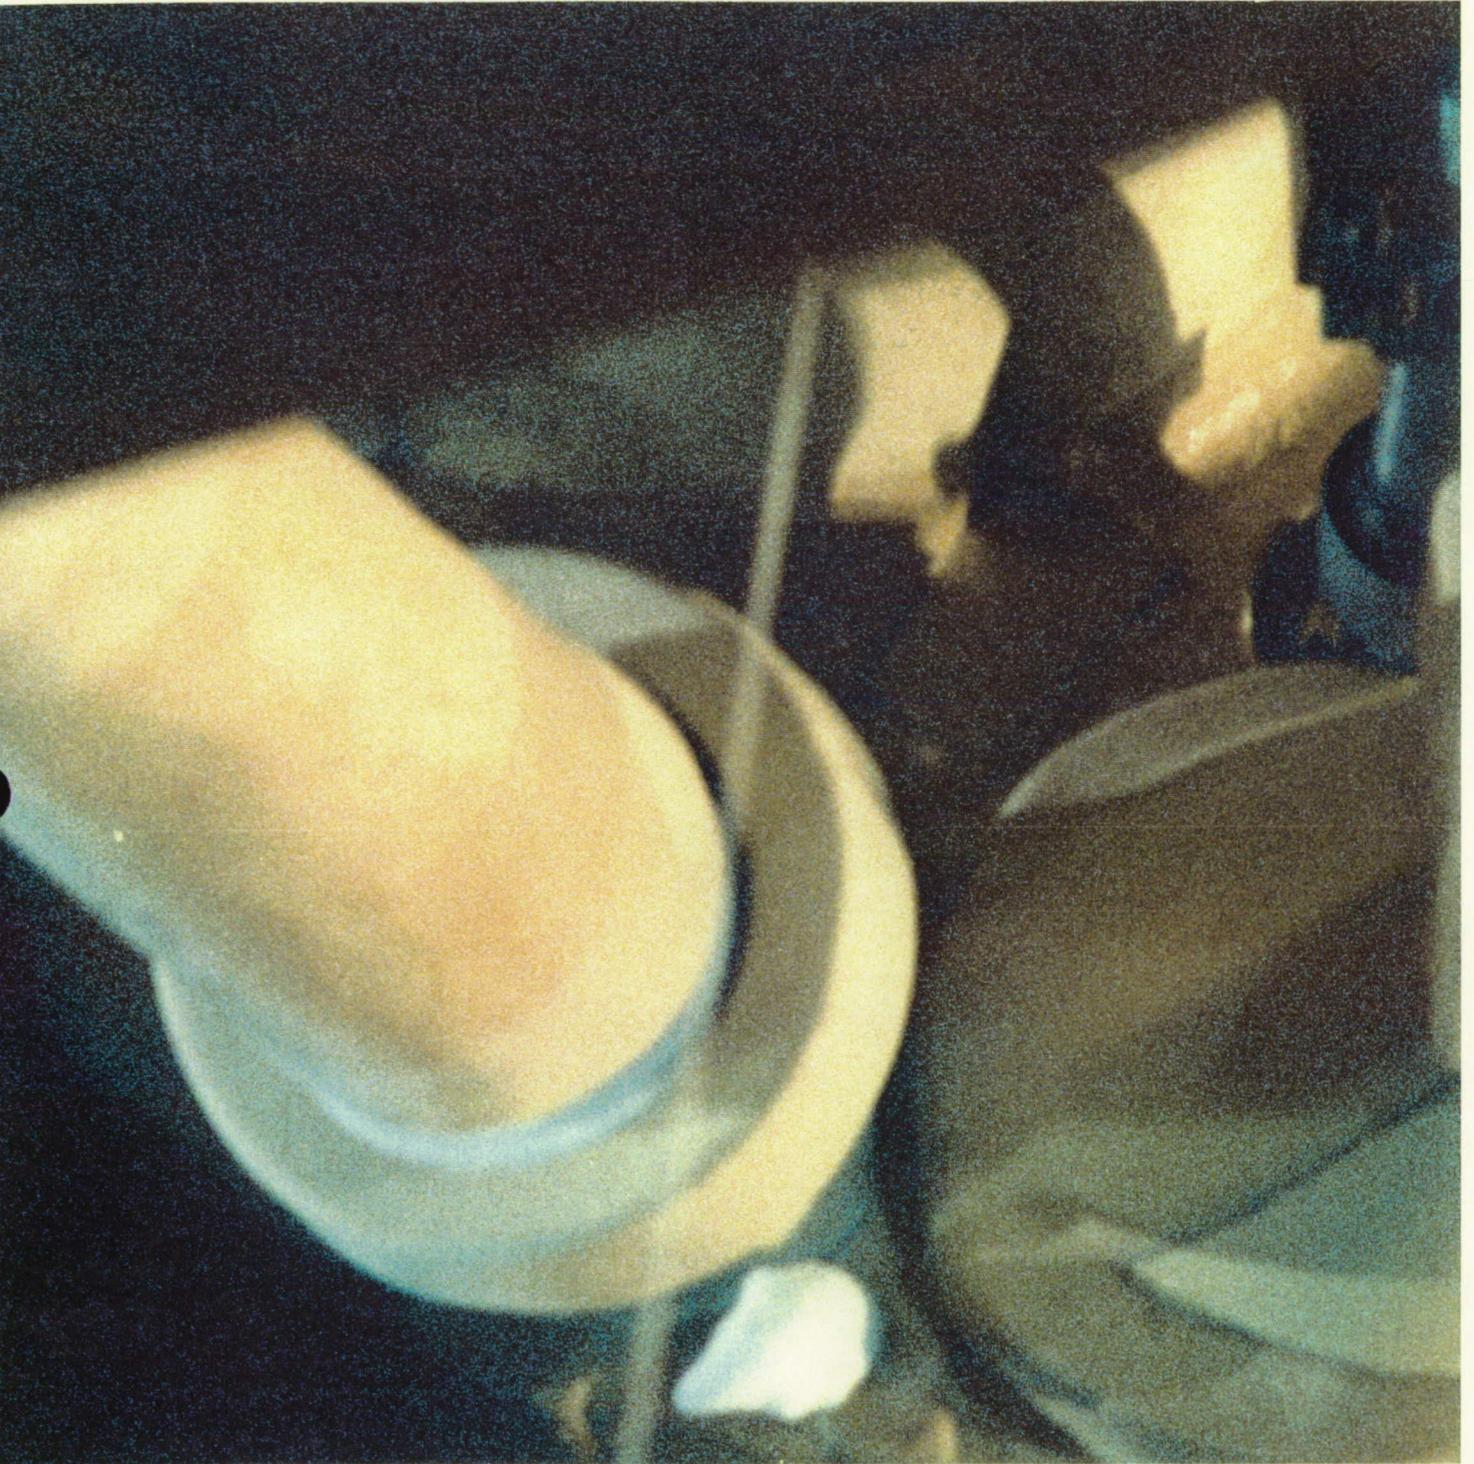
Less than usual amounts of ice/frost had formed on the ET/ORB LH2 umbilical. No unusual vapors or cryogenic drips had appeared during tanking, stable replenish, and launch.

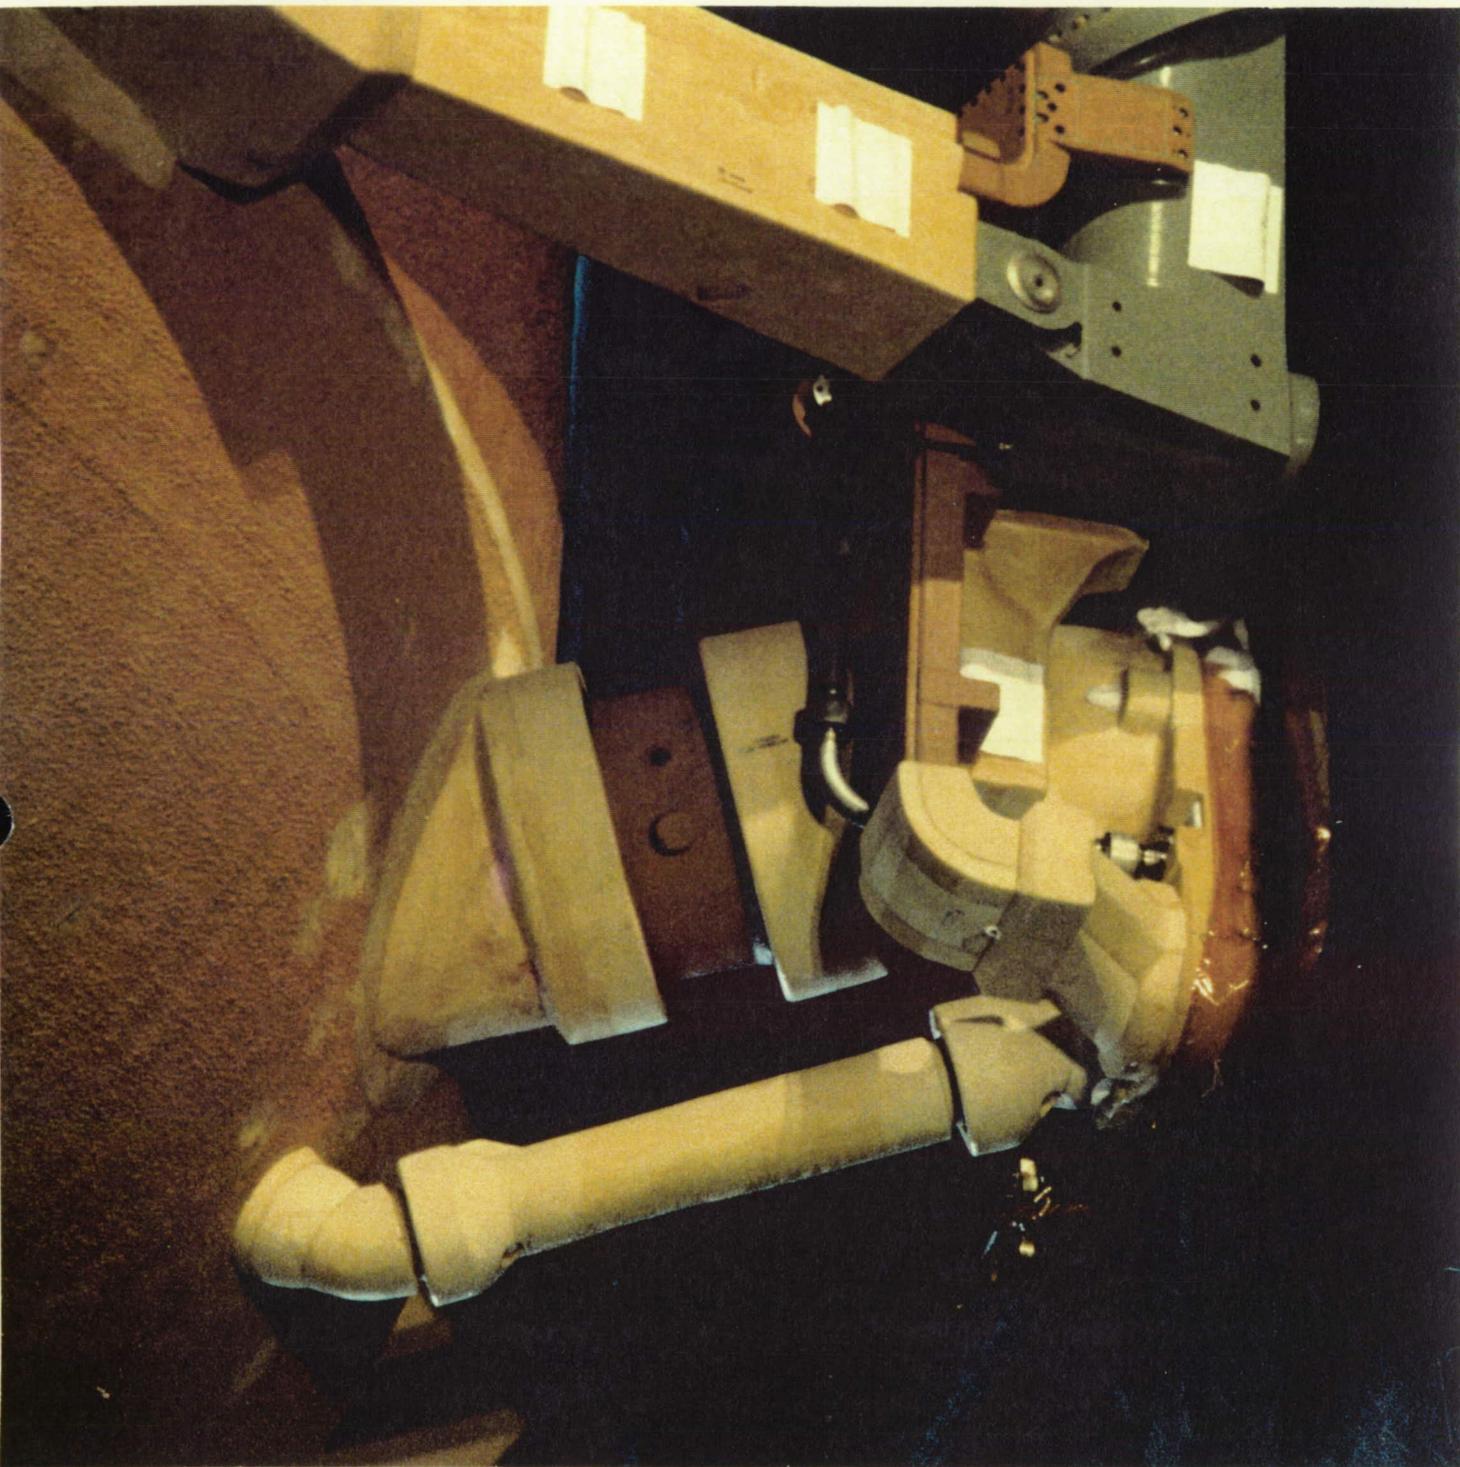
A 4-inch crack, propagating outboard from the ET interface, was most likely a continuation of the forward surface 12-inch crack along the inboard edge of the vertical strut/cable tray. The 4 inch crack exhibited some offset, which was caused by structural deflection rather than a TPS debond. Note ice formation over small TPS defect or thermal short on aft surface of strut TPS.

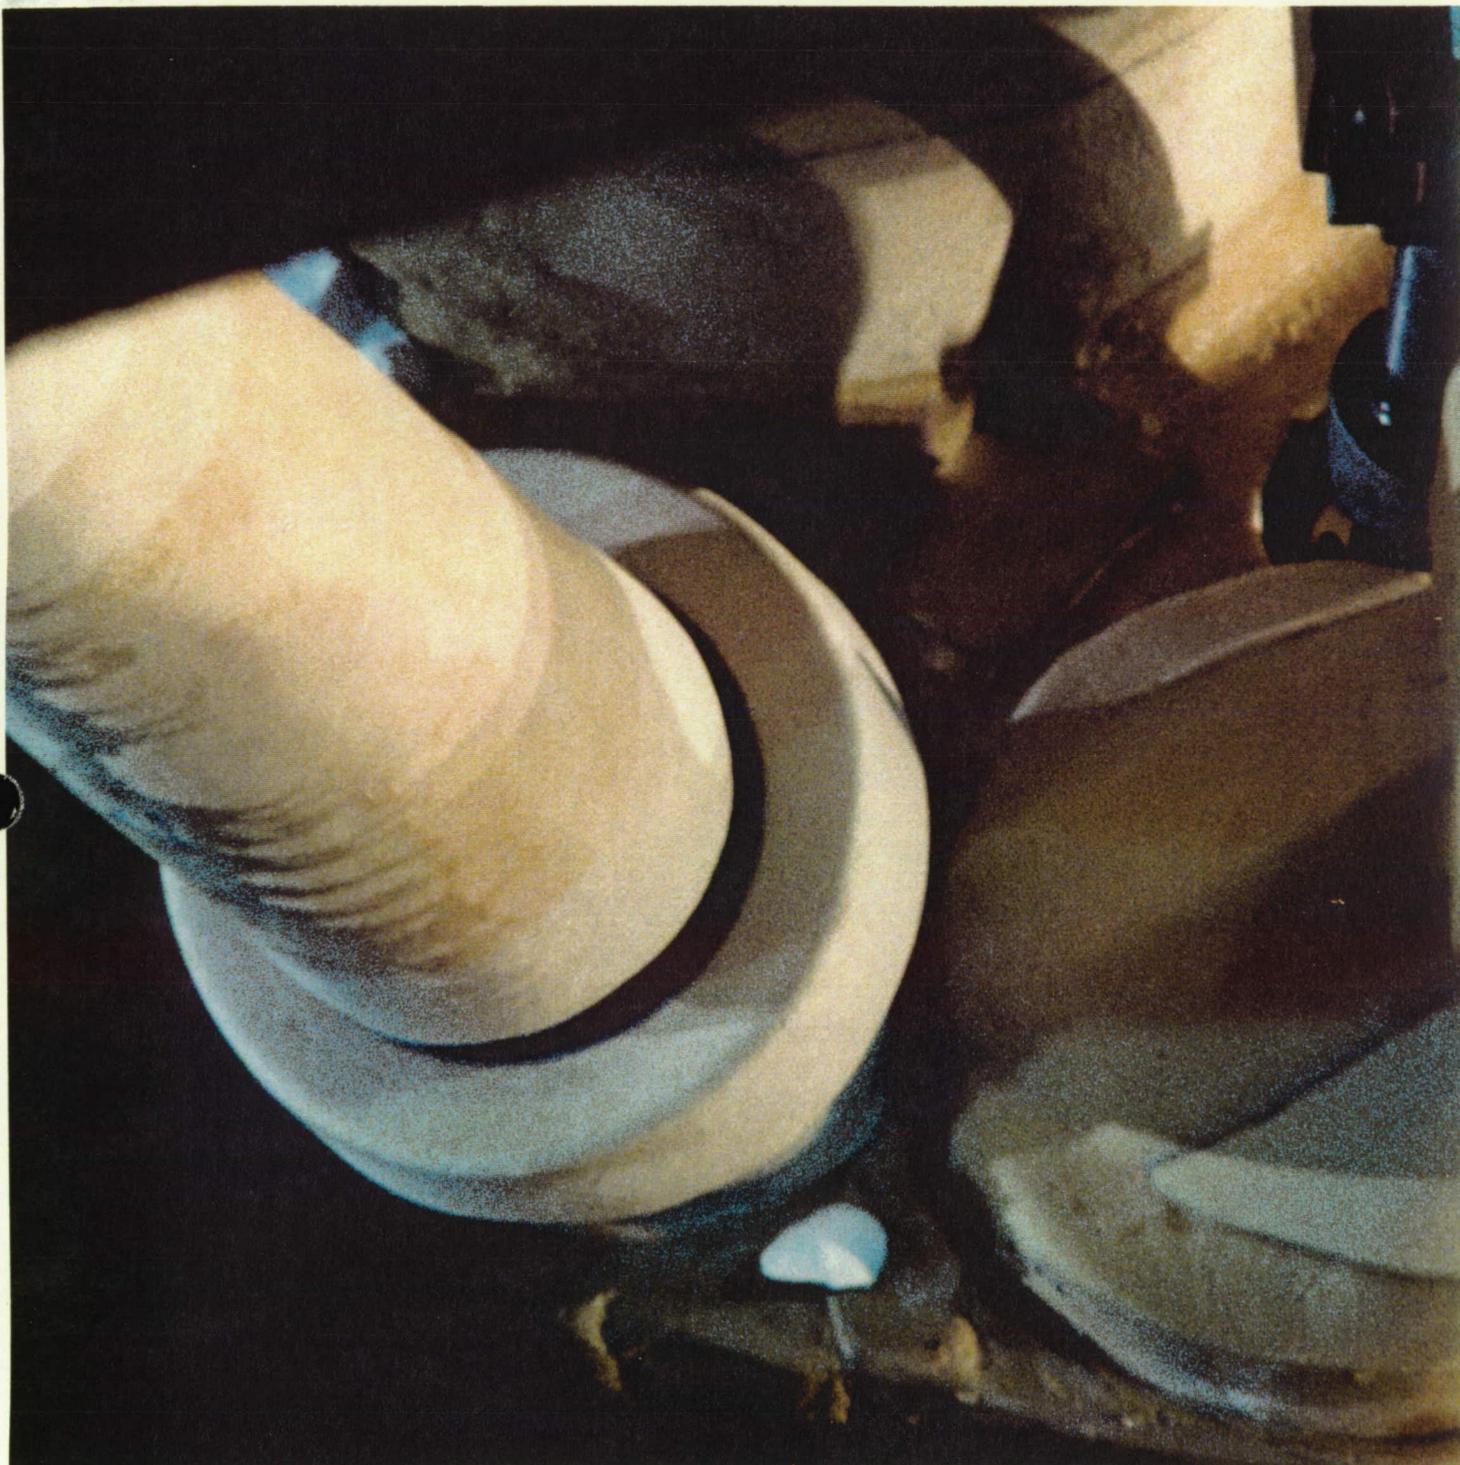
Less than usual amounts of ice/frost had formed on the ET/ORB LH2 umbilical. No unusual vapors or cryogenic drips had appeared during tanking, stable replenish, and launch.

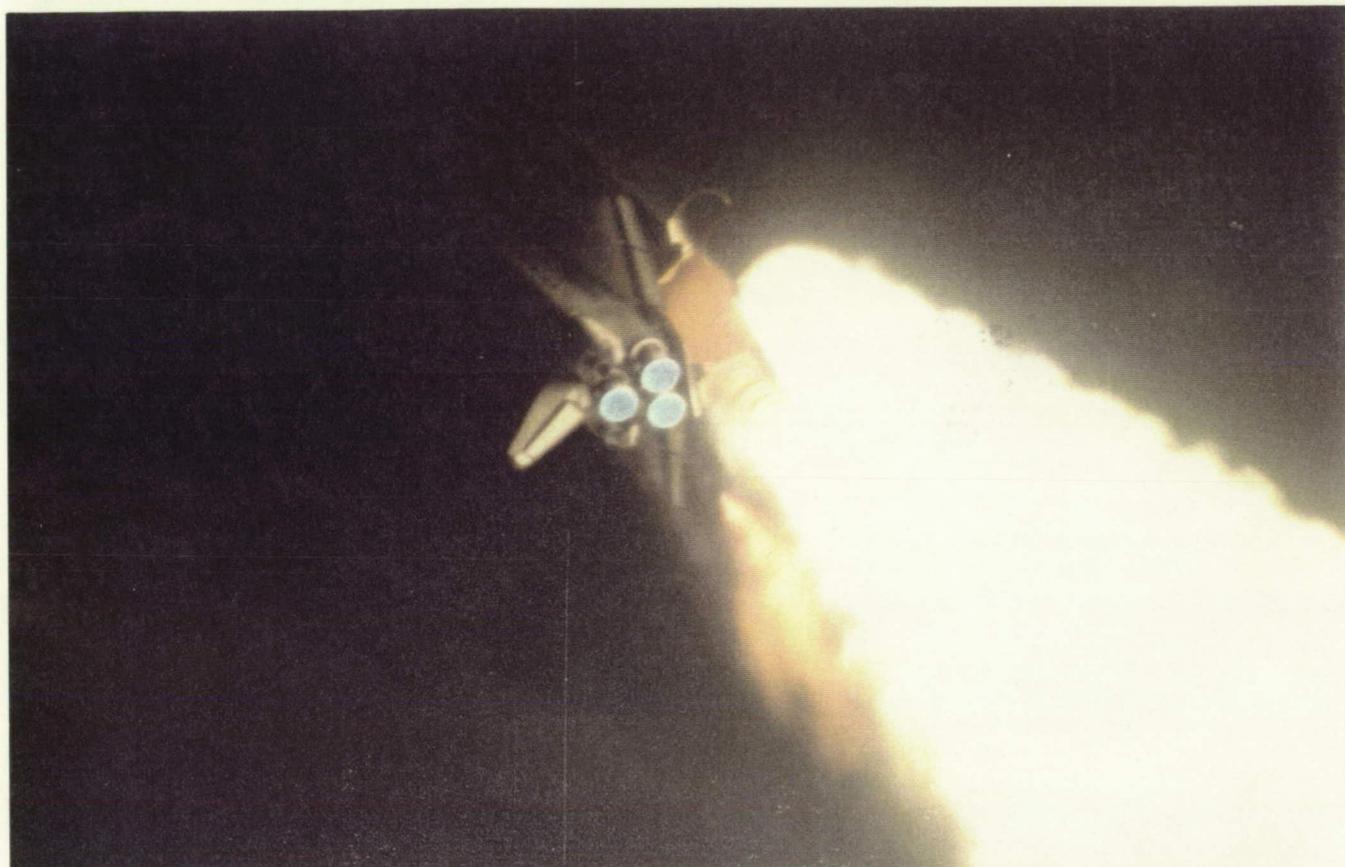
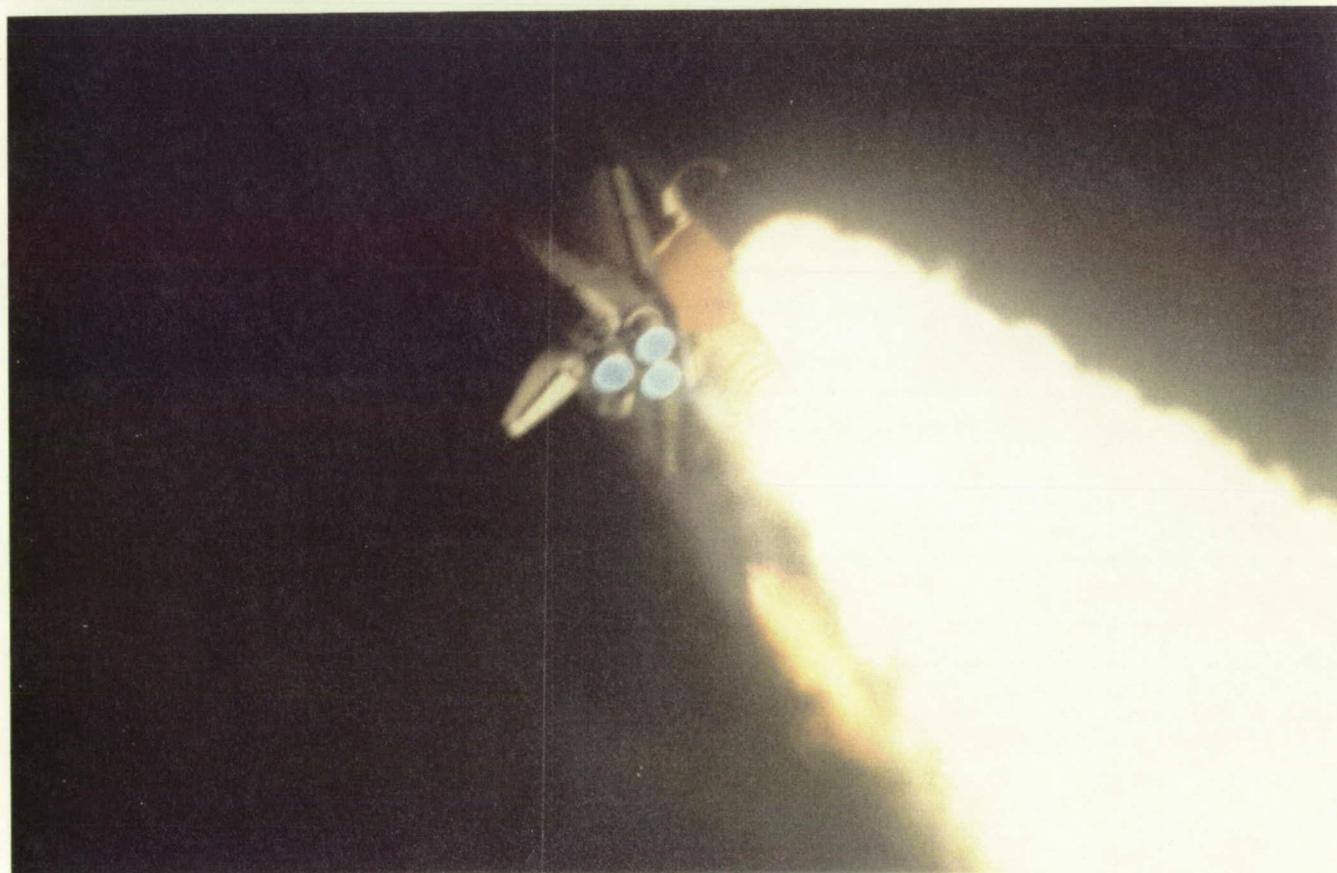
A thin, rectangular object, most likely a tile gap filler or GSE shim/spacer, originated from the left aft RCS stinger tiles (edge of the aft surface) fell during SSME ignition.

A large, orange flash, typically induced by debris, occurred in the SSME plume during ascent

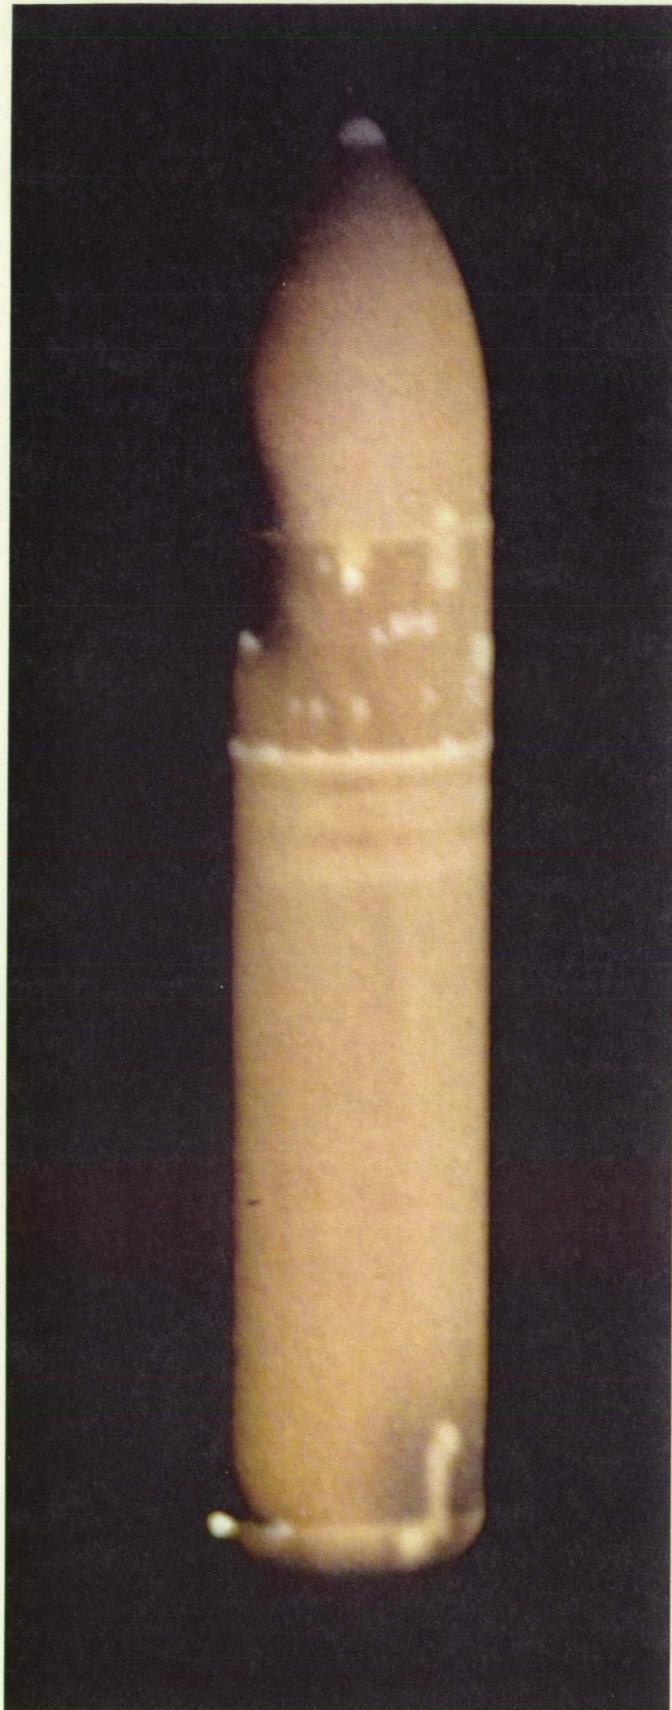
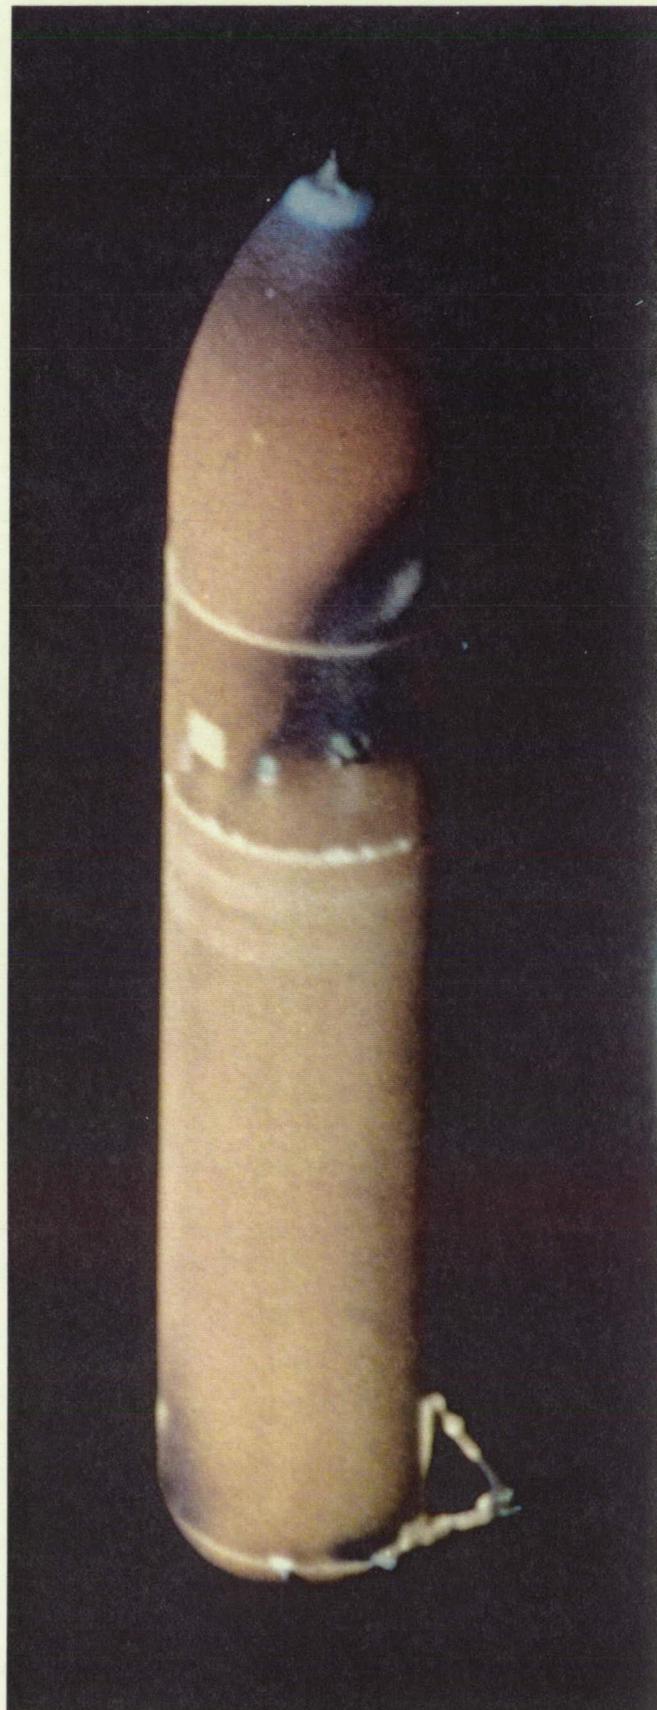
Eleven divots were visible in the intertank acreage on the ET -Z side. Numerous divots appeared in a line and may be indicative of a spray or processing problem. Depth could not be determined, but several of the divots were estimated to be 24 inches in diameter. Twelve divots, some of which were 10-12 inches in diameter, occurred in the -Z LH2 tank-to-intertank flange closeout.

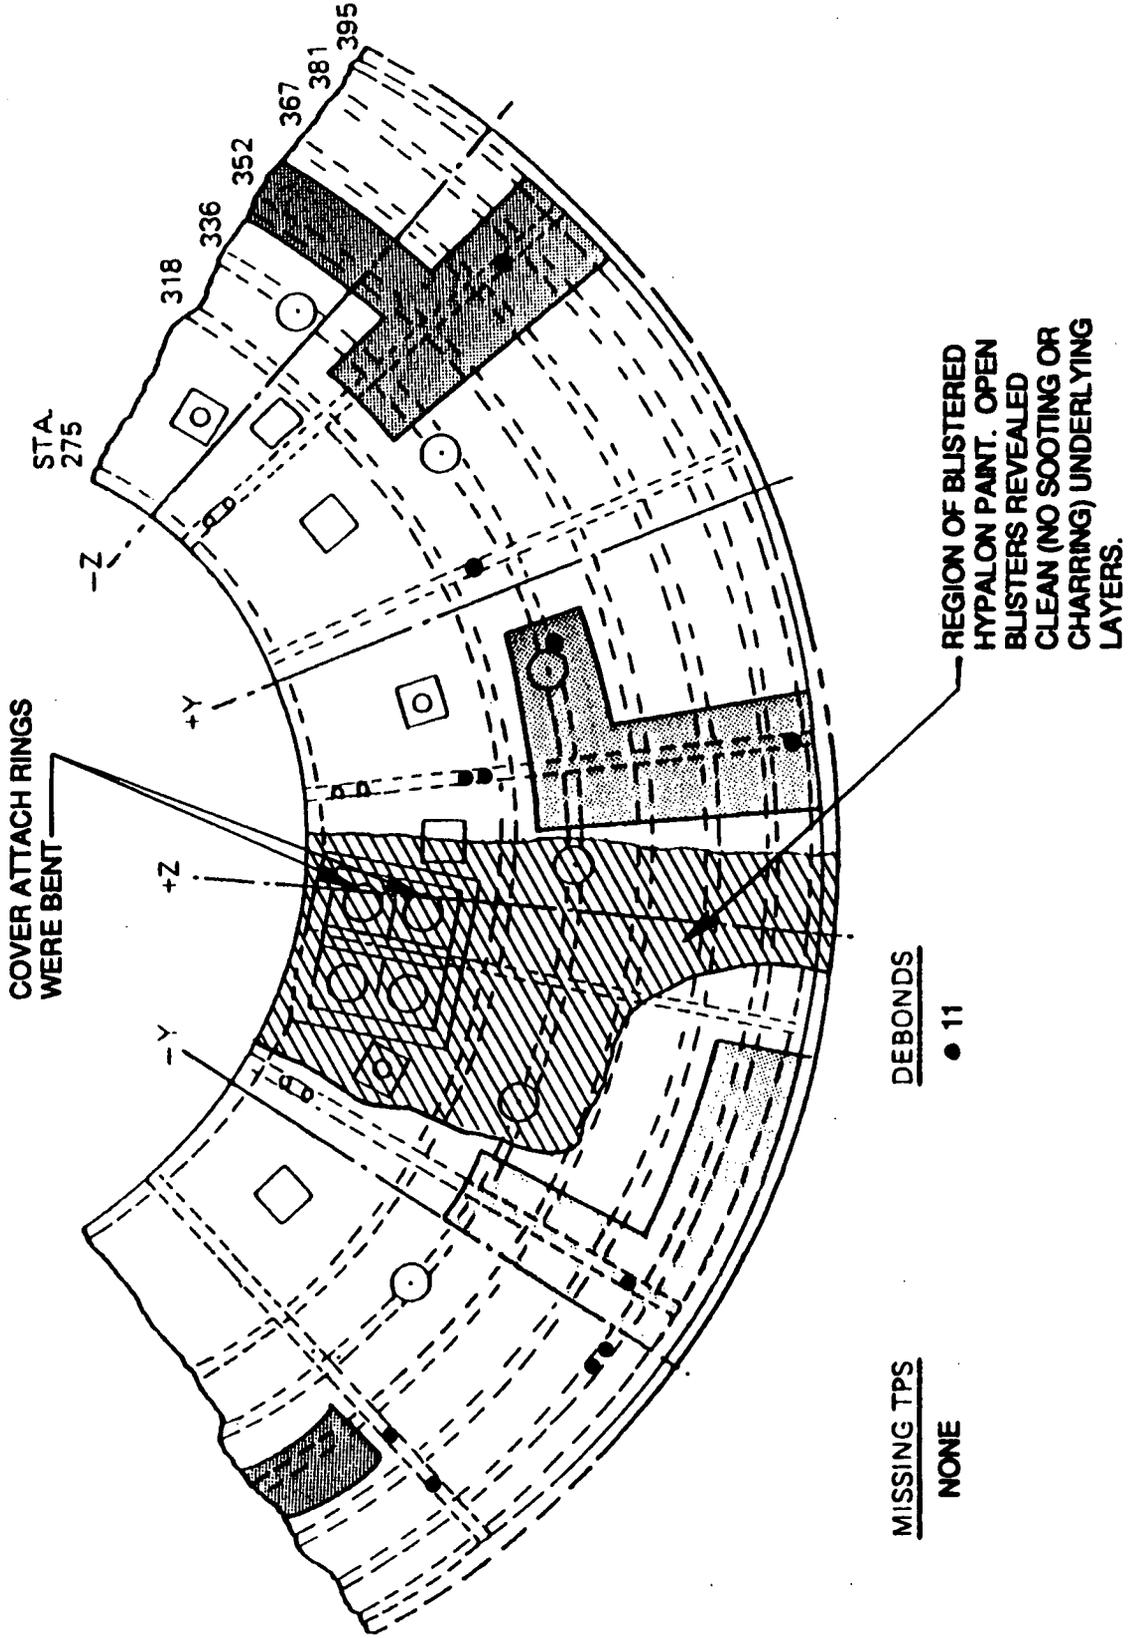
FIGURE 7. RIGHT SRB FRUSTUM

The RH frustum was missing no TPS, but had 11 MSA-2 debonds over fasteners (Figure 7). Significant blistering of the Hypalon paint top layer had occurred in an area between the -Y and +Y axes from the BSM's to the 395 ring frame. No sooting or charring was visible in the open paint blisters and on the Hypalon basecoat. All BSM aero heatshield covers were locked in the fully opened position, although the two right cover attach rings had been bent by parachute riser entanglement.

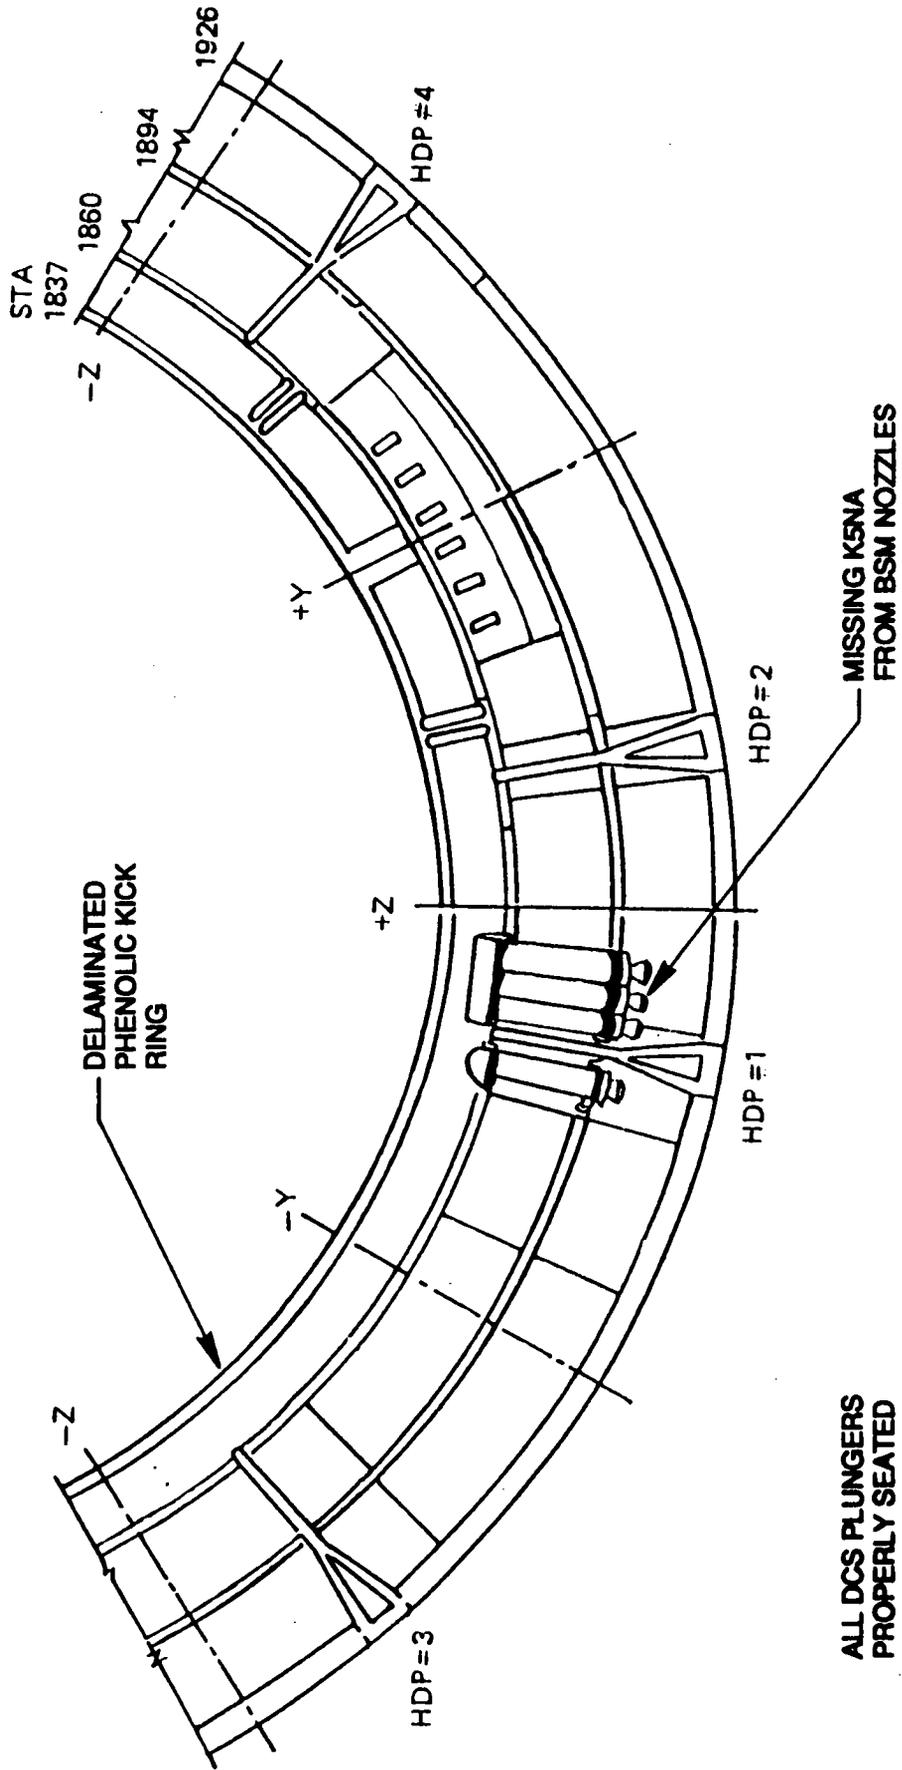
FIGURE 9. RIGHT SRB AFT SKIRT EXTERIOR TPS

The phenolic material on the kick ring was delaminated. The K5NA closeouts (protective domes) on the kick ring forward and aft fasteners are no longer used. RTV-133 has replaced the K5NA over the forward fasteners. The aft skirt acreage TPS was generally in good condition (Figure 9).

None of the aft skirt HDP EPON shim material was lost prior to splashdown. All four Debris Containment System (DCS) plungers were seated properly.

TYPICAL BLISTERING OF  
 HYPALON PAINT ON ET  
 ATTACH FITTING AND  
 SYSTEMS TUNNEL COVER

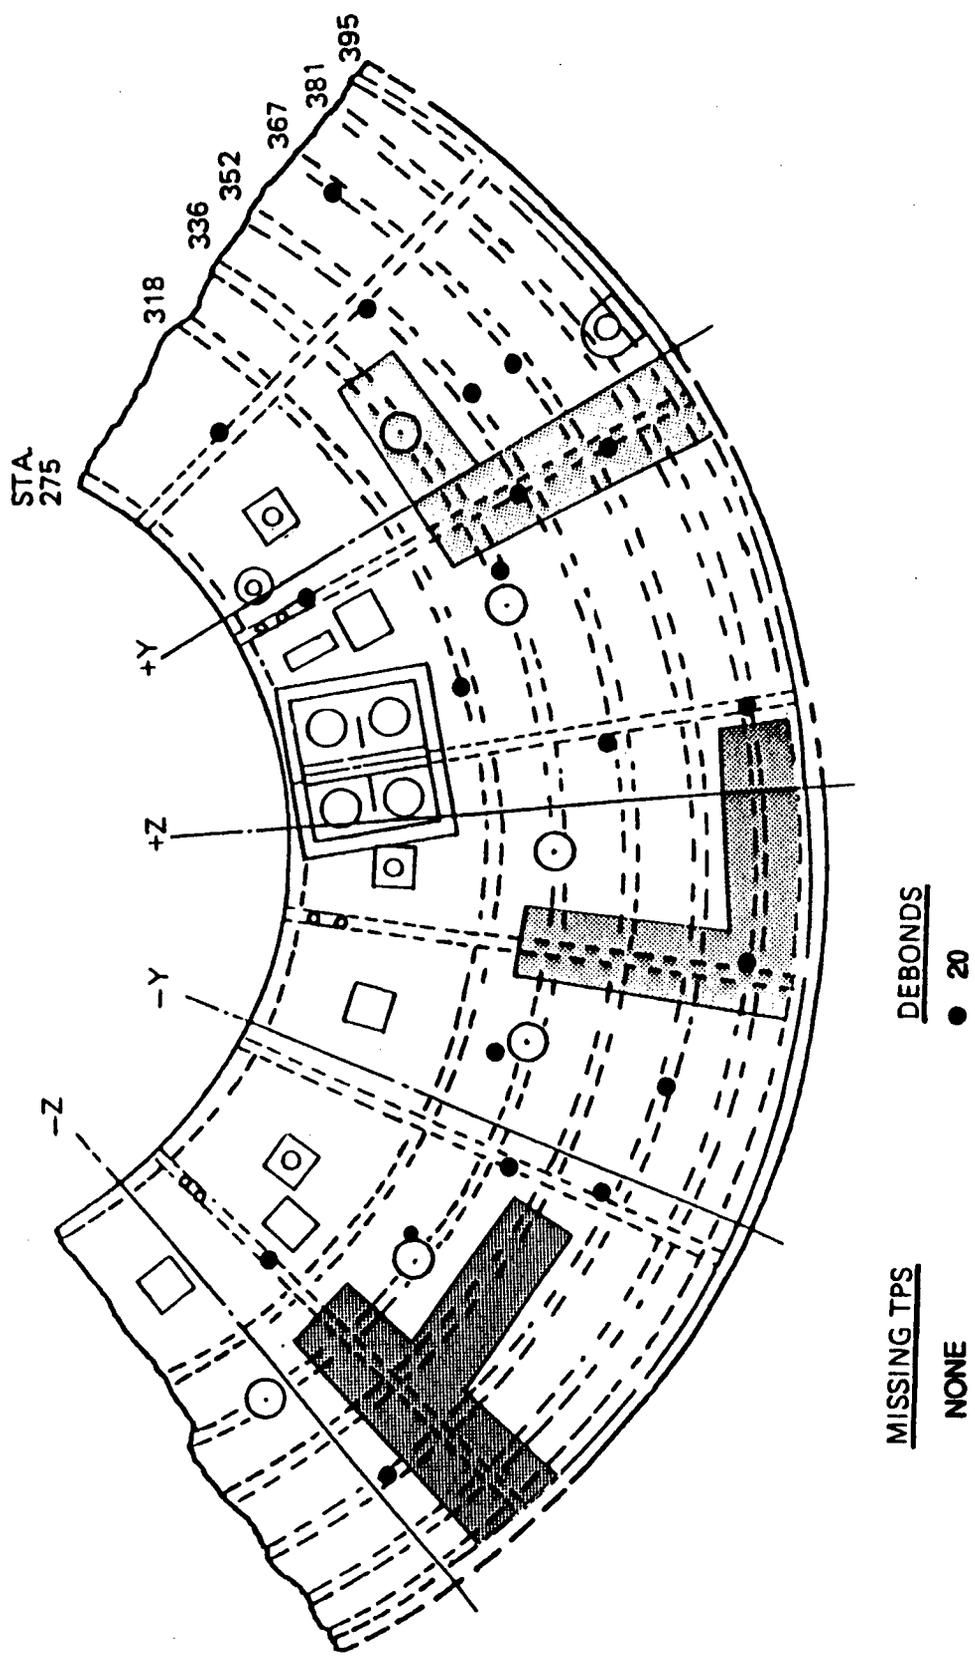
FIGURE 10. LEFT SRB FRUSTUM

The LH frustum was missing no TPS, but had a total of 20 MSA-2 debonds (Figure 10). Minor localized blistering of the Hypalon paint had occurred along the 395 ring. The BSM aero heat shield covers were locked in the fully opened position.

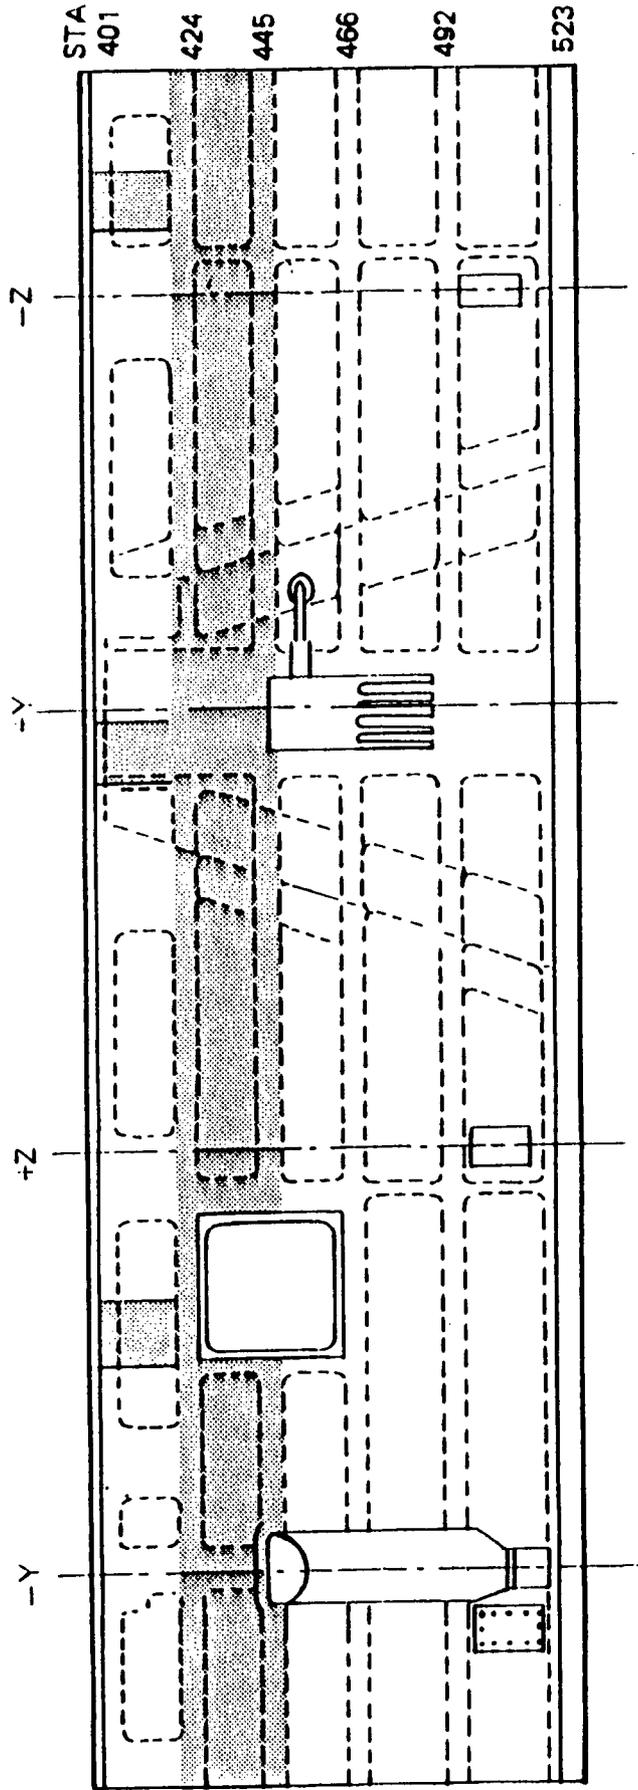
FIGURE 11. **LEFT SRB FWD SKIRT**

The LH forward skirt exhibited no debonds or missing TPS. Both RSS antennae covers/phenolic base plates were intact. Minor blistering of the Hypalon paint occurred near the ET/SRB attach point and on the systems tunnel cover (Figure 11). No pins were missing from the frustum severance ring. The forward separation bolt appeared to have separated cleanly.
