# Debris/Ice/TPS Assessment and Integrated Photographic Analysis for Shuttle Mission STS-56

May 1993

DEBRIS/ICE/TPS ASSESSMENT  
AND  
PHOTOGRAPHIC ANALYSIS  
OF  
SHUTTLE MISSION STS-56

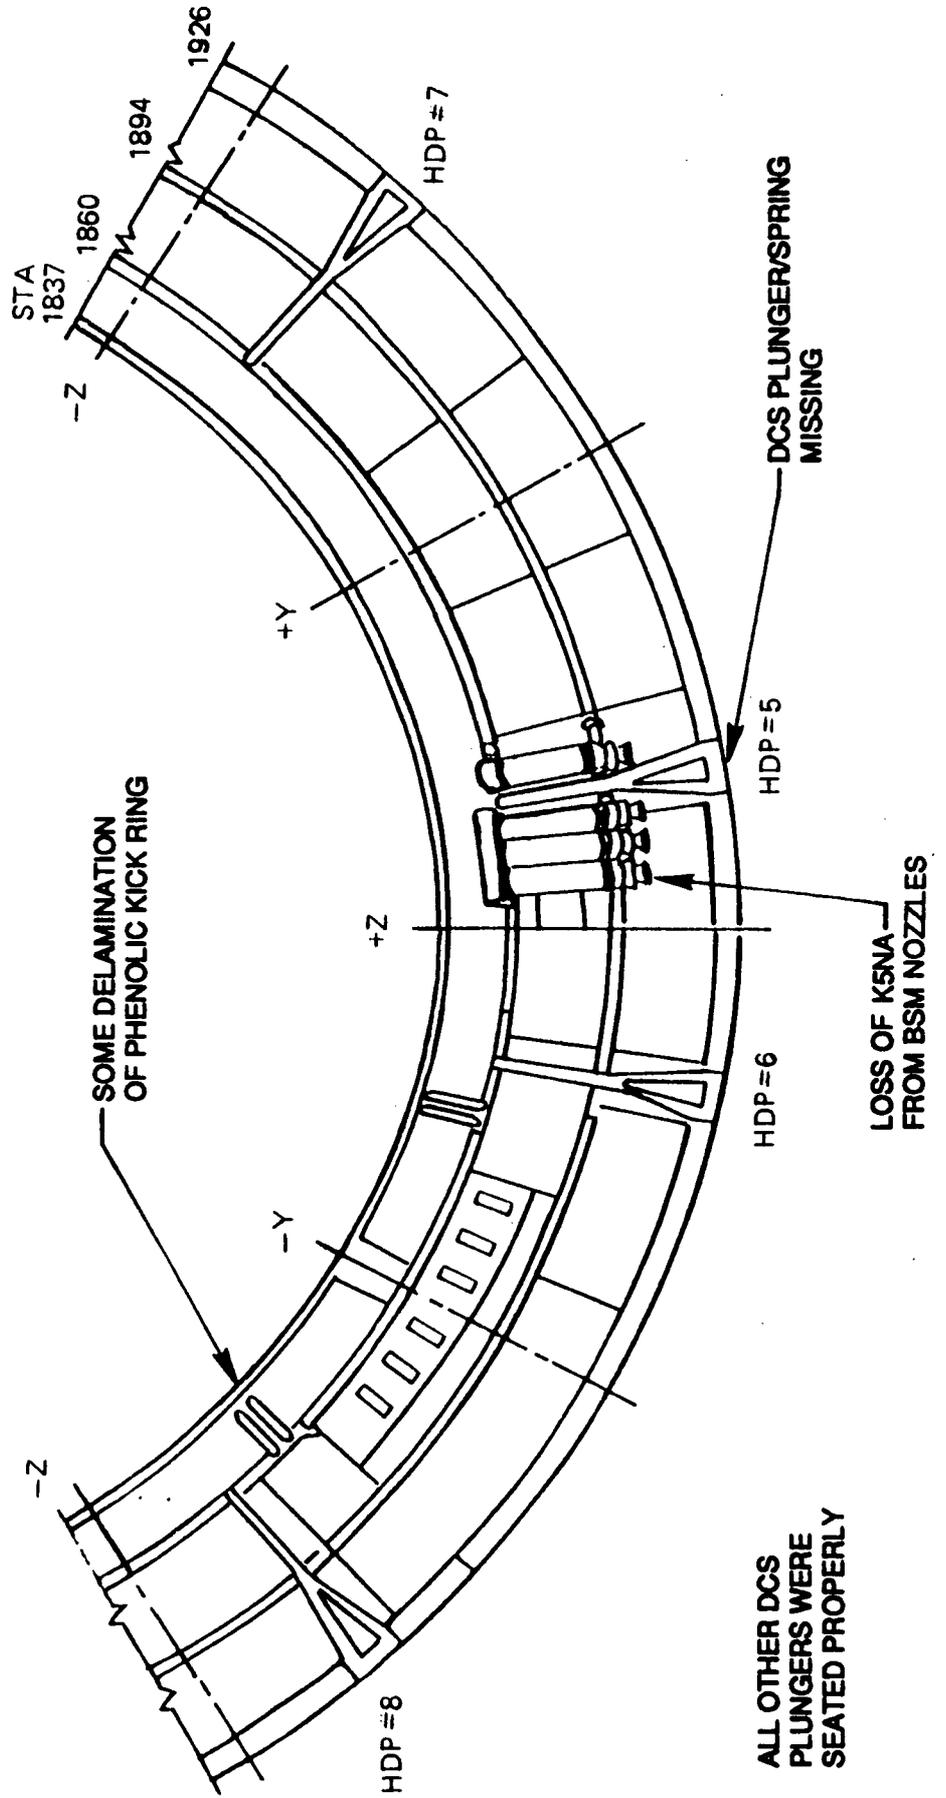
FIGURE 12. LEFT SRB AFT SKIRT EXTERIOR TPS

The phenolic material on the kick ring was delaminated in only localized areas. The K5NA closeouts (protective domes) on the kick ring forward and aft fasteners are no longer used. RTV-133 has replaced the K5NA over the forward fasteners. The aft skirt acreage TPS was generally in good condition (Figure 12).

TPS MISSING  
NONE

DEBONDS  
NONE

LOCALIZED BLISTERING OF  
HYPALON PAINT AROUND  
ET/SRB ATTACH FITTING AND  
SYSTEMS TUNNEL COVER

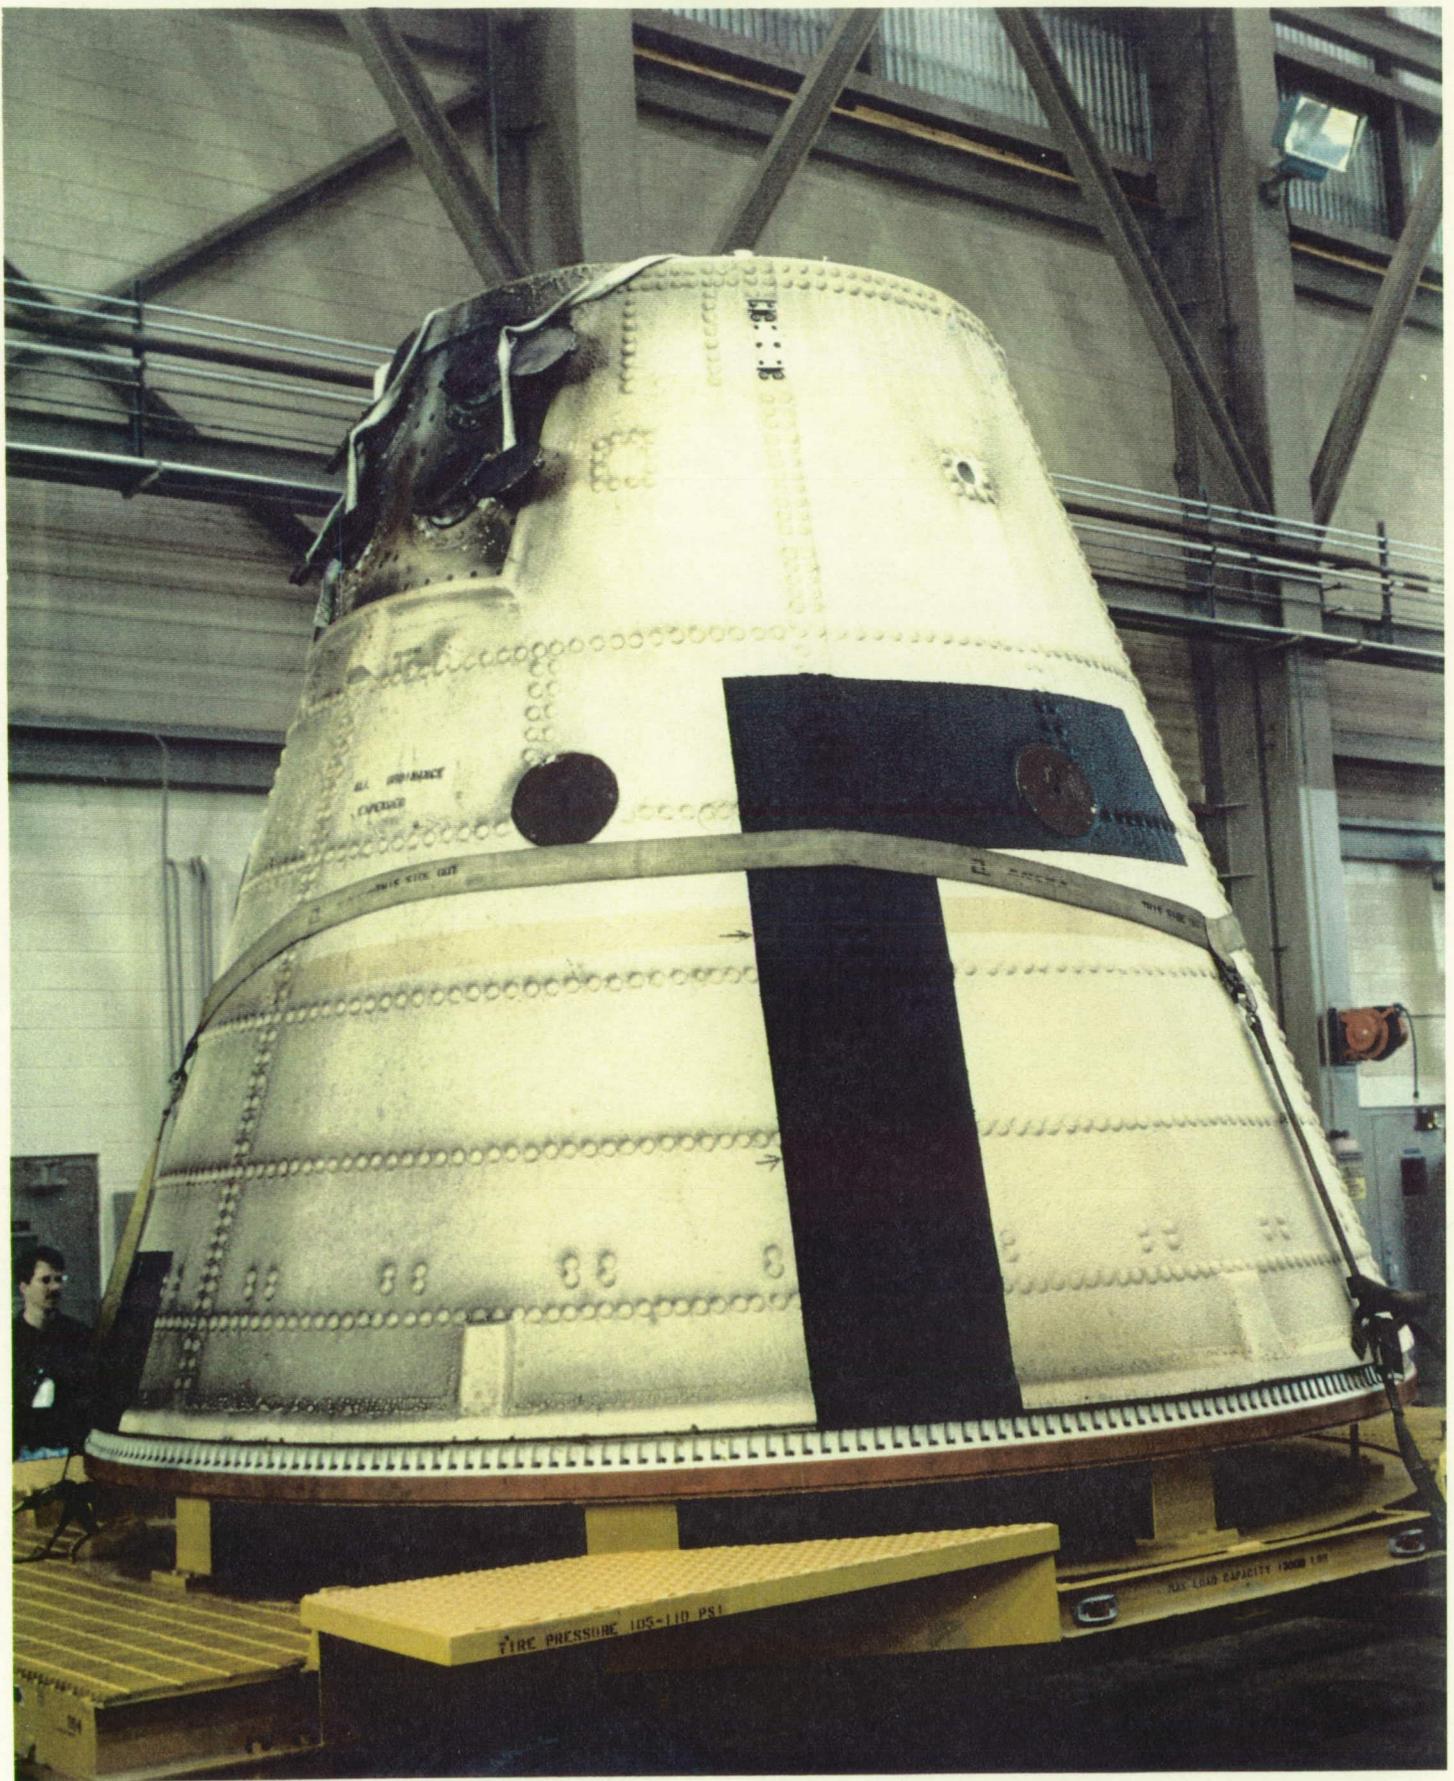
The LH frustum was missing no TPS, but had a total of 20 MSA-2 debonds. The BSM aero heat shield covers were locked in the fully opened position.

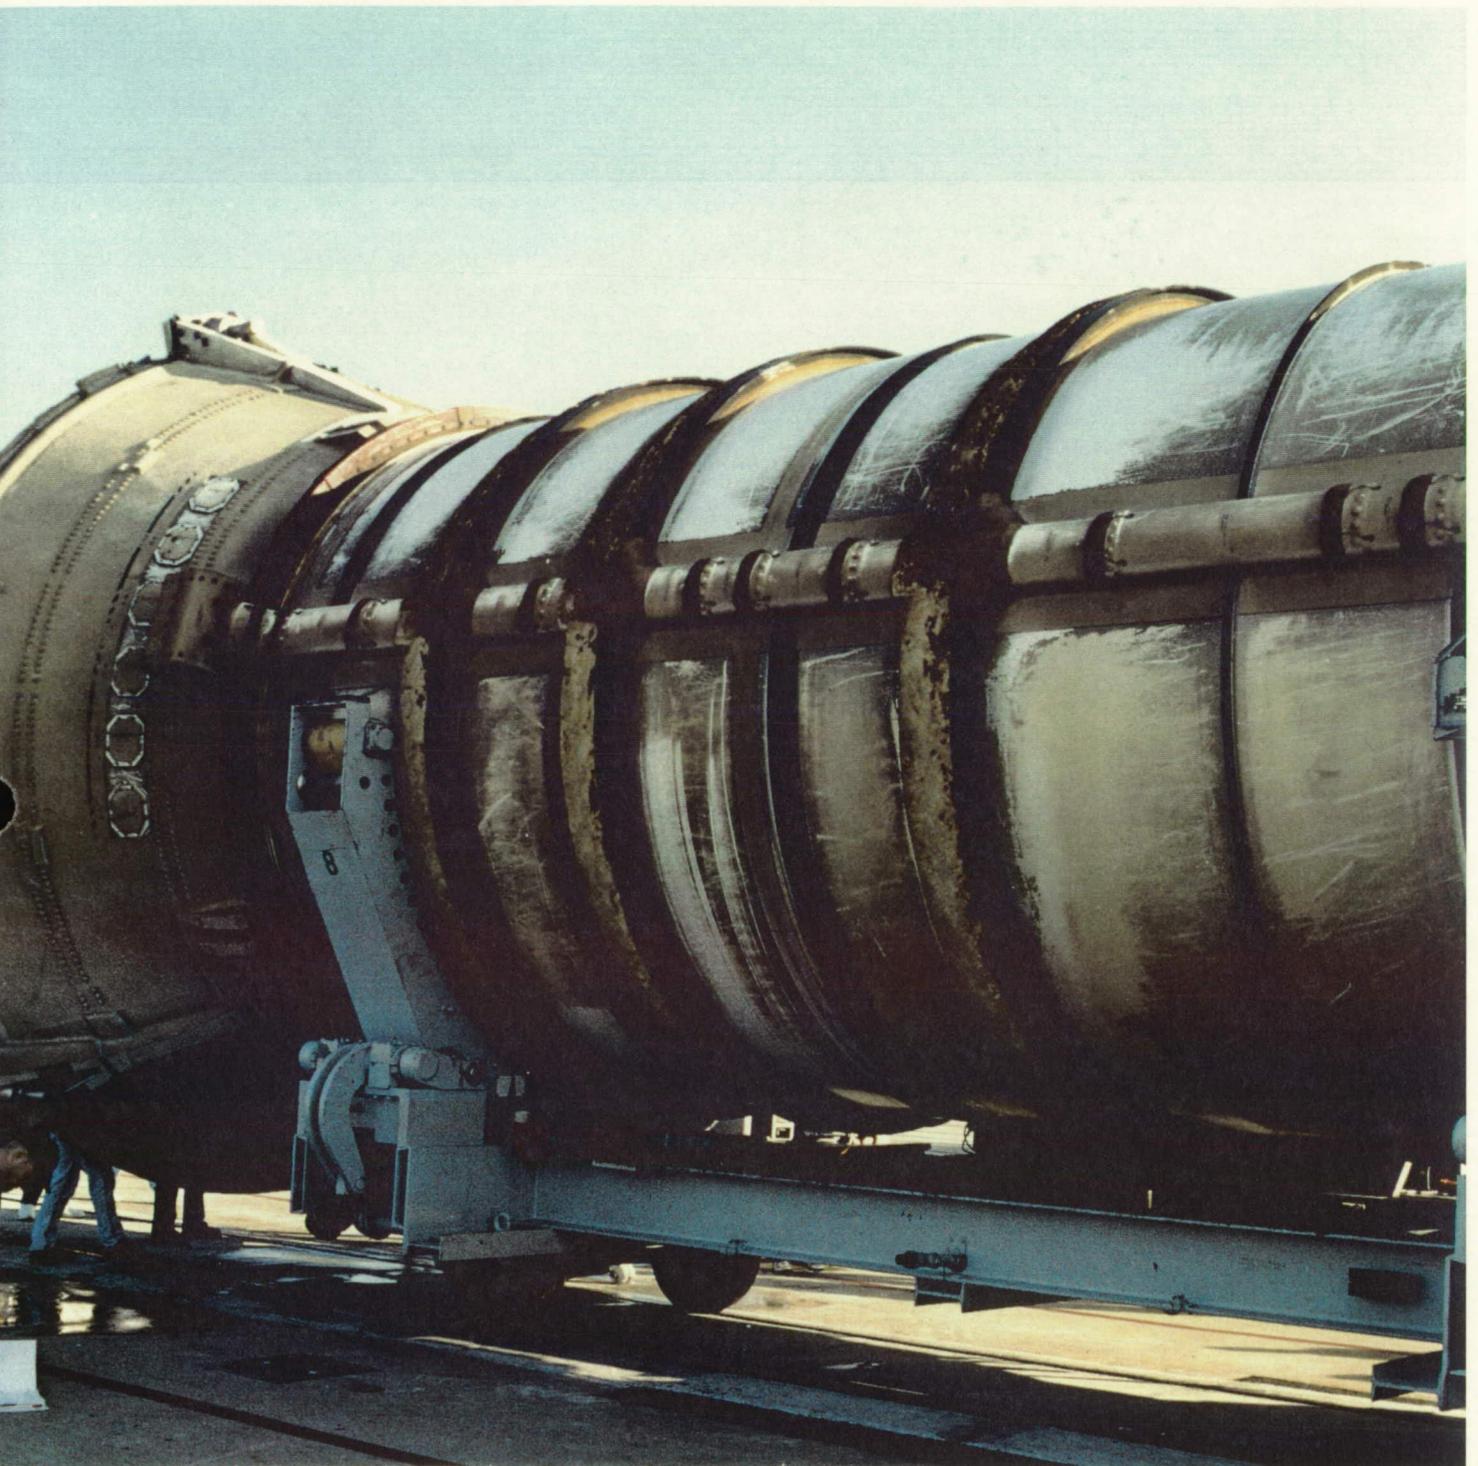
Post flight condition of the aft booster and aft skirt. The ET/SRB aft struts, ETA ring, IEA, IEA covers, and aft booster stiffener rings appeared undamaged.

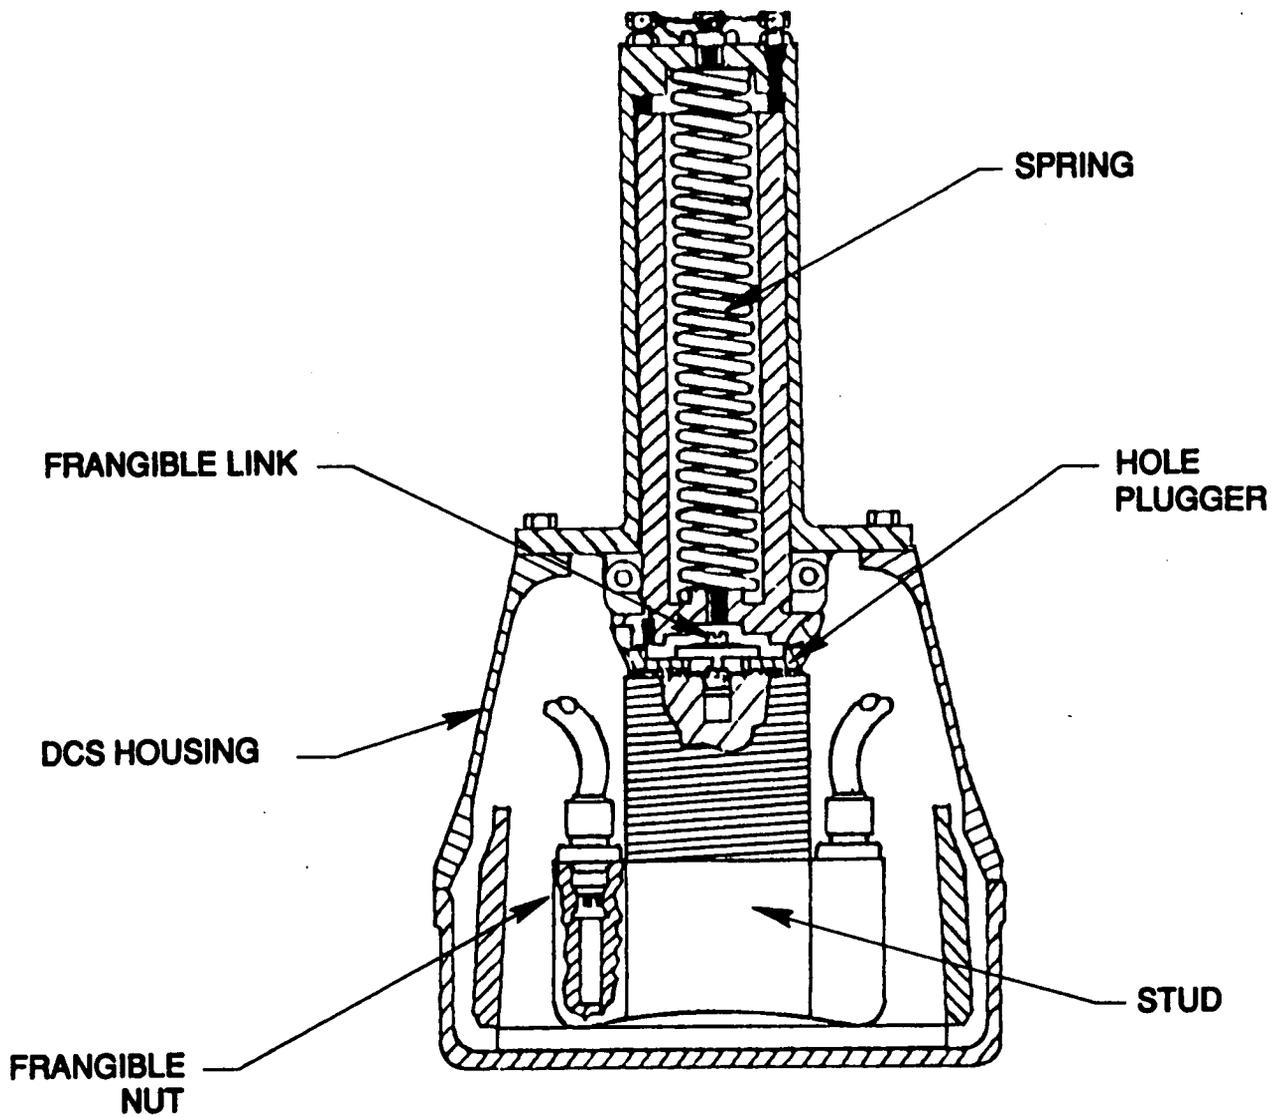
**Figure 13. DEBRIS CONTAINMENT SYSTEM (DCS)**

The current failure scenario suggests the frangible nut halves rebounded off the lead liner, symmetrically contacted the plunger assembly, and caused localized deformation to the plunger, which in turn allowed the plunger to pass through the stud hole (ref Figure 13). Once clear of the aft skirt/DCS housing, the plunger and spring became debris that could have been deflected by SRB plume impingement resulting in a potential threat to the vehicle. In this case, the frangible link connecting the plunger to the stud survived the launch environment.

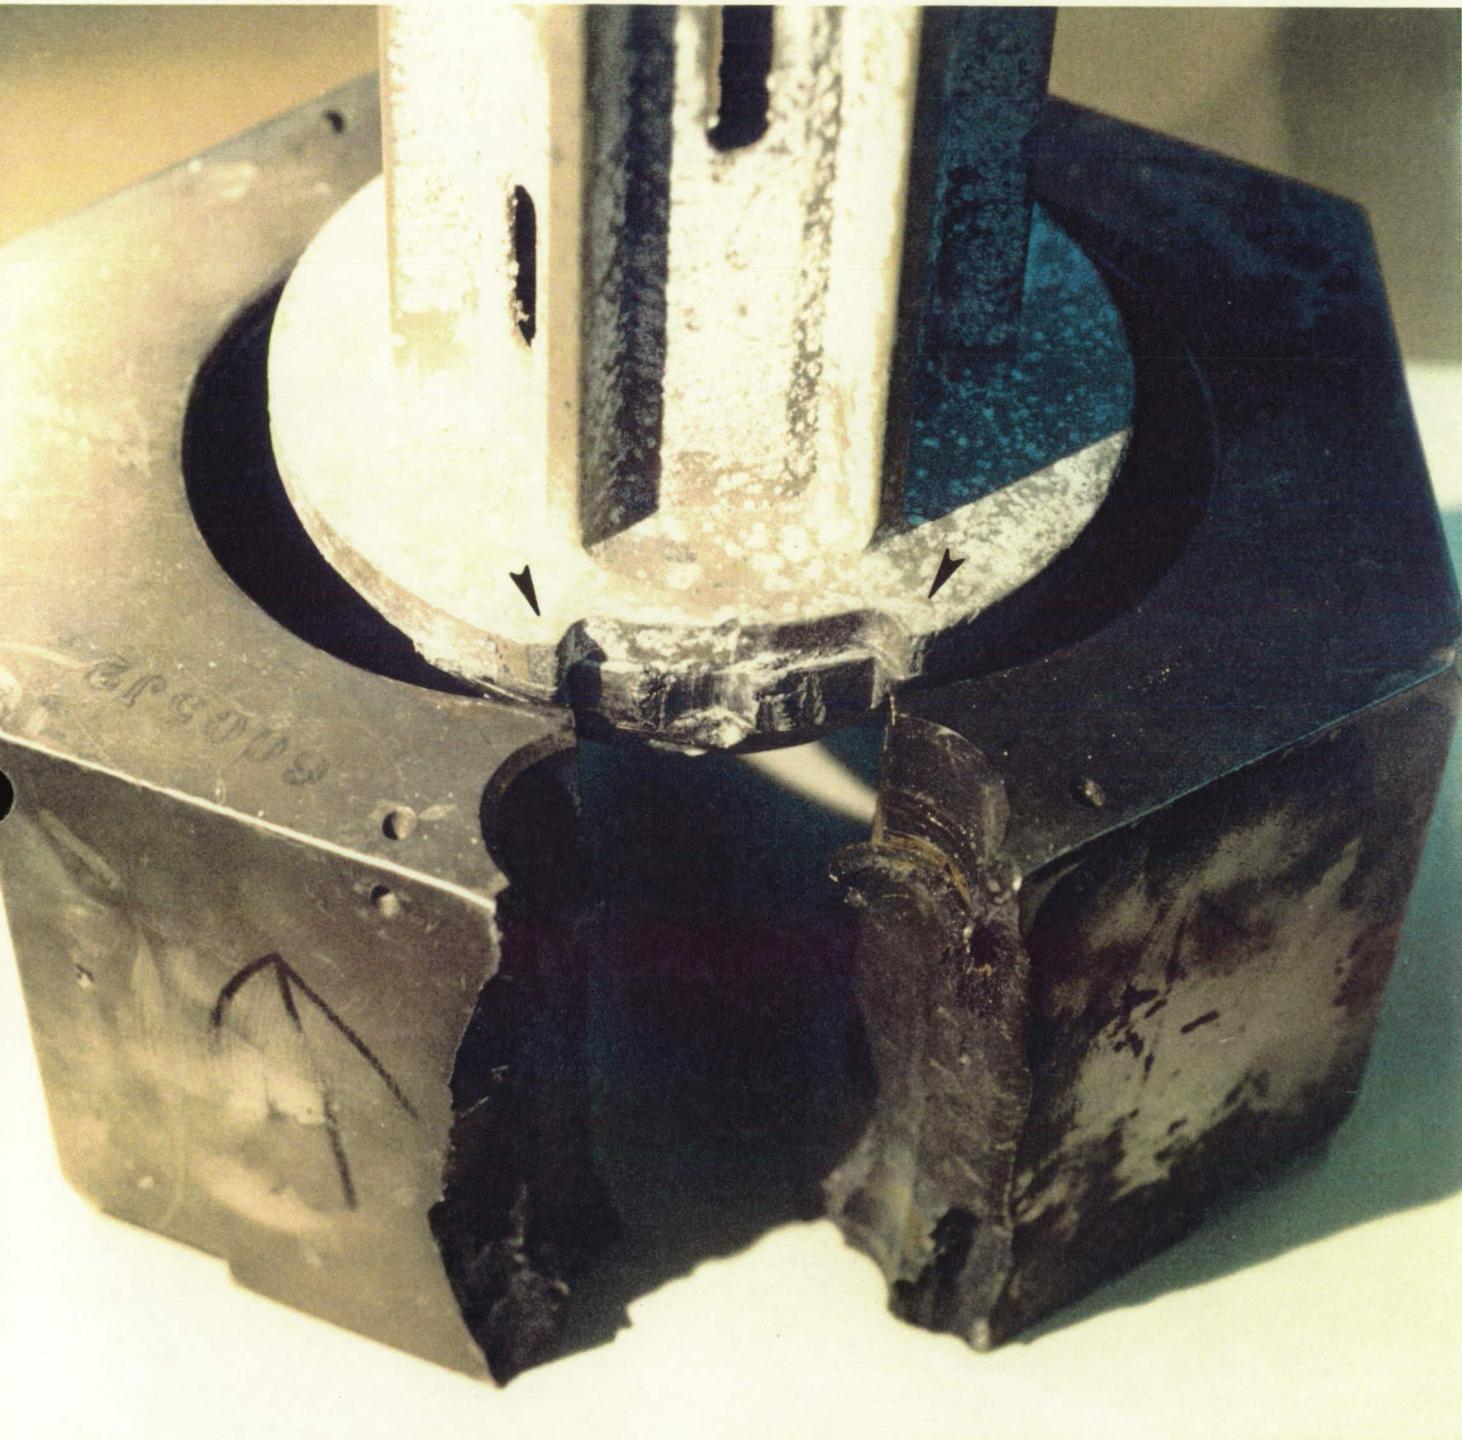
View showing frangible nut halves symmetrically contacting a DCS plunger assembly/hole plugger test article. The points of contact on the flight article had been materially deformed allowing the hole plugger/spring to exit the stud hole.

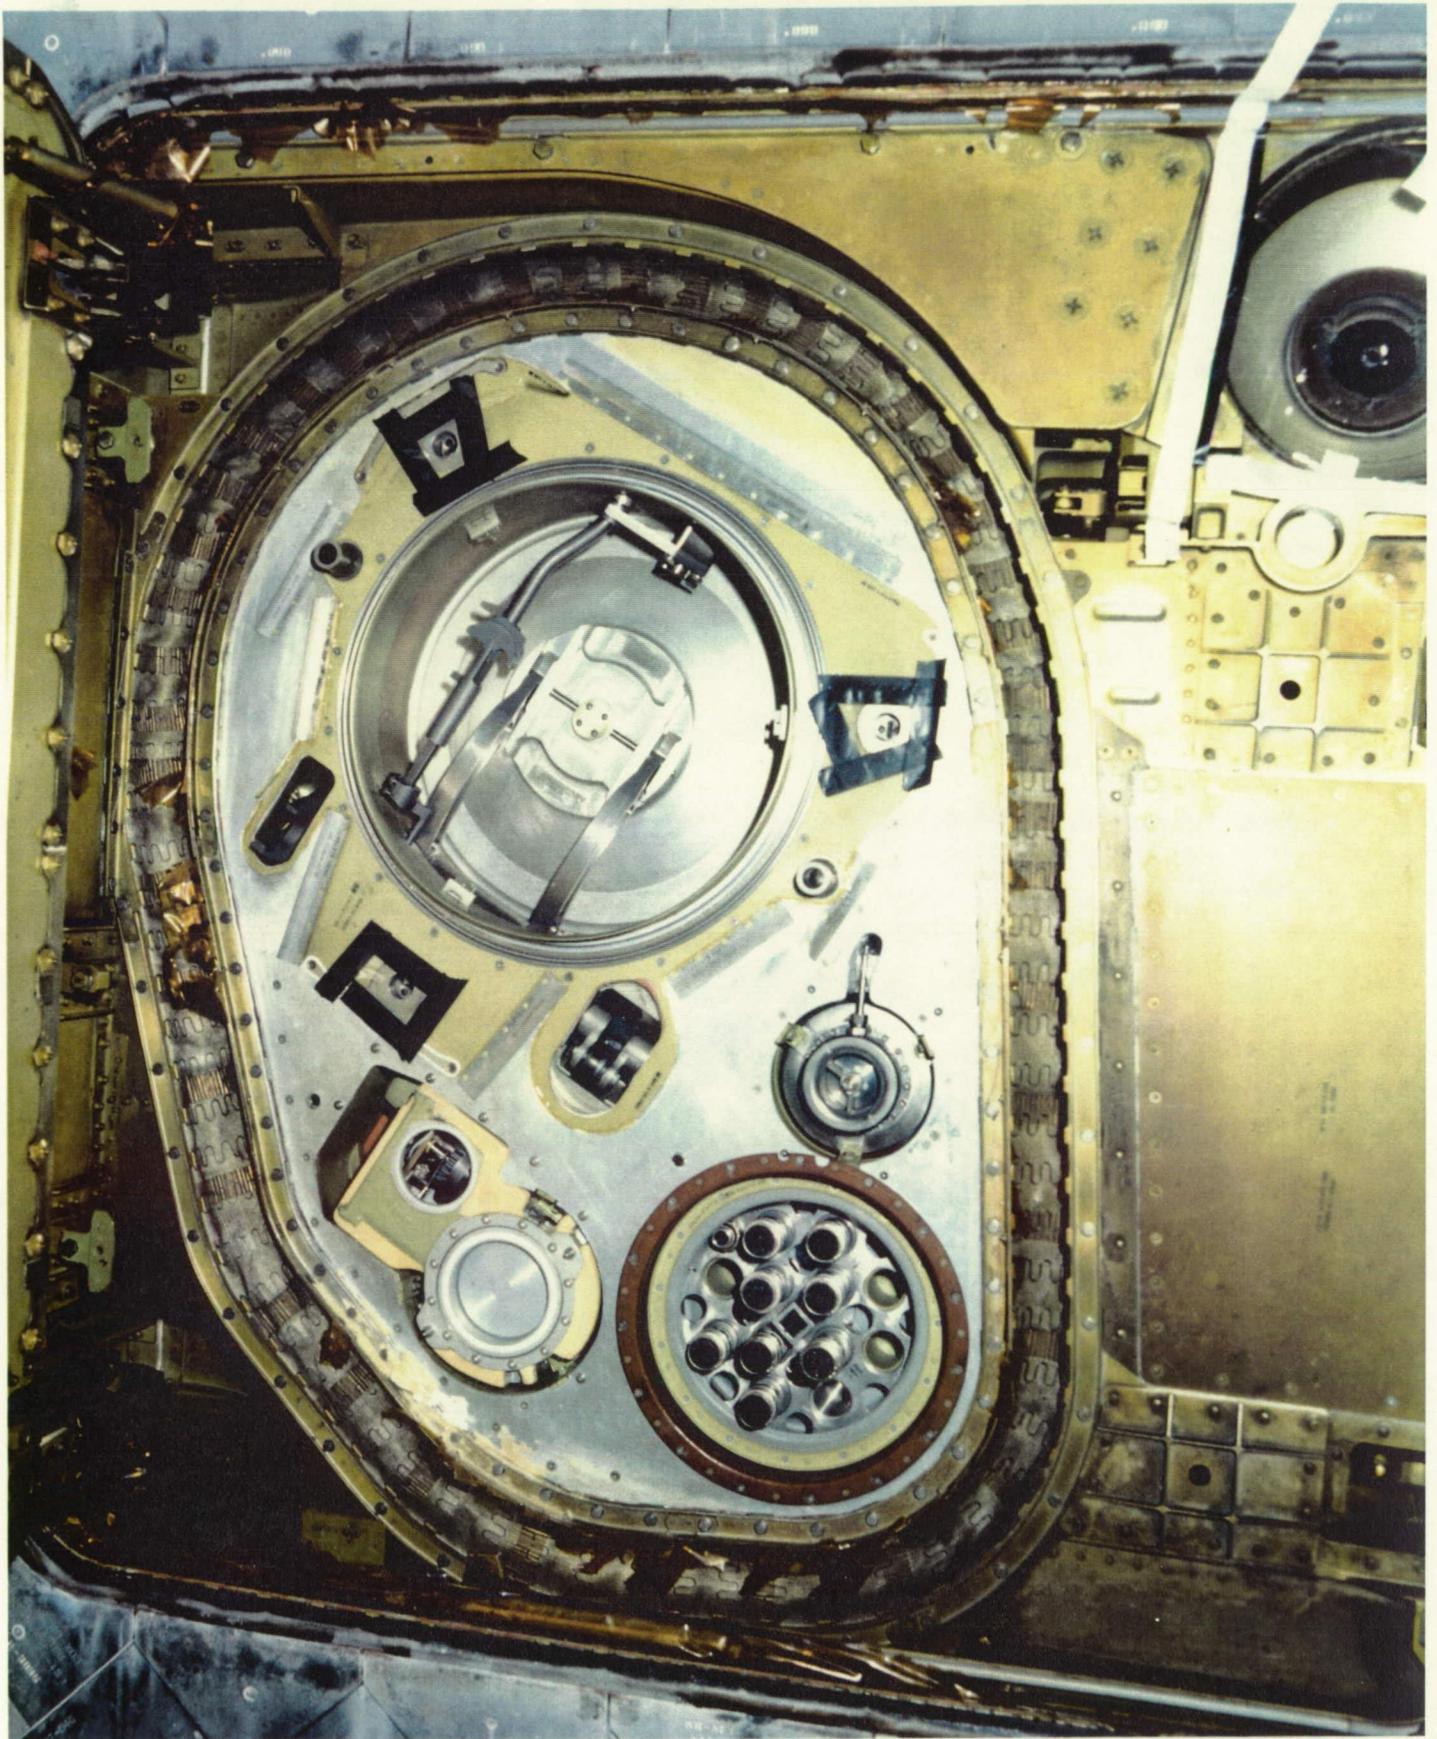
Overall view of the LH2 ET/ORB umbilical. All separation ordnance devices functioned properly. No flight hardware was found on the runway below the umbilical when the ET door was opened.

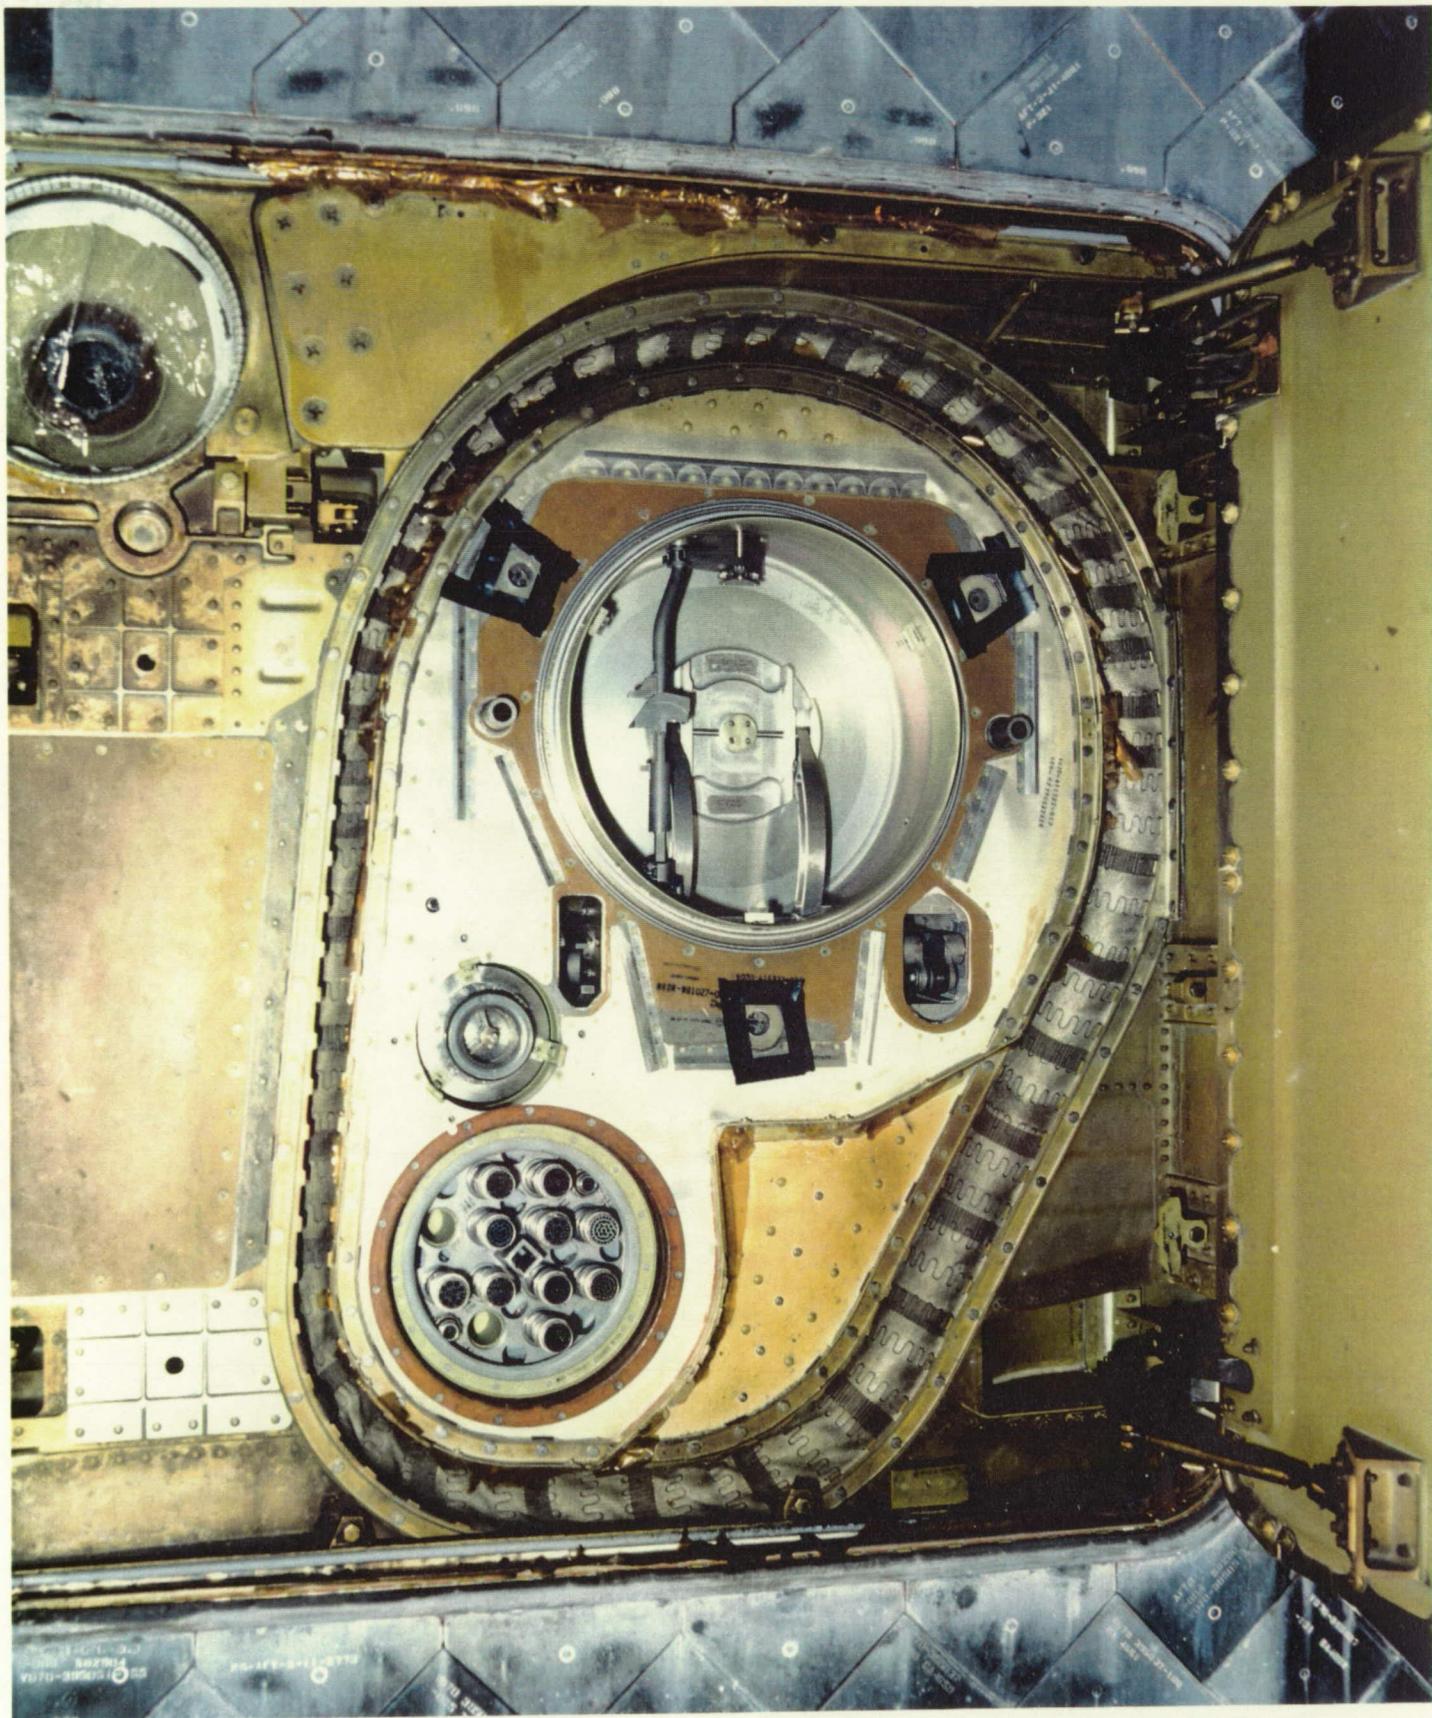
Overall view of the L02 ET/ORB umbilical. All separation ordnance devices functioned properly. No flight hardware was found on the runway below the umbilical when the ET door was opened.

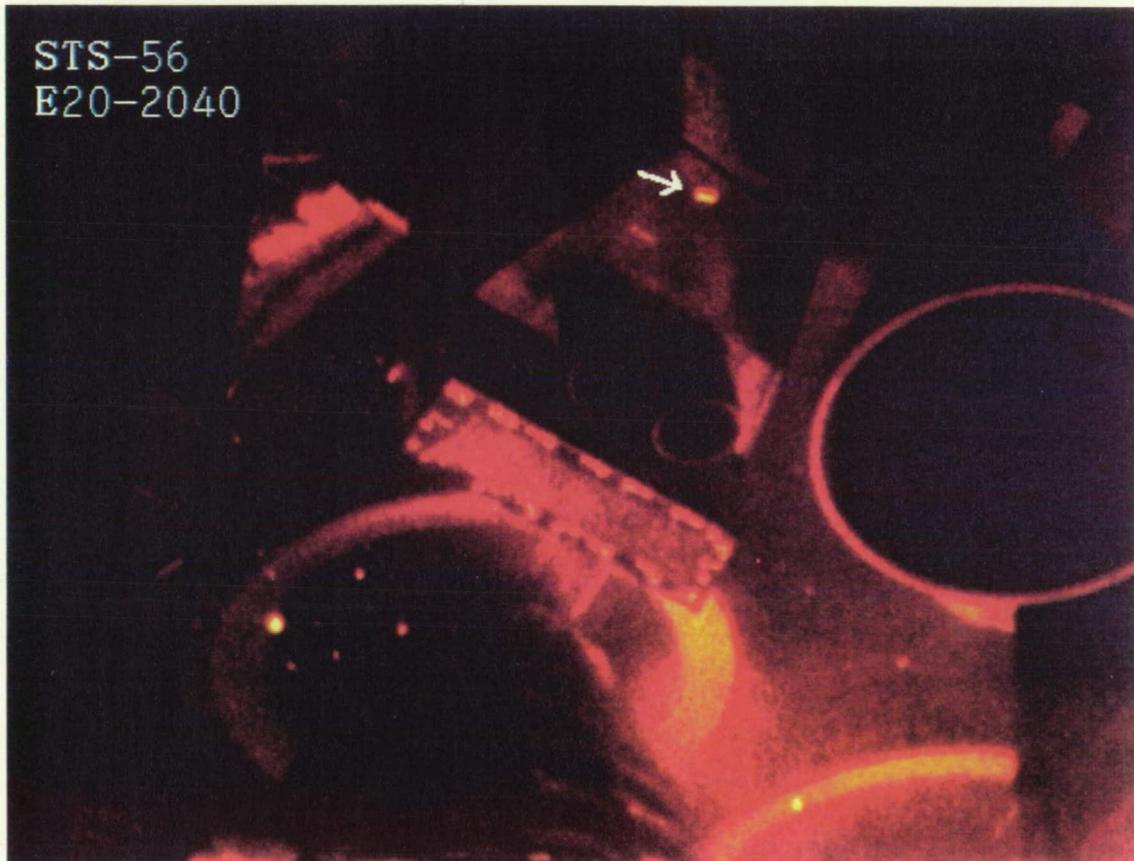
Figure 2.1.1.3 Debris from Left Aft RCS Stinger Area

A thin, rectangular object, dark on one side and light on the other, originated from the left aft RCS stinger area and fell aft during SSME ignition.

KSC stated that the debris from the left aft RCS stinger area (arrow) was possibly a tile gap filler or tile shim.

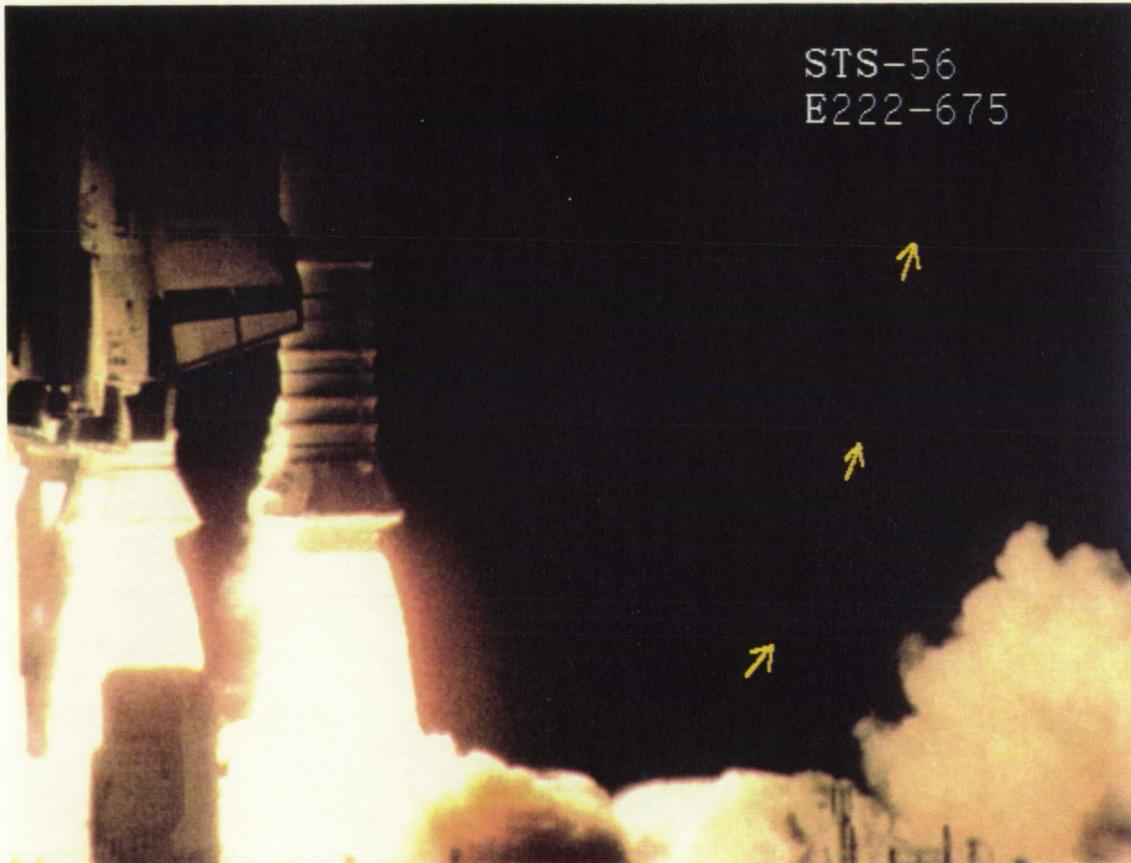
**Figure 2.1.2.1 Debris North of MLP after Liftoff**

Multiple pieces (at least five) of debris were seen above the SRB exhaust plume from approximately 0.9 seconds MET until 2.3 seconds MET. The objects were not seen to strike the vehicle. The debris appeared to be well north and east of the MLP and initially moved up and then down as the vehicle lifted off.

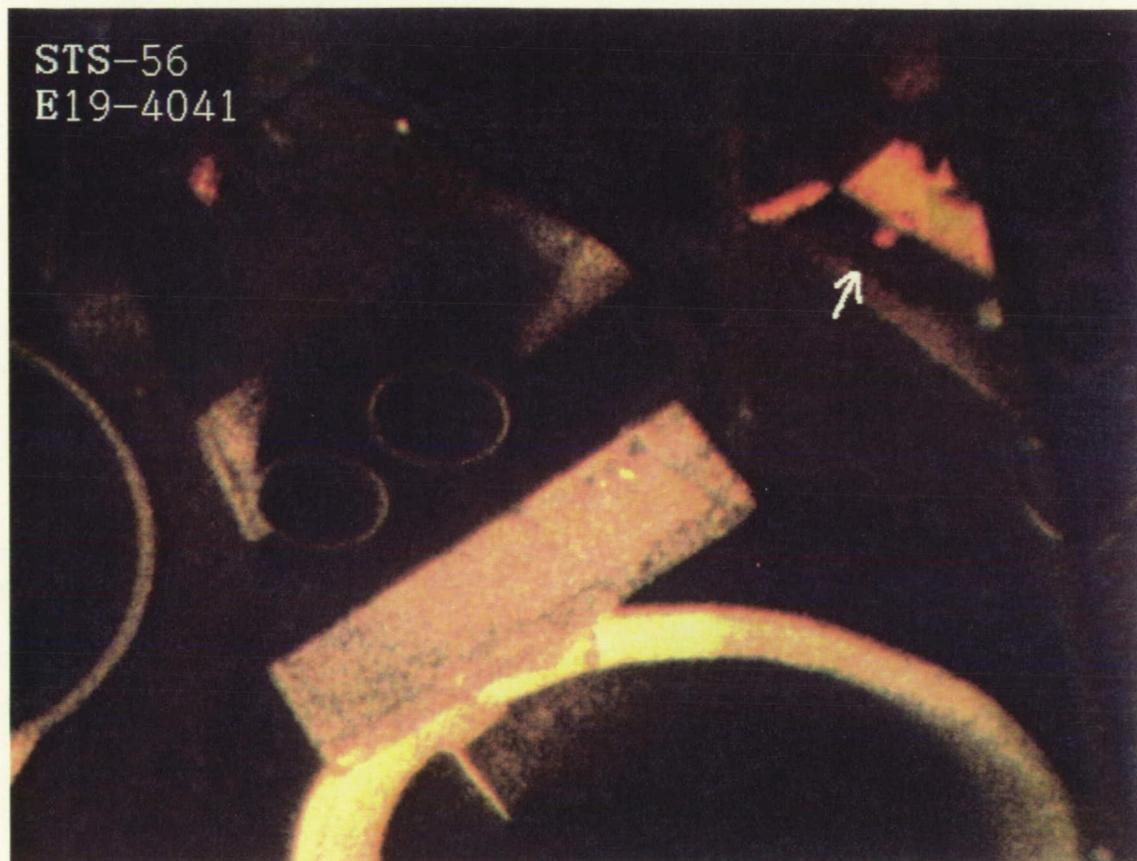
**Figure 2.1.2.3 Debris from LO2 TSM Carrier Plate**

A single light colored piece of debris appeared to originate between the LO2 TSM carrier plate and the Orbiter and fall aft at liftoff (0.335 seconds MET).

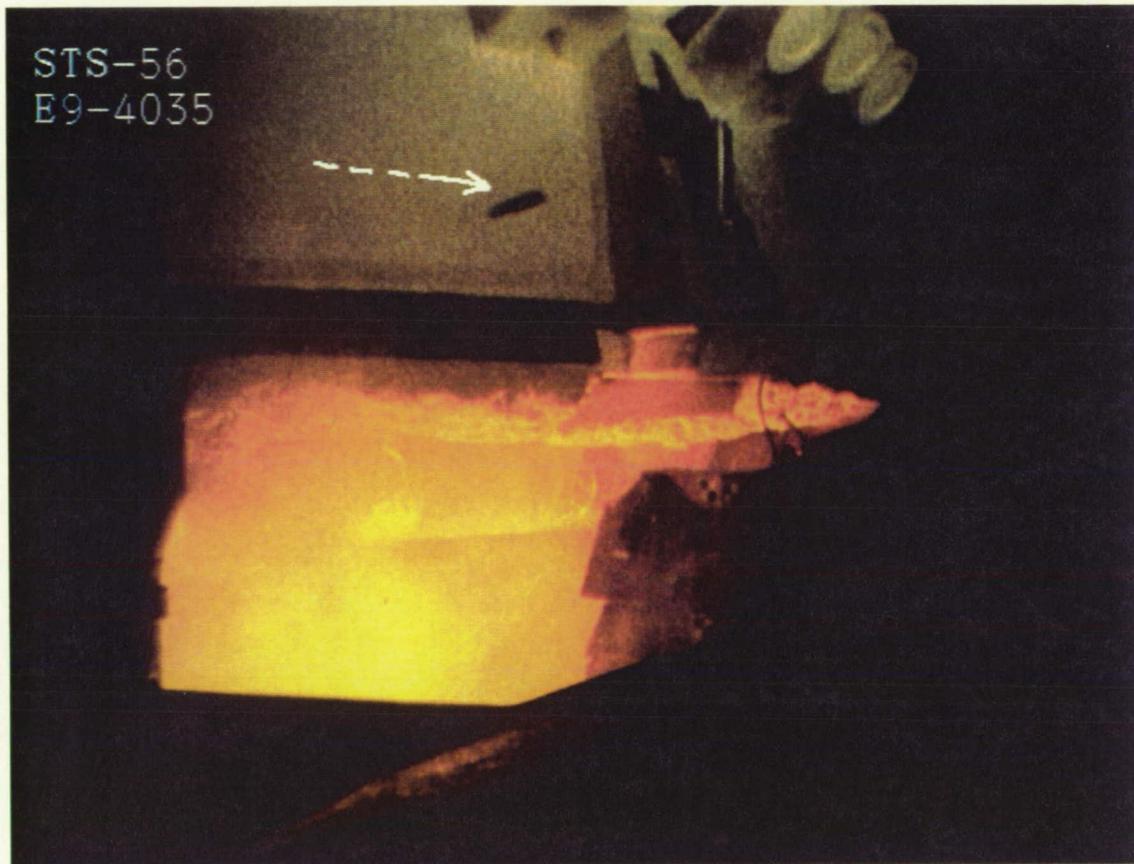
**Figure 2.1.2.4 Debris in Front of RSRB**

A thin flat rectangular piece of debris (light on one side and dark on the other) fell through the field of view from left to right in front of the right SRB at liftoff (0.562 seconds MET). The object did not appear to strike the vehicle.

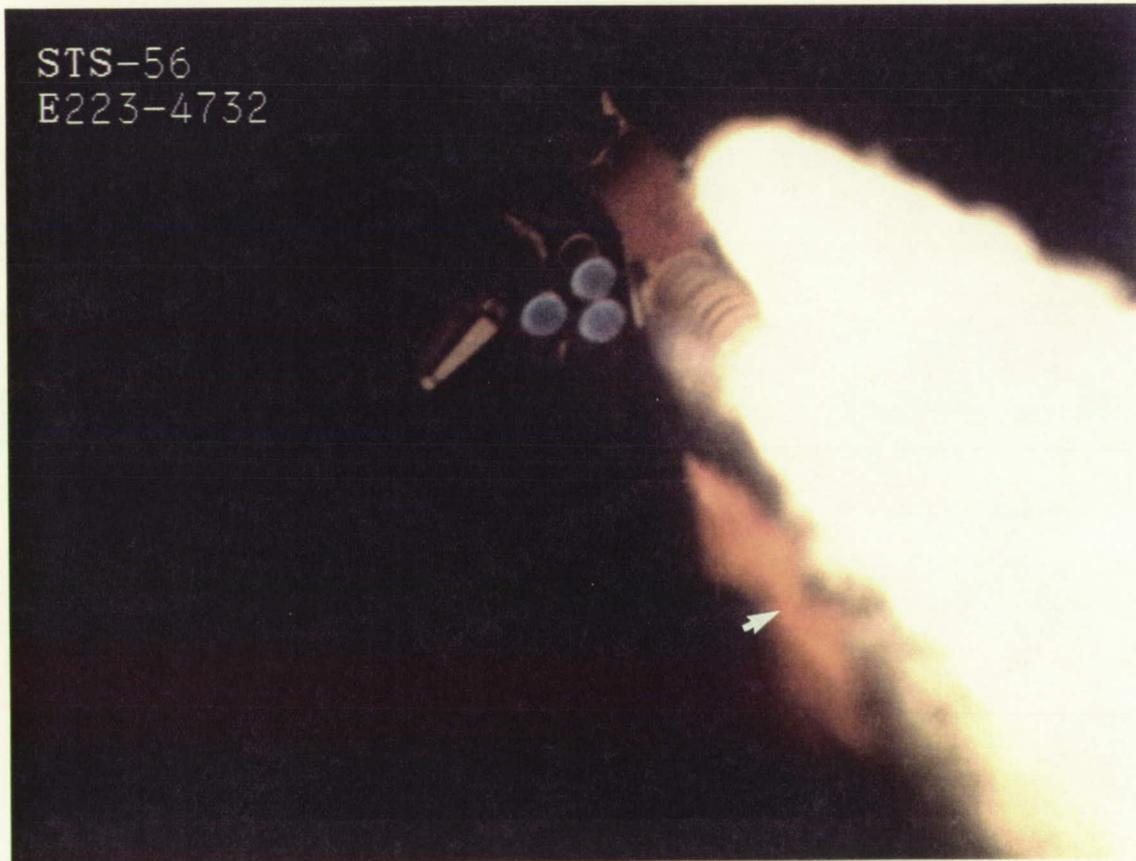
Figure 2.1.3.4 Debris Causing Orange Streak in SSME Plume

A single light colored piece of debris fell aft into the SSME plume and caused a bright orange streak at approximately 45.1 seconds MET. The streak was seen for 8 frames or 0.083 seconds.

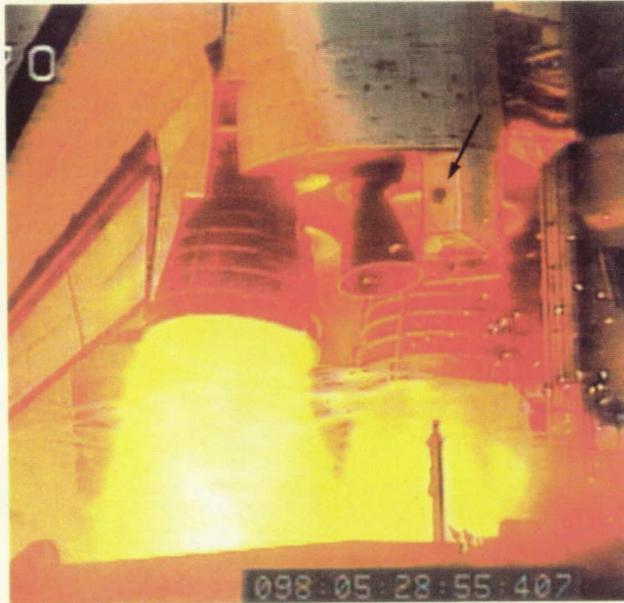
**Figure 2.2.1** Discoloration of the R2D RCS Cover

A discoloration of the R2D RCS cover on the right RCS stinger was noted before SSME startup.

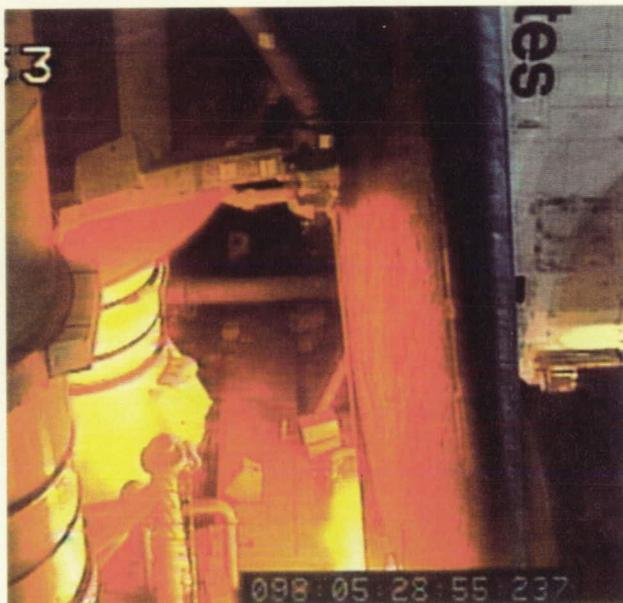
**Figure 2.2.2 Orange Vapor (Possibly Free-Burning Hydrogen) Noted under the Body Flap**

Orange vapor, possibly free burning hydrogen, was noted beneath the body flap and above the rims of SSME #1, SSME #2, and SSME #3 at SSME startup (T - 4.94 seconds on the camera E-4 view). Since free burning hydrogen is essentially colorless, engineers who reviewed films after the STS-38 mission believed that the orange cloud occurred due to impurities in the vapor. Similar events have been seen on past missions.

Orange vapor is visible beneath the body flap in the camera OTV-163 at SSME ignition.

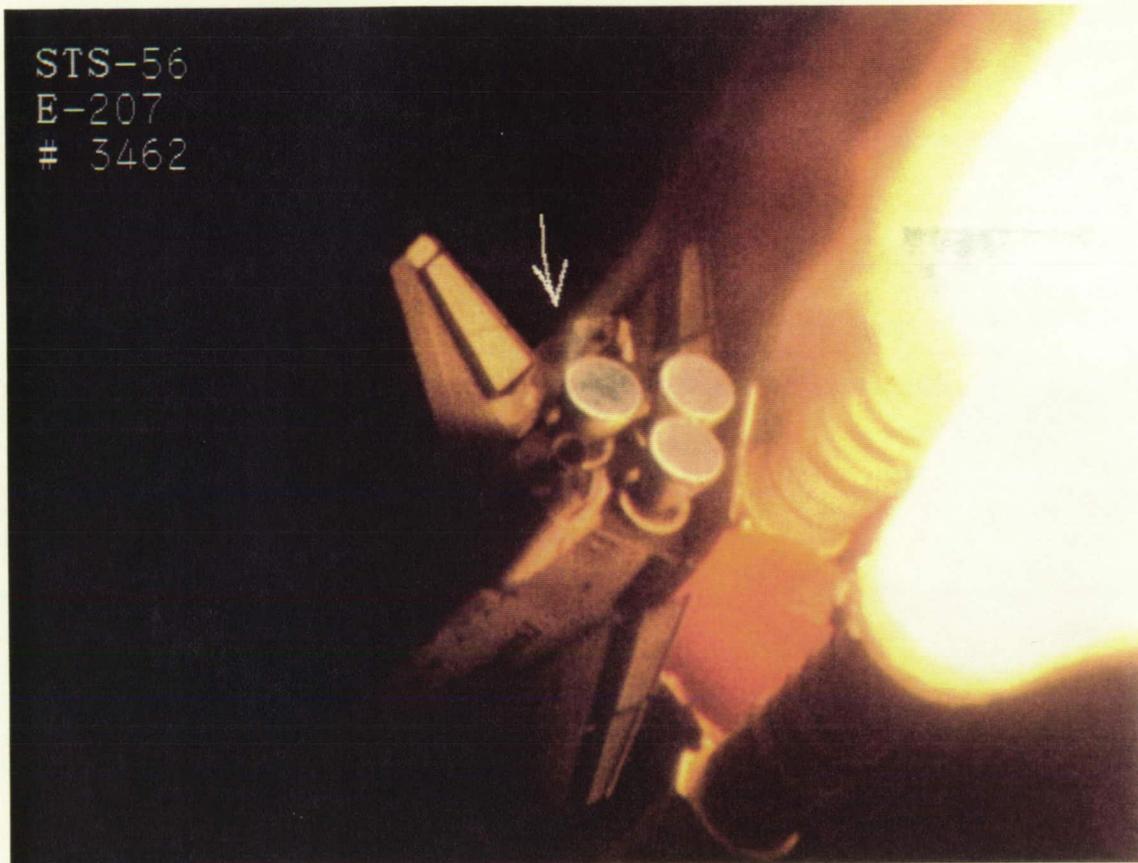
**Figure 2.3.2** Light Colored Vapor above SSME # 1 after Liftoff

A light colored vapor was noted above SSME #1 and traveled into the SSME plume after the roll maneuver at 58.84 seconds MET. The vapor was in view for four frames or 0.062 seconds.
