# Debris/Ice/TPS Assessment and Integrated Photographic Analysis for Shuttle Mission STS-56

May 1993

DEBRIS/ICE/TPS ASSESSMENT  
AND  
PHOTOGRAPHIC ANALYSIS  
OF  
SHUTTLE MISSION STS-56

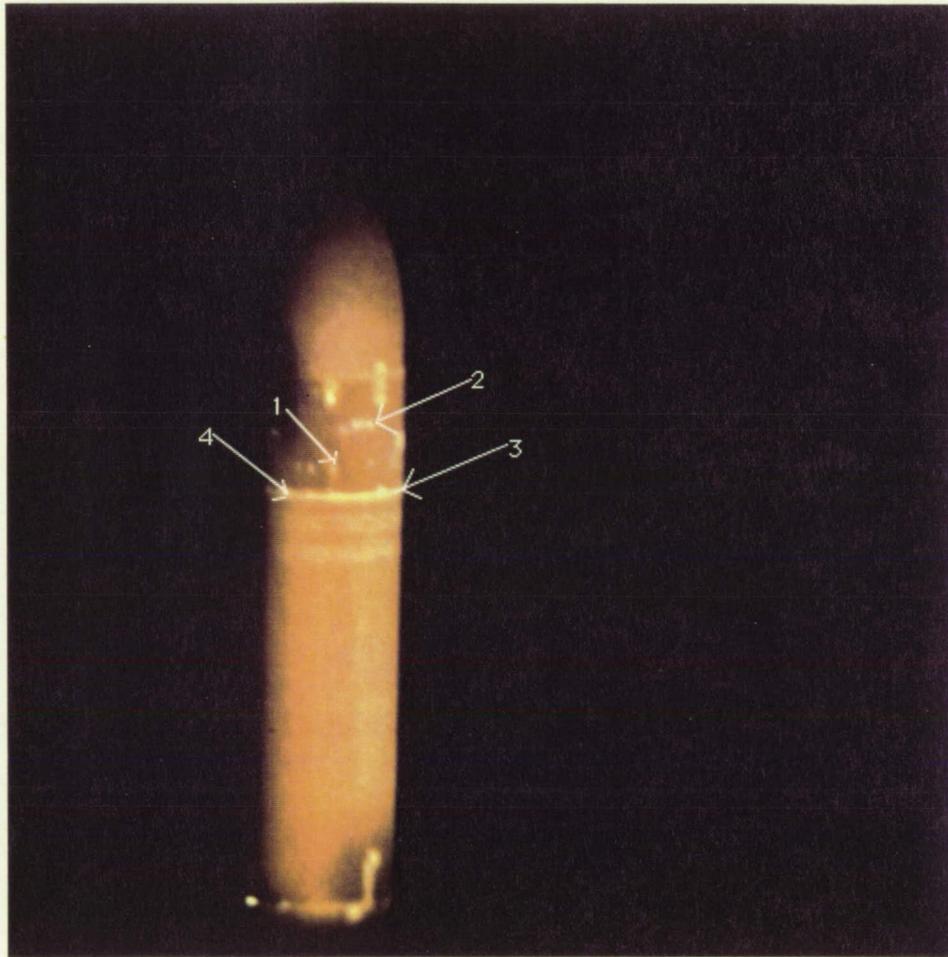
Figure 2.3.6 Divots on ET

Six or more light colored marks or divots were visible on the intertank TPS on the -Z or far side of the ET. These marks ranged between 18 and 26 inches (Figure 2.3.6 arrows 1 and 2). This view was taken while the ET was 2.30 km from the Orbiter at approximately eleven minutes after ET separation. The light colored mark visible on the ET LH2 tank/aft dome interface is the RSRB/ET aft attach. The TPS on the ET nose and aft dome appeared charred as usual. The booster separation motor (BSM) burn scars on the LO2 tank appeared typical to previous missions.

Approximately five marks or divots are visible on the LH2/Intertank closeout flange on the -Y axis of the ET in the above view. The divots in this area ranged between 16 and 24 inches (Figure 2.3.6 arrows 3 and 4). Bright marks are visible on the aft ET/Orbiter attach bracing. These bright marks have been determined to be reflections of sunlight off normal protuberances on the attach bracing.

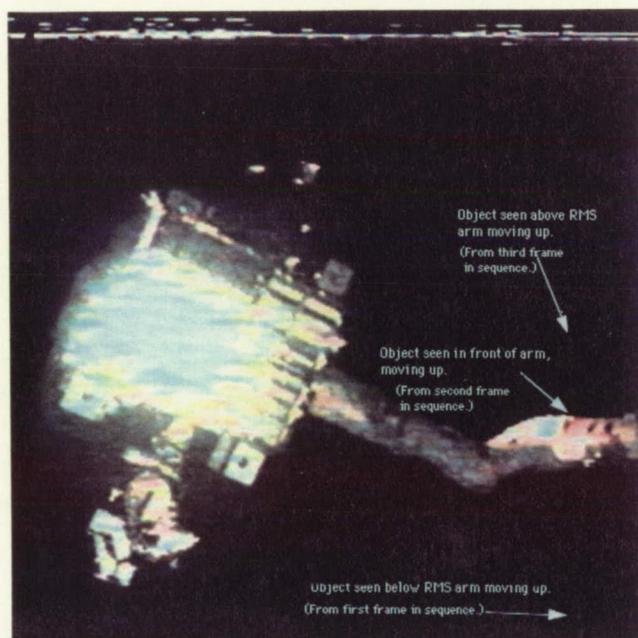
**Figure 2.4.1 Debris Seen During Spartan Capture**

The white debris object annotated above was seen on video during the Spartan capture. Measurements of the size and velocity of this object were made and provided to the mission evaluation manager. The diameter of the RMS end effector was used for scale in order to determine the size of the object. The diameter of the RMS is 13.6 inches without the thermal blanket material. The object was seen to pass in front of the RMS arm. Therefore a maximum size estimate of the object was made assuming the debris to be at the same distance as the arm. The dimension of the object was determined to be approximately 2 x 3 inches. The diameter of the RMS in the image was probably slightly greater than 13.6 inches because the thermal blanket material was attached. This would make the maximum size of the debris object slightly larger.

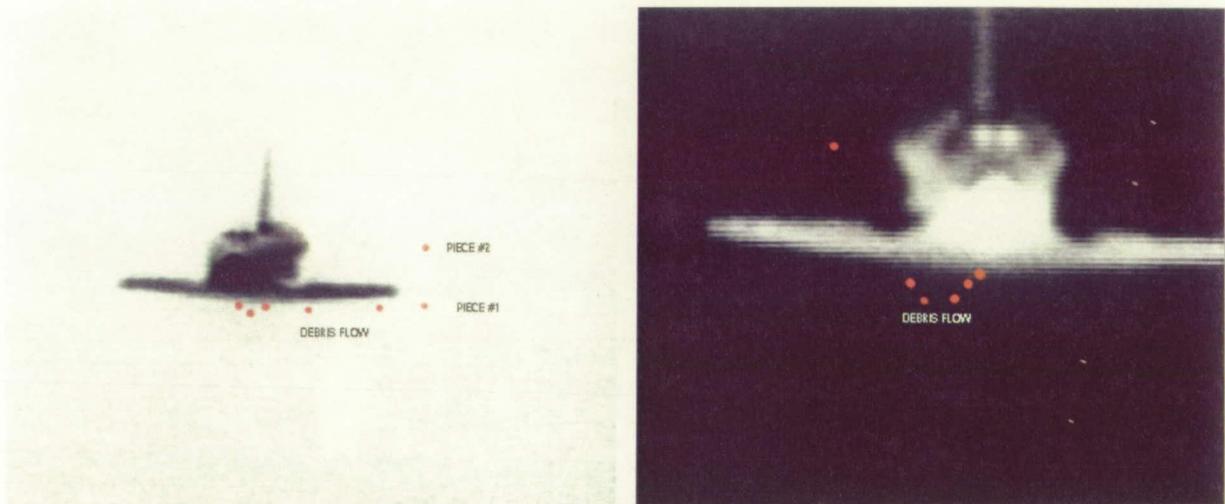
Figure 2.5.2 Debris from Nose Wheel Door Area Before Landing

Several pieces of debris appeared to fall from the nose wheel area at nose gear door opening on the above infrared views. Additional debris may have fallen from the main gear area. The debris traveled along the underside of the Orbiter and toward the left wing. KSC reported that the warm objects falling away from the nose landing gear area were gap fillers. The gap fillers were inserted into open spaces after the closure of the landing gear door(s) to prevent heat intrusion during reentry.

The red dots on the views above trace the path of the debris seen at the time the landing gear doors were opened. The view on the left is negative infrared taken from the west side of runway 33. The view from the right is a positive infrared taken from the east side of runway 33.

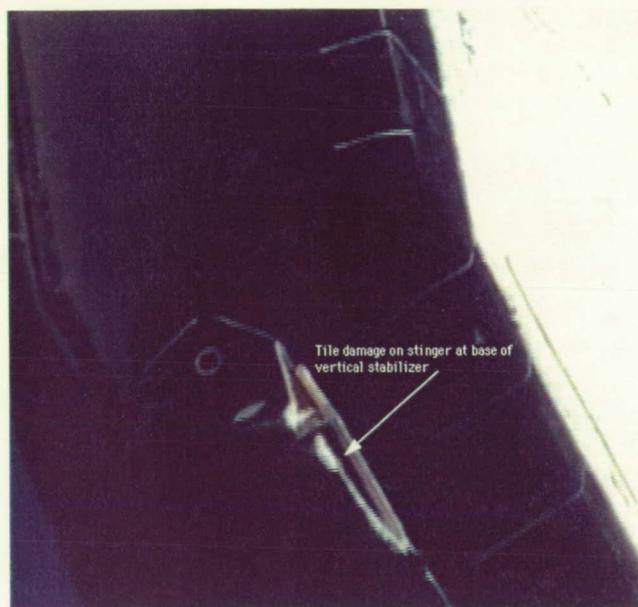
**Figure 2.5.4 Tile Damage to Vertical Stabilizer Stinger**

Eight tile fragments found on the runway originated from the vertical stabilizer "stinger" and had been dislodged by contact with the drag chute riser lines during deployment.

Several tiles were seen to be damaged on the right aft edge of the vertical stabilizer stinger during the screening of the post landing video inspection views.

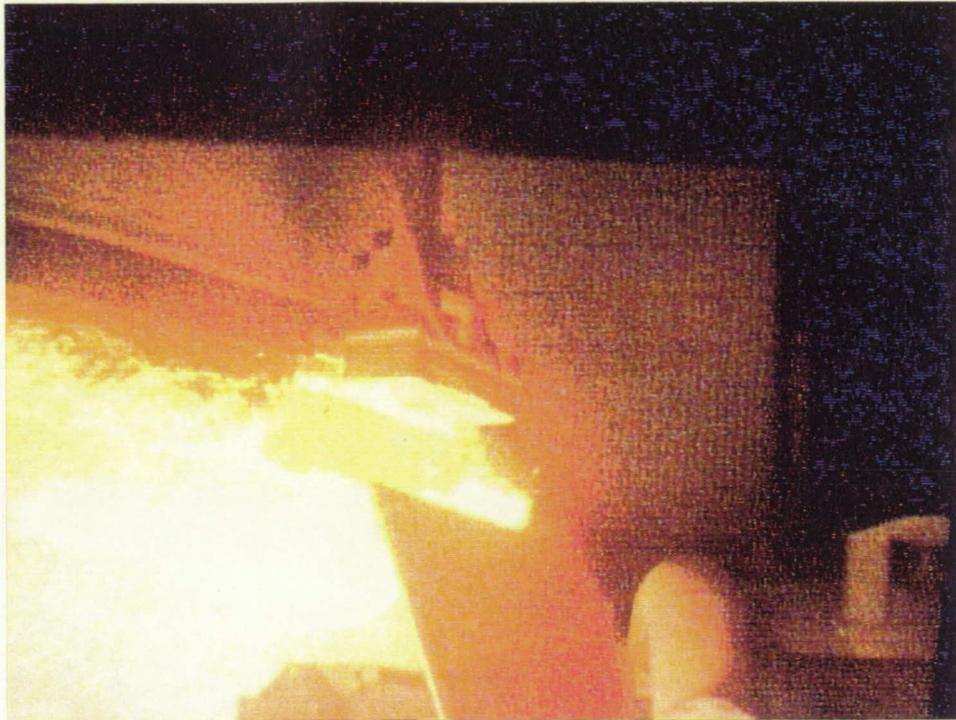
Figure 1 Discoloration on SRB Holddown Post M-4

A light discoloration on the SRB holddown post M-4 was noted during liftoff. This discoloration is shown in figure 1. A black mark was observed on the right SRB forward skirt below the access door prior to liftoff. This type of mark was previously observed on STS-54.

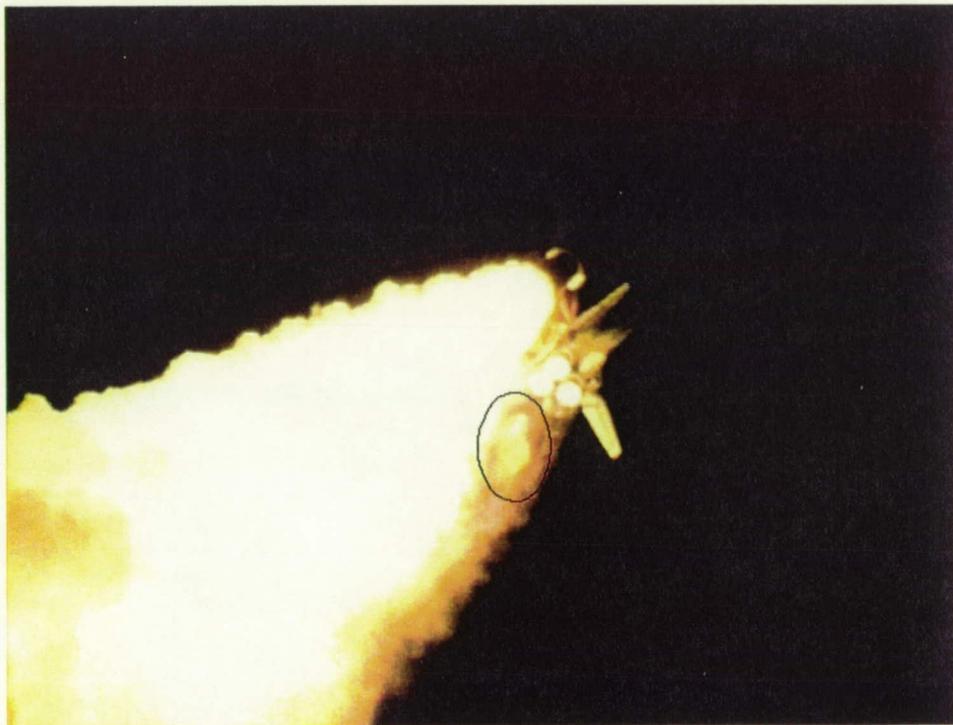
Figure 2 Large Flare in SSME Plume

Copious amounts of slag were observed exiting the SRM plumes during ascent. These observations are not considered anomalous because of the increase in image contrast resulting from the night sky conditions. One large piece of "slag" entered the SSME plume creating a large orange flare. This event is shown in figure 2 from camera E-222 at T+43.7 seconds.

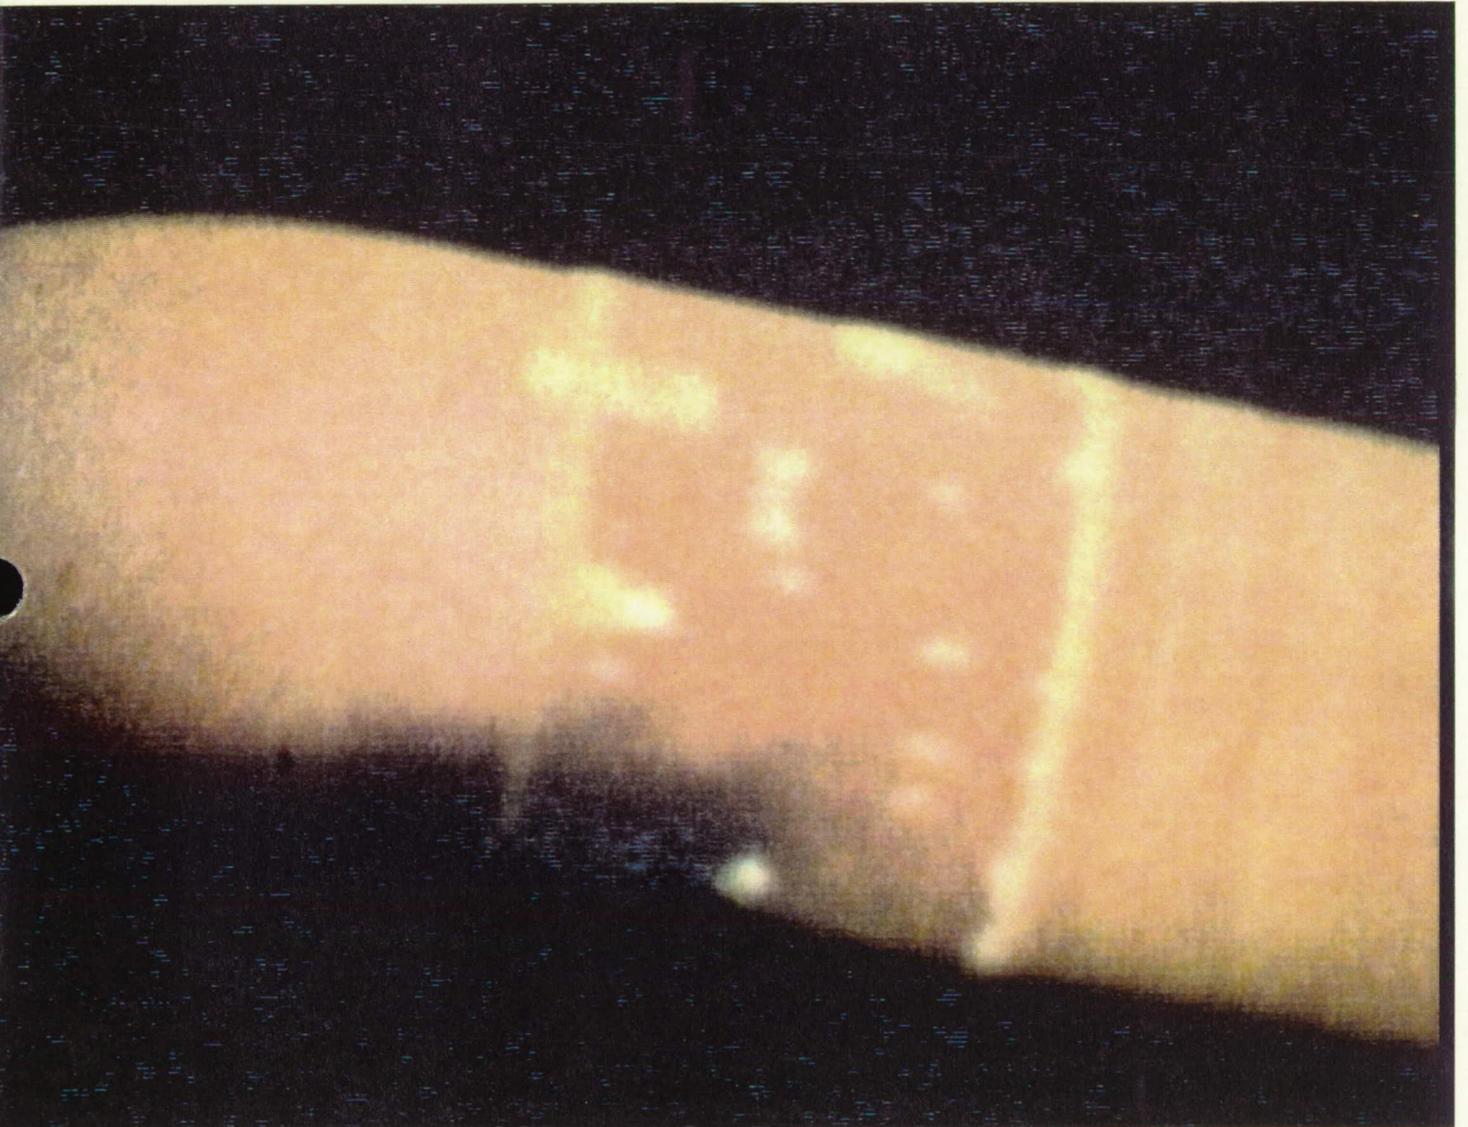
Figure 17 ET TPS Divots

Seventy-two frames of the ET after separation were received and reviewed. At least fifteen divots were noted on the LH2 intertank TPS acreage and on the LH2 intertank scarf joint on the -Z side of the ET. Figure 17 is a frame of film taken from the 35mm on-board camera showing these divots.
