LONG DURATION EXPOSURE FACILITY (LDEF) EXPERIMENT M0003
METEOROID AND DEBRIS SURVEY

M. J. Meshishnek, S. R. Gyetvay, K. W. Paschen, and J. M. Coggi
Mechanics and Materials Technology Center
The Aerospace Corporation
El Segundo, CA 90245-4691
Phone: 310/336-8760, Fax: 310/336-1636

A survey of the meteoroid and space debris impacts on LDEF experiment M0003 has been performed. The purpose of this survey was to document significant impact phenomenology and to obtain impact crater data for comparison to current space debris and micrometeoroid models. The survey consists of photomicrographs of significant impacts in a variety of material types; accurate measurements of impact crater coordinates and dimensions for selected experiment surfaces, and databasing of the crater data for reduction, manipulation, and comparison to models. Large area surfaces that were studied include the experiment power and data system (EPDS) sunshields, environment exposure control canister (EECC) sunshields, and the M0003 signal conditioning unit (SCU) covers. Crater diameters down to 25 microns were measured and catalogued. Both leading (D8) and trailing (D4) edge surfaces were studied and compared. The EPD

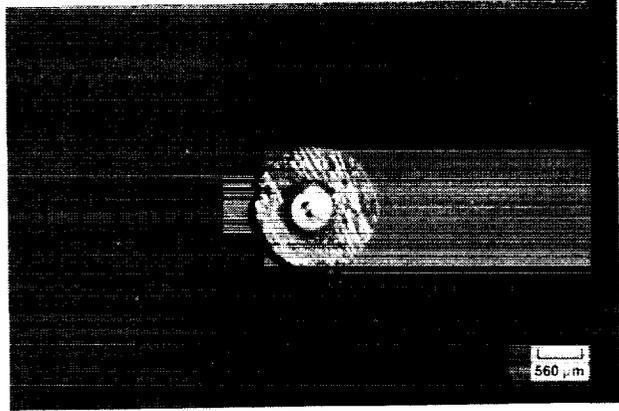
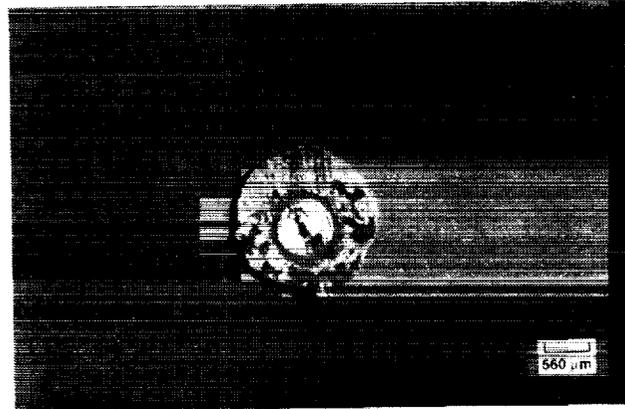
Figure V-2. Representative impacts in the D4 EPDS sunshield.

rims. In addition to craters, there were many circular areas of various sizes with a yellowish-green stain. Figure V-2 illustrates representative craters from this panel.

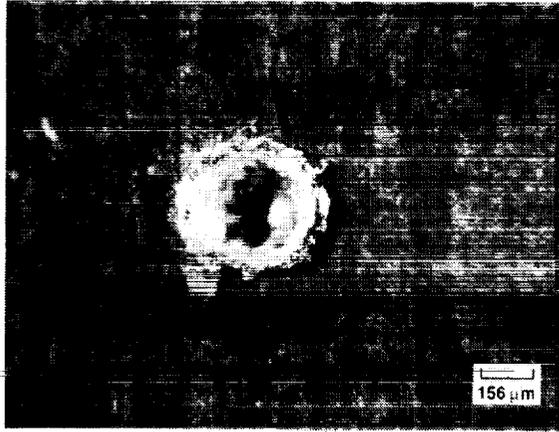
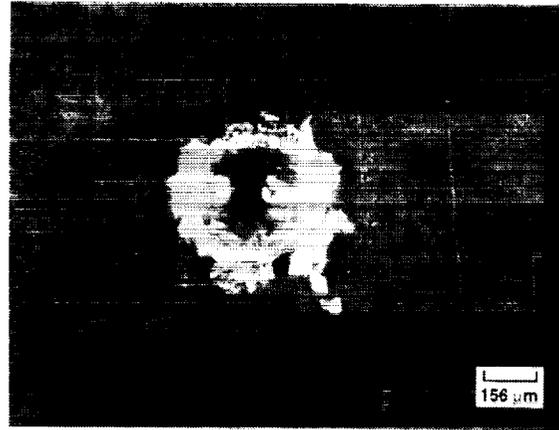
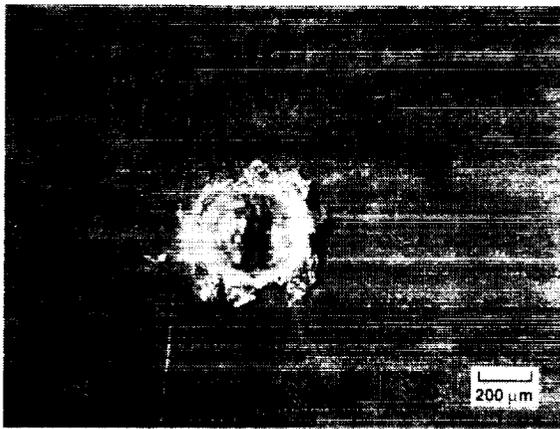
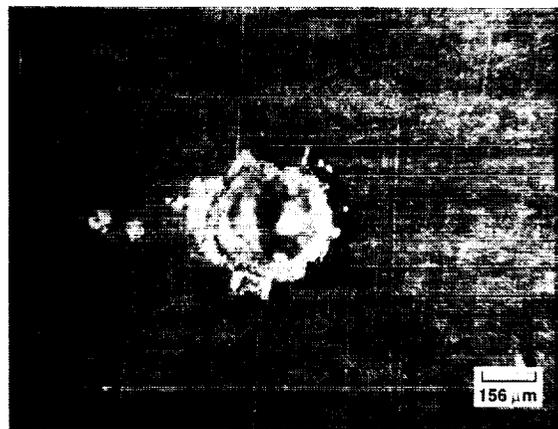
The D4 EECC sunshield was identical to that on D8 prior to launch; however, after LDEF retrieval, the surface of the aluminum panel was still shiny but had a reddish tinge due to staining from the ubiquitous contamination on LDEF.² There were also circular areas of brown residue of various sizes. The panel had the same flaws as the D8 sunshield. A count of 58 craters of 0.001 in. diameter and greater was made, or 314 craters/m². The largest crater was 0.015 in. in diameter. The phenomenology of the impacts on this surface was identical to that observed for the D8 panel. Figure V-4 shows representative impacts seen on this panel.

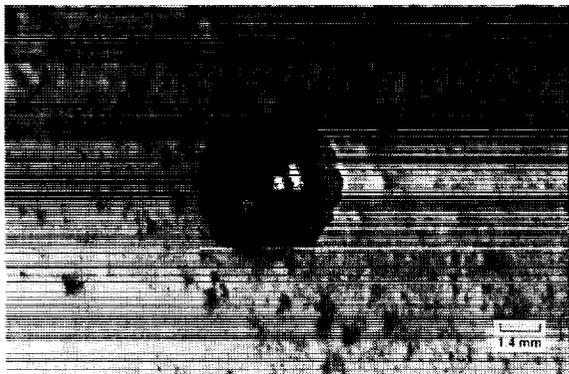
Figure V-5. Representative impacts in the D8 SCU cover

The D8 SCU cover was a box sunshield that fit over the signal conditioning unit on the D8 tray. It was constructed of aluminum sheet 0.086 cm (34 mils) thick and was double walled on the top surface, the surface scanned in this study. The aluminum was painted with a white thermal control paint, S13GLO, which is a zinc oxide pigment based paint that uses potassium silicate to encapsulate the pigment for UV stability. The binder for this paint is a methyl silicone material similar to GE RTV 602. The thickness of the paint was 230 microns (9 mils). This paint has significantly different mechanical properties than the Chemglaze A-276 paint used for the EPDS sunshields, primarily due to the elastomeric silicone binder, which imparts flexibility. The paint on the retrieved D8 SCU cover was crazed; however, it was still somewhat flexible and resilient, and the binder was still intact even after exposure to atomic oxygen. However, surface analysis using XPS indicated that a silicon dioxide coating had formed from the exposure. Moreover, the cover generally retained its white color in spite of the exposure to UV radiation. This was due to the interaction of atomic oxygen with the damaged material. The mechanism of this whitening process is still under investigation. The texture of the surface was quite rough as originally applied to the surface; the surface resembled, more than anything else, a stucco wall. This caused some difficulty in seeing and counting small impacts. In this material, the delaminated areas around the impacts were not folded back as on the D8 EPDS sunshield, but were simply eroded areas tapering down towards the craters. Bare metal between the crater and the delaminated area was observed on only three craters of the 59 that were counted in the diameter range of 0.001 in. and up giving a crater density of 434 craters/m². The largest crater was 0.075 in. in diameter with a 0.4 in. diameter area of bare metal surrounding the crater, with no apparent delamination of the paint beyond this melt zone. This impact would have punctured the aluminum if the surface had not been double thickness. The impact produced a deep crater in the material with a depth of 1.8 mm. This surface gave a lower crater density count than the other D8 panels, probably because the smaller impacts left no trace on the textured and resilient paint surface. Figure V-5 illustrates the response of this material to impacts.

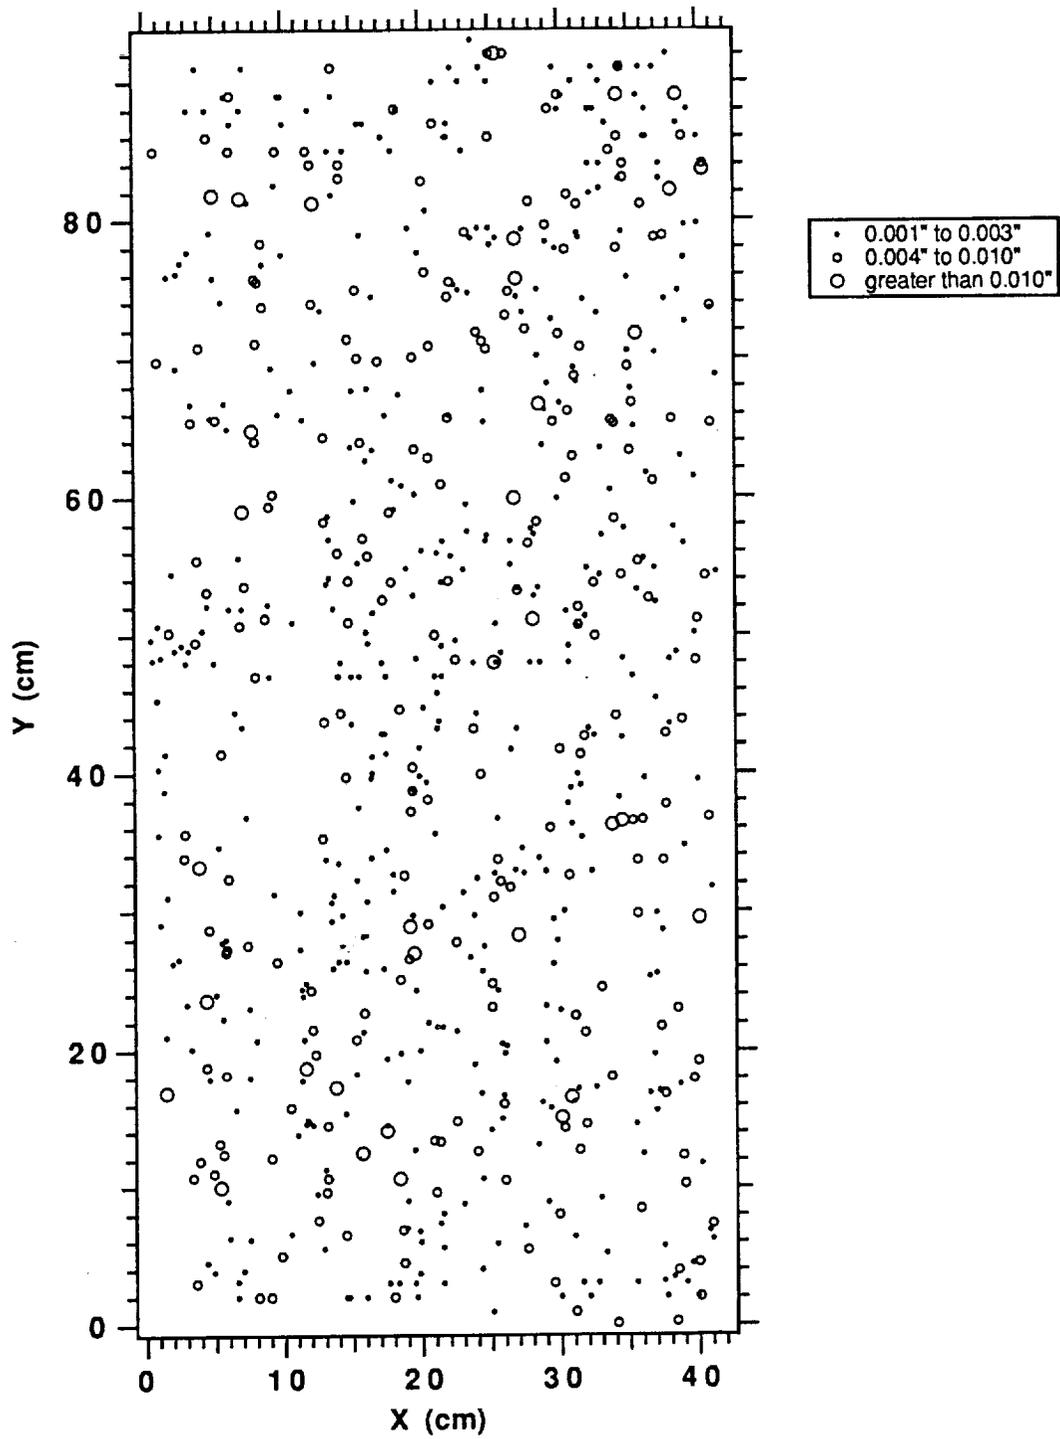
Figure V-7. Dot plot for D8 EPDS sunshield.

Before comparing this data to a model, a statistical analysis of the data was performed to determine the effect of the different panel surface areas on the sampling accuracy. This becomes especially important for the larger craters where the number of impacts per area is very small. Since the positions of all craters were determined in the survey, it was easy to compute distances between various craters to determine the mean distances between impacts. The spatial distribution of 701 craters with diameters greater than 0.0025 cm (25 microns) on the D8 EPDS sunshield was examined mathematically for areas of localized crater clusters. This involved calculating the mean crater separation distance and the standard deviation of the mean. Groupings of clusters would tend to decrease the mean crater separation and increase the relative standard deviation of the mean compared to a random spatial distribution. Using these statistics, comparisons of the D8 EPDS sunshield to computer-generated, random and clustered models indicated a definite "random" character to the actual crater distribution. This suggests that over time a net random spatial distribution of craters would be expected on a ram facing LEO-exposed surface. Results on the D4 EPDS sunshield were also found to be consistent with a "random" spatial distribution; however, lower crater densities on the trailing edge created a larger statistical uncertainty.

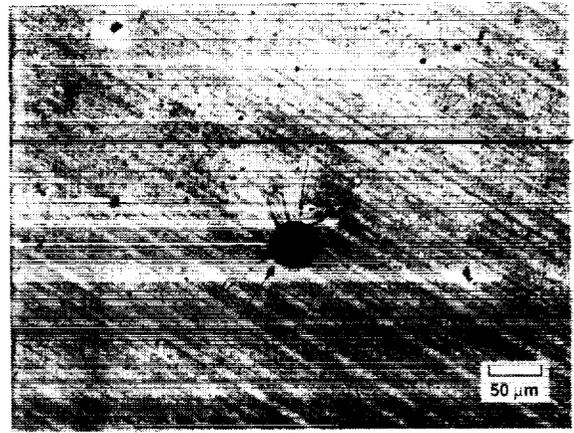
Figure VI-1. Typical impacts in the black anodized aluminum MOO3 hardware.

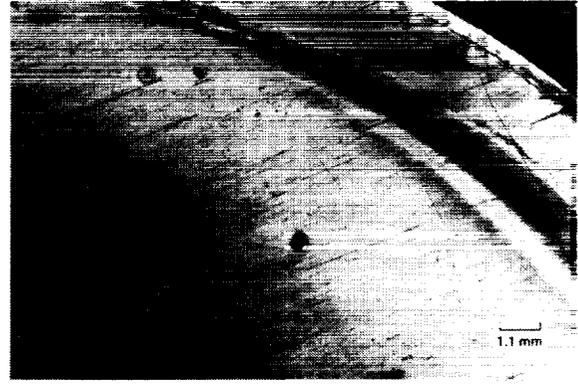
The response of unmounted molybdenum foils to impacts is shown in Figure VI-4. These are oxide-coated molybdenum foils approximately 2 mil thick. The sample shown in (a) has a SiO₂ coating while (b) is coated with a proprietary coating, P-273. The radial cracking of the silica layer is evident in (a); however, no such effect is seen in (b). The exit view shown in (c) indicates considerable spall of the metal. The sample shown in (d) is also oxide coated. The coating has also been shocked away around the impact site.

Figure VI-4. Impact perforations in coated molybdenum foils: a) Silica coated; b) P-238 coated; c) exit view of b); d) oxide coated Molybdenum.

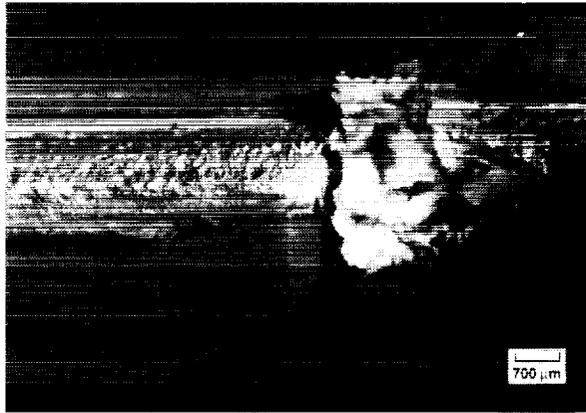
Figure VI-5 illustrates an interesting impact in a piece of tray hardware, the D8 canister aperture plate; the impactor hit the anodized and Teflon-coated aluminum at an oblique angle, producing a large amount of aluminum spatter on the adjacent sample, a zinc selenide IR witness plate. The aluminum spatter on this sample is shown in (b) and (c). These photos clearly illustrate the type and amount of collateral damage that may occur from hypervelocity impacts, especially to optics.

Figure VI-5. Impact damage causing collateral damage to optics

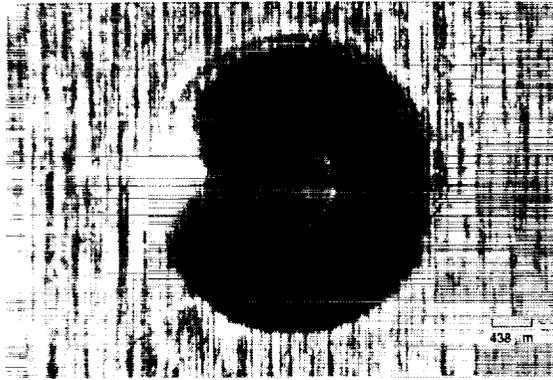
Figure VI-8. Impact damage to coated fused silica. (a) Magnesium fluoride coating; (b) Sodium fluoride coating.

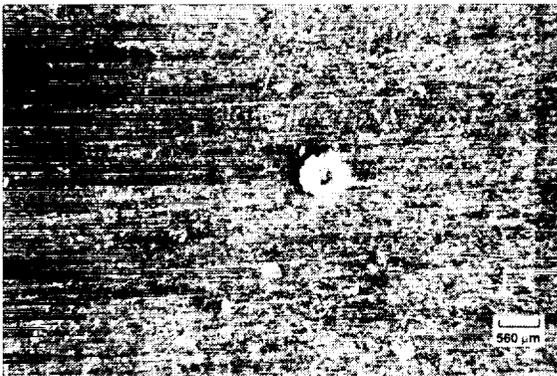
Figure VI-11. Representative impacts in metal matrix composites

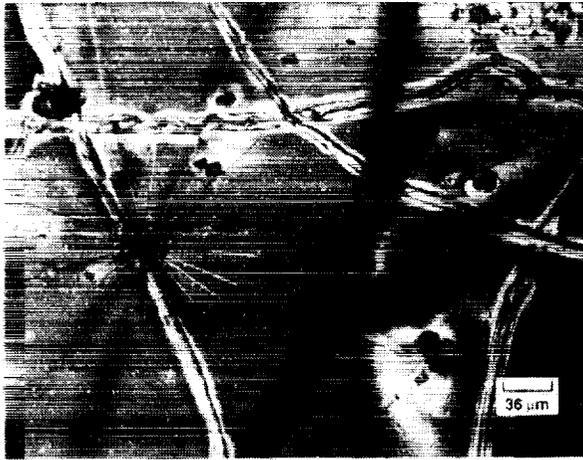
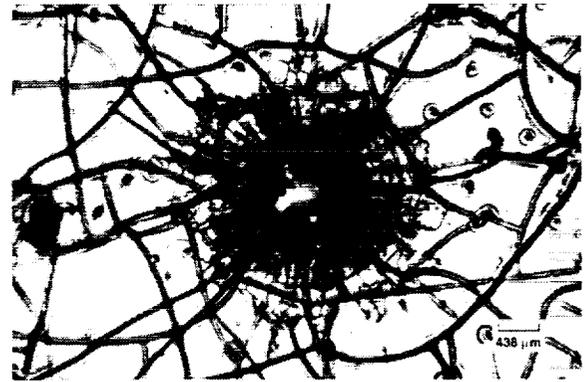
Impacts in polymeric materials produced interesting synergistic phenomena primarily due to the exposure of the materials to atomic oxygen on the leading edge and UV on the trailing edge. Figure VI-12 (b) shows the damage around an impact crater in a sample of black RTV 602 located on the trailing edge. The embrittlement caused by UV exposure has produced a large degree of cracking in the material and at the impact site. In comparison, Figure VI-12 (a) shows that an identical sample of this material located on the leading edge displays similar cracking of the material, but, in addition, there is radial, star-type cracking at the impact site due to reaction of atomic oxygen with the surface of the silicone, which produced a glassy surface layer of SiO_2 . The response of this surface layer to hypervelocity impacts is very similar to that observed with glasses such as silica. The larger degree of radial cracking in this sample relative to bulk fused silica may be due to the greater elastic response of the bulk RTV relative to the outer glassy layer due to the thin nature of this SiO_2 layer. Polymeric films that were not metallized did not exhibit unusual impact phenomenology or synergistic effects; rather they showed typical circular perforations that are assumed to be only slightly larger than the impactor. An impact site in a Tefzel strip is shown in (c). A plastic-metal laminate that received a perforating hit is shown in (d). This site displays the classic raised lip as a result of the melt and flow of the aluminum and vaporization of the polymer front surface.

Figure VI-12. Impacts in polymeric materials. a) leading-edge black RTV 602; b) trailing-edge black RTV 602; c) Tefzel strip; d) plastic-metal laminate.

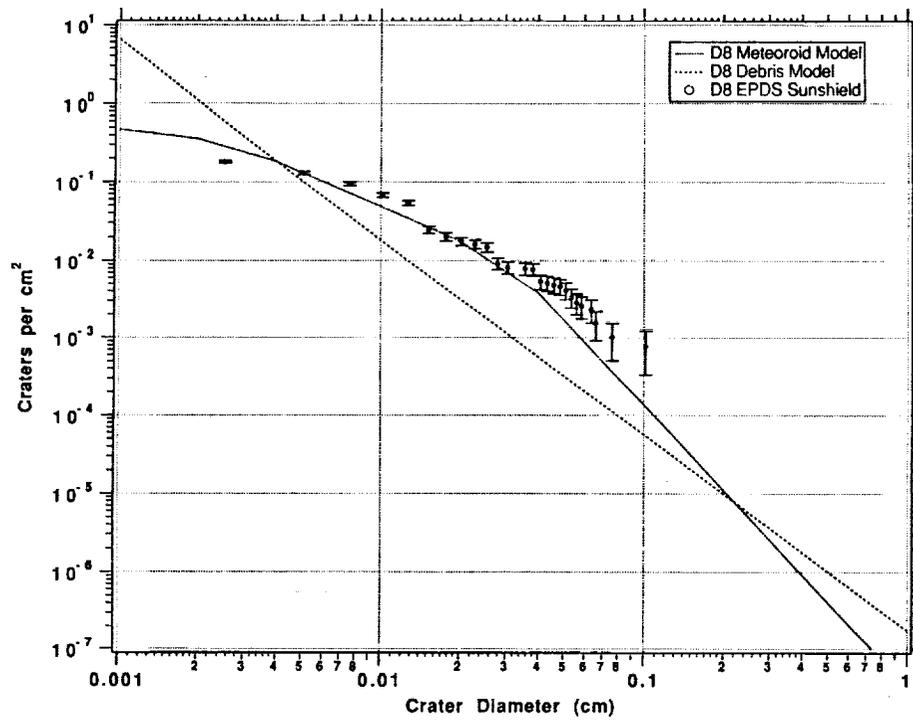
For the D8 surfaces (leading edge), the general trend of the data is more in line with the meteoroid model as opposed to the debris model. While the sum of these models gives as good or better fit to the data in the intermediate range, the rollover of the crater population below roughly 100 microns is not predicted by the debris model. For the D4 surfaces (trailing edge), the correlation of the data to the meteoroid model prediction is better; however, the same rolloff of the crater number density at small diameters is observed to be more pronounced than predicted by the model. This may be a consequence of small particles impacting primarily in the anodic oxide layer, which is harder and more dense than the aluminum substrate. This would produce correspondingly smaller craters and cause a leftward shift to the data points.

Figure VII-3. D8 EPDS sunshield data compared to meteoroid/debris models.

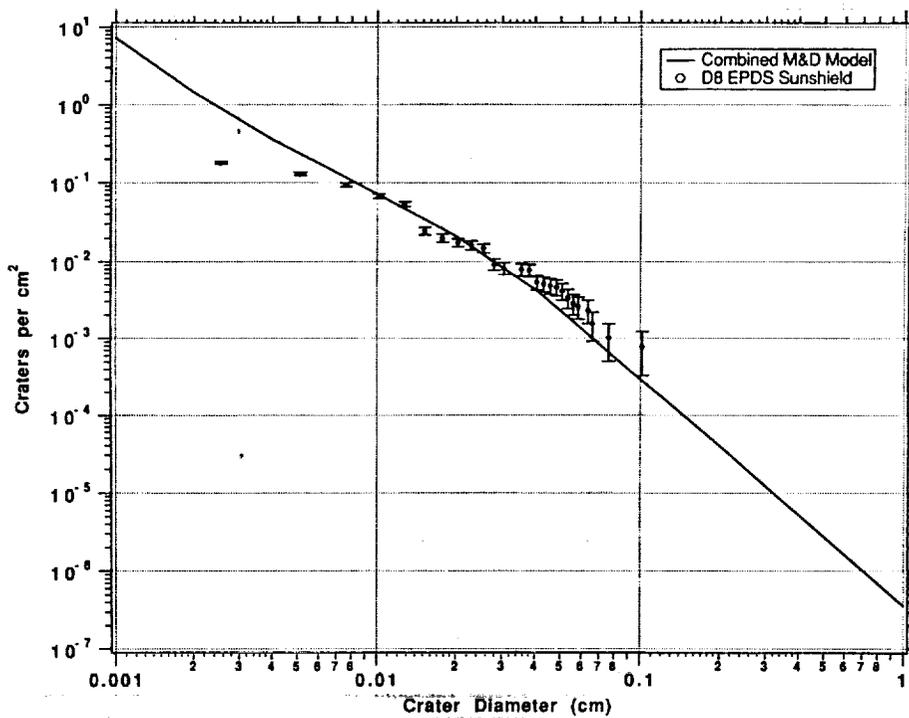
Figure VII-4. D8 EPDS sunshield data compared to the sum of meteoroid and debris models.

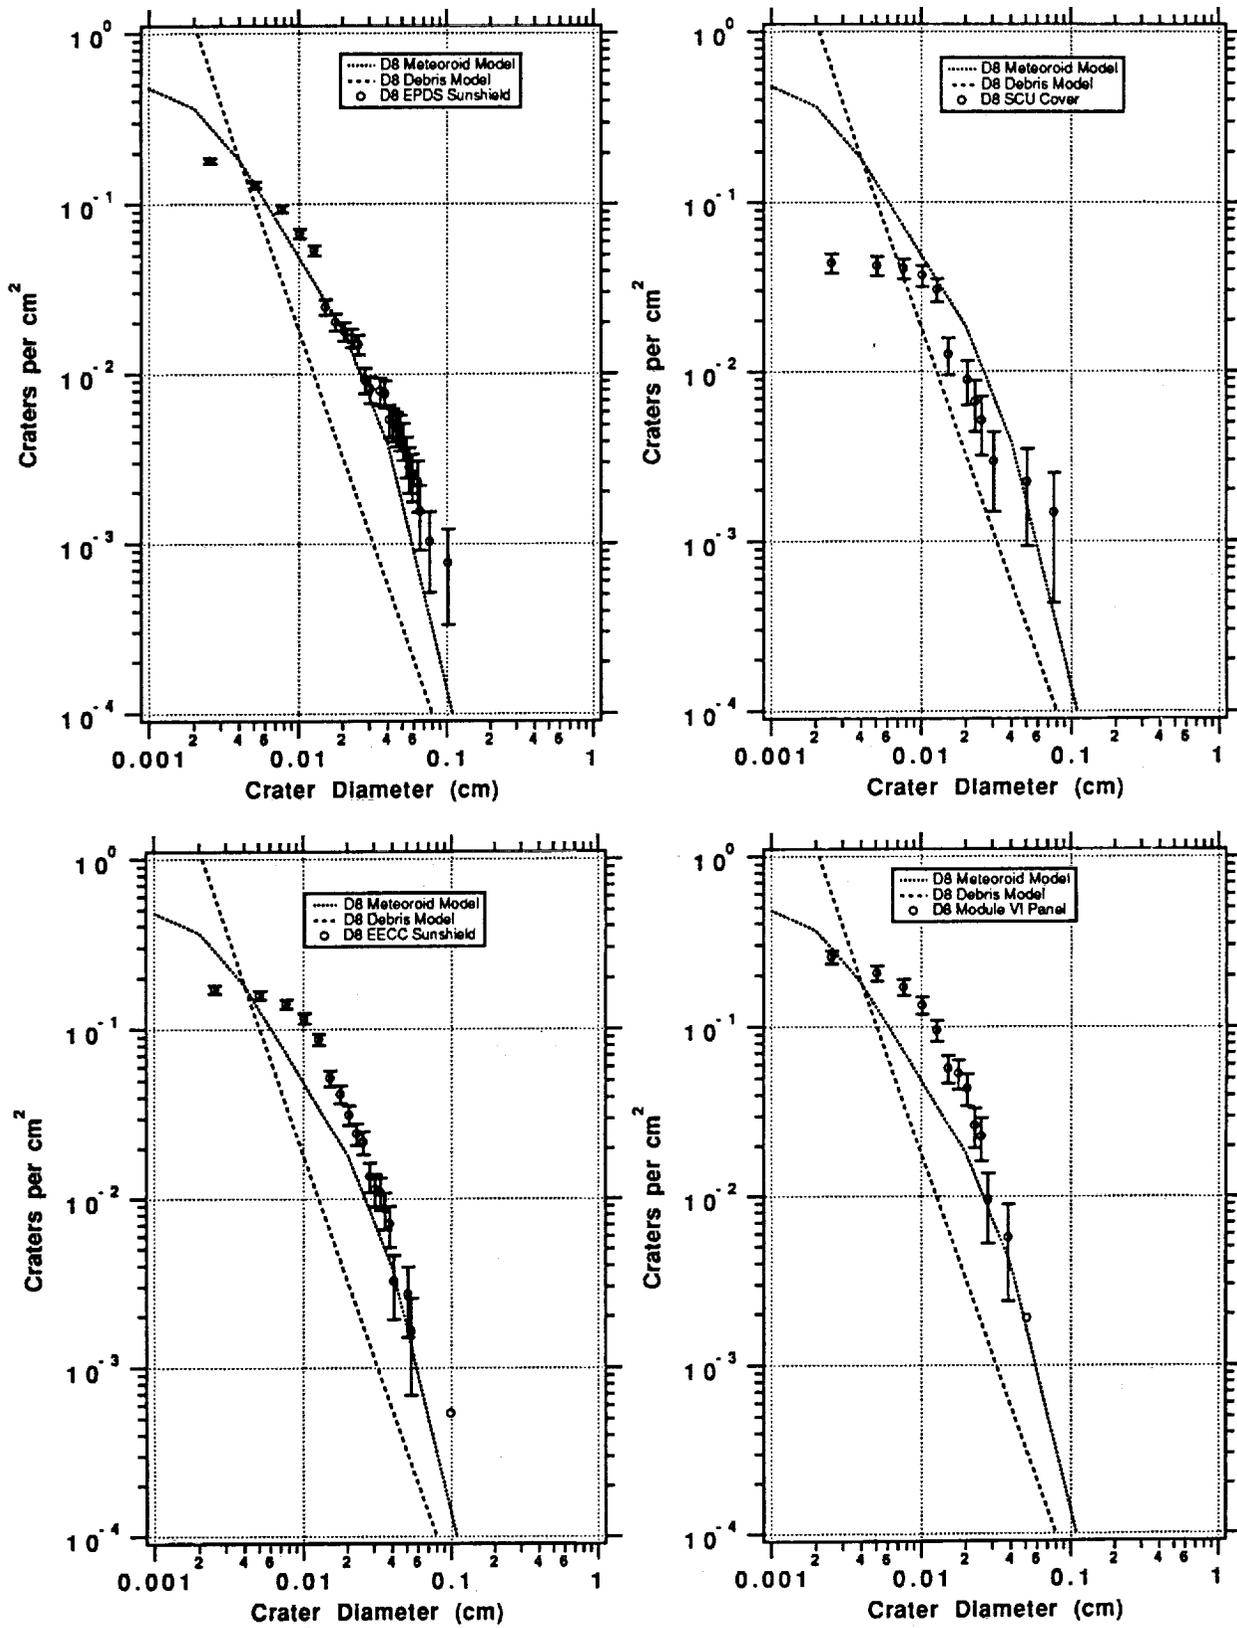
Inspection of the curves for the D8 surfaces reveals some additional trends. The anodized aluminum panels on the leading edge give nearly identical fits to the model, with marked deviation from the prediction lines at diameters of 300 microns and smaller. This deviation amounts to a factor of about 2 for craters with diameters in the 100-micron range. In contrast, the two painted panels gave very different distributions, presumably due to the different materials used in the paints (silicone vs. urethane), as well as the high degree of surface roughness present in the S13GLO paint. Generally, the models give over predictions when compared to the data obtained for this surface. For the EPDS sunshield, the correlation appears very good, except below 50 microns. The disturbing point about the D8 surfaces is the slope of the curves relative to the model predictions at large diameters. While statistically the data does not indicate this with certainty, the trend is obvious and may indicate a divergence between theory and experimental data.

Figure VII-5. Graphs for each D8 surface compared to models.

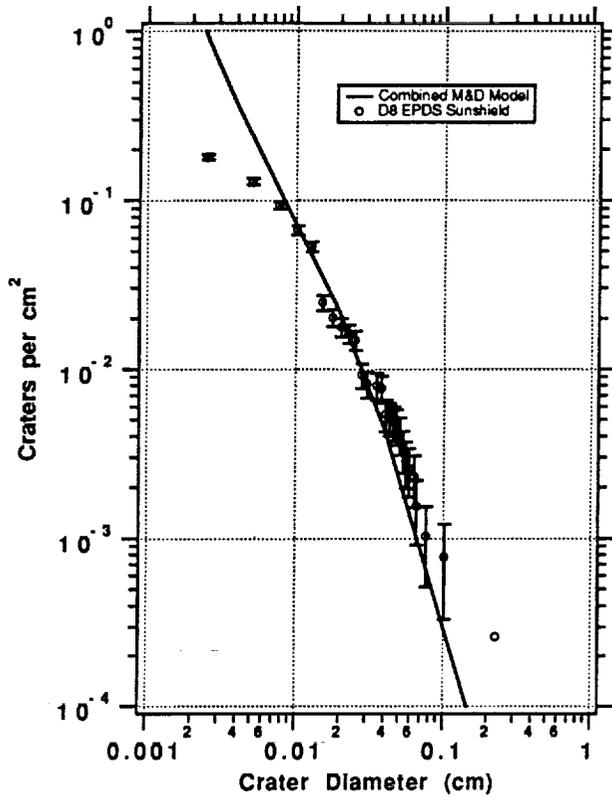
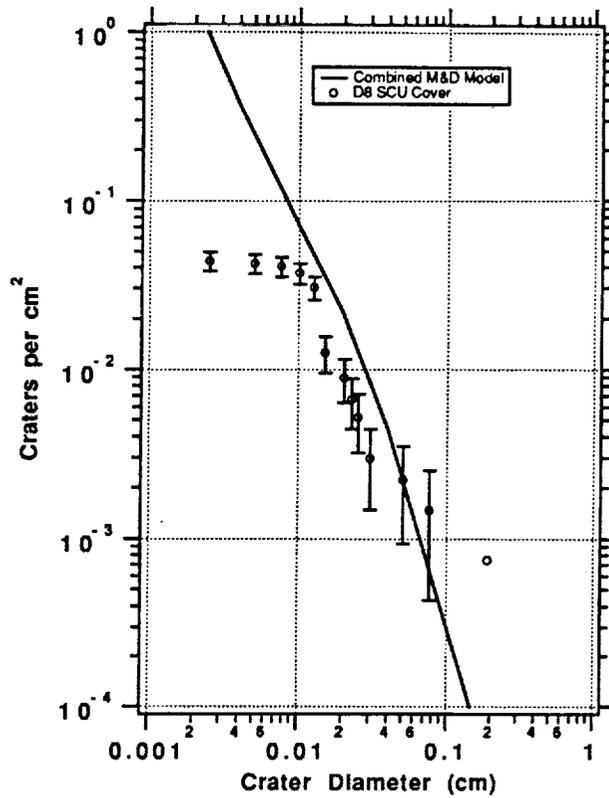
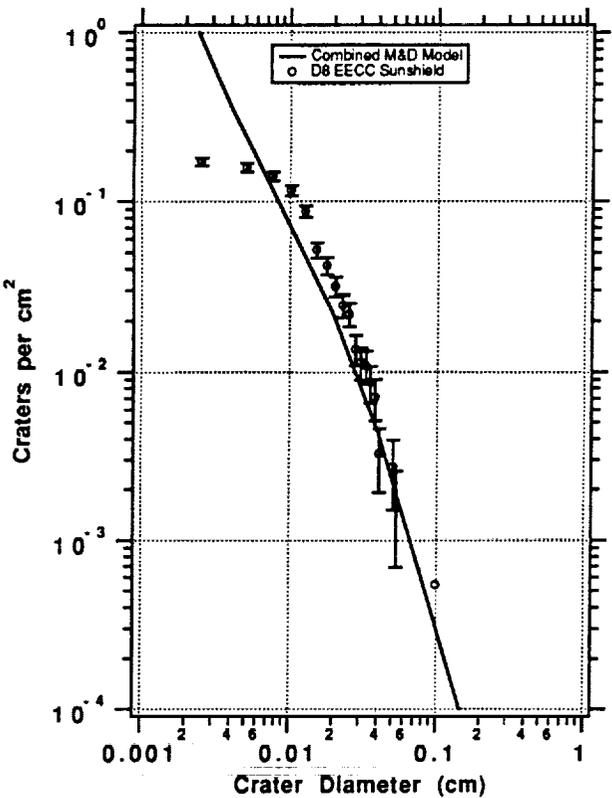
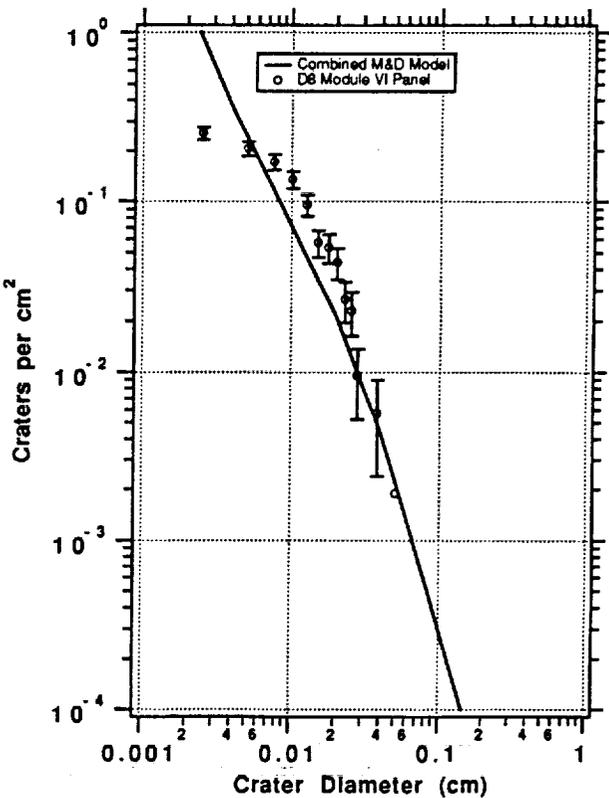
Figure VII-6. Graphs of each D8 surface compared to models' sums.

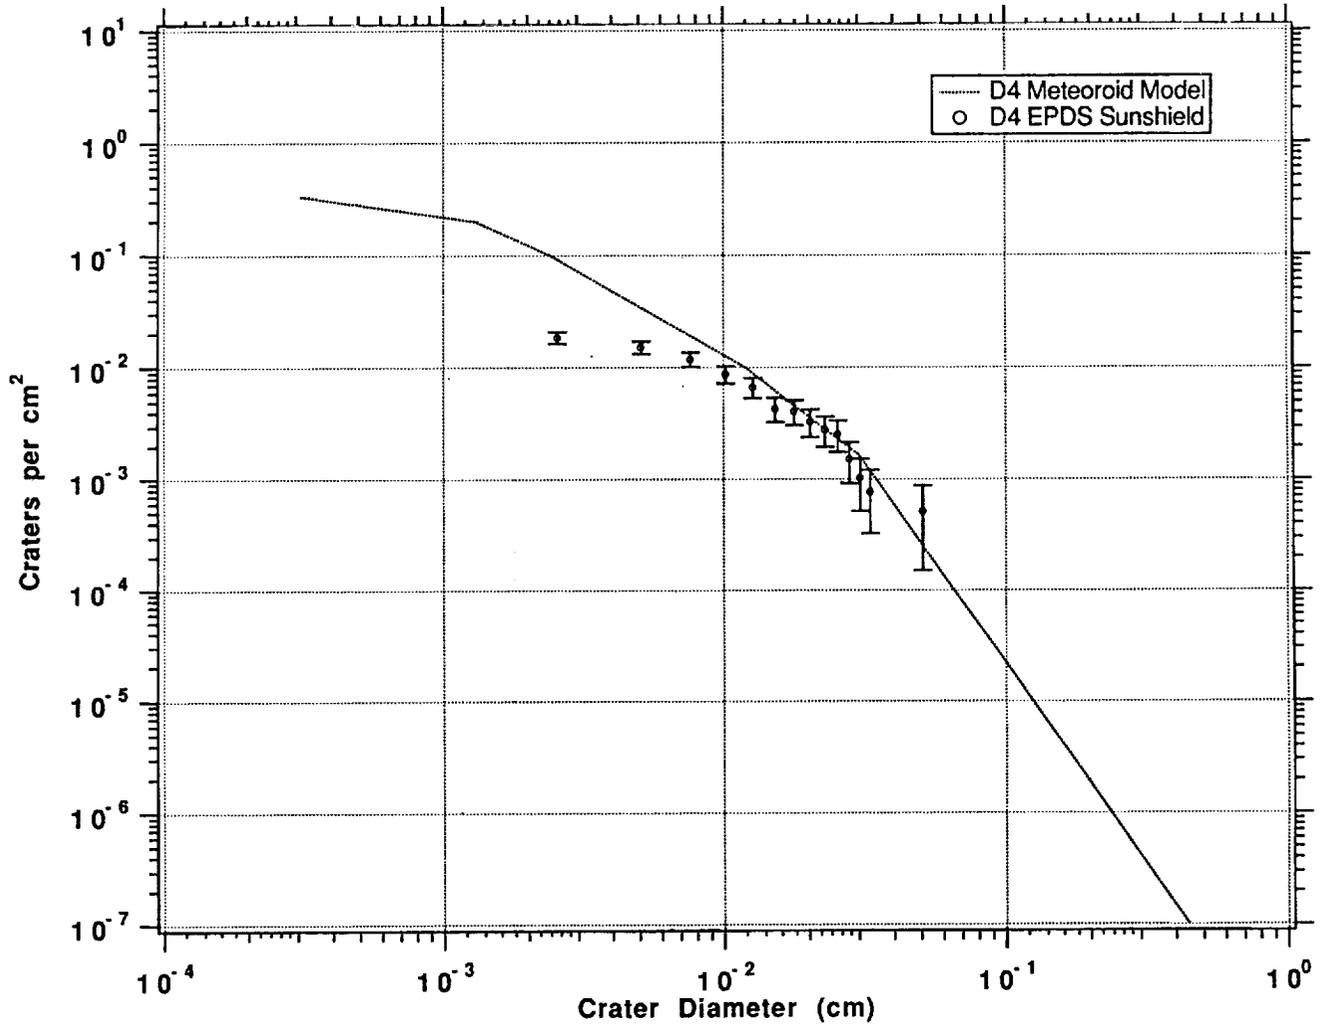
For the D4 surfaces, the correlation between theory and experiment is much better. Examples of excellent correlation are provided by the anodized aluminum panels. The painted surfaces, however, still have a more pronounced rollover below 100 microns.

Figure VII-7. D4 EPDS data compared to meteoroid model.
